# Albia Municipal Airport

## Pavement Management Report

**AUGUST 2025**

# ALBIA MUNICIPAL AIRPORT PAVEMENT MANAGEMENT REPORT

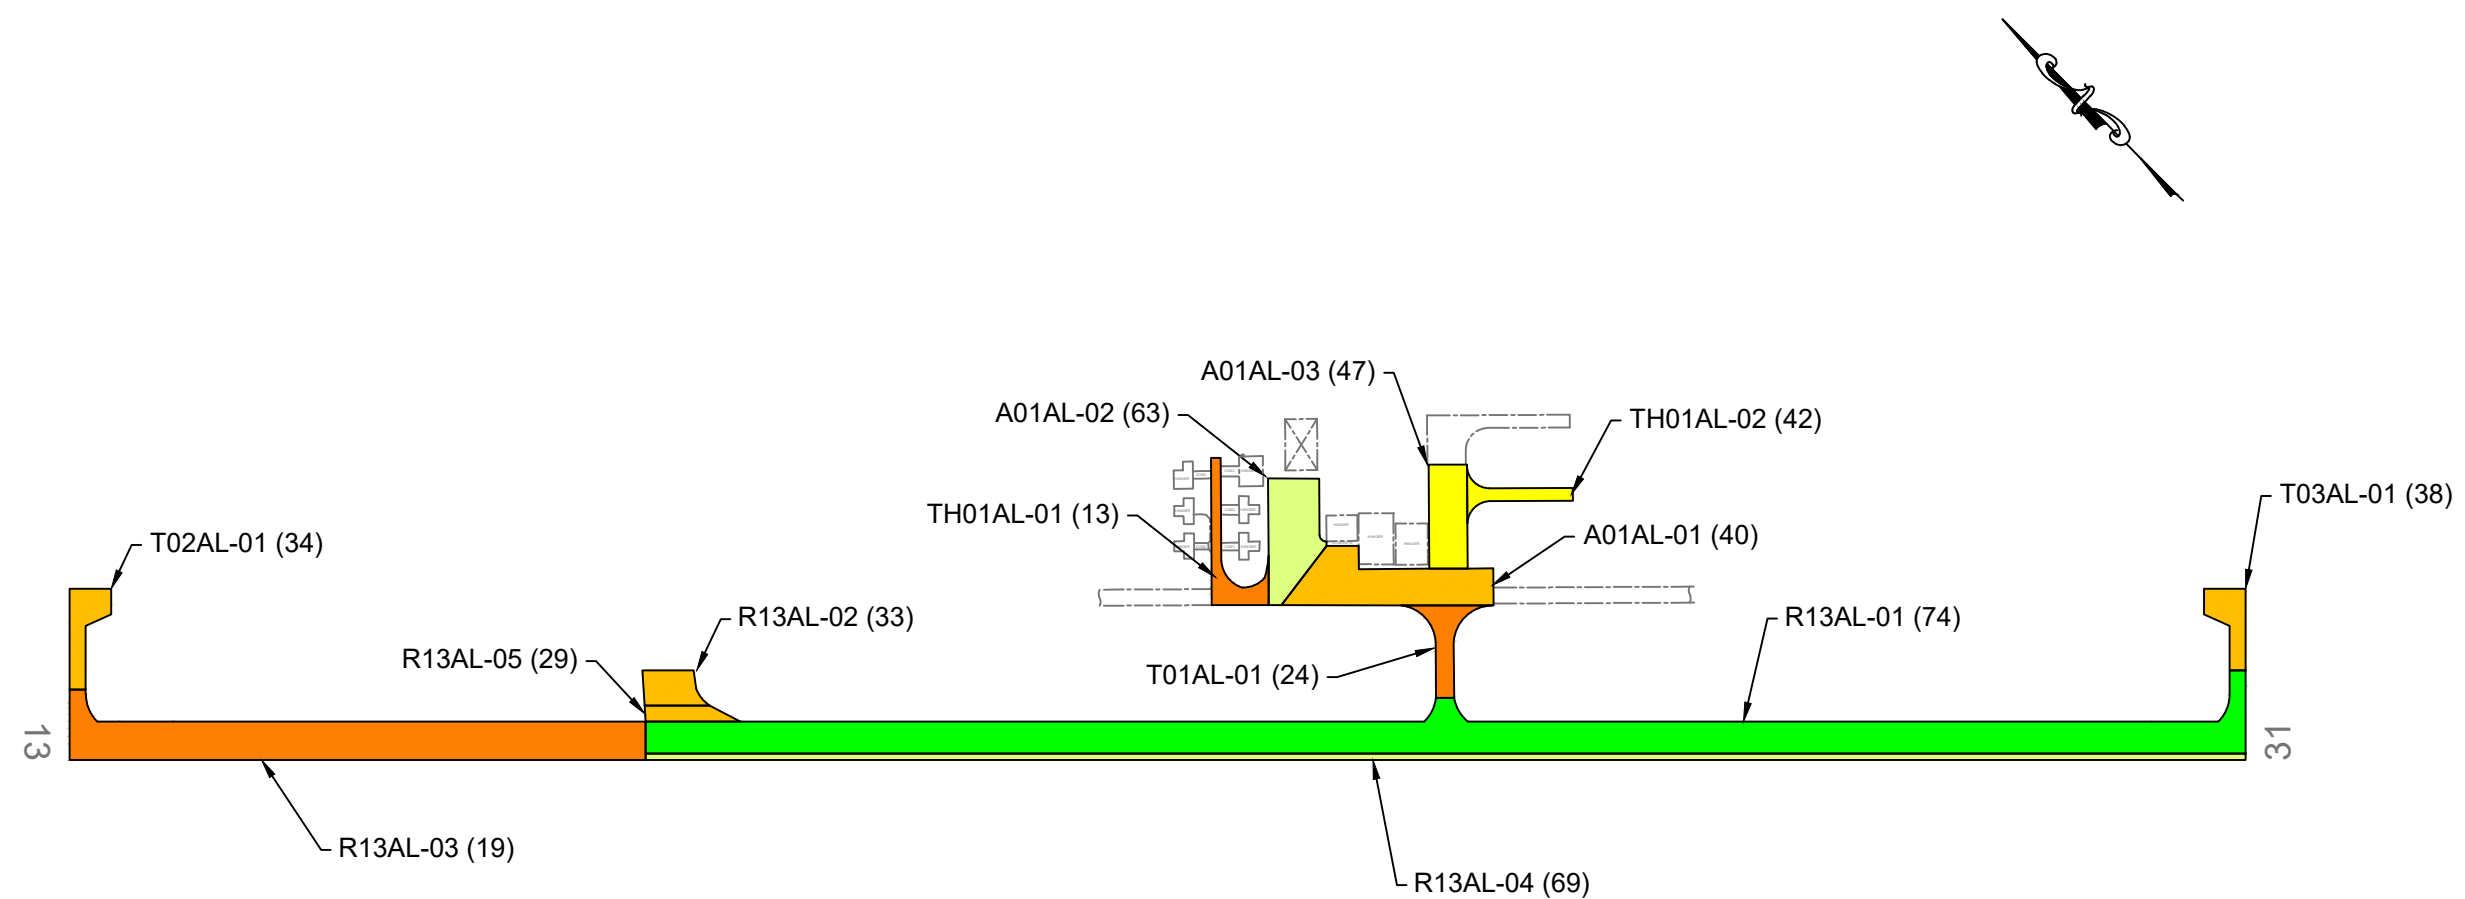
FIGURE 8. PCI MAP.

The pavements at Albia Municipal Airport were inspected in March 2025. The 2025 area-weighted condition of Albia Municipal Airport is 54, with conditions ranging from 13 to 74 (on a scale of 0 [failed] to 100 [excellent]). During the previous pavement inspection in 2021, the area-weighted PCI of the airport was 56.

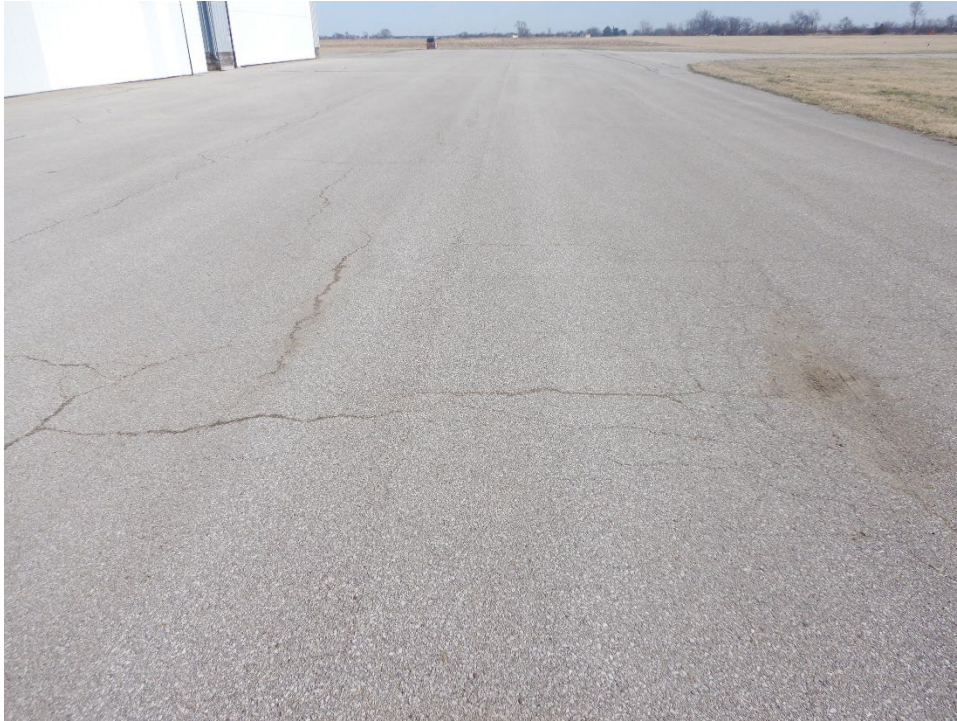
| Branch | Section | Surface Type | Section Area (sf) | LCD | 2025 PCI | % Distress Due to Load | % Distress Due to Climate/Durability | % Distress Due to Other | Type of Distress |
|---|---|---|---|---|---|---|---|---|---|
| A01AL | 01 | AAC | 20,142 | 6/1/2003 | 40 | 38 | 59 | 3 | Alligator Cracking, L&T Cracking, Raveling, Rutting, Swelling, Weathering |

A01AL-01. Overview.

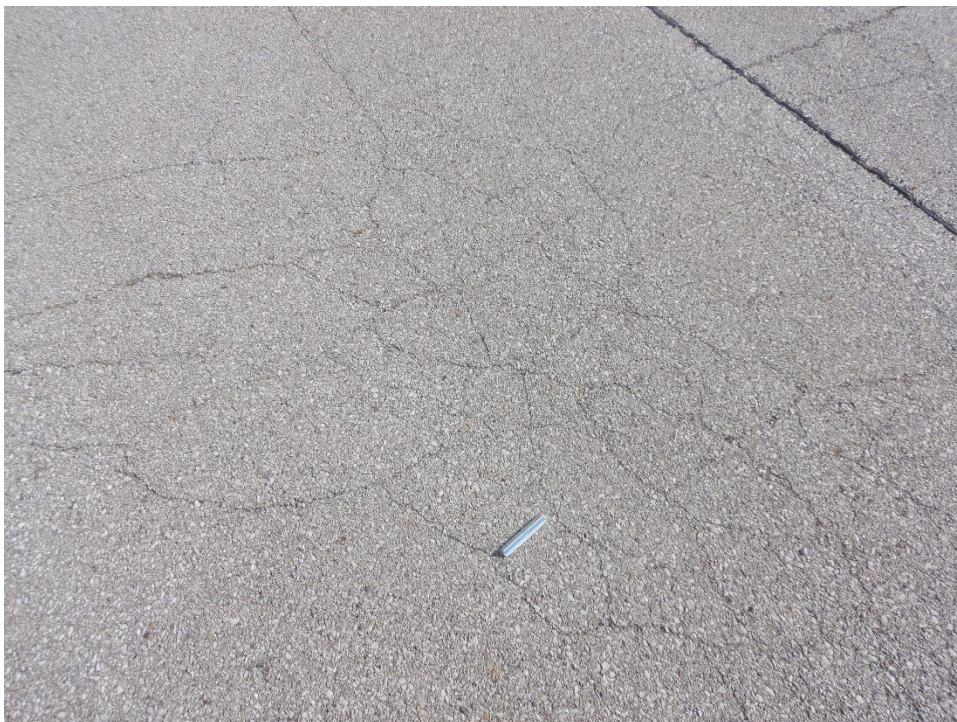
A01AL-01. Alligator Cracking (Sample Unit No. 05).

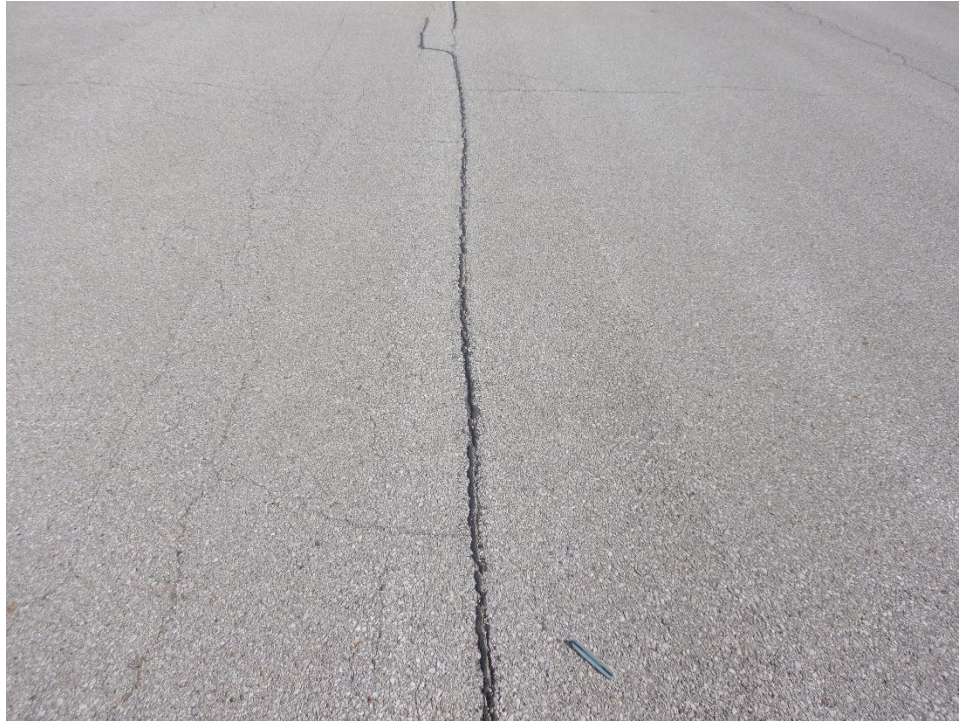
A01AL-01. L&T Cracking (Sample Unit No. 05).

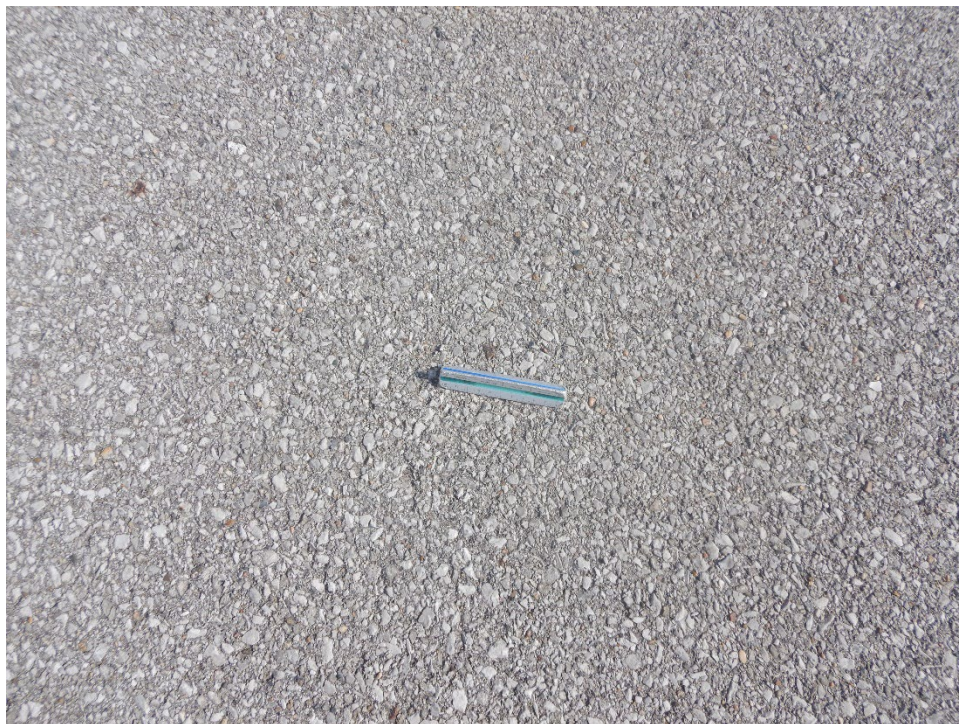
A01AL-01. Weathering (Sample Unit No. 05).

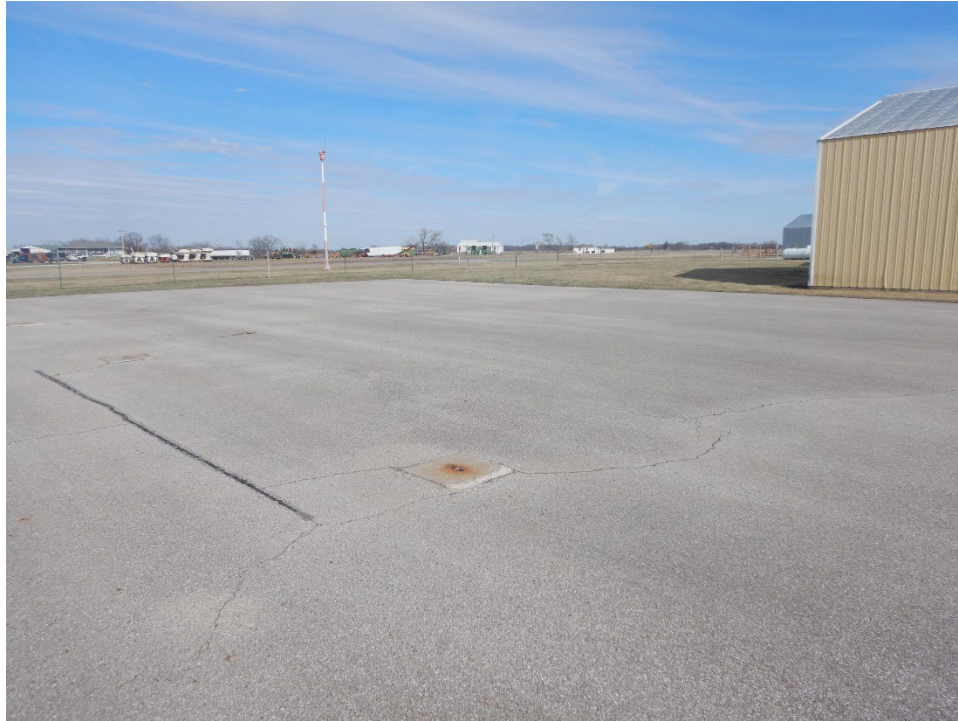
| Branch | Section | Surface Type | Section Area (sf) | LCD | 2025 PCI | % Distress Due to Load | % Distress Due to Climate/Durability | % Distress Due to Other | Type of Distress |
|---|---|---|---|---|---|---|---|---|---|
| A01AL | 02 | AC | 13,649 | 6/4/2003 | 63 | 0 | 75 | 25 | Depression, L&T Cracking, Raveling, Swelling, Weathering |

A01AL-02. Overview.

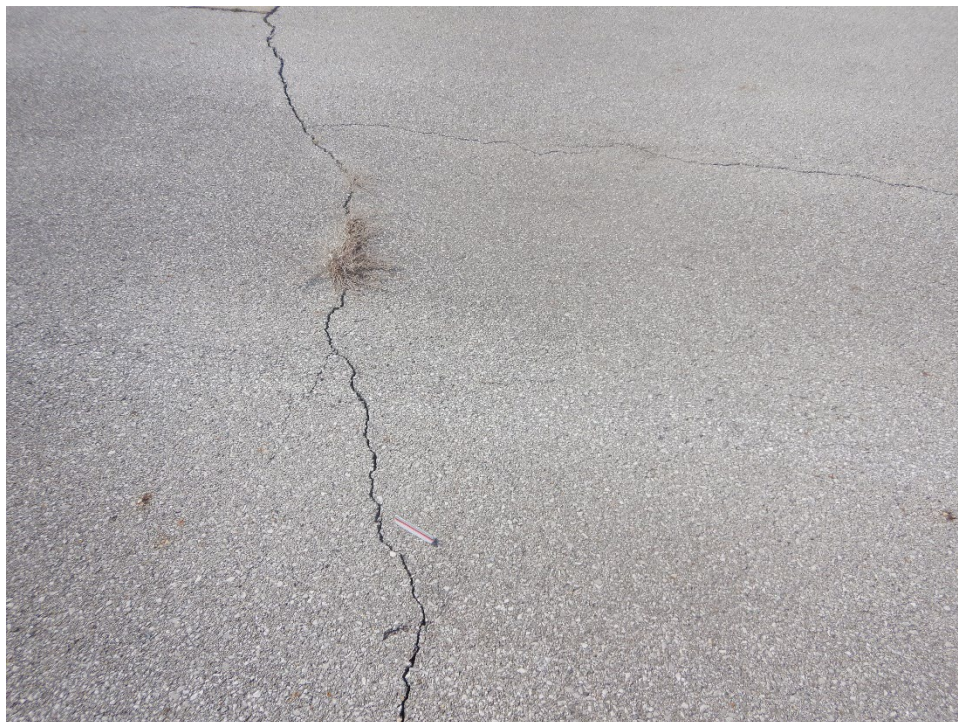
A01AL-02. L&T Cracking (Sample Unit No. 03).

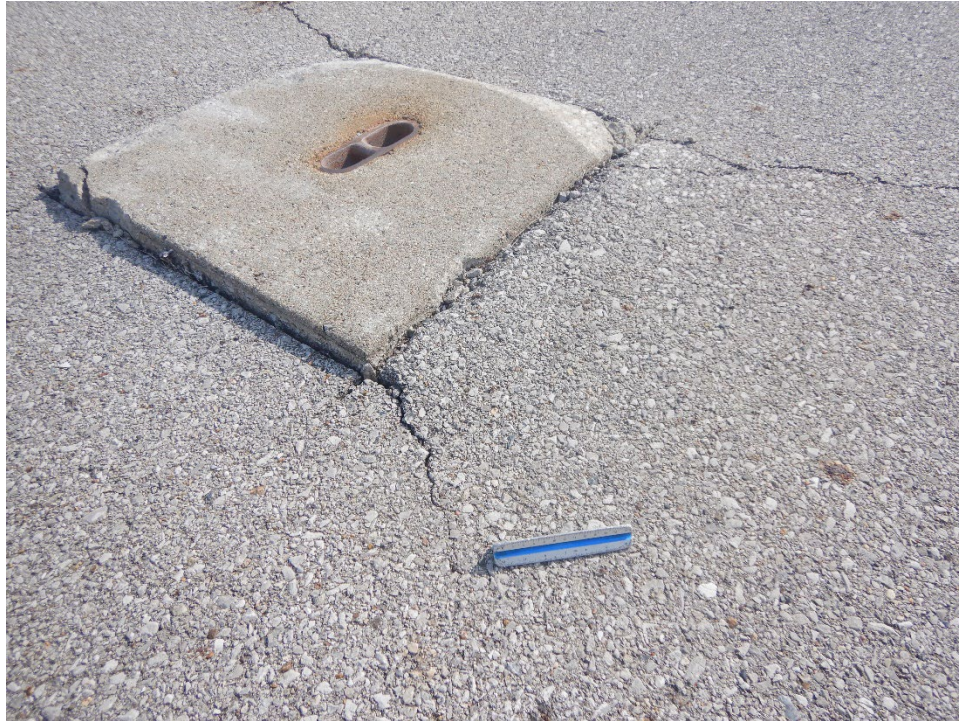
A01AL-02. Swelling (Sample Unit No. 03).

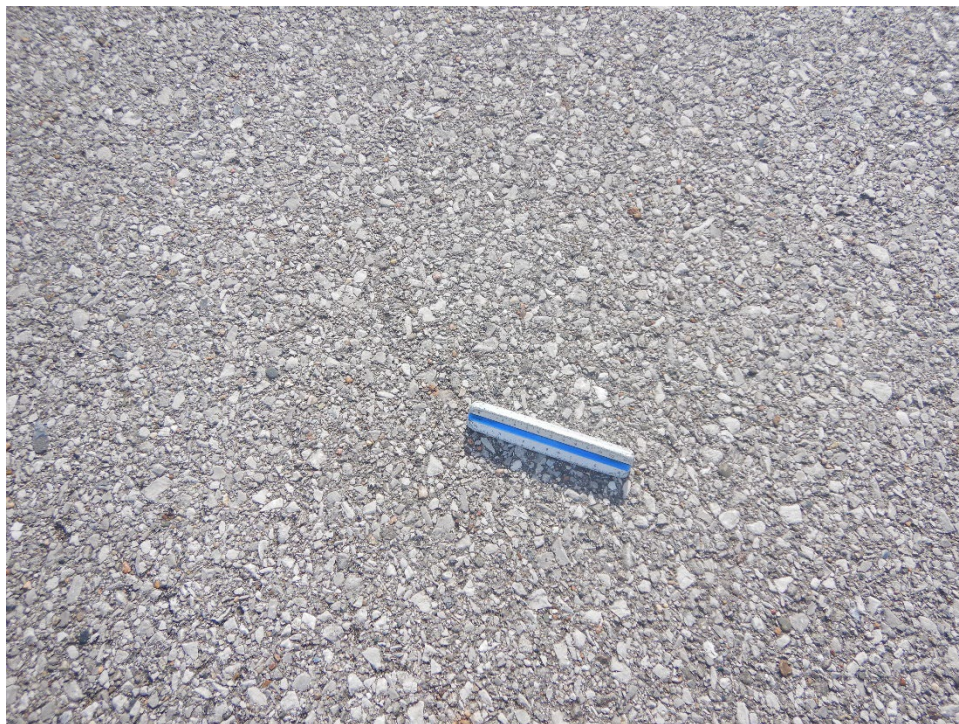
A01AL-02. Weathering (Sample Unit No. 03).

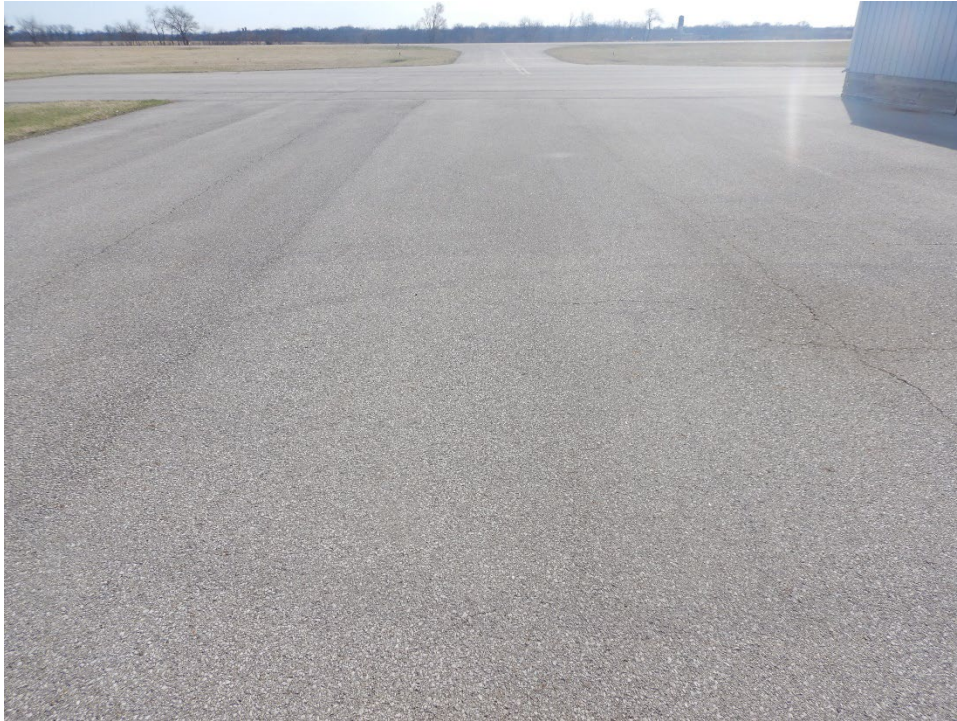
| Branch | Section | Surface Type | Section Area (sf) | LCD | 2025 PCI | % Distress Due to Load | % Distress Due to Climate/Durability | % Distress Due to Other | Type of Distress |
|---|---|---|---|---|---|---|---|---|---|
| A01AL | 03 | AC | 9,748 | 6/1/2003 | 47 | 41 | 44 | 15 | Alligator Cracking, Depression, L&T Cracking, Patching, Rutting, Weathering |

A01AL-03. Overview.

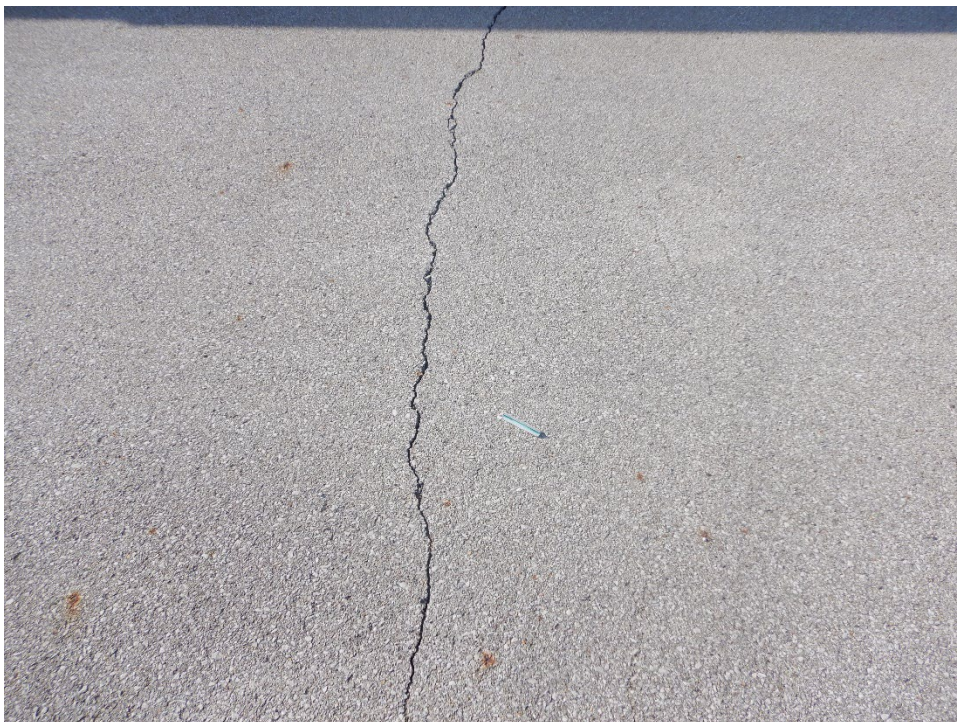
A01AL-03. L&T Cracking (Sample Unit No. 01).

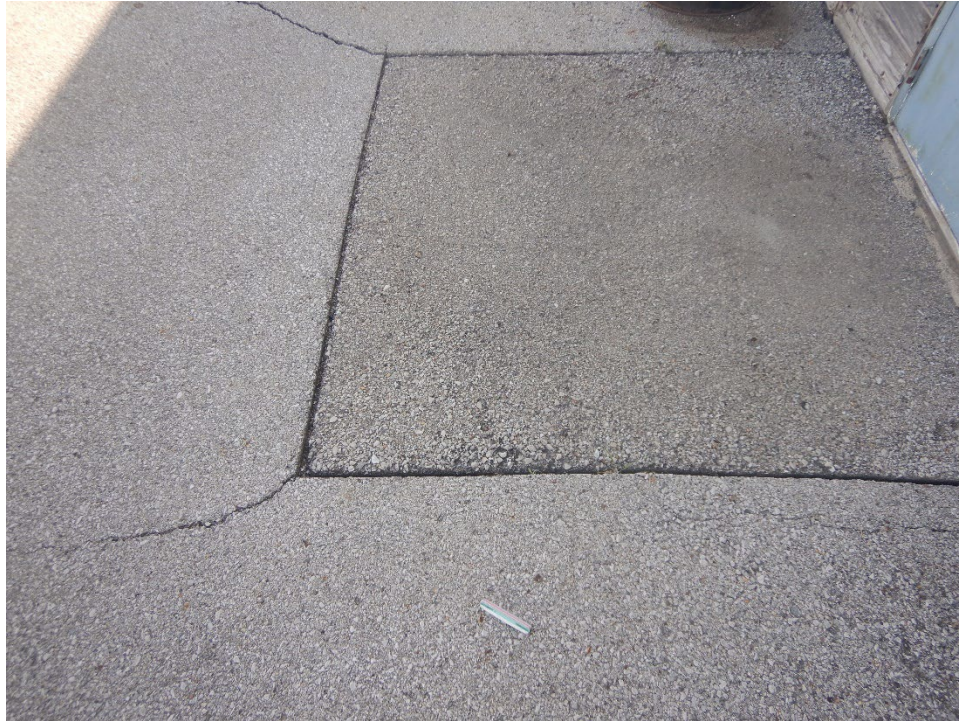
A01AL-03. Patching (Sample Unit No. 01).

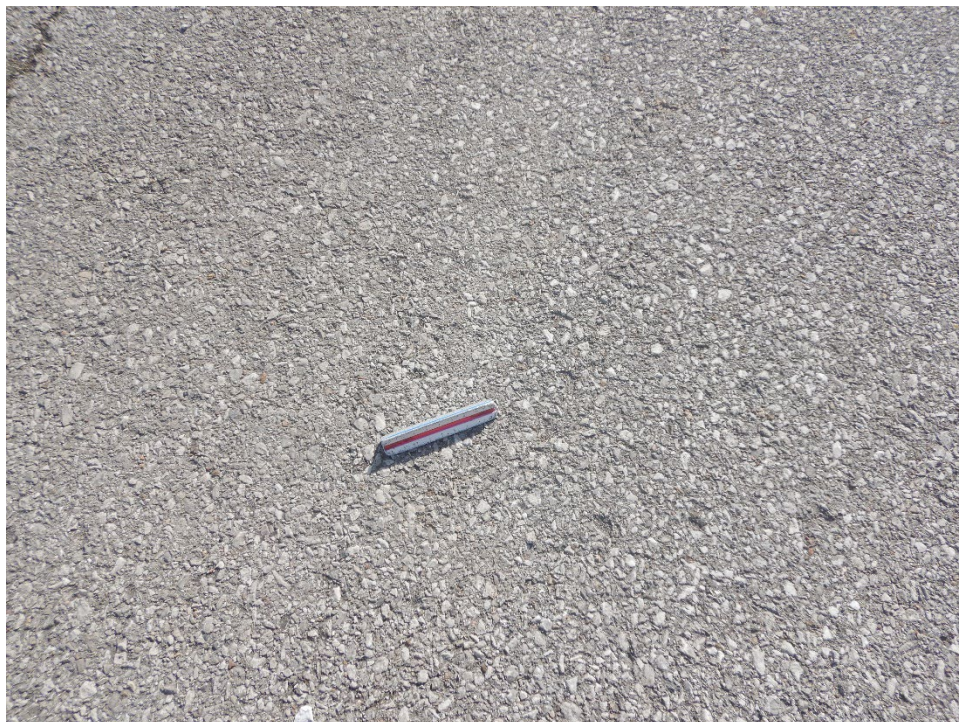
A01AL-03. Weathering (Sample Unit No. 01).

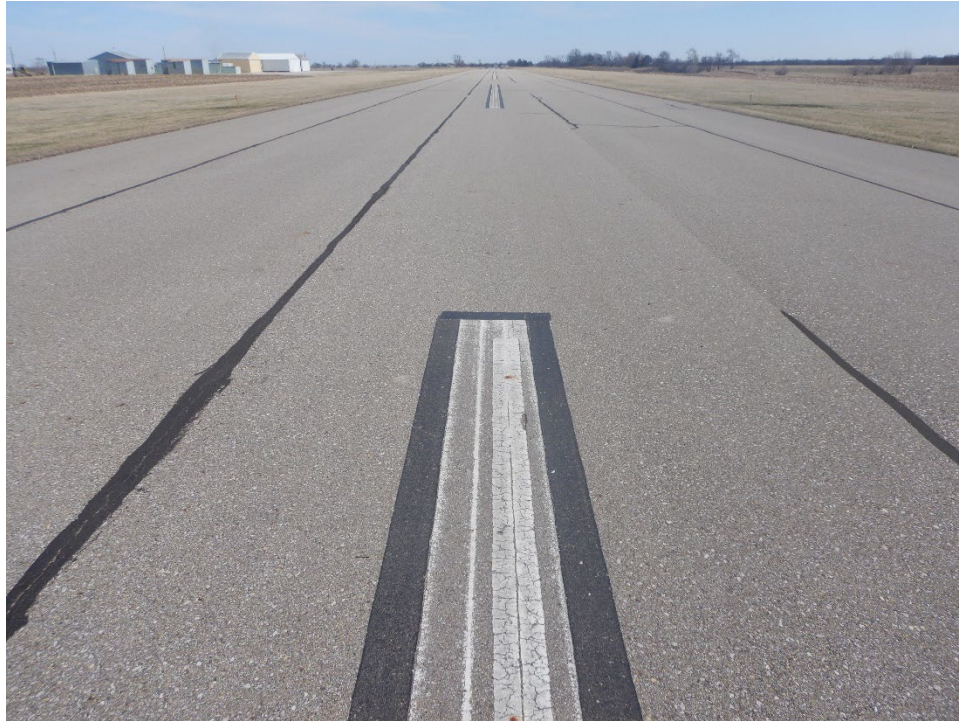
| Branch | Section | Surface Type | Section Area (sf) | LCD | 2025 PCI | % Distress Due to Load | % Distress Due to Climate/Durability | % Distress Due to Other | Type of Distress |
|---|---|---|---|---|---|---|---|---|---|
| R13AL | 01 | AAC | 129,008 | 7/1/2015 | 74 | 0 | 100 | 0 | L&T Cracking, Weathering |

R13AL-01. Overview.

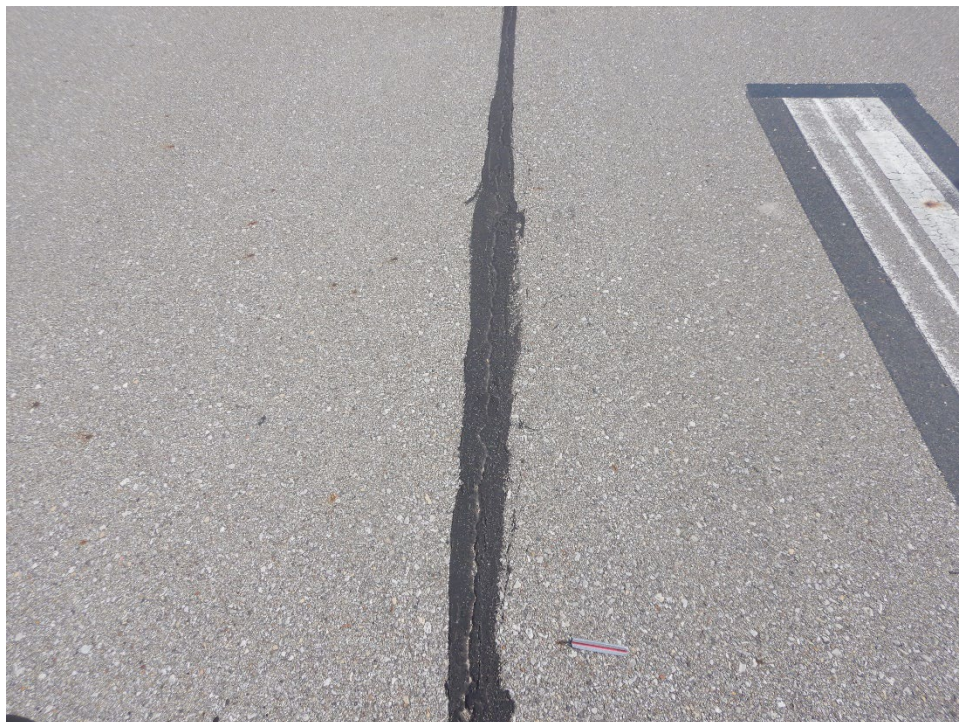
R13AL-01. L&T Cracking (Sample Unit No. 025).

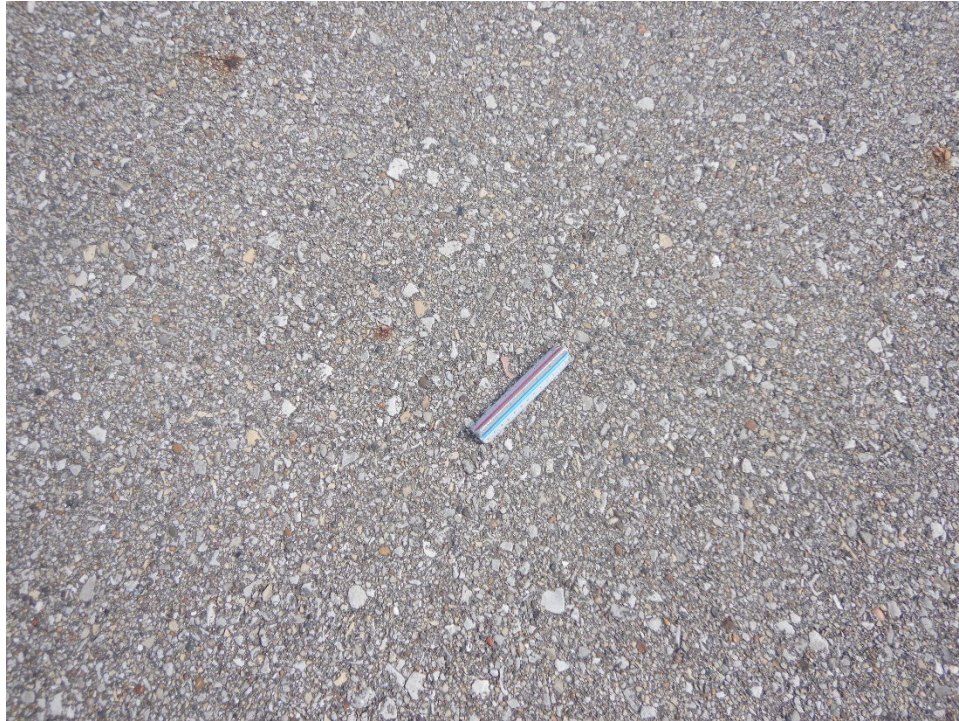
R13AL-01. Weathering (Sample Unit No. 025).

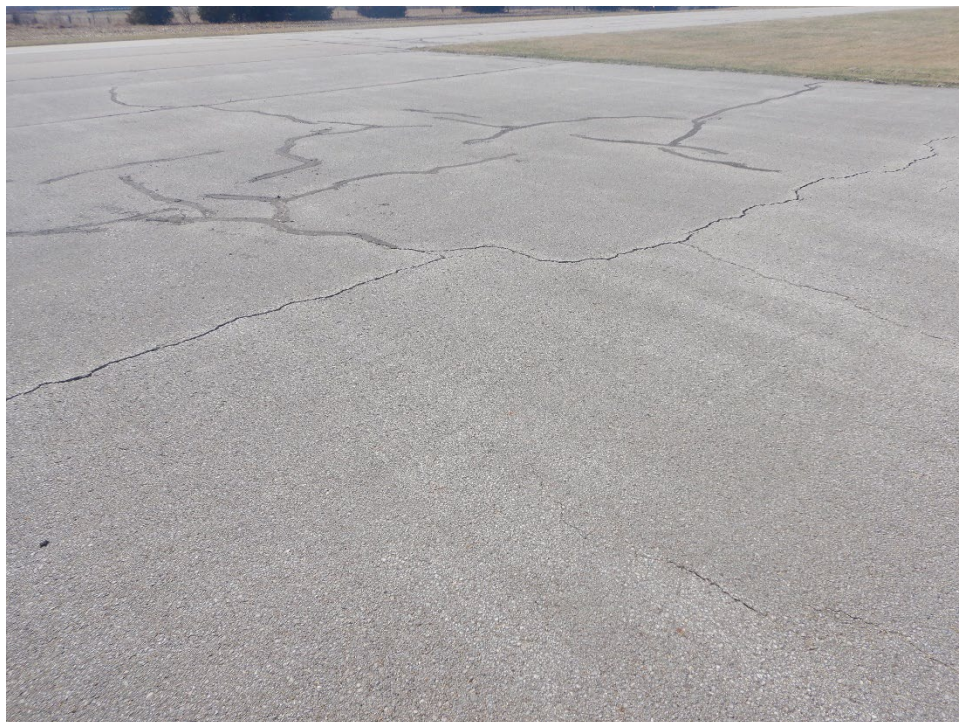
| Branch | Section | Surface Type | Section Area (sf) | LCD | 2025 PCI | % Distress Due to Load | % Distress Due to Climate/Durability | % Distress Due to Other | Type of Distress |
|---|---|---|---|---|---|---|---|---|---|
| R13AL | 02 | AAC | 4,696 | 5/1/1981 | 33 | 0 | 100 | 0 | L&T Cracking, Raveling |

R13AL-02. Overview.

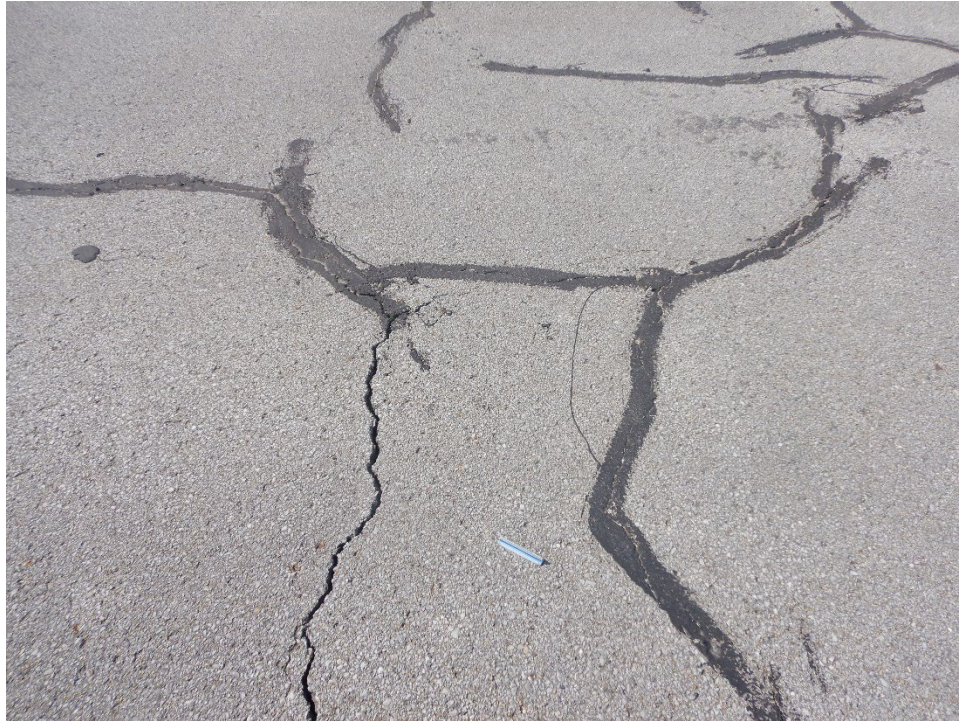
R13AL-02. L&T Cracking (Sample Unit No. 01).

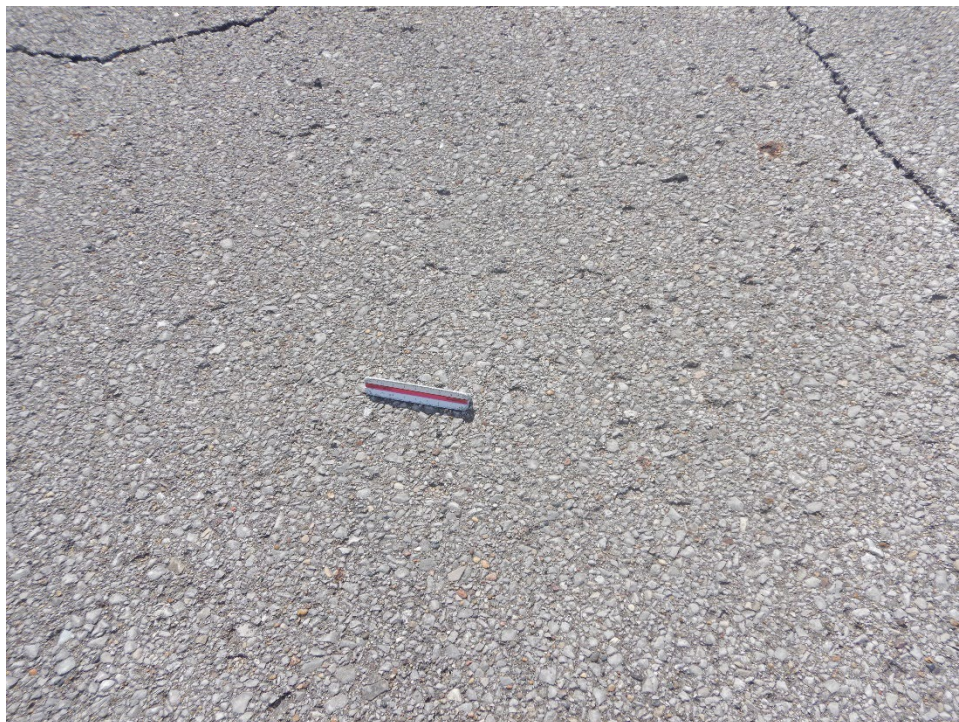
R13AL-02. Raveling (Sample Unit No. 01).

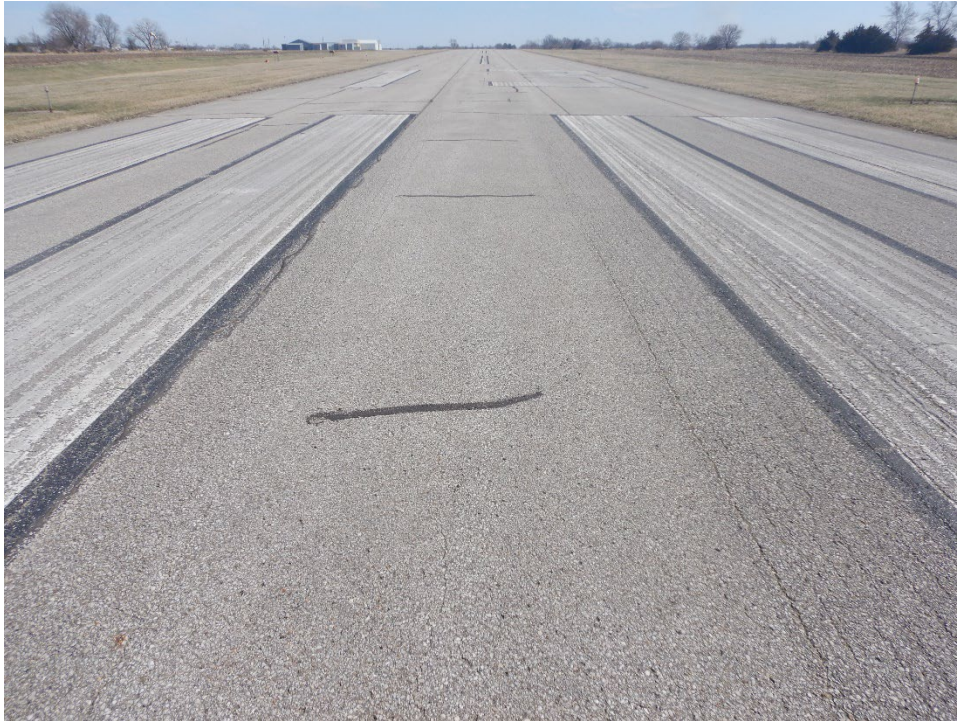
| Branch | Section | Surface Type | Section Area (sf) | LCD | 2025 PCI | % Distress Due to Load | % Distress Due to Climate/Durability | % Distress Due to Other | Type of Distress |
|---|---|---|---|---|---|---|---|---|---|
| R13AL | 03 | AC | 55,477 | 1/1/1998 | 19 | 32 | 68 | 0 | Alligator Cracking, L&T Cracking, Raveling, Rutting |

R13AL-03. Overview.

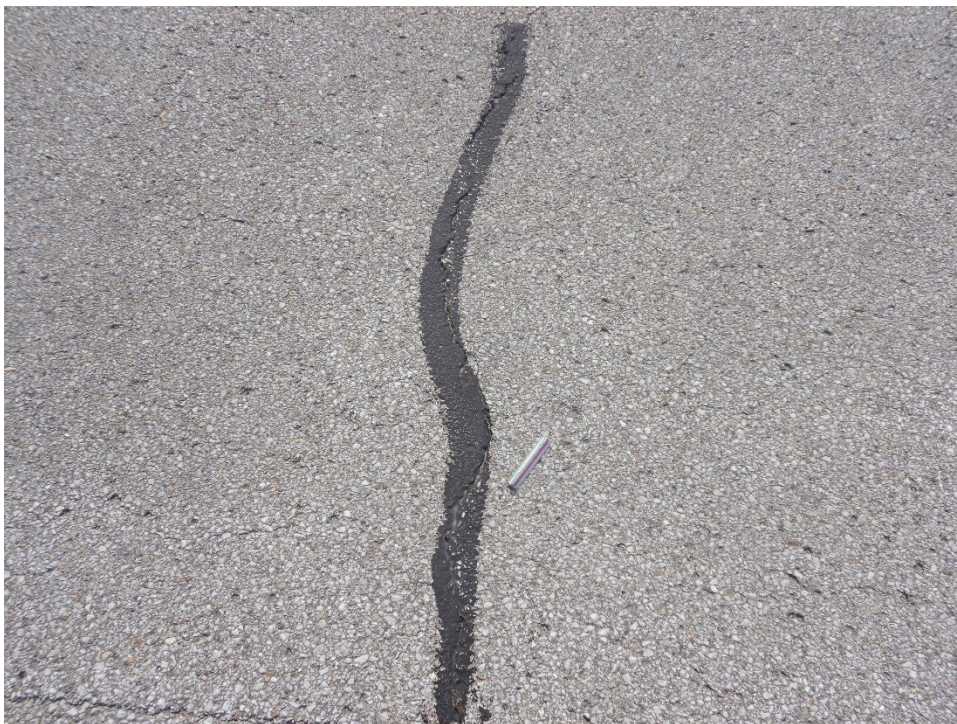
R13AL-03. L&T Cracking (Sample Unit No. 08).

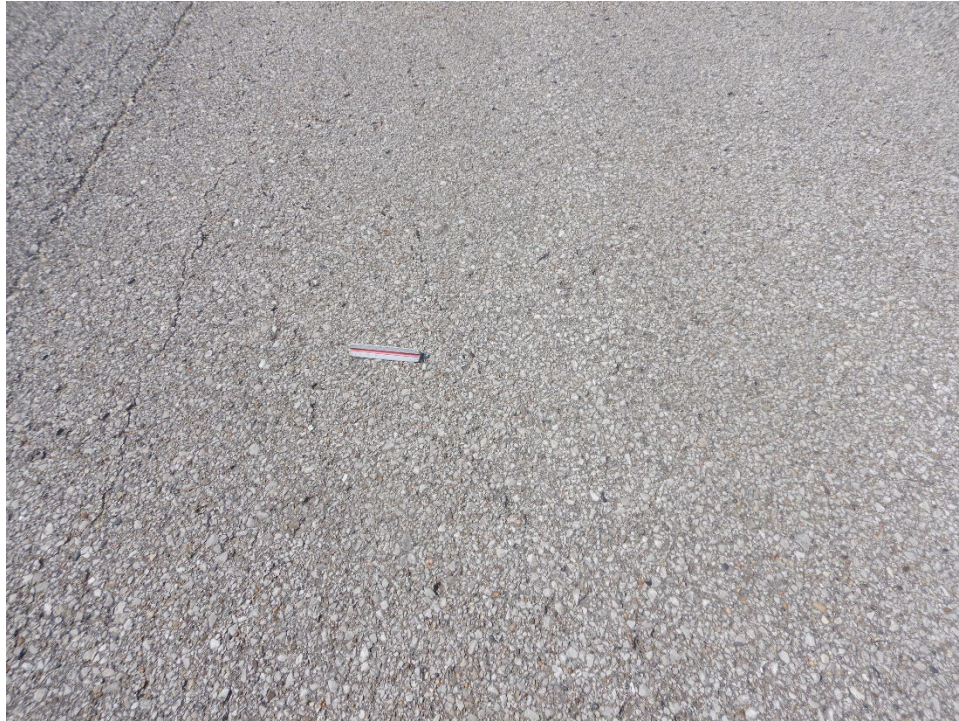
R13AL-03. Raveling (Sample Unit No. 08).

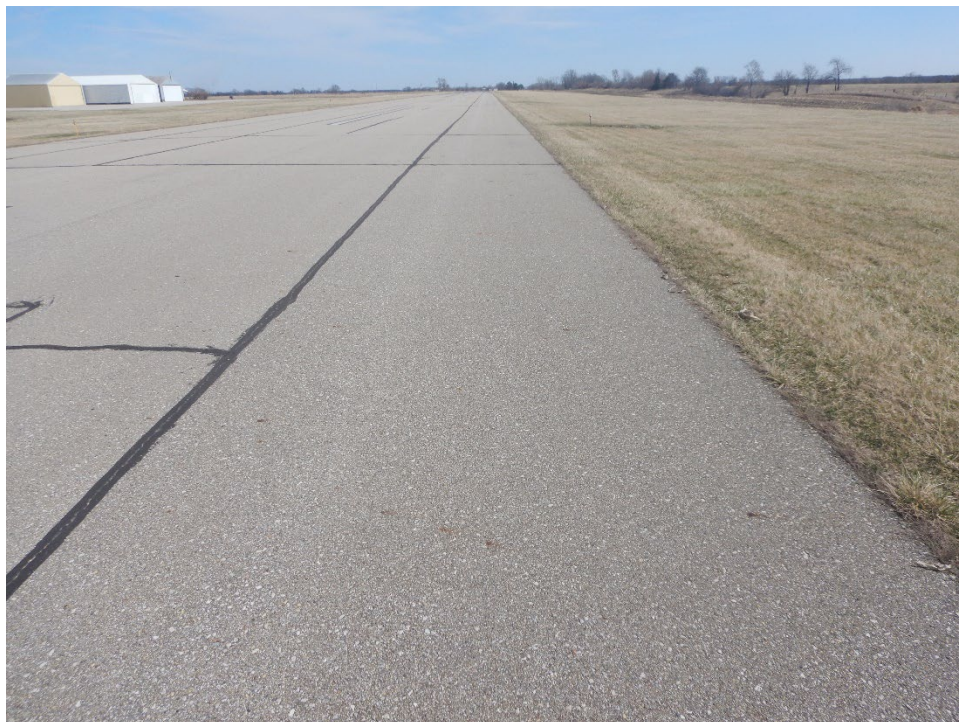
| Branch | Section | Surface Type | Section Area (sf) | LCD | 2025 PCI | % Distress Due to Load | % Distress Due to Climate/Durability | % Distress Due to Other | Type of Distress |
|---|---|---|---|---|---|---|---|---|---|
| R13AL | 04 | AAC | 25,000 | 7/1/2015 | 69 | 0 | 100 | 0 | L&T Cracking, Weathering |

R13AL-04. Overview.

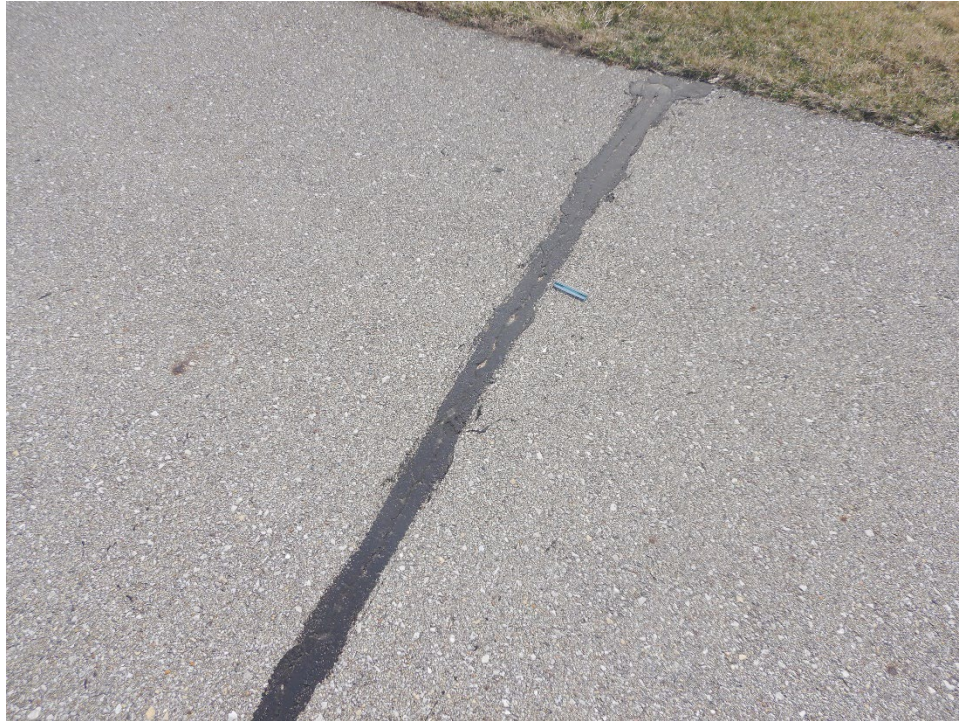
R13AL-04. L&T Cracking (Sample Unit No. 04).

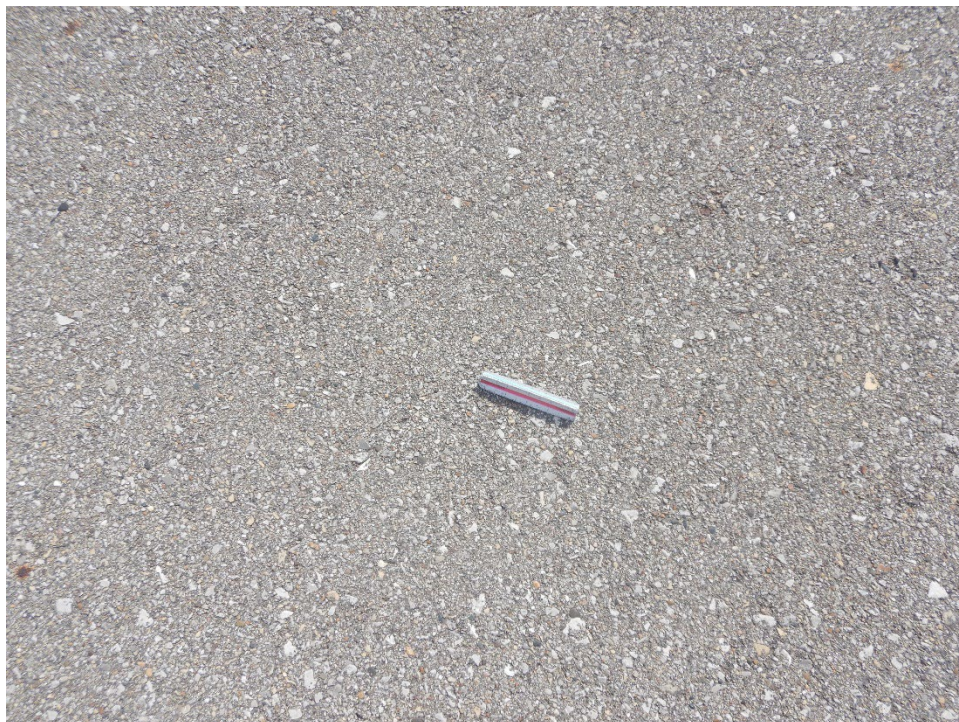
R13AL-04. Weathering (Sample Unit No. 04).

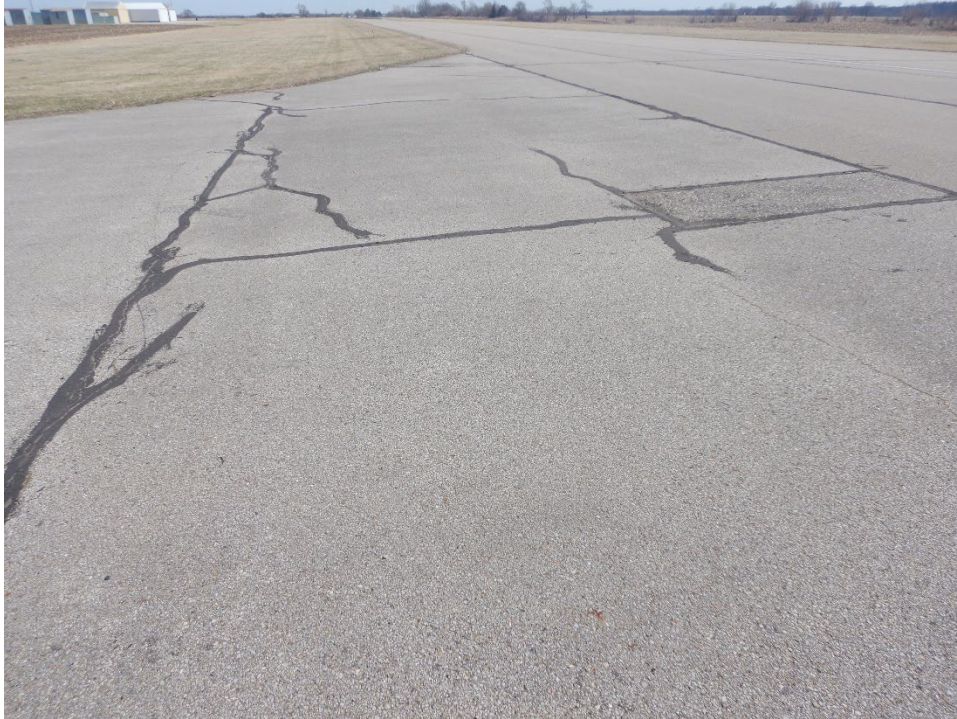
| Branch | Section | Surface Type | Section Area (sf) | LCD | 2025 PCI | % Distress Due to Load | % Distress Due to Climate/Durability | % Distress Due to Other | Type of Distress |
|---|---|---|---|---|---|---|---|---|---|
| R13AL | 05 | AAC | 3,100 | 6/1/1981 | 29 | 0 | 100 | 0 | L&T Cracking, Patching, Raveling |

R13AL-05. Overview.

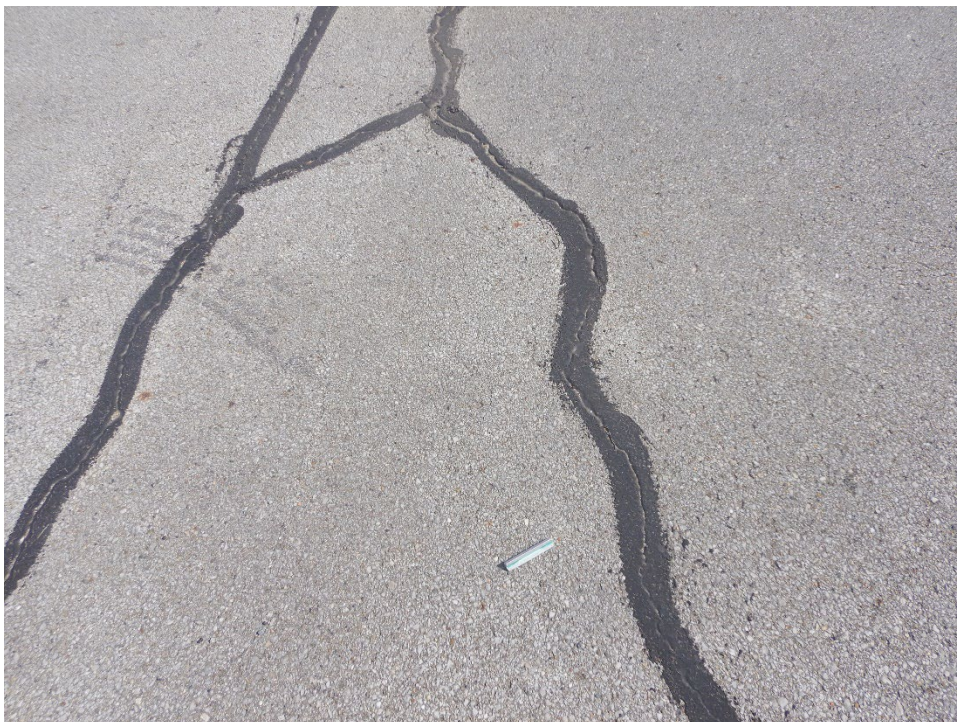
R13AL-05 L&T. Cracking (Sample Unit No. 01).

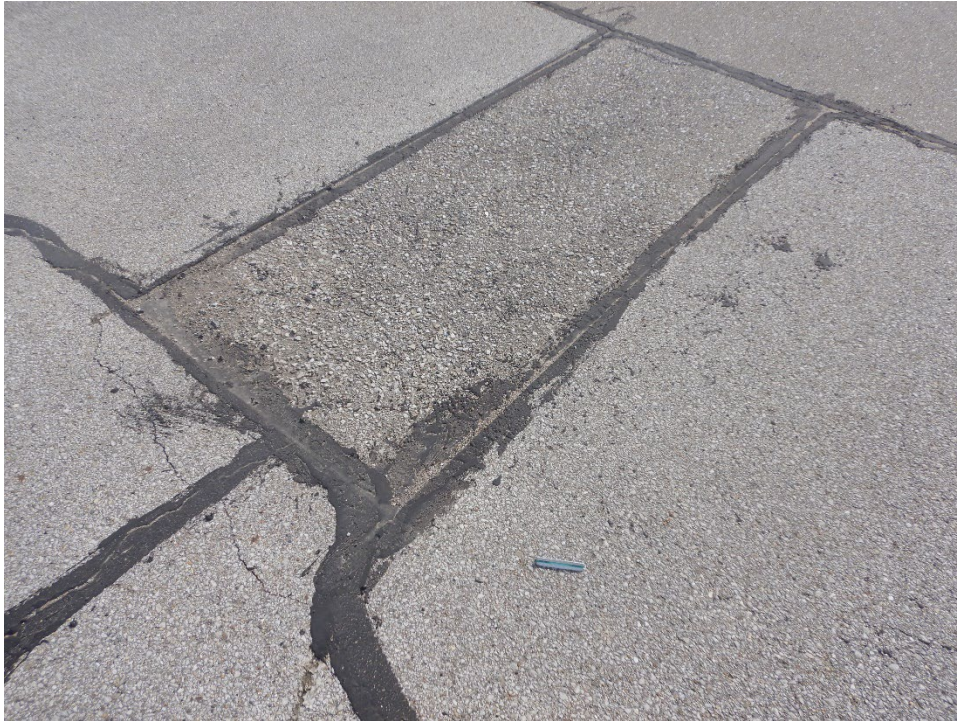
R13AL-05. Patching (Sample Unit No. 01).

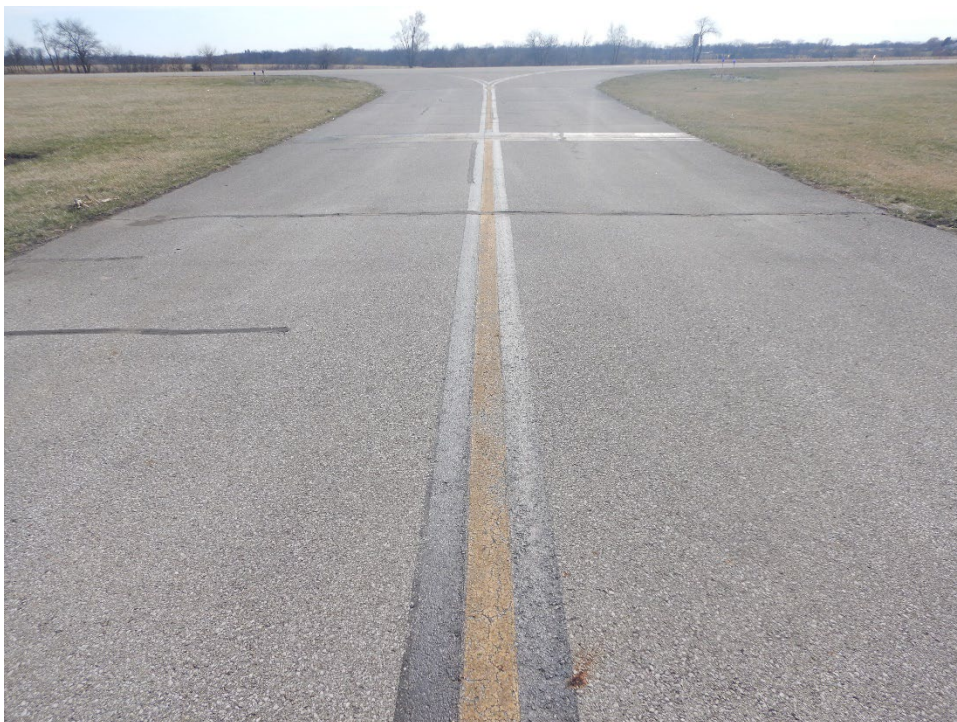
| Branch | Section | Surface Type | Section Area (sf) | LCD | 2025 PCI | % Distress Due to Load | % Distress Due to Climate/Durability | % Distress Due to Other | Type of Distress |
|---|---|---|---|---|---|---|---|---|---|
| T01AL | 01 | AAC | 5,680 | 6/1/2003 | 24 | 65 | 30 | 5 | Alligator Cracking, Depression, L&T Cracking, Raveling, Rutting, Weathering |

Taxiway 01 contained one section that was in *Poor* condition and connected the apron area to Runway 13/31. Low- and medium-severity alligator cracking, medium-severity depression, and low- and high-severity L&T cracking were identified, with the low-severity cracking mostly sealed and the high-severity cracking due to spalling along the crack. Low-severity raveling, rutting, and weathering were also observed.

T01AL-01. Overview.
