# Albia Municipal Airport

## Pavement Management Report

**AUGUST 2025**

# ALBIA MUNICIPAL AIRPORT PAVEMENT MANAGEMENT REPORT

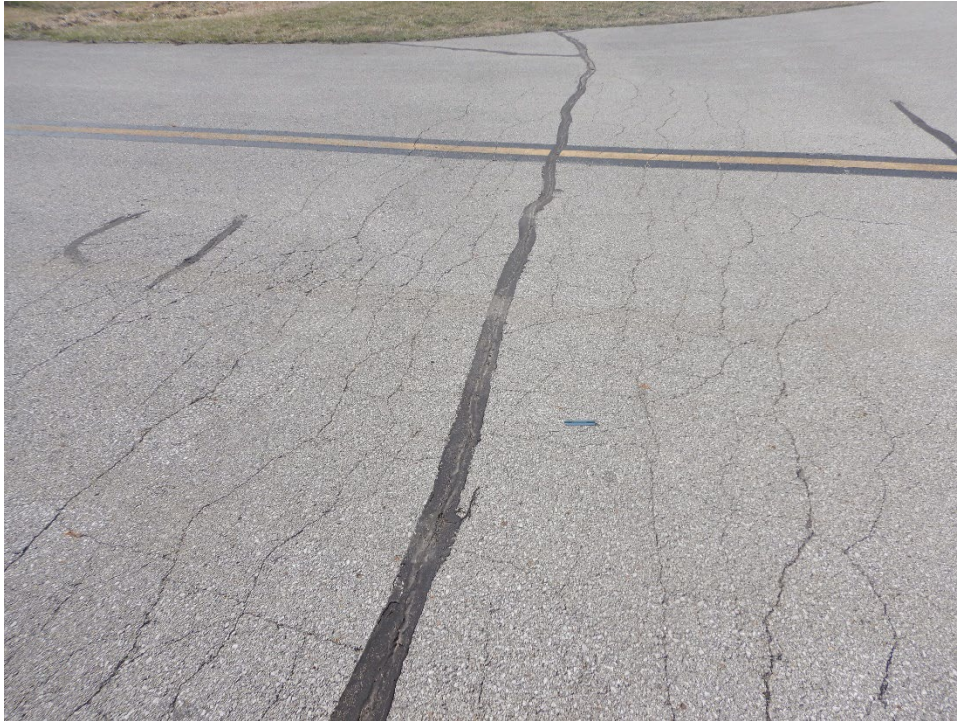
T01AL-01. Alligator Cracking (Sample Unit No. 01).

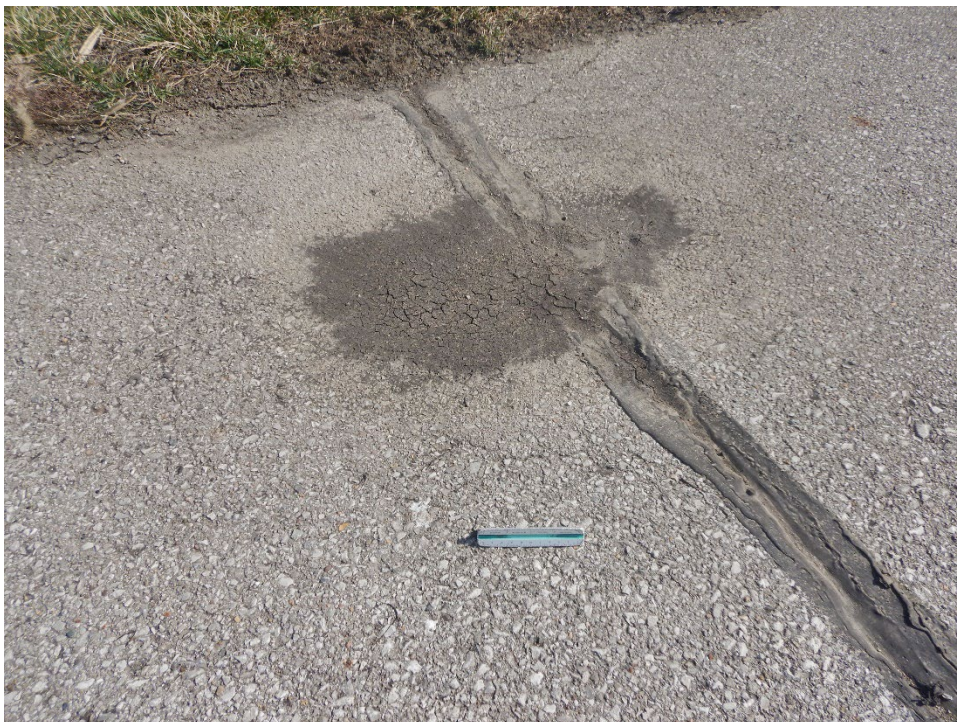
T01AL-01. Depression (Sample Unit No. 01).

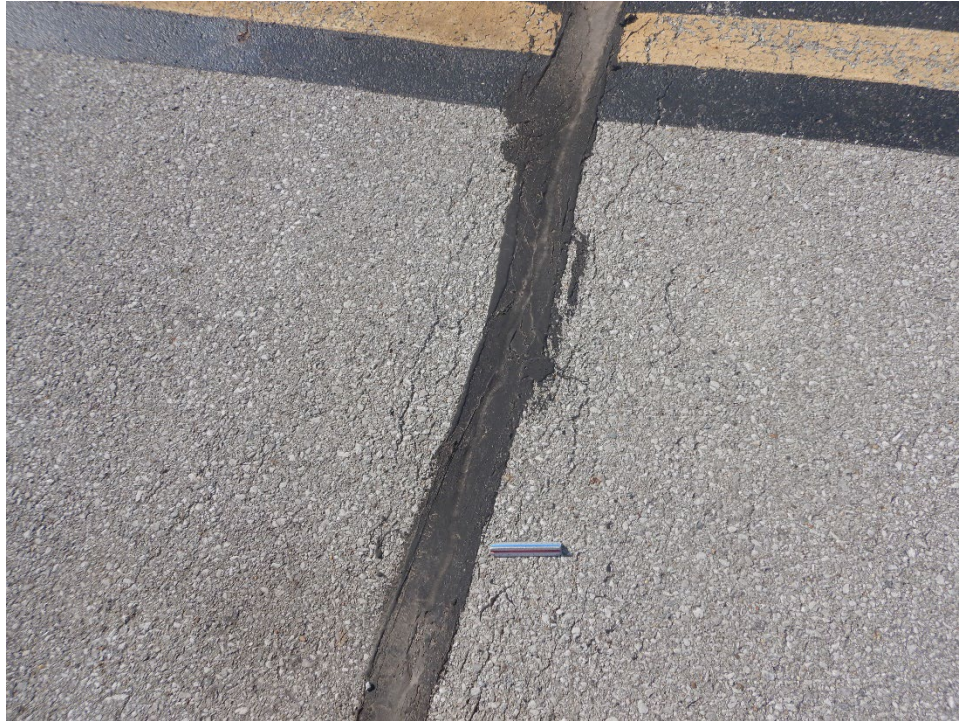
T01AL-01. L&T Cracking (Sample Unit No. 01) (1).

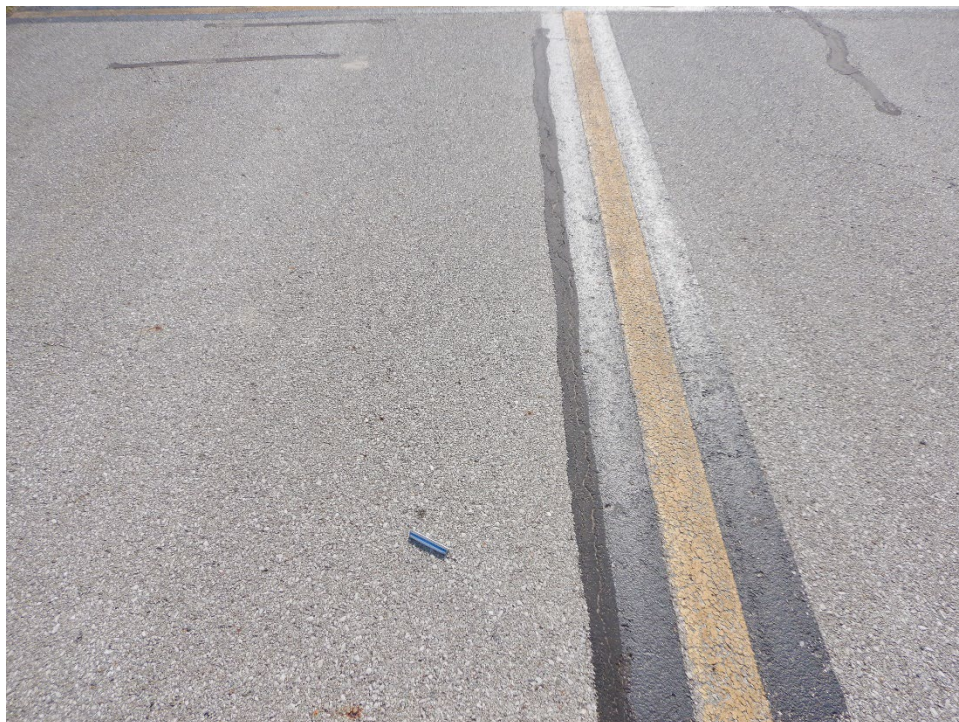
T01AL-01. L&T Cracking (Sample Unit No. 01) (2).

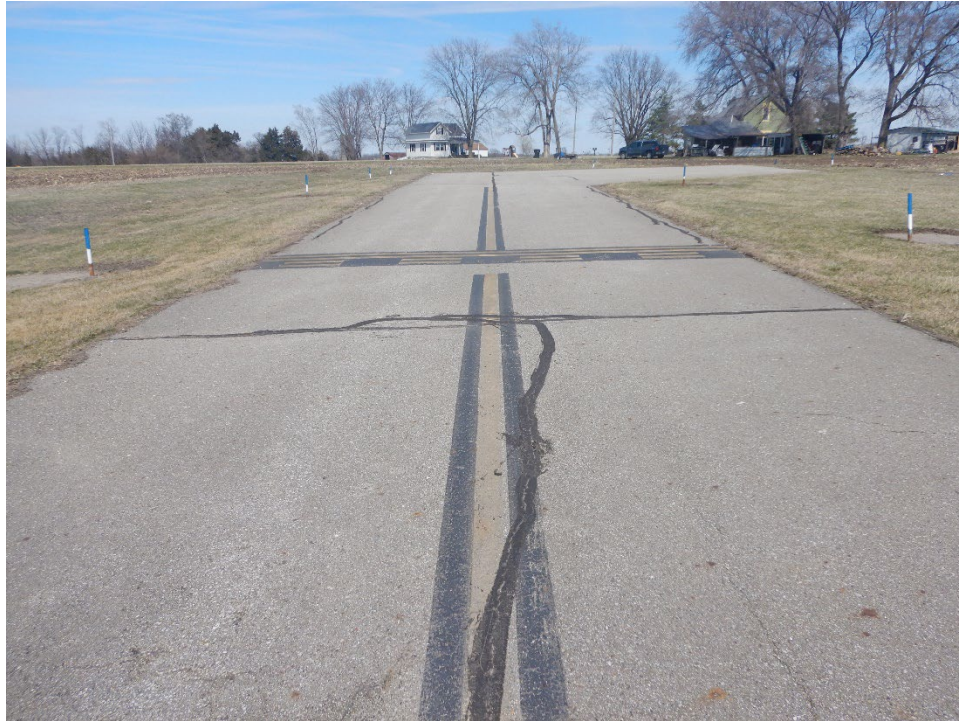
| Branch | Section | Surface Type | Section Area (sf) | LCD | 2025 PCI | % Distress Due to Load | % Distress Due to Climate/Durability | % Distress Due to Other | Type of Distress |
|---|---|---|---|---|---|---|---|---|---|
| T02AL | 01 | AC | 5,898 | 6/1/2010 | 34 | 38 | 62 | 0 | Alligator Cracking, L&T Cracking, Raveling, Weathering |

Taxiway 02 was defined by one section in *Poor* condition having low-severity alligator cracking along with all severities of L&T cracking. The low-severity cracking was mostly sealed, and the medium-severity cracking was due to unsatisfactory crack sealant. Low- and medium-severity raveling and weathering were also identified.

T02AL-01. Overview.

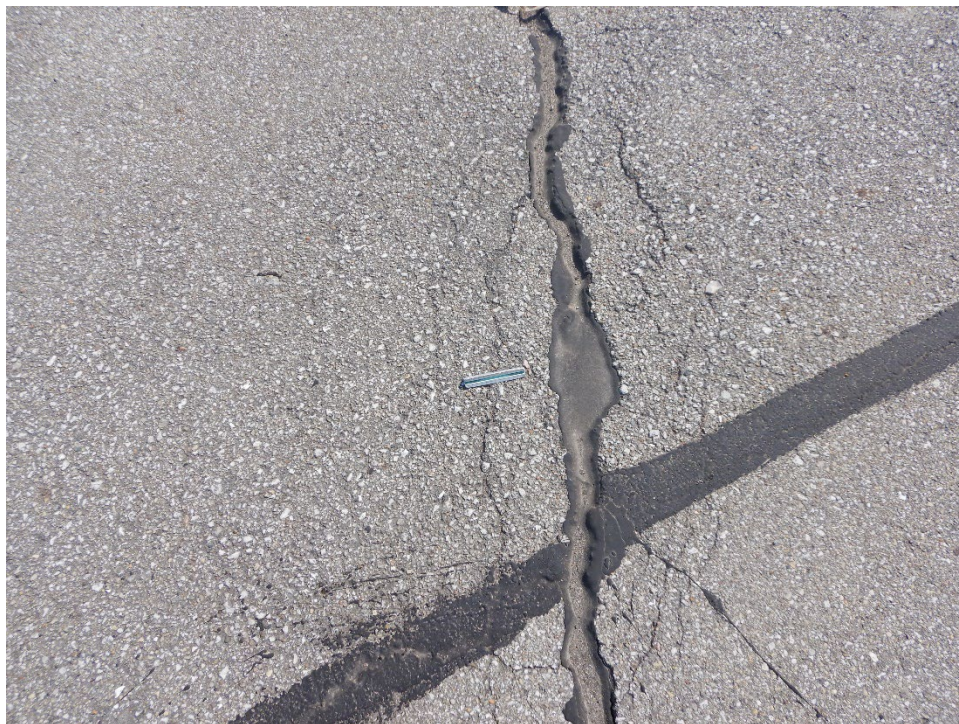
T02AL-01. L&T Cracking (Sample Unit No. 01) (1).

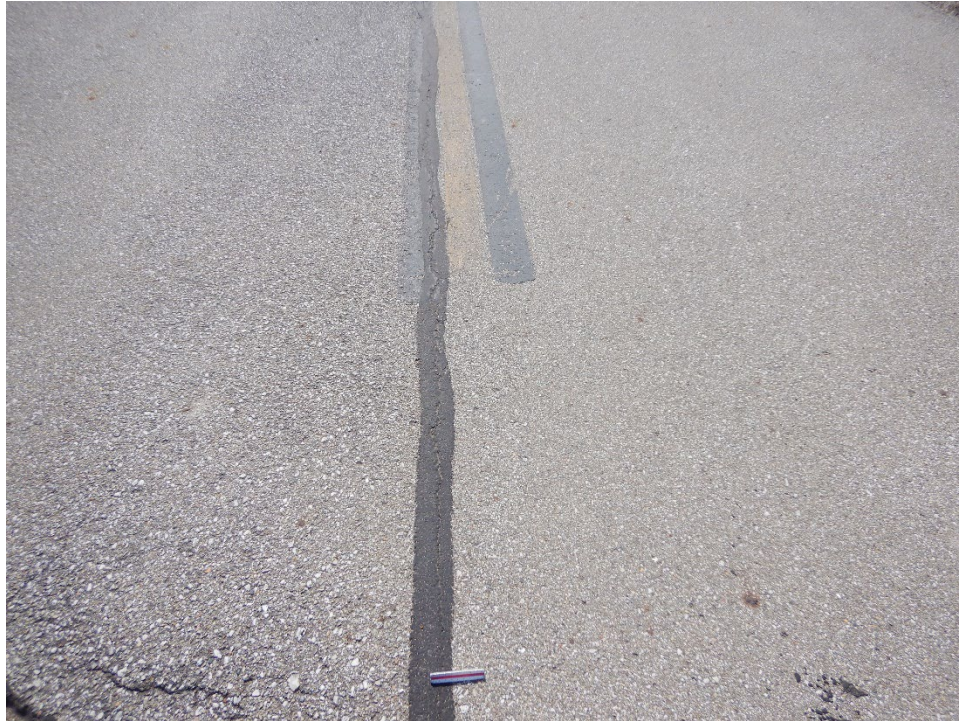
T02AL-01. L&T Cracking (Sample Unit No. 01) (2).

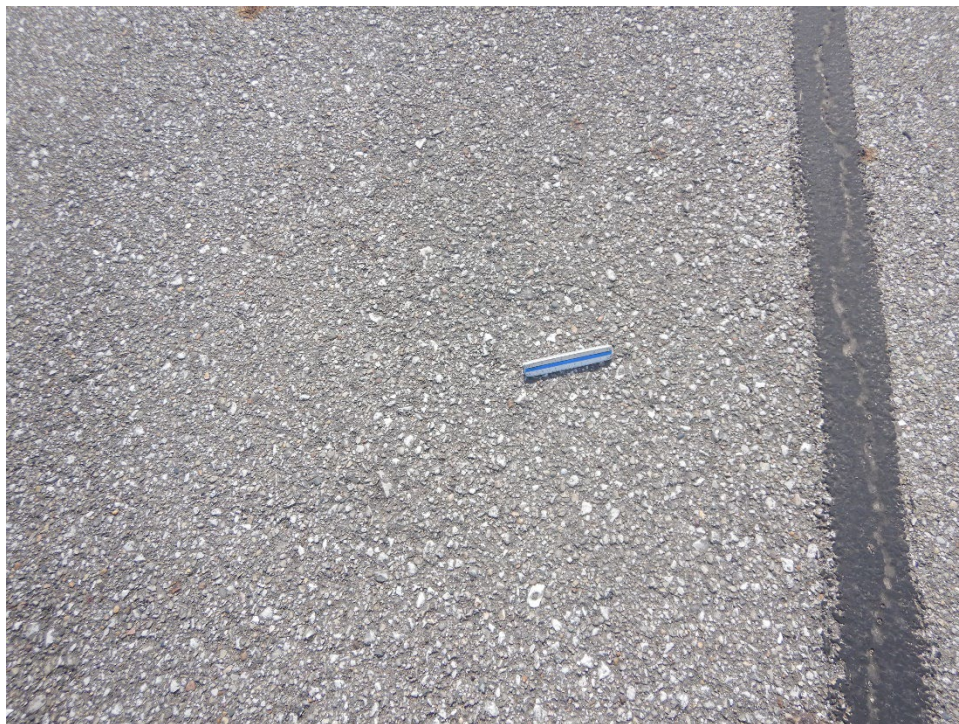
T02AL-01. Weathering (Sample Unit No. 01).

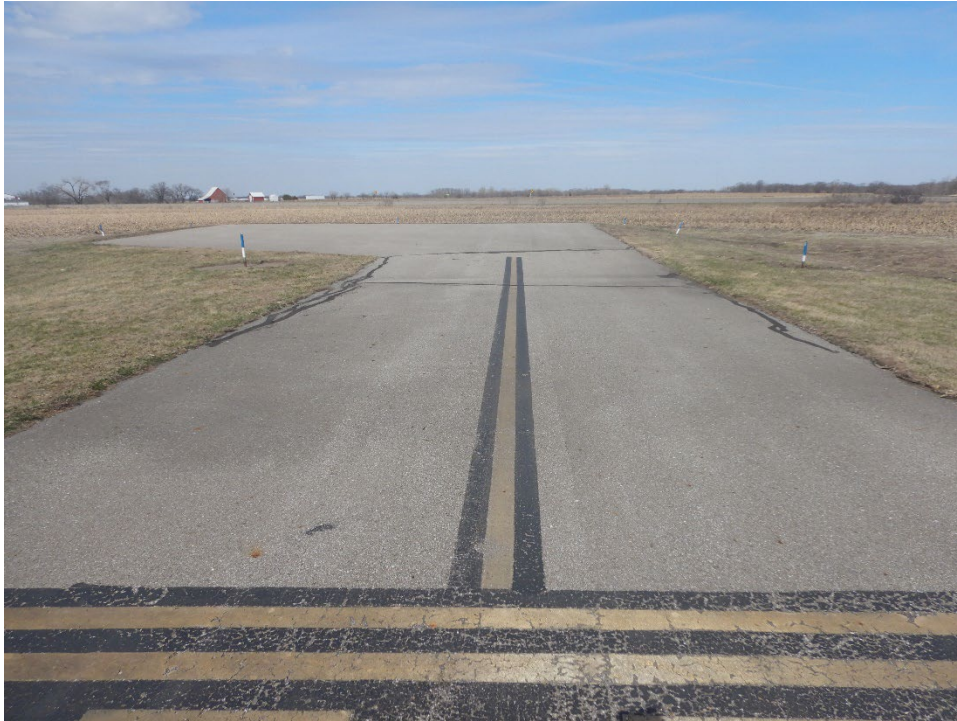
| Branch | Section | Surface Type | Section Area (sf) | LCD | 2025 PCI | % Distress Due to Load | % Distress Due to Climate/Durability | % Distress Due to Other | Type of Distress |
|---|---|---|---|---|---|---|---|---|---|
| T03AL | 01 | AC | 5,148 | 6/1/2010 | 38 | 52 | 46 | 2 | Alligator Cracking, L&T Cracking, Raveling, Swelling, Weathering |

Taxiway 03 consisted of one section that was in *Poor* condition. Low- and medium-severity alligator cracking and weathering, low- and high-severity L&T cracking, and low-severity raveling and swelling were observed. The low-severity cracking was sealed.

T03AL-01. Overview.

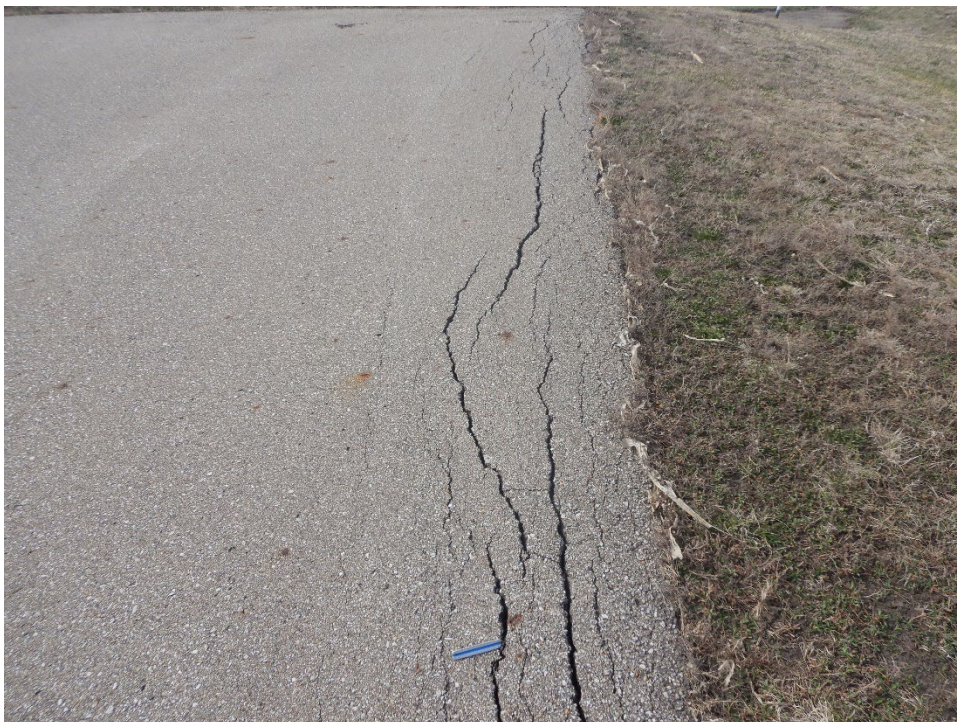
T03AL-01. Alligator Cracking (Sample Unit No. 01).

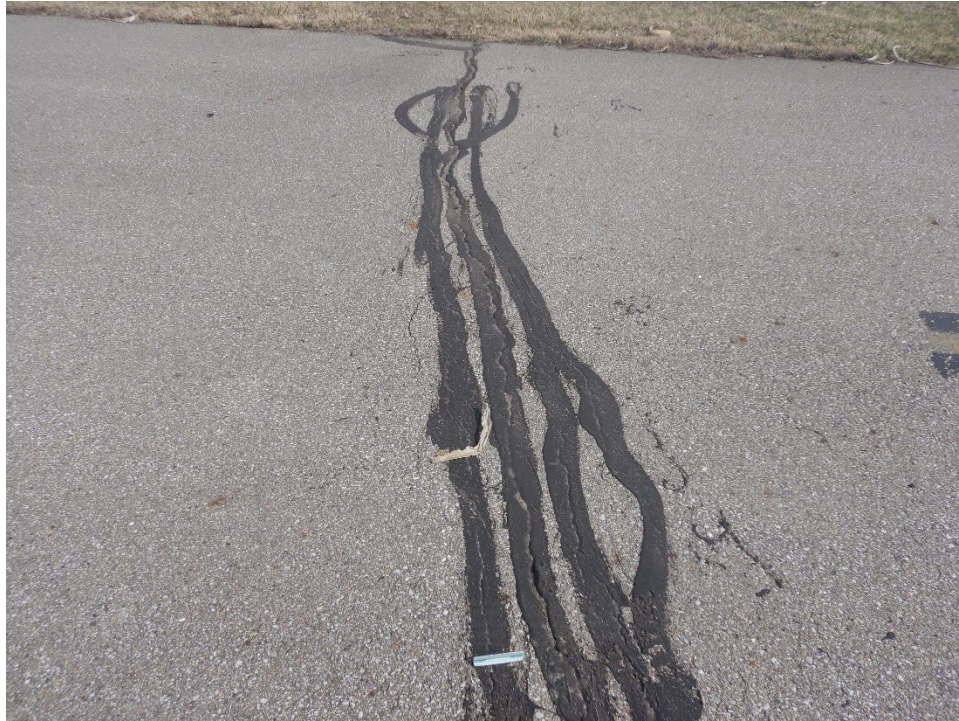
T03AL-01. L&T Cracking (Sample Unit No. 01).

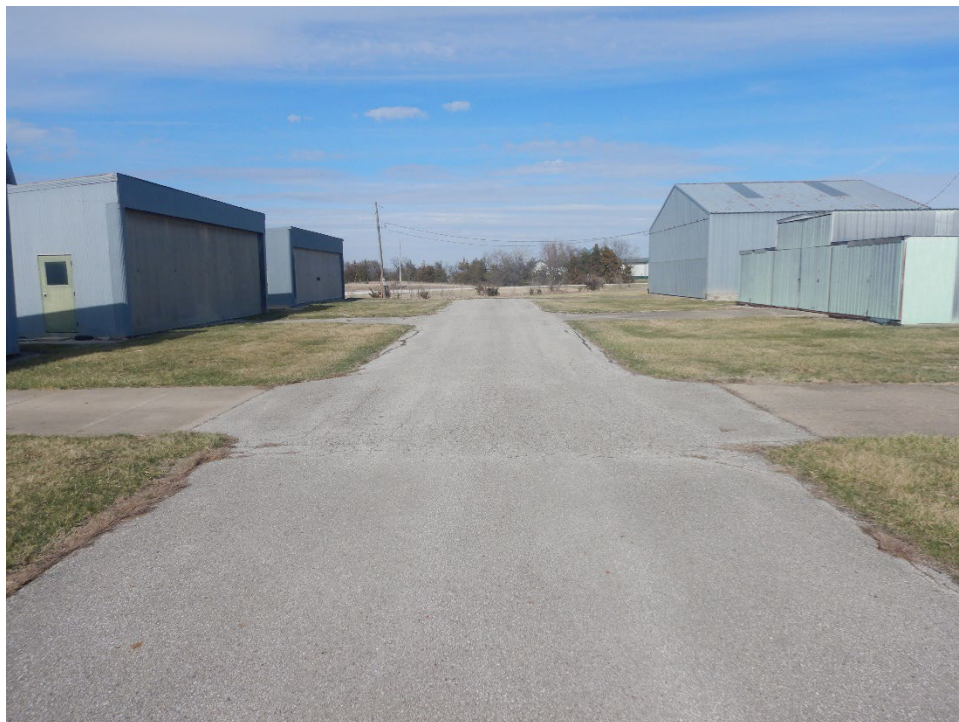
| Branch | Section | Surface Type | Section Area (sf) | LCD | 2025 PCI | % Distress Due to Load | % Distress Due to Climate/Durability | % Distress Due to Other | Type of Distress |
|---|---|---|---|---|---|---|---|---|---|
| TH01AL | 01 | AC | 6,185 | 6/4/2003 | 13 | 57 | 43 | 0 | Alligator Cracking, L&T Cracking, Raveling, Rutting, Weathering |

TH01AL-01. Overview.

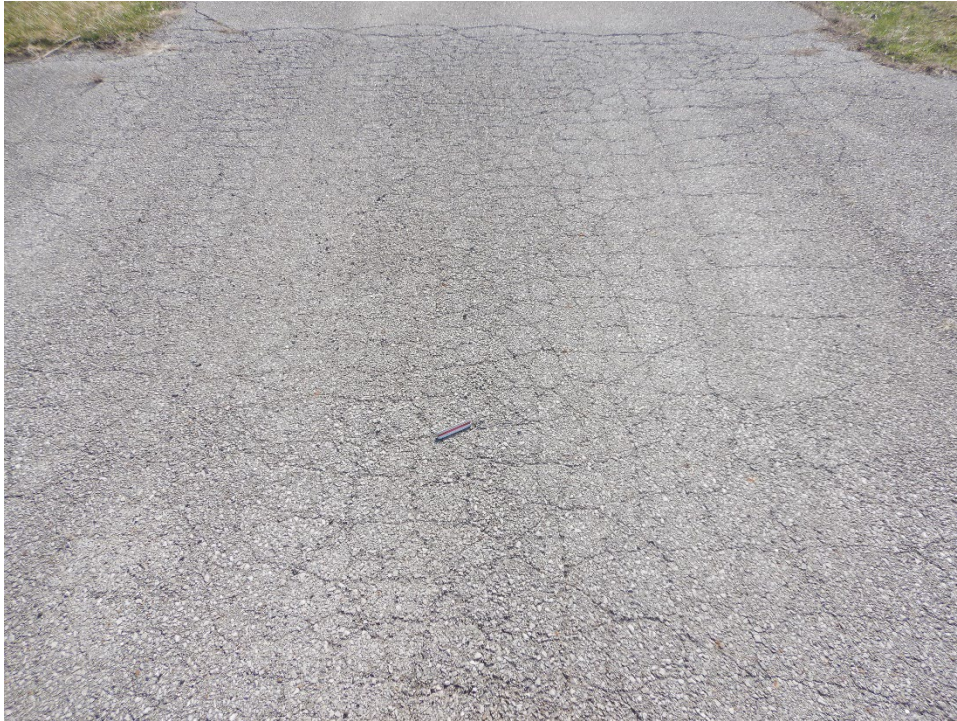
TH01AL-01. Alligator Cracking (Sample Unit No. 01).

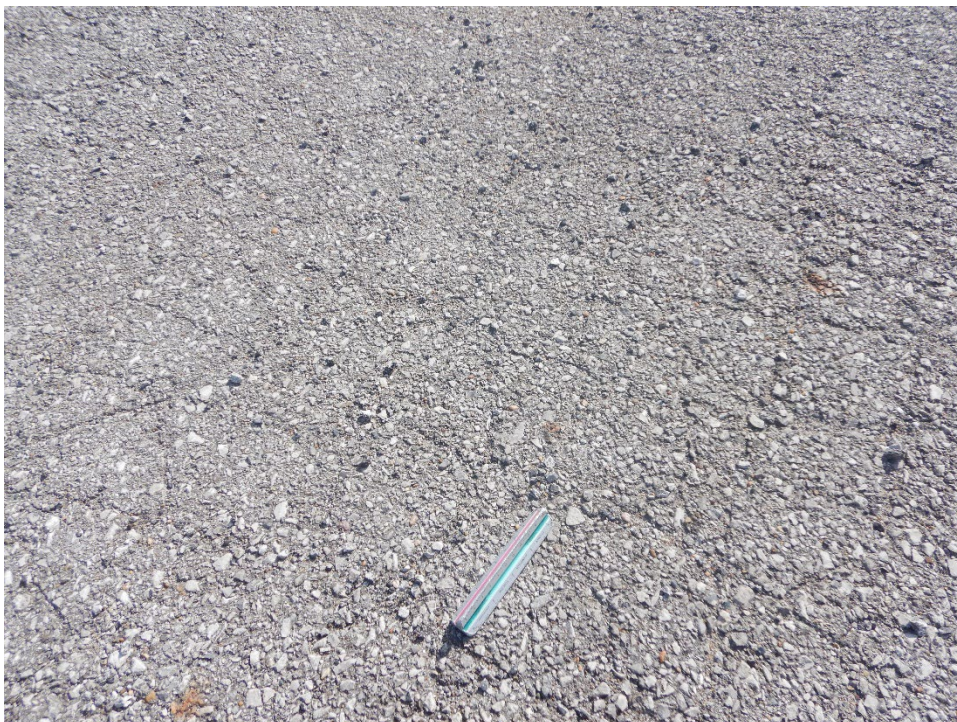
TH01AL-01. Raveling (Sample Unit No. 01).

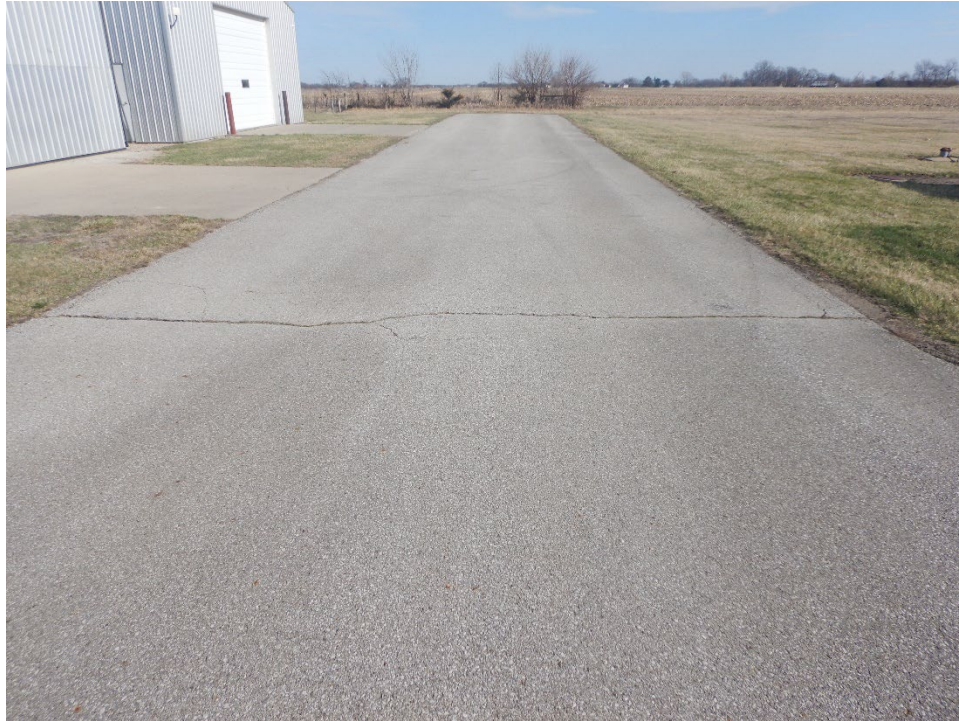
| Branch | Section | Surface Type | Section Area (sf) | LCD | 2025 PCI | % Distress Due to Load | % Distress Due to Climate/Durability | % Distress Due to Other | Type of Distress |
|---|---|---|---|---|---|---|---|---|---|
| TH01AL | 02 | AC | 3,845 | 1/1/2004 | 42 | 34 | 60 | 6 | Alligator Cracking, L&T Cracking, Raveling, Swelling, Weathering |

TH01AL-02. Overview.

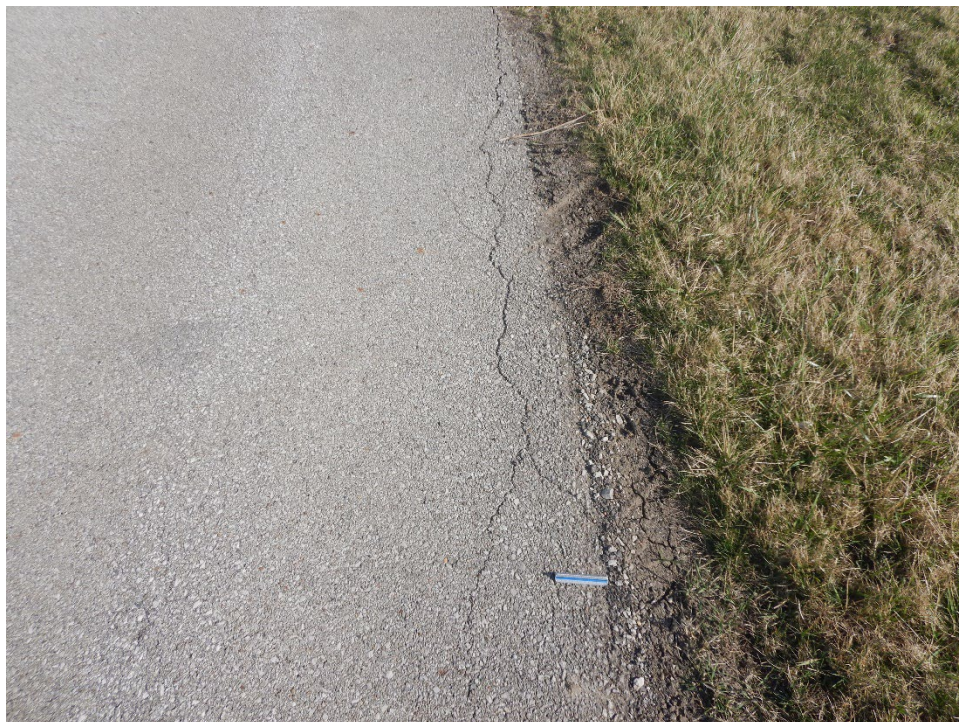
TH01AL-02. Alligator Cracking (Sample Unit No. 01).

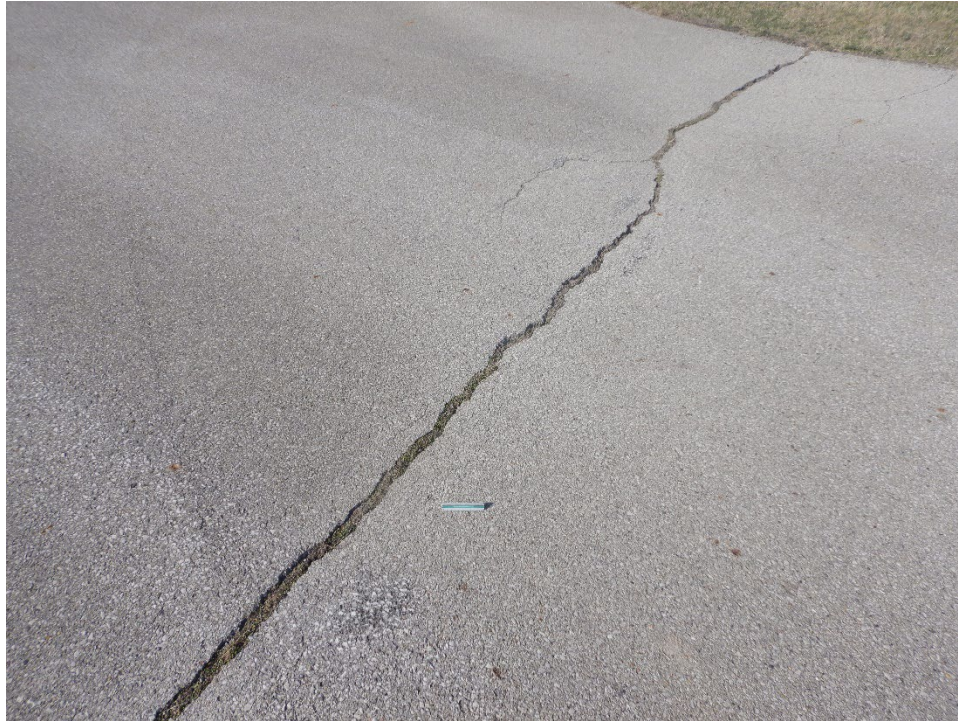
TH01AL-02. L&T Cracking (Sample Unit No. 01).

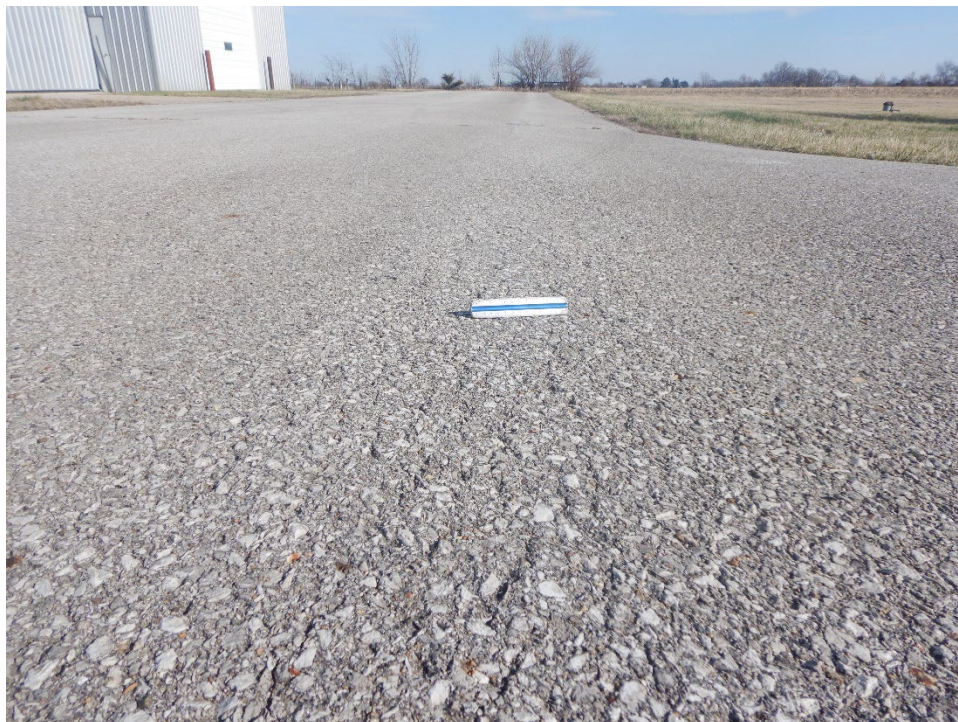
TH01AL-02. Swelling (Sample Unit No. 01).
