Algona Municipal Airport

Pavement Management Report

JULY 2023

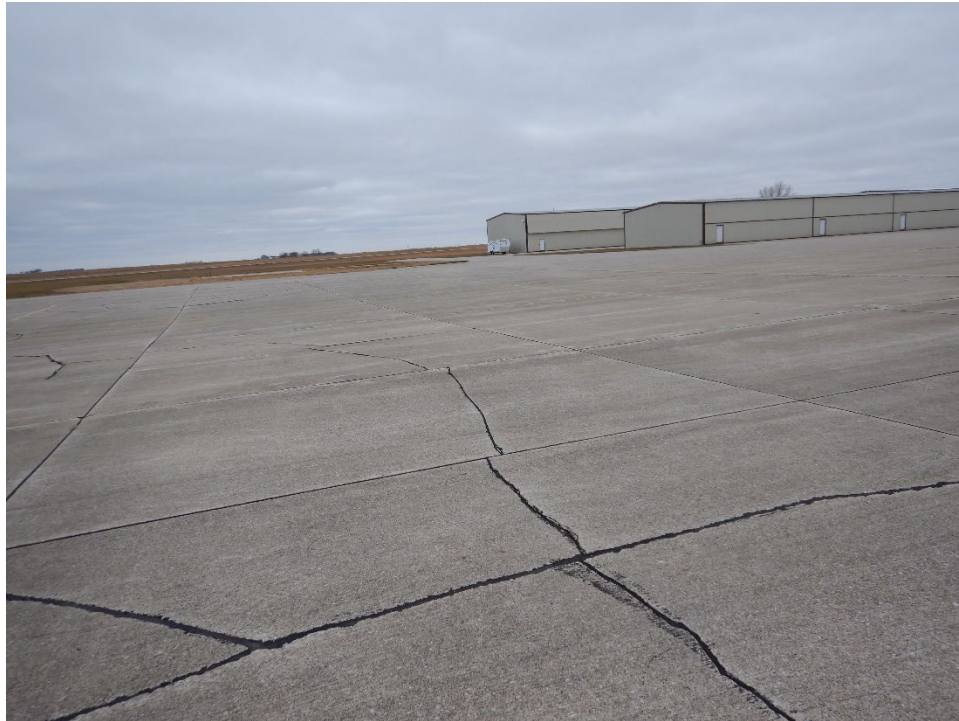
A01AG-01. Overview.

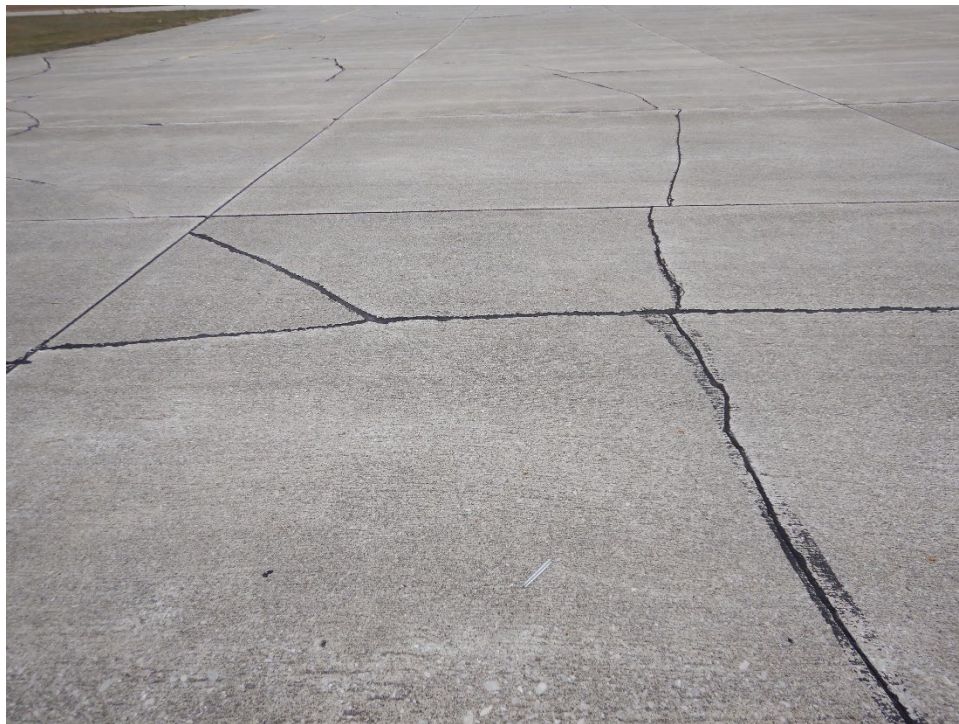
A01AG-01. Shattered Slab (Sample Unit No. 06).

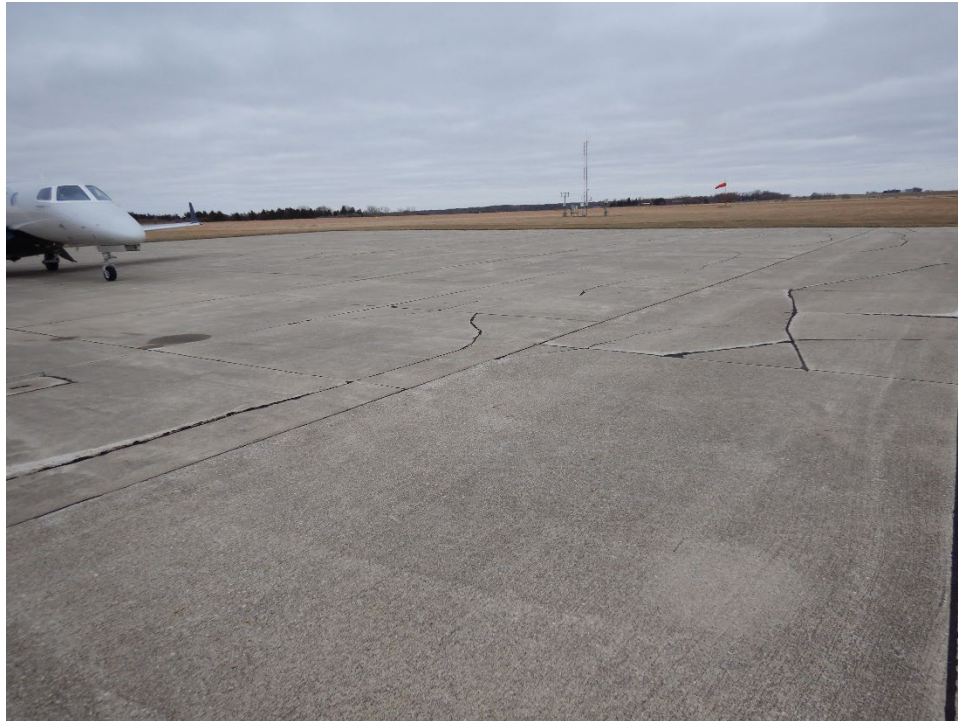
A01AG-02. Overview.

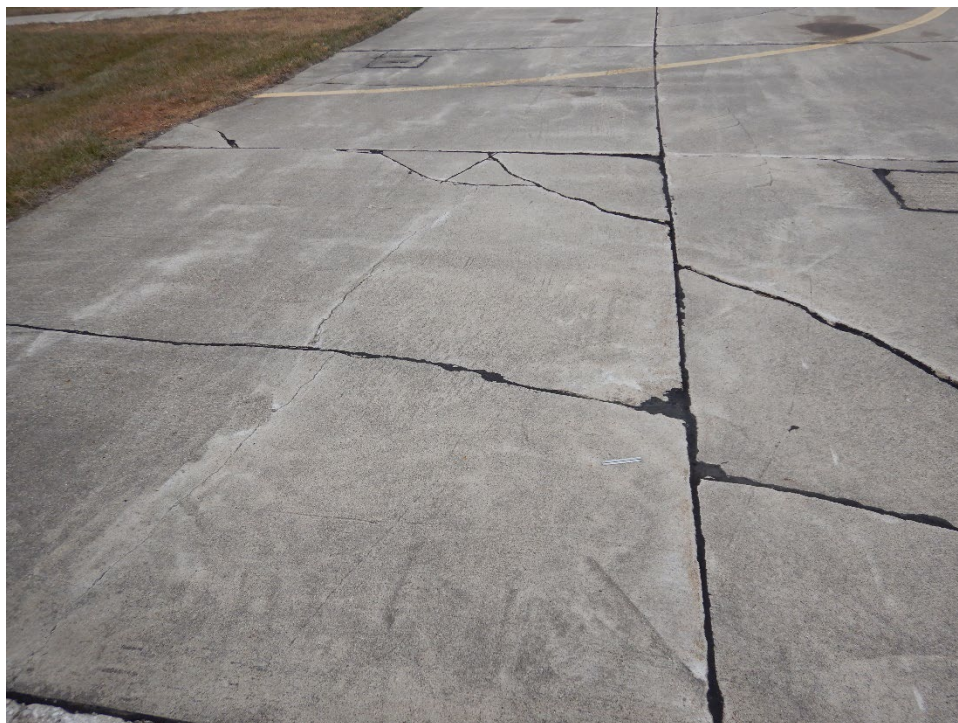
A01AG-02. Shattered Slab (Sample Unit No. 01).

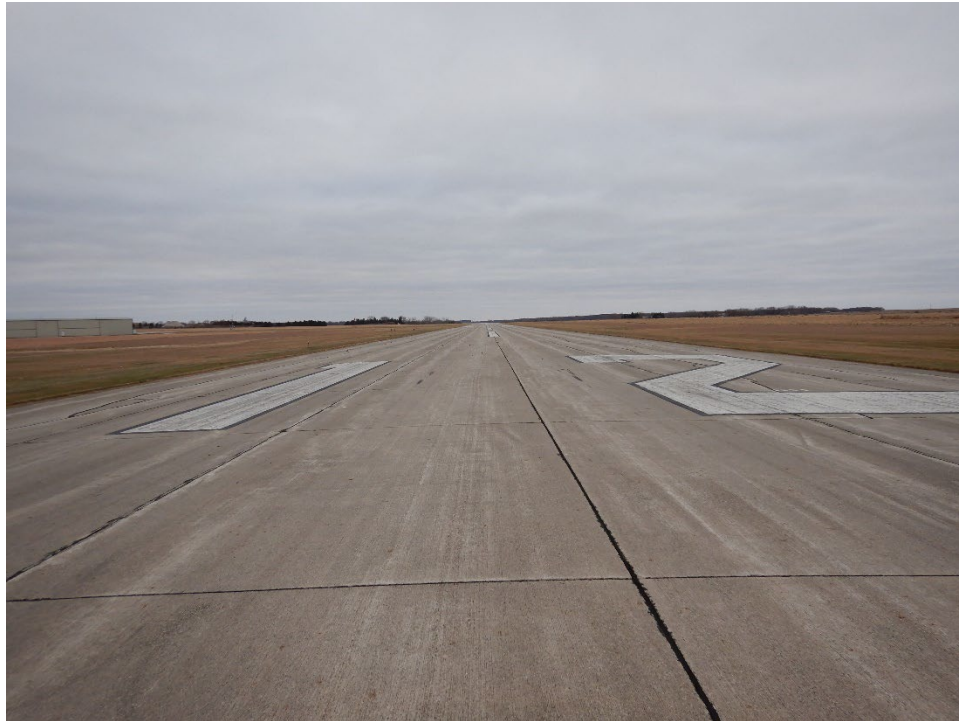
R12AG-01. Overview.

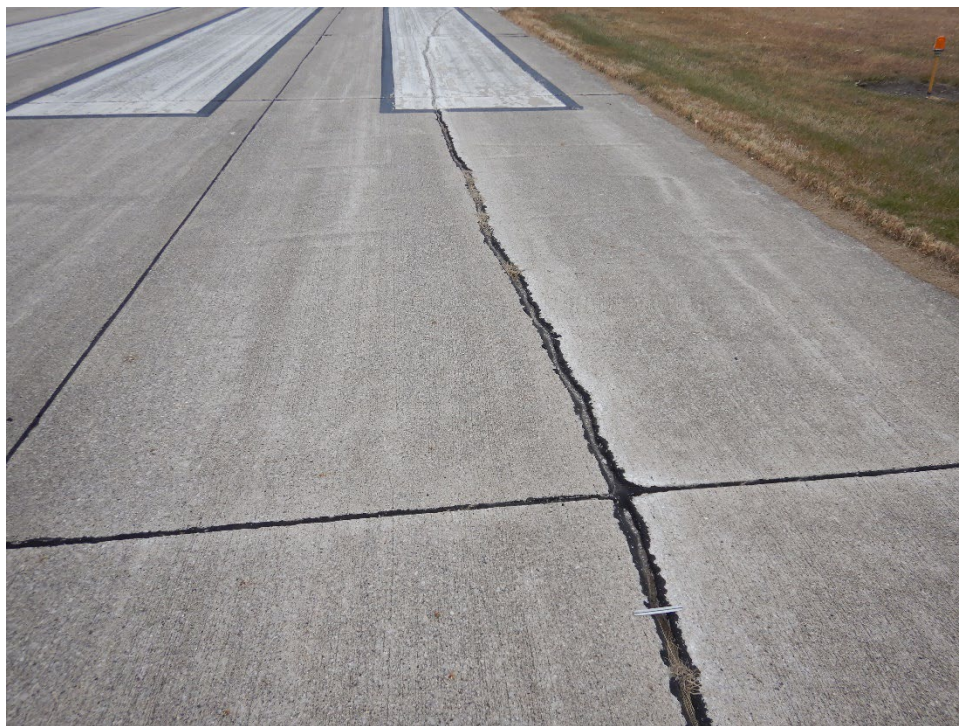
R12AG-01. LTD Cracking (Sample Unit No. 05).

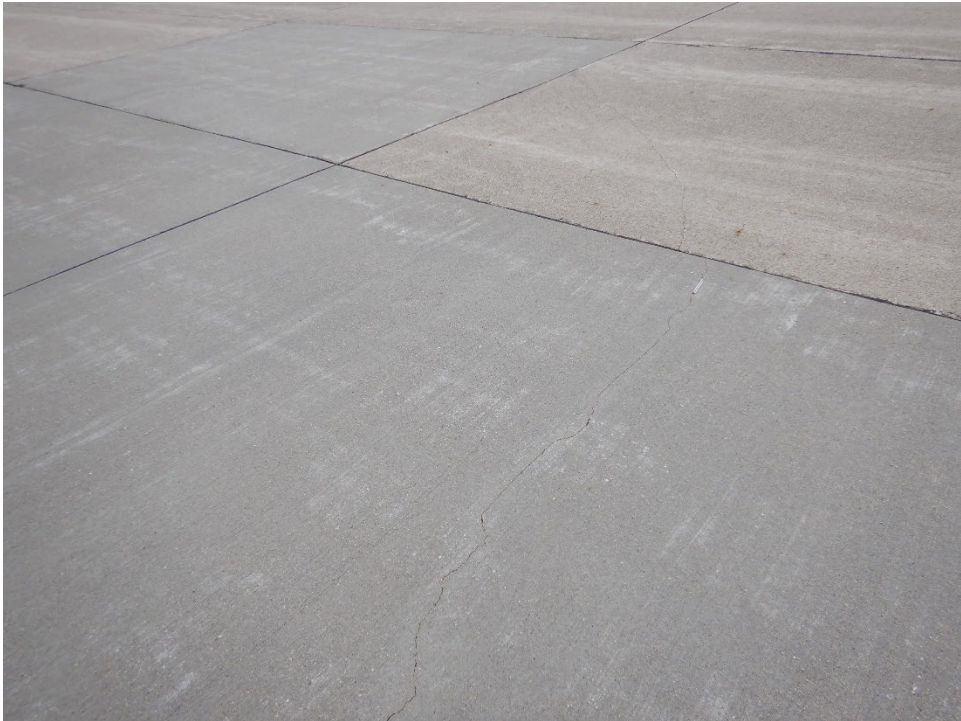
R12AG-01. LTD Cracking (Sample Unit No. 32).

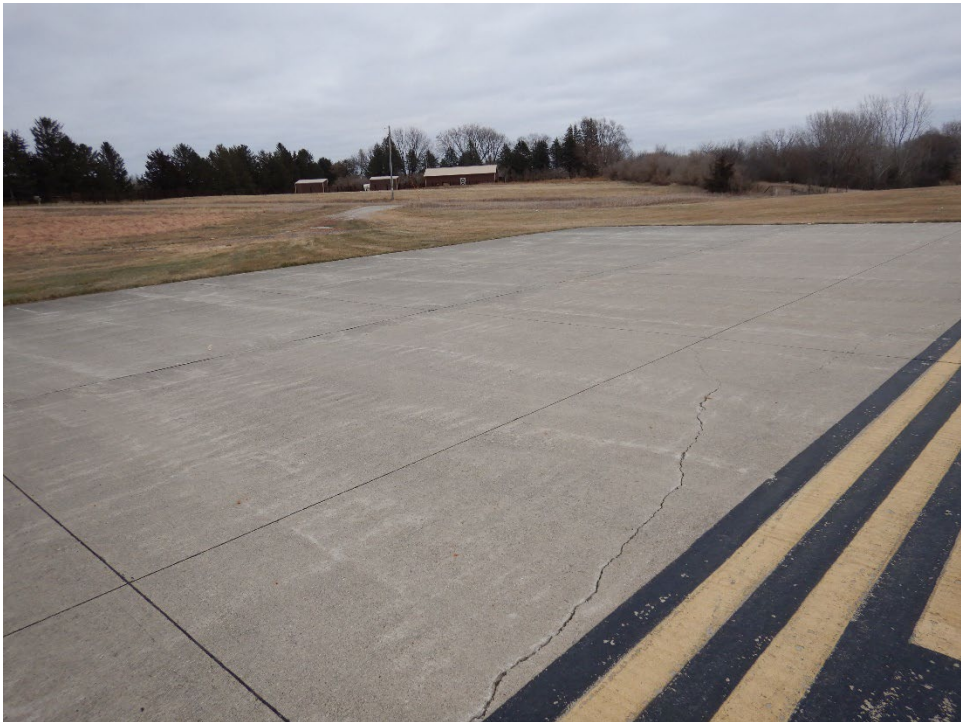
R12AG-02. Overview.

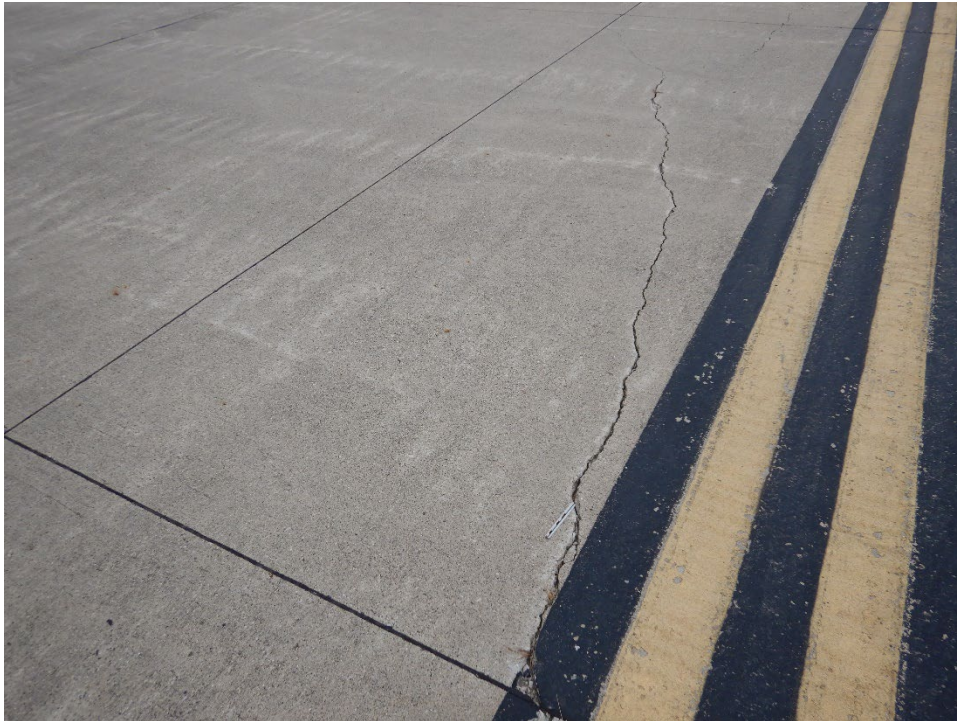
R12AG-02. LTD Cracking (Sample Unit No. 01).

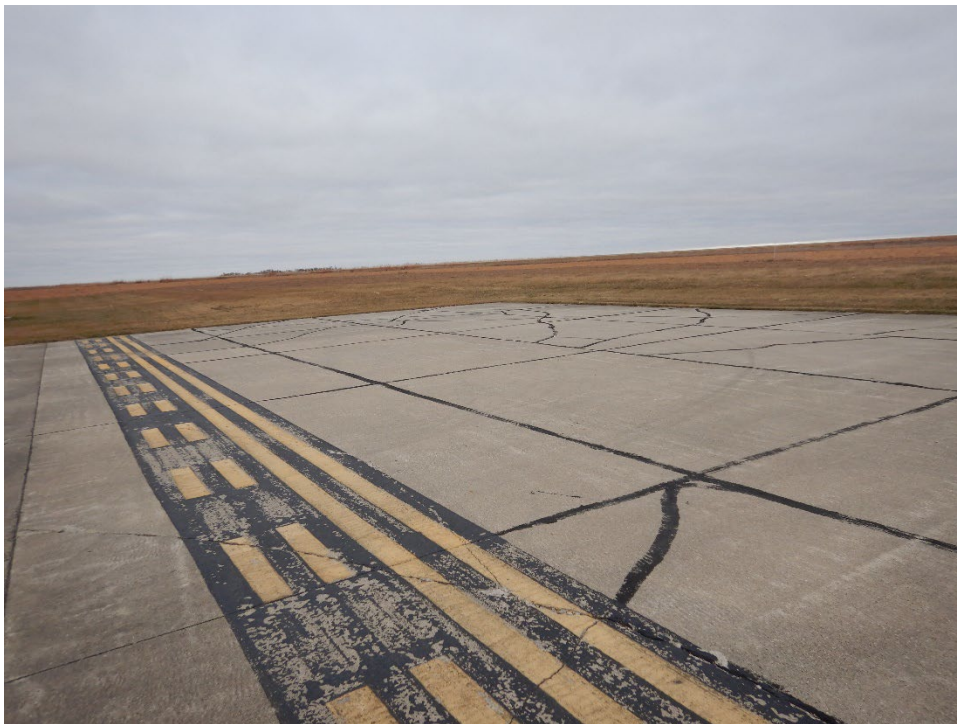
R12AG-03. Overview.

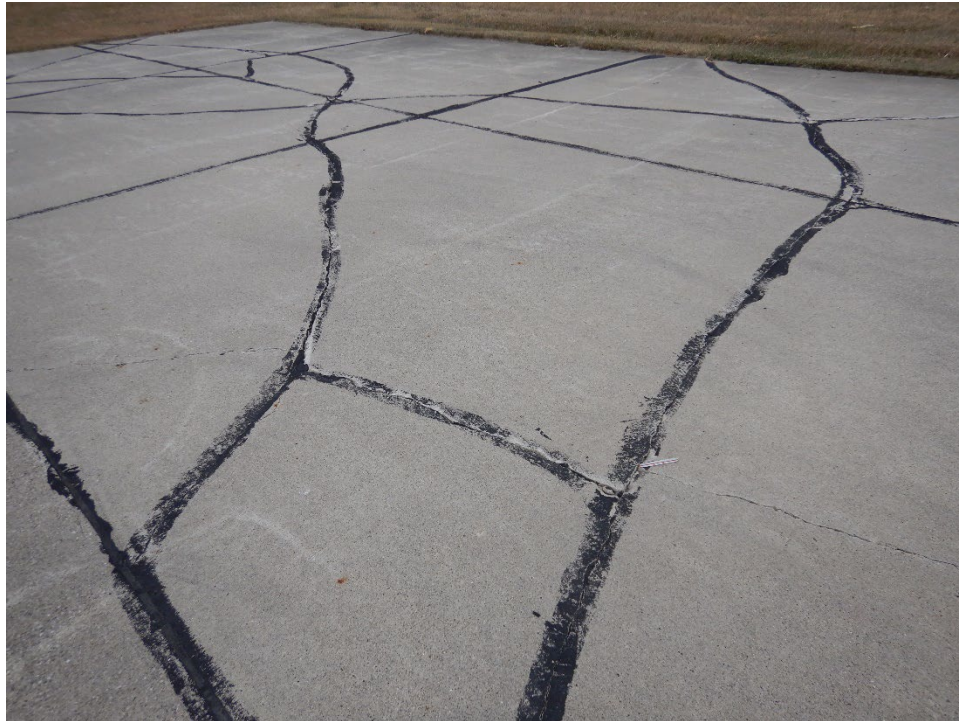
R12AG-03. Shattered Slab (Sample Unit No. 01).

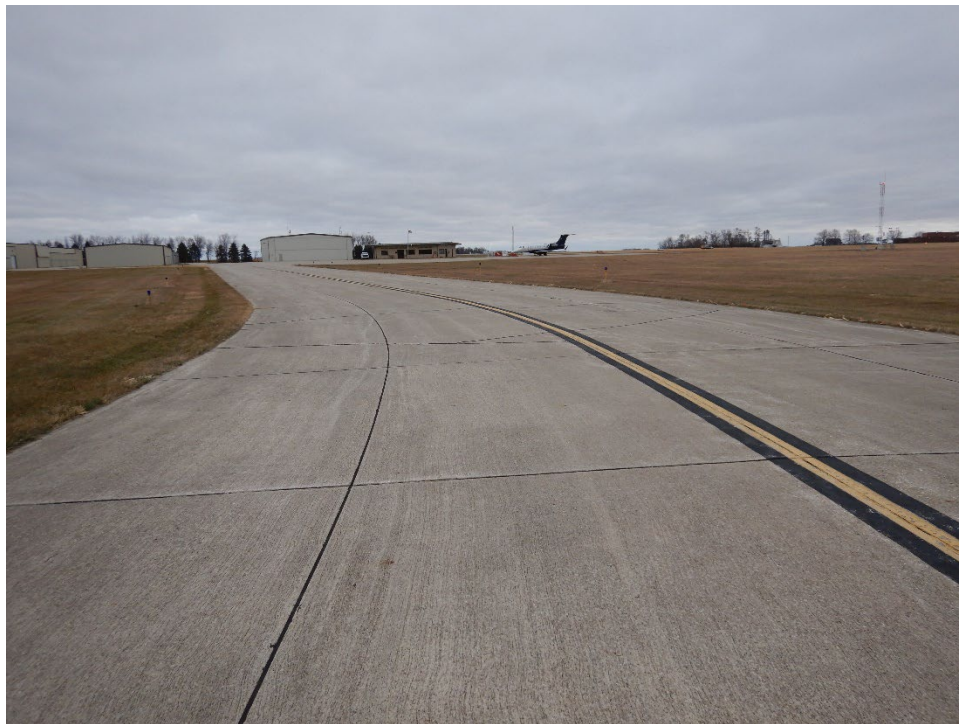
T01AG-01. Overview.

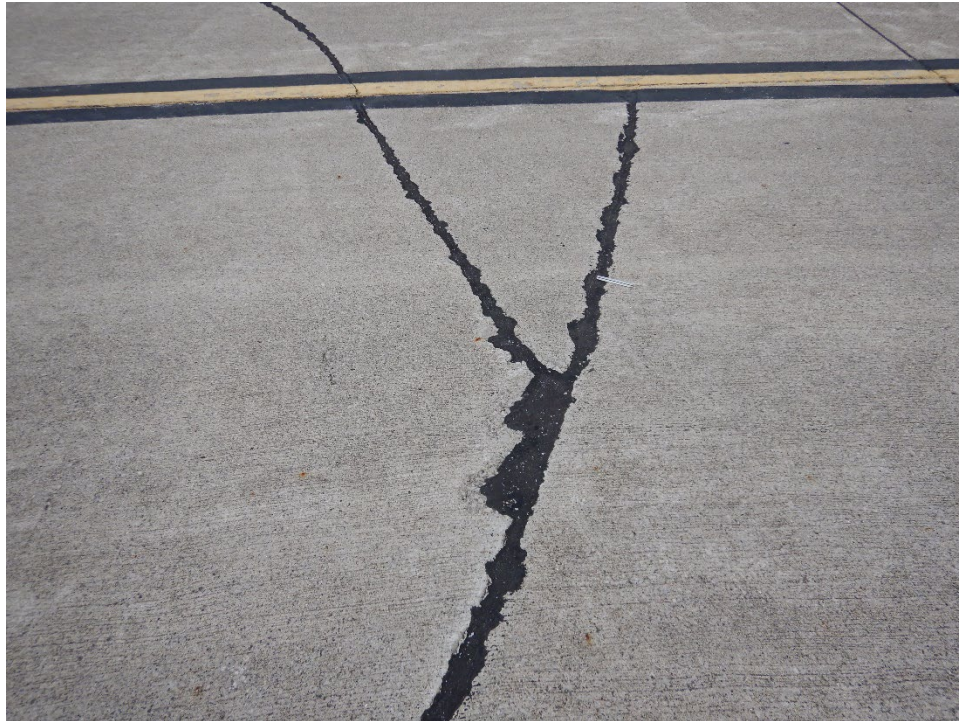
T01AG-01. LTD Cracking (Sample Unit No. 04).

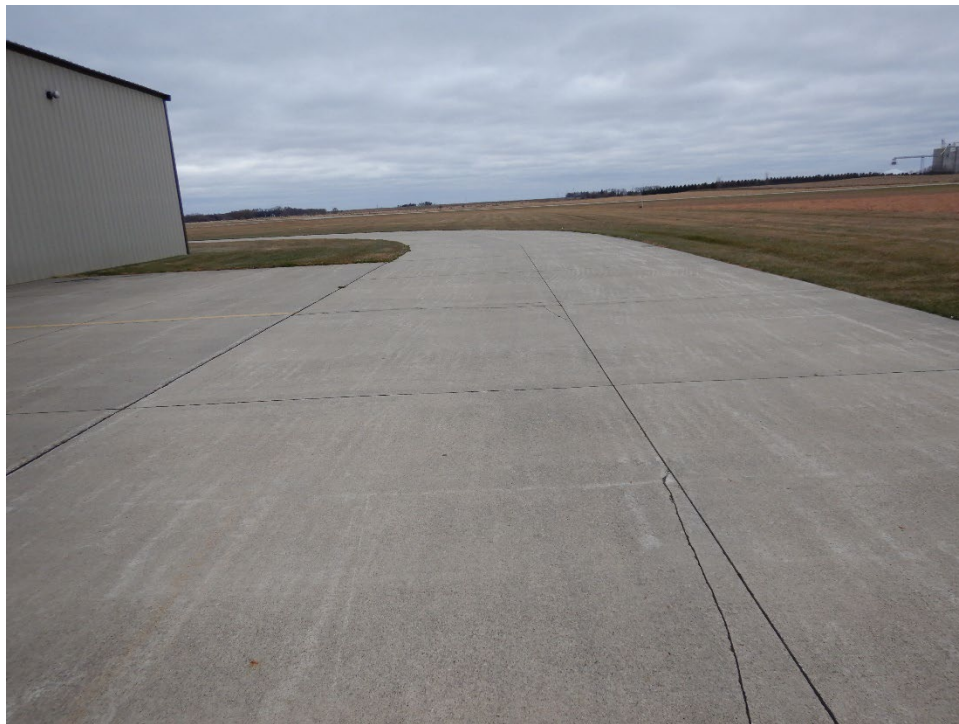
TH01AG-01. Overview.

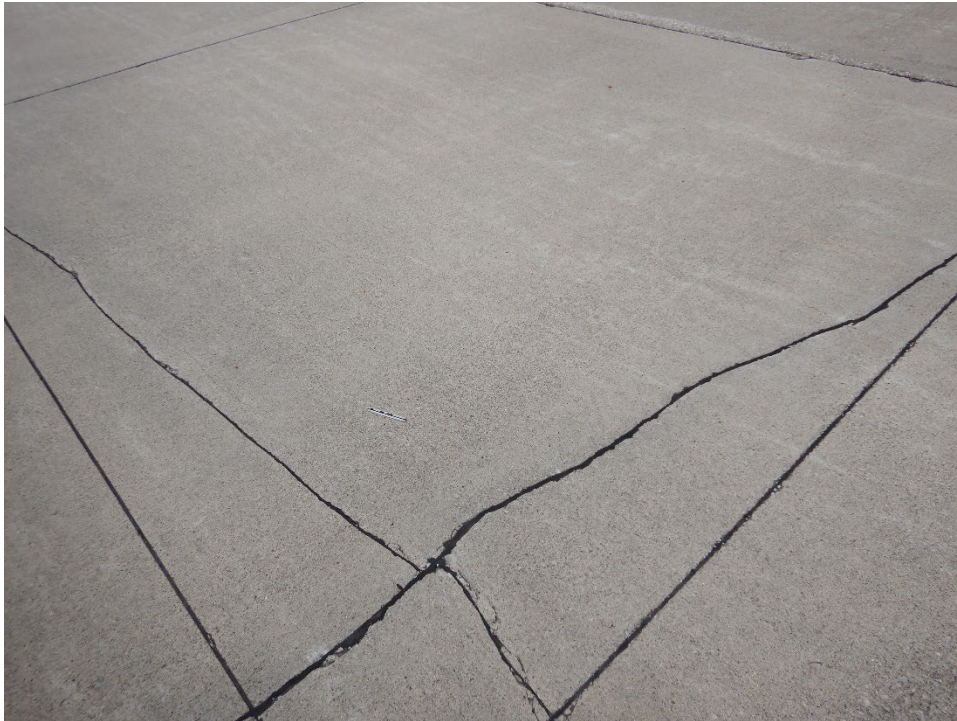
TH01AG-01. Shattered Slab (Sample Unit No. 03).

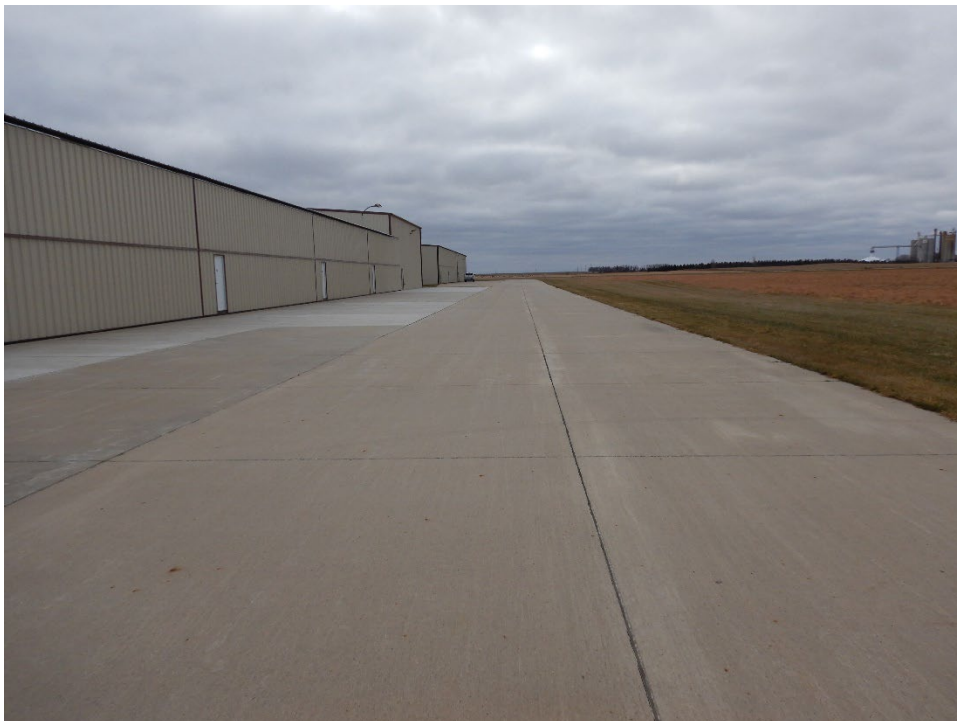
TH01AG-02. Overview.

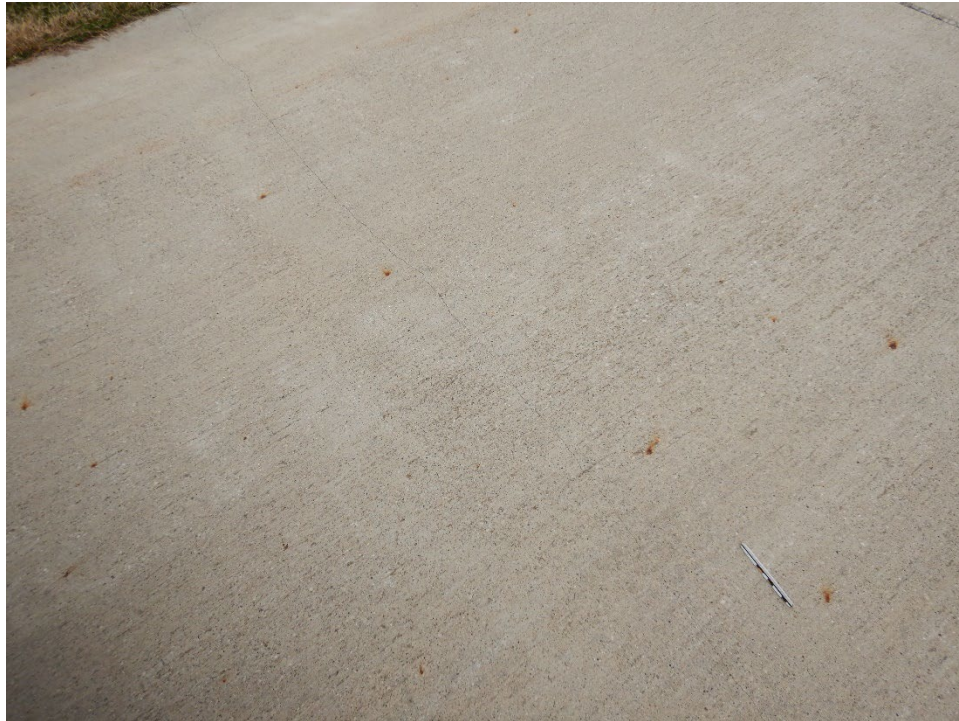
TH01AG-02. LTD Cracking (Sample Unit No. 03).

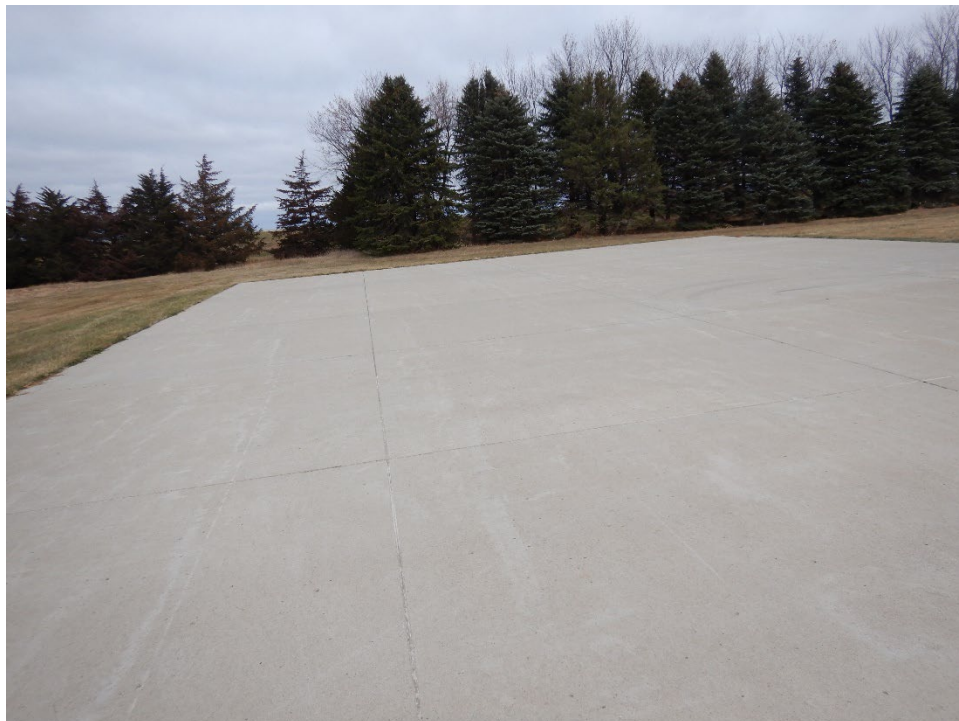
TH01AG-03. Overview.

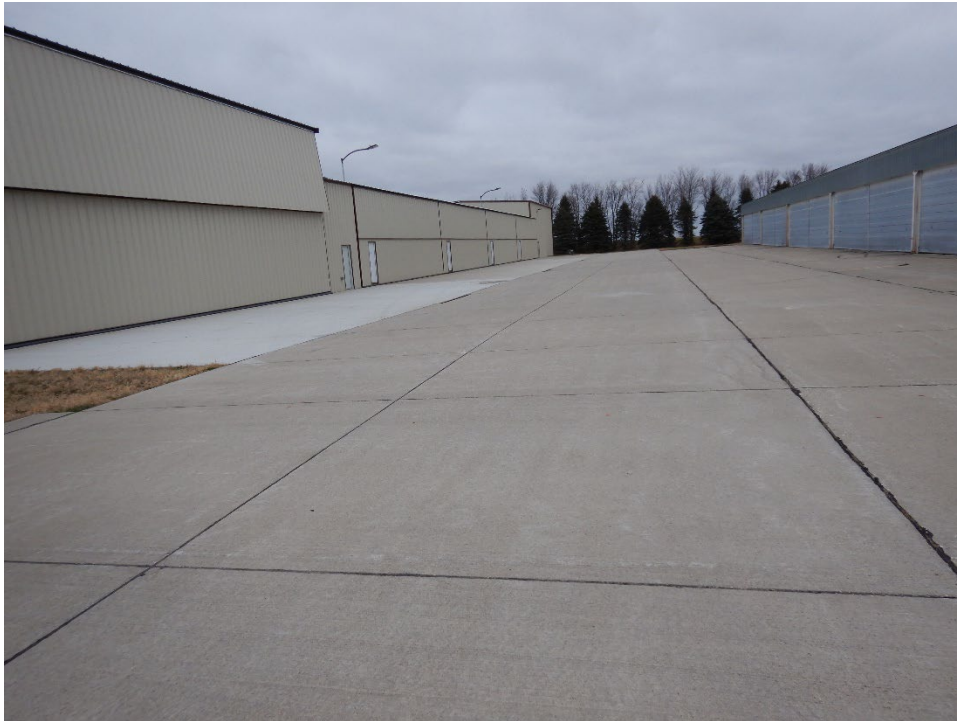
TH01AG-04. Overview.

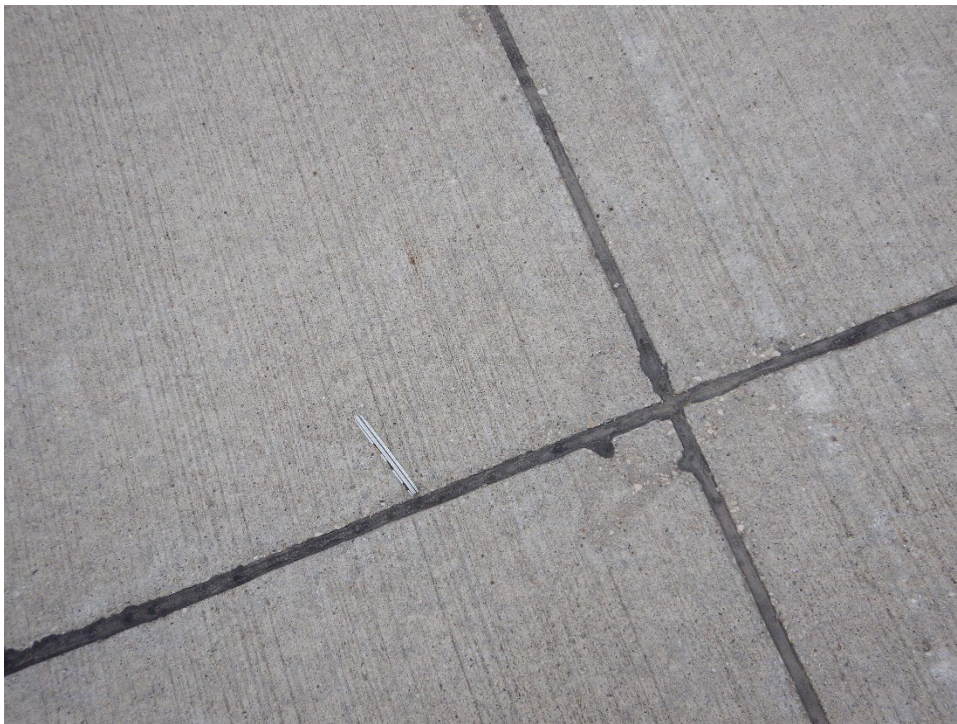
TH01AG-04. Joint Seal Damage (Sample Unit No. 02).

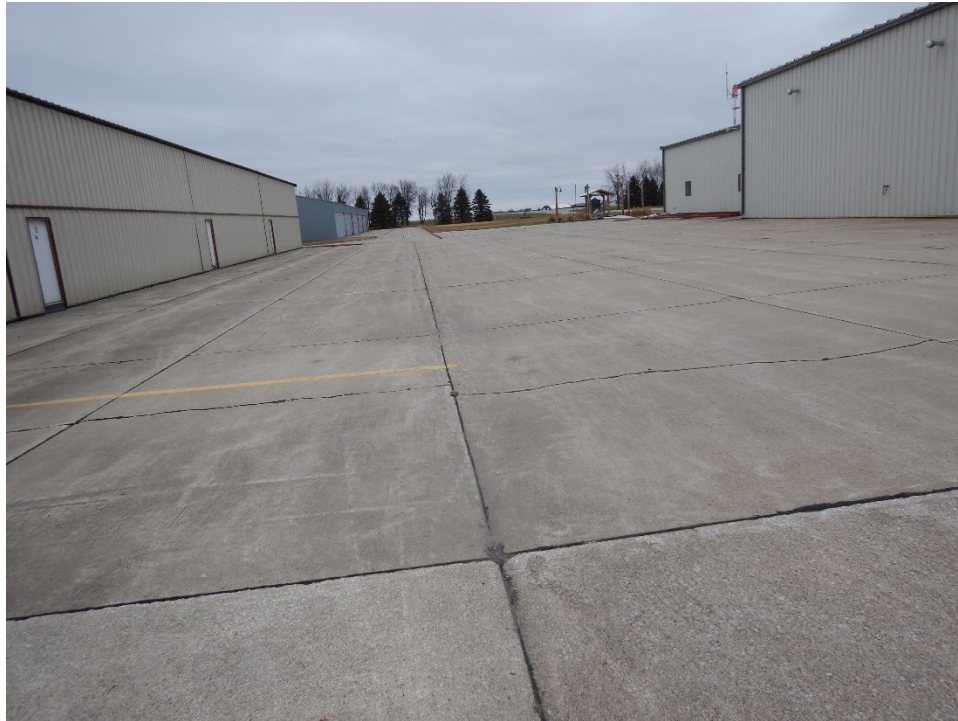
TH01AG-05. Overview.

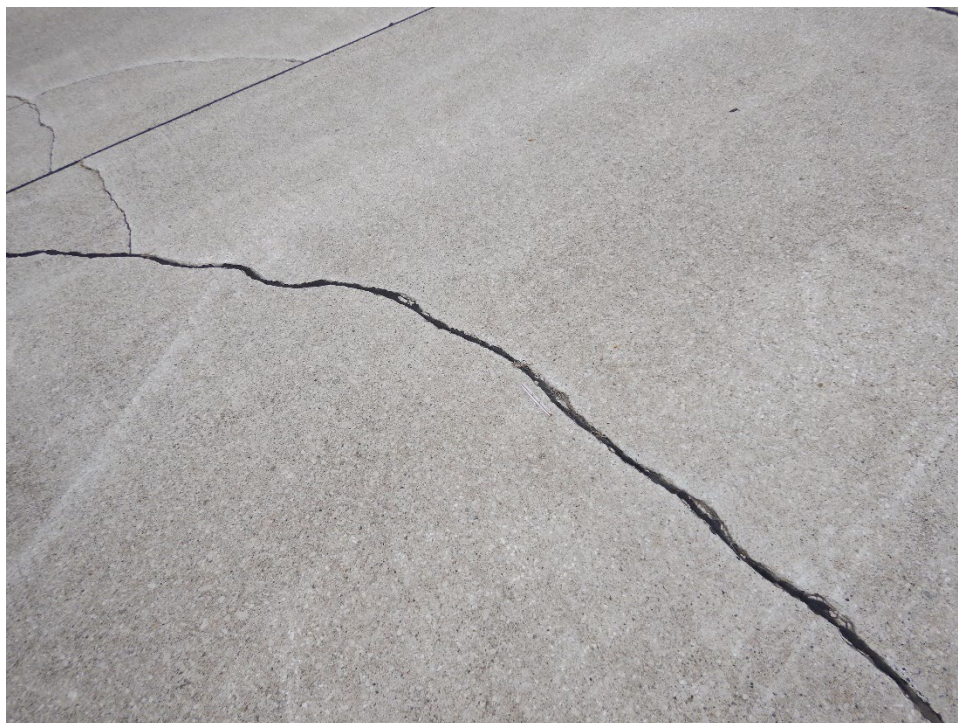
TH01AG-05. LTD Cracking (Sample Unit No. 01).

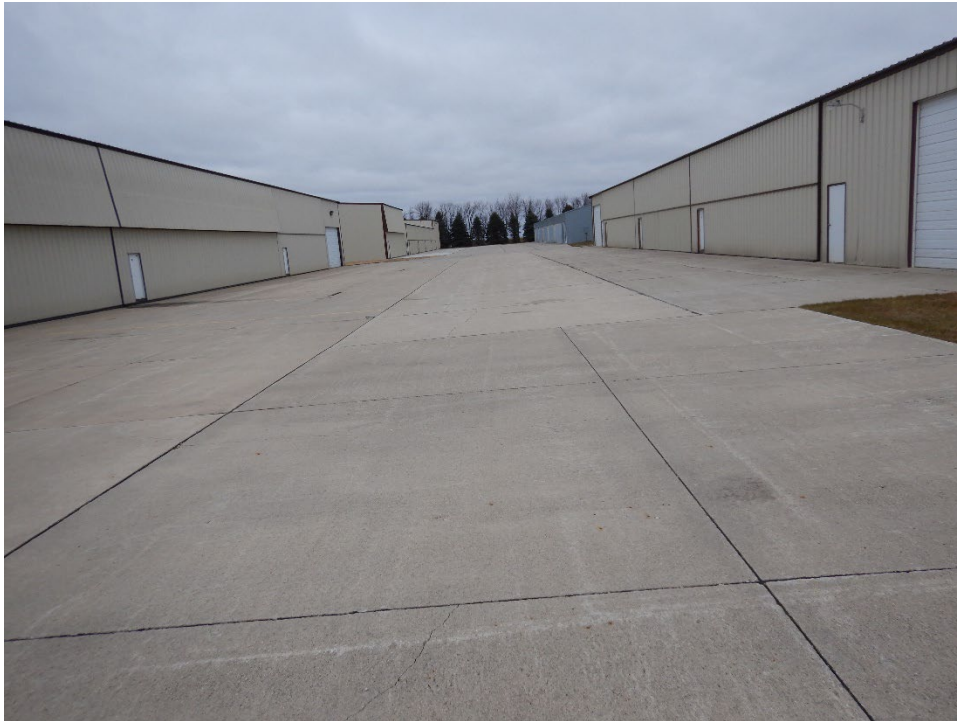
TH01AG-06. Overview.

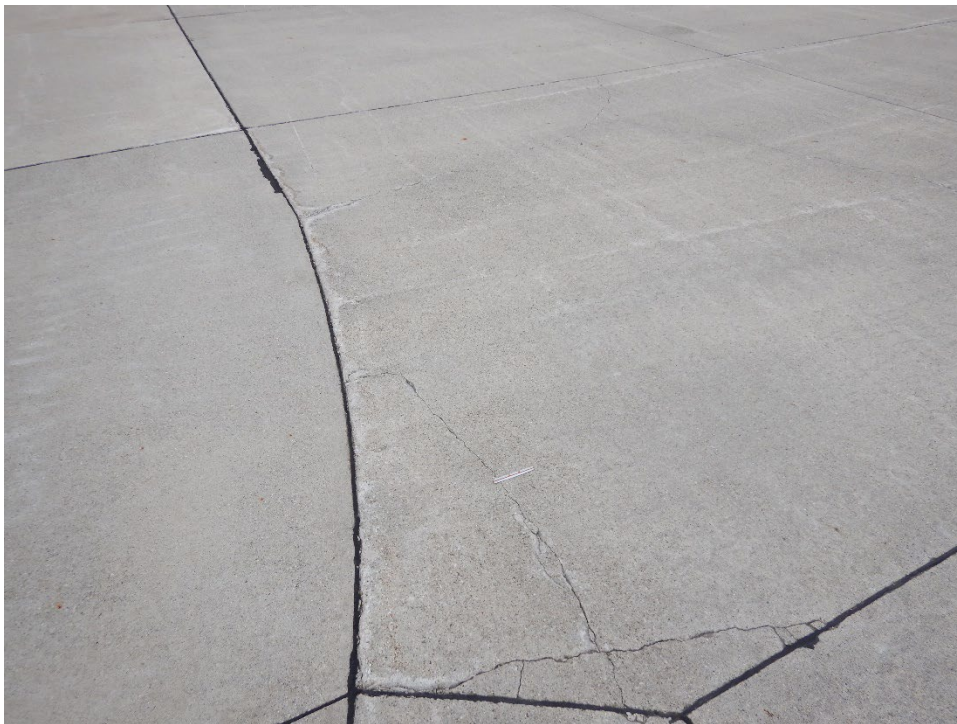
TH01AG-06. Shattered Slab (Sample Unit No. 05).
