# Algona Municipal Airport

## Pavement Management Report

**AUGUST 2026**

# ALGONA MUNICIPAL AIRPORT PAVEMENT MANAGEMENT REPORT

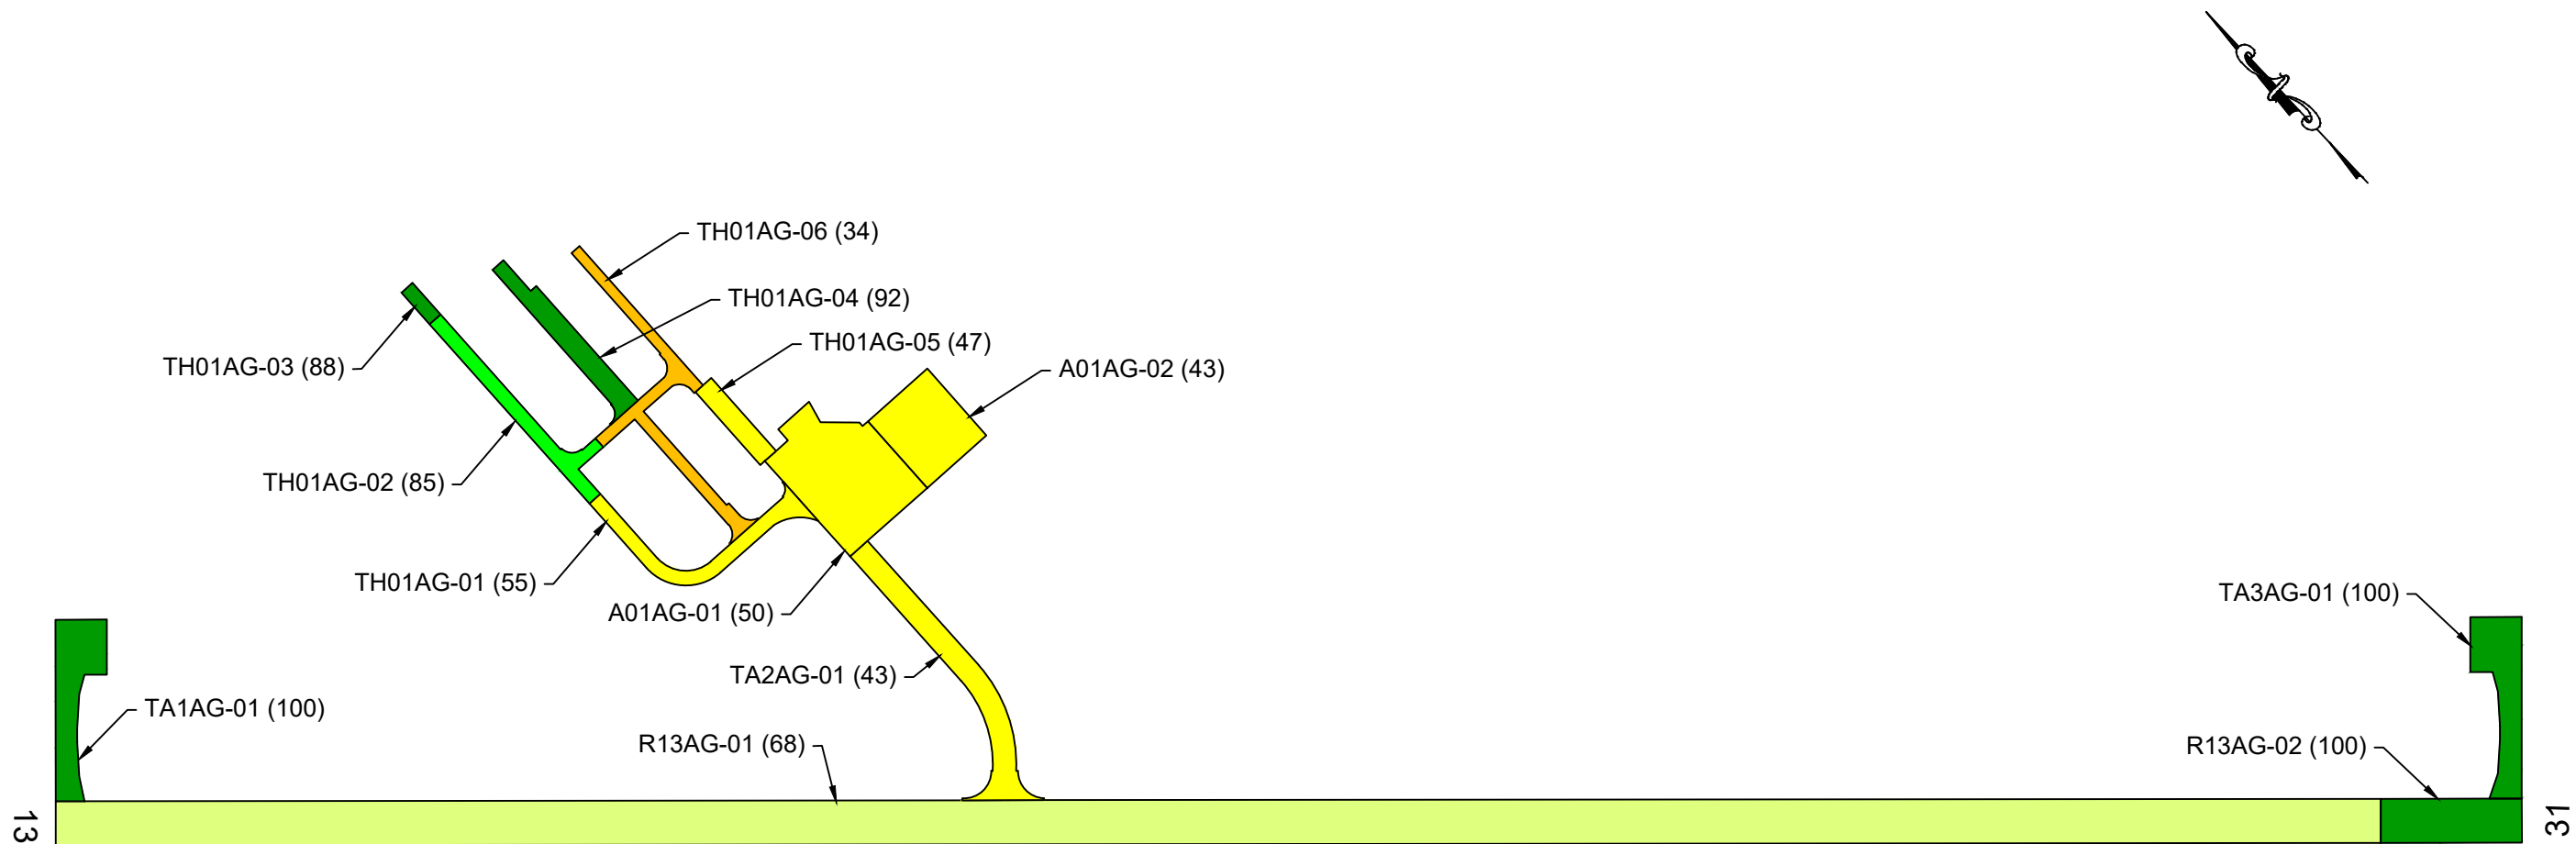
FIGURE 8. PCI MAP.

The pavements at Algona Municipal Airport were inspected in February 2026. The 2026 area-weighted condition of Algona Municipal Airport is 67, with conditions ranging from 34 to 100 (on a scale of 0 [*Failed*] to 100 [*Excellent*]). During the previous pavement inspection in 2022, the area-weighted PCI of the airport was 63.

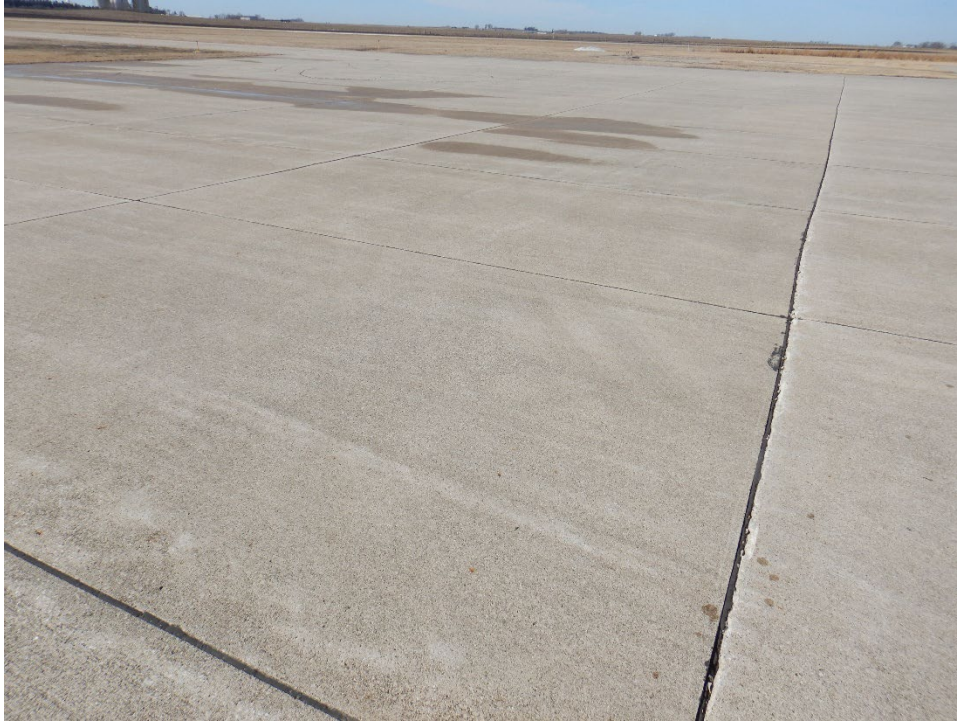
The apron area was defined by two sections. Section 01 contained low- and medium-severity corner spalling, faulting, LTD cracking, and shattered slab; high-severity joint seal damage and large patching; and medium- and high-severity joint spalling. Low- and medium-severity corner break, joint spalling, LTD cracking, and shattered slab; low- and high-severity corner spalling; low-severity faulting, large patching, and small patching; high-severity joint seal damage; and shrinkage cracking were identified in Section 02.

A01AG-01. Overview.

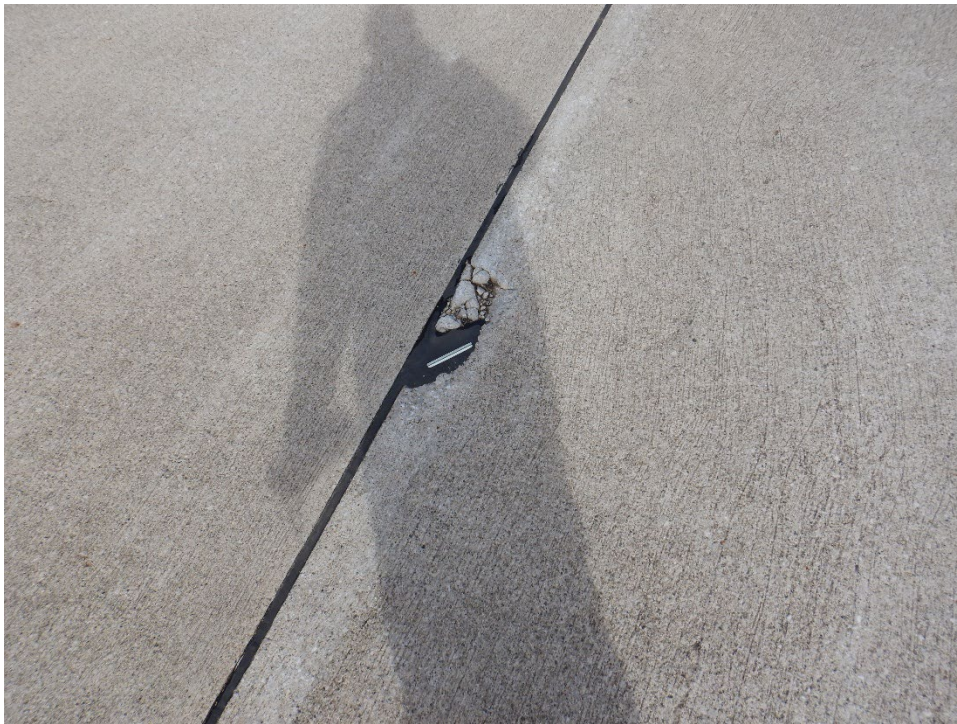
A01AG-01. Joint Spalling (Sample Unit No. 06).

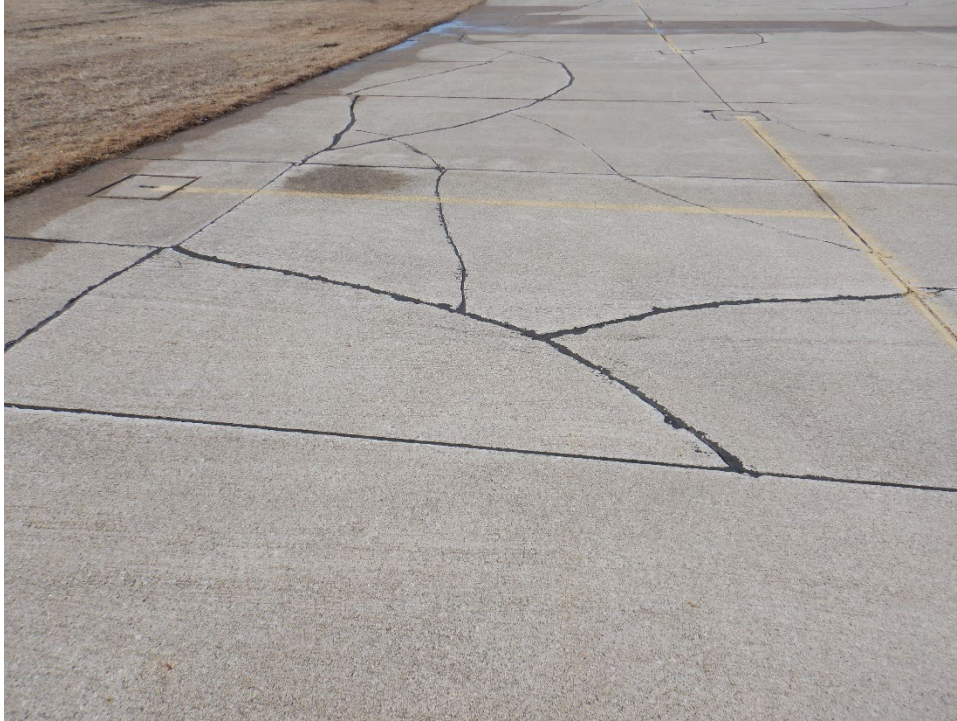
A01AG-01. Shattered Slab (Sample Unit No. 06).

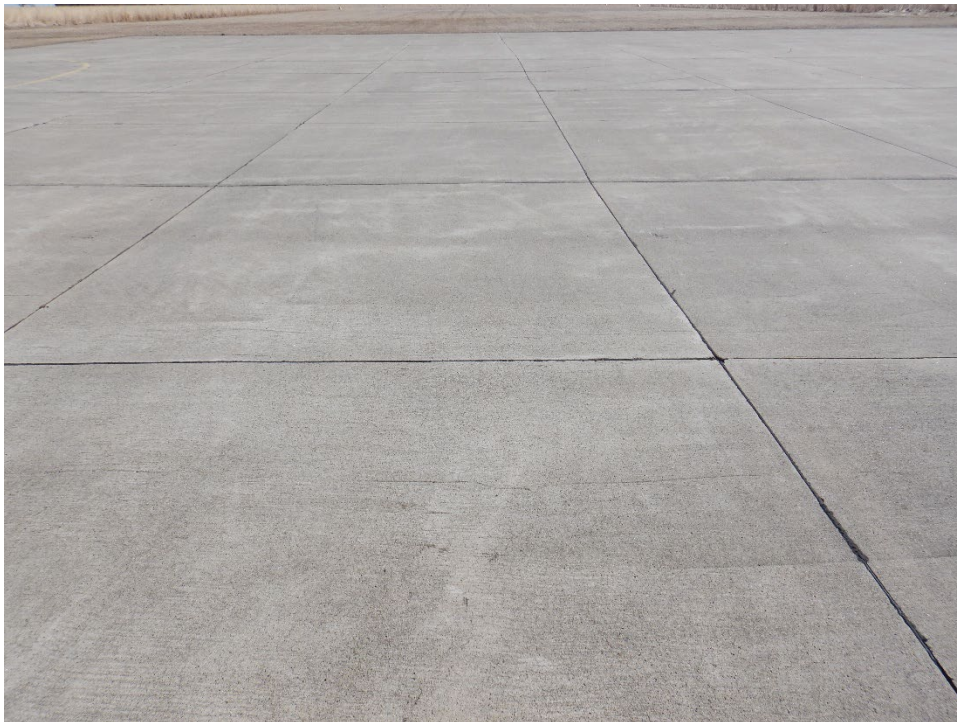
A01AG-02. Overview.

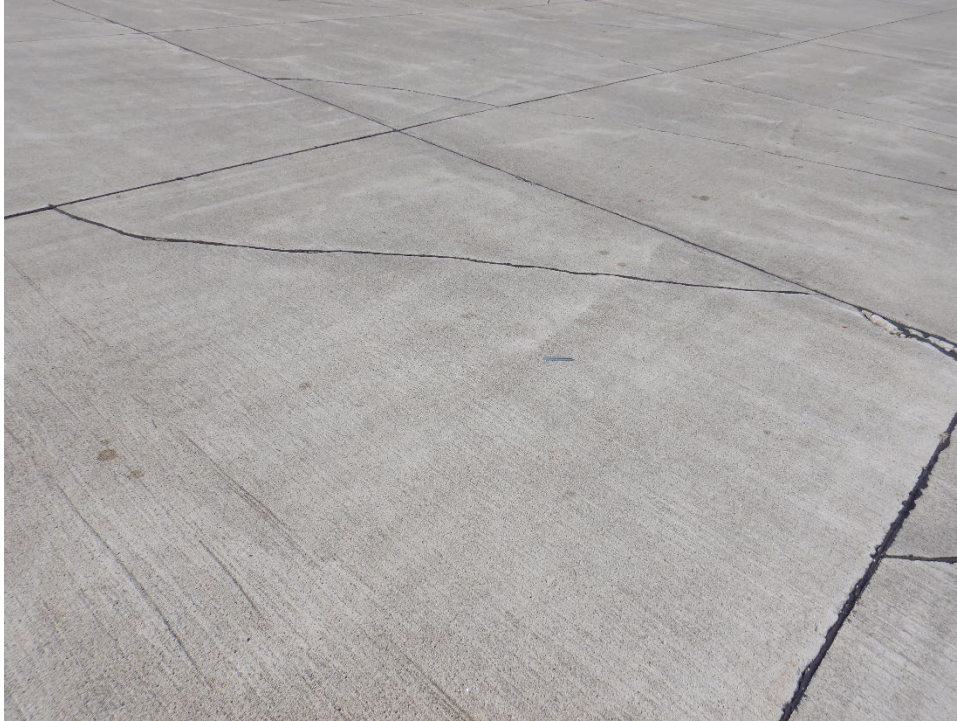
A01AG-02. LTD Cracking (Sample Unit No. 02).

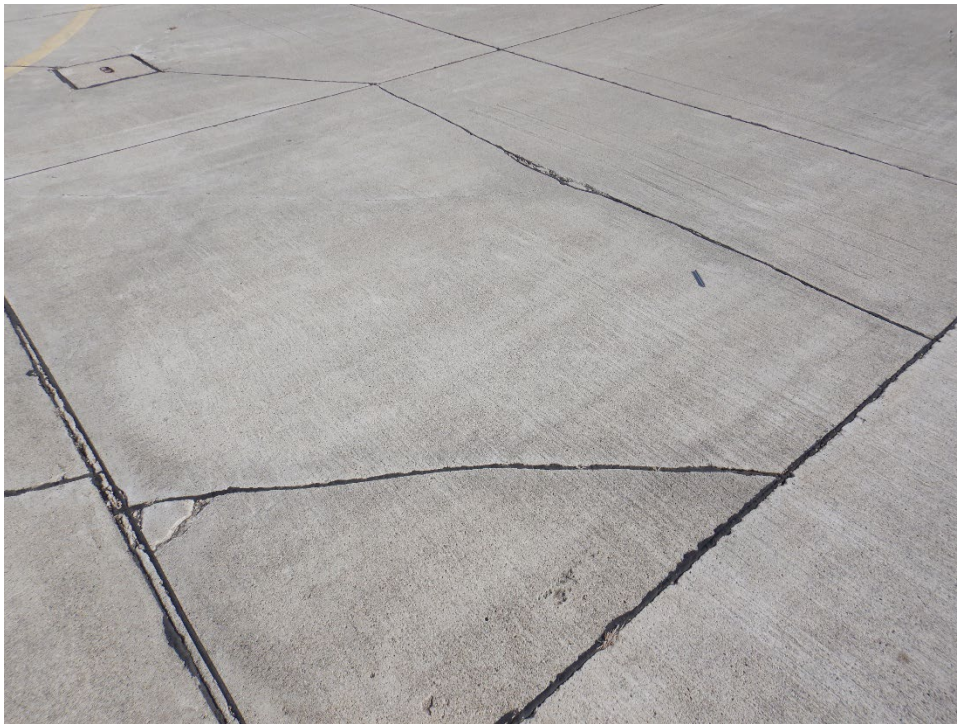
A01AG-02. Shattered Slab (Sample Unit No. 02).

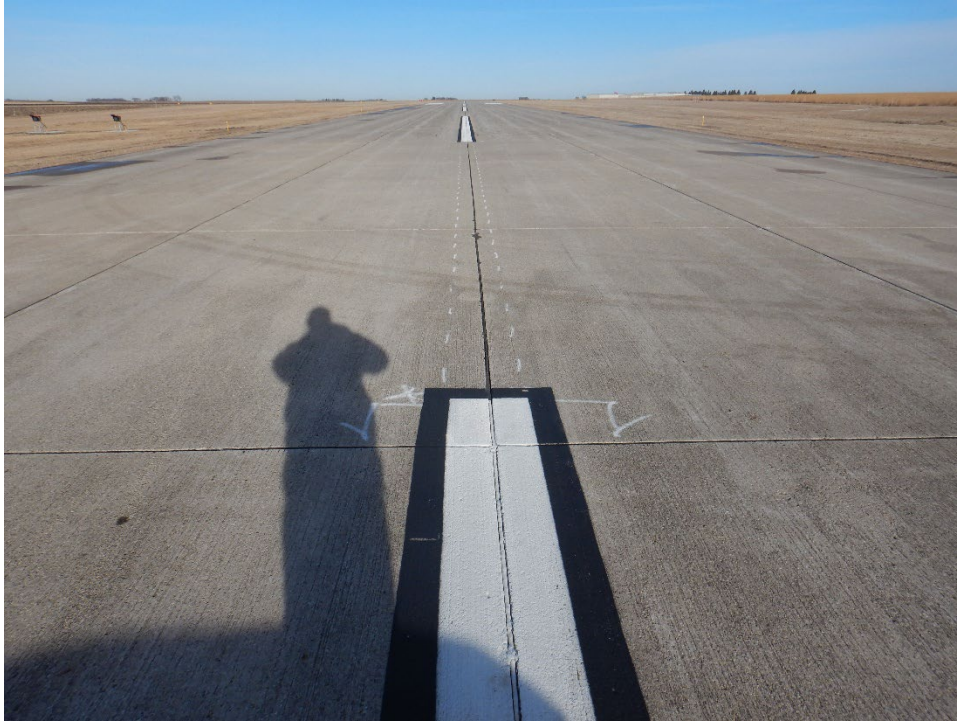
Runway 13/31 was defined by two sections. Most of the runway was Section 01 and had areas of low- and medium-severity corner break, corner spalling, faulting, joint spalling, and longitudinal, transverse, and diagonal (LTD) cracking; low-severity shattered slab; high-severity joint seal damage; and medium-severity small patching. Section 02 was in *Excellent* condition with no distress noted at the time of inspection.

R13AG-01. Overview.

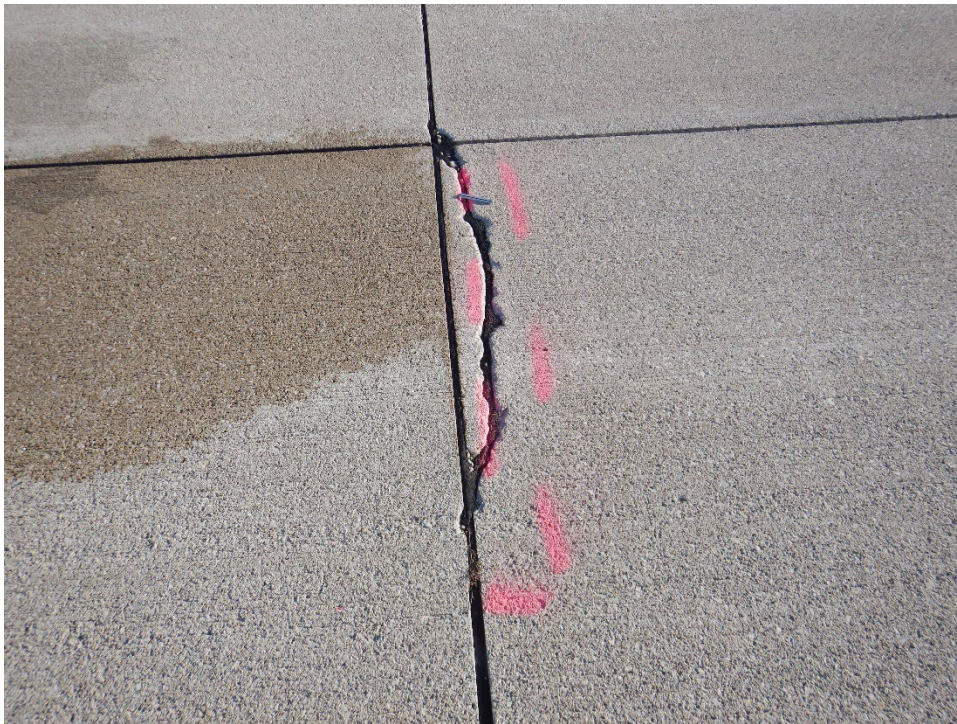
R13AG-01. Joint Spalling (Sample Unit No. 44).

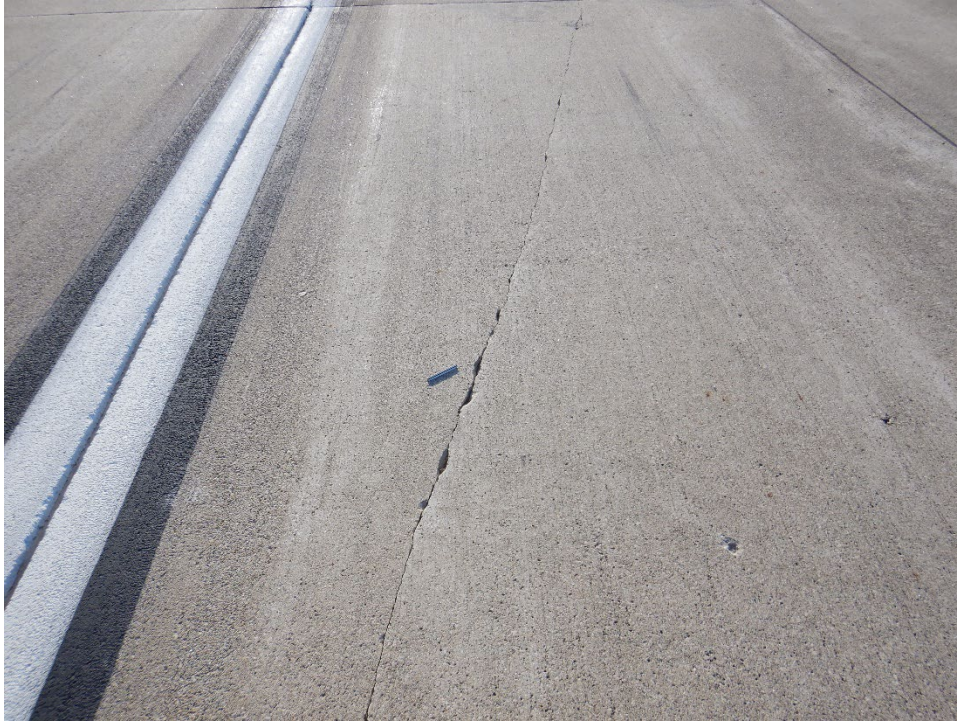
R13AG-01. LTD Cracking (Sample Unit No. 39).

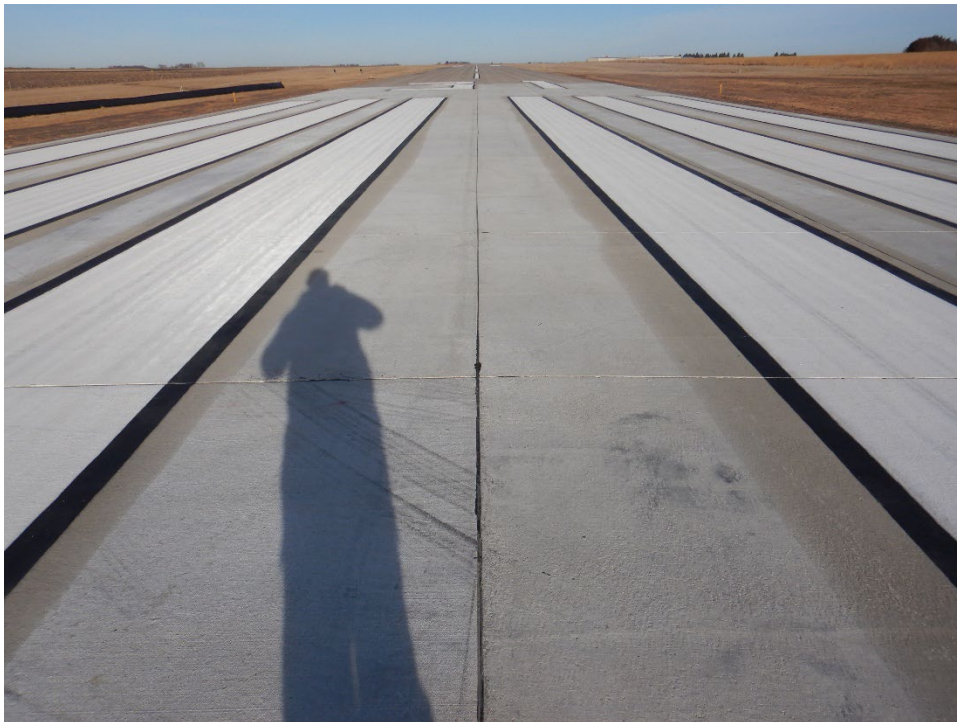
R13AG-02. Overview.

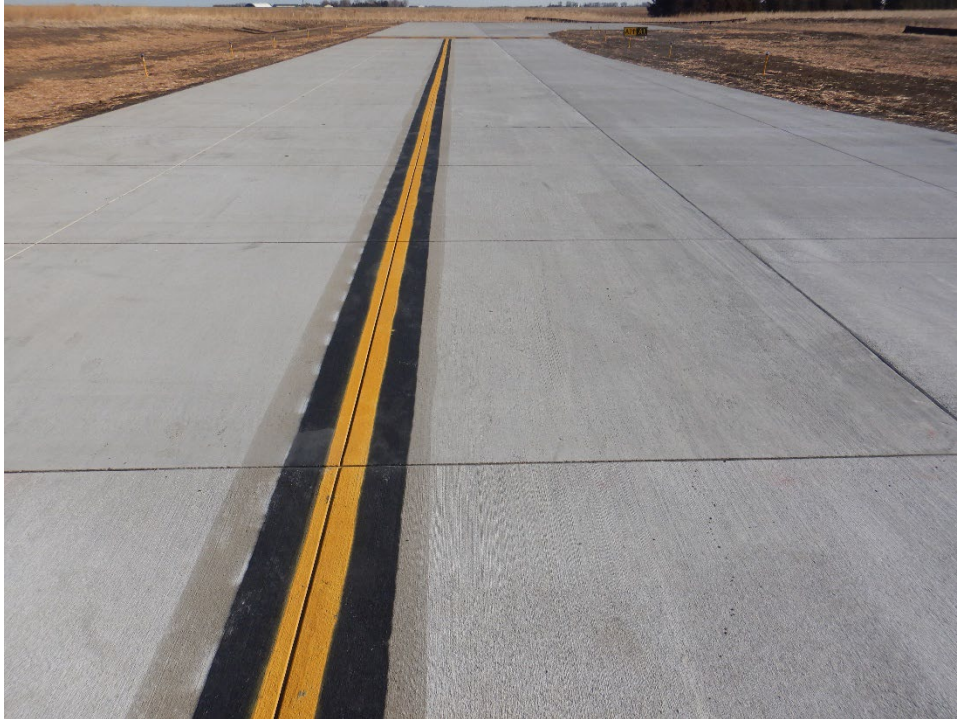
Taxiways A1 and A3 each consisted of one section in *Excellent* condition. No distress was identified in either section during the inspection.

TA1AG-01. Overview.

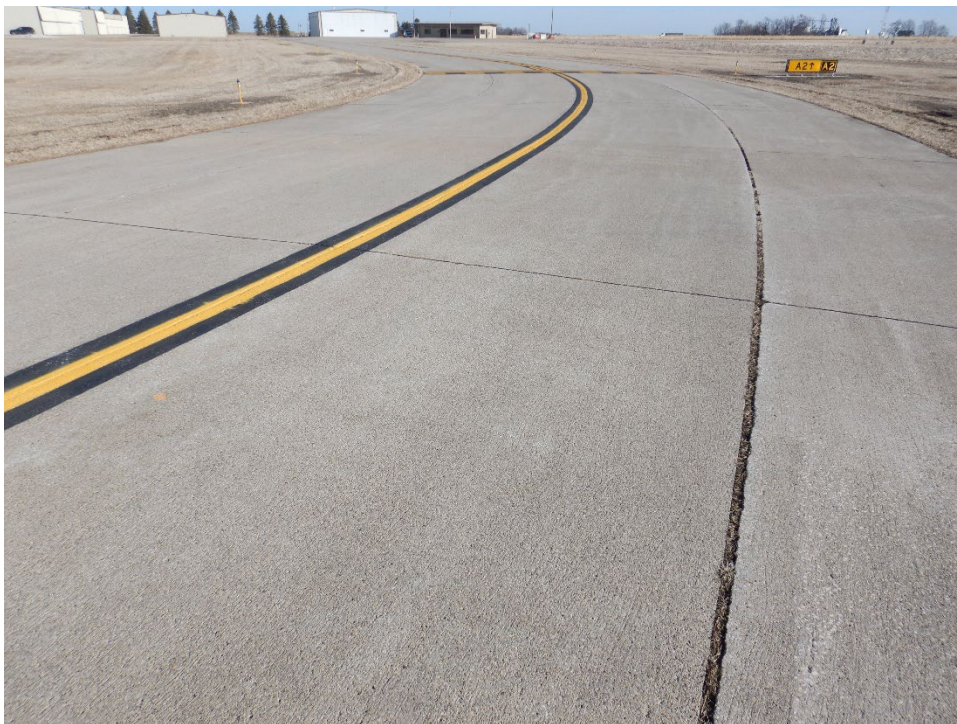
Taxiway A2 contained one section. Low- and high-severity corner break, low- and medium-severity corner spalling and LTD cracking, low-severity faulting and small patching, high-severity joint seal damage, medium- and high-severity joint spalling, and shrinkage cracking were recorded in Section 01 during the inspection.

TA2AG-01. Overview.

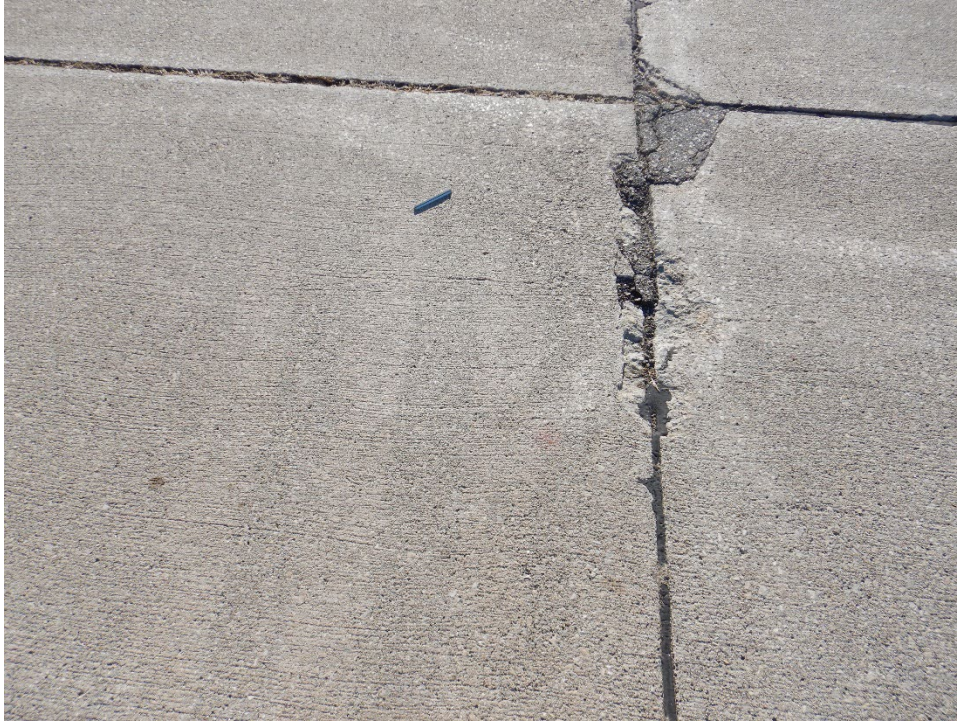
TA2AG-01. Joint Seal Damage (Sample Unit No. 05).

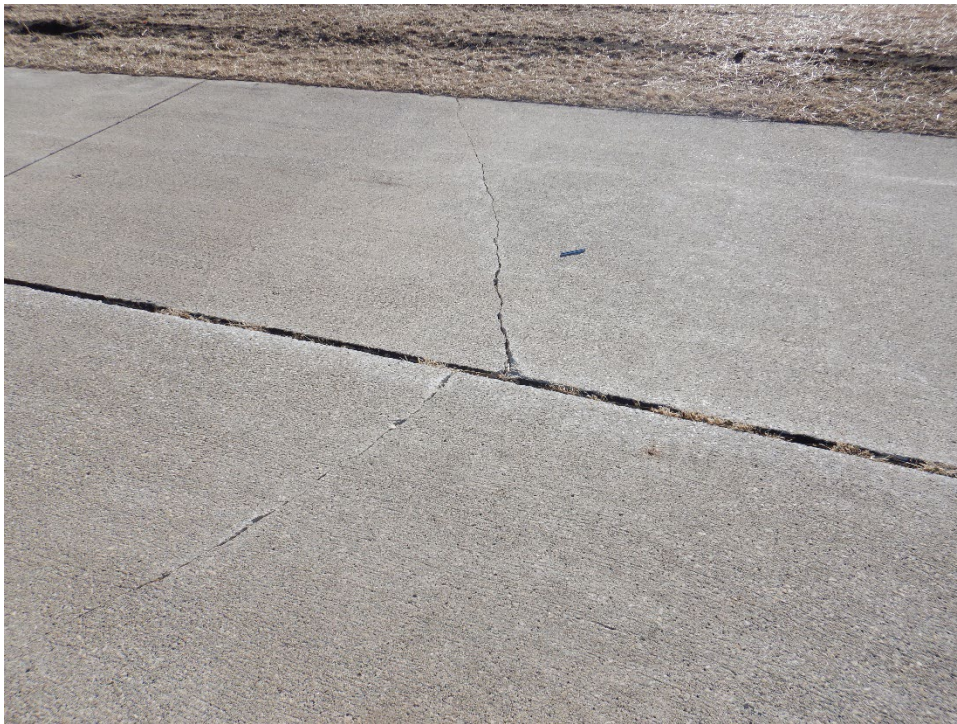
TA2AG-01. LTD Cracking (Sample Unit No. 05).

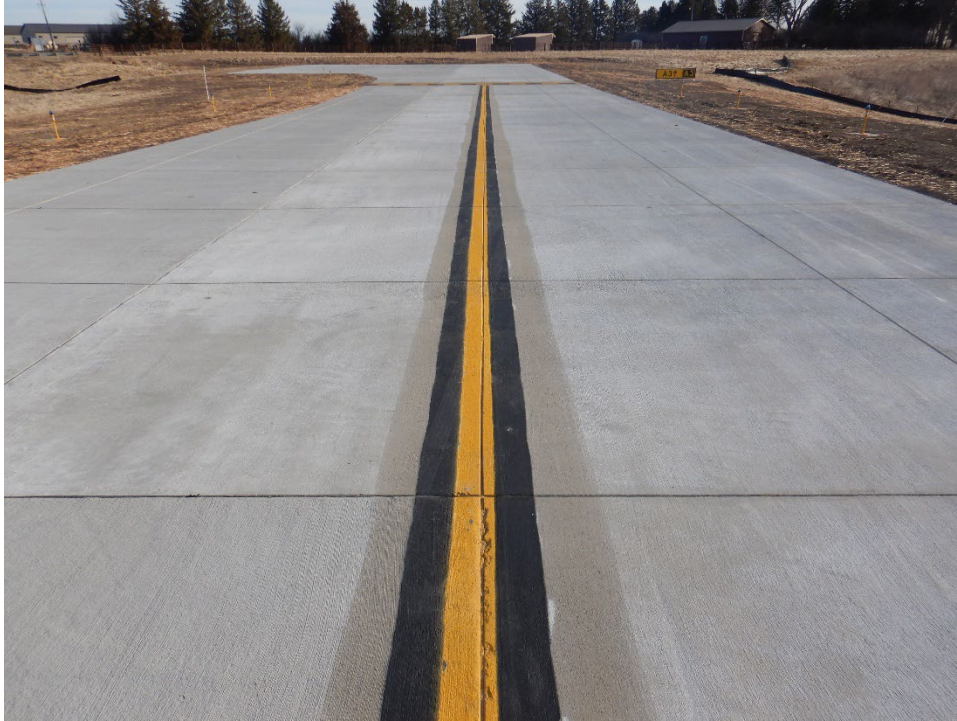
TA3AG-01. Overview.

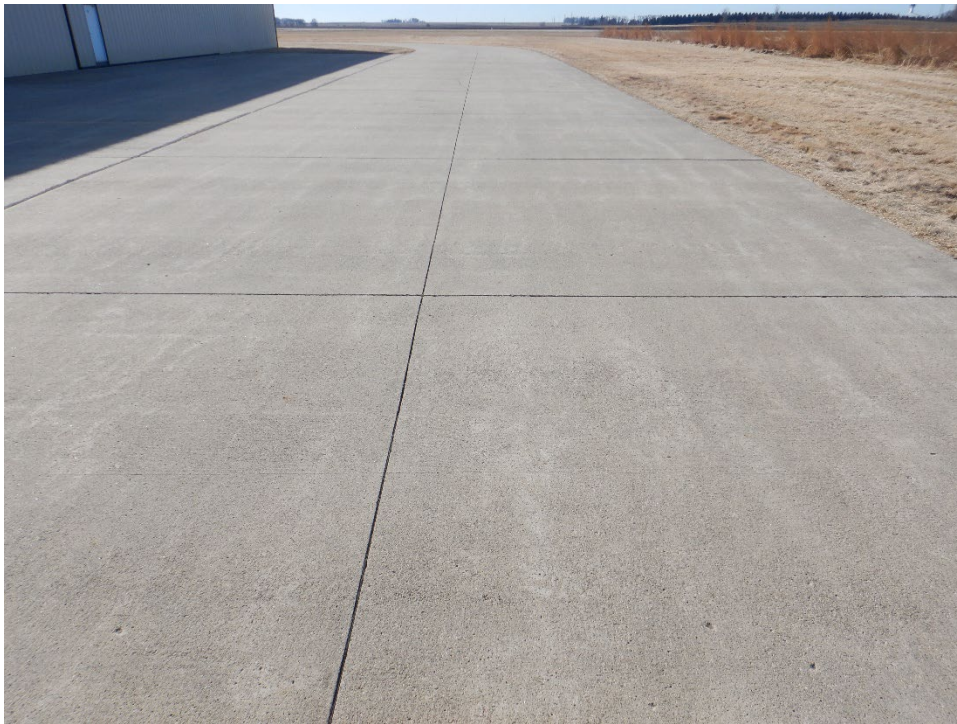
The T-hangar area consisted of six sections. Section 01 contained low- and medium-severity corner break, LTD cracking, joint spalling, and shattered slab; medium-severity joint seal damage; and shrinkage cracking. Low-severity corner spalling and LTD cracking, high-severity joint seal damage, and shrinkage cracking were recorded in Section 02. Section 03 had high-severity joint seal damage noted throughout. In Section 04, areas of low-severity joint seal damage, low- and medium-severity LTD cracking, and shrinkage cracking were observed. Section 05 had medium-severity corner break and LTD cracking, low-severity corner spalling and faulting, high-severity joint seal damage, and shrinkage cracking noted during the inspection. Section 06 was in *Poor* condition. Areas of low- and medium-severity corner break and LTD cracking, low-severity corner spalling and faulting, high-severity joint seal damage and joint spalling, all severities of shattered slabs, and shrinkage cracking were recorded during the inspection.

TH01AG-01. Overview.

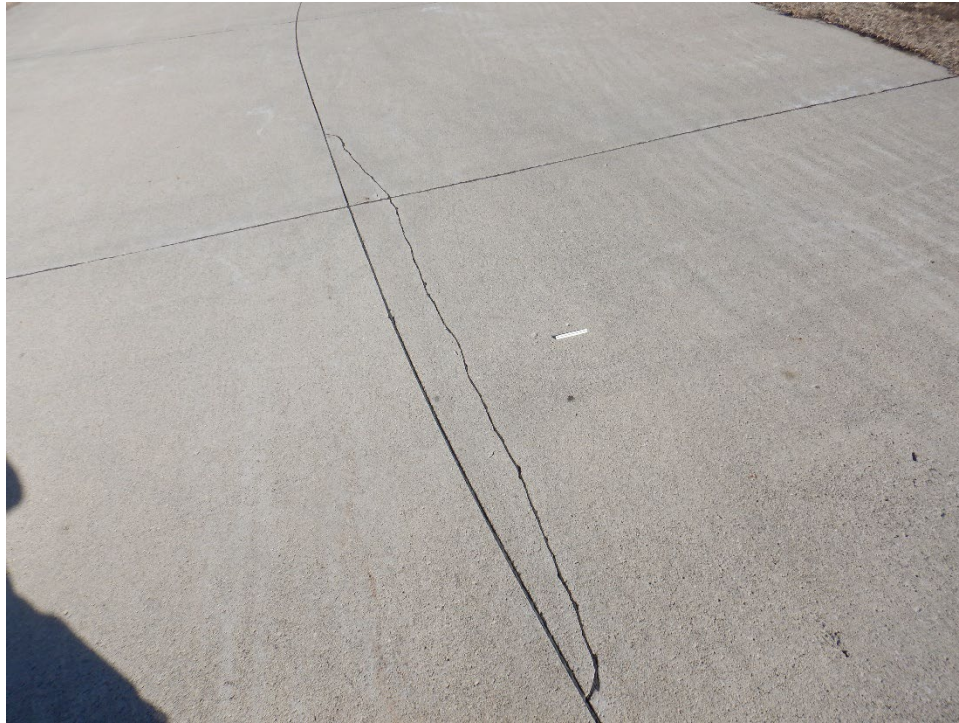
TH01AG-01. LTD Cracking (Sample Unit No. 01).

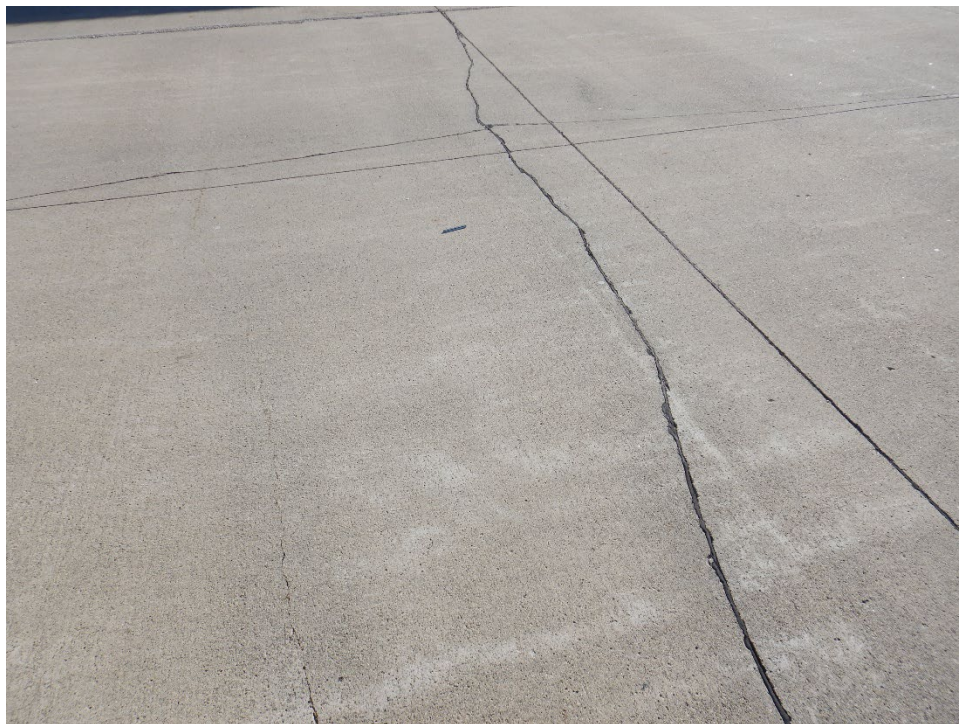
TH01AG-01. LTD Cracking (Sample Unit No. 02).

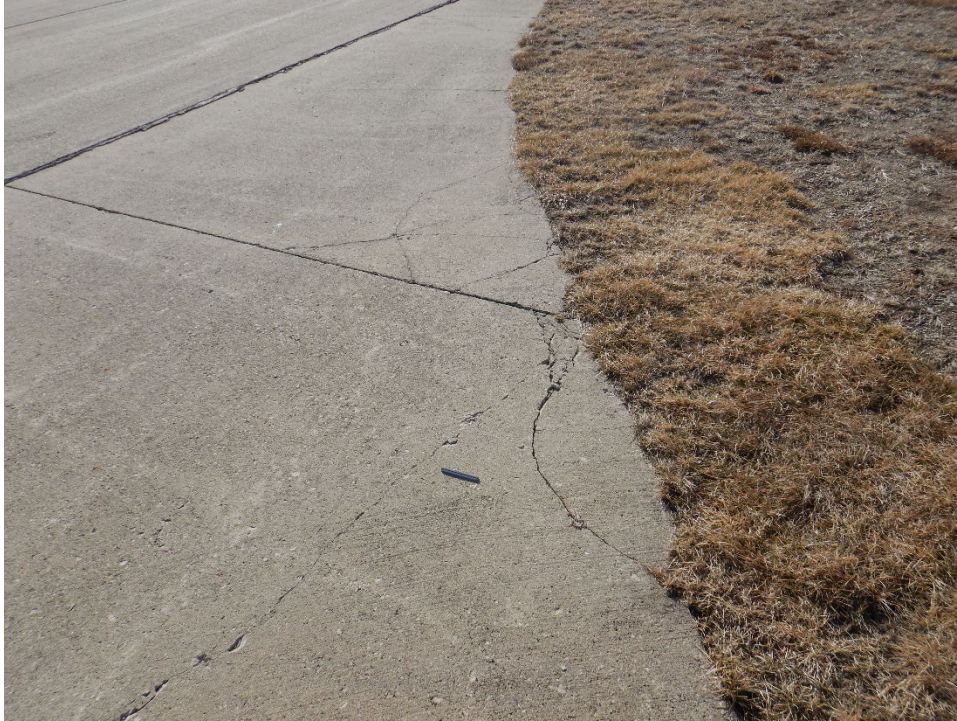
TH01AG-01. Shattered Slab (Sample Unit No. 01).

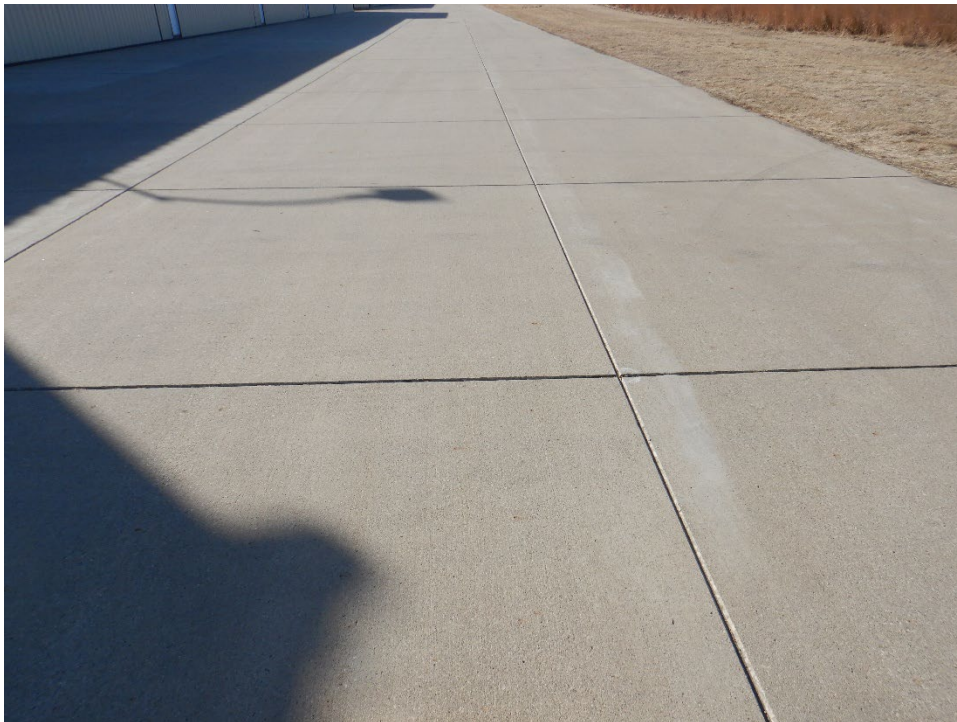
TH01AG-02. Overview.

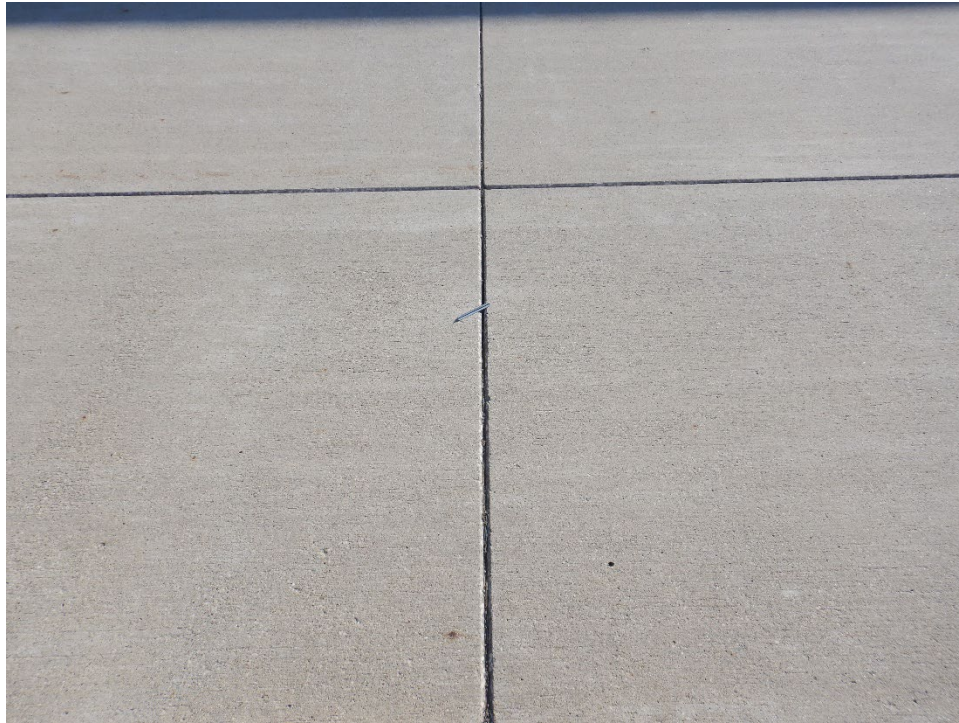
TH01AG-02. Joint Seal Damage (Sample Unit No. 02).

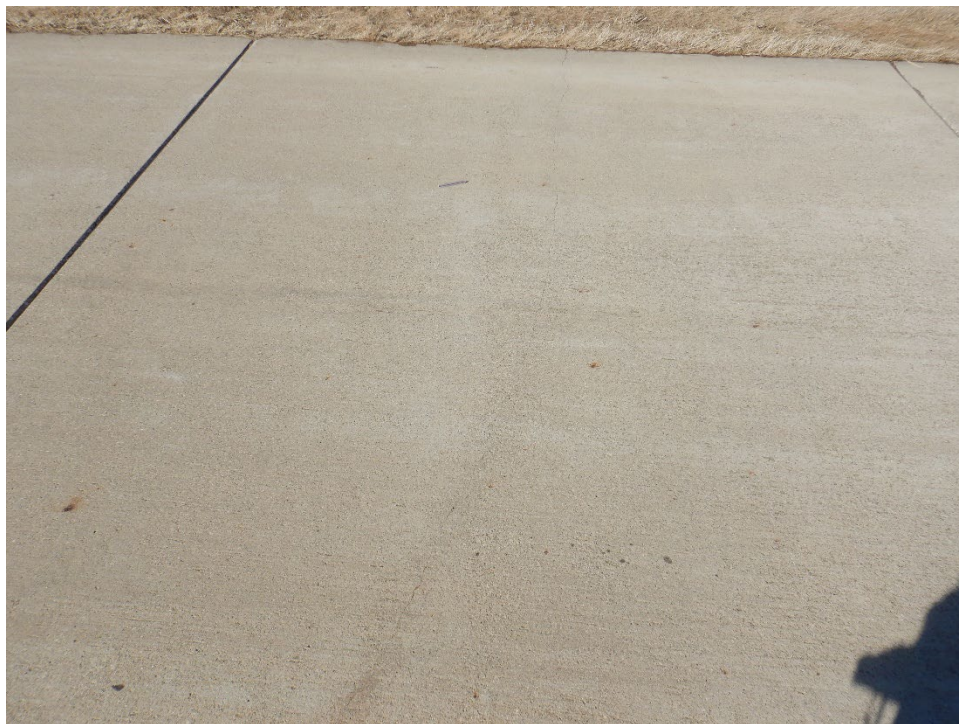
TH01AG-02. LTD Cracking (Sample Unit No. 03).

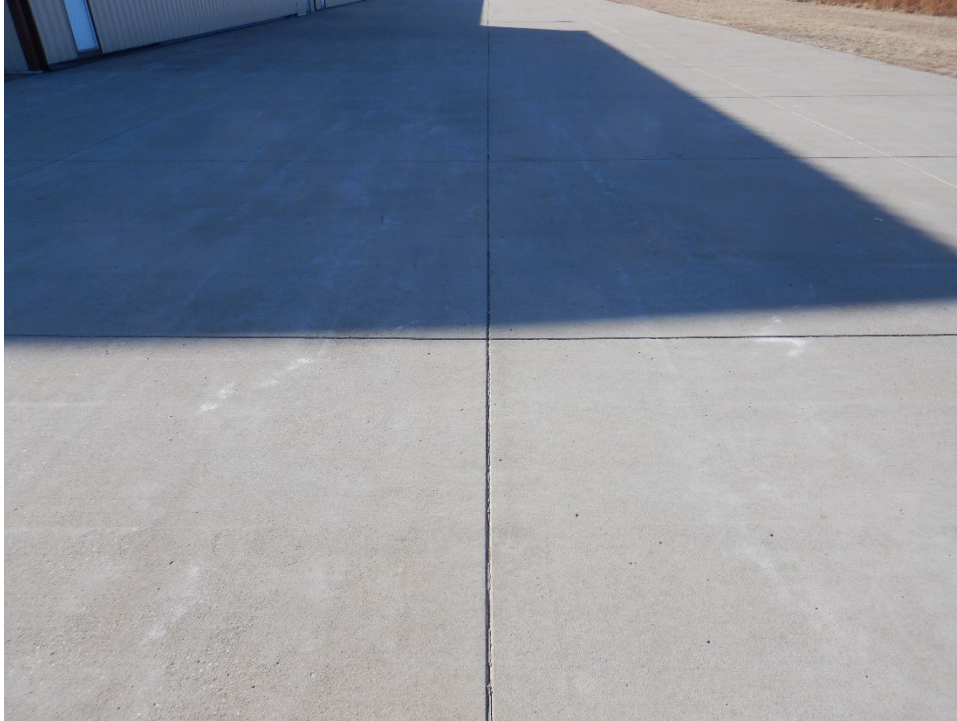
TH01AG-03. Overview.

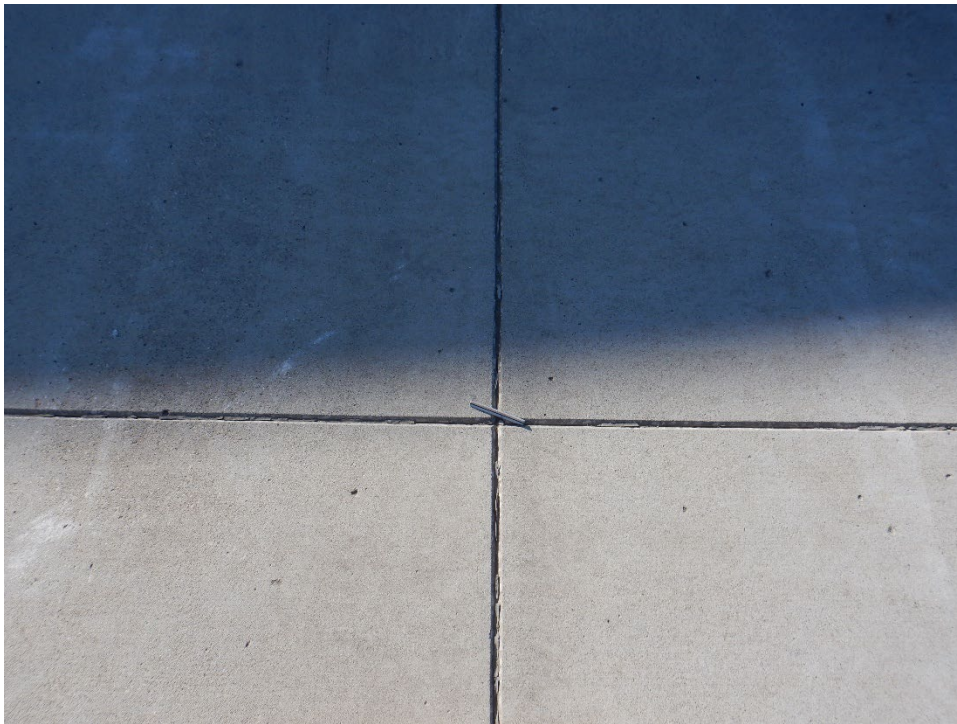
TH01AG-03. Joint Seal Damage (Sample Unit No. 01) (1).

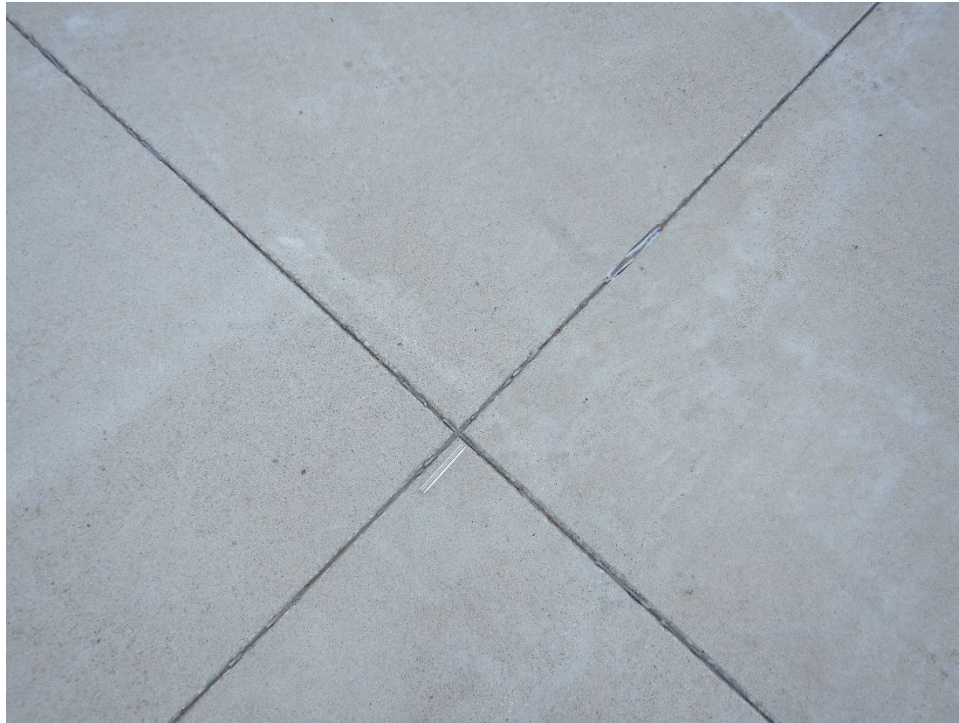
TH01AG-03. Joint Seal Damage (Sample Unit No. 01) (2).

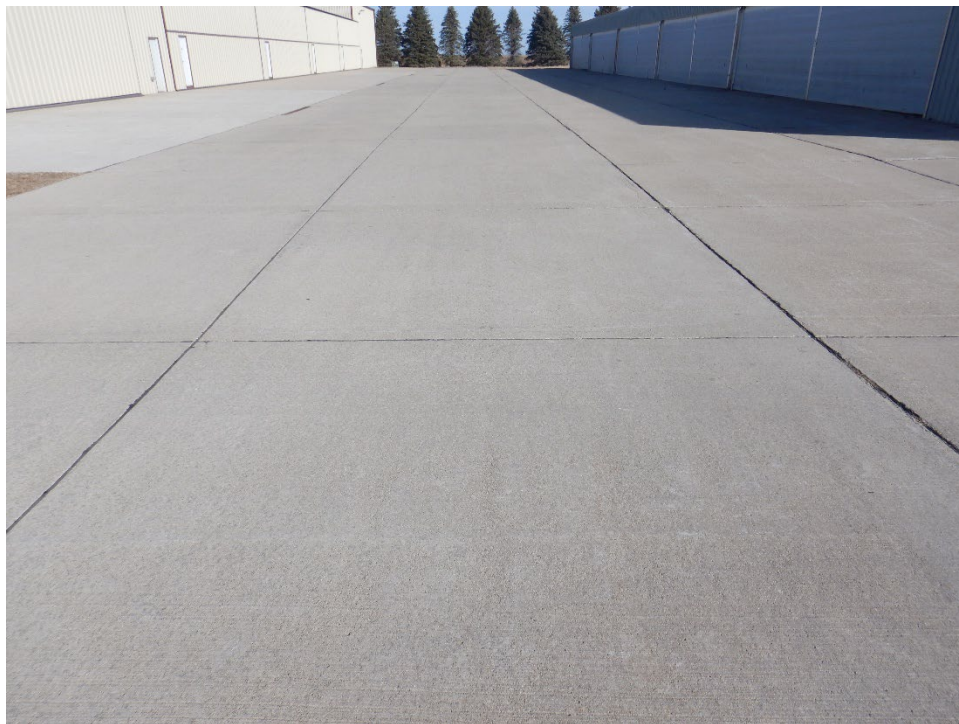
TH01AG-04. Overview.

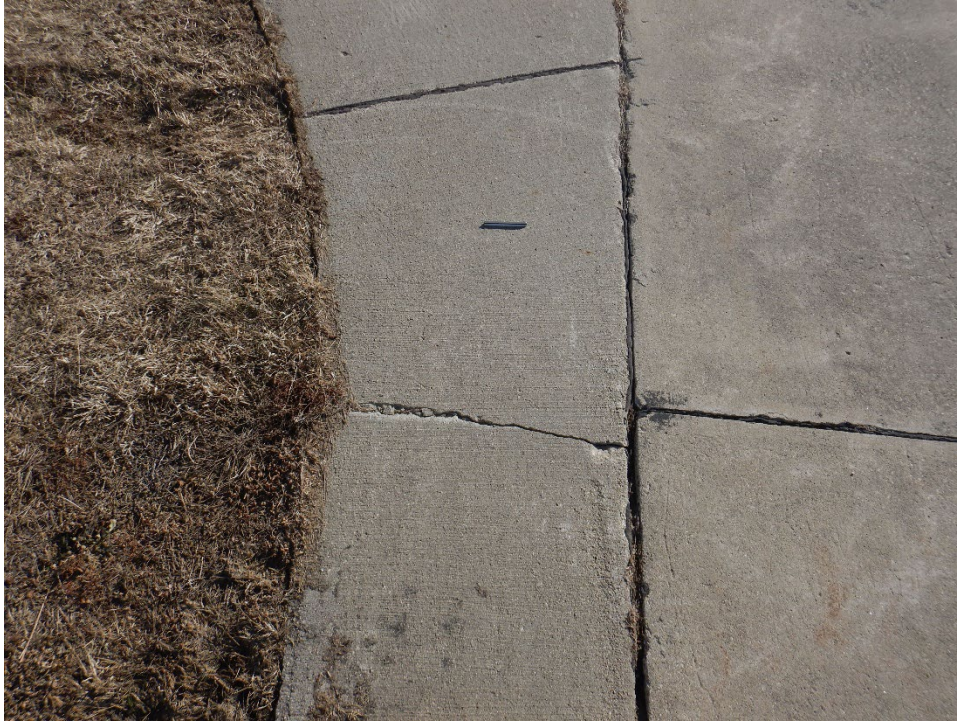
TH01AG-04. LTD Cracking (Sample Unit No. 02).

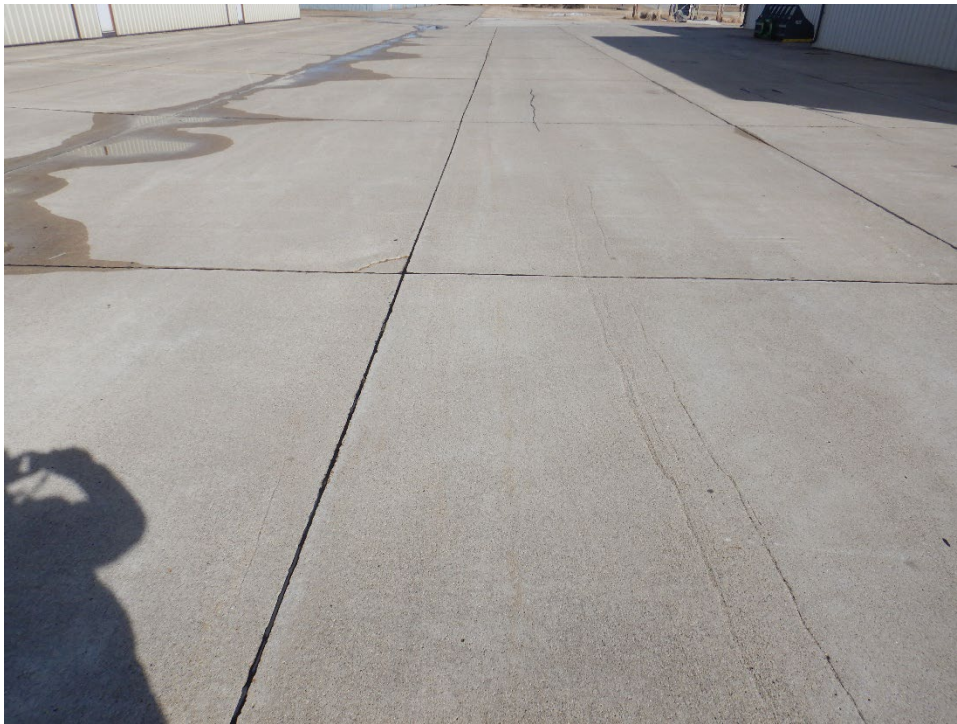
TH01AG-05. Overview.

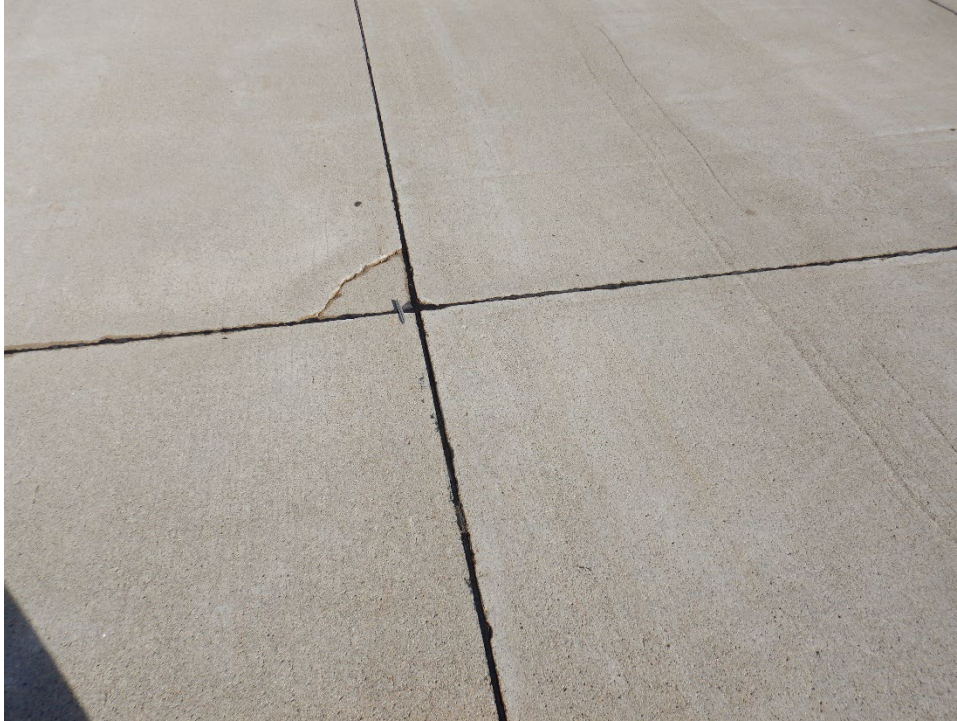
TH01AG-05. Joint Seal Damage (Sample Unit No. 01).
