# Algona Municipal Airport

## Pavement Management Report

**AUGUST 2026**

# ALGONA MUNICIPAL AIRPORT PAVEMENT MANAGEMENT REPORT

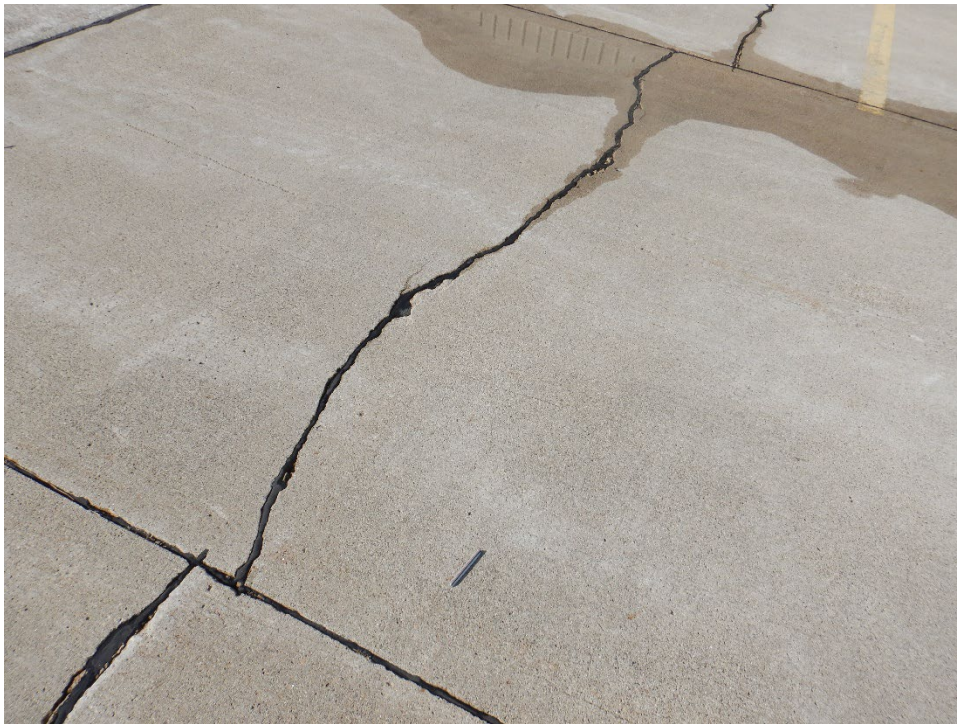
TH01AG-05. LTD Cracking (Sample Unit No. 01).

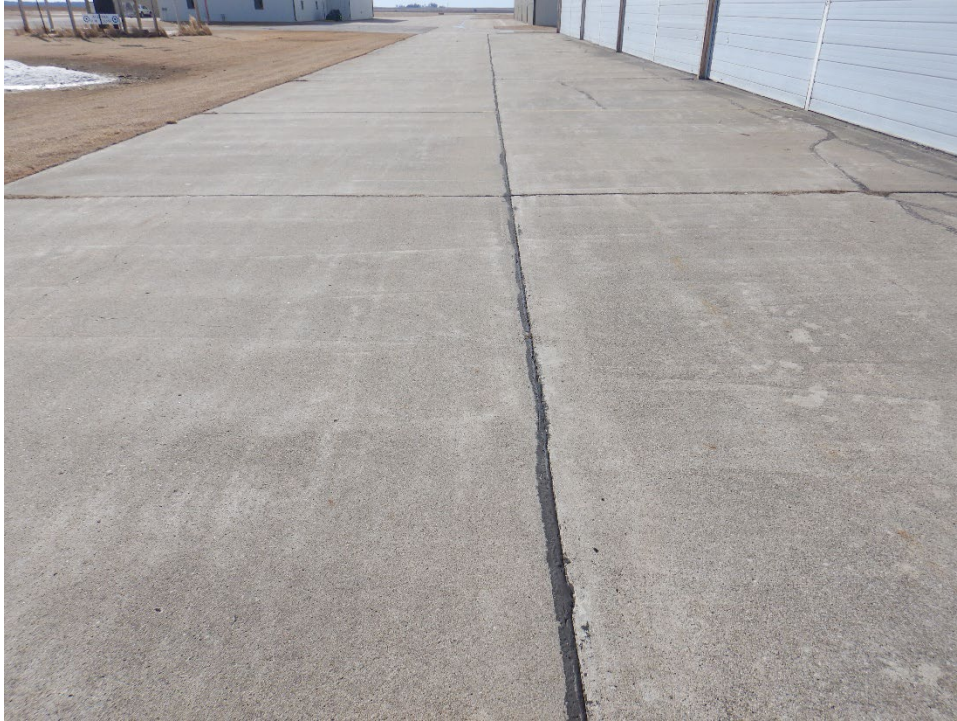
TH01AG-06. Overview.

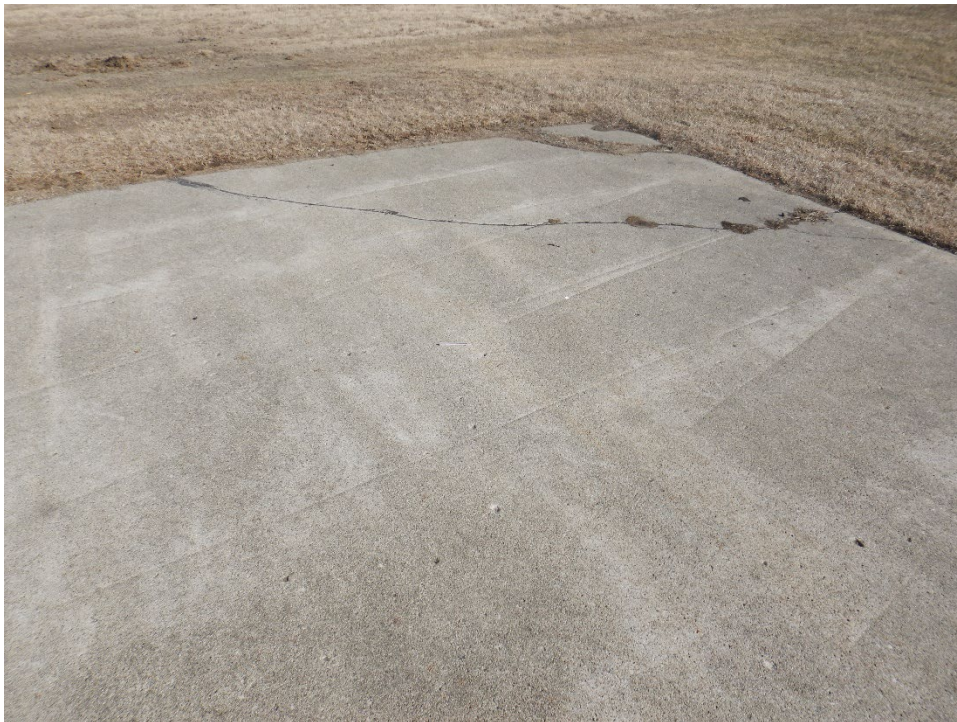
TH01AG-06. LTD Cracking (Sample Unit No. 01).

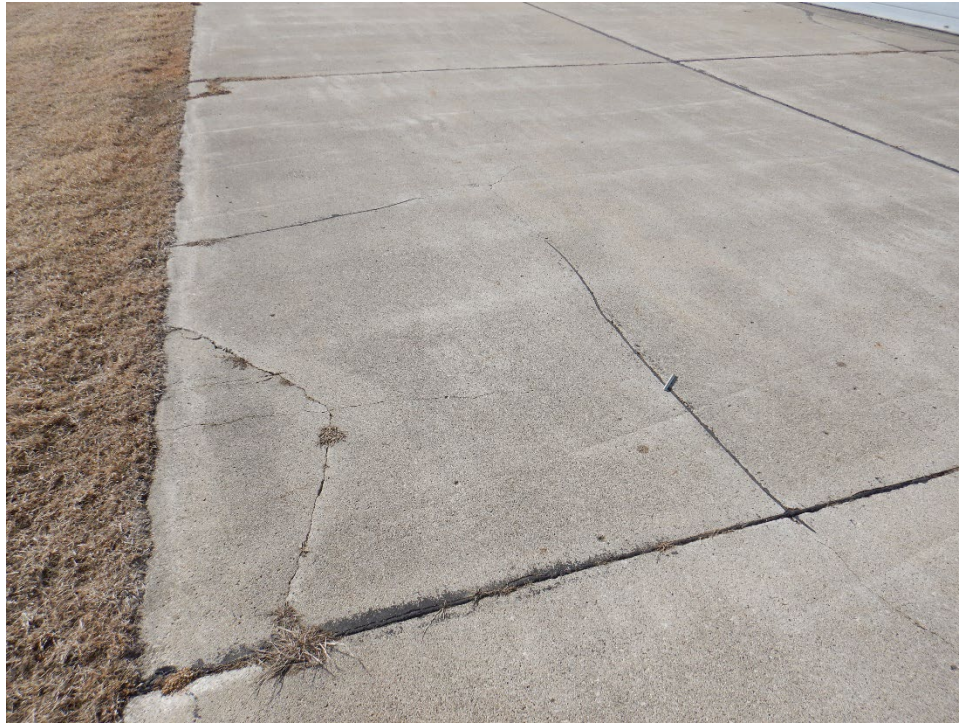
TH01AG-06. Shattered Slab (Sample Unit No. 01).
