# Ames Municipal Airport

## Pavement Management Report

**AUGUST 2026**

# AMES MUNICIPAL AIRPORT PAVEMENT MANAGEMENT REPORT

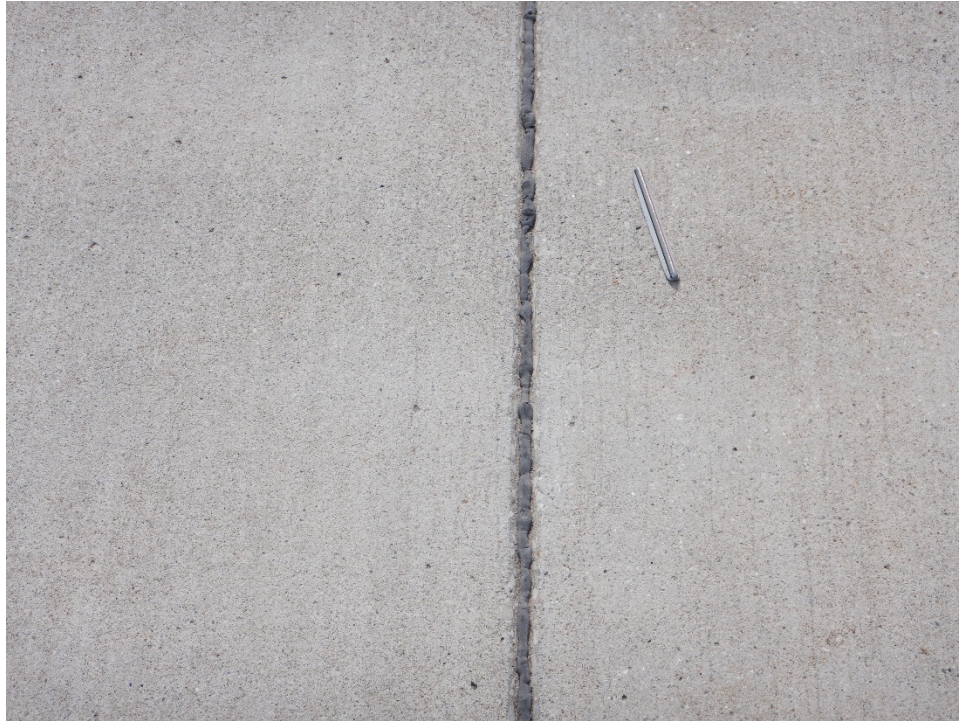
The apron area contained two sections. Section 01 was in *Excellent* condition with no distress noted at the time of inspection. Section 02 contained medium-severity LTD cracking and joint seal damage and low-severity joint spalling, corner spalling, scaling, and small patching.

A01AM-02. Joint Seal Damage (Sample Unit No. 64).

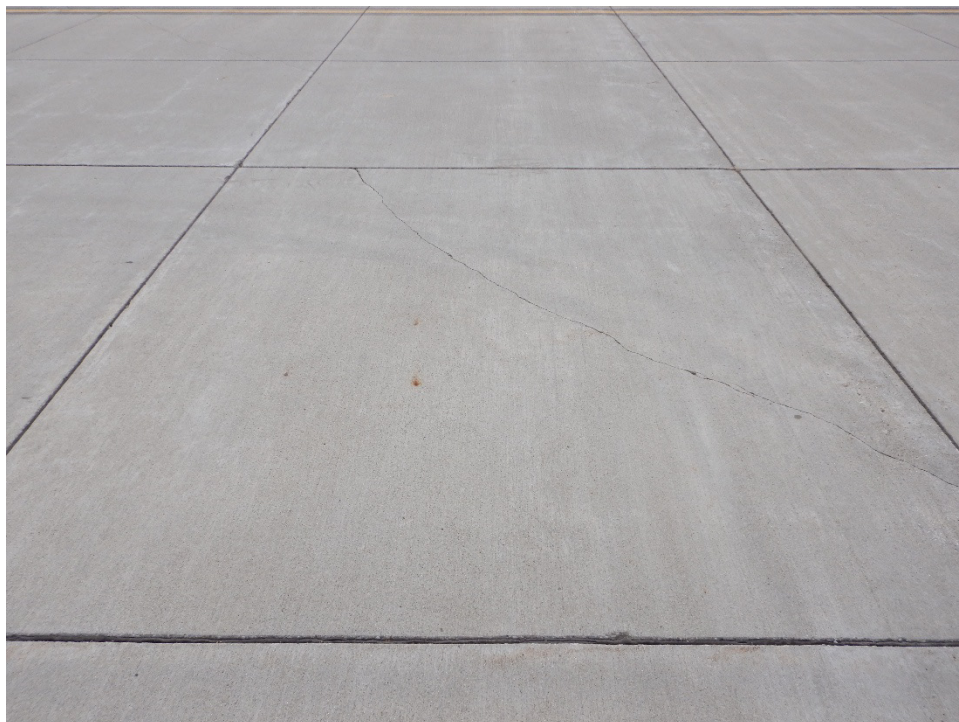
A01AM-02. LTD Cracking (Sample Unit No. 14).

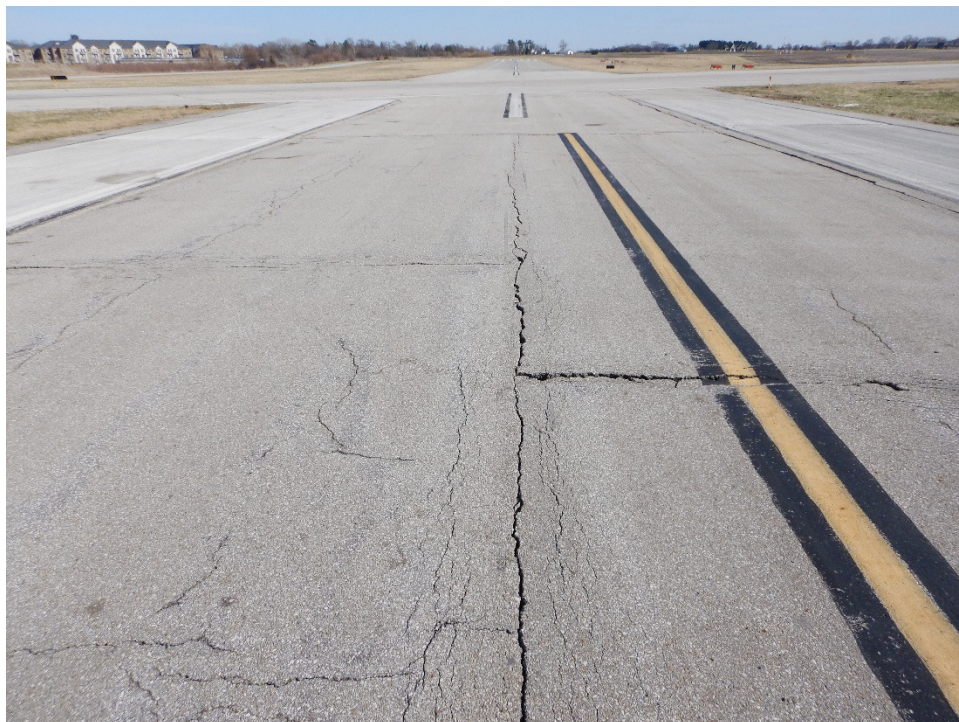
R13AM-02. Overview.

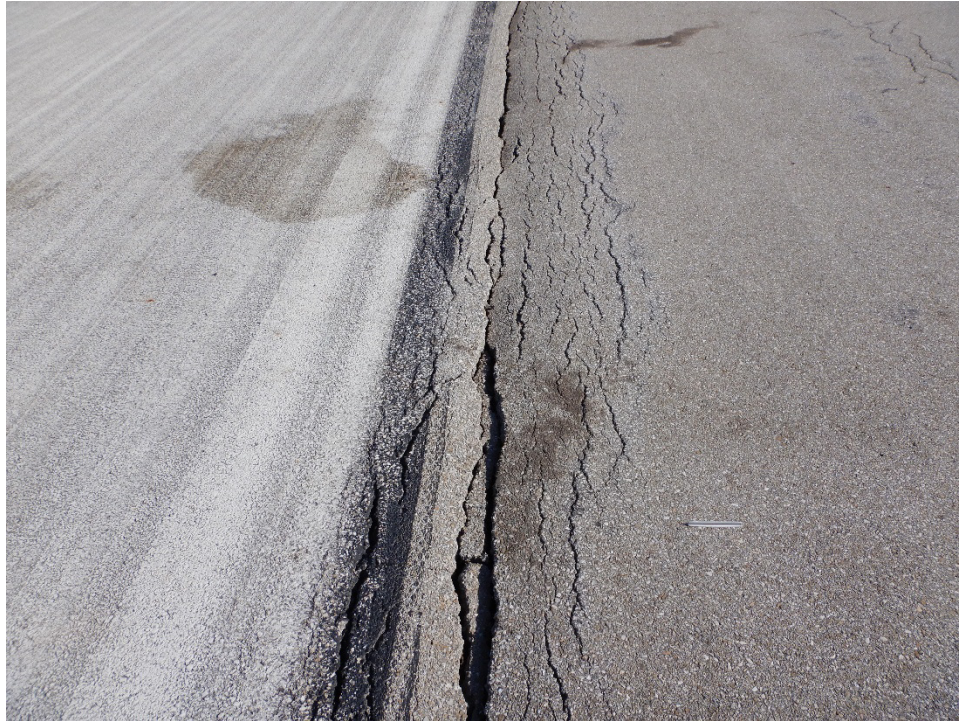
R13AM-02. L&T Cracking (Sample Unit No. 01).

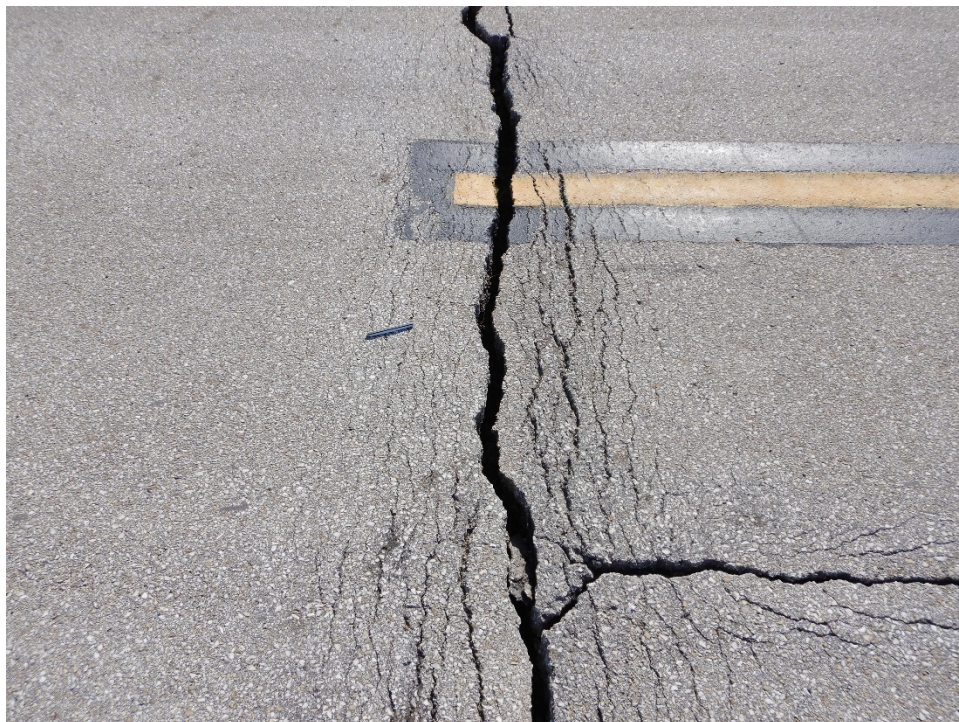
R13AM-02. L&T Cracking (Sample Unit No. 02).

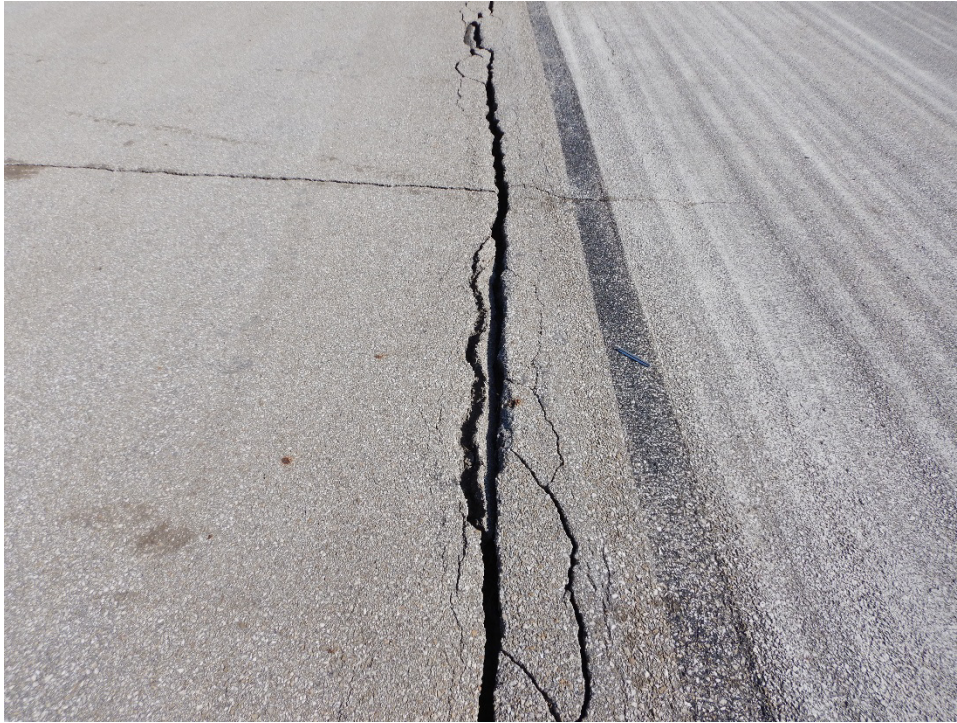
R13AM-02. L&T Cracking (Sample Unit No. 04).

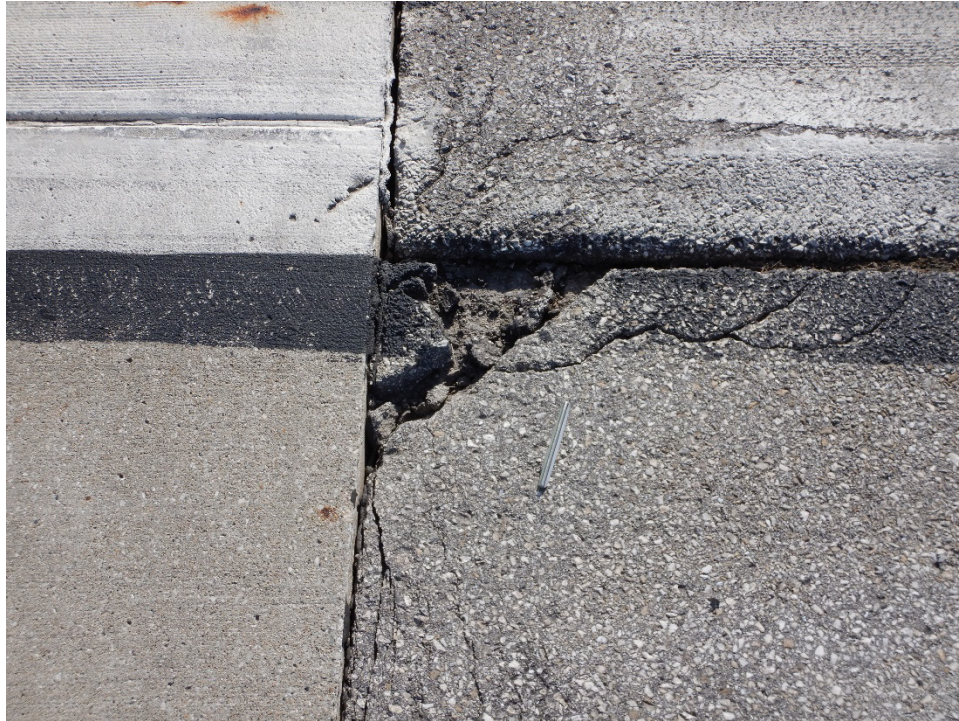
R13AM-03. L&T Cracking (Sample Unit No. 01) (2).

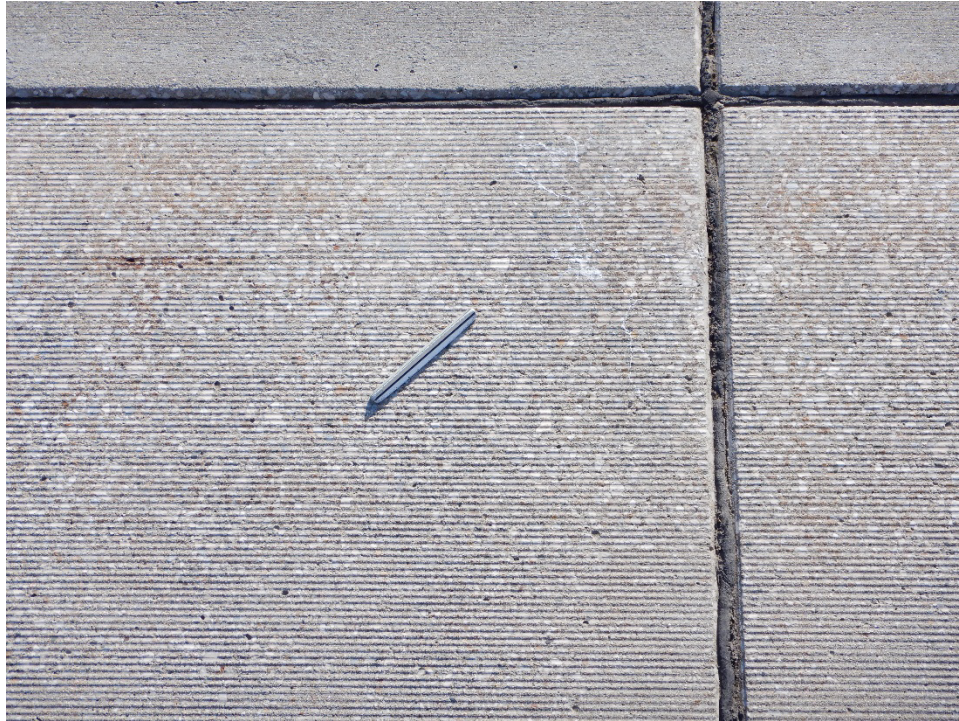
R13AM-04. ASR (Sample Unit No. 17).

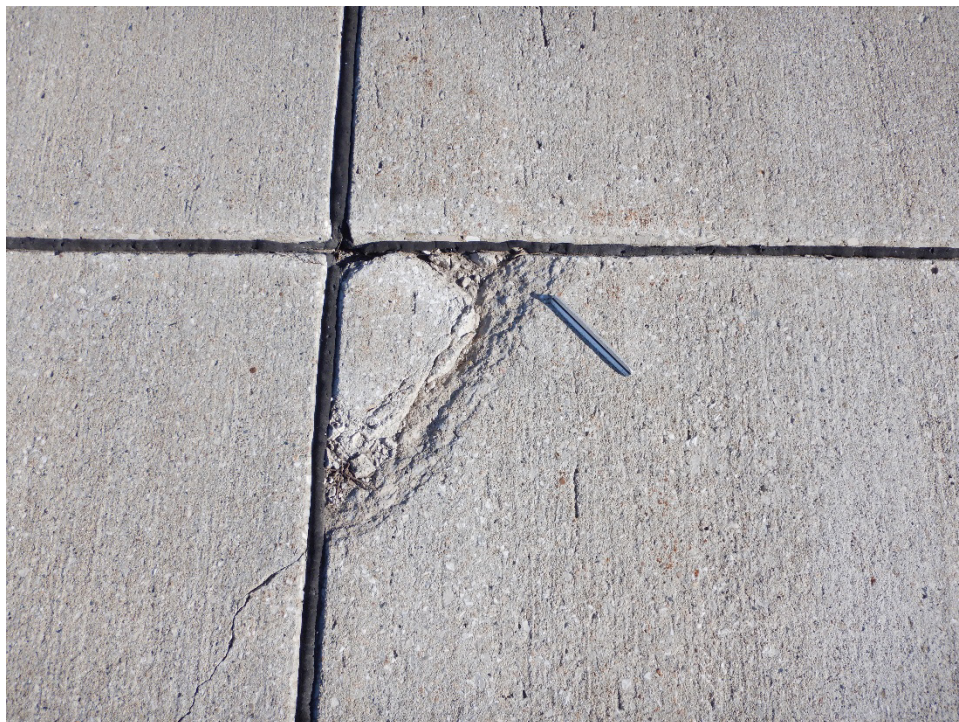
R13AM-04. Corner Spalling (Additional Sample Unit No. 05).

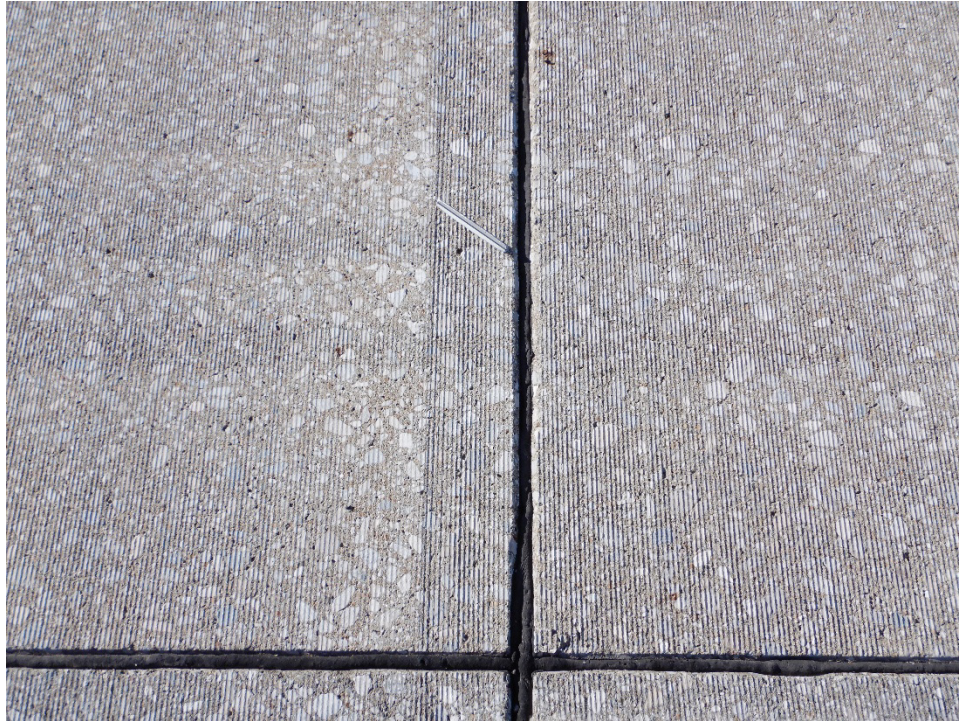
R13AM-04. Joint Seal Damage (Sample Unit No. 03).

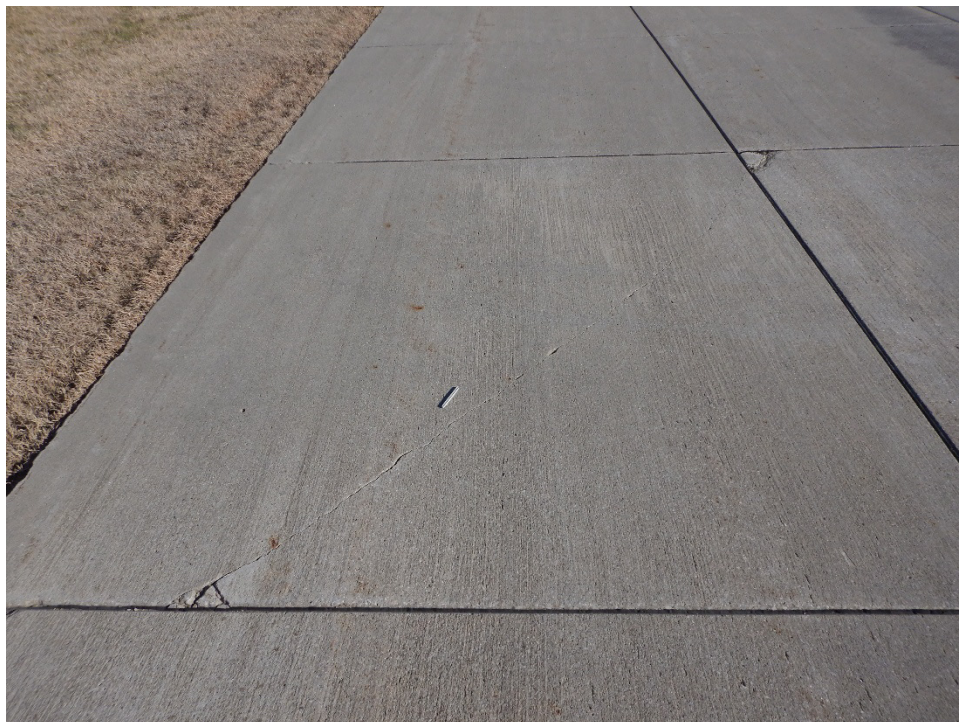
R13AM-04. LTD Cracking (Additional Sample Unit No. 05).

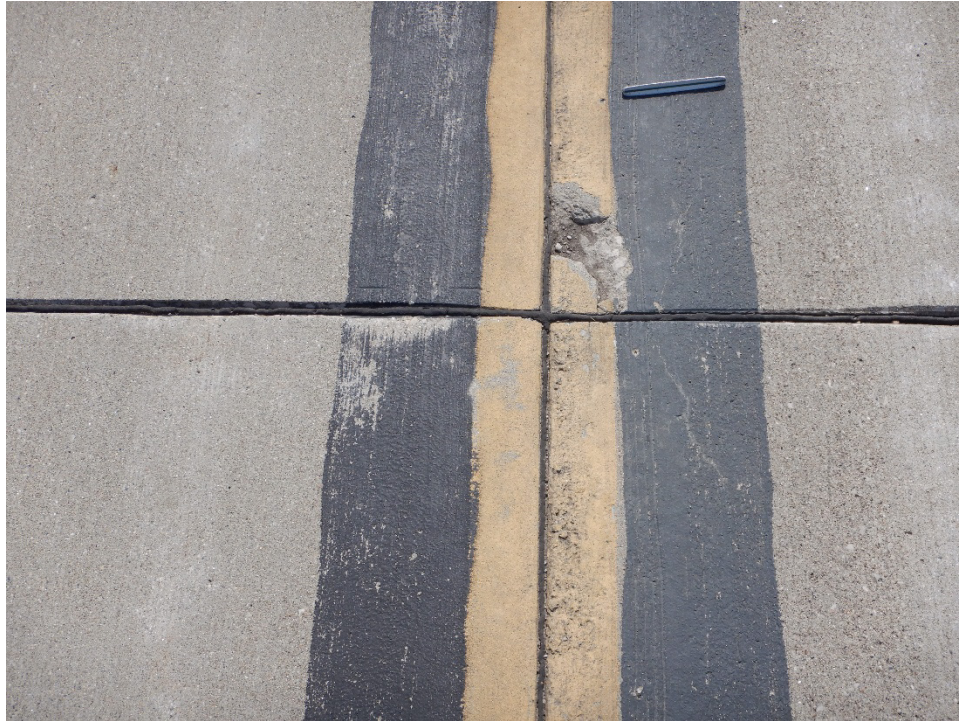
T13AM-01. Corner Spalling (Sample Unit No. 10).

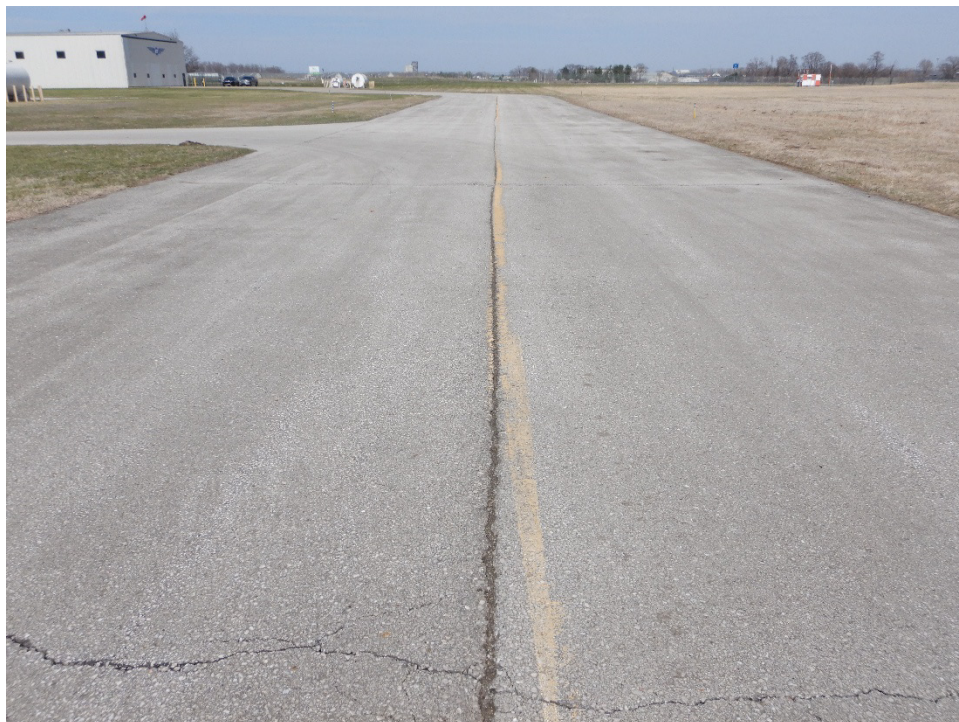
T13AM-02. Overview.

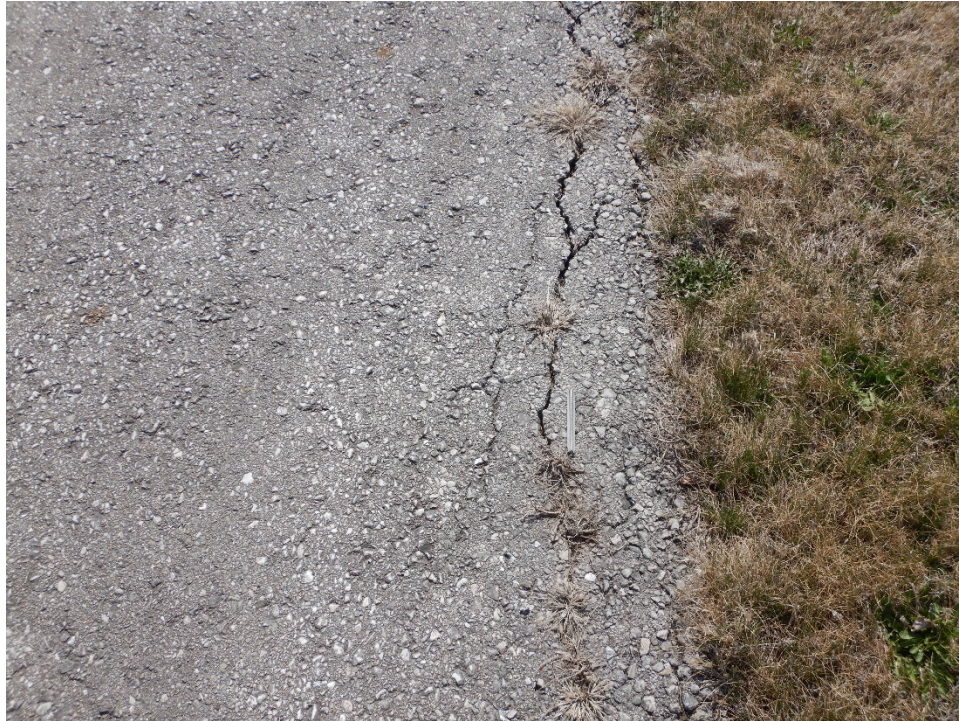
T13AM-02. Alligator Cracking (Sample Unit No. 02).

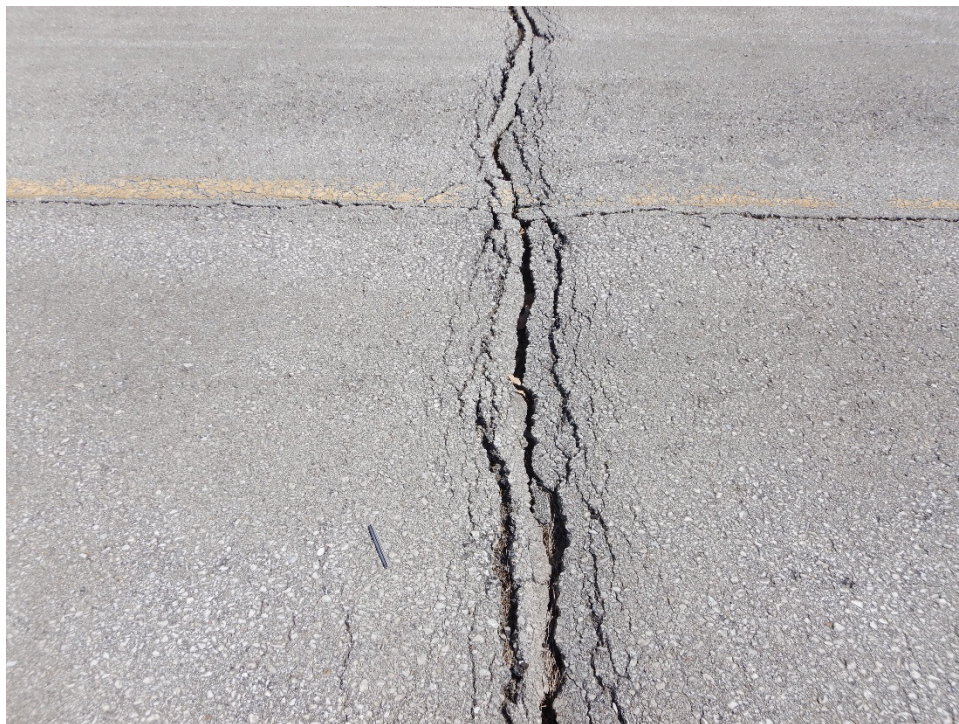
T13AM-02. L&T Cracking (Sample Unit No. 02) (1).

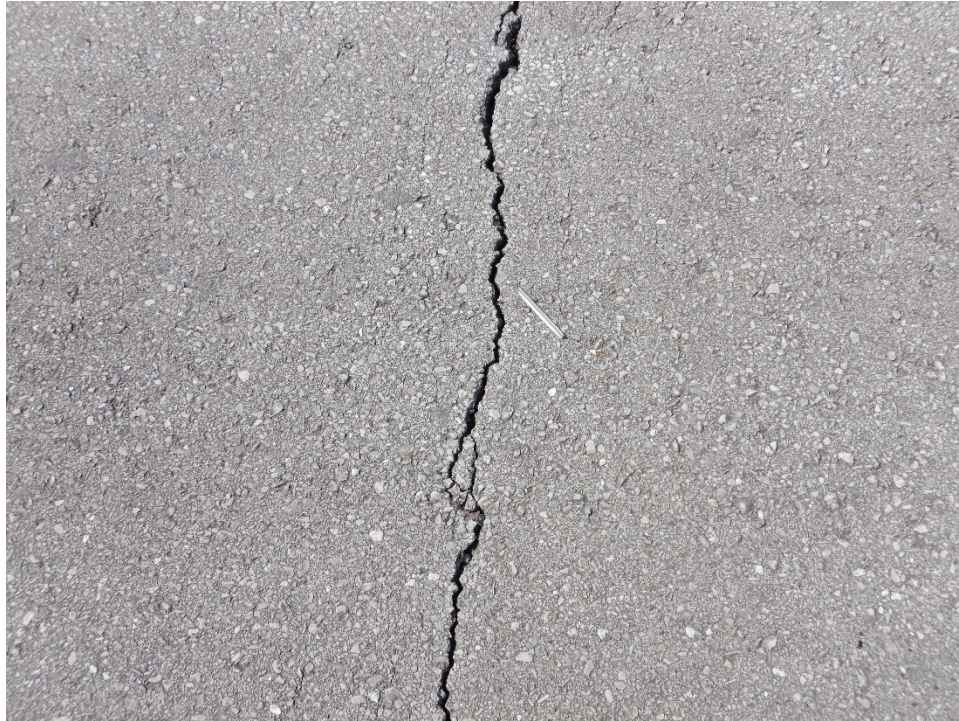
T13AM-02. L&T Cracking (Sample Unit No. 02) (2).

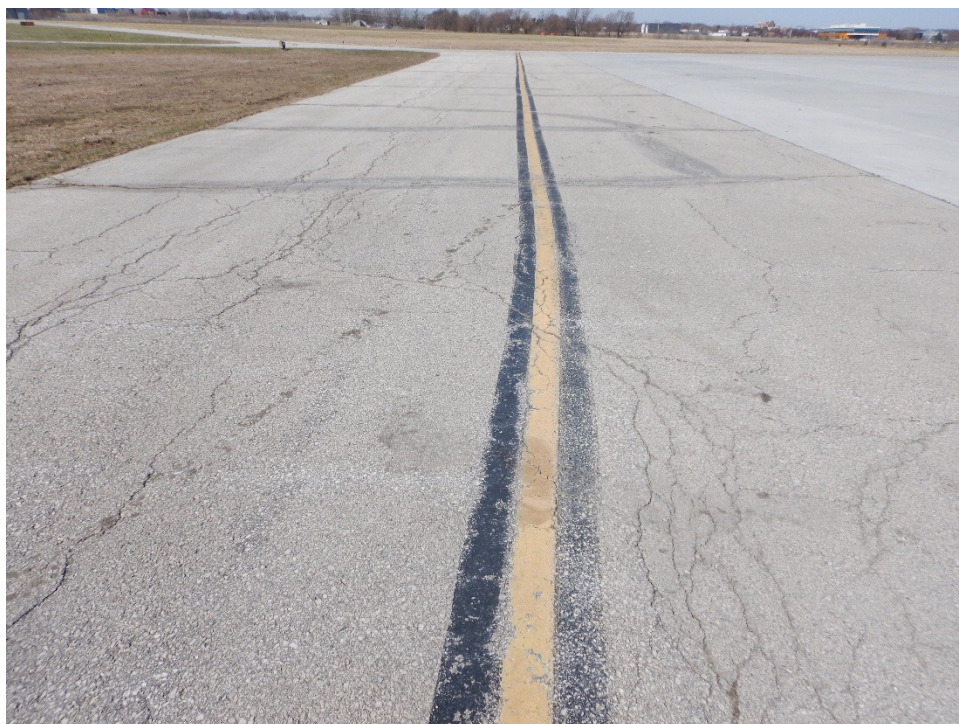
TA1AM-02. Overview.

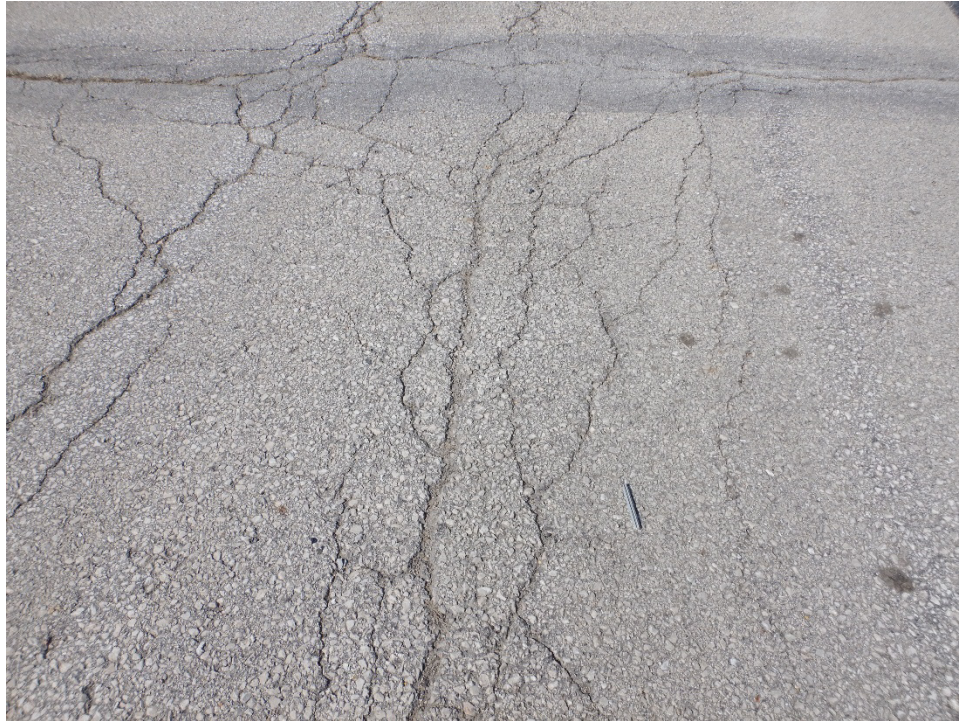
TA1AM-02. Alligator Cracking (Sample Unit No. 01).

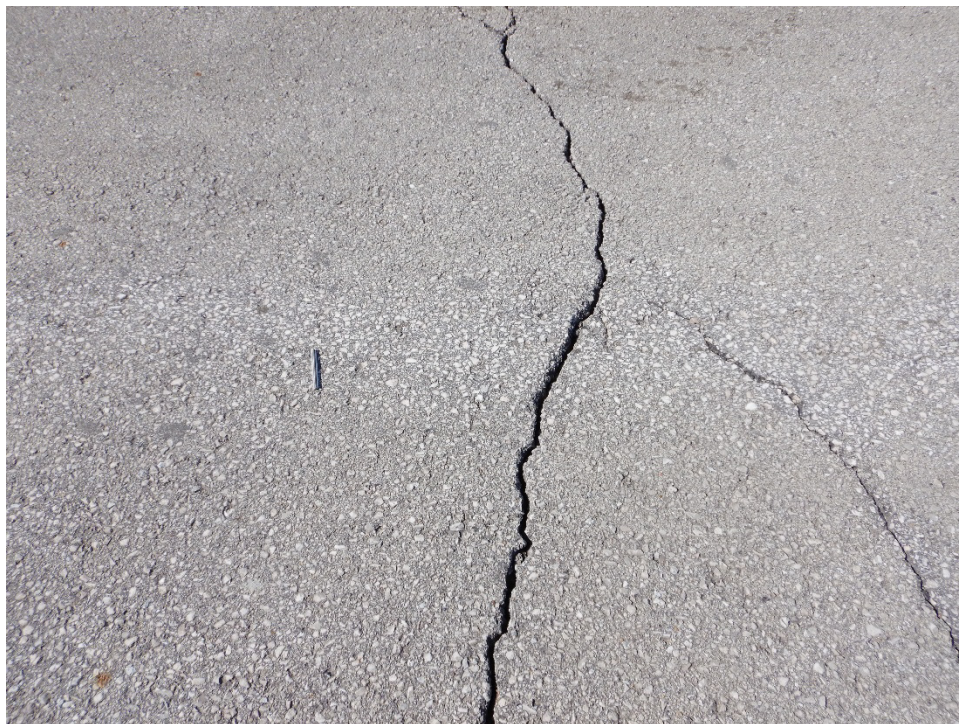
TA1AM-02. L&T Cracking (Sample Unit No. 03).

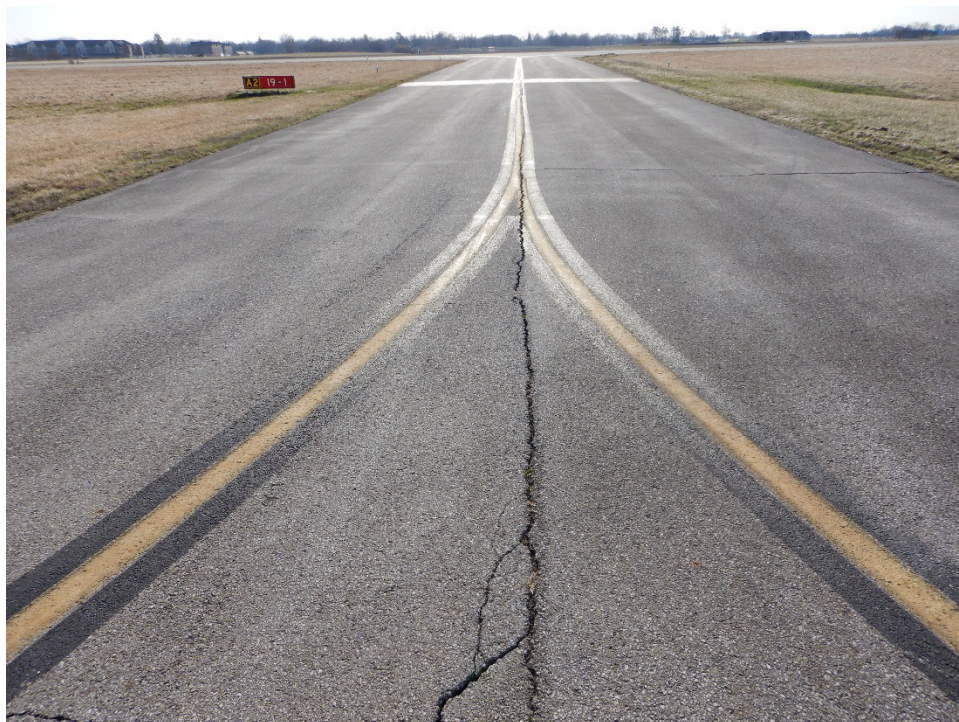
TA2AM-01. Overview.

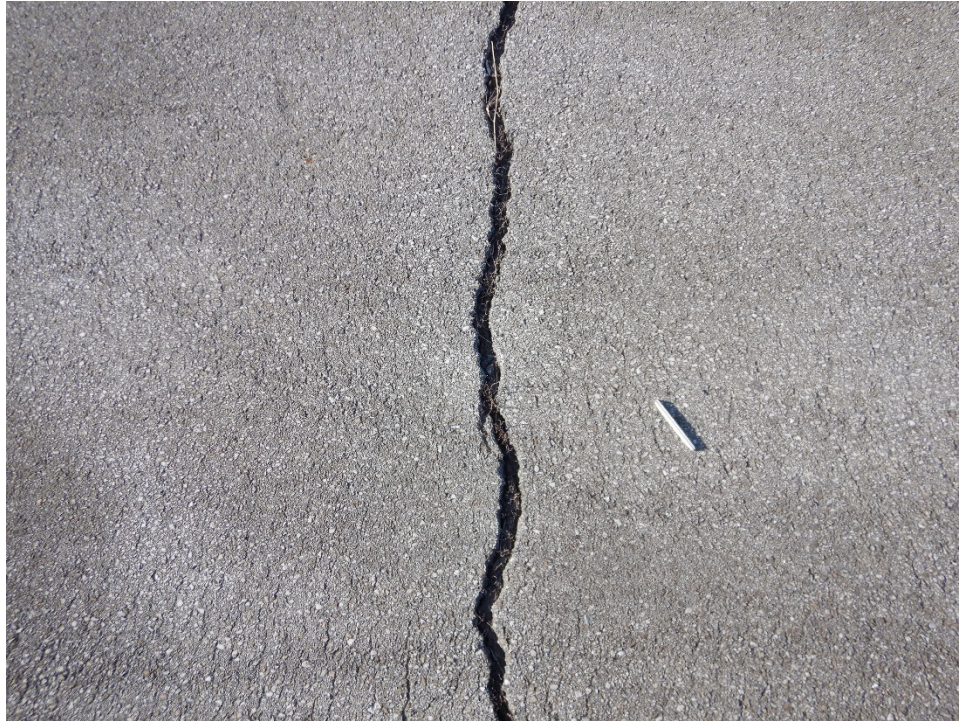
TA2AM-01. L&T Cracking (Sample Unit No. 01).

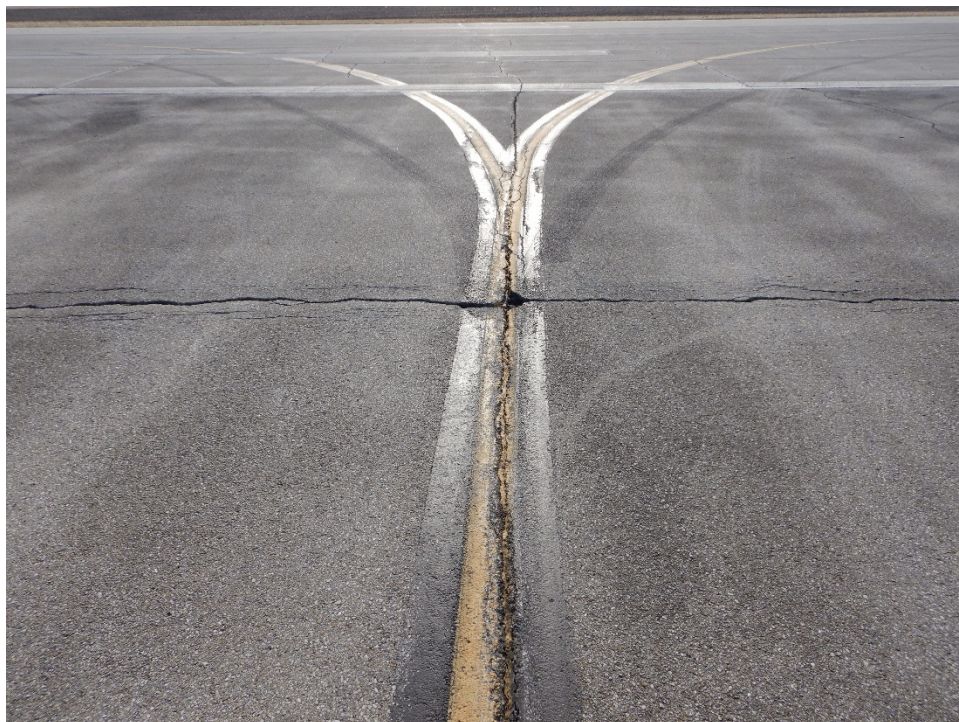
TA2AM-02. Overview.

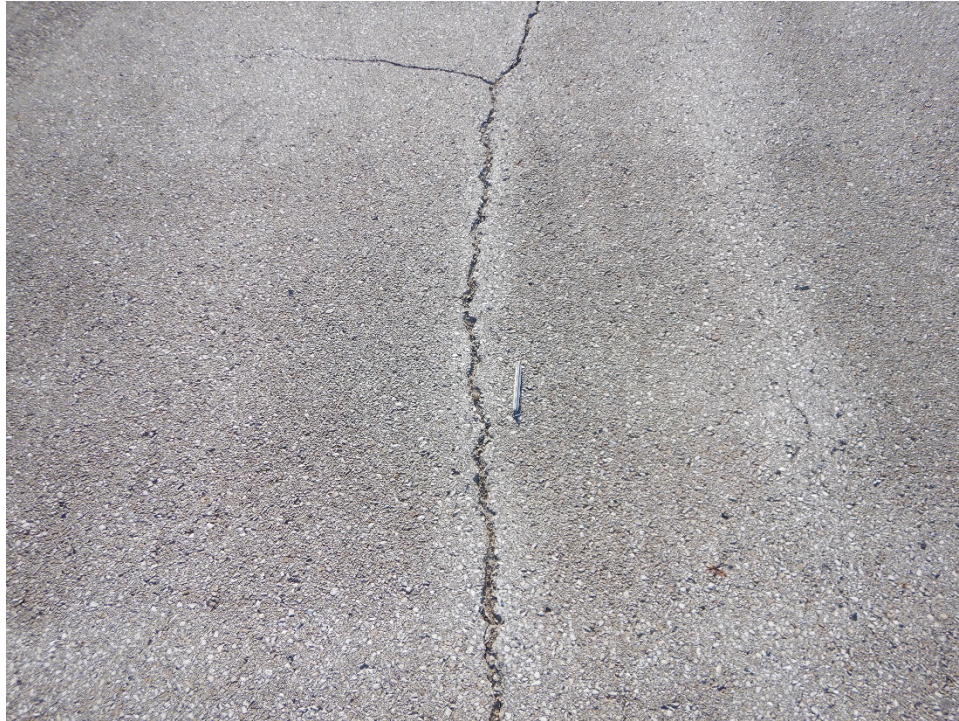
TA3AM-02. L&T Cracking (Sample Unit No. 01) (1).

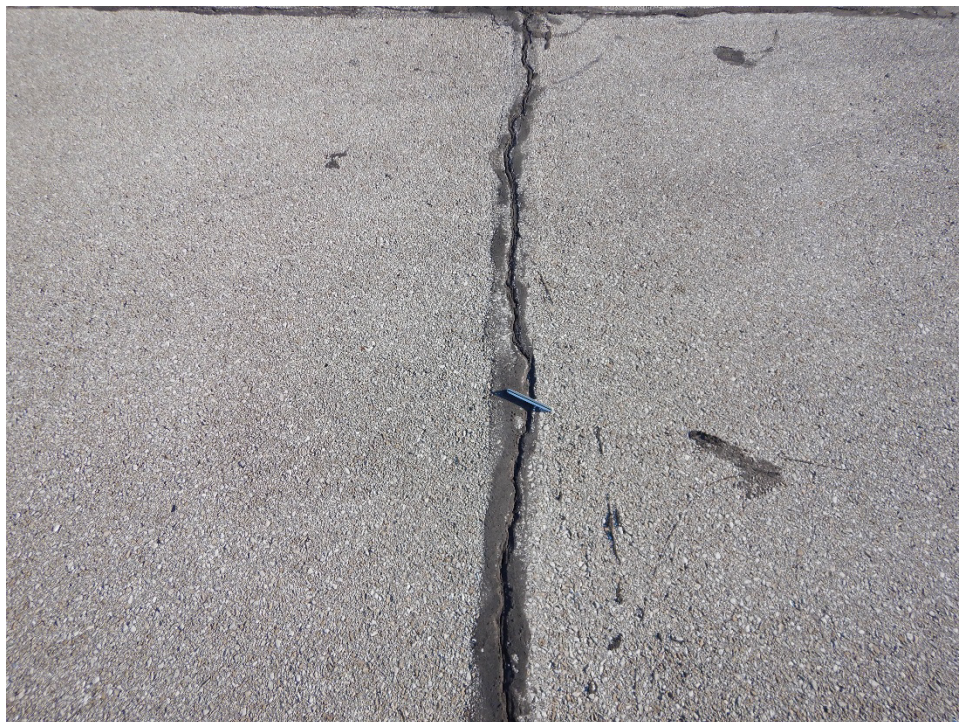
TA3AM-02. L&T Cracking (Sample Unit No. 01) (2).

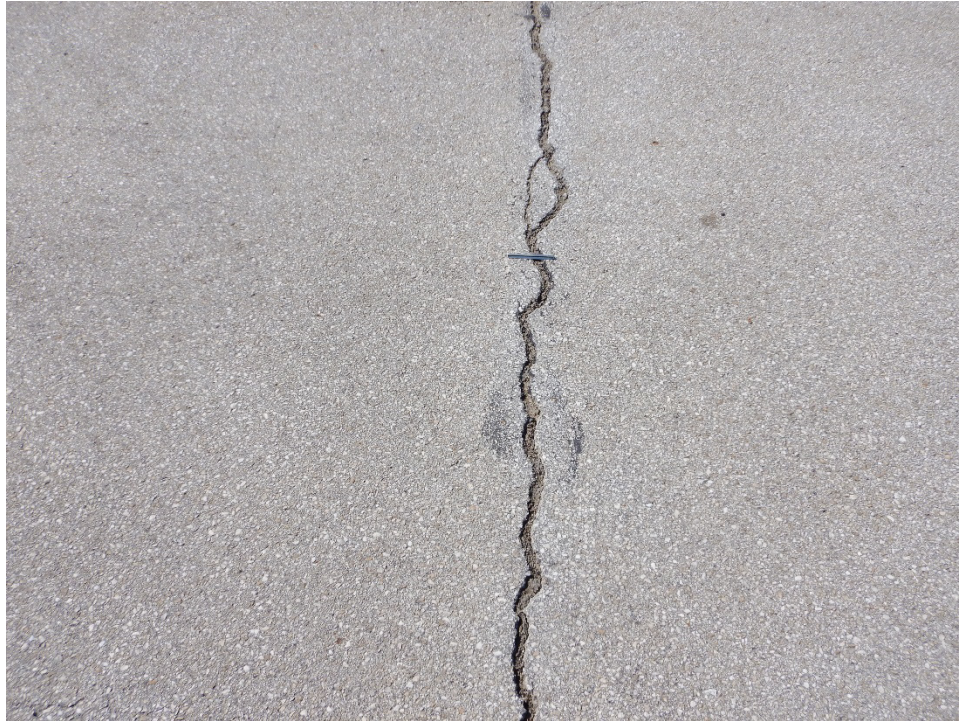
TA4AM-02. L&T Cracking (Sample Unit No. 01) (2).

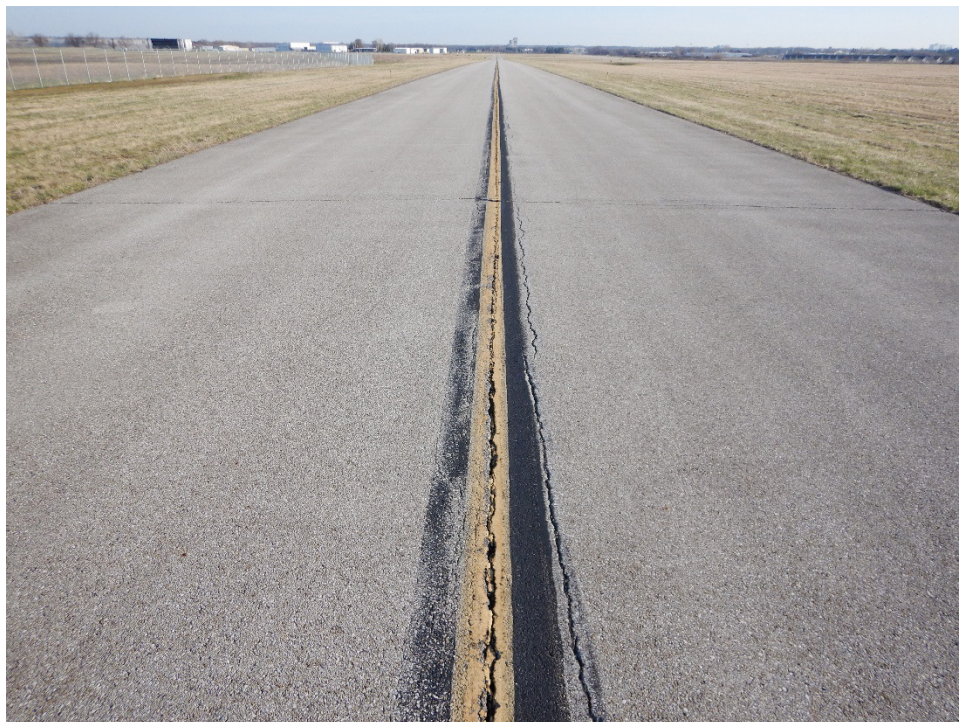
TAAM-02. Overview.

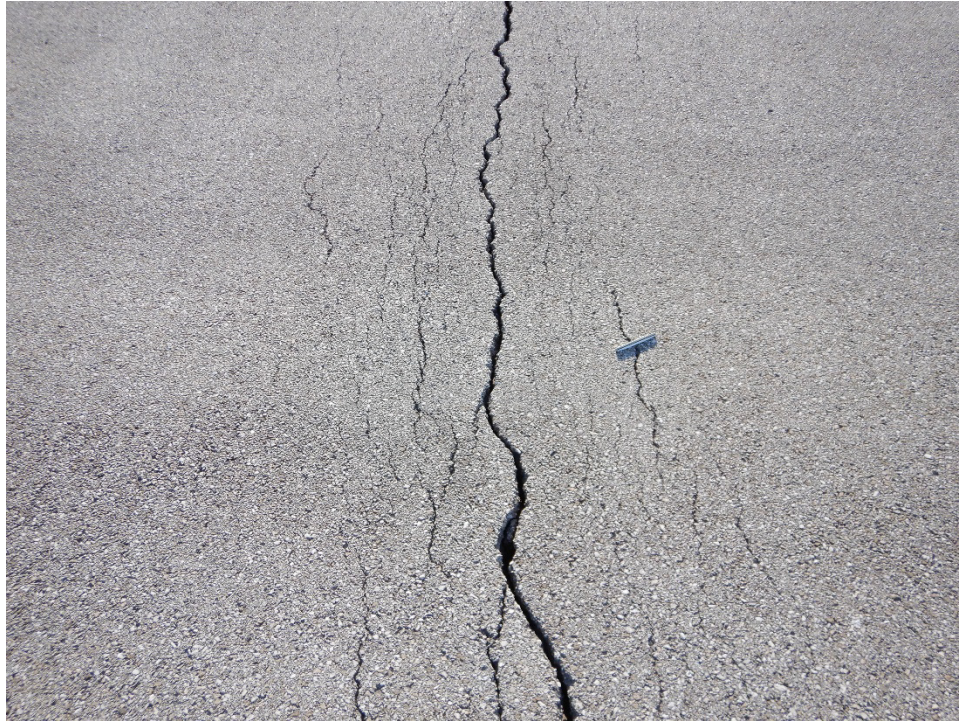
TAAM-02. L&T Cracking (Sample Unit No. 04) (2).

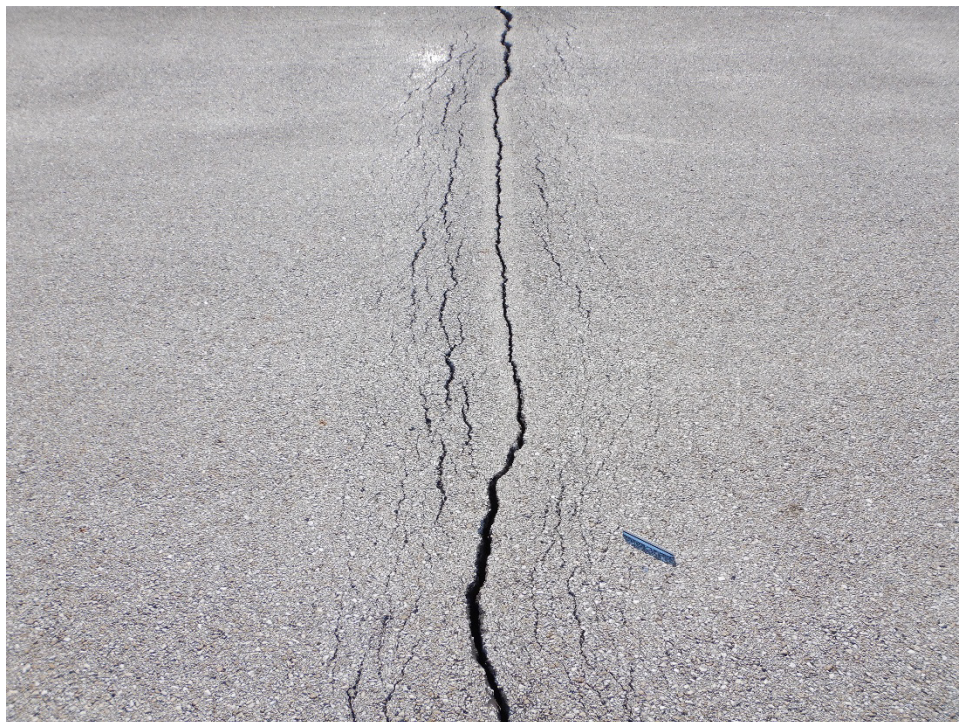
TAAM-02. L&T Cracking (Sample Unit No. 10).

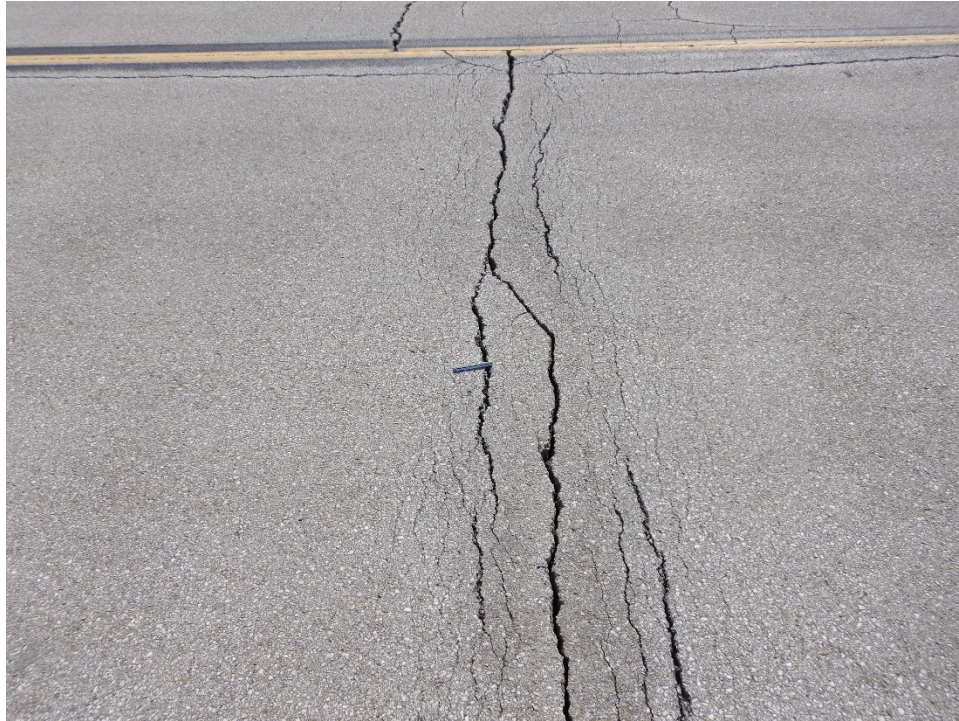
TAAM-04. L&T Cracking (Sample Unit No. 04).

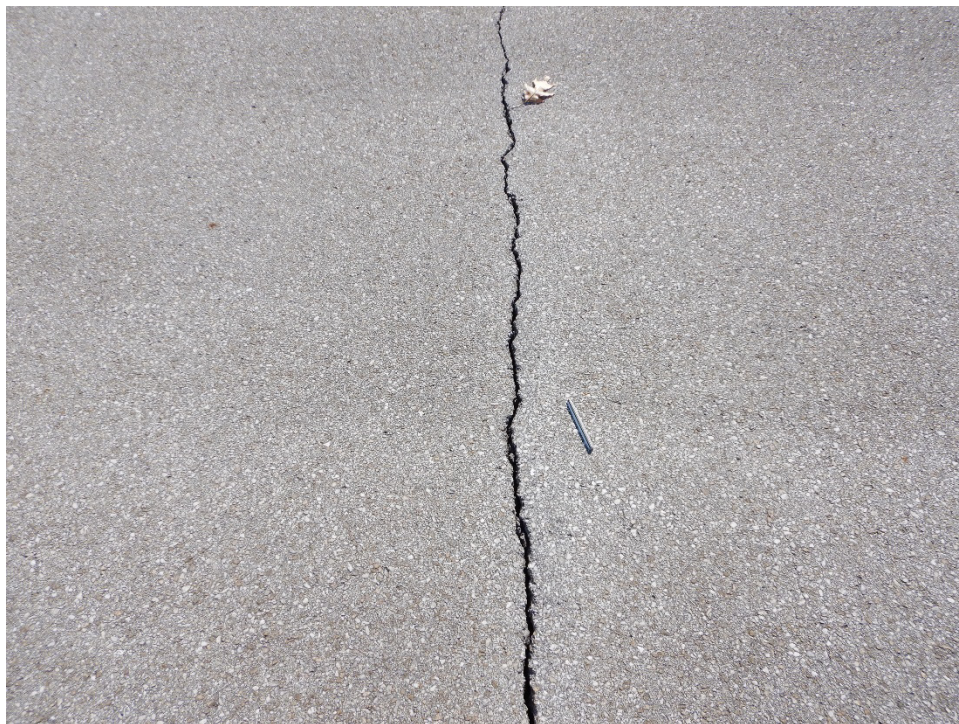
TAAM-04. L&T Cracking (Sample Unit No. 05).

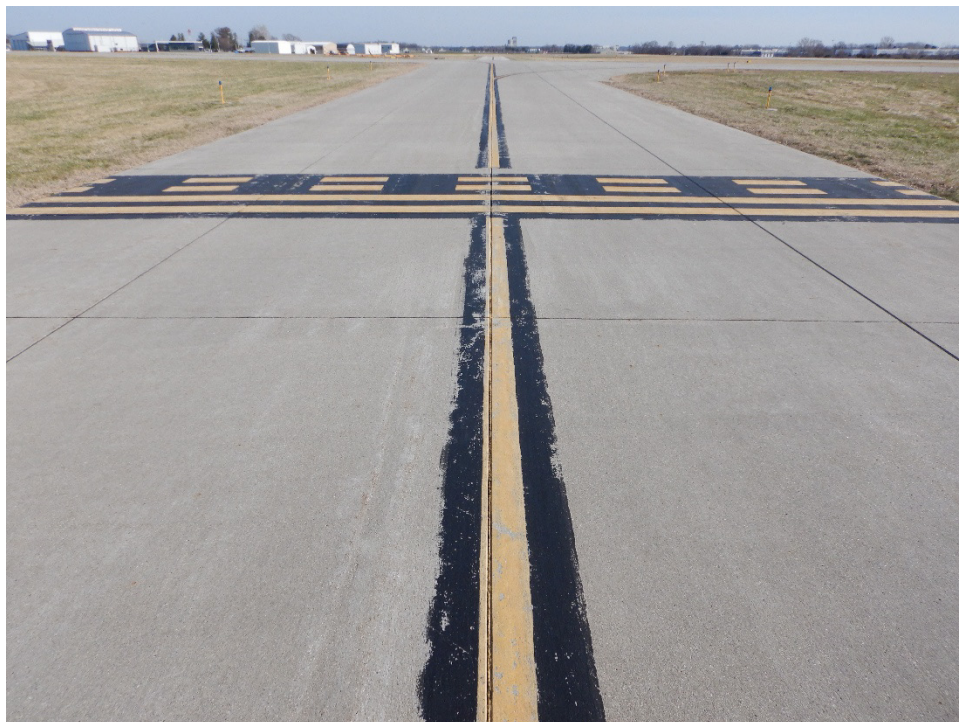
TAAM-05. Overview.

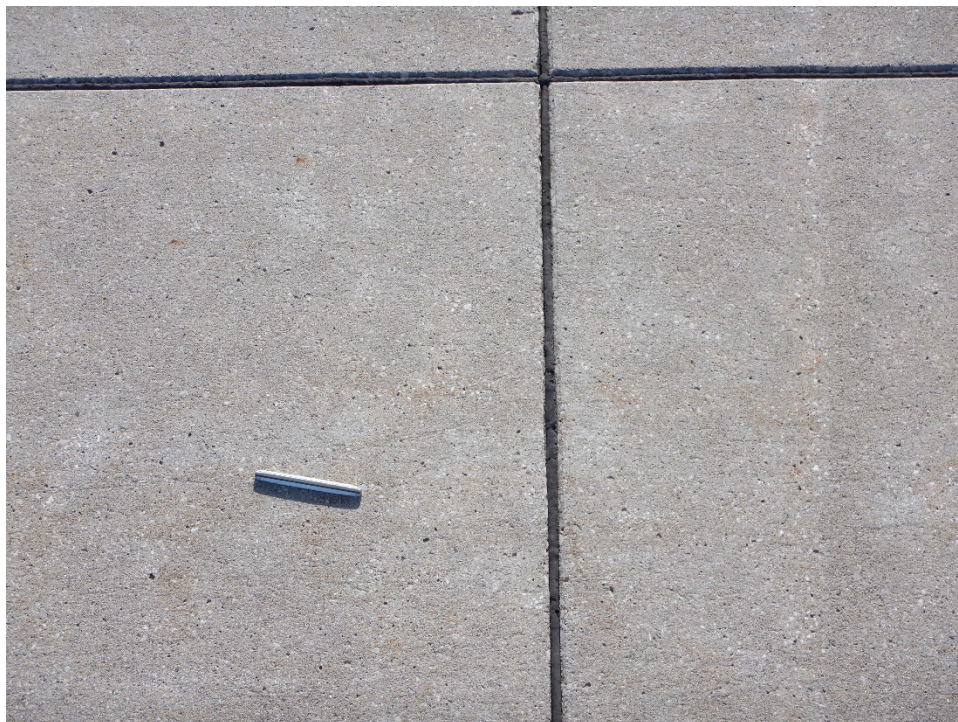
TAAM-05. Joint Seal Damage (Sample Unit No. 04).

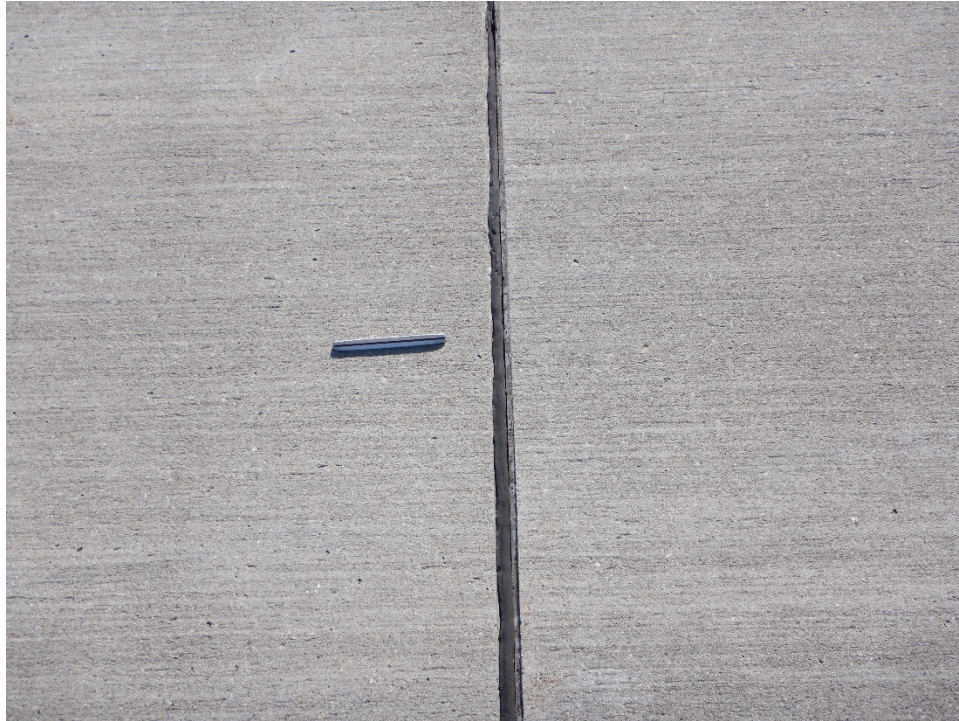
TAAM-07. Joint Seal Damage (Sample Unit No. 03).
