# Ames Municipal Airport

## Pavement Management Report

**AUGUST 2026**

# AMES MUNICIPAL AIRPORT PAVEMENT MANAGEMENT REPORT

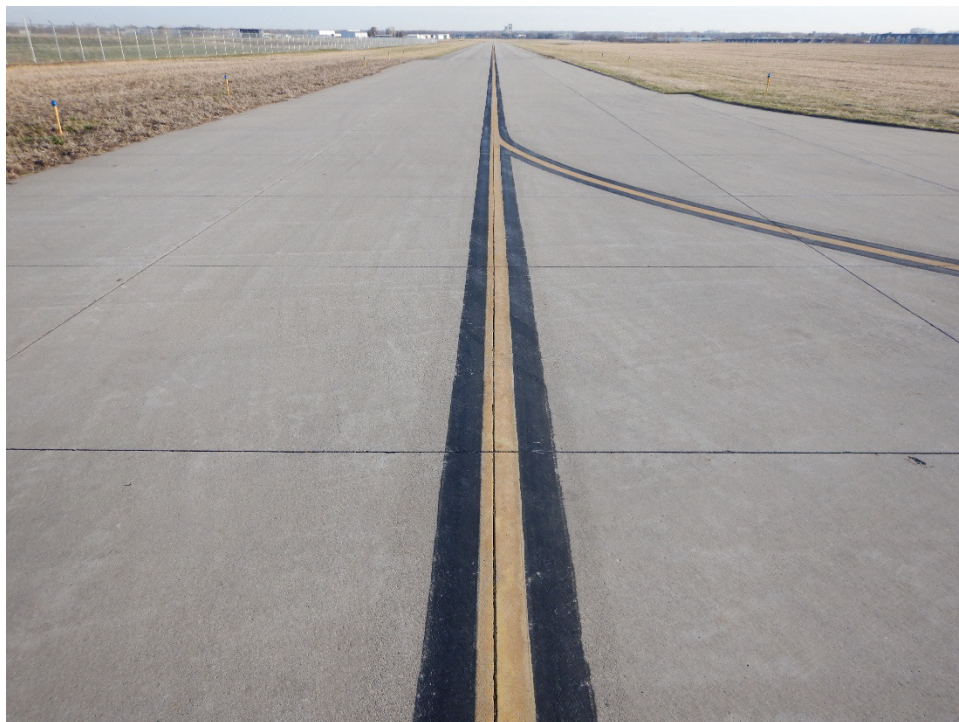
TAAM-08. Overview.

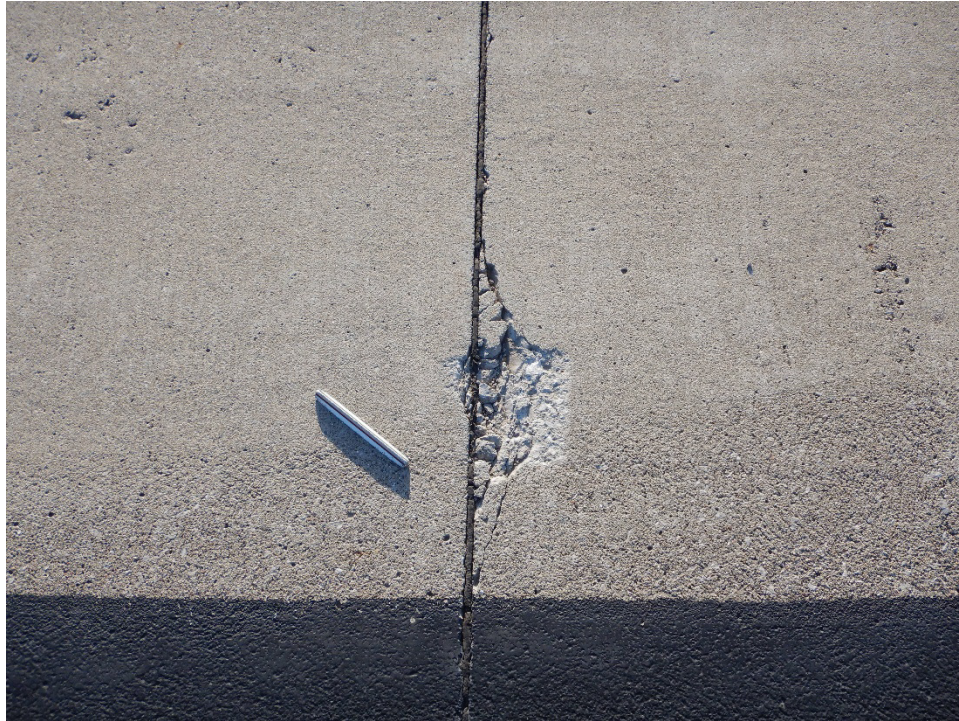
TAAM-08. Joint Spalling (Sample Unit No. 04).

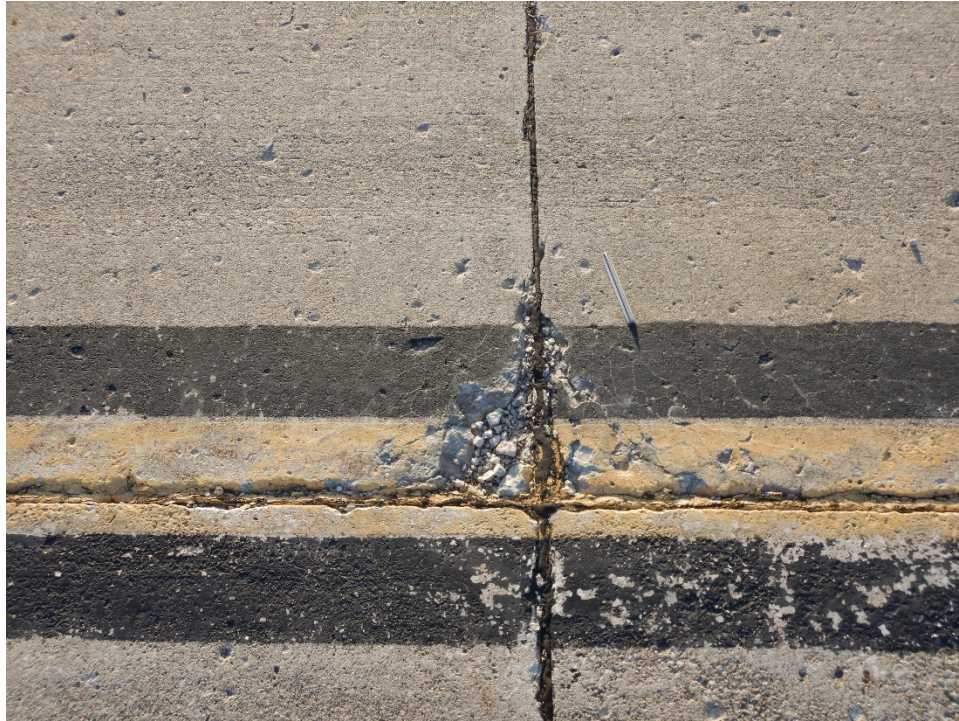
TAAM-09. ASR (Sample Unit No. 24).

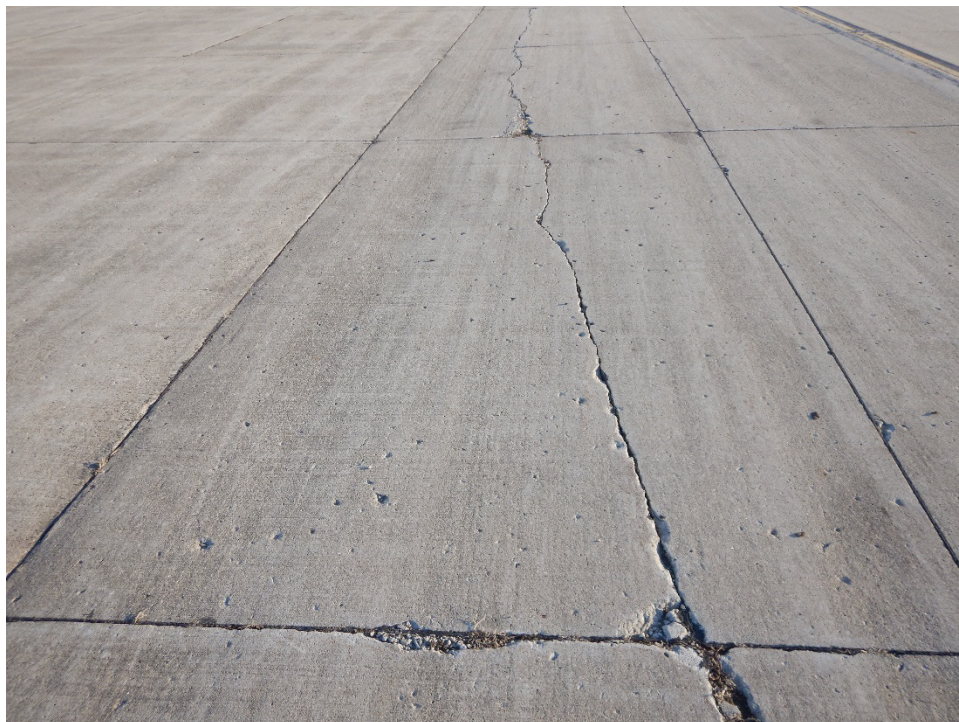
TAAM-09. LTD Cracking (Sample Unit No. 24).

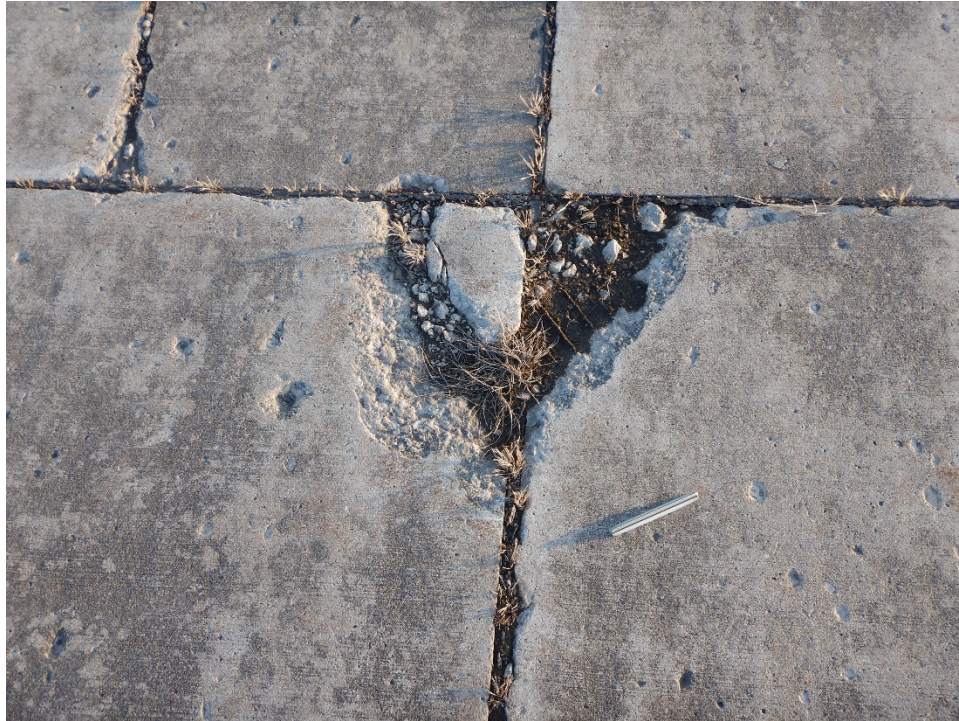
TAAM-10. ASR (Sample Unit No. 06) (2).

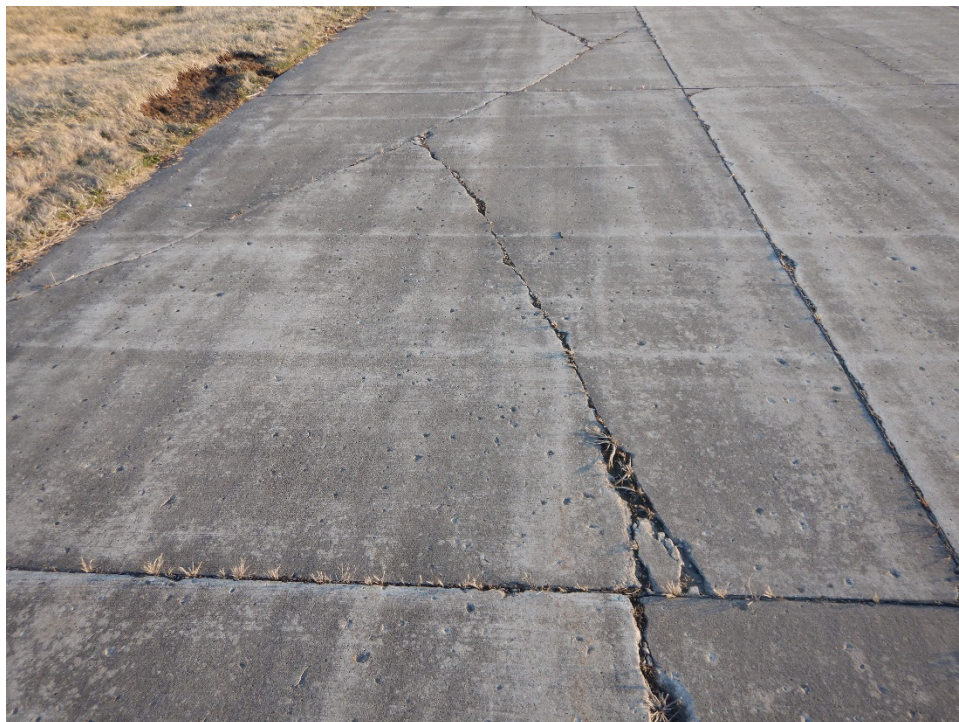
TAAM-10. LTD Cracking (Sample Unit No. 06).

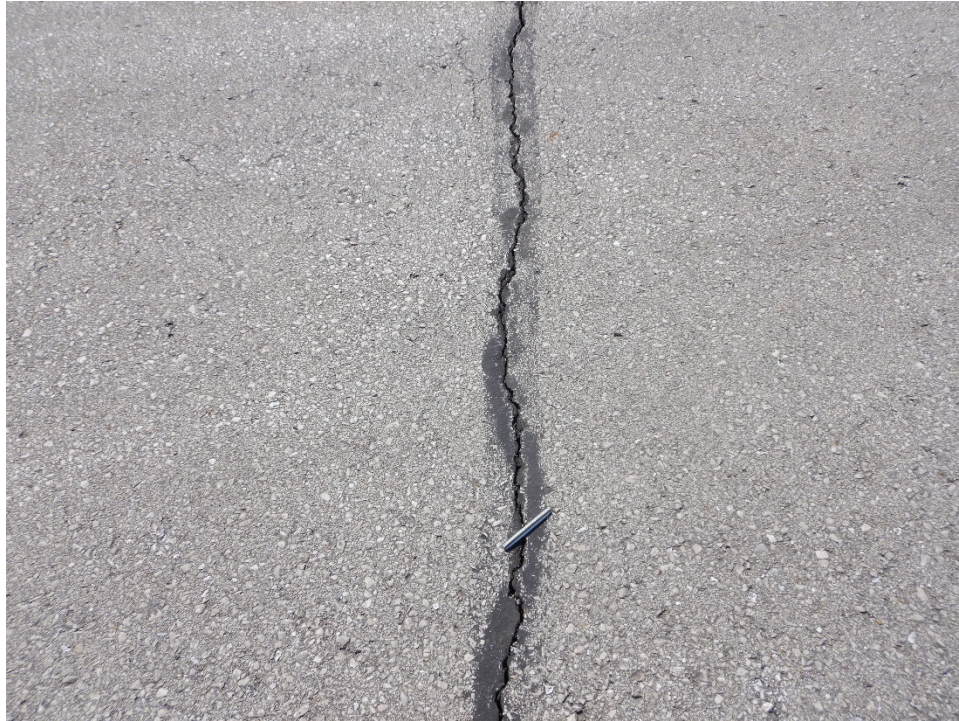
TB1AM-01. L&T Cracking (Sample Unit No. 02).

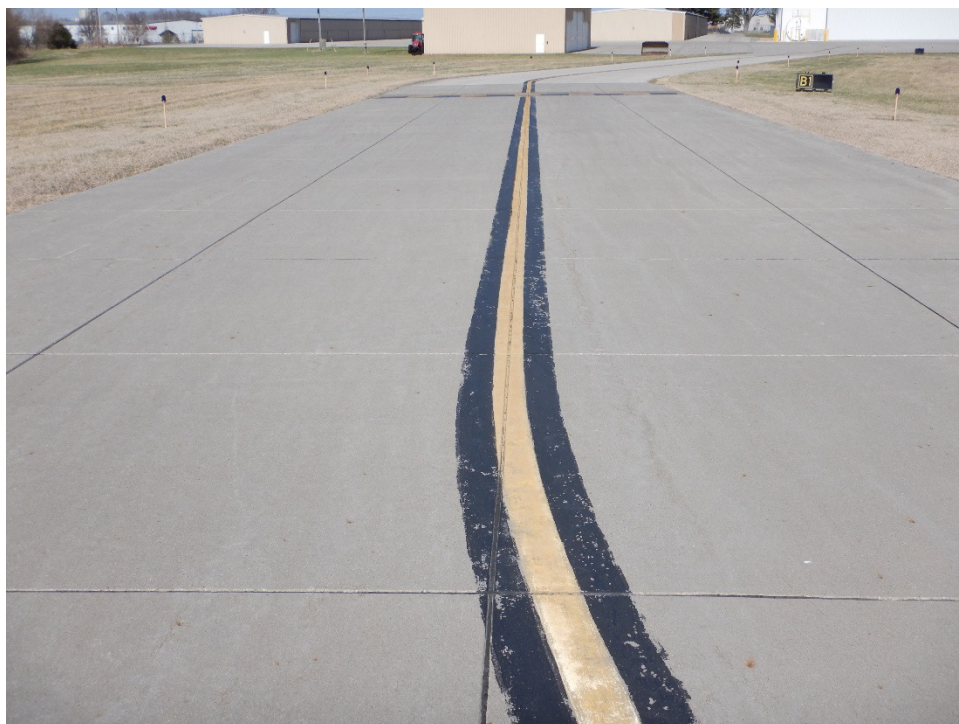
TB1AM-02. Overview.

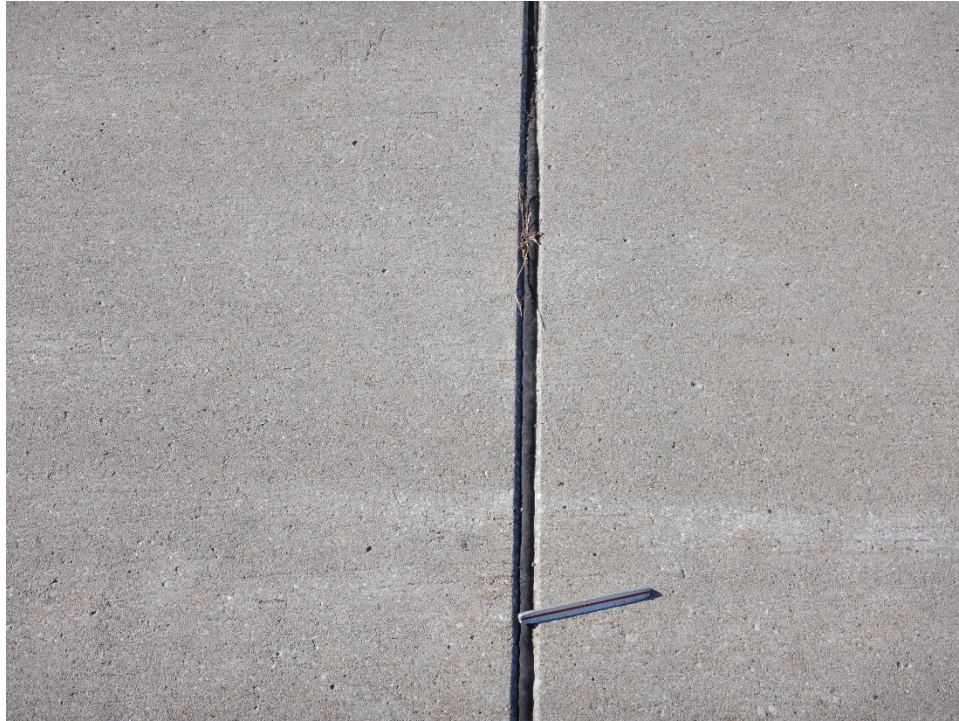
TB1AM-02. Joint Seal Damage (Sample Unit No. 03).

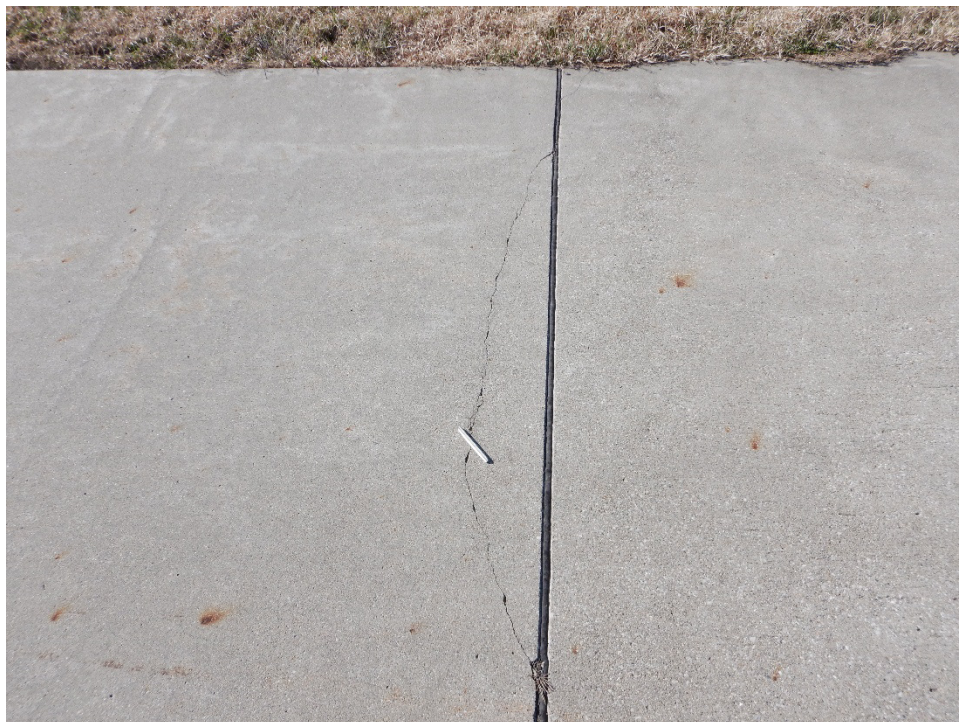
TB1AM-02. Joint Spalling (Sample Unit No. 04).

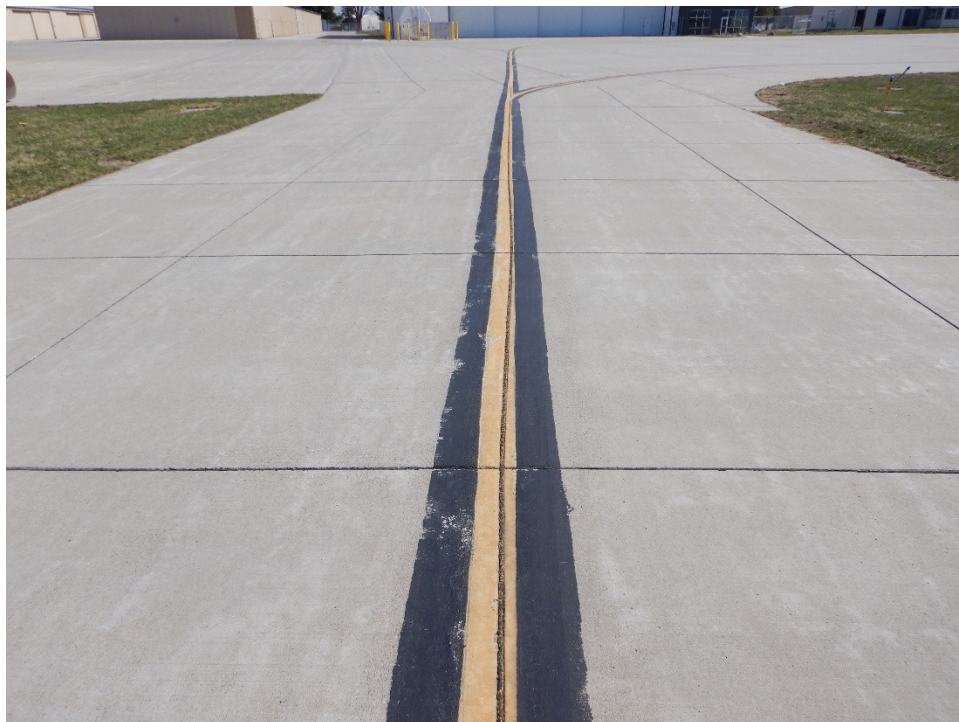
TB1AM-04. Overview.

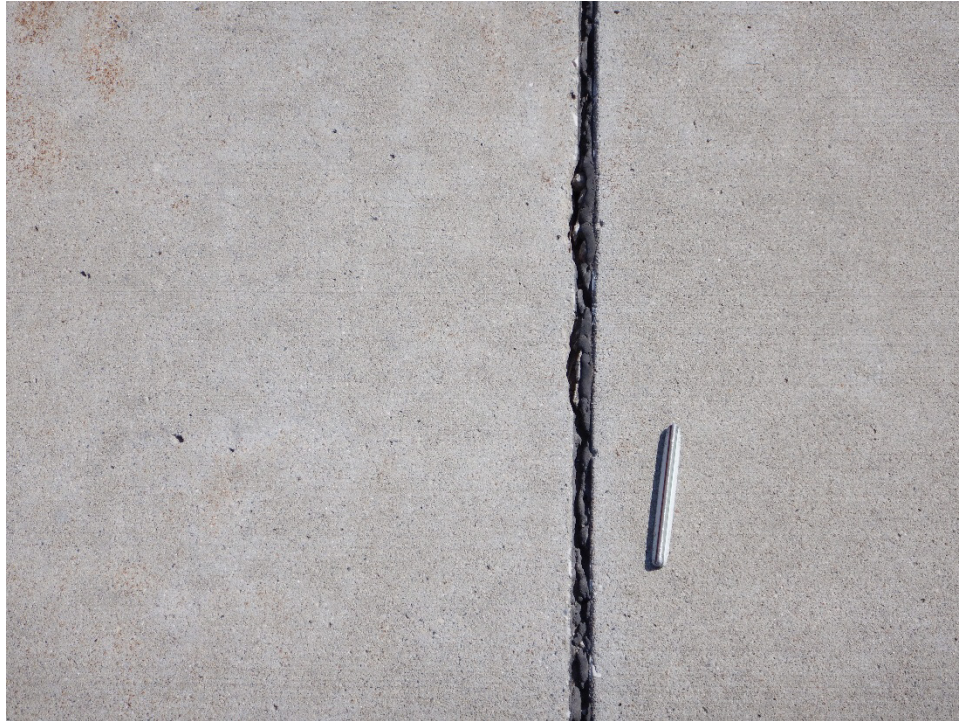
TB1AM-04. Joint Seal Damage (Sample Unit No. 02).

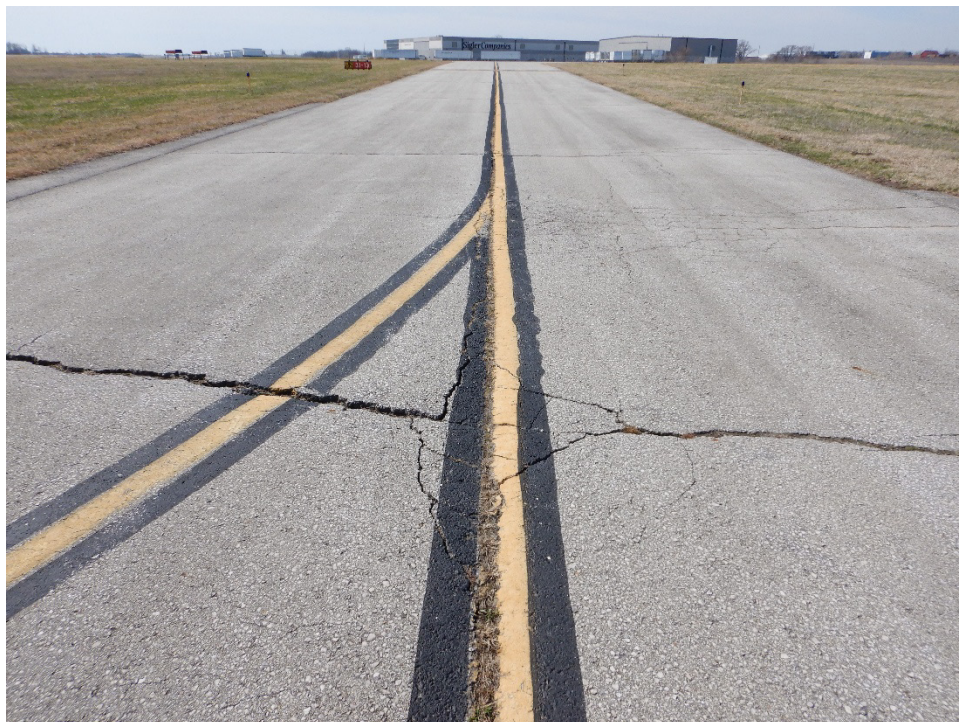
TB2AM-01. Overview.

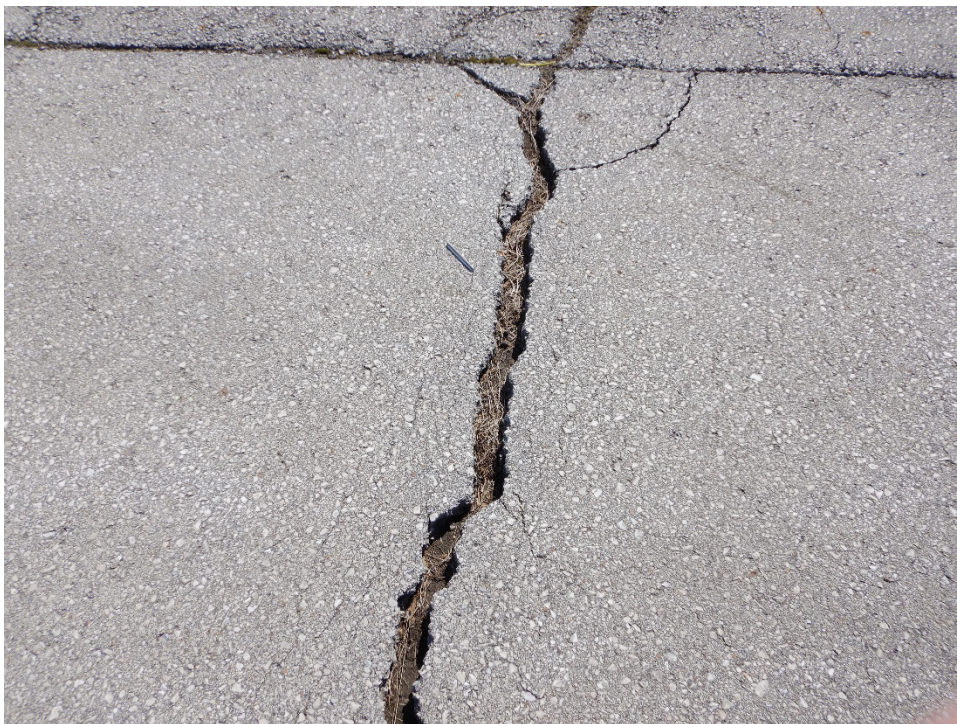
TB2AM-01. L&T Cracking (Sample Unit No. 01).

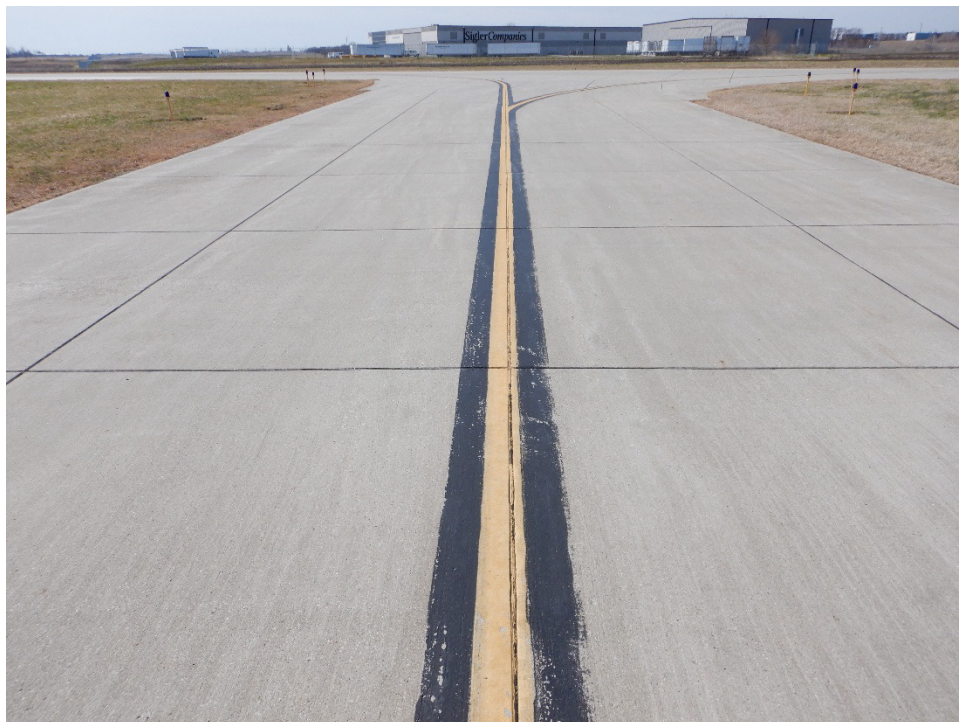
TB2AM-02. Overview.

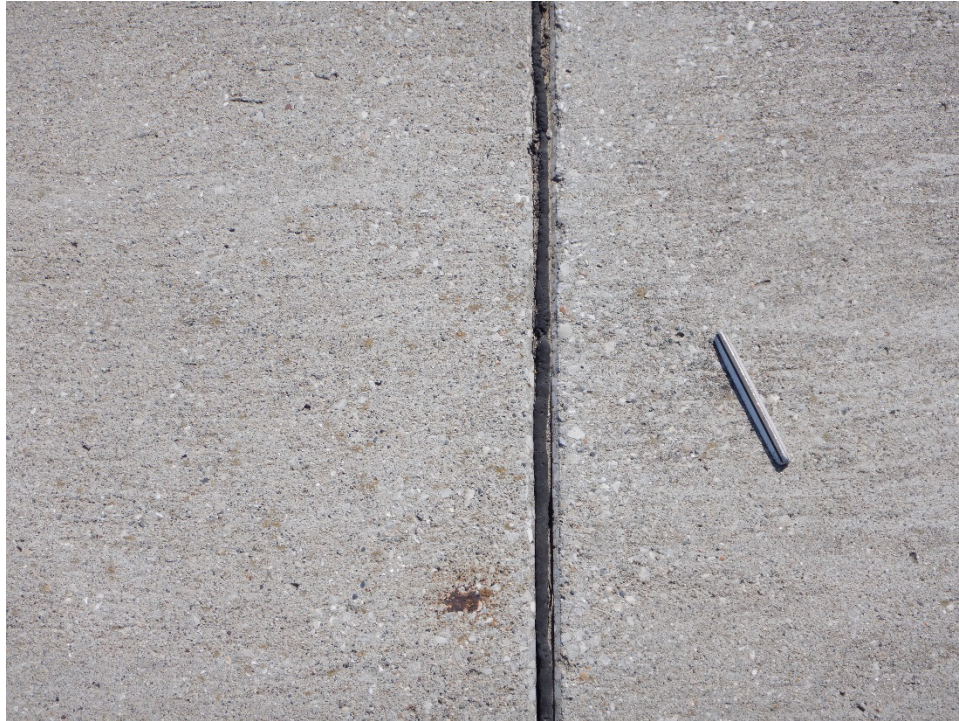
TB2AM-02. Joint Seal Damage (Sample Unit No. 02).

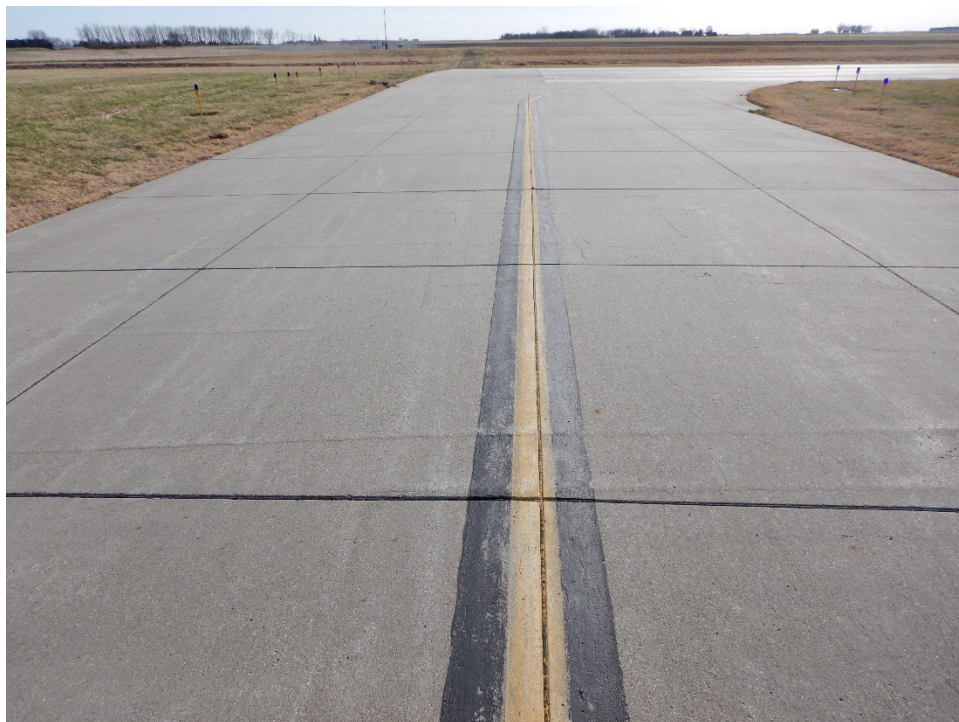
TB3AM-01. Overview.

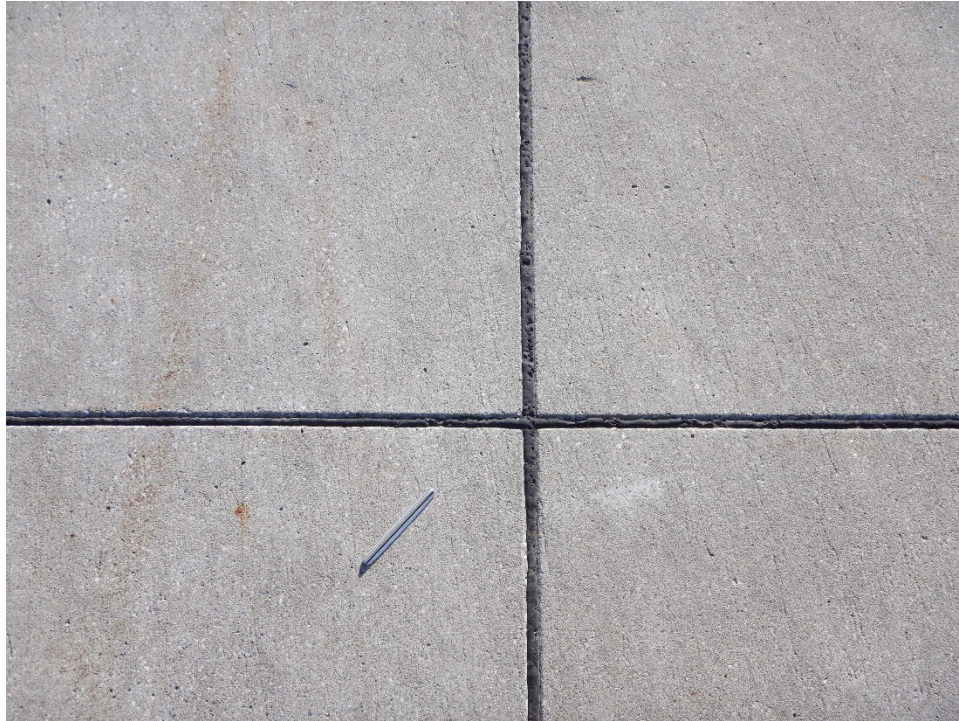
TB3AM-01. Joint Seal Damage (Sample Unit No. 02).

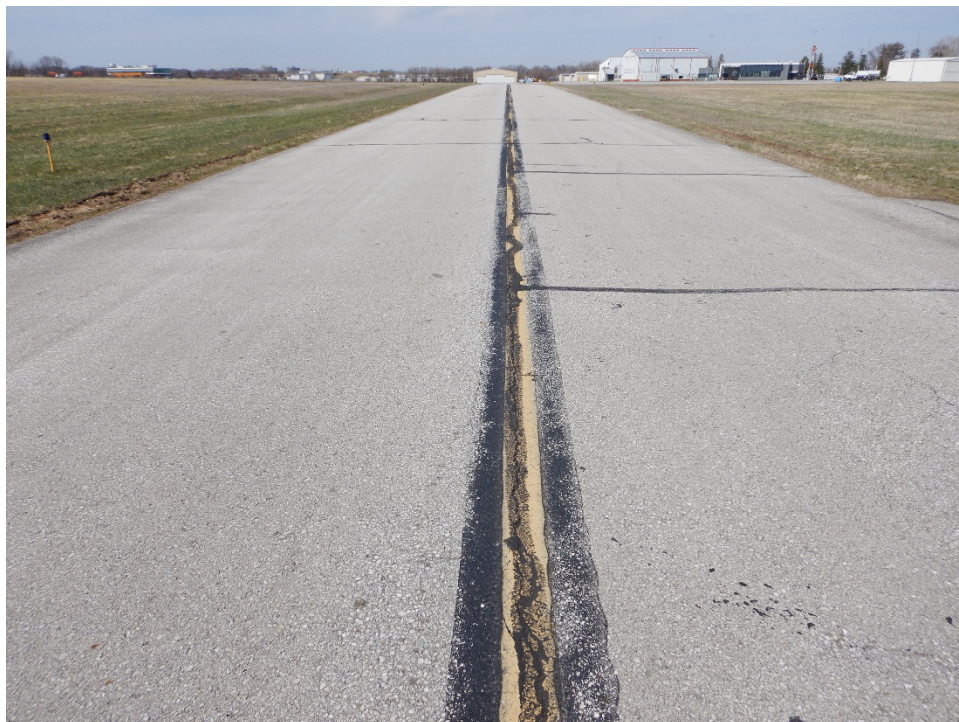
TBAM-01. Overview.

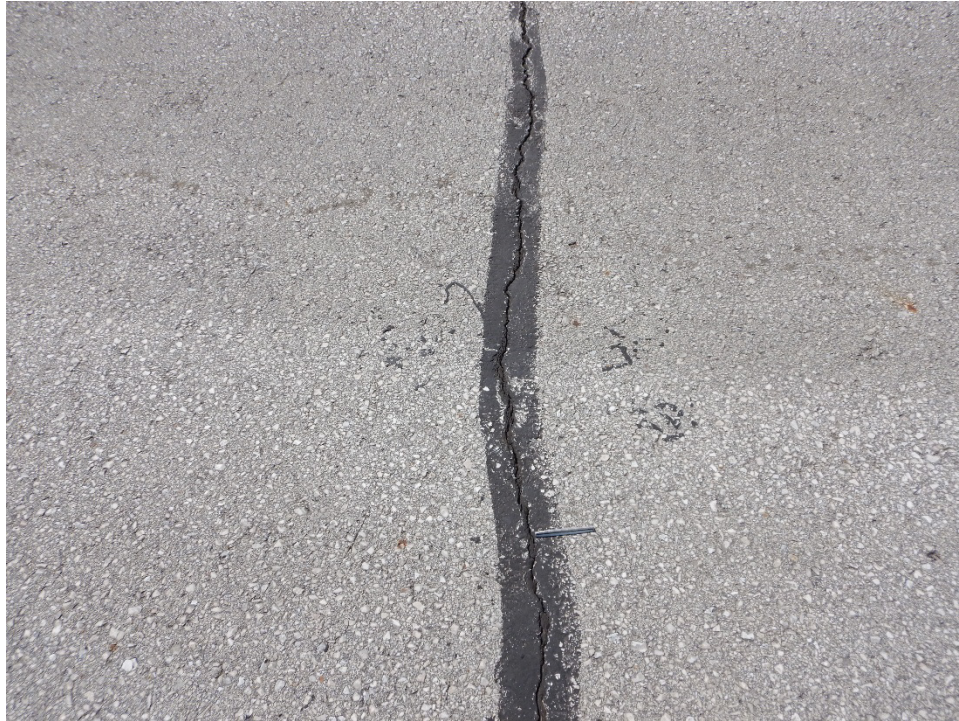
TBAM-01. L&T Cracking (Sample Unit No. 07) (1).

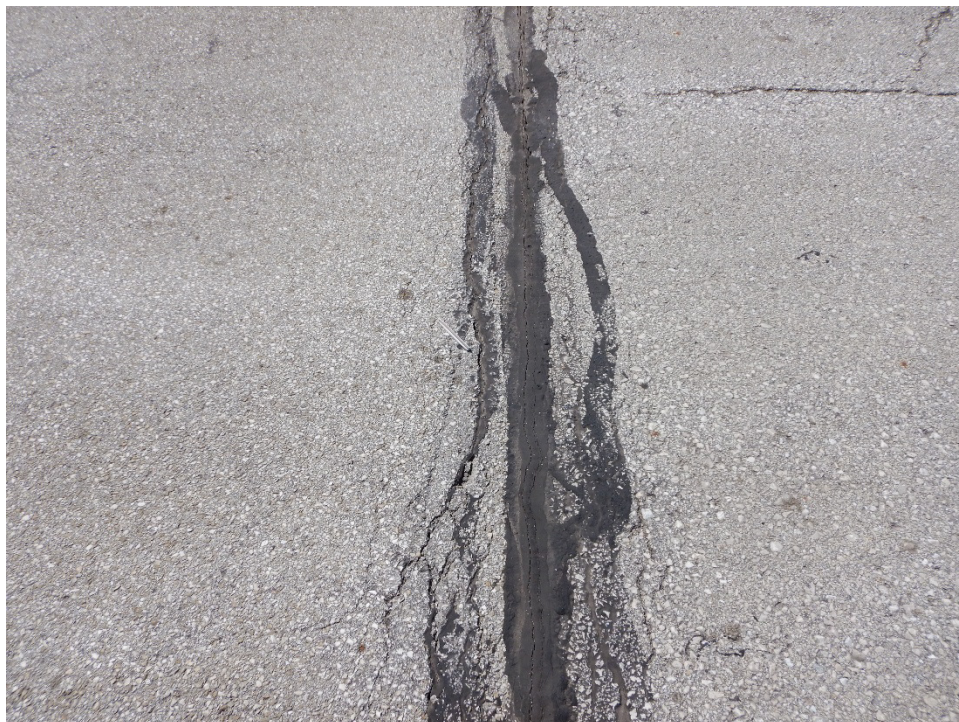
TBAM-01. L&T Cracking (Sample Unit No. 07) (2).

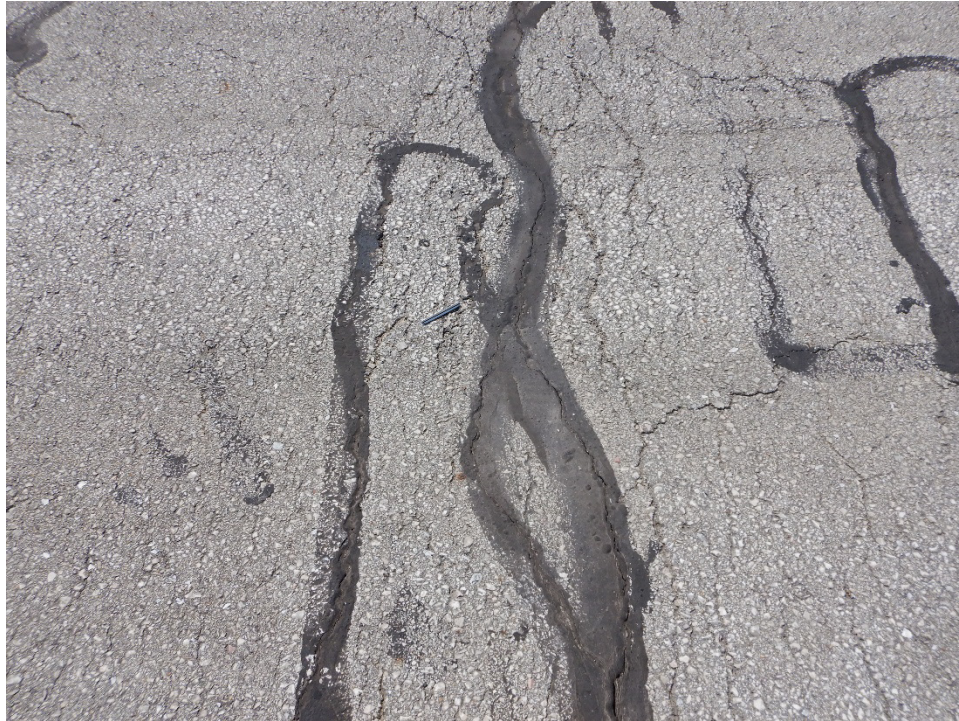
TBAM-01. L&T Cracking (Sample Unit No. 09) (1).

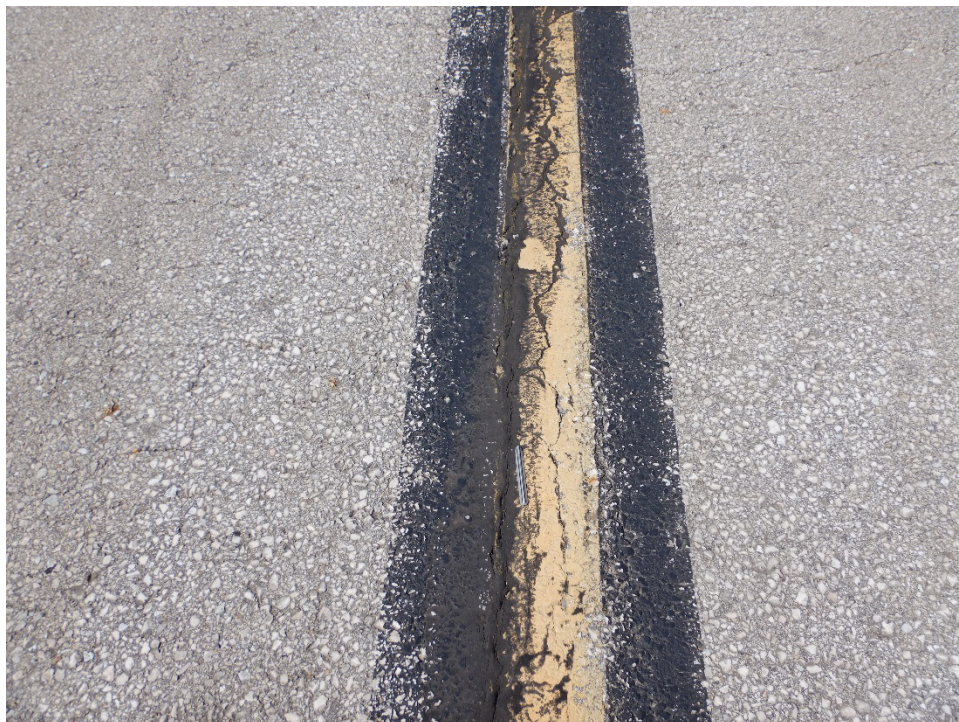
TBAM-01. L&T Cracking (Sample Unit No. 09) (2).

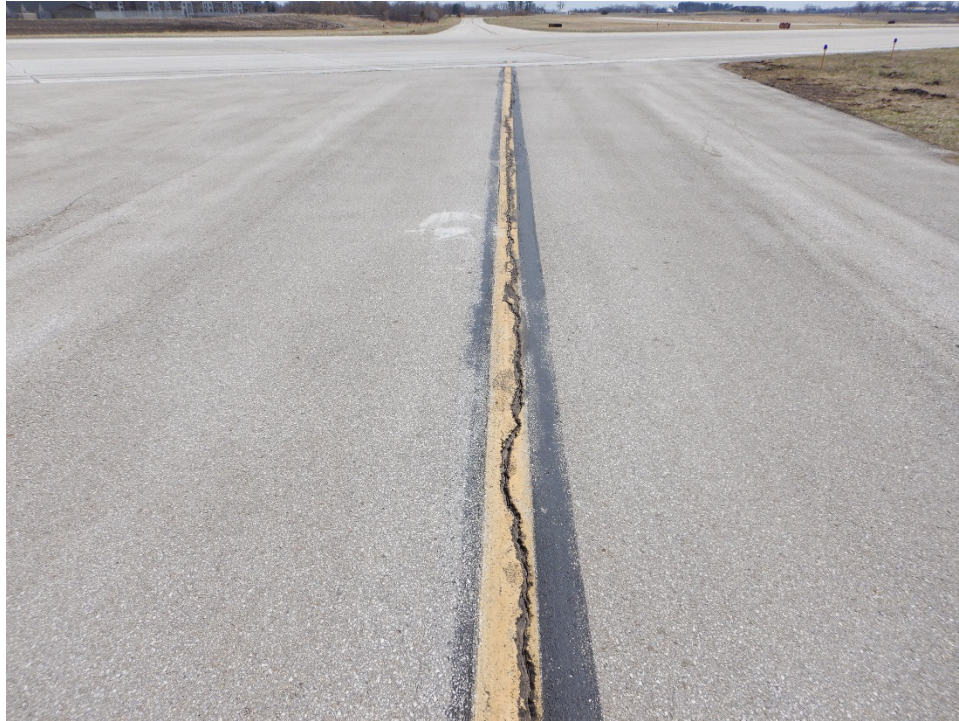
TBAM-02. Overview.

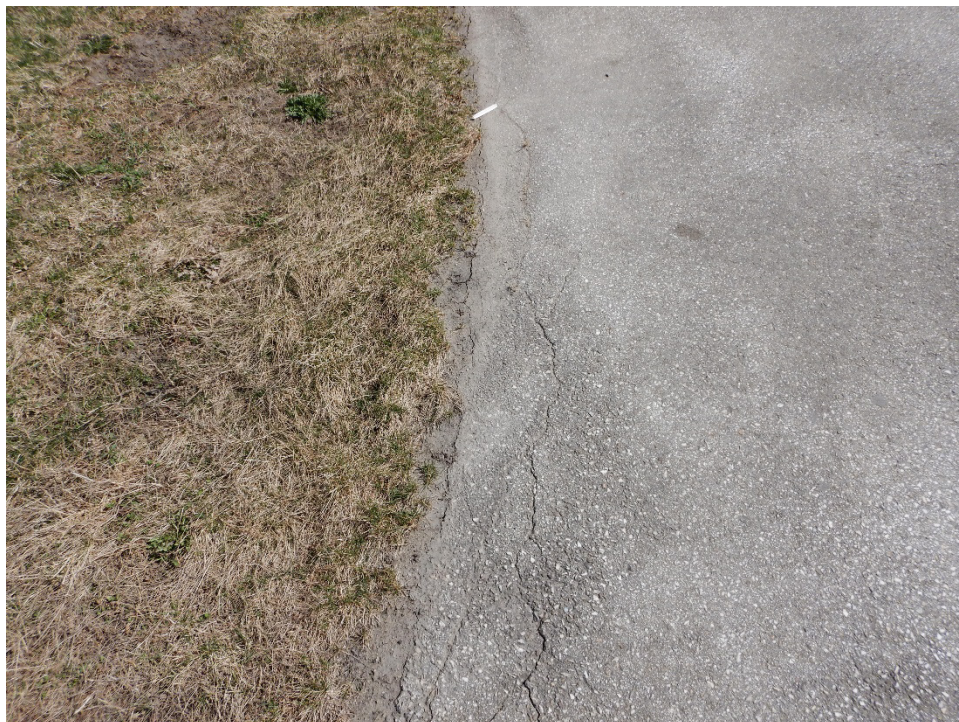
TBAM-02. Alligator Cracking (Sample Unit No. 01).

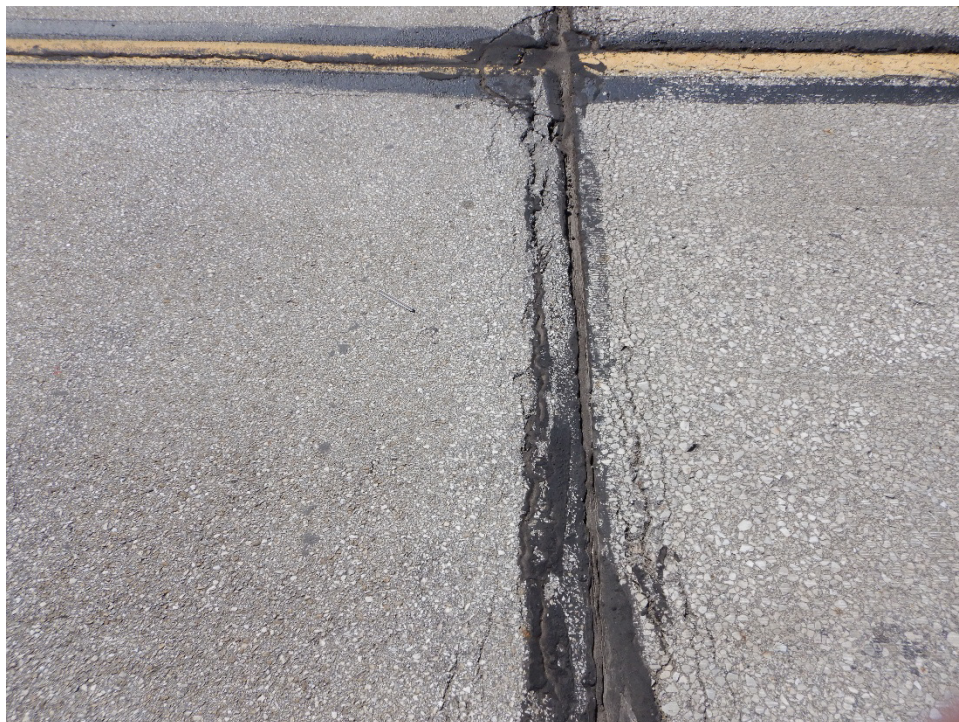
TBAM-02. L&T Cracking (Sample Unit No. 01) (2).

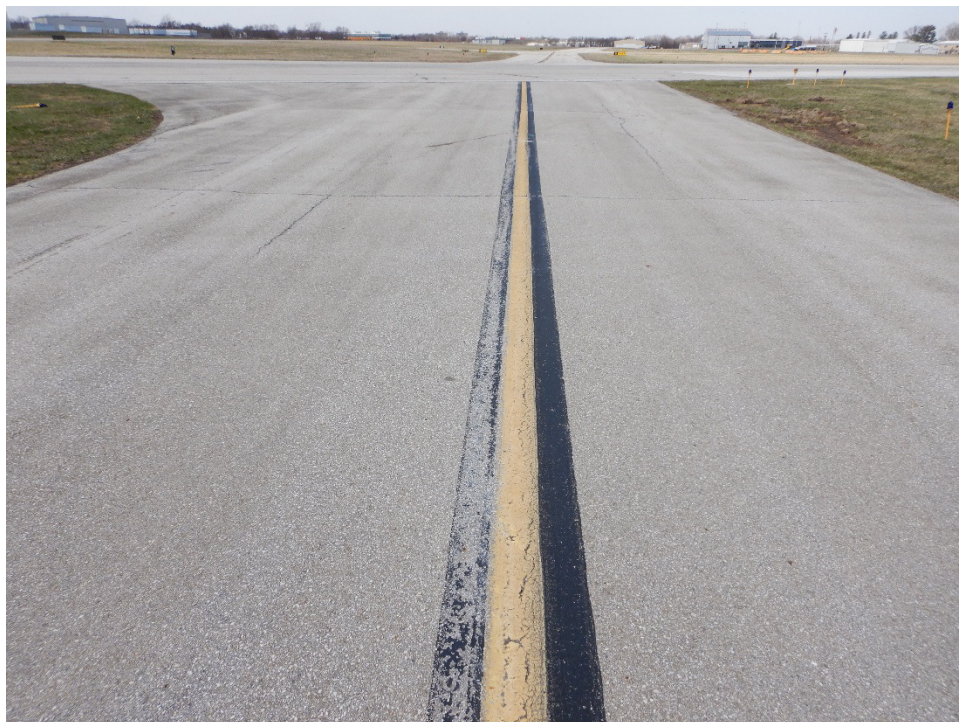
TBAM-03. Overview.

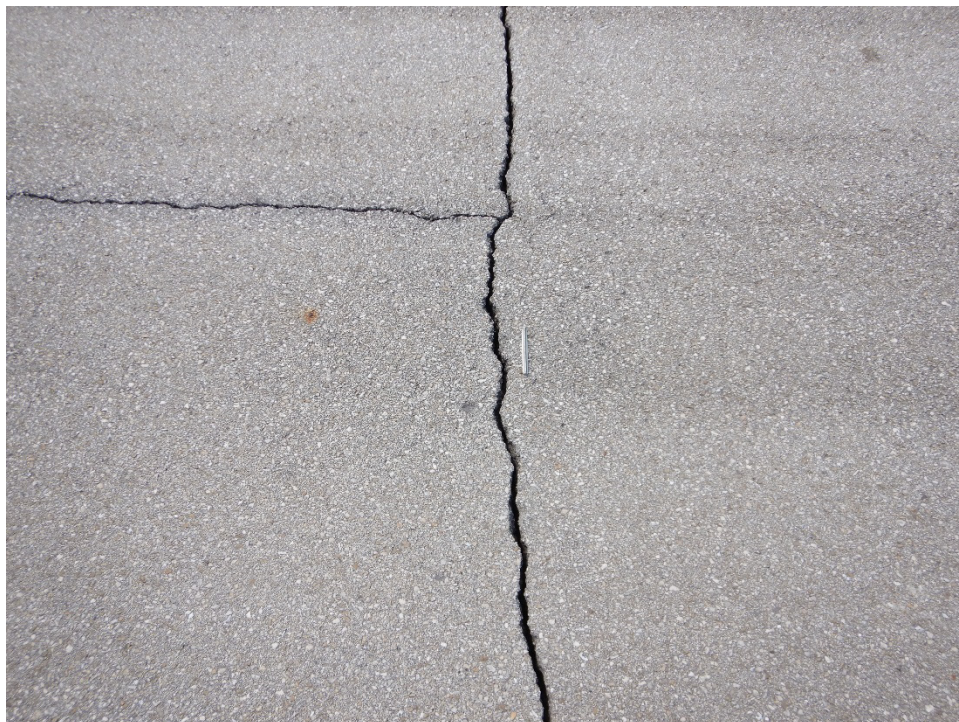
TBAM-03. L&T Cracking (Sample Unit No. 01).

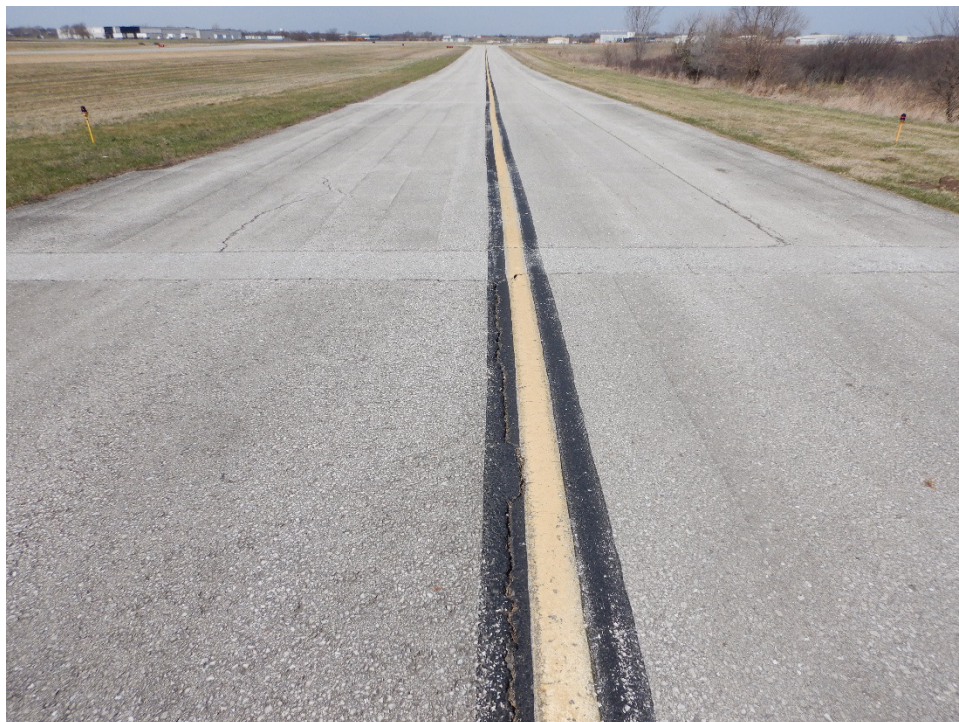
TBAM-04. Overview.

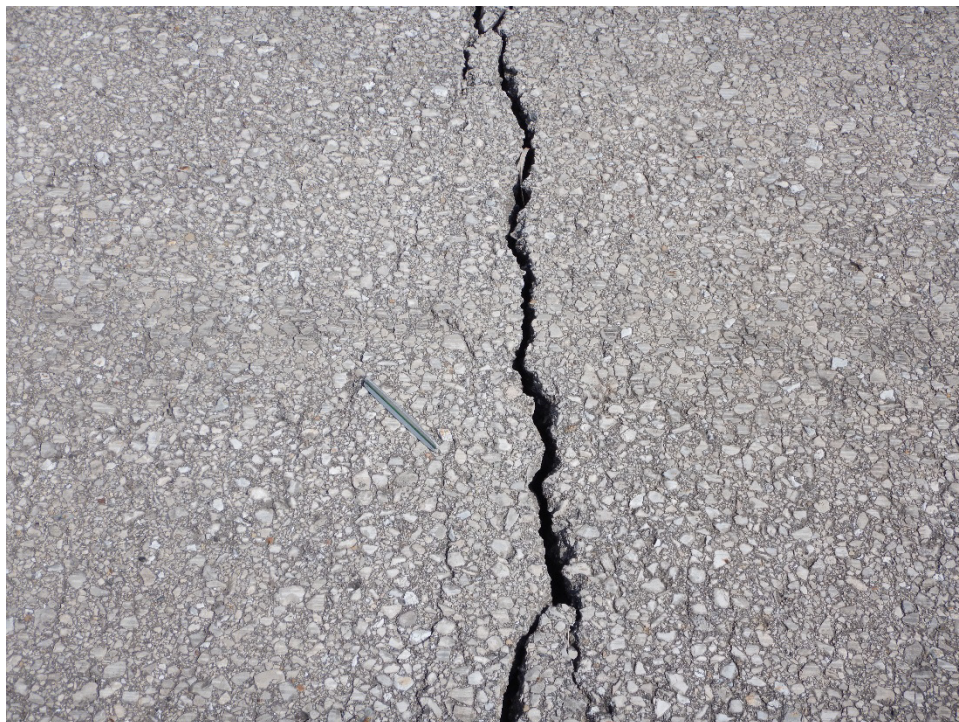
TBAM-04. L&T Cracking (Sample Unit No. 02).

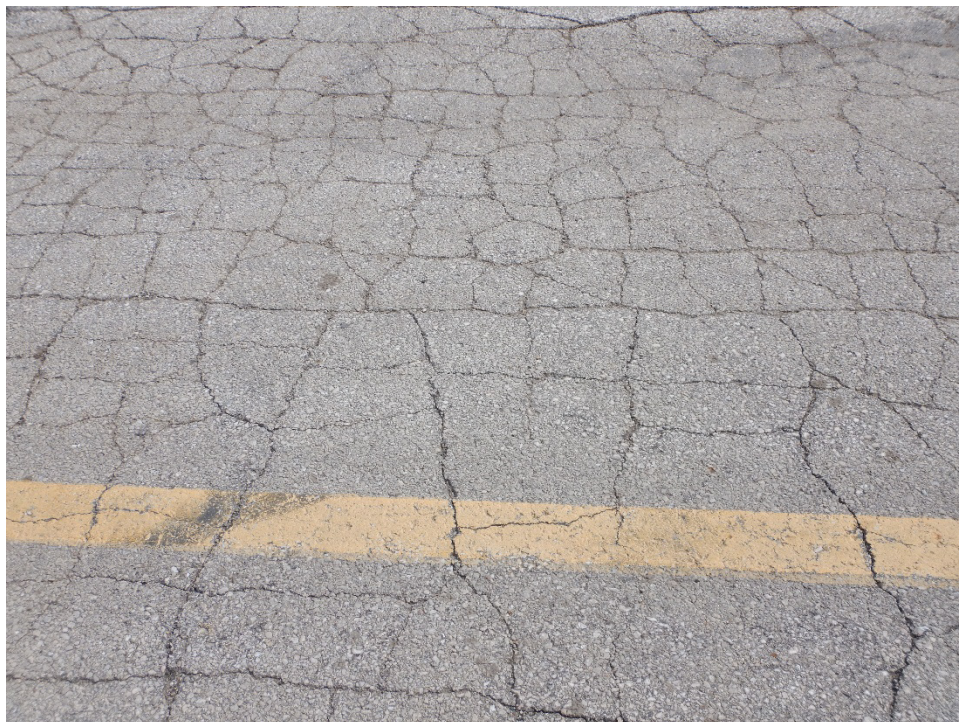
TH01AM-01. Alligator Cracking (Sample Unit No. 02).

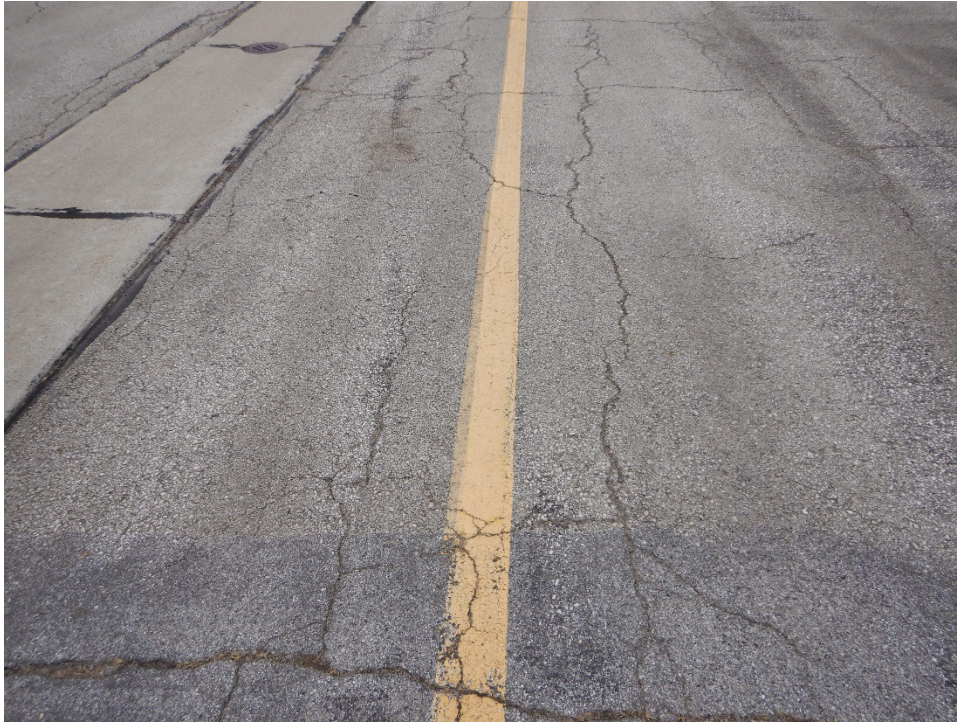
TH01AM-01. Block Cracking (Sample Unit No. 12).

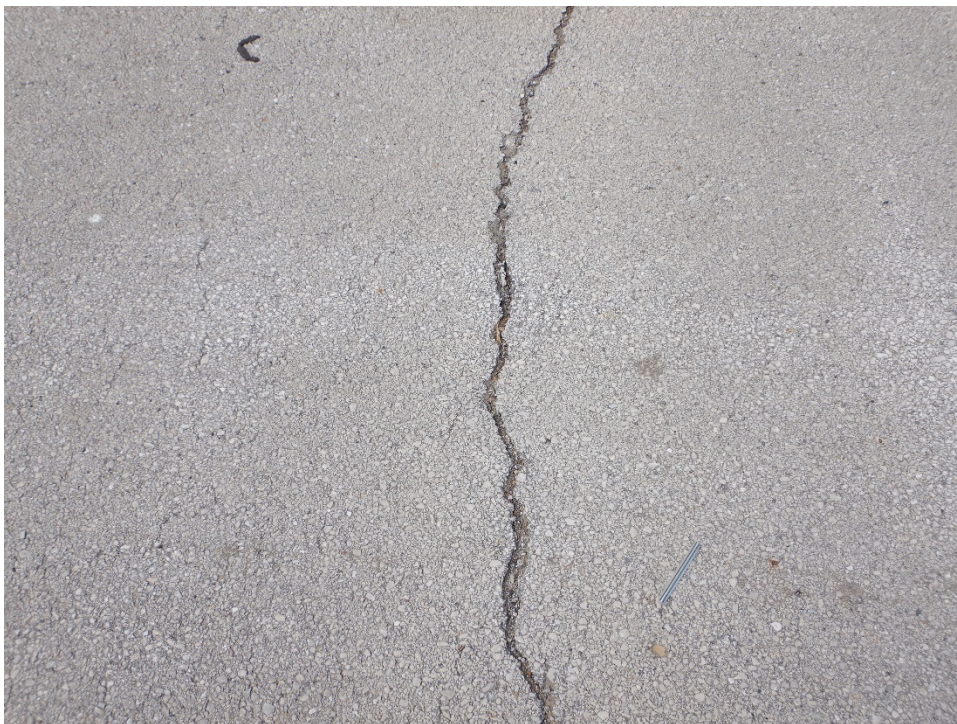
TH01AM-01. L&T Cracking (Sample Unit No. 02).
