# Ankeny Regional Airport

## Pavement Management Report

**AUGUST 2025**

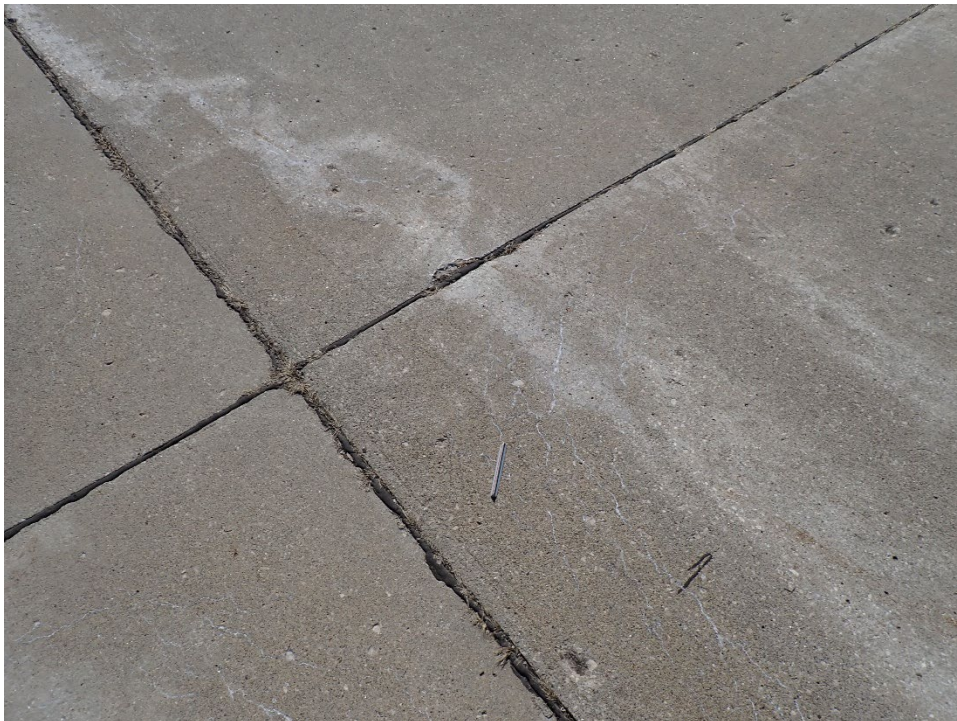
A01AN-01. ASR (Sample Unit No. 40).

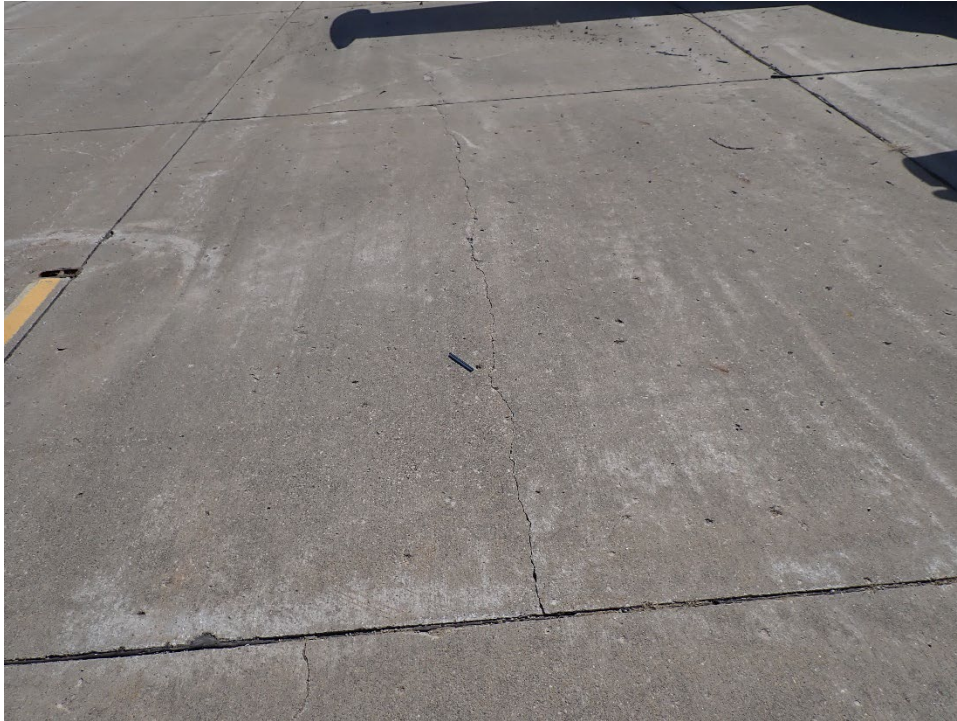
A01AN-01. LTD Cracking (Sample Unit No. 36).

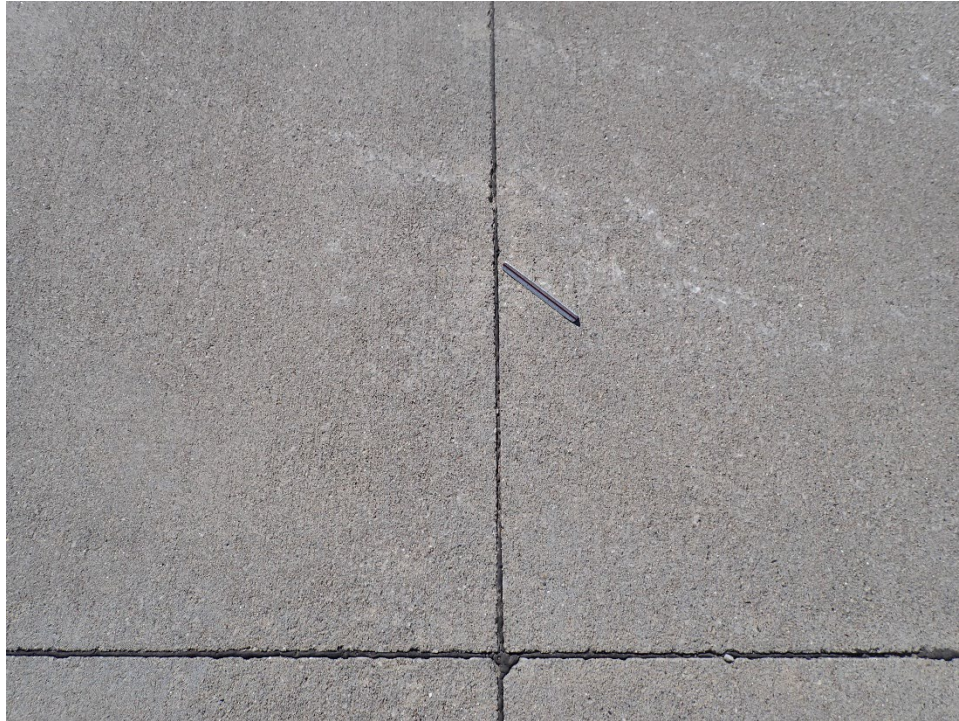
A01AN-03. Joint Seal Damage (Sample Unit No. 08).

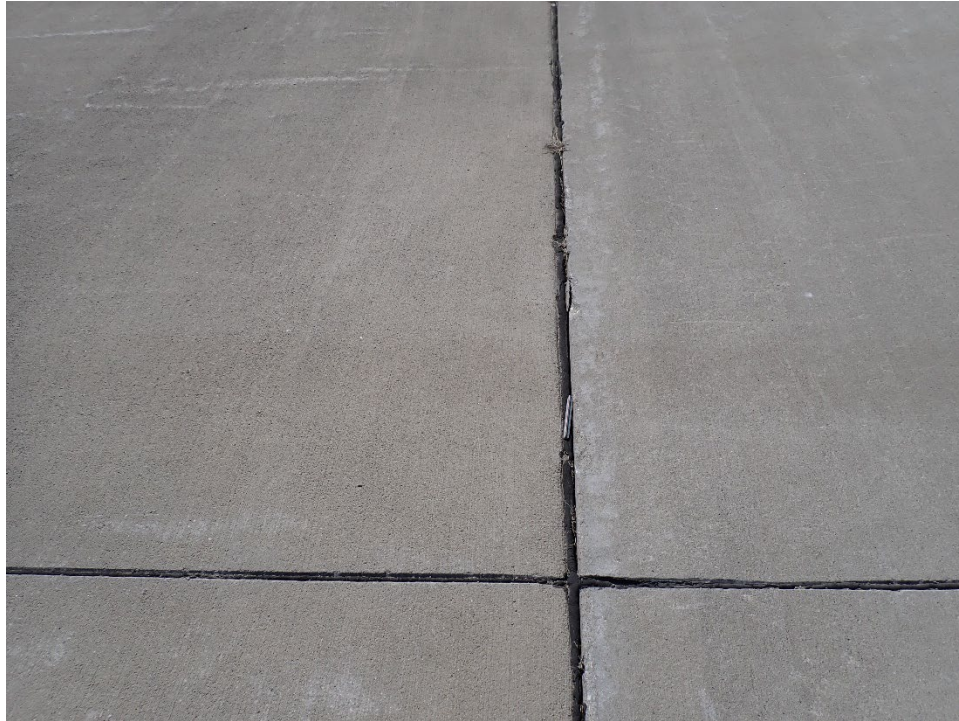
A02AN-01. Joint Seal Damage (Sample Unit No. 09).

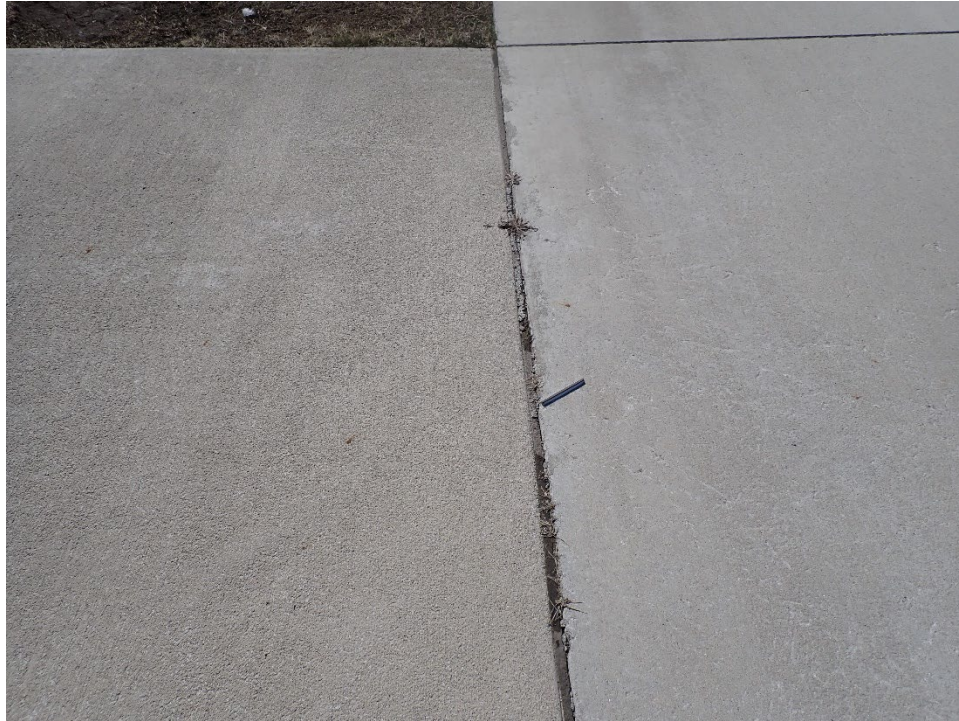
A02AN-02. Joint Seal Damage (Sample Unit No. 09).

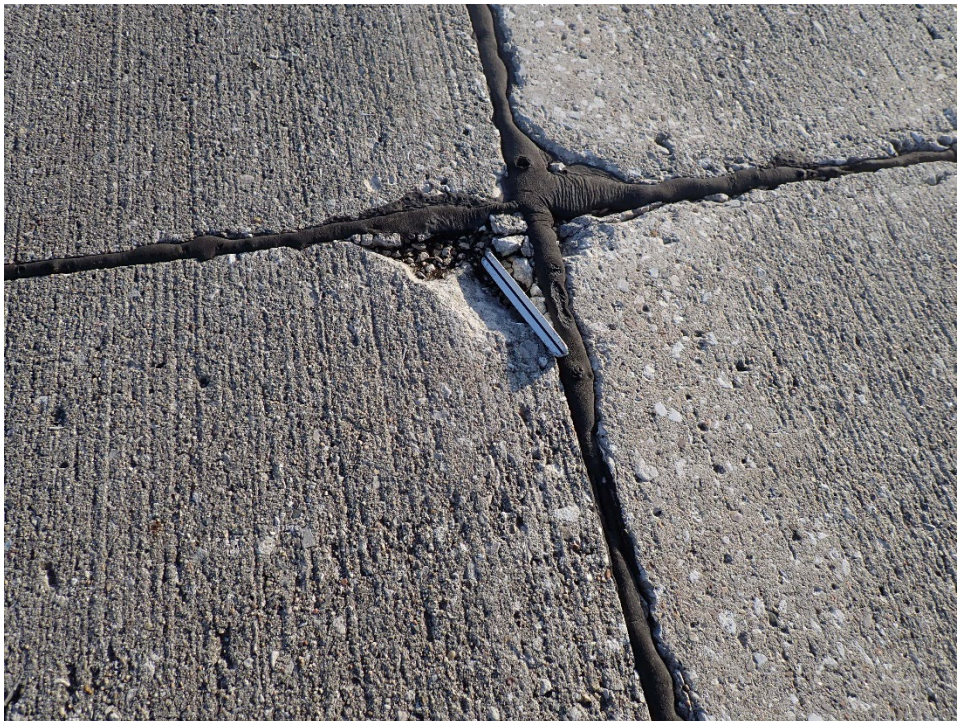
R04AN-01. Corner Spalling (Sample Unit No. 13).

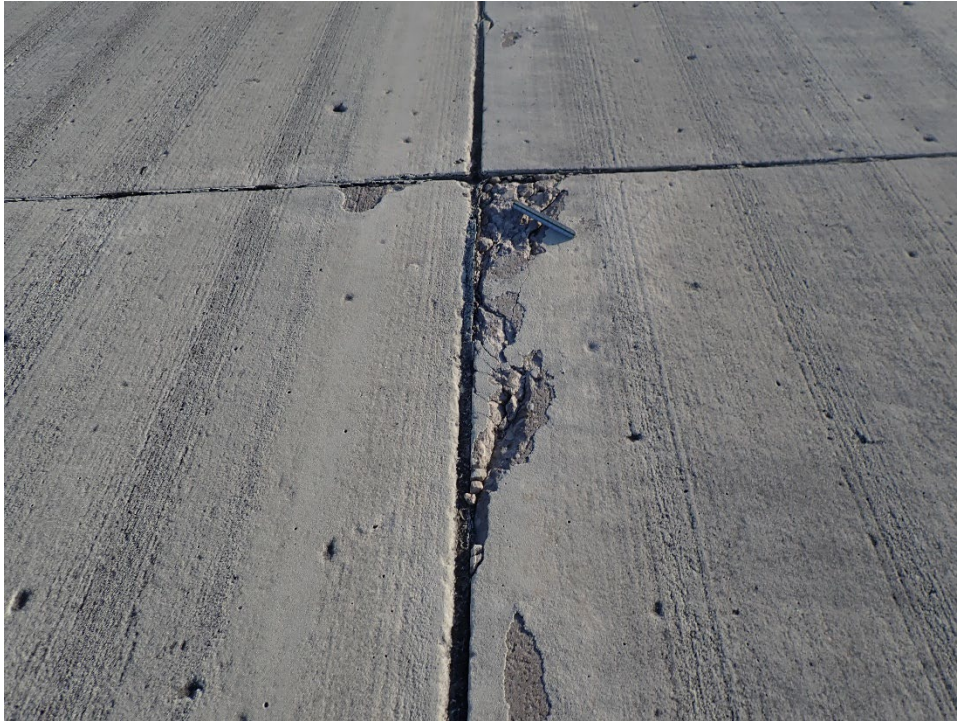
R04AN-01. Joint Spalling (Sample Unit No. 21).

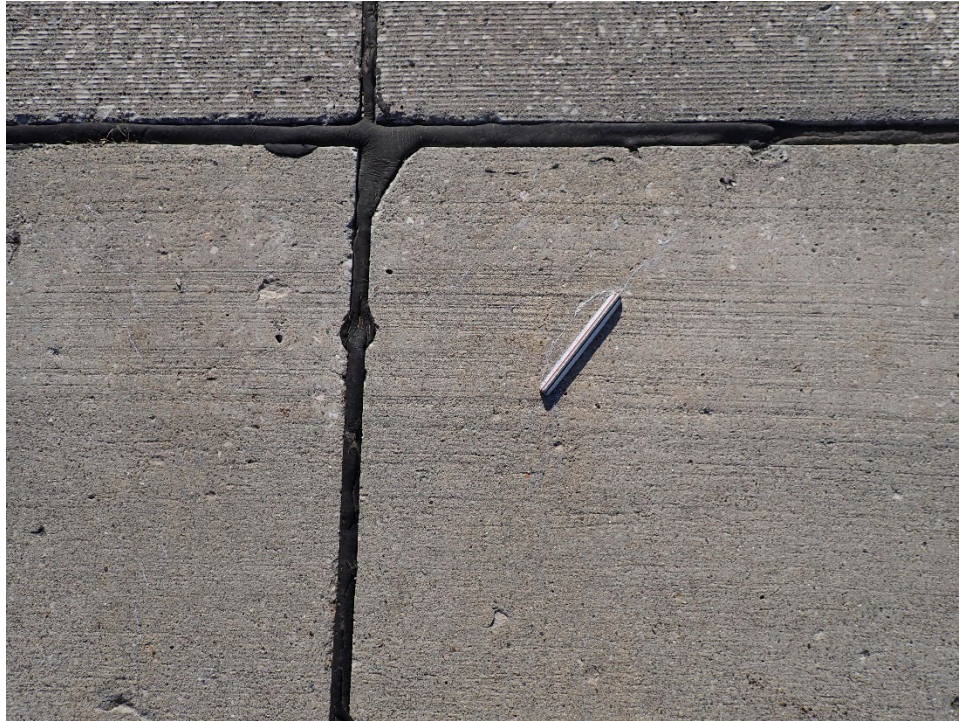
R04AN-02. ASR (Sample Unit No. 04).

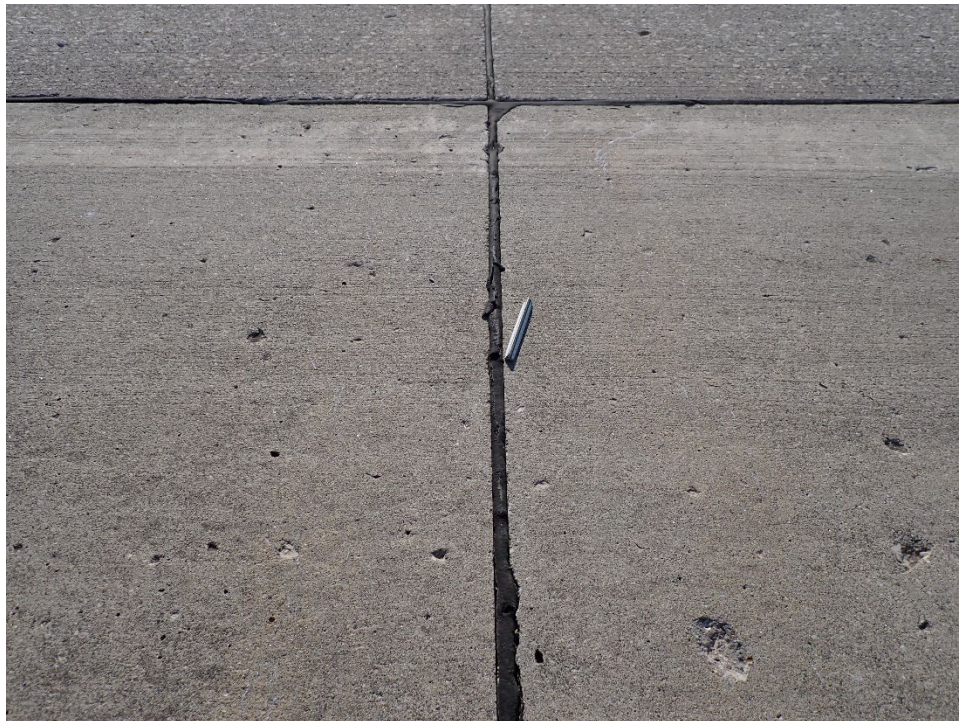
R04AN-02. Joint Seal Damage (Sample Unit No. 04).

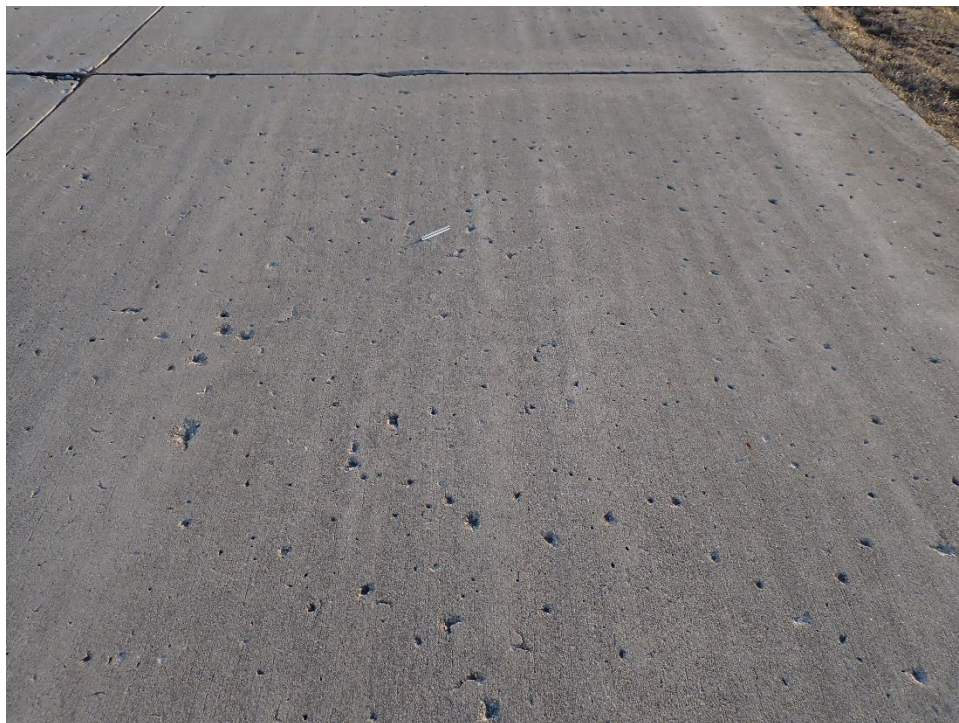
R04AN-03. Popouts (Sample Unit No. 05).

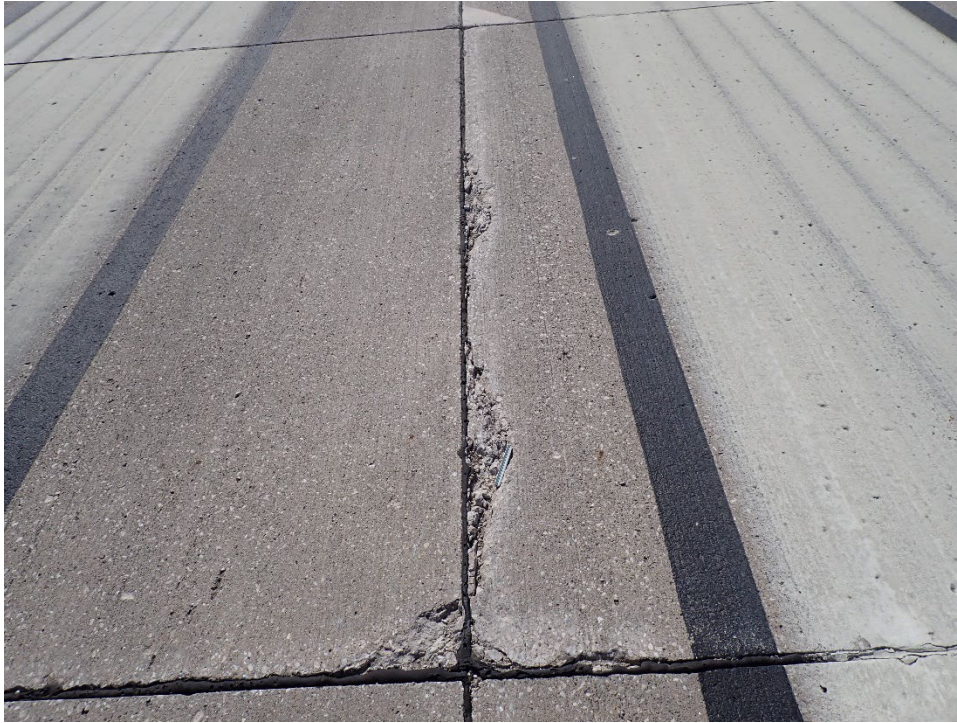
R04AN-04. ASR (Sample Unit No. 43).

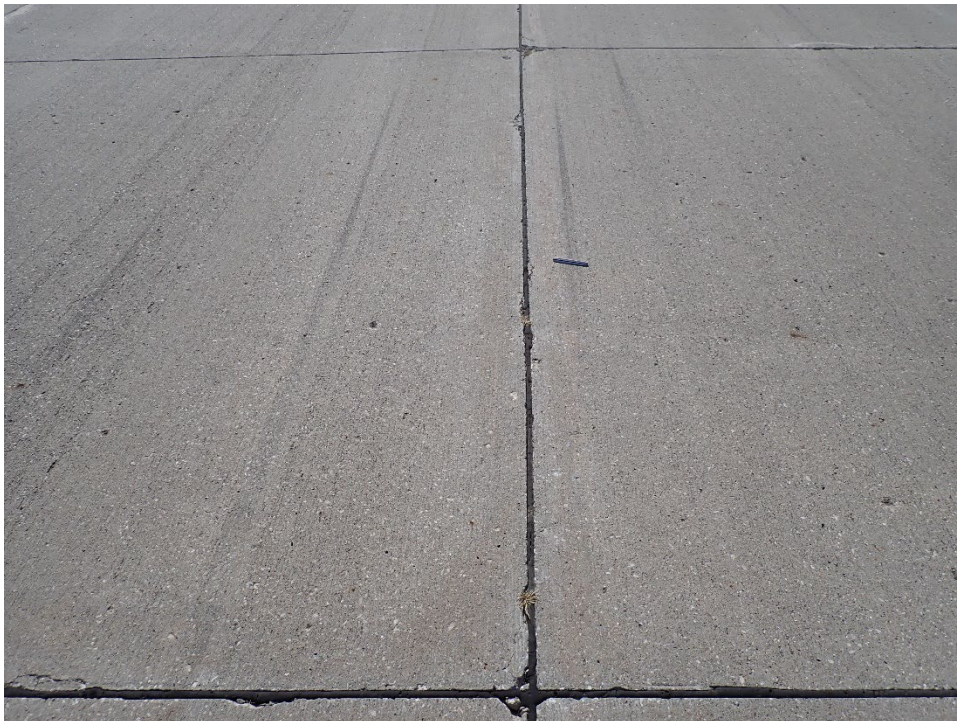
R04AN-04. Joint Seal Damage (Sample Unit No. 28).

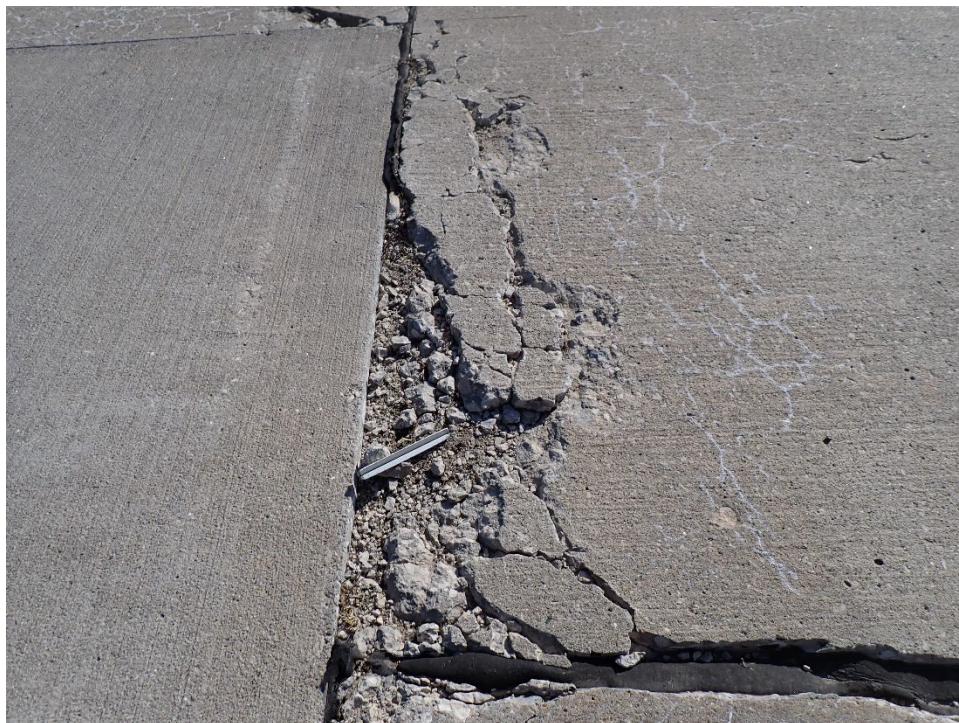
R18AN-01. ASR (Sample Unit No. 63).

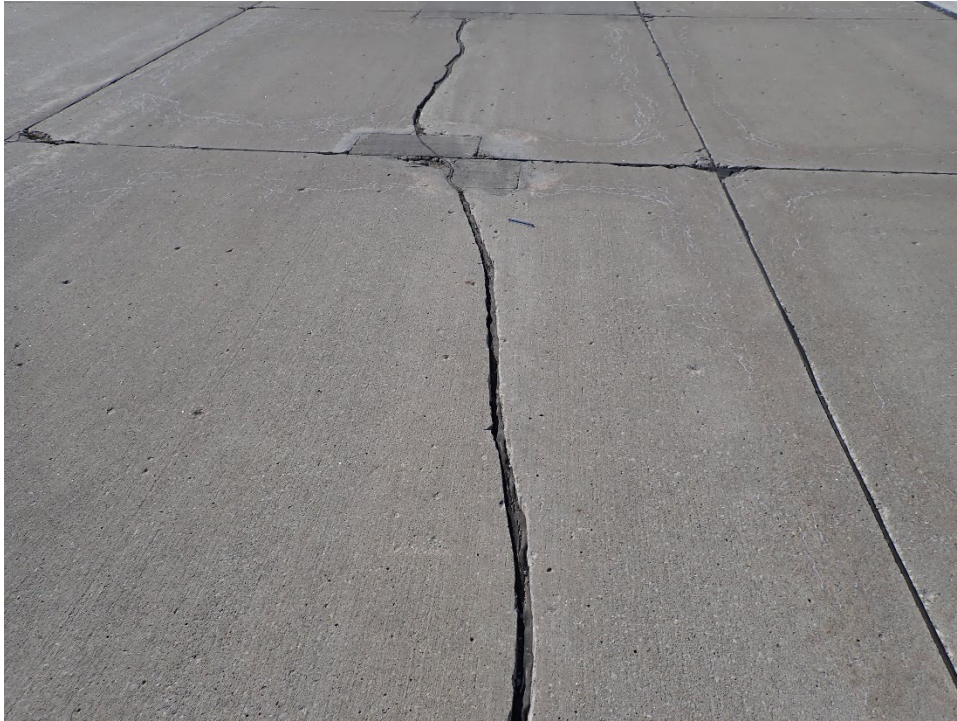
R18AN-01. LTD Cracking (Sample Unit No. 63).

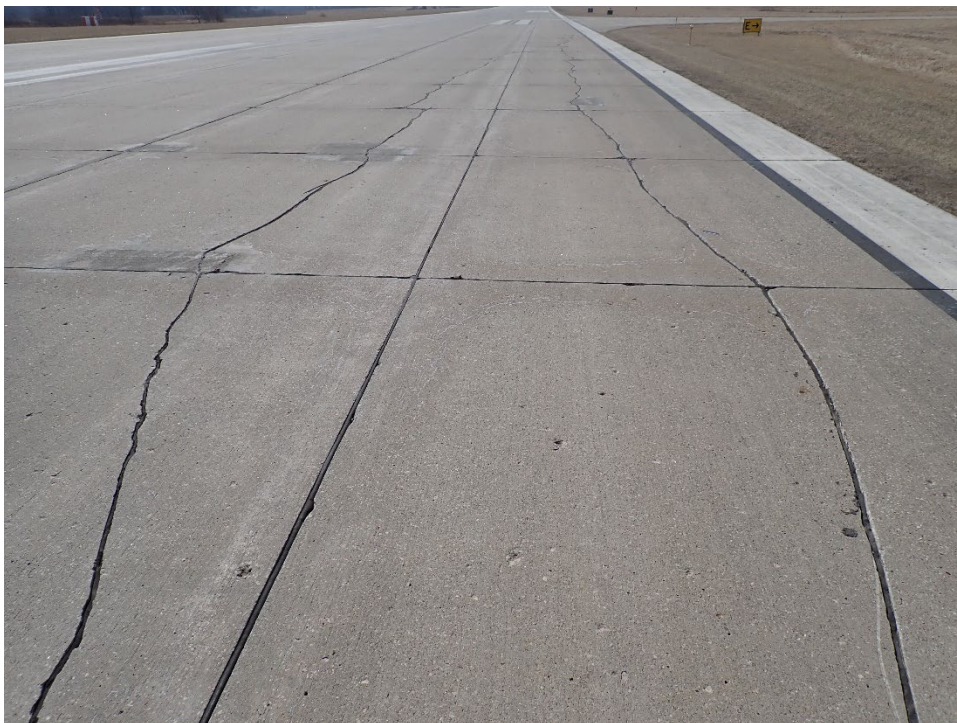
R18AN-01. LTD Cracking (Sample Unit No. 99).

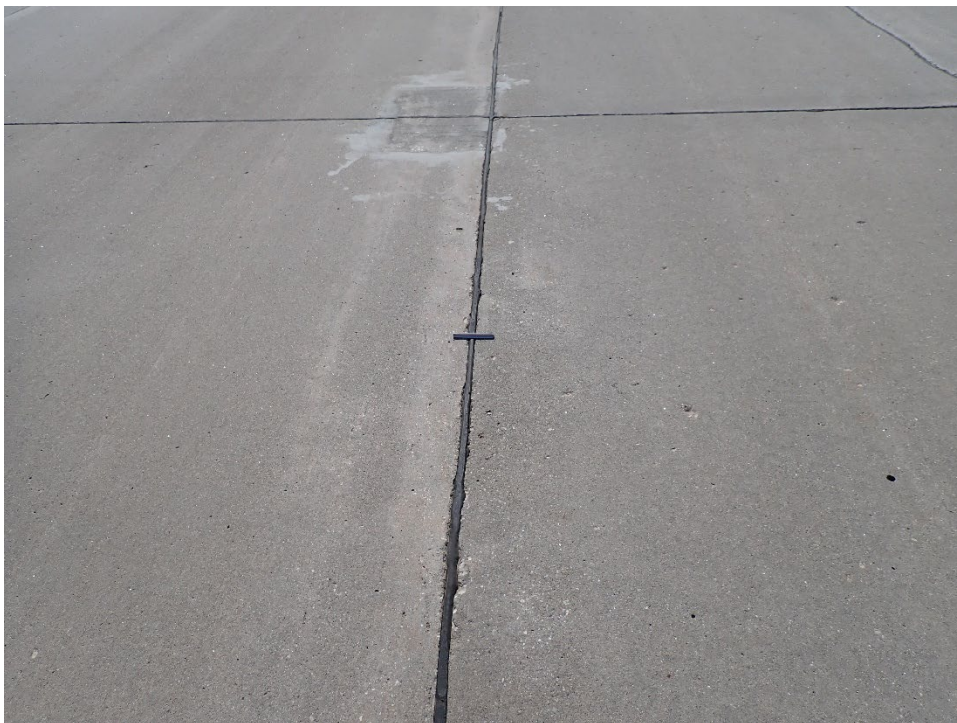
R18AN-02. Joint Seal Damage (Sample Unit No. 31).

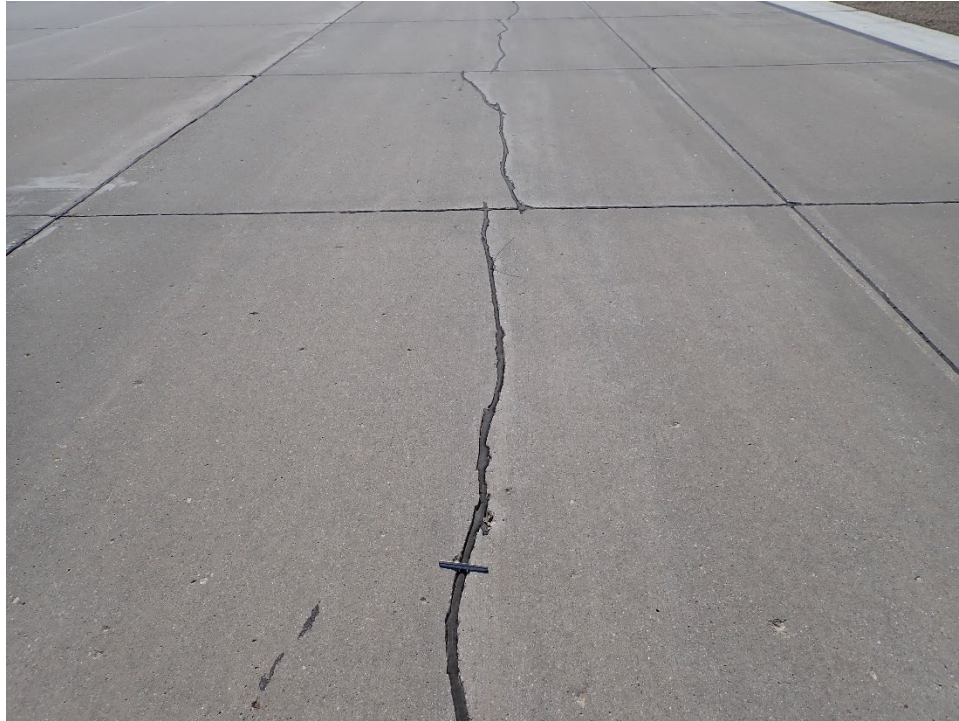
R18AN-02. LTD Cracking (Sample Unit No. 31).

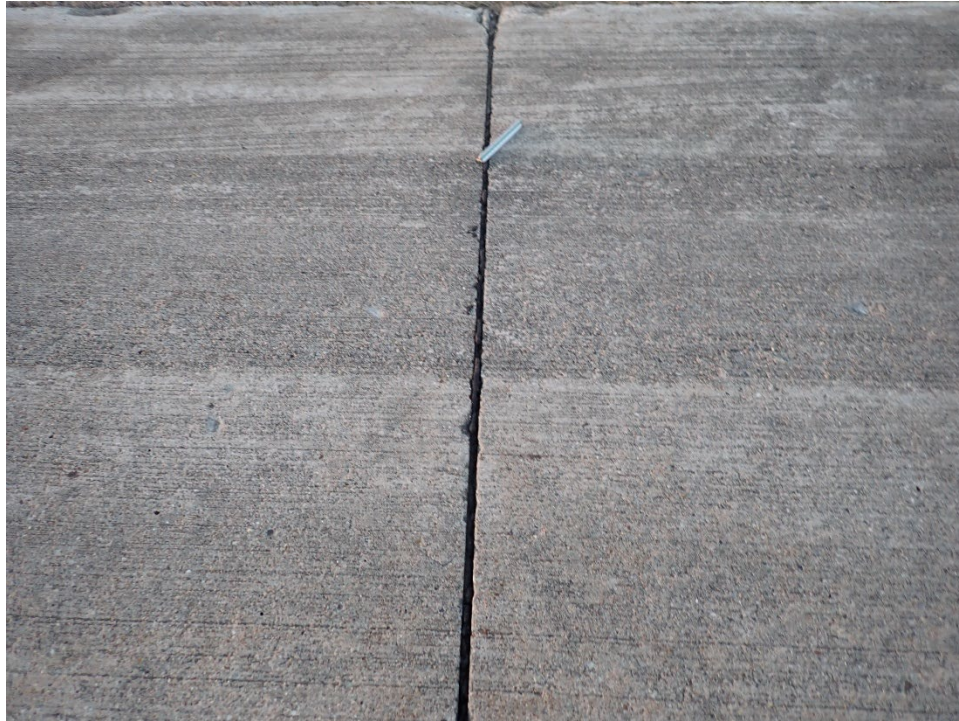
T01AN-01. Joint Seal Damage (Sample Unit No. 10).

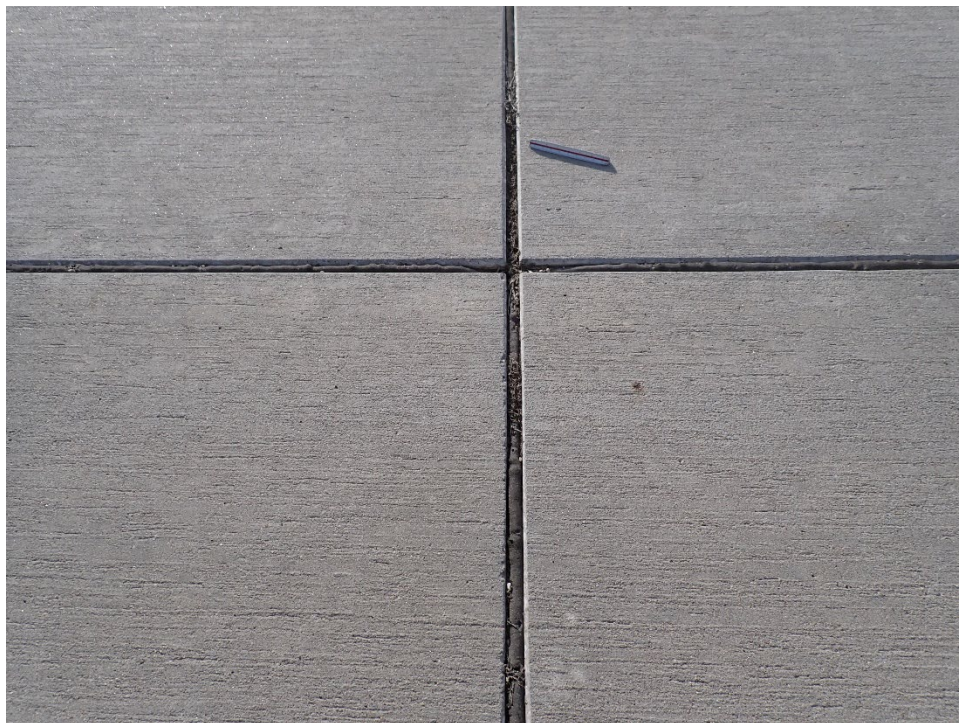
T01AN-01. Joint Seal Damage (Sample Unit No. 14).

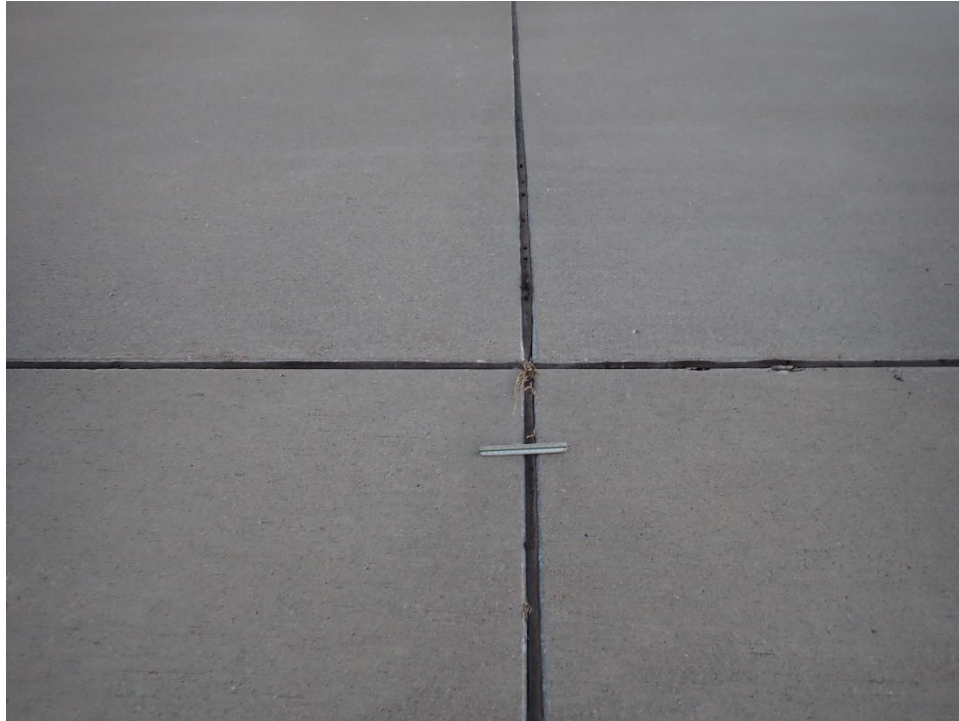
T01AN-01. Joint Seal Damage (Sample Unit No. 33).

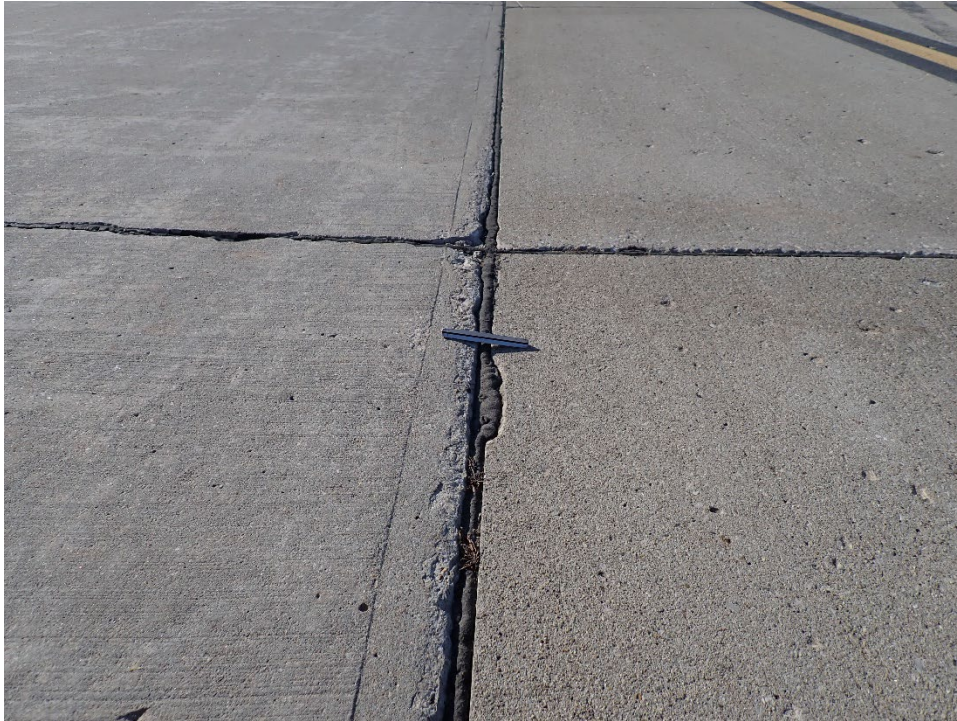
T02AN-01. Faulting (Sample Unit No. 12).

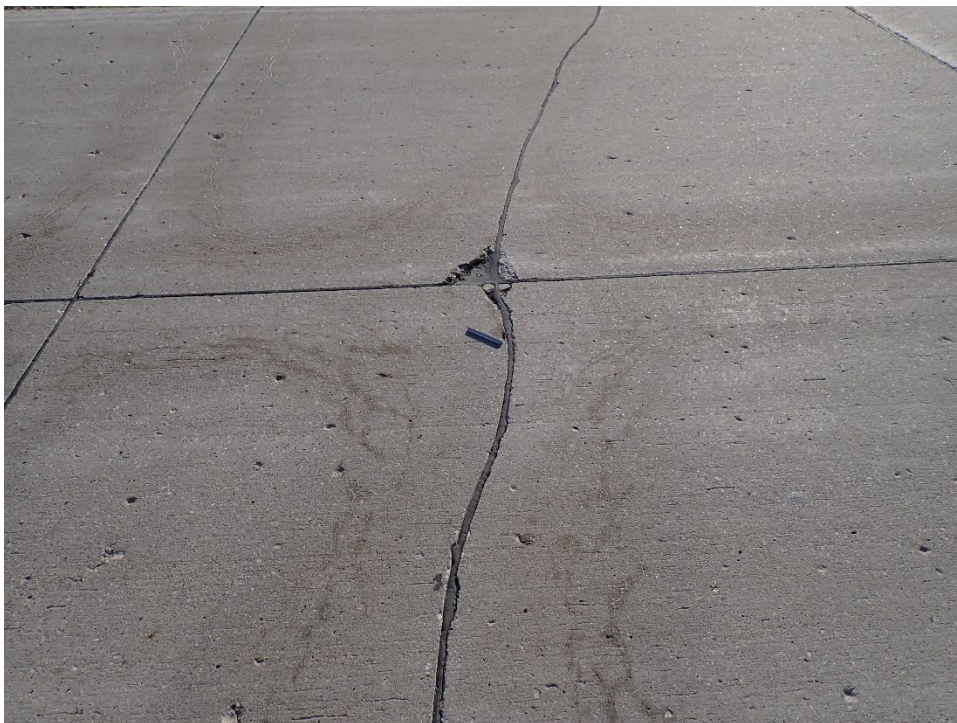
T02AN-01. LTD Cracking (Sample Unit No. 03).

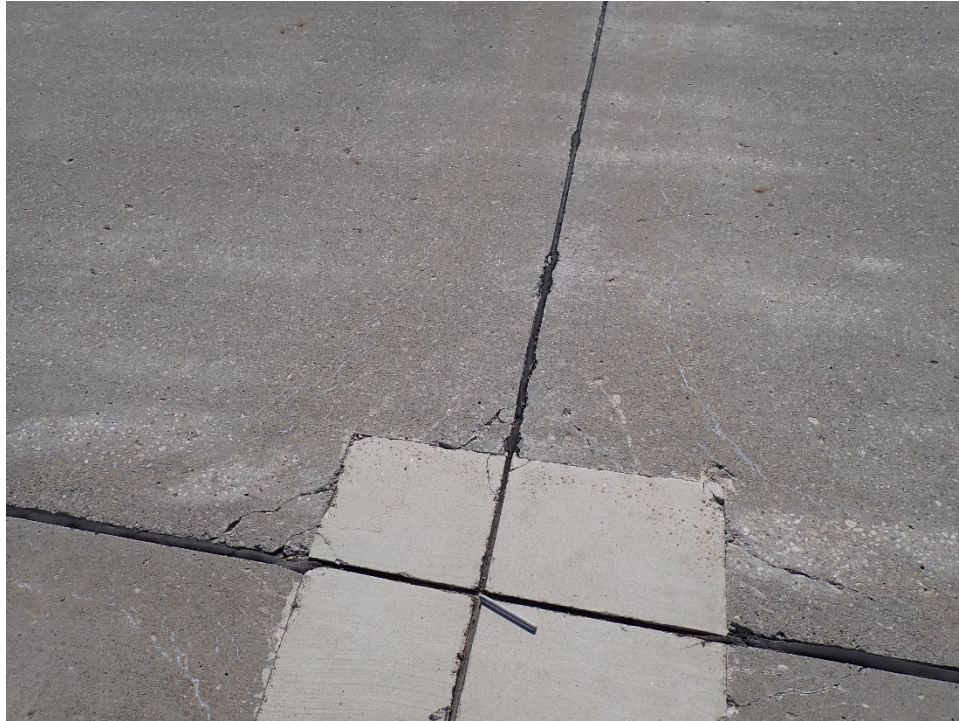
T03AN-01. ASR (Sample Unit No. 04).

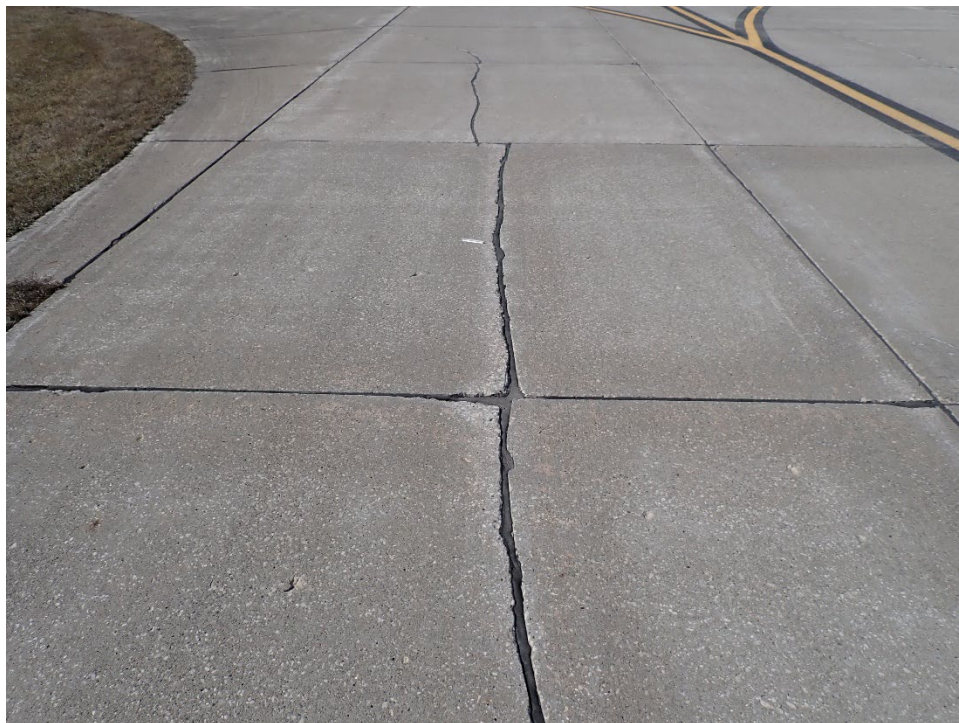
T03AN-01. LTD Cracking (Sample Unit No. 01).

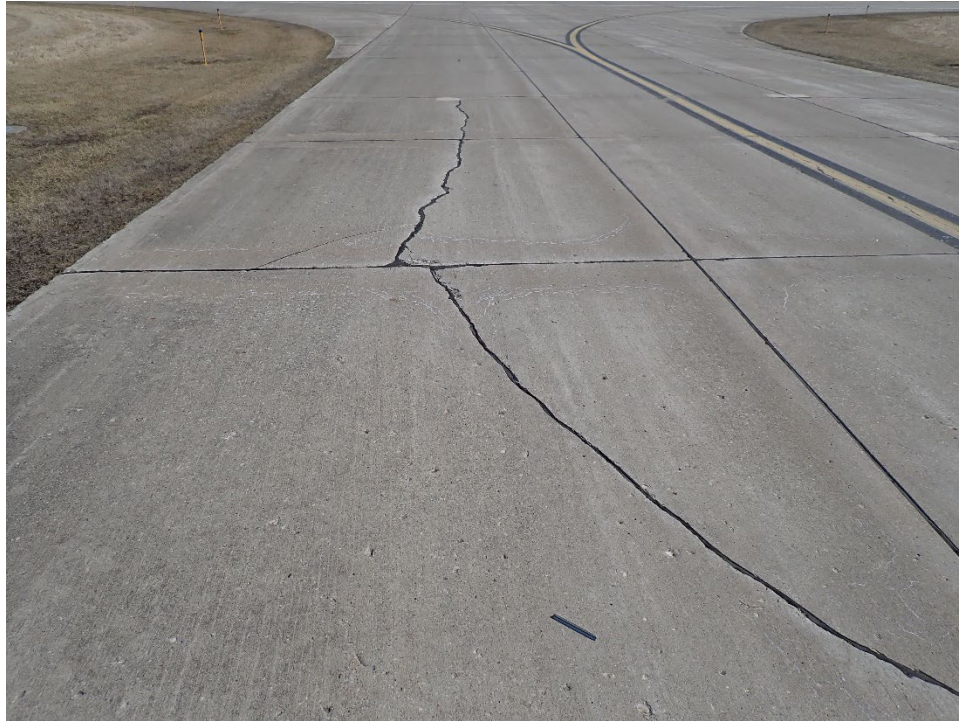
T03AN-01. LTD Cracking (Sample Unit No. 04).

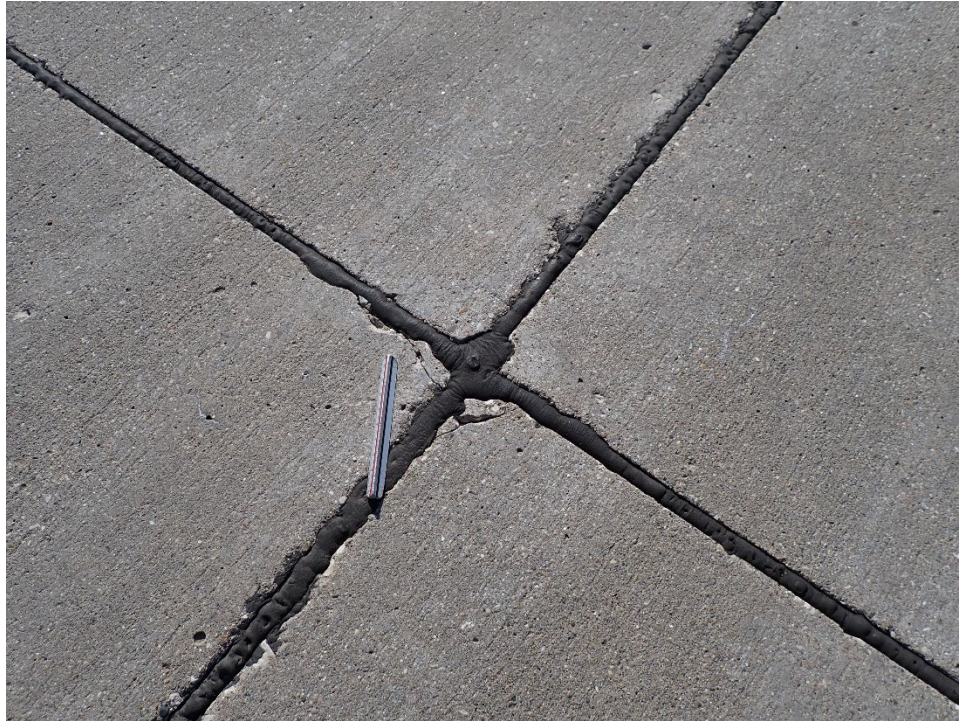
T04AN-01. ASR (Sample Unit No. 03).

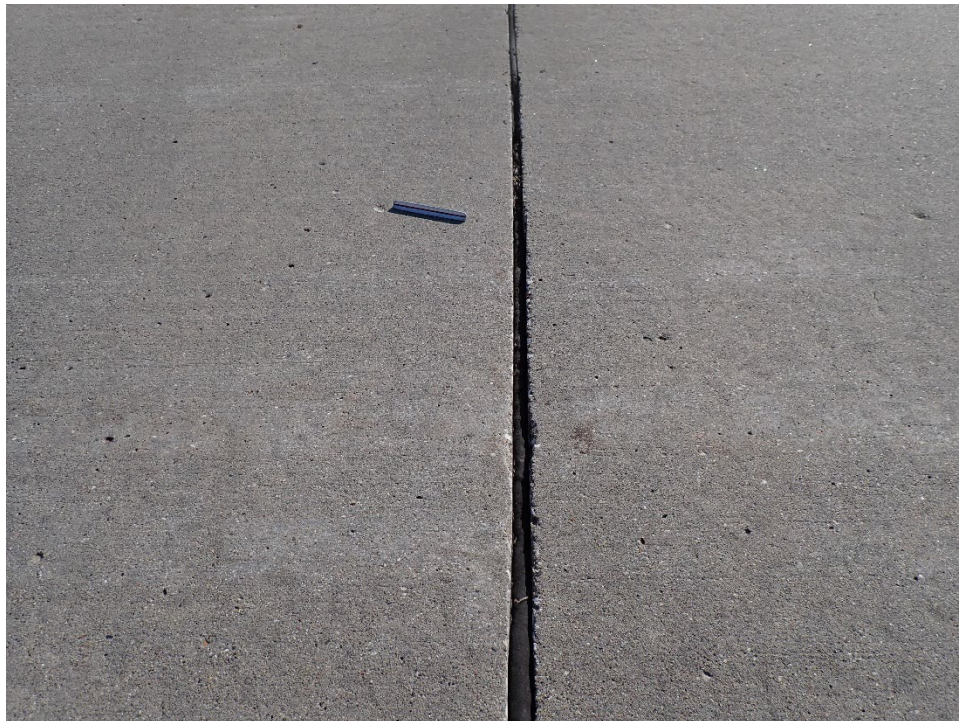
T04AN-01. Joint Seal Damage (Sample Unit No. 03).

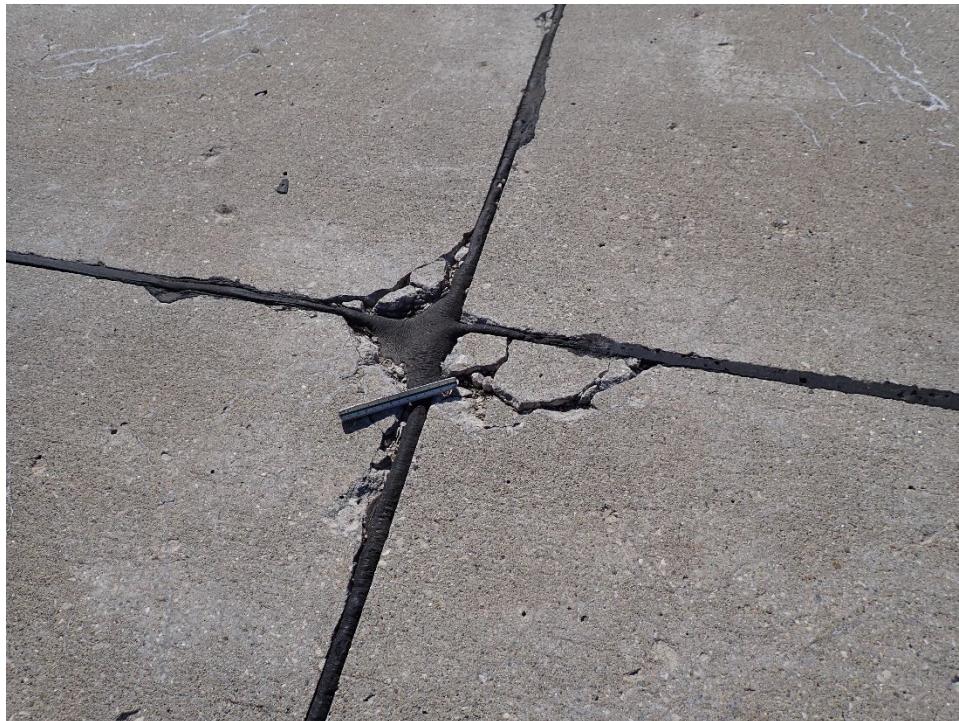
T05AN-01. ASR (Sample Unit No. 05).

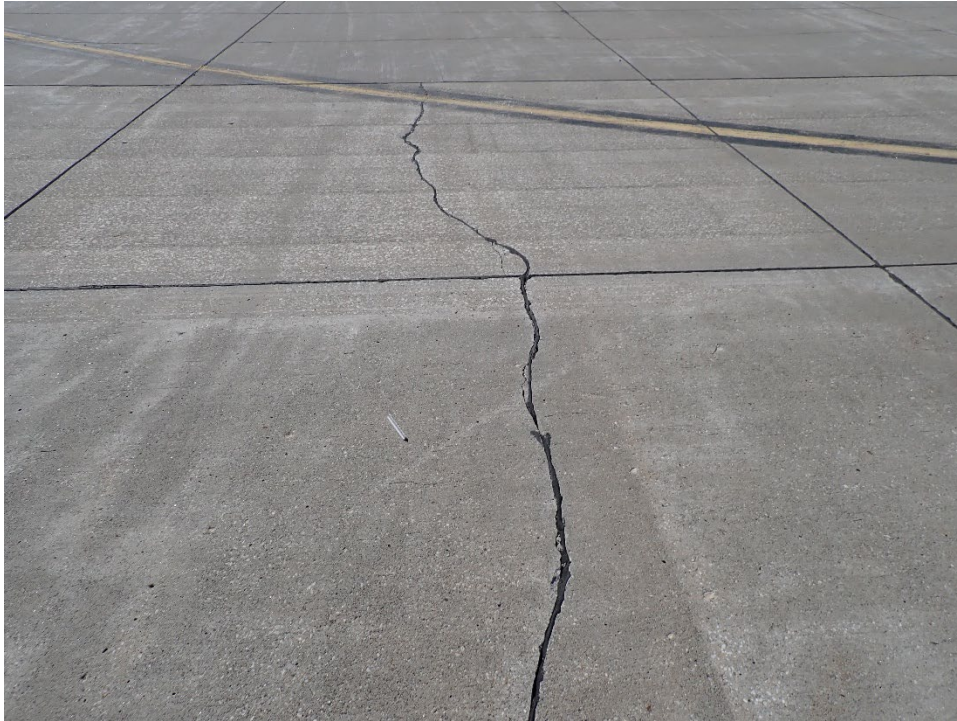
T05AN-01. LTD Cracking (Sample Unit No. 05).

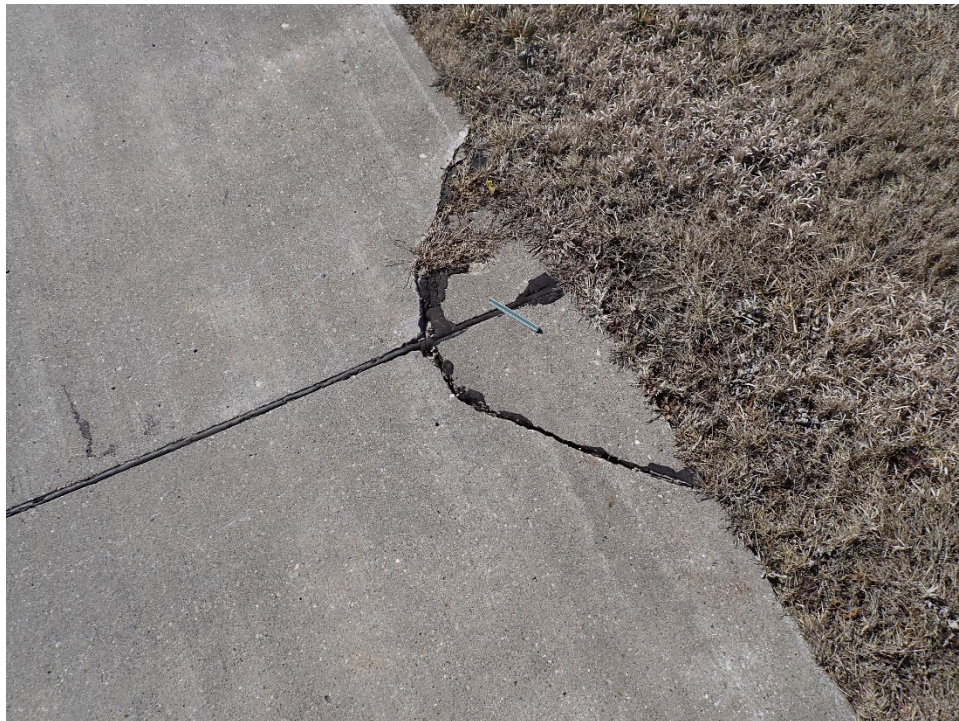
T06AN-01. Corner Break (Sample Unit No. 02).

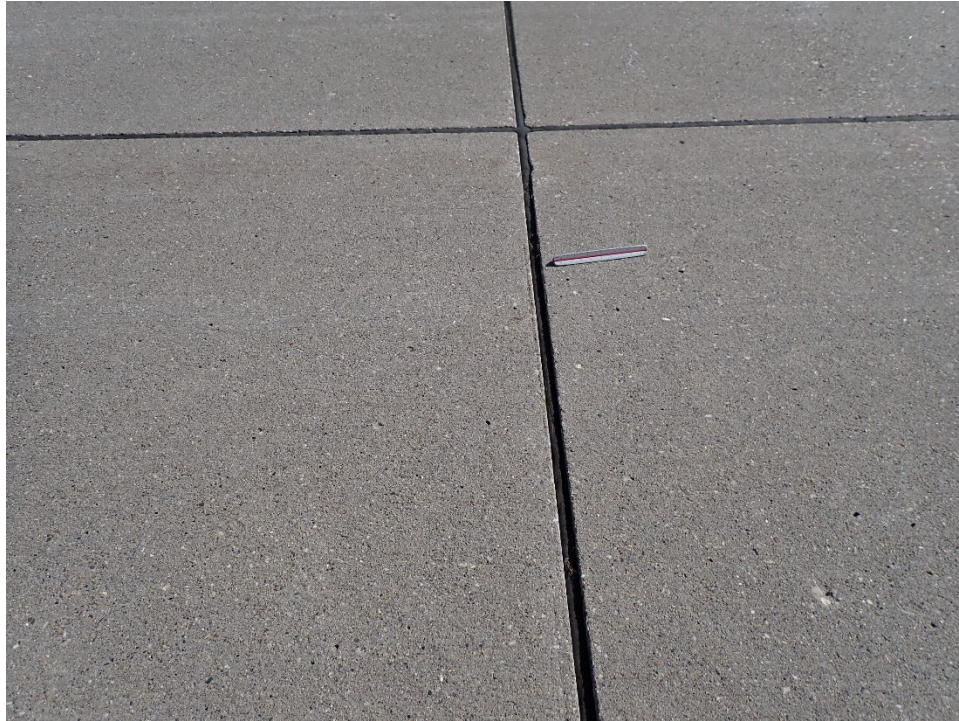
T06AN-01. Joint Seal Damage (Sample Unit No. 02).

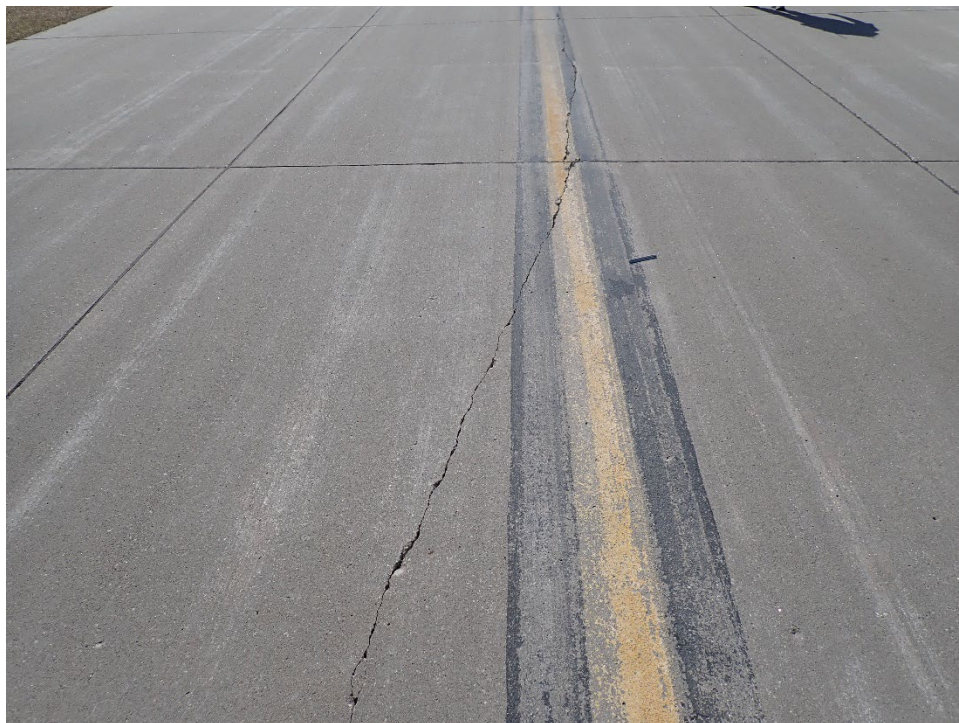
T06AN-01. LTD Cracking (Sample Unit No. 15).

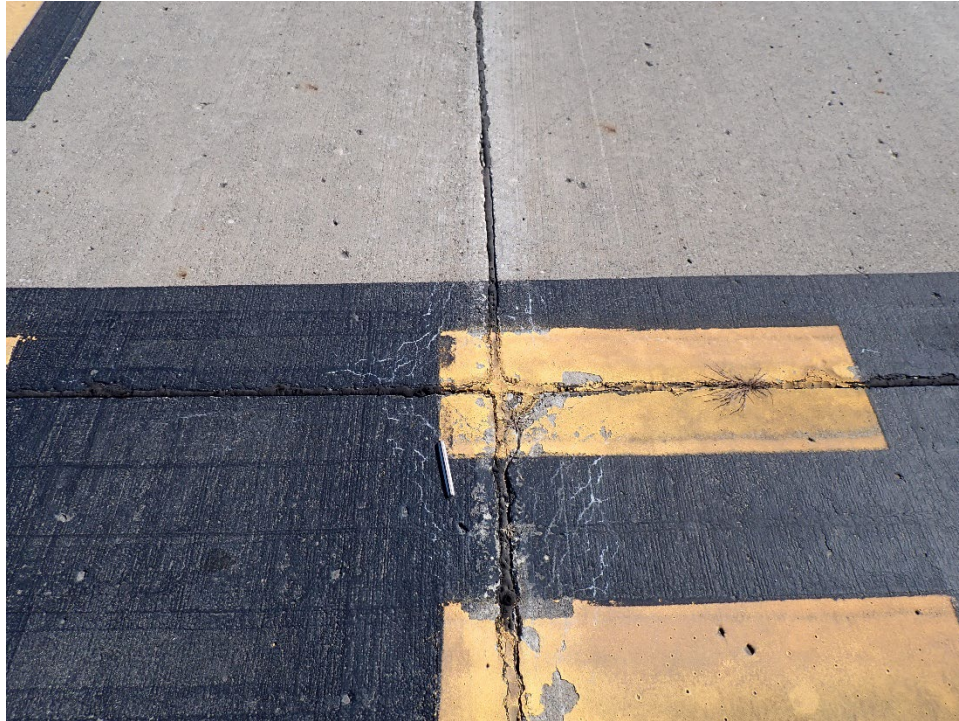
T08AN-01. ASR (Sample Unit No. 06).
