# Ankeny Regional Airport

## Pavement Management Report

**AUGUST 2025**

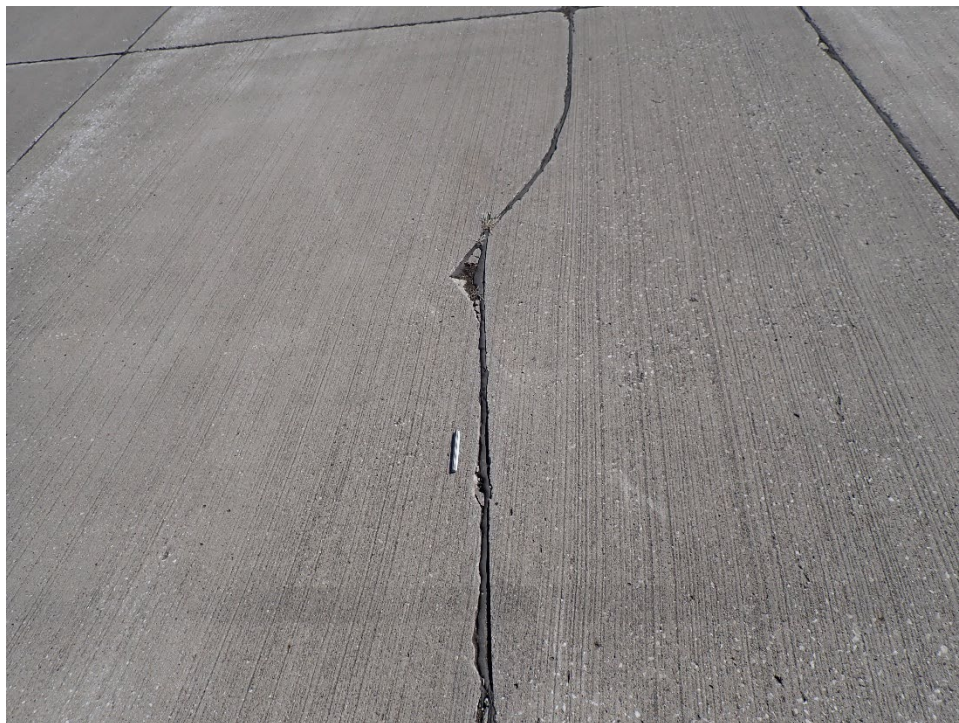
T08AN-01. LTD Cracking (Sample Unit No. 03).

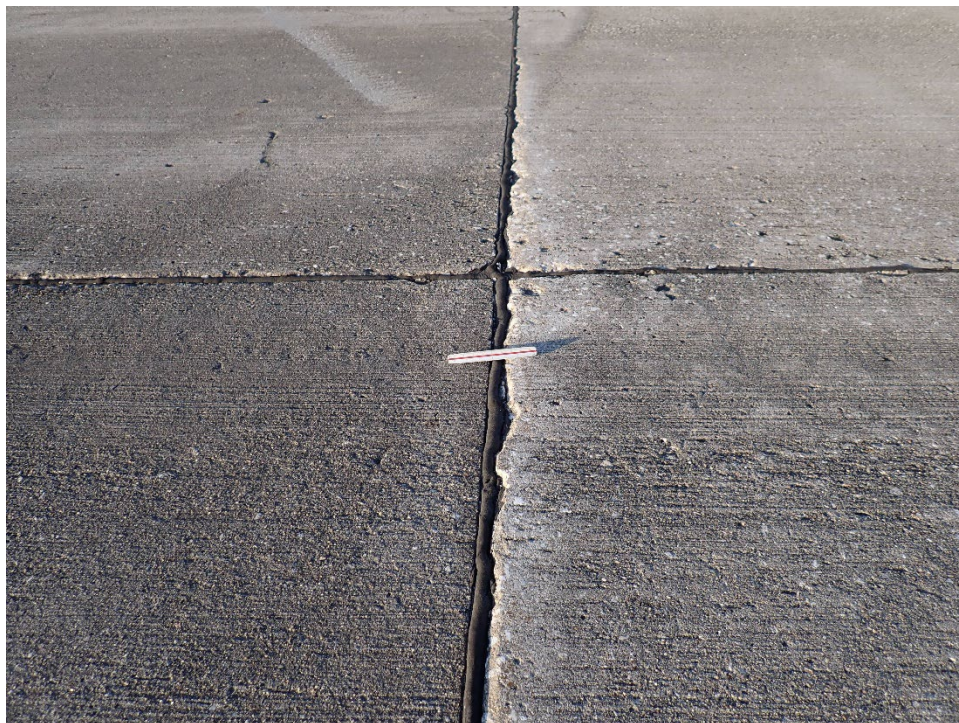
T09AN-01. Faulting (Sample Unit No. 04).

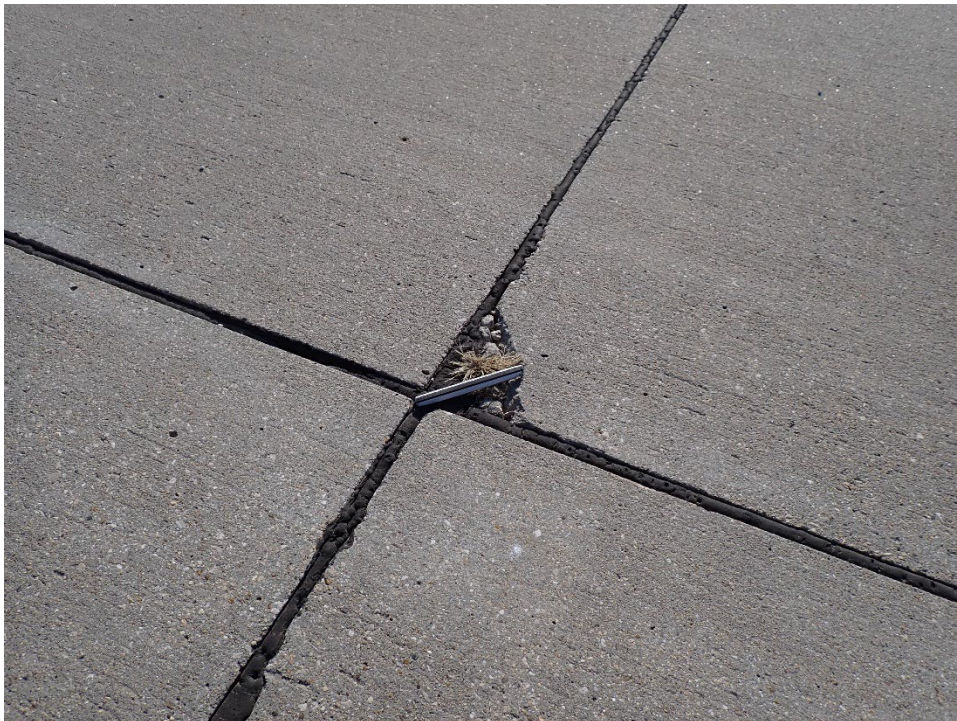
T12AN-01. Corner Spalling (Sample Unit No. 06).

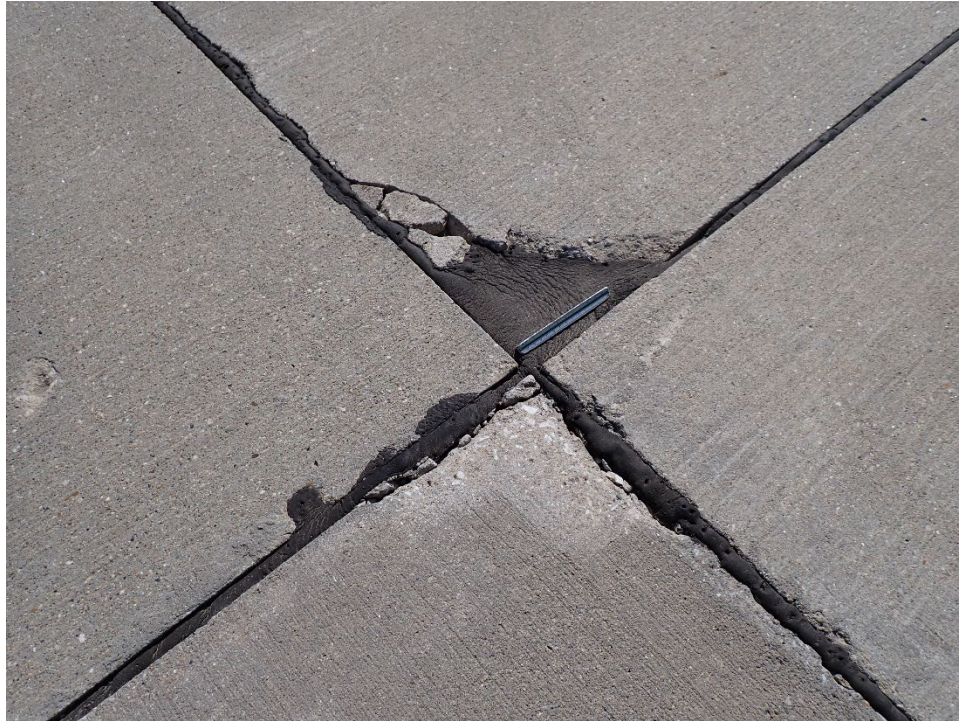
T12AN-01. Corner Spalling (Sample Unit No. 18).

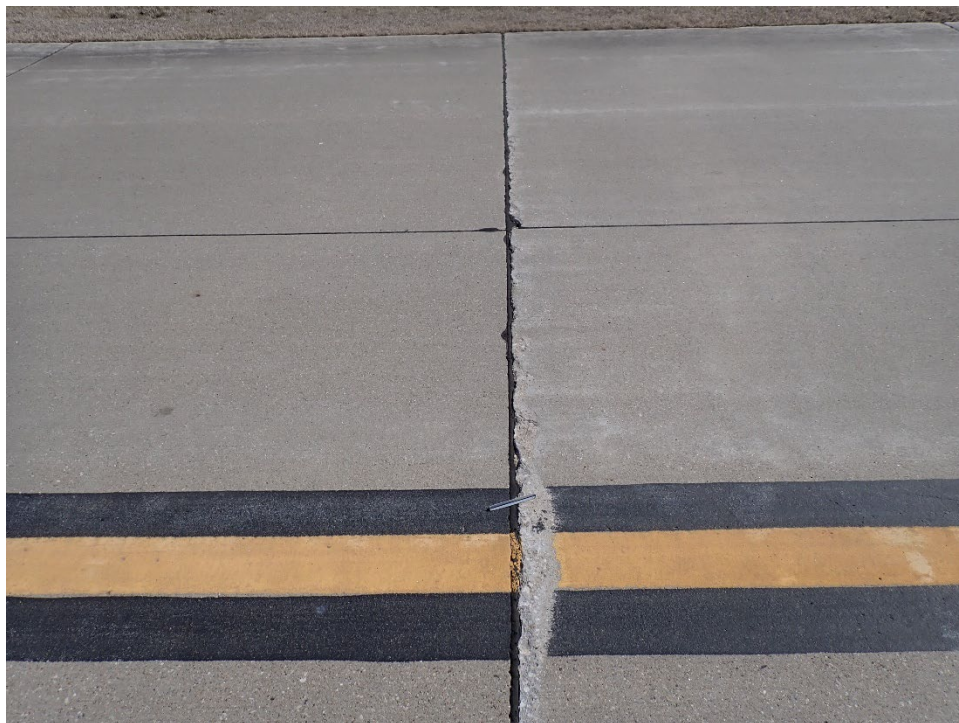
T12AN-01. Faulting (Sample Unit No. 09).

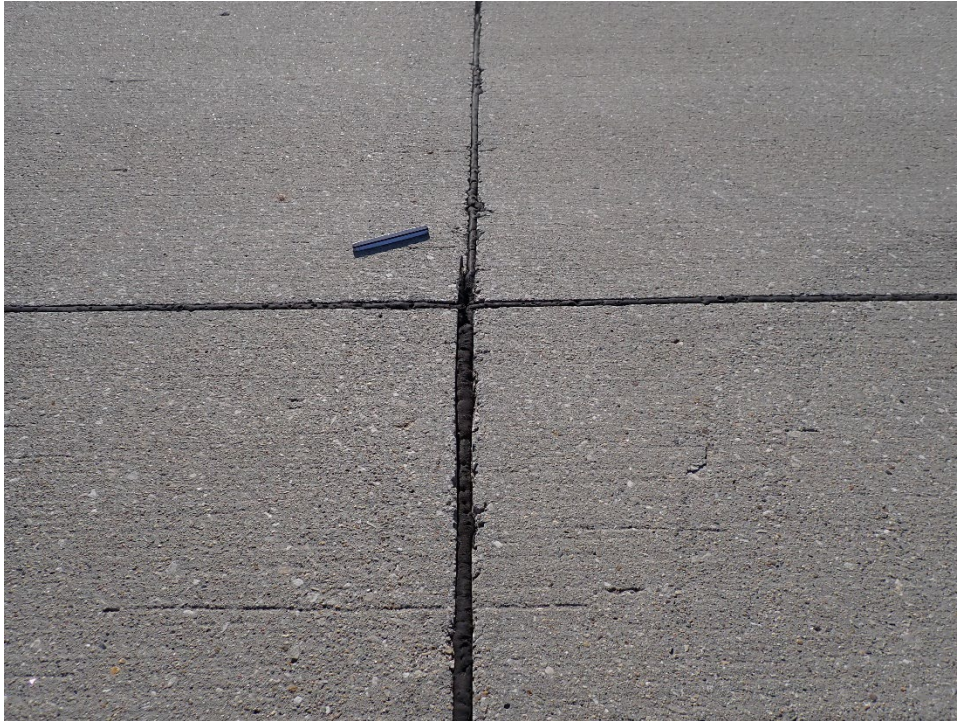
T12AN-01. Joint Seal Damage (Sample Unit No. 03).

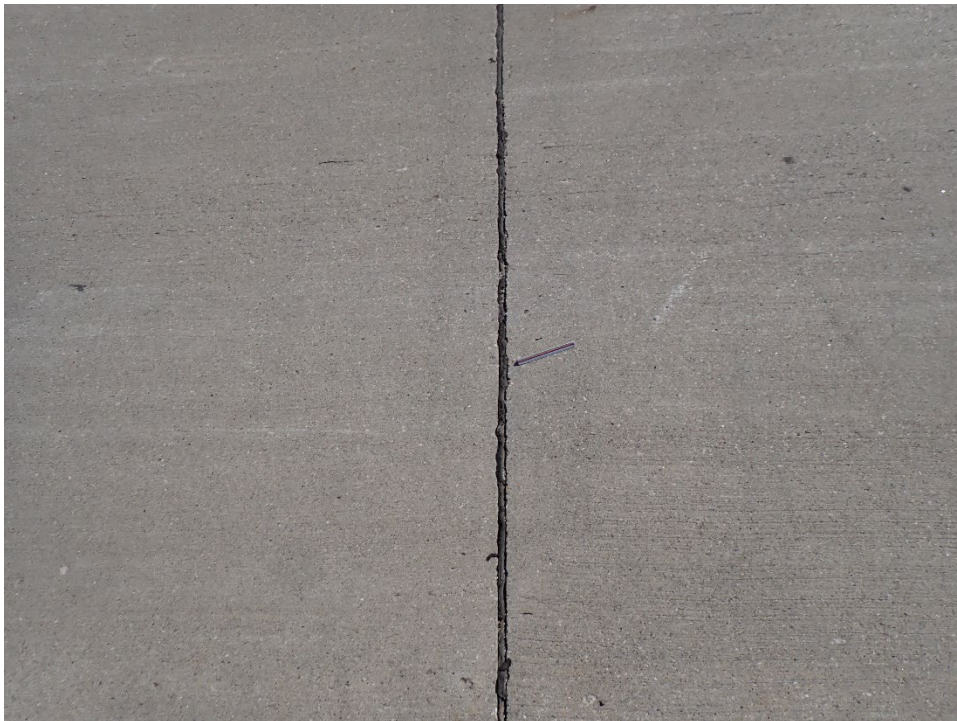
T12AN-01. Joint Seal Damage (Sample Unit No. 21).

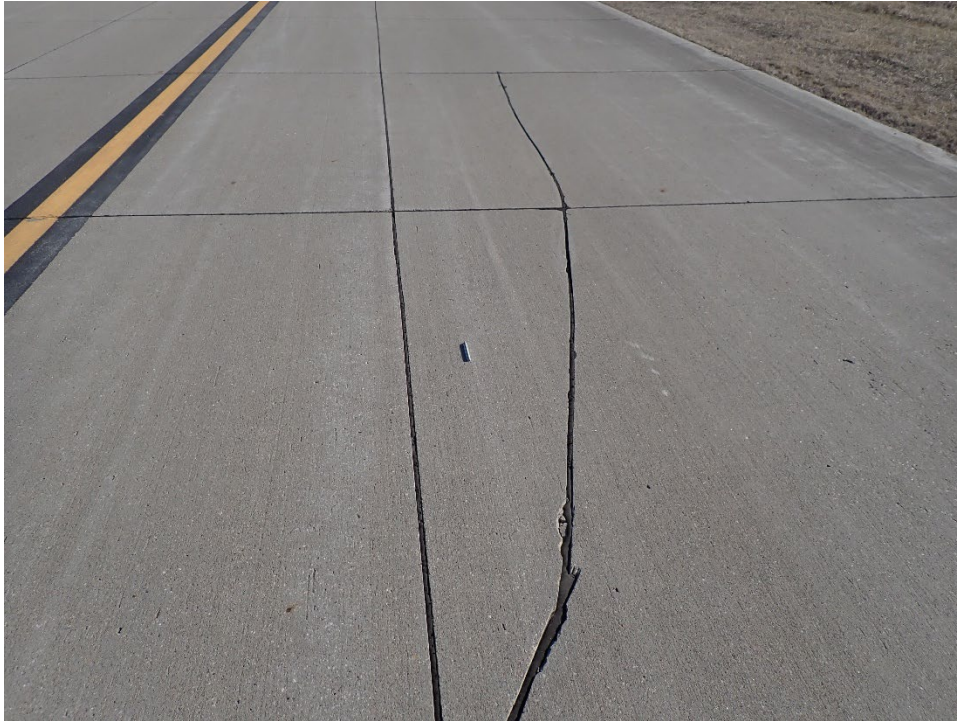
T12AN-01. LTD Cracking (Sample Unit No. 06).

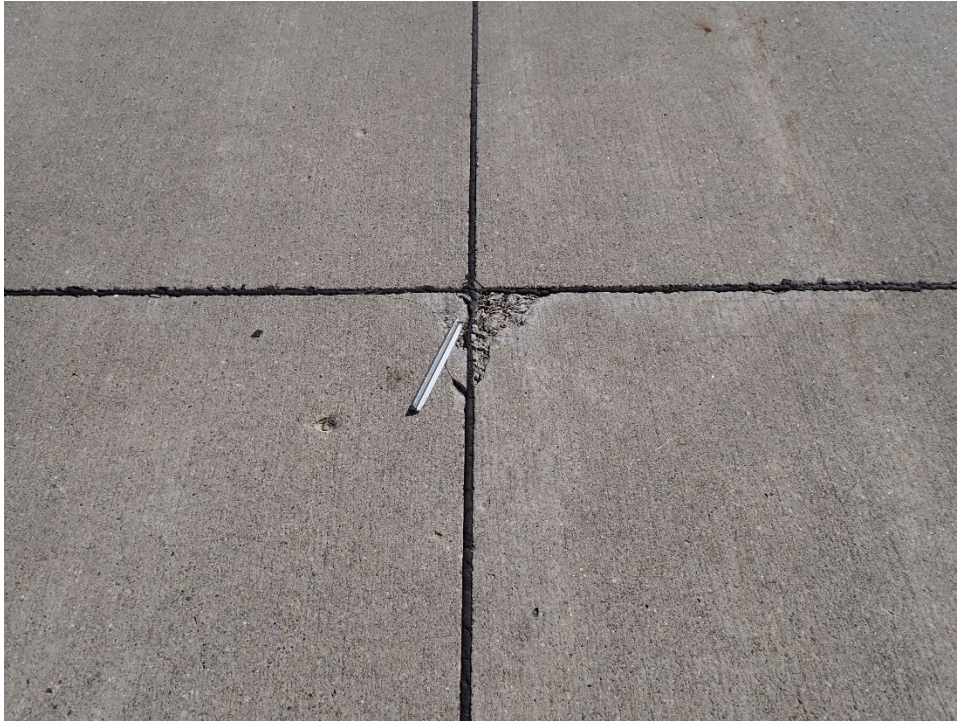
T13AN-01. ASR (Sample Unit No. 08) (2).

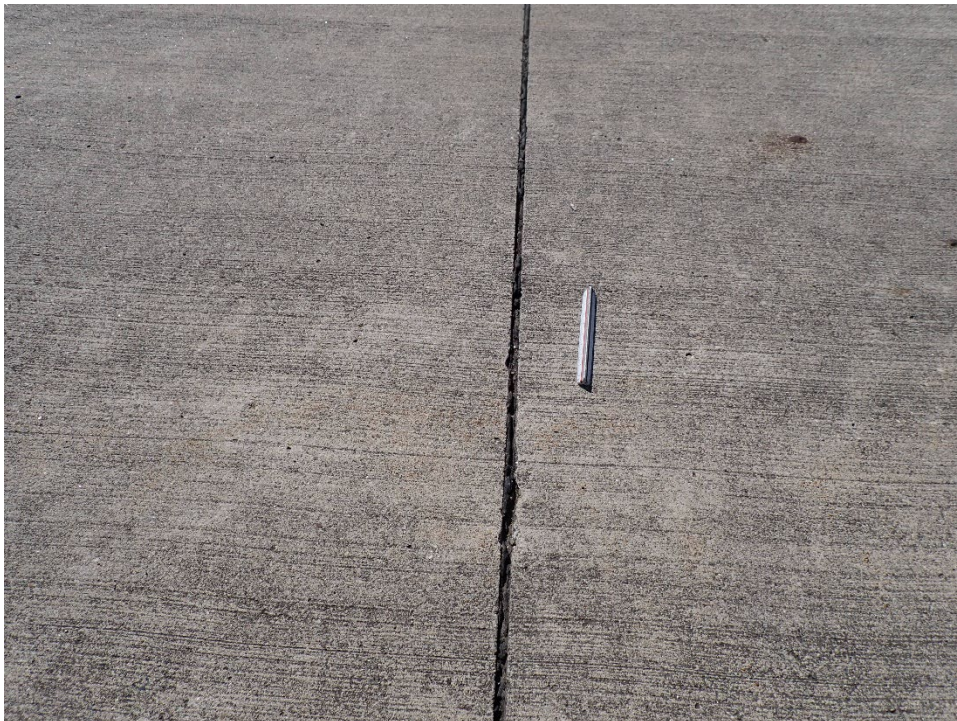
T13AN-01. Joint Seal Damage (Sample Unit No. 03).

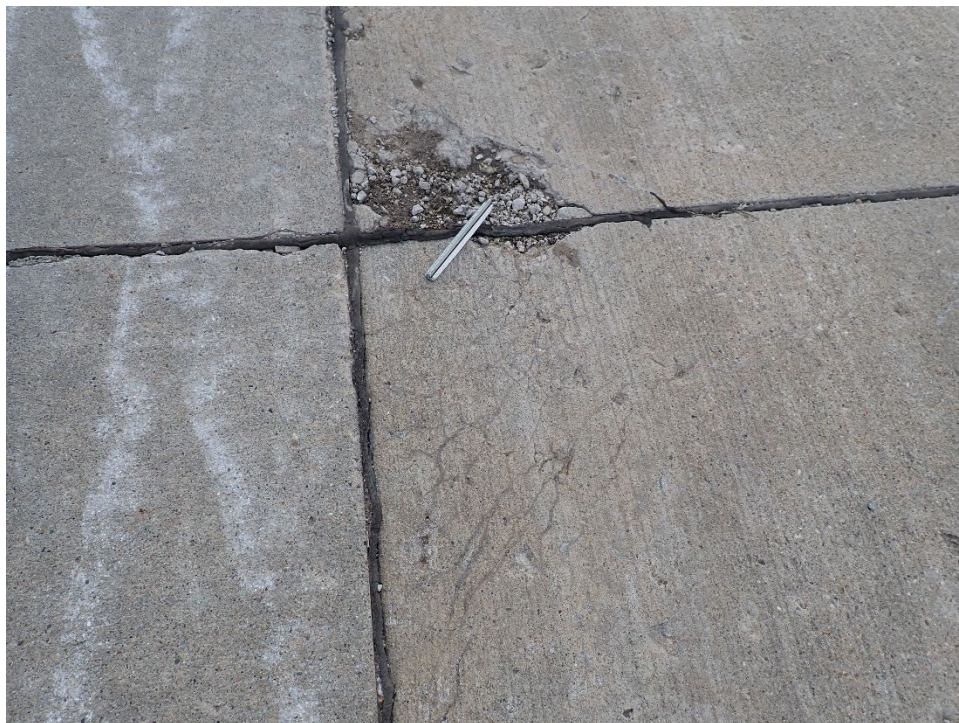
TH01AN-01. ASR (Sample Unit No. 01).

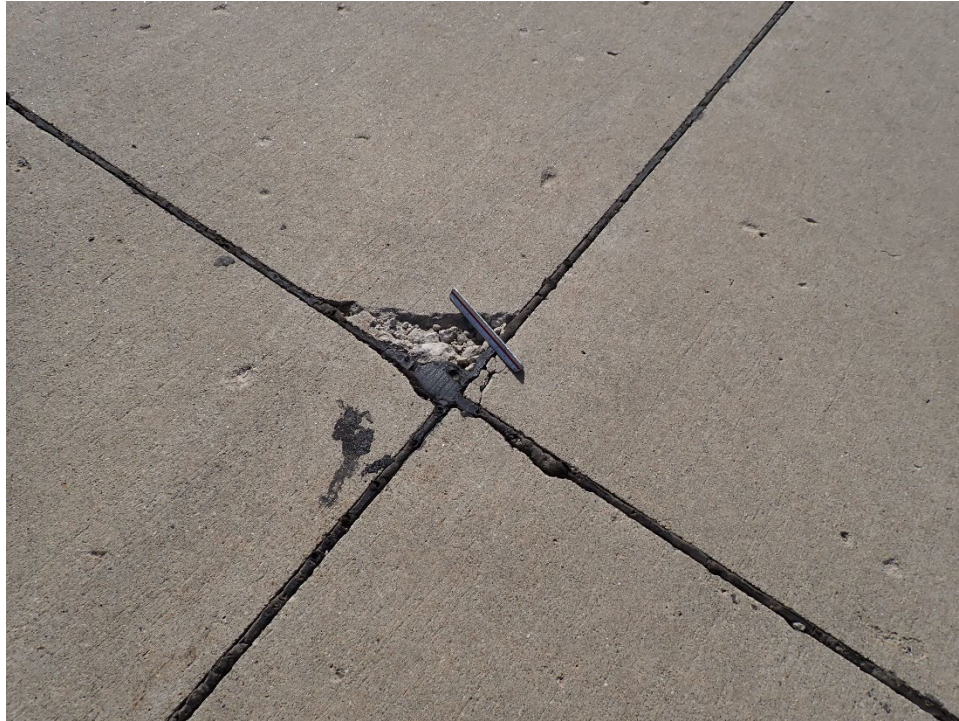
TH01AN-01. Corner Spalling (Sample Unit No. 09).

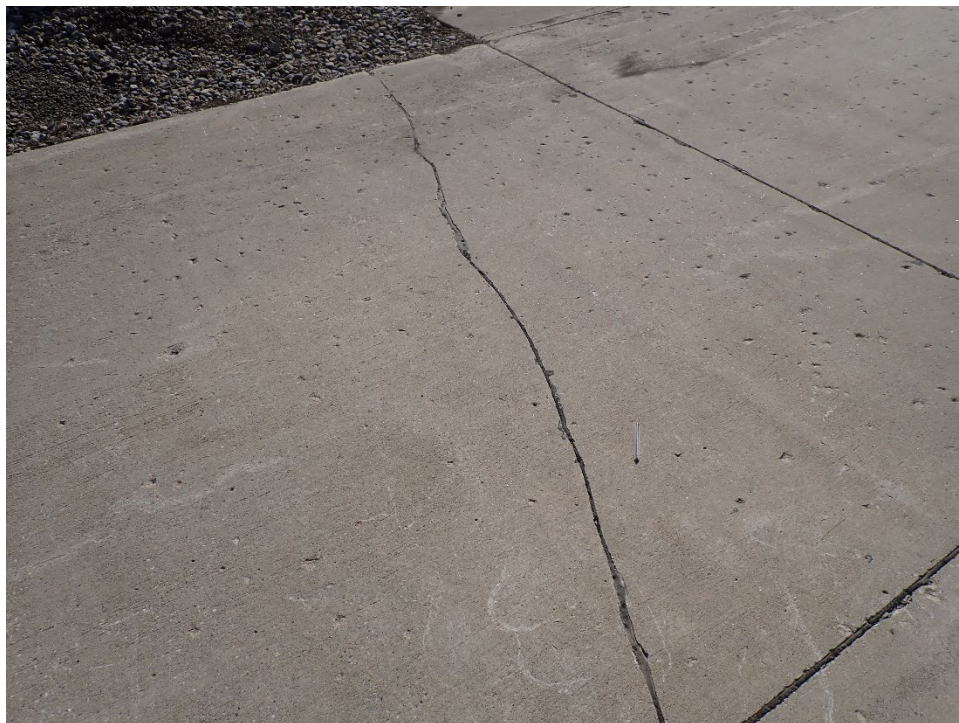
TH01AN-01. LTD Cracking (Sample Unit No. 09).

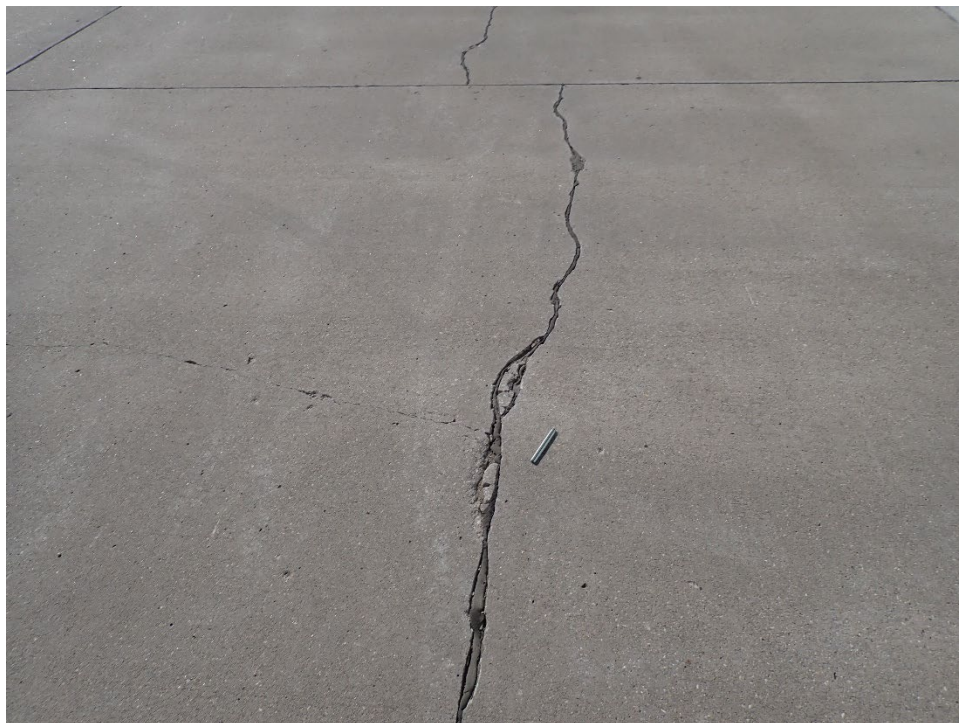
TH01AN-02. LTD Cracking (Sample Unit No. 18).

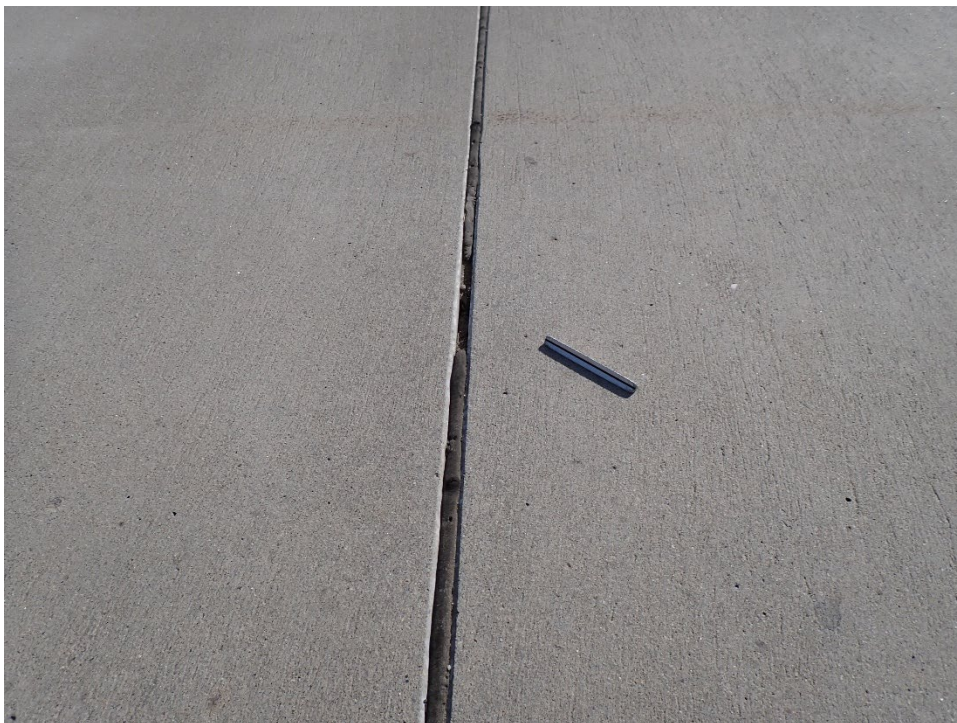
TH01AN-04. Joint Seal Damage (Sample Unit No. 07).
