# Belle Plaine Municipal Airport

## Pavement Management Report

**AUGUST 2025**

# BELLE PLAINE MUNICIPAL AIRPORT PAVEMENT MANAGEMENT REPORT

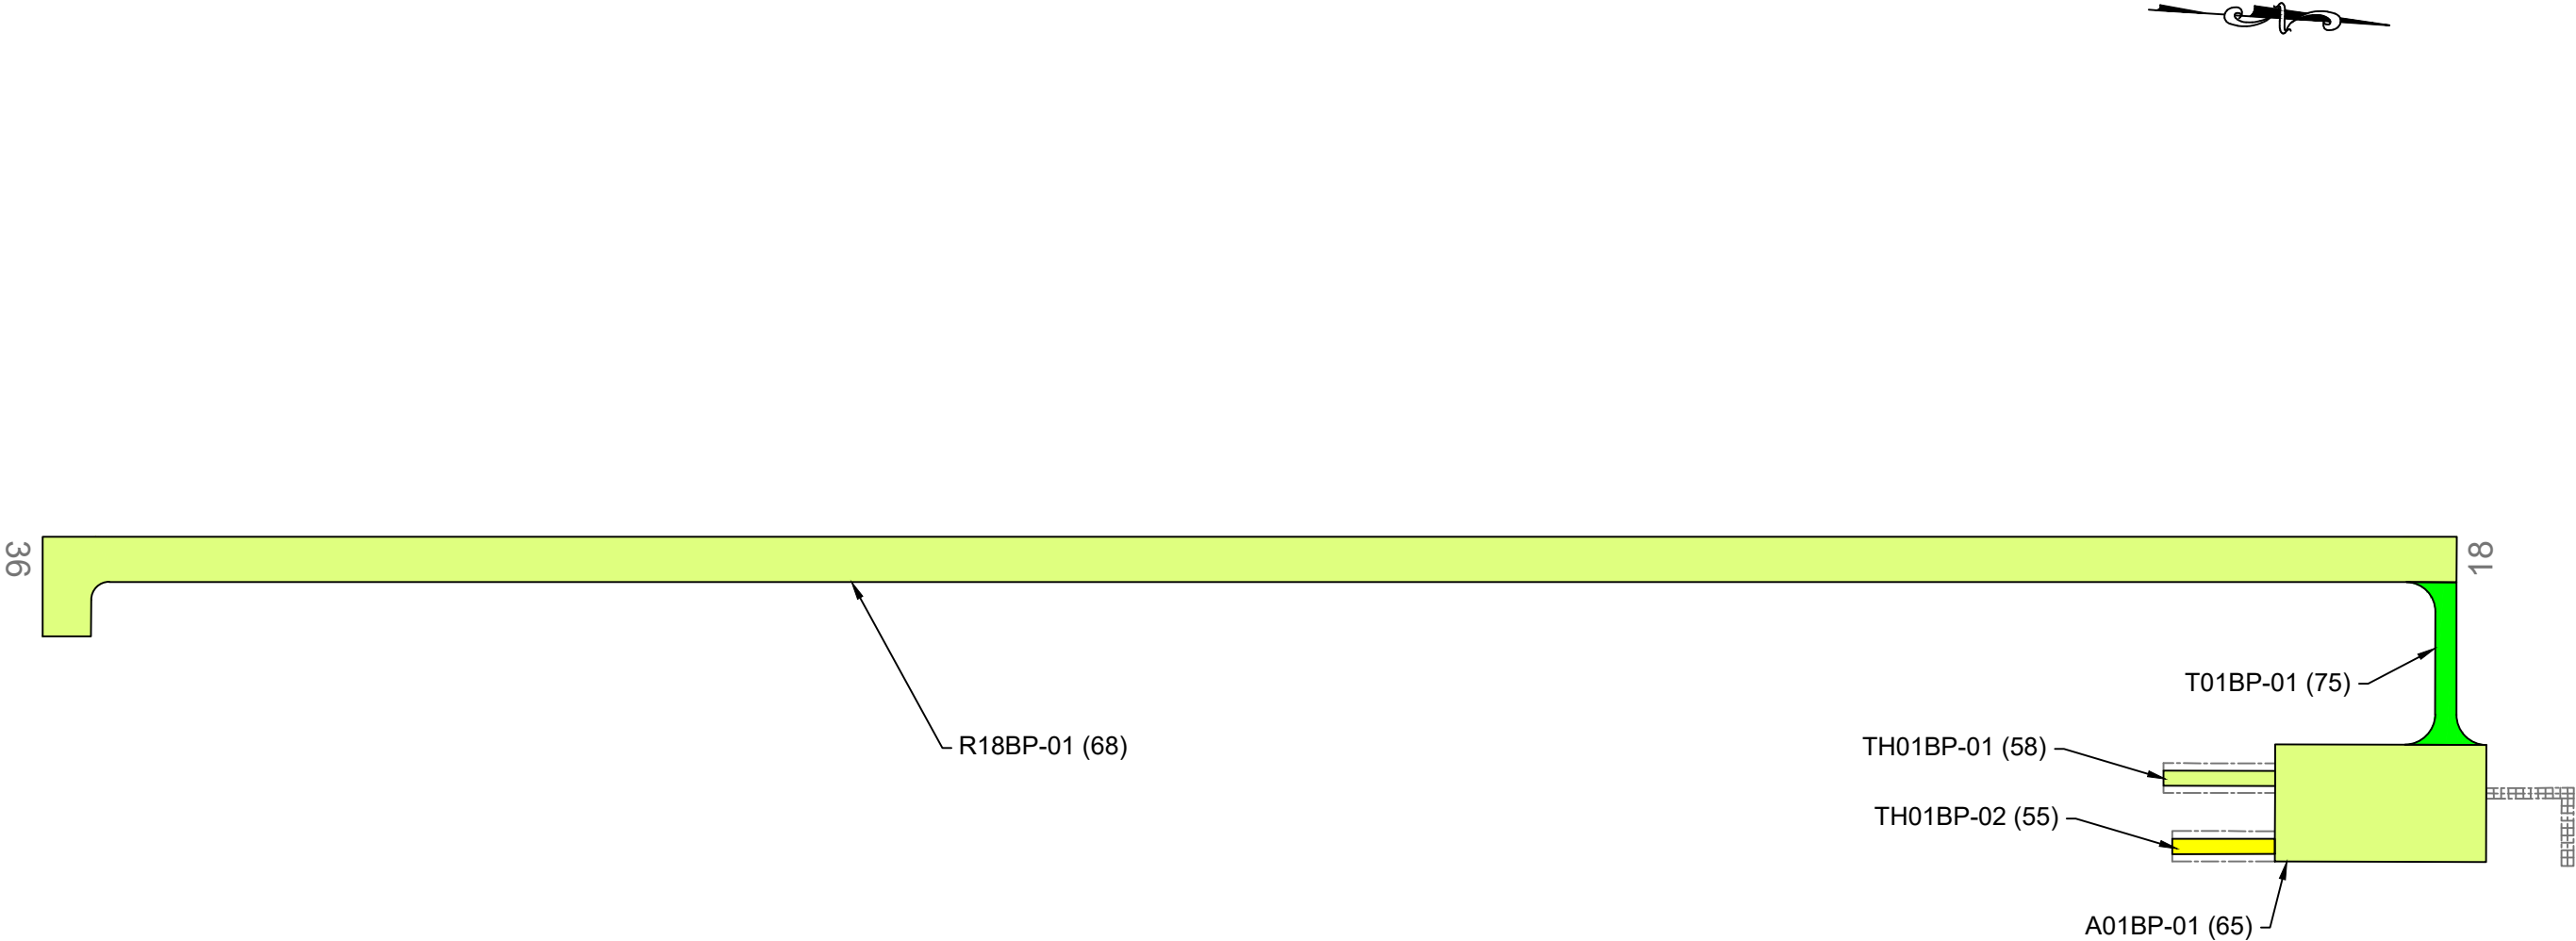
FIGURE 8. PCI MAP.

The pavements at Belle Plaine Municipal Airport were inspected in March 2025. The 2025 area-weighted condition of Belle Plaine Municipal Airport is 67, with conditions ranging from 55 to 75 (on a scale of 0 [failed] to 100 [excellent]). During the previous pavement inspection in 2021, the area-weighted PCI of the airport was 69.

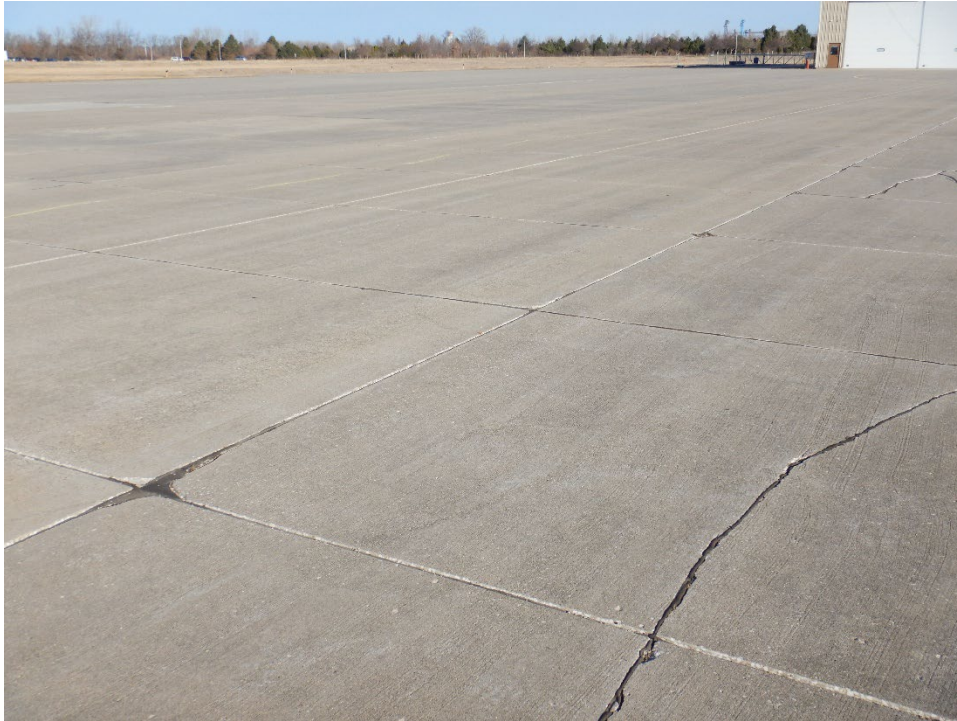
A01BP-01. Overview.

The apron area was defined by one section. Section 01 had areas of low- and medium-severity ASR, joint seal damage, LTD cracking, and corner break; high-severity corner spalling; medium-severity joint spalling and shattered slab; and shrinkage cracking identified at the time of inspection. An atypical area of low-severity faulting and small patching was observed and recorded as an additional sample unit in accordance with ASTM D5340.

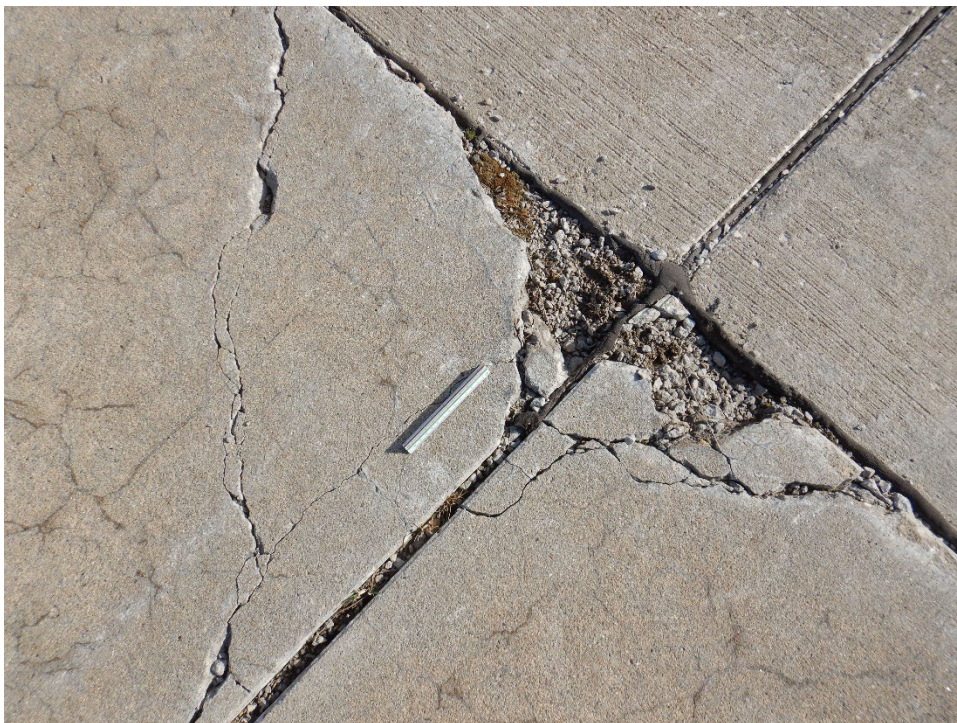
A01BP-01. ASR (Additional Sample Unit No. 17).

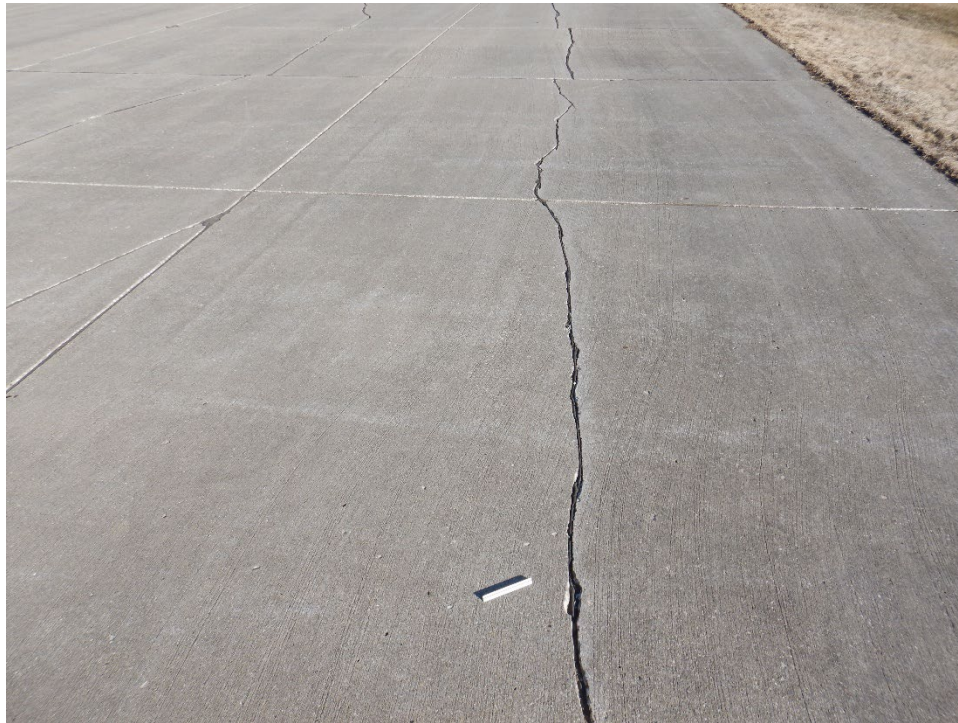
A01BP-01. LTD Cracking (Sample Unit No. 20).

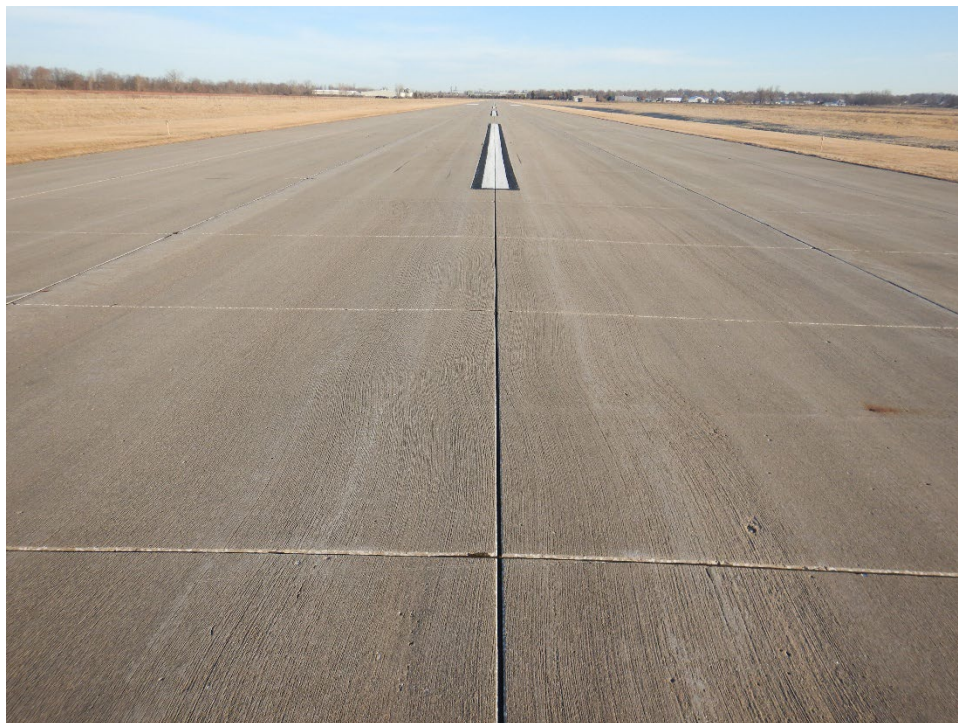
R18BP-01. Overview.

Runway 18/36 consisted of one section that contained areas of low- and medium-severity ASR, joint seal damage, joint spalling, and longitudinal, transverse, and diagonal (LTD) cracking; low-severity corner break, large patching, small patching, and faulting; and all severities of corner spalling.

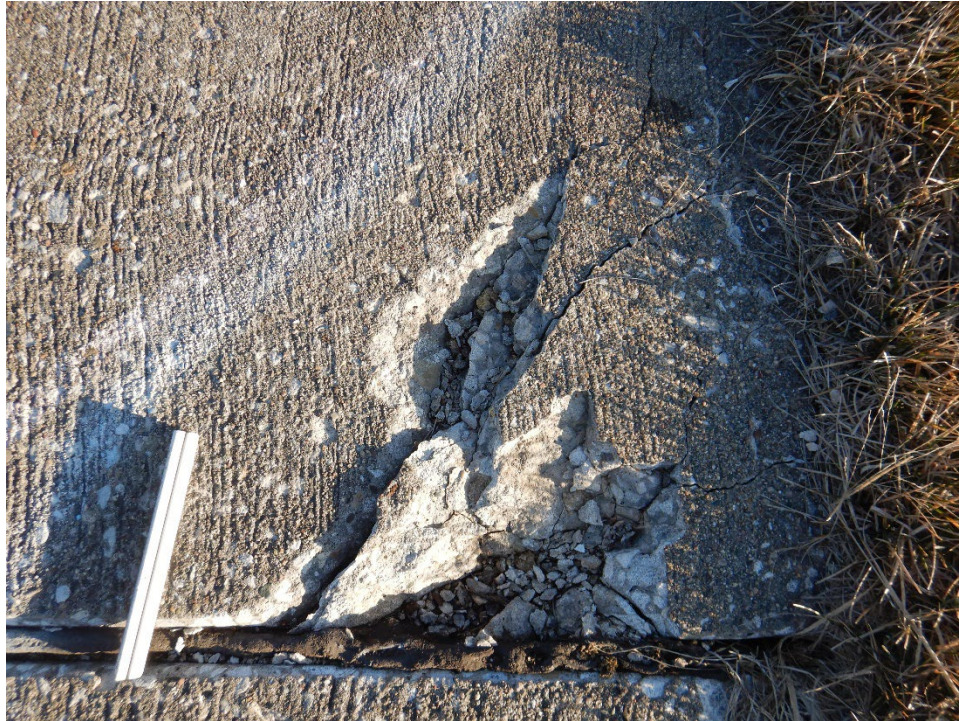
R18BP-01. ASR (Sample Unit No. 95).

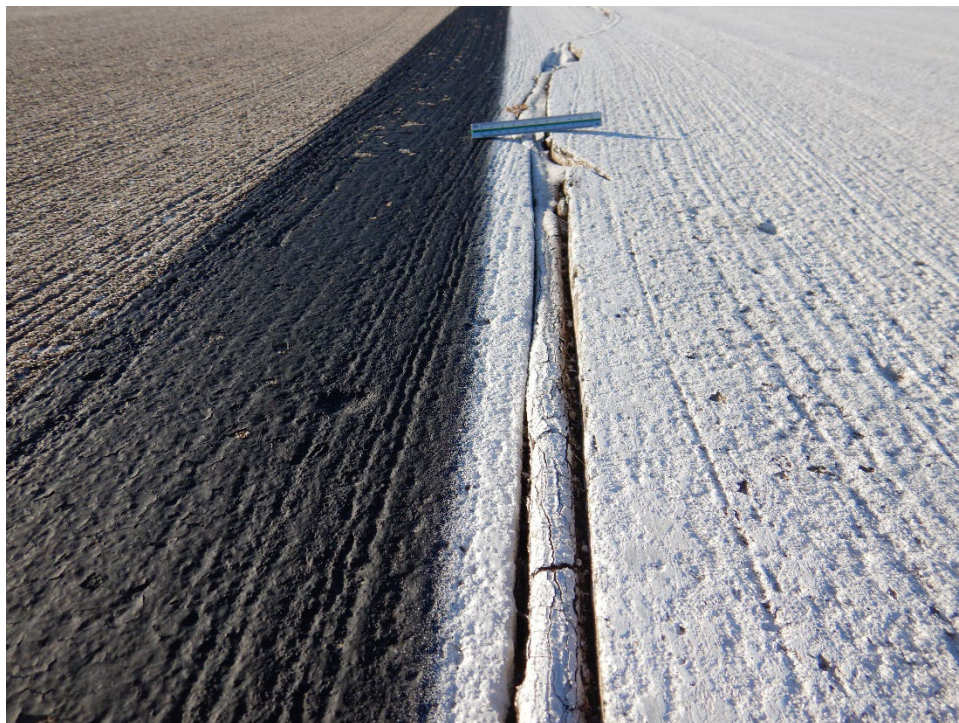
R18BP-01. Faulting (Sample Unit No. 75).

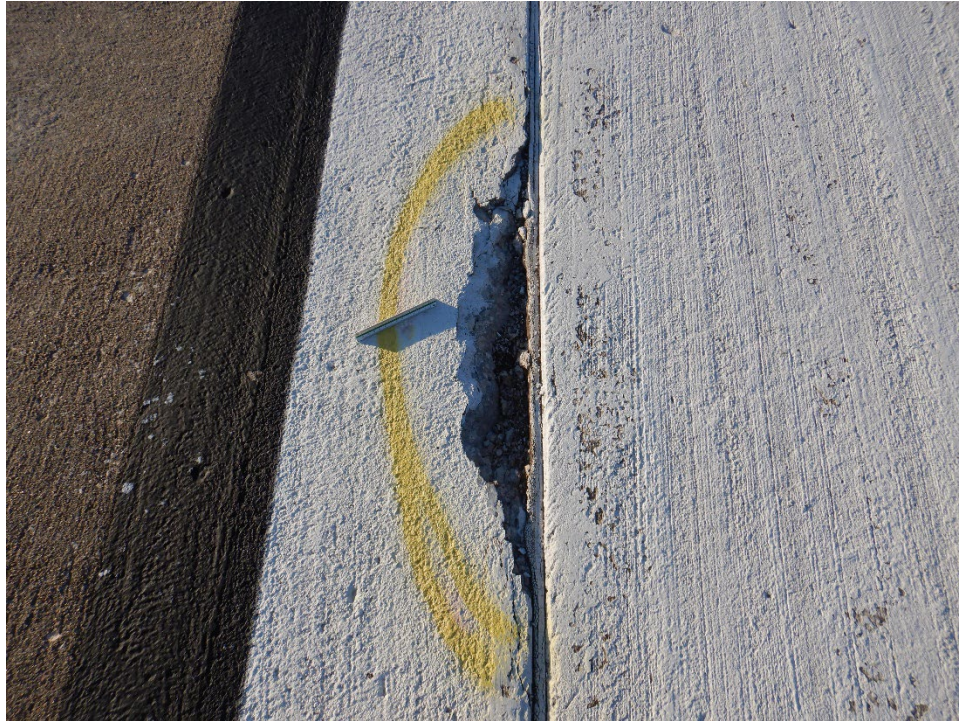
R18BP-01. Joint Spalling (Sample Unit No. 95).

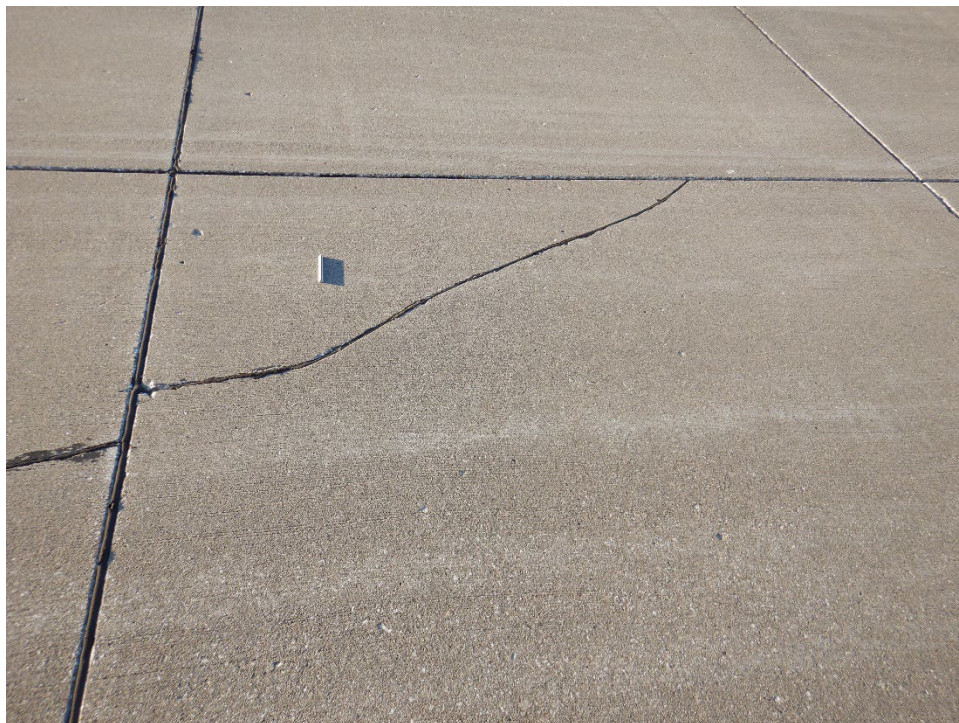
R18BP-01. LTD Cracking (Sample Unit No. 102).

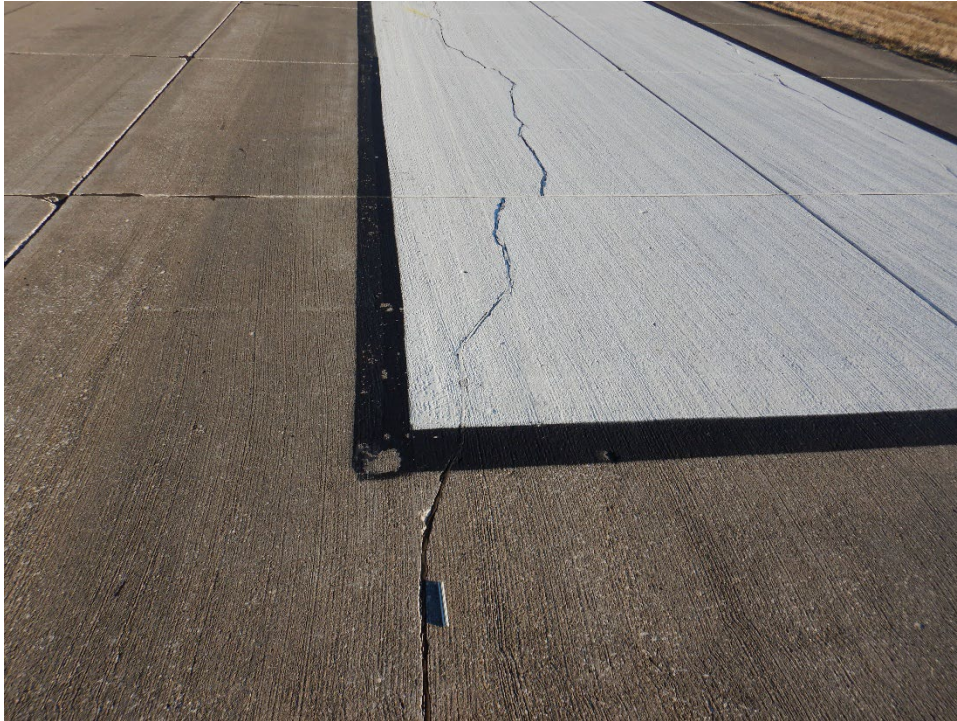
R18BP-01. LTD Cracking (Sample Unit No. 75).

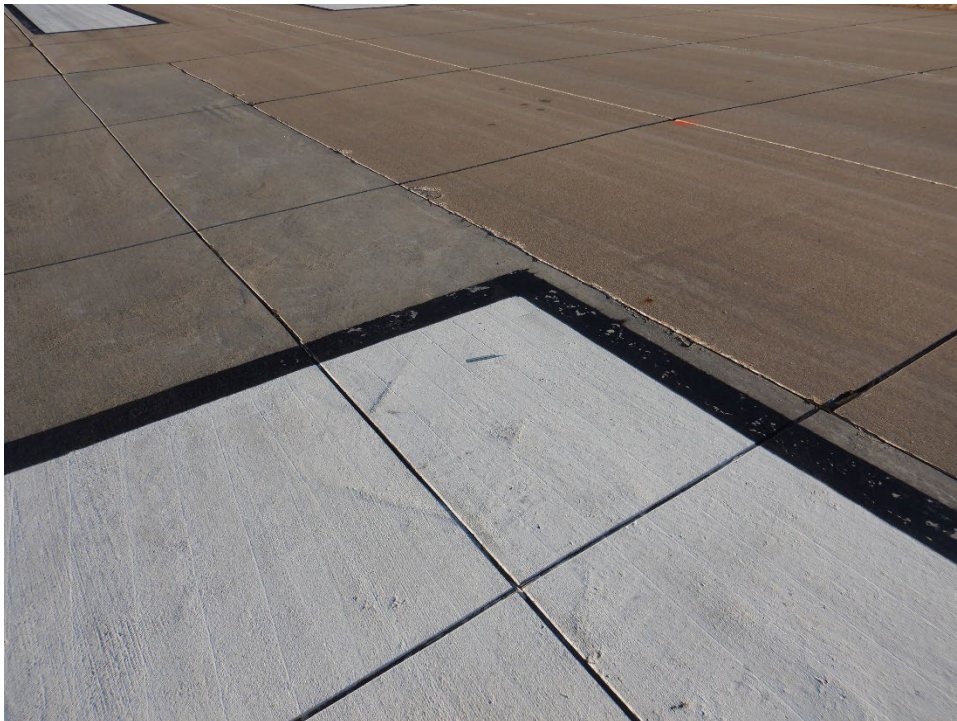
R18BP-01. Large Patching (Sample Unit No. 95).

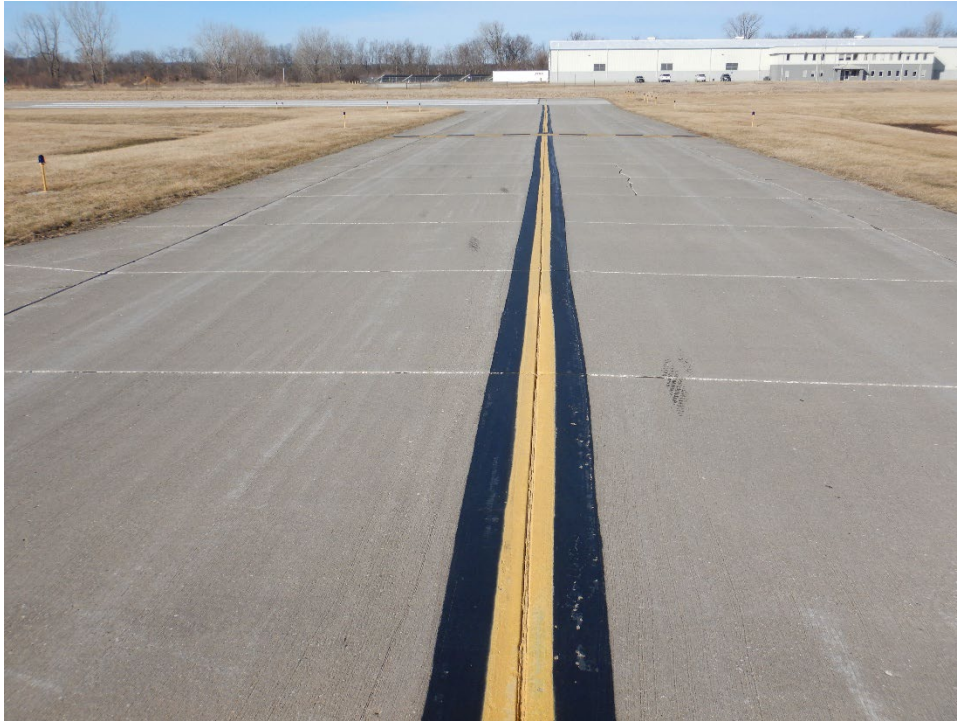
T01BP-01. Overview.

The taxiway was comprised of one section. Low-severity ASR, joint seal damage, shattered slab, and corner break; low- and medium-severity corner spalling and LTD cracking; and medium-severity joint spalling were observed in Section 01 during the inspection.

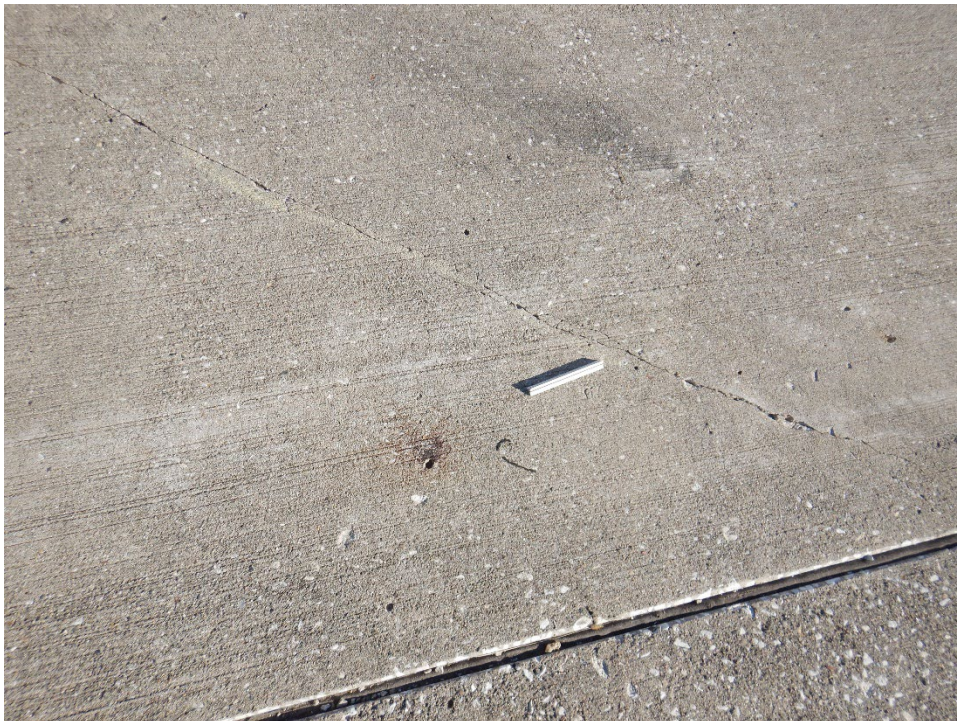
T01BP-01. LTD Cracking (Sample Unit No. 04).

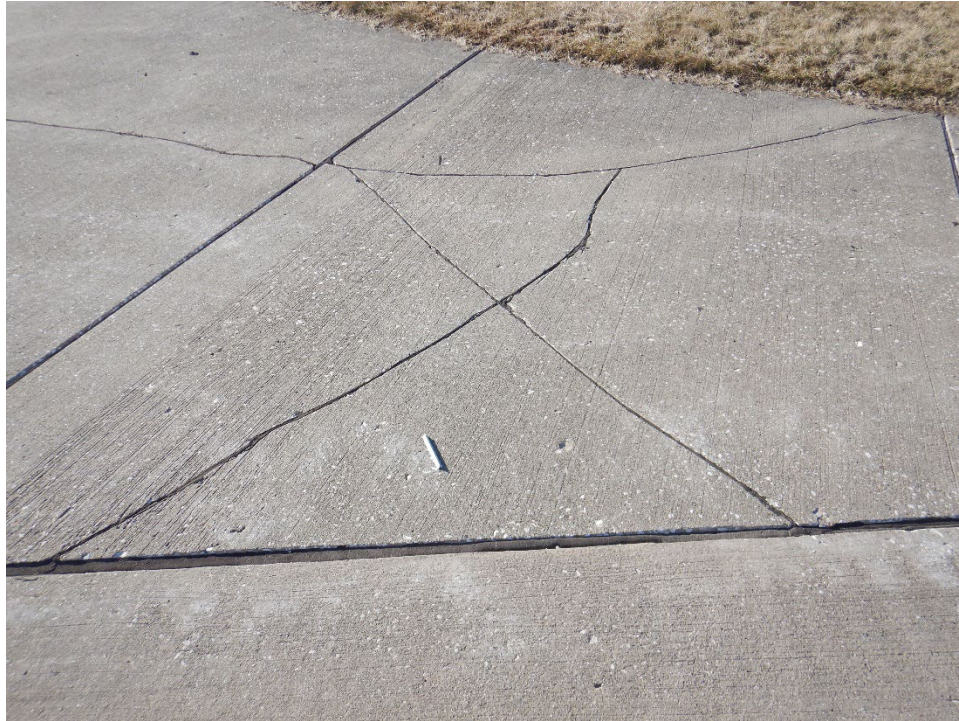
T01BP-01. Shattered Slab (Sample Unit No. 01).

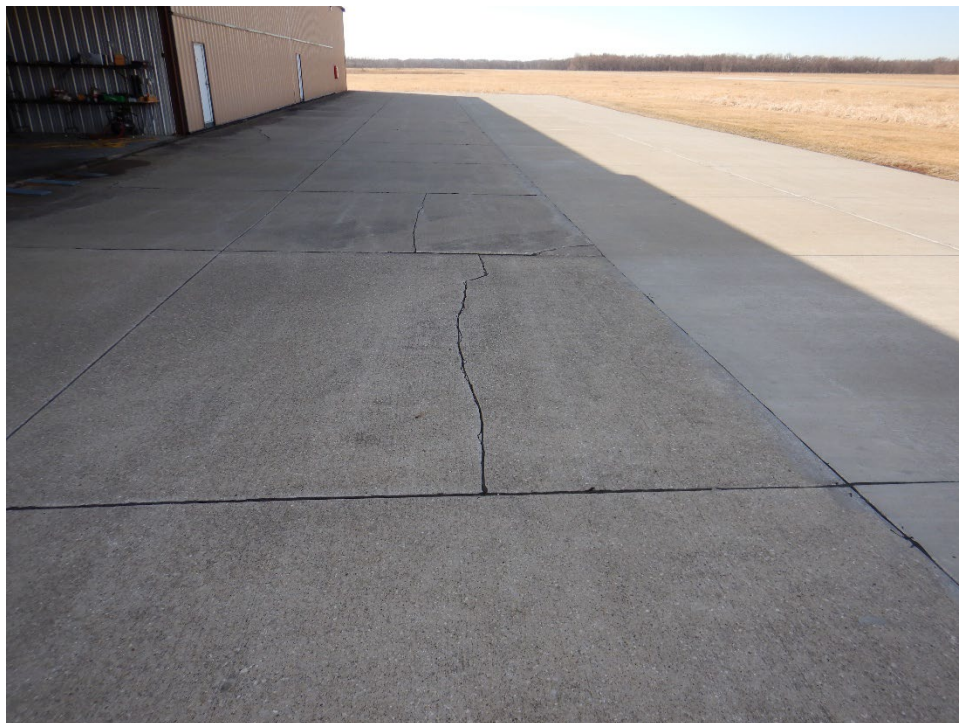
TH01BP-01. Overview.

The T-hangar area consisted of two sections. Section 01 contained low-severity ASR, corner break, and LTD cracking; medium-severity joint seal damage and shattered slab; and shrinkage cracking. Medium-severity joint spalling and low-severity ASR, corner break, faulting, and LTD cracking were observed in Section 02.

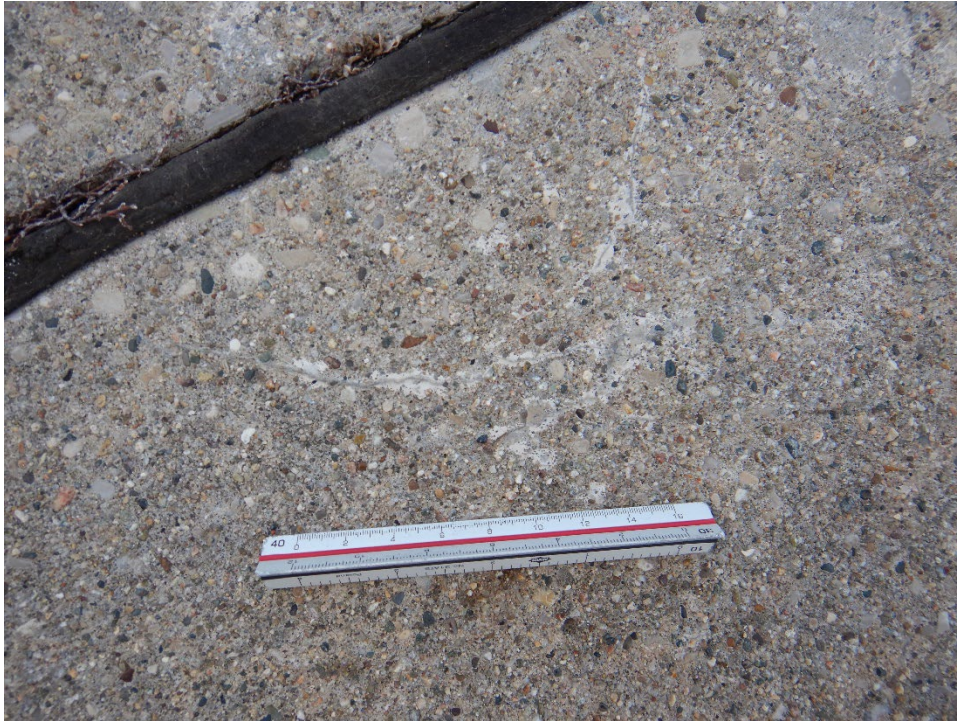
TH01BP-01. ASR (Sample Unit No. 01).

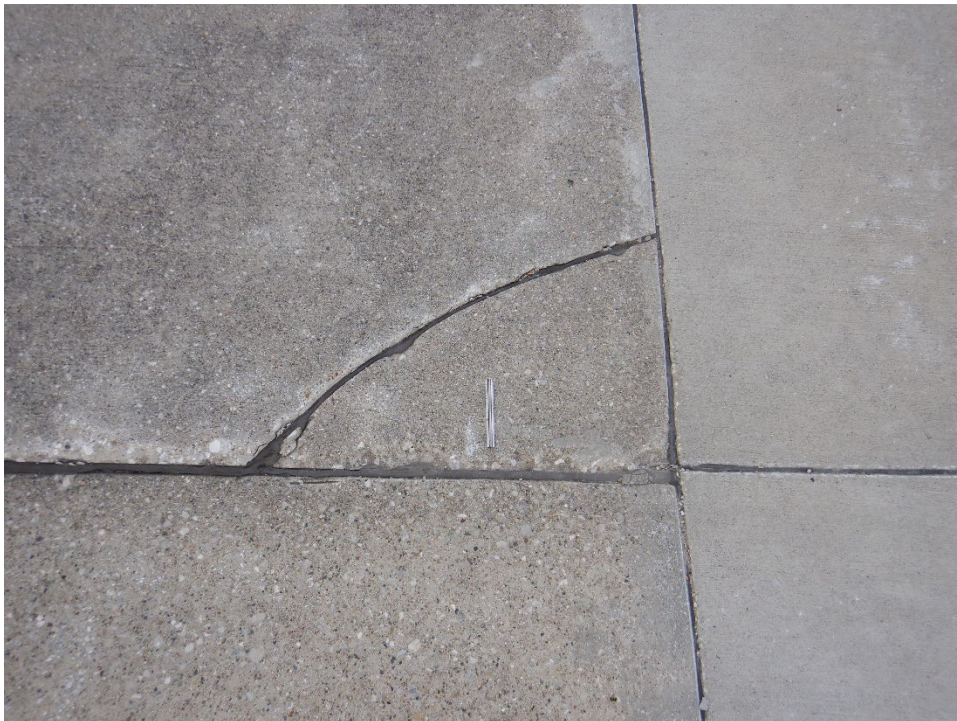
TH01BP-01. Corner Break (Sample Unit No. 01).

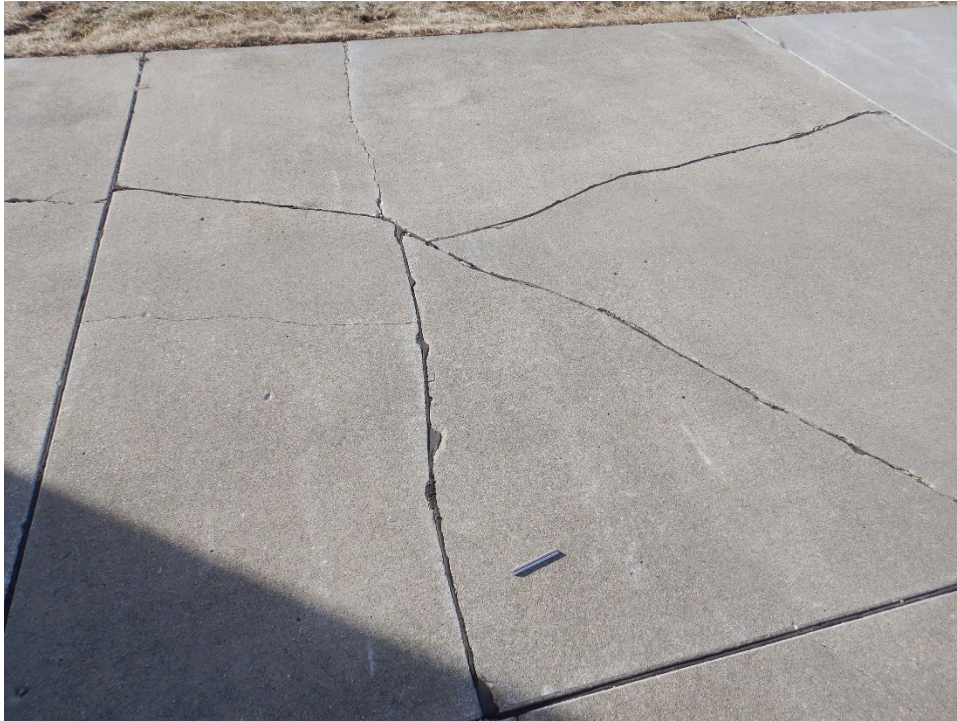
TH01BP-01. Shattered Slab (Sample Unit No. 01).

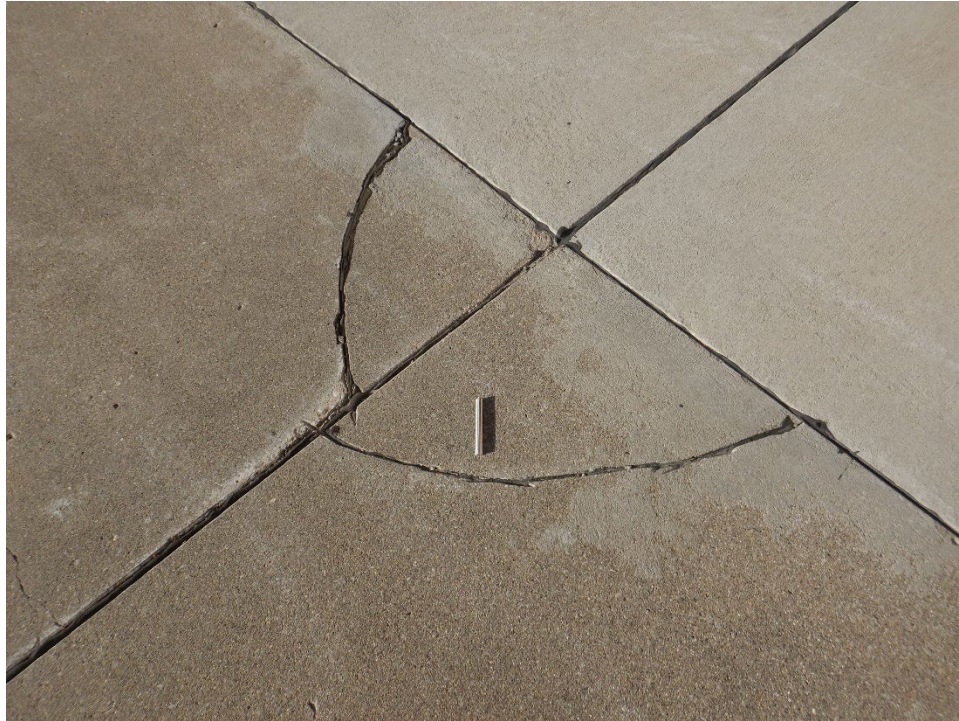
TH01BP-02. Corner Break (Sample Unit No. 01).

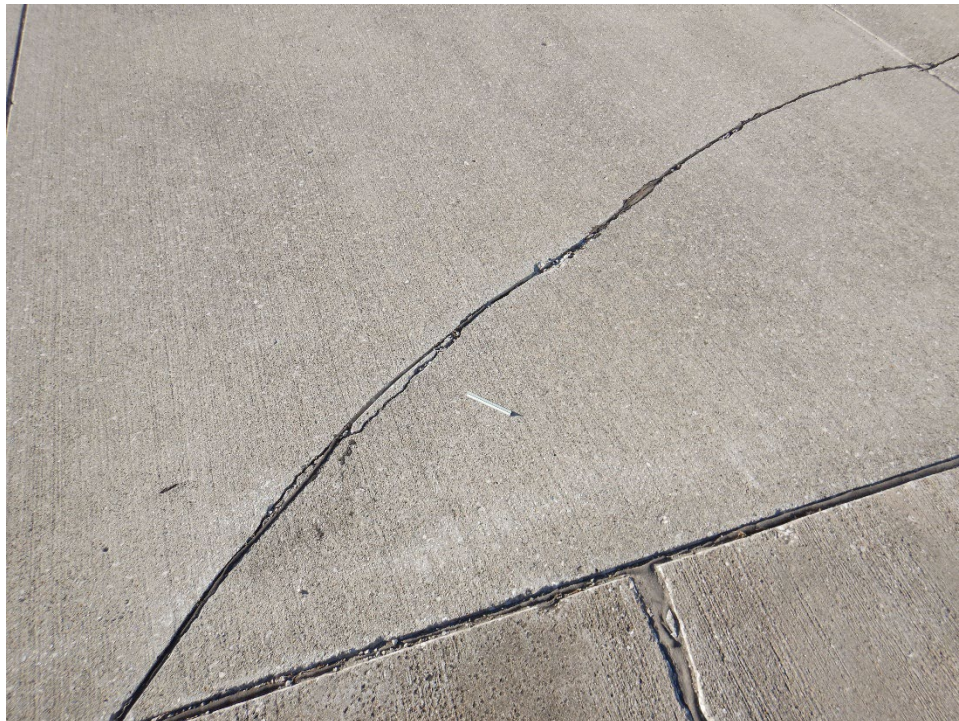
TH01BP-02. LTD Cracking (Sample Unit No. 01).
