# Bloomfield Municipal Airport

## Pavement Management Report

**AUGUST 2025**

# BLOOMFIELD MUNICIPAL AIRPORT PAVEMENT MANAGEMENT REPORT

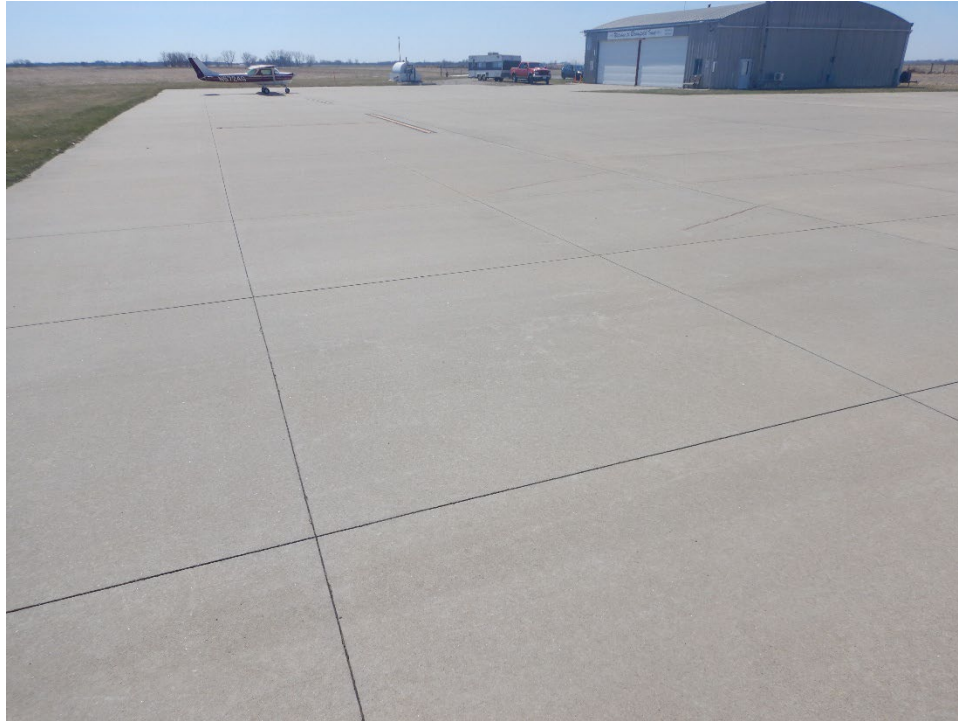
A01BL-01. Overview.

The taxiway consisted of one section in *Excellent* condition that connected the apron area to Runway 18/36. Only low-severity joint seal damage was recorded throughout Section 01.

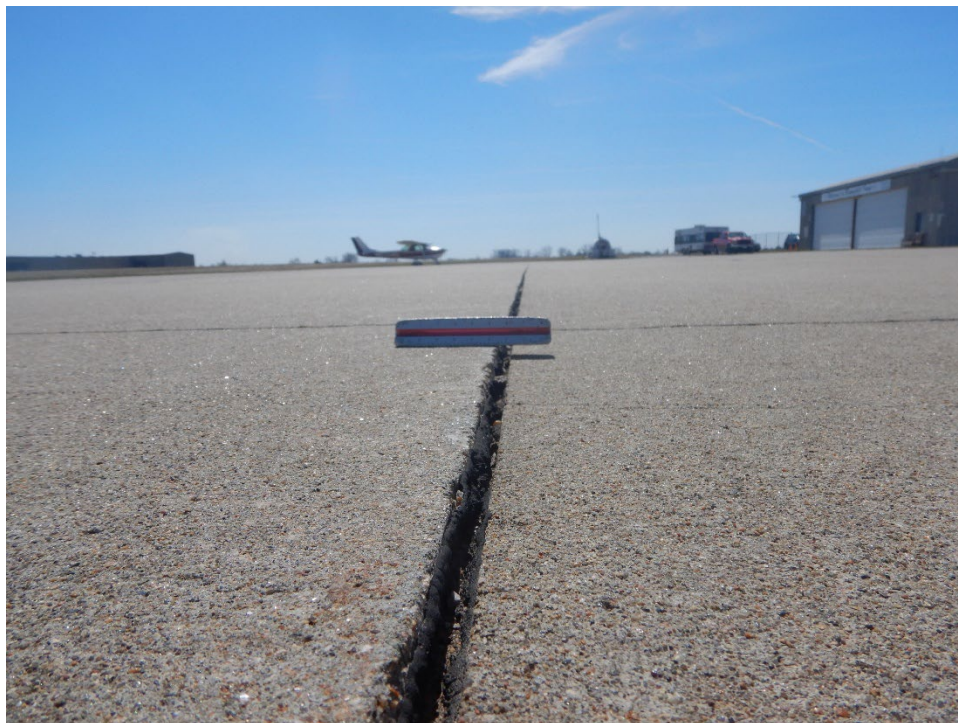
The apron area was defined by two sections. Section 01, connected to Taxiway 01, had low-severity faulting and medium- and high-severity joint seal damage. Section 02, connected to the T-hangars, contained low-severity corner break, corner spalling, and faulting, in addition to medium- and high-severity joint seal damage, low- and medium-severity joint spalling, and low-severity LTD cracking.

A01BL-01. Faulting (Sample Unit No. 05).

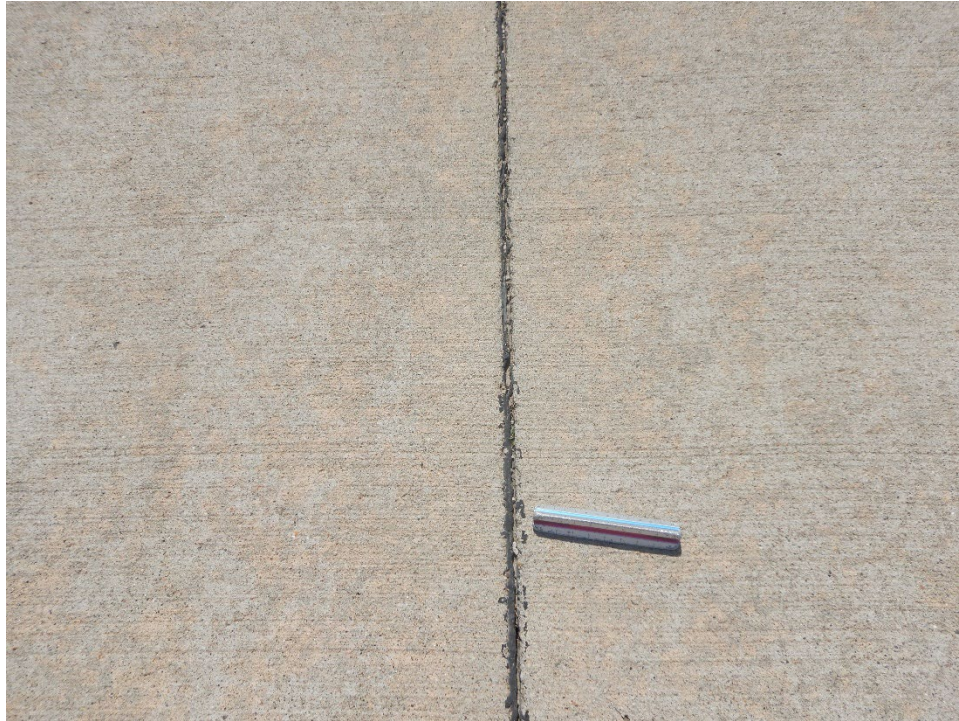
A01BL-01. Joint Seal Damage (Sample Unit No. 06).

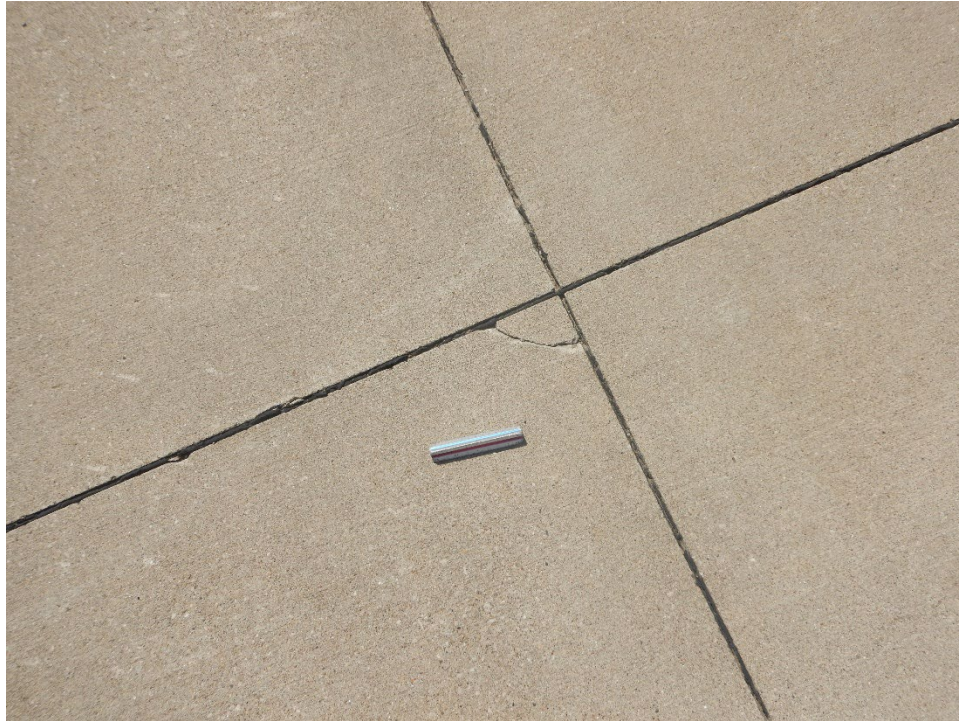
A01BL-02. Corner Spalling (Sample Unit No. 02).

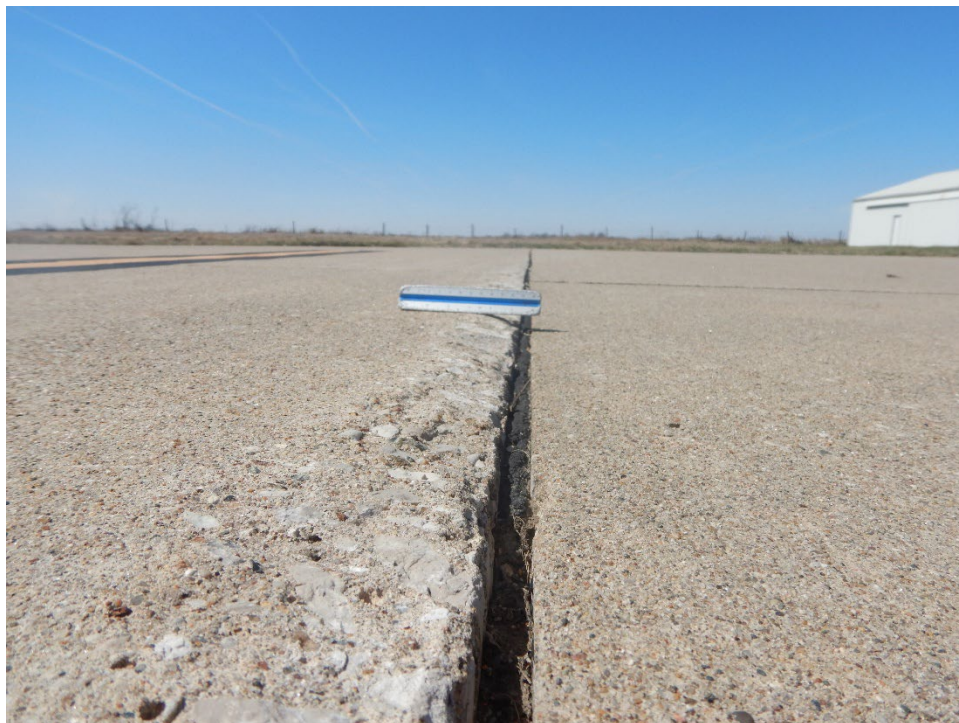
A01BL-02. Faulting (Sample Unit No. 02).

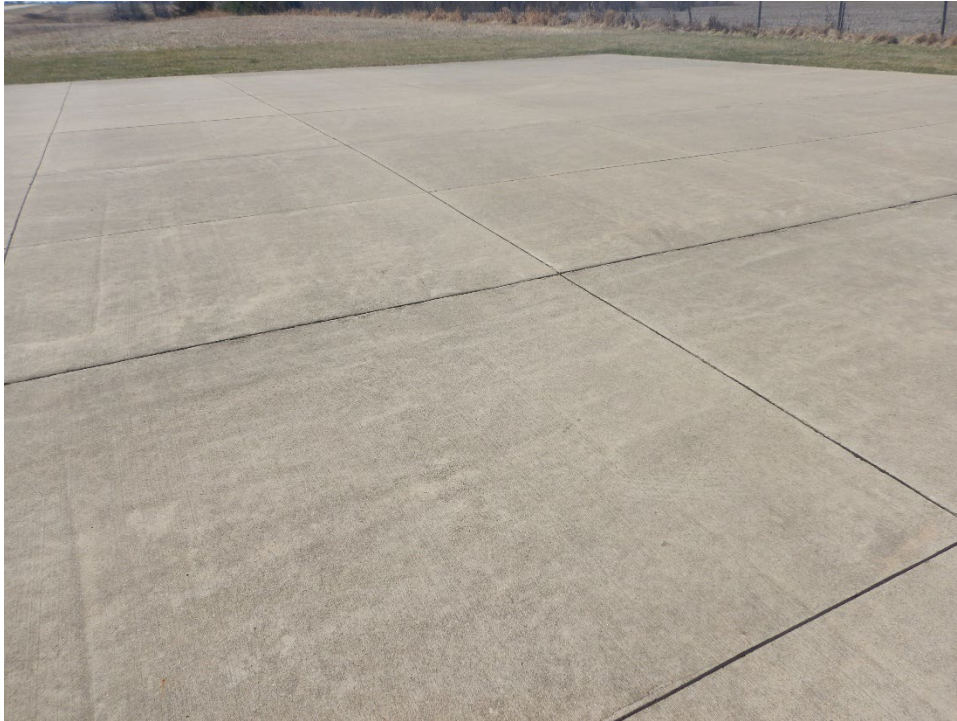
R18BL-01. Overview.

Runway 18/36 was comprised of three sections. Section 01, located on the northern part of the runway, contained areas of low-severity corner spalling and joint spalling; low- and medium-severity faulting and longitudinal, transverse, and diagonal (LTD) cracking; and high-severity joint seal damage. All severities of joint seal damage and low-severity small patching were observed in Section 02. Section 03 had low-severity corner break and LTD cracking, low- and medium-severity corner spalling and faulting, medium- and high-severity joint seal damage, and medium-severity joint spalling recorded at the time of inspection.

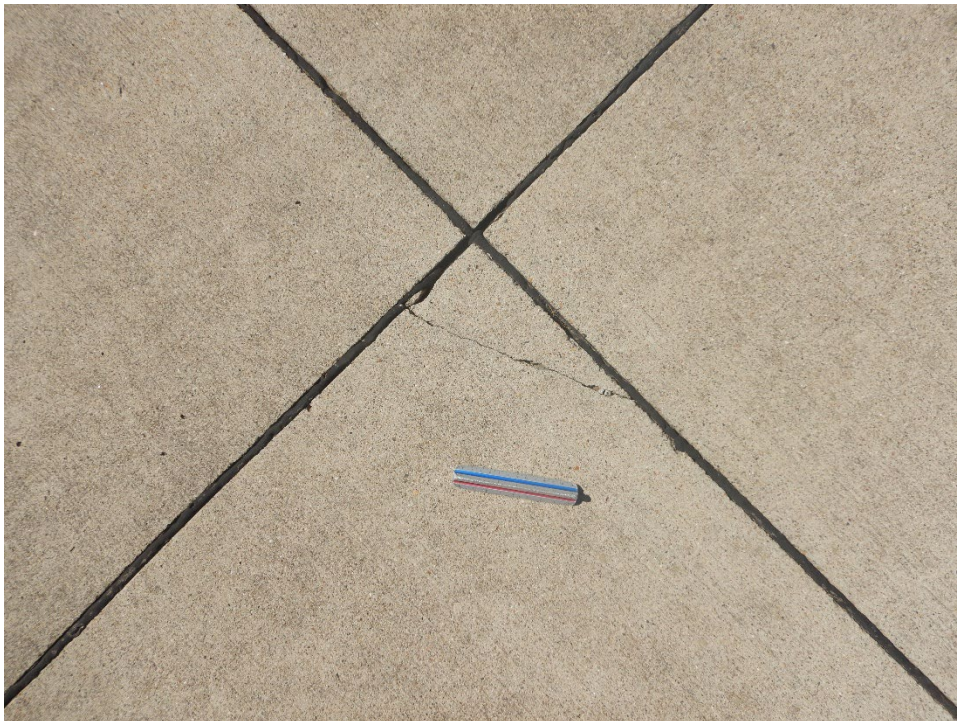
R18BL-01. Corner Spalling (Sample Unit No. 01).

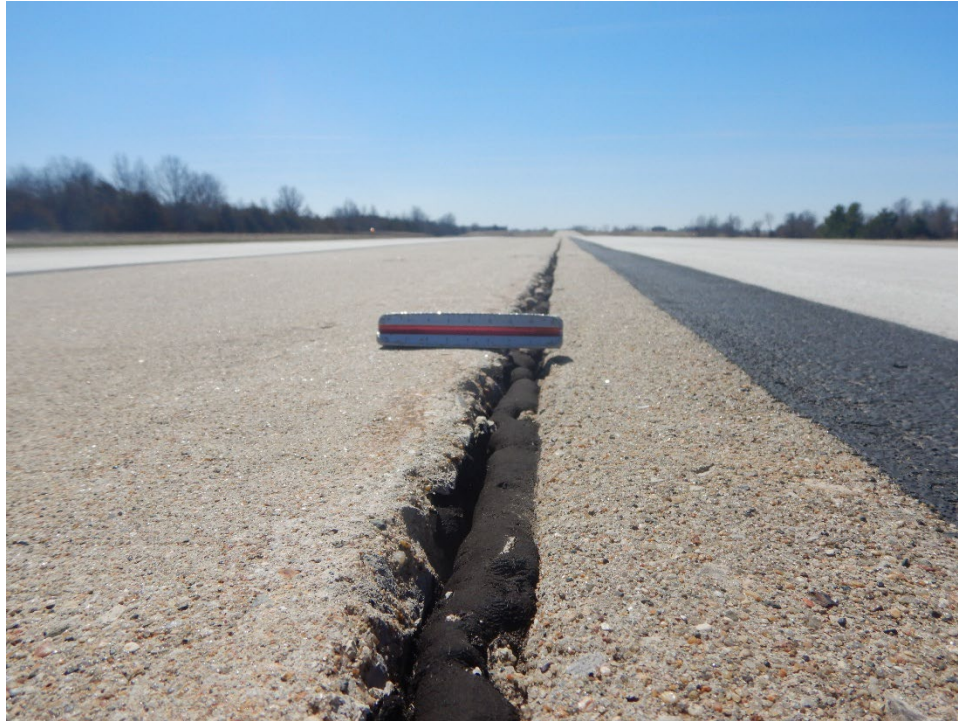
R18BL-01. Faulting (Sample Unit No. 09).

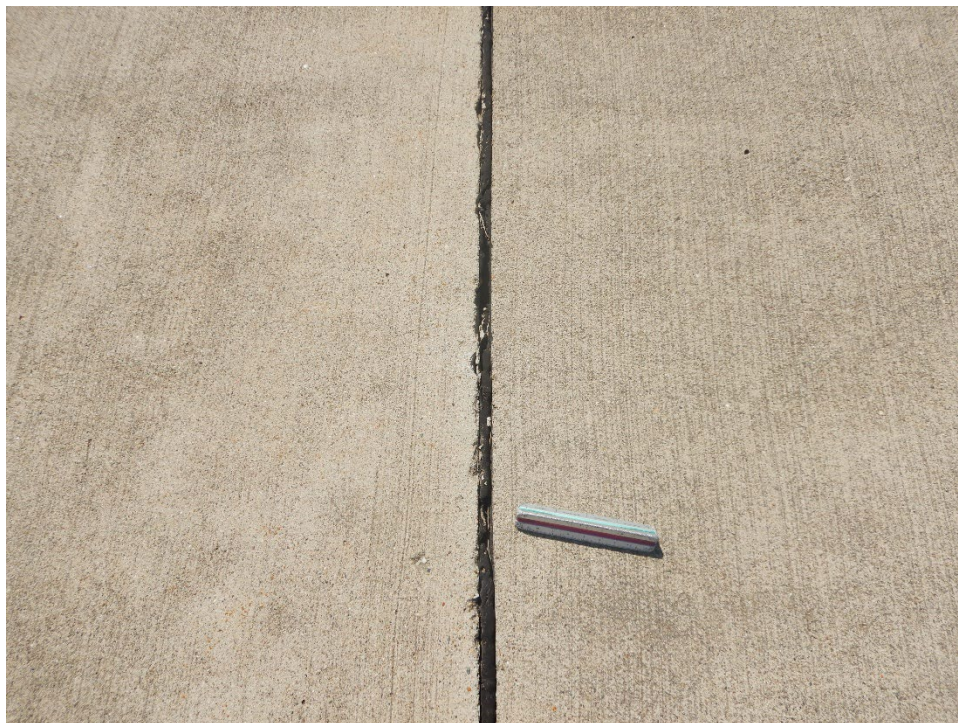
R18BL-01. Joint Seal Damage (Sample Unit No. 04).

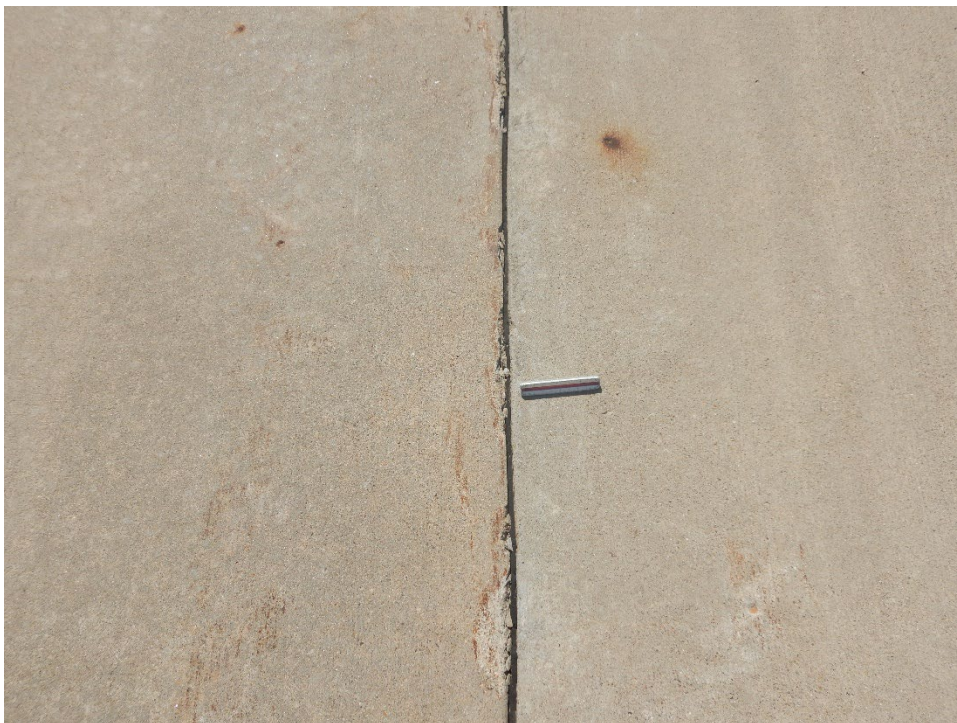
R18BL-02. Joint Seal Damage (Sample Unit No. 33).

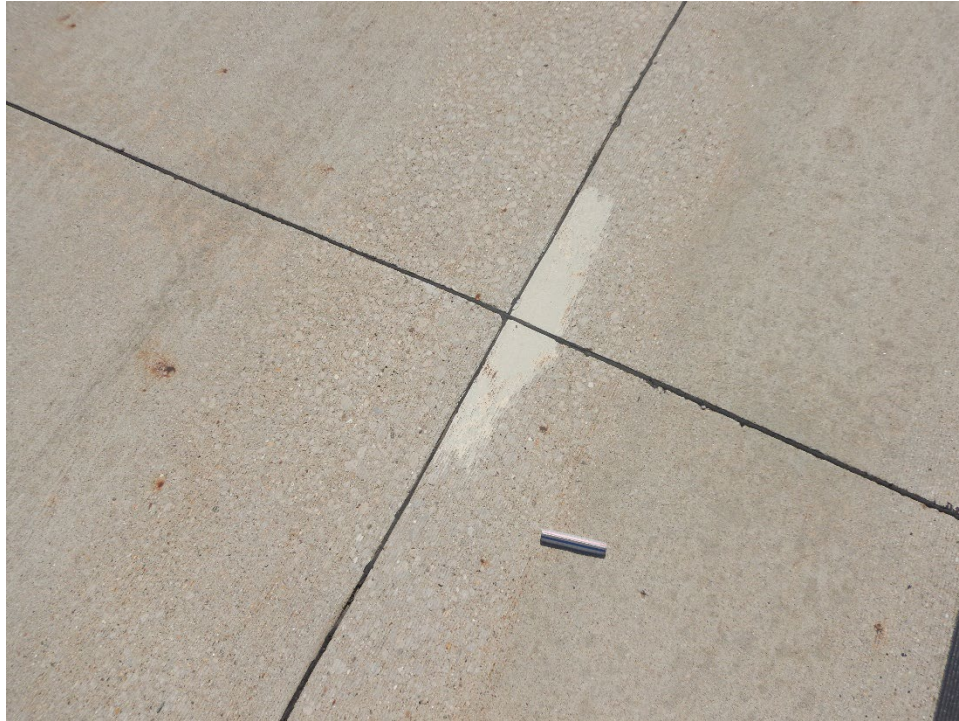
R18BL-02. Small Patching (Sample Unit No. 53).

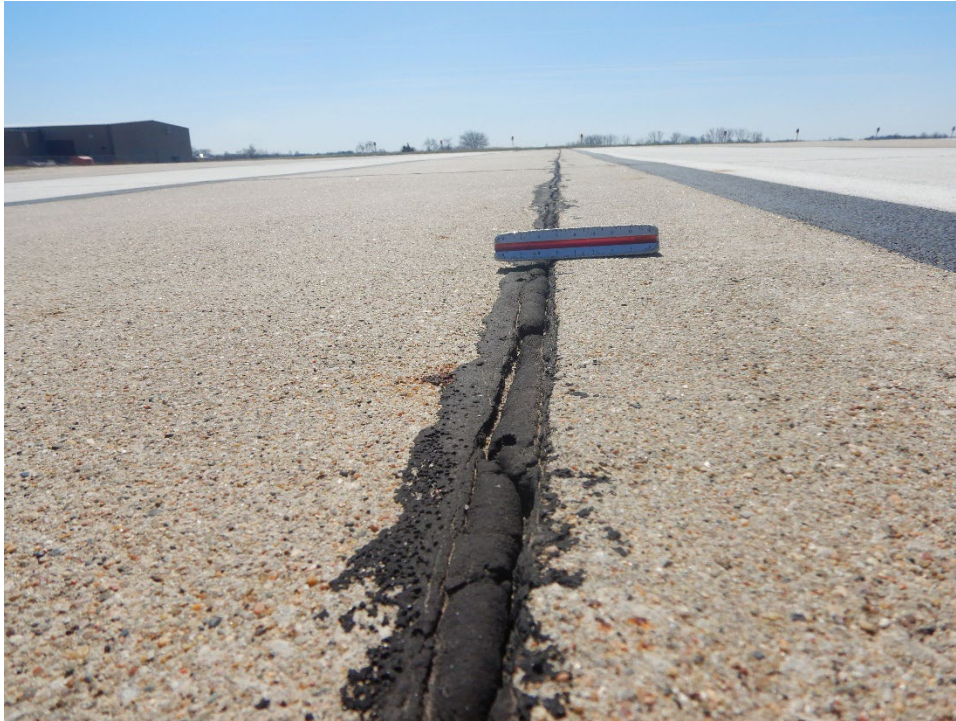
R18BL-03. Faulting (Sample Unit No. 03).

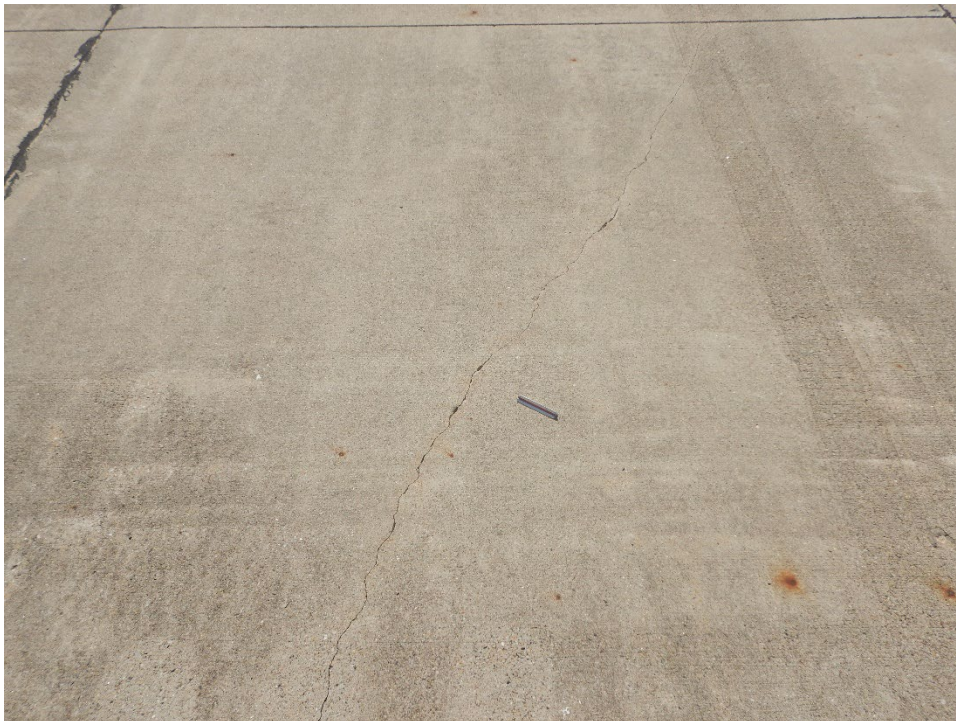
R18BL-03. LTD Cracking (Sample Unit No. 01).

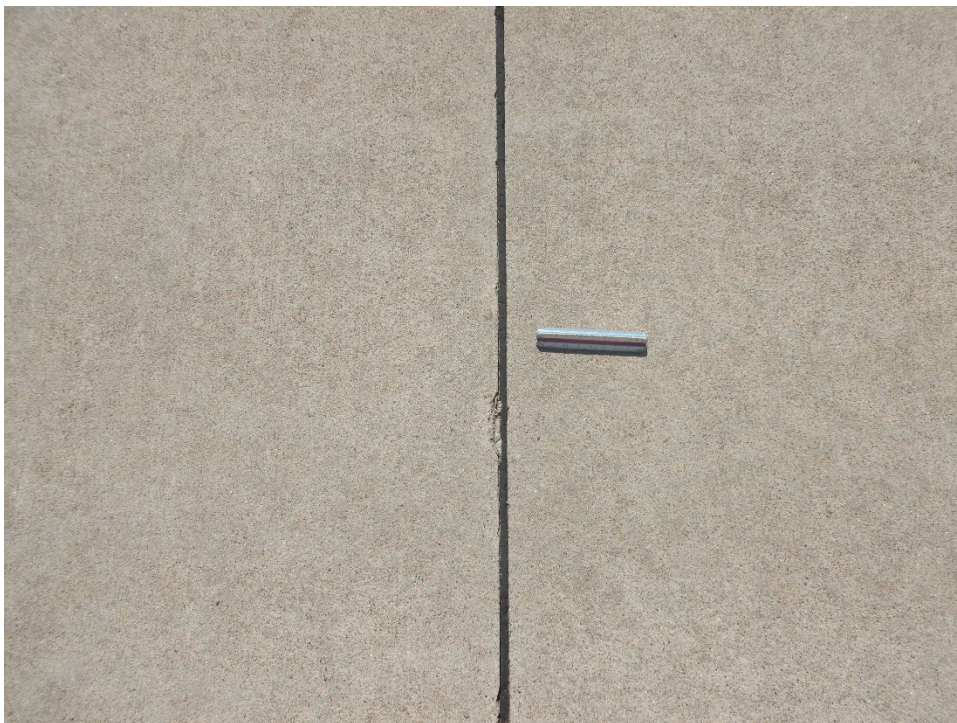
T01BL-01. Joint Seal Damage (Sample Unit No. 01).

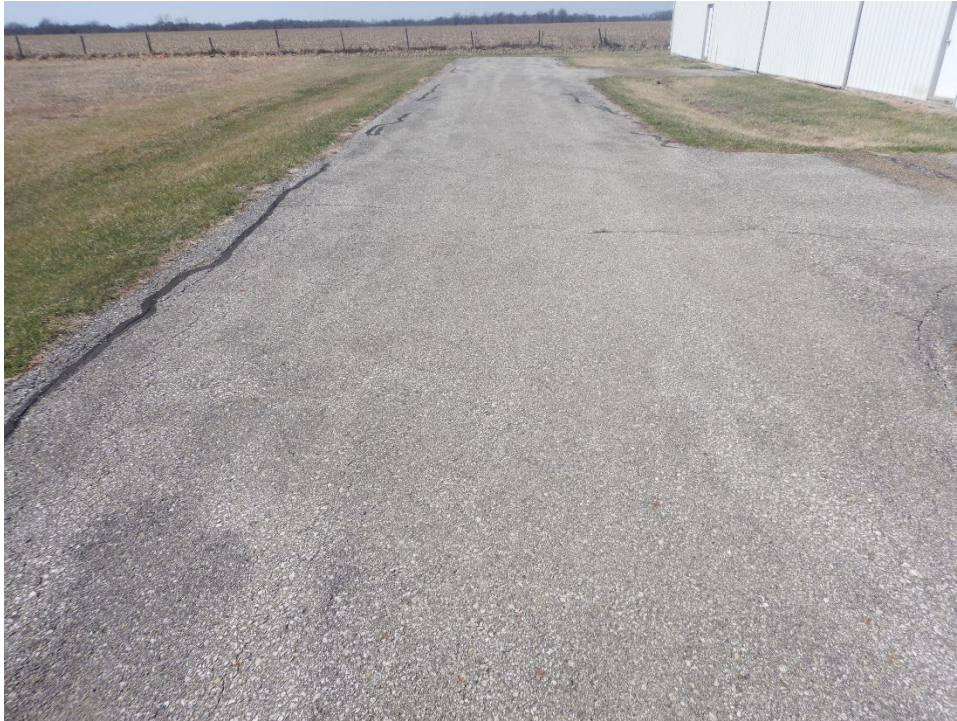
TH01BL-01. Overview.

The T-hangar area contained three sections. Section 01 was in *Poor* condition and had low-severity alligator cracking observed along the edge of the pavement along with low- and medium-severity longitudinal and transverse (L&T) cracking, medium-severity shoving, and high-severity weathering. The low-severity L&T cracking was unsealed, while the medium-severity L&T cracking was observed where either unsealed crack width exceeded 1/4 inch or the crack sealant was in an unsatisfactory condition. Low-severity corner break, medium-severity corner spalling, and high-severity joint seal damage were recorded in Section 02. Section 03 contained areas of low-severity ASR and shattered slab, low- and medium-severity faulting and LTD cracking, and high-severity joint seal damage.

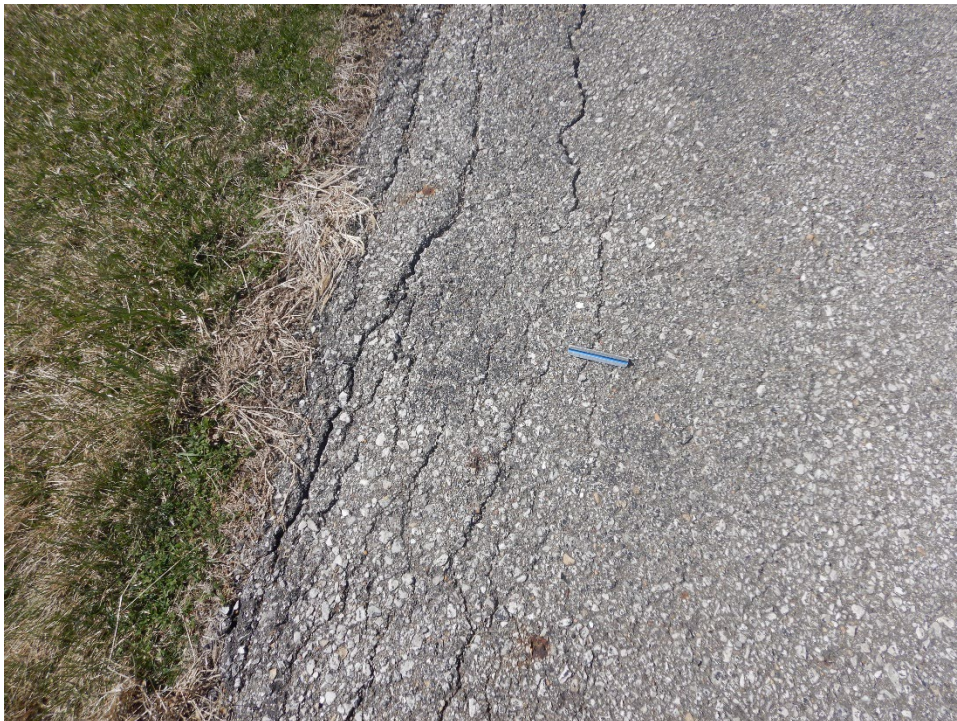
| <b>Distress Type</b> | <b>Probable Cause of Distress</b> |
|---|---|
| Alligator Cracking | Fatigue failure of the asphalt surface under repeated traffic loading. |

TH01BL-01. Alligator Cracking (Sample Unit No. 01).

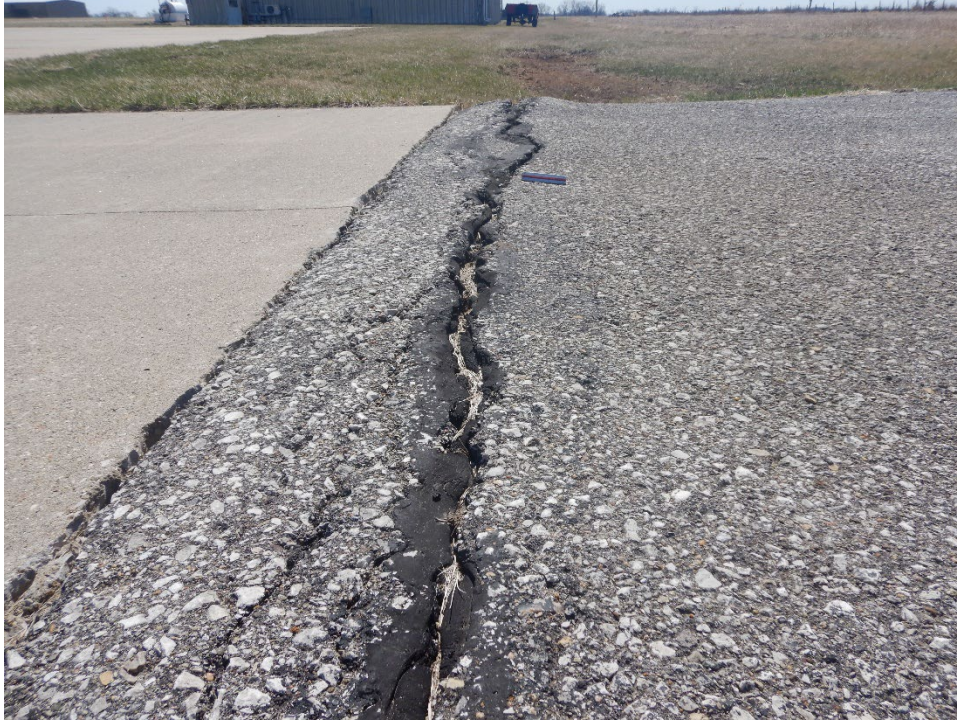
TH01BL-01. Shoving (Sample Unit No. 01).

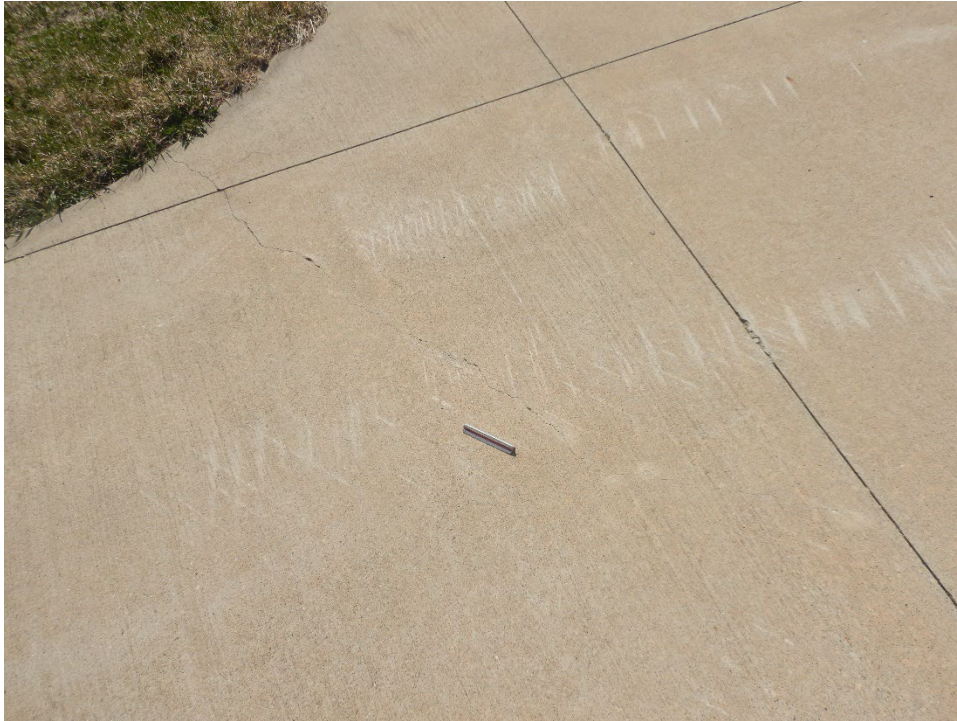
TH01BL-02. Corner Break (Sample Unit No. 01).

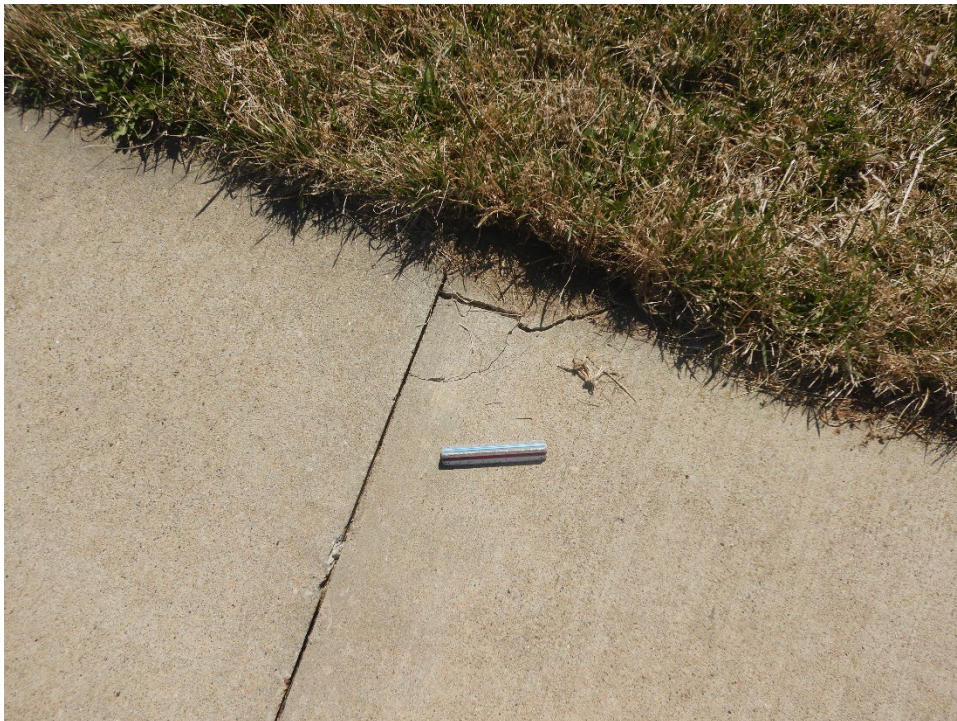
TH01BL-02. Corner Spalling (Sample Unit No. 01).

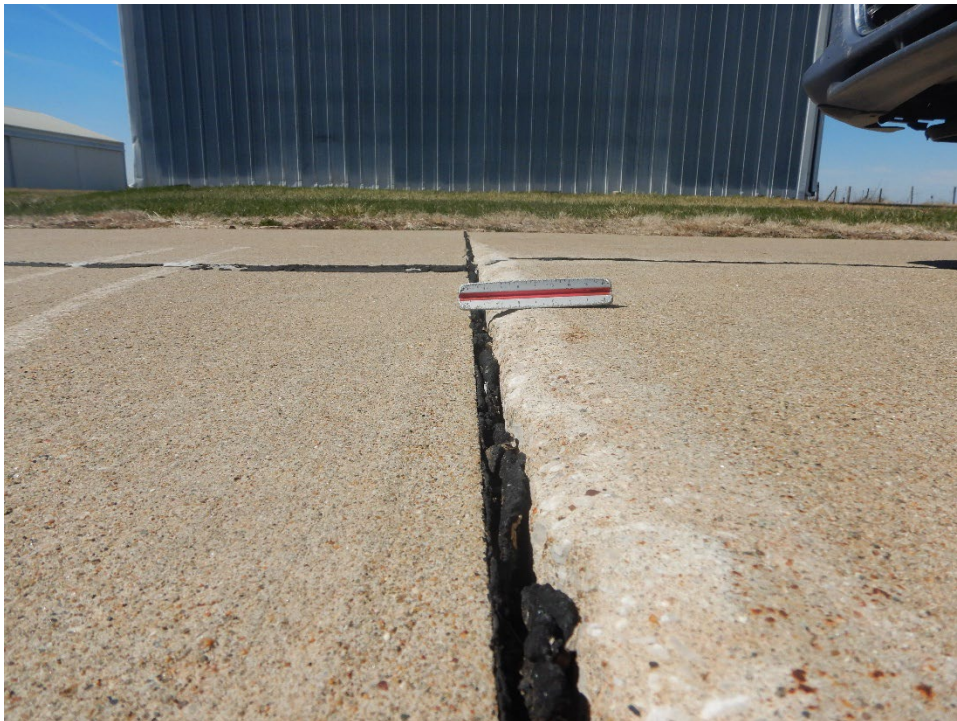
TH01BL-03. Faulting (Sample Unit No. 01).

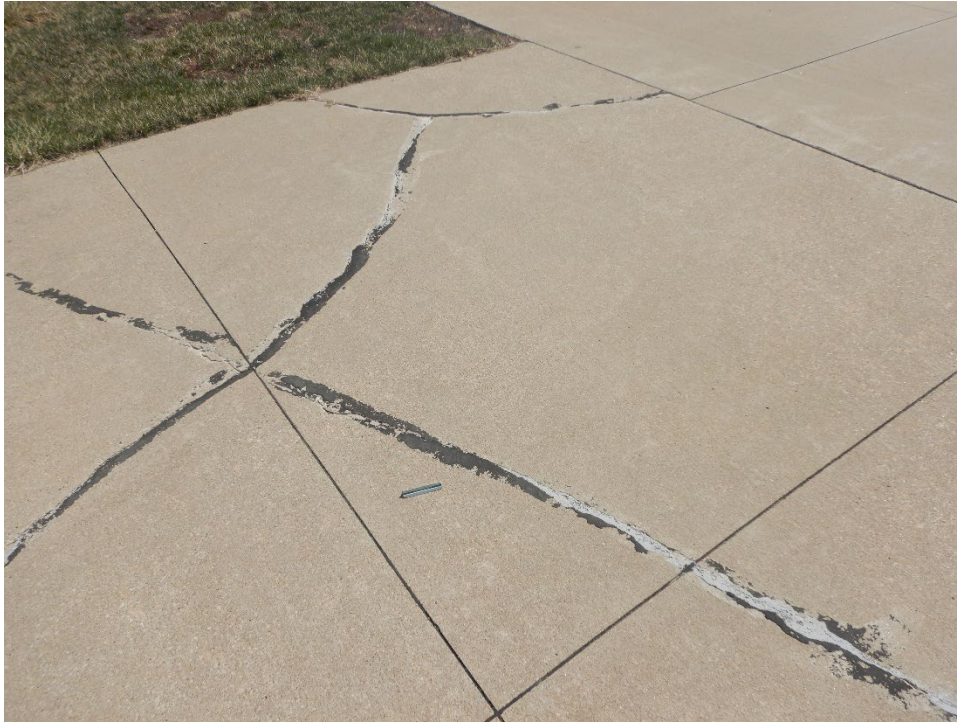
TH01BL-03. Shattered Slab (Sample Unit No. 01).
