Southeast Iowa Regional Airport

**Pavement Management Report**

#### AUGUST 2025

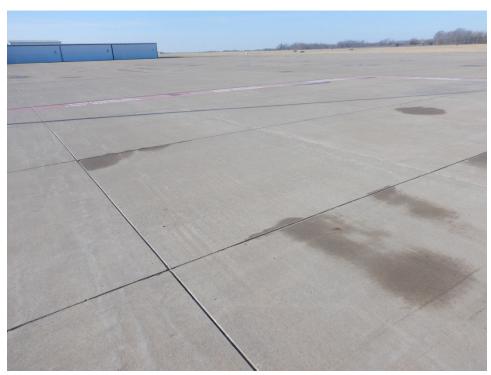
A01BR-01. Joint Seal Damage (Sample Unit No. 03).

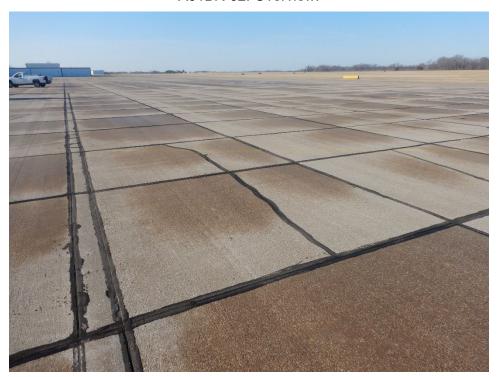
A01BR-02. LTD Cracking (Sample Unit No. 14).

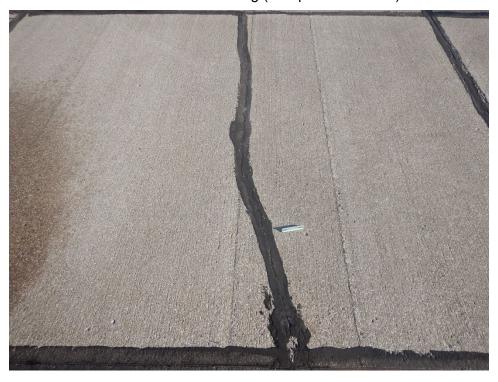
A01BR-02. Large Patching (Sample Unit No. 02).

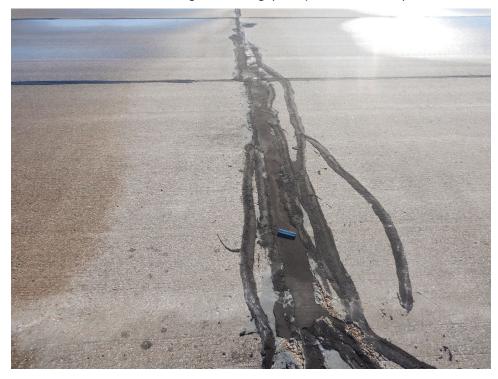
A01BR-02. Large Patching (Sample Unit No. 14).

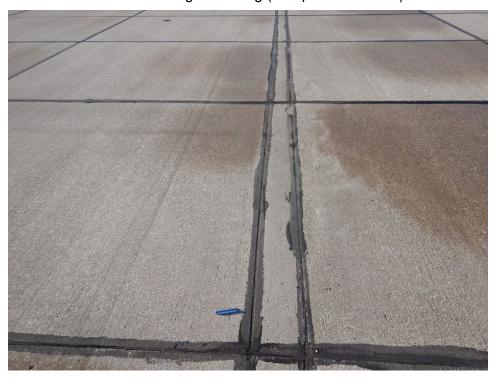
A01BR-02. Large Patching (Sample Unit No. 18).

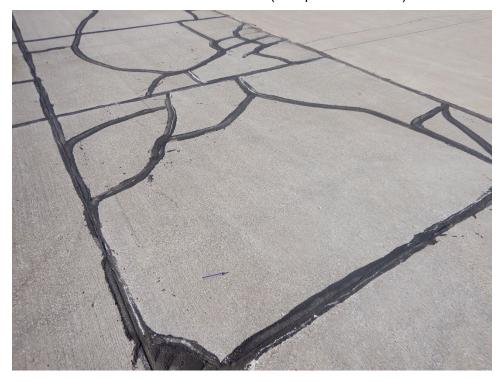
A01BR-02. Shattered Slab (Sample Unit No. 05).

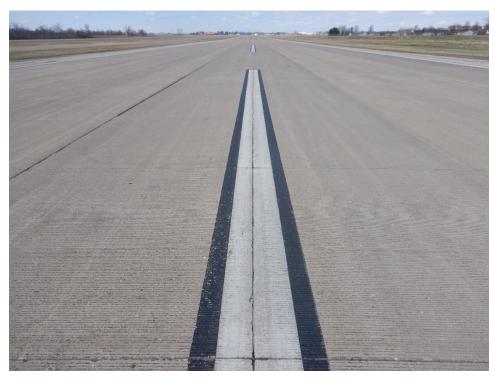
R12BR-01. ASR (Sample Unit No. 138).

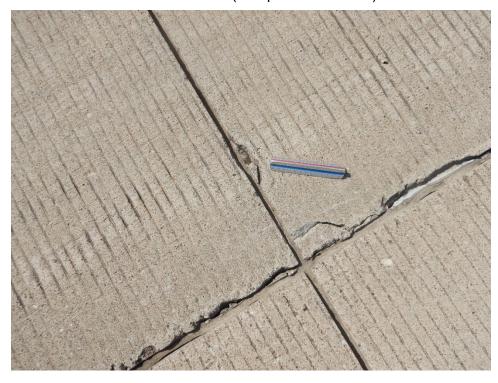
R12BR-01. Corner Spalling (Sample Unit No. 153).

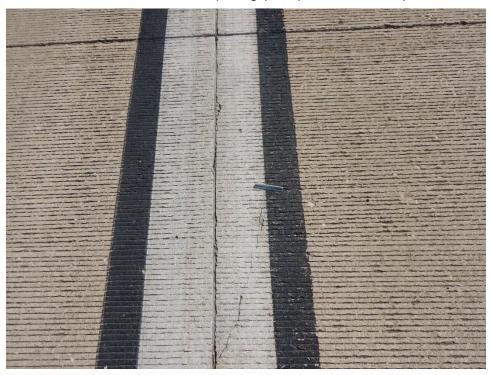
R12BR-01. Faulting (Sample Unit No. 004).

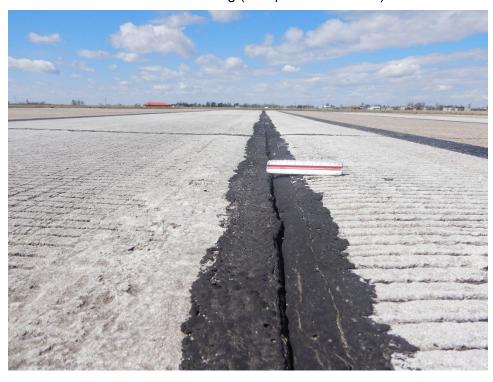
R12BR-01. Joint Seal Damage (Sample Unit No. 153).

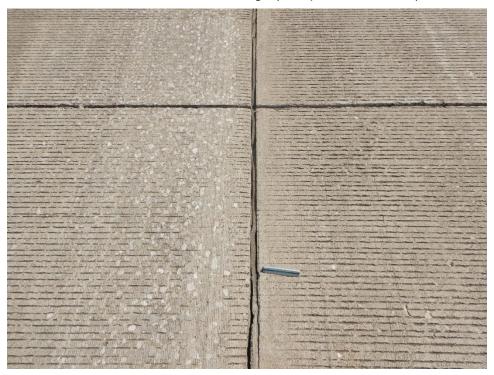
R12BR-01. Joint Spalling (Sample Unit No. 052).

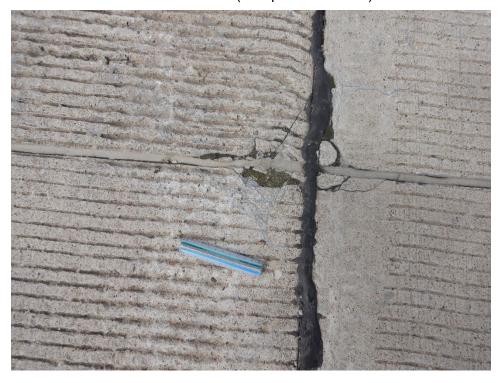
R12BR-02. ASR (Sample Unit No. 13).

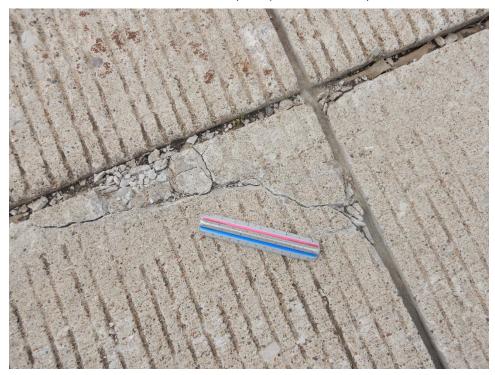
R12BR-02. Corner Spalling (Sample Unit No. 47).

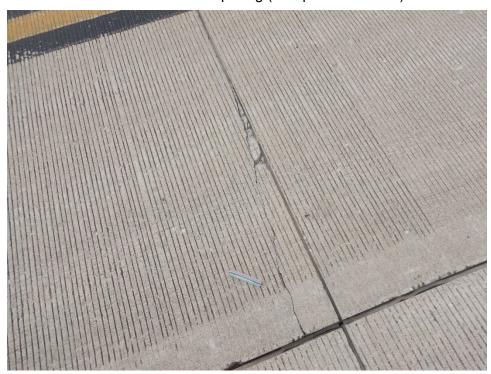
R12BR-02. Joint Seal Damage (Sample Unit No. 50).

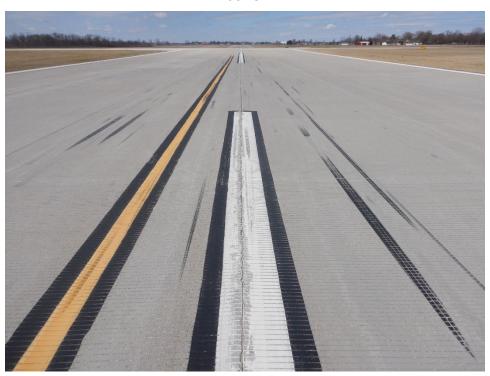
R12BR-03. Corner Spalling (Sample Unit No. 24).

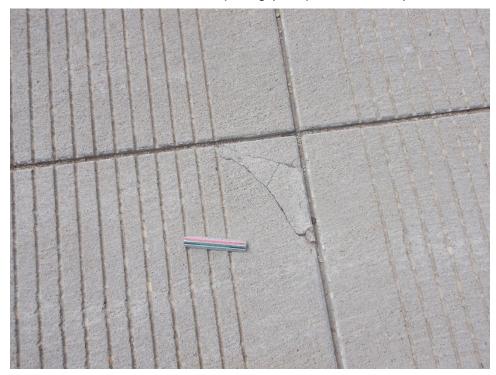
R12BR-03. LTD Cracking (Sample Unit No. 03).

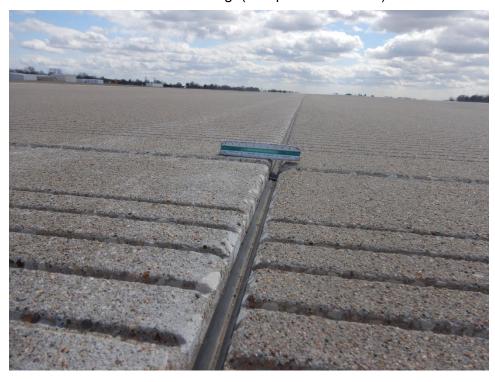
R18BR-01. LTD Cracking (Sample Unit No. 145).

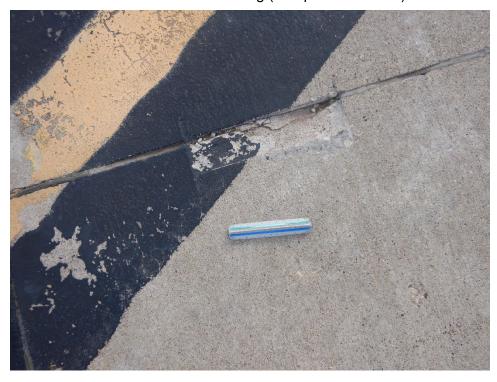
TA2BR-01. Small Patching (Sample Unit No. 04).

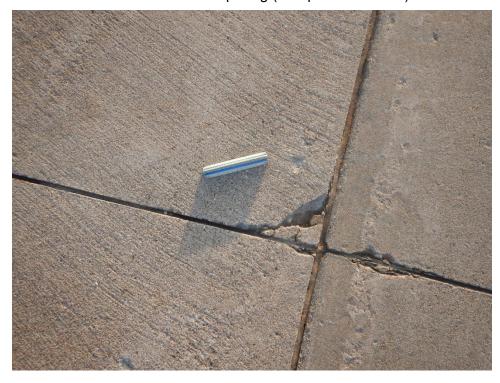
TA2BR-02. Corner Spalling (Sample Unit No. 05).

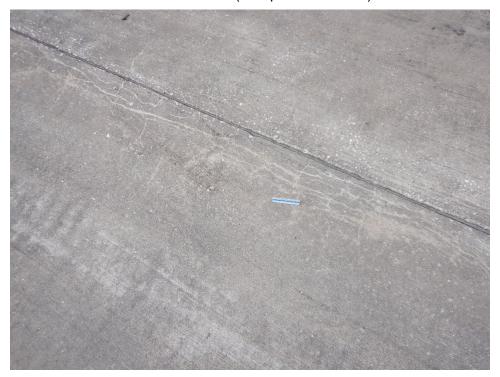
TA3BR-01. ASR (Sample Unit No. 02).

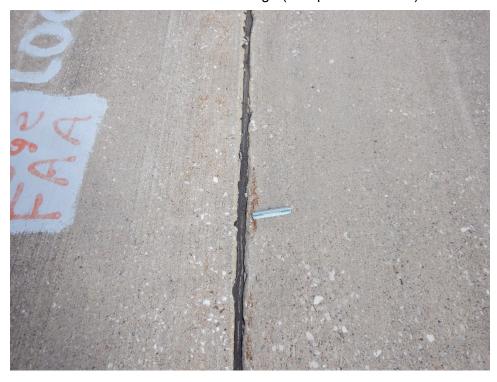
TA3BR-01. Joint Seal Damage (Sample Unit No. 03).

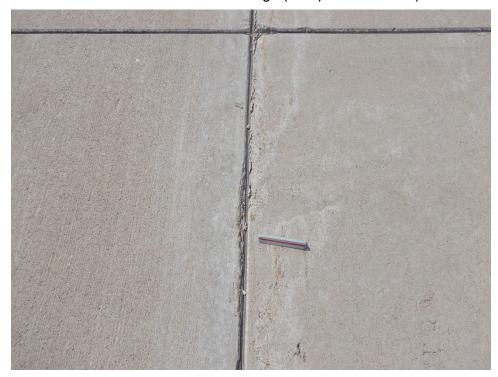
TA3BR-02. Joint Seal Damage (Sample Unit No. 02).

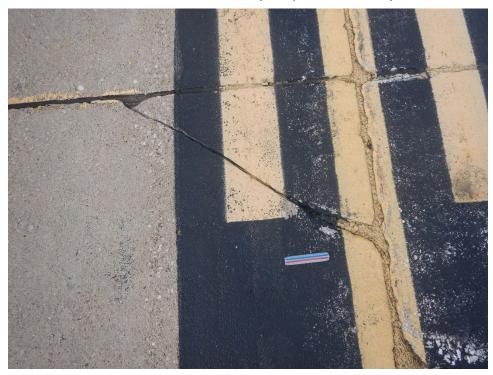
TABR-01. Corner Break (Sample Unit No. 03).

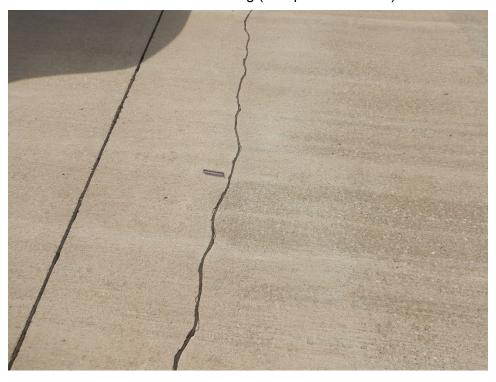
TABR-01. LTD Cracking (Sample Unit No. 05).

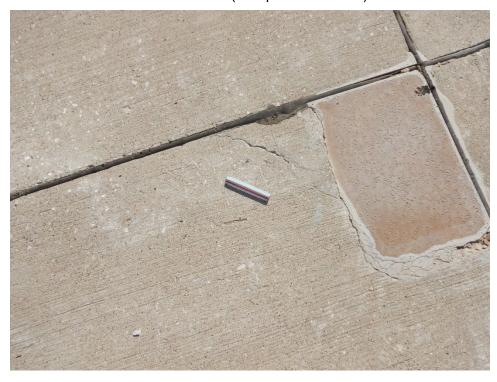
TABR-02. ASR (Sample Unit No. 94).

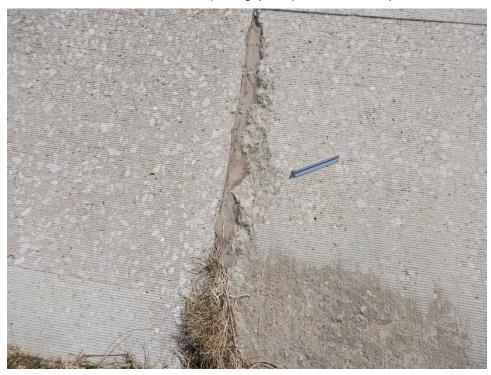
TABR-02. Joint Spalling (Sample Unit No. 94).

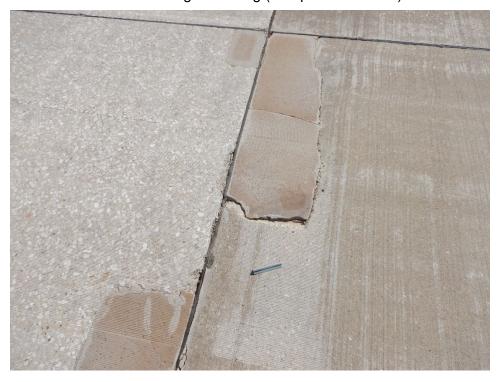
TABR-02. Large Patching (Sample Unit No. 94).

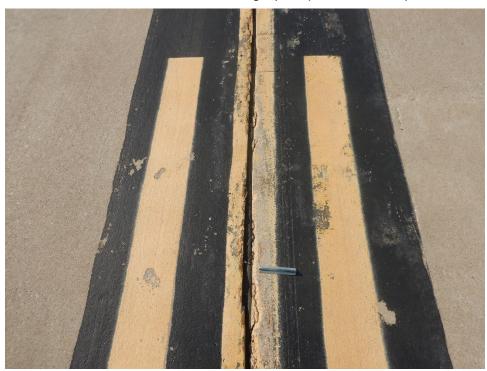
TBBR-02. Joint Seal Damage (Sample Unit No. 02).

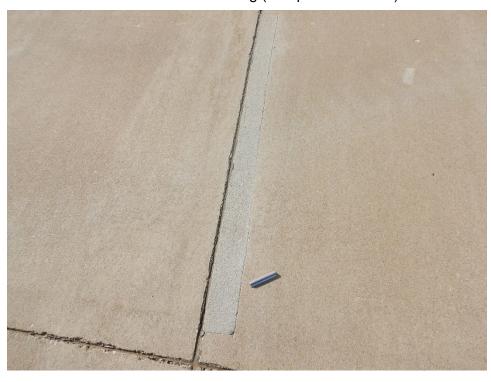
TBBR-02. Small Patching (Sample Unit No. 02).

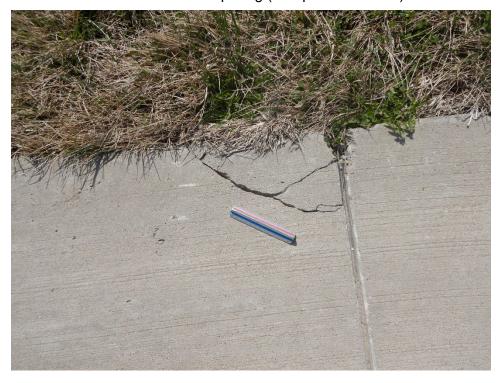
TBBR-03. Corner Spalling (Sample Unit No. 01).

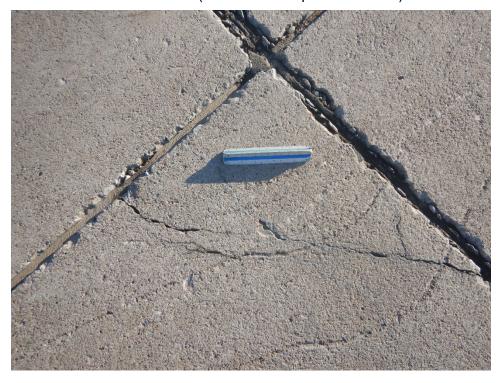
TCBR-01. ASR (Additional Sample Unit No. 11).

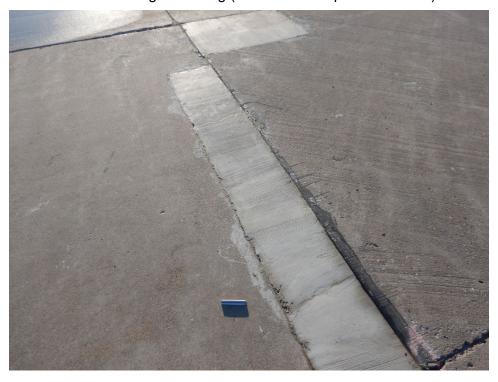
TCBR-01. Large Patching (Additional Sample Unit No. 11).

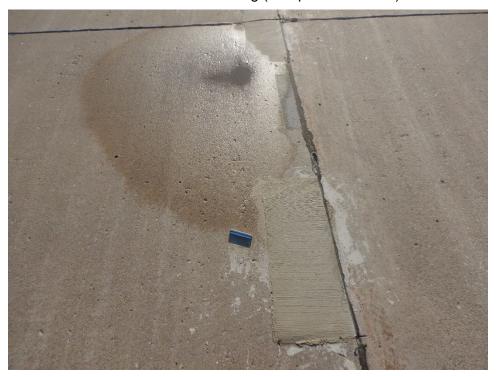
TCBR-01. Small Patching (Sample Unit No. 08).

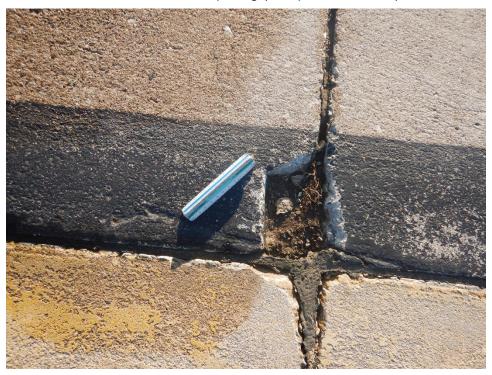
TDBR-03. Corner Spalling (Sample Unit No. 04).

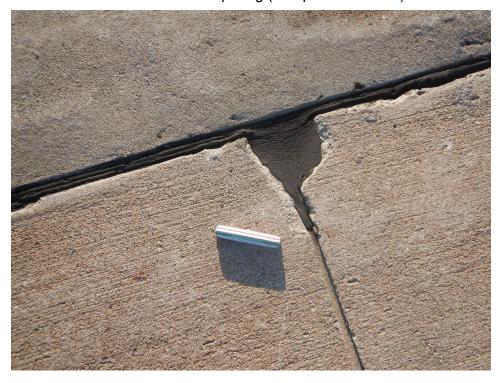
TDBR-03. Corner Spalling (Sample Unit No. 10).

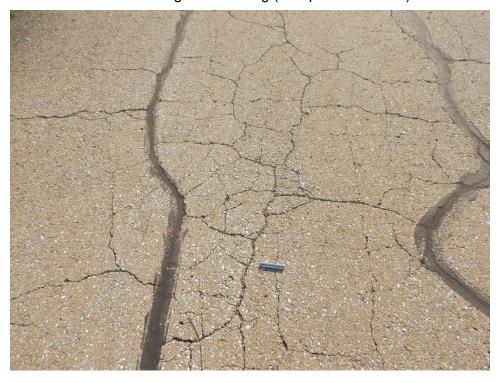
TDBR-04. Alligator Cracking (Sample Unit No. 02).

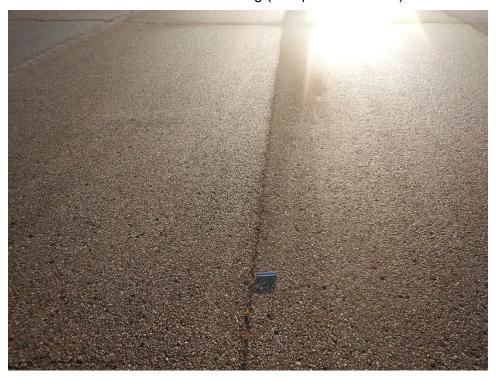
TH01BR-01. L&T Cracking (Sample Unit No. 02).

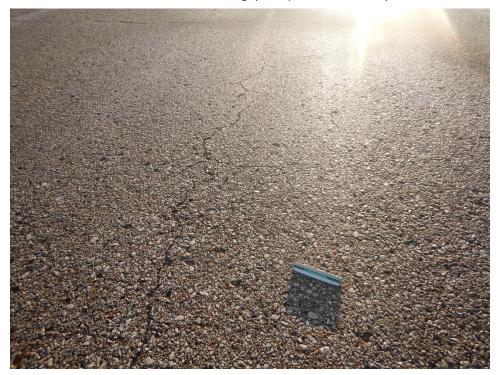
TH01BR-01. Raveling (Sample Unit No. 02).

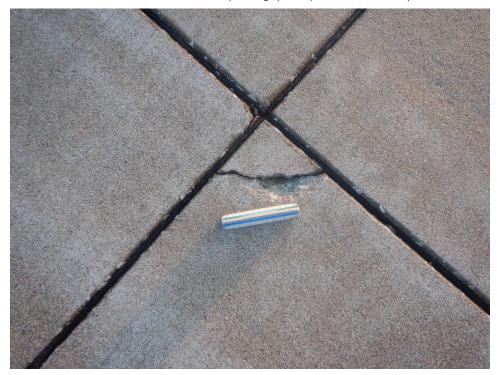
TH01BR-02. Corner Spalling (Sample Unit No. 04).

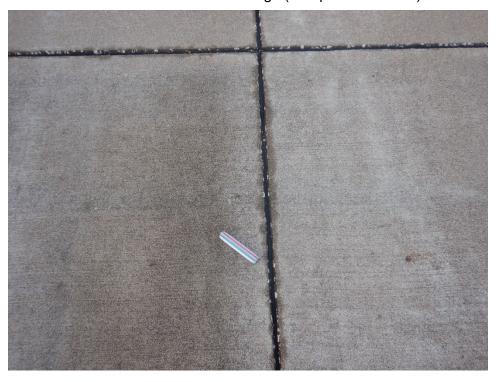
TH01BR-02. Joint Seal Damage (Sample Unit No. 08).

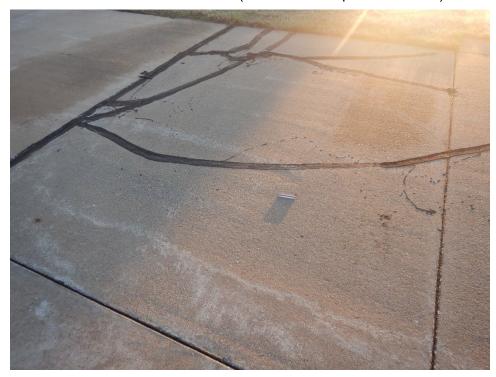
TH01BR-02. Shattered Slab (Additional Sample Unit No. 01).
