Centerville Municipal Airport

Pavement Management Report

JULY 2024

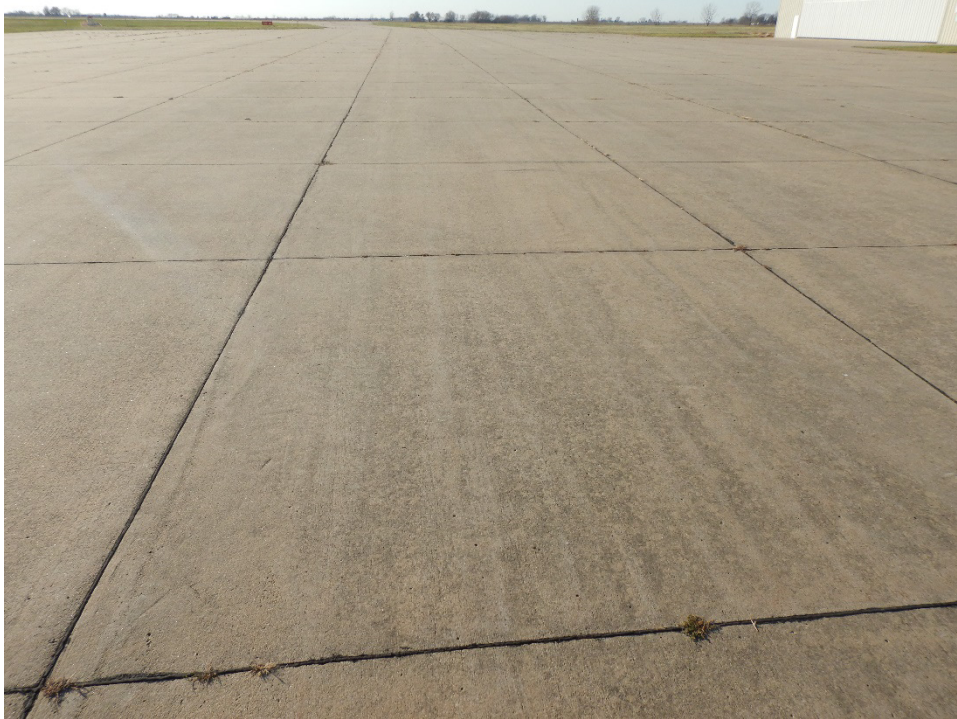
A01CE-01. Overview.

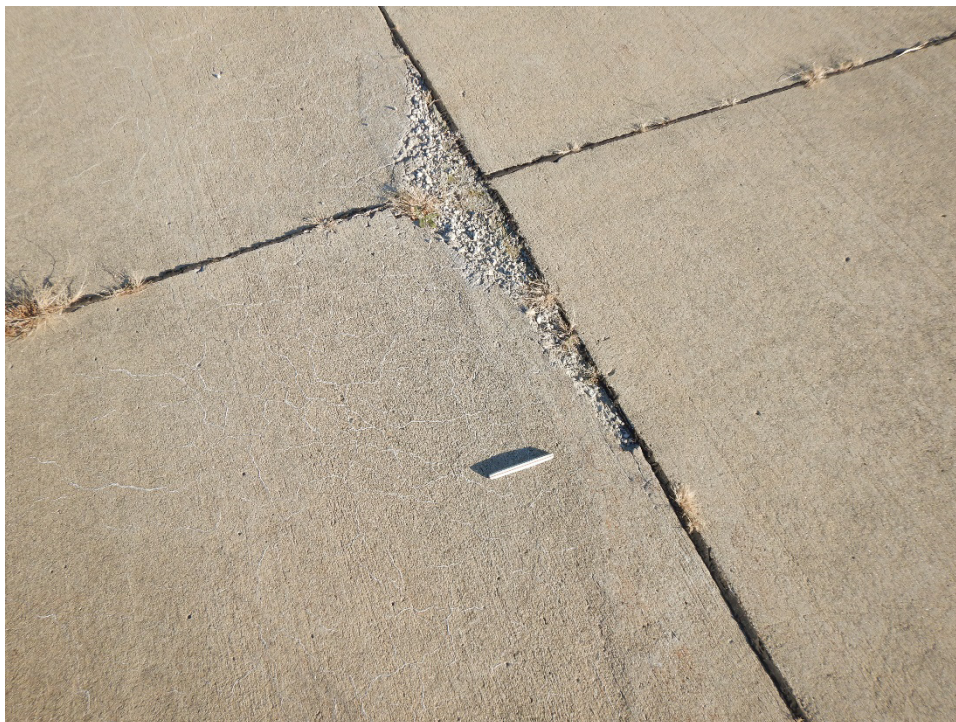
A01CE-01. ASR (Sample Unit No. 14).

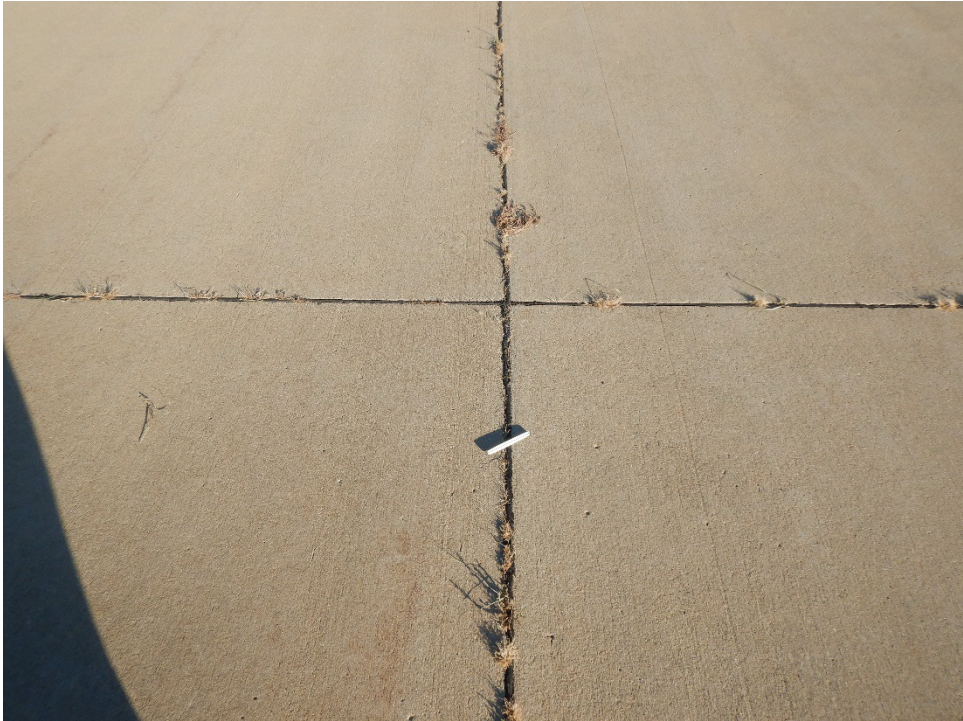
A01CE-01. Joint Seal Damage (Sample Unit No. 16).

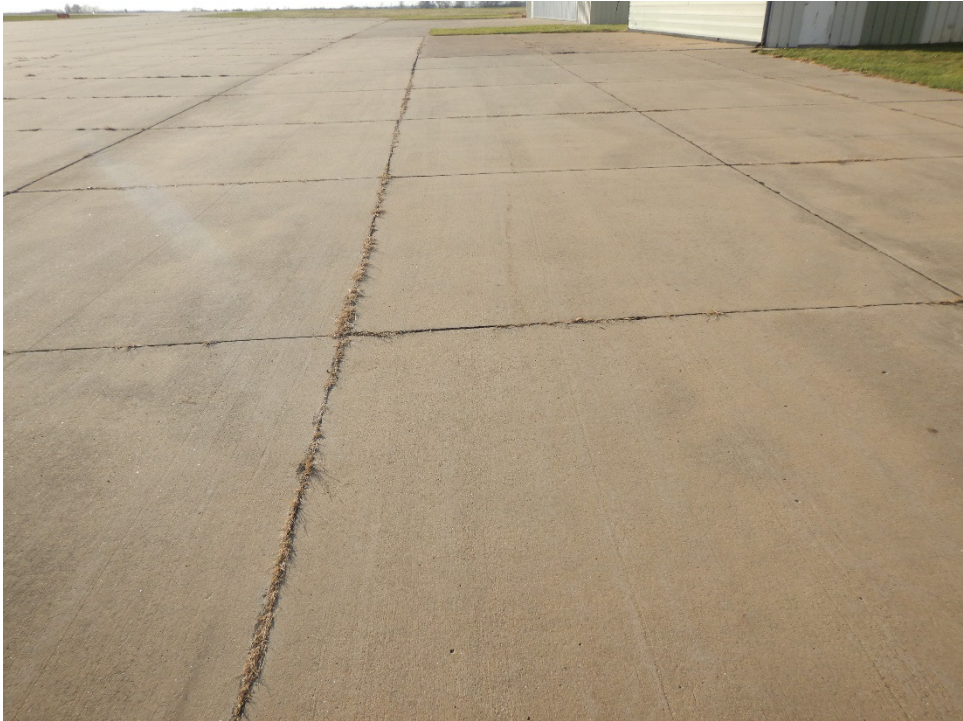
A01CE-02. Overview.

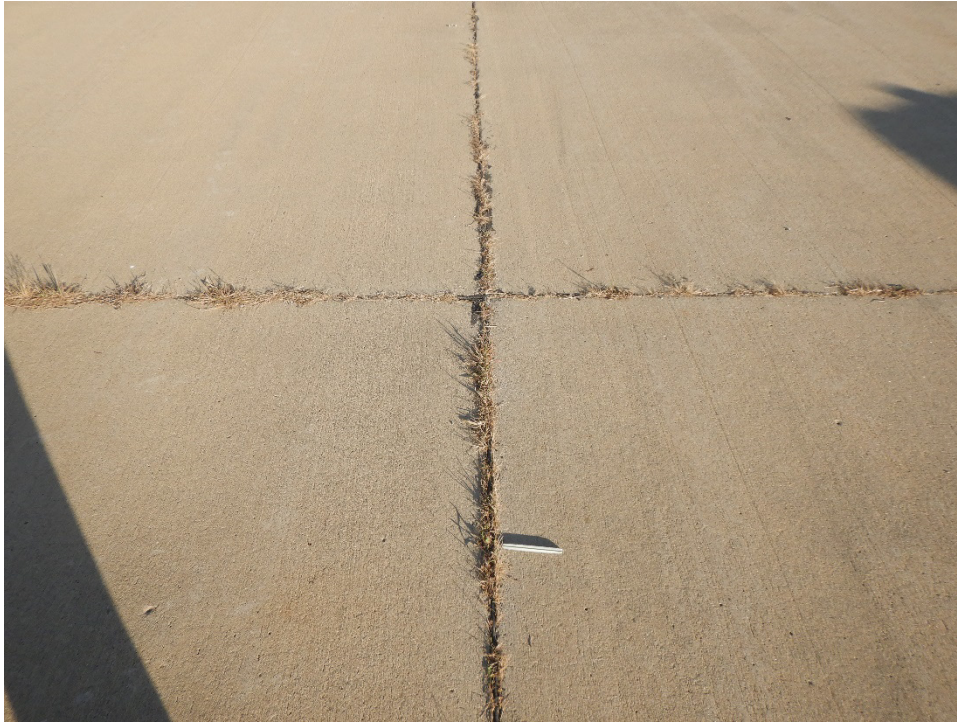
A01CE-02. Joint Seal Damage (Sample Unit No. 01).

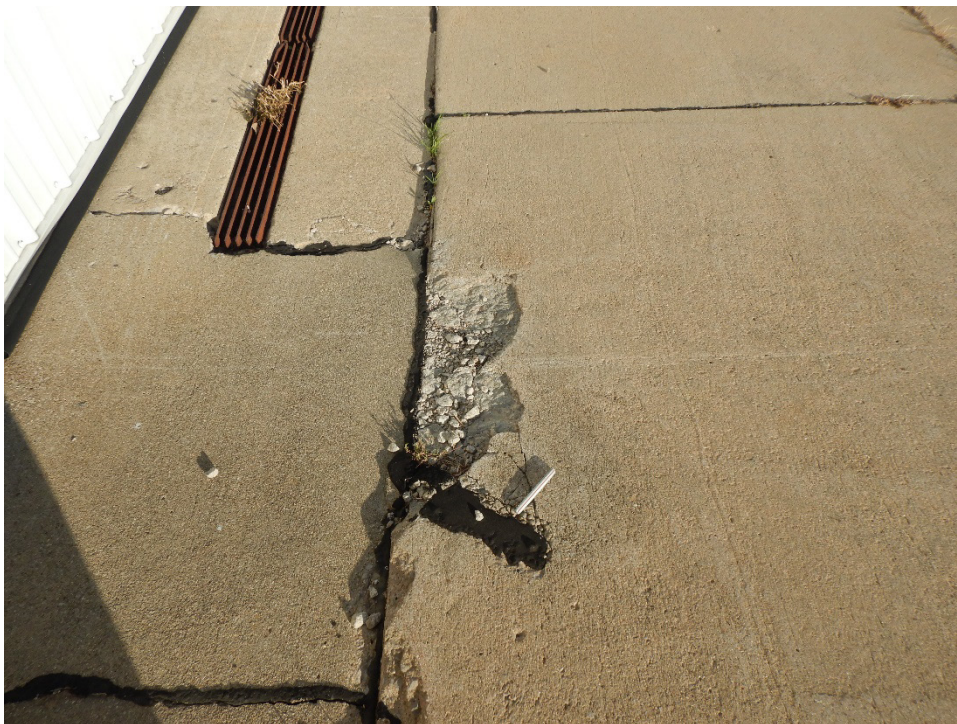
A01CE-02. Joint Spalling (Sample Unit No. 02).

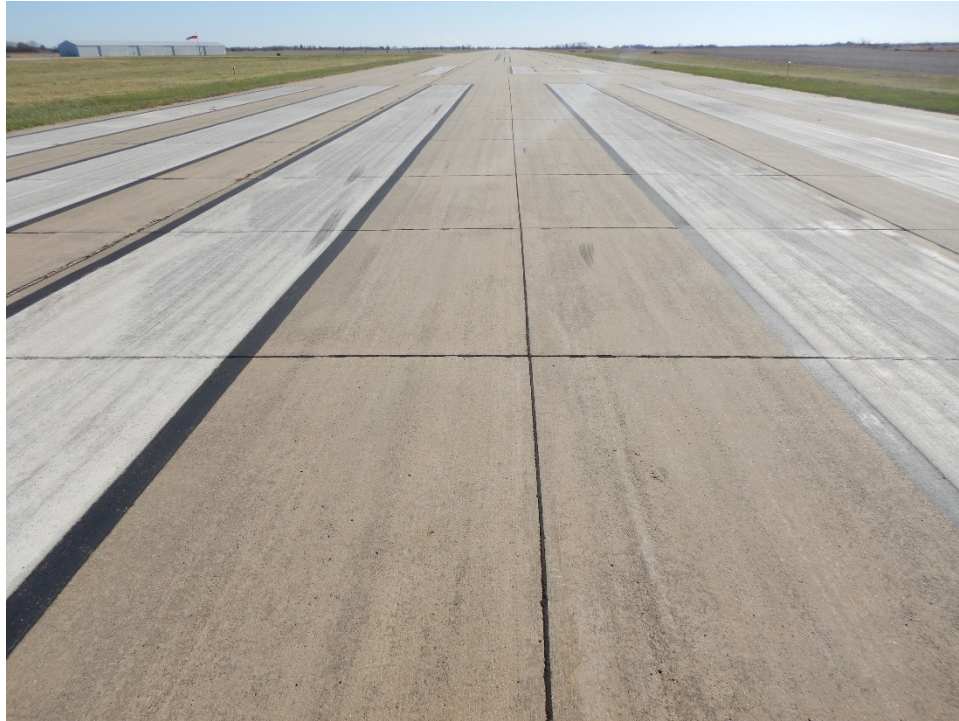
R16CE-01. Overview.

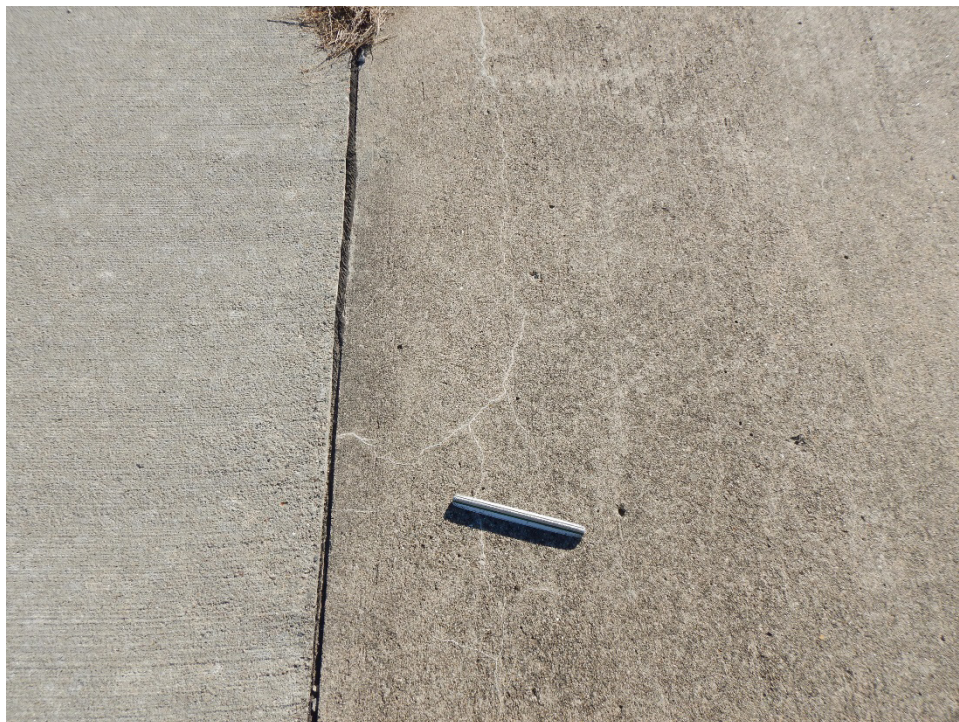
R16CE-01. ASR (Sample Unit No. 03).

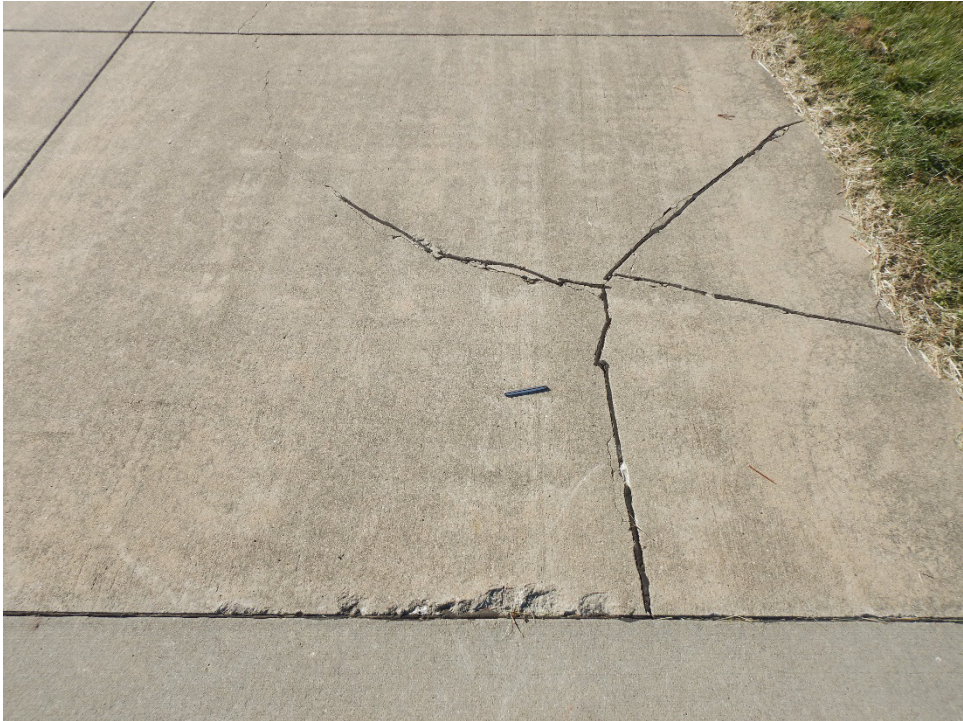
R16CE-01. Shattered Slab (Sample Unit No. 01).

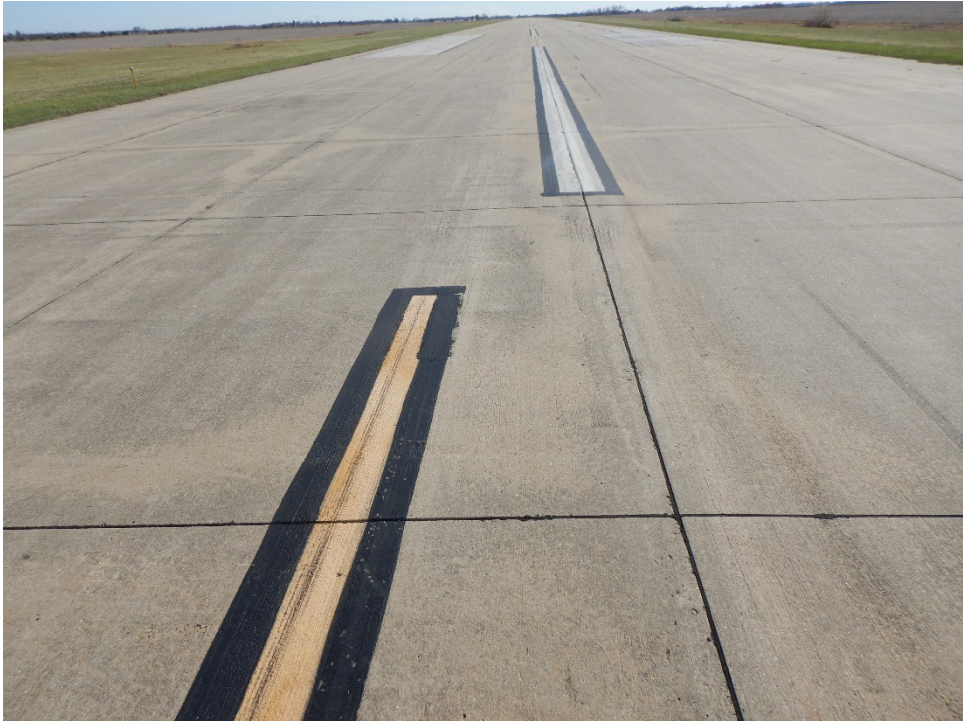
R16CE-02. Overview.

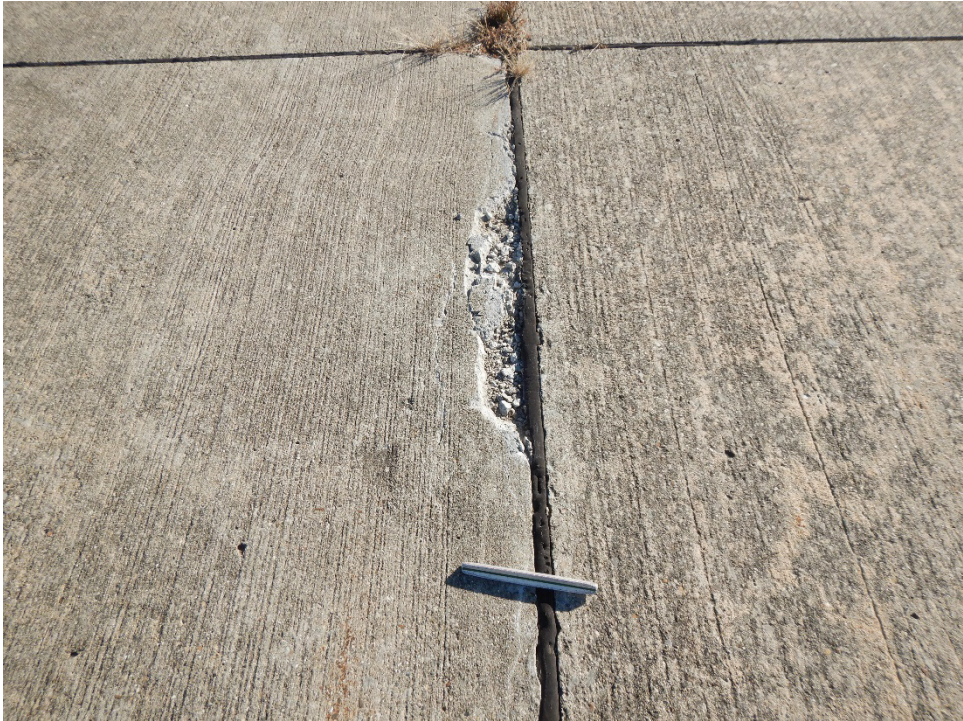
R16CE-02. ASR (Sample Unit No. 32).

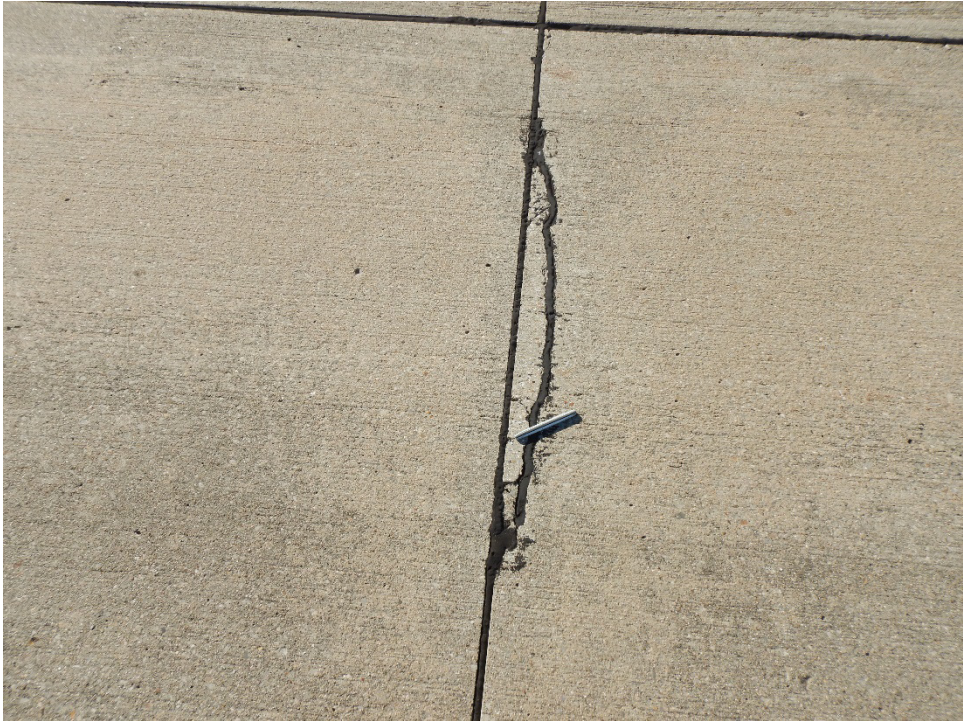
R16CE-02. Joint Spalling (Sample Unit No. 09).

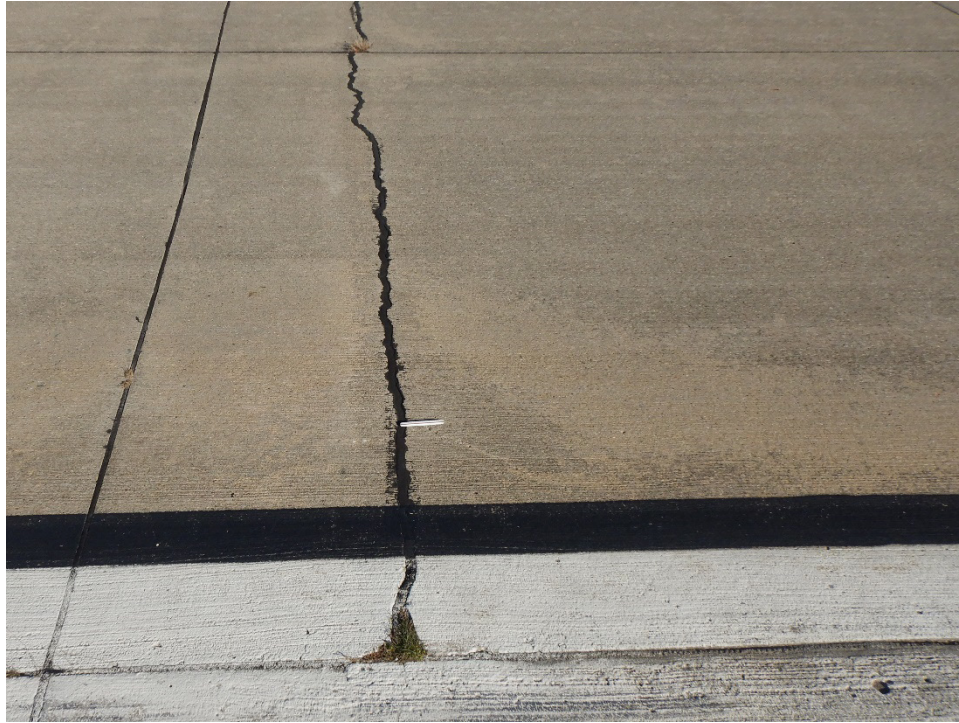
R16CE-02. LTD Cracking (Sample Unit No. 13).

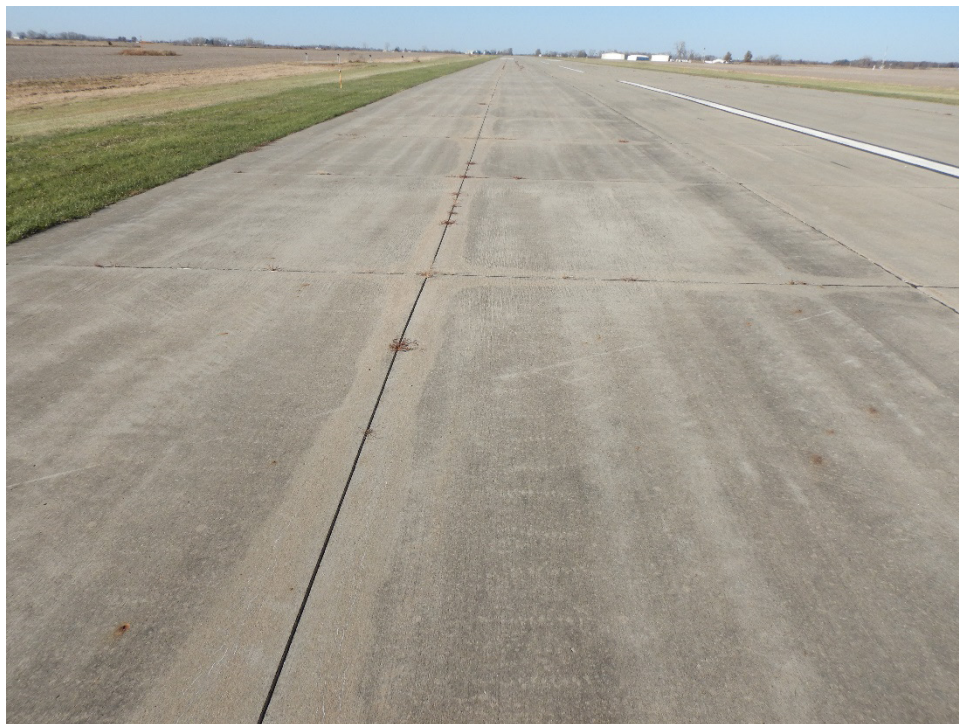
R16CE-03. Overview.

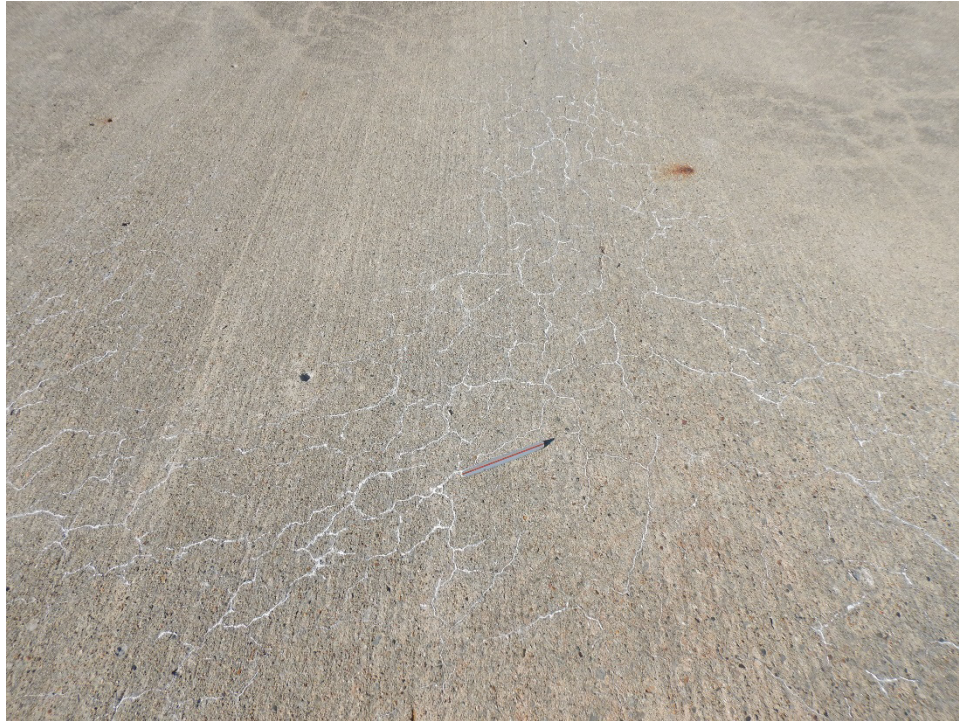
R16CE-03. ASR (Sample Unit No. 21).

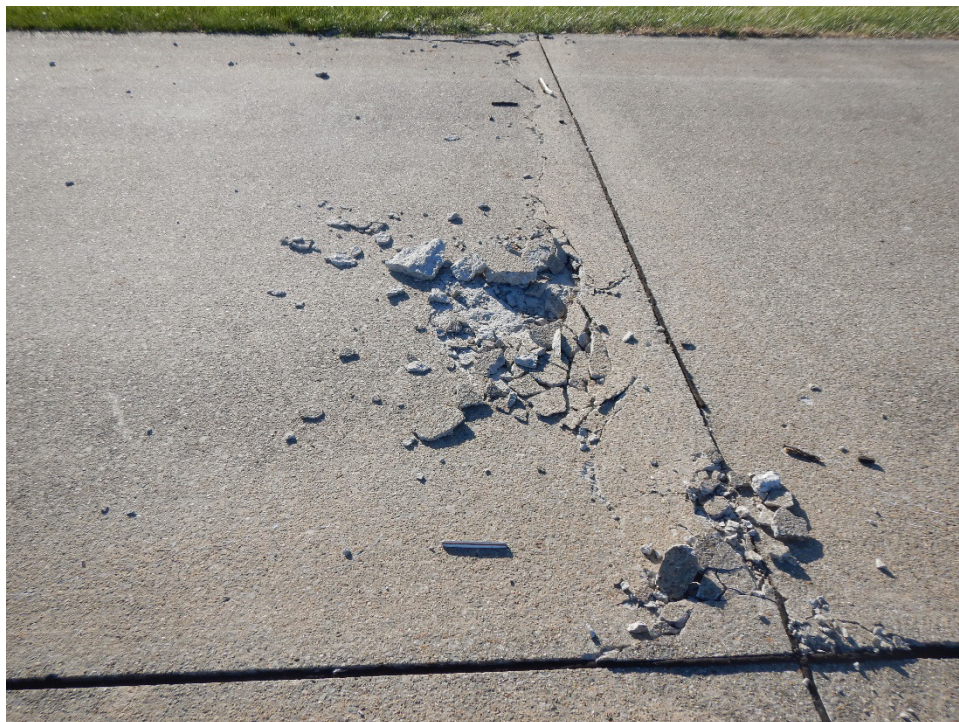
R16CE-03. Blow-Up (Additional Sample Unit No. 07).

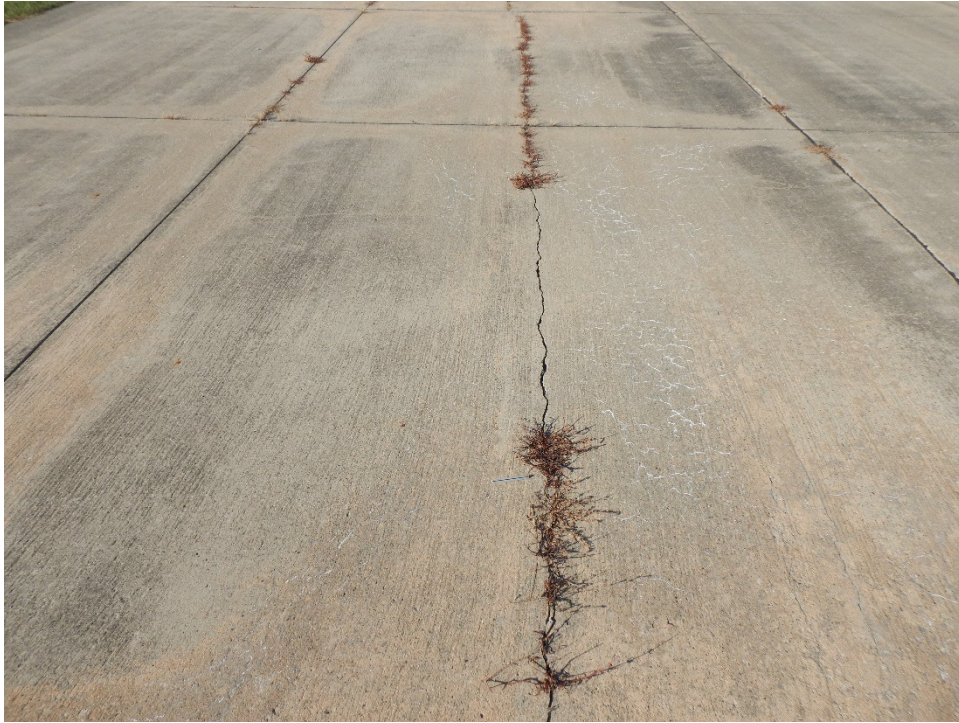
R16CE-03. LTD Cracking (Sample Unit No. 18).

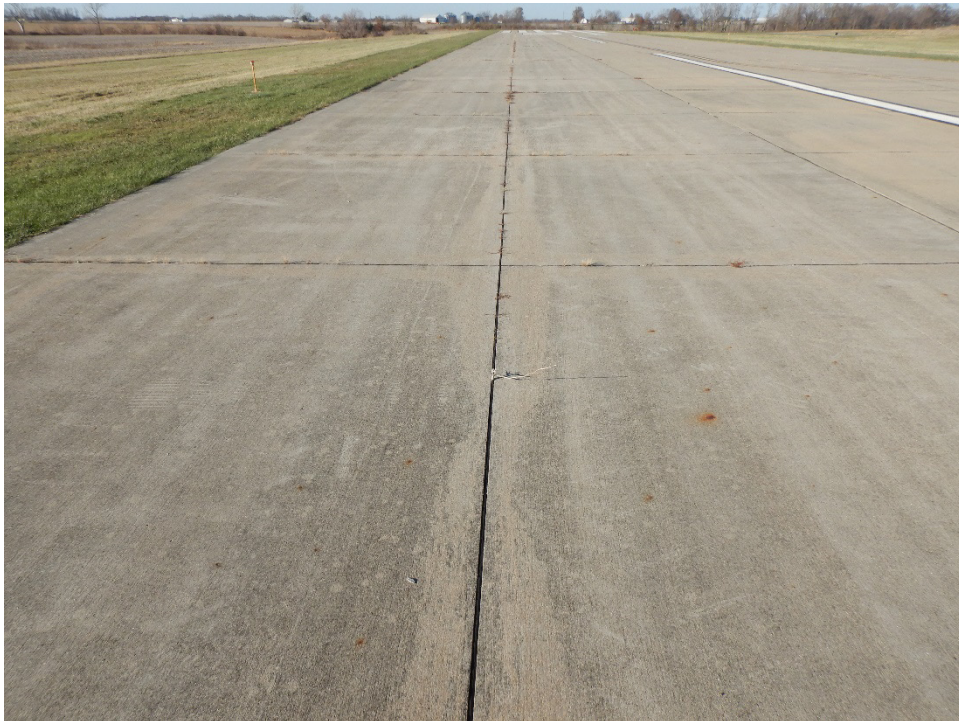
R16CE-04. Overview.

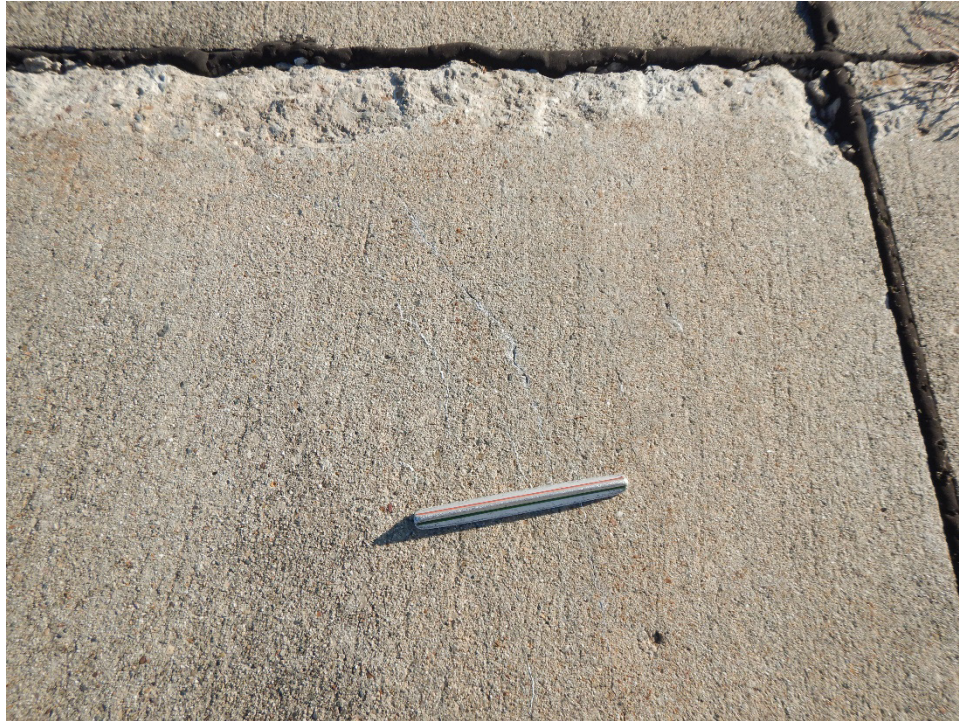
R16CE-04. ASR (Sample Unit No. 02).

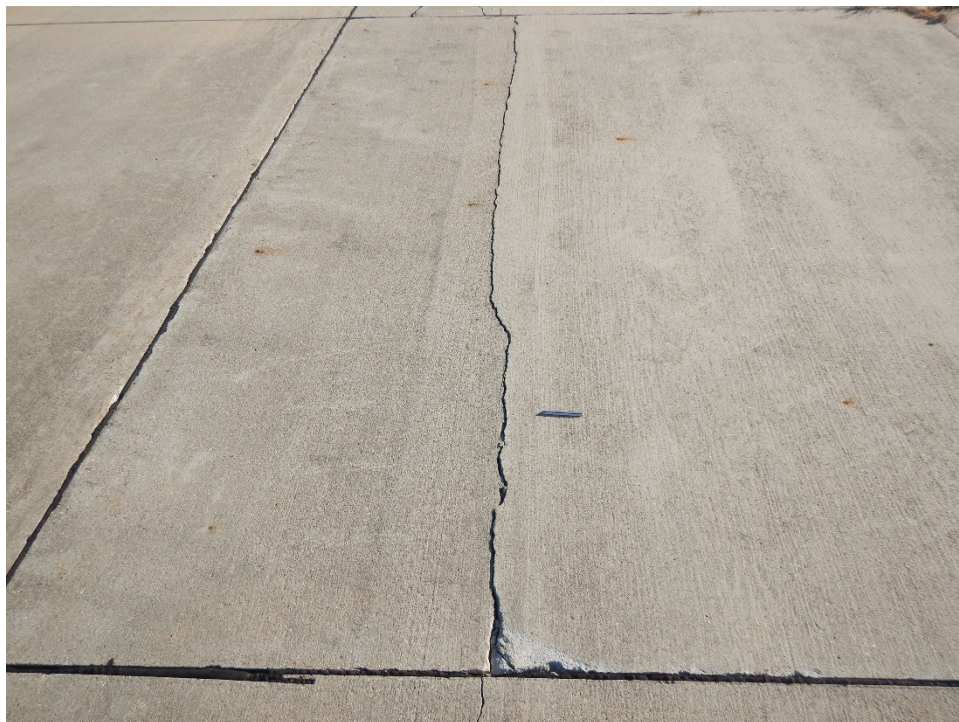
R16CE-04. LTD Cracking (Sample Unit No. 05).

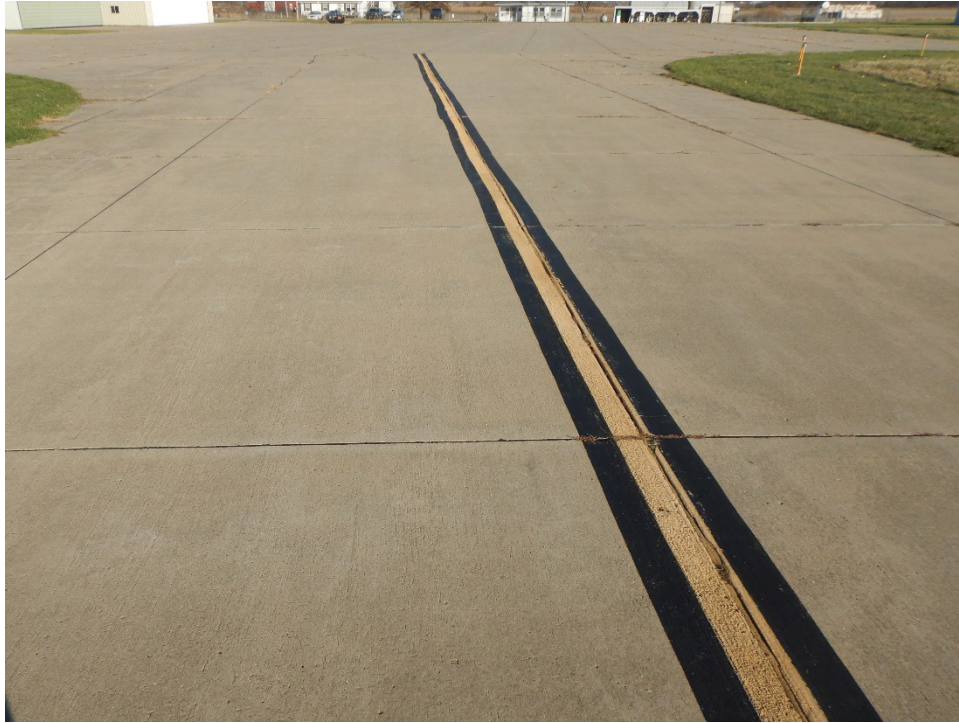
T01CE-01. Overview.

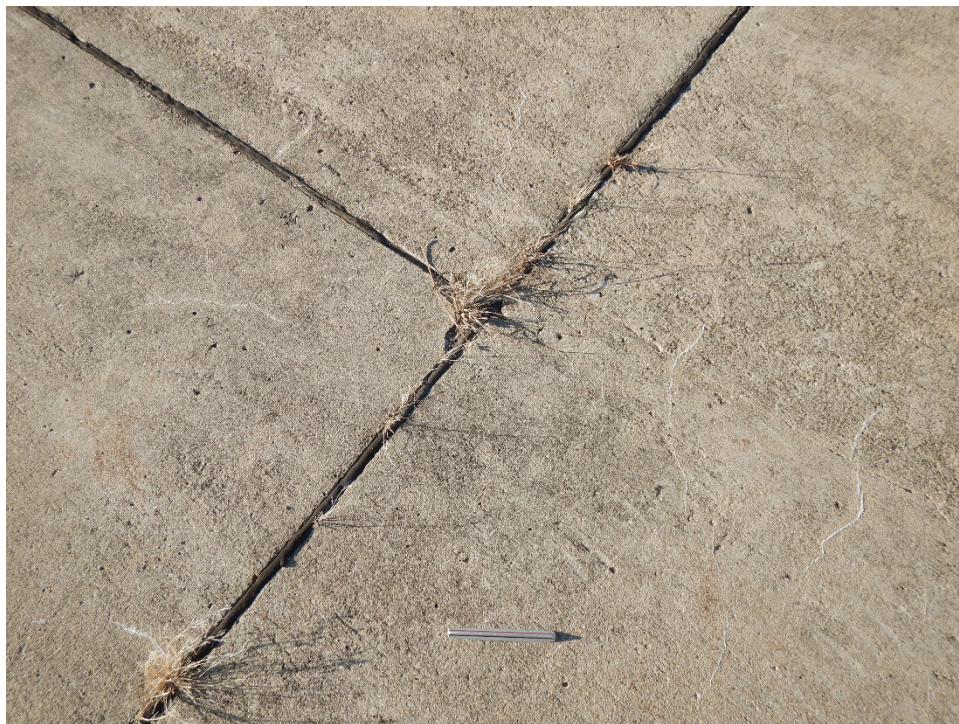
T01CE-01. ASR (Sample Unit No. 02).

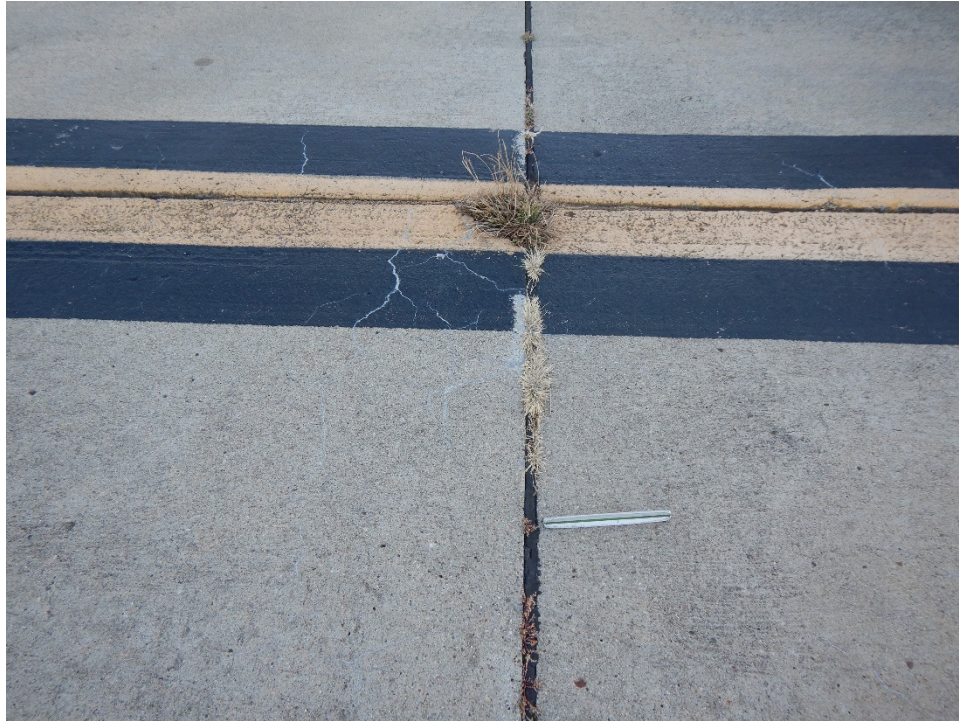
T01CE-01. Joint Seal Damage (Sample Unit No. 03).

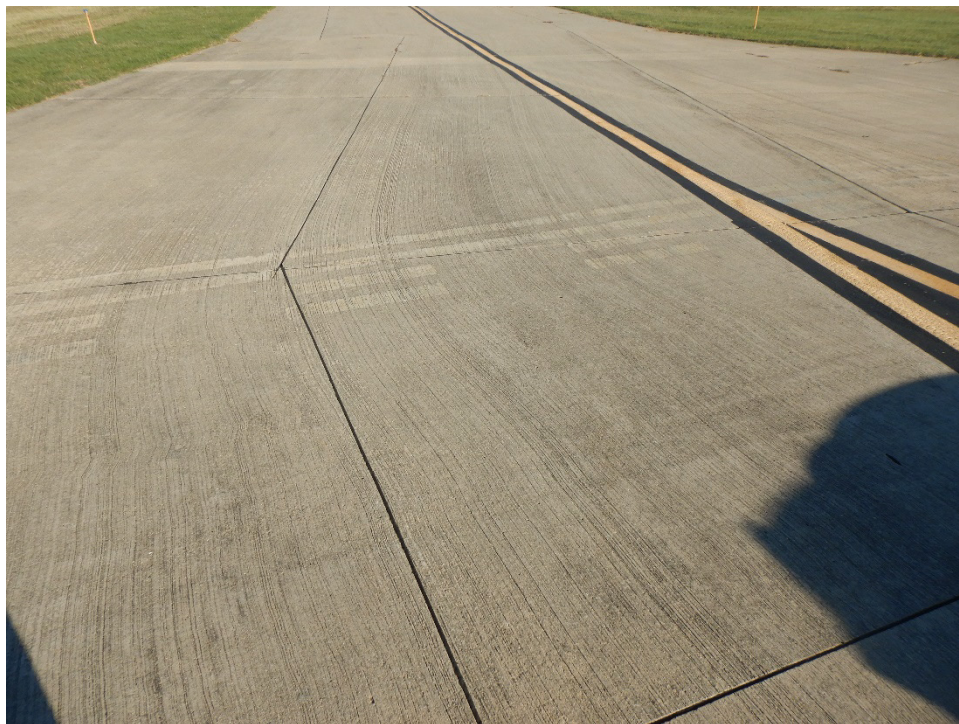
T01CE-02. Overview.

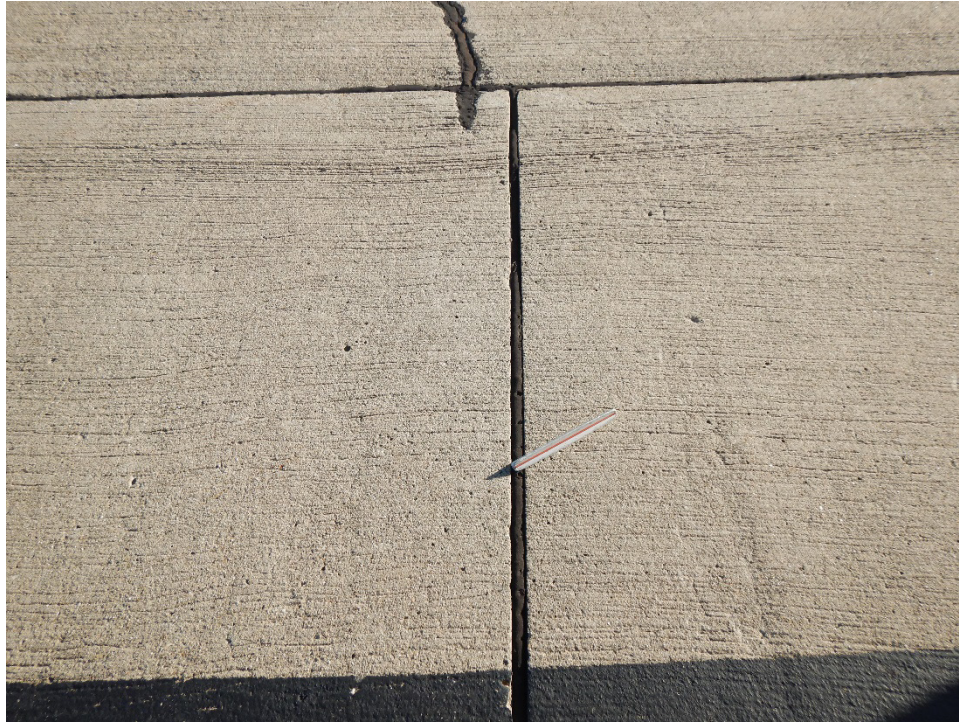
T01CE-02. Joint Seal Damage (Sample Unit No. 01).

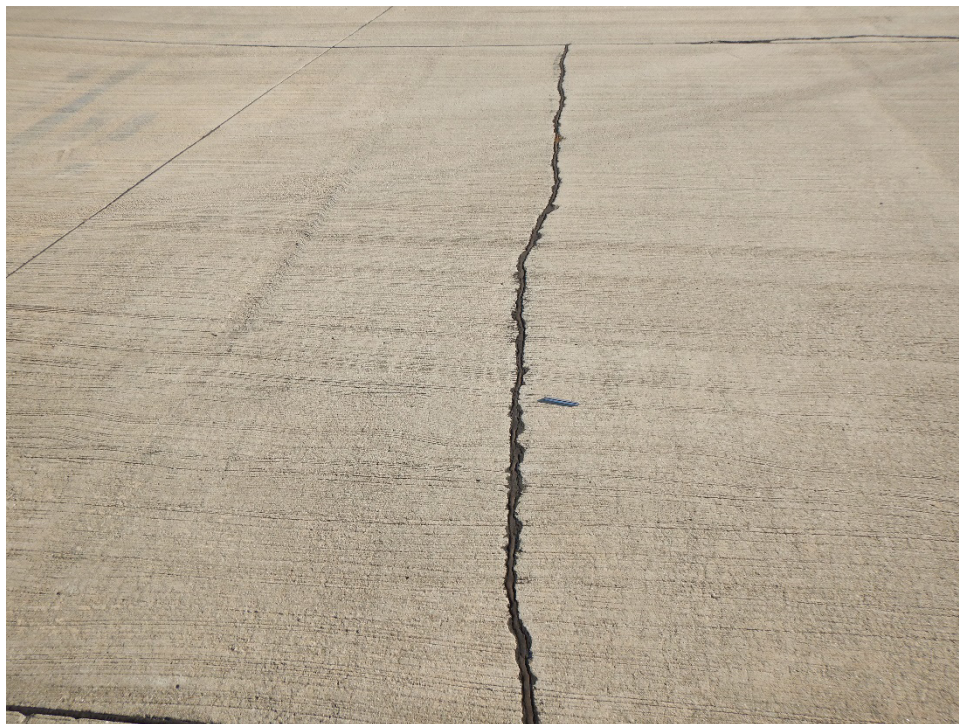
T01CE-02. LTD Cracking (Sample Unit No. 01).

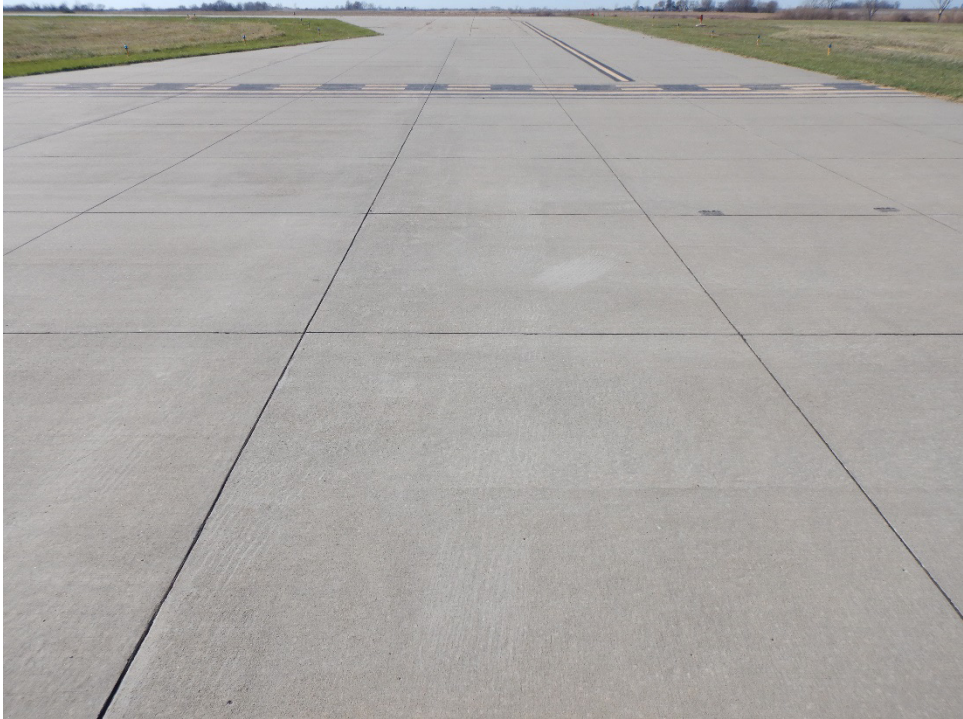
Taxiway 02 was defined by one section that contained medium-severity joint seal damage throughout. The section is connected to the Runway 34 approach.

T02CE-01. Overview.

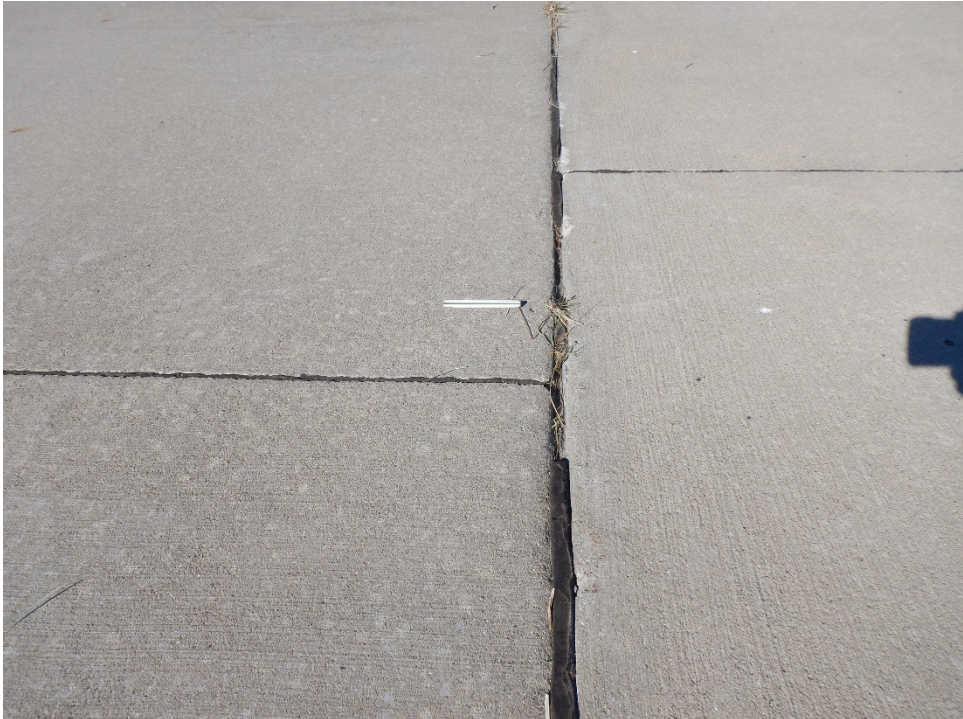
T02CE-01. Joint Seal Damage (Sample Unit No. 06).

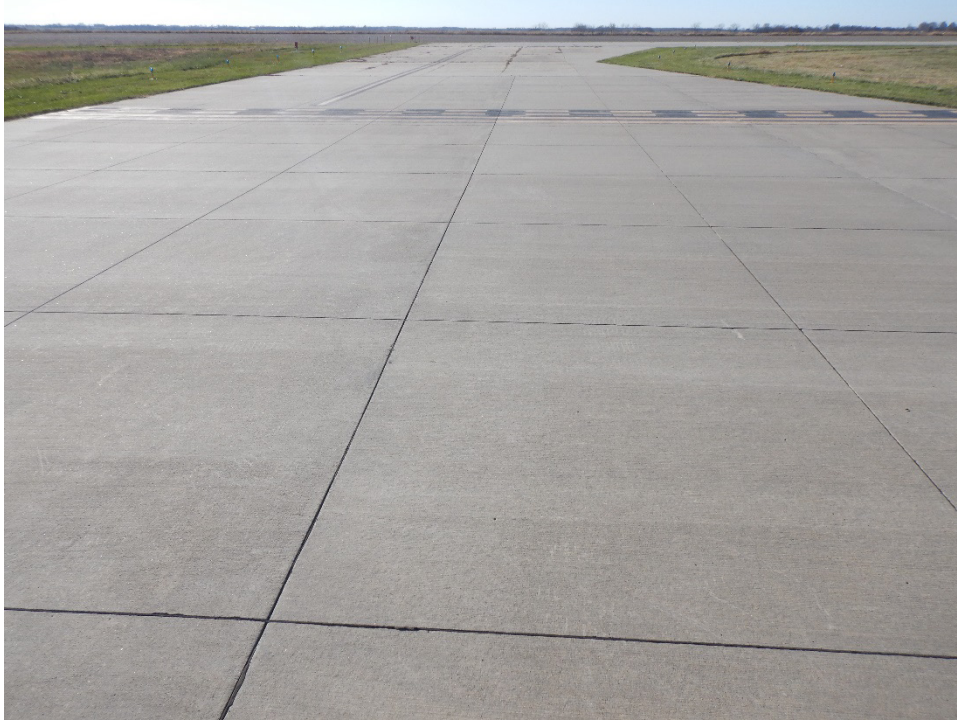
Taxiway 03 consisted of one section in excellent condition with only low-severity joint seal damage recorded throughout. The section is connected to the Runway 16 approach.

T03CE-01. Overview.

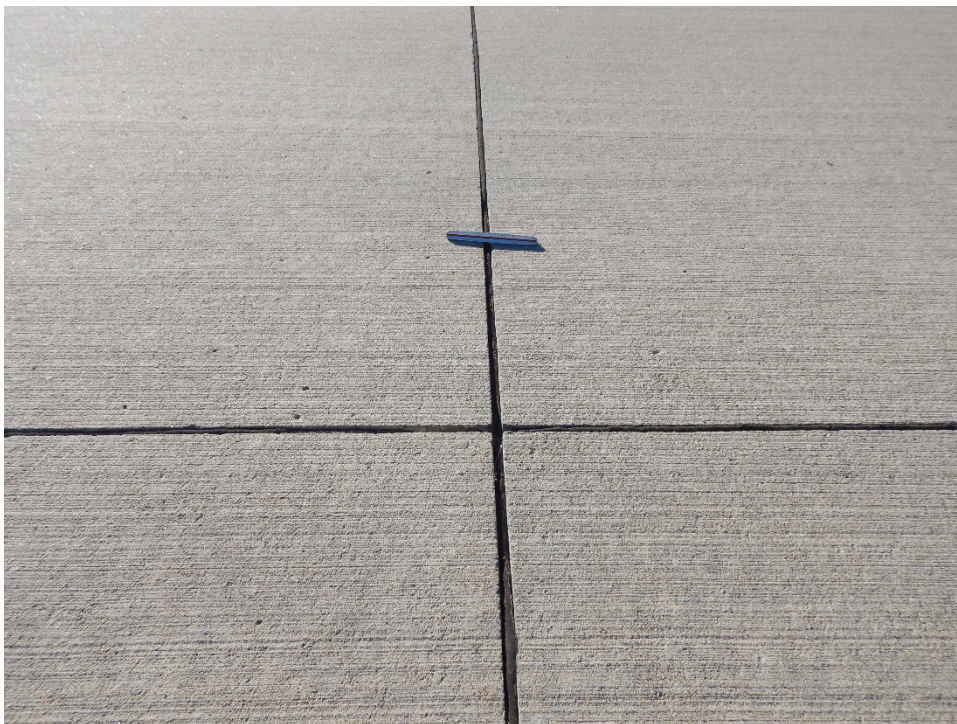
T03CE-01. Joint Seal Damage (Sample Unit No. 06).

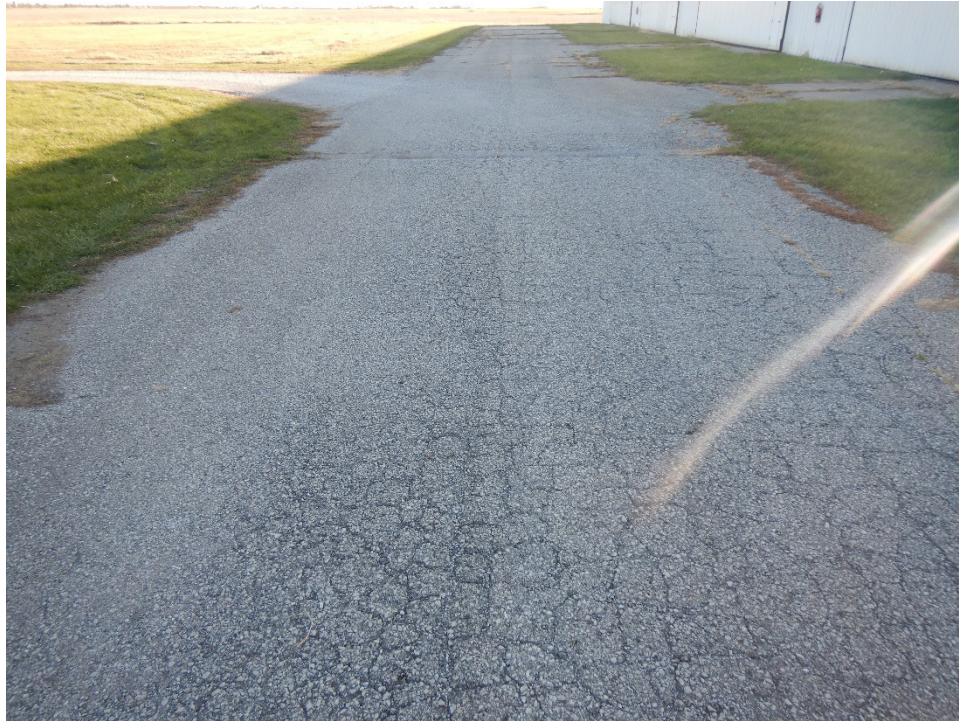
The T-hangar area was defined by one section. This section was in poor condition with low-severity rutting; low- and medium-severity longitudinal and transverse (L&T) cracking; medium-severity block cracking; low- and high-severity raveling; and medium- and high-severity alligator cracking and weathering identified. The low-severity L&T cracking was unsealed and the medium-severity L&T cracking was identified where unsealed crack widths exceeded 1/4 inch.

TH01CE-01. Overview.

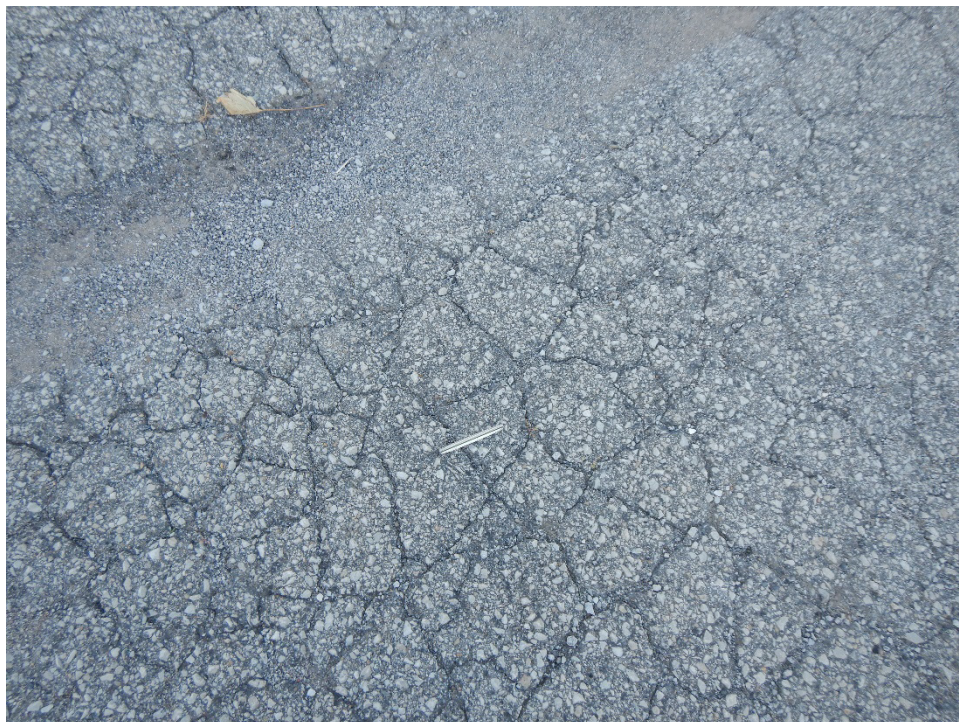
TH01CE-01. Alligator Cracking (Sample Unit No. 01).
