Centerville Municipal Airport

Pavement Management Report

JULY 2024

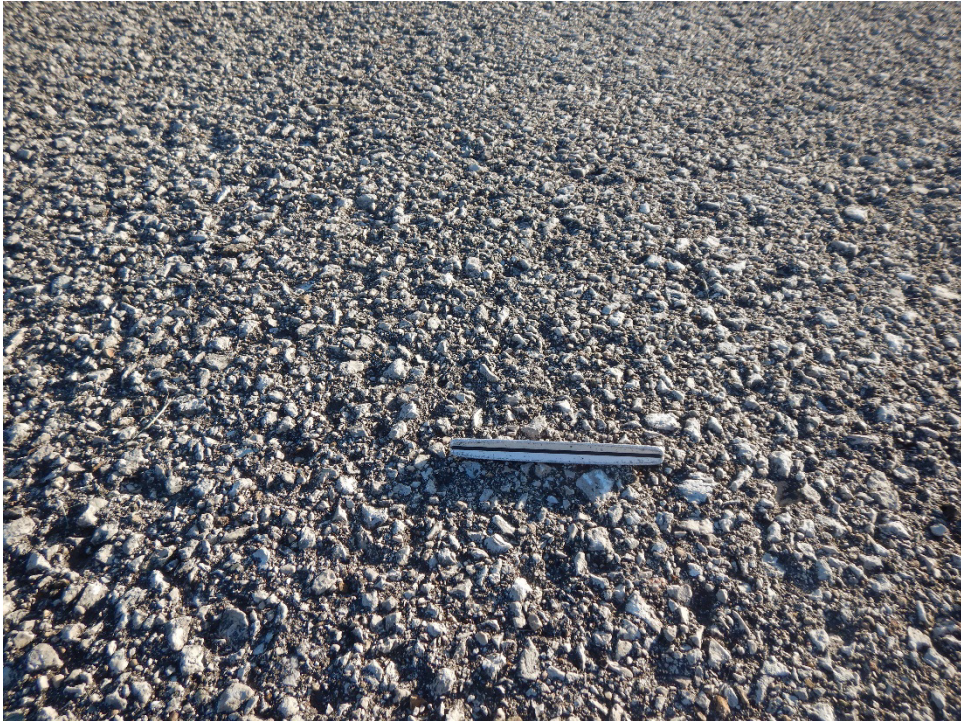
TH01CE-01. Weathering (Sample Unit No. 02).
