# Chariton Municipal Airport

## PAVEMENT MANAGEMENT REPORT

**JULY 2022**

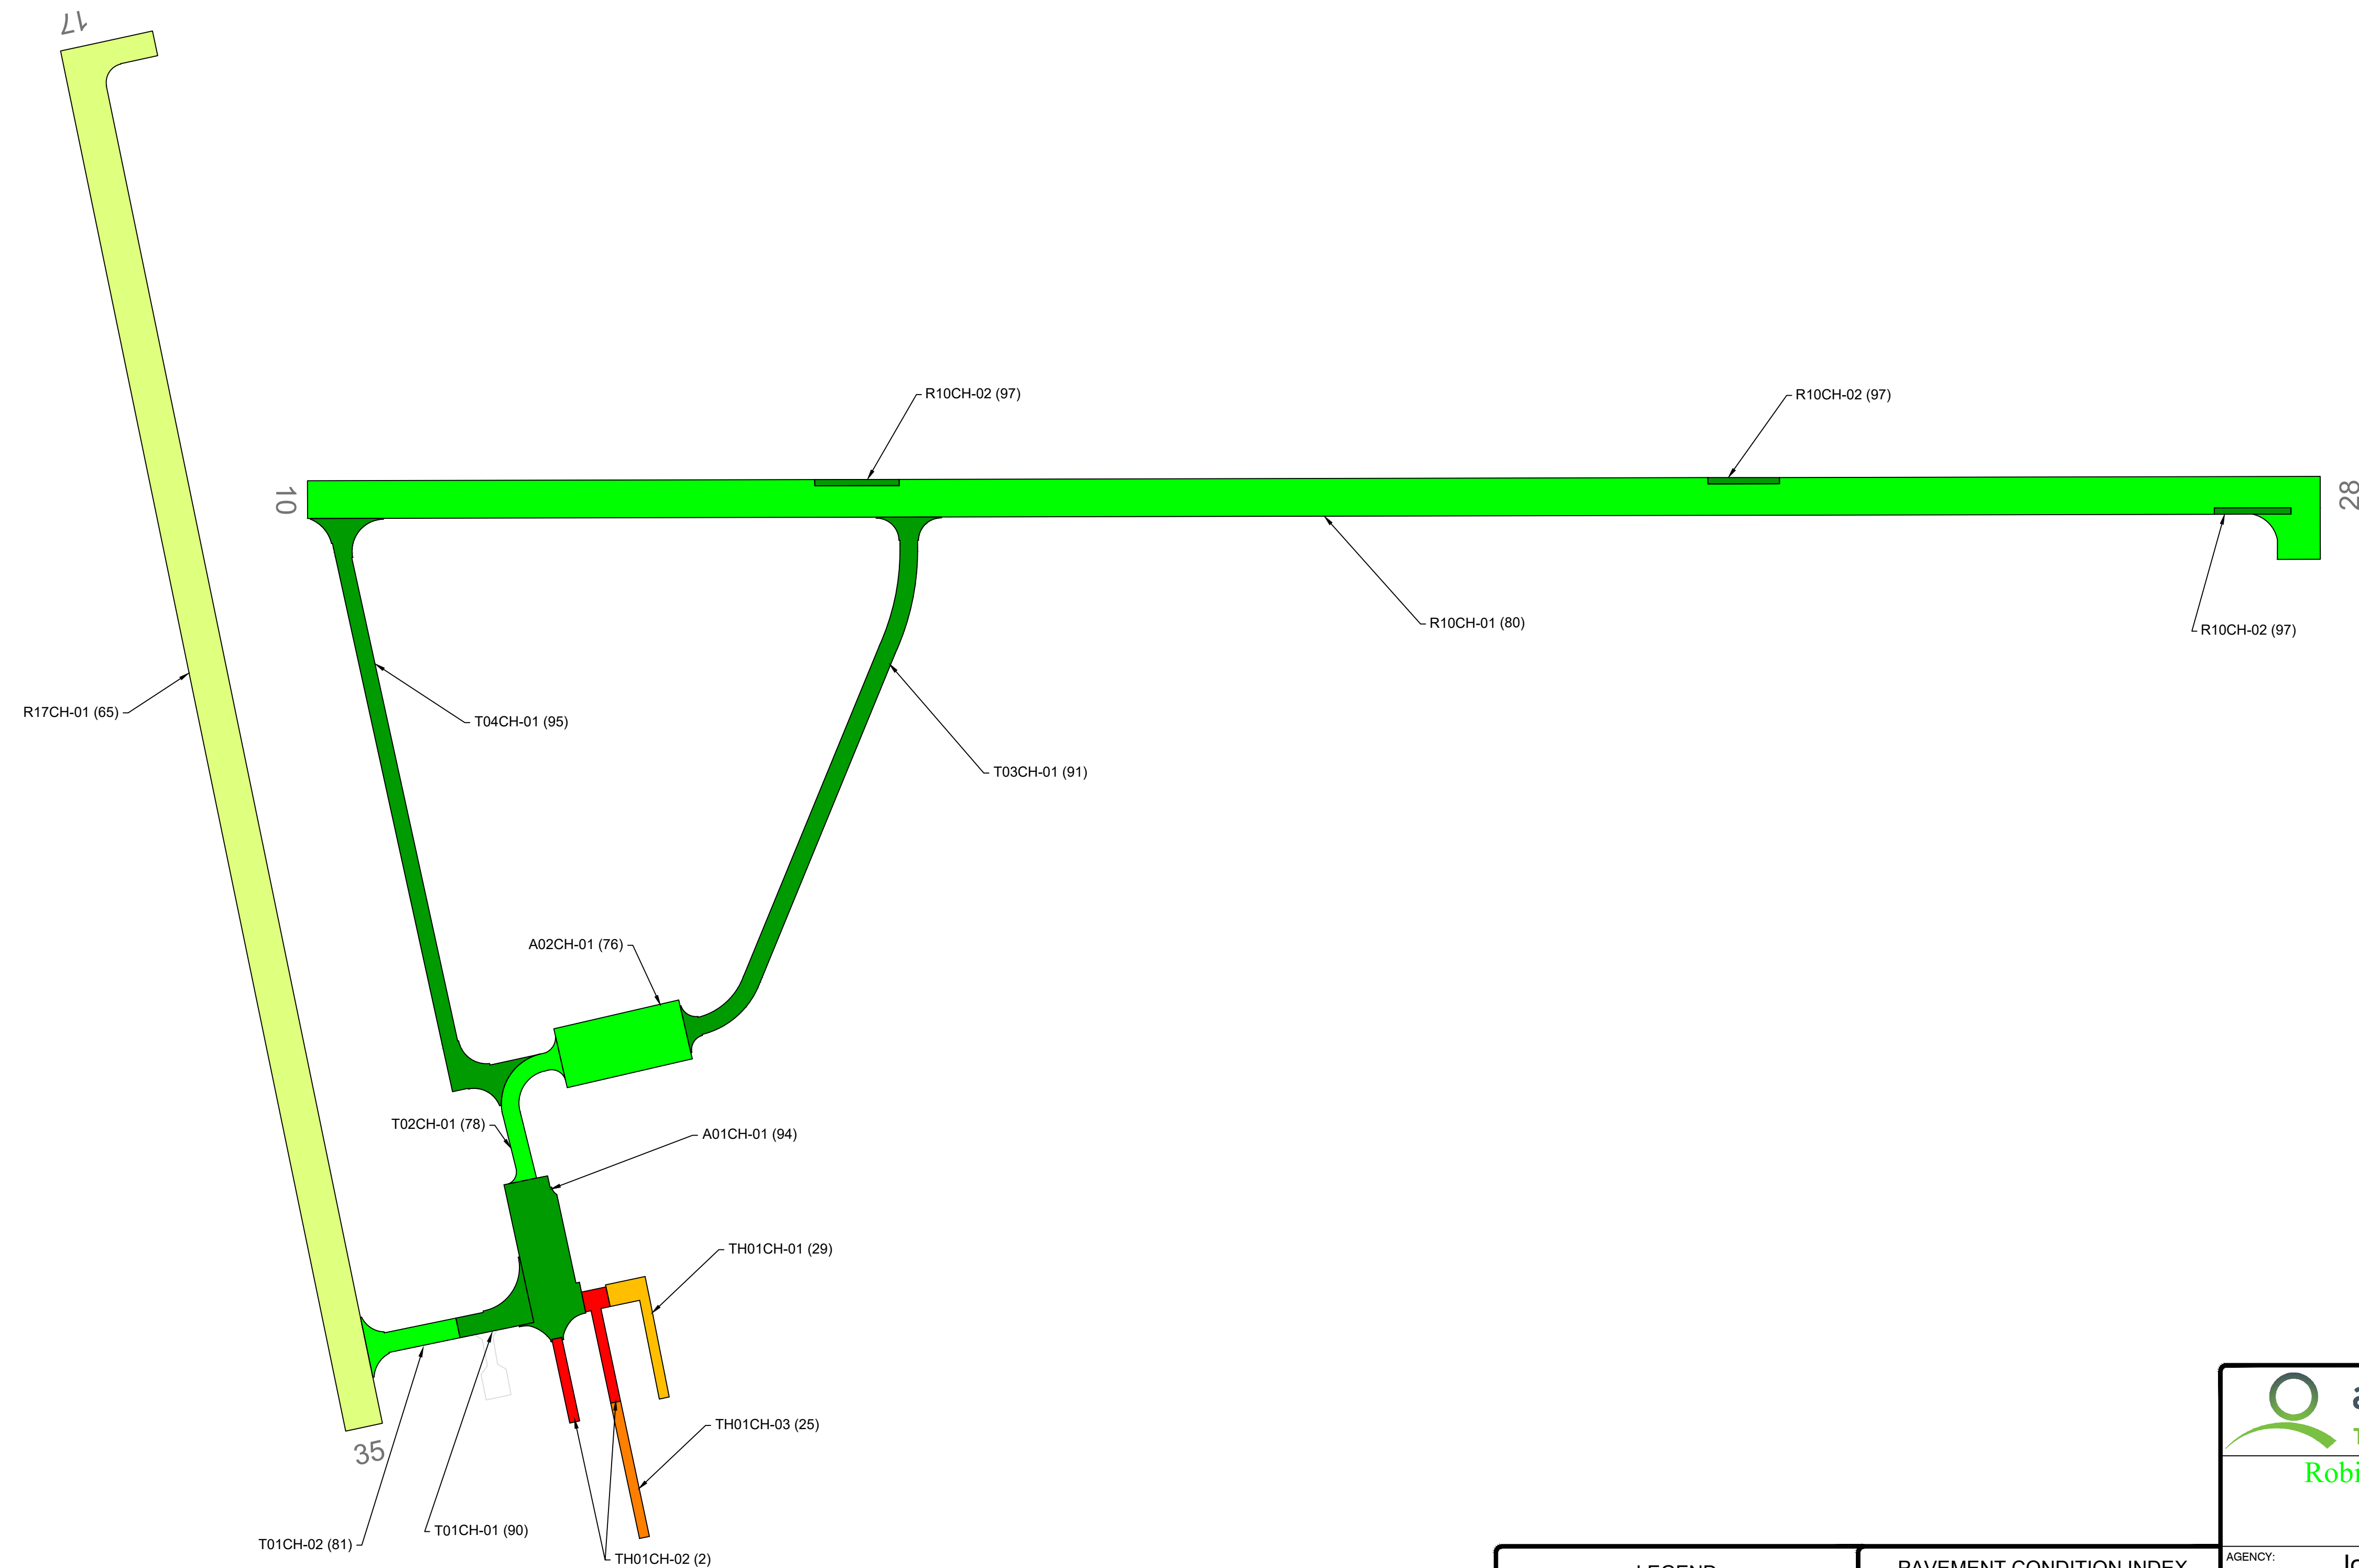
FIGURE 8. PCI MAP.

The pavements at Chariton Municipal Airport were inspected in November 2021. The 2021 area-weighted condition of Chariton Municipal Airport is 76, with conditions ranging from 2 to 97 (on a scale of 0 [failed] to 100 [excellent]). During the previous pavement inspection in 2018, the area-weighted PCI of the airport was 80.

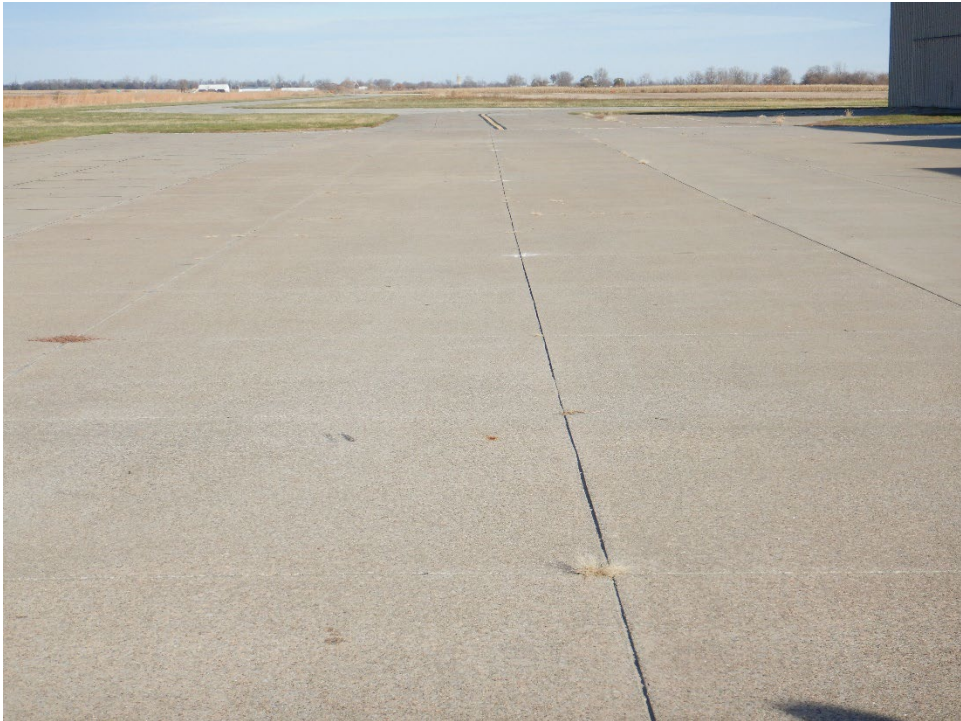
Apron 01 consisted of one section. Section 01 contained low- and medium-severity corner spalling and joint seal damage, as well as low-severity ASR, joint spalling, LTD cracking, and scaling. An atypical area with low-severity corner break was inspected as an additional sample unit according to ASTM D5340-20.

A01CH-01. Overview.

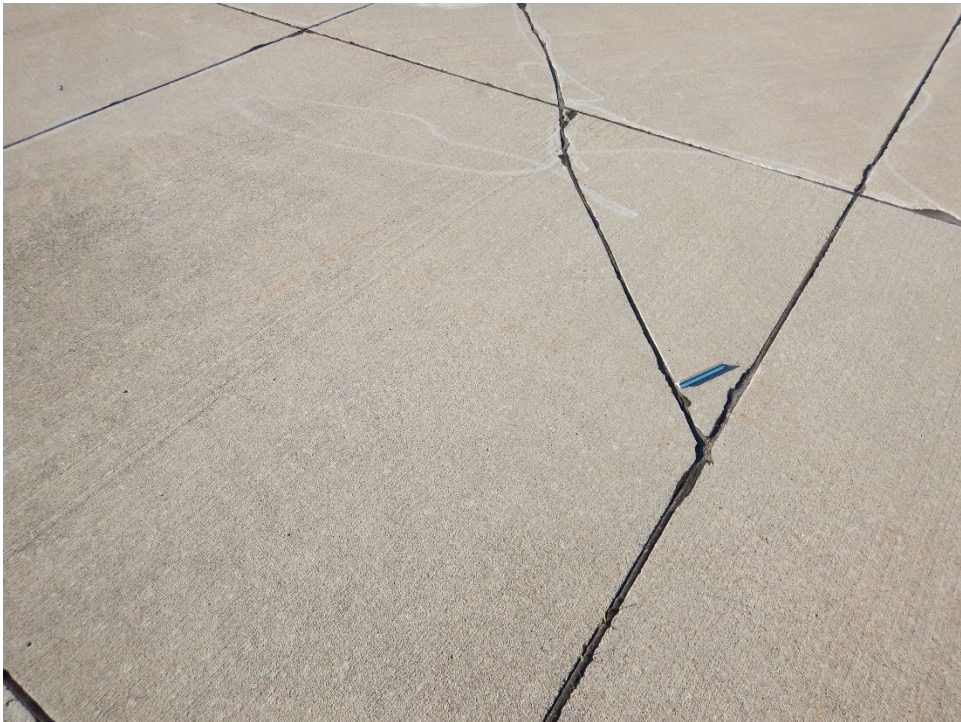
A01CH-01. Corner Break (Additional Sample Unit No. 11).

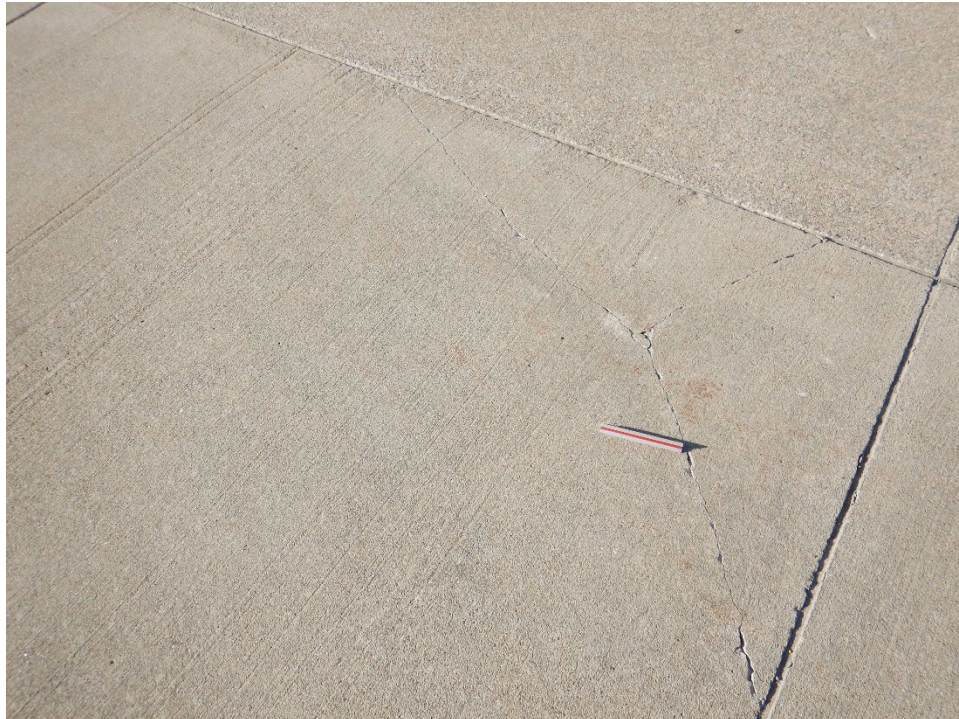
A01CH-01. LTD Cracking (Sample Unit No. 02).

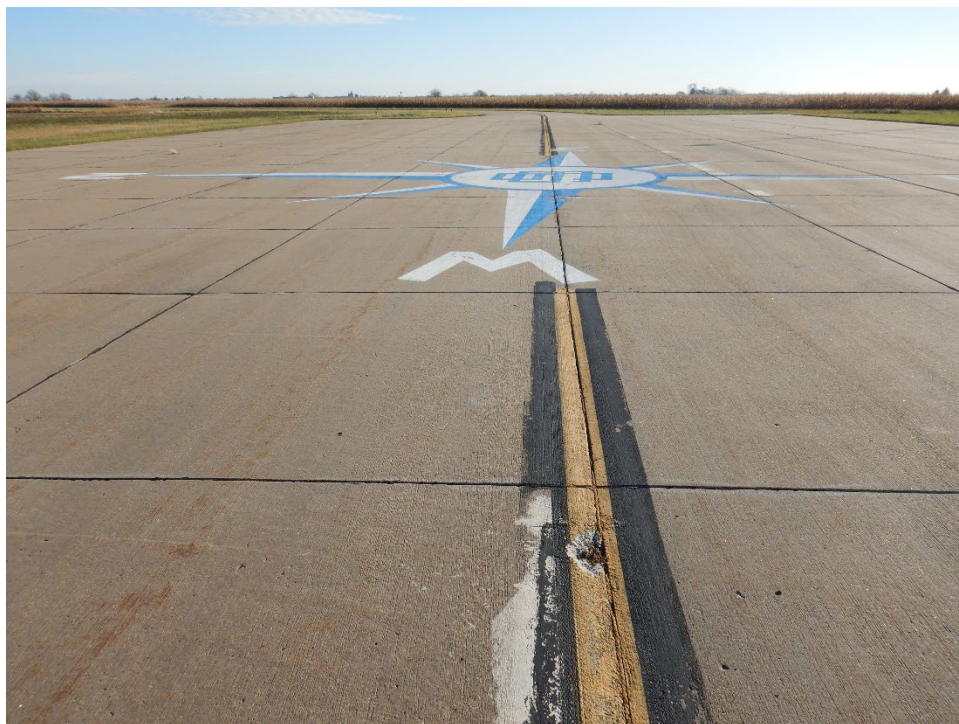
Apron 02 was defined by one section. Section 01 contained low- and medium-severity ASR and joint seal damage, medium-severity corner spalling and faulting, medium- and high-severity joint spalling, and low- and high-severity small patching.

A02CH-01. Overview.

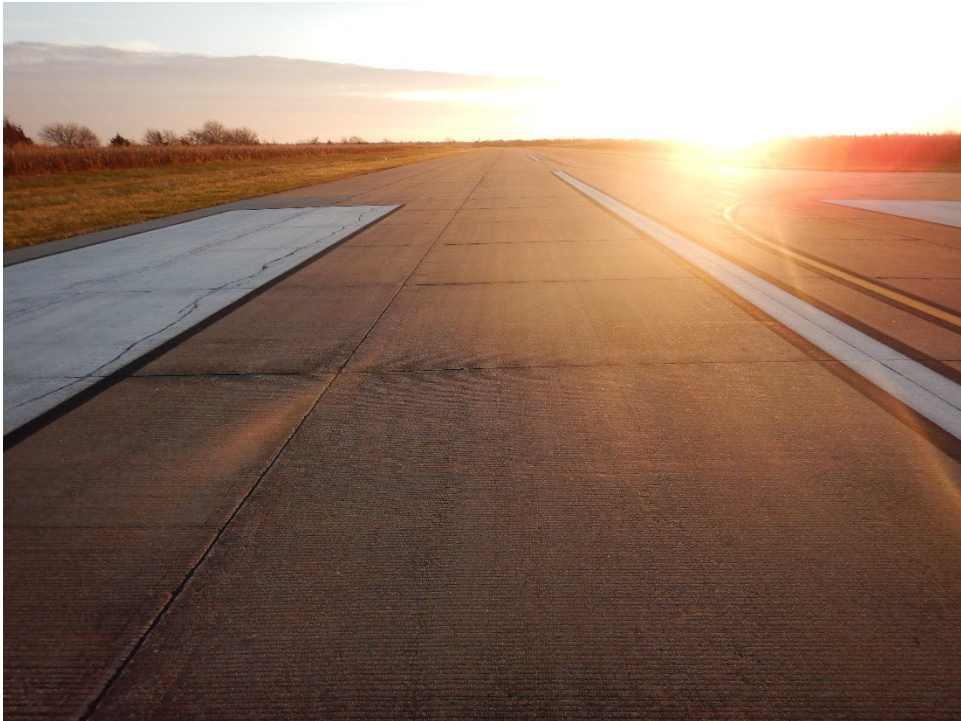
Runway 10/28 was defined by two sections. Section 01, which comprised most of the runway, had areas of low-severity ASR, corner break, and small patching; high-severity corner spalling and large patching; and low- and medium-severity joint seal damage and longitudinal, transverse, and diagonal (LTD) cracking recorded during the inspection. Section 02 was in excellent condition with only low-severity corner spalling and joint seal damage observed.

R10CH-01. Overview.

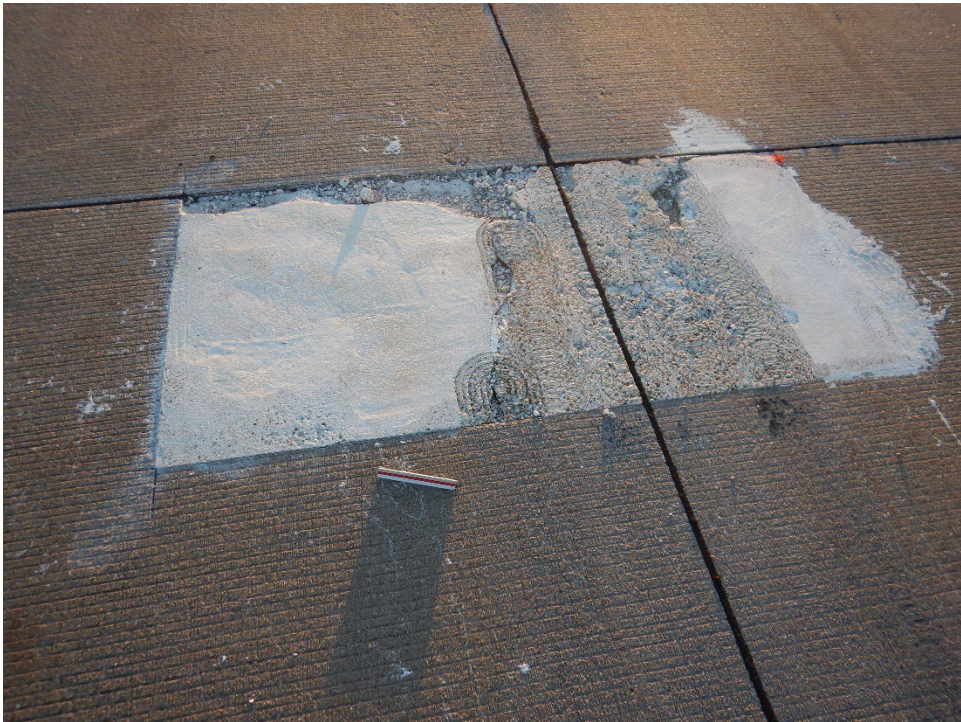
R10CH-01. Large Patching (Sample Unit No. 39).

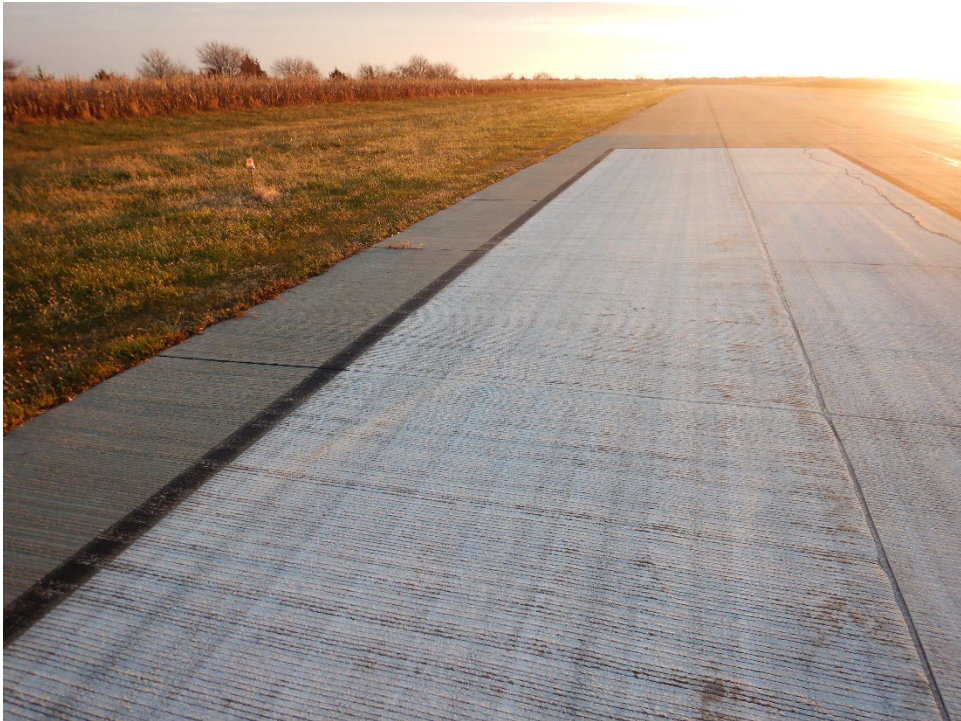
R10CH-02. Overview.

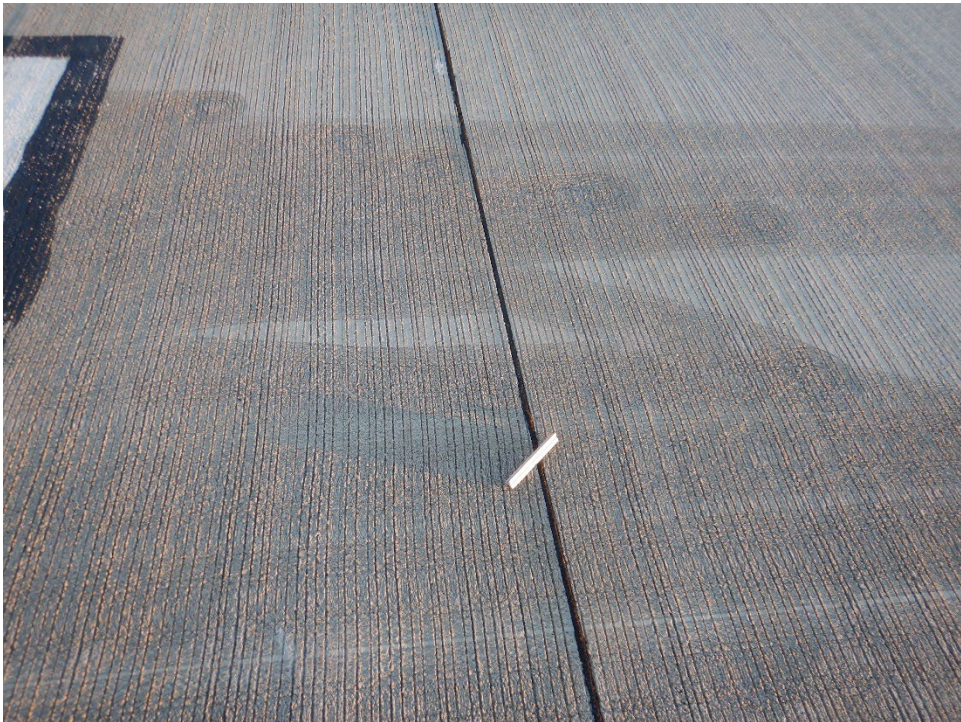
R10CH-02. Joint Seal Damage (Sample Unit No. 01).

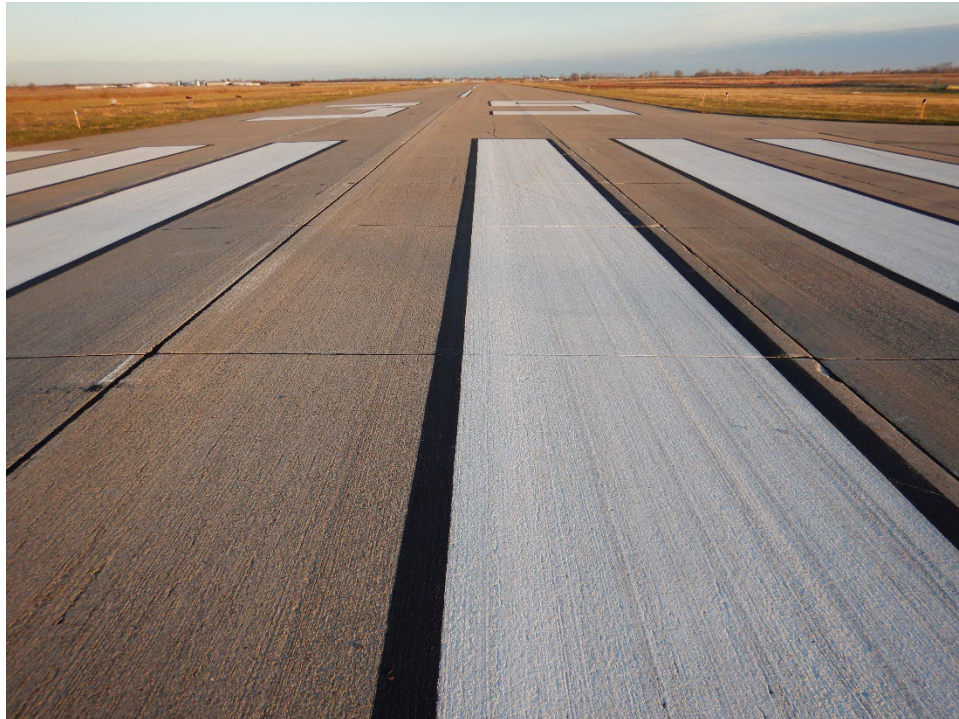
Runway 17/35 consisted of one section. Low-severity ASR, large patching, and joint seal damage; all severities of corner break and corner spalling; low- and medium-severity faulting, joint spalling, LTD cracking, and small patching; medium-severity shattered slab; and shrinkage cracking were recorded in Section 01.

R17CH-01. Overview.

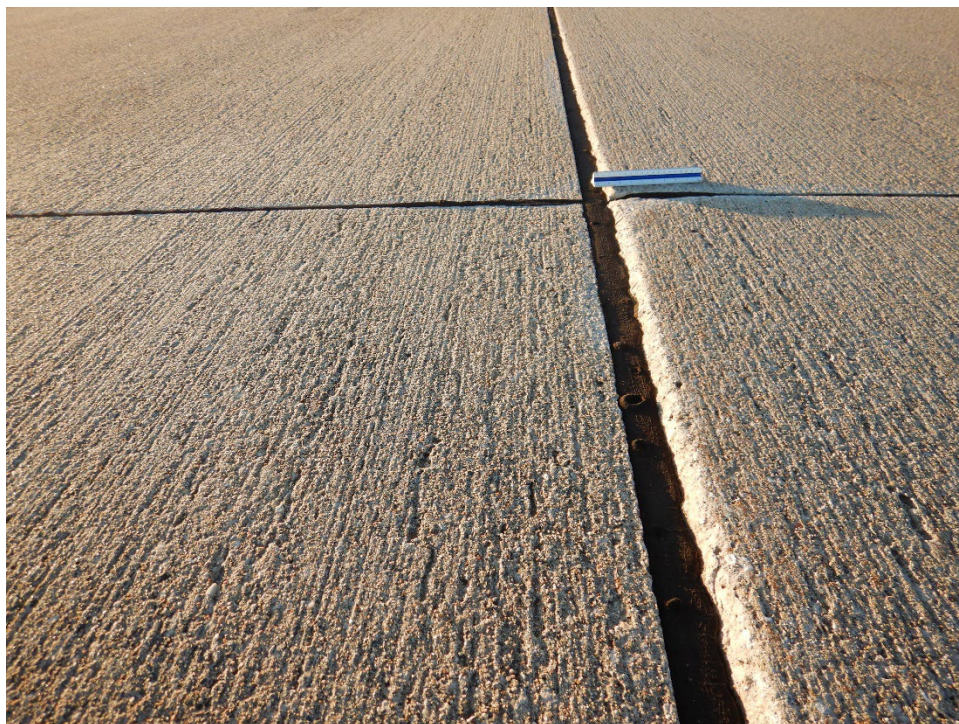
R17CH-01. Faulting (Sample Unit No. 45).

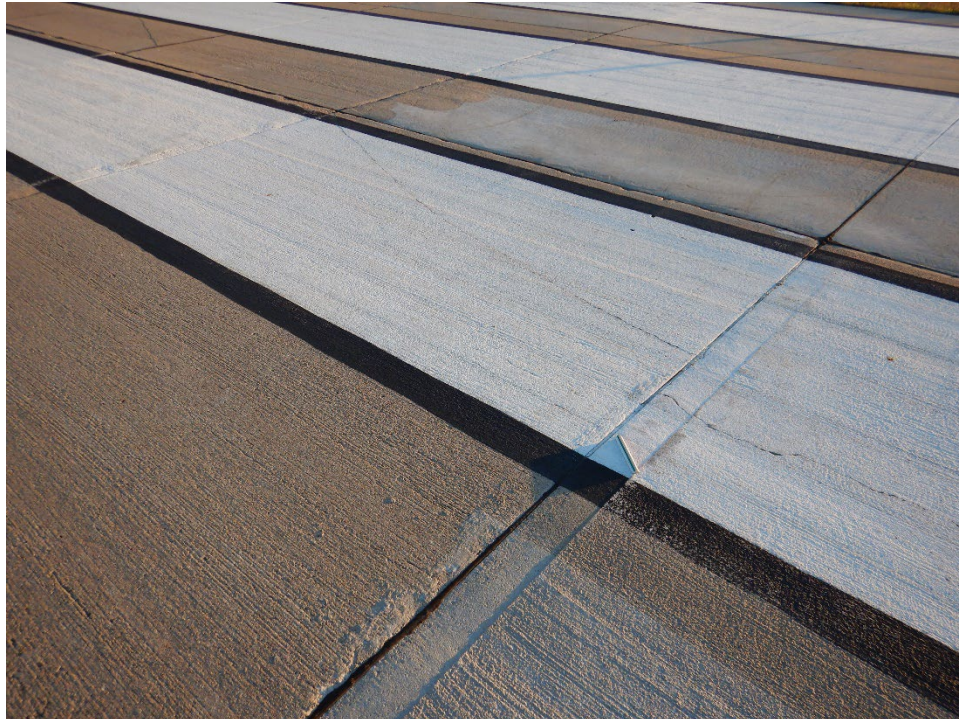
R17CH-01. LTD Cracking (Sample Unit No. 57).

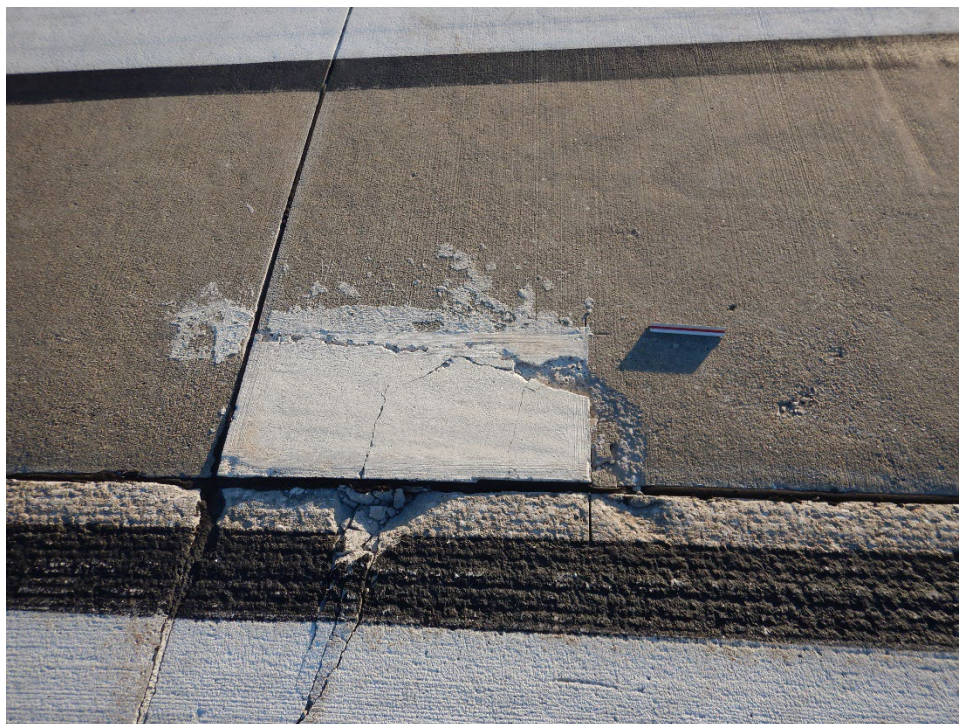
R17CH-01. Small Patching (Additional Sample Unit No. 04).

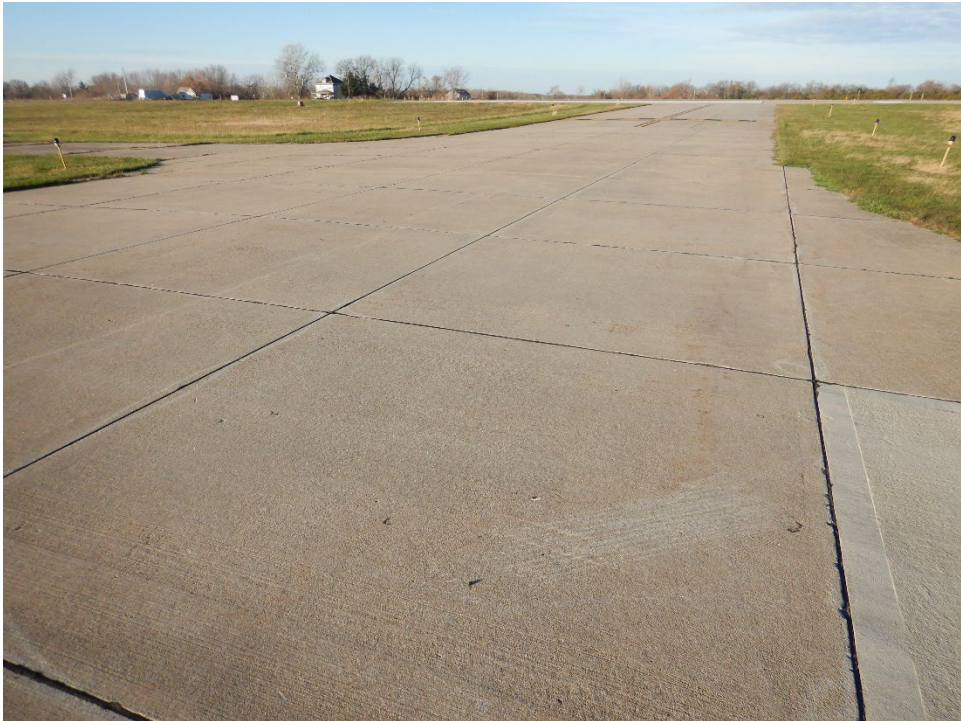
Taxiway 01 contained two sections that connected the Runway 35 approach with Apron 01. Medium-severity corner spalling and joint spalling and low-severity joint seal damage, LTD cracking, and large patching were noted in Section 01. Section 02 contained low-severity corner break, LTD cracking, joint seal damage, and scaling; low- and medium-severity faulting and joint spalling; shrinkage cracking; and medium-severity small patching.

T01CH-01. Overview.

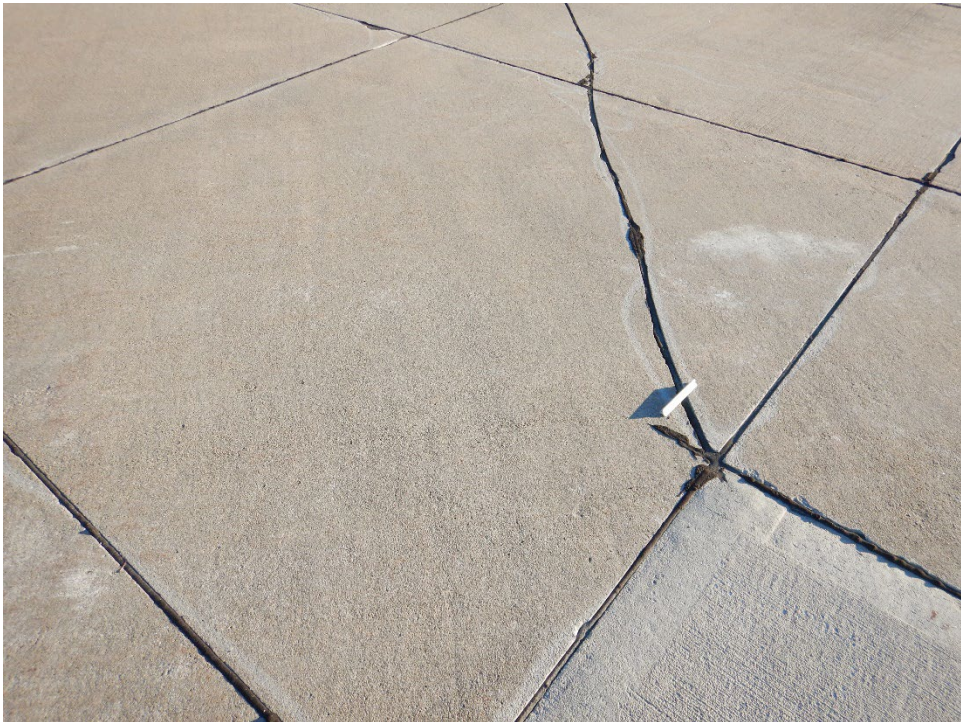
T01CH-01. LTD Cracking (Sample Unit No. 04).

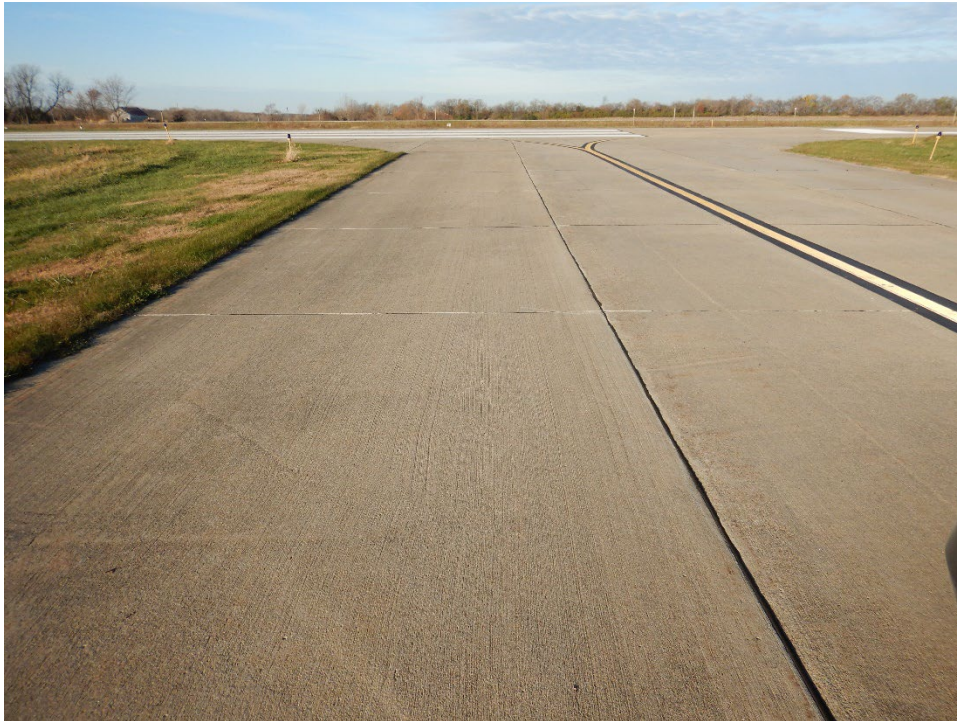
T01CH-02. Overview.

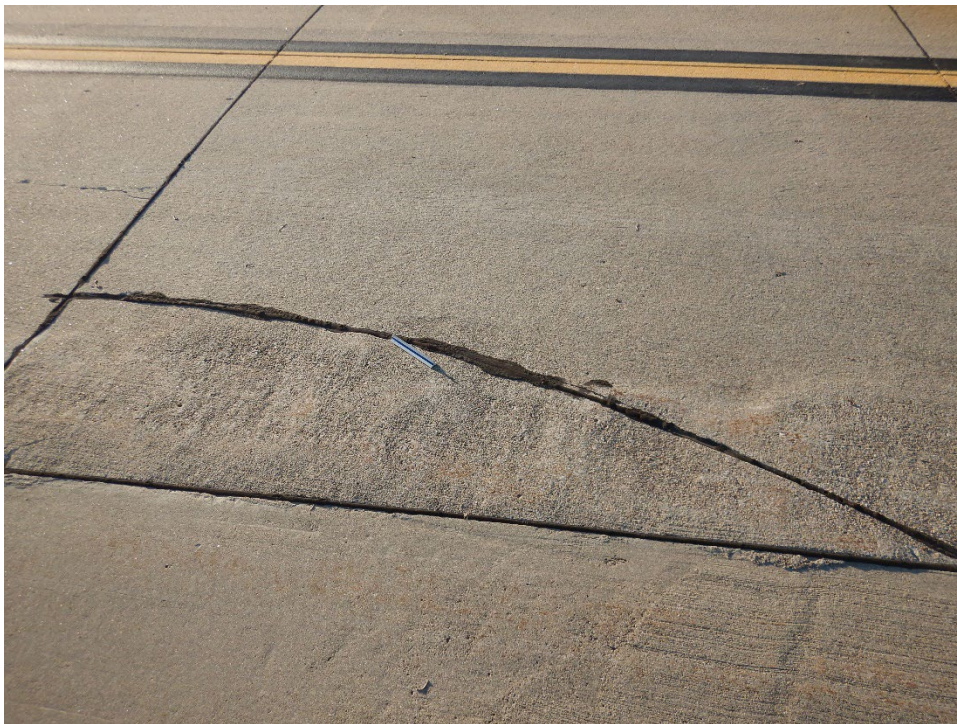
T01CH-02. LTD Cracking (Sample Unit No. 01).

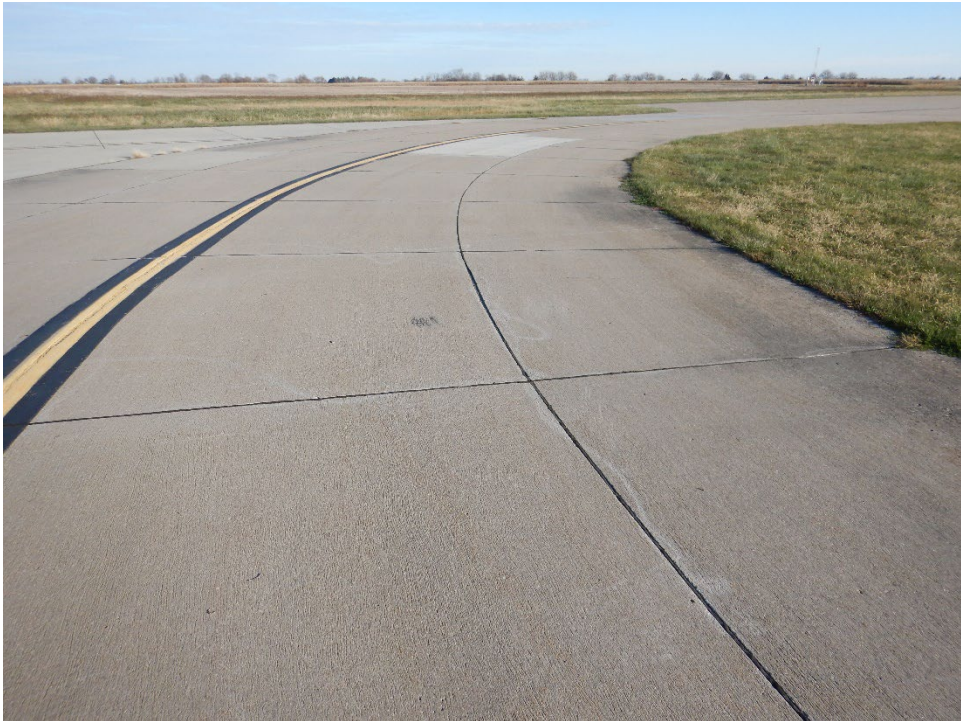
Taxiway 02, which connected the two apron areas, was defined by one section that contained low-severity ASR, large patching, and joint seal damage; medium-severity corner break; and low- and medium-severity corner spalling and LTD cracking. An atypical area with all severities of faulting was inspected as an additional sample unit, in accordance with ASTM D5340-20.

T02CH-01. Overview.

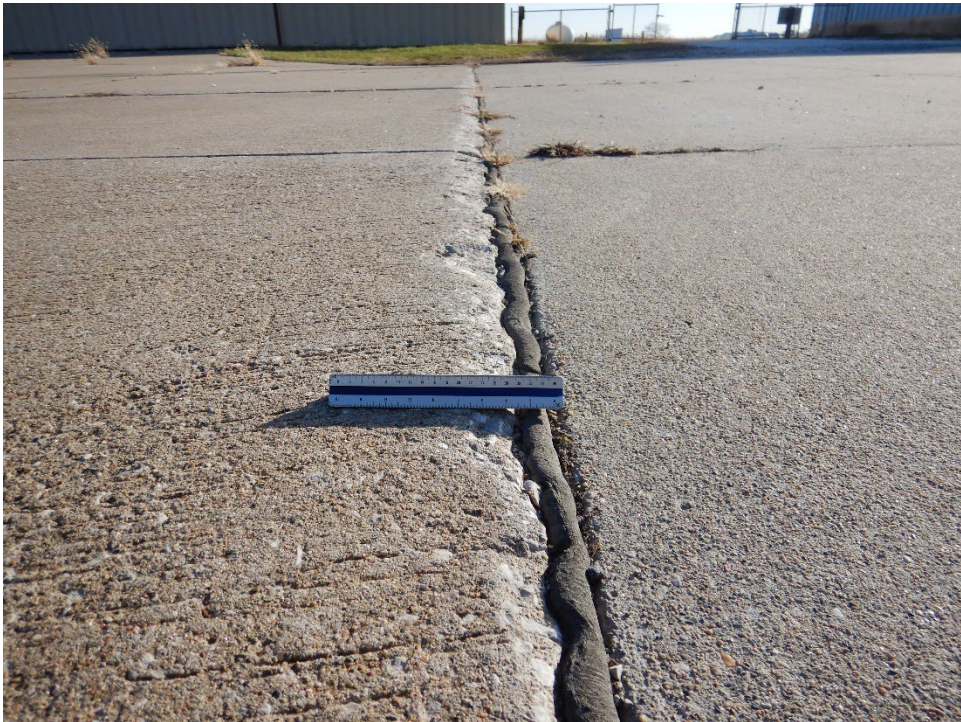
T02CH-01. Faulting (Additional Sample Unit No. 01).

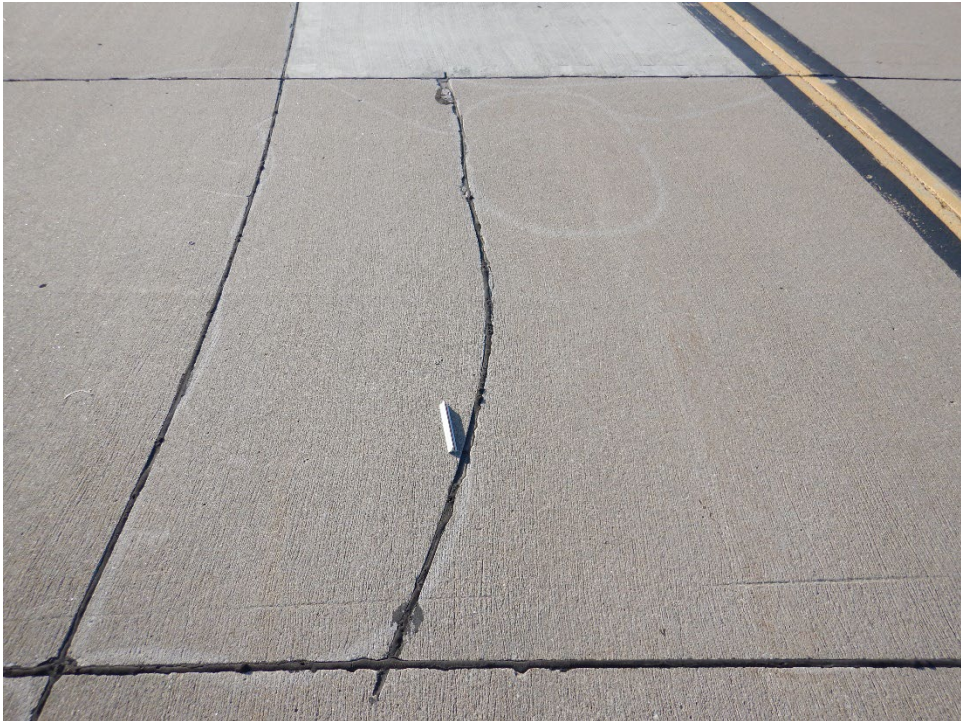
T02CH-01. LTD Cracking (Sample Unit No. 03).

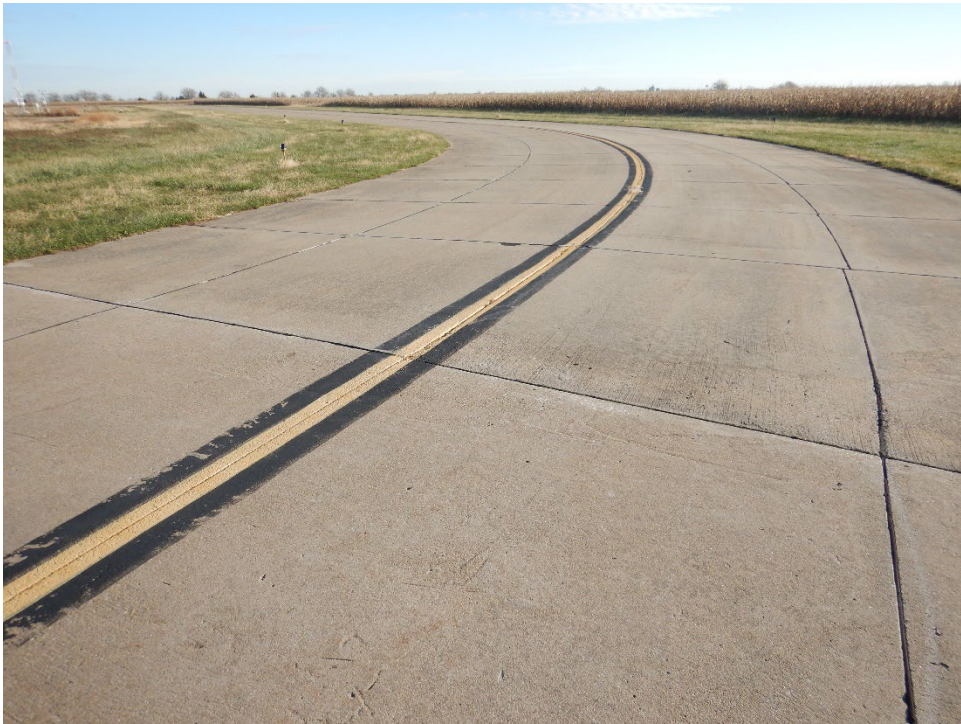
Taxiway 03 connected Runway 10/28 with Apron 02 and consisted of one section. Low-severity ASR, faulting, and scaling; low- and medium-severity joint seal damage; medium-severity joint spalling; and high-severity small patching were observed in Section 01.

T03CH-01. Overview.

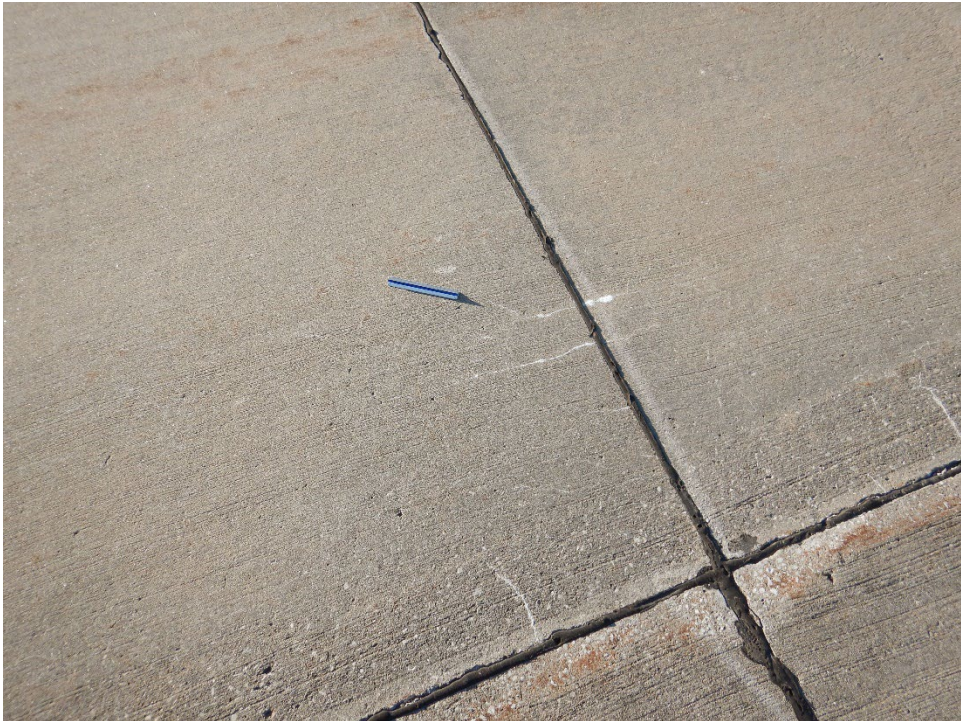
T03CH-01. ASR (Sample Unit No. 07).

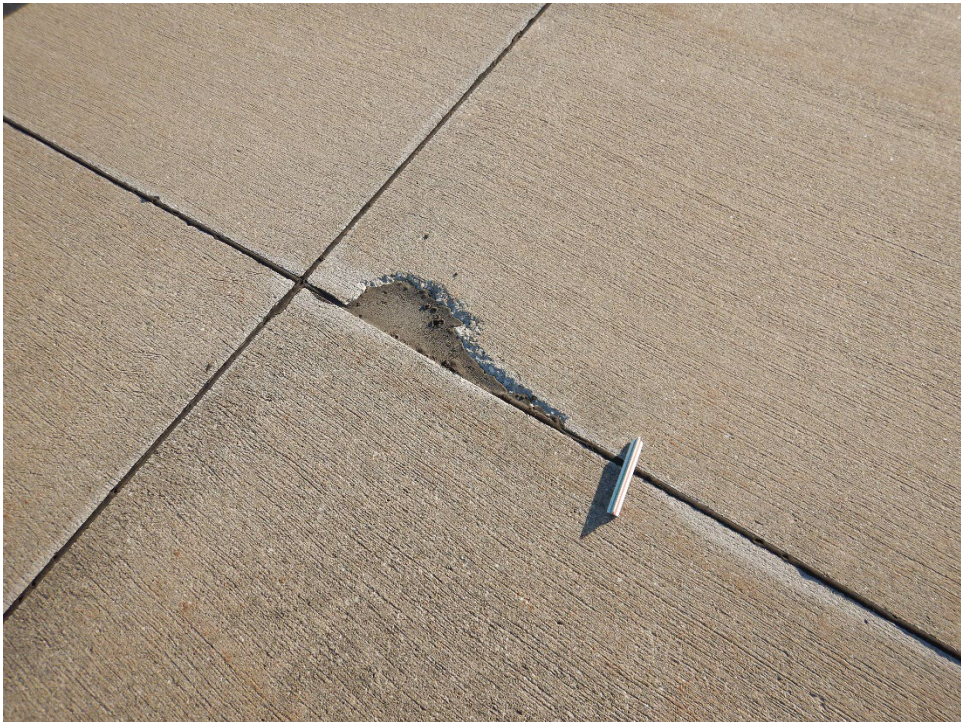
T03CH-01. Joint Spalling (Sample Unit No. 20).

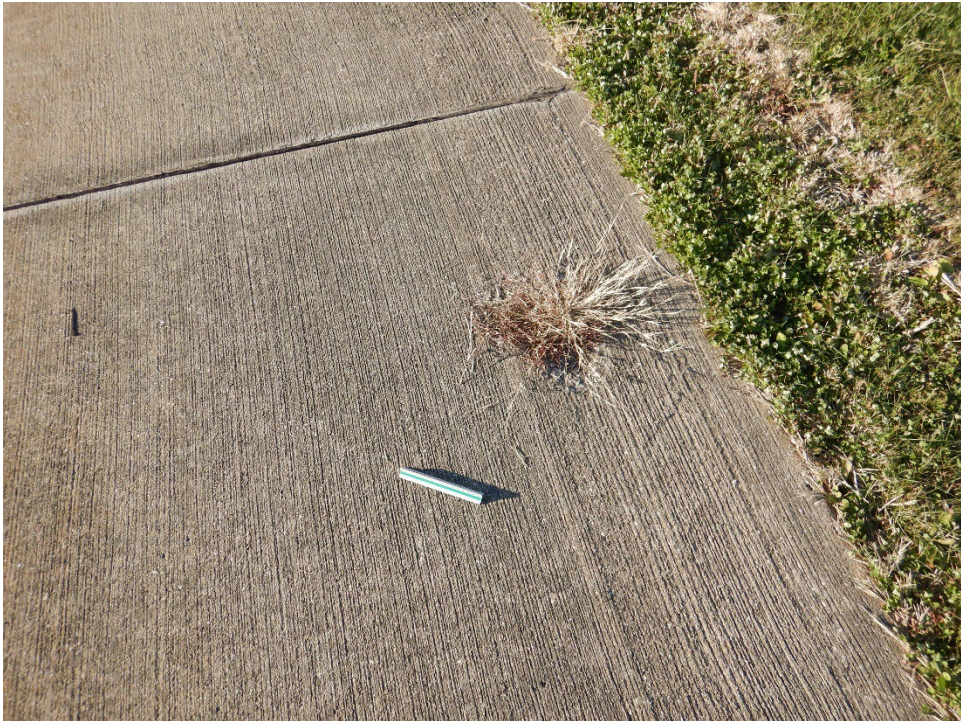
T03CH-01. Small Patching (Sample Unit No. 12).

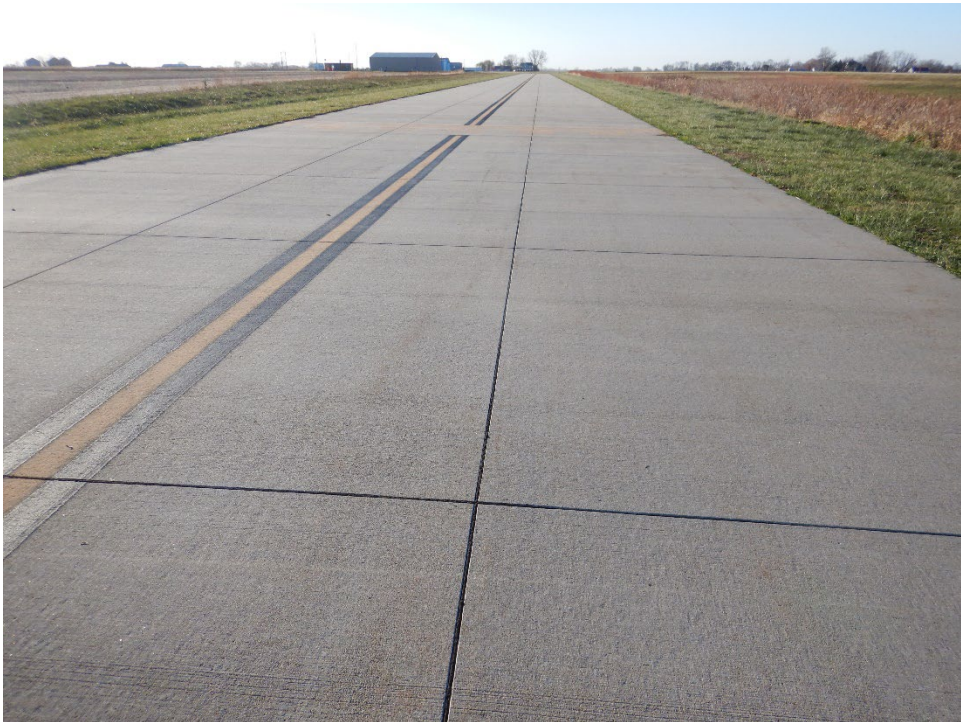
Taxiway 04 connected the Runway 10 approach with the apron area and was defined by one section. Section 01 contained low-severity corner spalling, low-severity faulting, and low- and medium-severity joint seal damage.

T04CH-01. Overview.

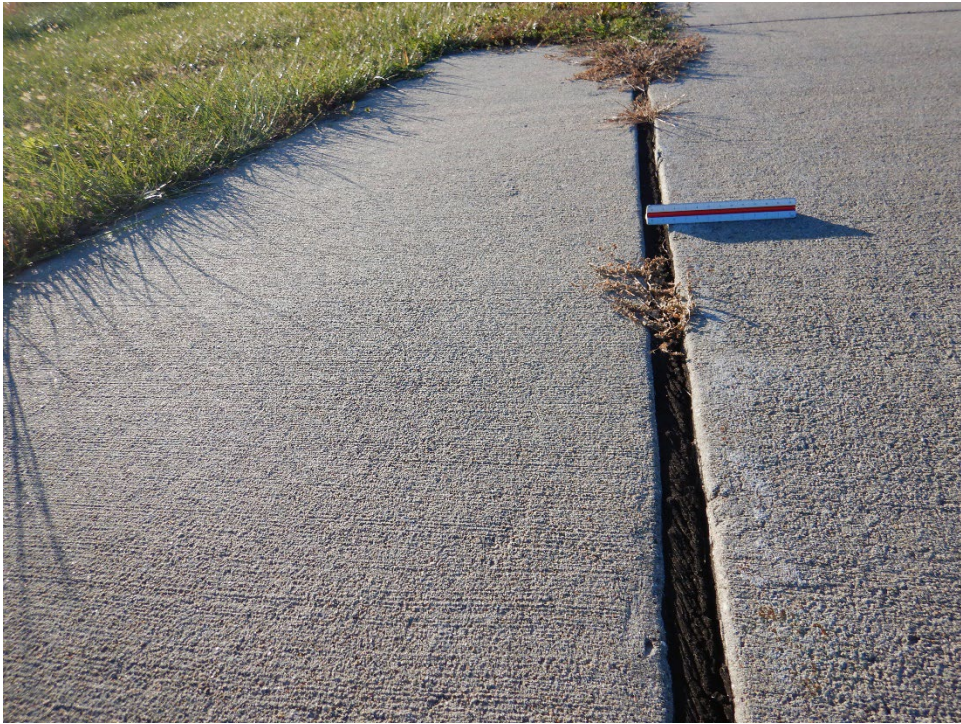
T04CH-01. Faulting (Sample Unit No. 15).

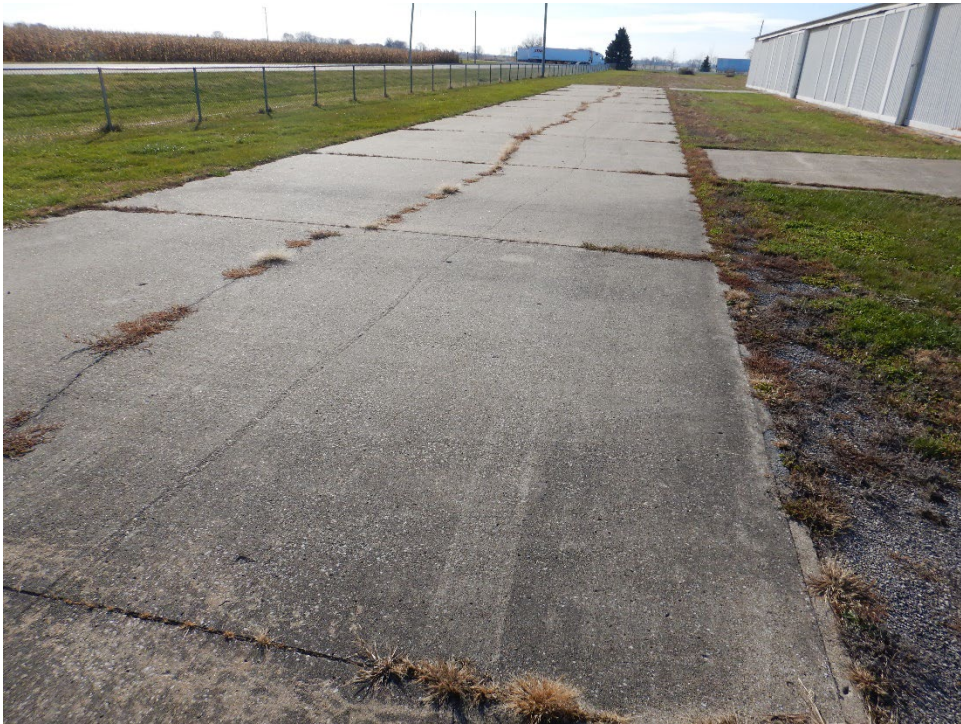
The T-hangar area contained three sections that were in poor condition. Section 01 had areas of low-severity ASR, high-severity corner spalling, medium- and high-severity faulting, high-severity joint seal damage, low- and medium-severity LTD cracking, and shrinkage cracking noted during the inspection. Low- and medium-severity ASR; medium-severity blow-up, corner break, and corner spalling; high-severity joint seal damage; and medium- and high-severity joint spalling, LTD cracking, scaling, and shattered slab were recorded in Section 02. Section 03 contained low-severity ASR, high-severity joint seal damage, and medium-severity LTD cracking and shattered slab.

TH01CH-01. Overview.
