# Chariton Municipal Airport

## PAVEMENT MANAGEMENT REPORT

**JULY 2022**

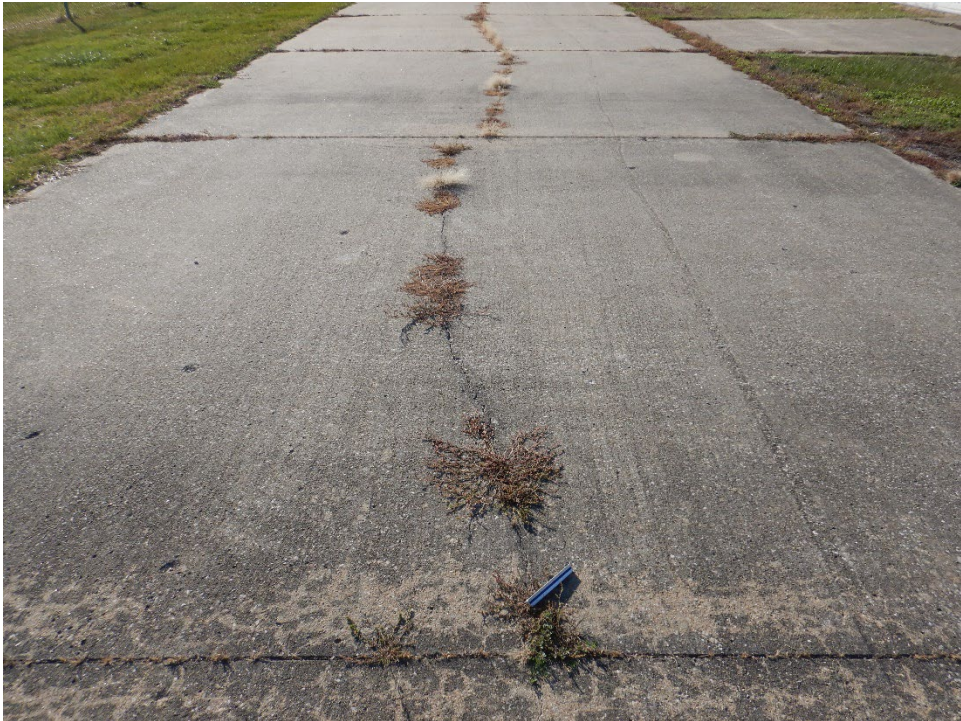
The T-hangar area contained three sections that were in poor condition. Section 01 had areas of low-severity ASR, high-severity corner spalling, medium- and high-severity faulting, high-severity joint seal damage, low- and medium-severity LTD cracking, and shrinkage cracking noted during the inspection. Low- and medium-severity ASR; medium-severity blow-up, corner break, and corner spalling; high-severity joint seal damage; and medium- and high-severity joint spalling, LTD cracking, scaling, and shattered slab were recorded in Section 02. Section 03 contained low-severity ASR, high-severity joint seal damage, and medium-severity LTD cracking and shattered slab.

TH01CH-01. LTD Cracking (Sample Unit No. 01).

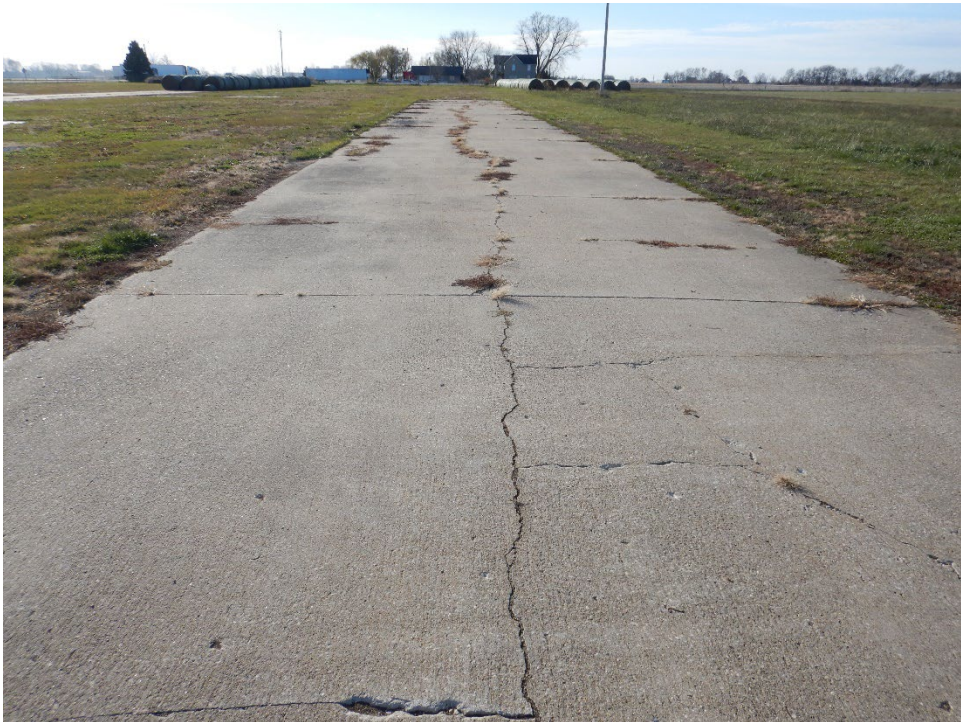
TH01CH-02. Overview.

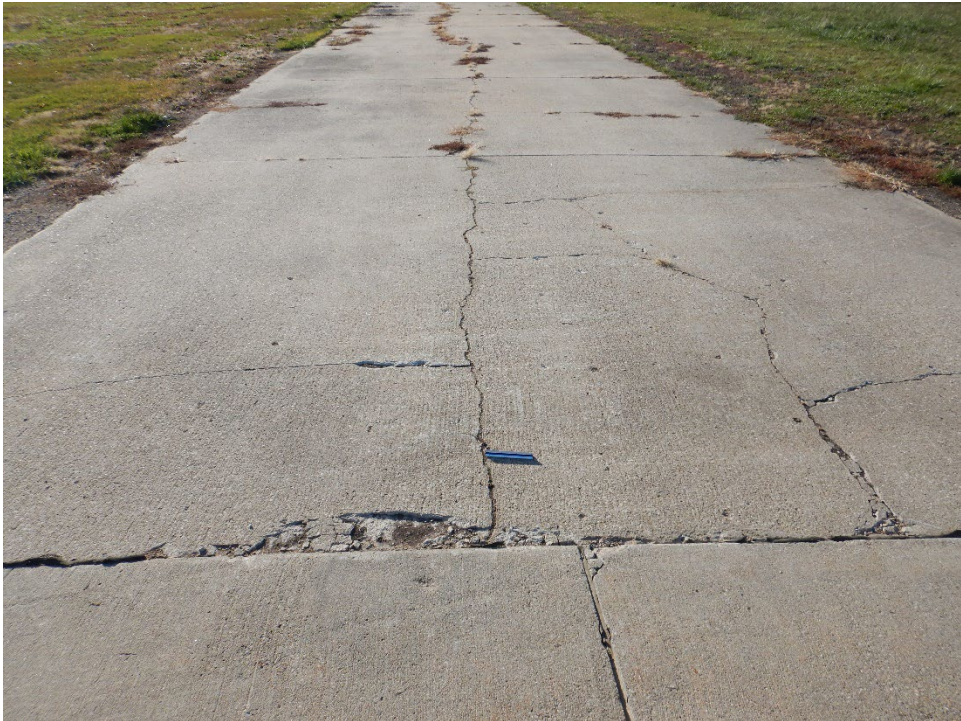
TH01CH-02. Shattered Slab (Sample Unit No. 01).

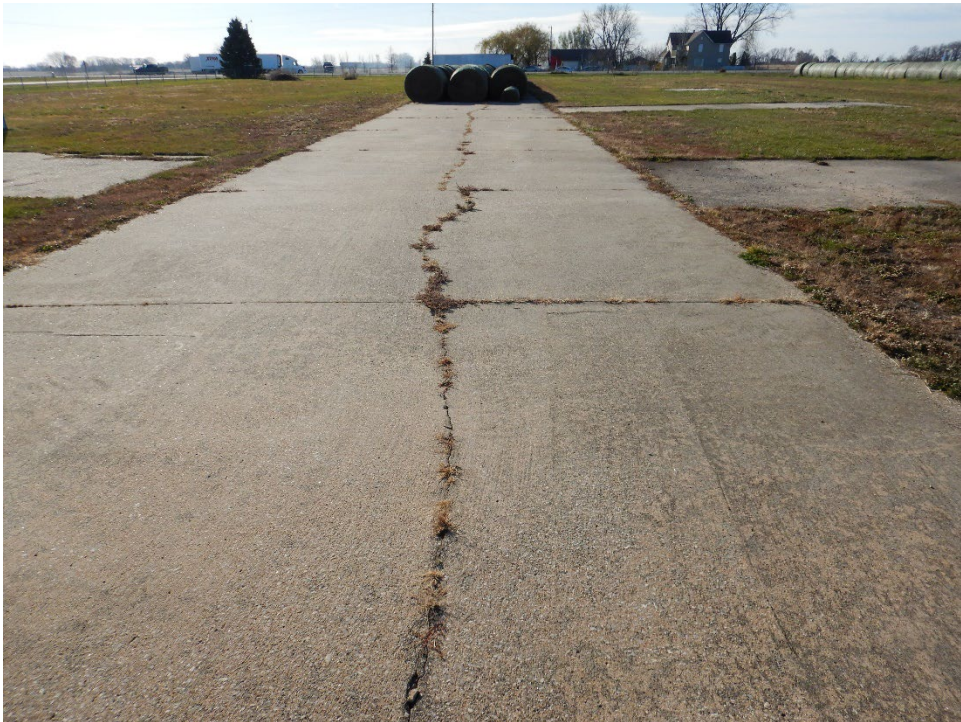
TH01CH-03. Overview.

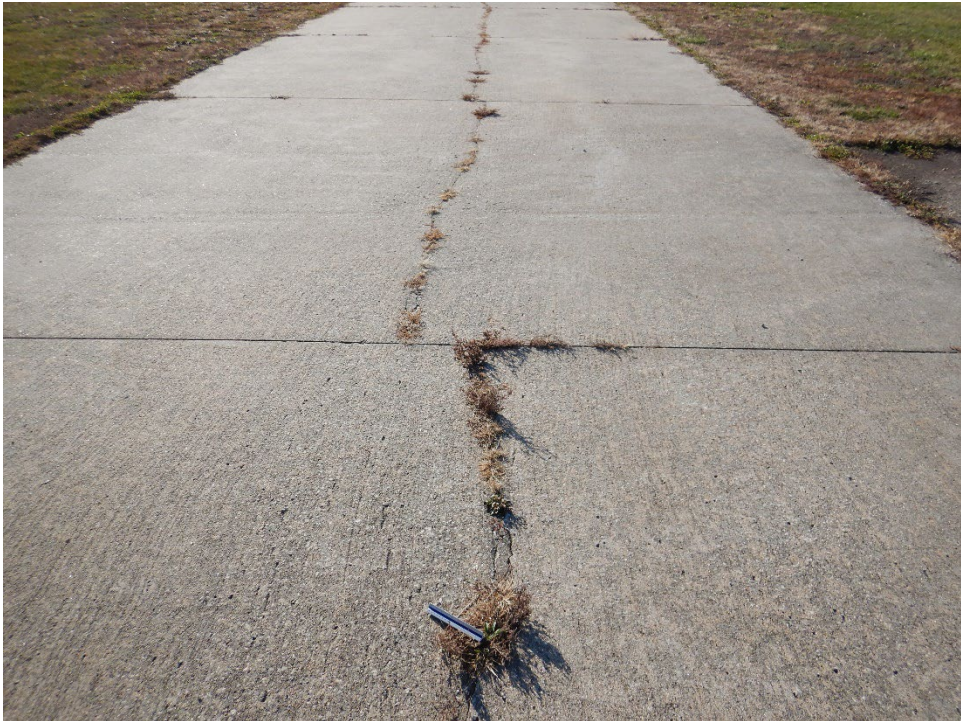
TH01CH-03. LTD Cracking (Sample Unit No. 01).
