Chariton Municipal Airport

Pavement Management Report

AUGUST 2025

CHARITON MUNICIPAL AIRPORT PAVEMENT MANAGEMENT REPORT

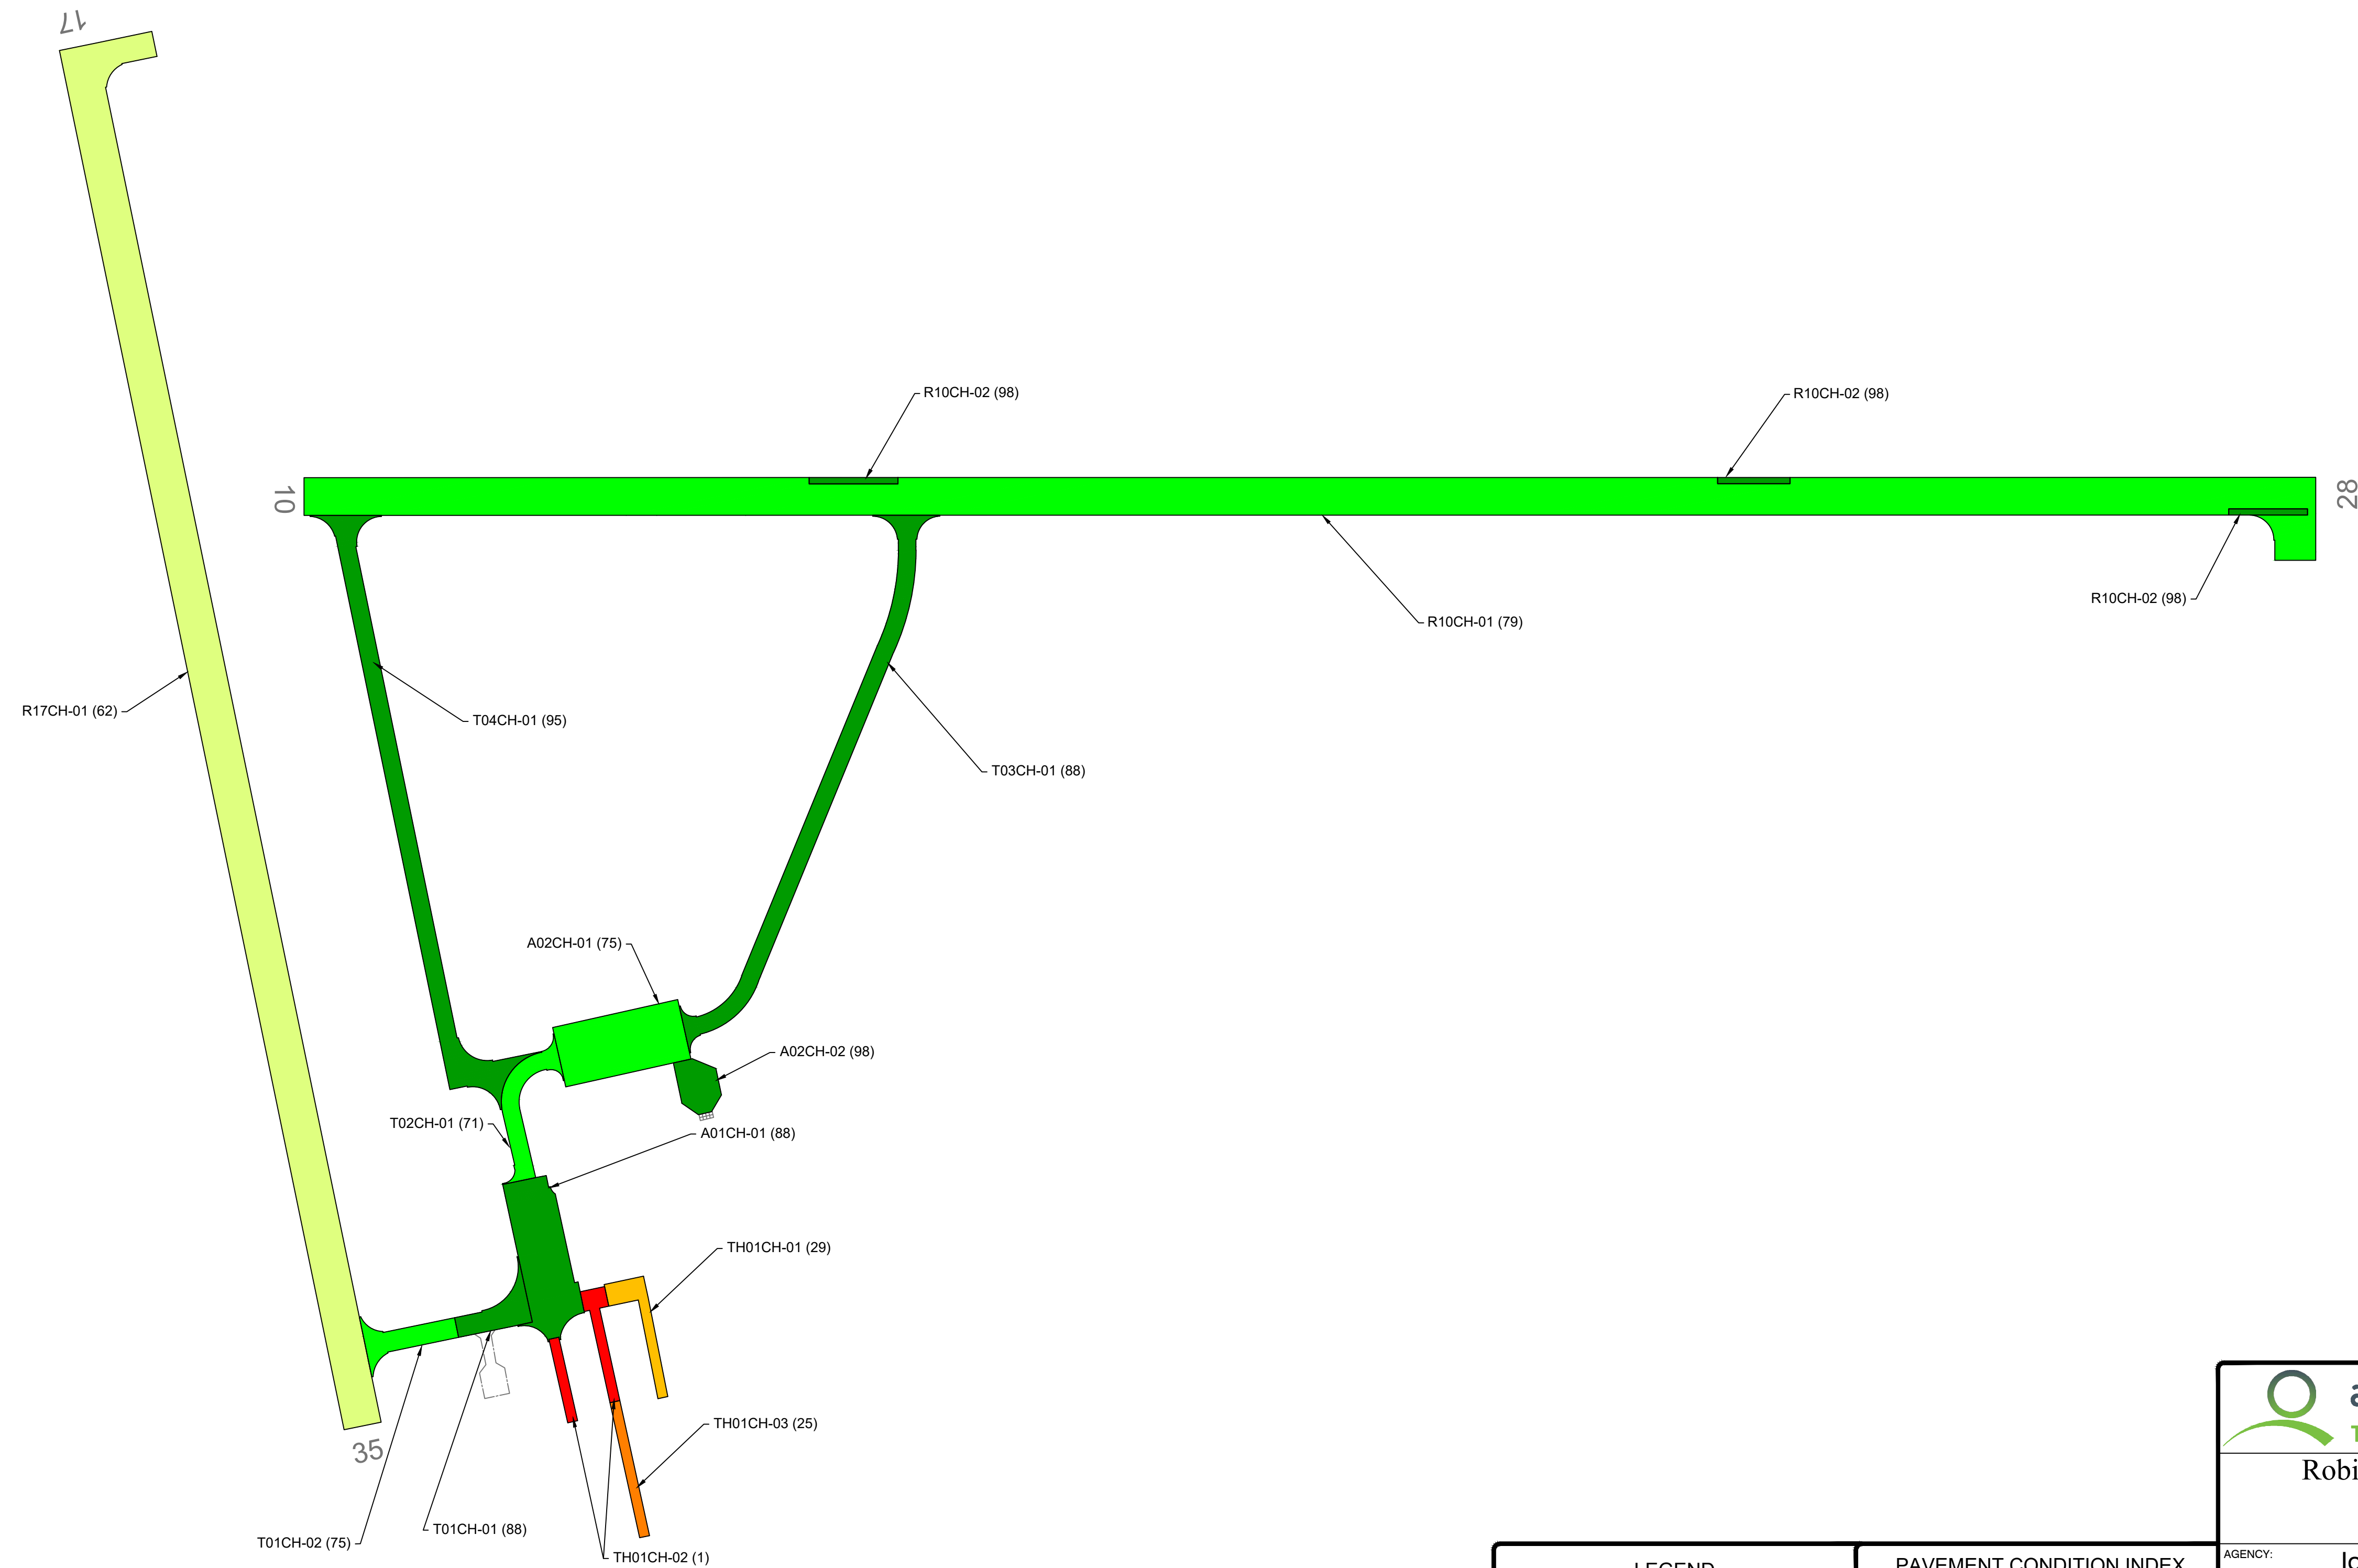
FIGURE 8. PCI MAP.

The pavements at Chariton Municipal Airport were inspected in March 2025. The 2025 area-weighted condition of Chariton Municipal Airport is 74, with conditions ranging from 1 to 98 (on a scale of 0 [failed] to 100 [excellent]). During the previous pavement inspection in 2021, the area-weighted PCI of the airport was 76.

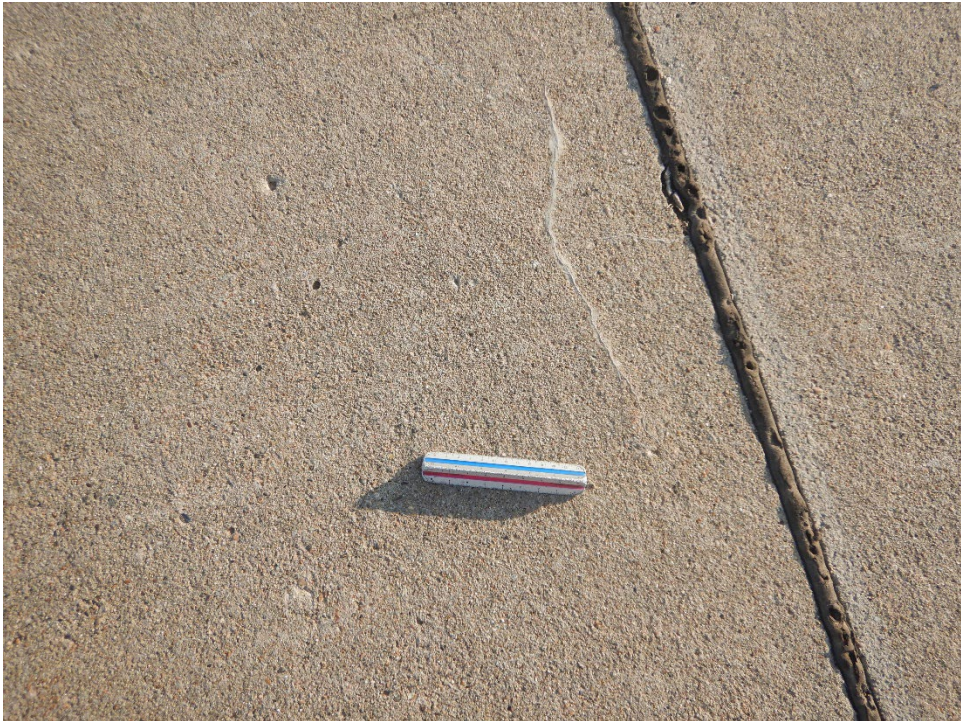
A01CH-01. ASR (Sample Unit No. 08).

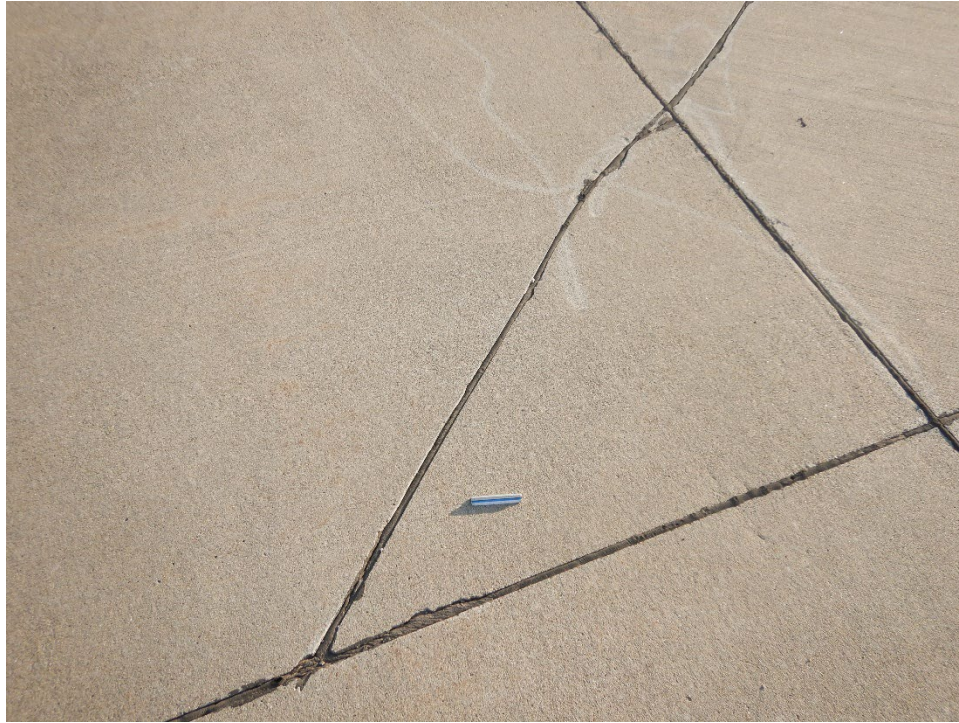
A01CH-01. Corner Break (Additional Sample Unit No. 11).

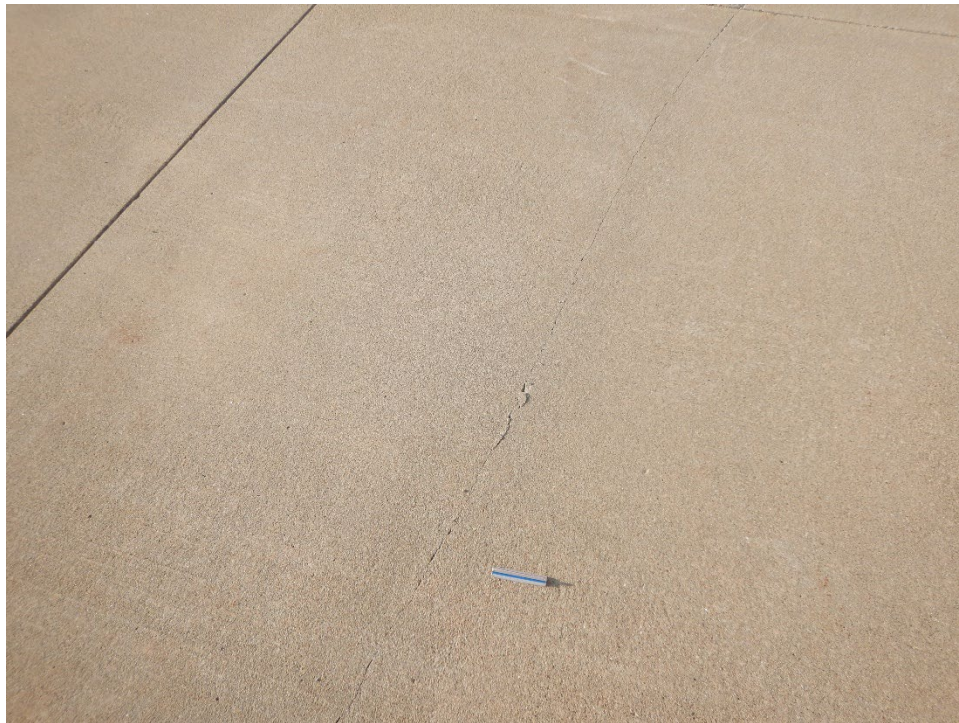
A01CH-01. LTD Cracking (Sample Unit No. 03).

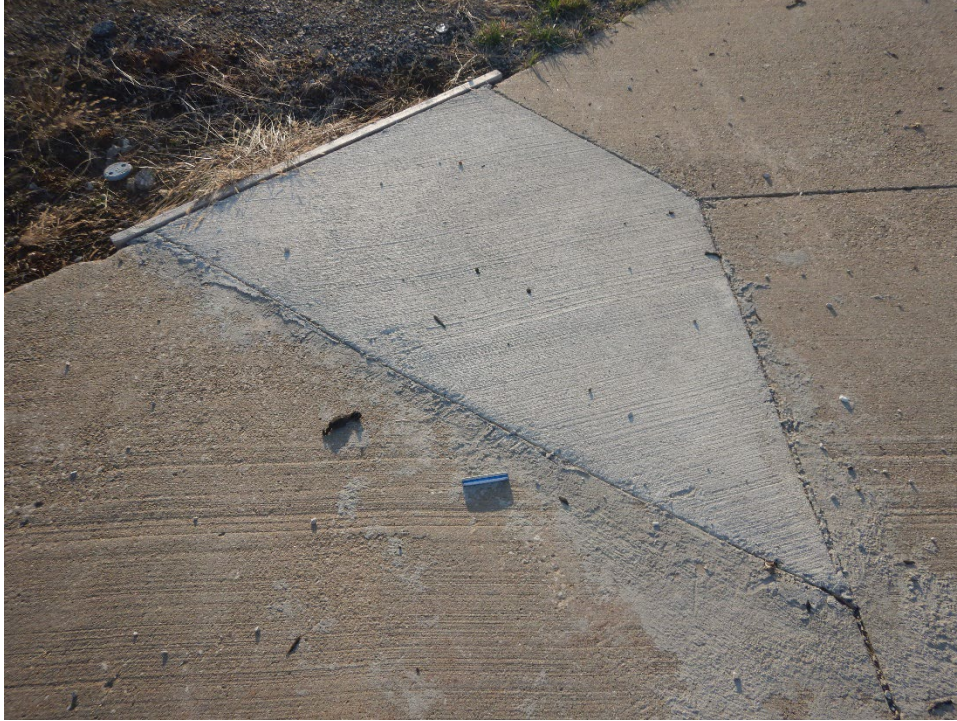
A01CH-01. Large Patching (Additional Sample Unit No. 13).

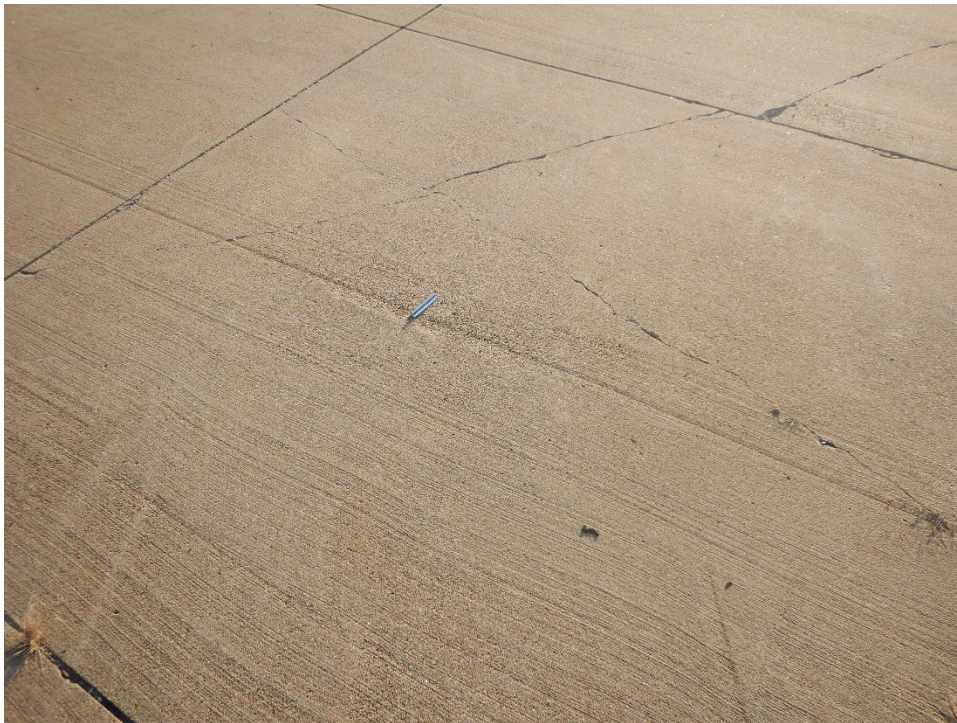
A01CH-01. Shattered Slab (Additional Sample Unit No. 13).

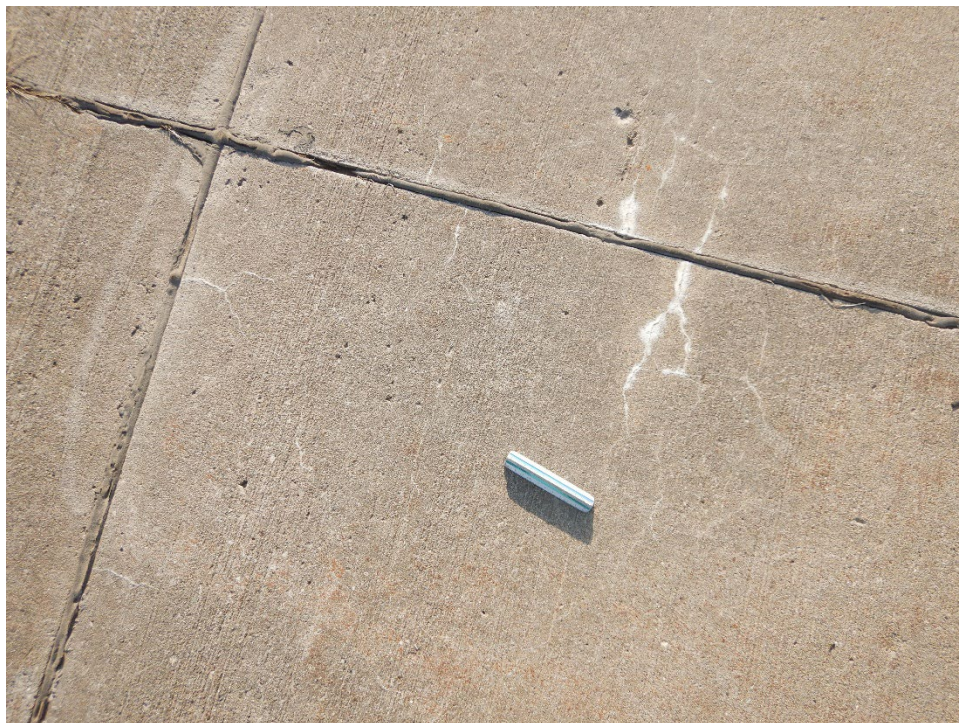
A02CH-01. ASR (Sample Unit No. 007).

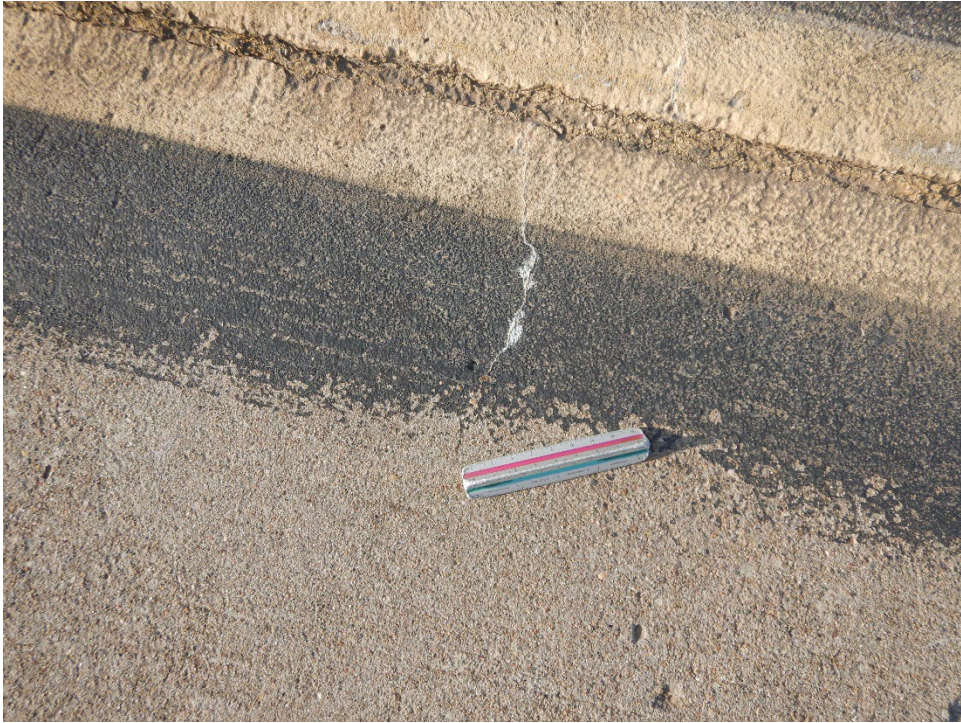
A02CH-01. ASR (Sample Unit No. 011).

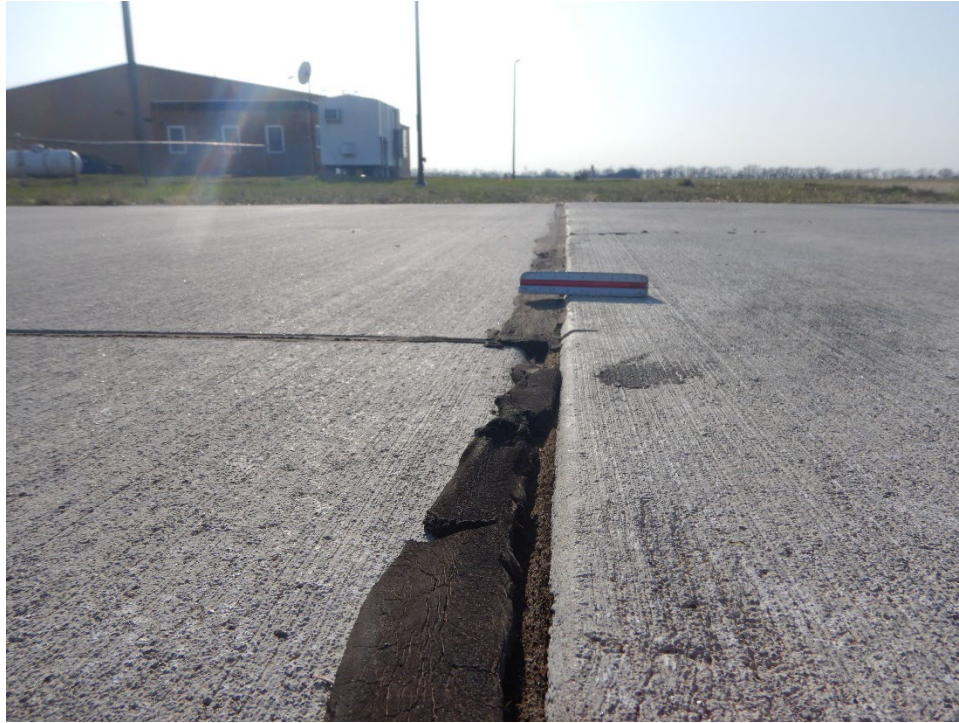
A02CH-02. Faulting (Sample Unit No. 01).

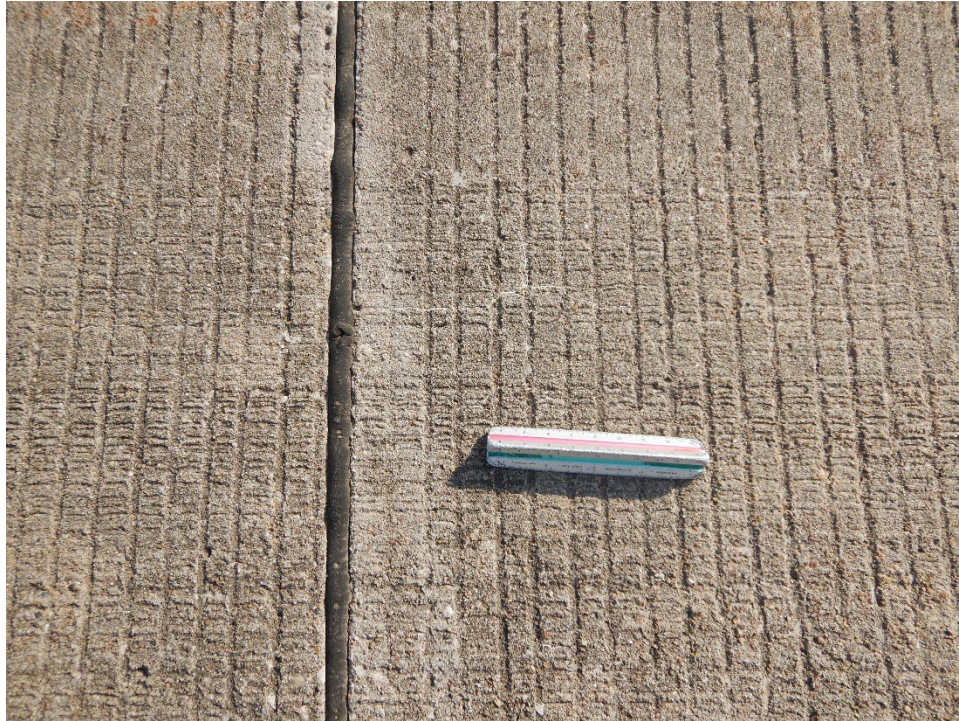
R10CH-01. ASR (Sample Unit No. 019).

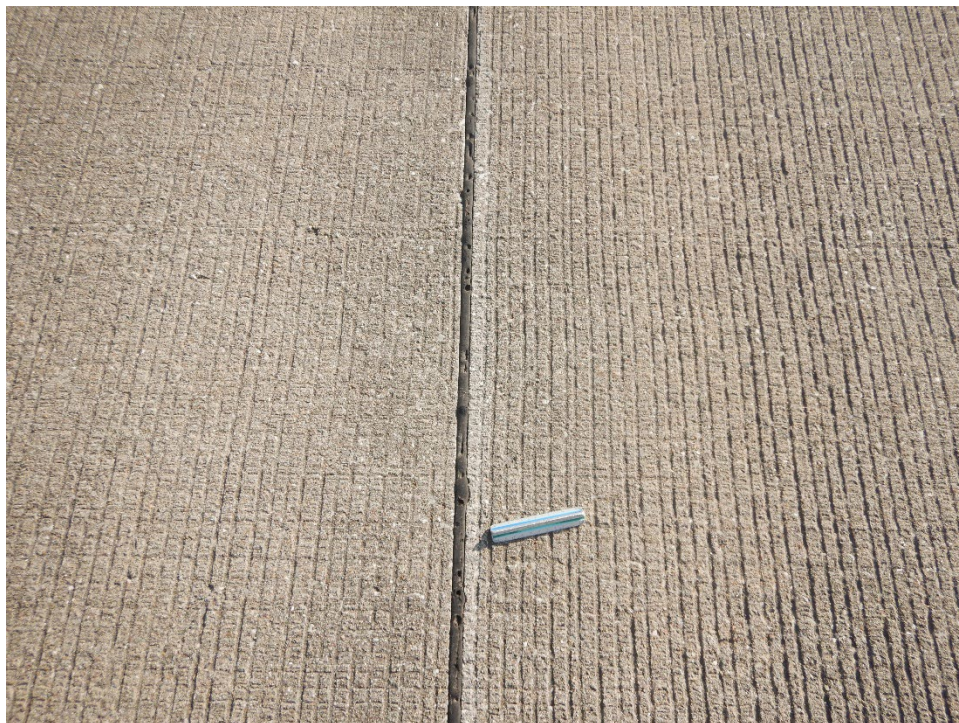
R10CH-01. Joint Seal Damage (Sample Unit No. 019).

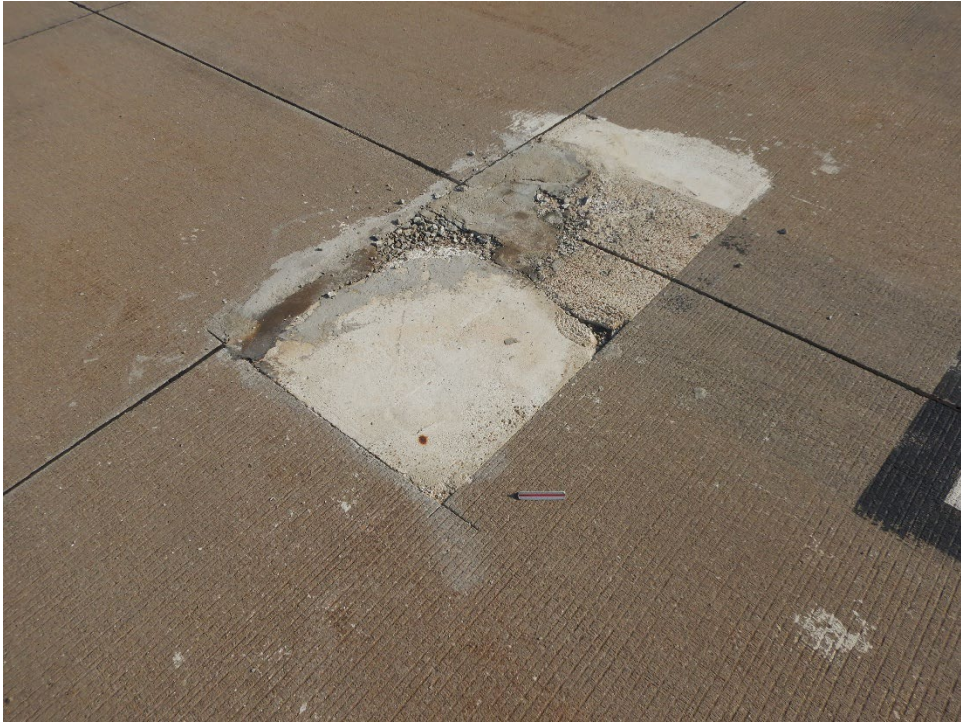
R10CH-01. Large Patching (Sample Unit No. 39).

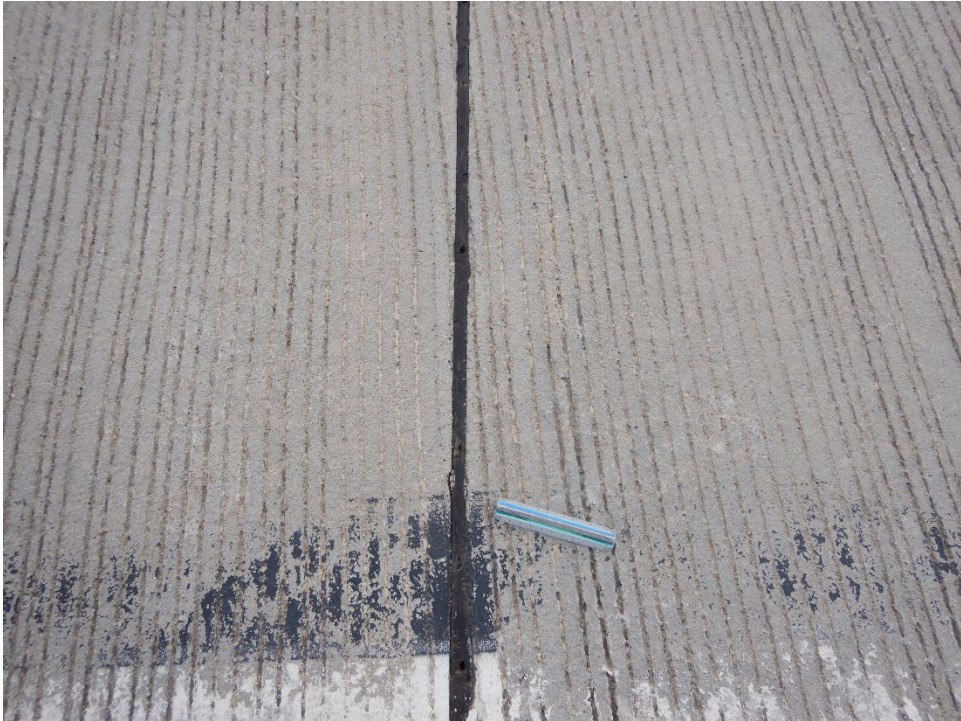
R10CH-02. Joint Seal Damage (Sample Unit No. 03).

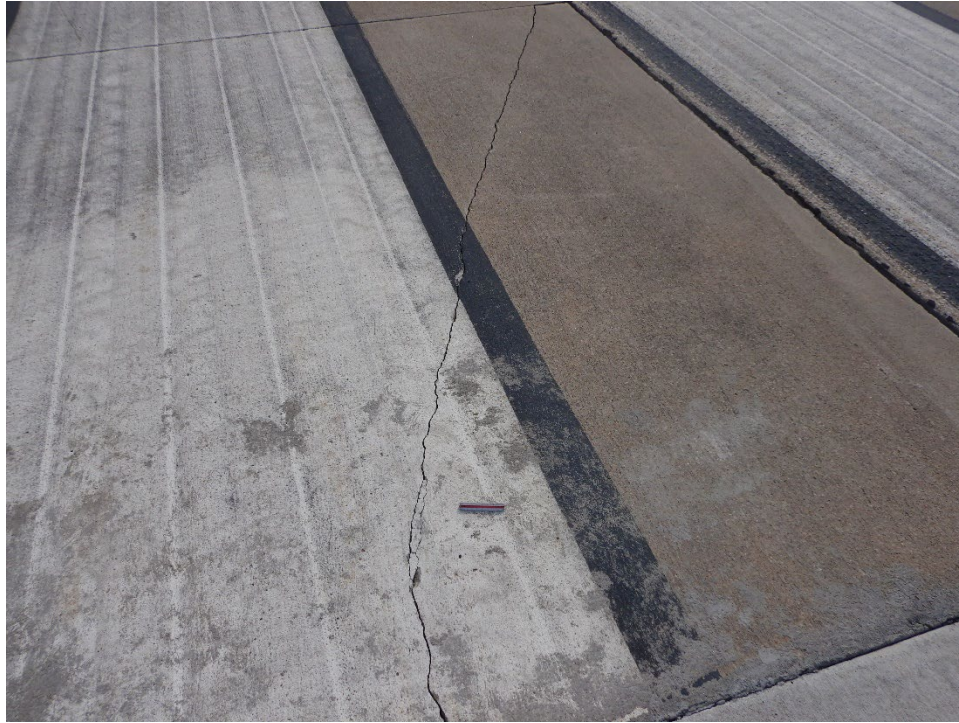
R17CH-01. LTD Cracking (Sample Unit No. 05).

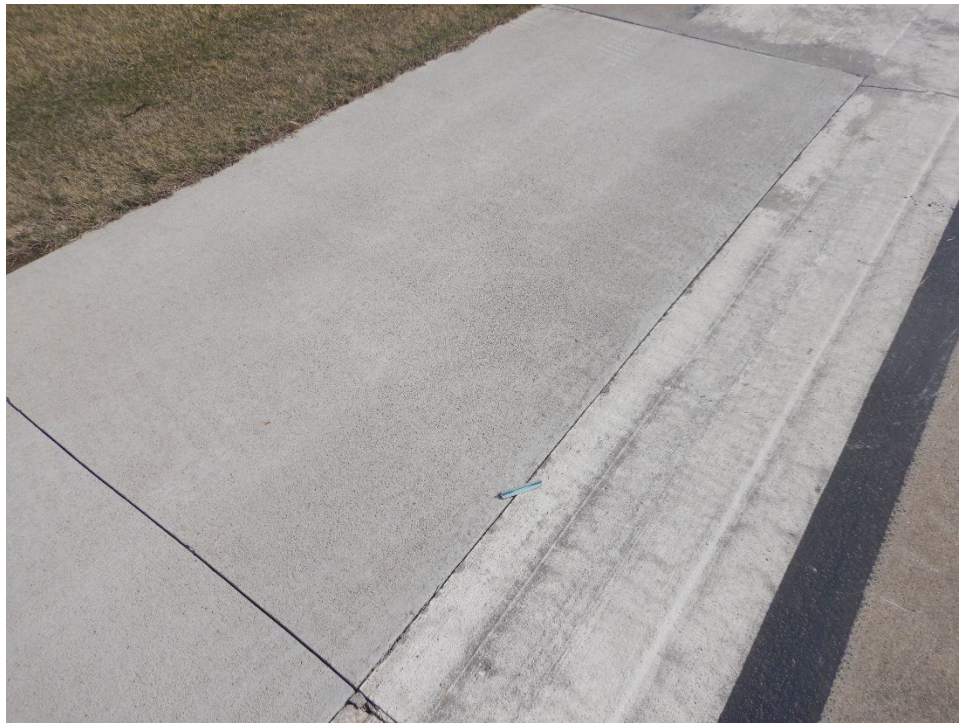
R17CH-01. Large Patching (Sample Unit No. 05).

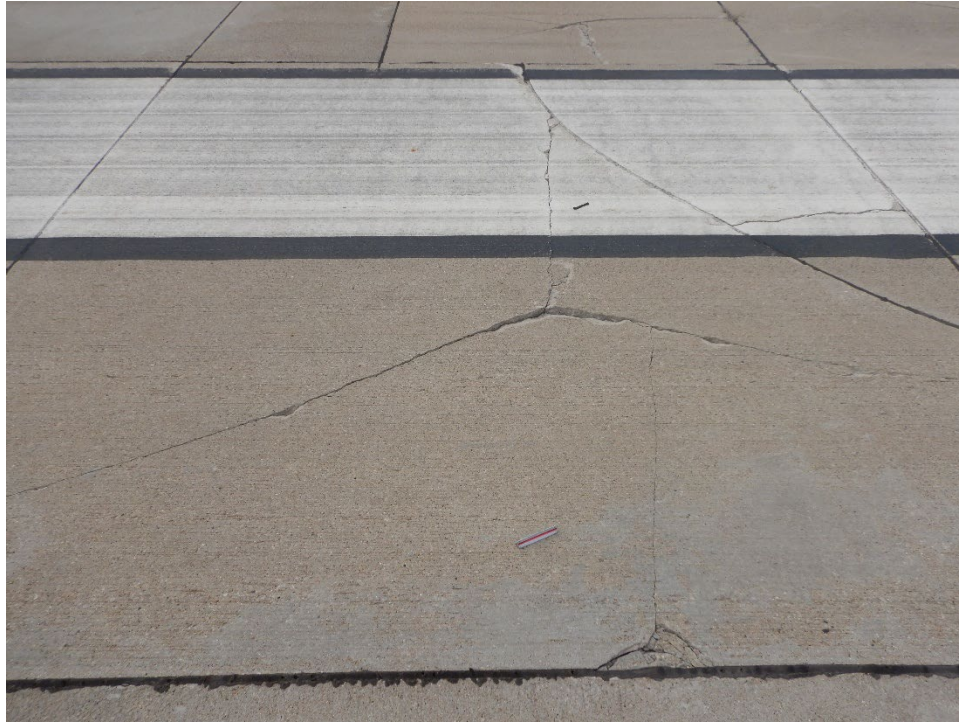
R17CH-01. Shattered Slab (Sample Unit No. 57).

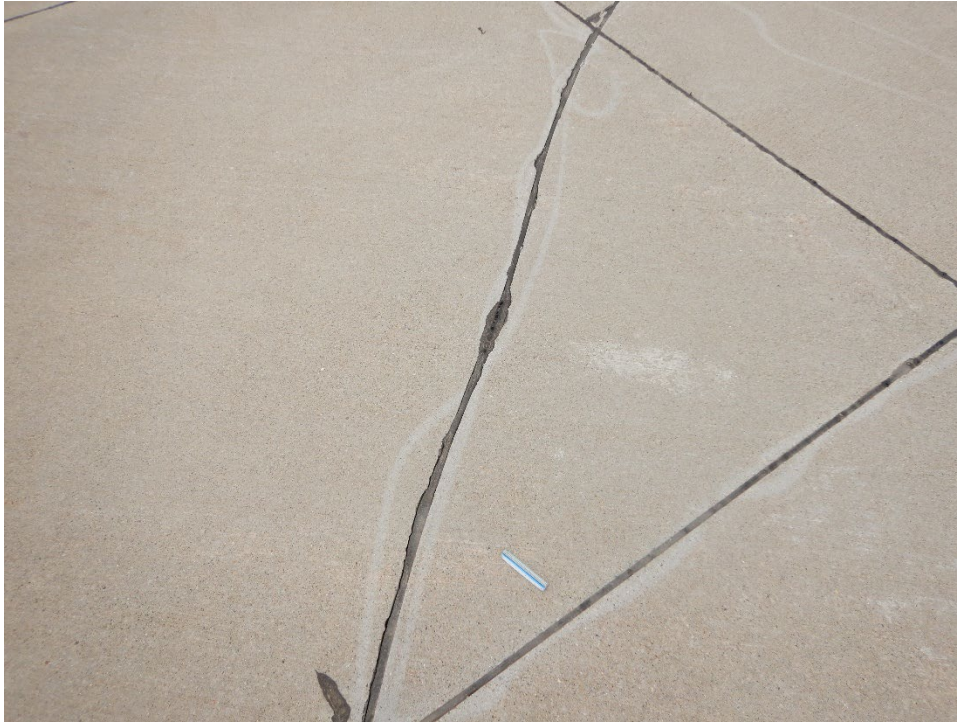
T01CH-01. LTD Cracking (Sample Unit No. 04).

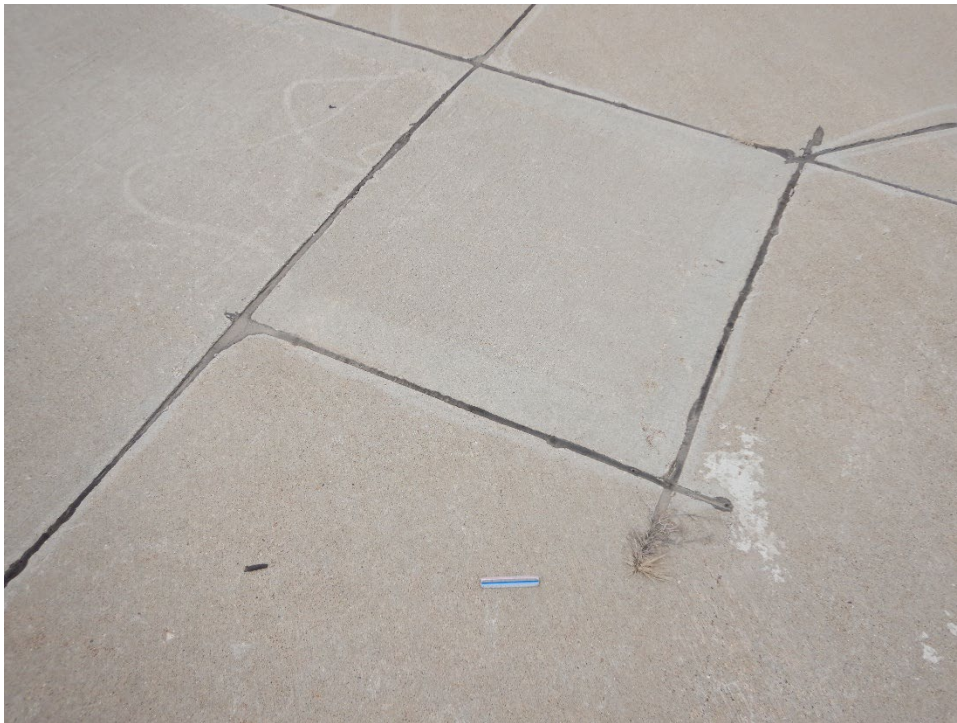
T01CH-01. Large Patching (Sample Unit No. 04).

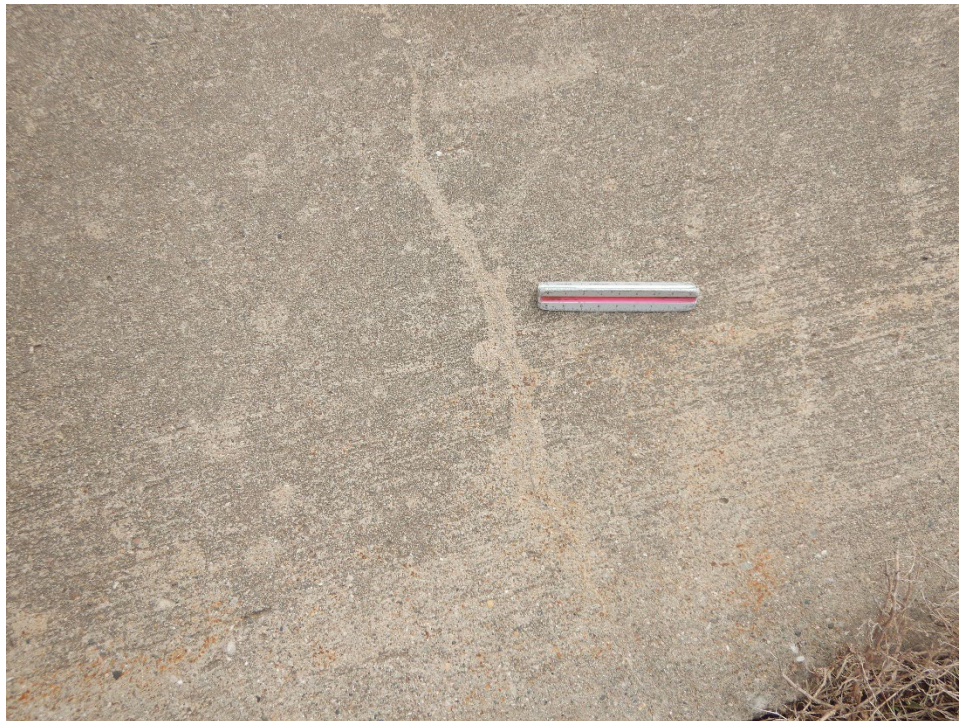
T01CH-02. ASR (Sample Unit No. 002).

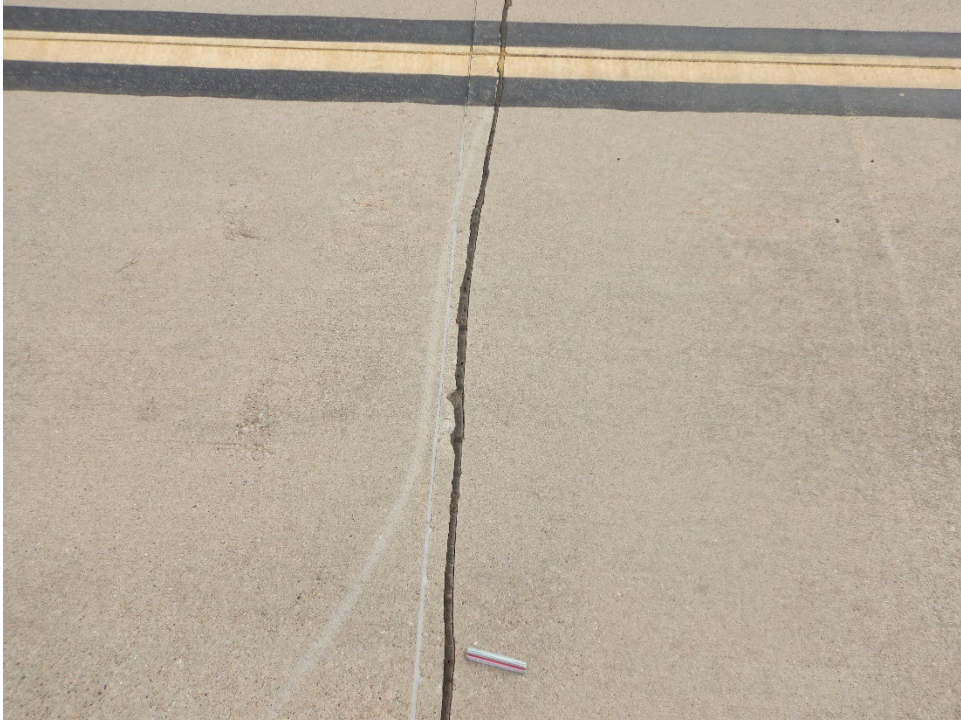
T01CH-02. Joint Spalling (Sample Unit No. 002).

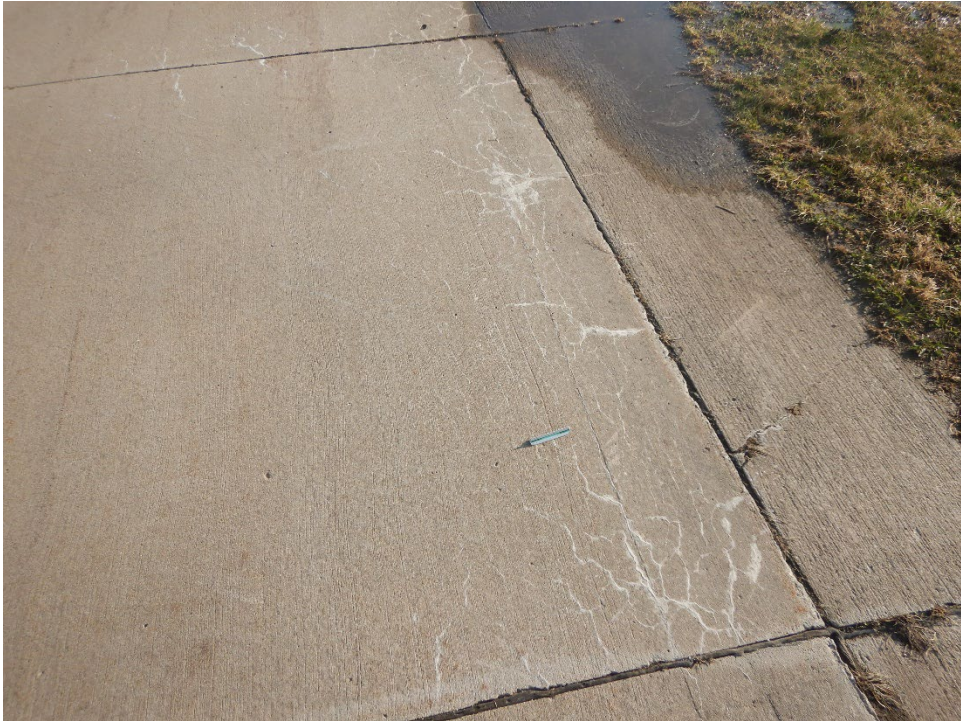
T02CH-01. ASR (Sample Unit No. 001).

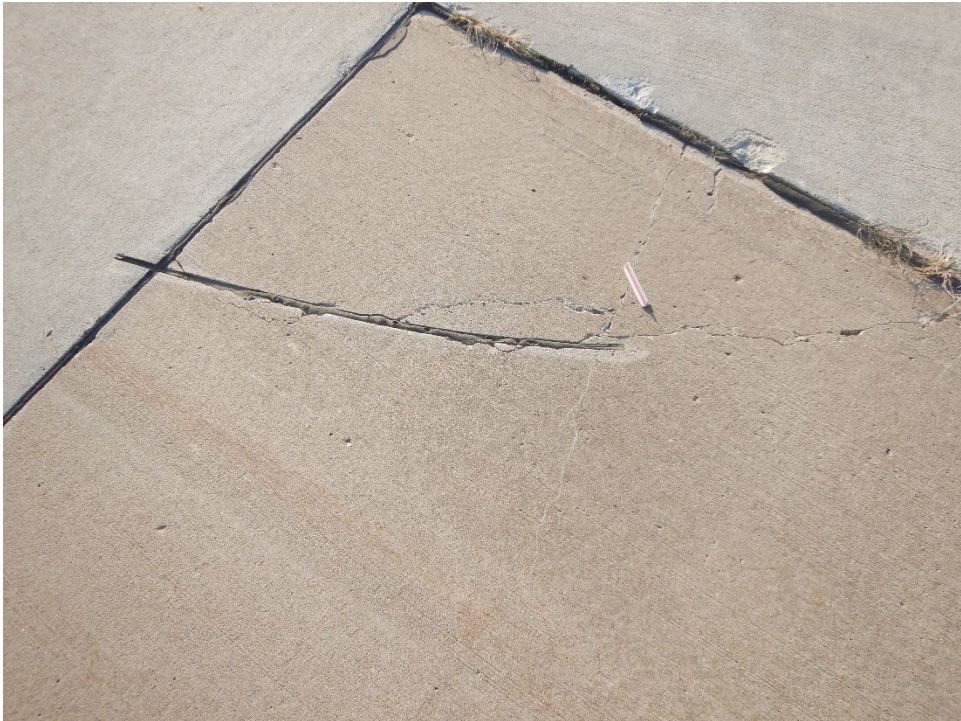
T02CH-01. Corner Break (Sample Unit No. 005).

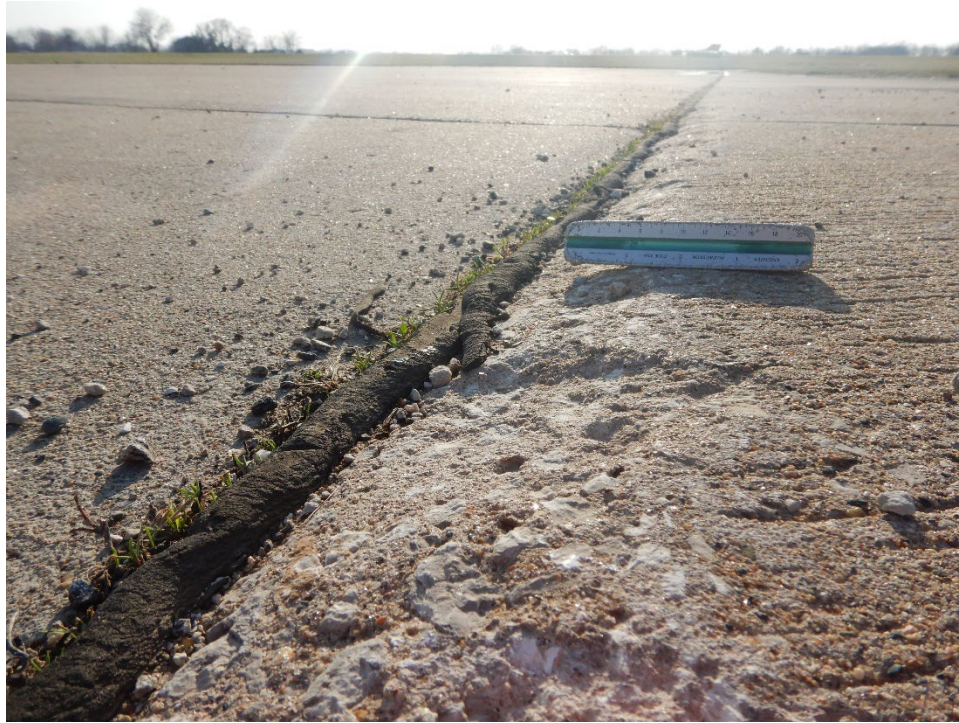
T02CH-01. Faulting (Sample Unit No. 001).

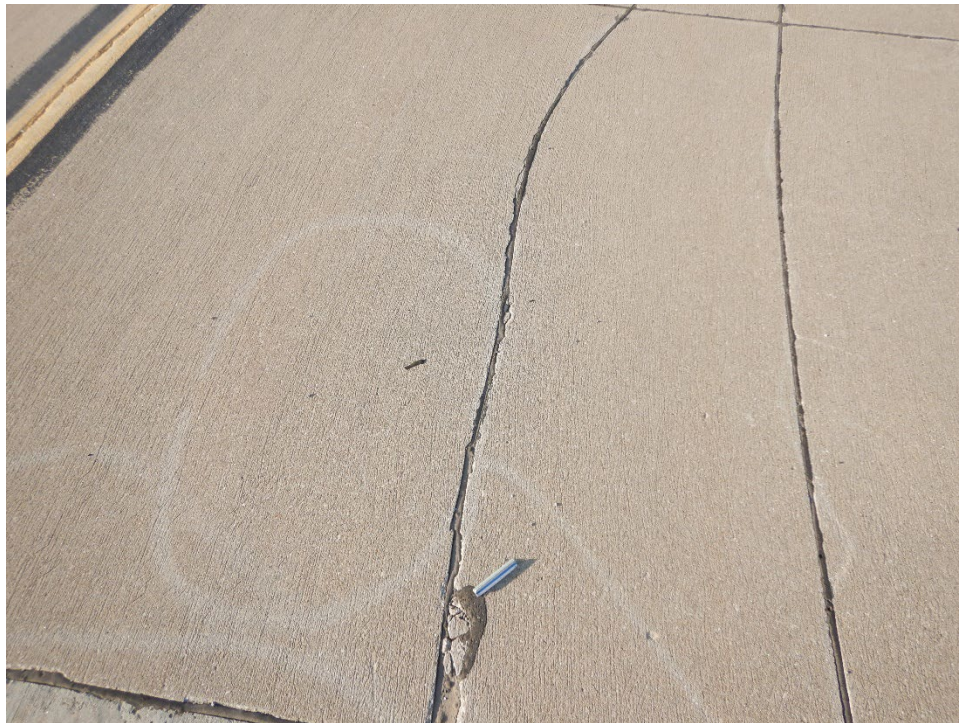
T02CH-01. LTD Cracking (Sample Unit No. 003).

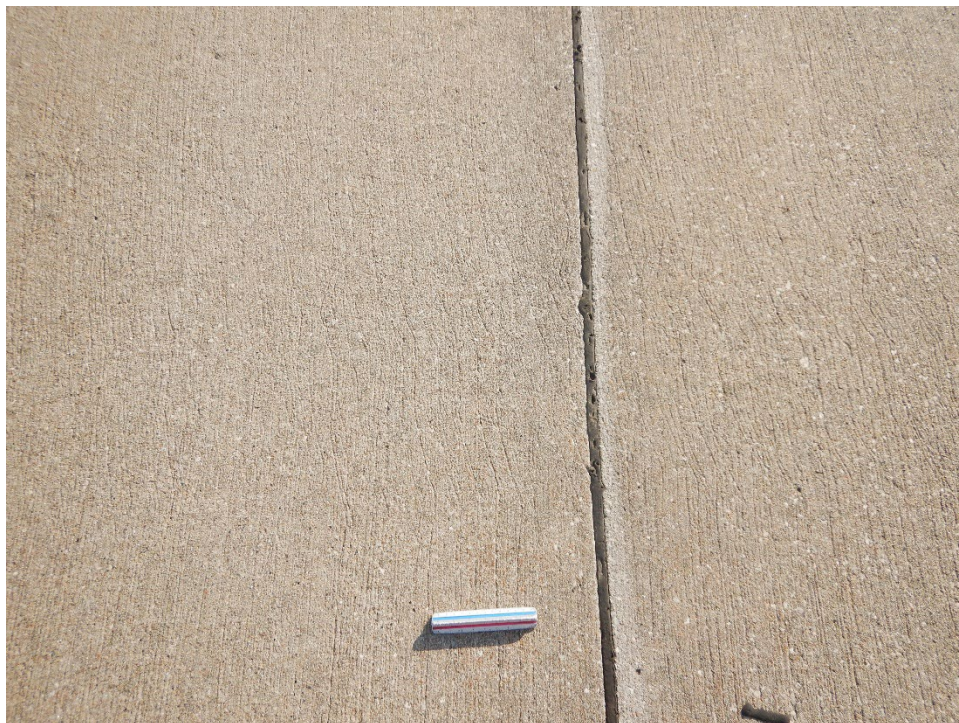
T03CH-01. Joint Seal Damage (Sample Unit No. 020).

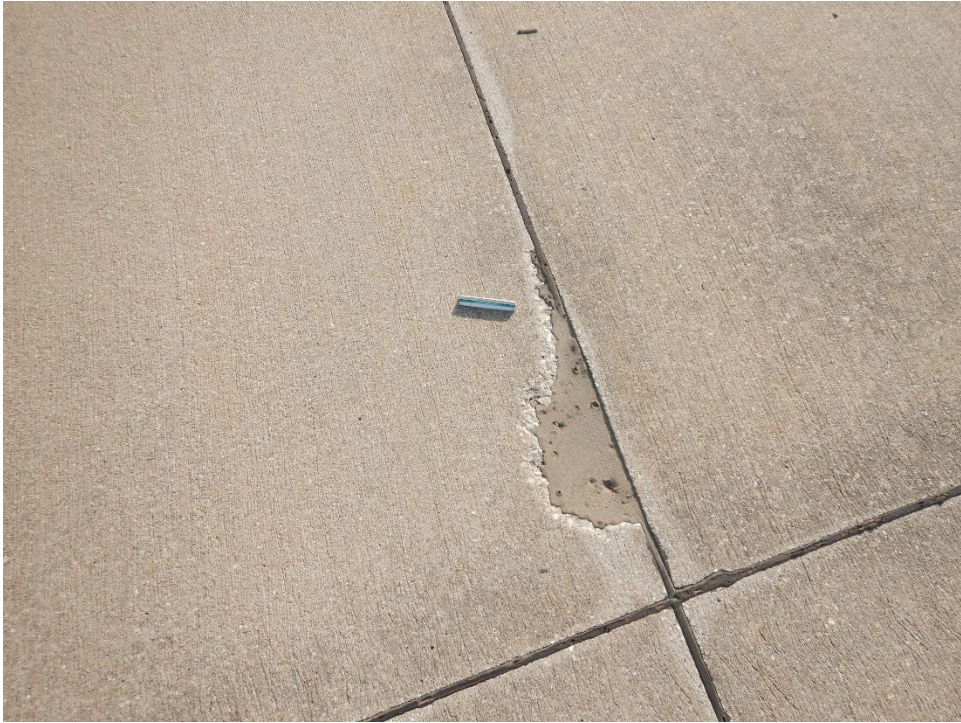
T03CH-01. Joint Spalling (Sample Unit No. 020).

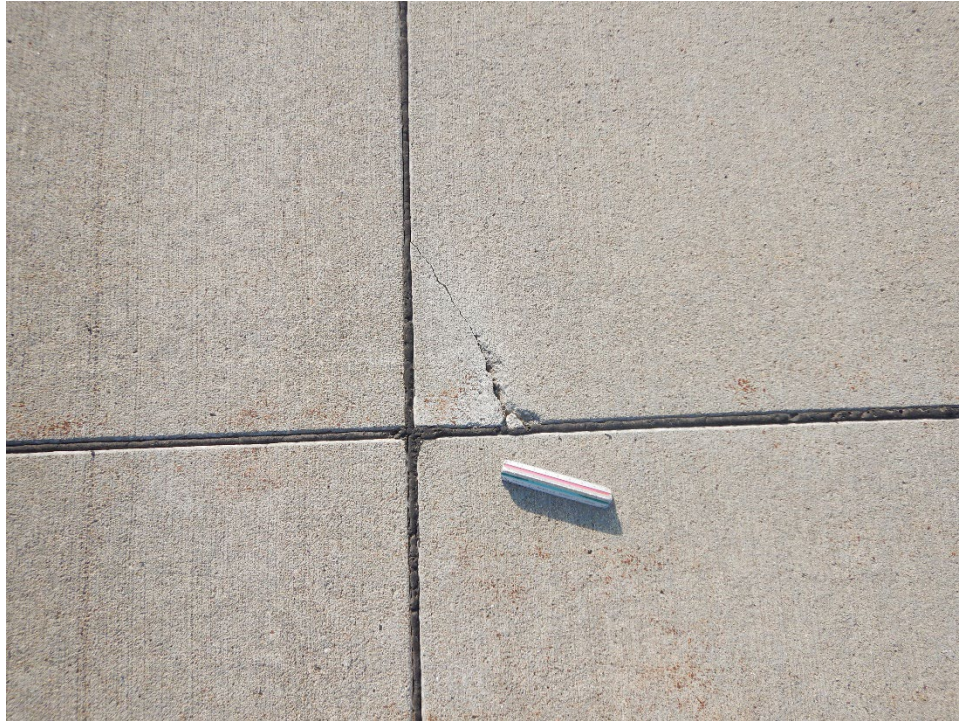
T04CH-01. Corner Spalling (Sample Unit No. 007).

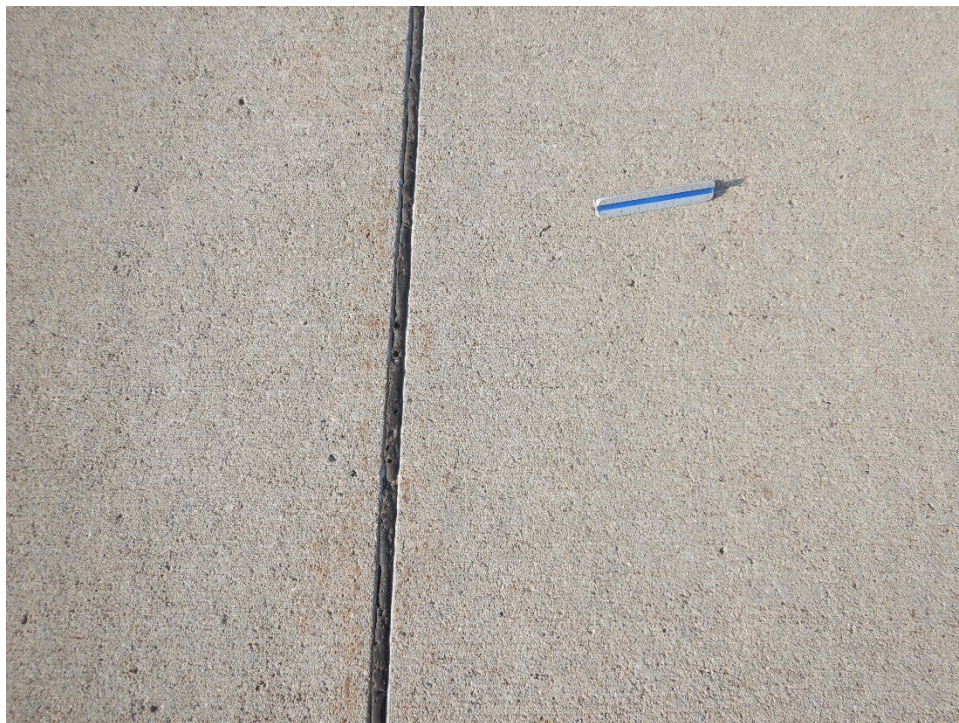
T04CH-01. Joint Seal Damage (Sample Unit No. 004).
