Chariton Municipal Airport

Pavement Management Report

AUGUST 2025

CHARITON MUNICIPAL AIRPORT PAVEMENT MANAGEMENT REPORT

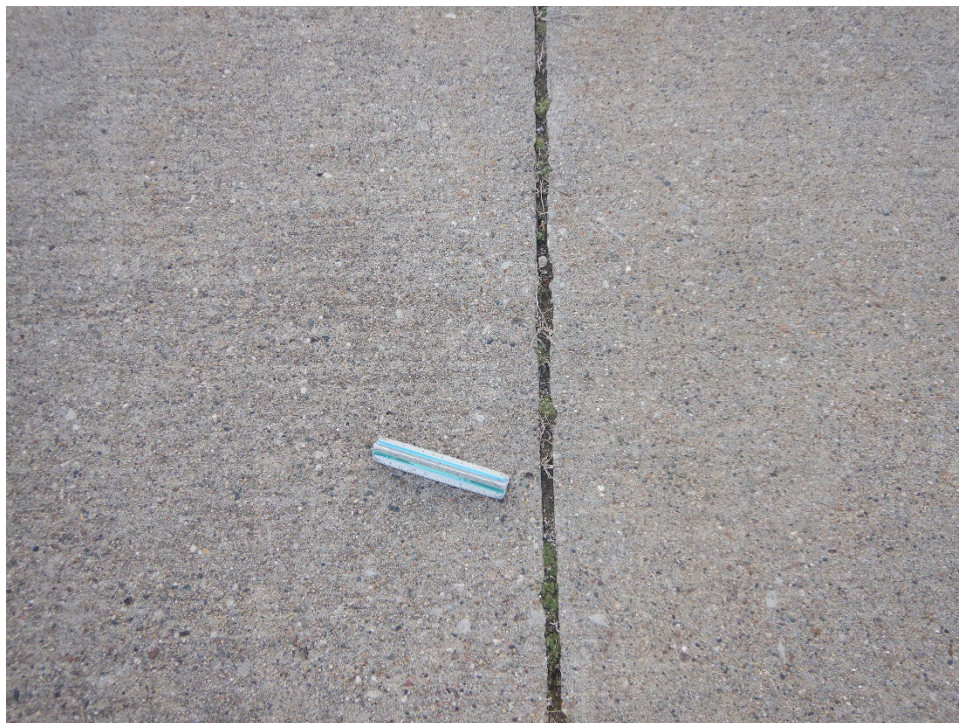
TH01CH-01. Joint Seal Damage (Sample Unit No. 01).

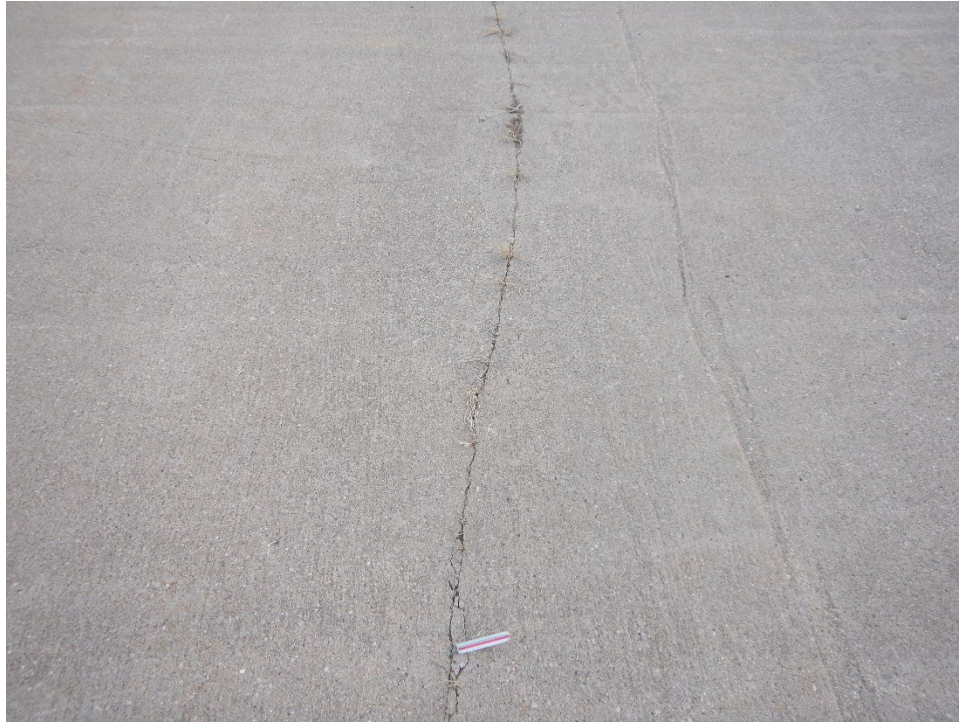
TH01CH-01. LTD Cracking (Sample Unit No. 01).

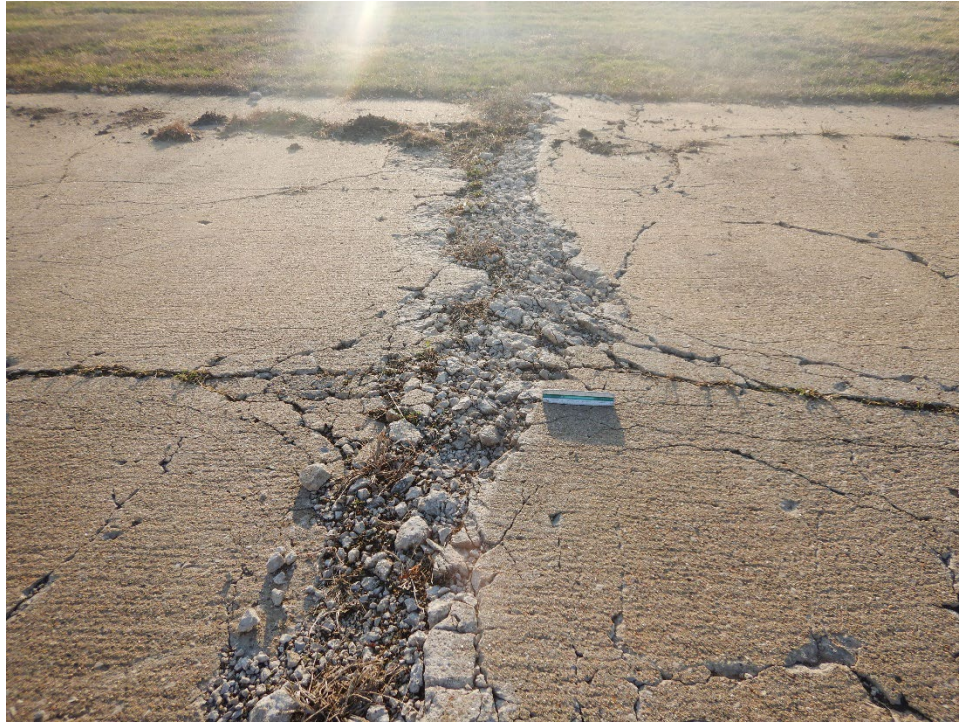
TH01CH-02. Blow-Up (Sample Unit No. 02).

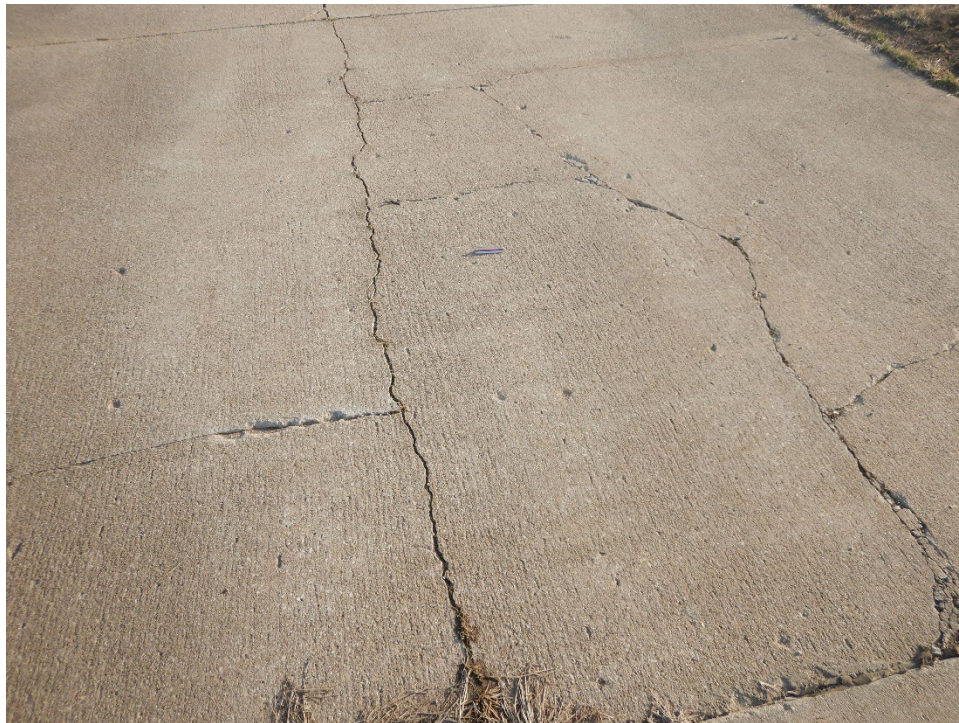
TH01CH-02. Shattered Slab (Sample Unit No. 01) (1).

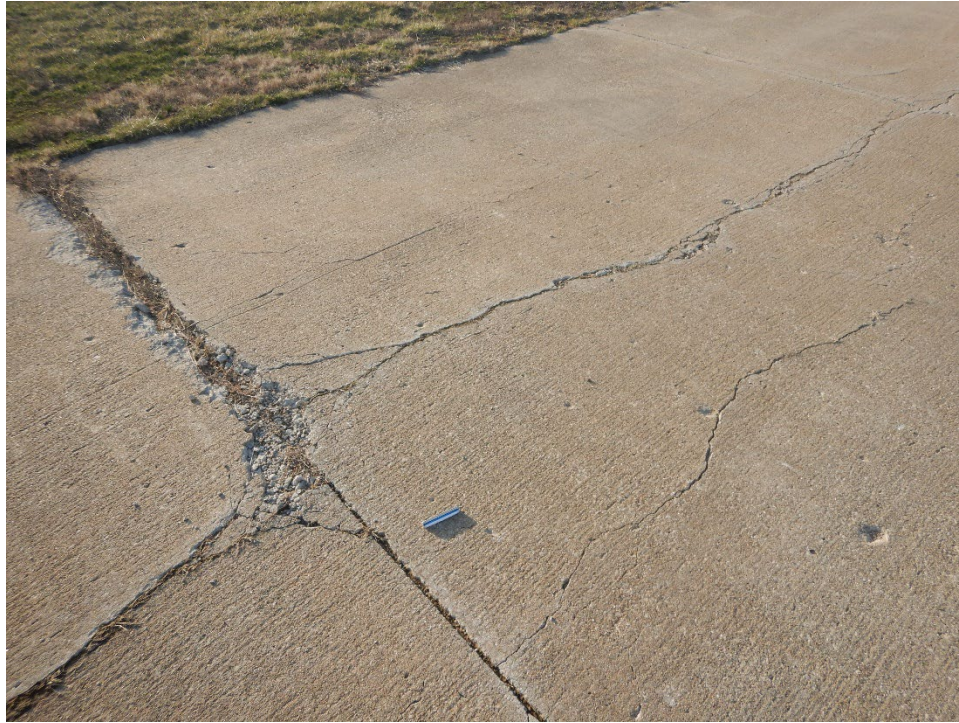
TH01CH-02. Shattered Slab (Sample Unit No. 01) (2).

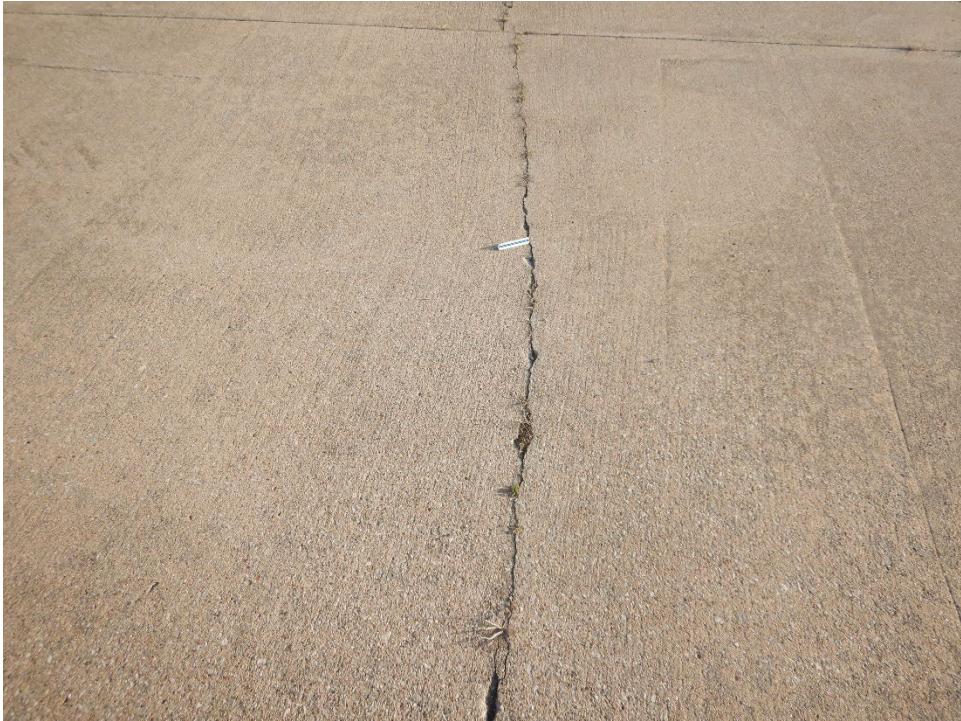
TH01CH-03. LTD Cracking (Sample Unit No. 01) (1).

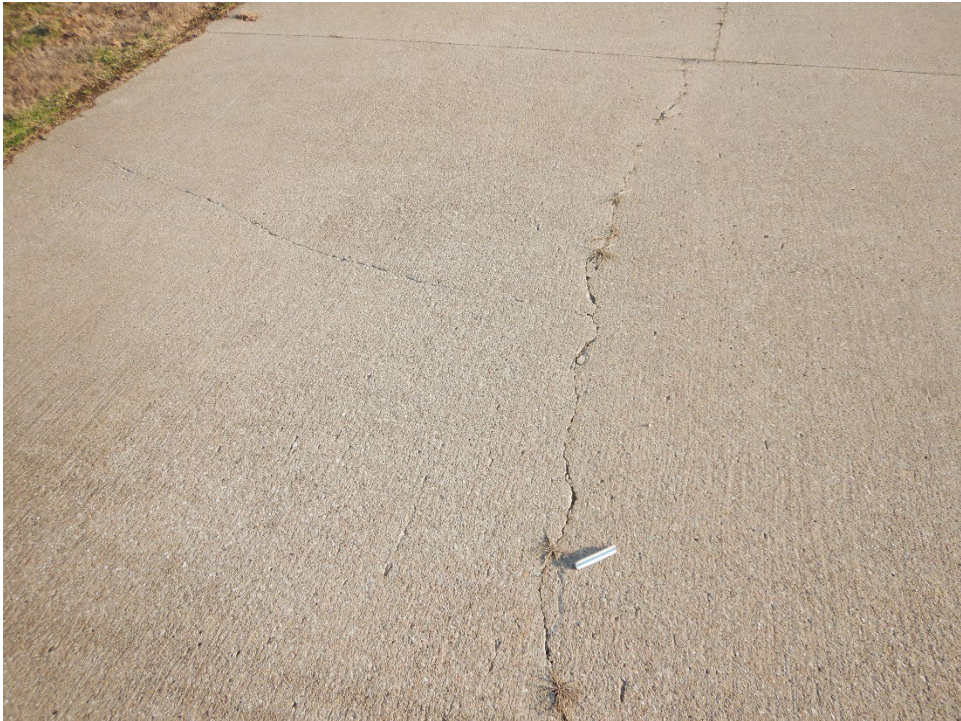
TH01CH-03. LTD Cracking (Sample Unit No. 01) (2).
