# Cherokee County Regional Airport

## Pavement Management Report

**AUGUST 2026**

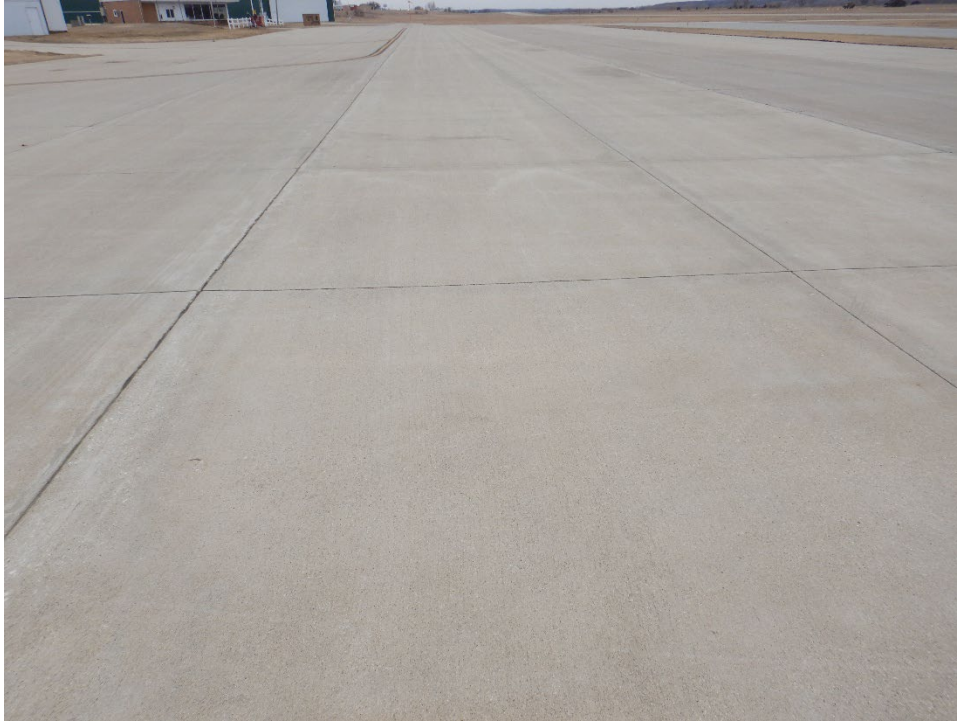
A01CK-01. Overview.

The apron area contained one section with low-severity corner break and faulting; low- and medium-severity corner spalling, joint seal damage, and LTD cracking; medium-severity joint spalling; and shrinkage cracking identified.

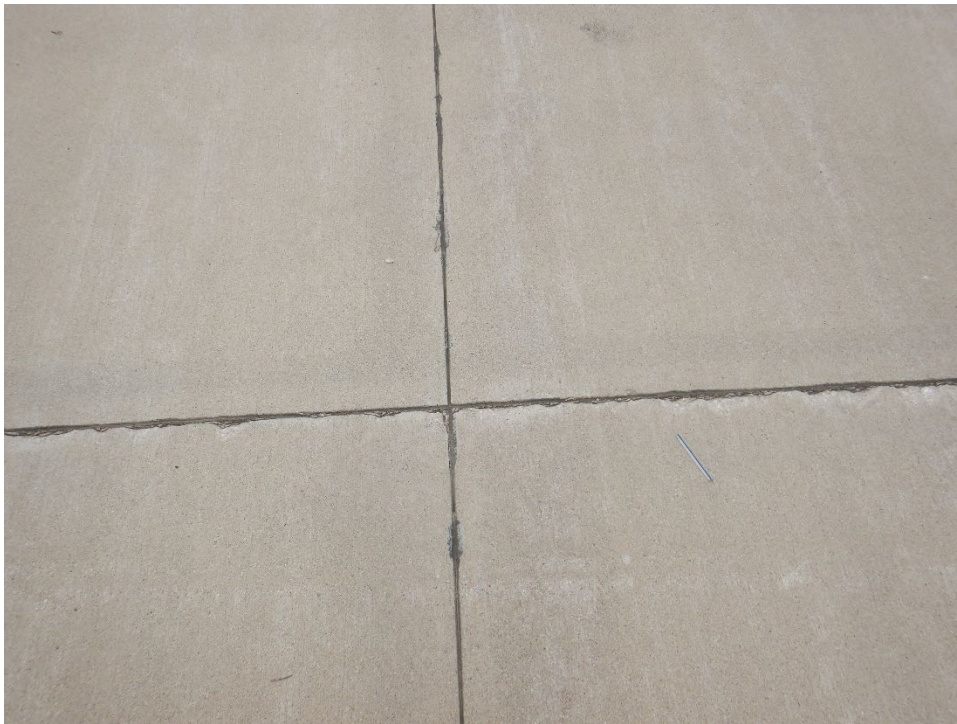
A01CK-01. Joint Seal Damage (Sample Unit No. 03).

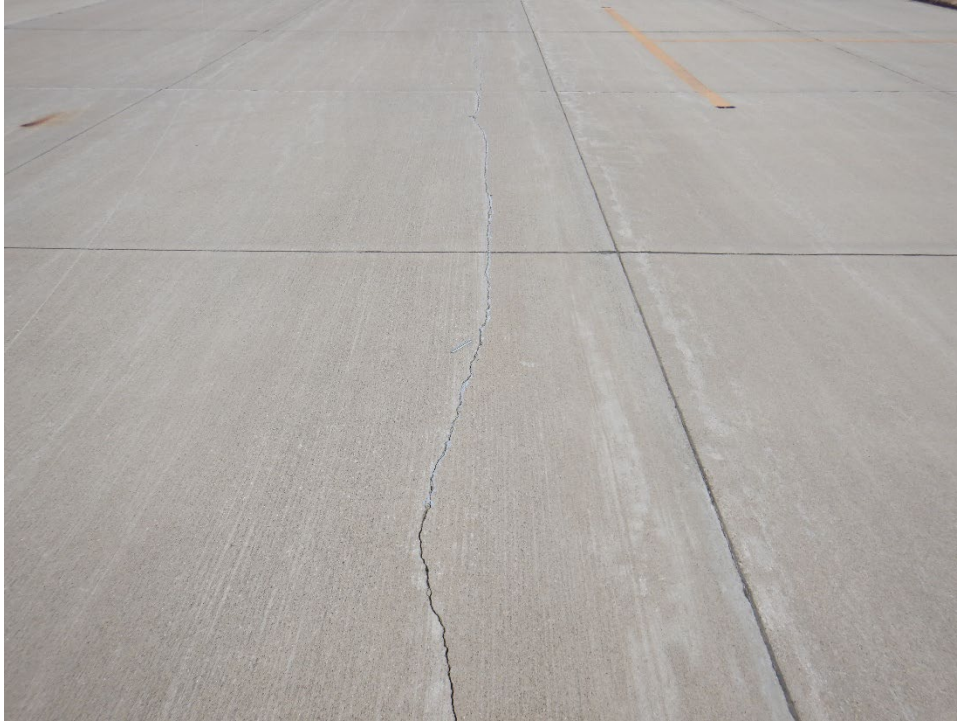
A01CK-01. LTD Cracking (Sample Unit No. 03).

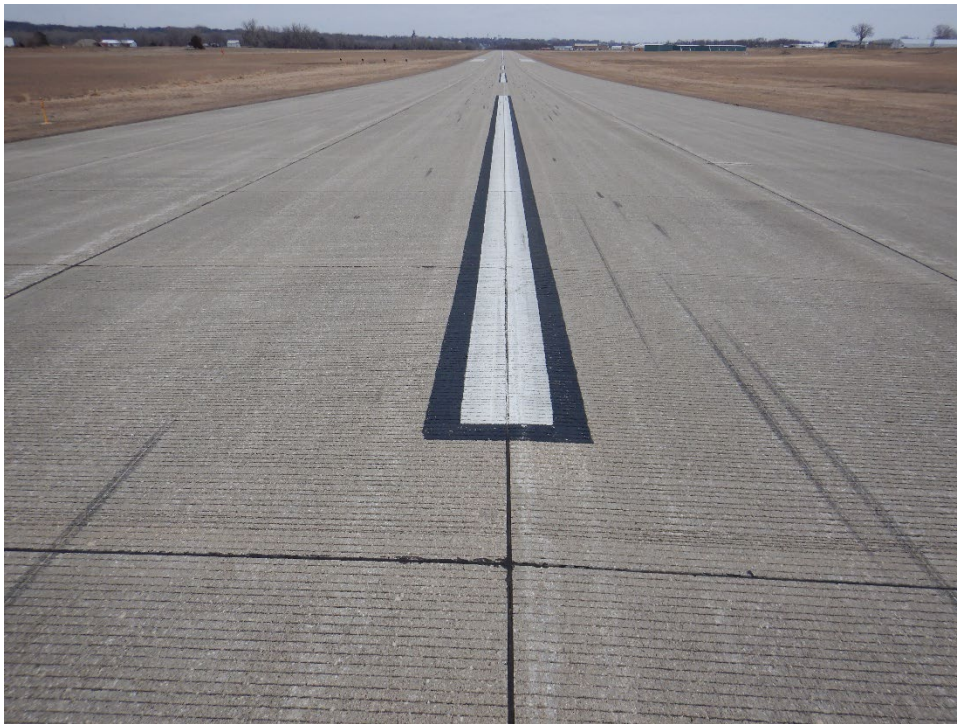
R18CK-01. Overview.

Runway 18/36 consisted of one section with medium-severity corner spalling, low-severity faulting and joint spalling, high-severity joint seal damage, and low- and medium-severity small patching recorded.

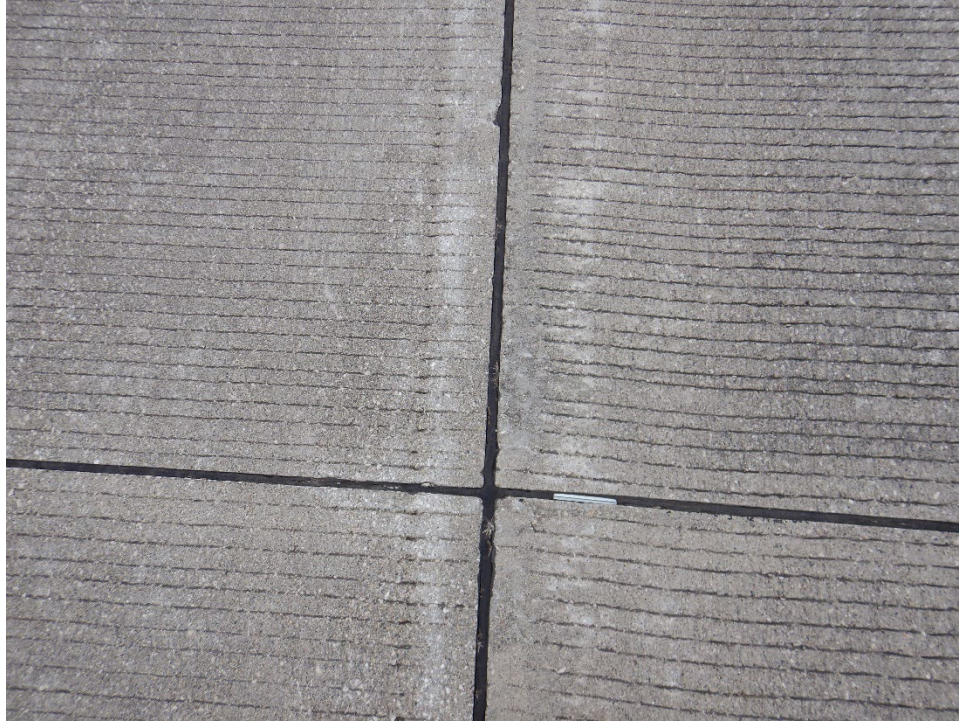
R18CK-01. Joint Seal Damage (Sample Unit No. 74).

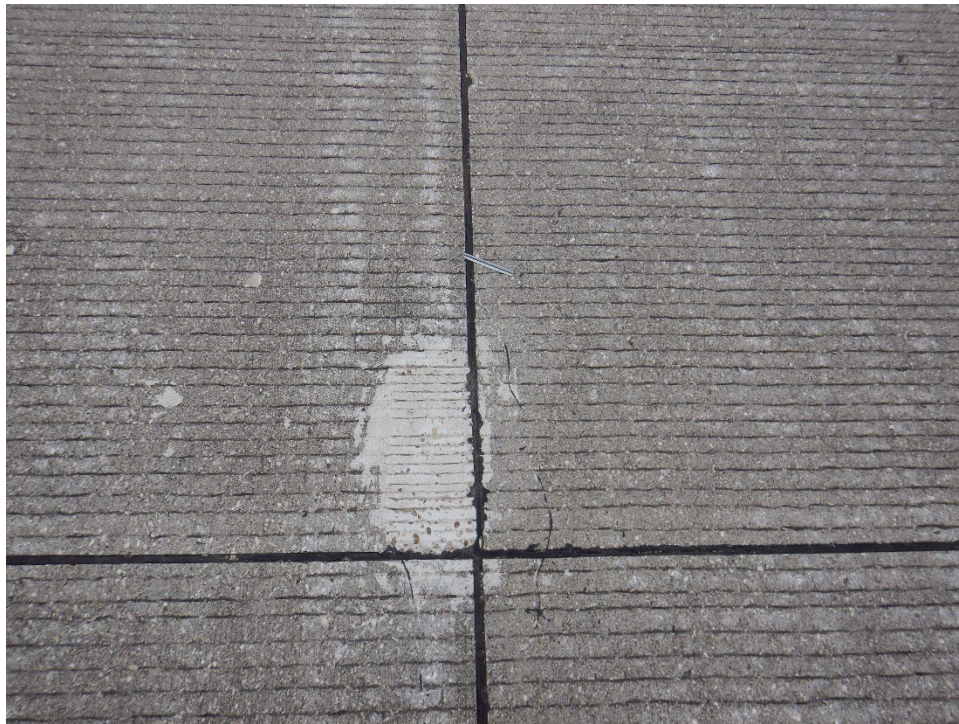
R18CK-01. Small Patching (Sample Unit No. 65).

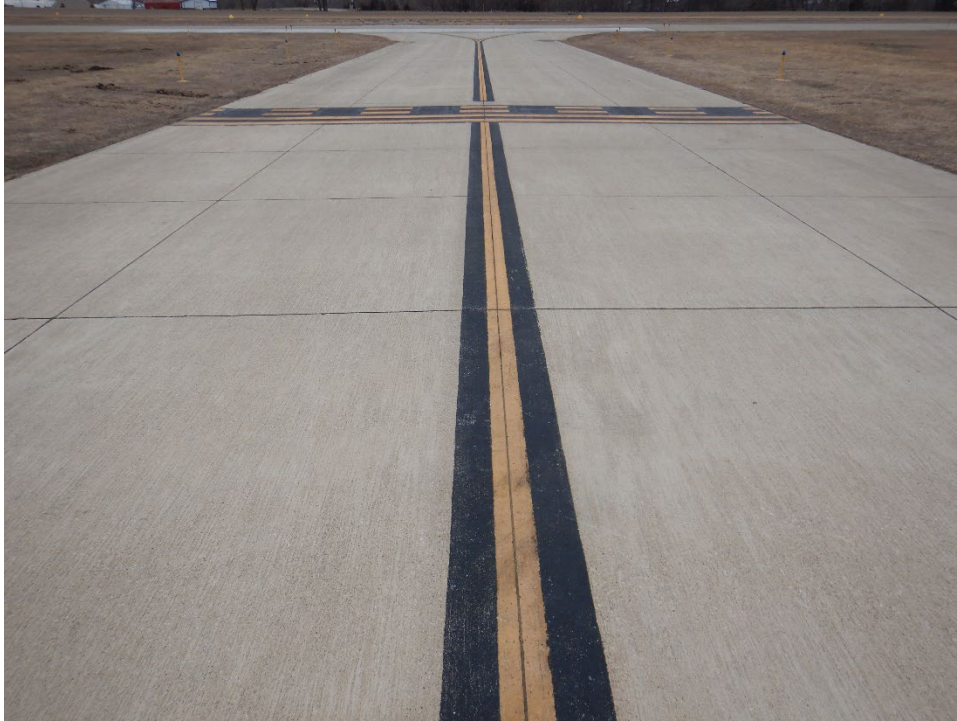
T01CK-01. Overview.

Taxiway 01 contained one section. Medium-severity joint seal damage and joint spalling and low-severity small patching and longitudinal, transverse, and diagonal (LTD) cracking were noted in Section 01.

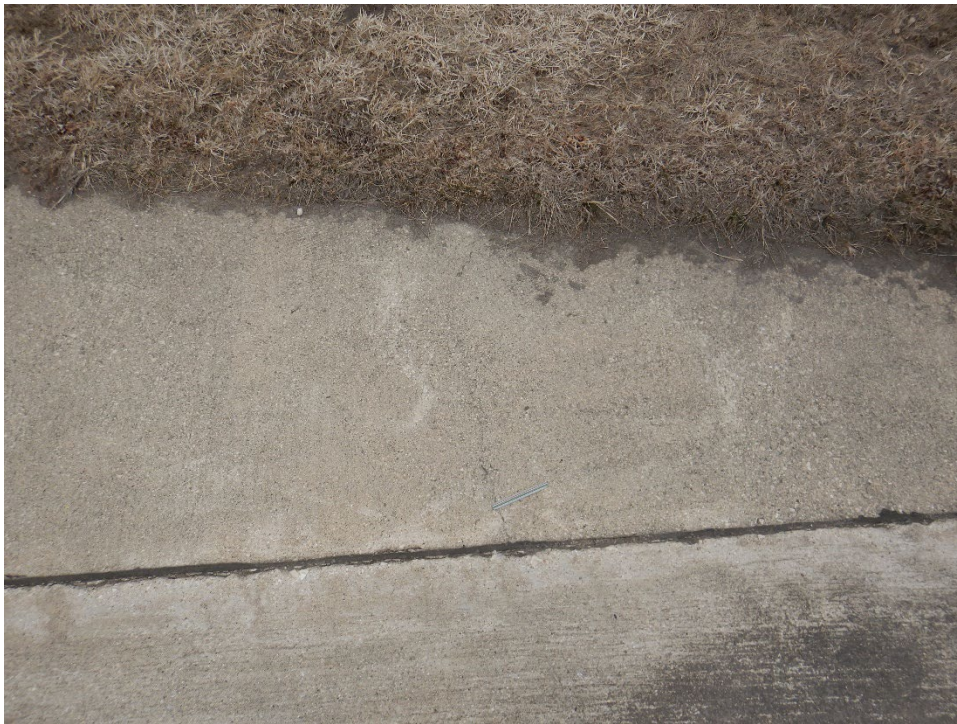
T01CK-01. LTD Cracking (Sample Unit No. 02).

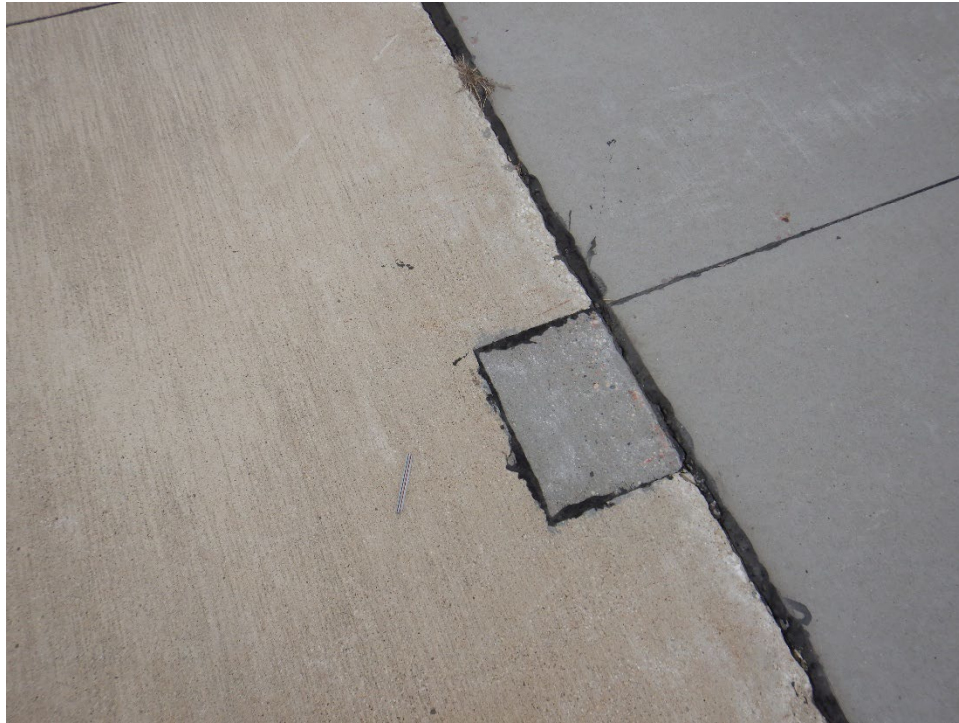
T01CK-01. Small Patching (Sample Unit No. 05).

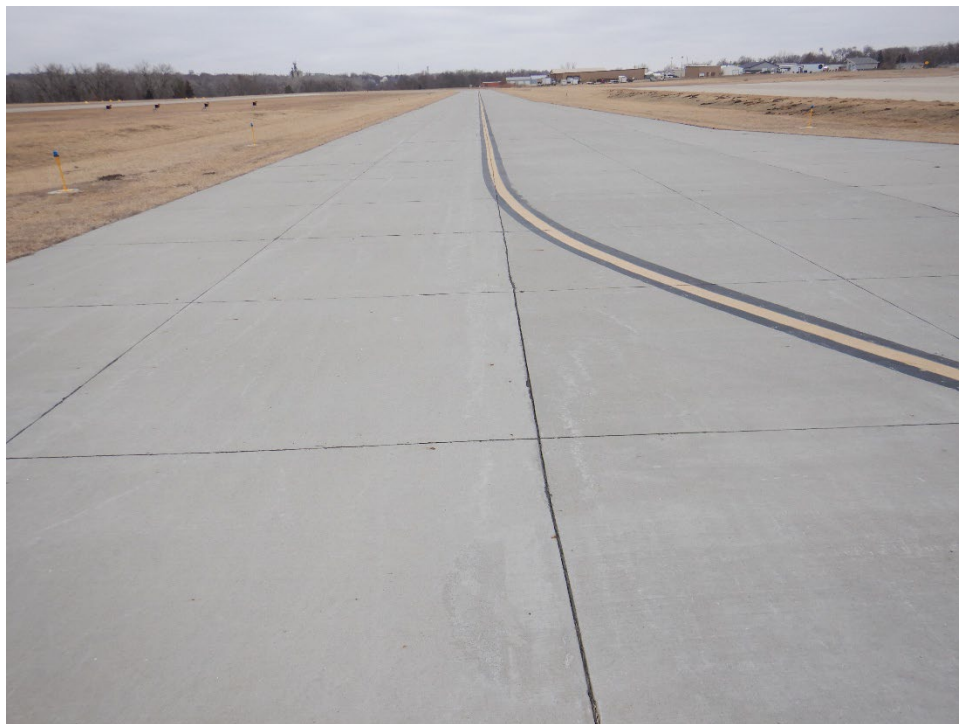
T02CK-01. Overview.

Taxiway 02 was defined by one section containing medium-severity joint seal damage and low-severity small patching. Atypical areas of medium-severity corner break and corner spalling and low- and medium-severity faulting and joint spalling were observed and recorded as additional sample units in accordance with ASTM D5340.

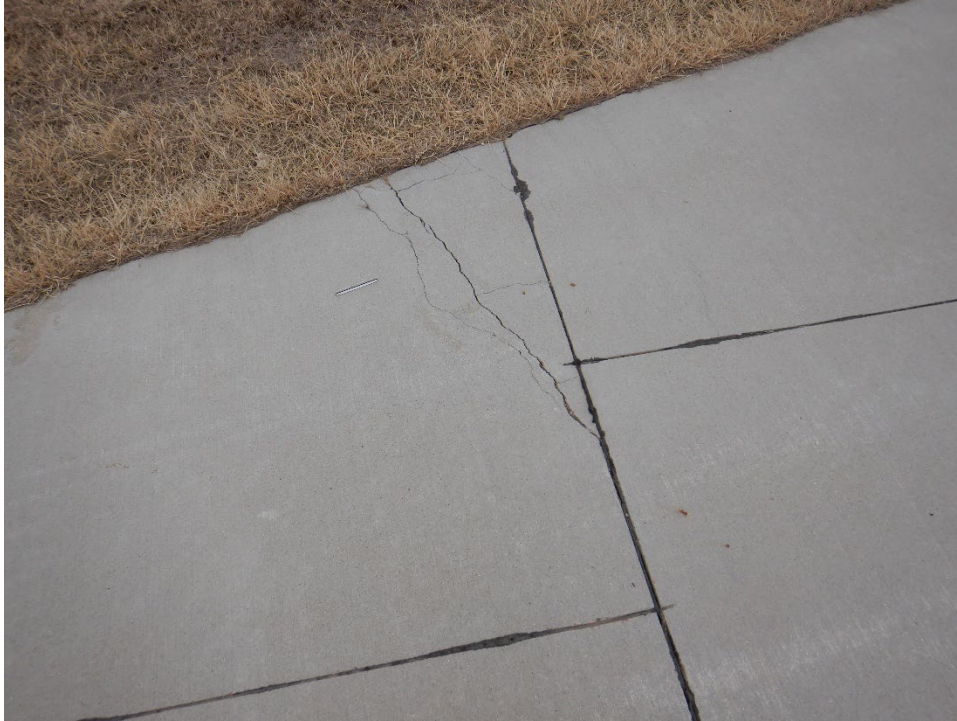
T02CK-01. Corner Break (Additional Sample Unit No. 04).

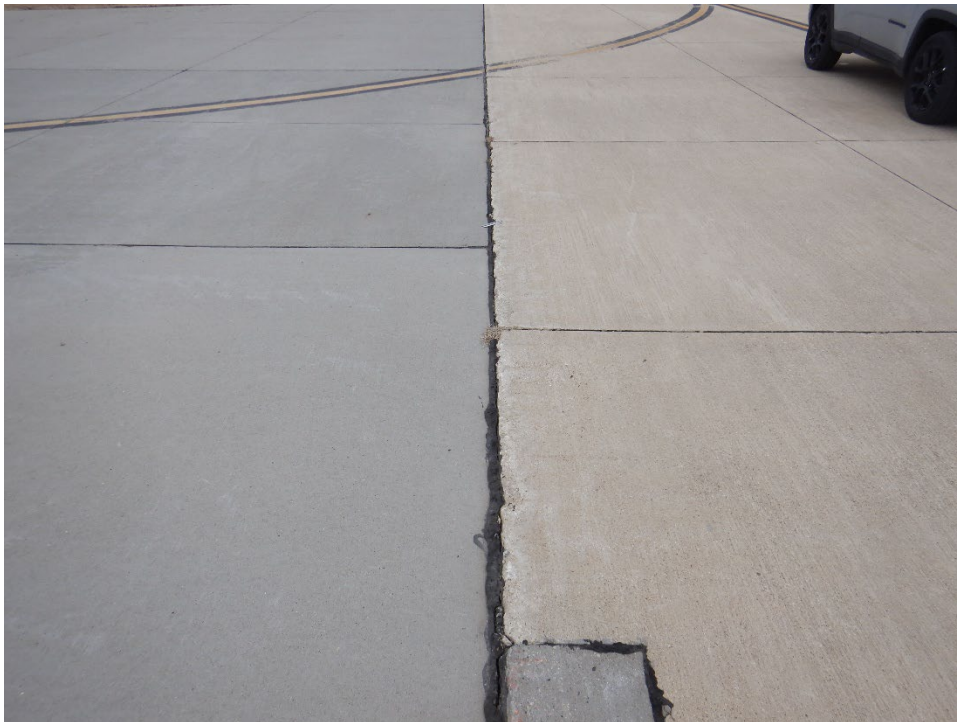
T02CK-01. Faulting (Additional Sample Unit No. 01).

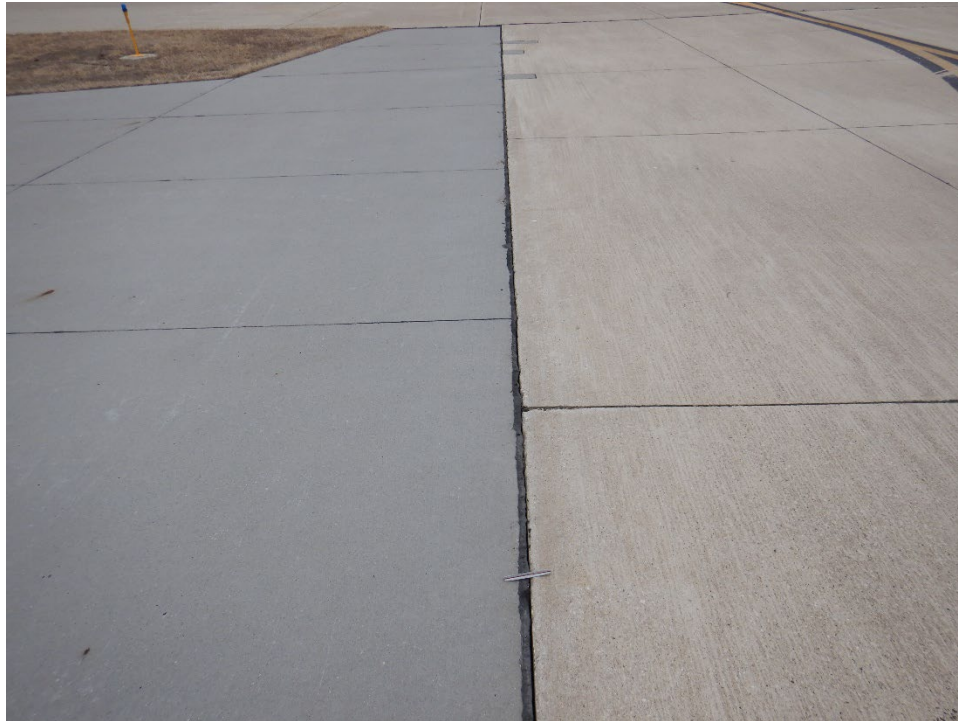
T02CK-01. Faulting (Additional Sample Unit No. 02).

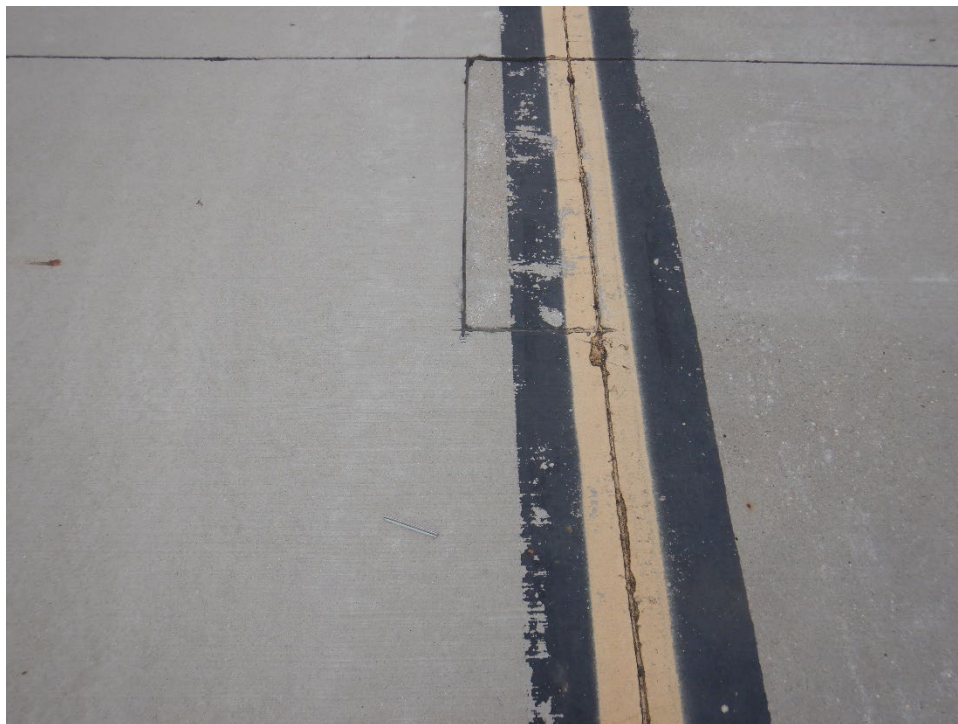
T02CK-01. Small Patching (Sample Unit No. 03).

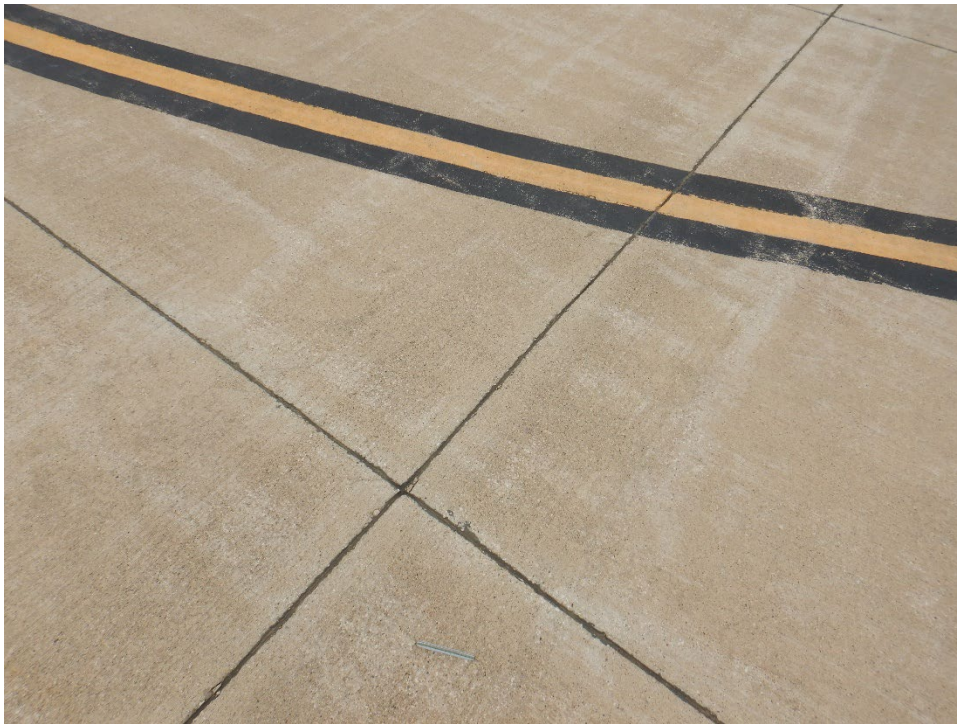
TH01CK-01. Joint Seal Damage (Sample Unit No. 01).

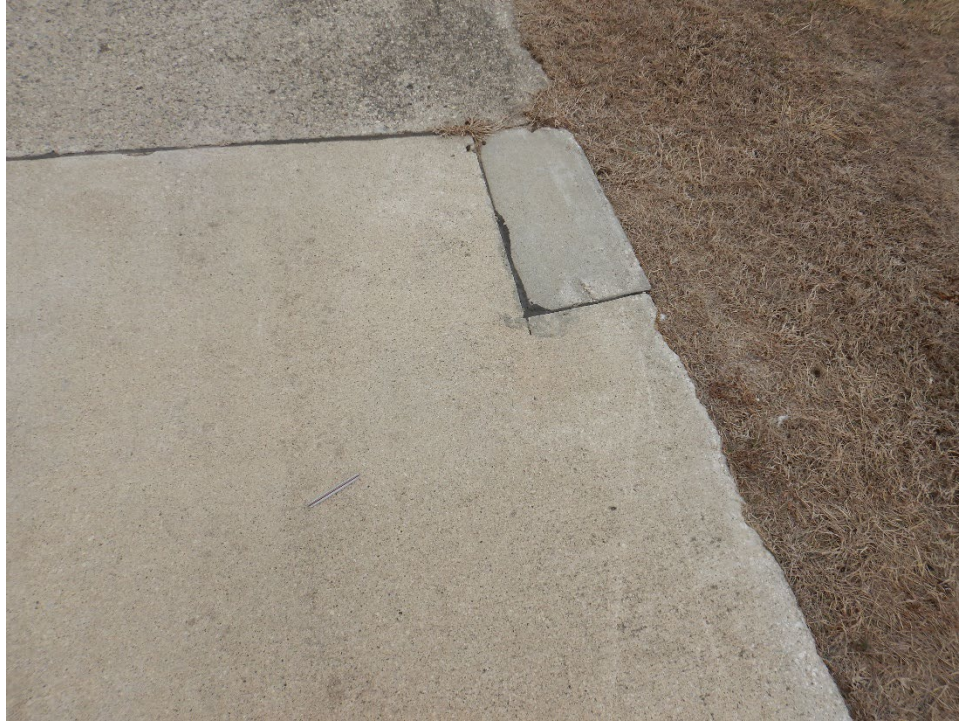
TH01CK-01. Small Patching (Sample Unit No. 01).

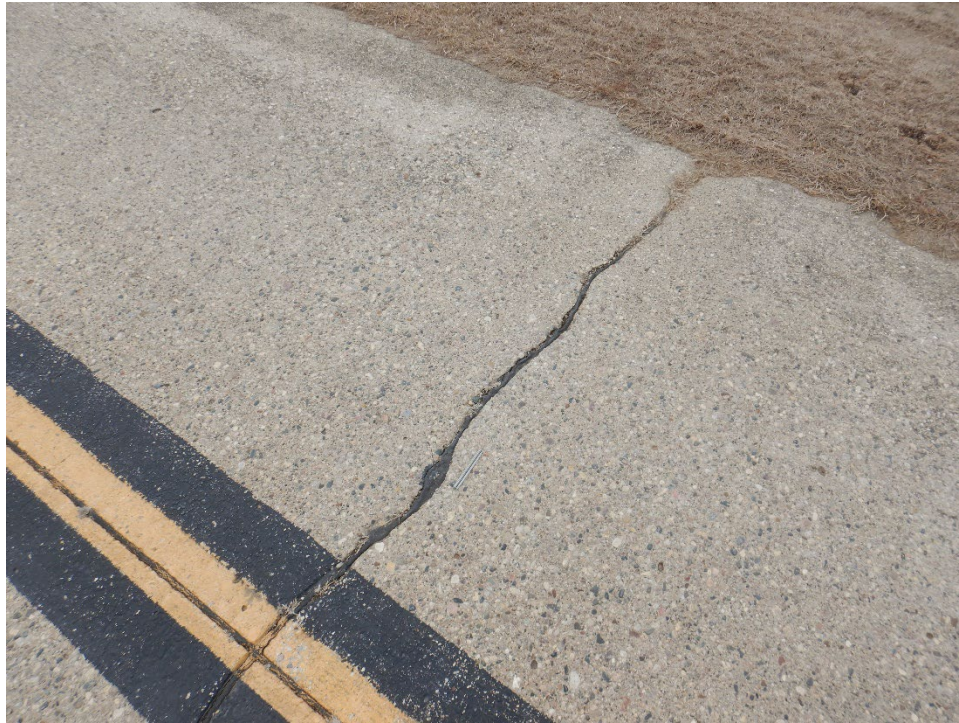
TH01CK-02. LTD Cracking (Sample Unit No. 01).

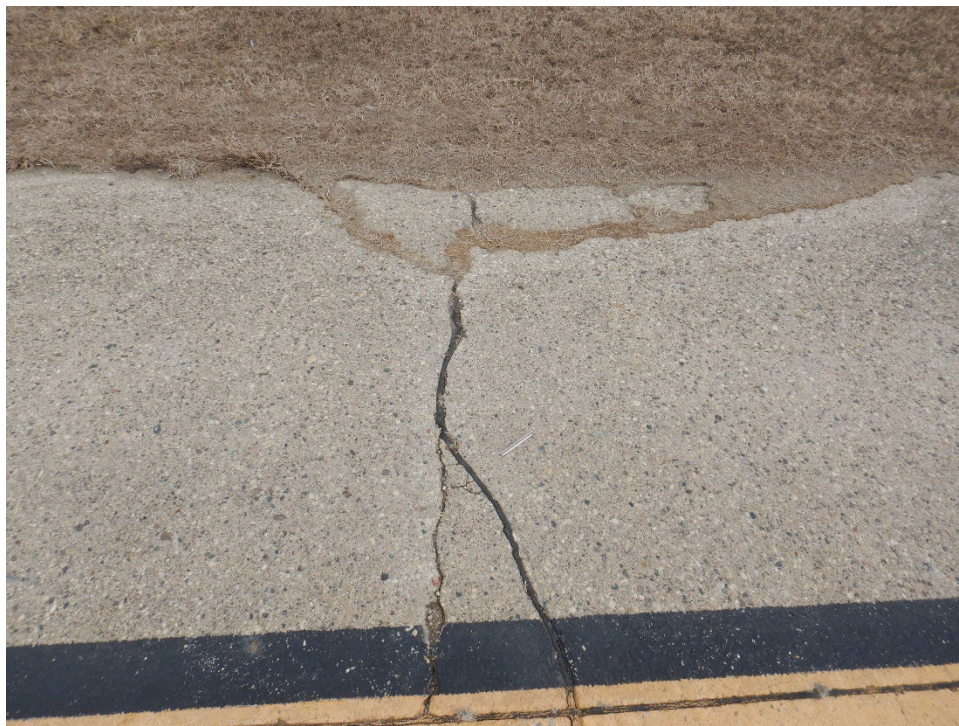
TH01CK-02. Shattered Slab (Sample Unit No. 01).

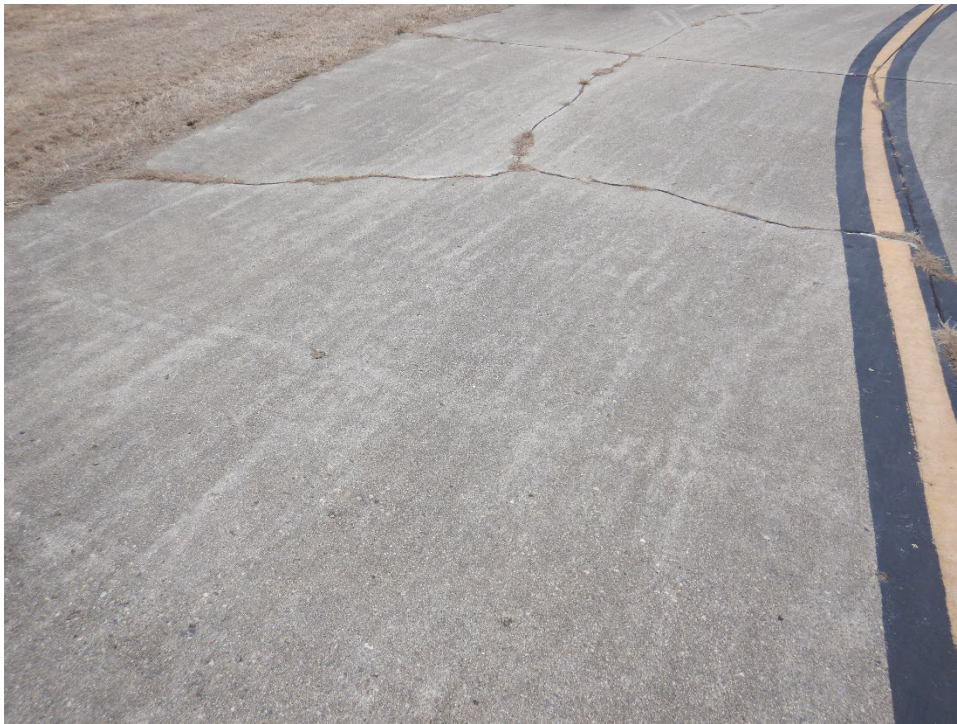
TH01CK-03. LTD Cracking (Sample Unit No. 04).

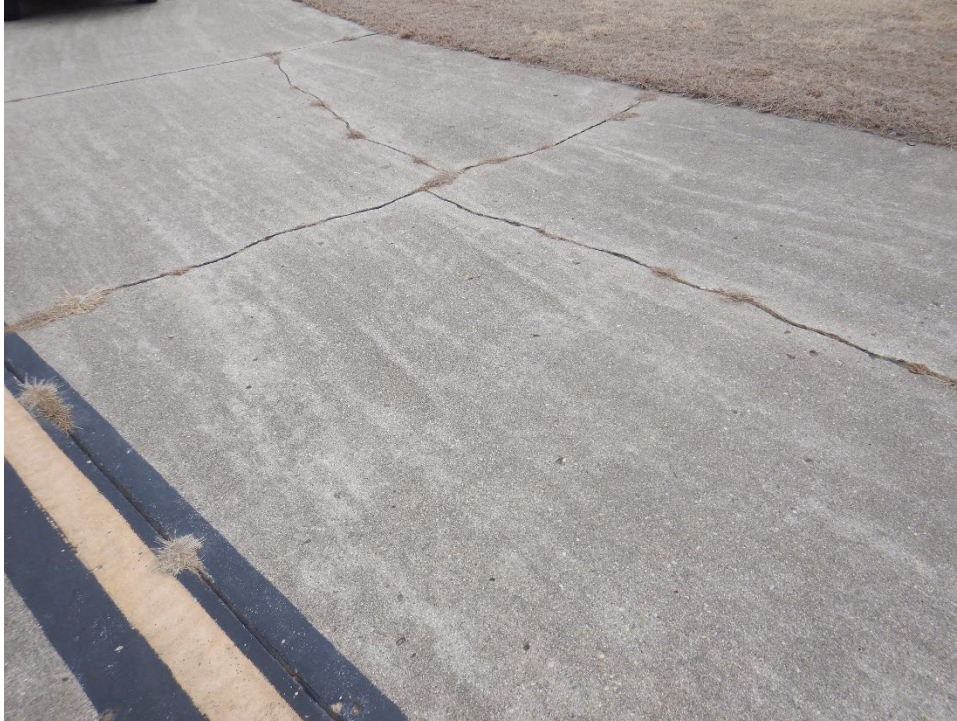
TH01CK-03. Shattered Slab (Sample Unit No. 04).

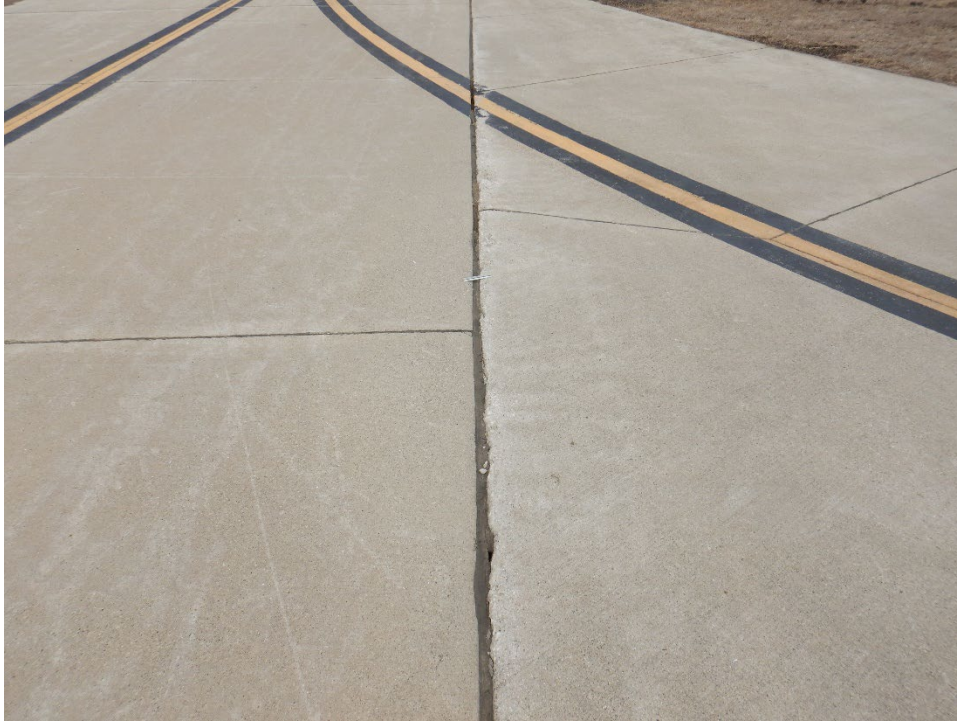
TH02CK-01. Faulting (Sample Unit No. 02).

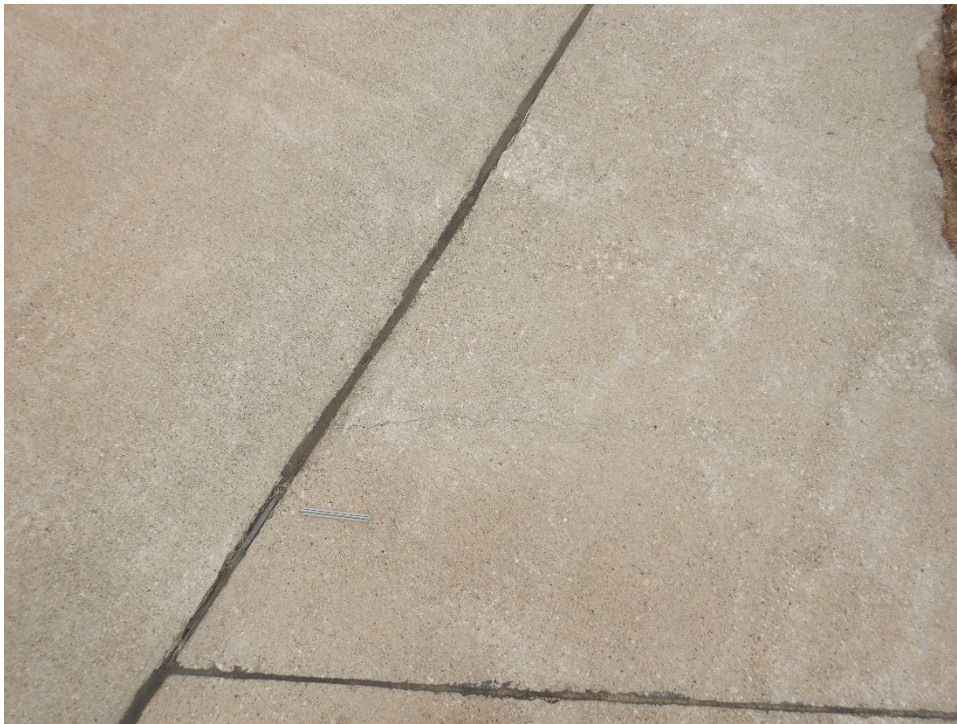
TH02CK-01. Shrinkage Cracking (Sample Unit No. 02).

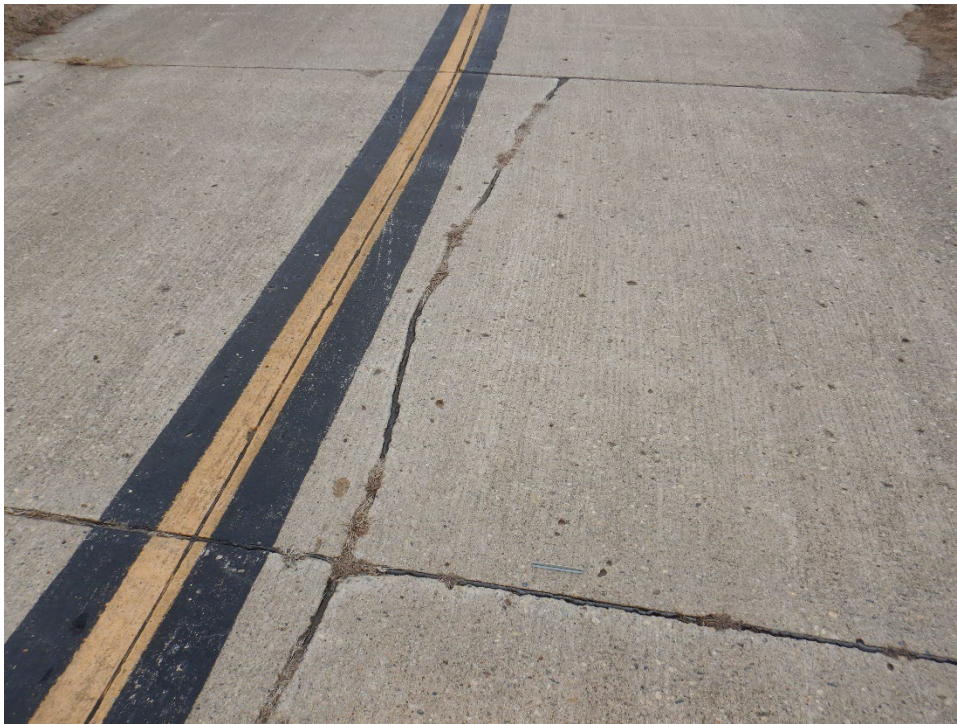
TH02CK-02. LTD Cracking (Sample Unit No. 01).

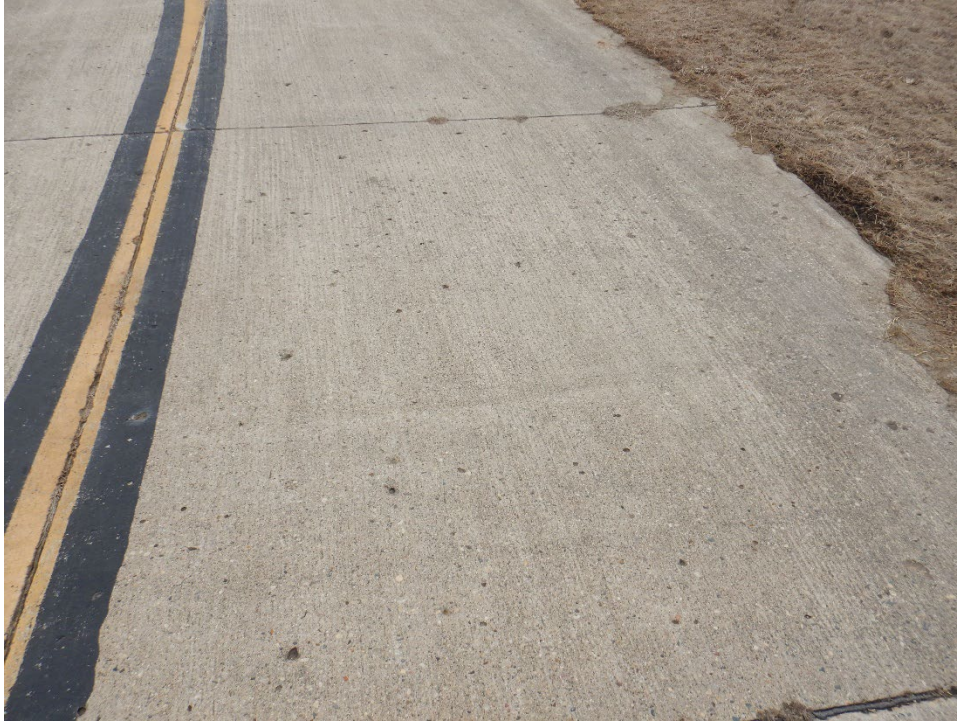
TH02CK-02. Popouts (Sample Unit No. 01).

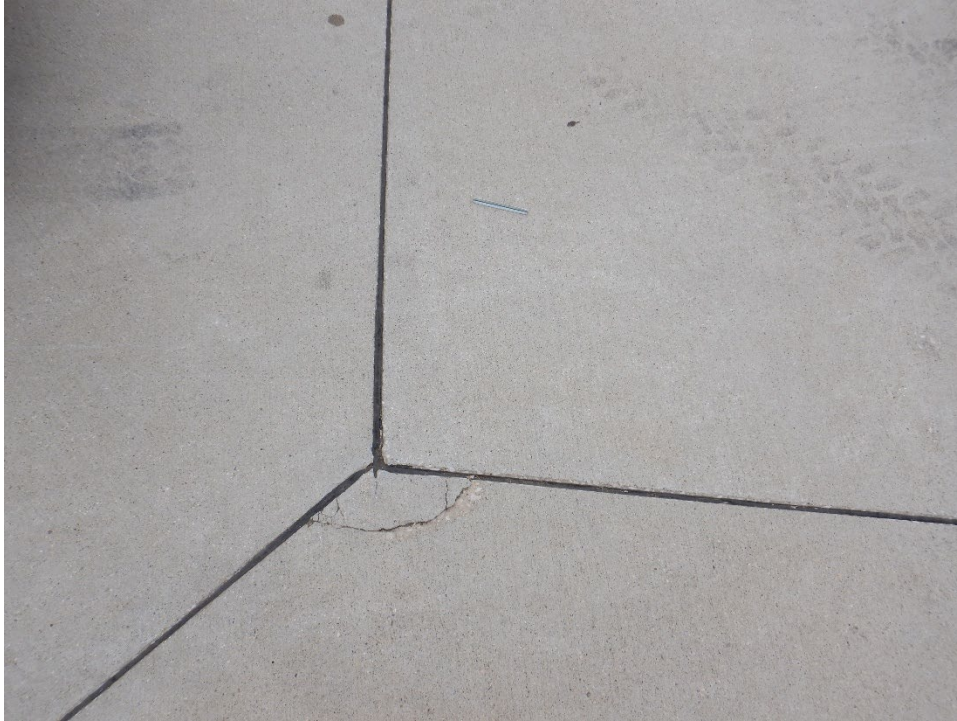
TH02CK-03. Corner Spalling (Sample Unit No. 04).

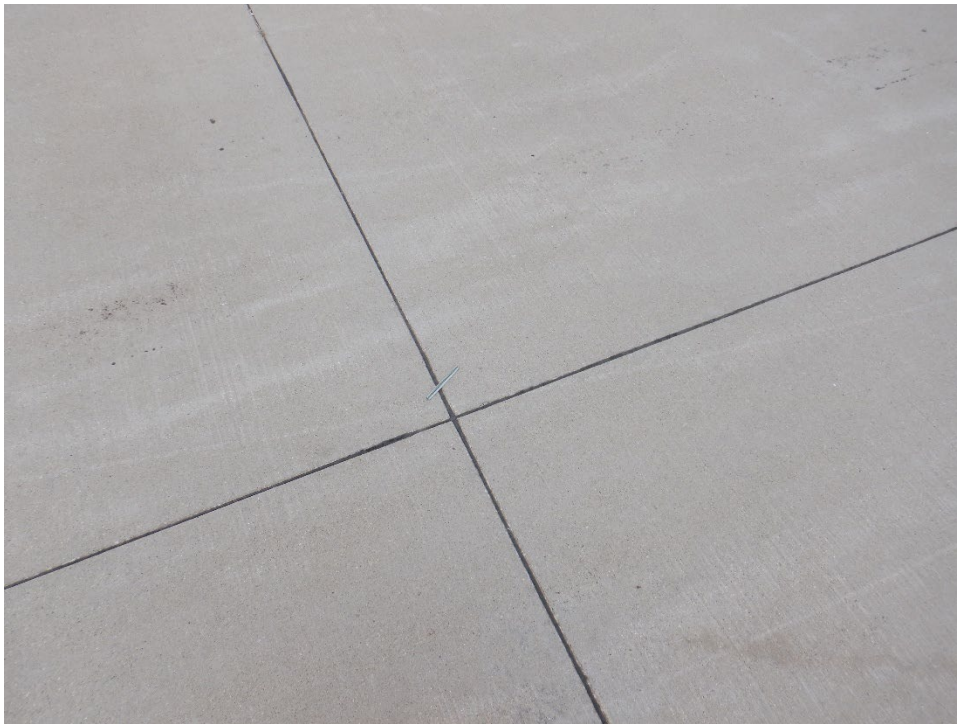
TH02CK-03. Joint Seal Damage (Sample Unit No. 04).

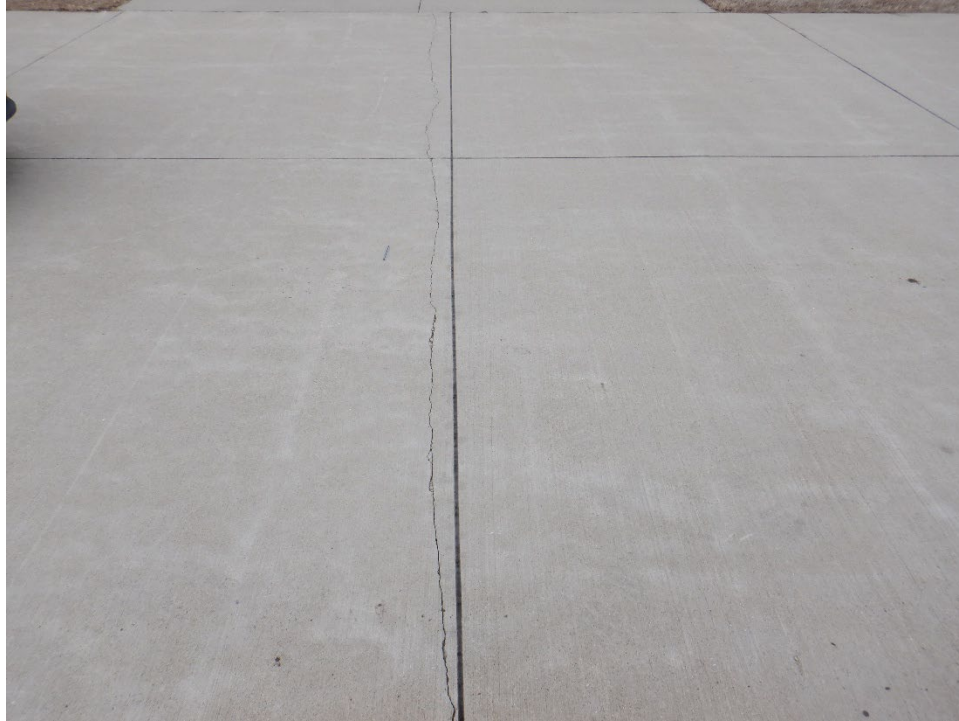
TH02CK-03. Joint Spalling (Sample Unit No. 02).
