# Clarinda-Schenck Field Airport

## Pavement Management Report

**AUGUST 2025**

# CLARINDA-SCHENCK FIELD AIRPORT PAVEMENT MANAGEMENT REPORT

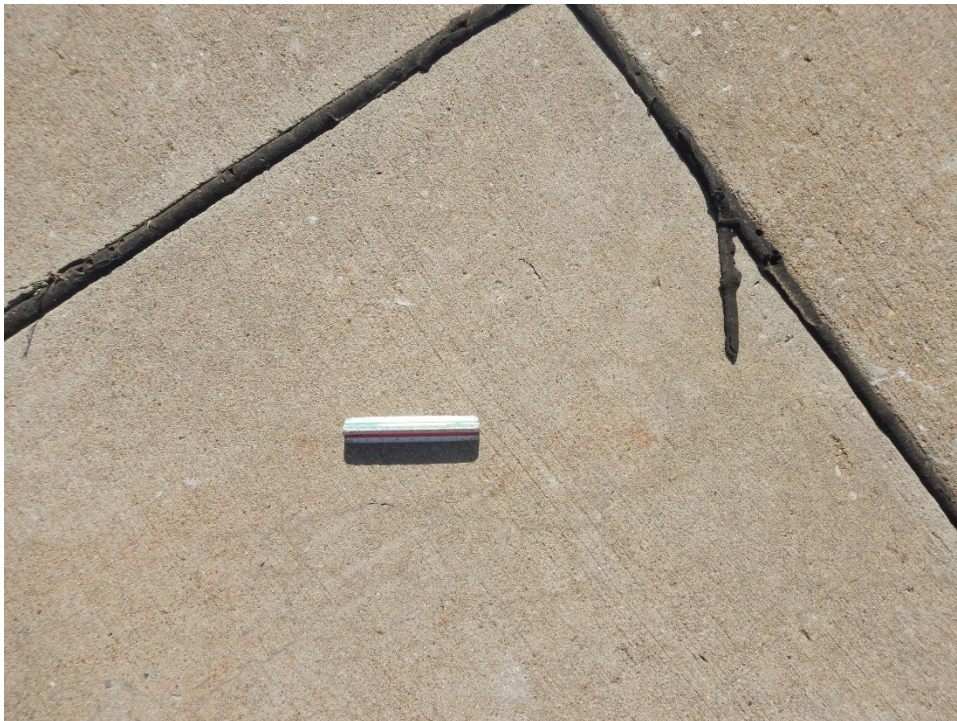
Clarinda-Schenck Field Airport was inspected on March 28, 2025. There were 11 pavement sections defined during the inspection. Alkali-silica reaction (ASR) was recorded at this airport according to the PCI procedure. The ASR was recorded where evidence of a precipitate was observed within some of the cracking in the PCC surface. It should be noted that laboratory testing in the form of petrographic analysis is the only definitive way to validate the presence of ASR; however, the formation of a precipitate is evidence of a reaction consistent with this type of materials-related distress.

A01CD-01. ASR (Sample Unit No. 01).

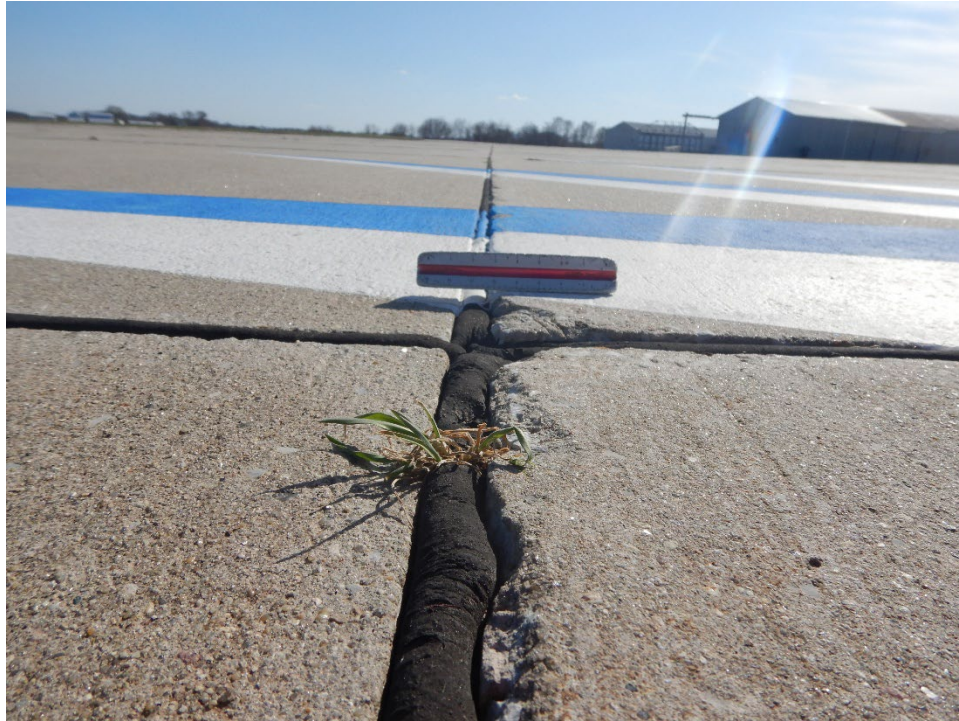
A01CD-01. Faulting (Sample Unit No. 13).

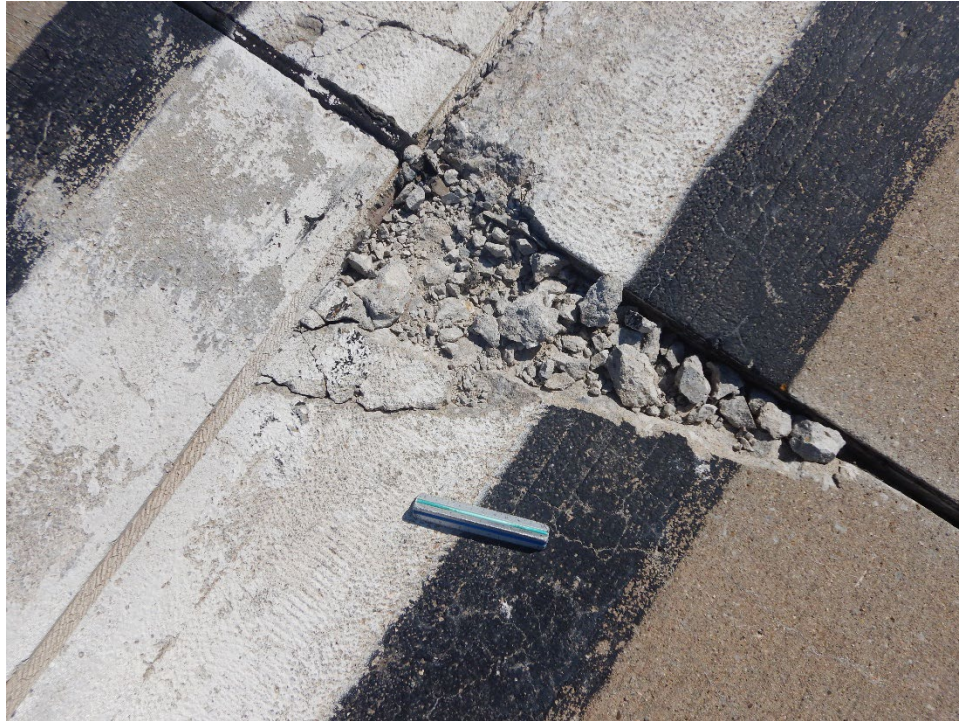
Runway 02/20 contained two sections. Section 01 had low- and high-severity ASR; low- and medium-severity corner spalling; and low-severity faulting, joint seal damage, large patching, small patching, and longitudinal, transverse, and diagonal (LTD) cracking. Low- and medium-severity joint seal damage and low-severity ASR, faulting, LTD cracking, and small patching were recorded in Section 02.

R02CD-01. ASR (Sample Unit No. 73).

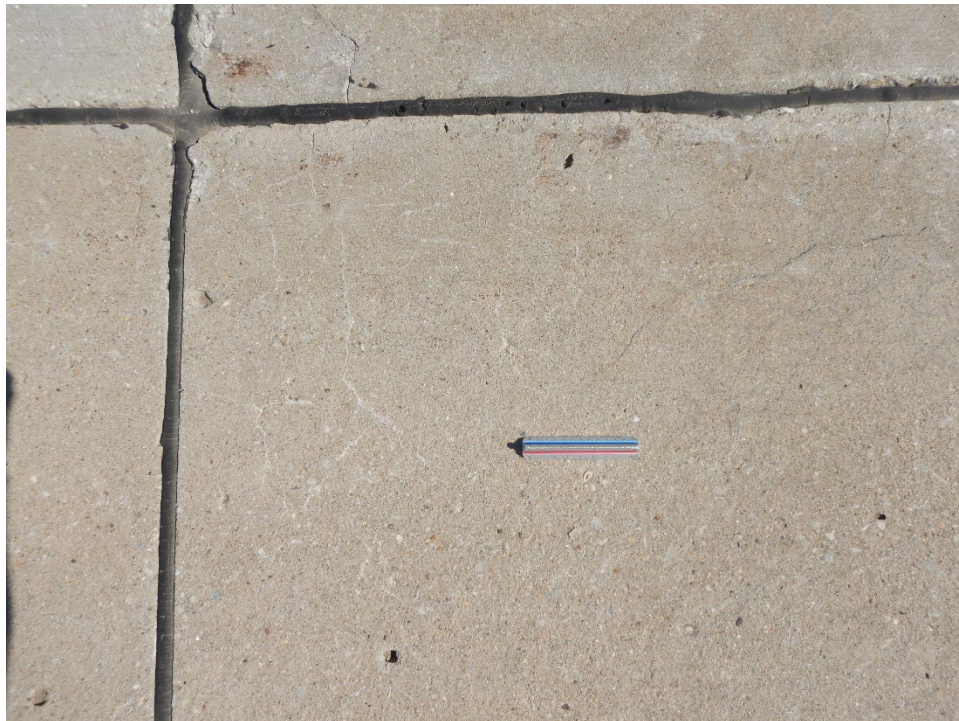
R02CD-01. ASR (Sample Unit No. 80).

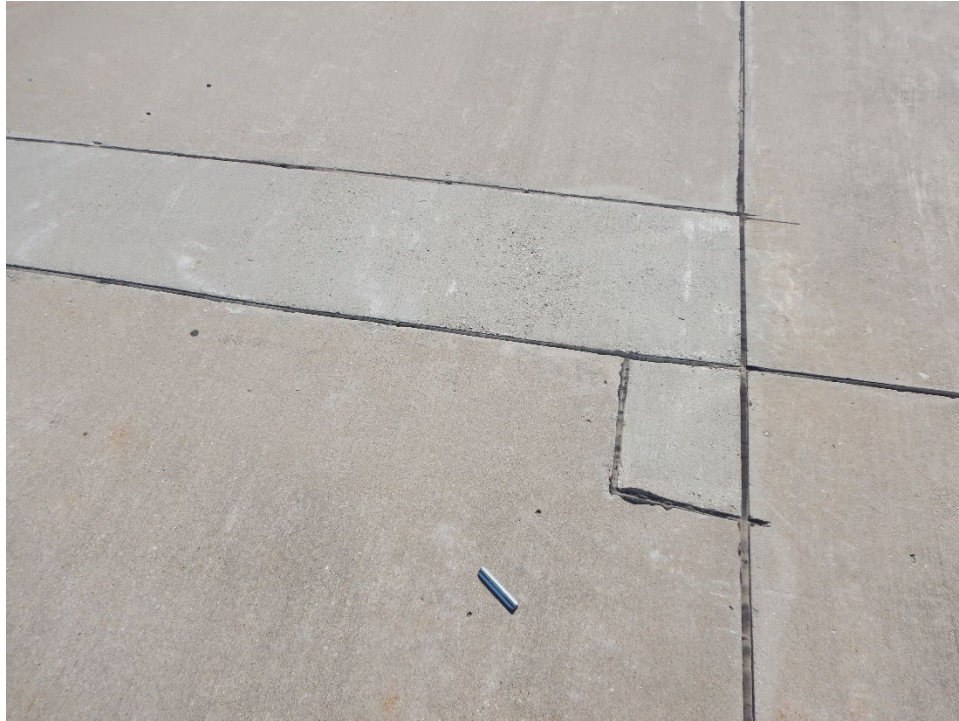
R02CD-01. Small Patching (Sample Unit No. 80).

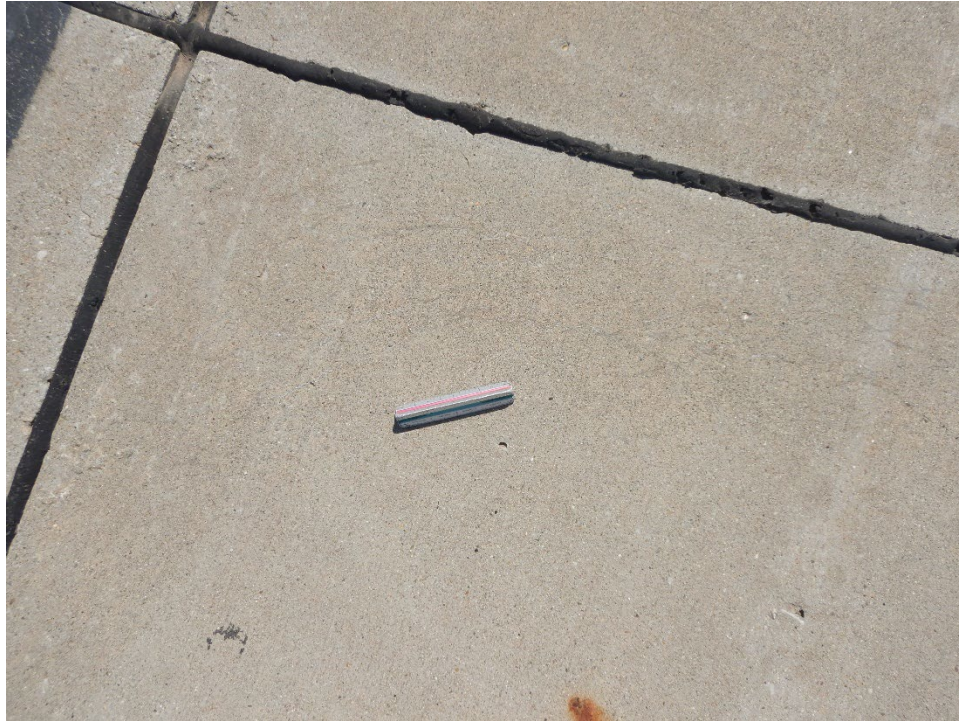
R02CD-02. ASR (Sample Unit No. 02).

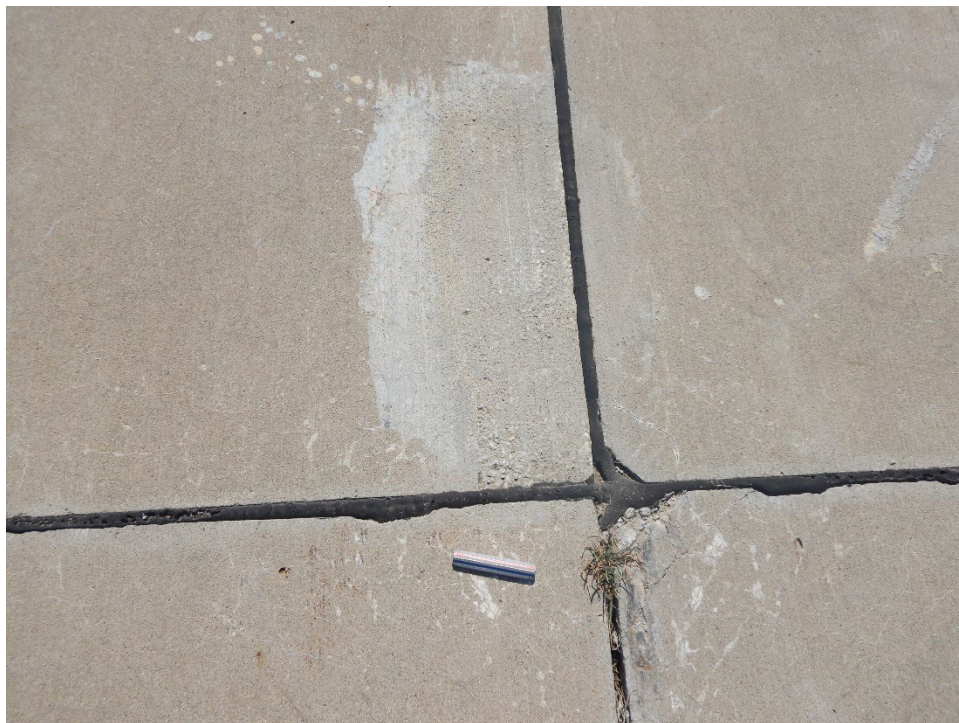
R02CD-02. Small Patching (Sample Unit No. 07).

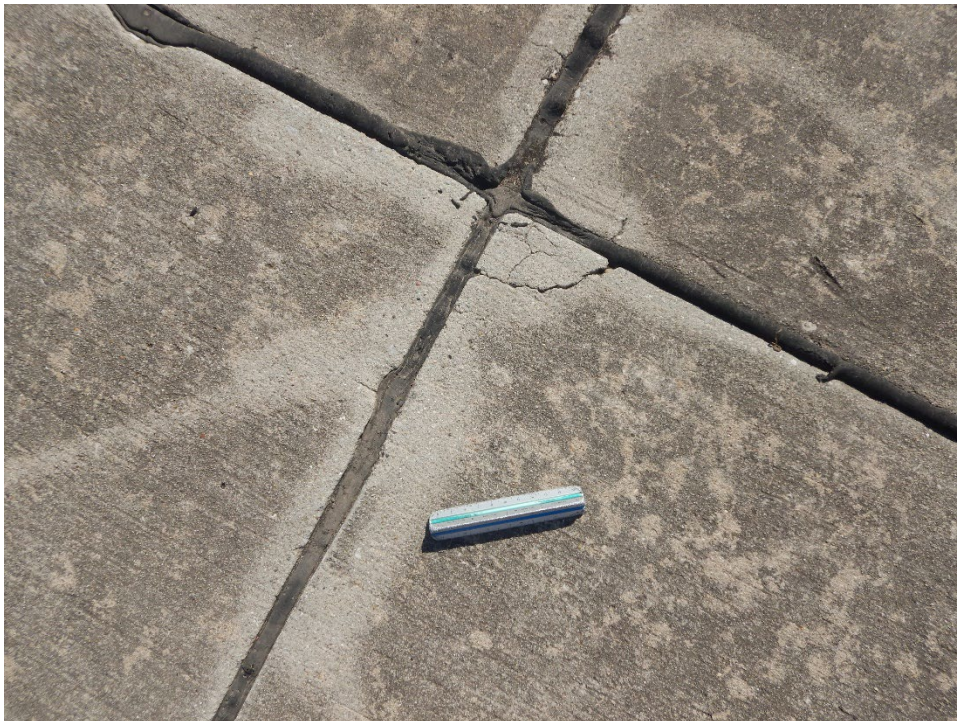
Runway 13/31 consisted of two sections. Low- and medium-severity faulting and low-severity corner spalling, joint seal damage, and LTD cracking were recorded in Section 01 while low-severity faulting, joint seal damage, and LTD cracking were noted in Section 02.

R13CD-01. Corner Spalling (Sample Unit No. 01).

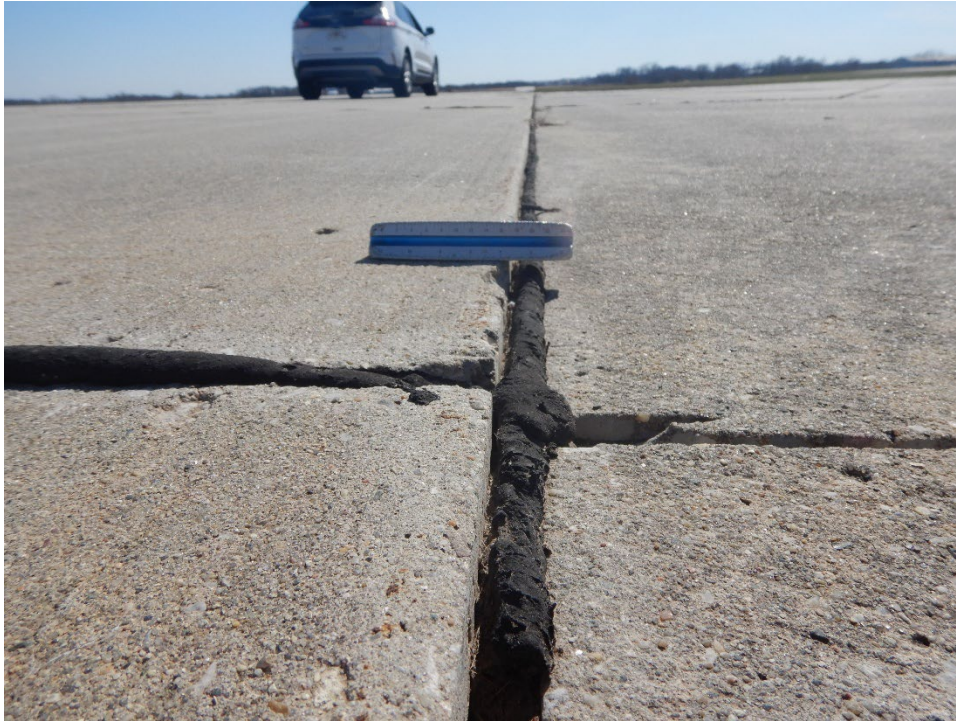
R13CD-01. Faulting (Sample Unit No. 01).

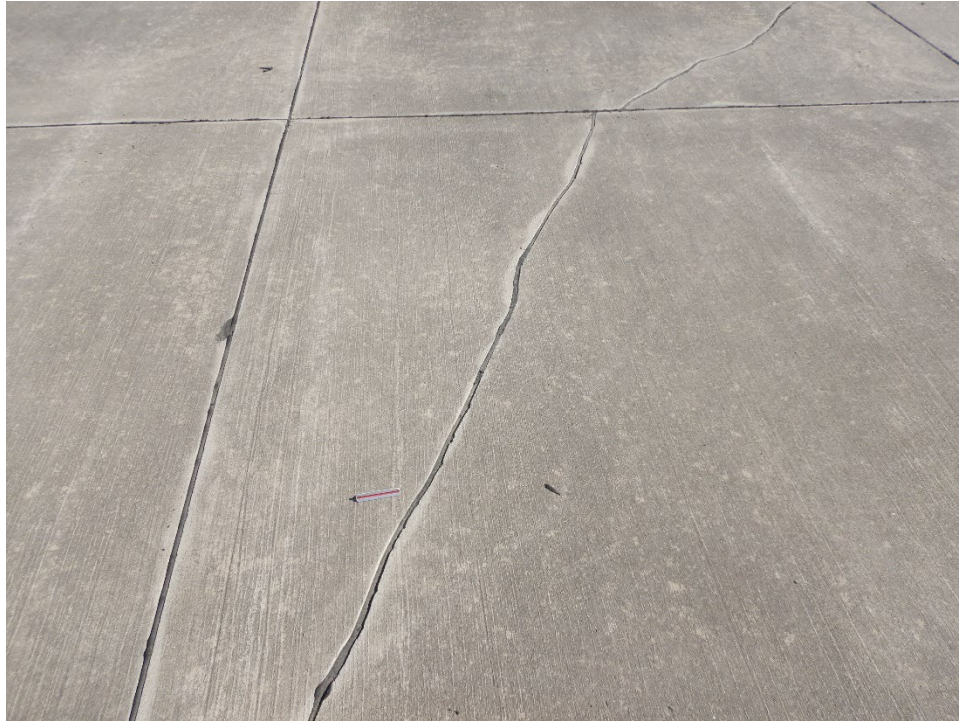
| <b>Distress Type</b> | <b>Probable Cause of Distress</b> |
|---|---|
| LTD Cracking | Combination of load repetition, curling stresses, and shrinkage stresses. |

R13CD-02. LTD Cracking (Sample Unit No. 02).

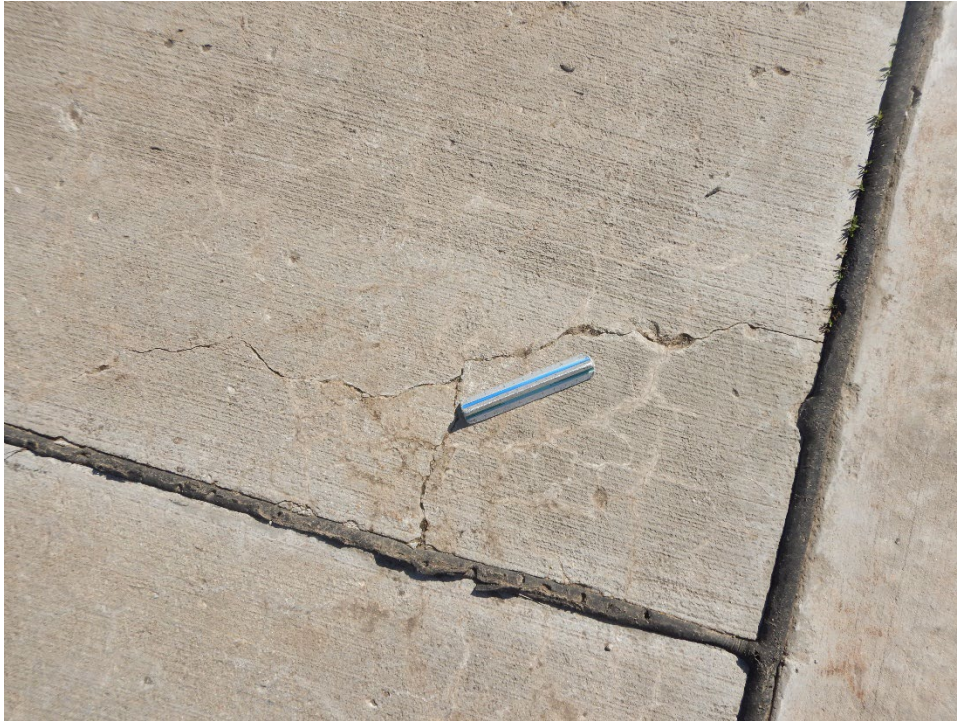
Taxiway 01 was comprised of one section that connected the apron area to Runway 02/20. Medium-severity joint spalling and low-severity ASR, joint seal damage, and LTD cracking were observed in Section 01.

T01CD-01. ASR (Sample Unit No. 07).

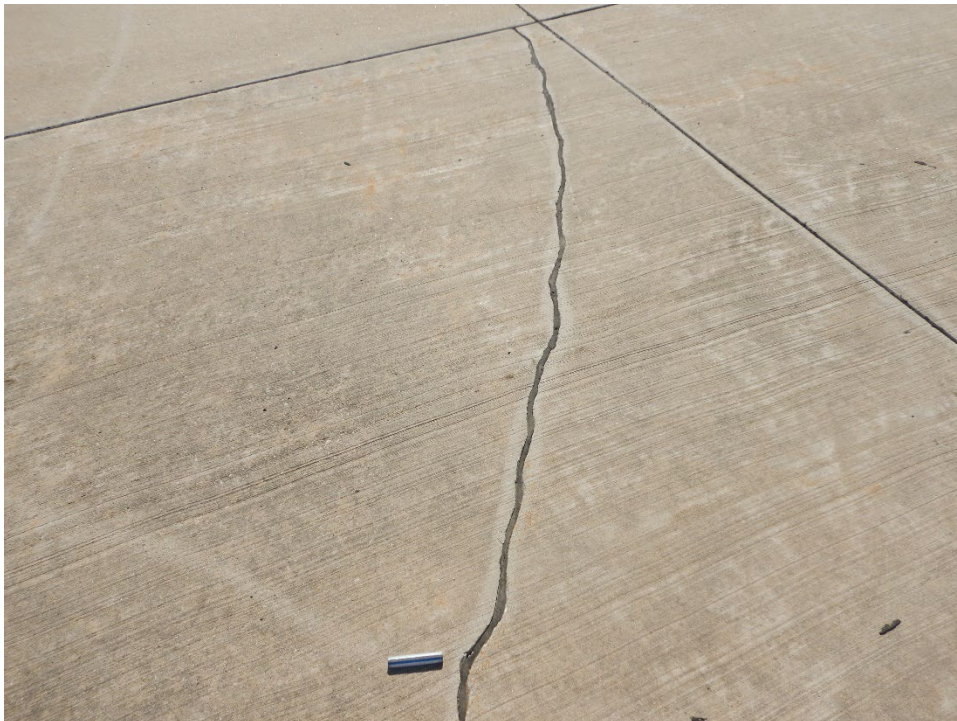
T01CD-01. LTD Cracking (Sample Unit No. 07).

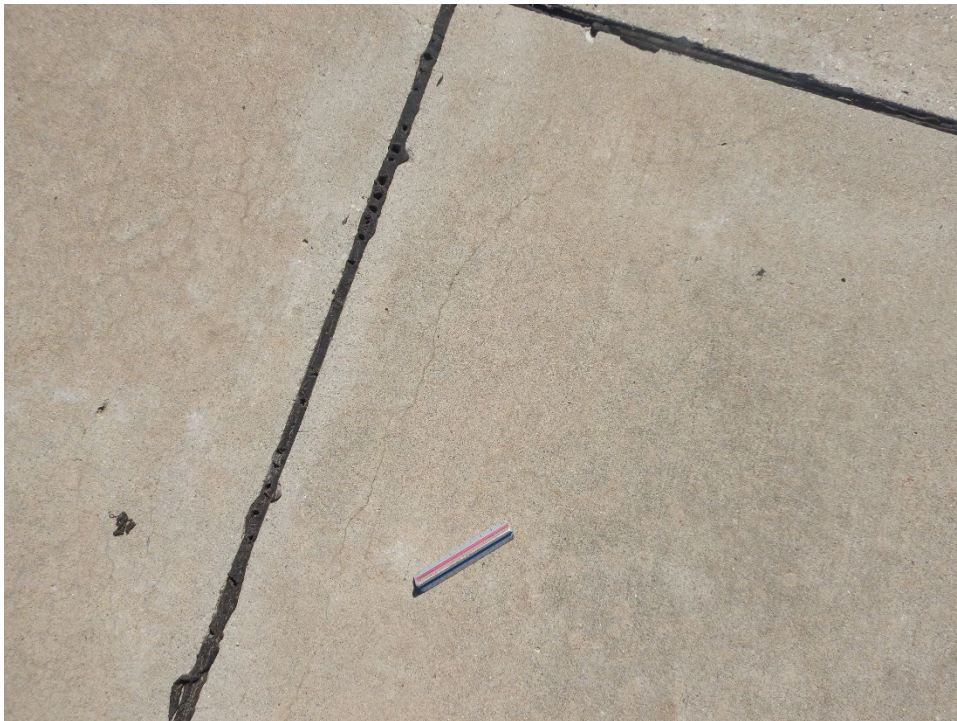
Taxiway 02 consisted of one section. Section 01 had low- and medium-severity ASR along with medium-severity joint seal damage. An atypical area of low-severity faulting was observed and recorded as an additional sample unit in accordance with ASTM D5340.

T02CD-01. ASR (Sample Unit No. 06).

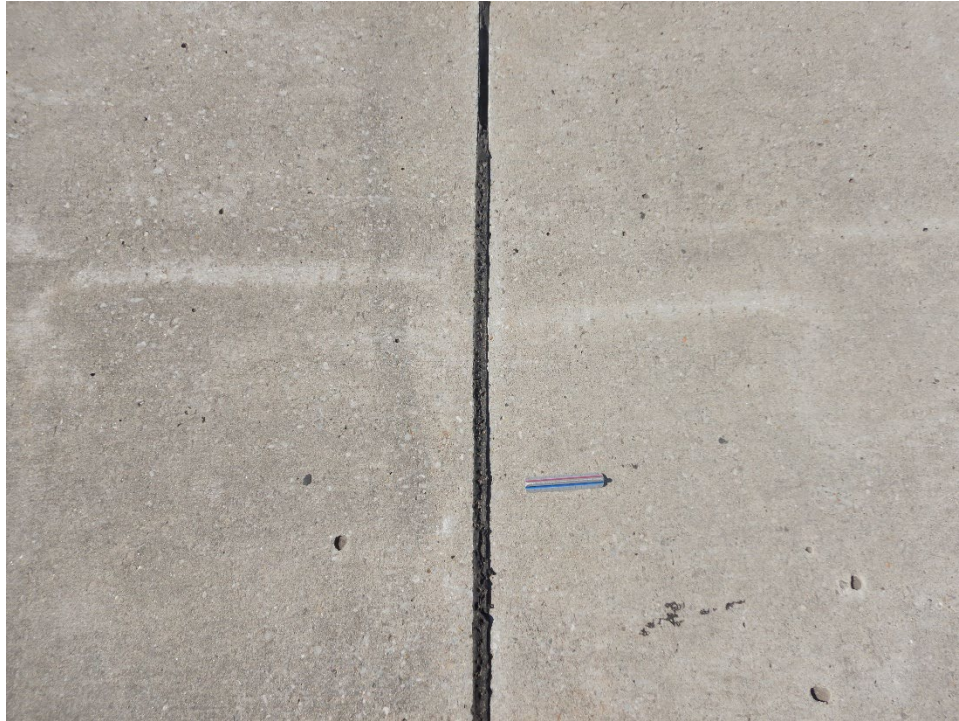
| <b>Distress Type</b> | <b>Probable Cause of Distress</b> |
|---|---|
| Joint Seal Damage | Stripping of joint sealant, extrusion of joint sealant, weed growth, hardening of the filler (oxidation), loss of bond to the slab edges, or absence of sealant in the joint. |

T02CD-01. Joint Seal Damage (Sample Unit No. 06).

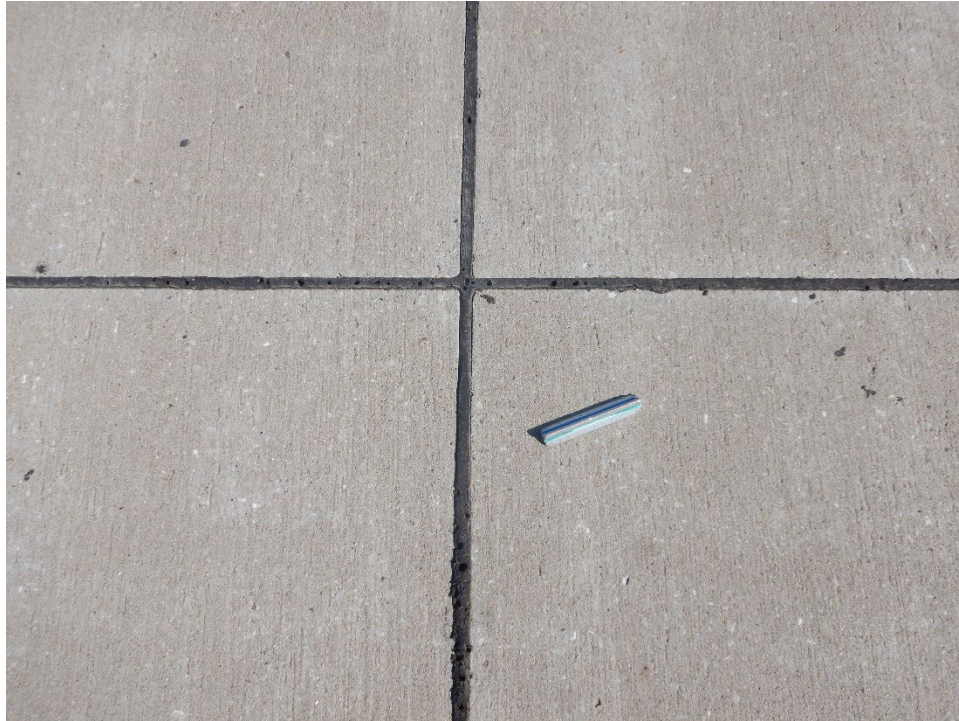
Taxiway 03 contained one section that was in *Excellent* condition with only low-severity joint seal damage identified throughout.

T03CD-01. Joint Seal Damage (Sample Unit No. 02).

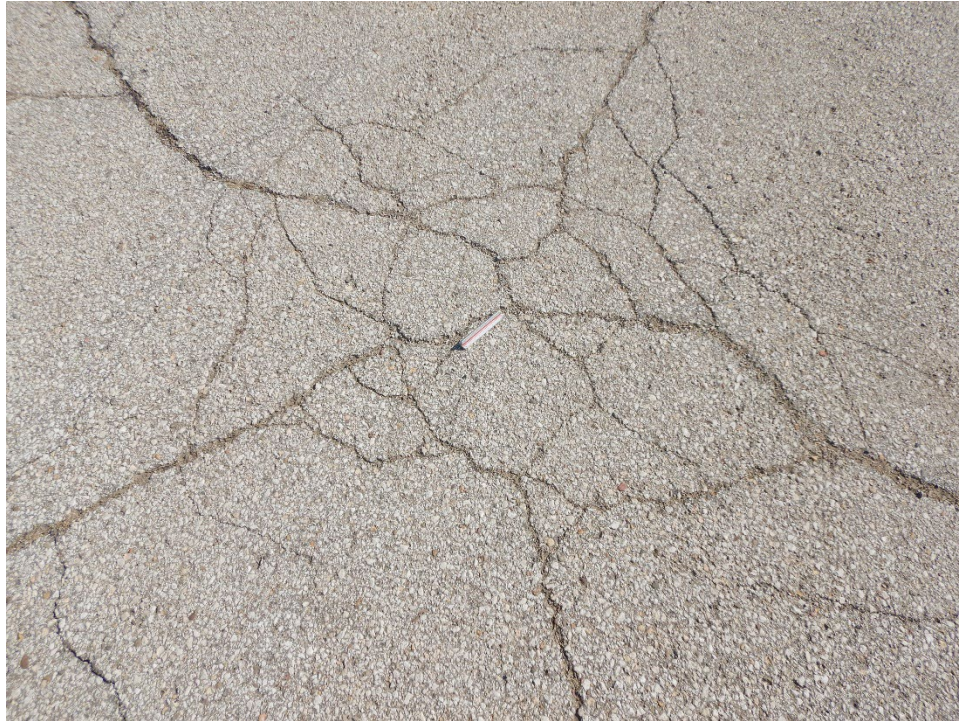
The T-hangar area was defined by three sections. Section 01 was in *Poor* condition with medium-severity alligator cracking and shoving, medium- and high-severity patching and longitudinal and transverse (L&T) cracking, high-severity raveling and weathering, and low-severity rutting observed during the inspection. Medium-severity L&T cracking was recorded where unsealed crack widths exceeded 1/4 inch, while high-severity L&T cracking was identified where crack width exceeded 3 inches. Low- and medium-severity corner spalling, medium- and high-severity joint seal damage, medium-severity joint spalling, low-severity LTD cracking, and shrinkage cracking were recorded in Section 02. Only medium-severity joint seal damage was recorded throughout Section 03.

| <b>Distress Type</b> | <b>Probable Cause of Distress</b> |
|---|---|
| Alligator Cracking | Fatigue failure of the asphalt surface under repeated traffic loading. |

TH01CD-01. Alligator Cracking (Sample Unit No. 01).

| <b>Distress Type</b> | <b>Severity Level</b> | <b>Maintenance Action</b> |
|---|---|---|
| Alligator Cracking | Medium | Asphalt Patch |

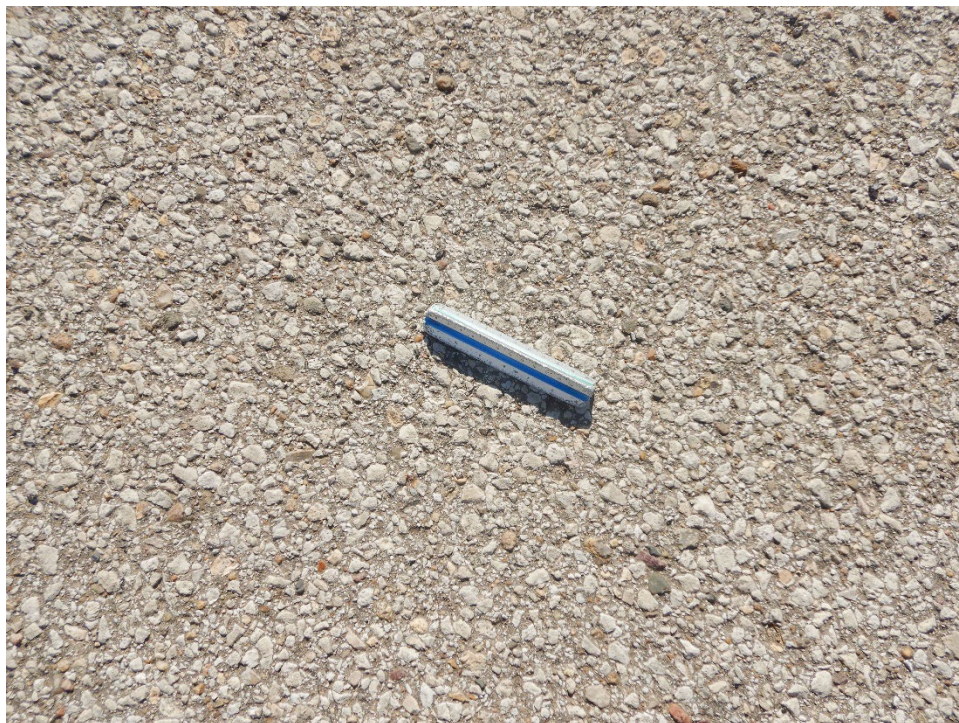
| <b>Distress Type</b> | <b>Probable Cause of Distress</b> |
|---|---|
| Weathering | Asphalt binder and/or fine aggregate may wear away as the pavement ages and hardens. |

TH01CD-01. Weathering (Sample Unit No. 01).

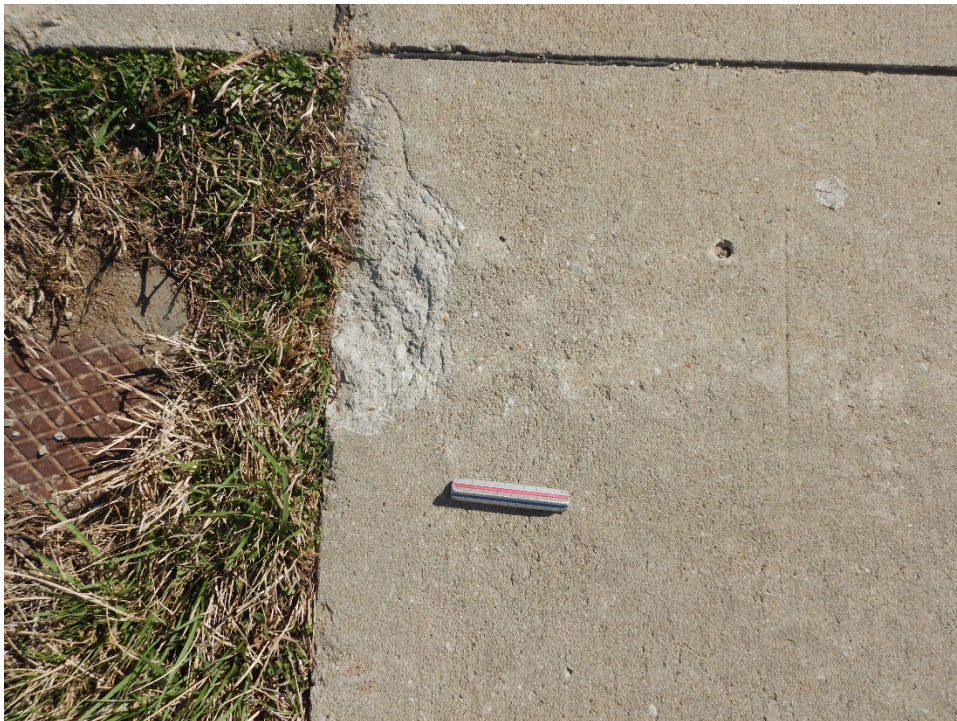
| <b>Distress Type</b> | <b>Probable Cause of Distress</b> |
|---|---|
| Spalling<br>(Joint and Corner) | Excessive stresses at the joint caused by infiltration of incompressible materials or traffic loads; weak concrete at the joint combined with traffic loads. |

TH01CD-02. Joint Spalling (Sample Unit No. 05).

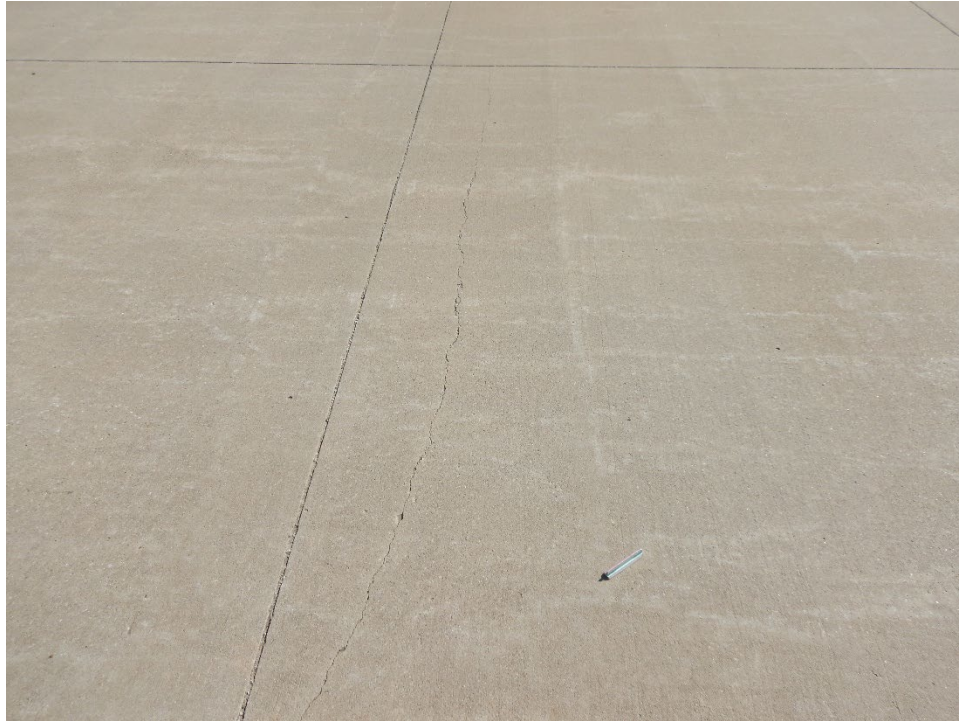
TH01CD-02. LTD Cracking (Sample Unit No. 06).

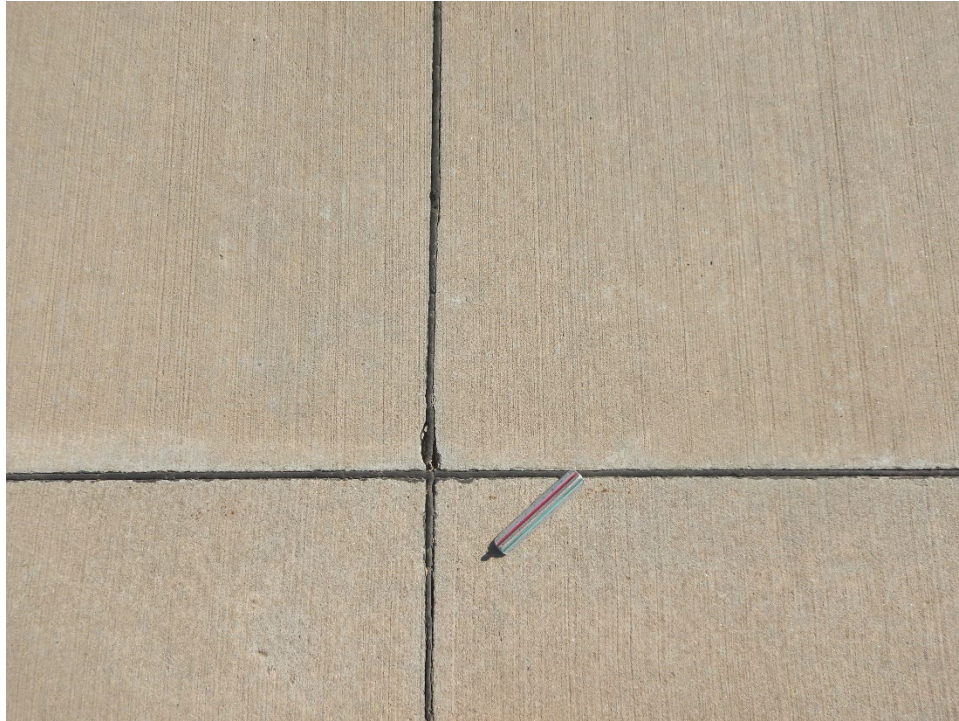
TH01CD-03. Joint Seal Damage (Sample Unit No. 03).
