# Clinton Municipal Airport

## Pavement Management Report

**AUGUST 2025**

# CLINTON MUNICIPAL AIRPORT PAVEMENT MANAGEMENT REPORT

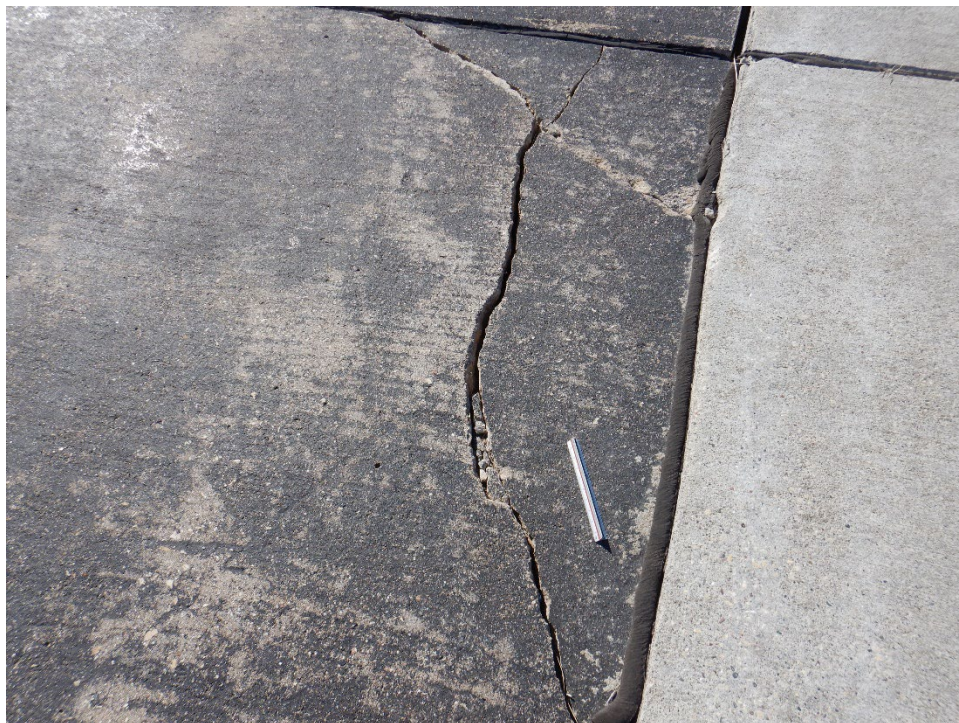
A01CN-01. Corner Break (Sample Unit No. 08).

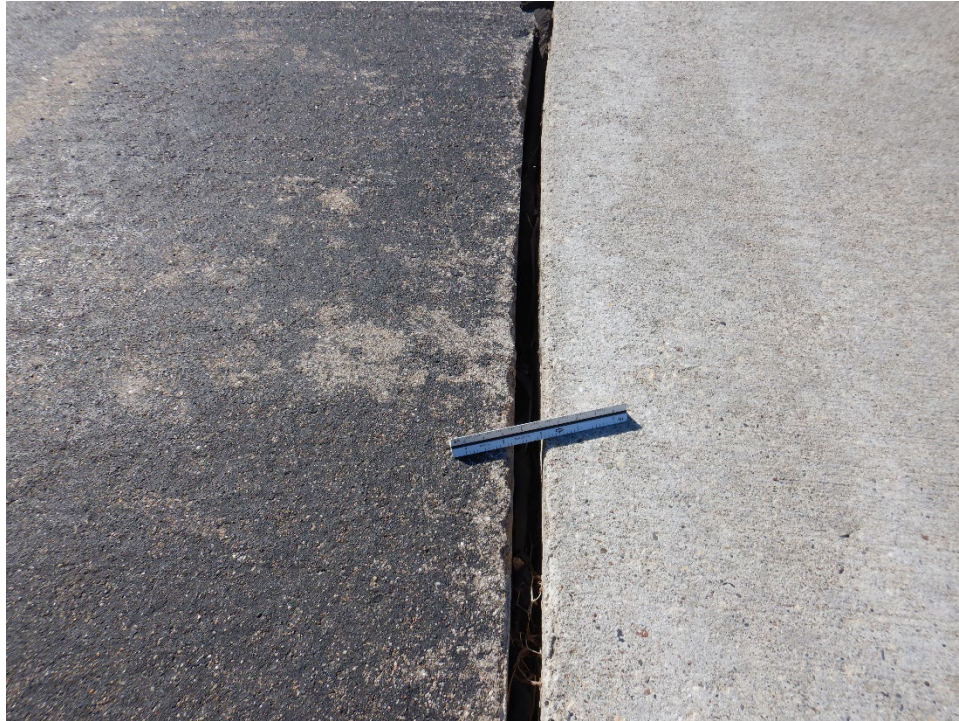
A01CN-01. Joint Seal Damage (Sample Unit No. 08).

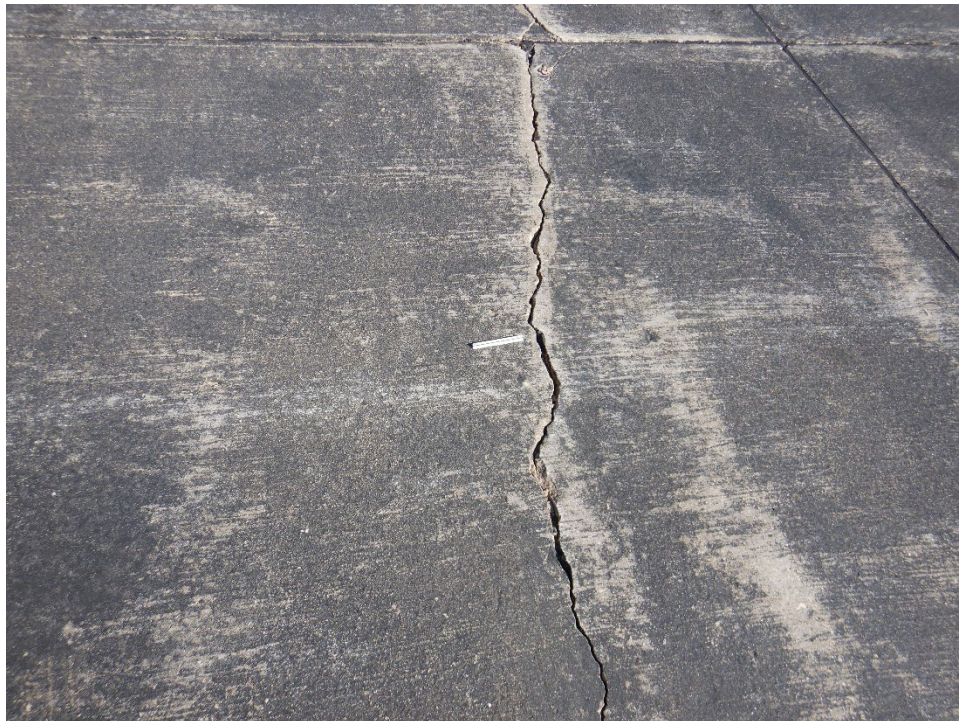
A01CN-01. LTD Cracking (Sample Unit No. 05).

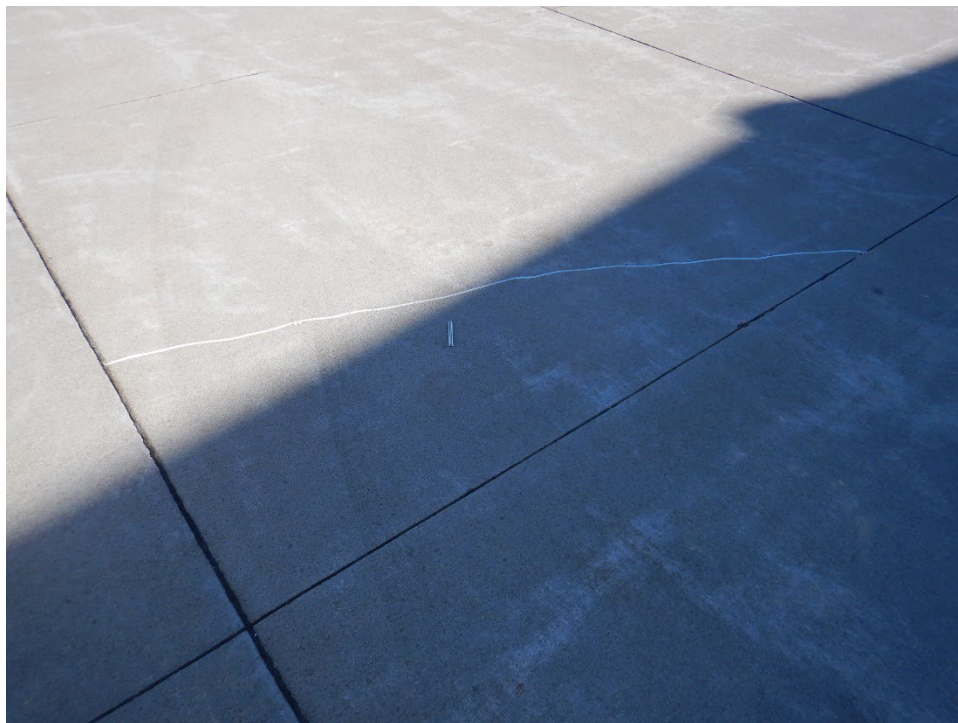
A01CN-02. LTD Cracking (Sample Unit No. 01).

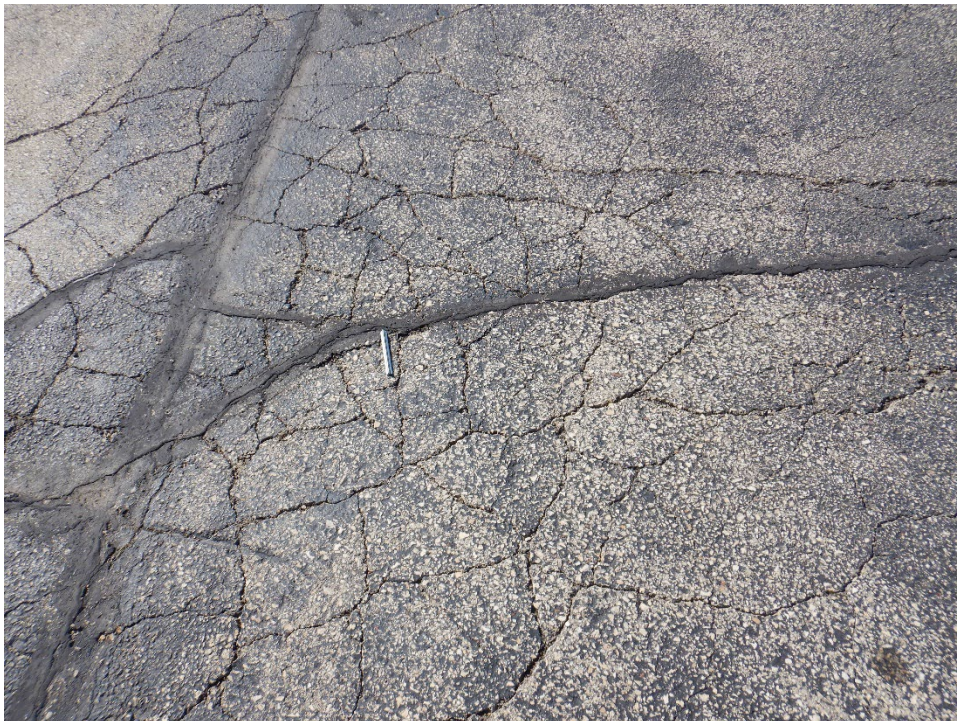
A01CN-03. Alligator Cracking (Sample Unit No. 01).

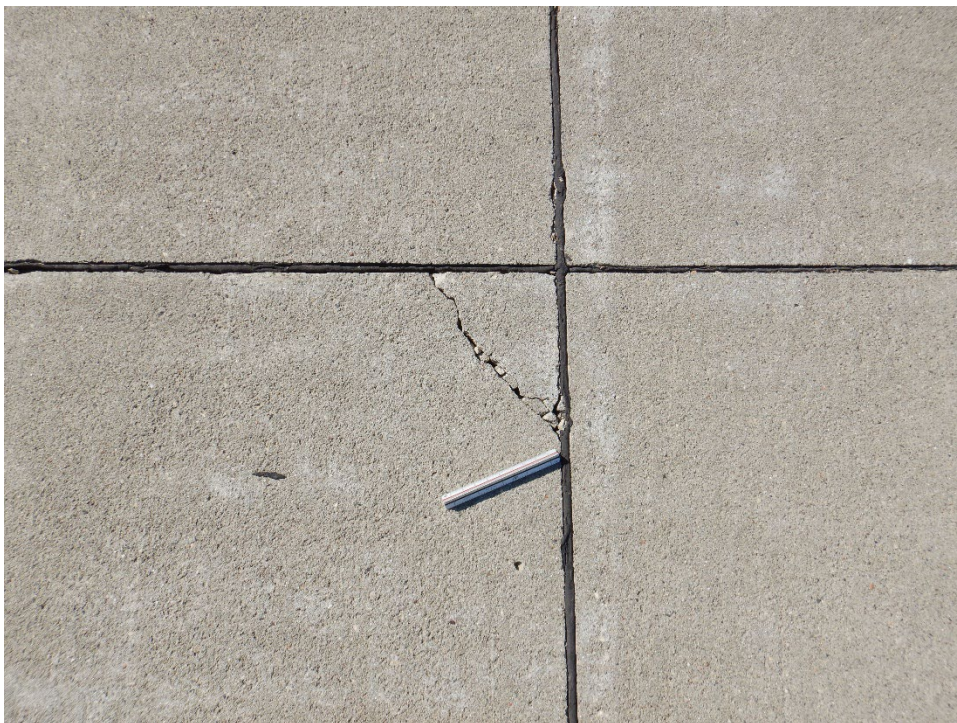
A01CN-04. Corner Spalling (Sample Unit No. 01).

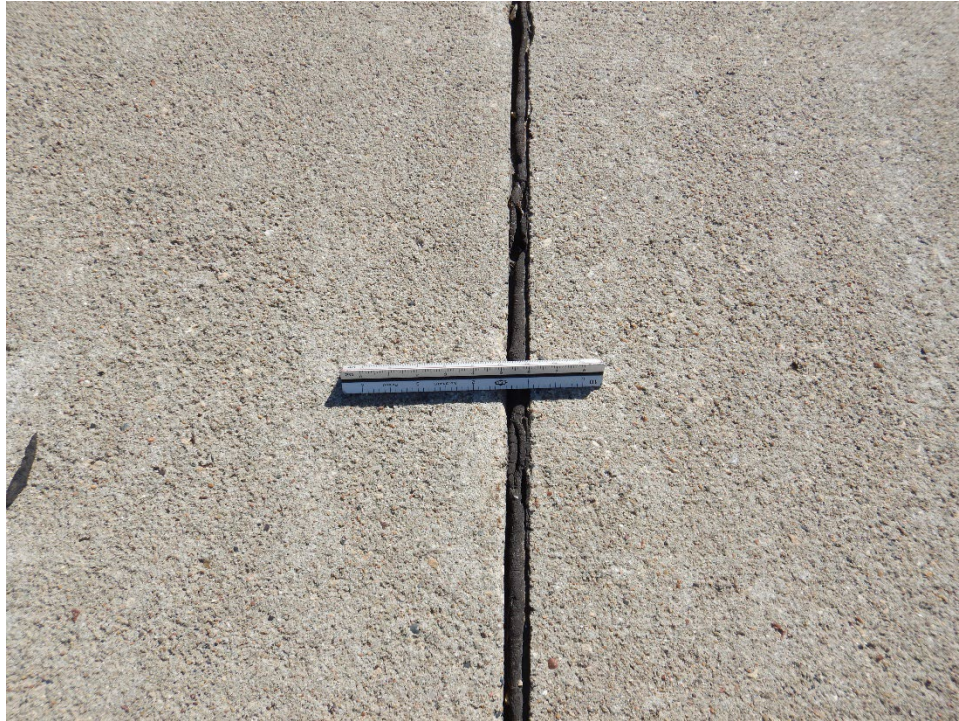
A01CN-04. Joint Seal Damage (Sample Unit No. 01).

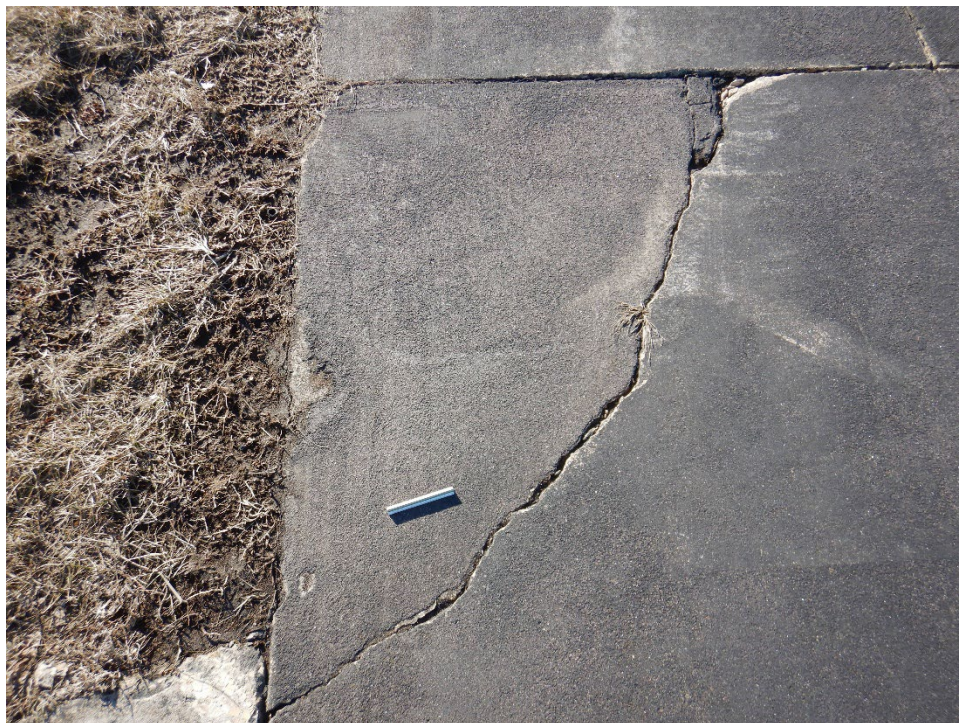
A02CN-01. Corner Break (Sample Unit No. 01).

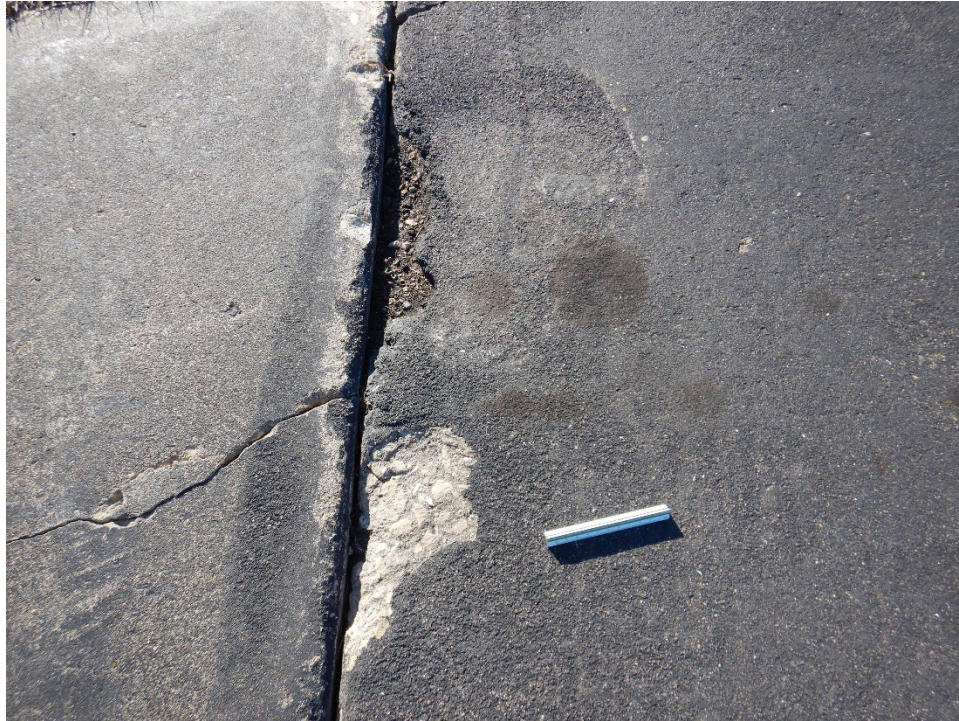
A02CN-01. Joint Spalling (Sample Unit No. 01).

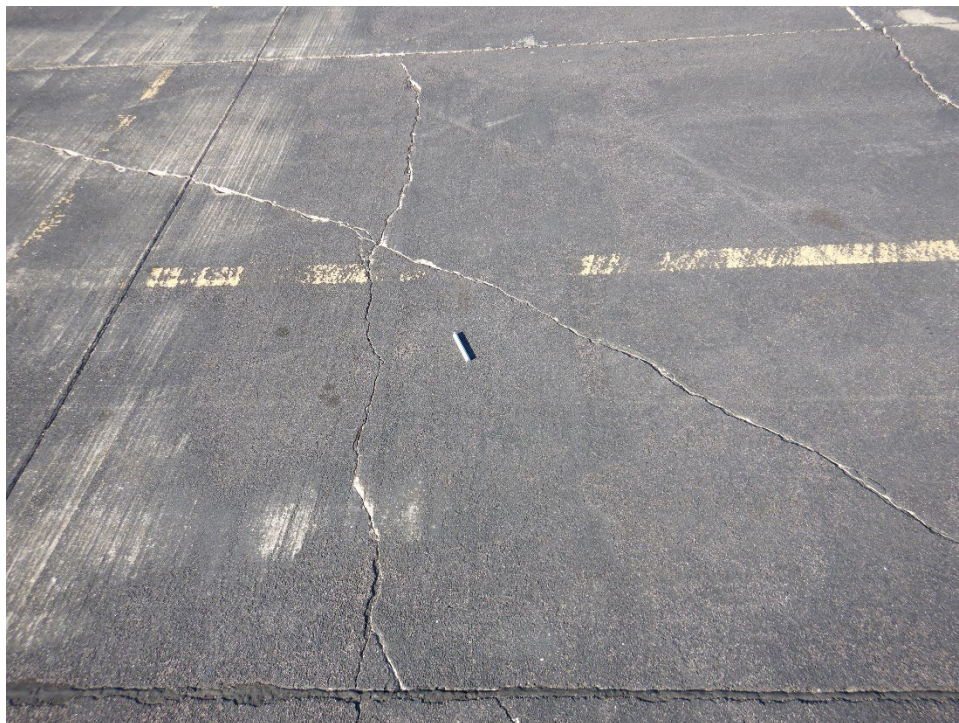
A02CN-01. Shattered Slab (Sample Unit No. 01).

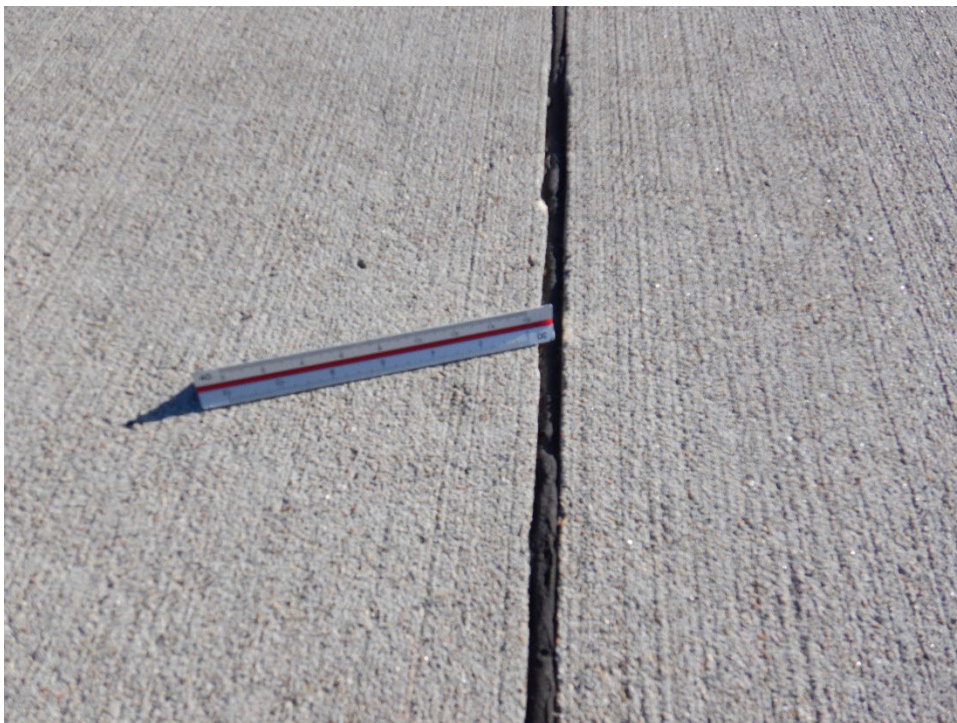
A02CN-02. Joint Seal Damage (Sample Unit No. 17).

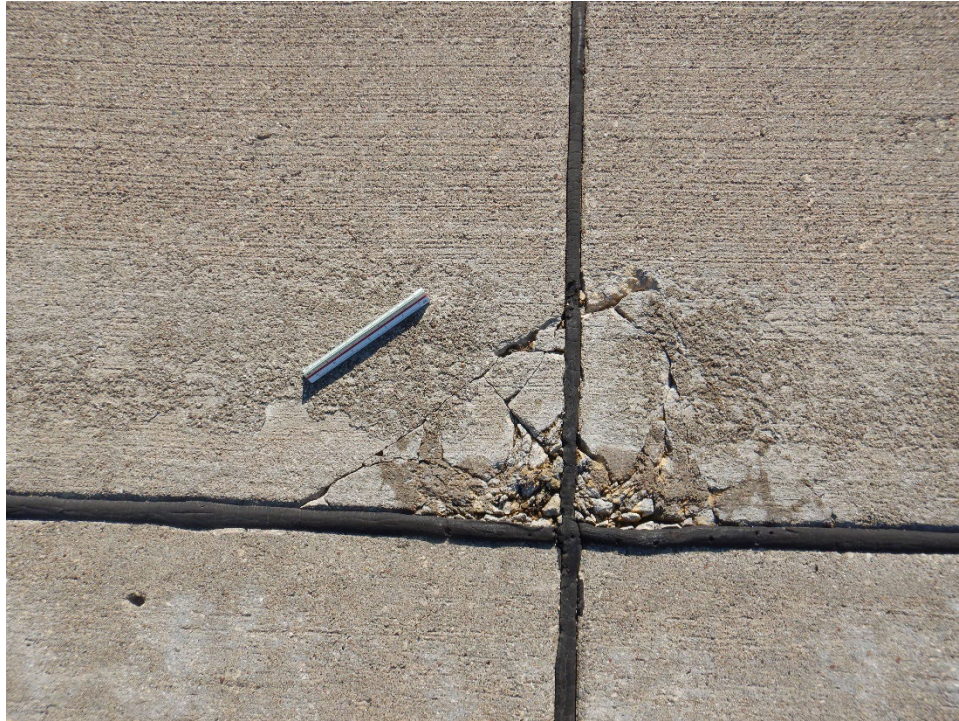
R03CN-01. Corner Spalling (Additional Sample Unit No. 110).

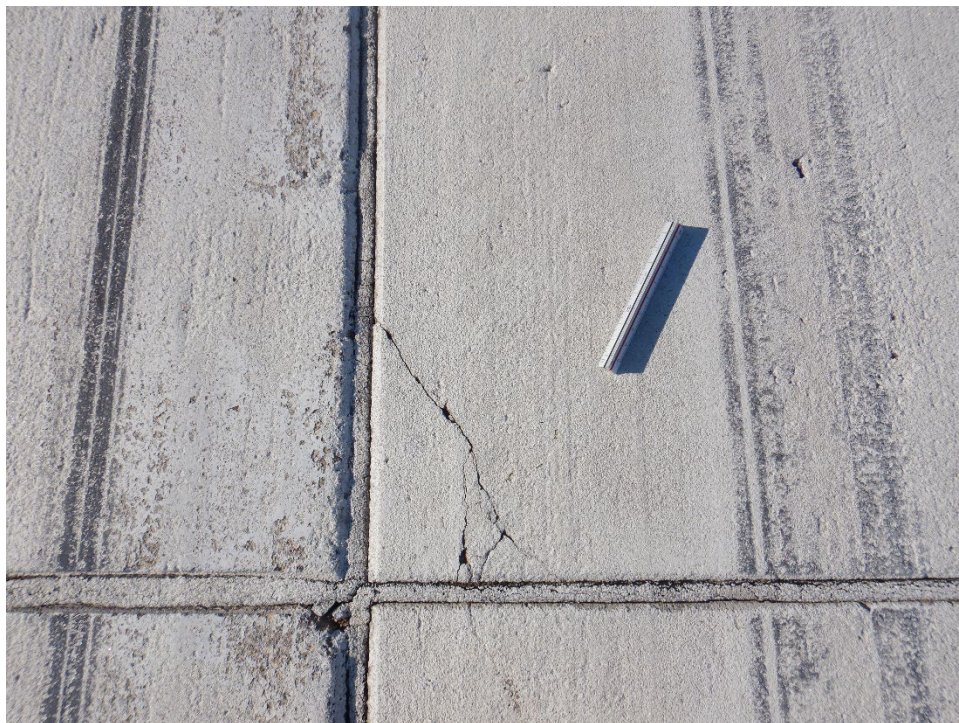
R03CN-01. Corner Spalling (Sample Unit No. 113).

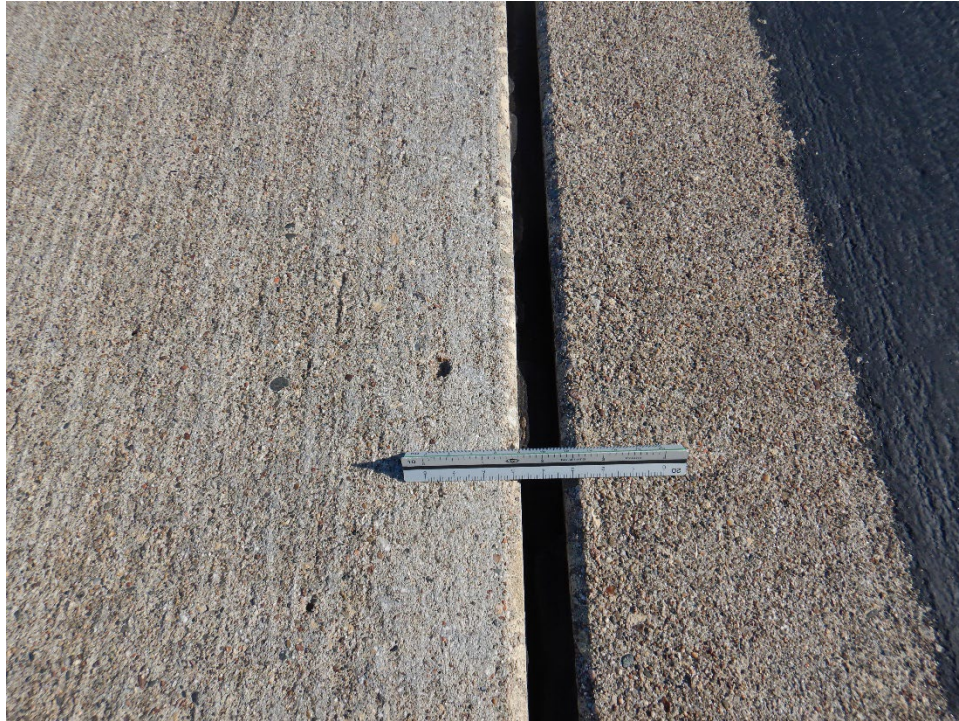
R03CN-01. Joint Seal Damage (Sample Unit No. 153).

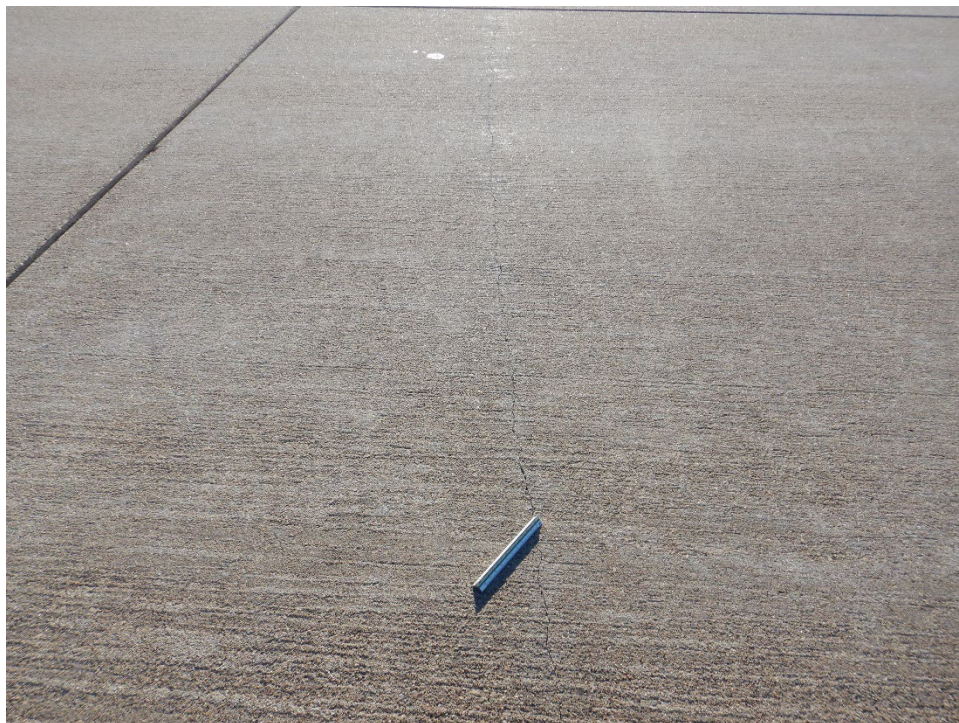
R03CN-01. LTD Cracking (Sample Unit No. 64).

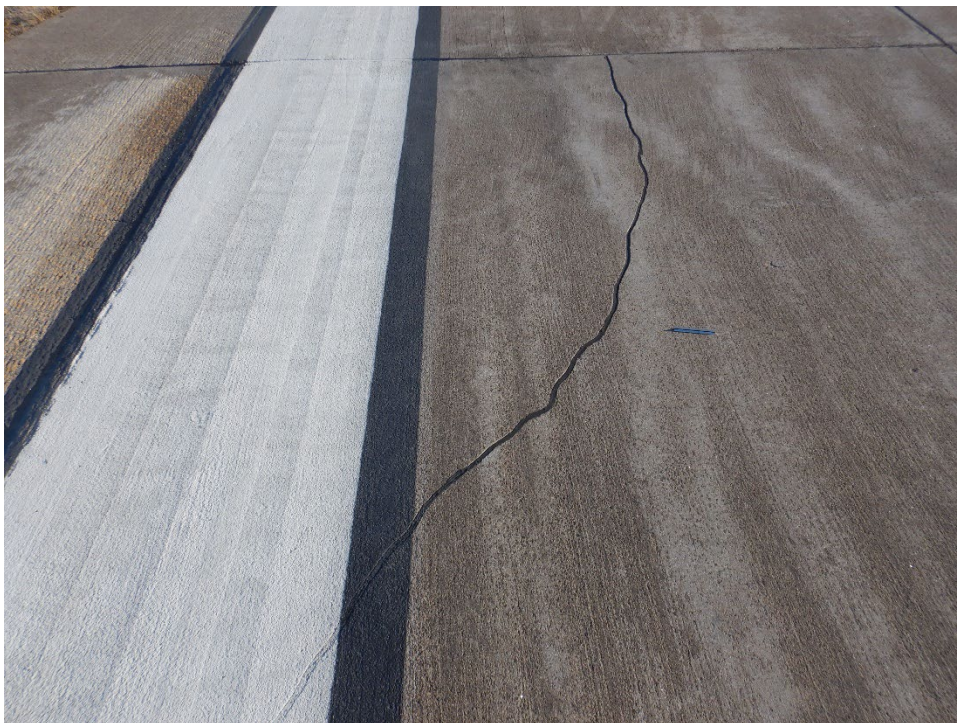
R03CN-02. LTD Cracking (Sample Unit No. 07).

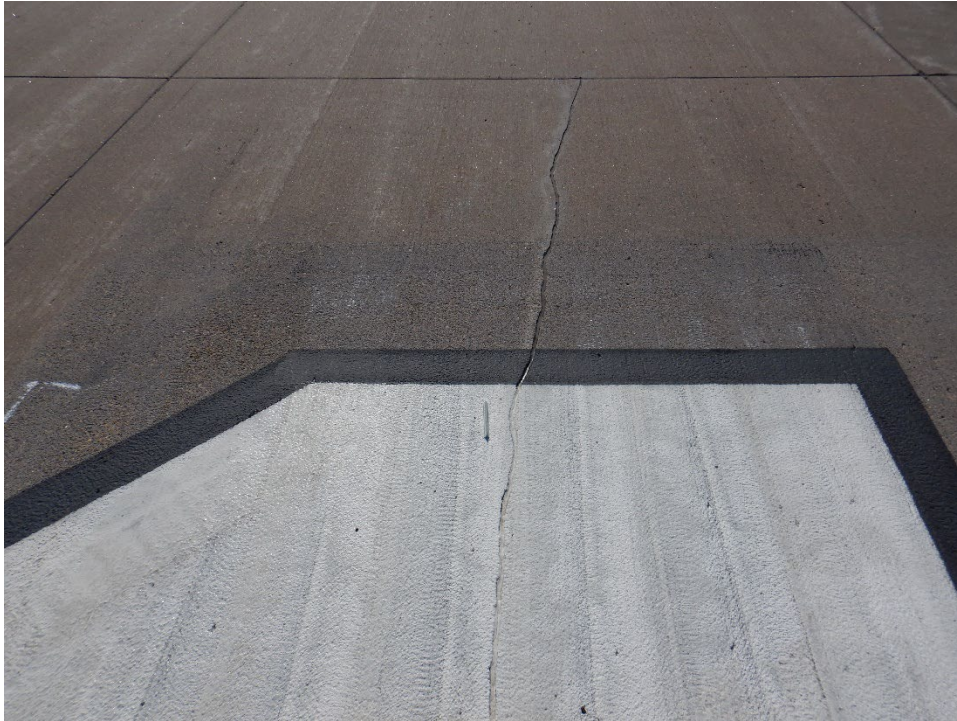
R14CN-01. LTD Cracking (Sample Unit No. 06).

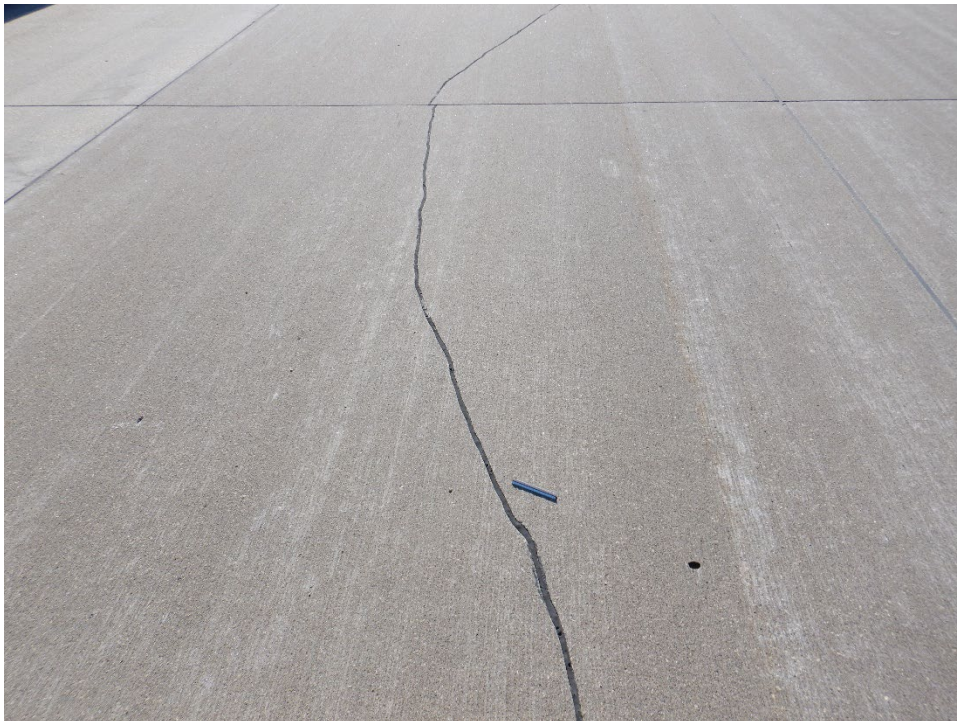
R14CN-01. LTD Cracking (Sample Unit No. 26).

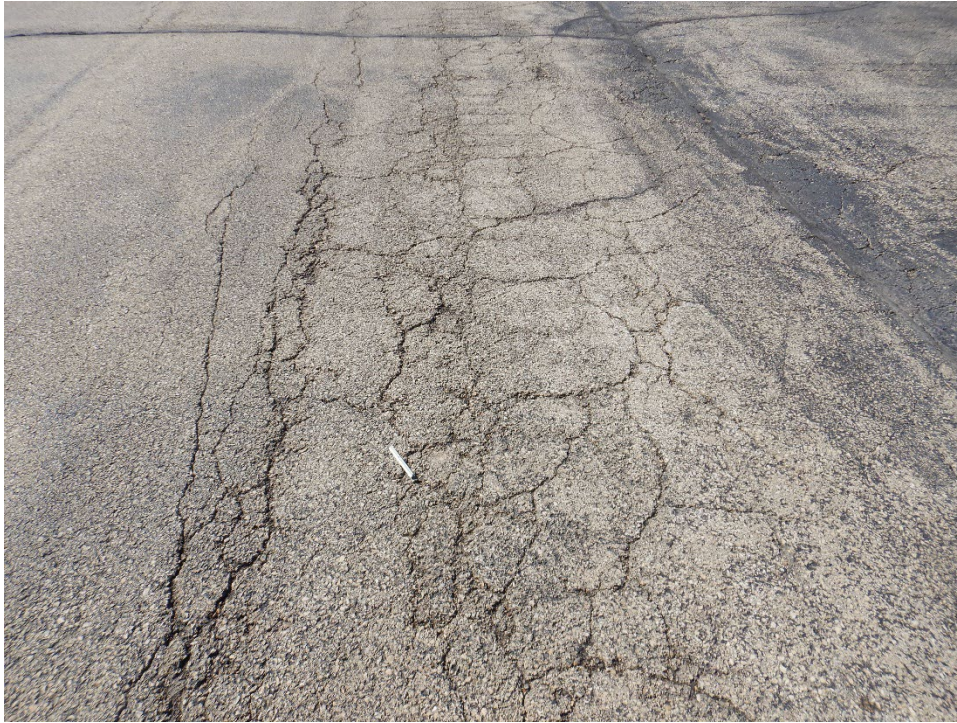
T04CN-01. Alligator Cracking (Sample Unit No. 02).

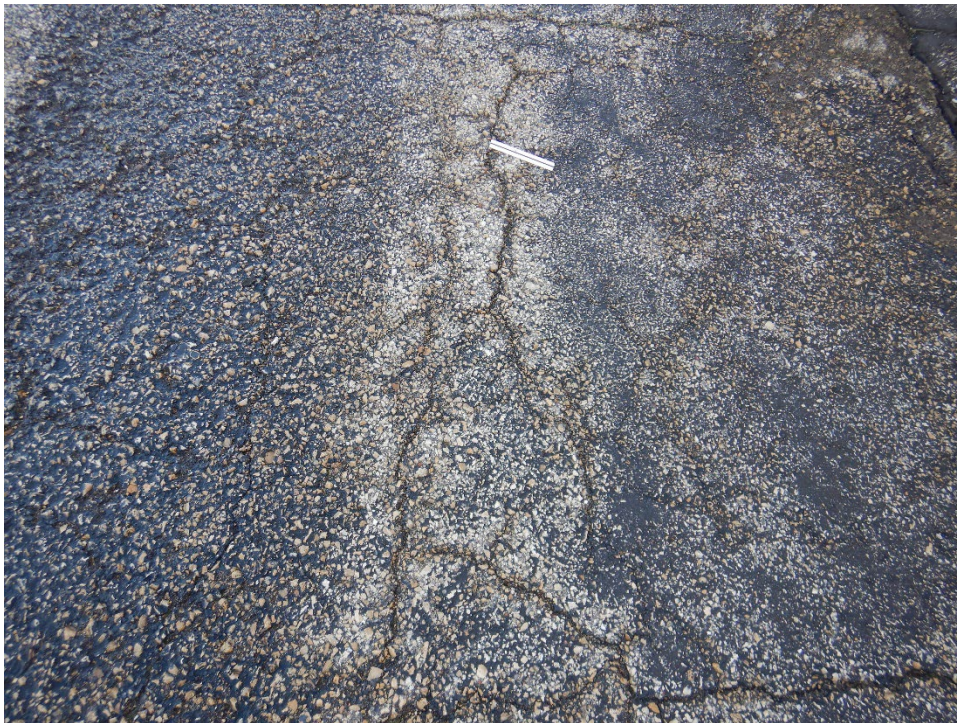
T04CN-01. L&T Cracking (Sample Unit No. 01).

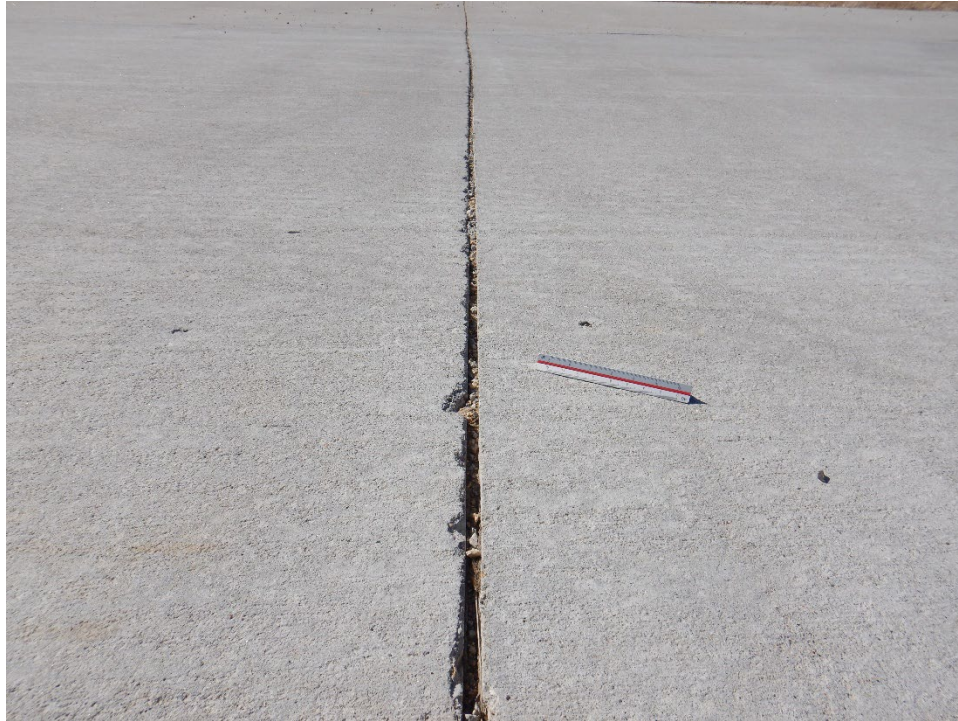
T04CN-02. Joint Seal Damage (Sample Unit No. 07).

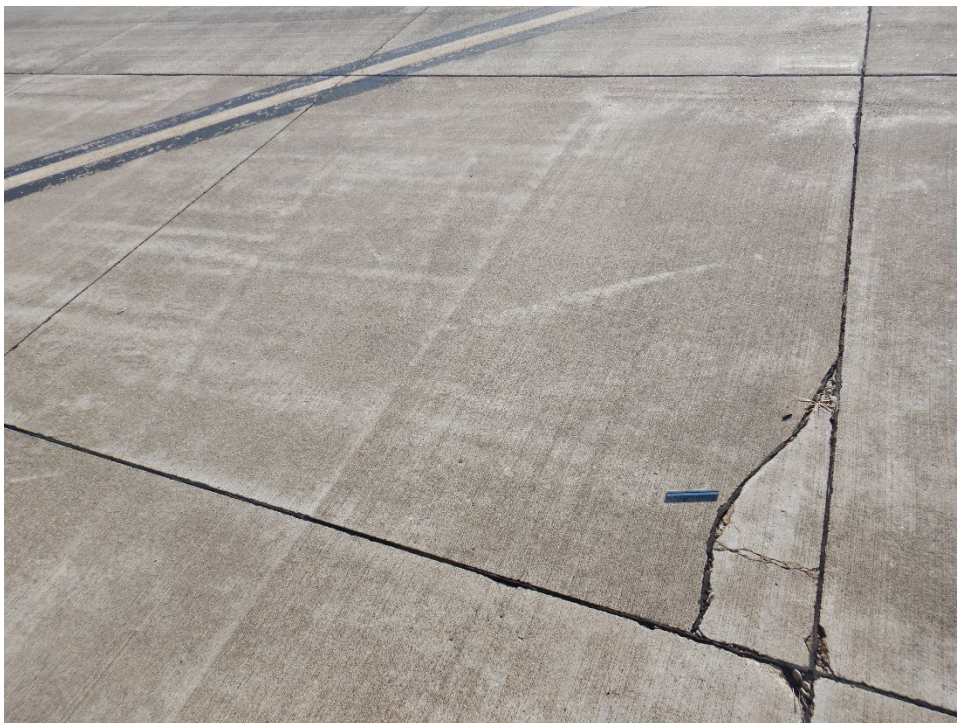
TA1CN-01. Corner Break (Sample Unit No. 04).

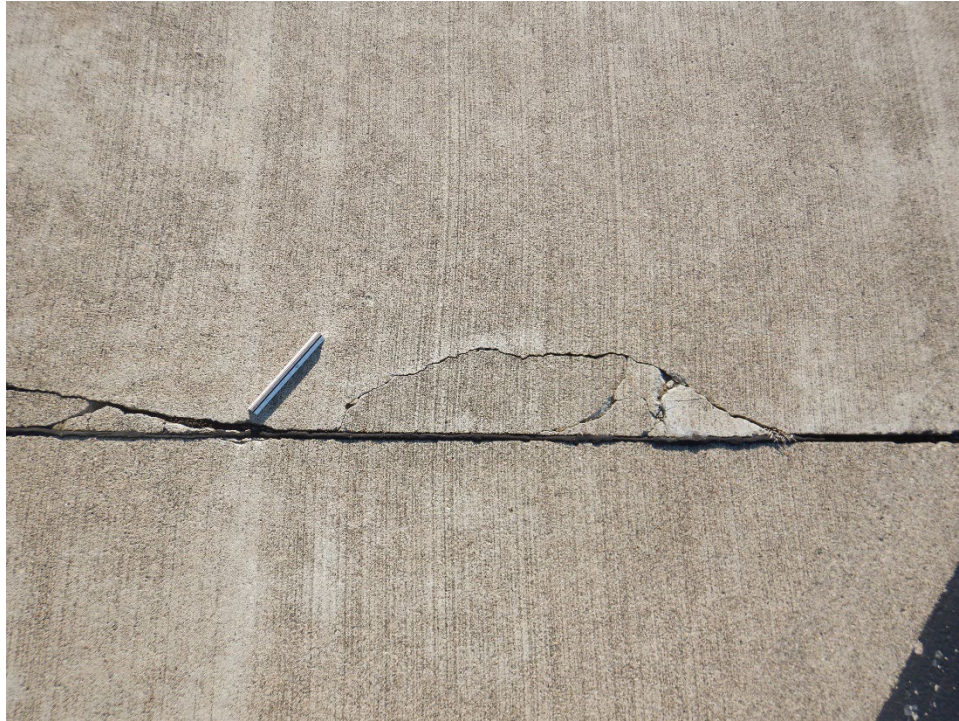
TA1CN-01. Joint Spalling (Sample Unit No. 04).

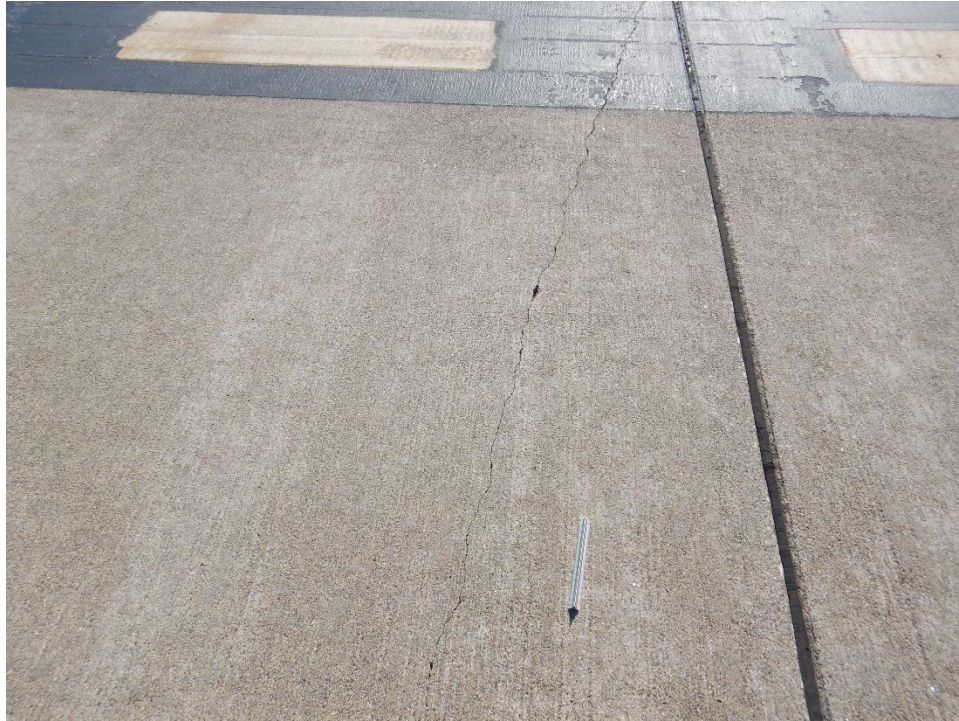
TA1CN-02. LTD Cracking (Sample Unit No. 05).

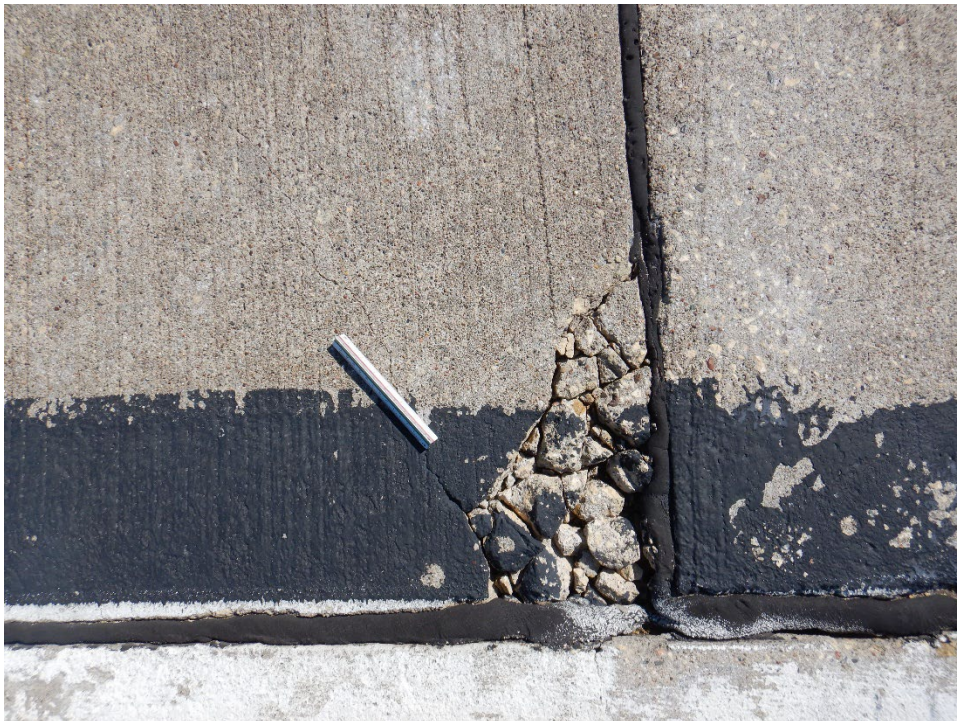
TACN-01. Corner Spalling (Sample Unit No. 01).

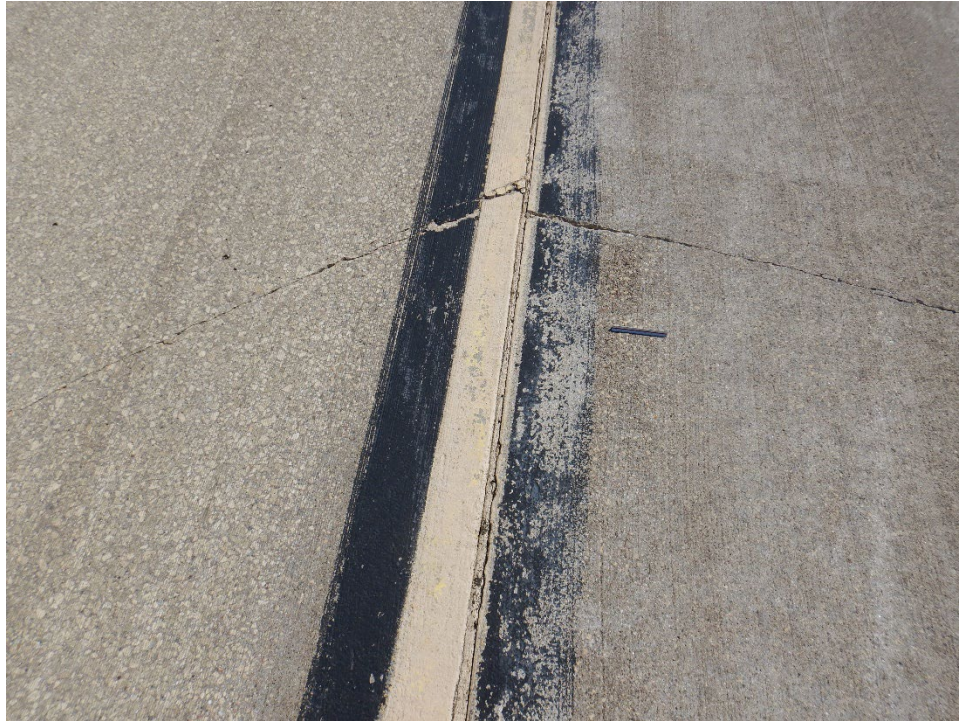
TACN-01. LTD Cracking (Sample Unit No. 01).

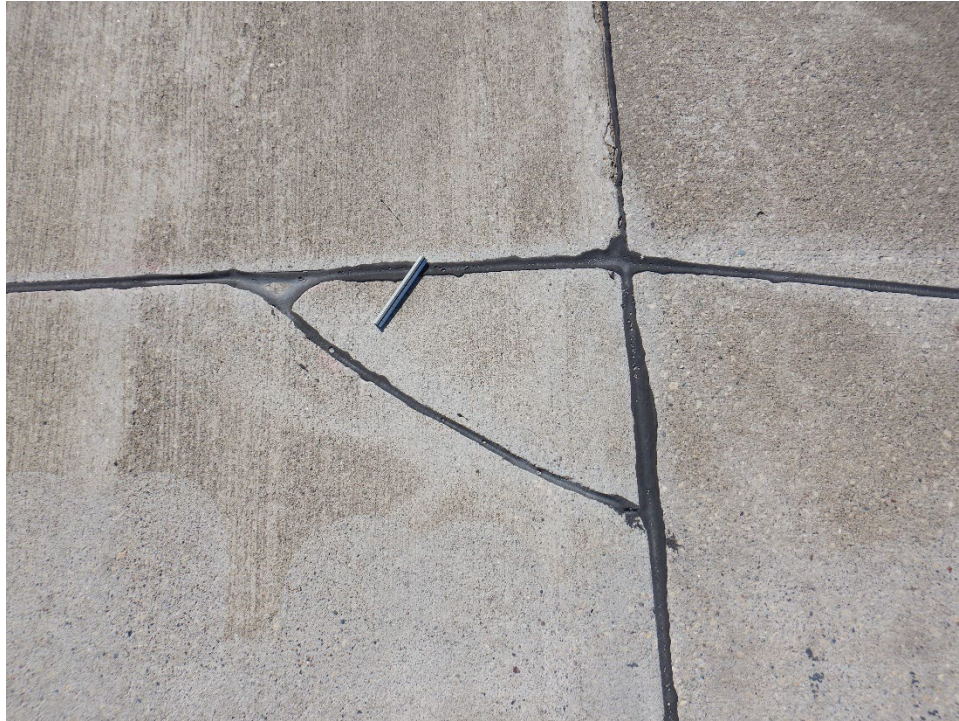
TACN-02. Corner Break (Sample Unit No. 01).

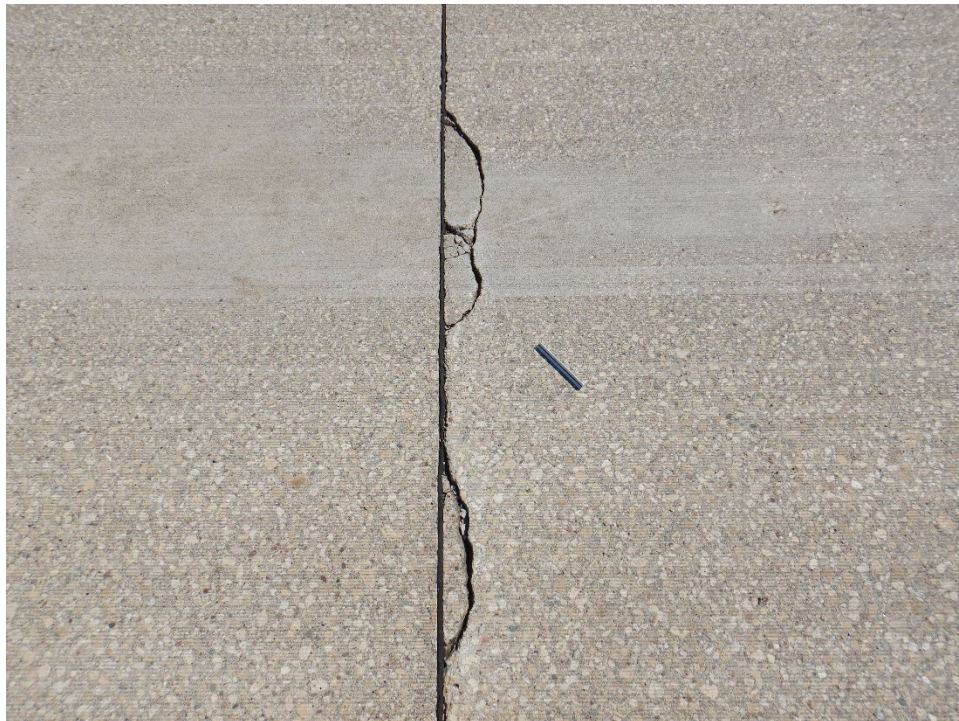
TACN-02. Joint Spalling (Sample Unit No. 10).

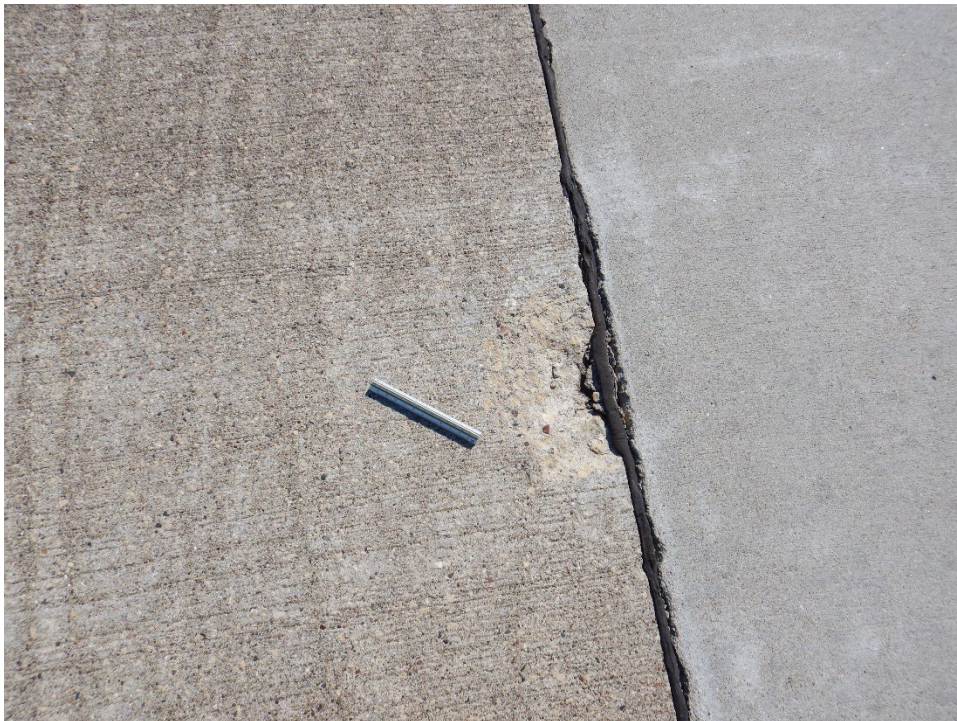
TACN-03. Joint Spalling (Sample Unit No. 42).

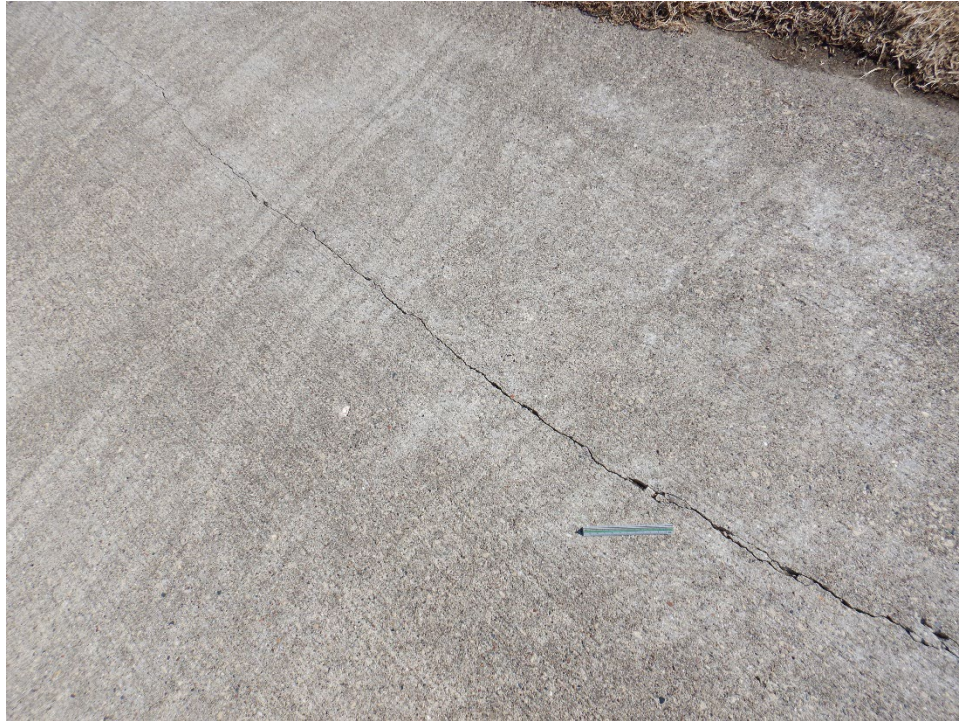
TACN-03. LTD Cracking (Sample Unit No. 42).

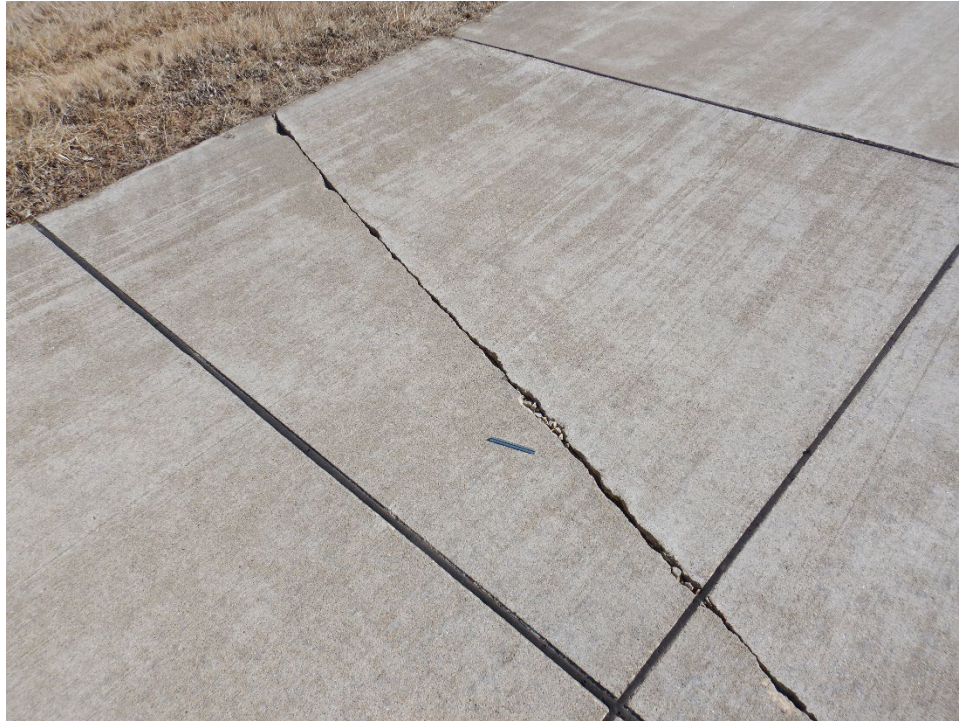
TACN-04. LTD Cracking (Sample Unit No. 05).

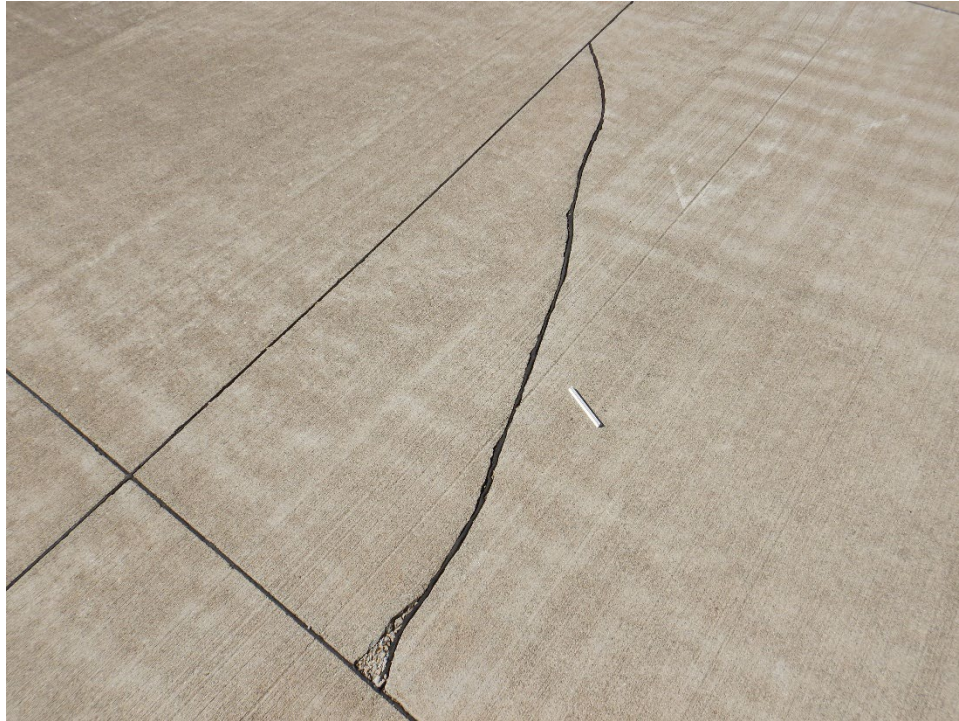
TBCN-01. LTD Cracking (Sample Unit No. 06).

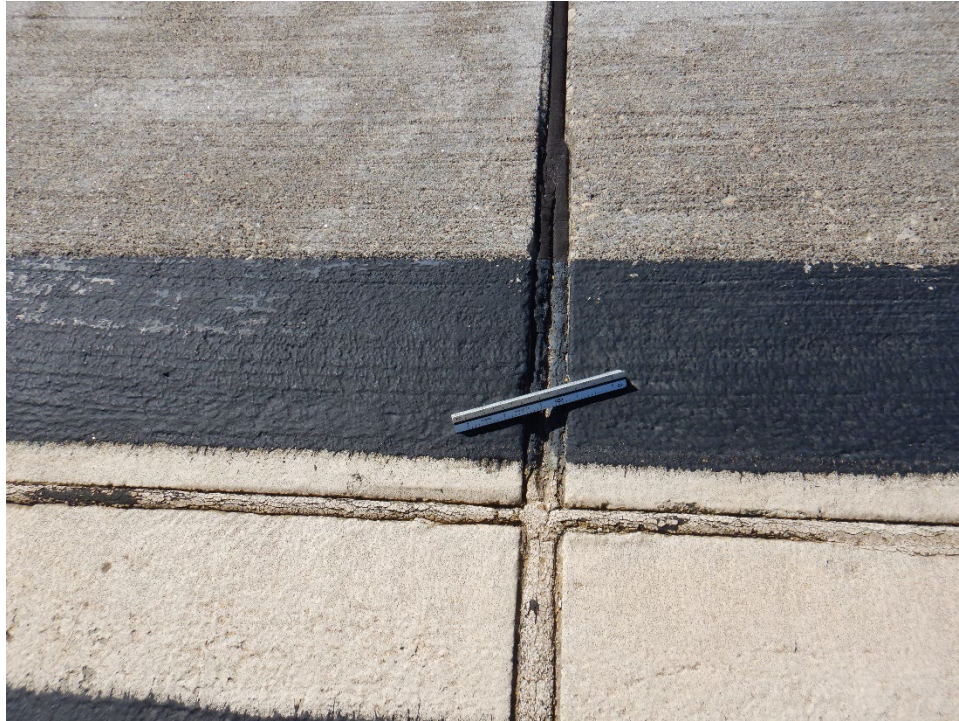
TBCN-02. Joint Seal Damage (Sample Unit No. 01).
