# Clinton Municipal Airport

## Pavement Management Report

**AUGUST 2025**

# CLINTON MUNICIPAL AIRPORT PAVEMENT MANAGEMENT REPORT

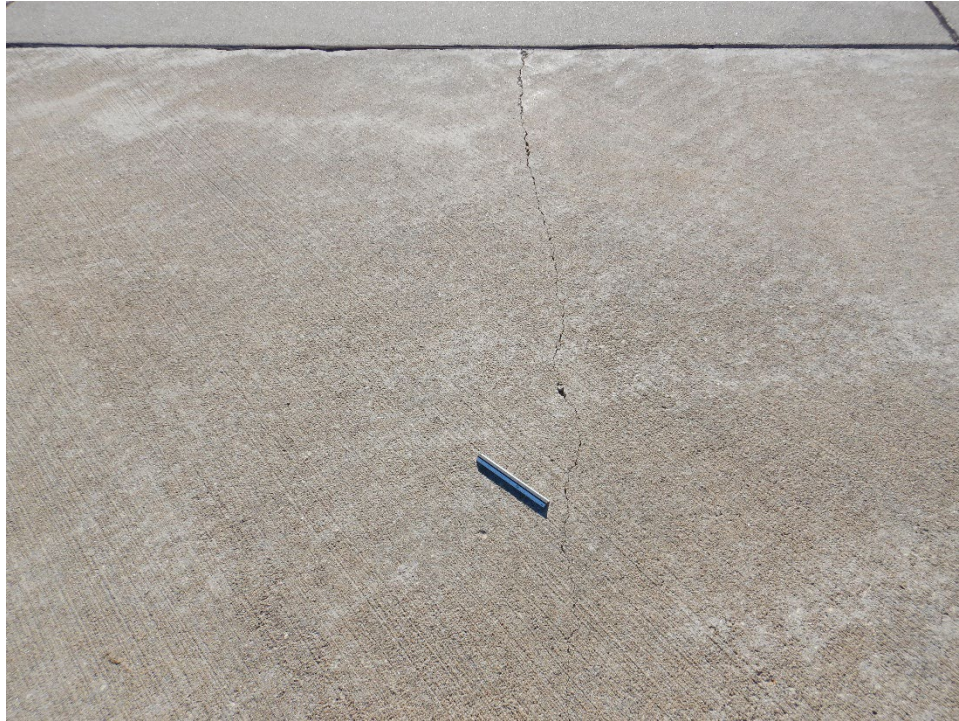
TCCN-01. LTD Cracking (Sample Unit No. 05).

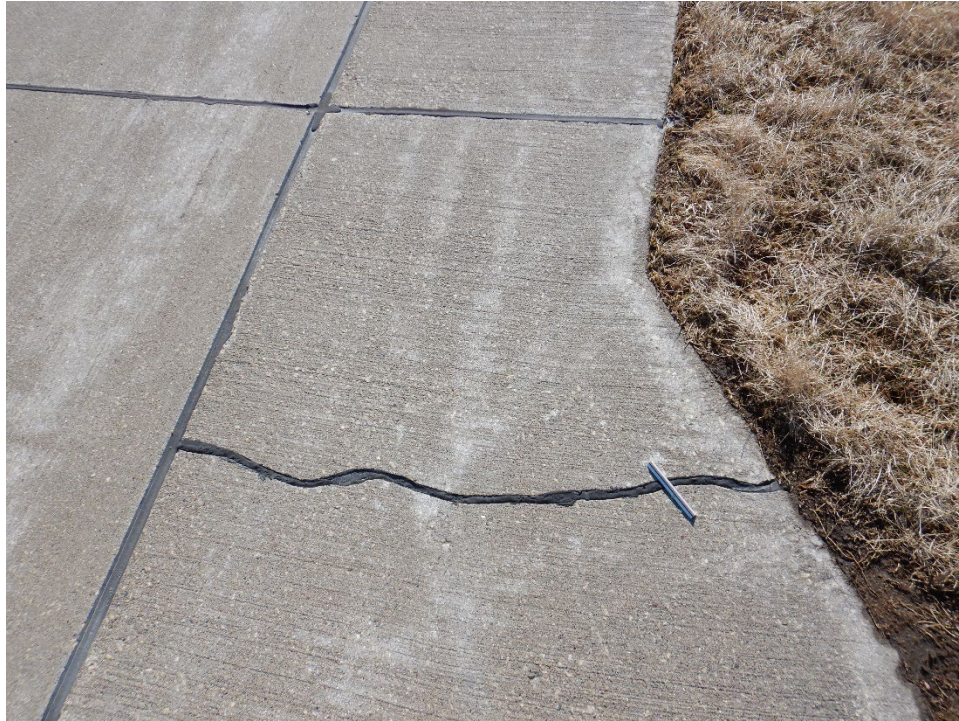
TCCN-02. LTD Cracking (Sample Unit No. 01).

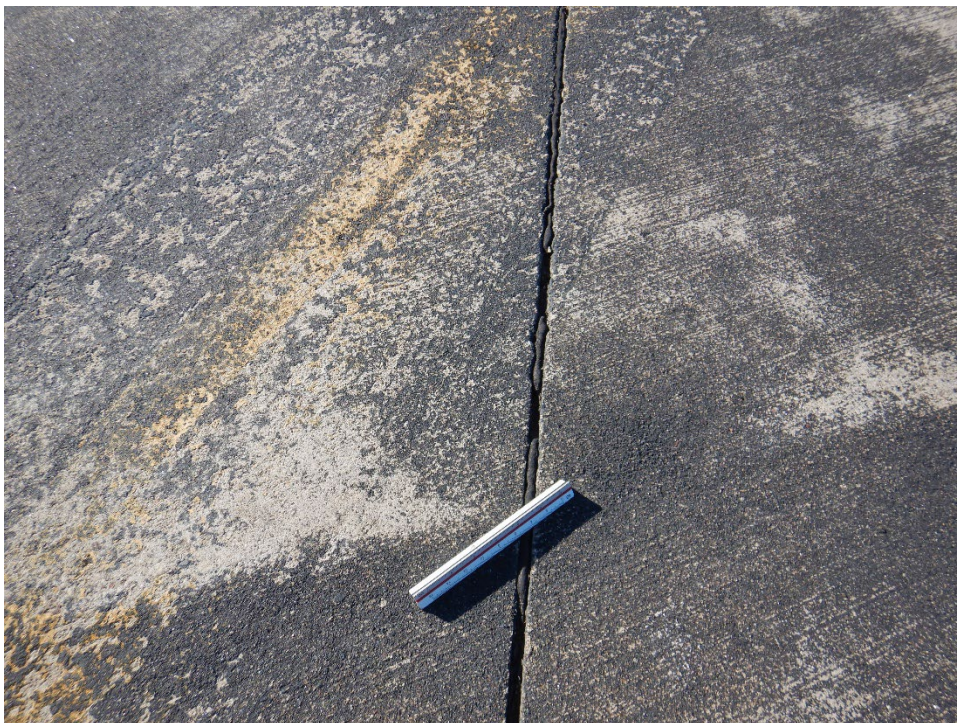
TCCN-03. Joint Seal Damage (Sample Unit No. 03).

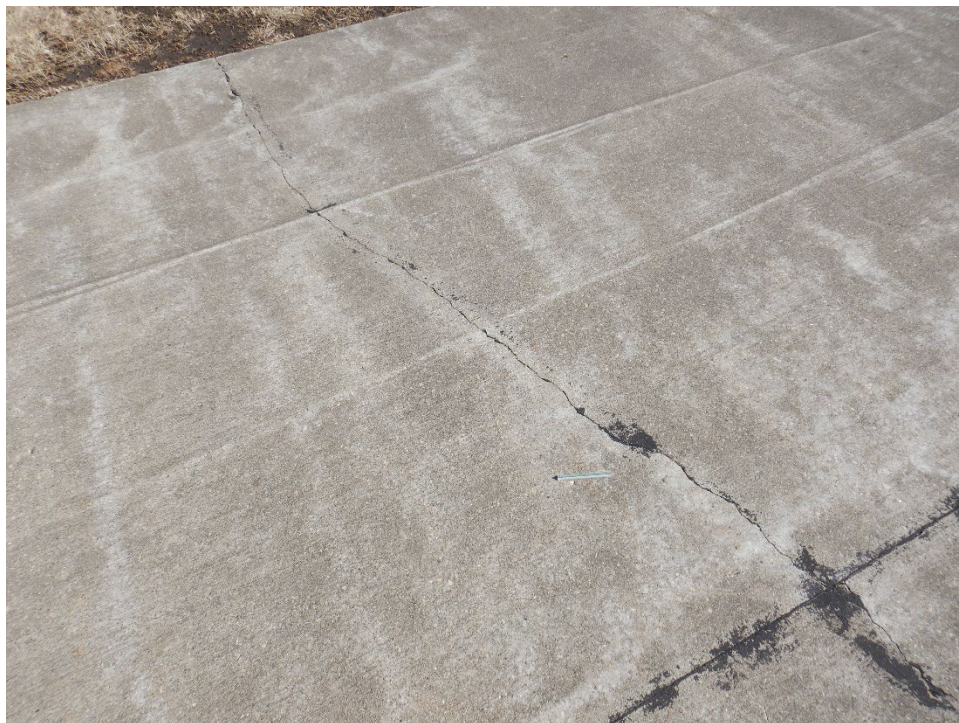
TH01CN-01. LTD Cracking (Sample Unit No. 04).

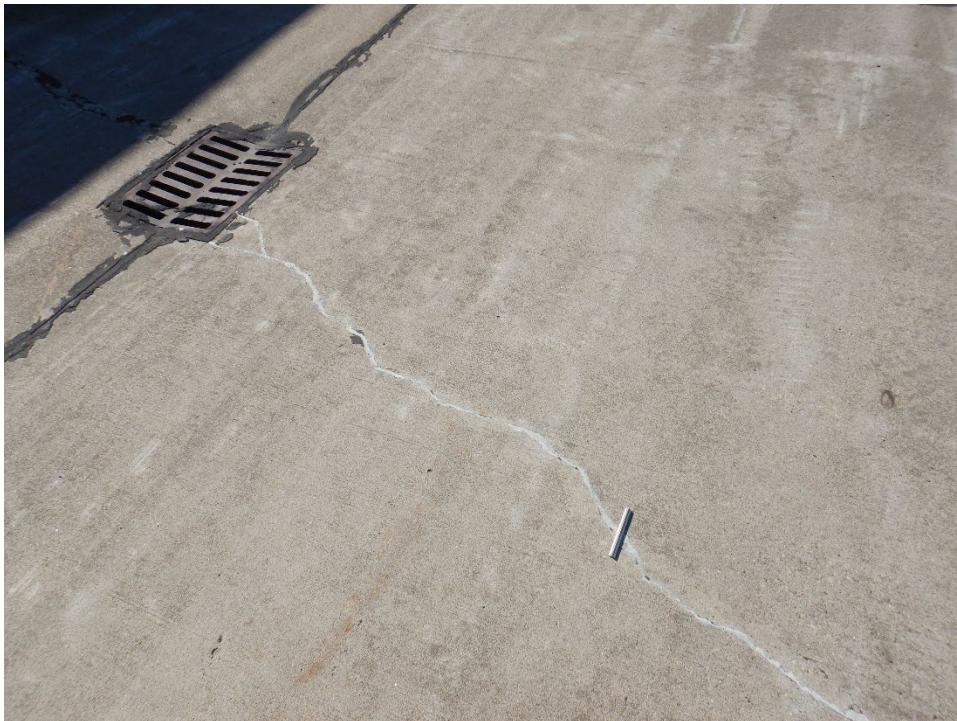
TH01CN-02. LTD Cracking (Sample Unit No. 01).

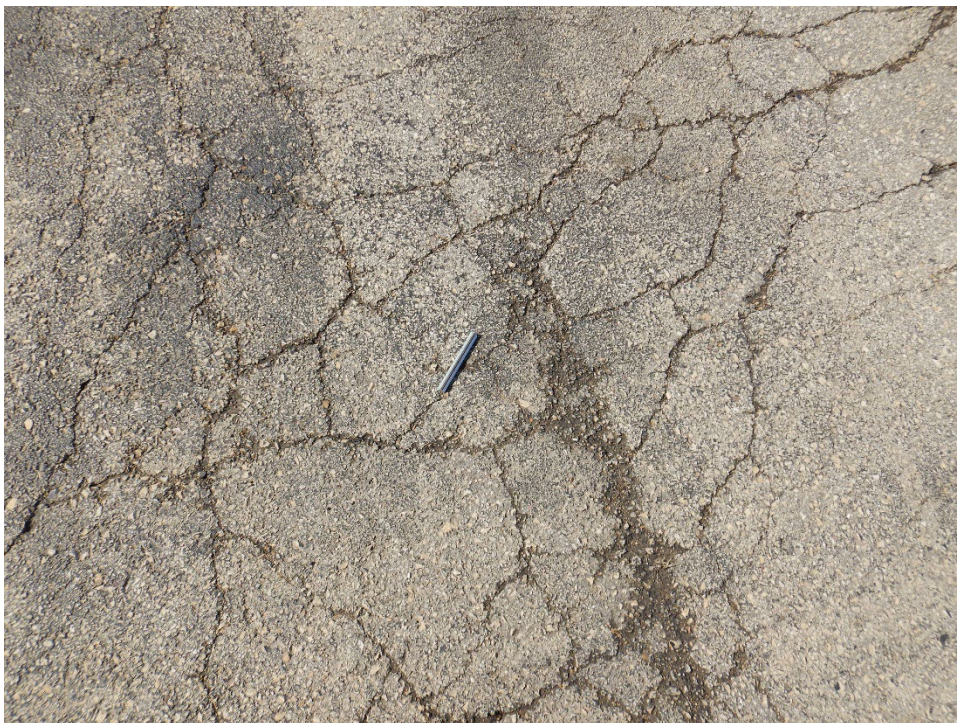
TH01CN-03. Alligator Cracking (Sample Unit No. 01).

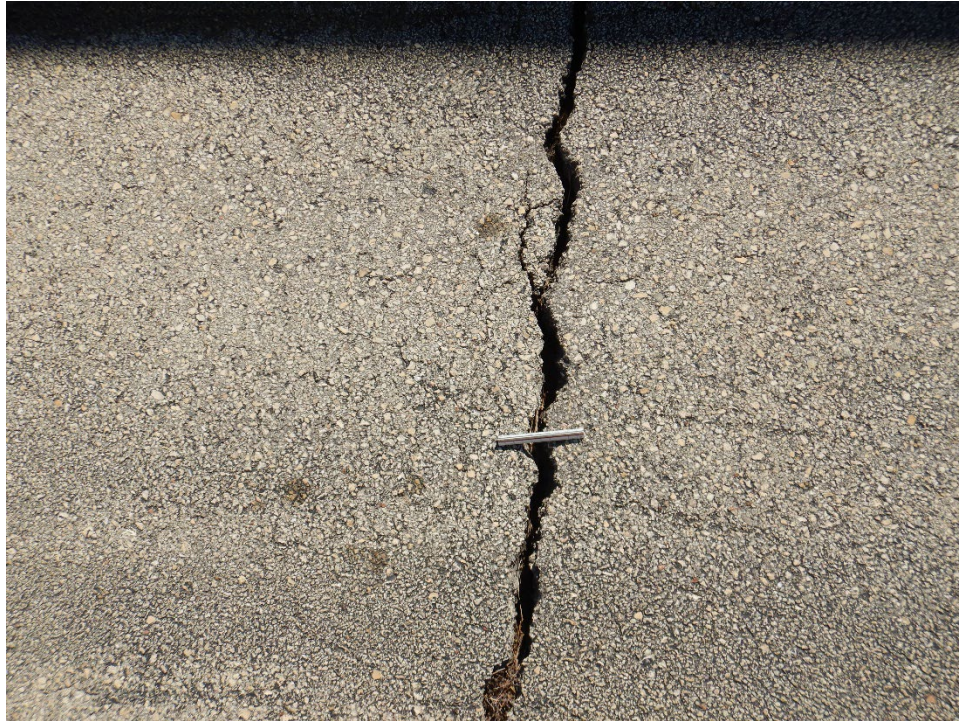
TH01CN-03. L&T Cracking (Sample Unit No. 01).
