# Corning Municipal Airport

## Pavement Management Report

**AUGUST 2025**

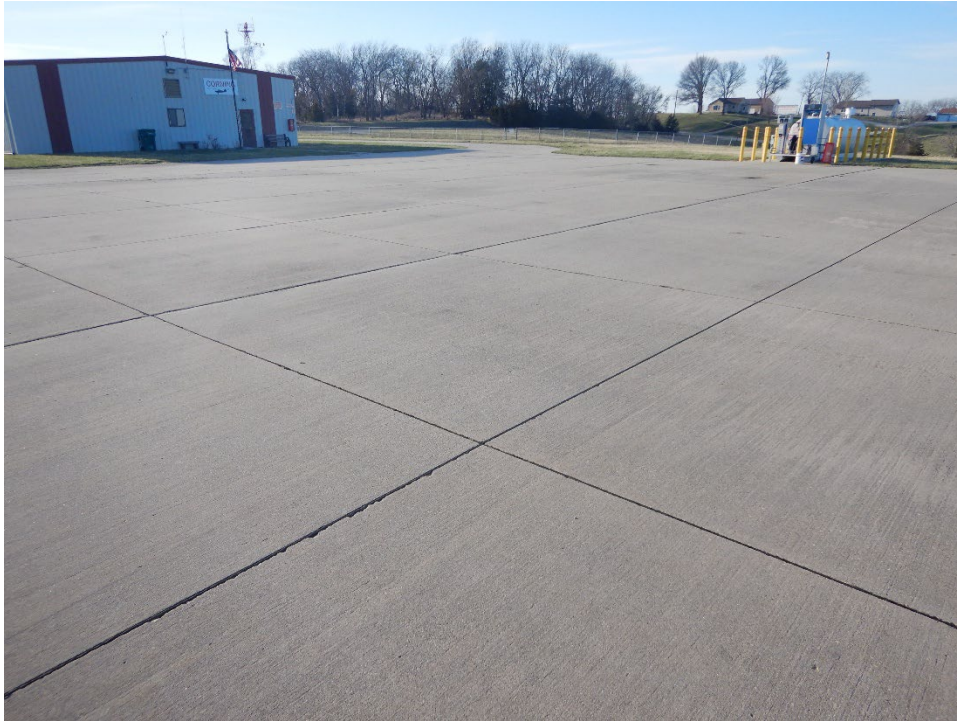
The apron area contained one section. In Section 01, low-severity ASR, faulting, joint seal damage, joint spalling, and LTD cracking; low- and medium-severity corner spalling; and shrinkage cracking were identified. An atypical area of medium- and high-severity shattered slab was observed and recorded as an additional sample unit in accordance with ASTM D5340.

A01CO-01. Overview.

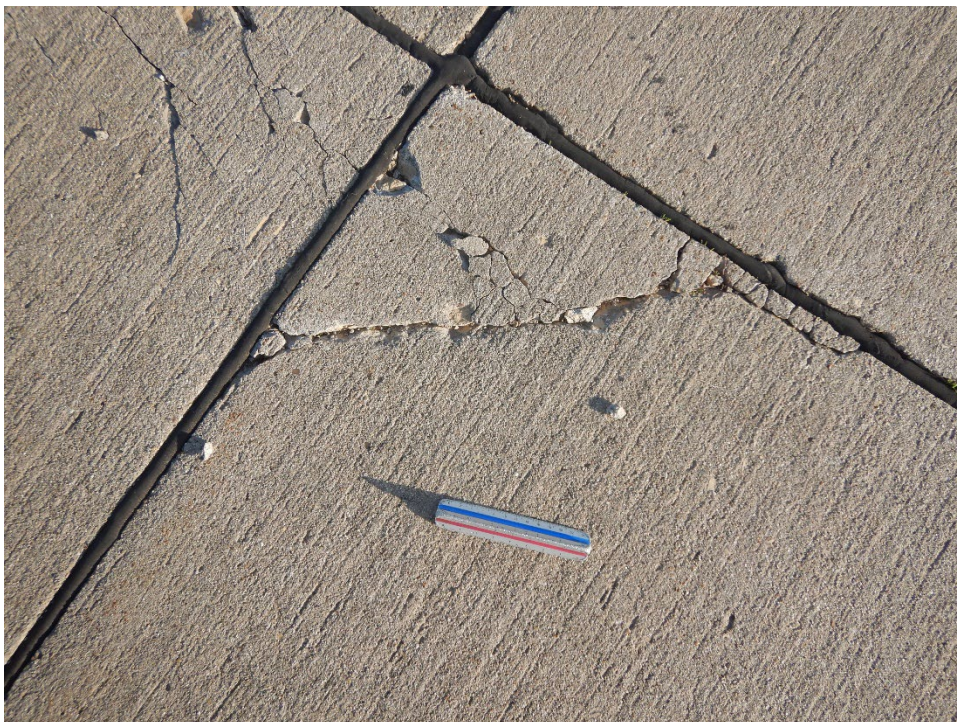
A01CO-01. Corner Spalling (Sample Unit No. 005).

| Branch | Section | Distress Type | Severity | Distress Quantity | Distress Unit | Maintenance Action | Unit Cost | 2025 Estimated Cost |
|---|---|---|---|---|---|---|---|---|
| A01CO | 01 | Corner Spalling | Medium | 4 | Slabs | Patching - PCC Partial Depth | \$40.74 | \$388 |

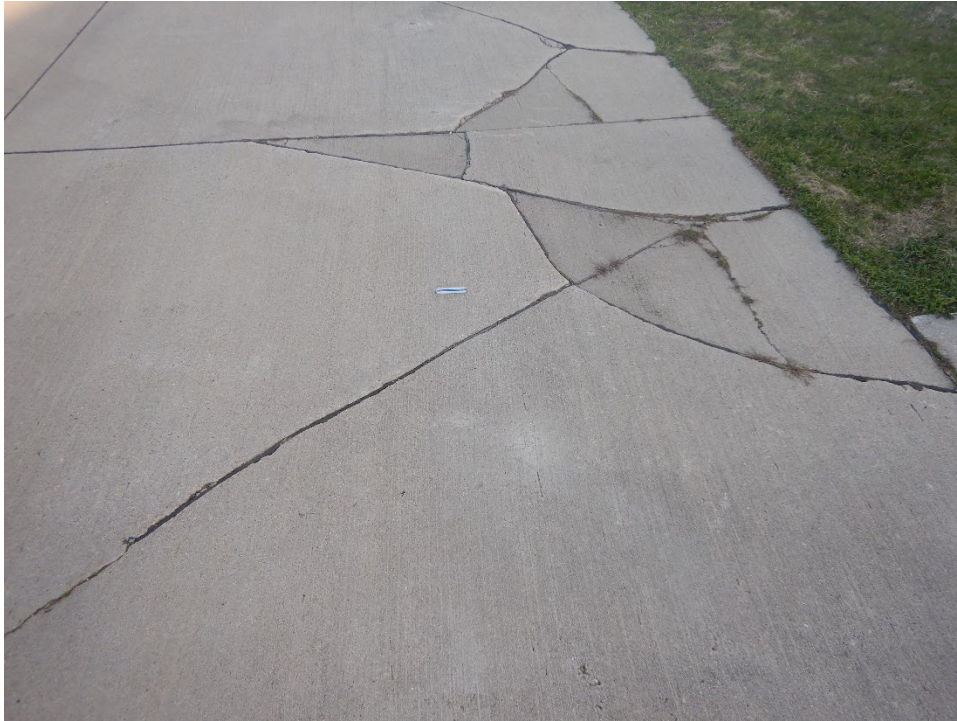
A01CO-01. Shattered Slab (Additional Sample Unit No. 004).

| Branch | Section | Distress Type | Severity | Distress Quantity | Distress Unit | Maintenance Action | Unit Cost | 2025 Estimated Cost |
|---|---|---|---|---|---|---|---|---|
| A01CO | 01 | Shattered Slab | Medium | 1 | Slabs | Slab Replacement - PCC | \$18.19 | \$2,619 |
| A01CO | 01 | Shattered Slab | High | 1 | Slabs | Slab Replacement - PCC | \$18.19 | \$2,619 |

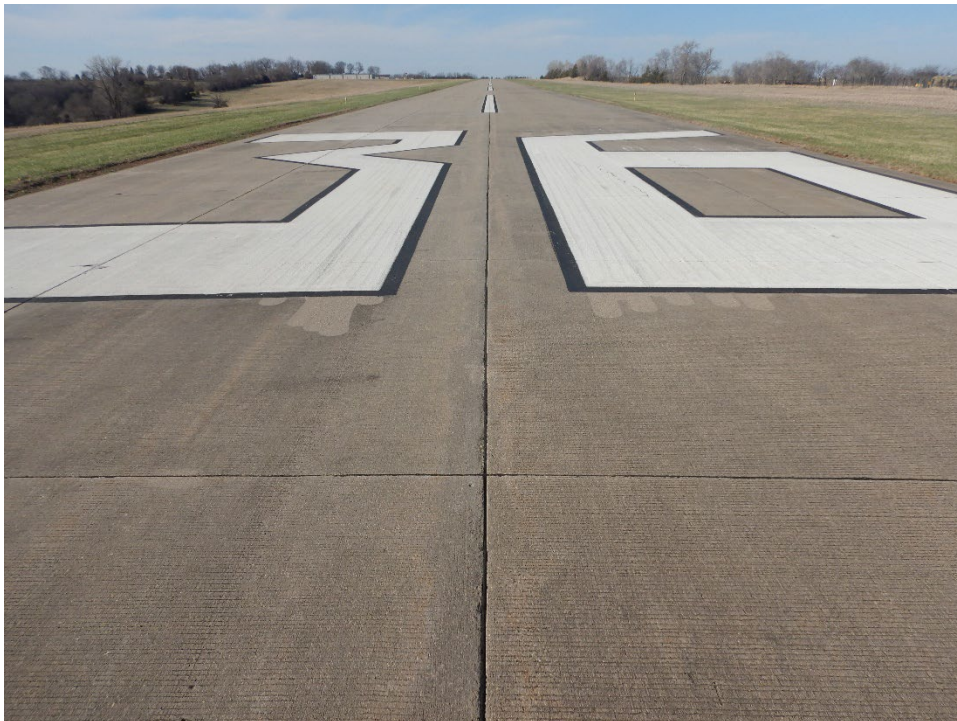
Runway 18/36 consisted of one section that contained areas of low-severity ASR, small patching and joint seal damage; all severities of corner spalling; and low- and medium-severity joint spalling and longitudinal, transverse, and diagonal (LTD) cracking. An atypical area of medium-severity shattered slab was observed and recorded as an additional sample unit in accordance with ASTM D5340.

R18CO-01. Overview.

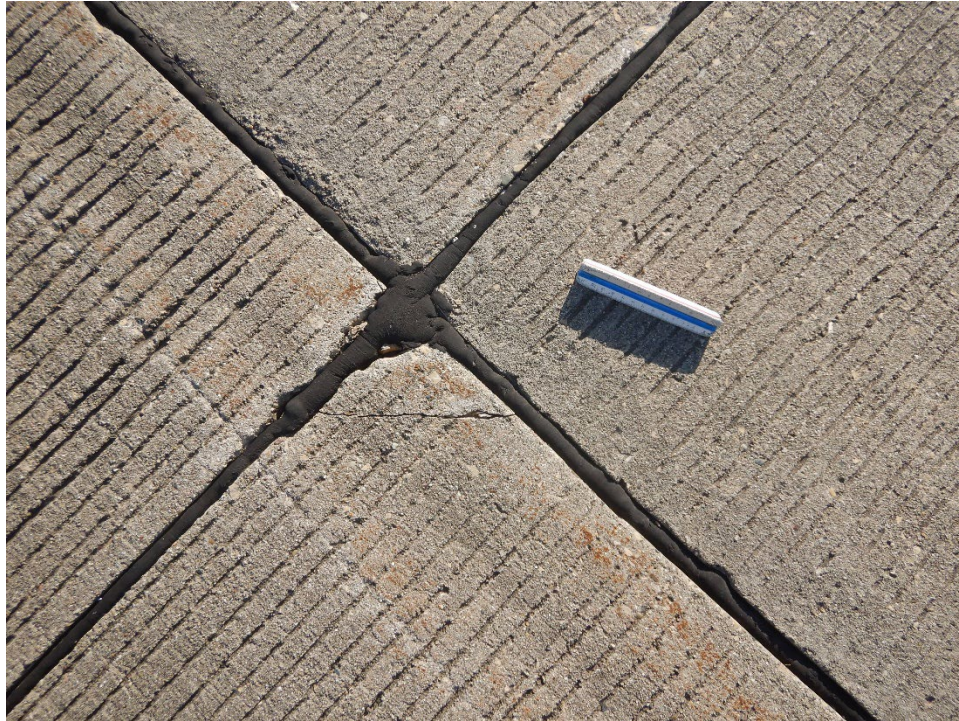
R18CO-01. Corner Spalling (Sample Unit No. 040).

| Branch | Section | Distress Type | Severity | Distress Quantity | Distress Unit | Maintenance Action | Unit Cost | 2025 Estimated Cost |
|---|---|---|---|---|---|---|---|---|
| R18CO | 01 | Corner Spalling | Medium | 134 | Slabs | Patching - PCC Partial Depth | \$40.74 | \$14,723 |
| R18CO | 01 | Corner Spalling | High | 20 | Slabs | Patching - PCC Partial Depth | \$40.74 | \$2,149 |

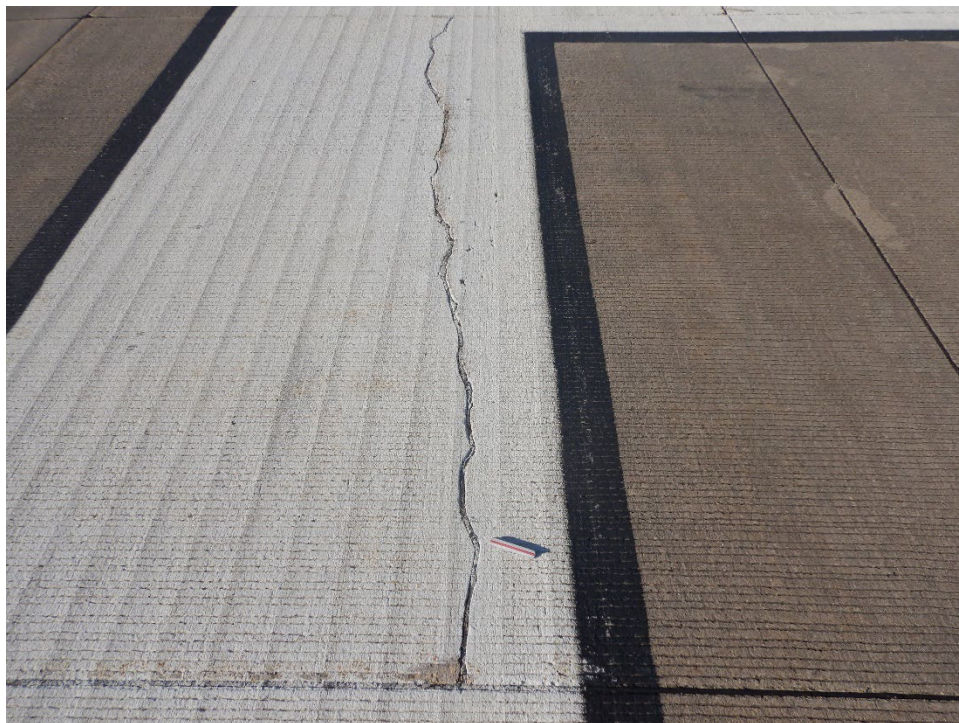
R18CO-01. LTD Cracking (Sample Unit No. 040).

| Branch | Section | Distress Type | Severity | Distress Quantity | Distress Unit | Maintenance Action | Unit Cost | 2025 Estimated Cost |
|---|---|---|---|---|---|---|---|---|
| R18CO | 01 | LTD Cracking | Medium | 5 | Slabs | Crack Sealing - PCC | \$3.27 | \$200 |

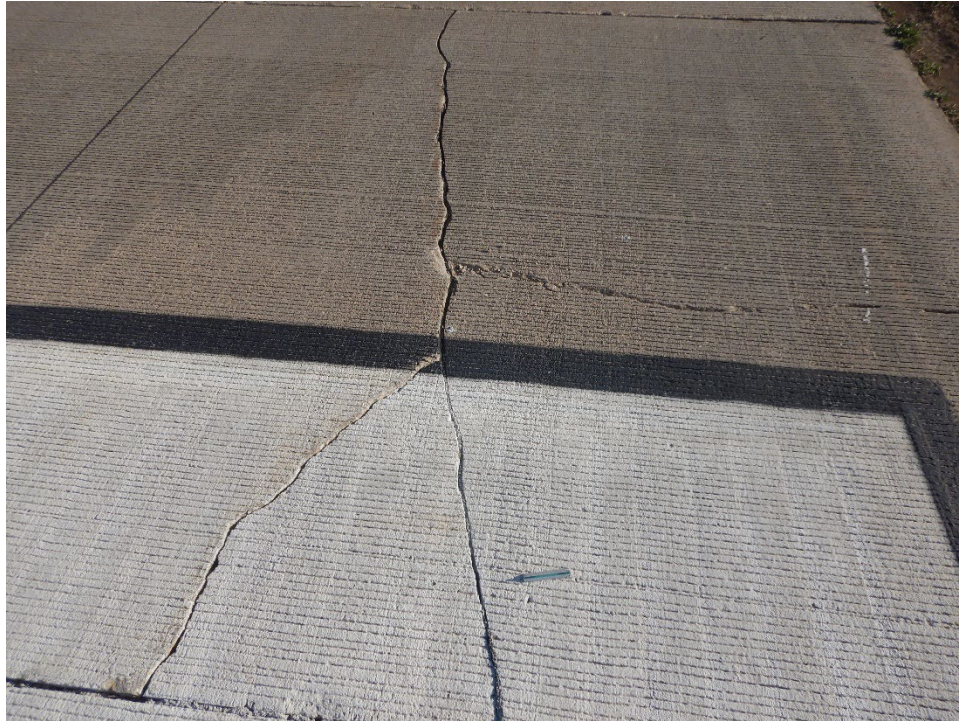
R18CO-01. Shattered Slab (Additional Sample Unit No. 005).

| Branch | Section | Distress Type | Severity | Distress Quantity | Distress Unit | Maintenance Action | Unit Cost | 2025 Estimated Cost |
|---|---|---|---|---|---|---|---|---|
| R18CO | 01 | Shattered Slab | Medium | 1 | Slabs | Slab Replacement - PCC | \$18.19 | \$2,842 |

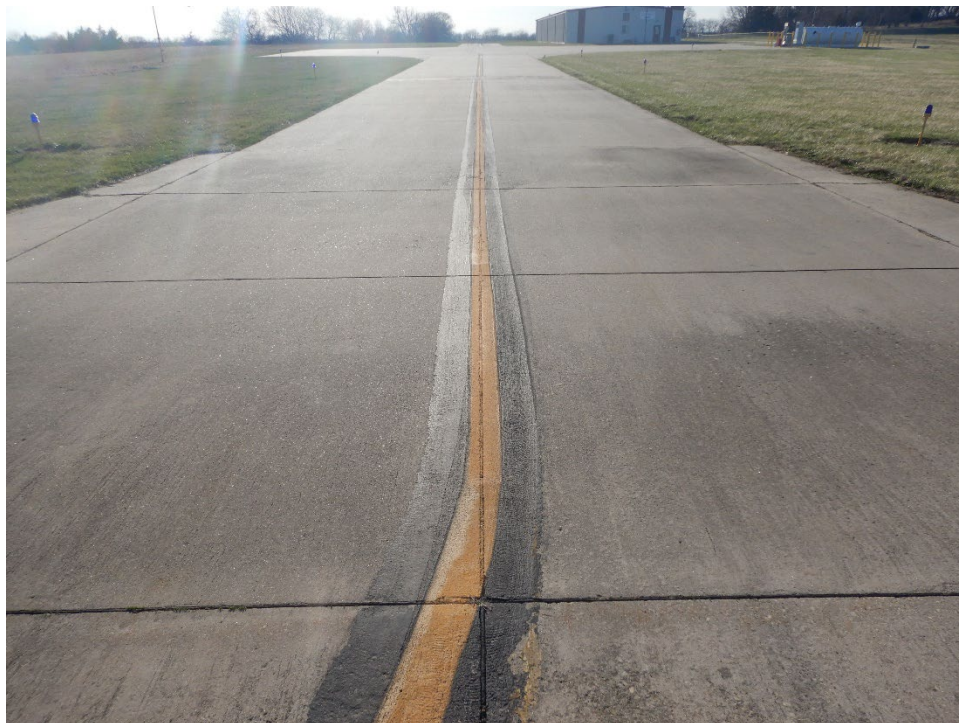
The taxiway was comprised of one section. Low-severity LTD cracking and low- and medium-severity corner spalling, faulting, joint seal damage, and joint spalling were observed in Section 01.

T01CO-01. Overview.

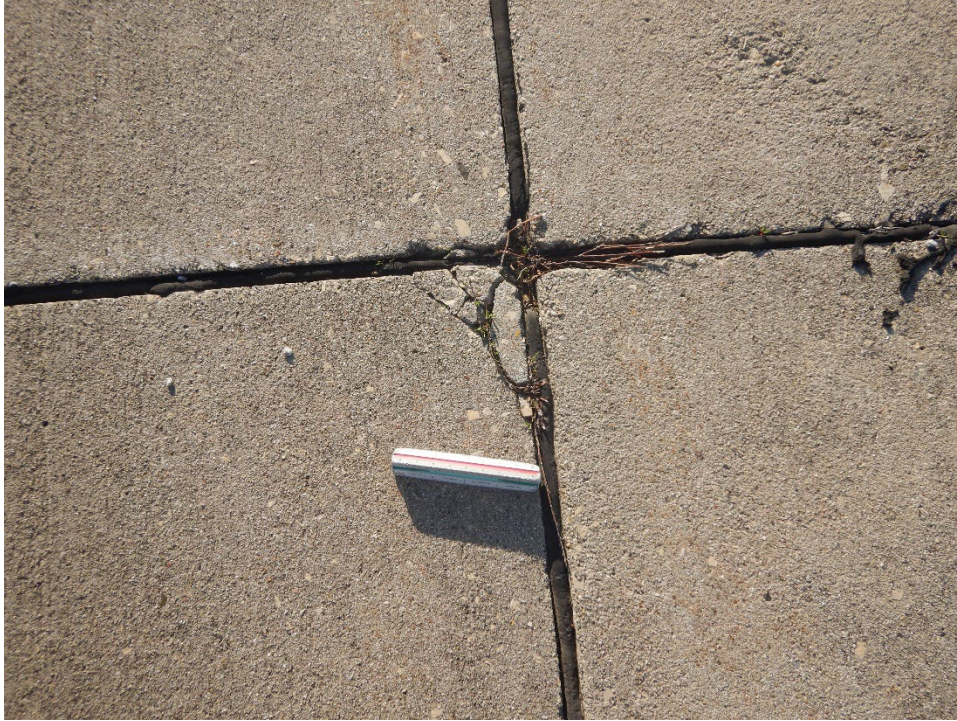
T01CO-01. Corner Spalling (Sample Unit No. 003).

| Branch | Section | Distress Type | Severity | Distress Quantity | Distress Unit | Maintenance Action | Unit Cost | 2025 Estimated Cost |
|---|---|---|---|---|---|---|---|---|
| T01CO | 01 | Corner Spalling | Medium | 3 | Slabs | Patching - PCC Partial Depth | \$40.74 | \$329 |

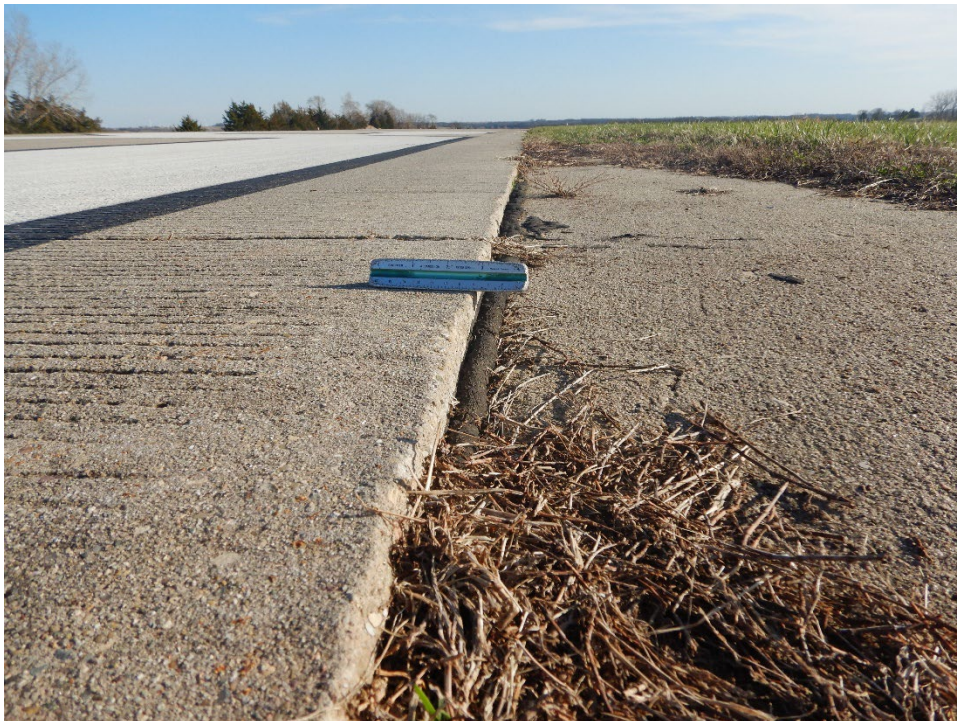
T01CO-01. Faulting (Sample Unit No. 003).
