# Cresco-Allen Church Field Airport

## Pavement Management Report

**AUGUST 2025**

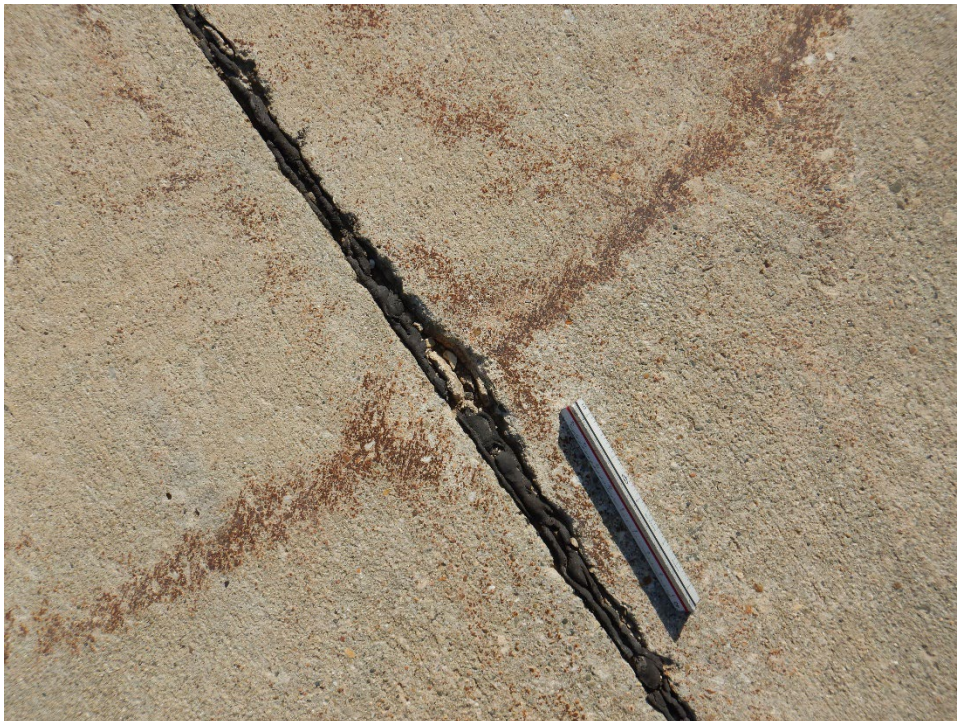
Apron 01 consisted of three sections. Section 01 contained high-severity joint seal damage and low- and medium-severity joint spalling. Section 02 was in *Poor* condition with low- and medium-severity corner break, LTD cracking, and corner spalling; high-severity joint seal damage; and medium-severity shattered slab observed. Section 03 was also in *Poor* condition, with areas of low-severity corner break and corner spalling, high-severity joint seal damage, and low- and medium-severity LTD cracking and shattered slab.

A01CR-01. Joint Seal Damage (Sample Unit No. 01).

| Branch | Section | Distress Type | Severity | Distress Quantity | Distress Unit | Maintenance Action | Unit Cost | 2025 Estimated Cost |
|---|---|---|---|---|---|---|---|---|
| A01CR | 01 | Joint Seal Damage | High | 20 | Slabs | Joint Seal (Localized) | \$3.27 | \$1,229 |

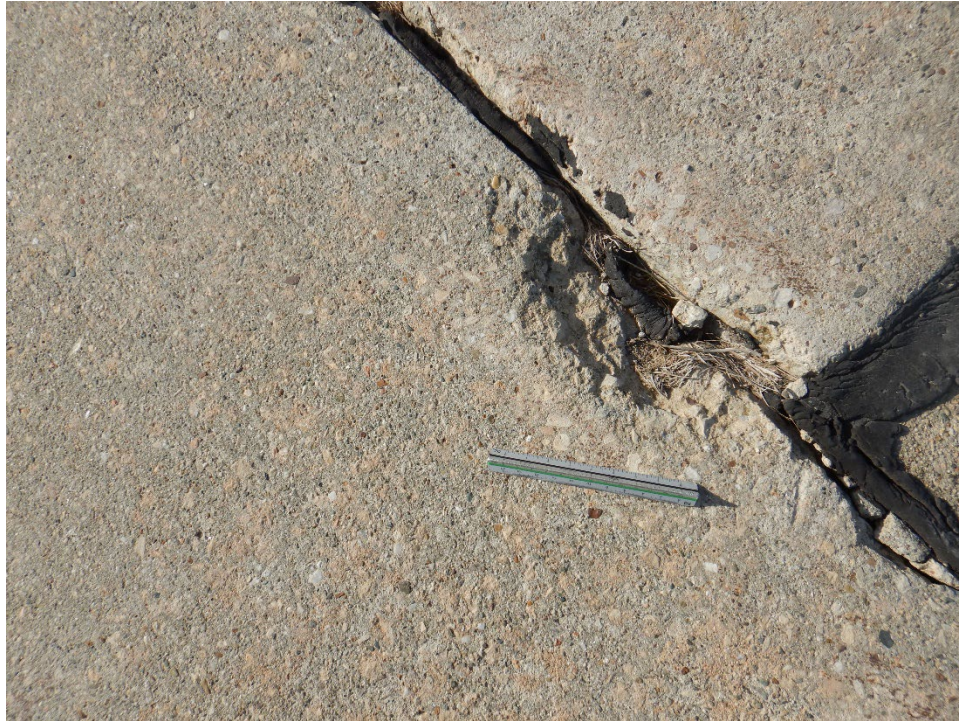
A01CR-01. Joint Spalling (Sample Unit No. 01).

| Branch | Section | Distress Type | Severity | Distress Quantity | Distress Unit | Maintenance Action | Unit Cost | 2025 Estimated Cost |
|---|---|---|---|---|---|---|---|---|
| A01CR | 01 | Joint Spalling | Medium | 2 | Slabs | Patching - PCC Partial Depth | \$40.74 | \$526 |

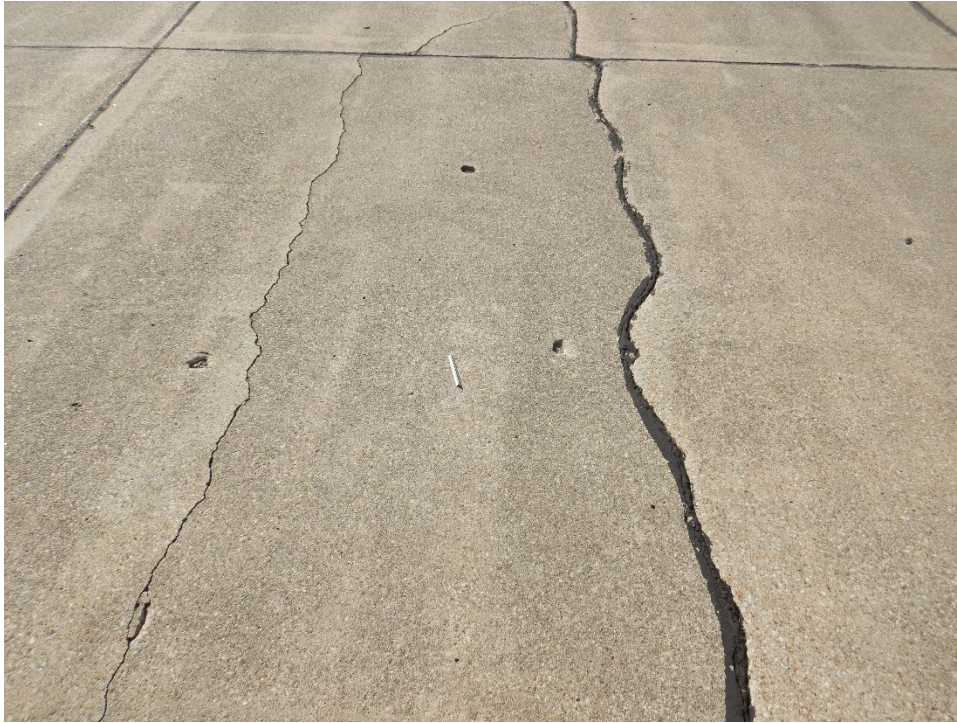
A01CR-02. LTD Cracking (Sample Unit No. 01).

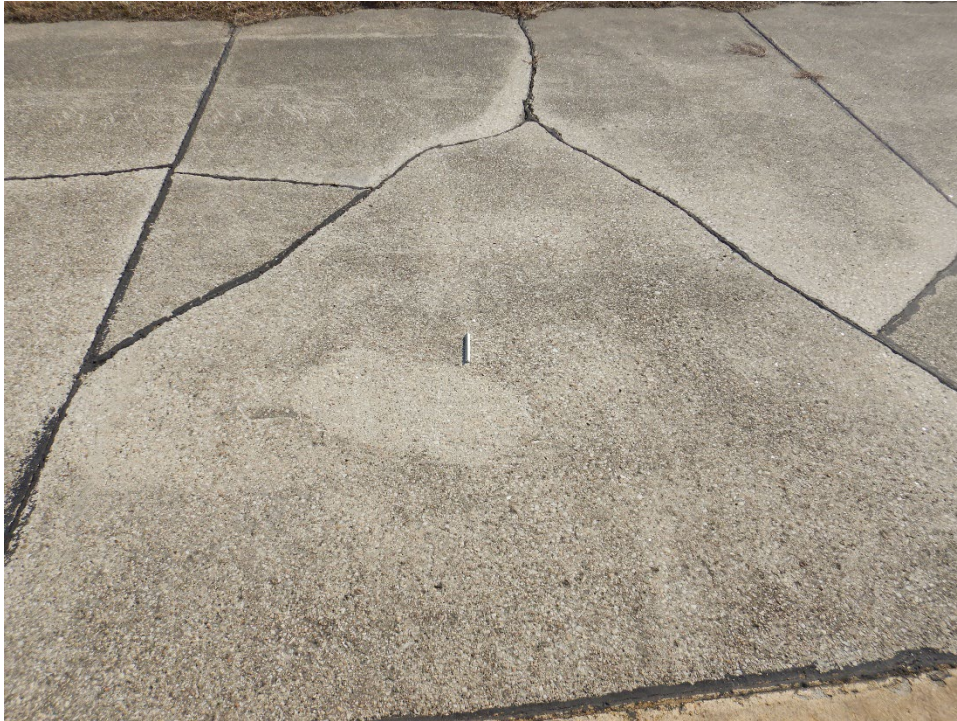
A01CR-03. Shattered Slab (Sample Unit No. 02).

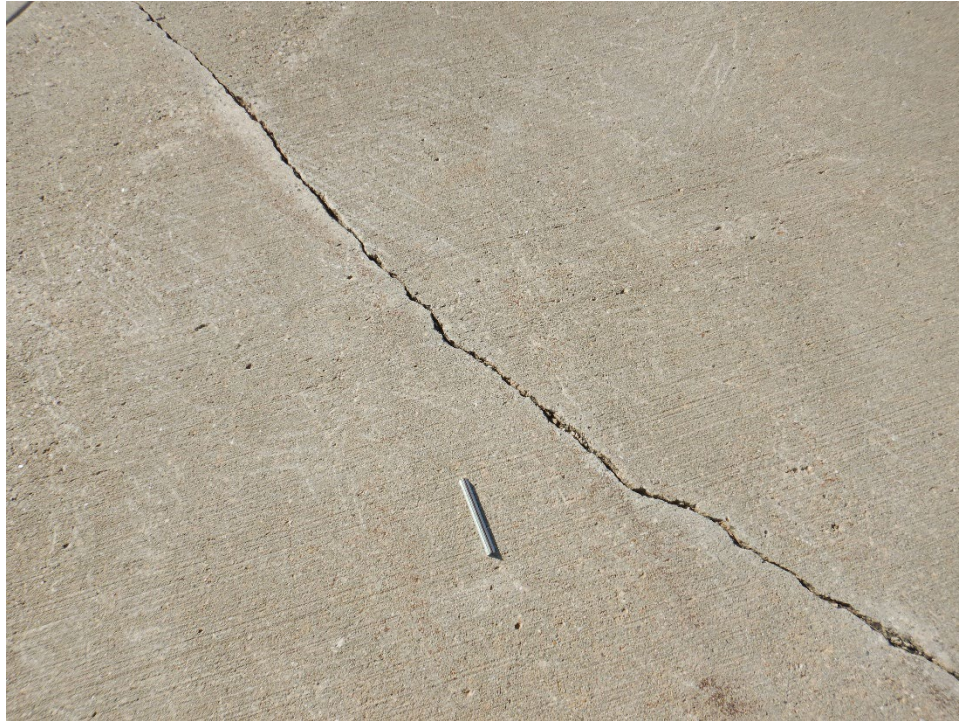
Apron 02 contained two sections. Section 01 contained low-severity corner spalling, large patching, and small patching; high-severity joint seal damage; medium-severity joint spalling; and low- and medium-severity LTD cracking. Low-severity ASR, corner break, and faulting; medium-severity corner spalling and joint spalling; and low- and medium-severity LTD cracking were observed in Section 02.

A02CR-01. LTD Cracking (Sample Unit No. 02) (2).

| Branch | Section | Distress Type | Severity | Distress Quantity | Distress Unit | Maintenance Action | Unit Cost | 2025 Estimated Cost |
|---|---|---|---|---|---|---|---|---|
| A02CR | 01 | LTD Cracking | Medium | 1 | Slabs | Crack Sealing - PCC | \$3.27 | \$40 |

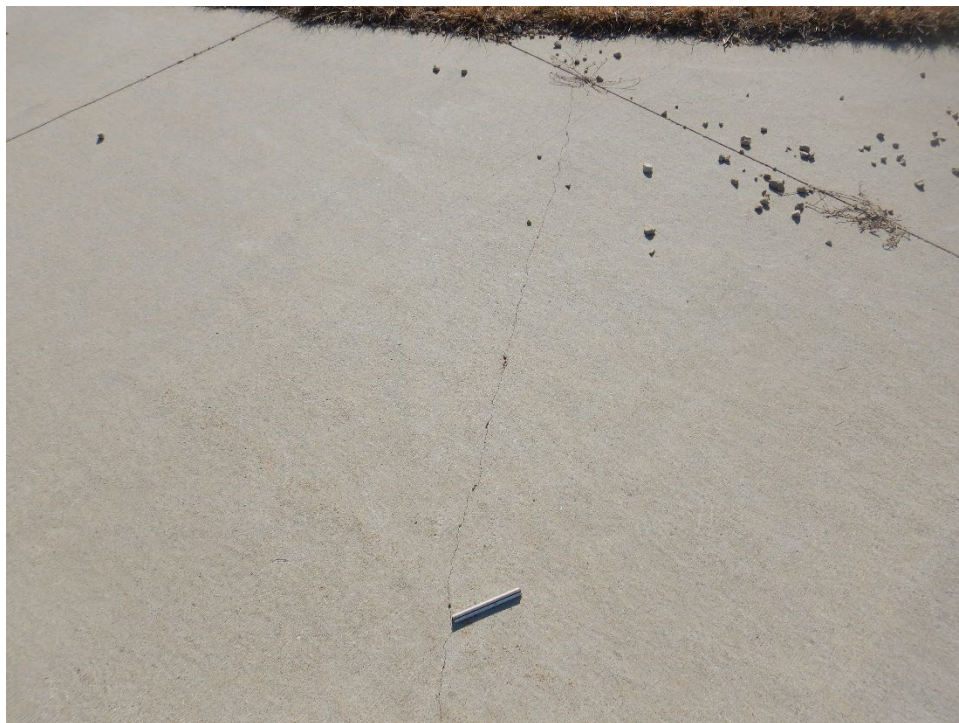
A02CR-01. LTD Cracking (Sample unit No. 02) (1).

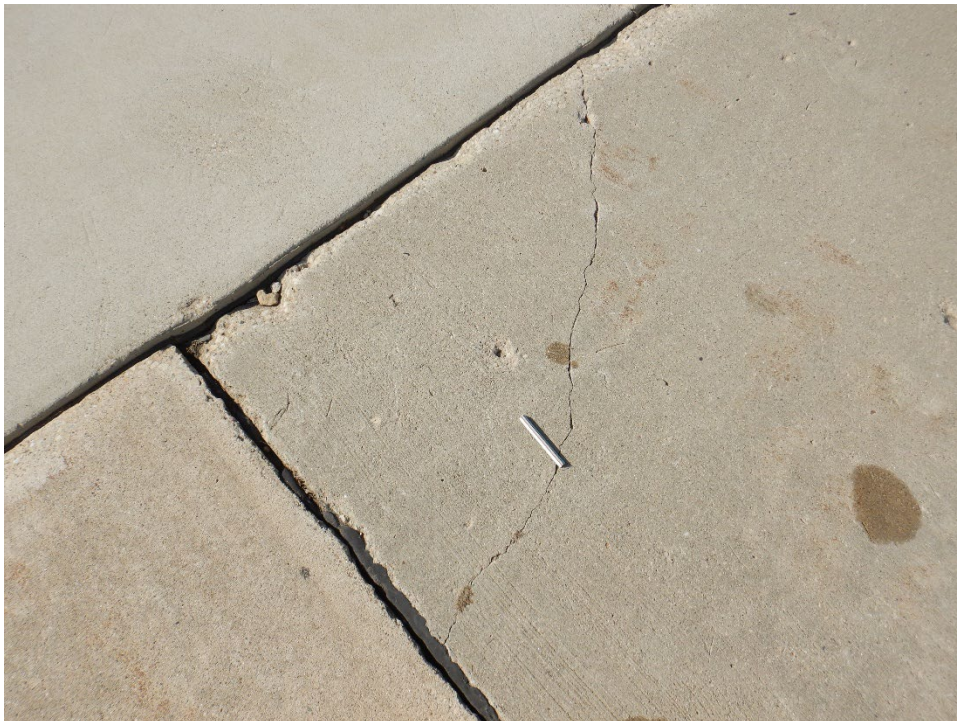
A02CR-02. Corner Break (Sample Unit No. 01).

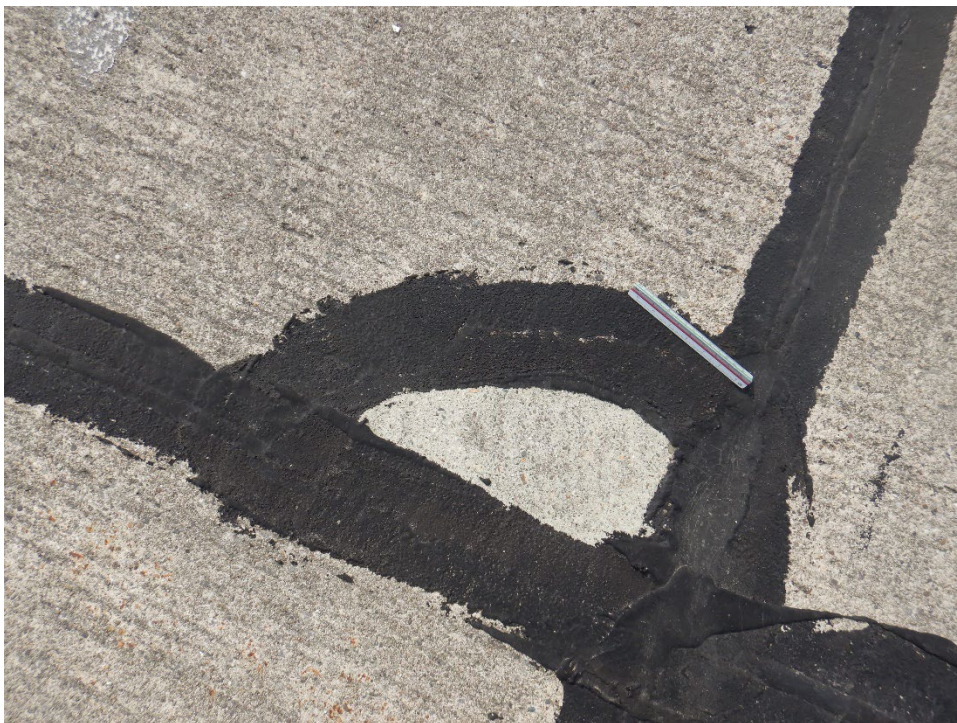
Runway 15/33 consisted of two sections. Section 01 contained areas of low- and medium-severity small patching and low-severity ASR, corner break, faulting, joint spalling, large patching, and longitudinal, transverse, and diagonal (LTD) cracking. Section 02 was similar to Section 01 with the observed distresses including low-severity ASR, joint spalling, LTD cracking, and small patching.

R15CR-01. Small Patching (Sample Unit No. 04).

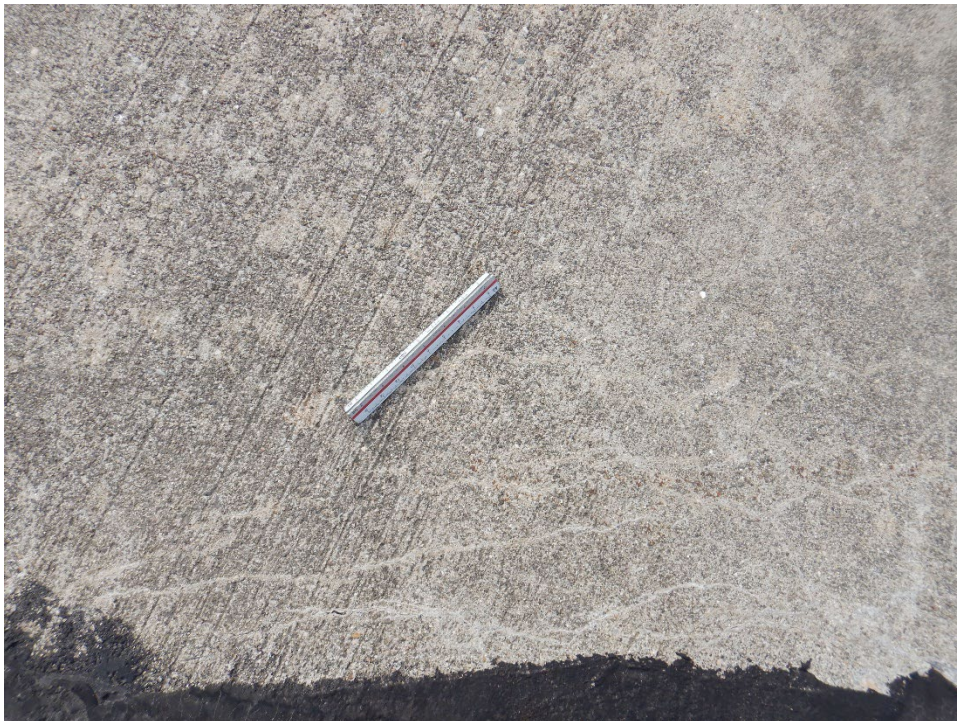
Cresco-Ellen Church Field Airport was inspected on March 13, 2025. There were 11 pavement sections defined during the inspection. Alkali-silica reaction (ASR) was recorded at this airport according to the PCI procedure. The ASR was recorded where evidence of a precipitate was observed within some of the cracking in the PCC surface. It should be noted that laboratory testing in the form of petrographic analysis is the only definitive way to validate the presence of ASR; however, the formation of a precipitate is evidence of a reaction consistent with this type of materials-related distress.

R15CR-02. ASR (Sample Unit No. 01).

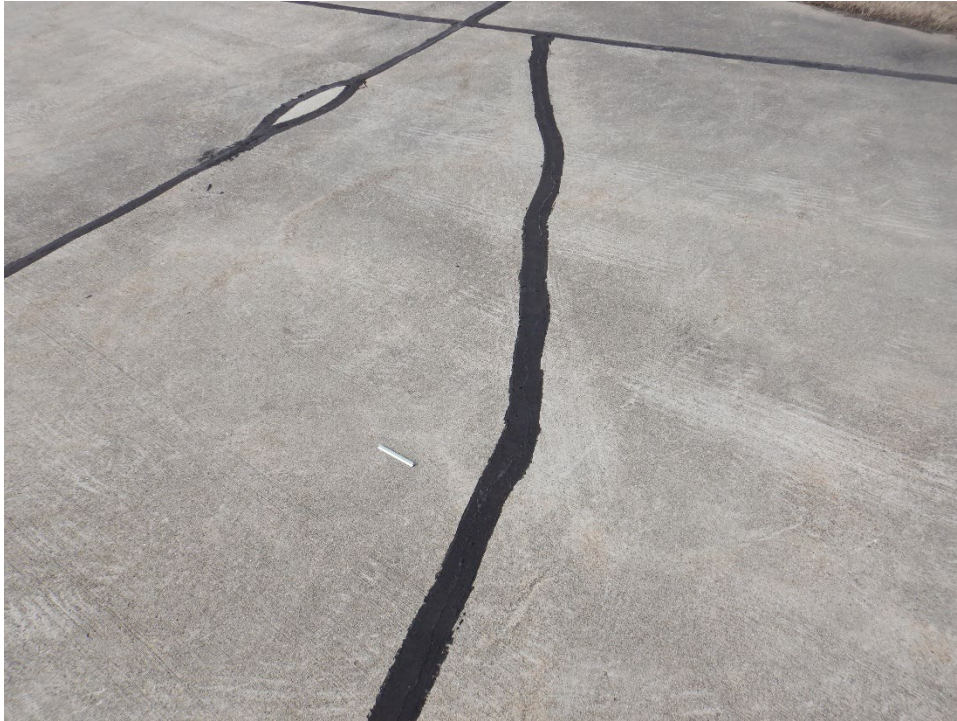
R15CR-02. LTD Cracking (Sample Unit No. 01).

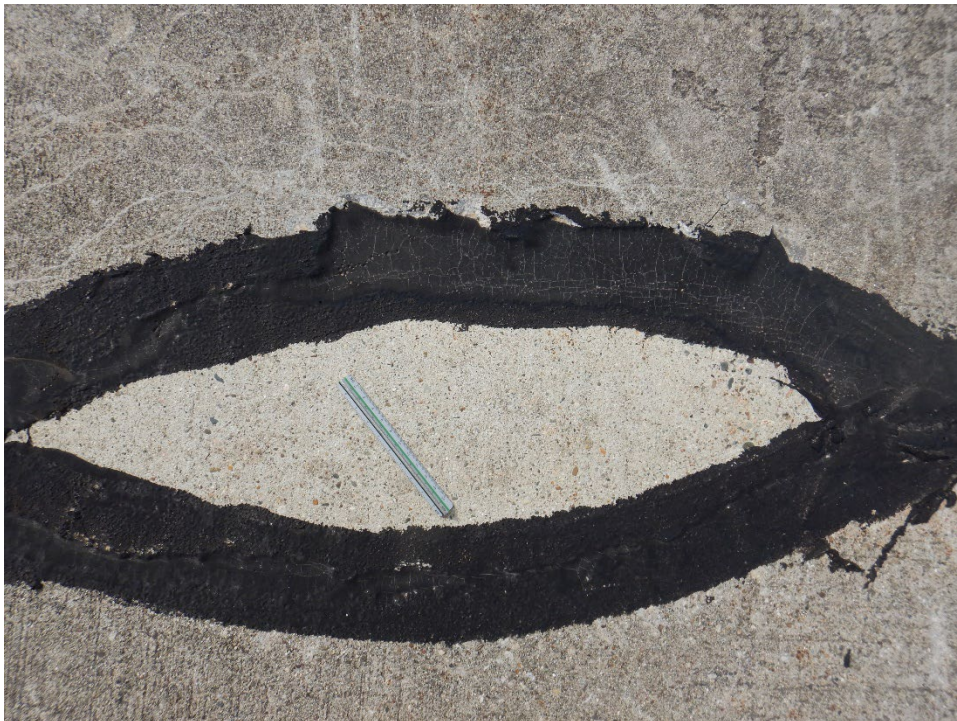
R15CR-02. Small Patching (Sample Unit No. 01).

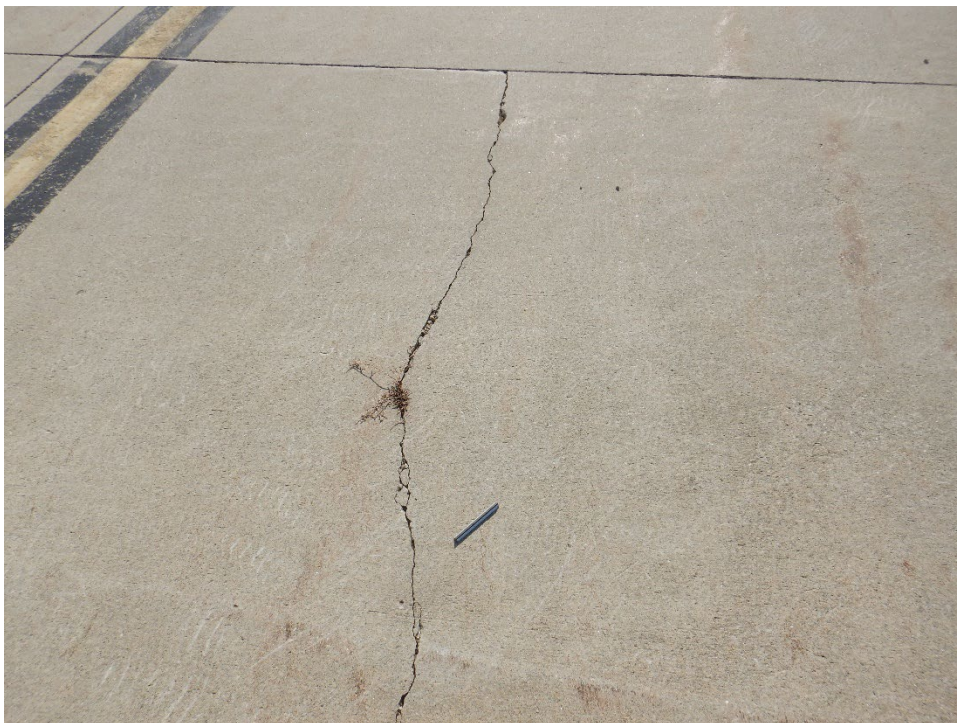
Taxiway 01 was defined by one section that contained high-severity joint seal damage and medium-severity LTD cracking.

T01CR-01. LTD Cracking (Sample Unit No. 01).

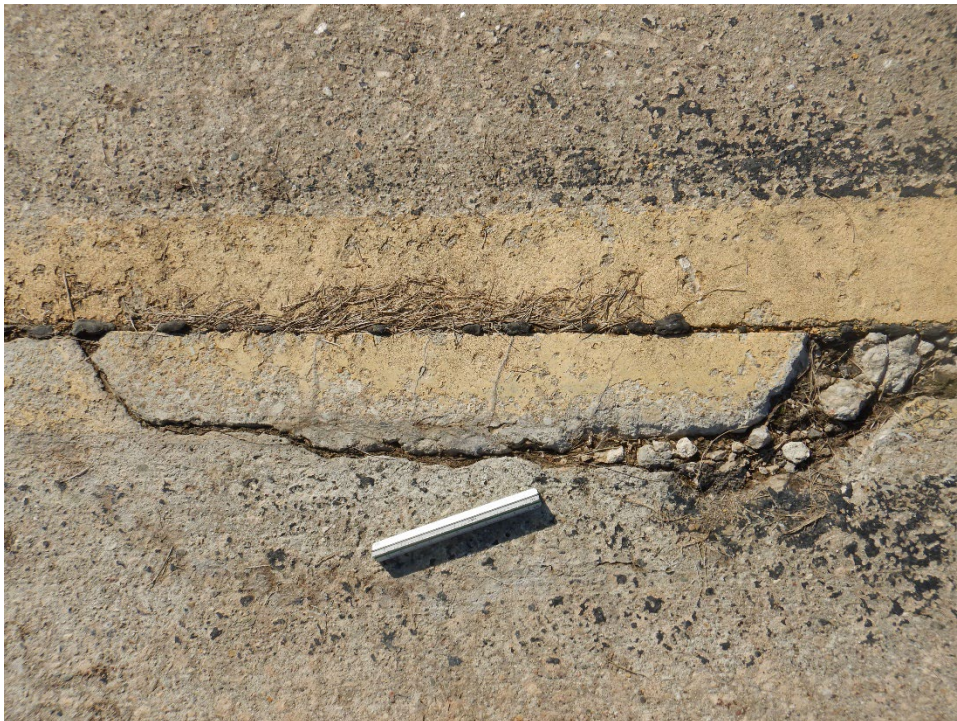
Taxiway 02 consisted of one section. Distresses observed in Section 01 during the inspection included high-severity joint seal damage and low- and medium-severity ASR and joint spalling.

T02CR-01. ASR (Sample Unit No. 01).

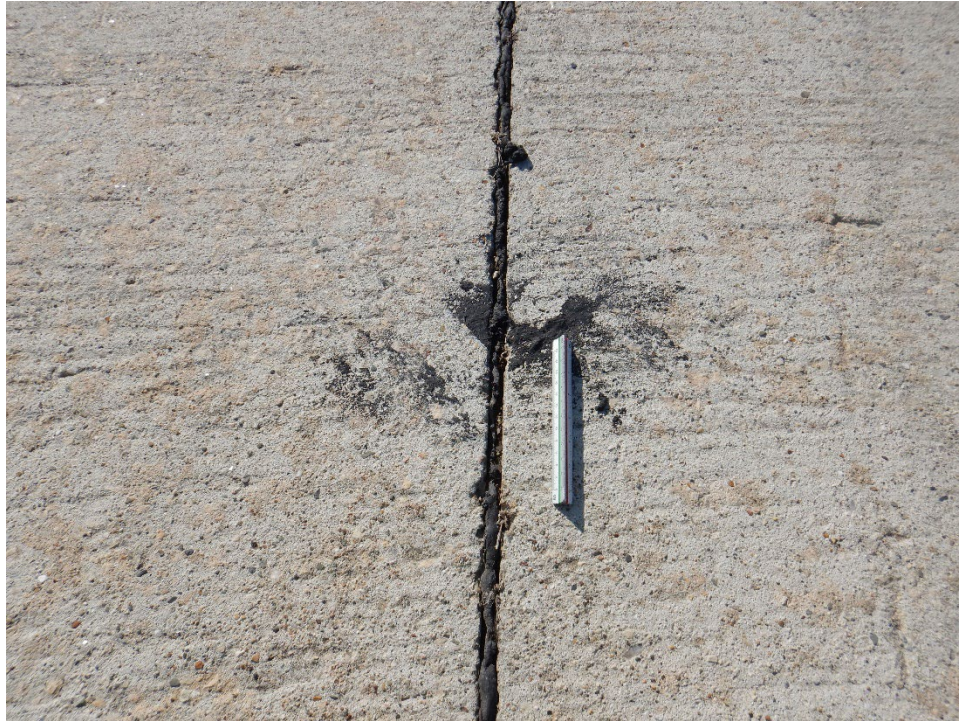
T02CR-01. Joint Seal Damage (Sample Unit No. 01).

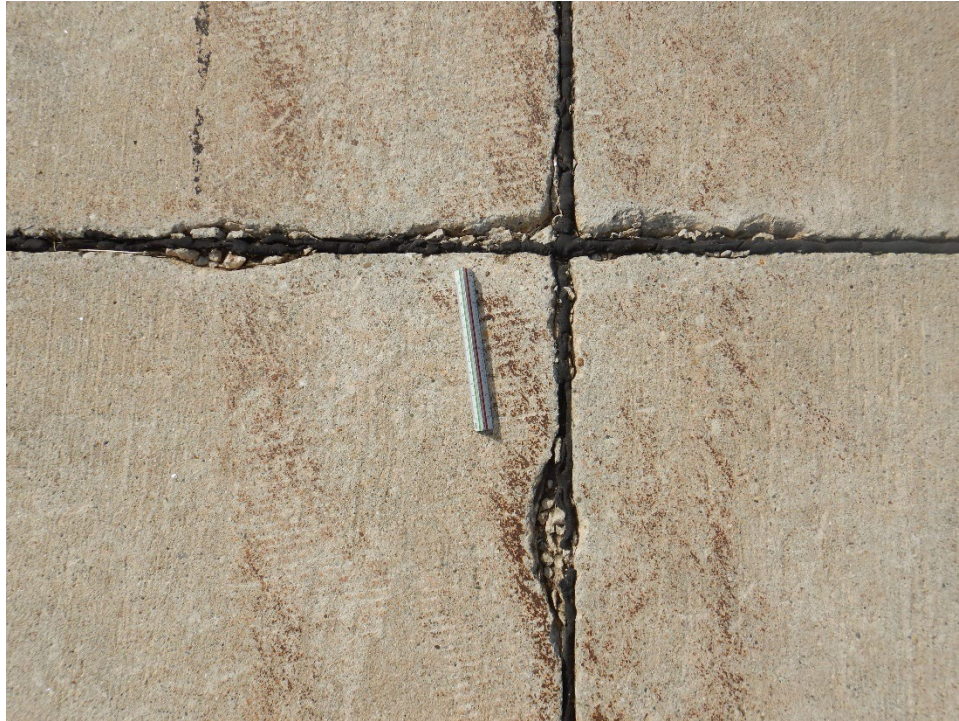
Taxiway 03 contained one section. Low- and medium-severity faulting and LTD cracking and high-severity joint seal damage were recorded in Section 01.

T03CR-01. Joint Seal Damage (Sample Unit No. 07).

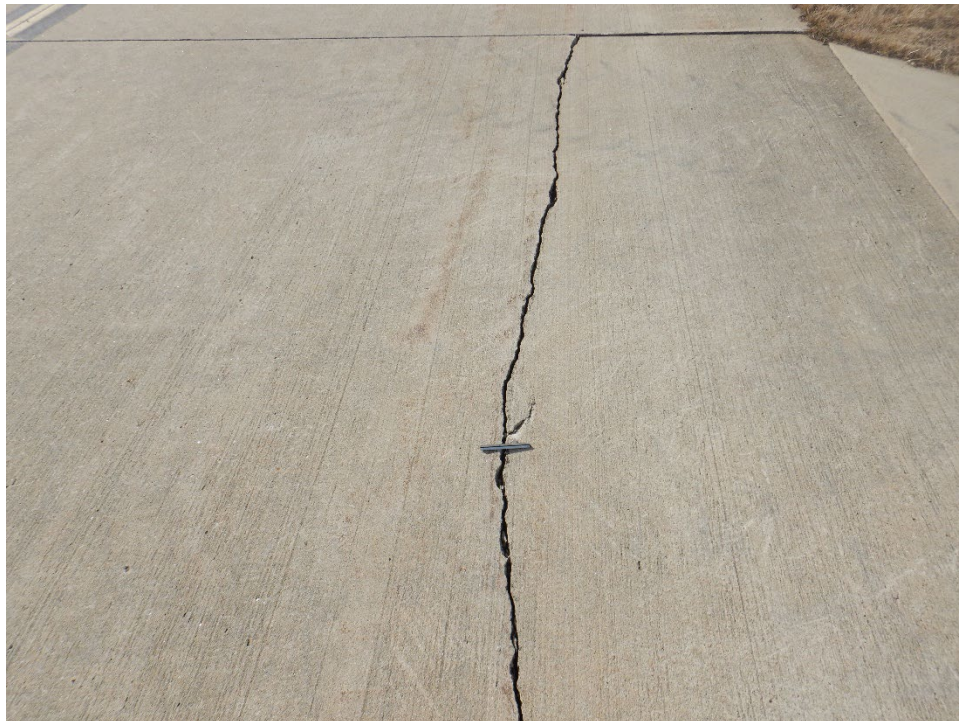
T03CR-01. LTD Cracking (Sample Unit No. 03).

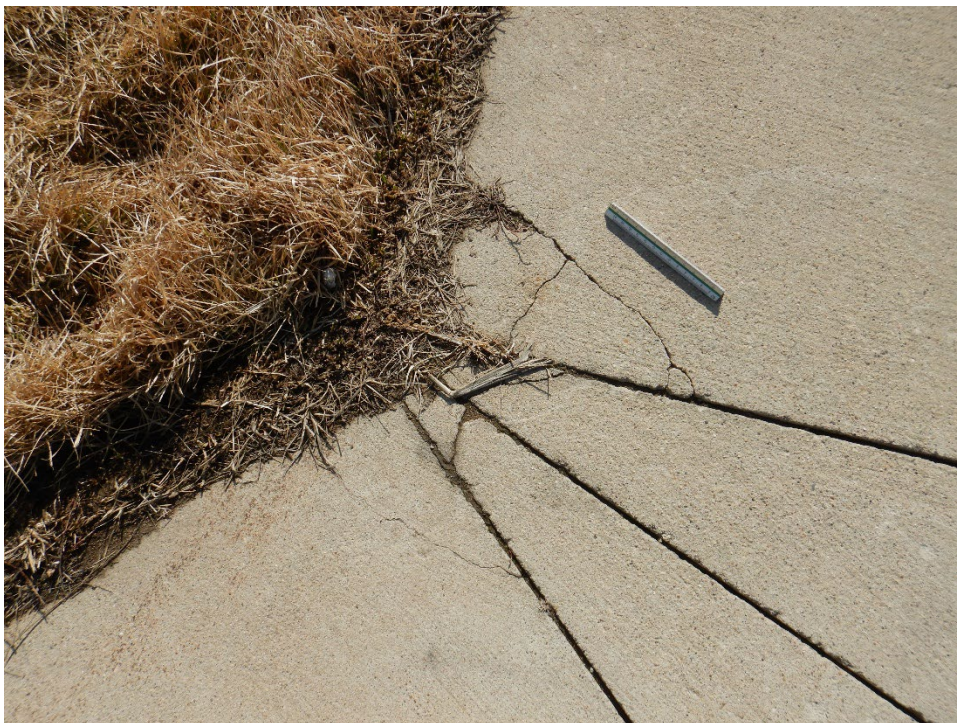
Taxiway 04 was defined by one section with low-severity corner spalling and high-severity joint seal damage identified at the time of inspection.

T04CR-01. Corner Spalling (Sample Unit No. 02).

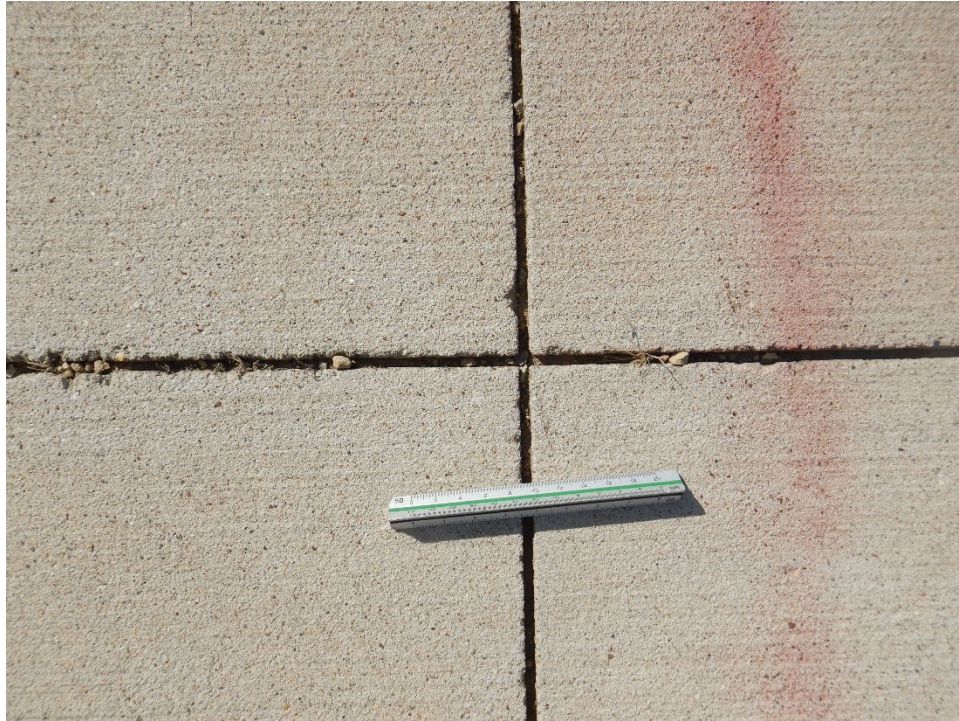
T04CR-01. Joint Seal Damage (Sample Unit No. 02).
