# Creston Municipal Airport

## Pavement Management Report

**AUGUST 2025**

# CRESTON MUNICIPAL AIRPORT PAVEMENT MANAGEMENT REPORT

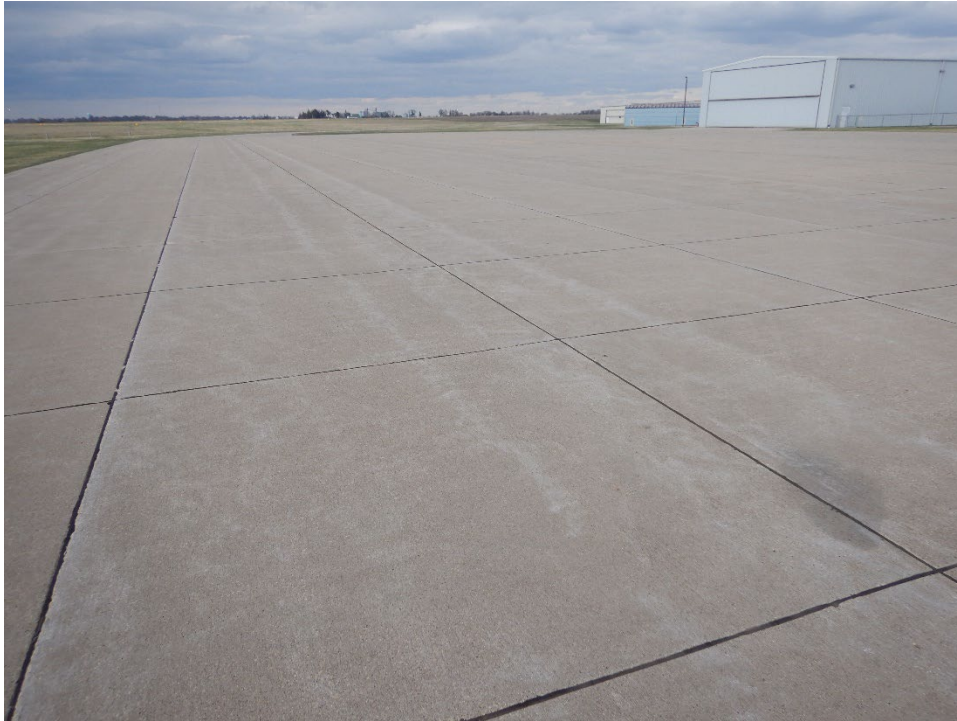
A01CT-01. Overview.

The apron area consisted of one section. Low- and medium-severity corner break, joint spalling, and LTD cracking; low-severity corner spalling and faulting; medium- and high-severity joint seal damage; and medium-severity shattered slab were observed in Section 01.

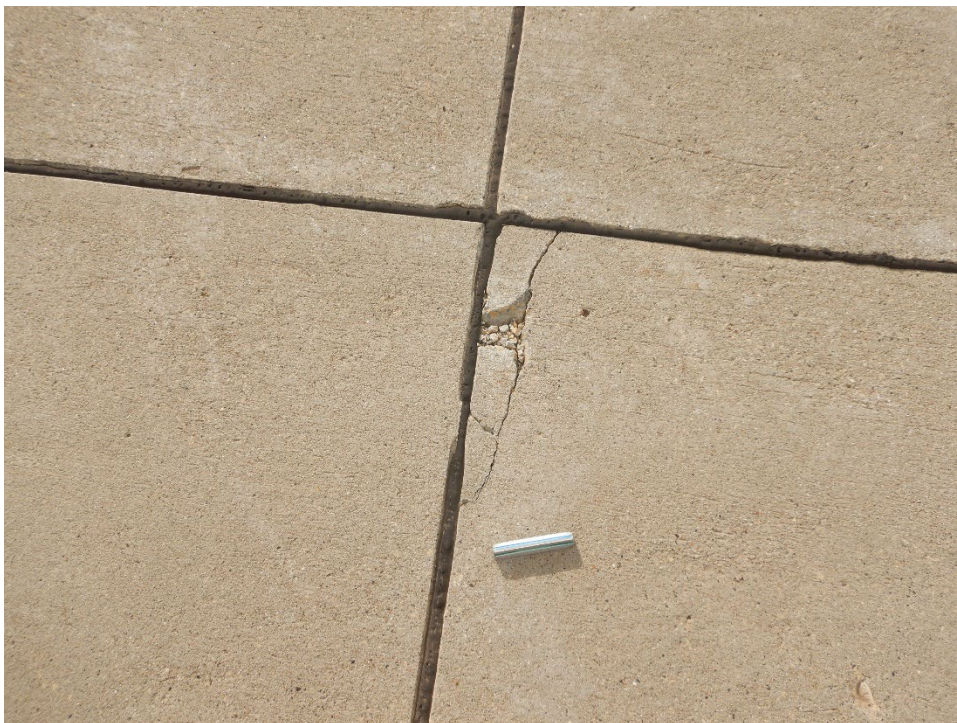
A01CT-01. Joint Spalling (Sample Unit No. 006).

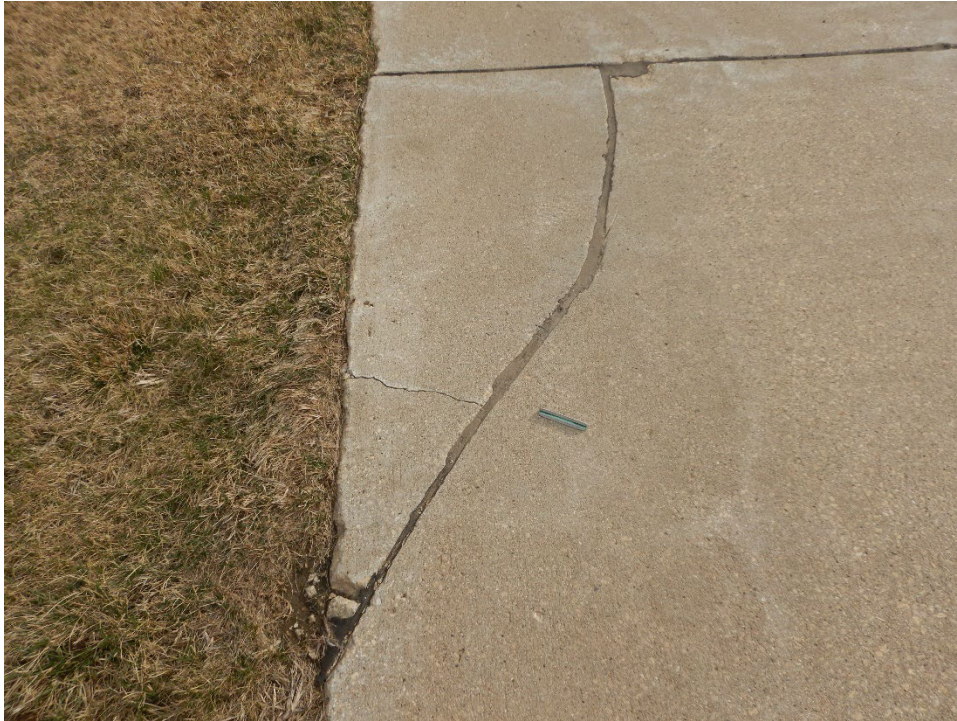
A01CT-01. LTD Cracking (Sample Unit No. 006).

| Branch | Section | Distress Type | Severity | Distress Quantity | Distress Unit | Maintenance Action | Unit Cost | 2025 Estimated Cost |
|---|---|---|---|---|---|---|---|---|
| A01CT | 01 | LTD Cracking | Medium | 8 | Slabs | Crack Sealing - PCC | \$3.27 | \$245 |

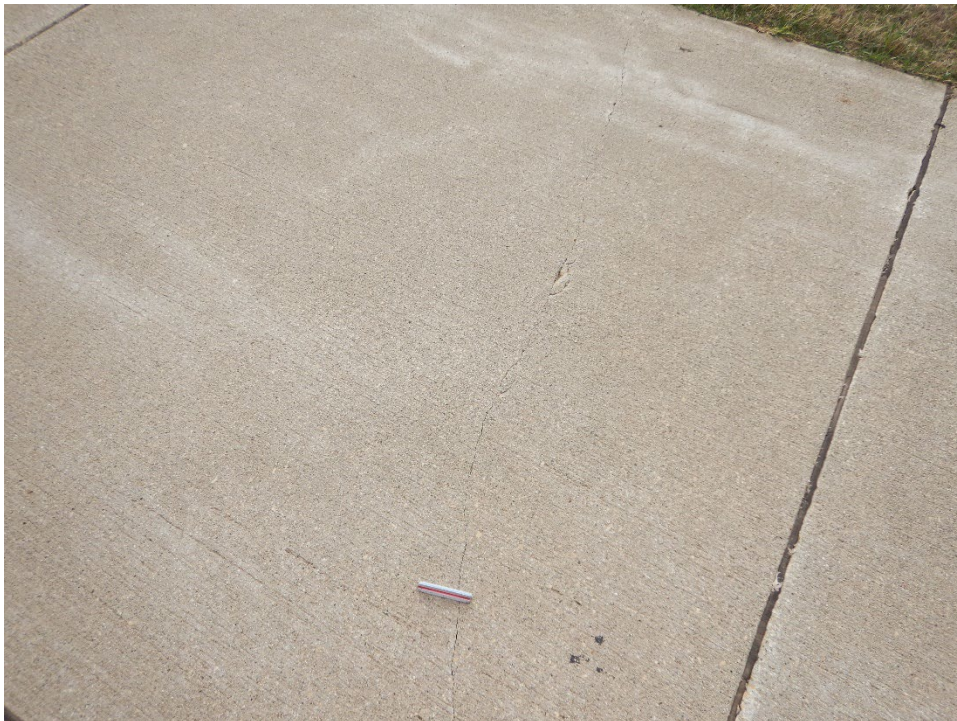
A01CT-01. LTD Cracking (Sample Unit No. 029).

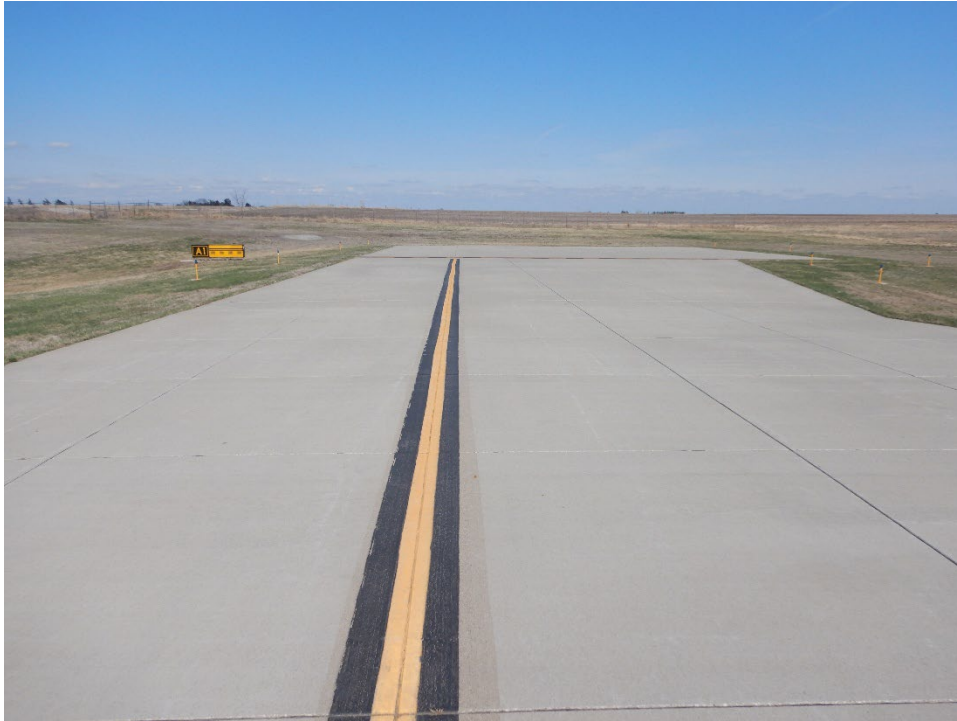
R16CT-01. Overview.

Runway 16/34 consisted of three sections; one section located at each end of the runway and the remaining section being the runway itself. Low- and medium-severity joint seal damage and joint spalling were observed in Section 01. Sections 02 and 04 were in *Excellent* condition. Section 02 was recently rehabilitated with areas of low-severity joint spalling, shrinkage cracking, and low-severity small patching noted. Low-severity joint seal damage was recorded in Section 04.

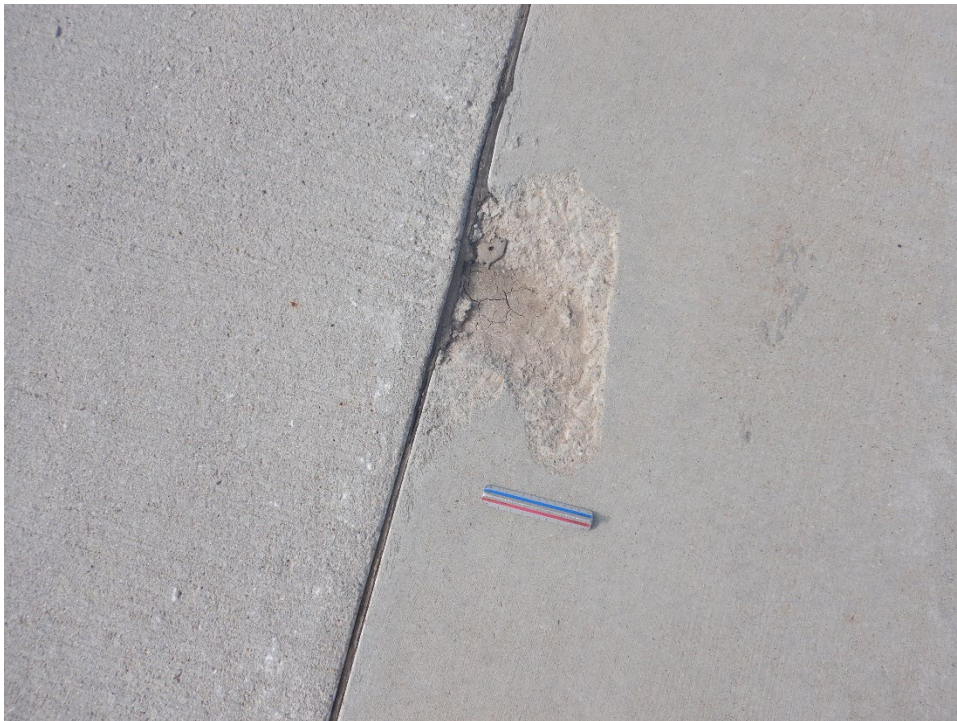
R16CT-01. Joint Spalling (Sample Unit No. 10).

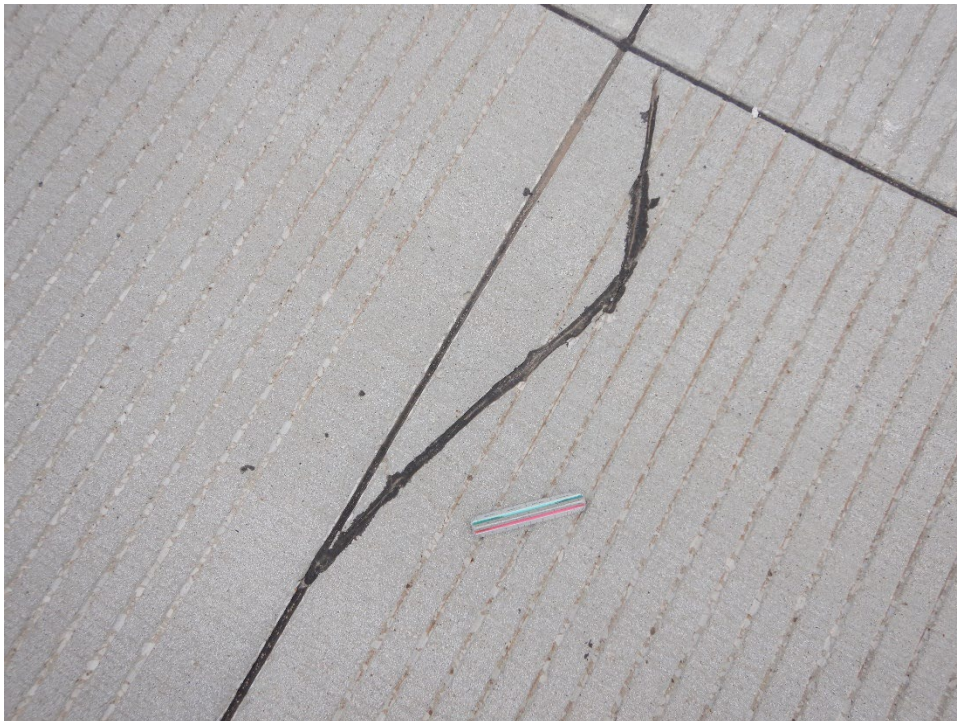
R16CT-02. Joint Spalling (Sample Unit No. 027).

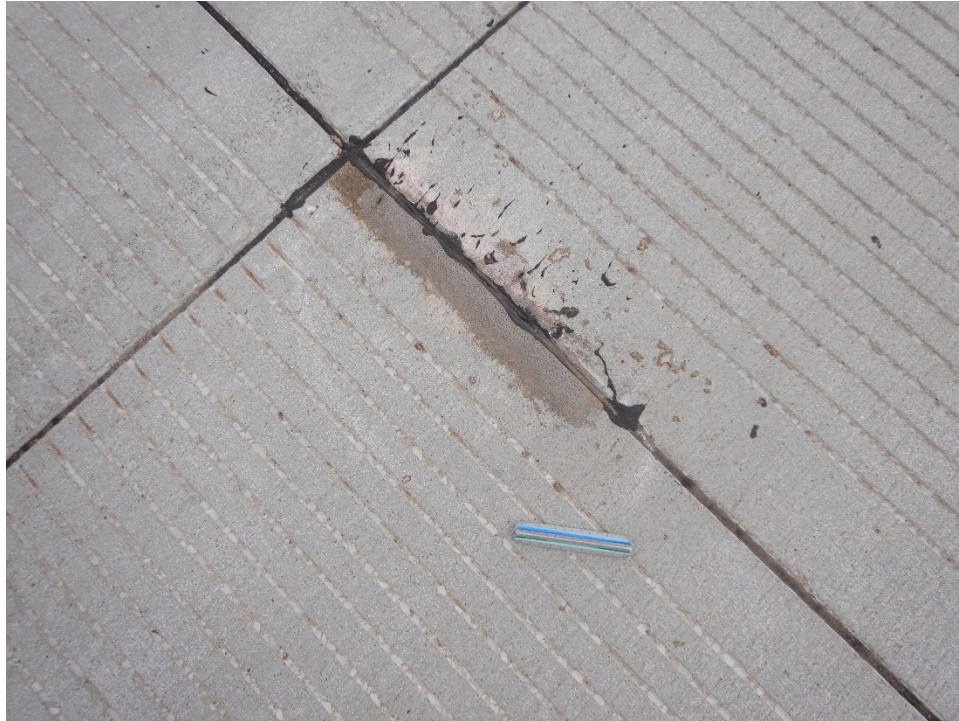
R16CT-02. Small Patching (Sample Unit No. 067).

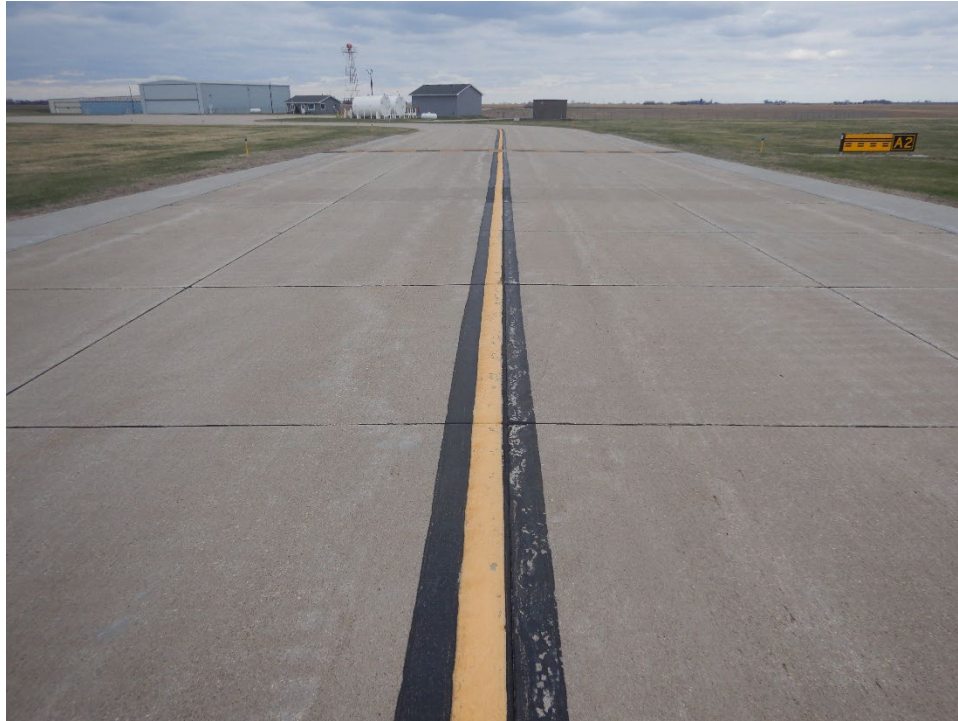
T01CT-01. Overview.

The taxiway contained one section that connected the apron area to Runway 16/34. Low-severity ASR and corner break, low- and medium-severity corner spalling and faulting, high-severity joint seal damage, and medium-severity longitudinal, transverse, and diagonal (LTD) cracking were recorded within Section 01.

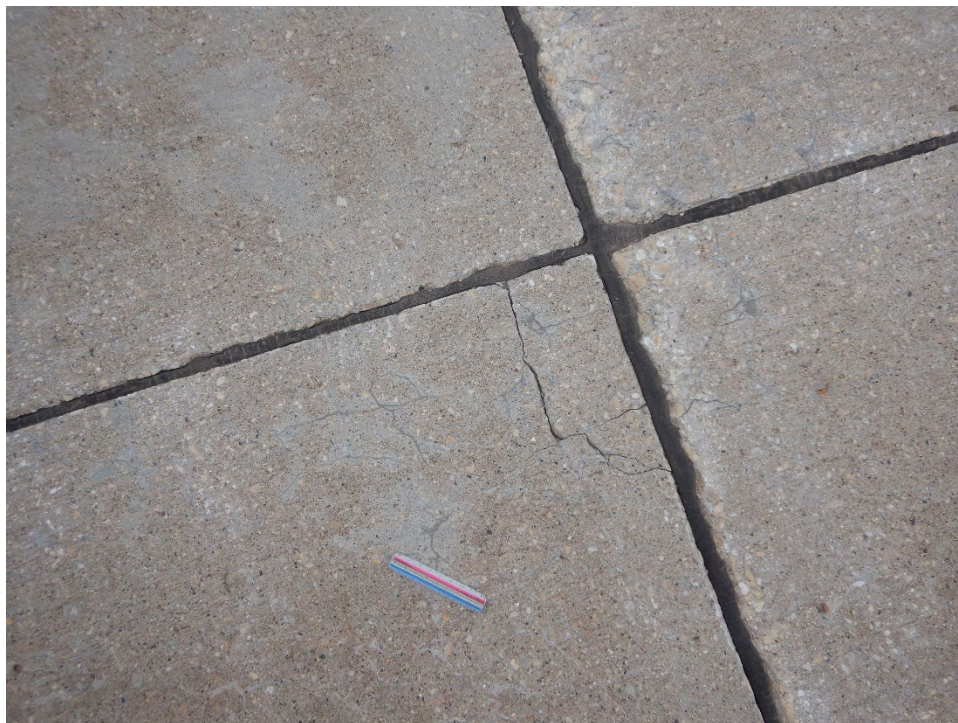
Creston Municipal Airport was inspected on March 29, 2025. There were seven pavement sections defined during the inspection. Alkali-silica reaction (ASR) was recorded at this airport according to the PCI procedure. The ASR was recorded where evidence of a precipitate was observed within some of the cracking in the PCC surface. It should be noted that laboratory testing in the form of petrographic analysis is the only definitive way to validate the presence of ASR; however, the formation of a precipitate is evidence of a reaction consistent with this type of materials-related distress.

T01CT-01. ASR (Sample Unit No. 01).

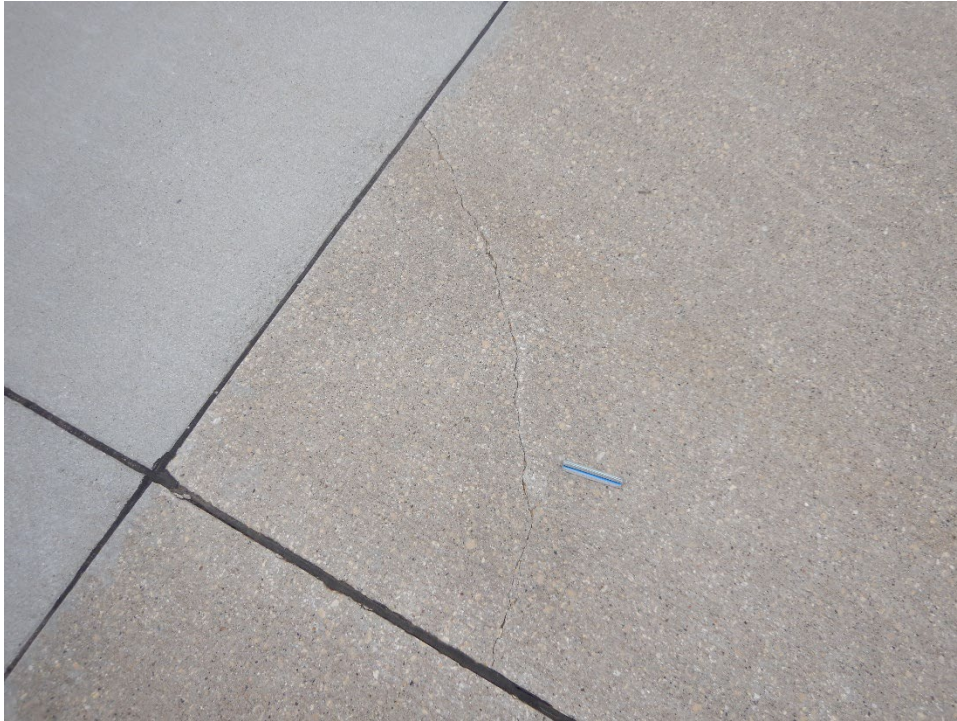
T01CT-01. Corner Break (Sample Unit No. 01).

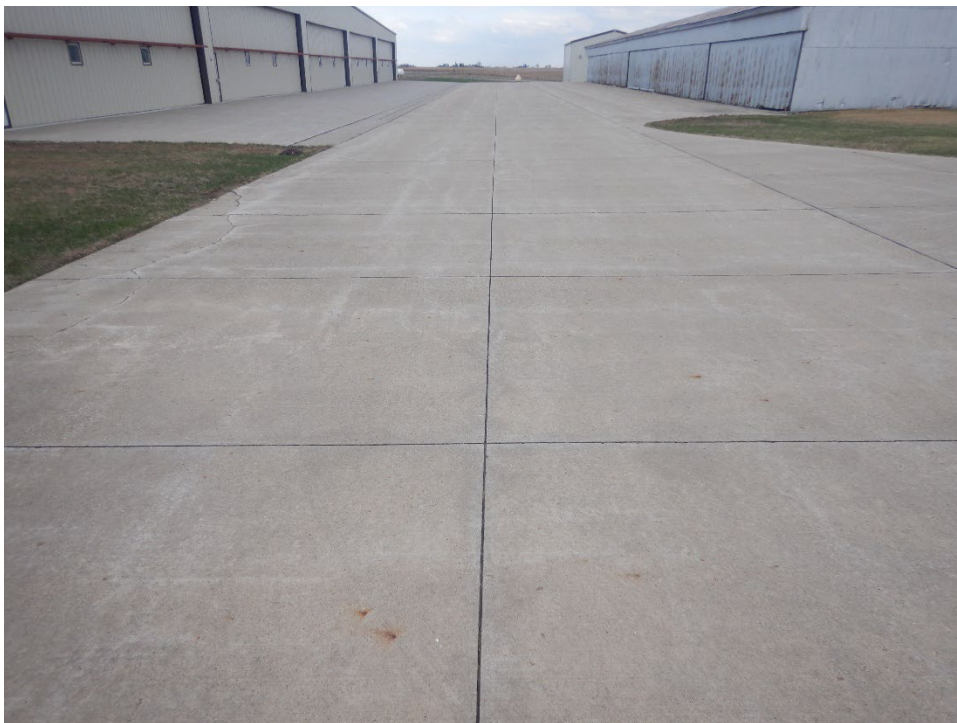
TH01CT-01. Overview.

The T-hangar area was defined by two sections. Section 01 had low- and medium-severity ASR, LTD cracking, and corner break; high-severity joint seal damage; medium-severity joint spalling; popouts; and all severities of shattered slab. Low-severity ASR and faulting, medium- and high-severity joint seal damage, low- and high-severity joint spalling, and medium-severity LTD cracking were noted in Section 02.

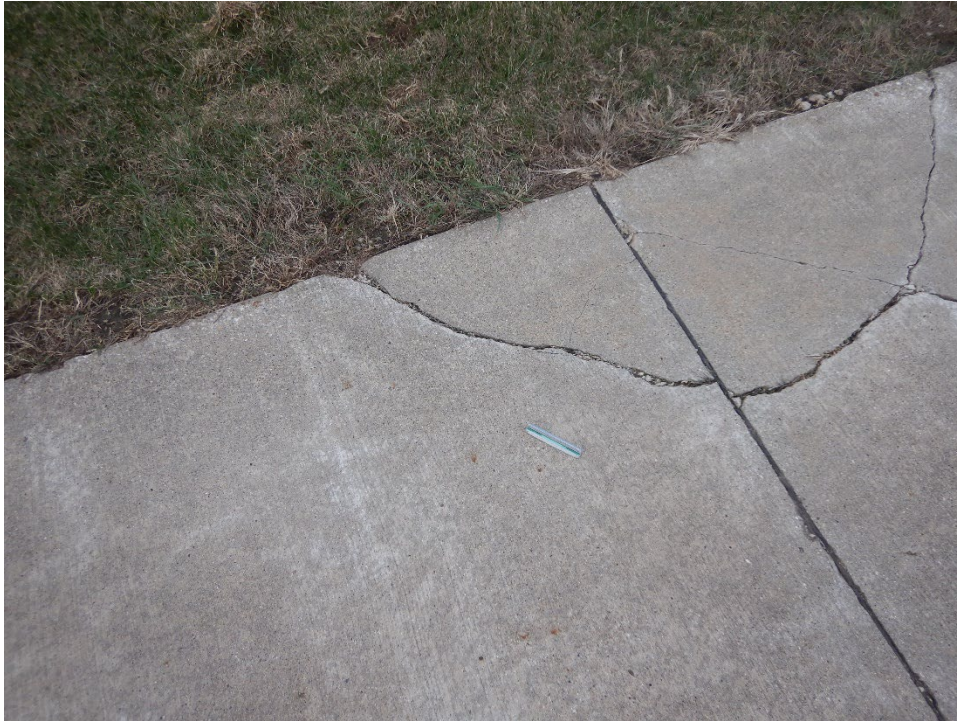
TH01CT-01. Corner Break (Sample Unit No. 03).

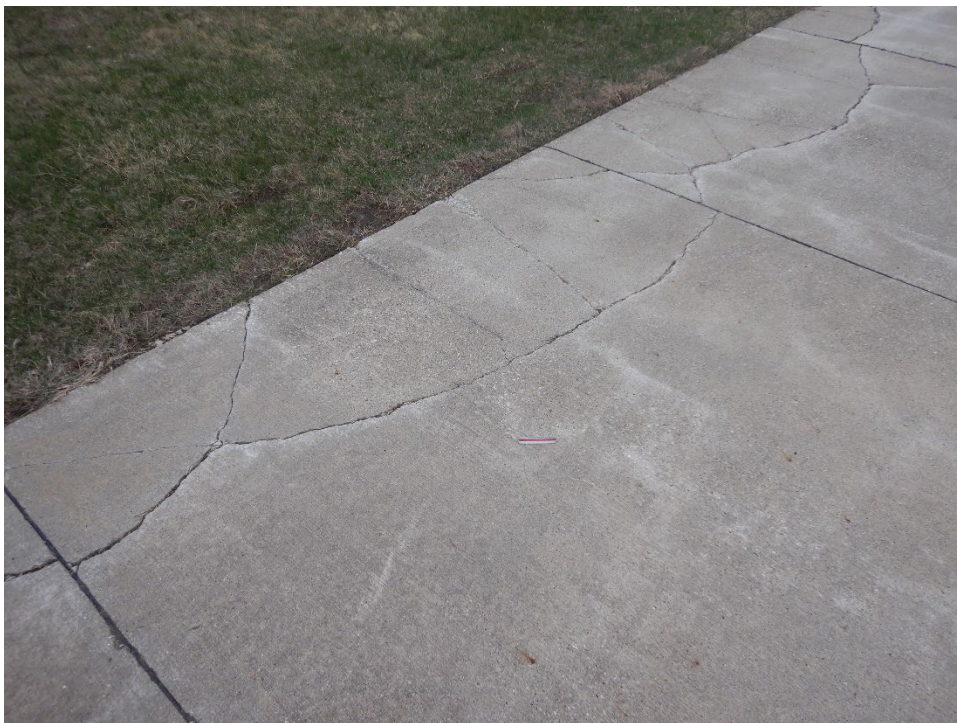
TH01CT-01. Shattered Slab (Sample Unit No. 03).

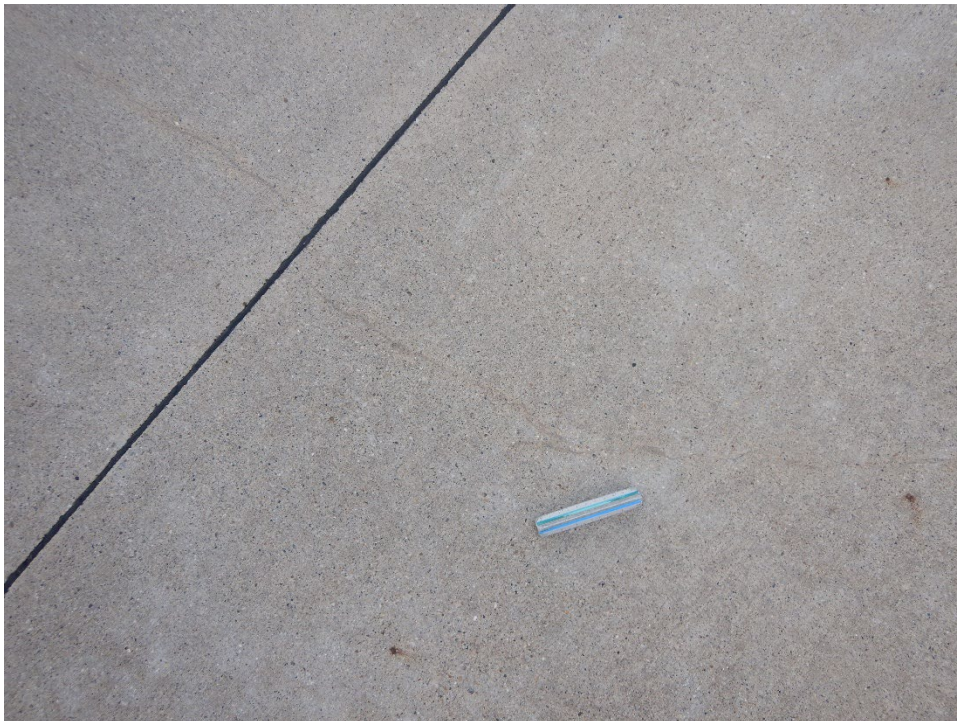
TH01CT-02. ASR (Sample Unit No. 05).

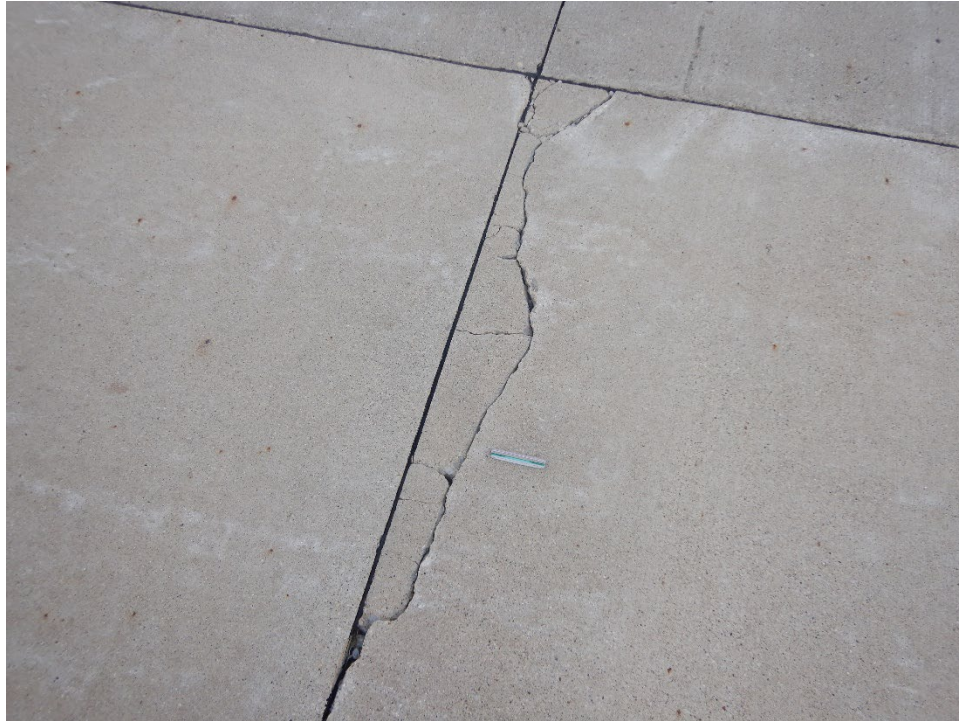
TH01CT-02. Joint Spalling (Sample Unit No. 04).

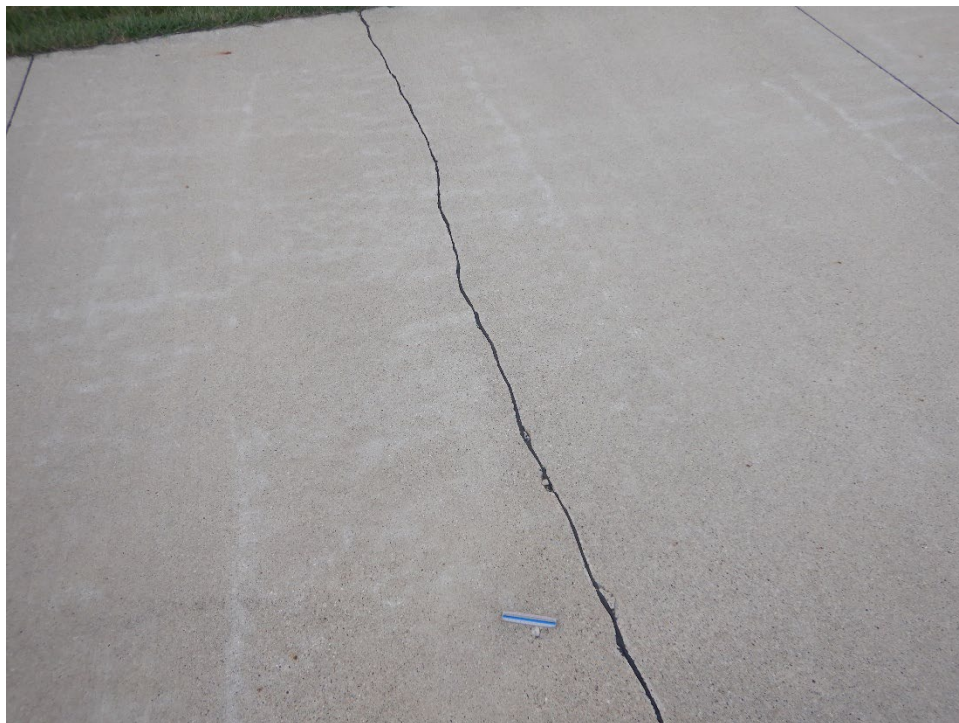
TH01CT-02. LTD Cracking (Sample Unit No. 05).
