# Davenport Municipal Airport

## Pavement Management Report

**AUGUST 2026**

# DAVENPORT MUNICIPAL AIRPORT PAVEMENT MANAGEMENT REPORT

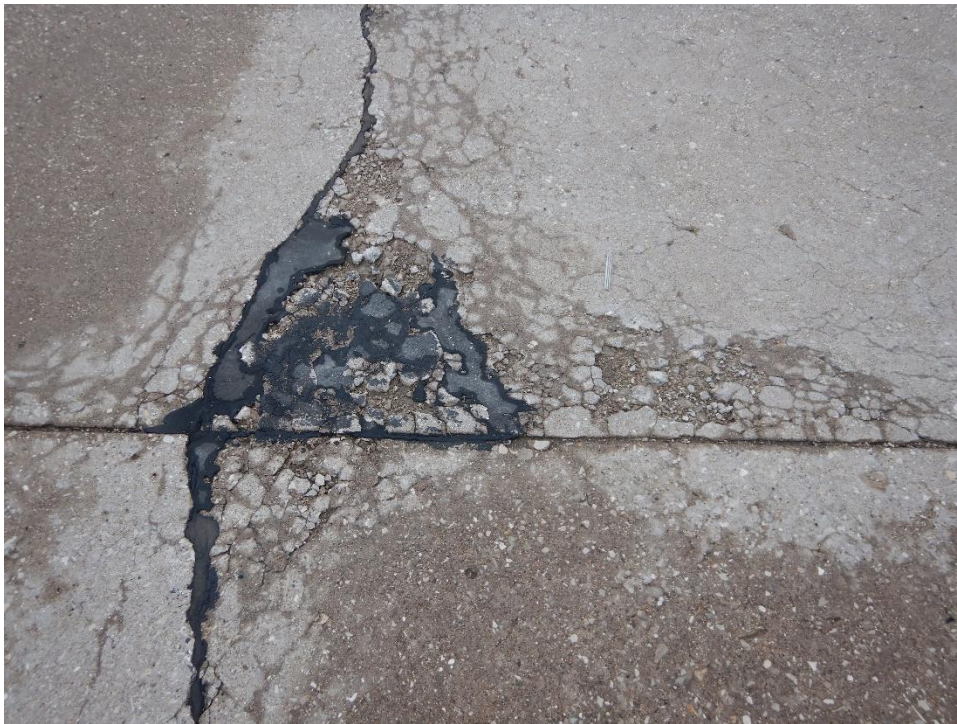
A01DA-01. ASR (Sample Unit No. 07).

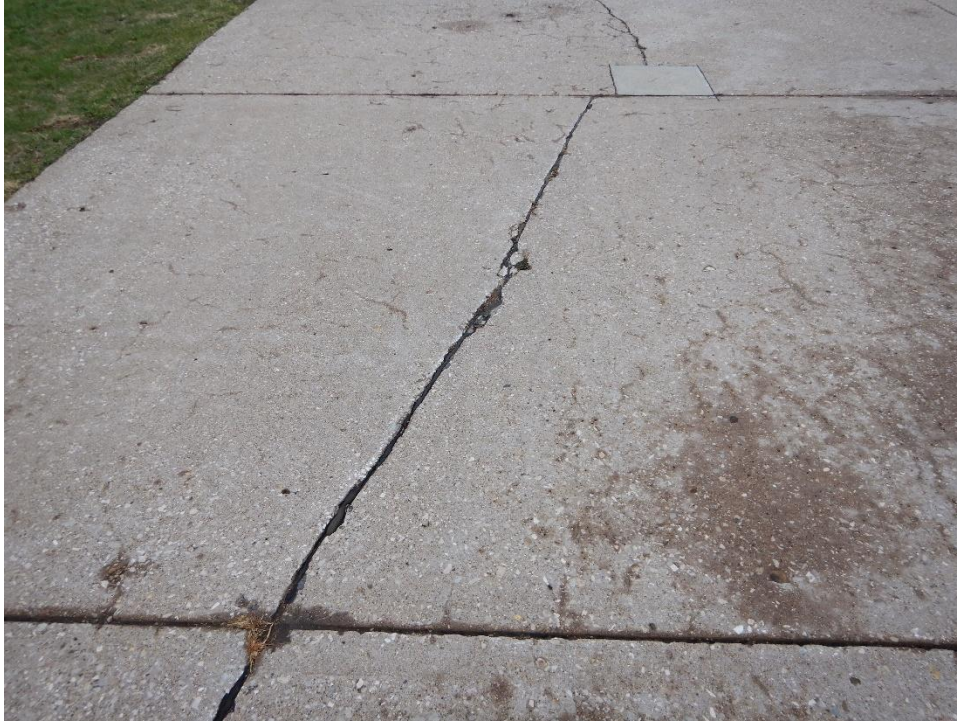
A01DA-01. LTD Cracking (Sample Unit No. 07).

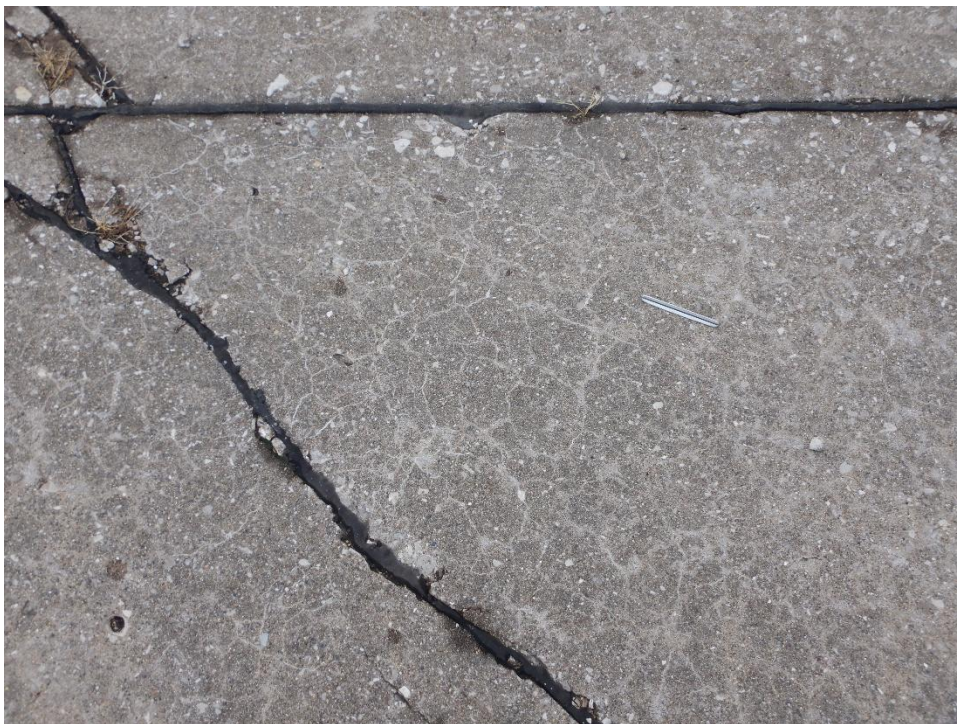
A02DA-01. ASR (Sample Unit No. 04).

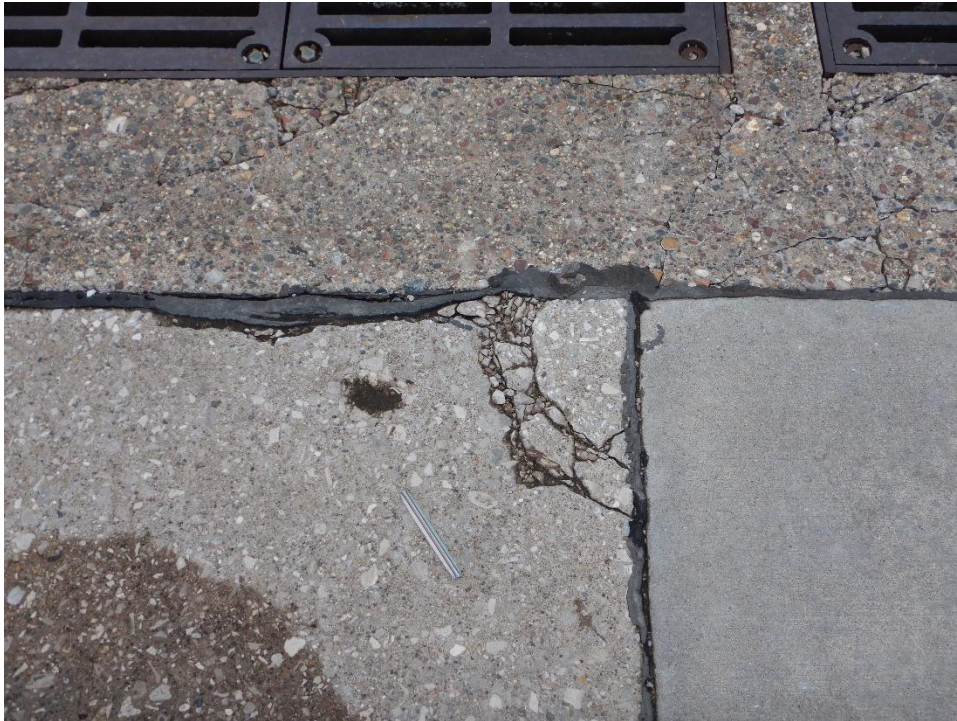
A02DA-01. Corner Spalling (Sample Unit No. 09).

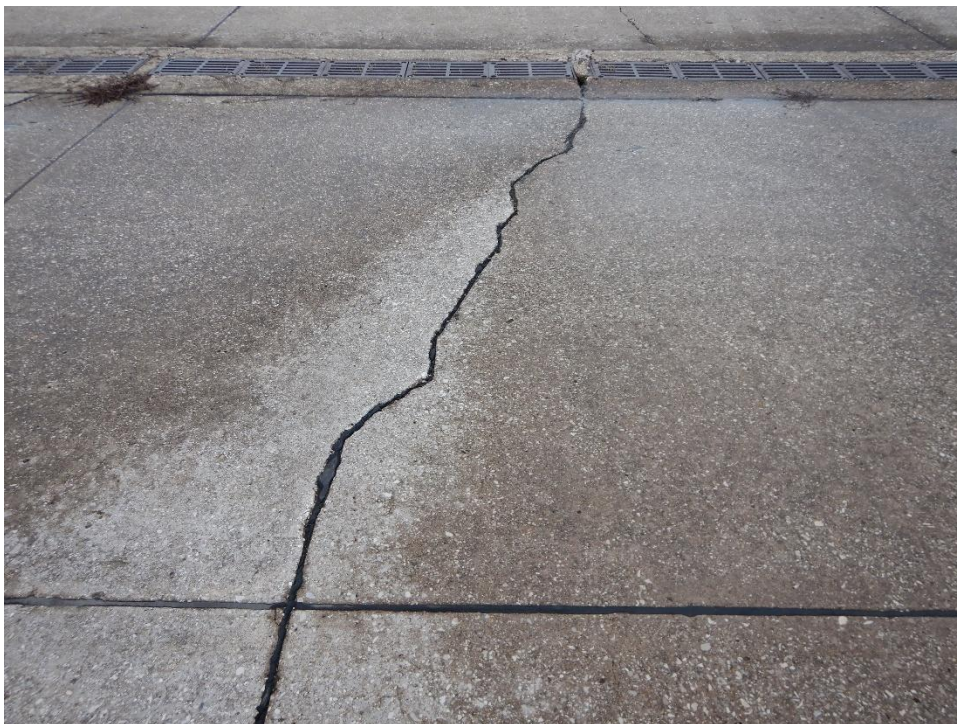
A02DA-01. LTD Cracking (Sample Unit No. 07).

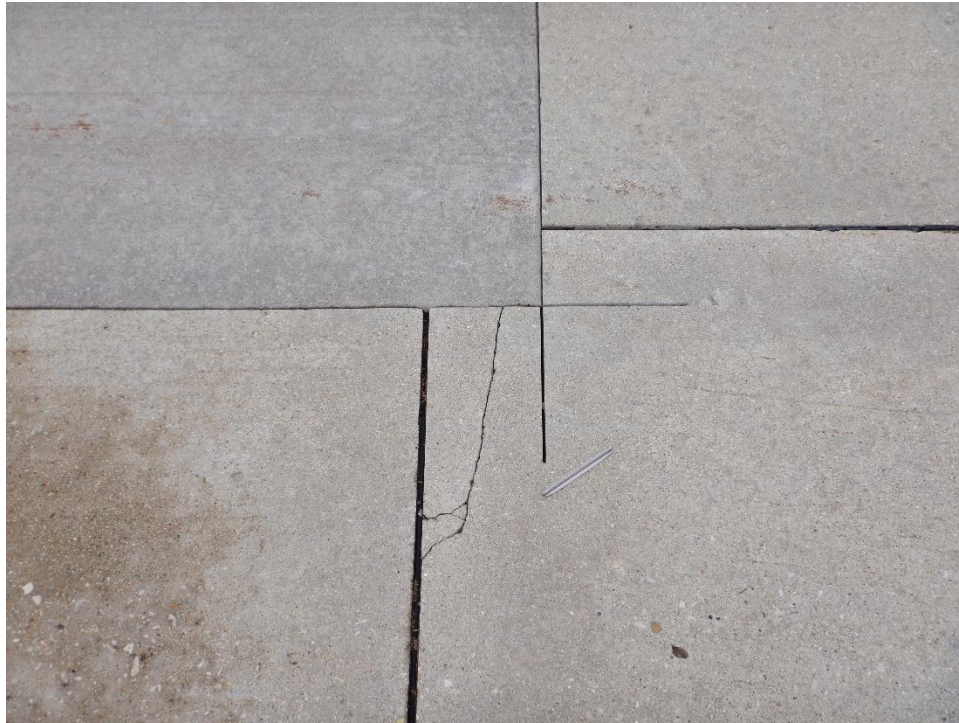
A02DA-02. Corner Spalling (Sample Unit No. 04).

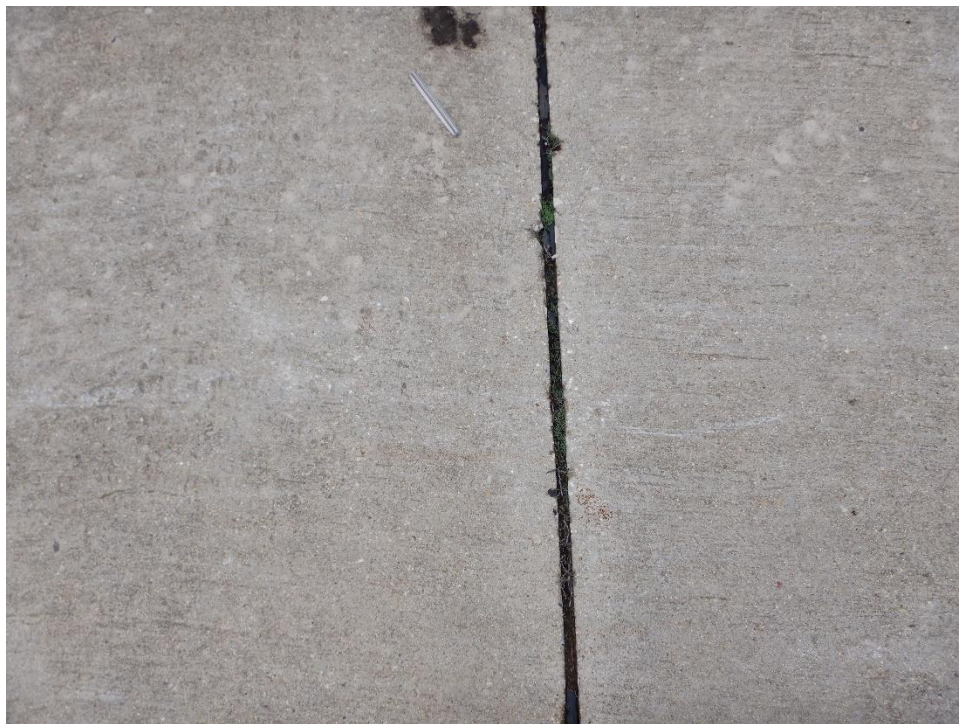
A02DA-02. Joint Seal Damage (Sample Unit No. 04).

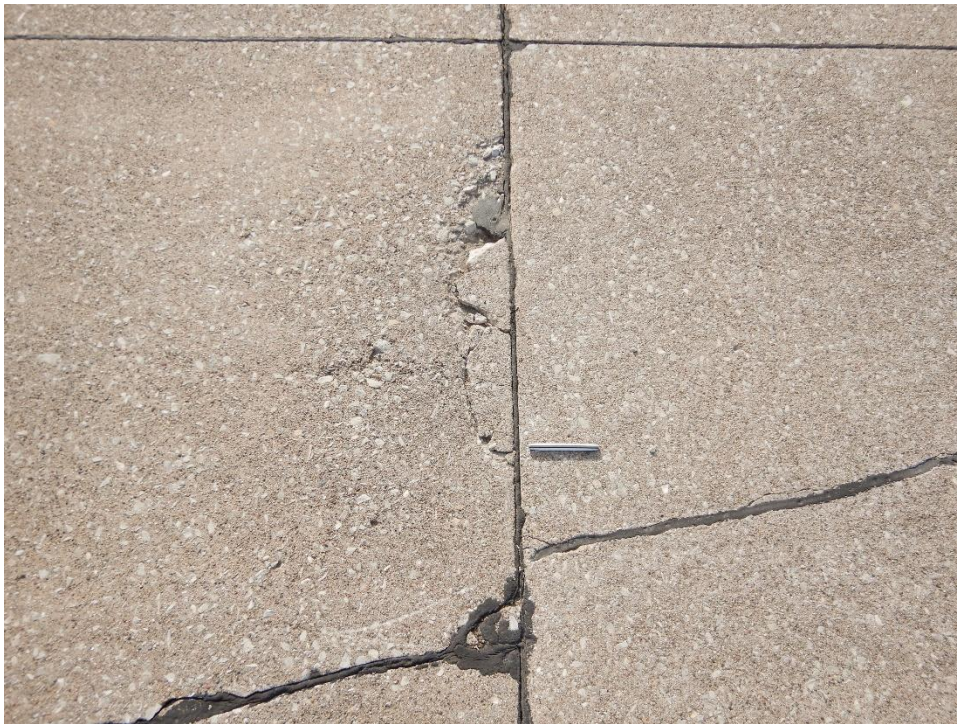
A03DA-01. Joint Spalling (Sample Unit No. 04).

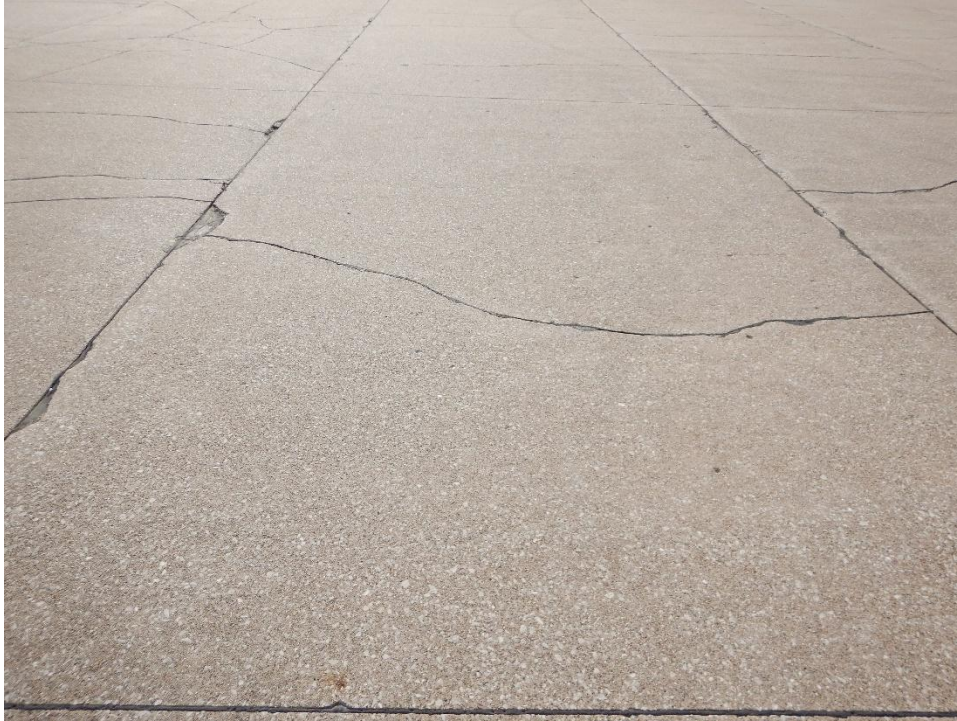
A03DA-01. LTD Cracking (Sample Unit No. 04).

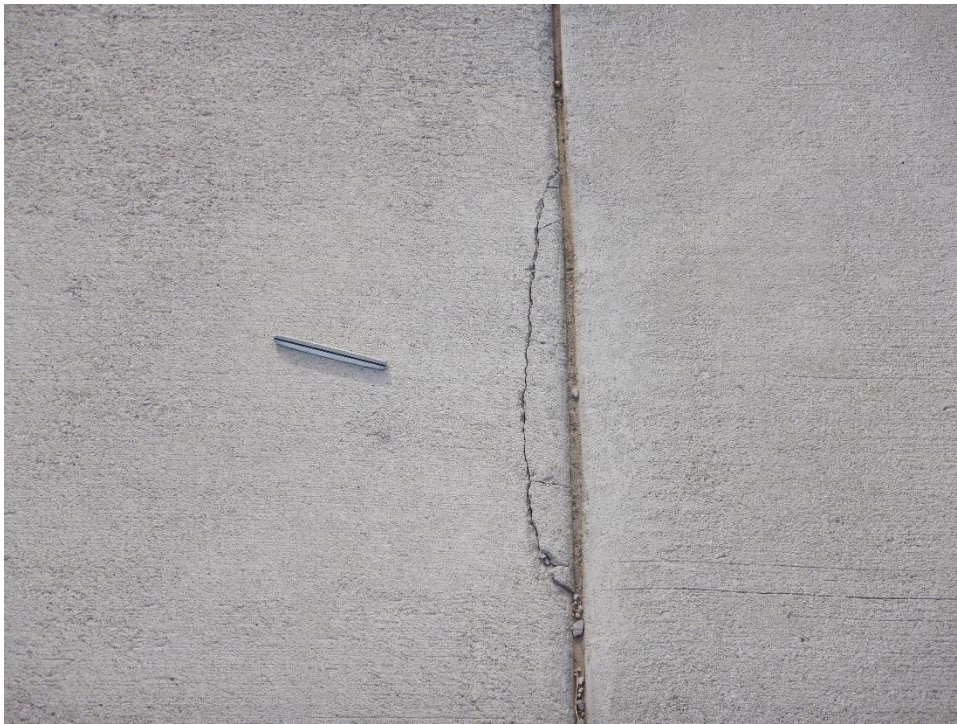
A04DA-01. Joint Spalling (Sample Unit No. 14).

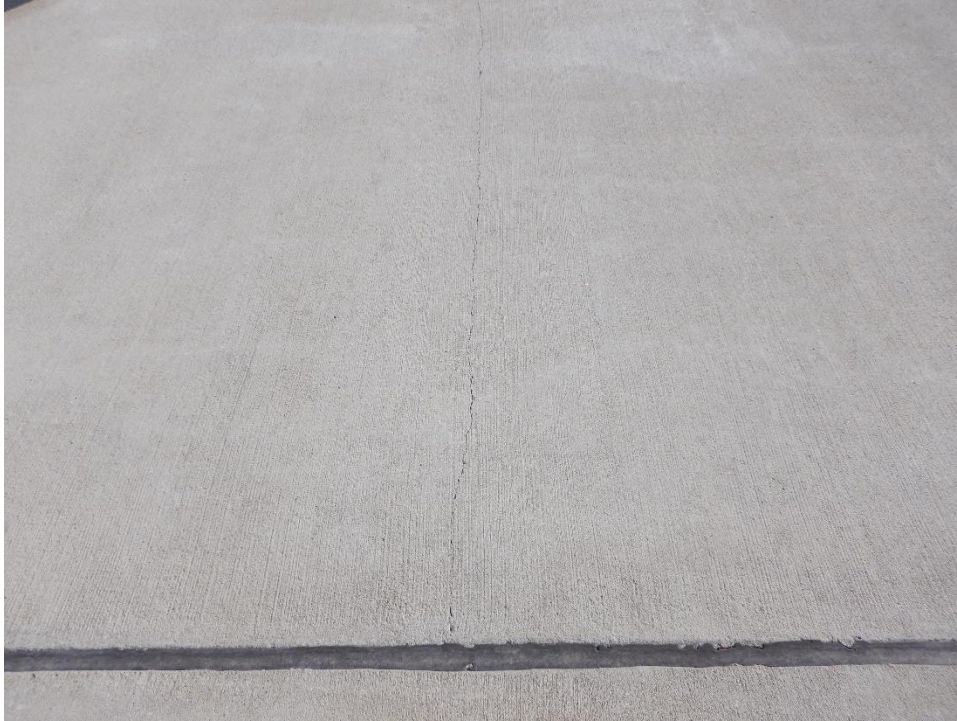
A04DA-01. LTD Cracking (Sample Unit No. 12).

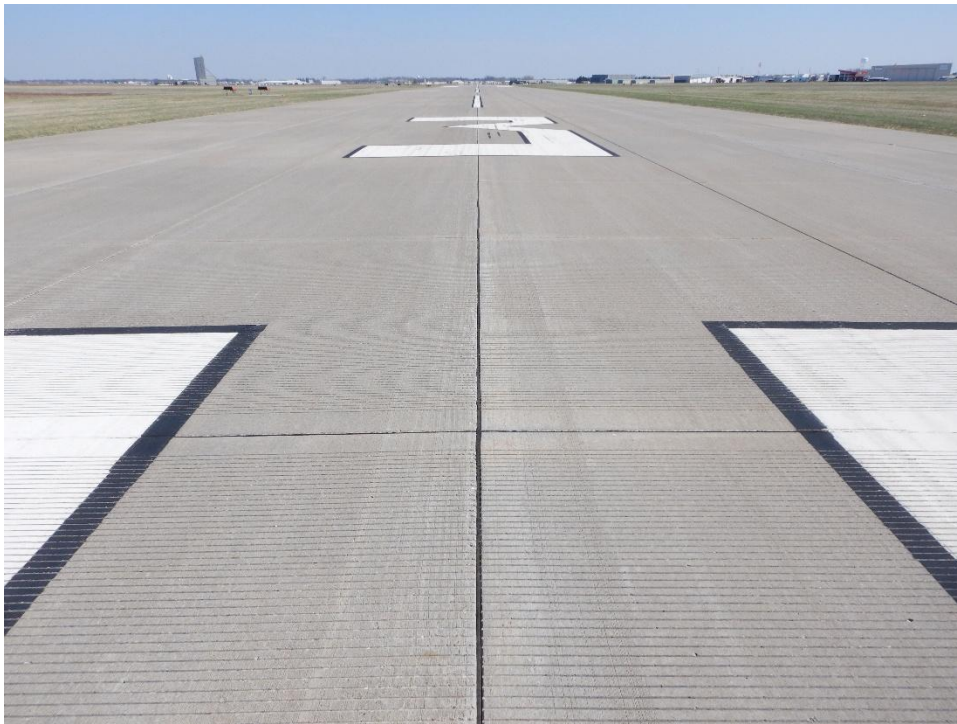
R03DA-01. Overview.

Runway 03/21 consisted of one section that contained low-severity faulting and medium-severity joint seal damage.

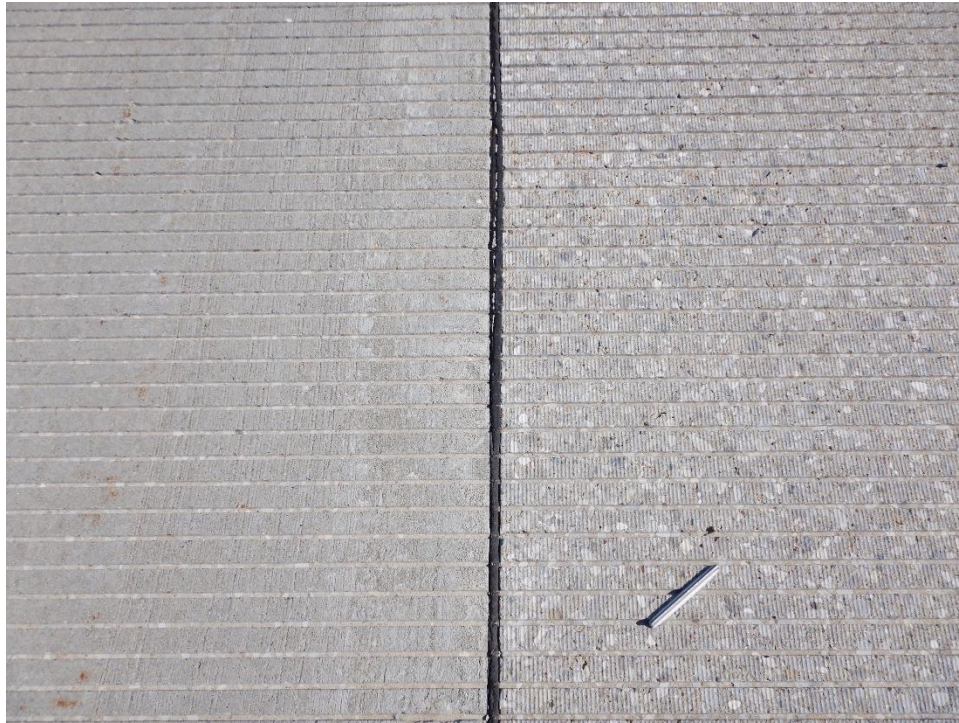
R03DA-01. Joint Seal Damage (Sample Unit No. 99).

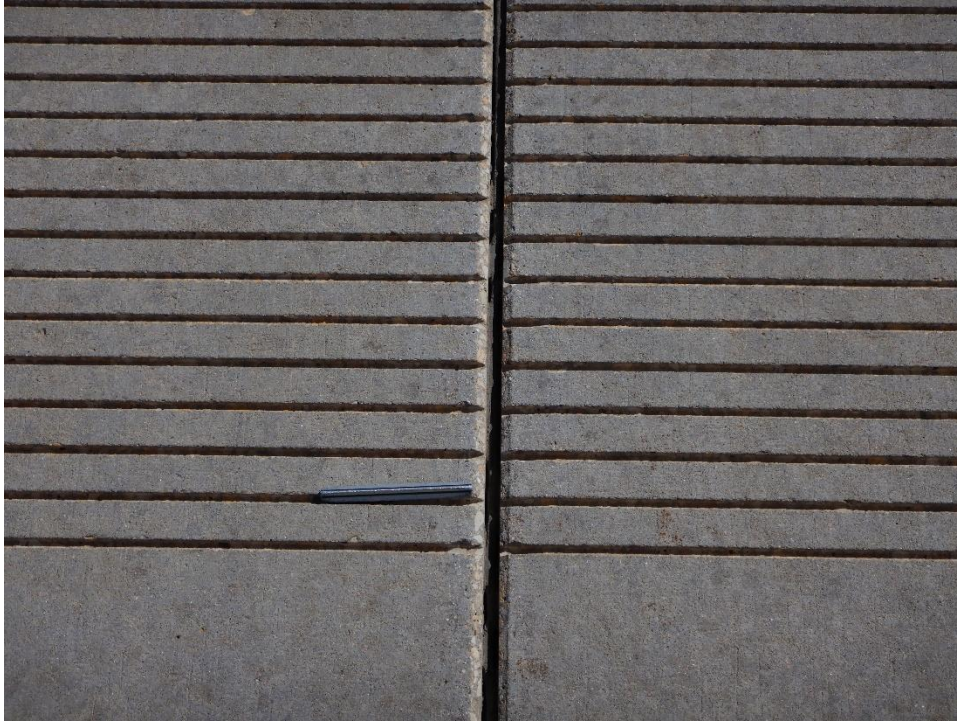
R15DA-01. Joint Seal Damage (Sample Unit No. 61).

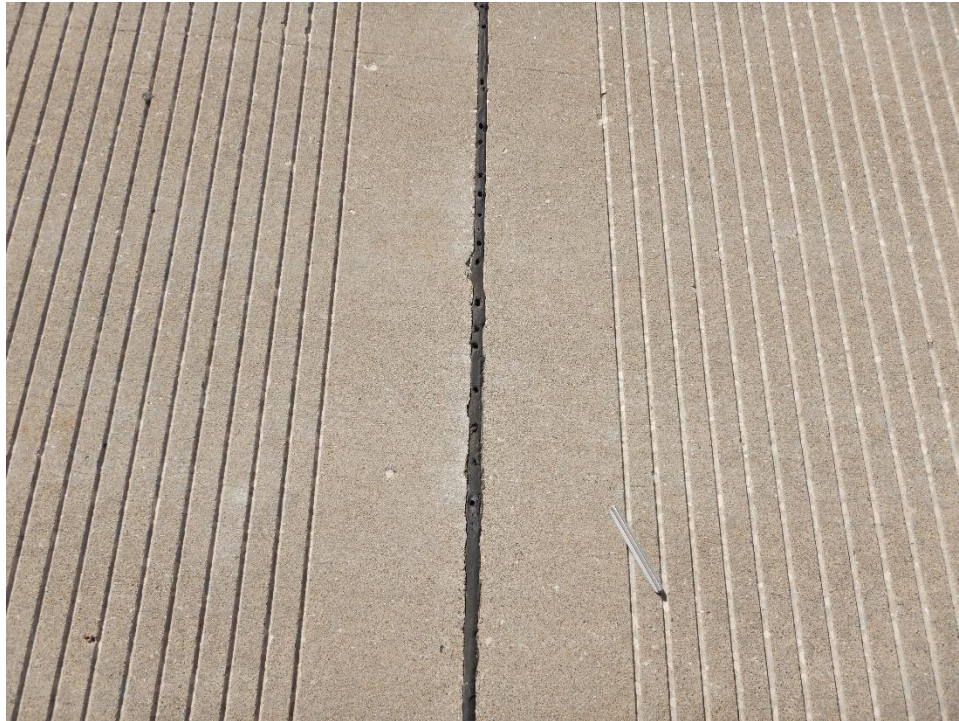
R15DA-02. Joint Seal Damage (Sample Unit No. 15).

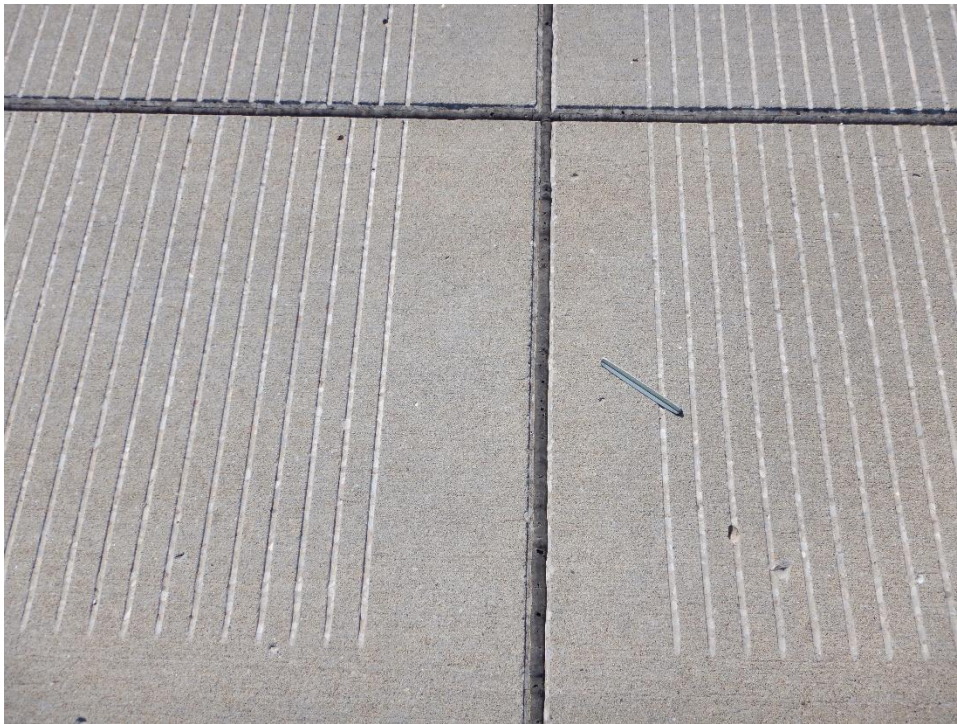
R15DA-03. Joint Seal Damage (Sample Unit No. 35).

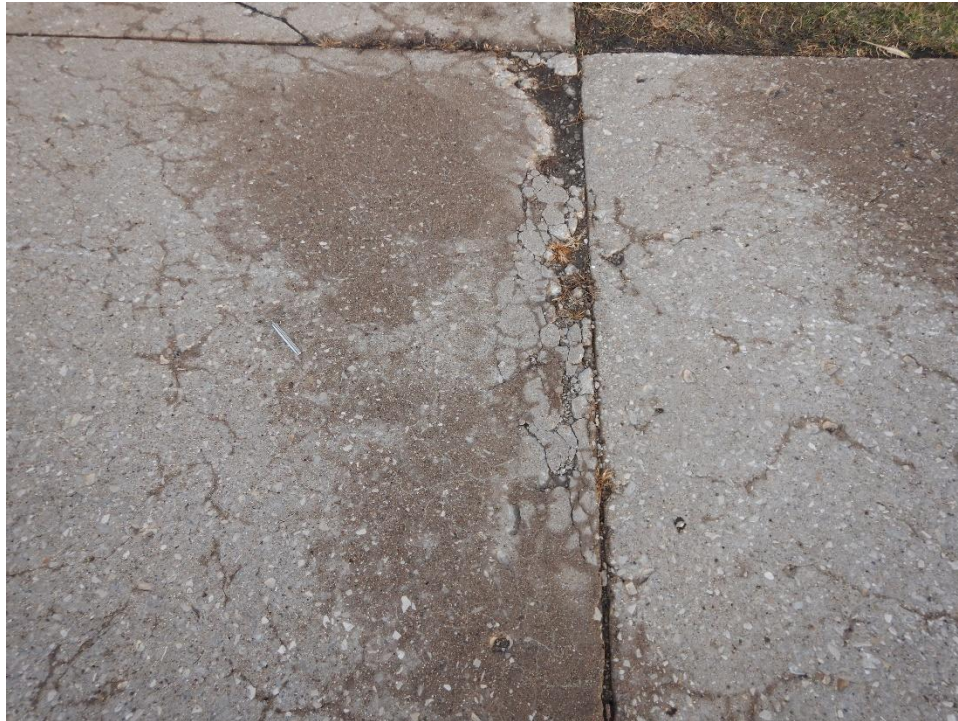
T05DA-01. ASR (Sample Unit No. 02).

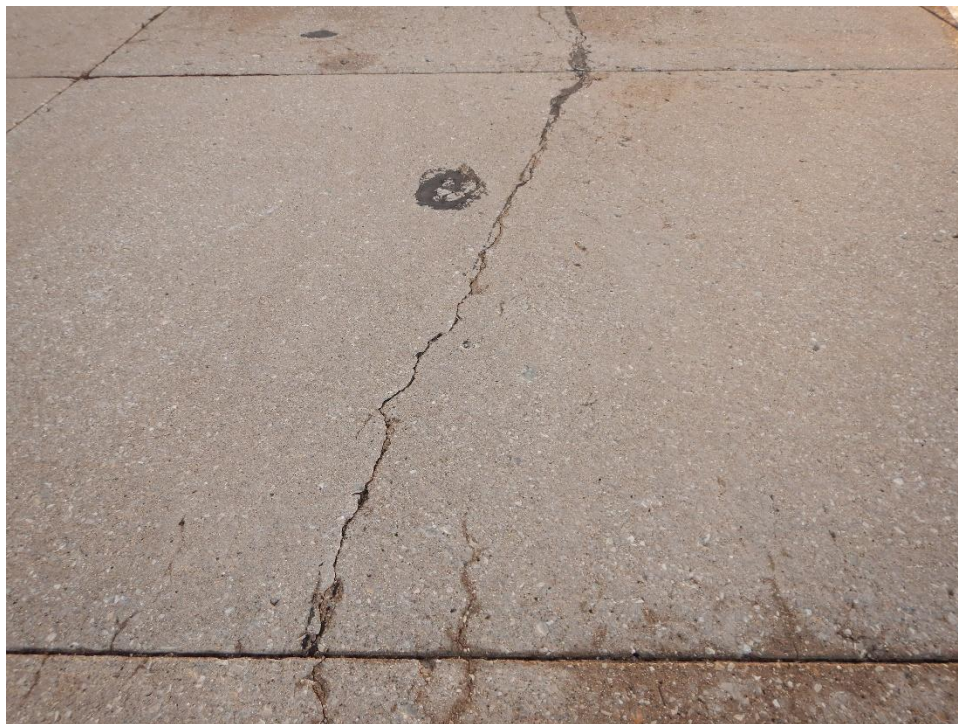
T05DA-01. LTD Cracking (Sample Unit No. 02).

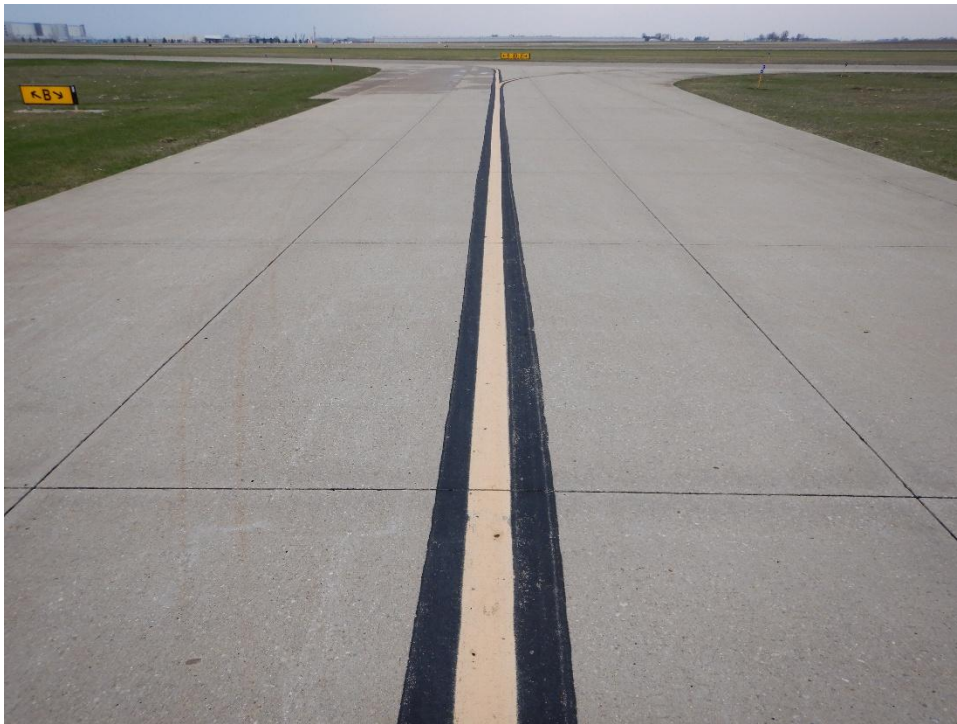
T06DA-01. Overview.

Taxiway 06 consisted of one section that contained areas of low-severity corner spalling and LTD cracking, high-severity joint seal damage, medium-severity joint spalling, and shrinkage cracking.

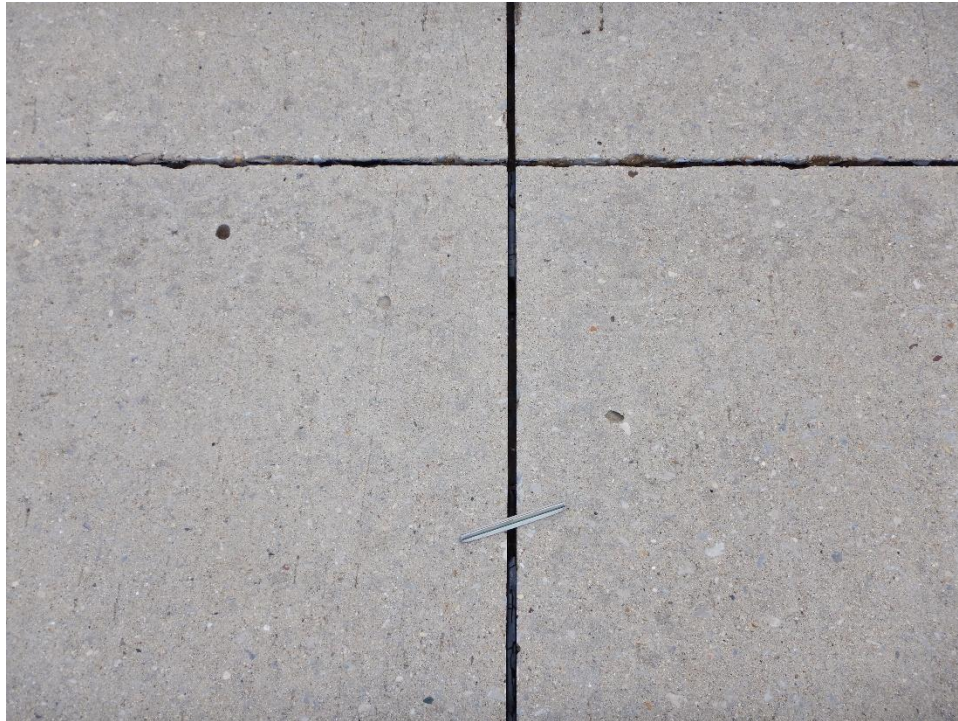
T06DA-01. Joint Seal Damage (Sample Unit No. 01).

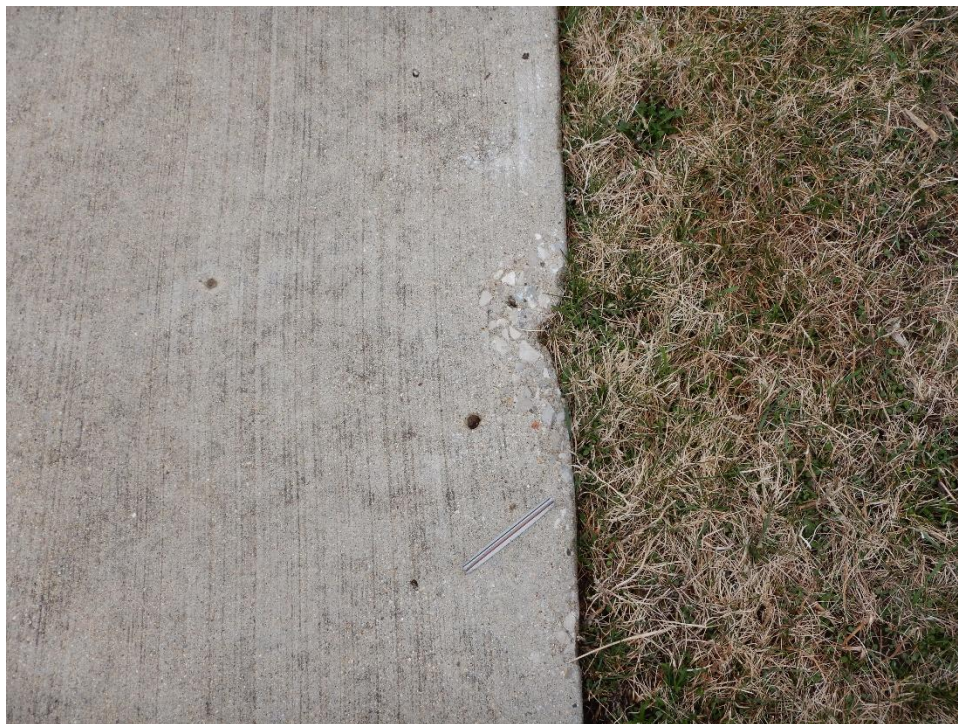
T06DA-01. Joint Spalling (Sample Unit No. 01).

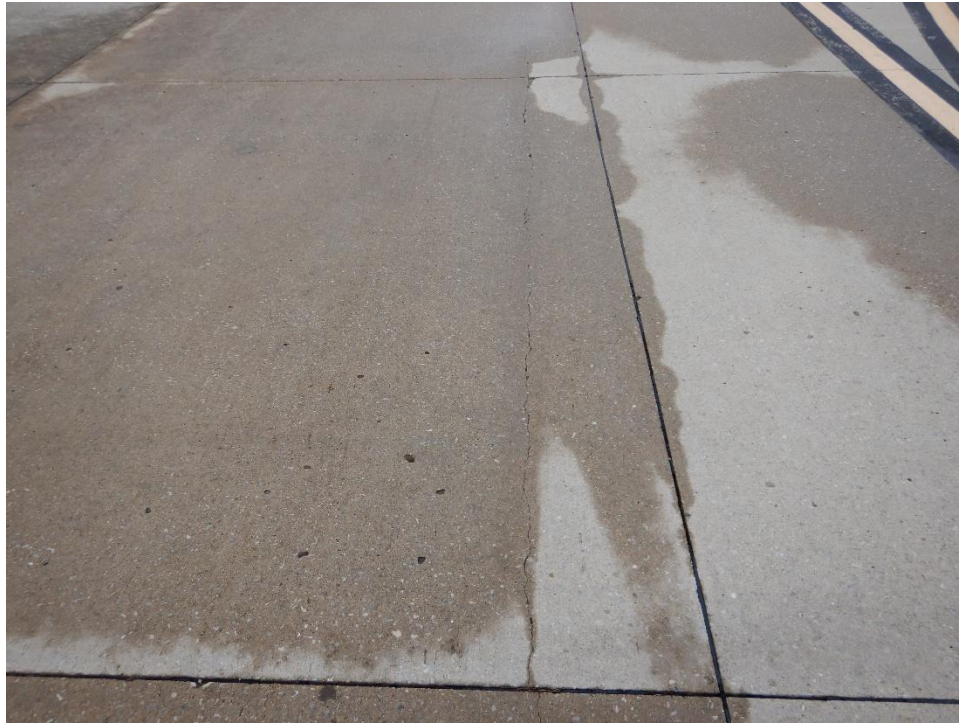
T06DA-01. LTD Cracking (Sample Unit No. 02).

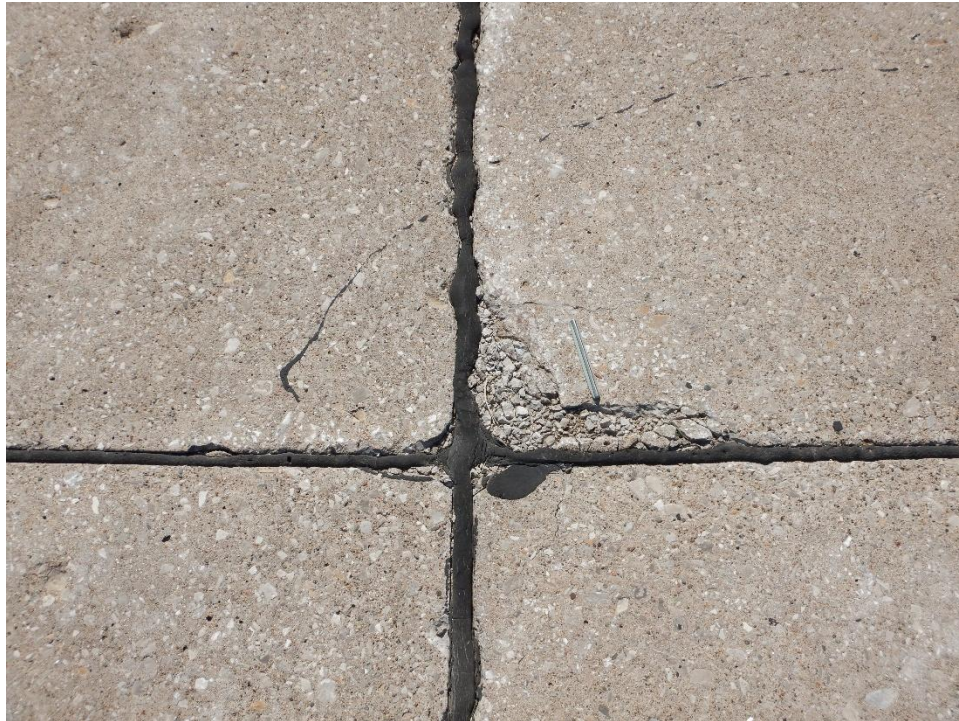
TADA-01. ASR (Additional Sample Unit No. 04).

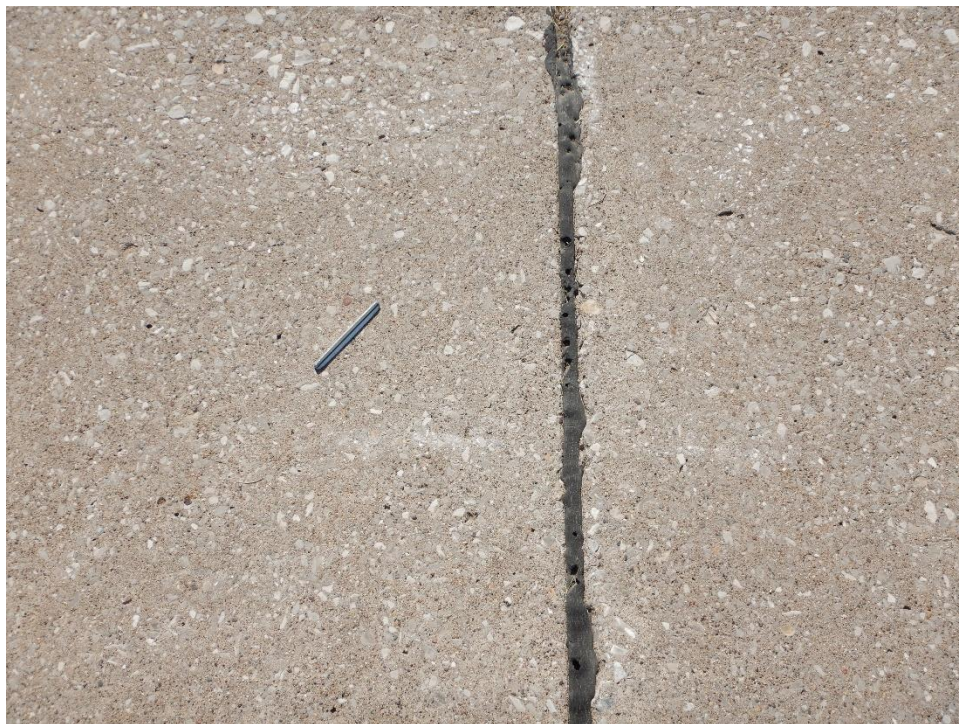
TADA-01. Joint Seal Damage (Sample Unit No. 05).

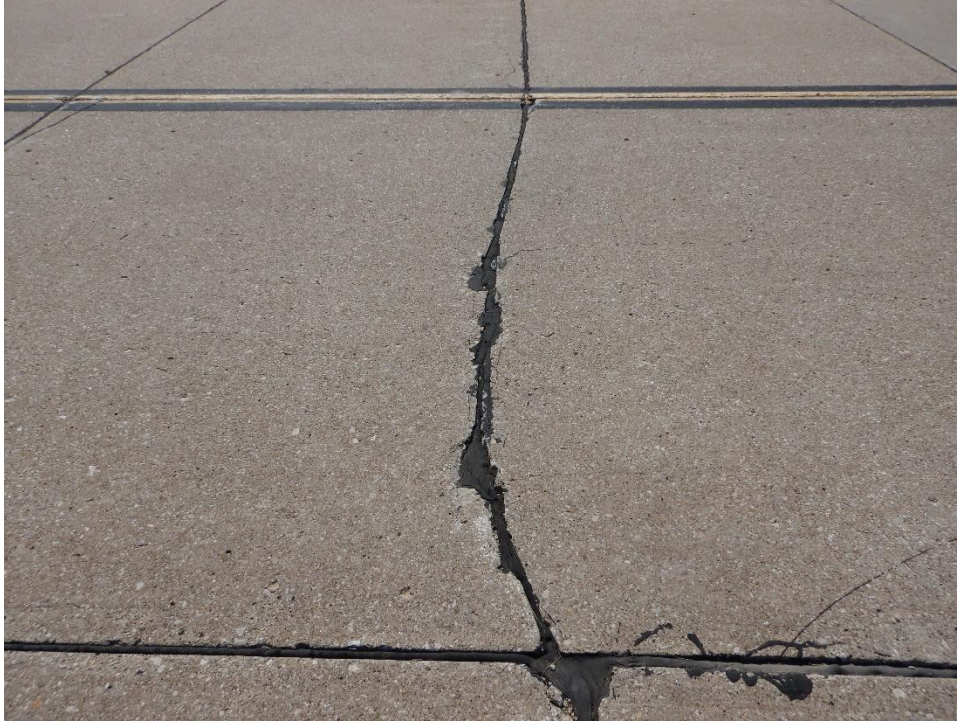
TADA-01. LTD Cracking (Additional Sample Unit No. 04).

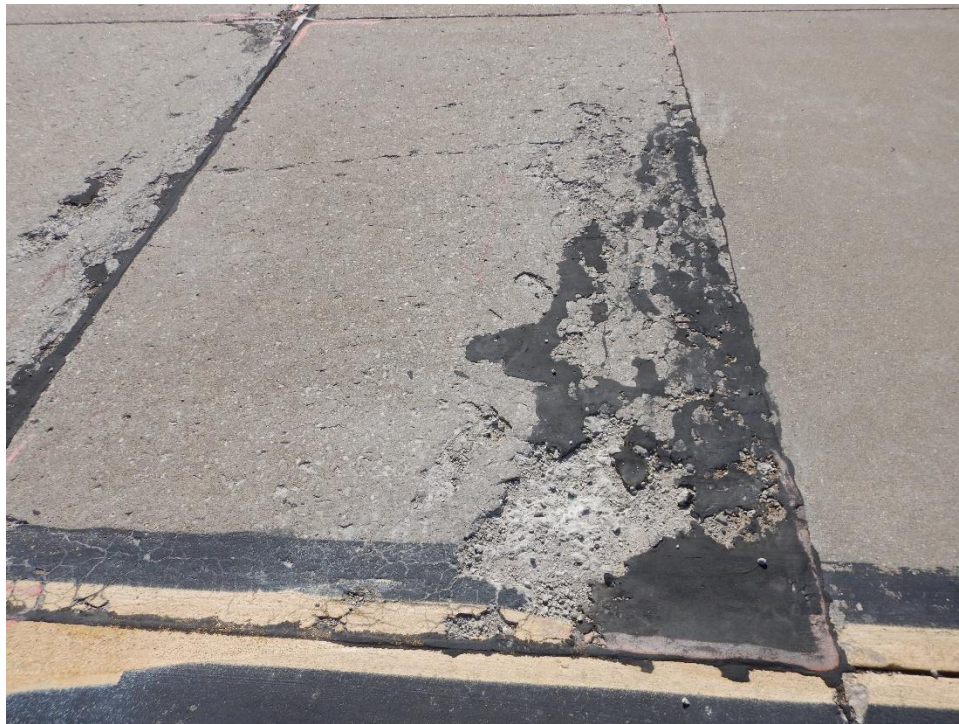
TADA-02. ASR (Sample Unit No. 08) (2).

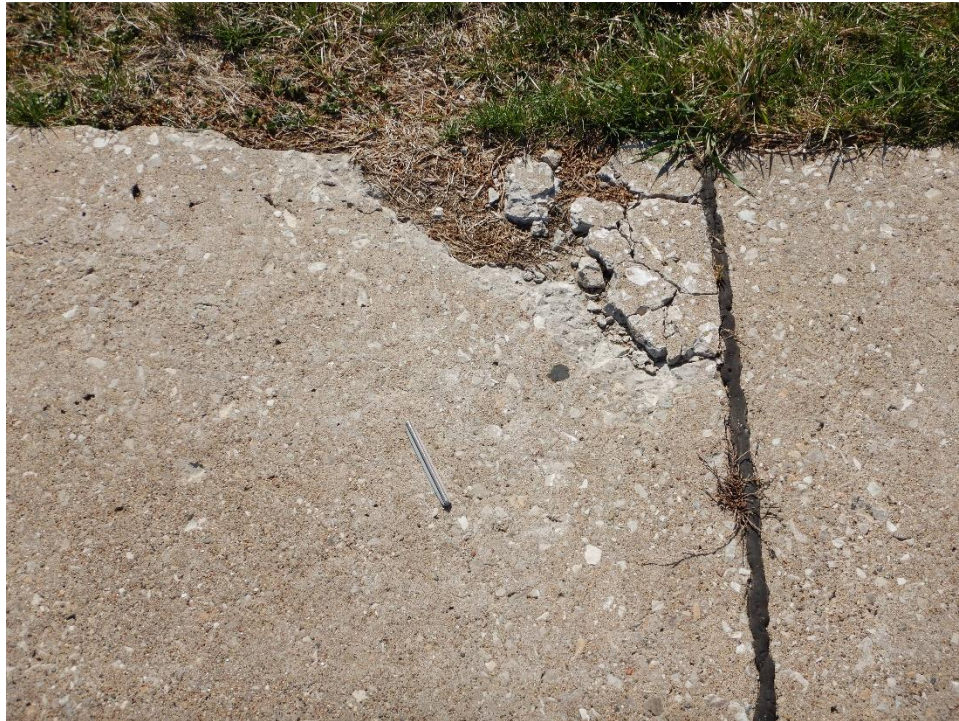
TADA-02. Corner Spalling (Sample Unit No. 04).

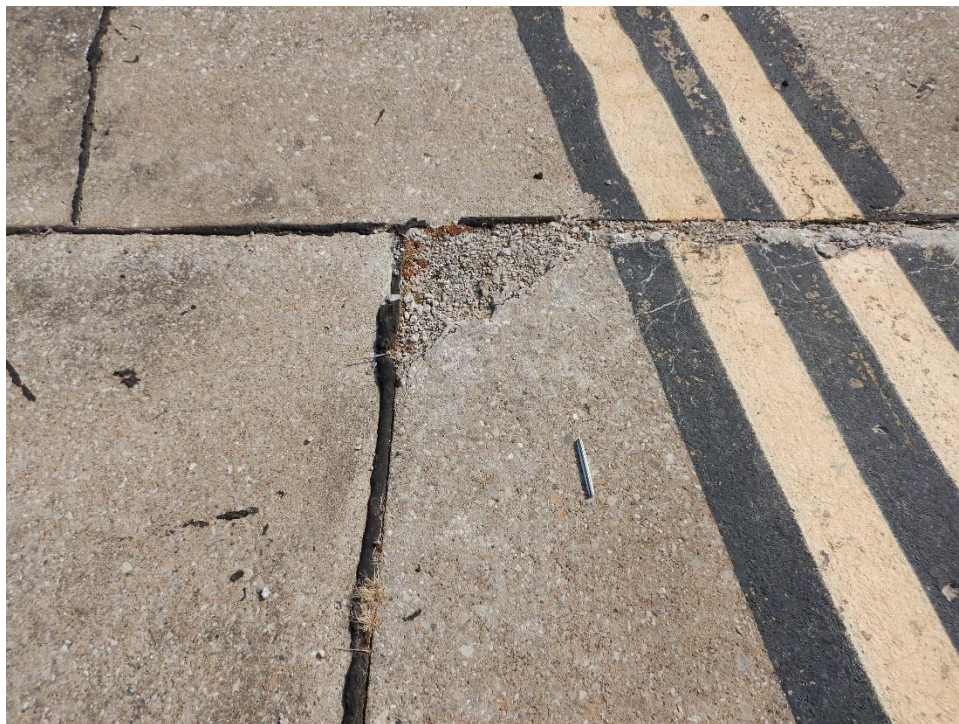
TADA-03. ASR (Sample Unit No. 03).

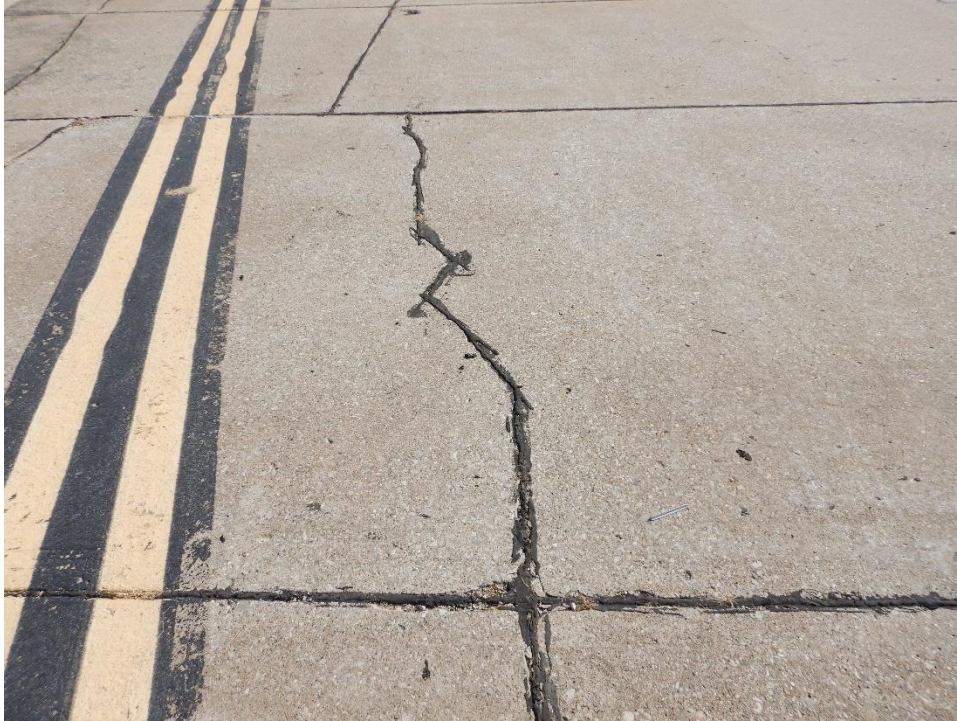
TADA-03. LTD Cracking (Sample Unit No. 03).

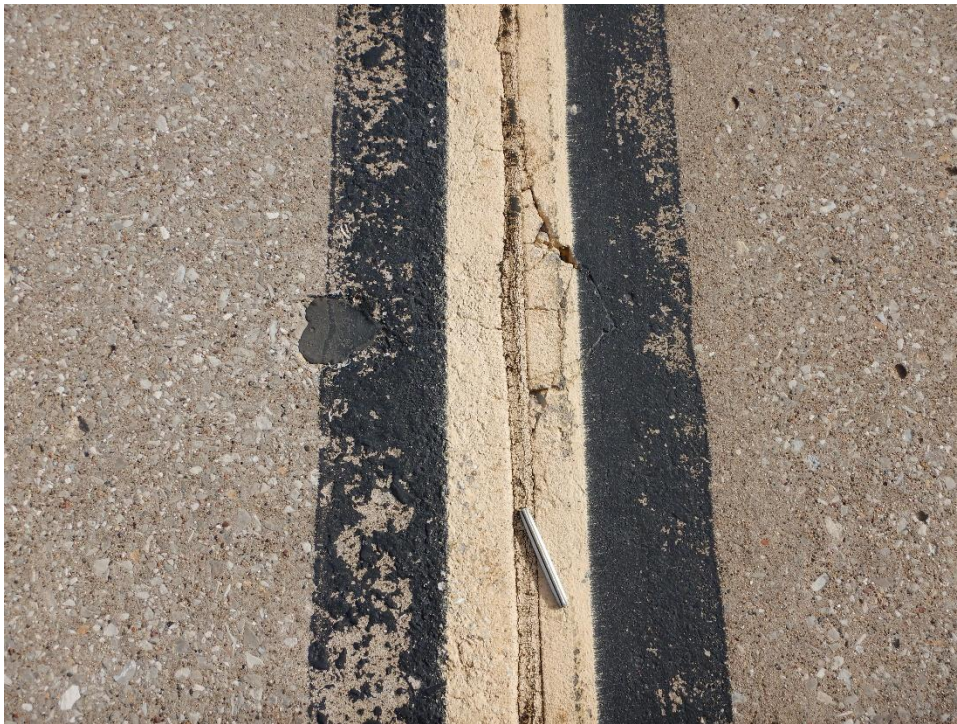
TADA-04. Joint Spalling (Sample Unit No. 04).

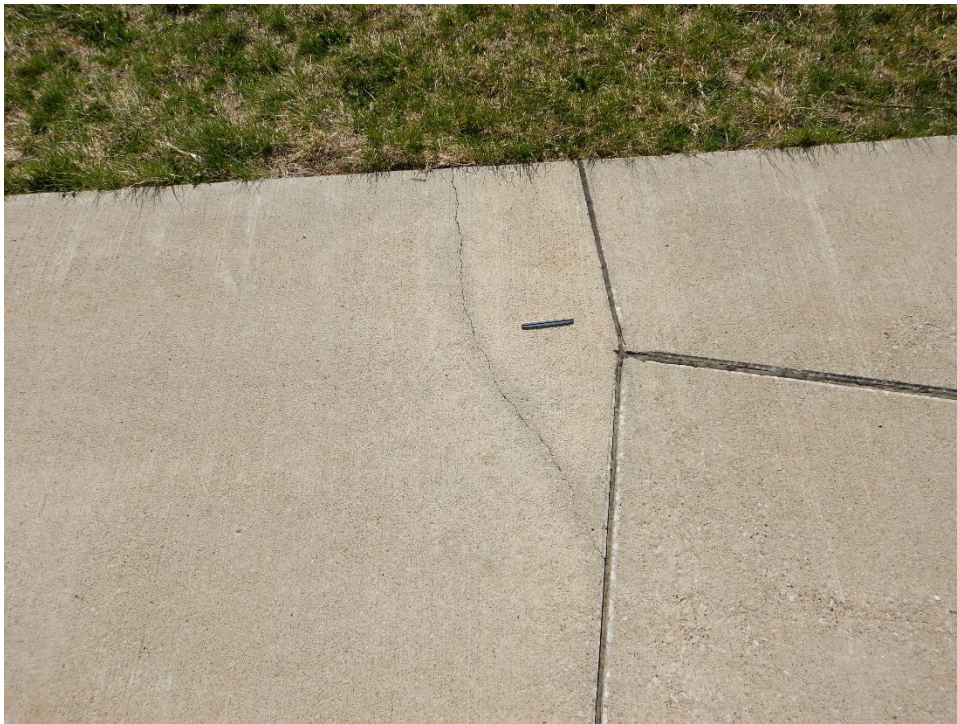
TADA-05. Corner Break (Sample Unit No. 08).

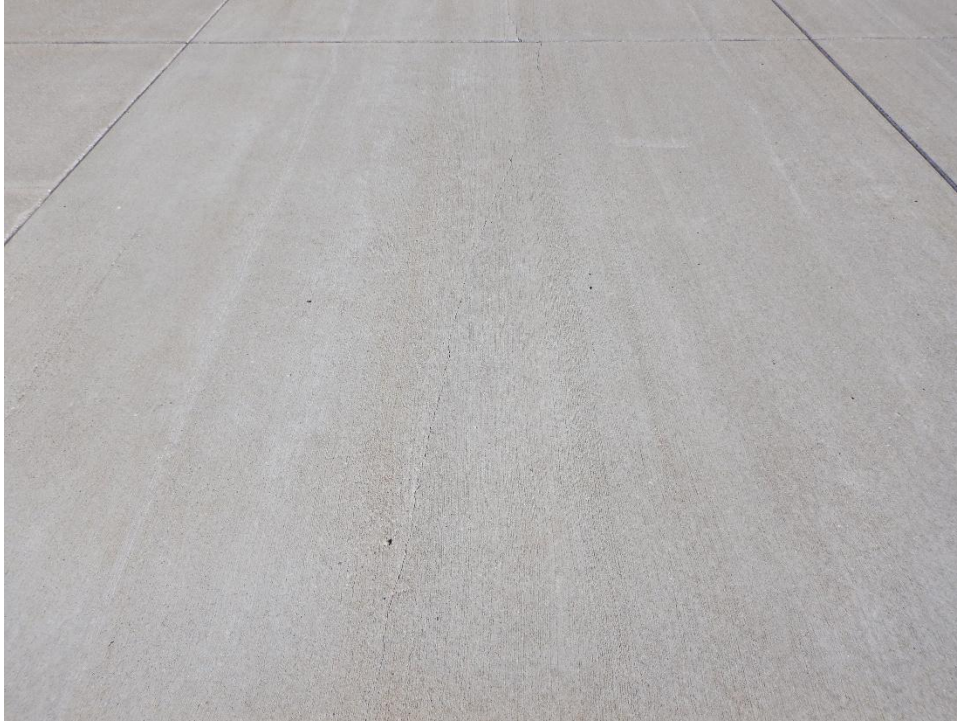
TADA-05. LTD Cracking (Sample Unit No. 01).

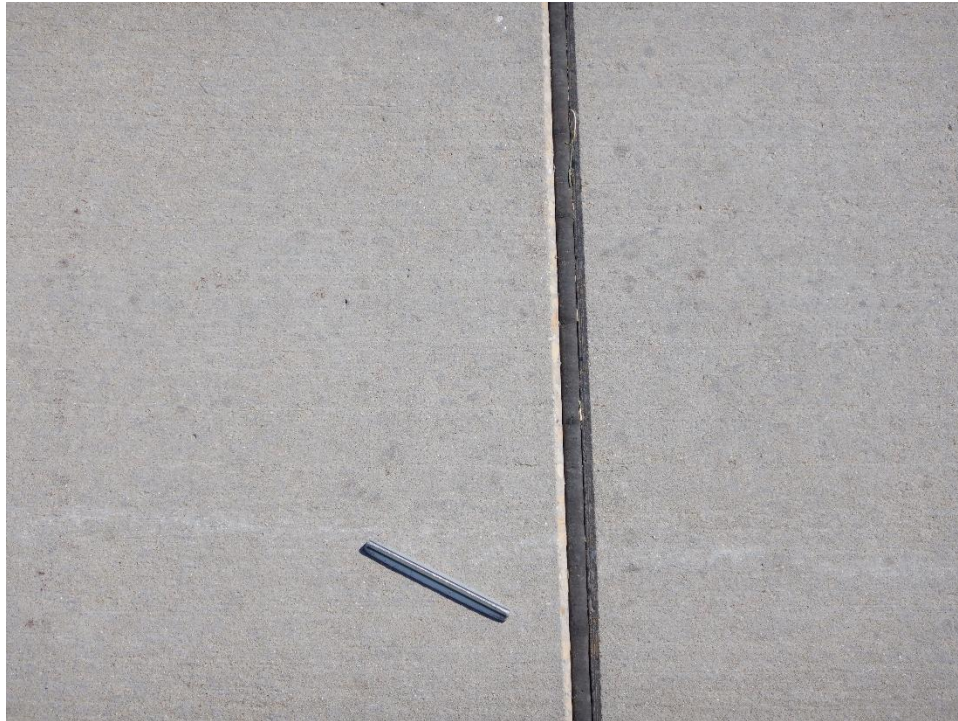
TADA-06. Joint Seal Damage (Sample Unit No. 06).
