# Davenport Municipal Airport

## Pavement Management Report

**AUGUST 2026**

# DAVENPORT MUNICIPAL AIRPORT PAVEMENT MANAGEMENT REPORT

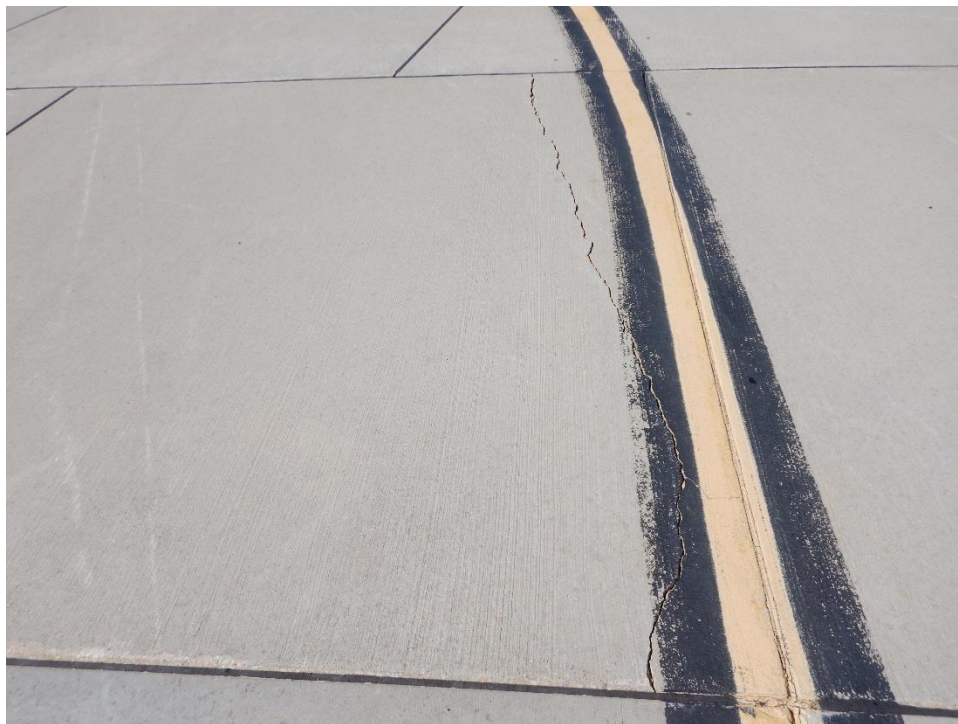
TADA-06. LTD Cracking (Additional Sample Unit No. 08).

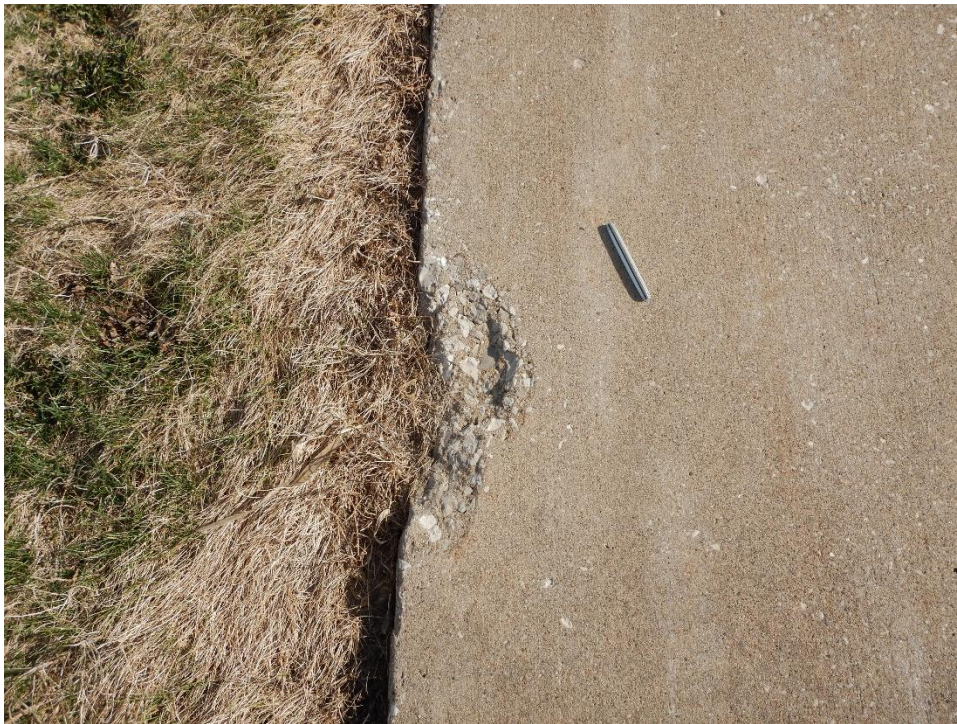
TADA-07. Joint Spalling (Sample Unit No. 17) (1).

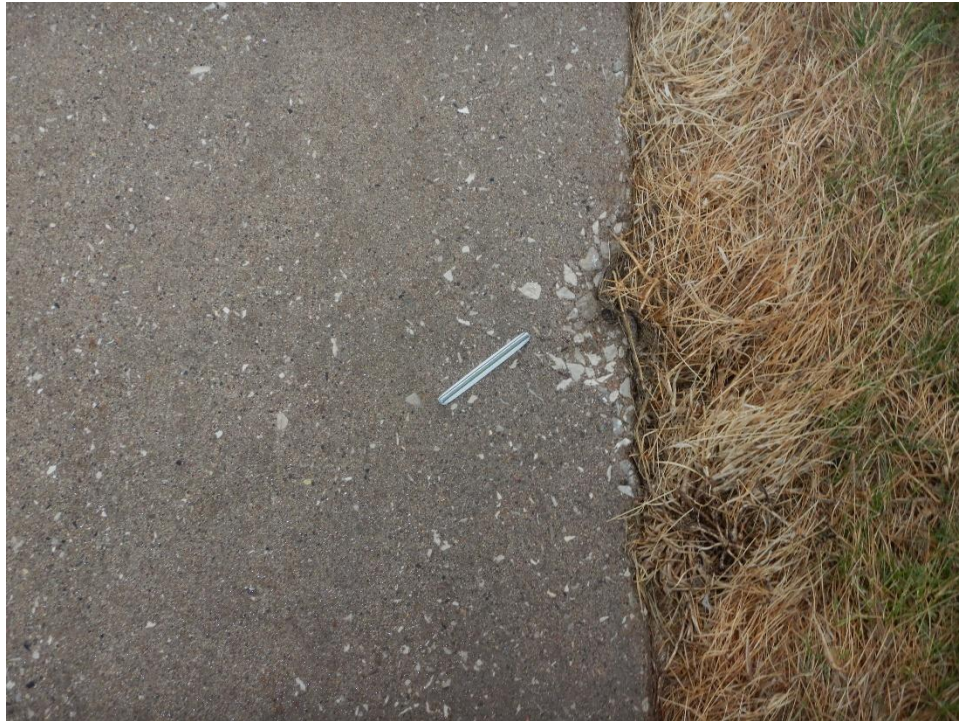
TADA-07. Joint Spalling (Sample Unit No. 17) (2).

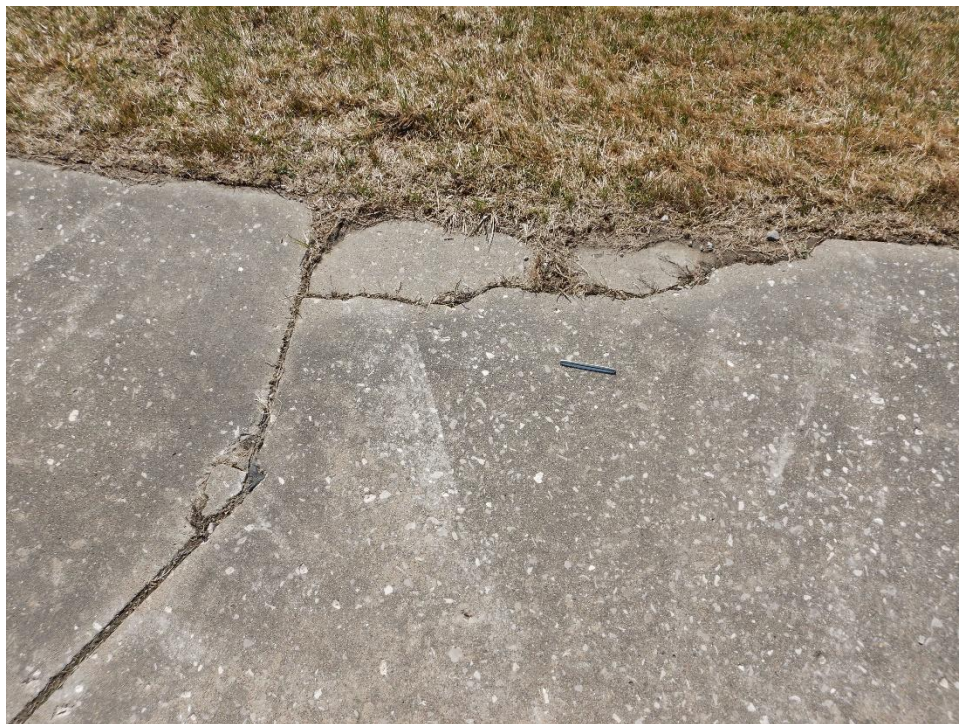
TB1DA-02. Corner Break (Sample Unit No. 04).

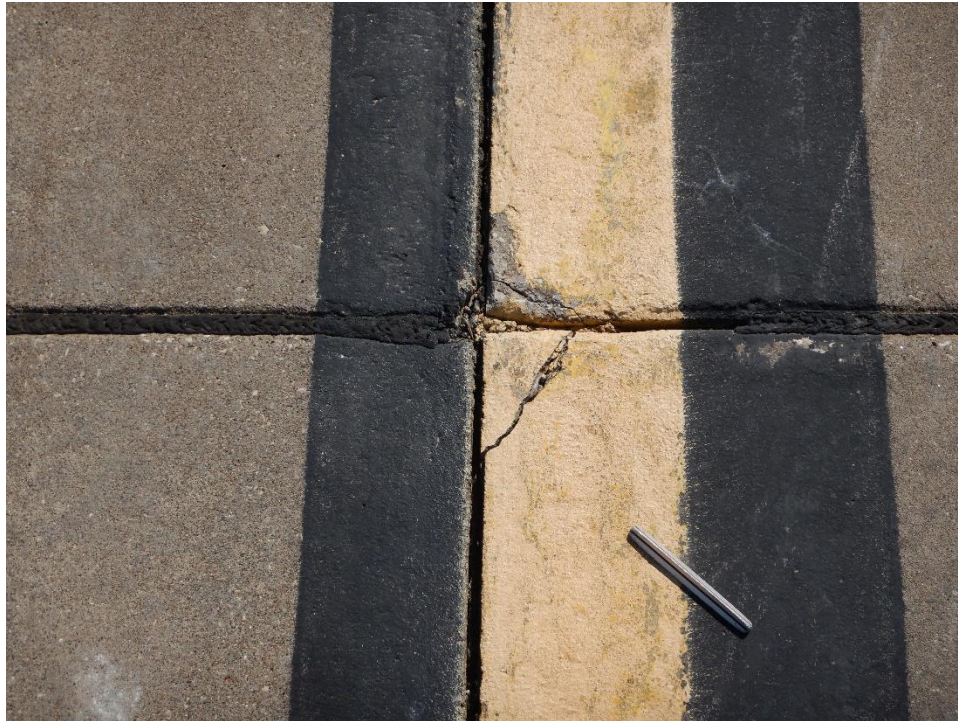
TB1DA-02. Corner Spalling (Sample Unit No. 01).

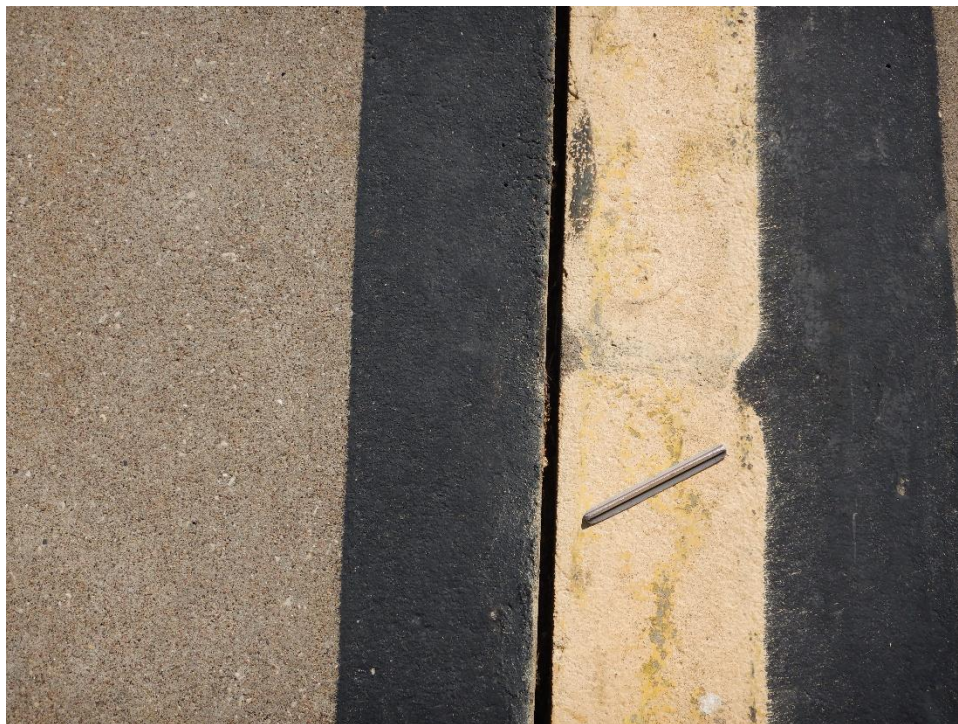
TB1DA-02. Joint Seal Damage (Sample Unit No. 01).

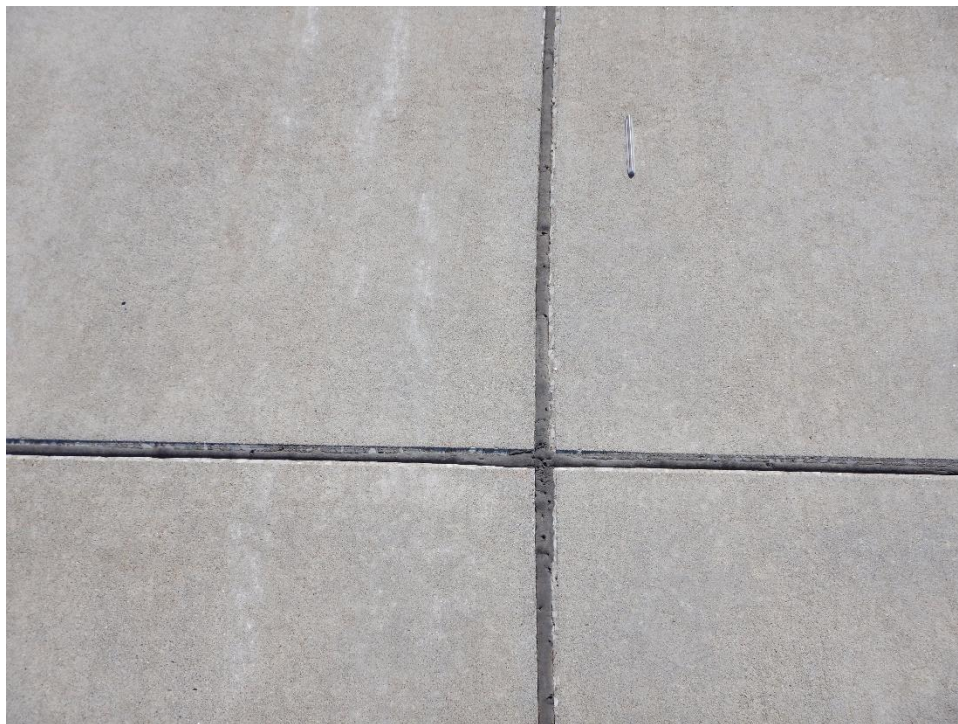
TB1DA-03. Joint Seal Damage (Sample Unit No. 03).

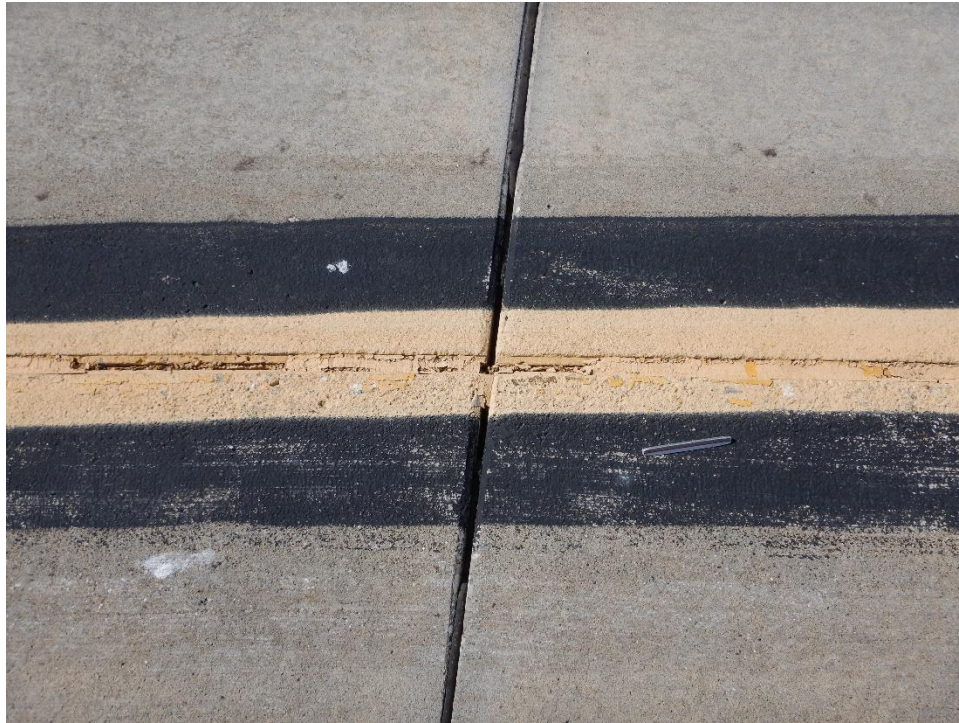
TB1DA-03. Joint Seal Damage (Sample Unit No. 04).

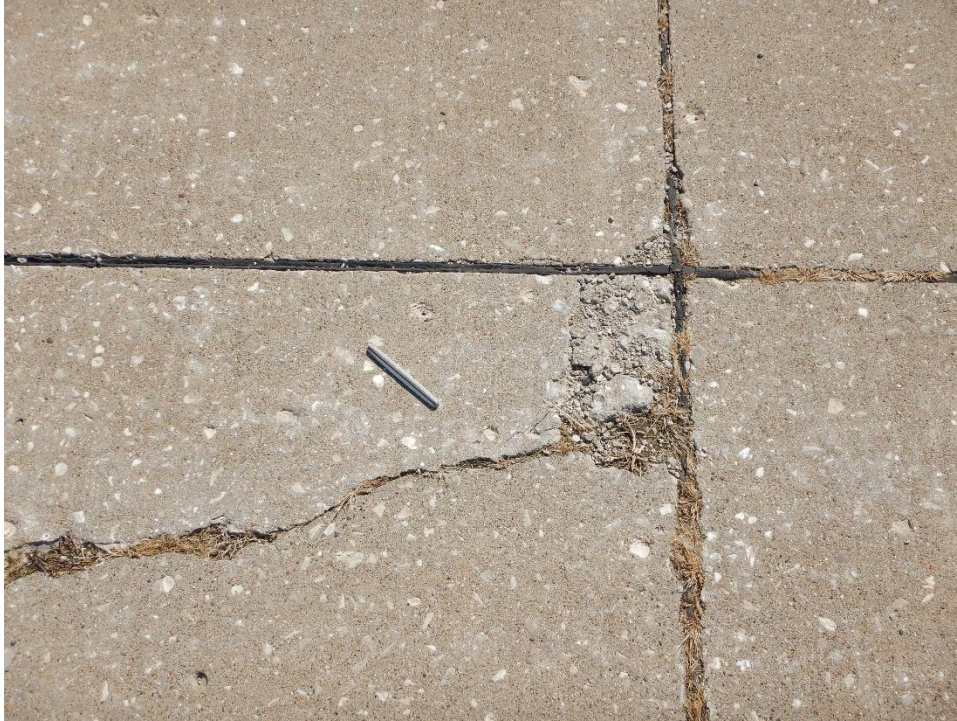
TBDA-01. ASR (Sample Unit No. 02).

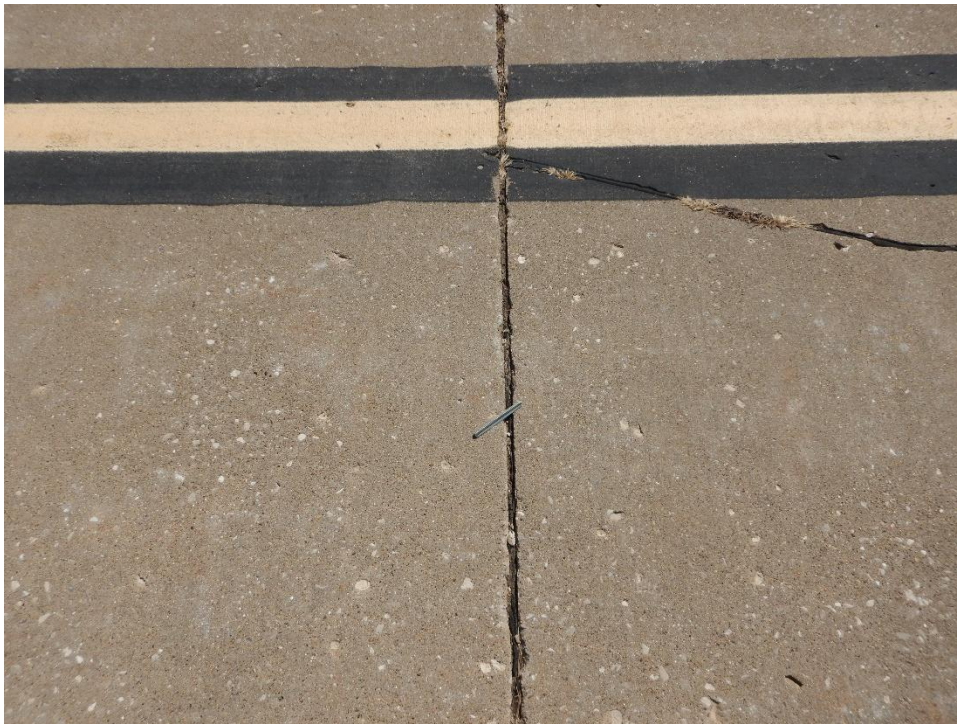
TBDA-01. Joint Seal Damage (Sample Unit No. 02).

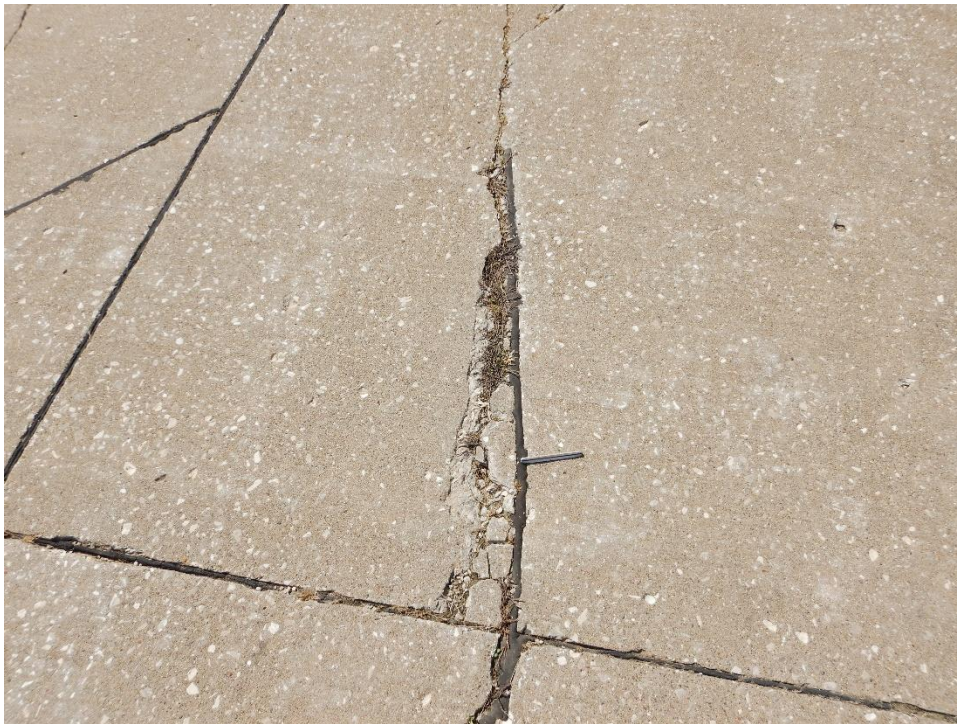
TBDA-01. LTD Cracking (Sample Unit No. 02) (2).

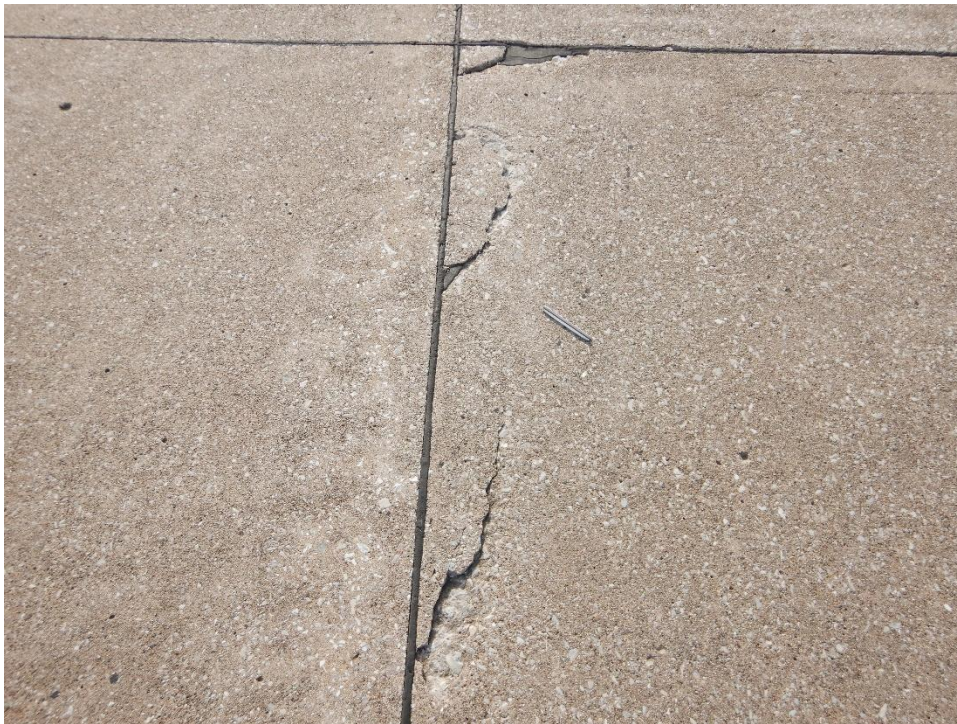
TCDA-01. Joint Spalling (Sample Unit No. 10).

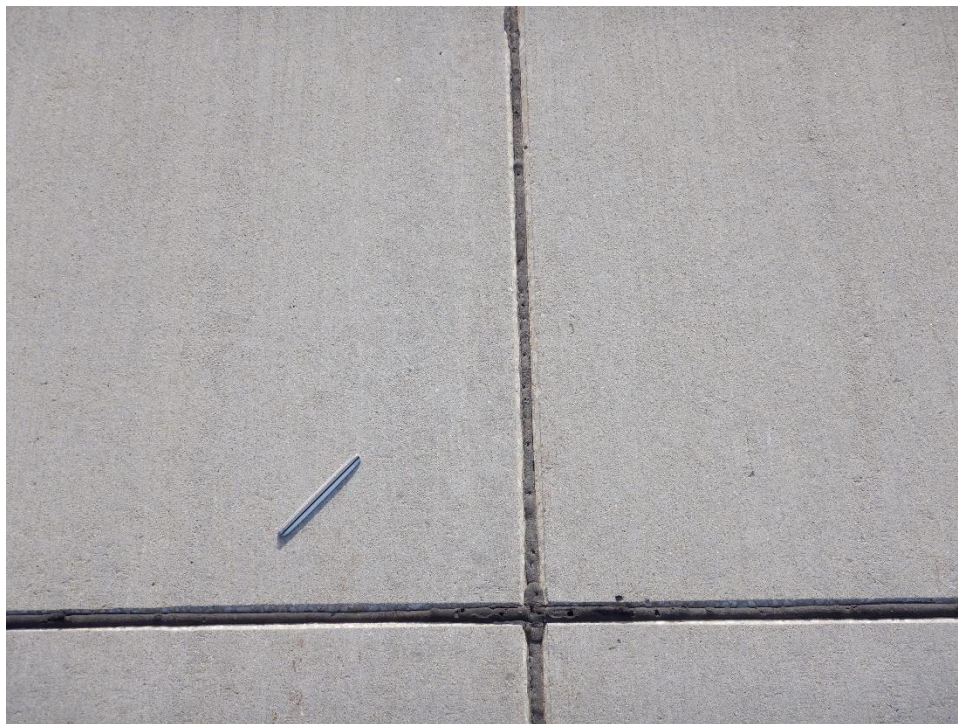
TCDA-03. Joint Seal Damage (Sample Unit No. 03).

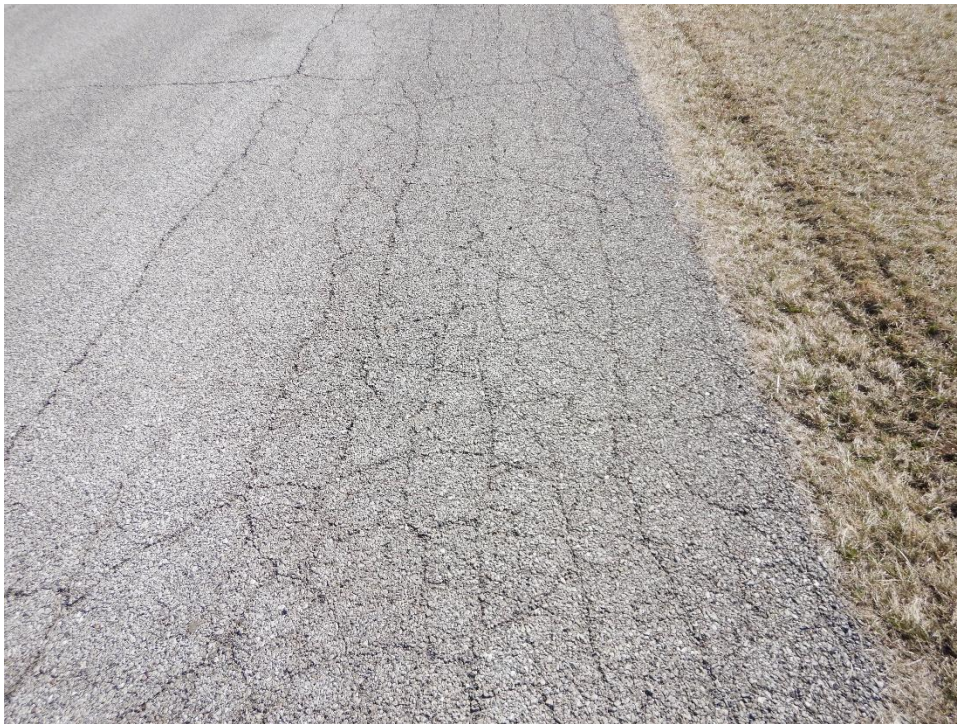
TH01DA-01. Alligator Cracking (Sample Unit No. 02).

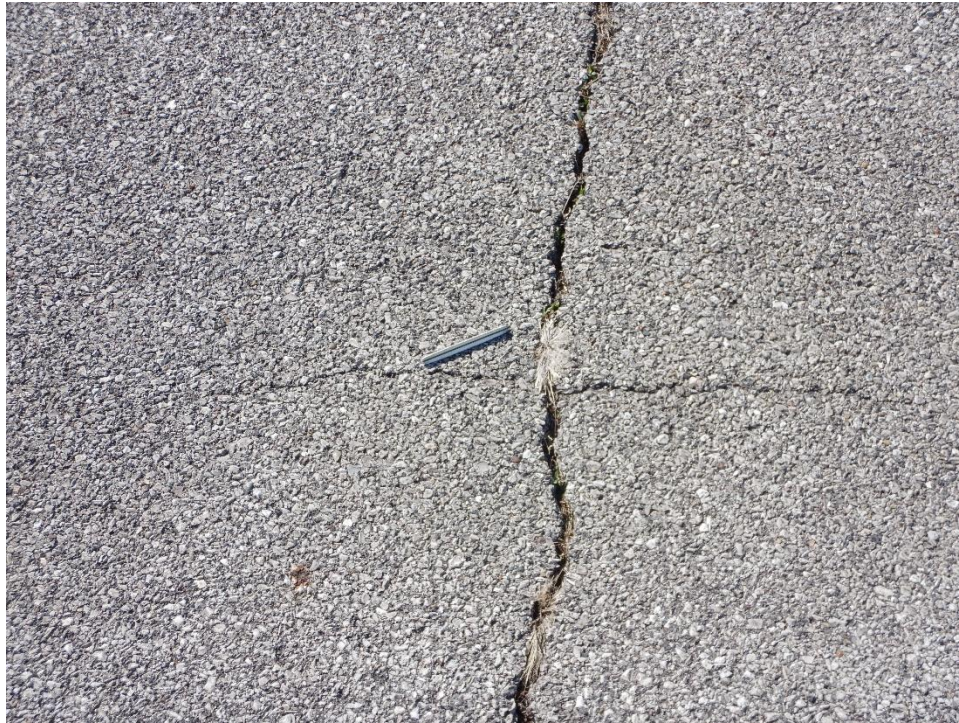
TH01DA-01. L&T Cracking (Sample Unit No. 02).

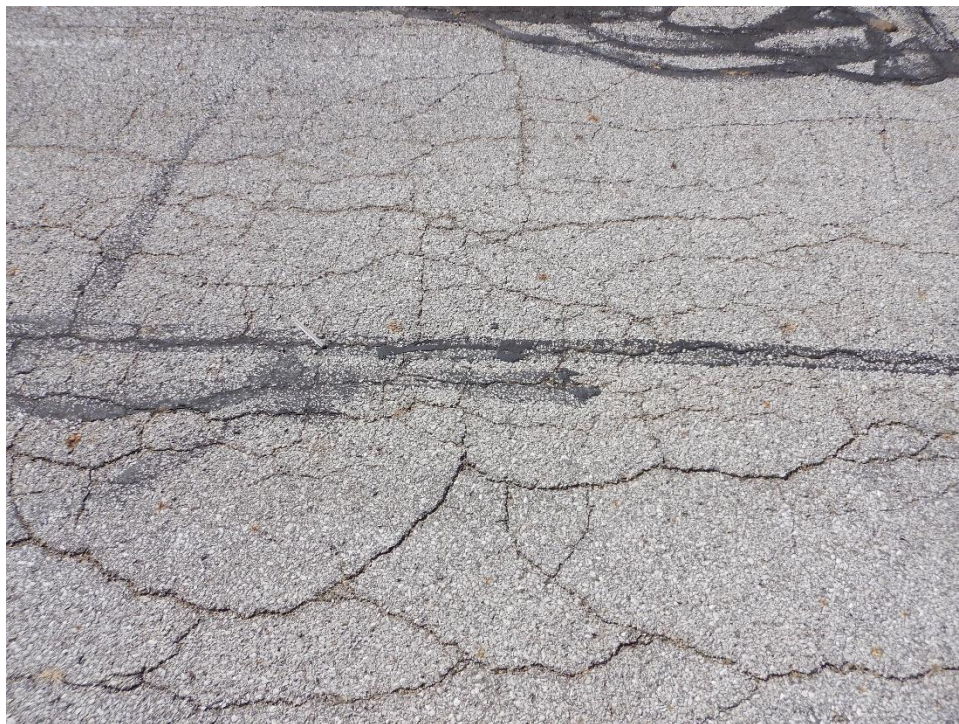
TH01DA-02. Alligator Cracking (Sample Unit No. 05).

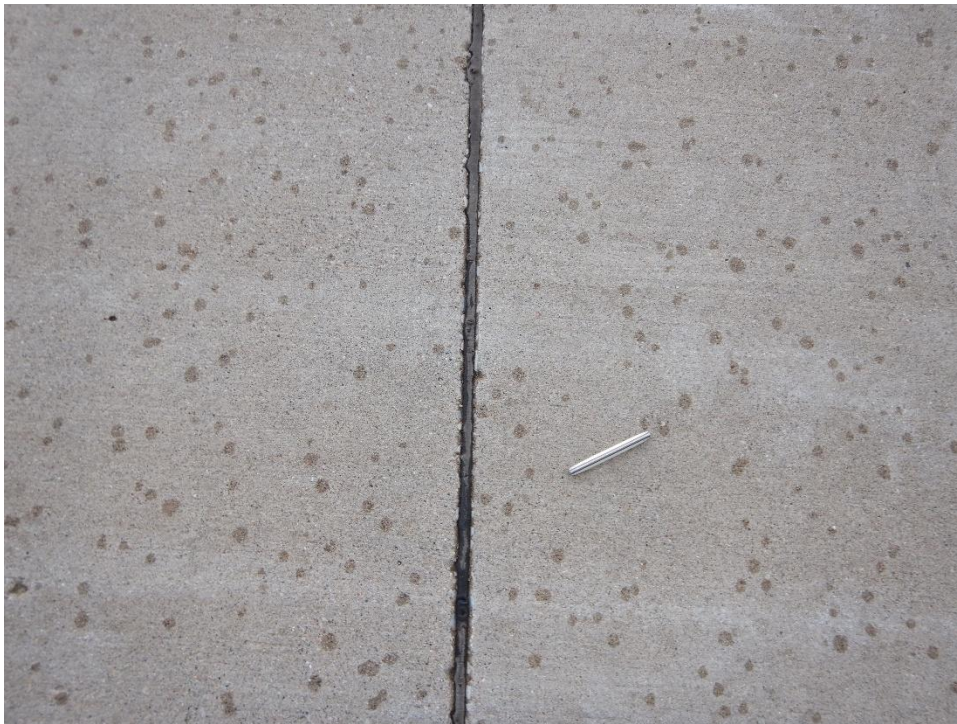
TH01DA-03. Joint Seal Damage (Sample Unit No. 02).

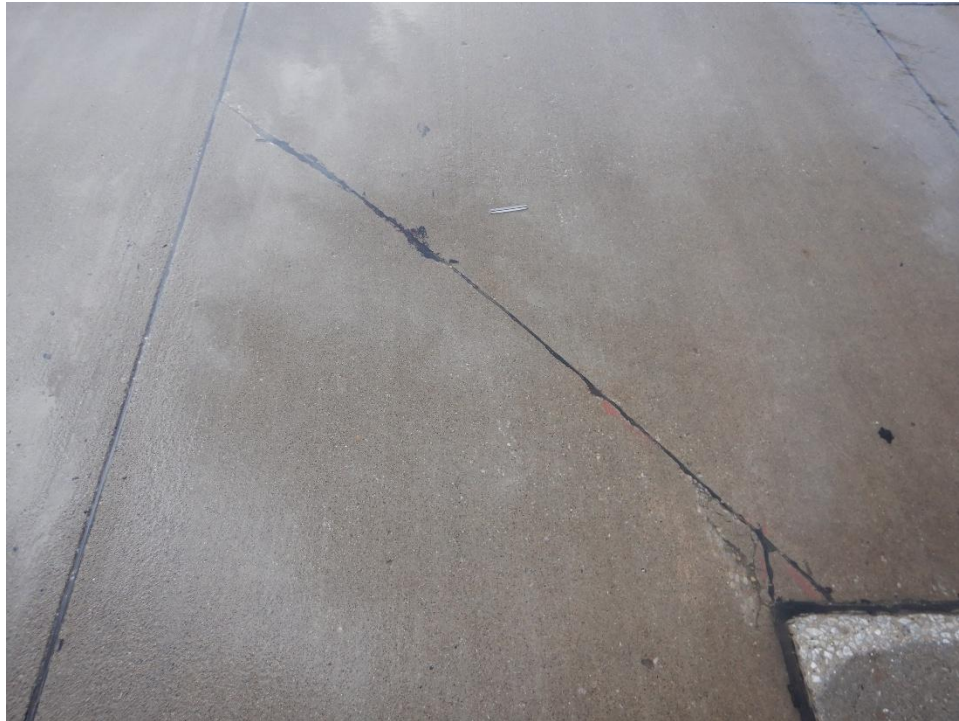
TH01DA-03. LTD Cracking (Sample Unit No. 07).

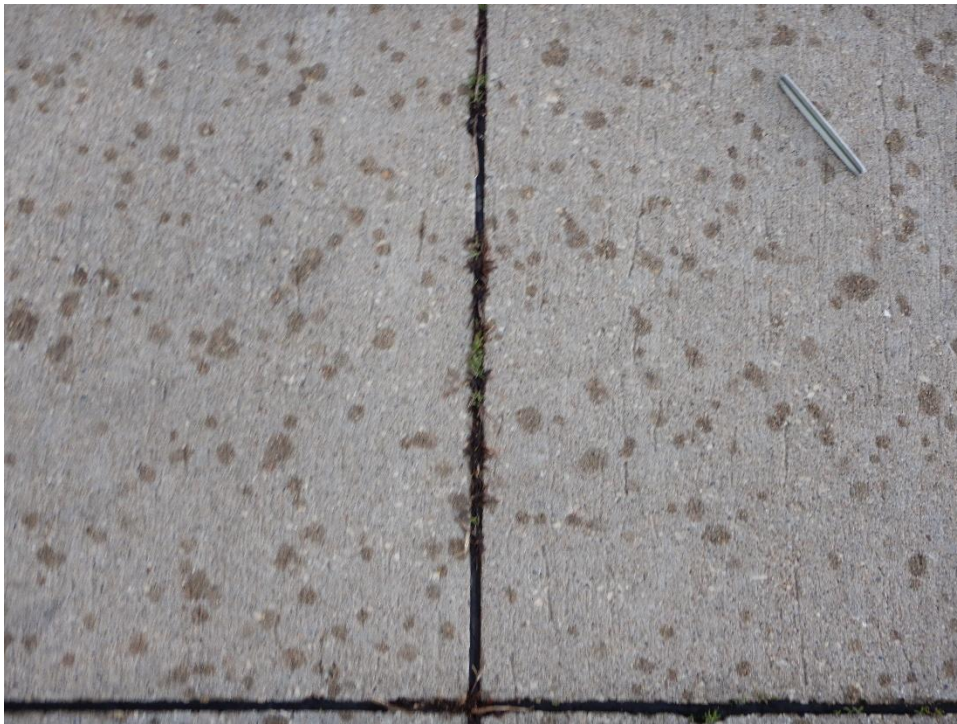
TH01DA-04. Joint Seal Damage (Sample Unit No. 05).
