# Denison Municipal Airport

## Pavement Management Report

**AUGUST 2025**

# DENISON MUNICIPAL AIRPORT PAVEMENT MANAGEMENT REPORT

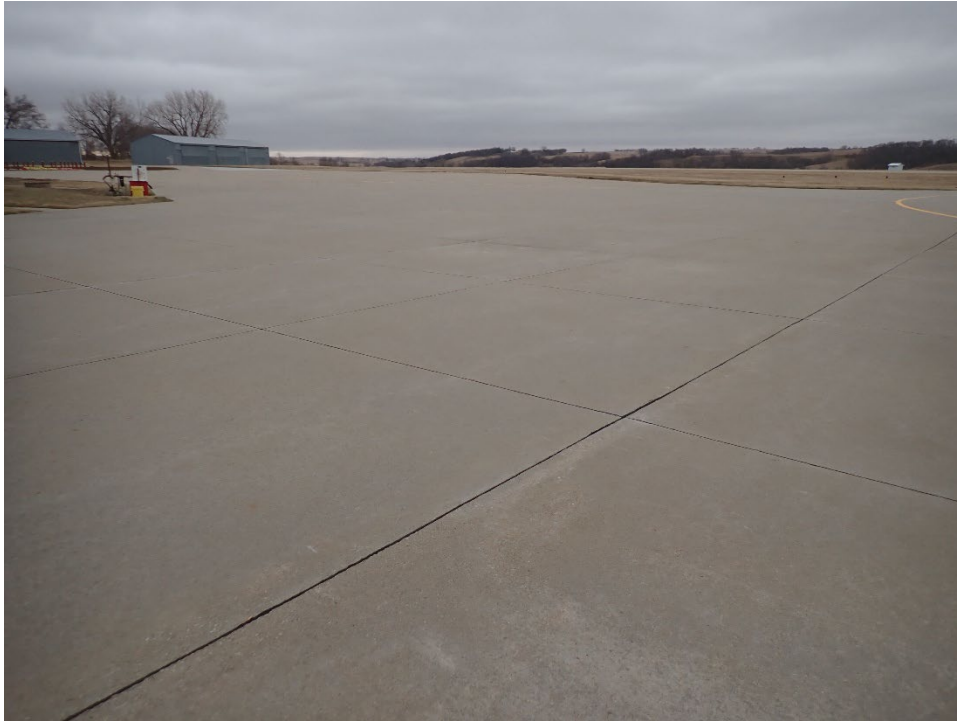
A01DN-01. Overview.

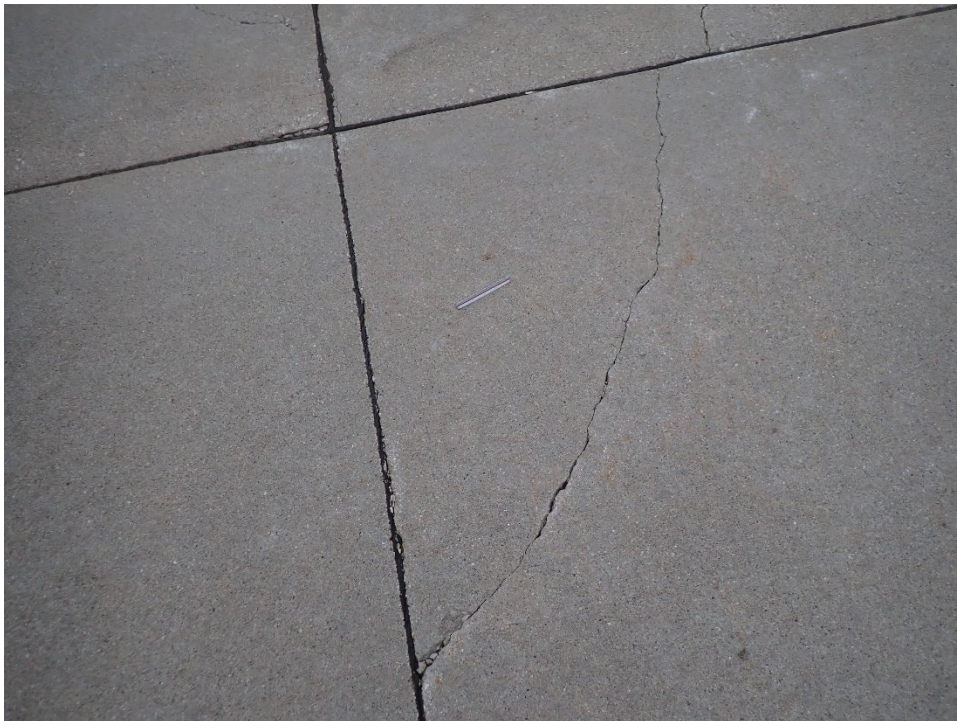
A01DN-01. Corner Break (Sample Unit No. 04).

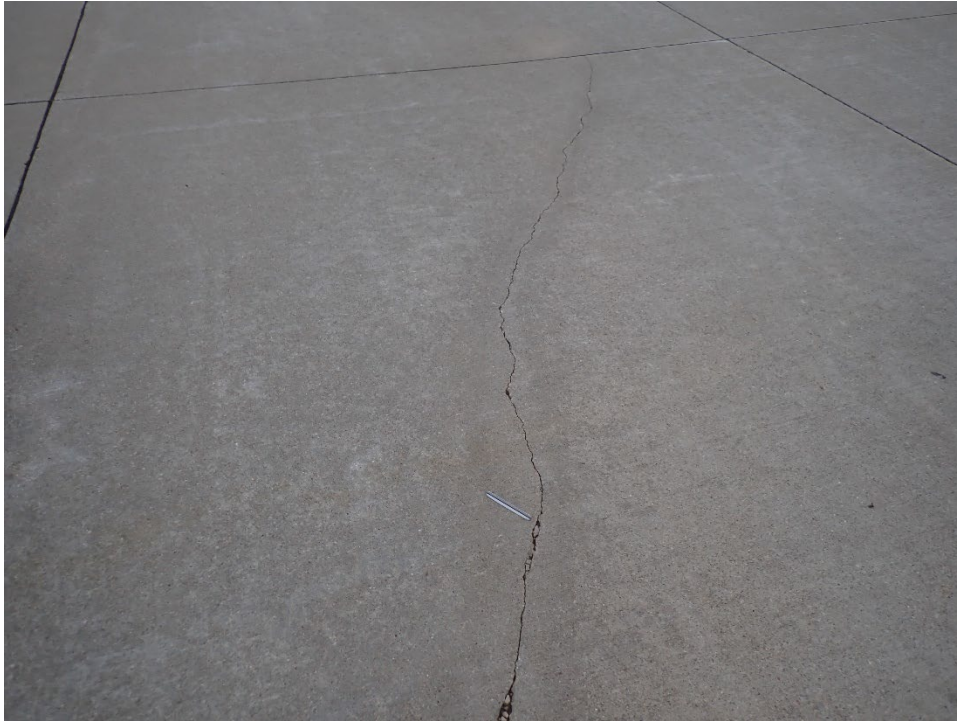
A01DN-01. LTD Cracking (Sample Unit No. 04).

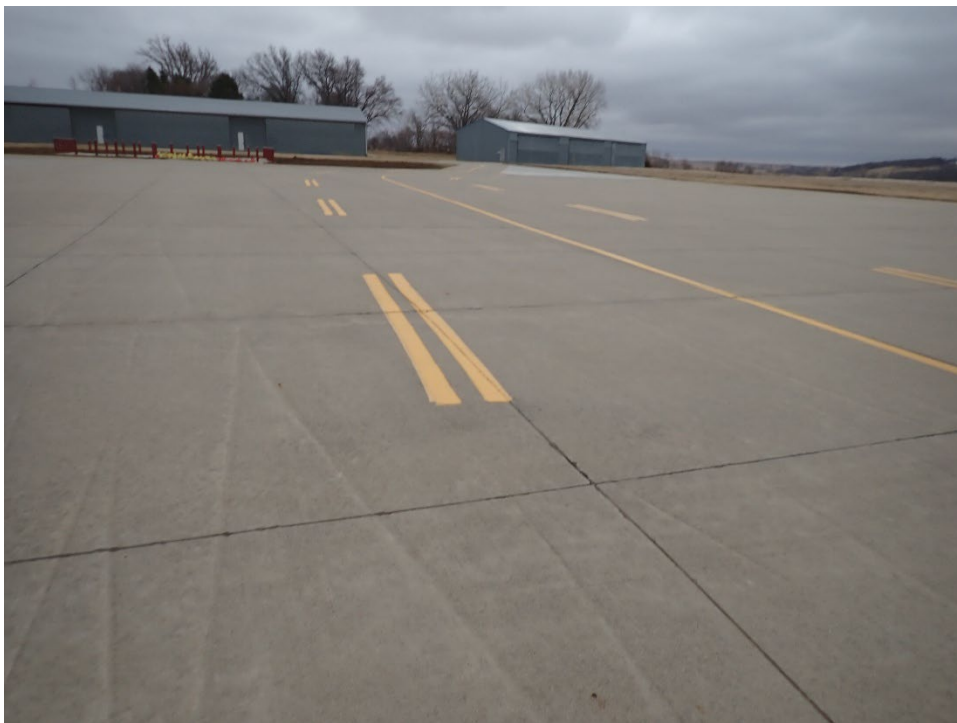
A01DN-02. Overview.

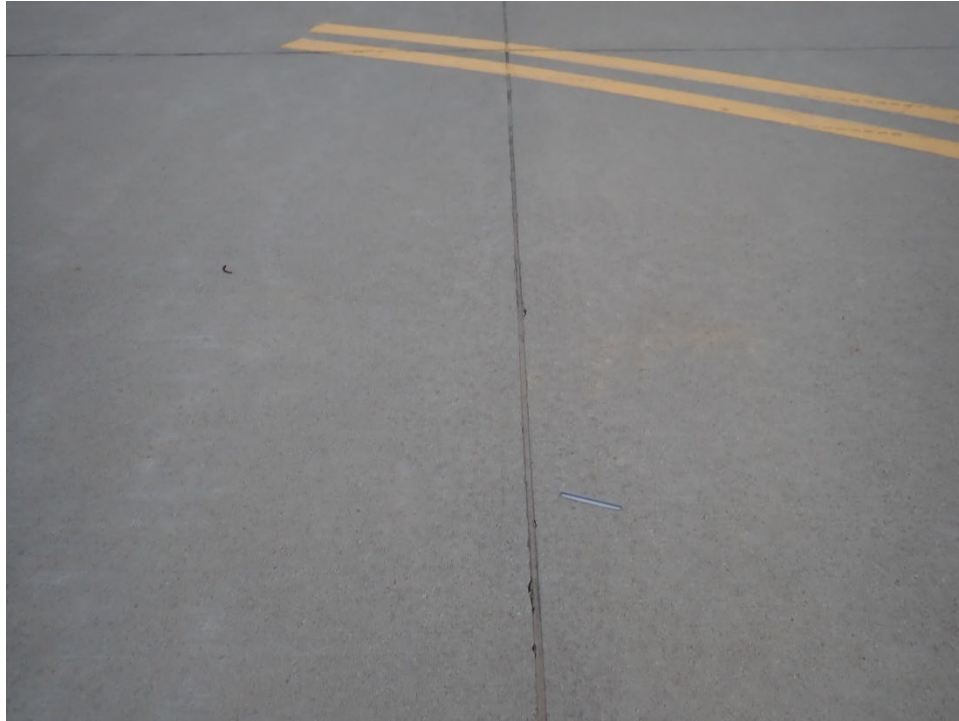
A01DN-02. Joint Seal Damage (Sample Unit No. 08).

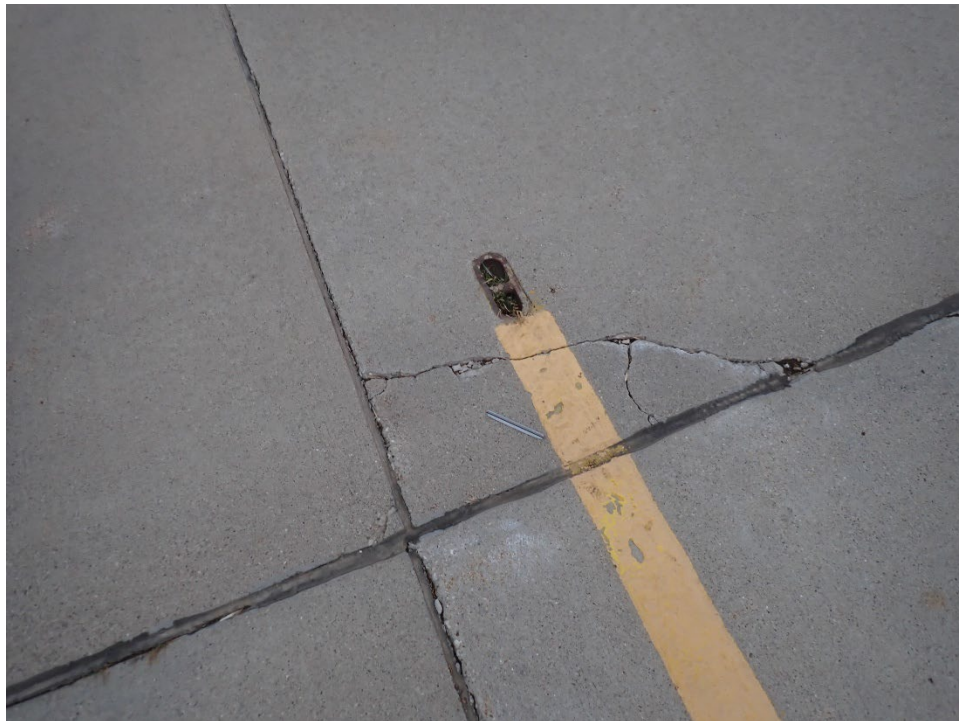
A01DN-02. Joint Spalling (Sample Unit No. 06).

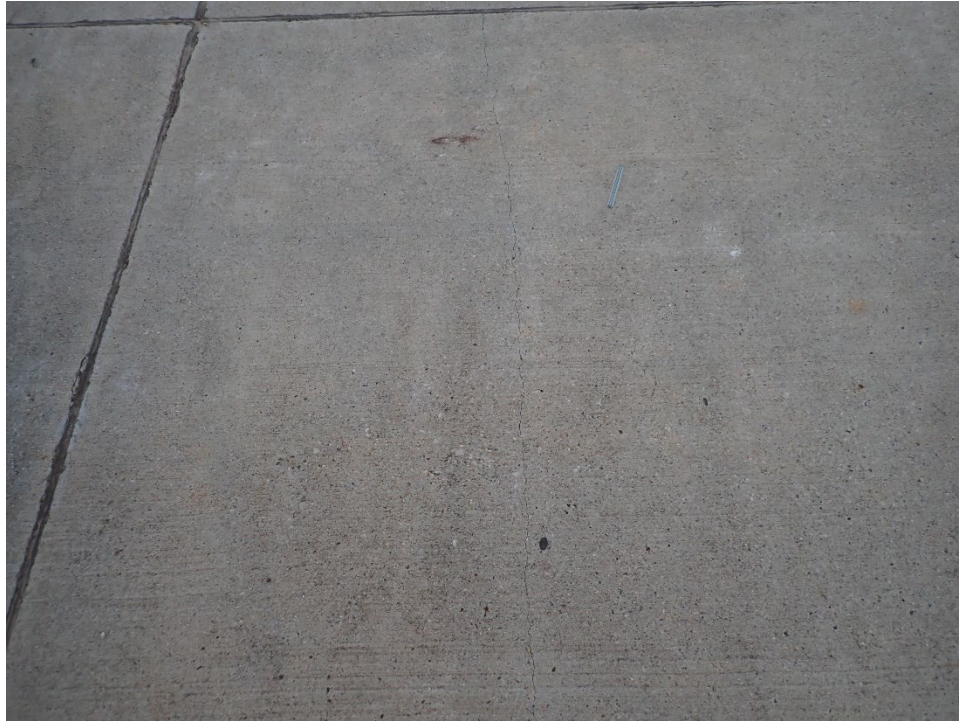
A01DN-02. LTD Cracking (Sample Unit No. 03).

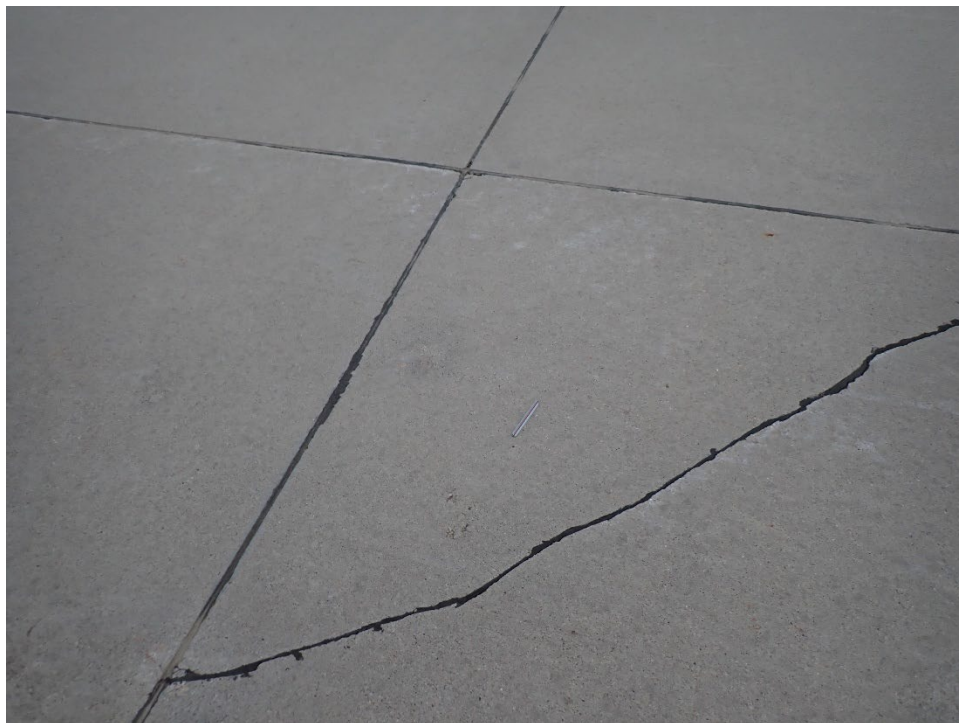
A01DN-02. LTD Cracking (Sample Unit No. 08).

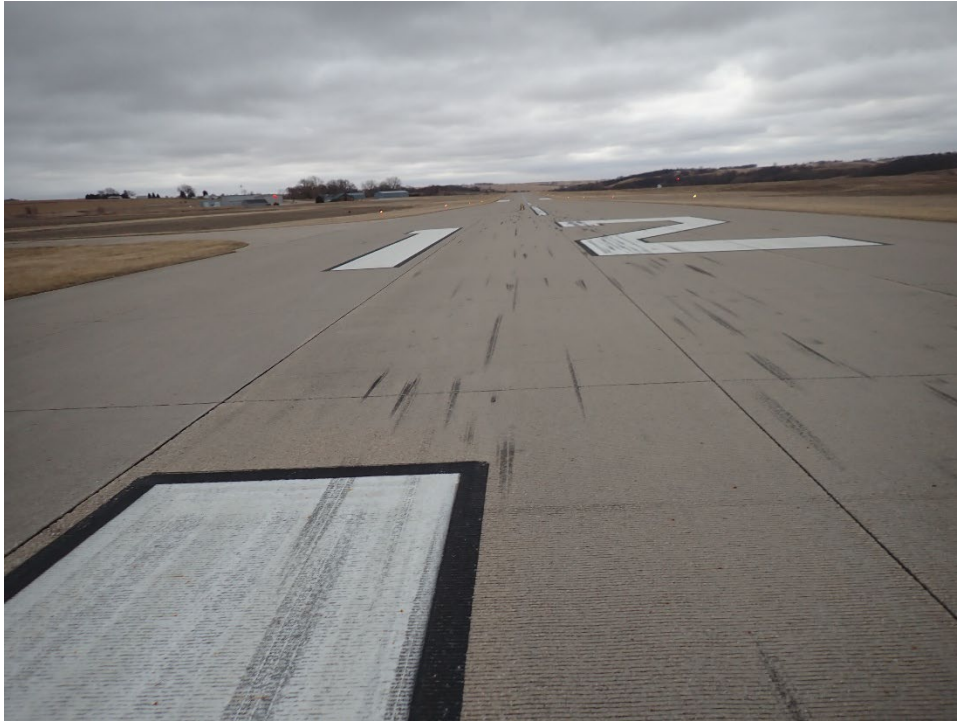
R12DN-01. Overview.

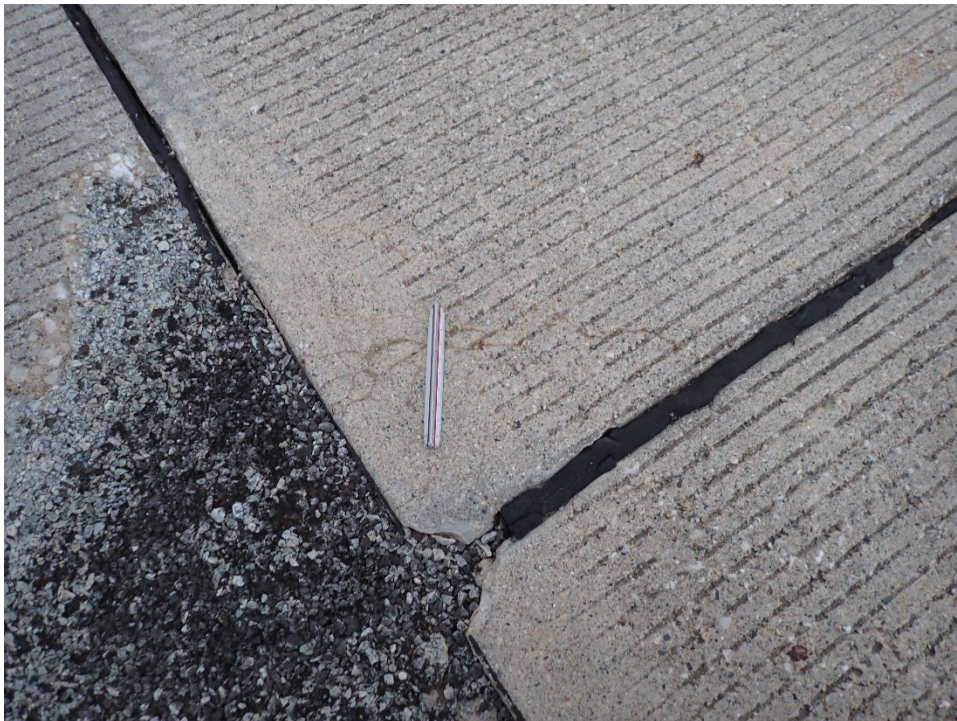
R12DN-01. ASR (Additional Sample Unit No. 36).

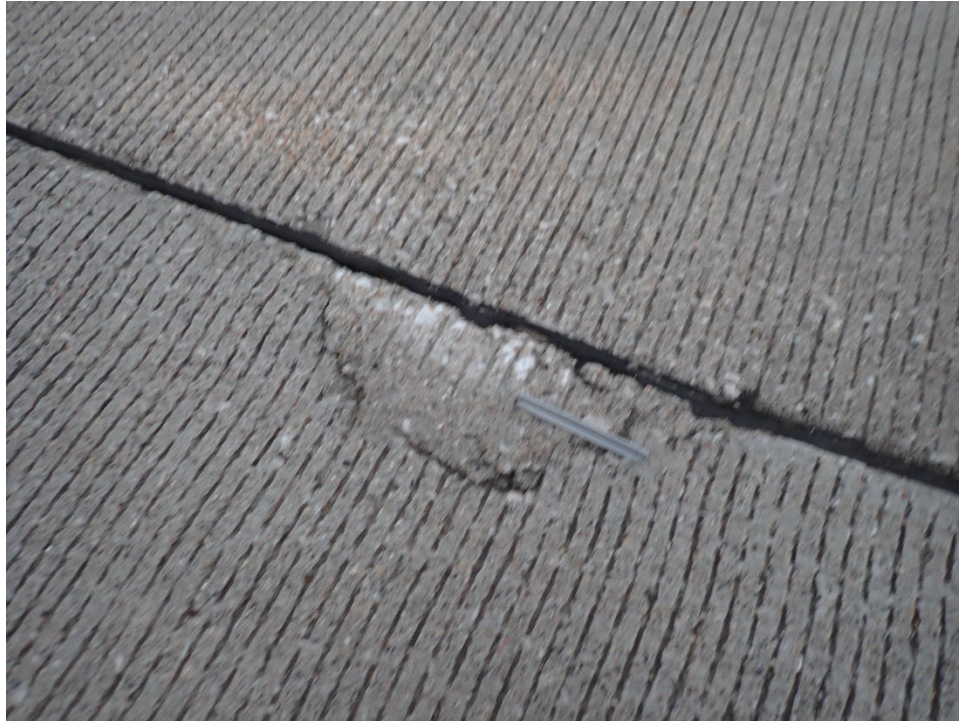
R12DN-01. Joint Spalling (Sample Unit No. 13).

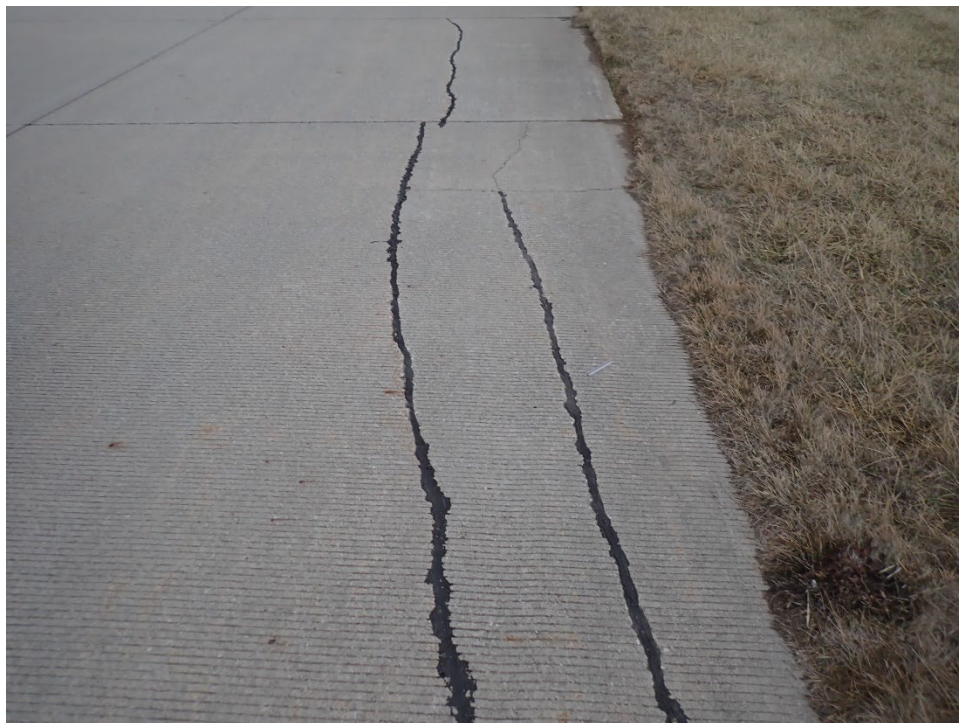
R12DN-01. Shattered Slab (Additional Sample Unit No. 36).

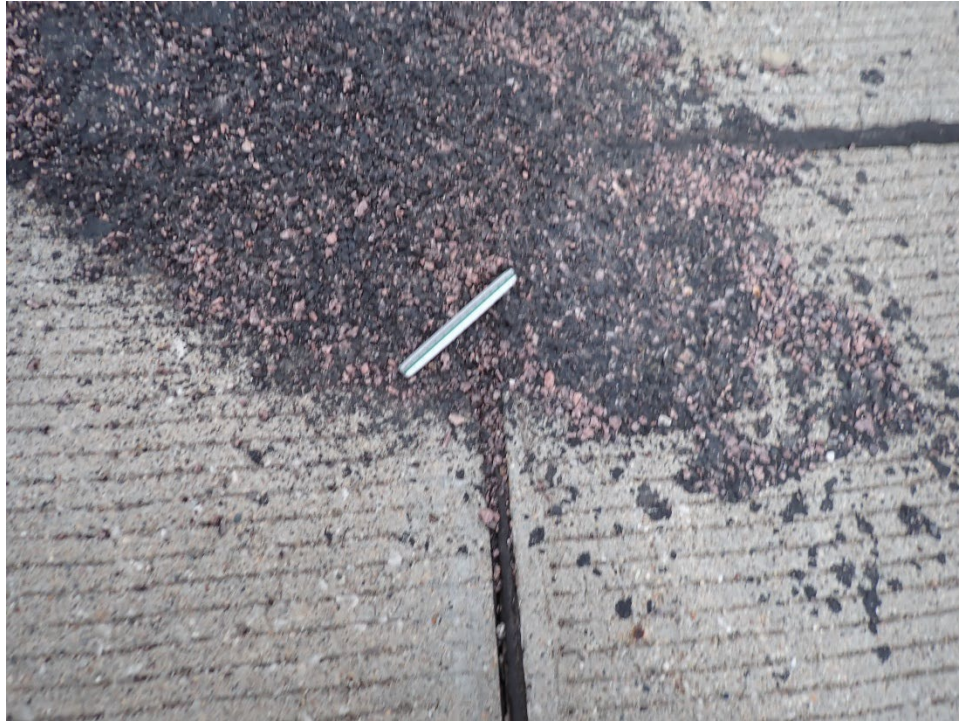
R12DN-01. Small Patching (Sample Unit No. 35).

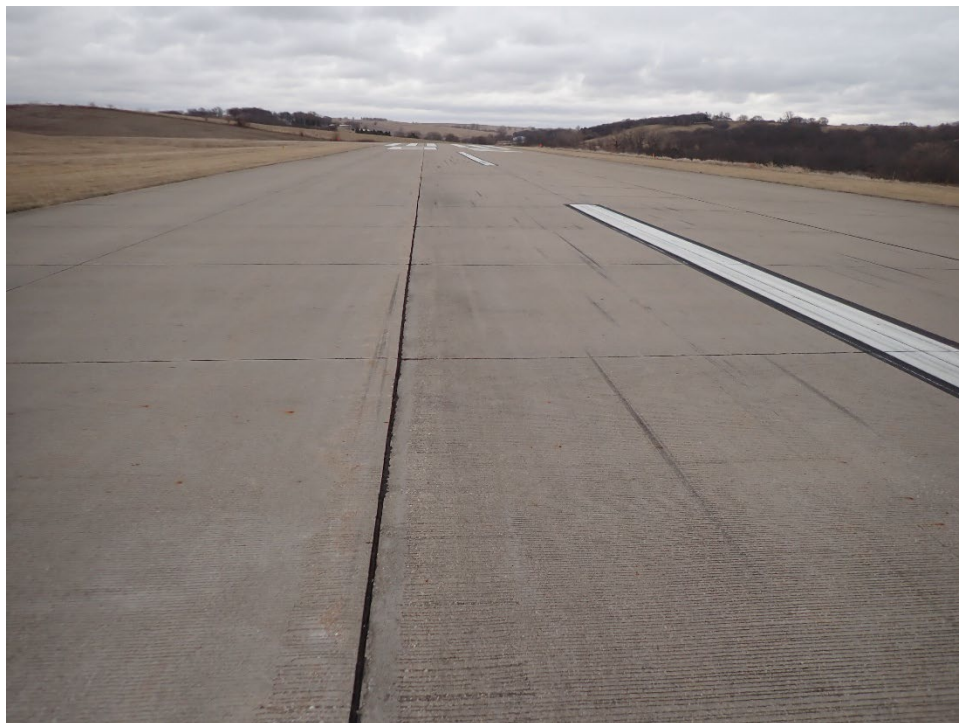
R12DN-02. Overview.

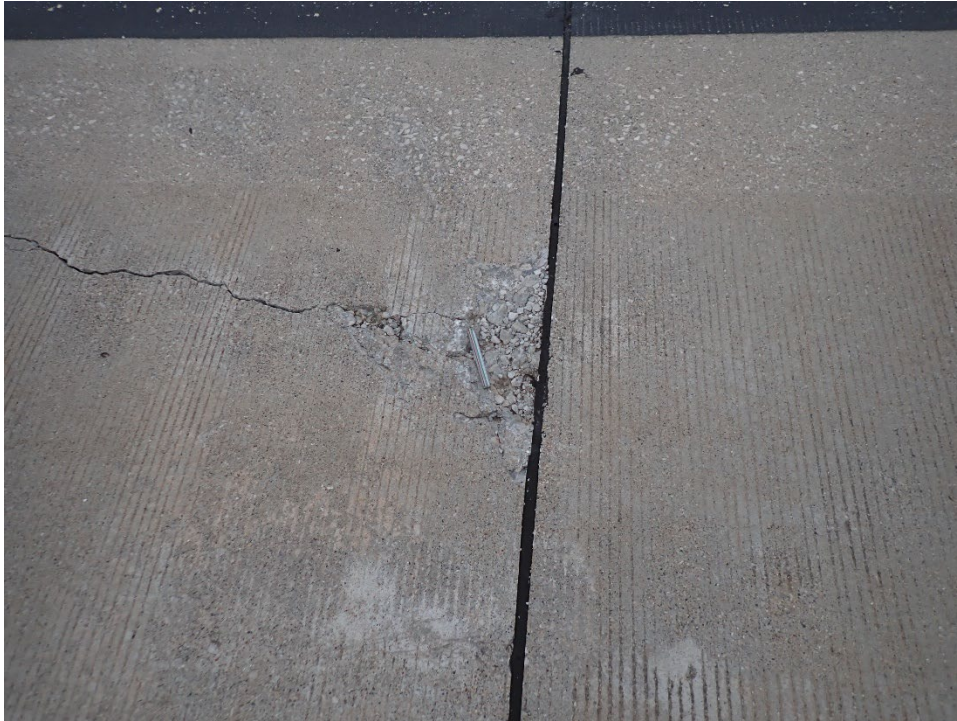
R12DN-02. ASR (Additional Sample Unit No. 15).

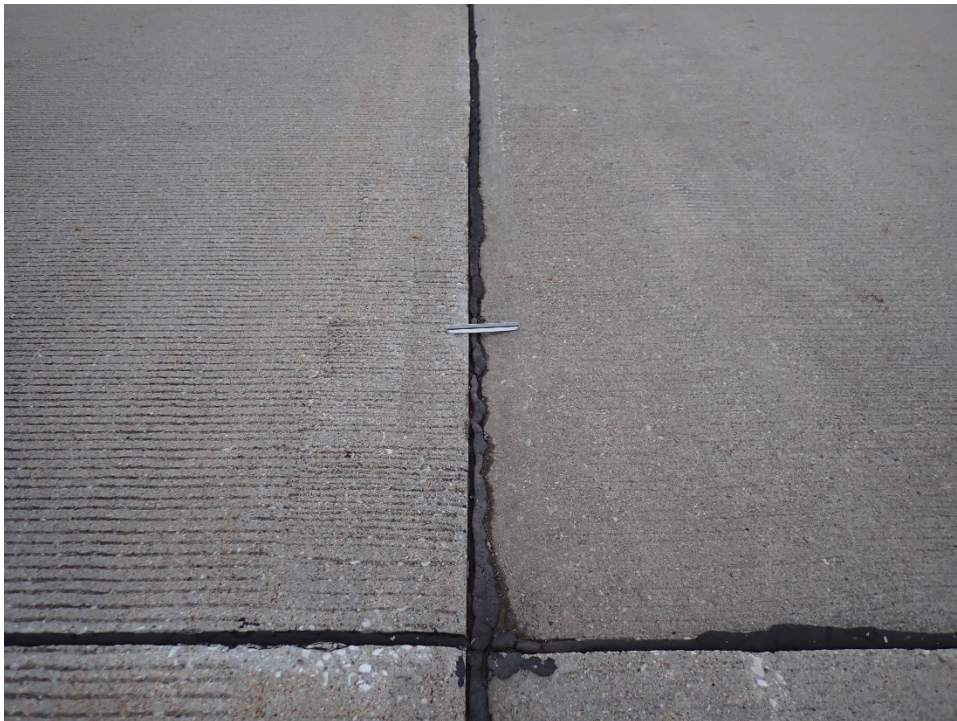
R12DN-02. Faulting (Sample Unit No. 02).

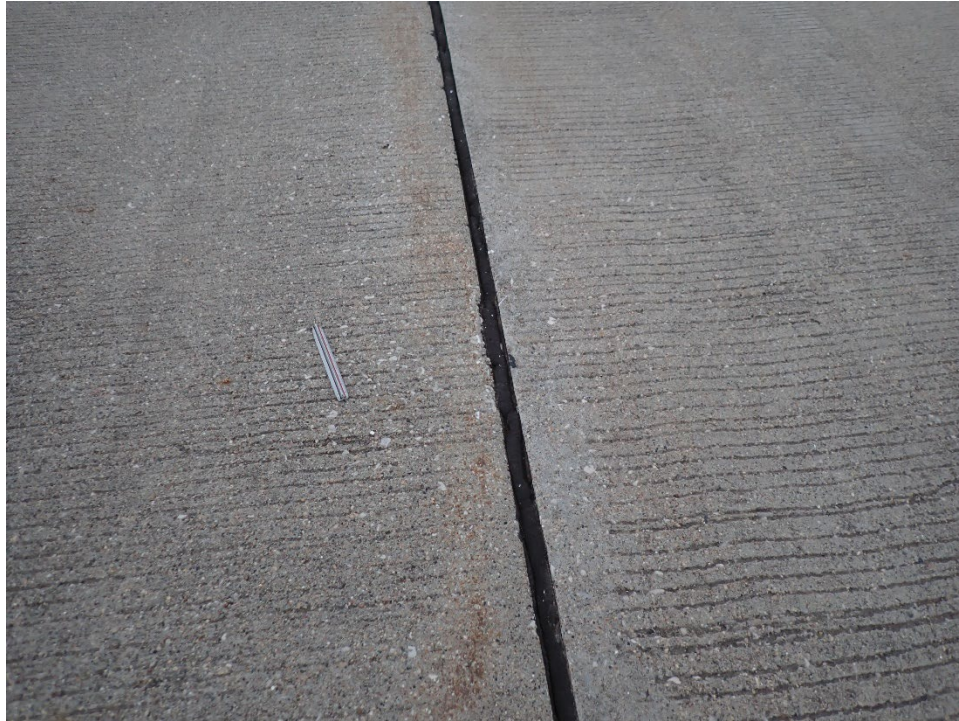
R12DN-02. Joint Seal Damage (Sample Unit No. 09).

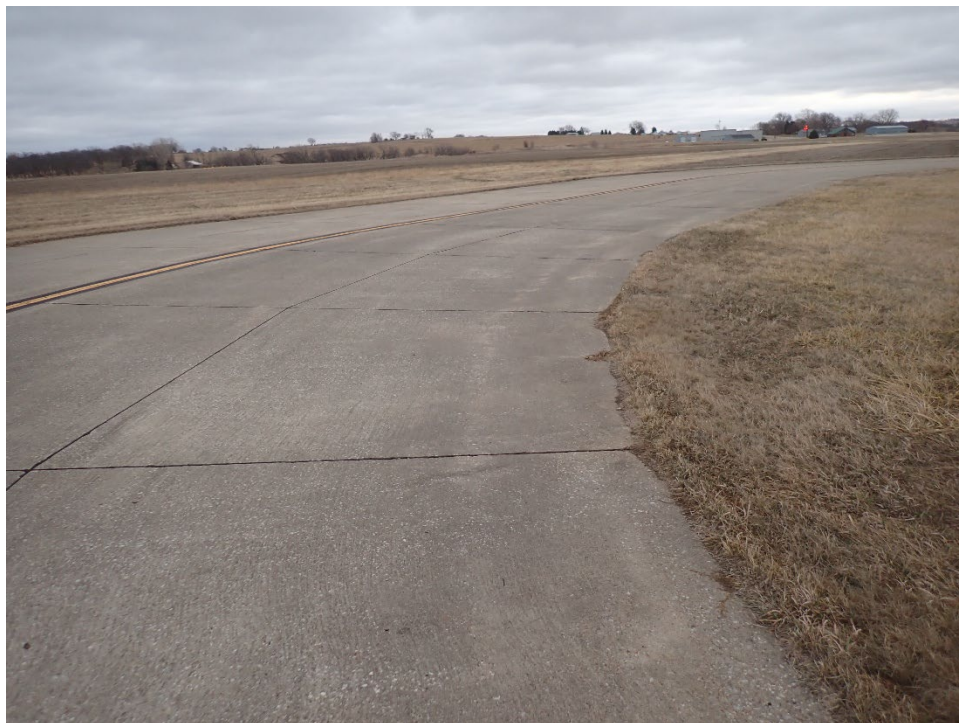
R12DN-03. Overview.

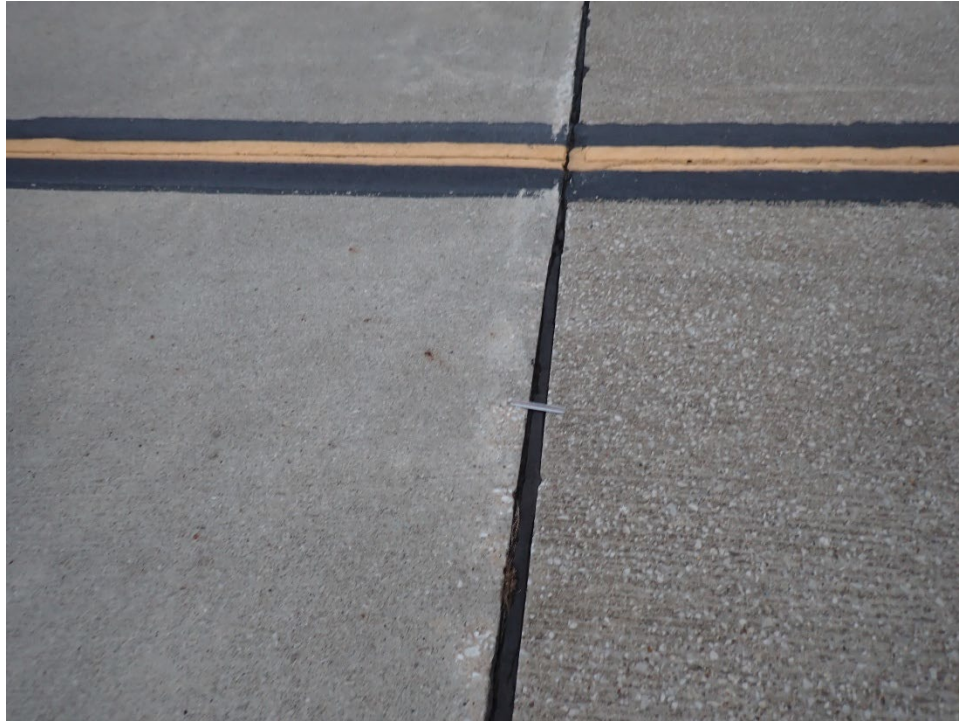
R12DN-03. Faulting (Sample Unit No. 01).

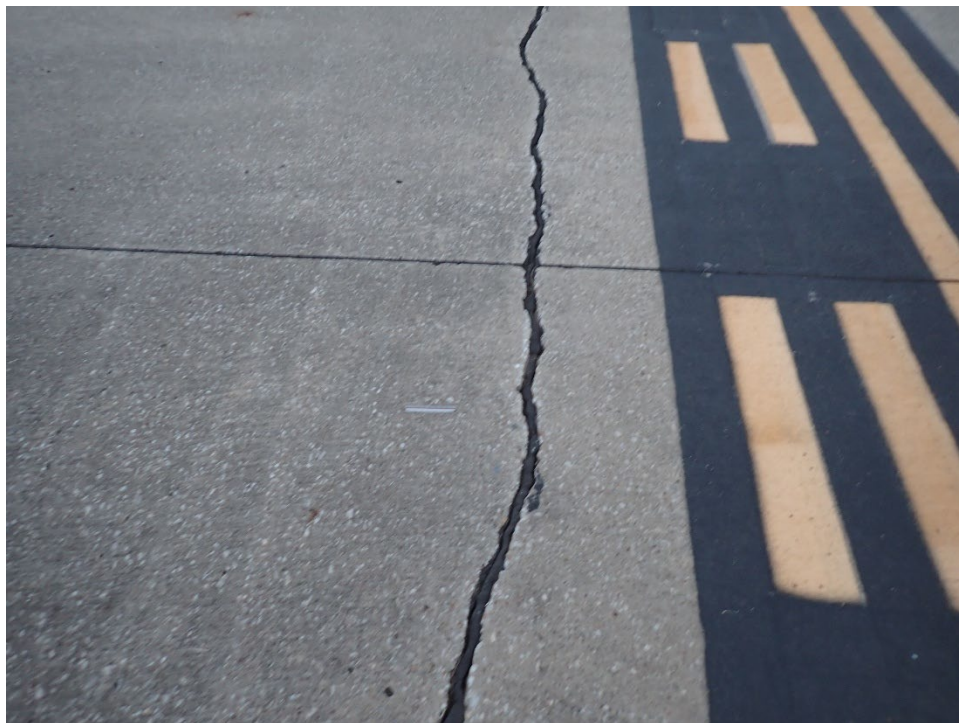
R12DN-03. LTD Cracking (Sample Unit No. 01).

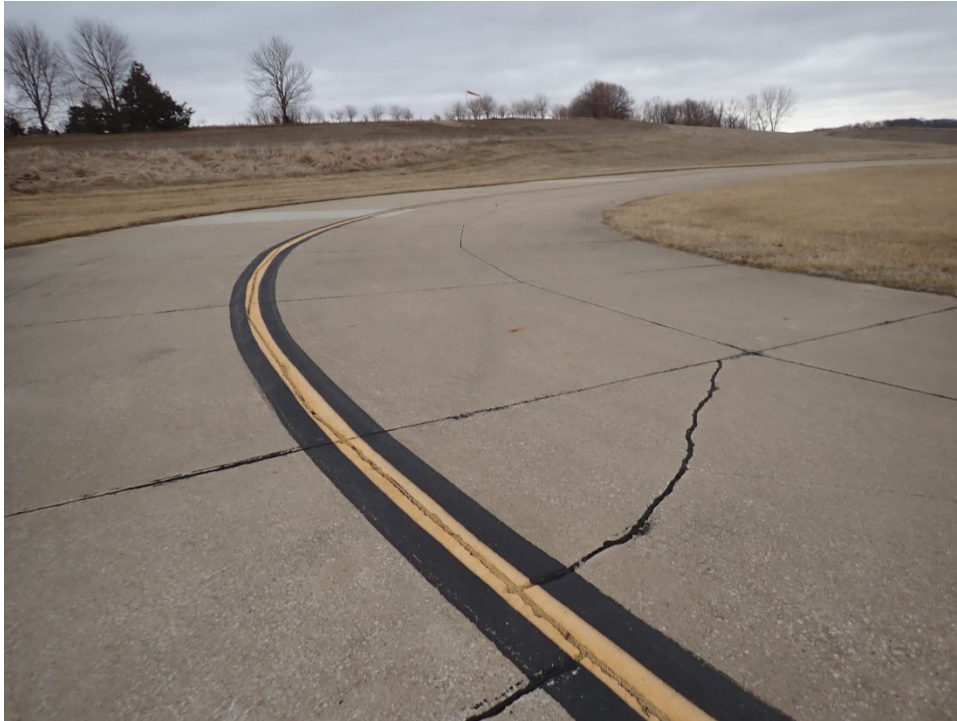
R12DN-04. Overview.

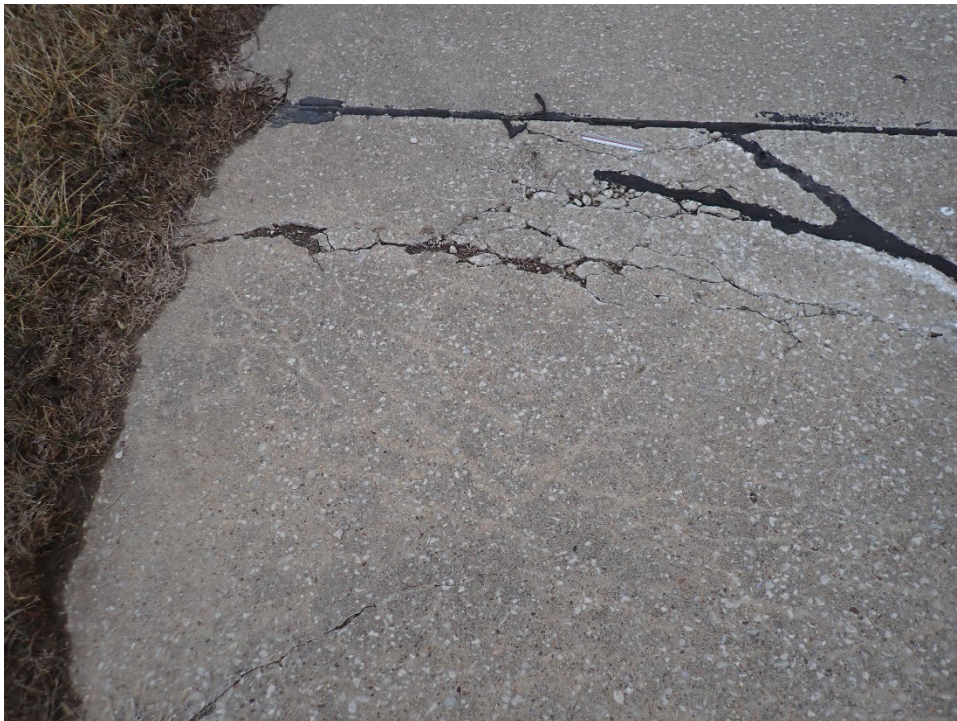
R12DN-04. ASR (Sample Unit No. 01).

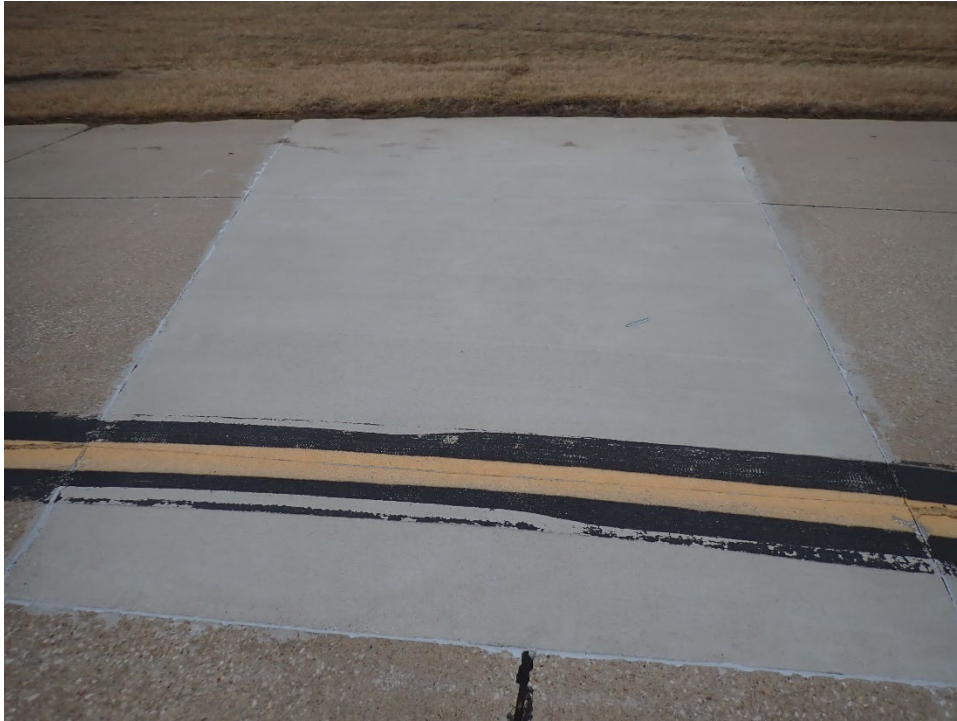
R12DN-04. Large Patching (Sample Unit No. 02).

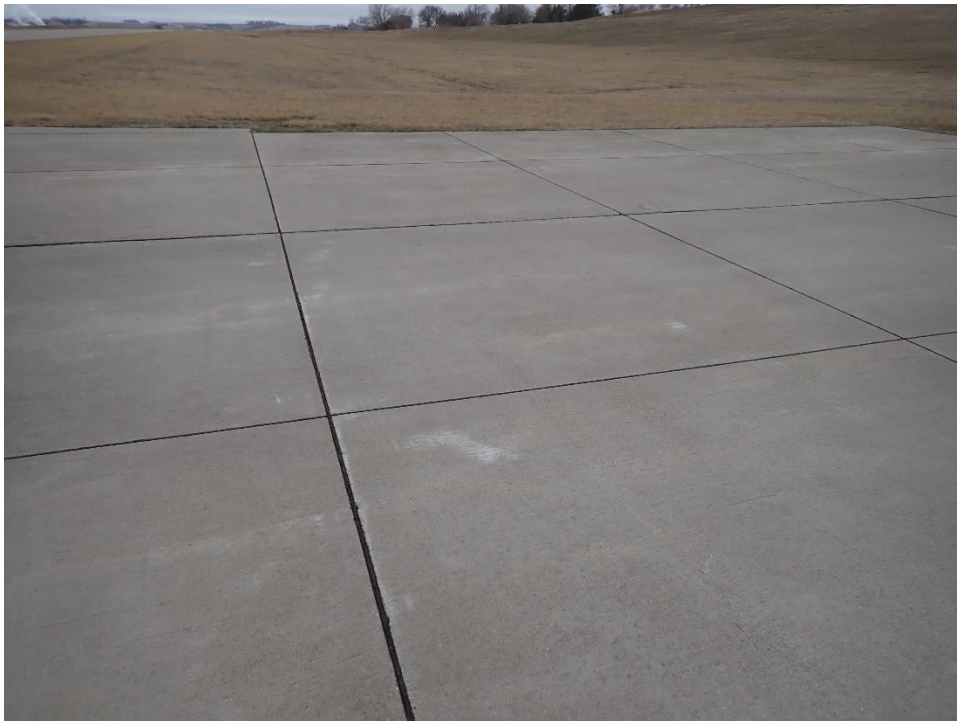
R12DN-05. Overview.

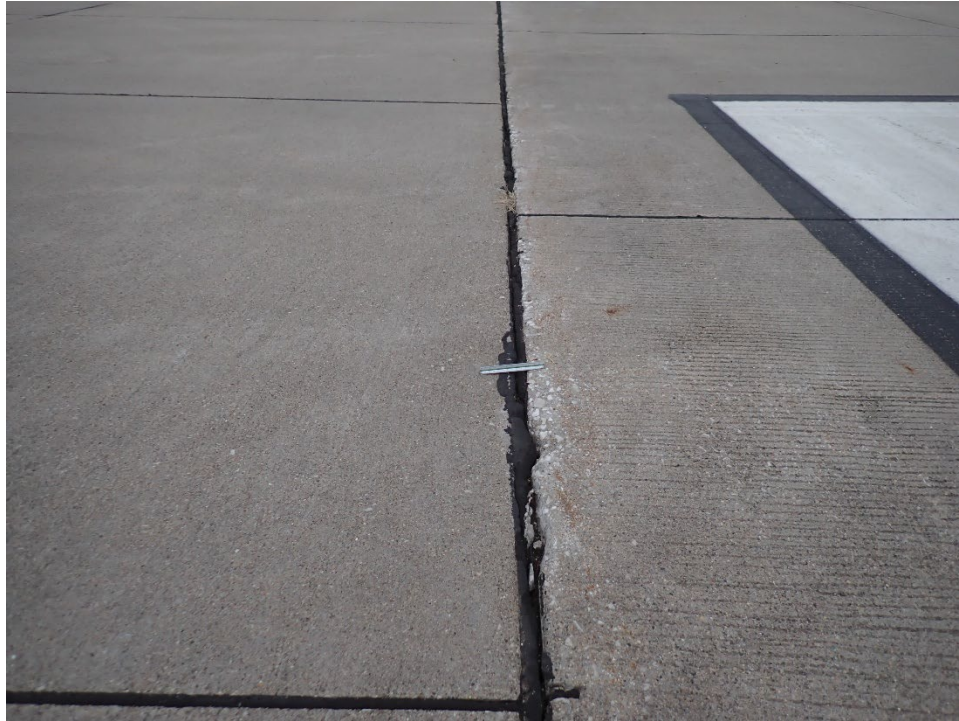
R12DN-05. Faulting (Sample Unit No. 02).

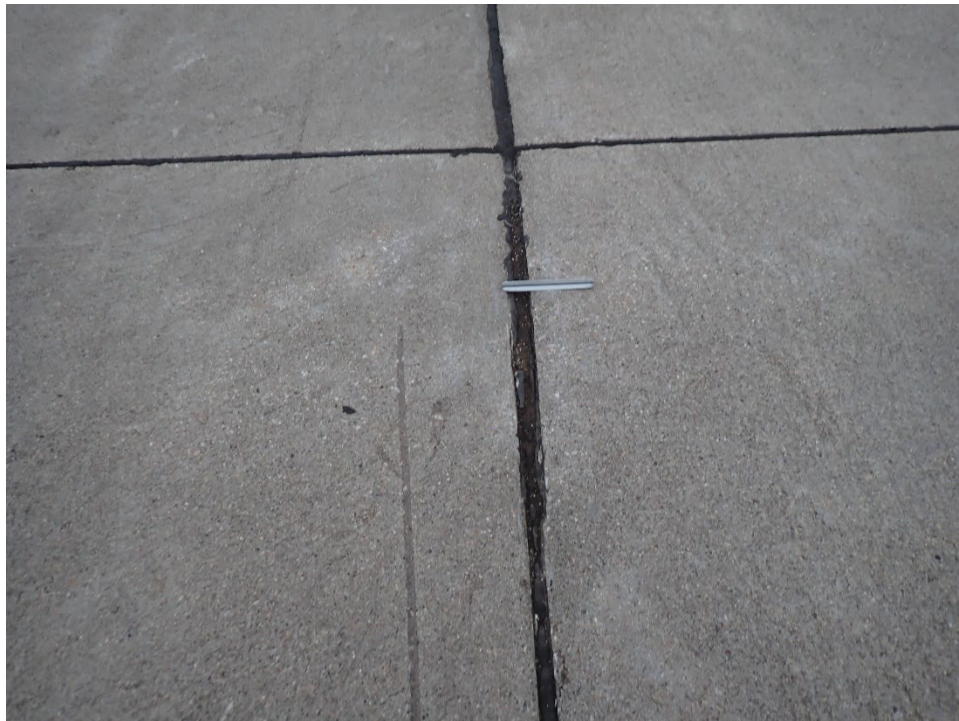
R12DN-05. Joint Seal Damage (Sample Unit No. 02).

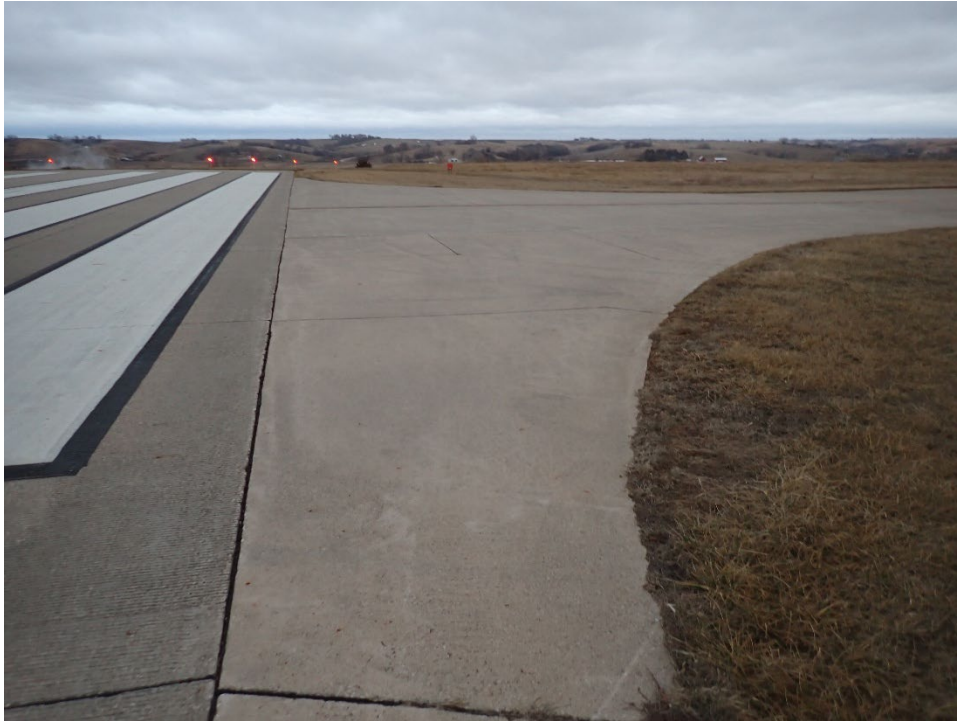
R12DN-06. Overview.

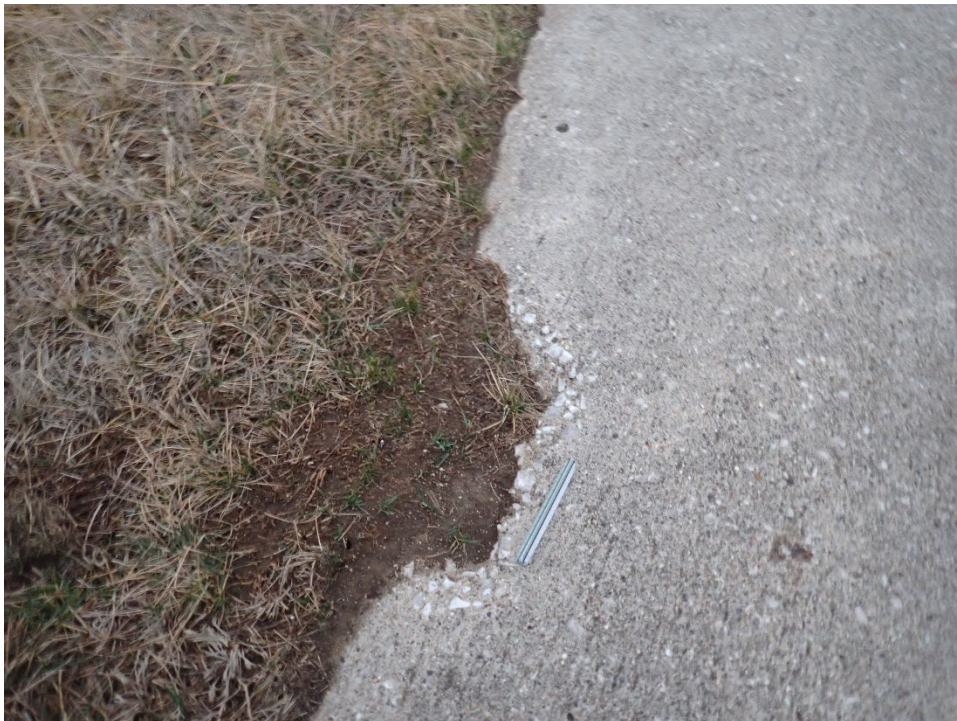
R12DN-06. Joint Spalling (Sample Unit No. 01).

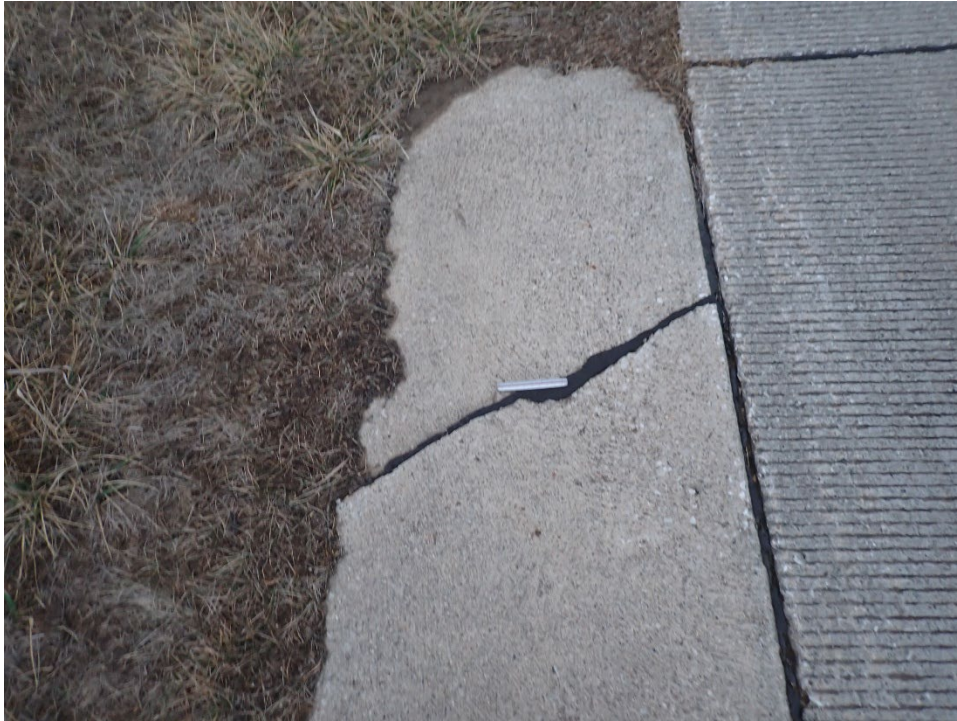
R12DN-06. LTD Cracking (Sample Unit No. 02).

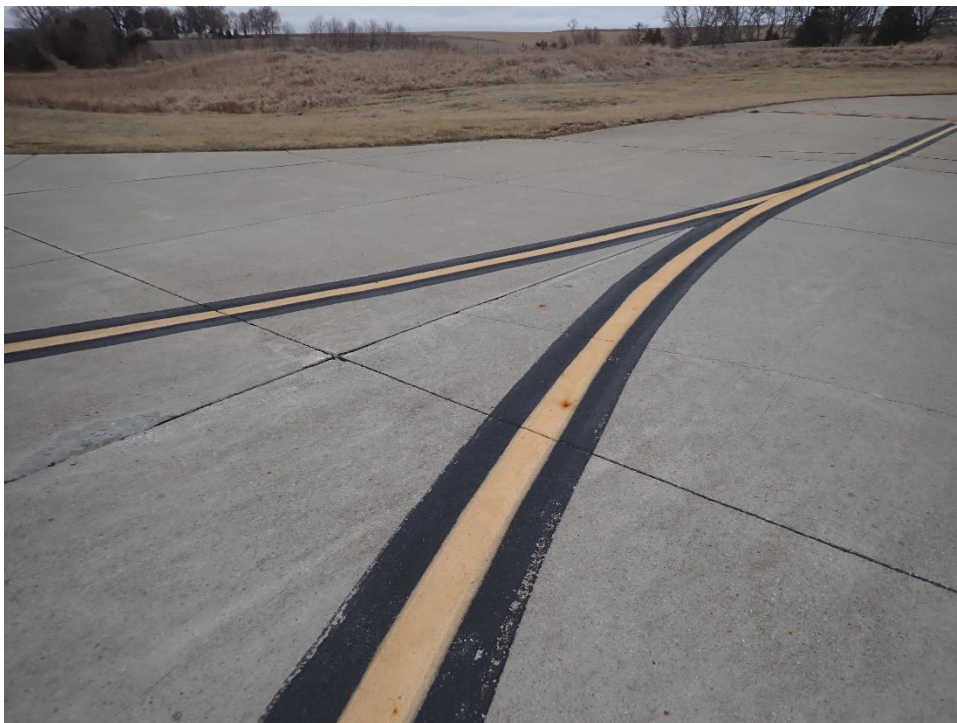
R12DN-07. Overview.

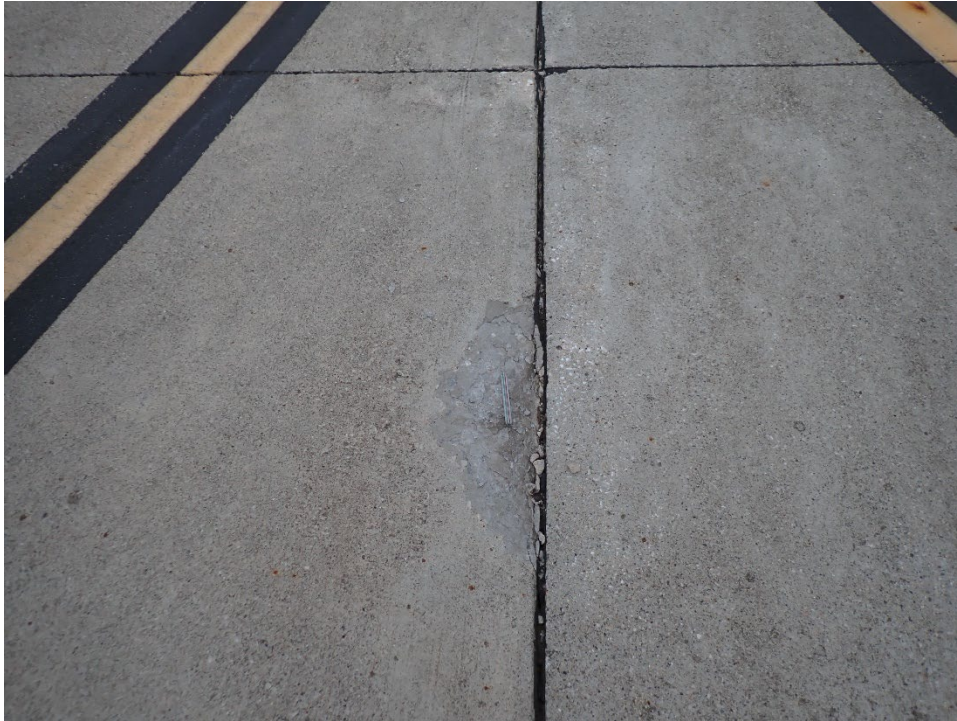
R12DN-07. Joint Spalling (Sample Unit No. 01).

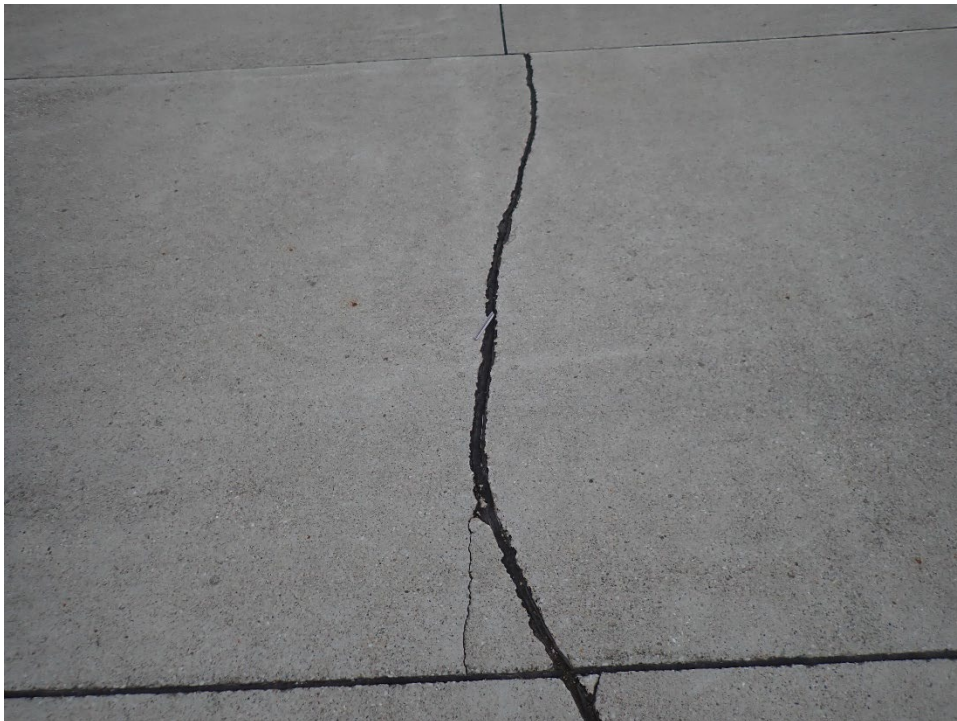
R12DN-07. LTD Cracking (Sample Unit No. 01).

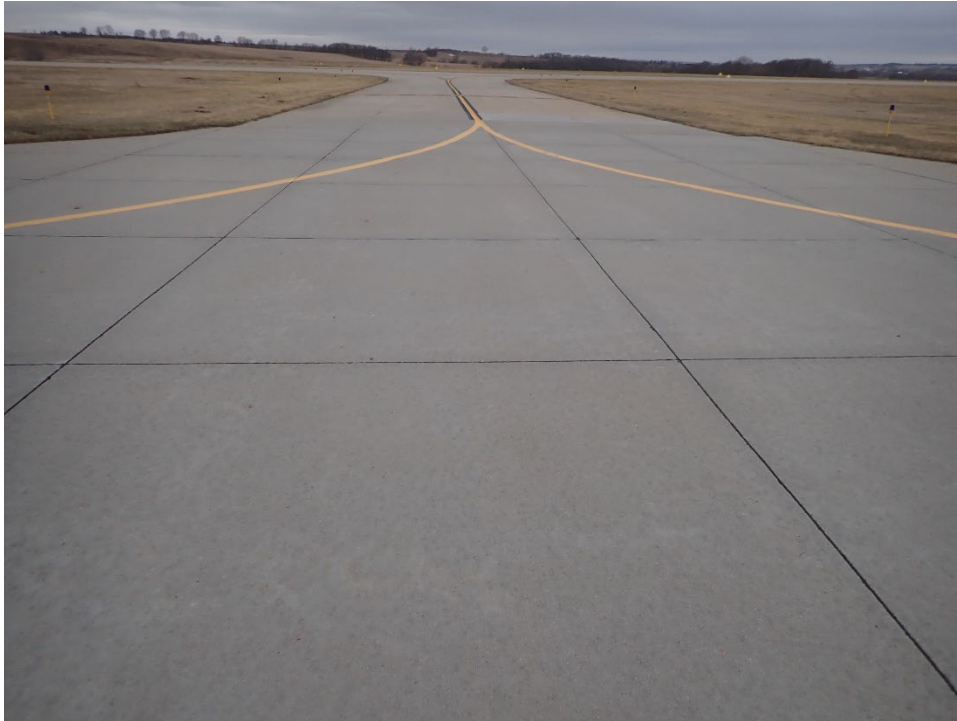
T01DN-01. Overview.
