# Denison Municipal Airport

## Pavement Management Report

**AUGUST 2025**

# DENISON MUNICIPAL AIRPORT PAVEMENT MANAGEMENT REPORT

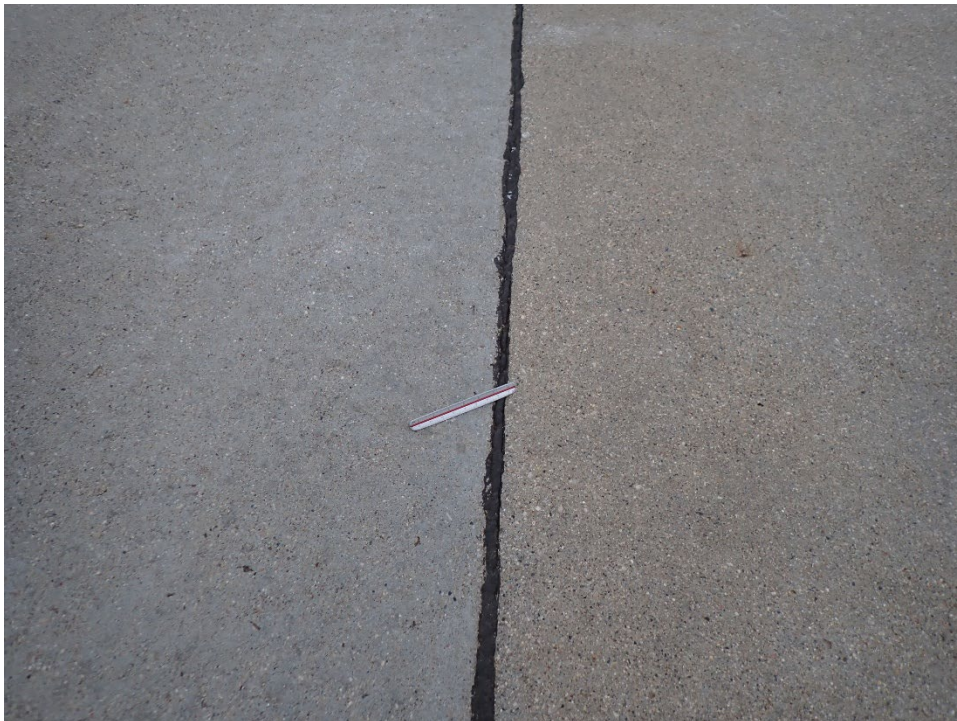
T01DN-01. Joint Seal Damage (Sample Unit No. 02).

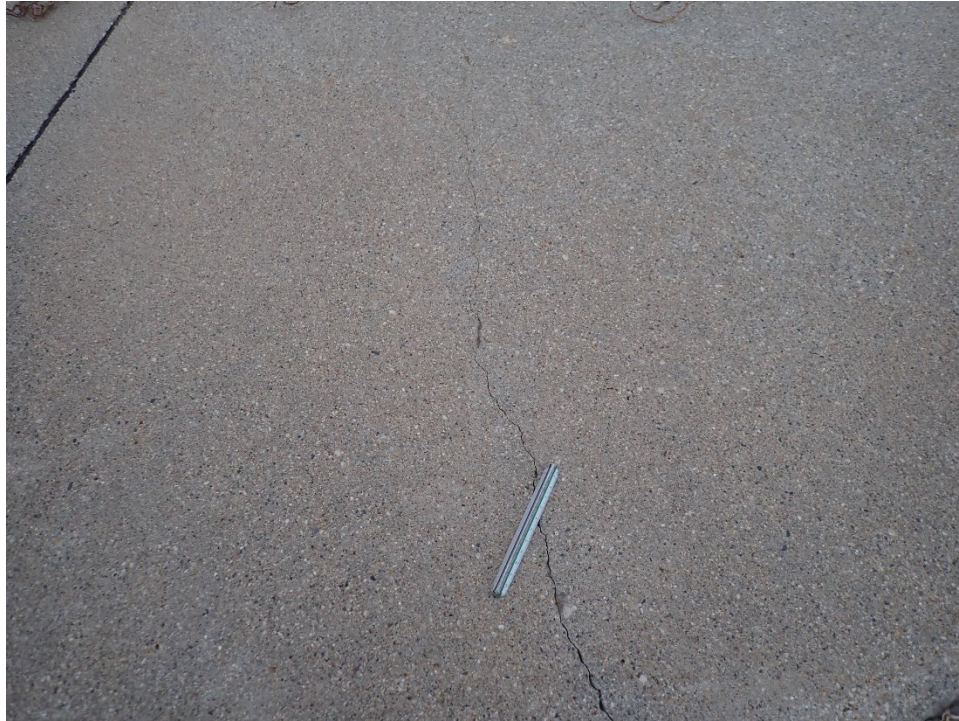
T01DN-01. LTD Cracking (Sample Unit No. 02).

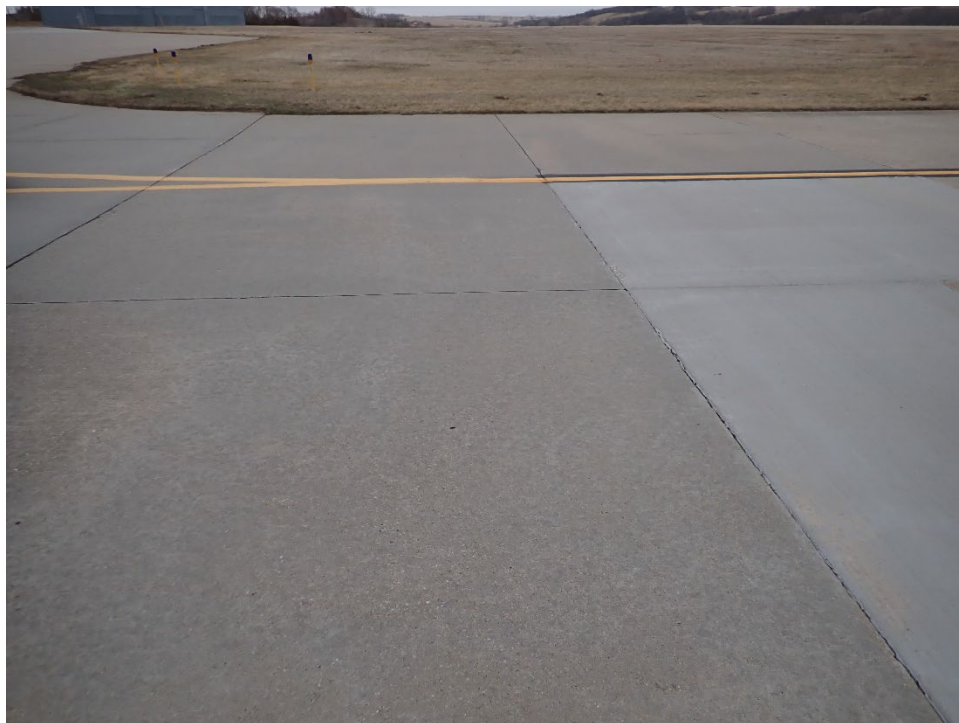
T01DN-02. Overview.

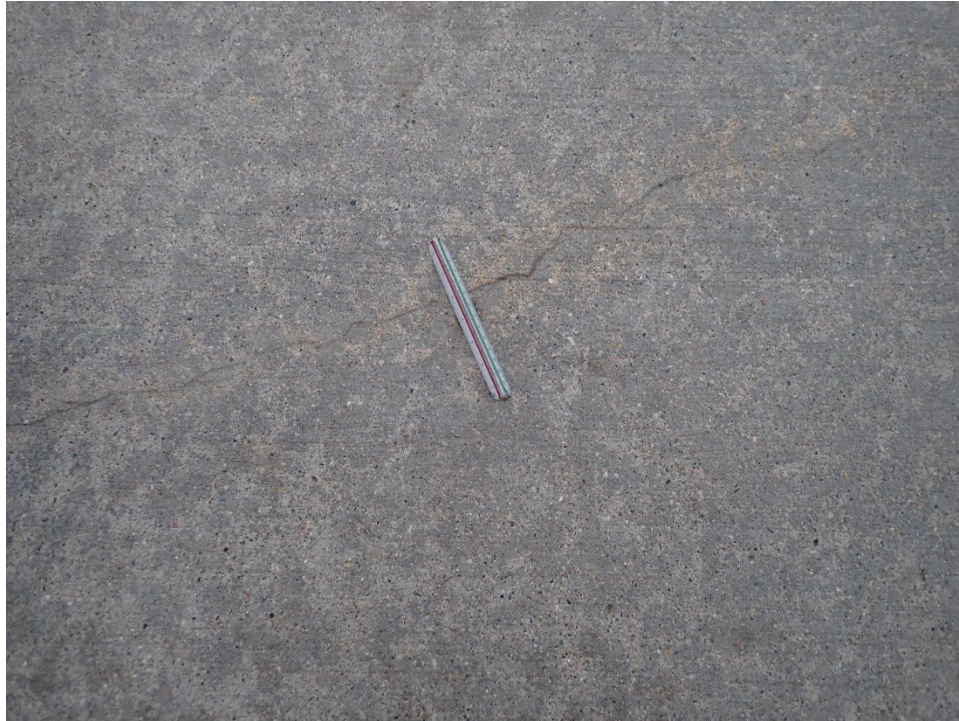
T01DN-02. ASR (Sample Unit No. 01).

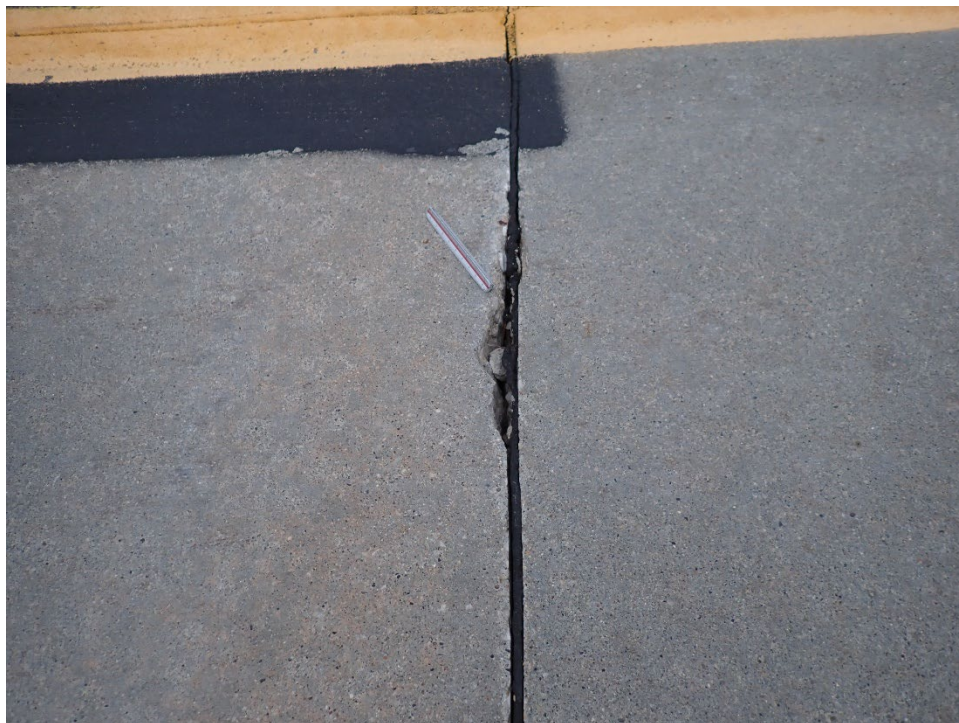
T01DN-02. Joint Seal Damage (Sample Unit No. 01).

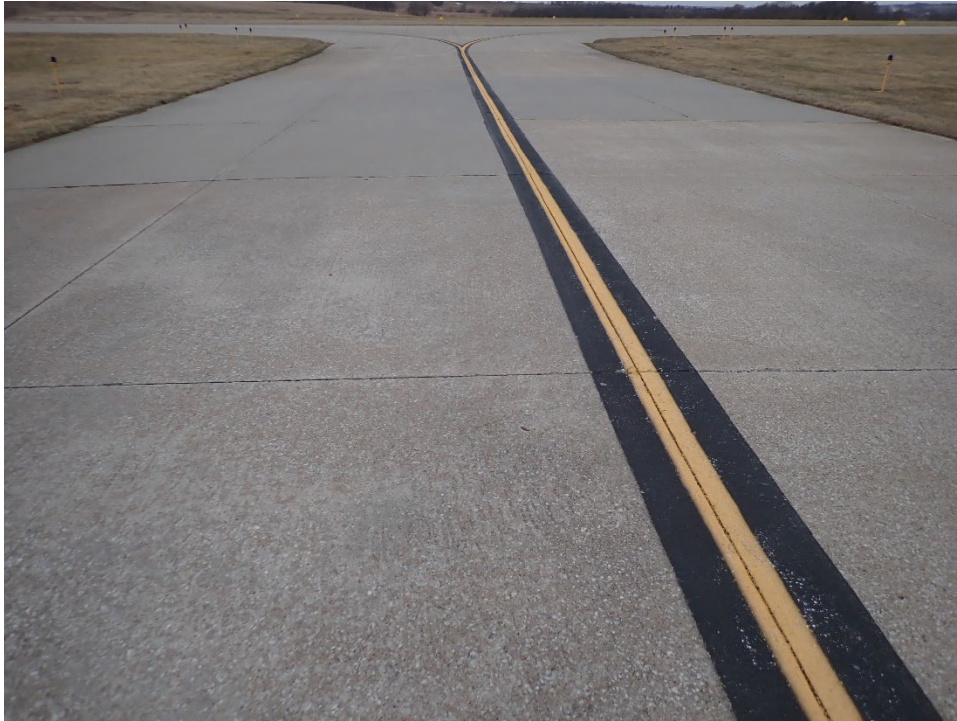
T01DN-03. Overview.

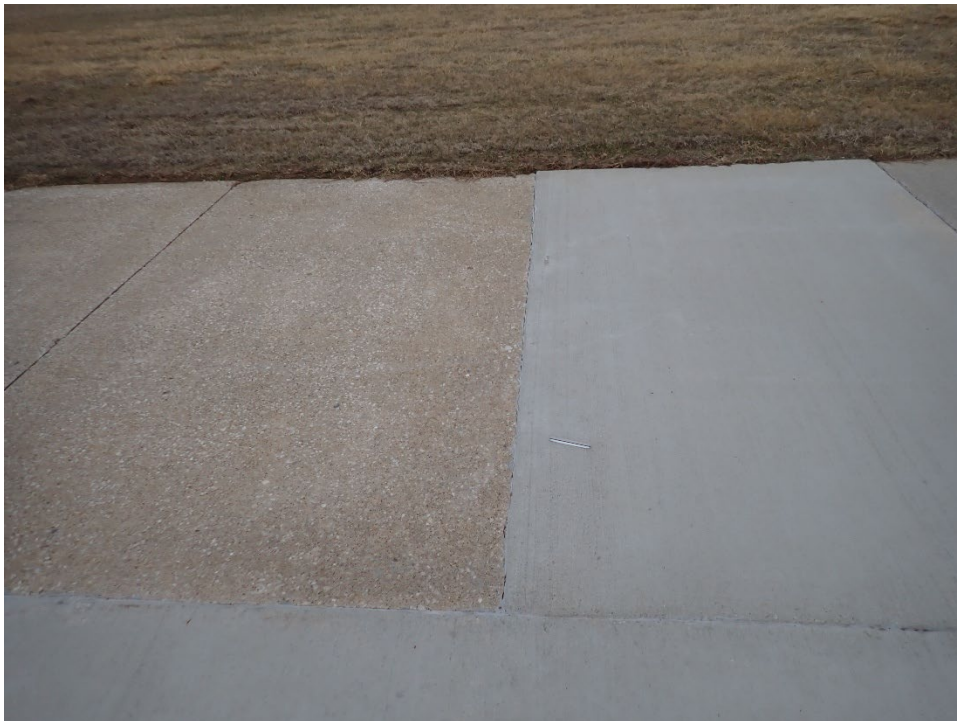
T01DN-03. Large Patching (Sample Unit No. 02).

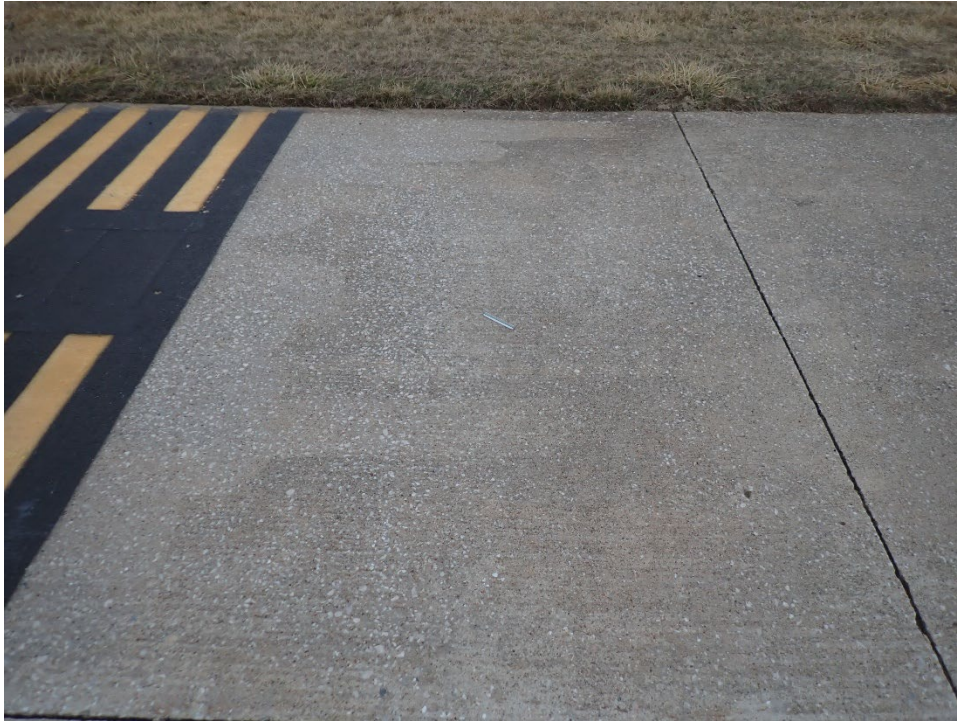
T01DN-03. Scaling (Sample Unit No. 01).

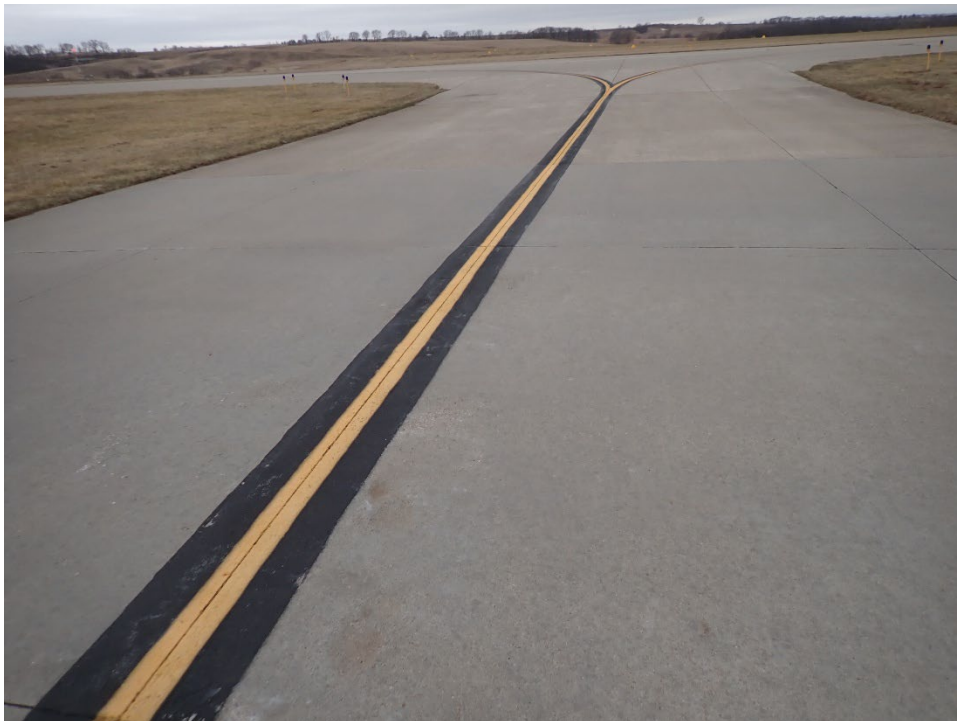
T01DN-04. Overview.

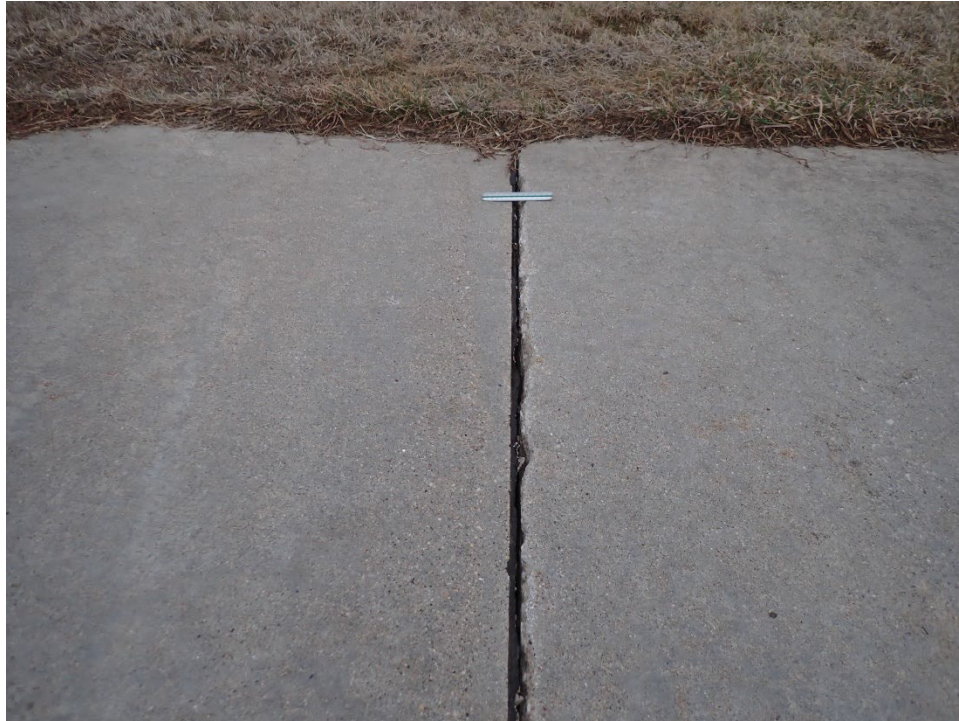
T01DN-04. Faulting (Sample Unit No. 01).

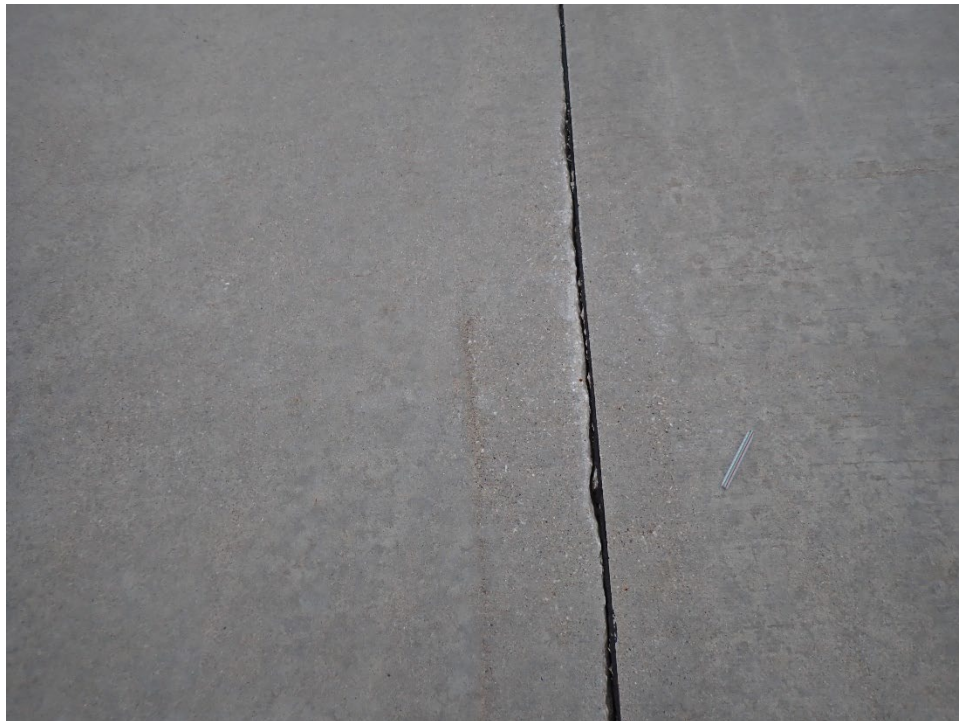
T01DN-04. Joint Seal Damage (Sample Unit No. 01).

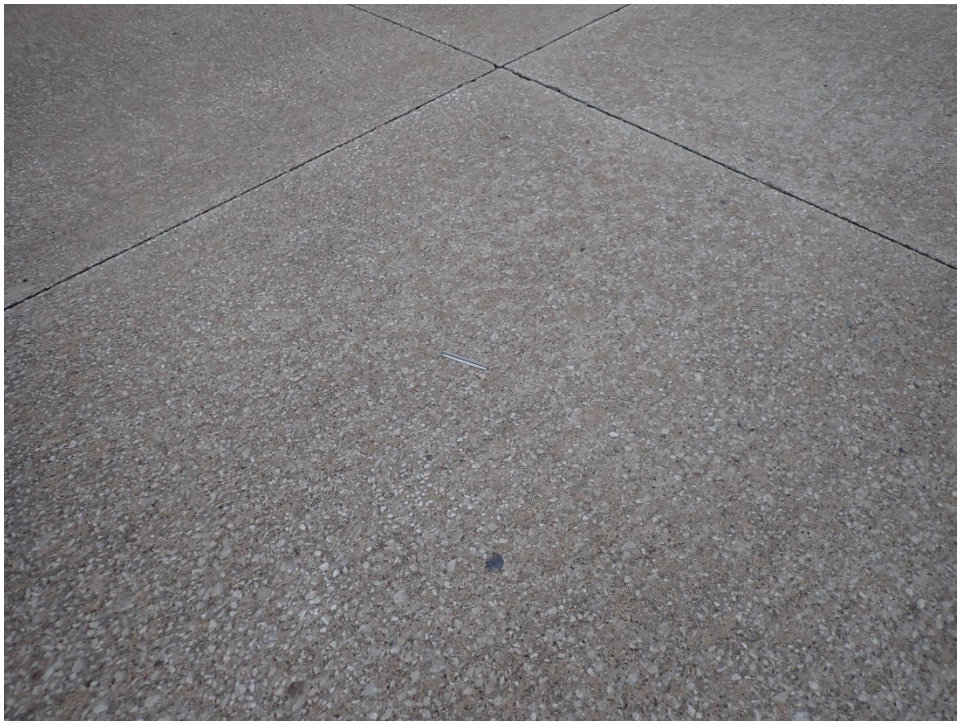
T01DN-05 Scaling. (Sample Unit No. 01).

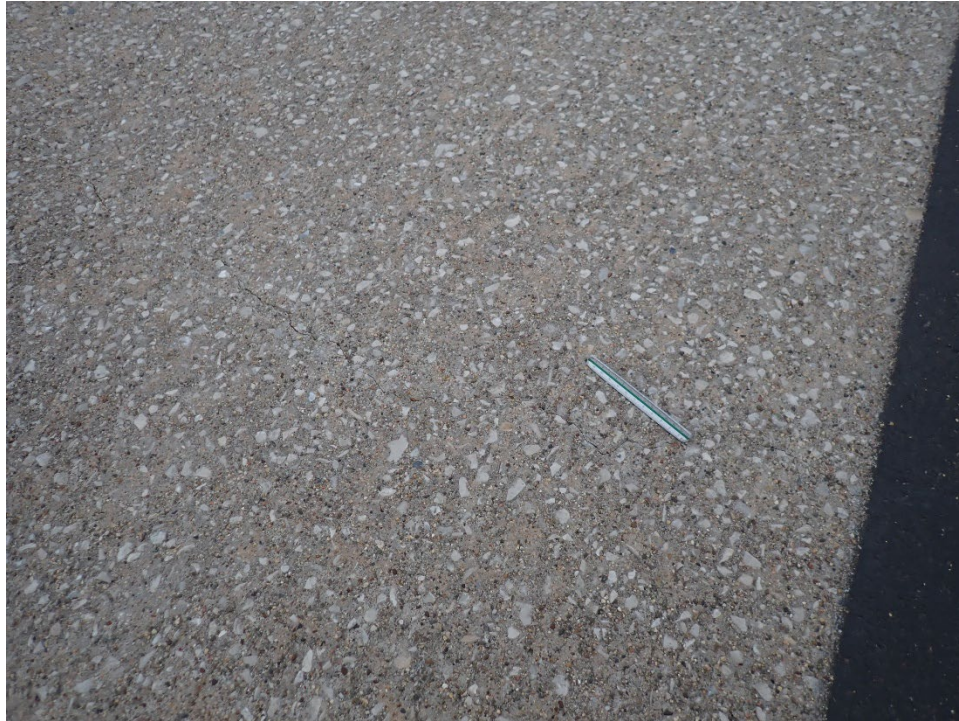
T01DN-05. Shrinkage Cracking (Sample Unit No. 01).

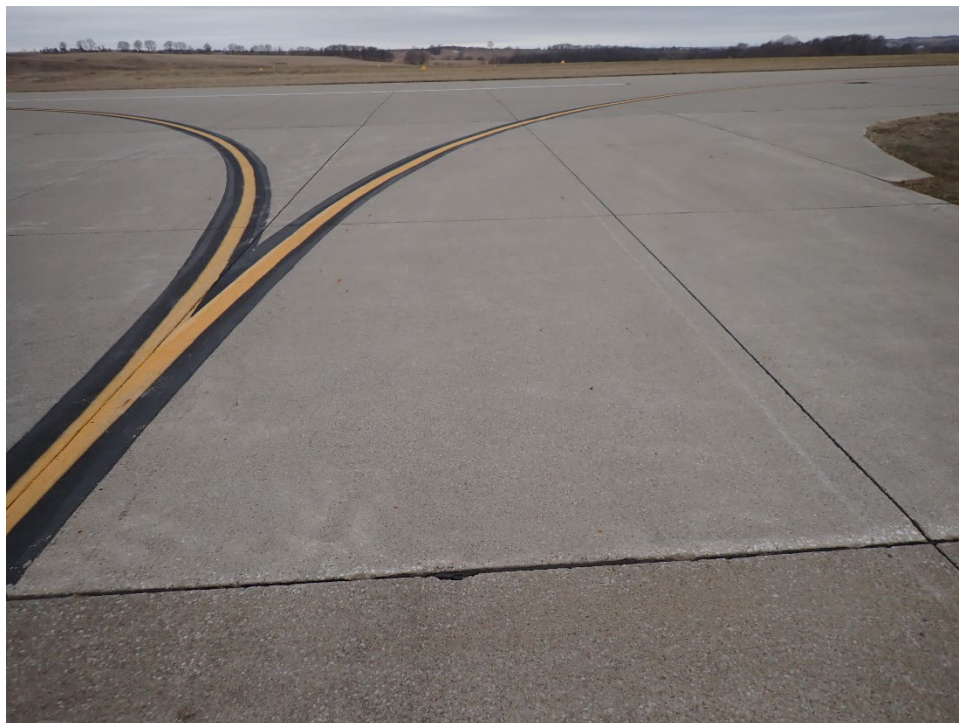
T01DN-06. Overview.

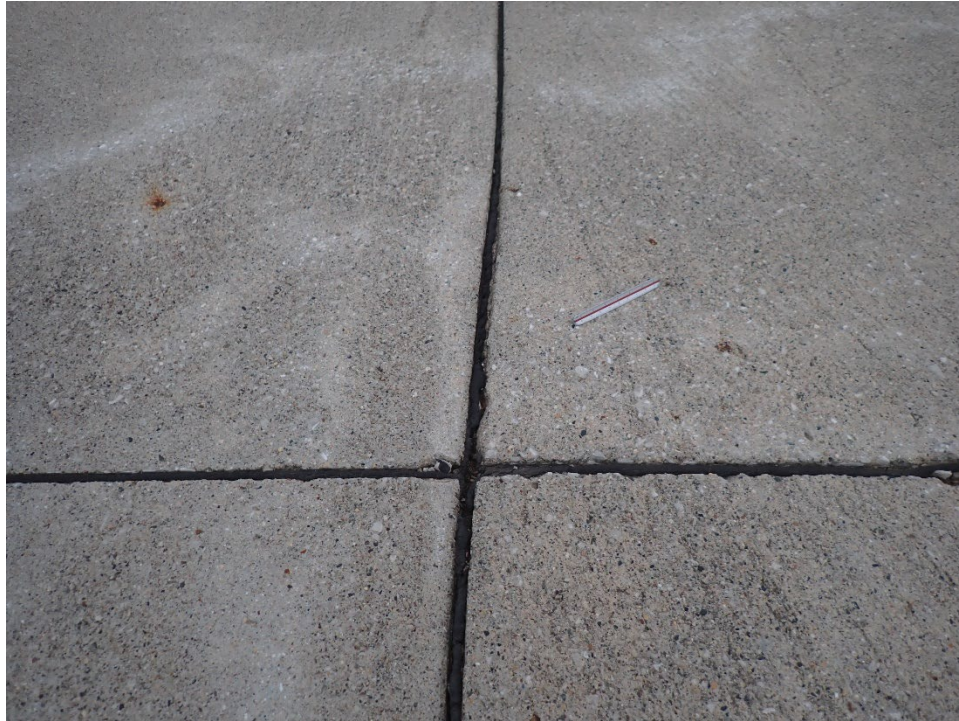
T01DN-06. Joint Seal Damage (Sample Unit No. 01).

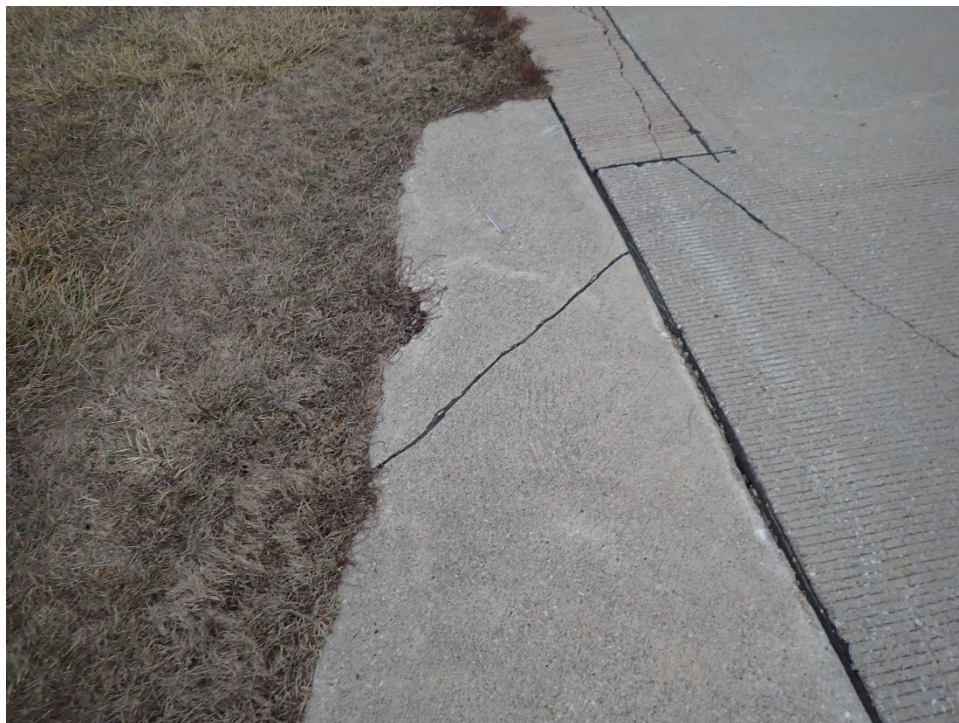
T01DN-06. LTD Cracking (Sample Unit No. 01).

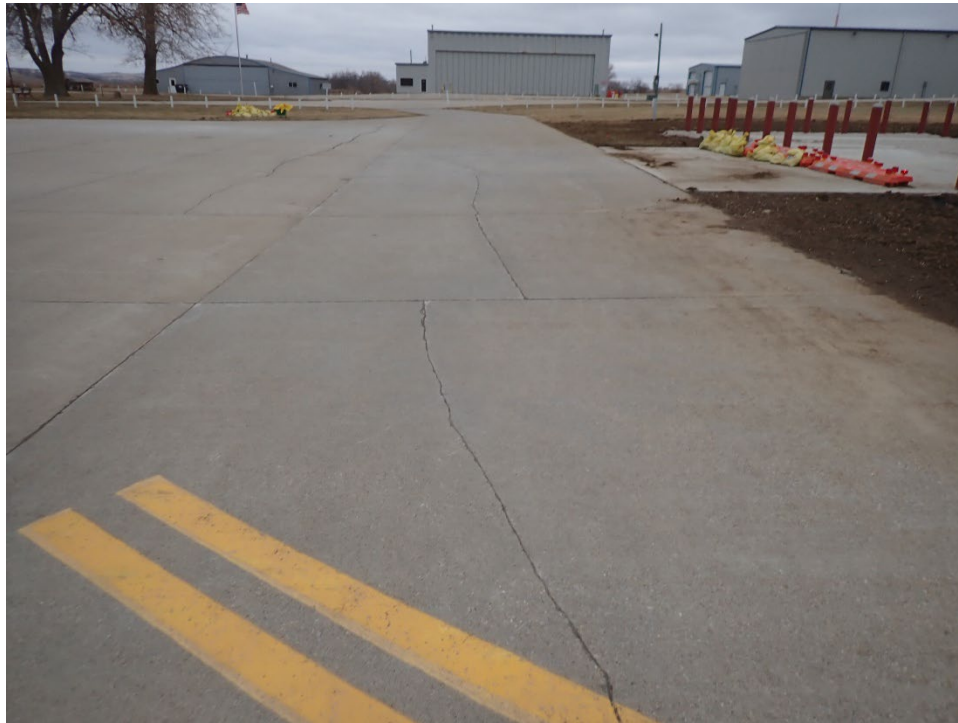
TH01DN-01. Overview.

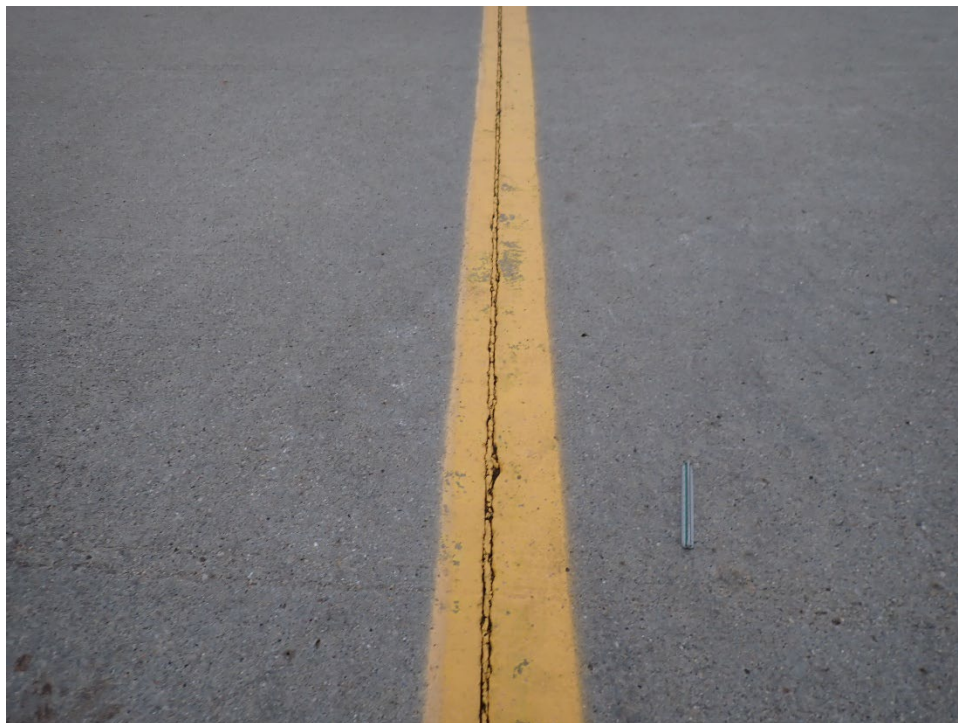
TH01DN-01. Joint Seal Damage (Sample Unit No. 02).

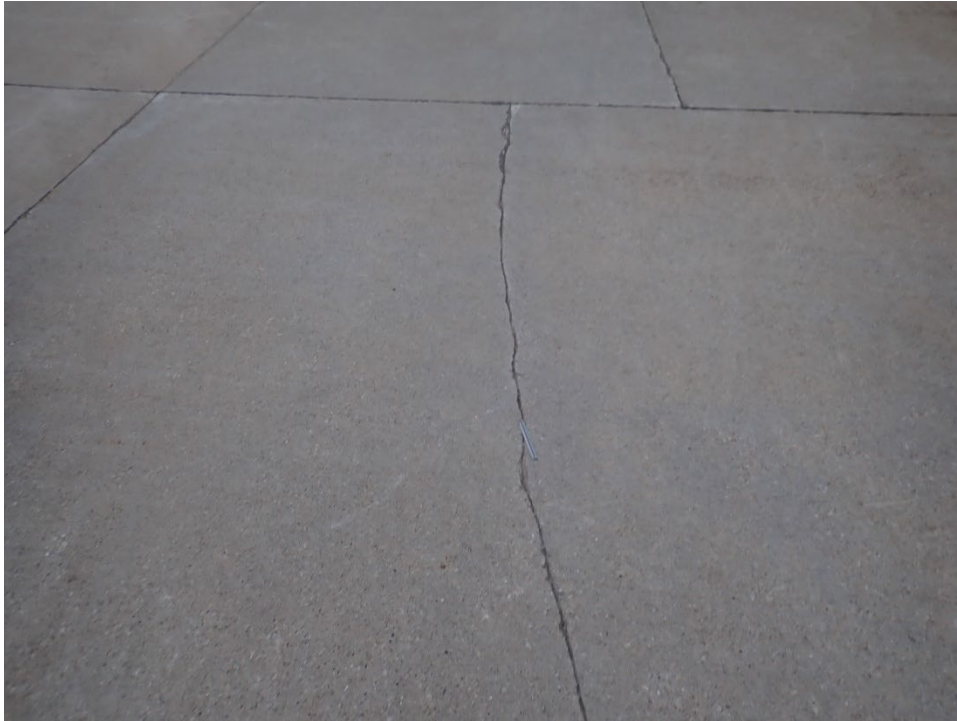
TH01DN-01. LTD Cracking (Sample Unit No. 01).

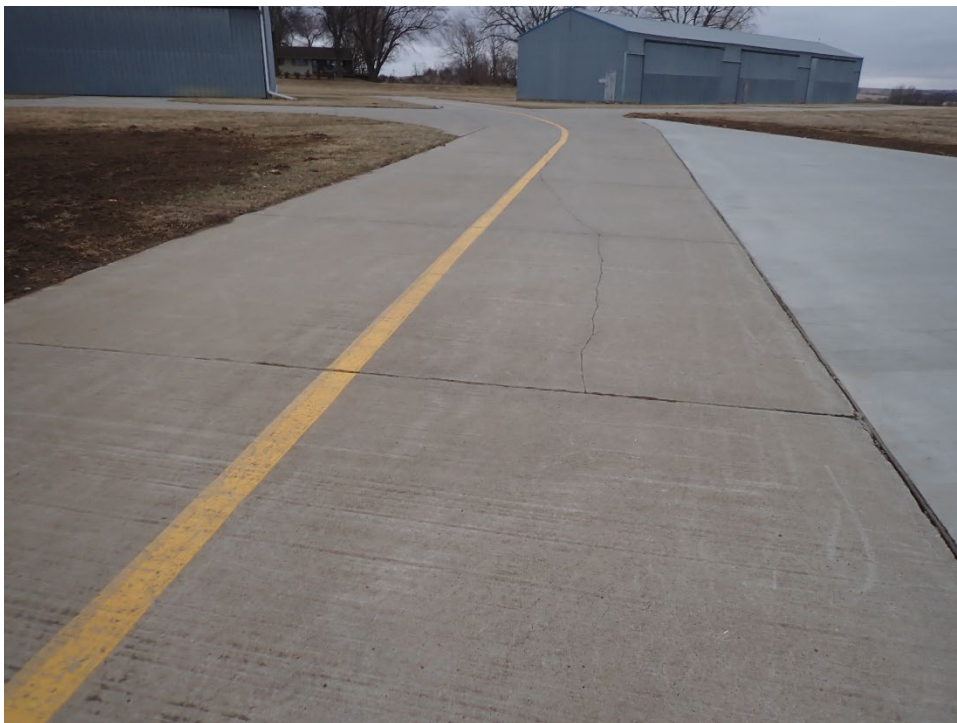
TH01DN-02. Overview.

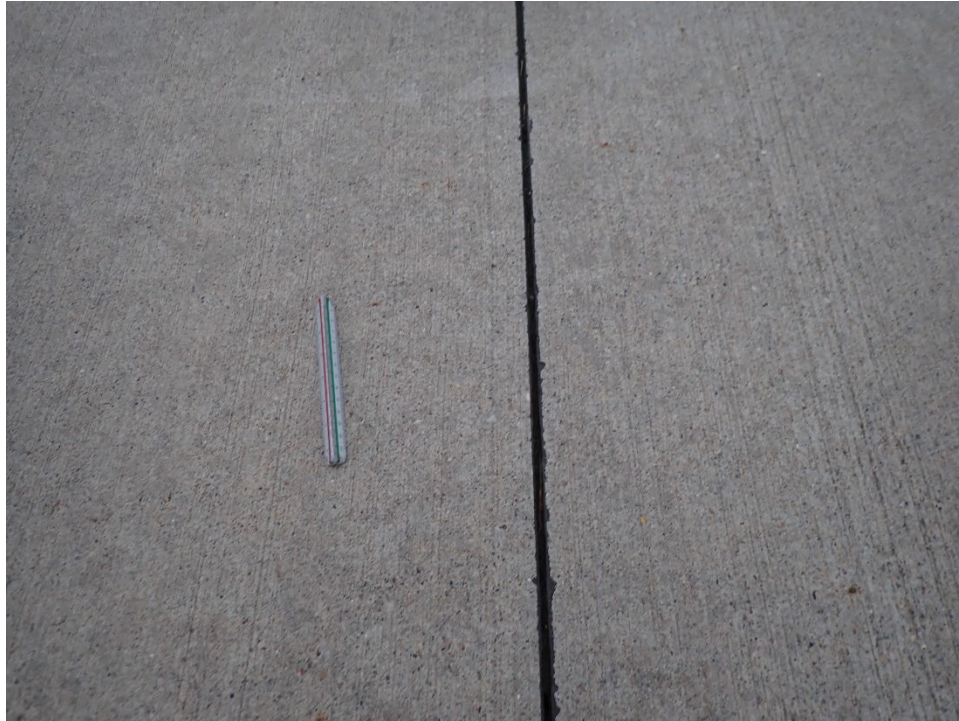
TH01DN-02. Joint Seal Damage (Sample Unit No. 02) (1).

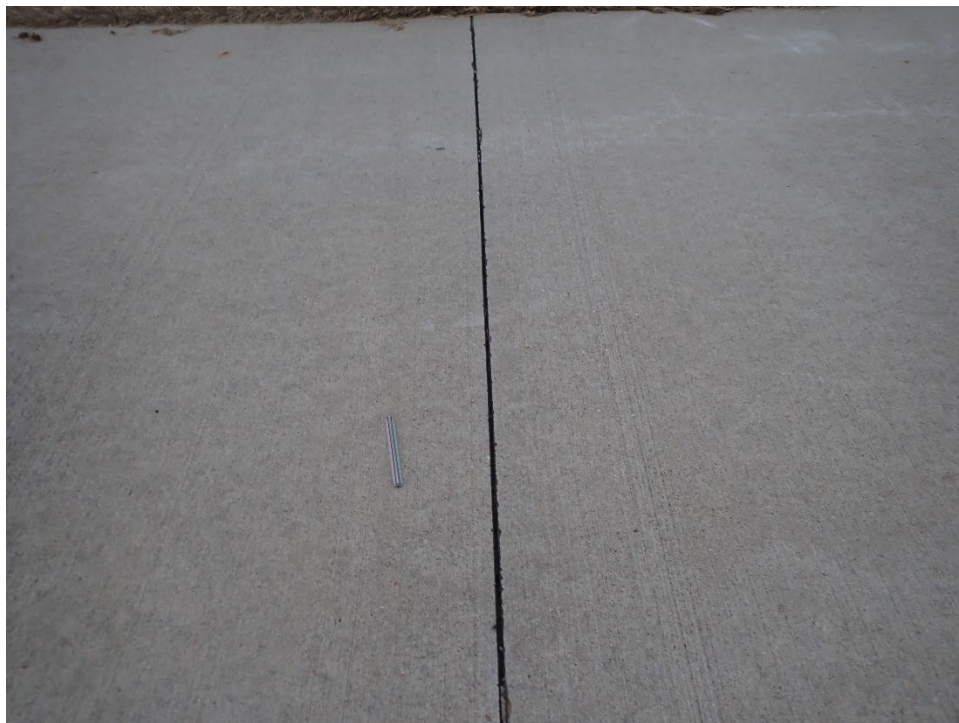
TH01DN-02. Joint Seal Damage (Sample Unit No. 02) (2).

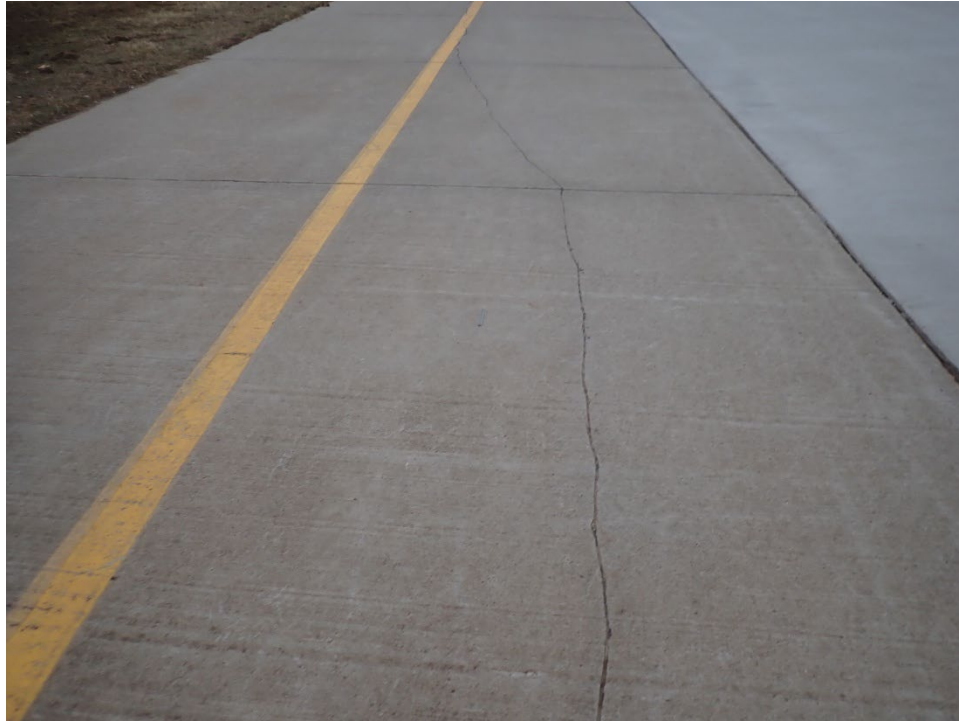
TH01DN-02. LTD Cracking (Sample Unit No. 01).

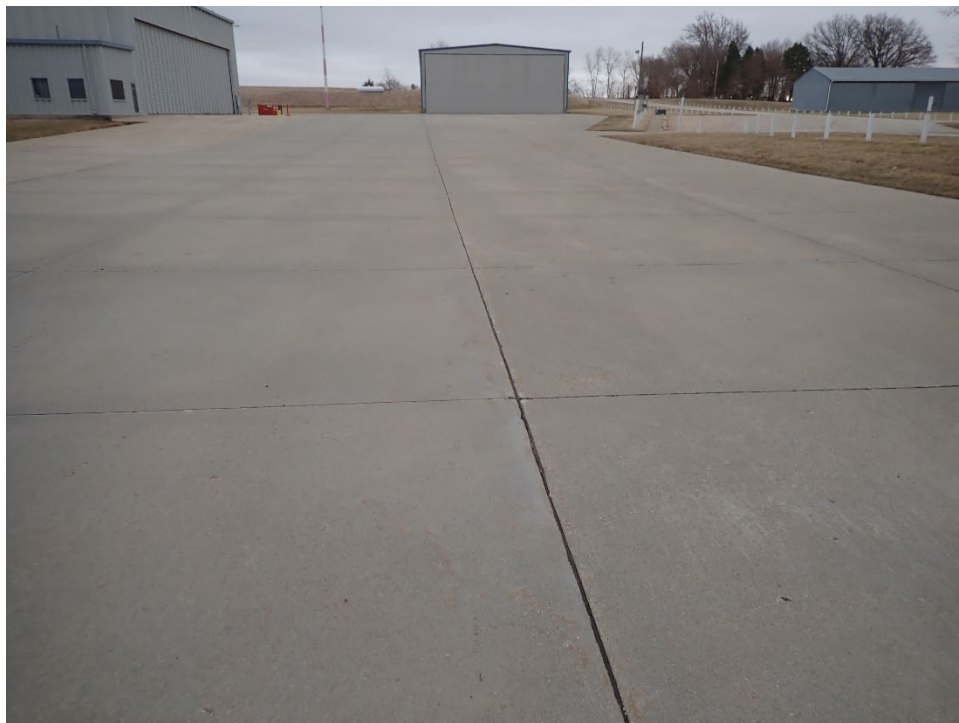
TH01DN-03. Overview.

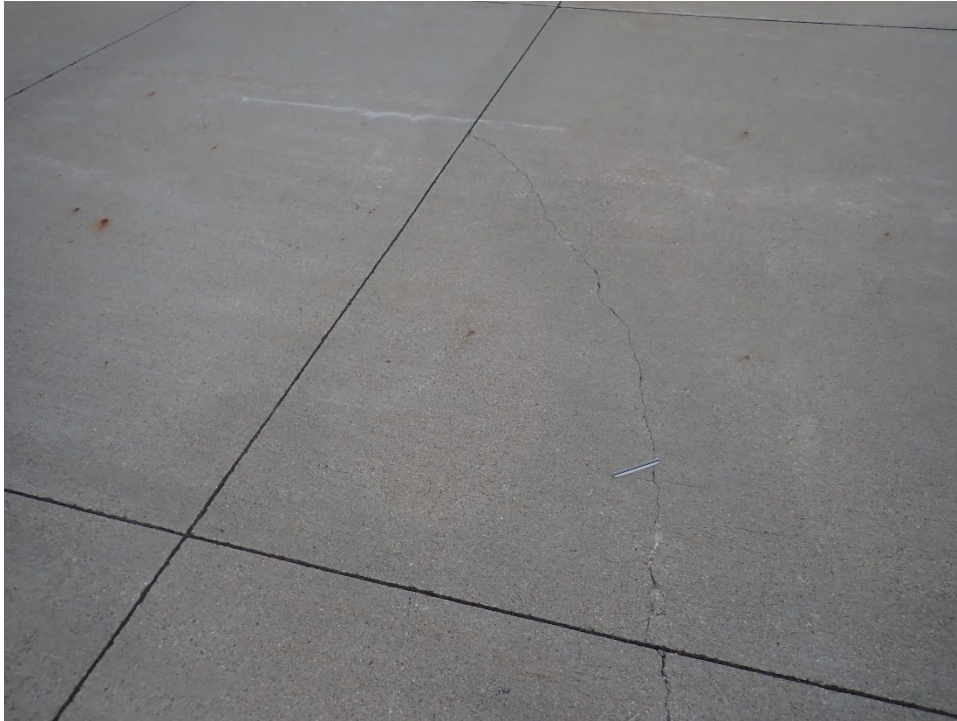
TH01DN-03. Corner Break (Sample Unit No. 01).

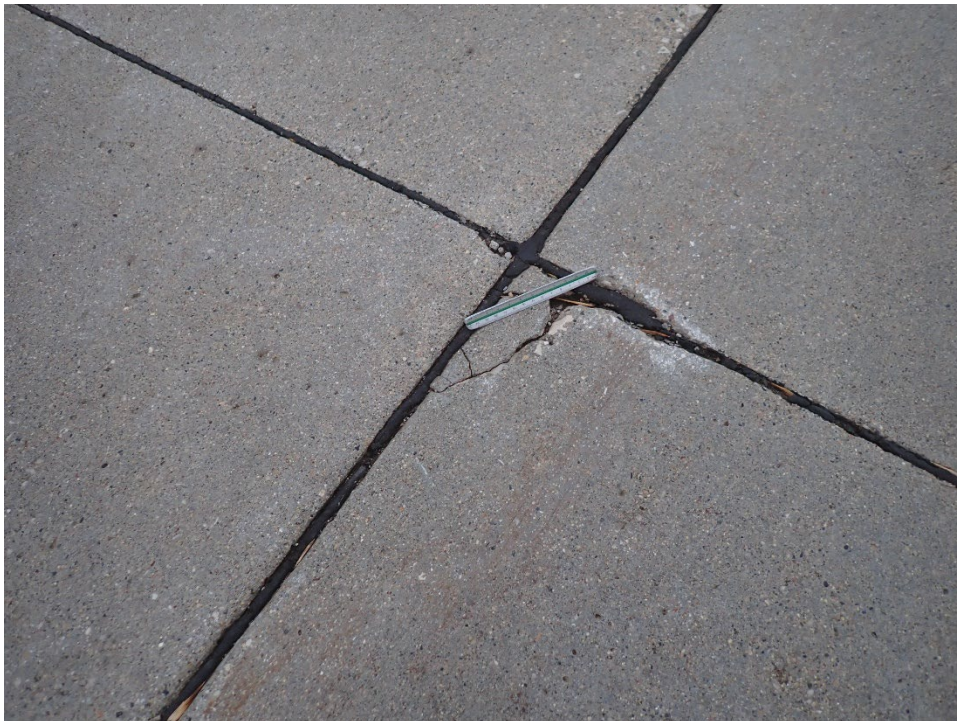
TH01DN-03. Corner Spalling (Sample Unit No. 03).

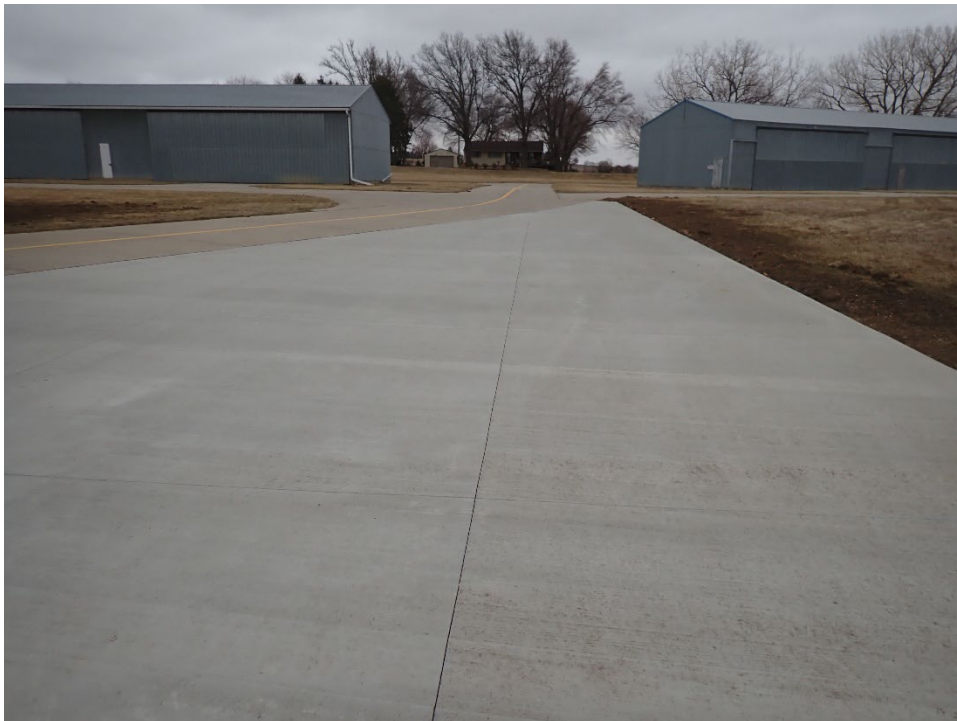
TH01DN-04. Overview.

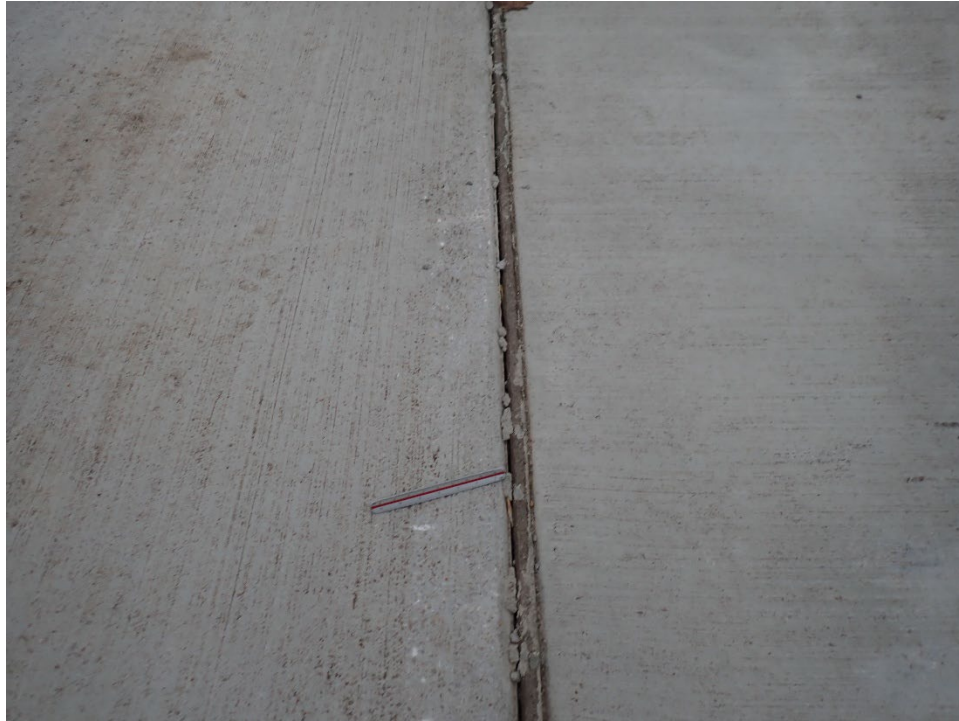
TH01DN-04. Joint Seal Damage (Sample Unit No. 01).

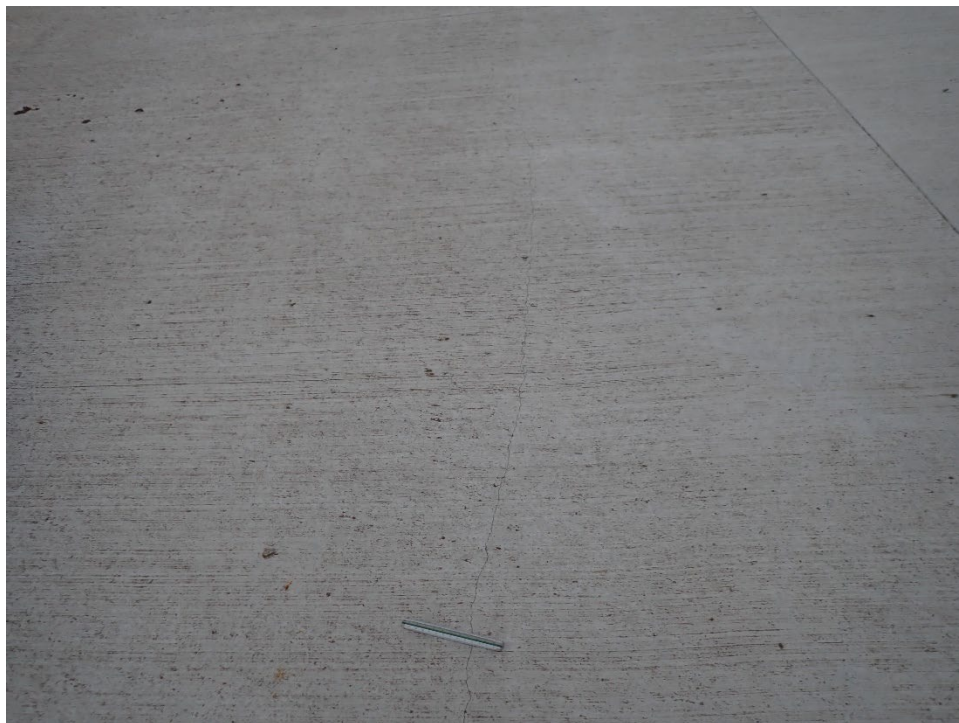
TH01DN-04. Shrinkage Cracking (Sample Unit No. 01).
