# Eagle Grove Municipal Airport

## Pavement Management Report

**AUGUST 2025**

# EAGLE GROVE MUNICIPAL AIRPORT PAVEMENT MANAGEMENT REPORT

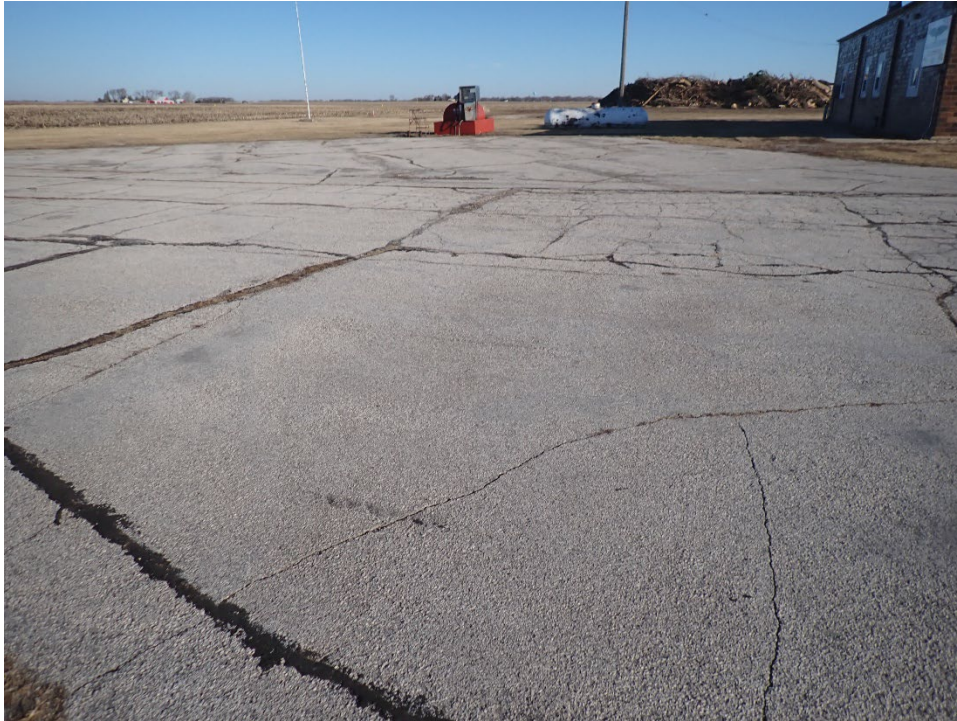
A01EG-01. Overview.

The apron area was defined by one section in *Poor* condition. Medium-severity longitudinal and transverse (L&T) cracking and block cracking were identified where either the crack sealant was no longer in satisfactory condition, unsealed crack widths exceeded 1/4 inch, or secondary cracking had developed. Additionally, all severities of alligator cracking; low-severity depression; low-severity, unsealed L&T cracking; high-severity raveling; and medium-severity rutting and weathering were observed during the inspection.

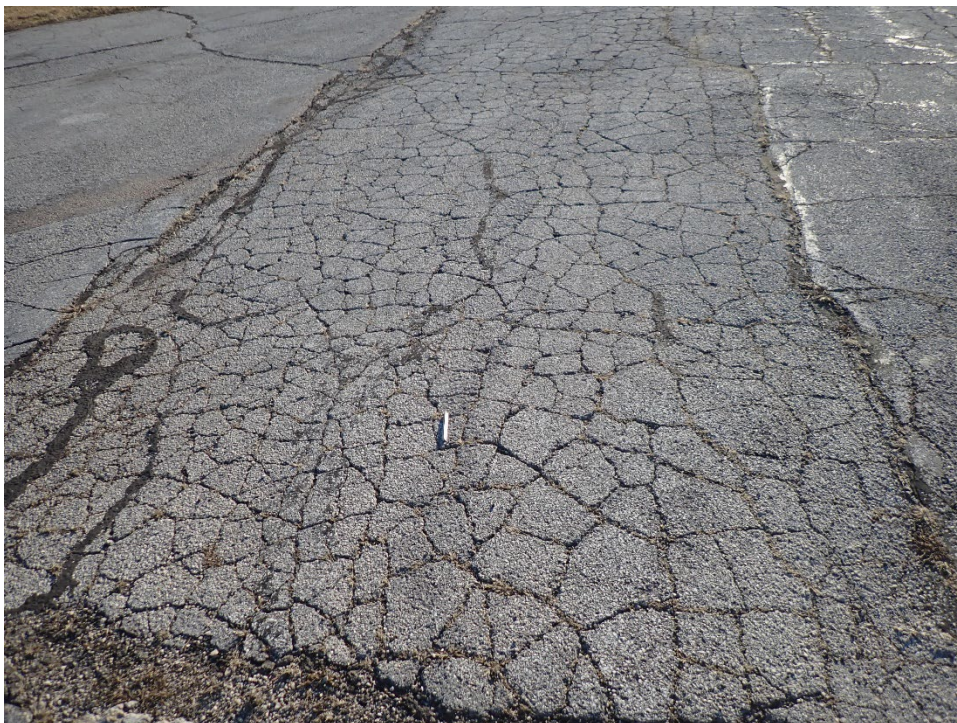
| <b>Distress Type</b> | <b>Probable Cause of Distress</b> |
|---|---|
| Alligator Cracking | Fatigue failure of the asphalt surface under repeated traffic loading. |

A01EG-01. Alligator Cracking (Sample Unit No. 02).

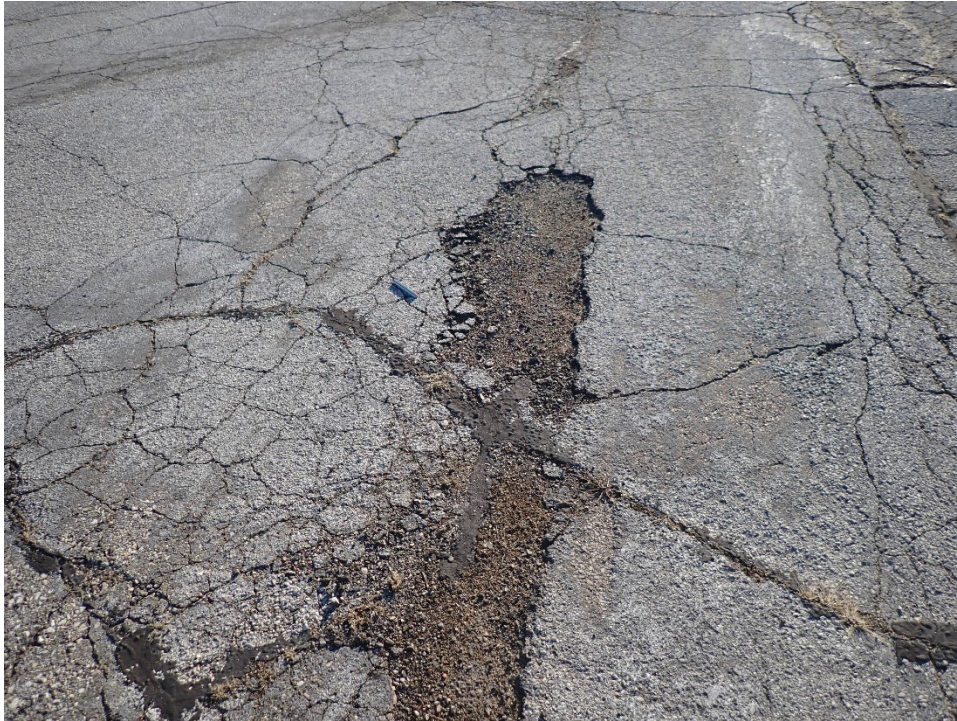
A01EG-01. Raveling (Sample Unit No. 02).

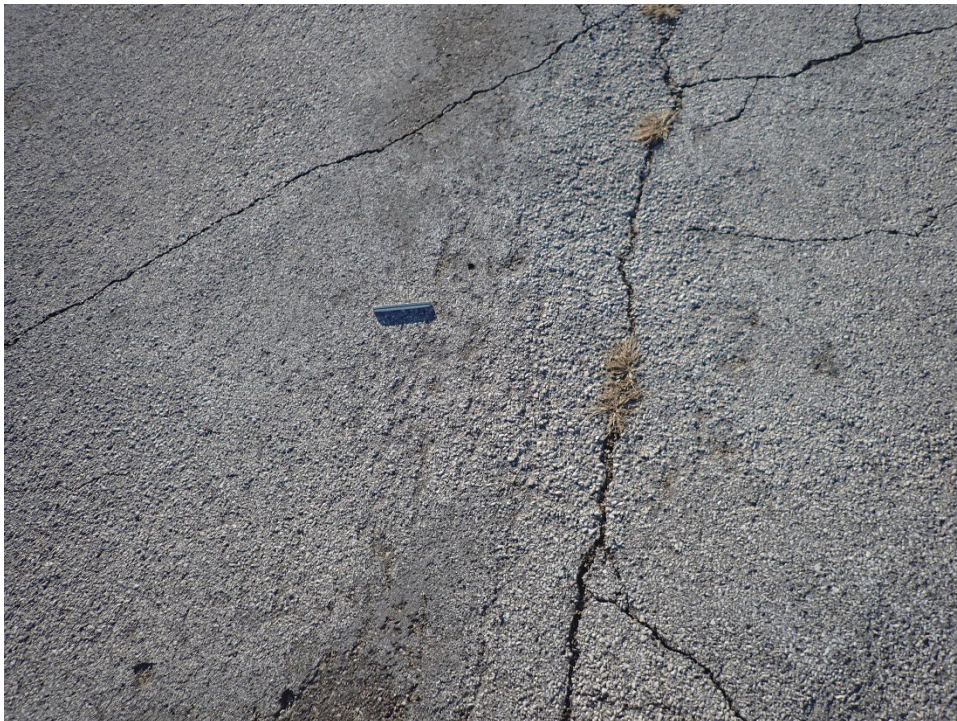
| <b>Distress Type</b> | <b>Probable Cause of Distress</b> |
|---|---|
| Weathering | Asphalt binder and/or fine aggregate may wear away as the pavement ages and hardens. |

A01EG-01. Weathering (Sample Unit No. 01).

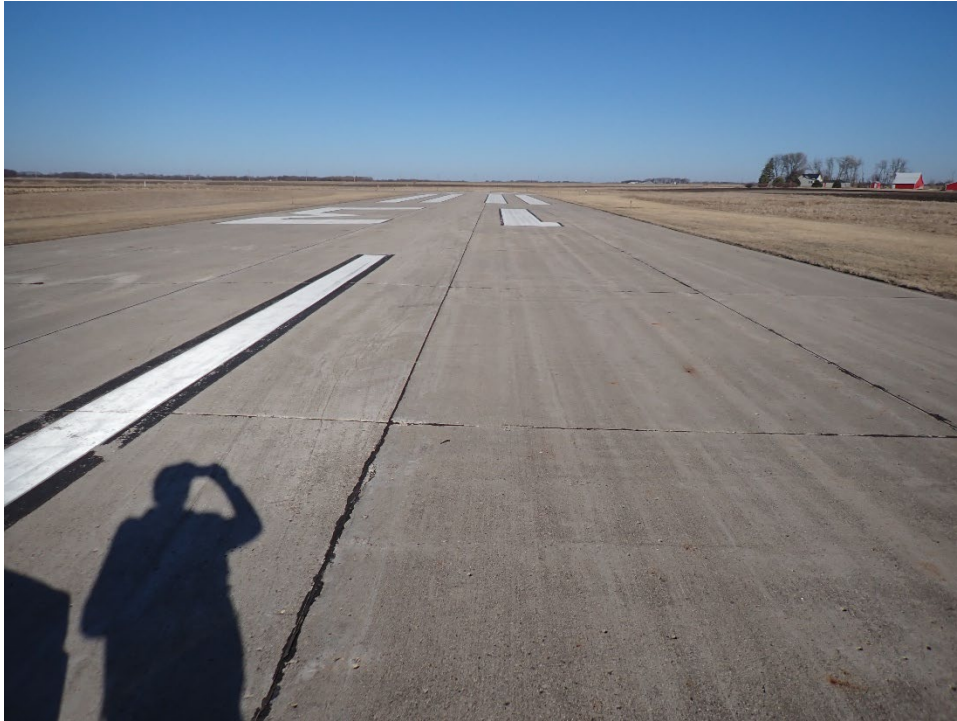
R13EG-01. Overview.

Runway 13/31 contained two sections. Section 01 was in *Poor* condition with all severities of ASR and longitudinal, transverse, and diagonal (LTD) cracking; low-severity corner break and faulting; medium- and high-severity corner spalling and joint spalling; high-severity joint seal damage; popouts; medium-severity shattered slab and small patching; and shrinkage cracking. Distresses recorded in Section 02 included all severities of corner spalling, low-severity faulting and small patching, high-severity joint seal damage, medium- and high-severity joint spalling, medium-severity LTD cracking and shattered slab, and shrinkage cracking.

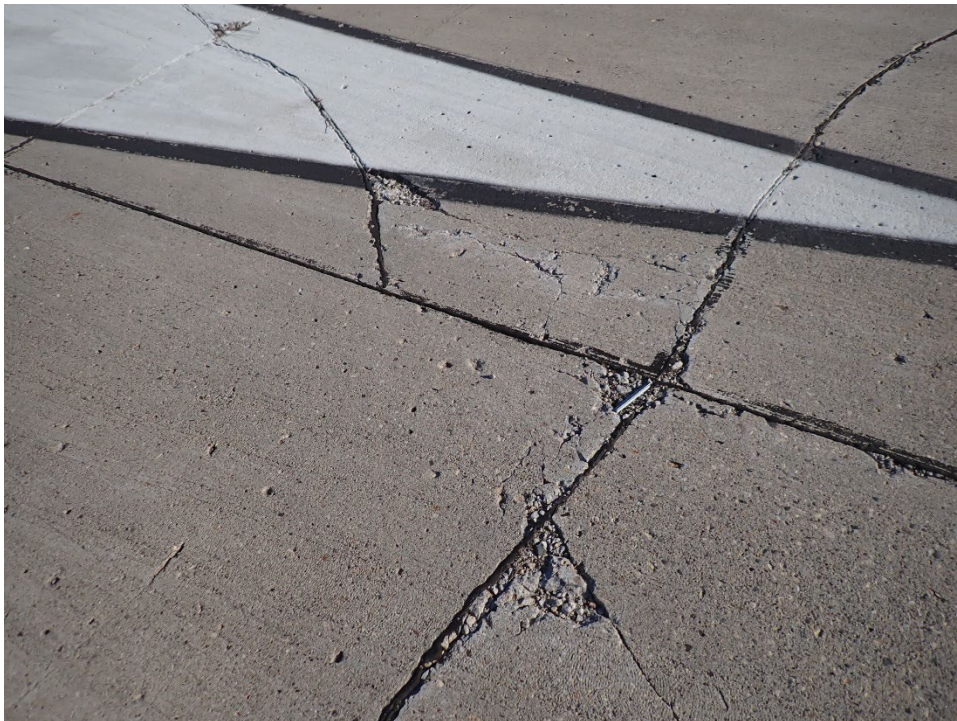
Eagle Grove Municipal Airport was inspected on March 17, 2025. There were five pavement sections defined during the inspection. Alkali-silica reaction (ASR) was recorded at this airport according to the PCI procedure. The ASR was recorded where evidence of a precipitate was observed within some of the cracking in the PCC surface. It should be noted that laboratory testing in the form of petrographic analysis is the only definitive way to validate the presence of ASR; however, the formation of a precipitate is evidence of a reaction consistent with this type of materials-related distress.

R13EG-01. ASR (Sample Unit No. 04).

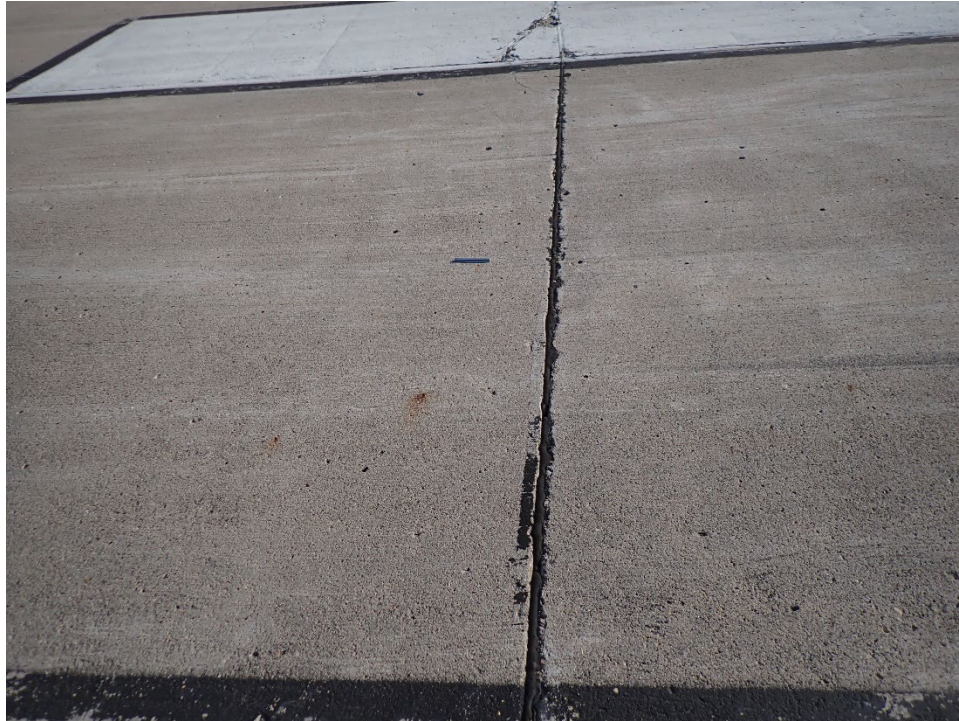
| <b>Distress Type</b> | <b>Probable Cause of Distress</b> |
|---|---|
| Joint Seal Damage | Stripping of joint sealant, extrusion of joint sealant, weed growth, hardening of the filler (oxidation), loss of bond to the slab edges, or absence of sealant in the joint. |

R13EG-01. Joint Seal Damage (Sample Unit No. 05).

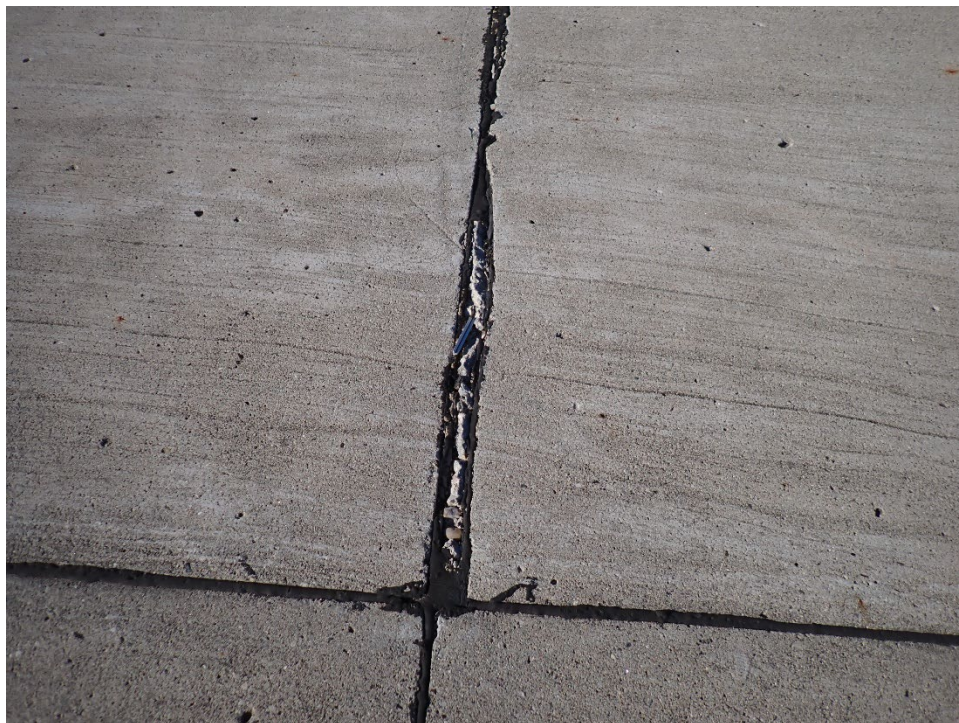
| <b>Distress Type</b> | <b>Probable Cause of Distress</b> |
|---|---|
| Spalling<br>(Joint and Corner) | Excessive stresses at the joint caused by infiltration of incompressible materials or traffic loads; weak concrete at the joint combined with traffic loads. |

R13EG-01. Joint Spalling (Sample Unit No. 07).

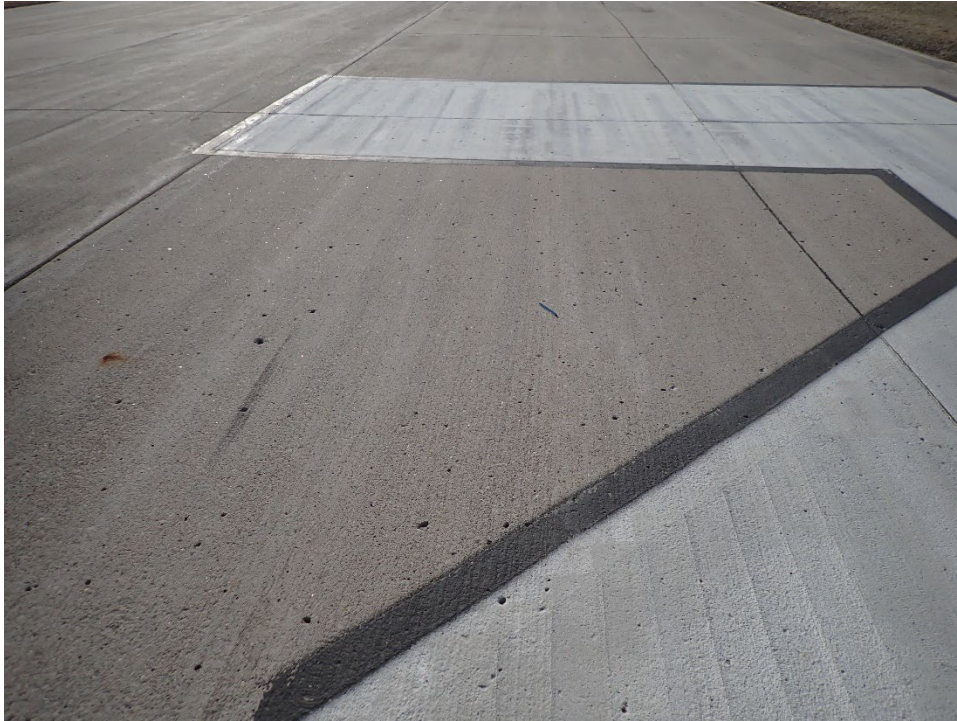
R13EG-01. Popouts (Sample Unit No. 08).

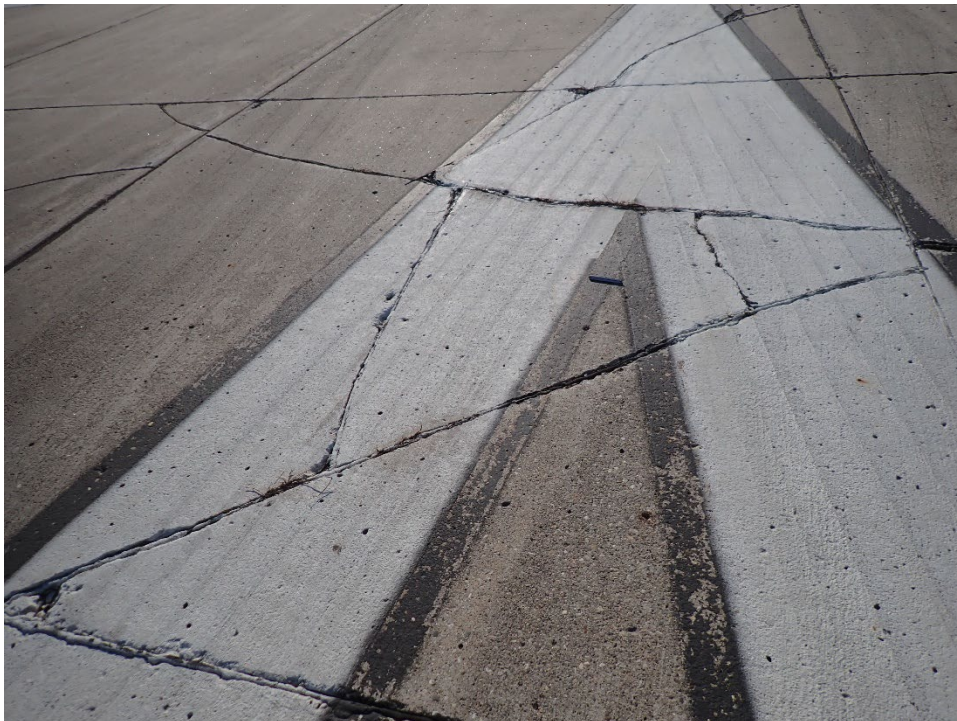
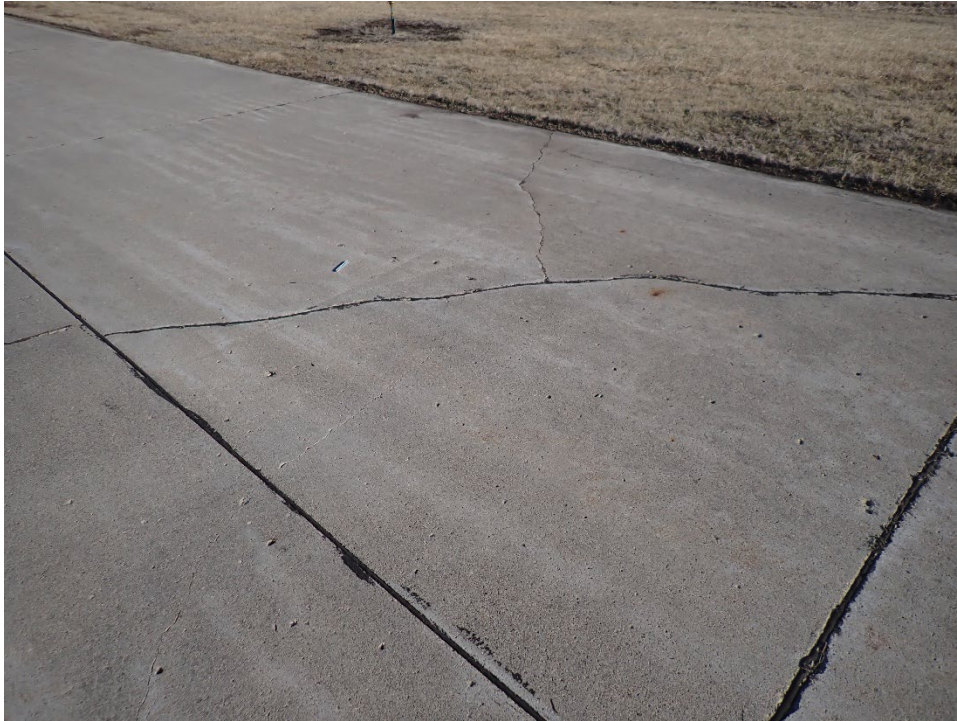
R13EG-01. Shattered Slab (Sample Unit No. 04).

R13EG-01. Shattered Slab (Sample Unit No. 07).

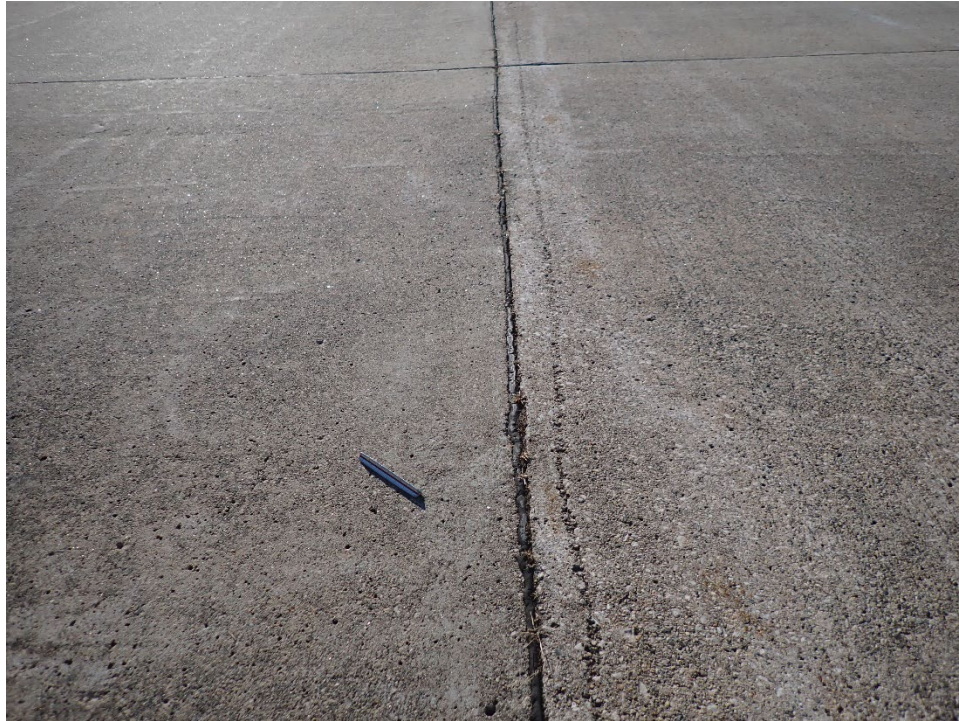
R13EG-02. Joint Seal Damage (Sample Unit No. 03).

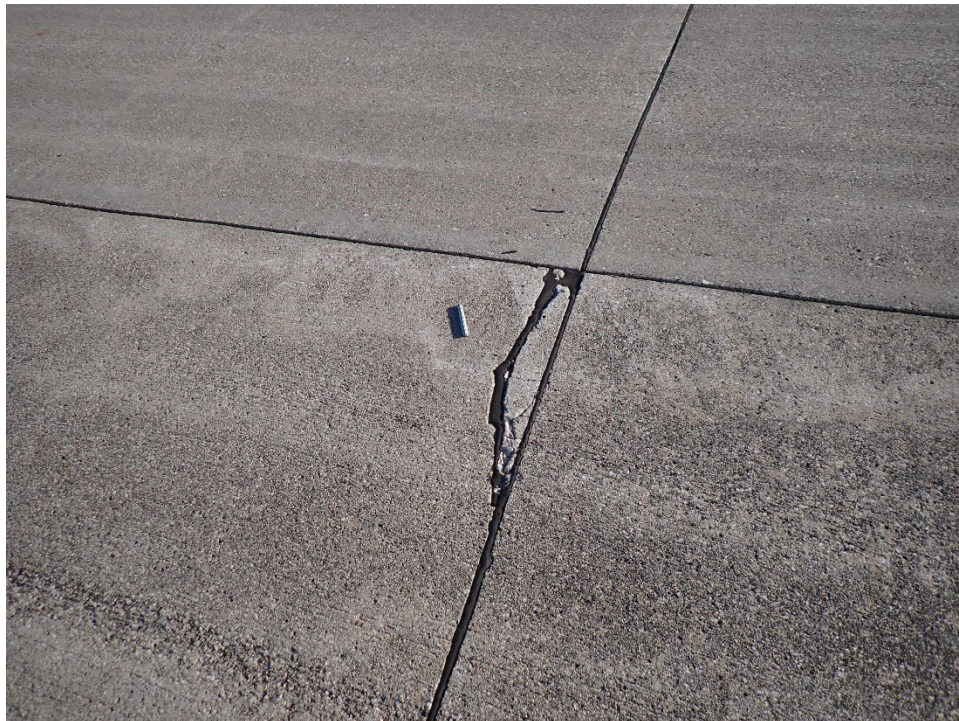
R13EG-02. Joint Spalling (Sample Unit No. 34).

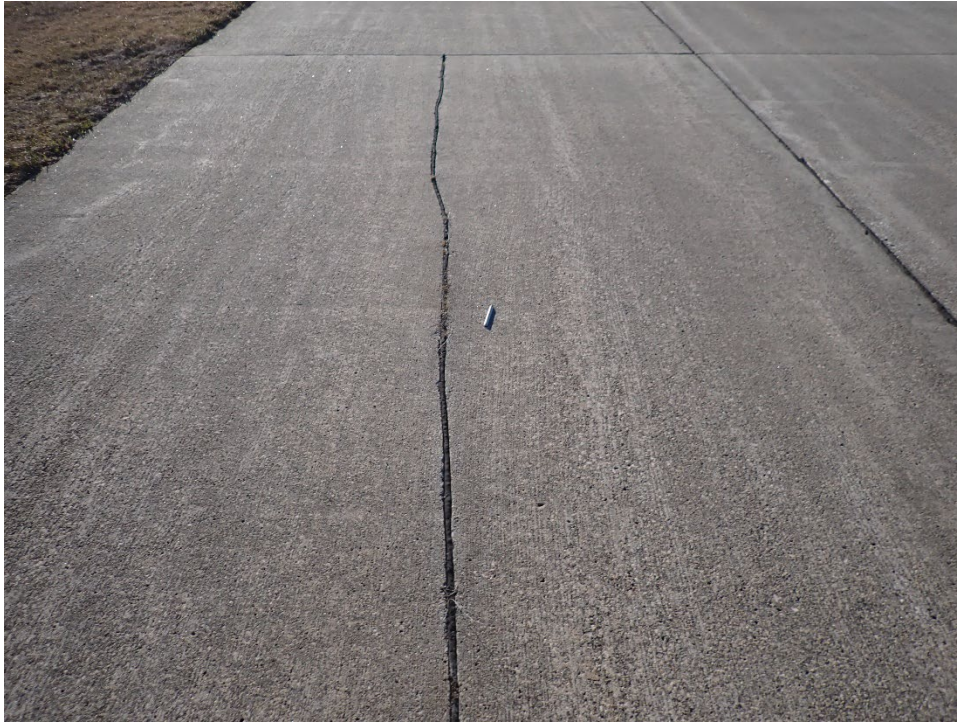
| <b>Distress Type</b> | <b>Probable Cause of Distress</b> |
|---|---|
| LTD Cracking | Combination of load repetition, curling stresses, and shrinkage stresses. |

R13EG-02. LTD Cracking (Sample Unit No. 34).

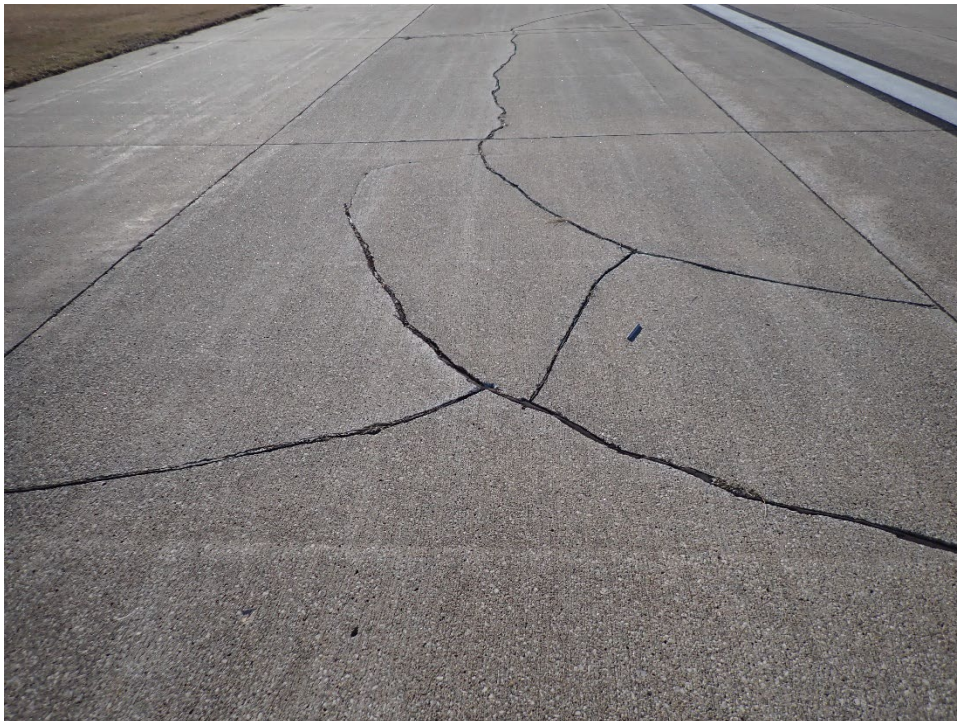
R13EG-02. Shattered Slab (Sample Unit No. 17).

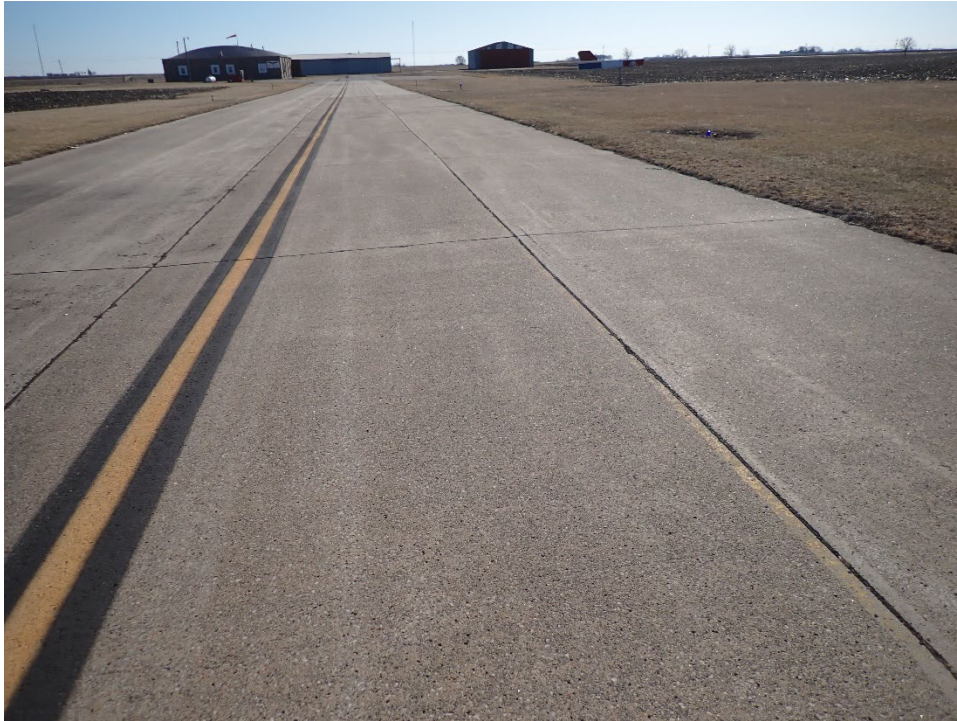
T01EG-01. Overview.

The taxiway consisted of two sections. Section 01 was in *Poor* condition with multiple distresses recorded. Those distresses included low- and medium-severity corner break, medium- and high-severity corner spalling, low-severity faulting, high-severity joint seal damage, all severities of joint spalling, medium-severity LTD cracking and shattered slab, and shrinkage cracking. Section 02 was also in *Poor* condition with areas of all severities of ASR, medium- and high-severity corner spalling, low- and medium-severity faulting, high-severity joint seal damage, medium-severity LTD cracking, and popouts observed.

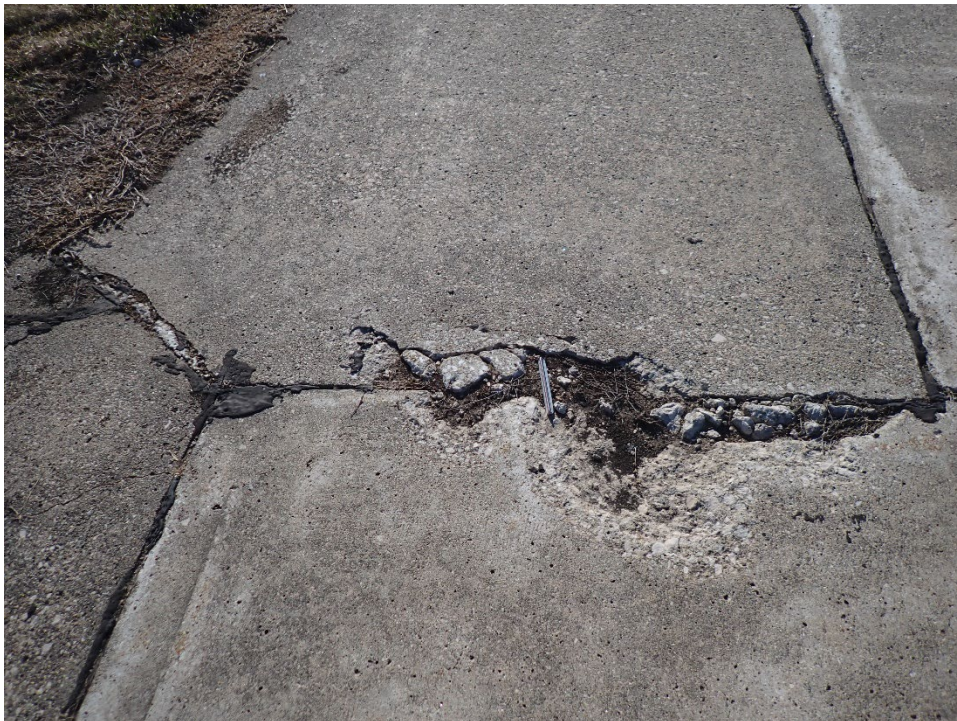
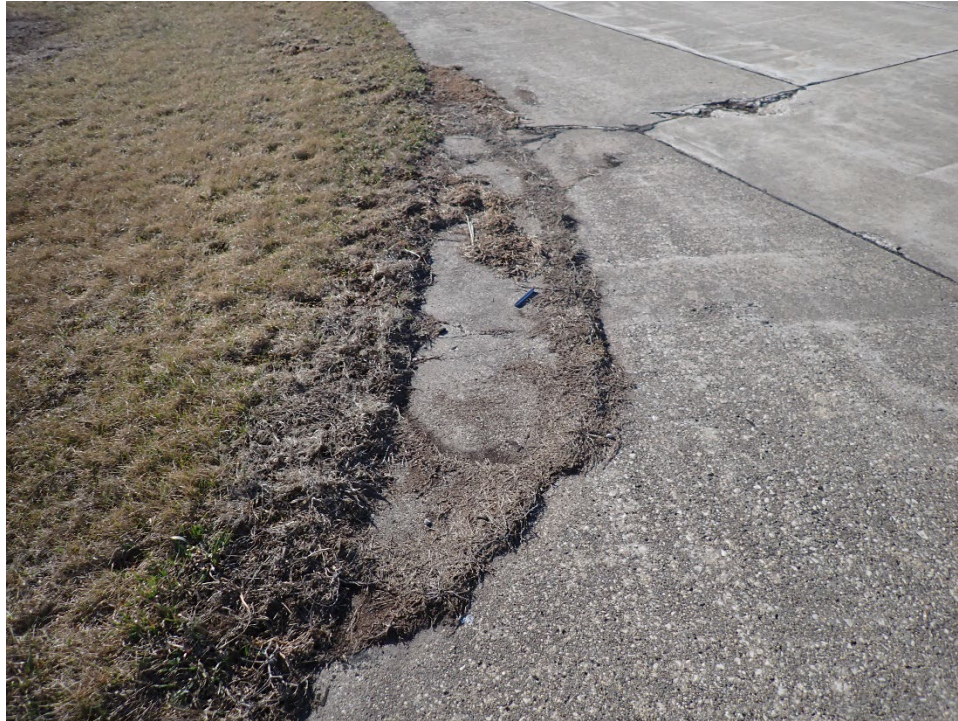
T01EG-01. Joint Spalling (Sample Unit No. 01) (1).

T01EG-01. Joint Spalling (Sample Unit No. 01) (2).

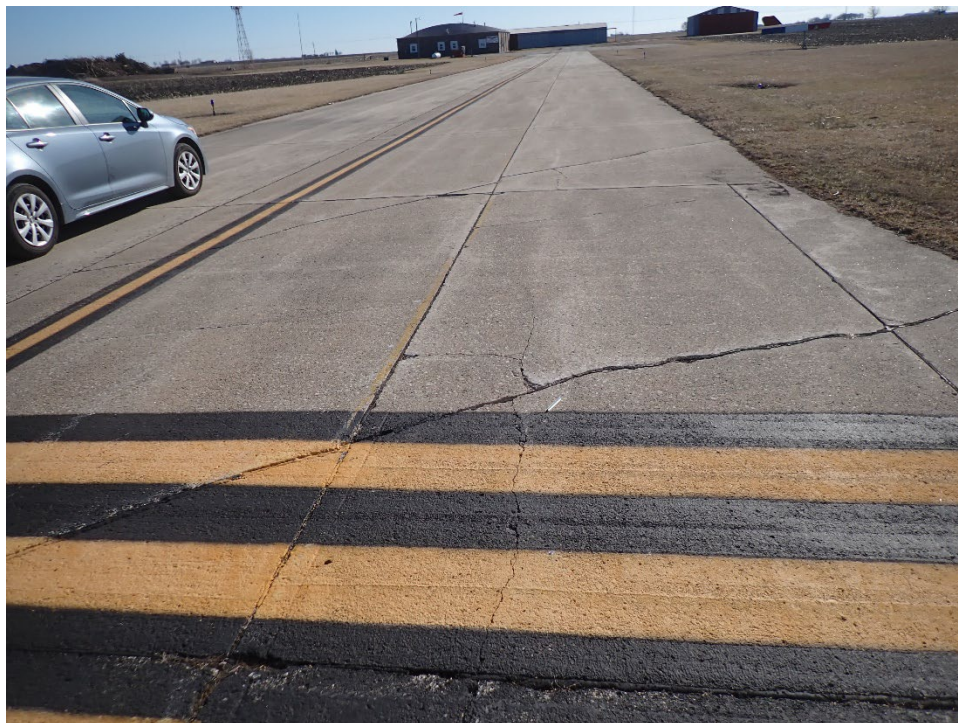
T01EG-01. Shattered Slab (Sample Unit No. 02).

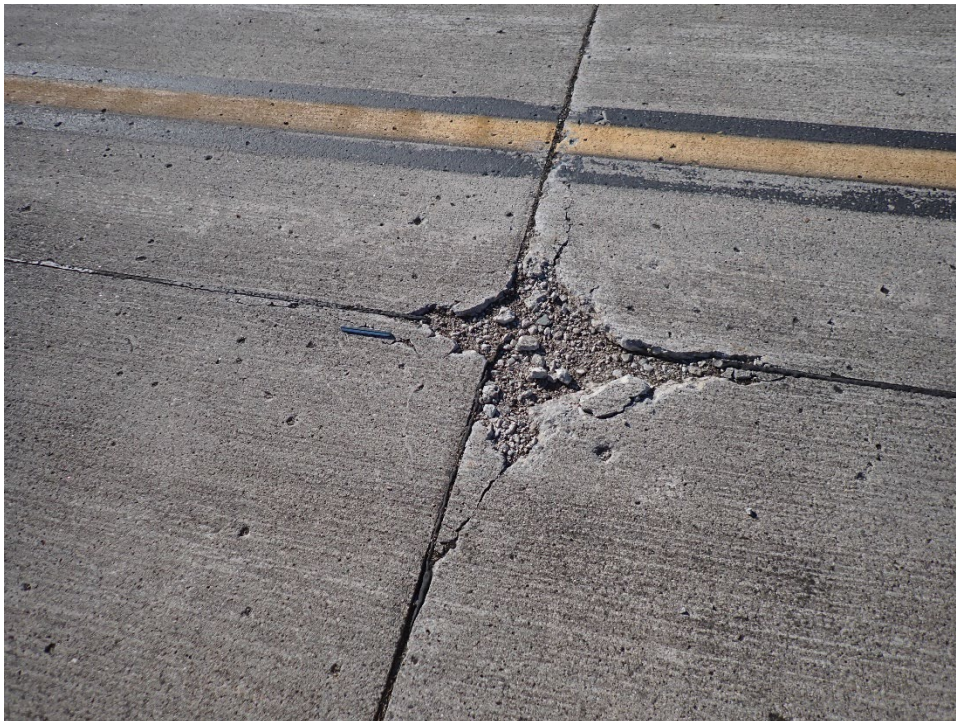
T01EG-02. ASR (Sample Unit No. 03).

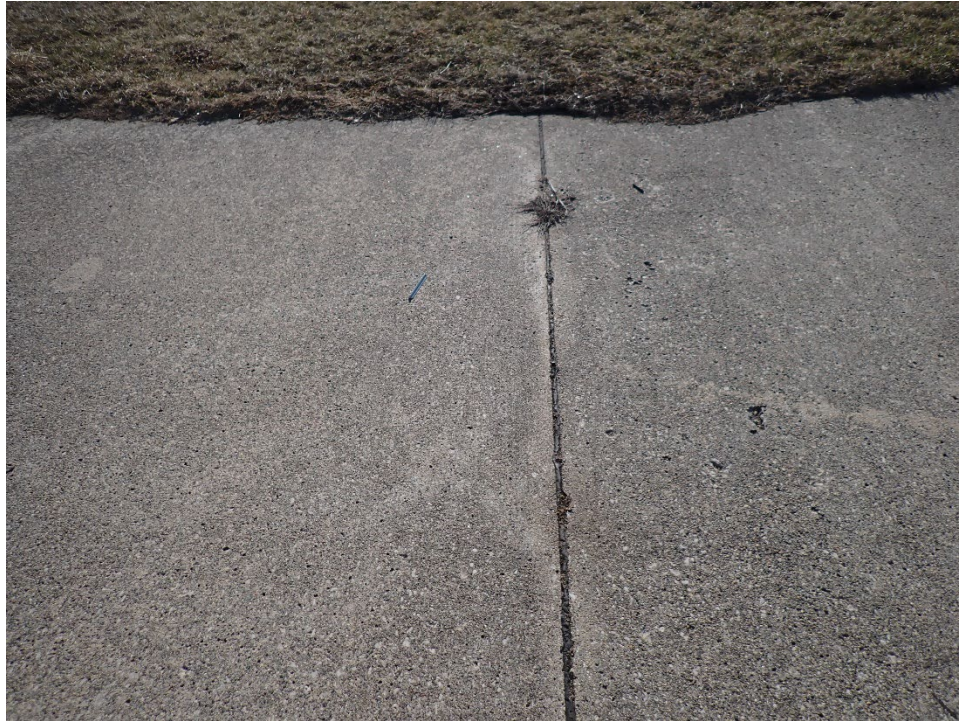
T01EG-02. Joint Seal Damage (Sample Unit No. 04).

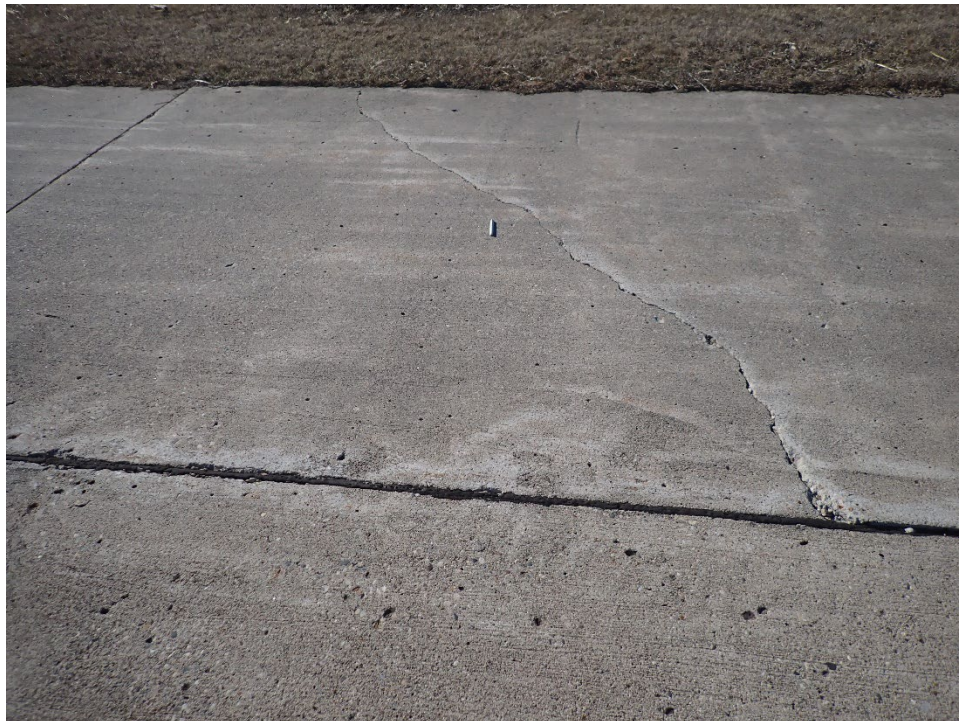
T01EG-02. LTD Cracking (Sample Unit No. 02).
