# Emmetsburg Municipal Airport

## Pavement Management Report

**AUGUST 2026**

# EMMETSBURG MUNICIPAL AIRPORT PAVEMENT MANAGEMENT REPORT

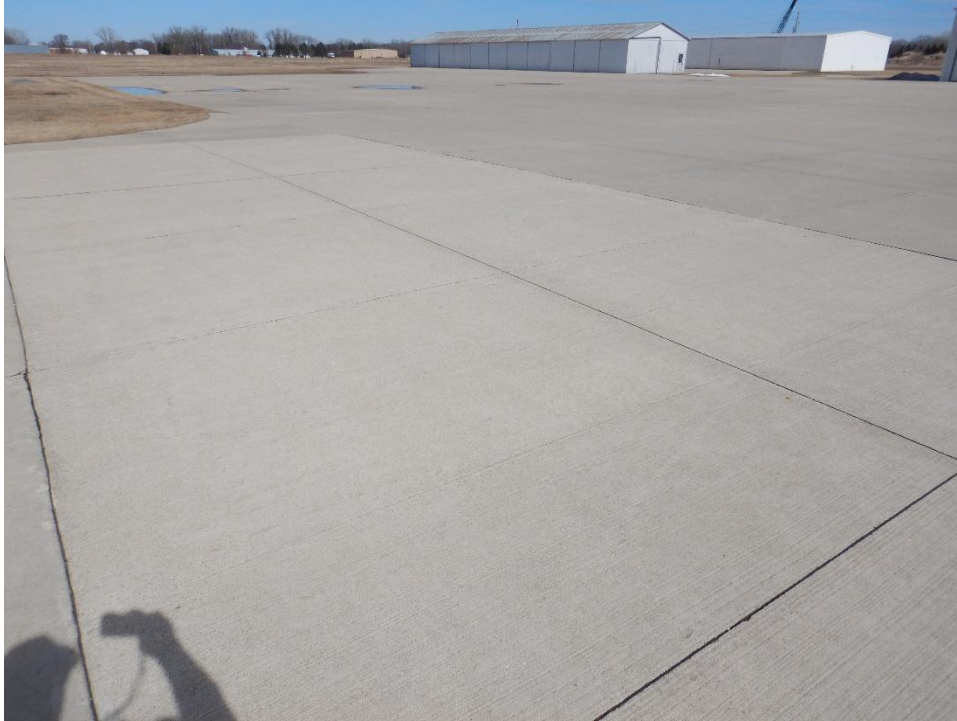
A01EM-01. Overview.

The apron area contained two sections. Section 01 had low-severity corner break, faulting, and LTD cracking; high-severity corner spalling and joint seal damage; and medium-severity joint spalling identified during the inspection. Low-severity corner spalling and high-severity joint seal damage were observed in Section 02.

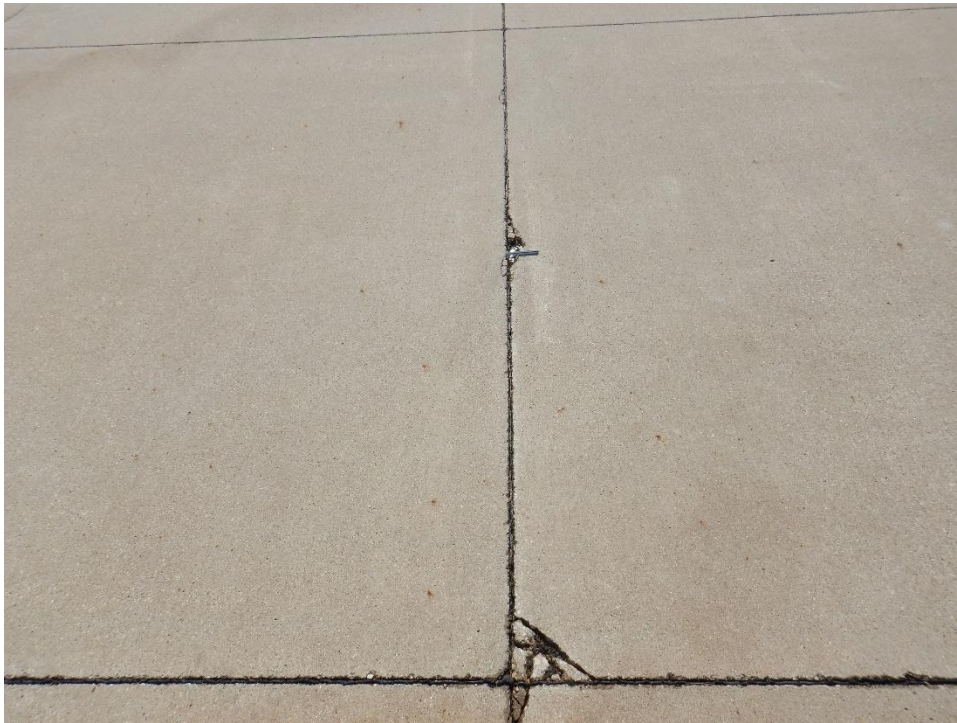
| <b>Distress Type</b> | <b>Probable Cause of Distress</b> |
|---|---|
| Spalling<br>(Joint and Corner) | Excessive stresses at the joint caused by infiltration of incompressible materials or traffic loads; weak concrete at the joint combined with traffic loads. |

A01EM-01. Corner Spalling (Sample Unit No. 16).

| Branch | Section | Distress Type | Severity | Distress Quantity | Distress Unit | Maintenance Action | Unit Cost | 2026 Estimated Cost |
|---|---|---|---|---|---|---|---|---|
| A01EM | 01 | Corner Spalling | High | 11 | Slabs | Patching - PCC Partial Depth | \$41.68 | \$1,284 |

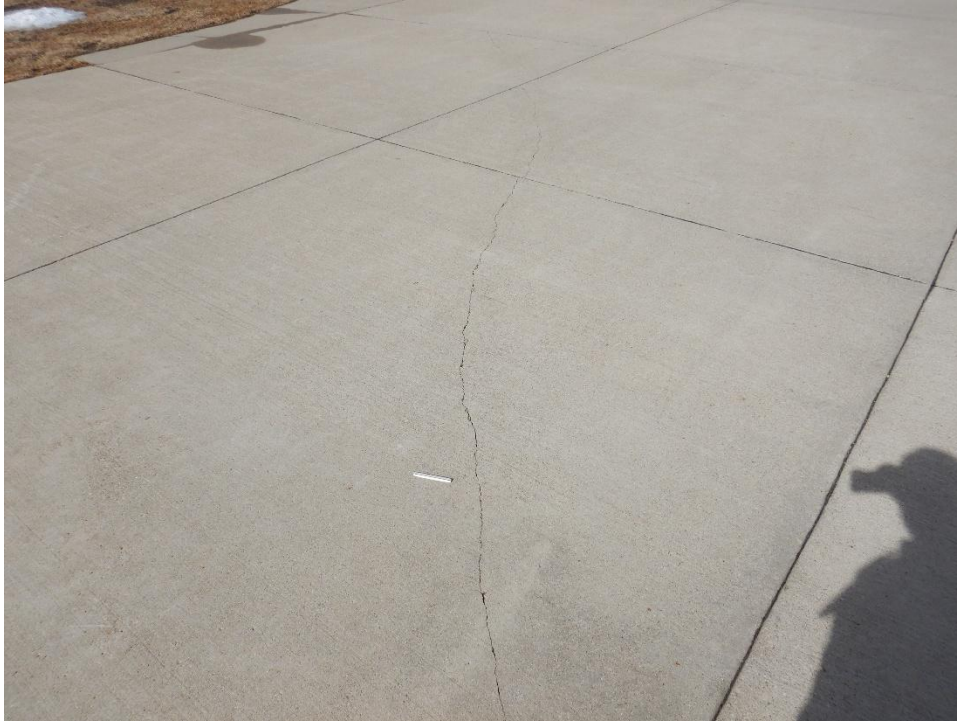
| <b>Distress Type</b> | <b>Probable Cause of Distress</b> |
|---|---|
| LTD Cracking | Combination of load repetition, curling stresses, and shrinkage stresses. |

A01EM-01. LTD Cracking (Sample Unit No. 21).

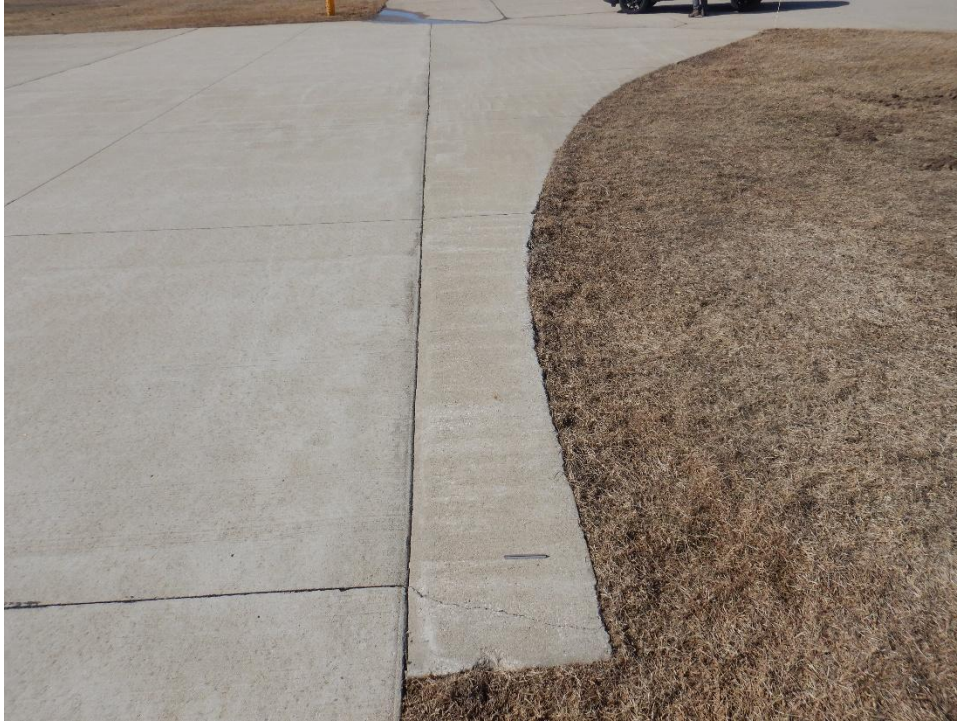
A01EM-02. Corner Break (Sample Unit No. 06).

| Branch | Section | Distress Type | Severity | Distress Quantity | Distress Unit | Maintenance Action | Unit Cost | 2026 Estimated Cost |
|---|---|---|---|---|---|---|---|---|
| A01EM | 02 | Corner Break | Low | 1 | Slabs | Crack Sealing - PCC | \$3.35 | \$34 |

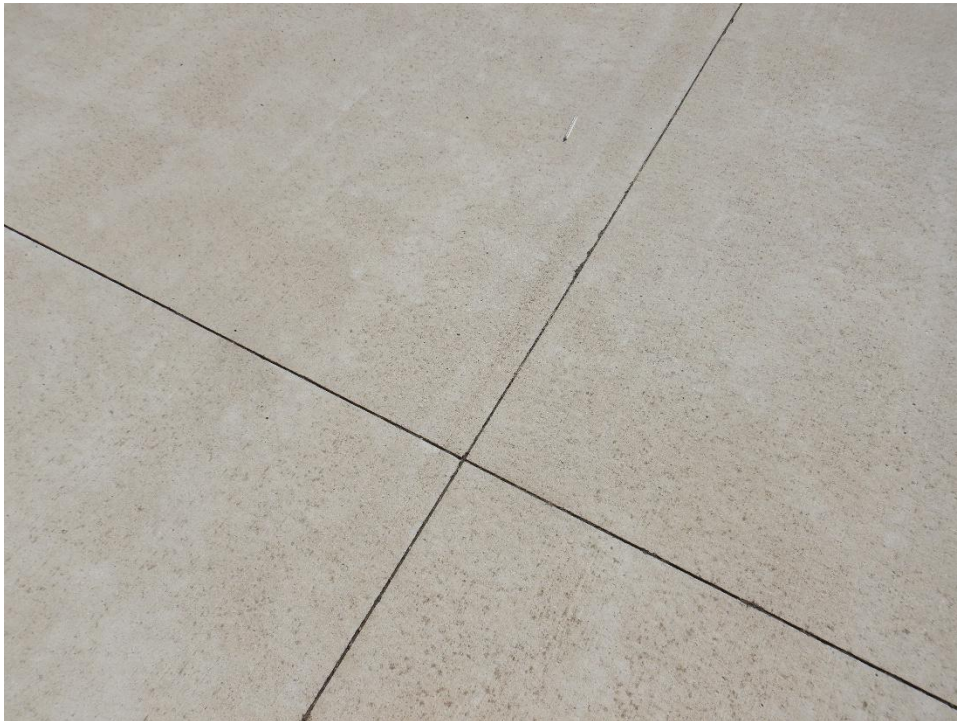
| <b>Distress Type</b> | <b>Probable Cause of Distress</b> |
|---|---|
| Joint Seal Damage | Stripping of joint sealant, extrusion of joint sealant, weed growth, hardening of the filler (oxidation), loss of bond to the slab edges, or absence of sealant in the joint. |

A01EM-02. Joint Seal Damage (Sample Unit No. 03).

| Branch | Section | Distress Type | Severity | Distress Quantity | Distress Unit | Maintenance Action | Unit Cost | 2026 Estimated Cost |
|---|---|---|---|---|---|---|---|---|
| A01EM | 02 | Joint Seal Damage | High | 102 | Slabs | Joint Seal (Localized) | \$3.35 | \$6,160 |

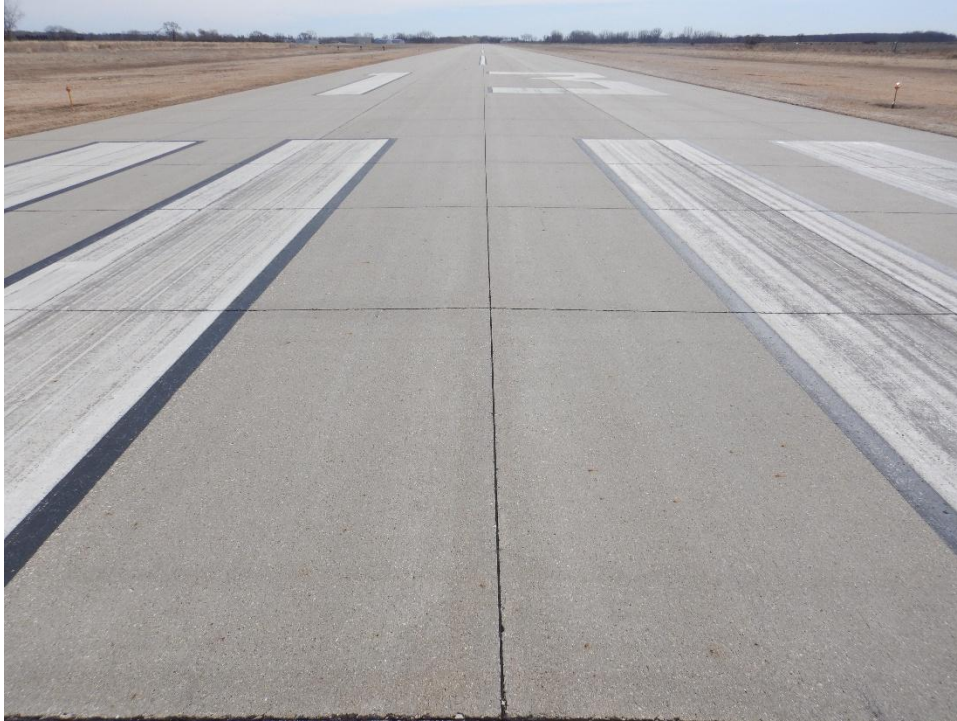
R13EM-01. Overview.

Runway 13/31 consisted of one section with low- and high-severity corner spalling, high-severity joint seal damage, and medium-severity joint spalling and longitudinal, transverse, and diagonal (LTD) cracking.

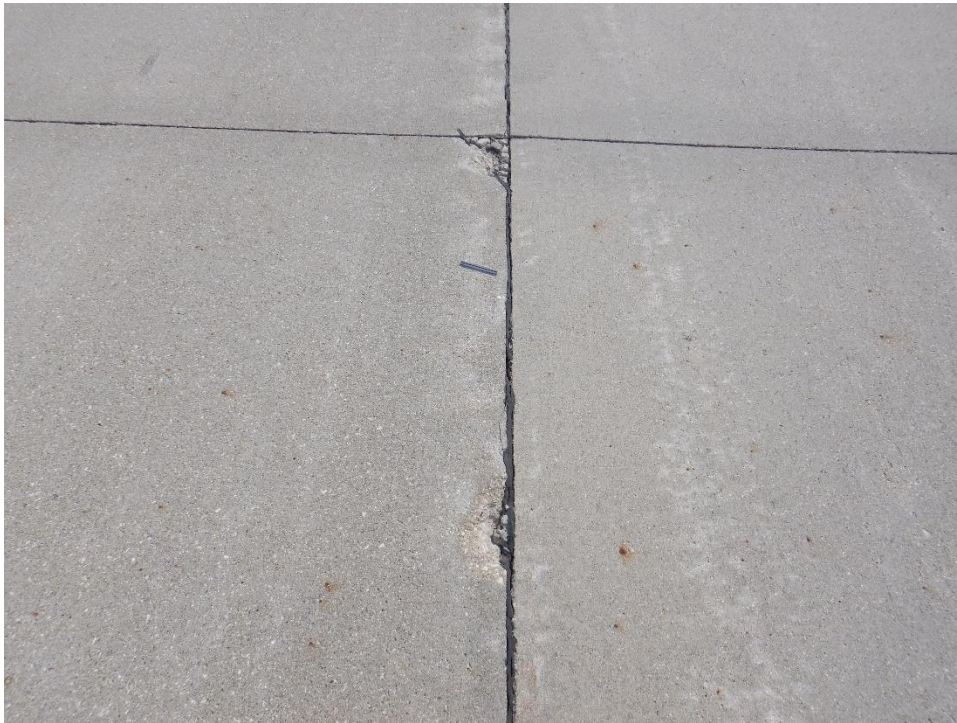
R13EM-01. Joint and Corner Spalling (Sample Unit No. 72).

| Branch | Section | Distress Type | Severity | Distress Quantity | Distress Unit | Maintenance Action | Unit Cost | 2026 Estimated Cost |
|---|---|---|---|---|---|---|---|---|
| R13EM | 01 | Corner Spalling | High | 10 | Slabs | Patching - PCC Partial Depth | \$41.68 | \$1,126 |
| R13EM | 01 | Joint Spalling | Medium | 10 | Slabs | Patching - PCC Partial Depth | \$41.68 | \$2,703 |

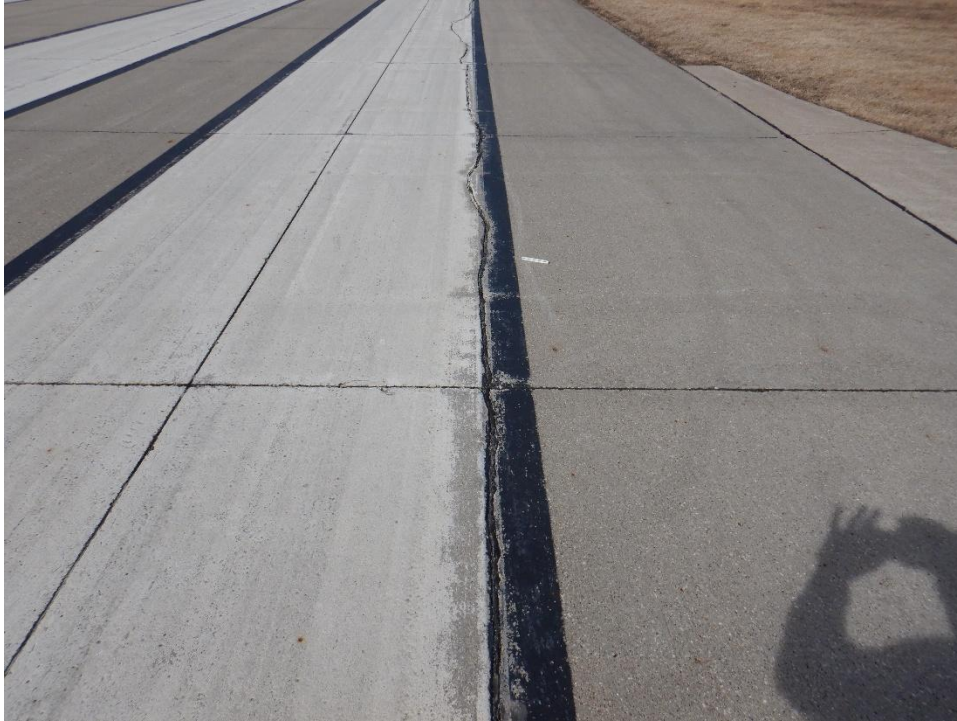
R13EM-01. LTD Cracking (Sample Unit No. 03).

| Branch | Section | Distress Type | Severity | Distress Quantity | Distress Unit | Maintenance Action | Unit Cost | 2026 Estimated Cost |
|---|---|---|---|---|---|---|---|---|
| R13EM | 01 | LTD Cracking | Medium | 40 | Slabs | Crack Sealing - PCC | \$3.35 | \$1,346 |

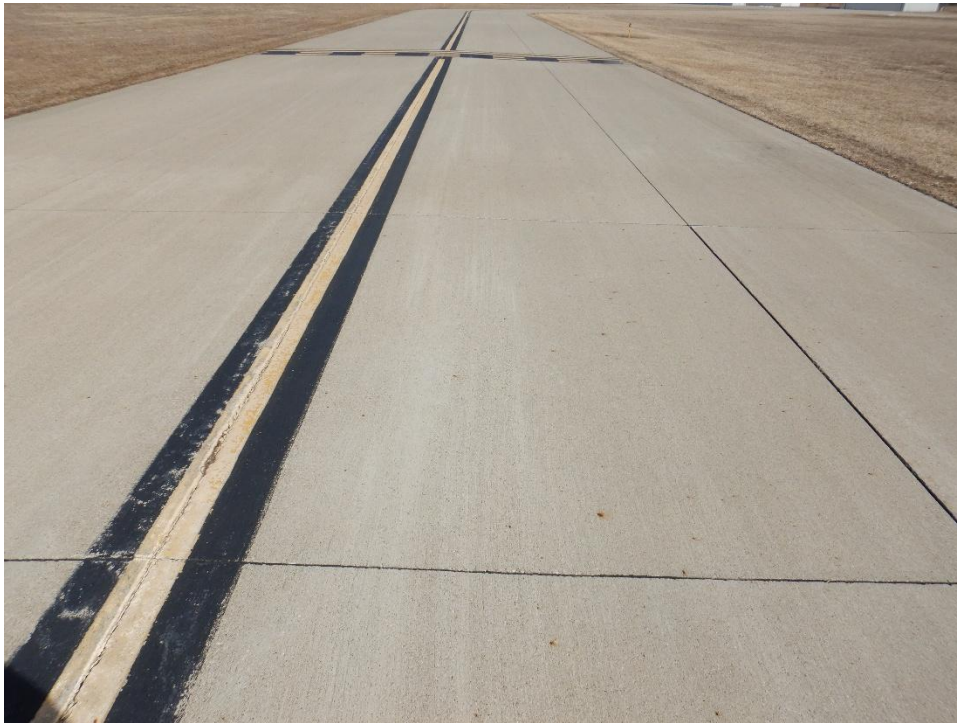
T01EM-01. Overview.

The taxiway was defined by one section that contained areas of high-severity joint seal damage and low-severity faulting and LTD cracking.

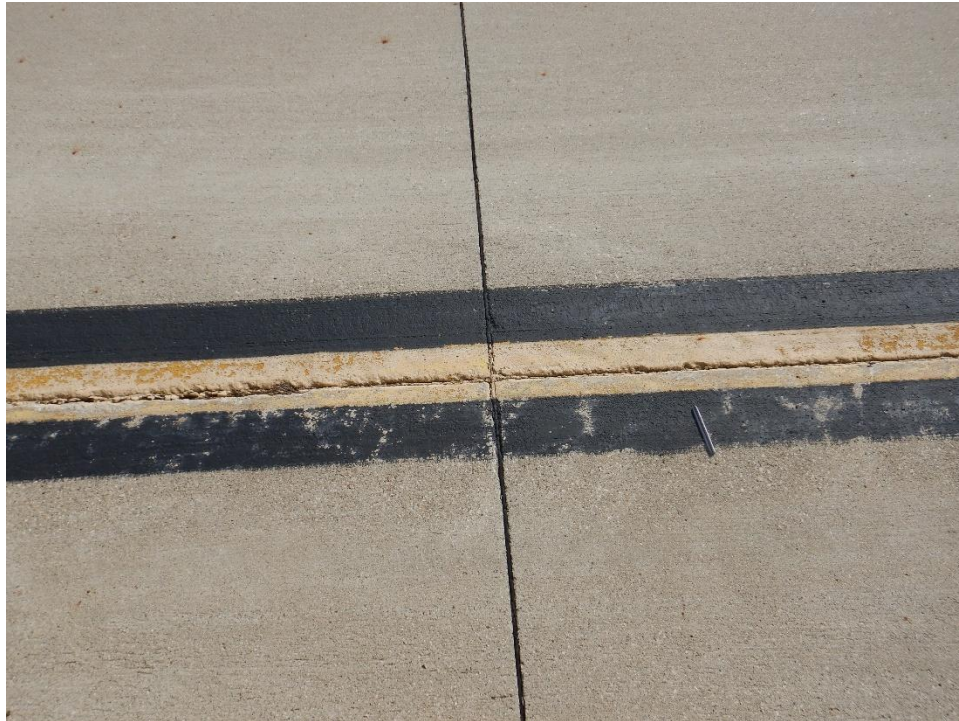
T01EM-01. Joint Seal Damage (Sample Unit No. 02).

| Branch | Section | Distress Type | Severity | Distress Quantity | Distress Unit | Maintenance Action | Unit Cost | 2026 Estimated Cost |
|---|---|---|---|---|---|---|---|---|
| T01EM | 01 | Joint Seal Damage | High | 223 | Slabs | Joint Seal (Localized) | \$3.35 | \$12,977 |

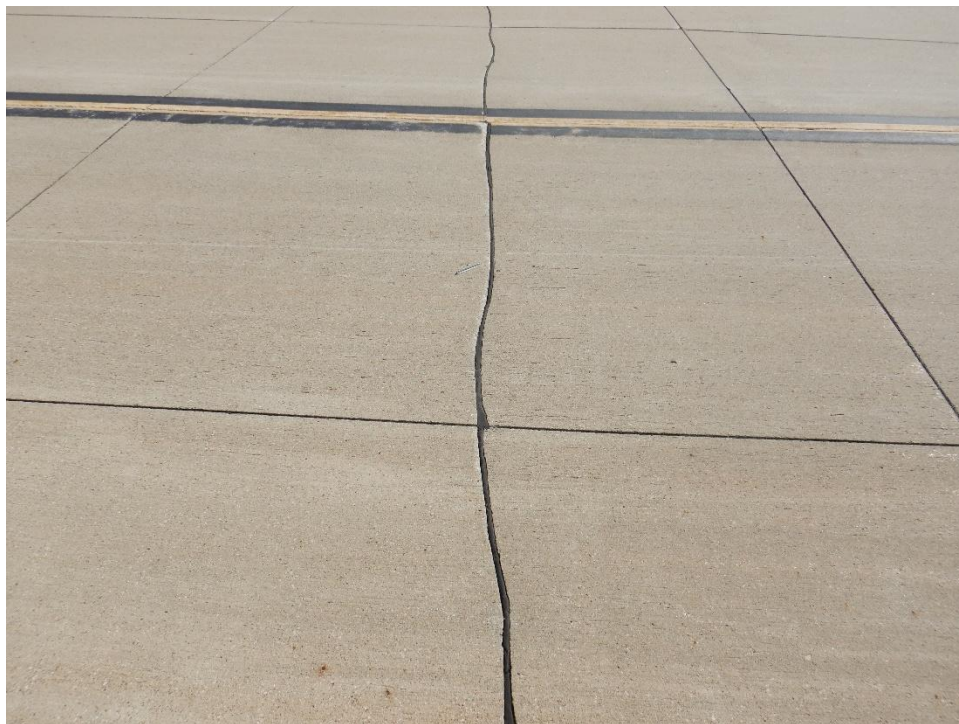
T01EM-01. LTD Cracking (Sample Unit No. 02).

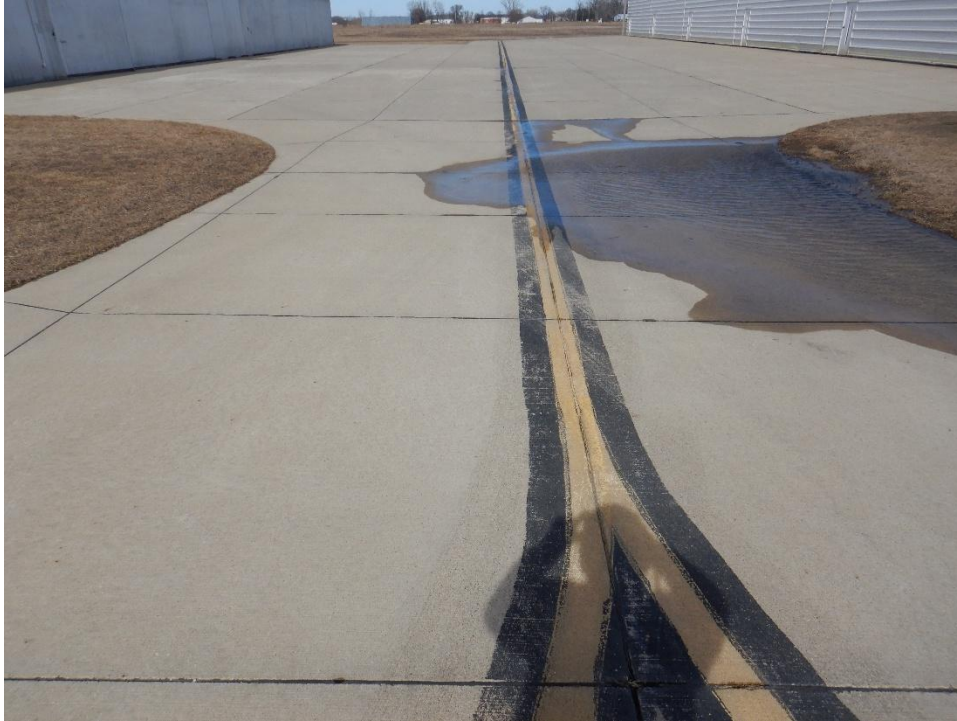
TH01EM-01. Overview.

The T-hangar area consisted of one section. Medium-severity corner spalling, faulting, joint seal damage, and joint spalling were recorded in Section 01.

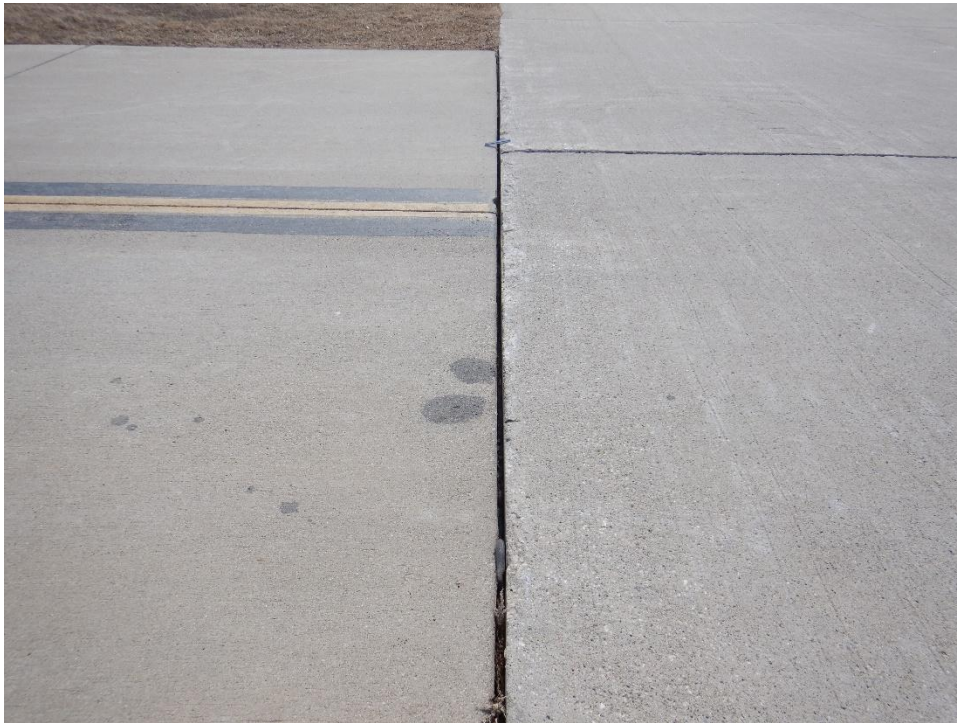
TH01EM-01. Faulting (Sample Unit No. 01).
