# Estherville Municipal Airport

## Pavement Management Report

**AUGUST 2026**

# ESTHERVILLE MUNICIPAL AIRPORT PAVEMENT MANAGEMENT REPORT

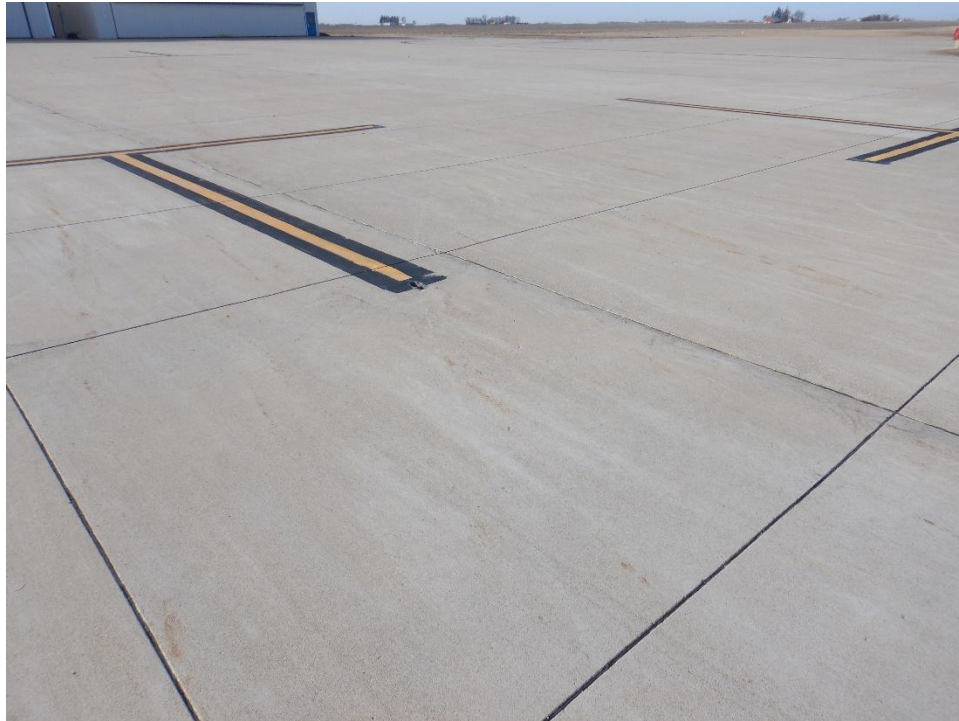
A01ES-01. Overview.

The apron area contained three sections. Section 01 had medium-severity corner spalling and joint spalling and low-severity corner break, joint seal damage, and LTD cracking recorded at the time of inspection. Sections 02 and 03 were in *Excellent* condition and contained only medium-severity joint spalling.

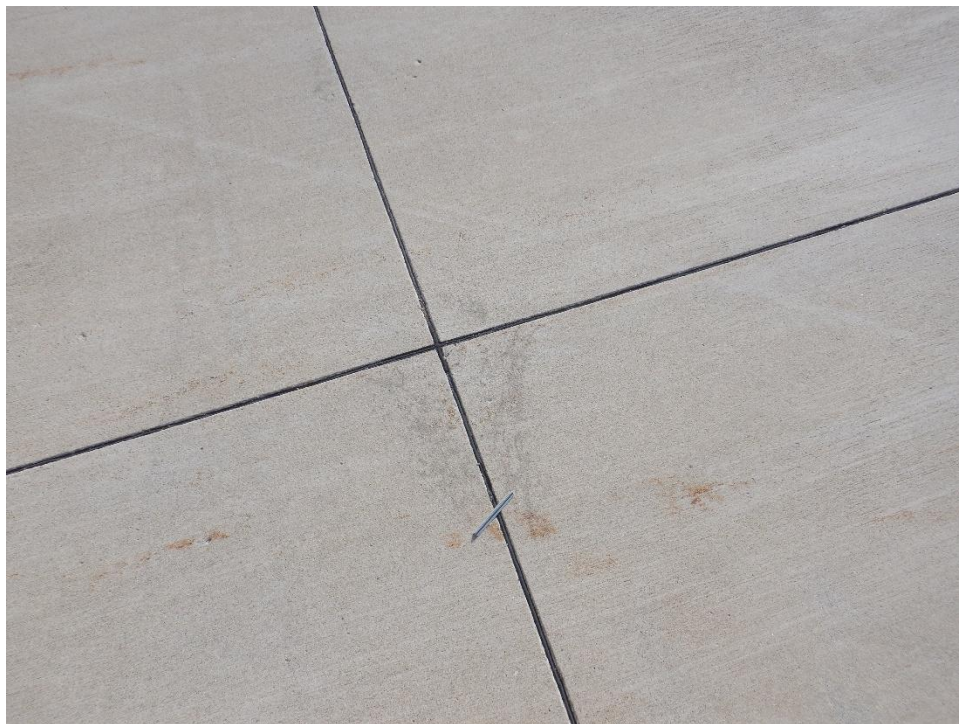
A01ES-01. Joint Seal Damage (Sample Unit No. 12).

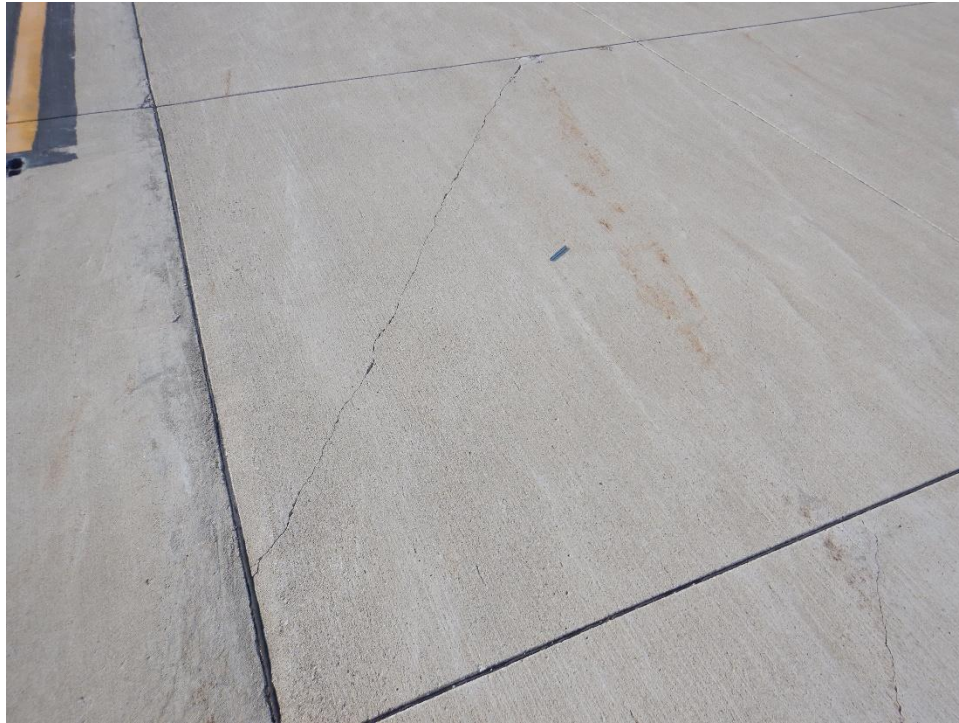
A01ES-01. LTD Cracking (Sample Unit No. 12).

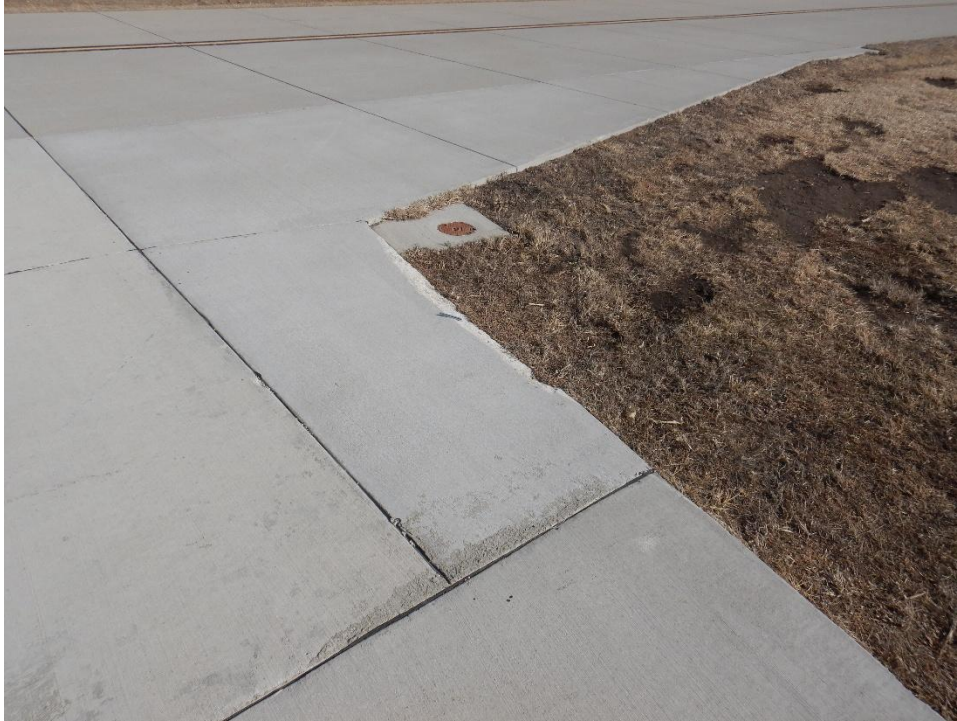
A01ES-02. Joint Spalling (Sample Unit No. 05).

| Branch | Section | Distress Type | Severity | Distress Quantity | Distress Unit | Maintenance Action | Unit Cost | 2026 Estimated Cost |
|---|---|---|---|---|---|---|---|---|
| A01ES | 02 | Joint Spalling | Medium | 1 | Slabs | Patching - PCC Partial Depth | \$41.68 | \$359 |

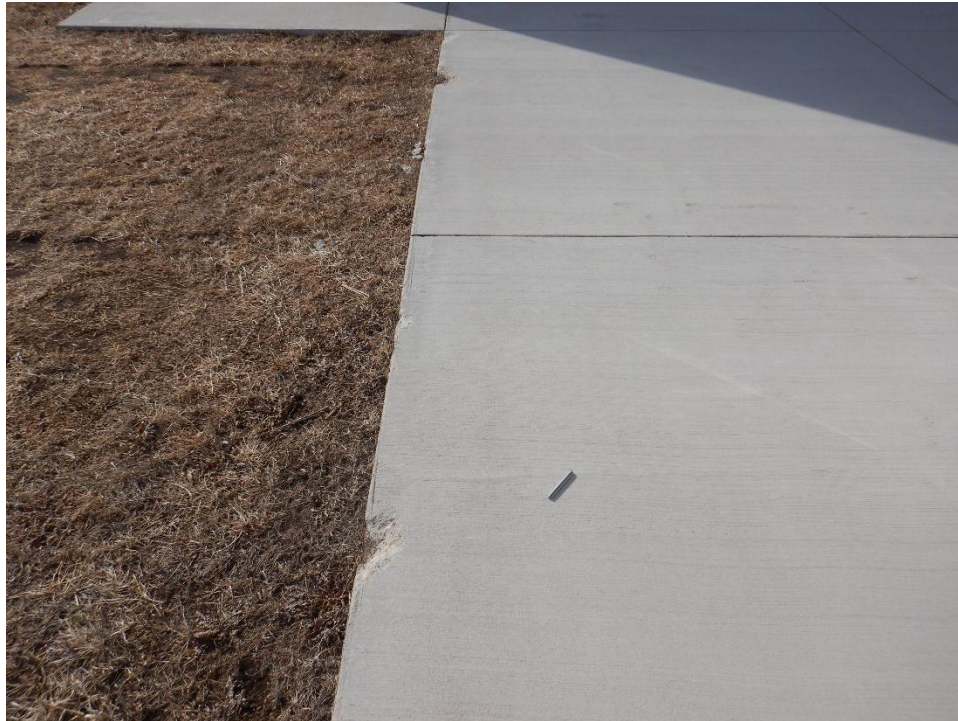
A01ES-03. Joint Spalling (Sample Unit No. 03).

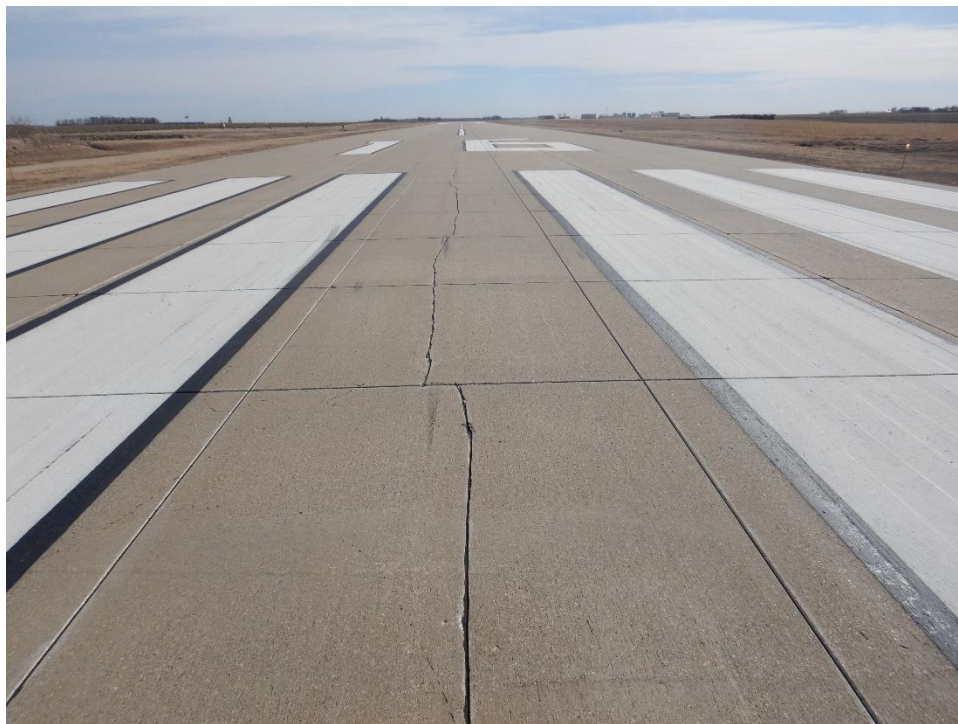
R16ES-01. Overview.

Runway 16/34 consisted of one section in *Excellent* condition. Low-severity longitudinal, transverse, and diagonal (LTD) cracking and low- and medium-severity small patching were recorded in Section 01.

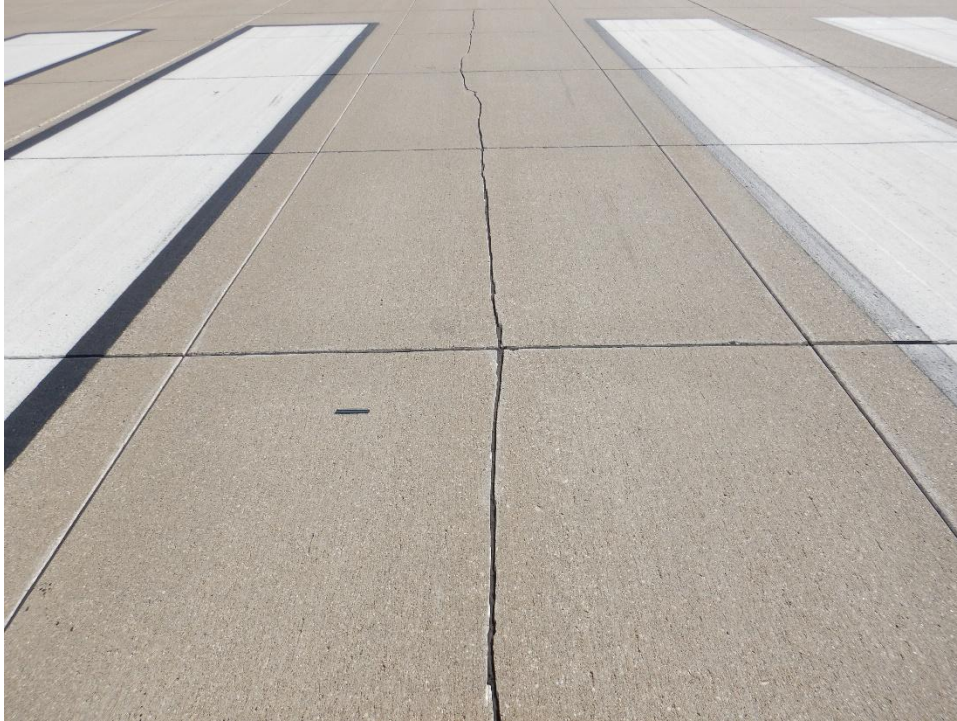
R16ES-01. LTD Cracking (Sample Unit No. 160).

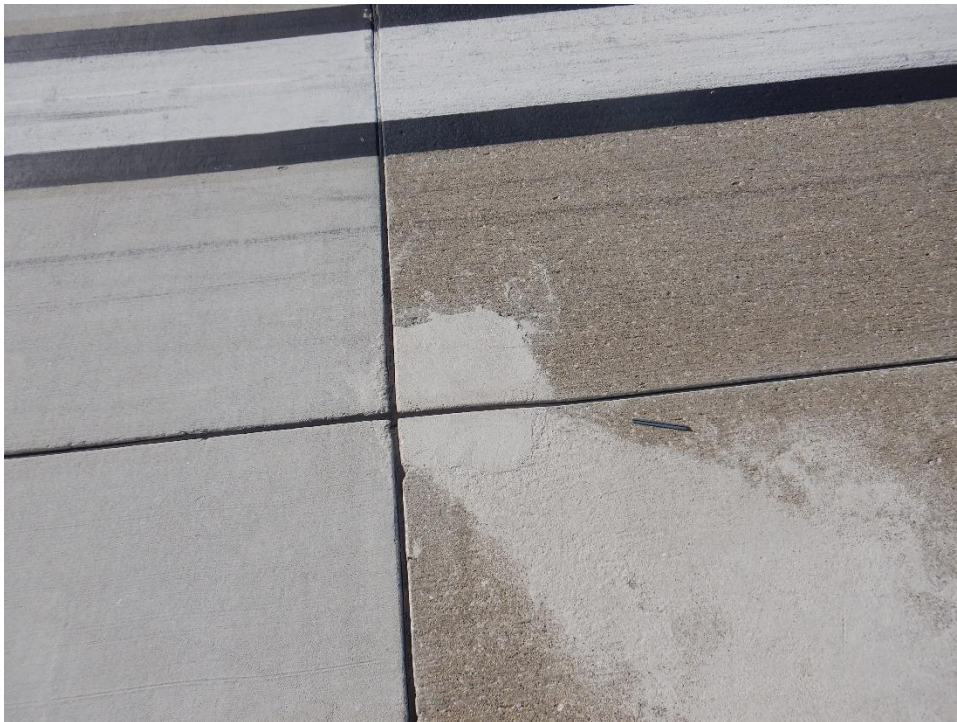
R16ES-01. Small Patching (Sample Unit No. 150).

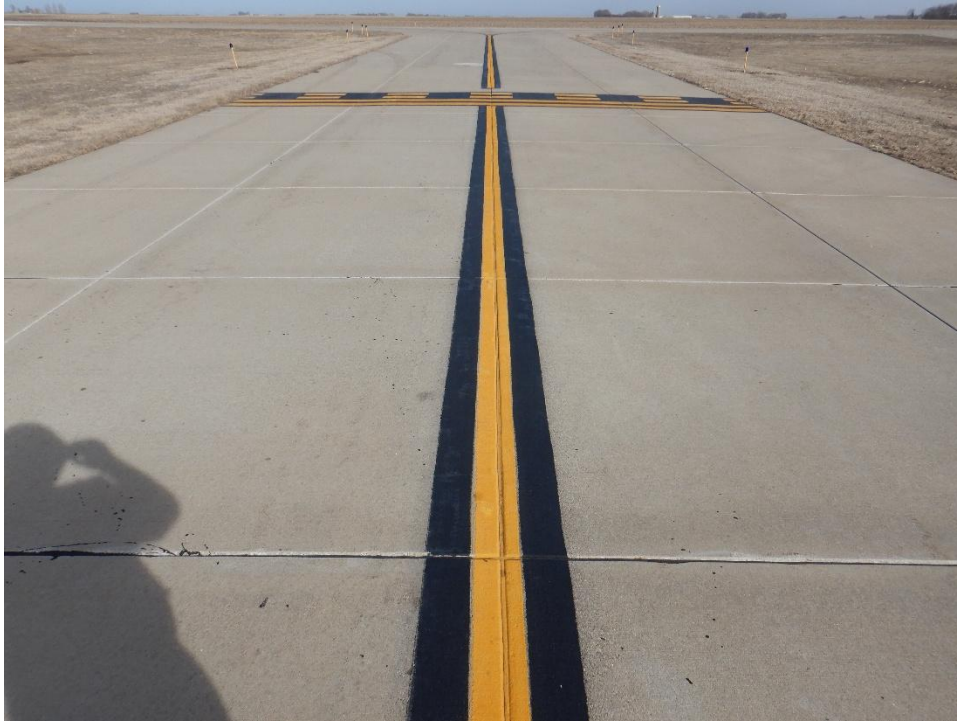
T01ES-01. Overview.

Taxiway 01 was defined by two sections. Section 01 was in *Excellent* condition and had only low-severity small patching noted during the inspection. Low-severity corner break and joint seal damage, low- and high-severity corner spalling, medium-severity joint spalling, and low- and medium-severity LTD cracking were identified in Section 02.

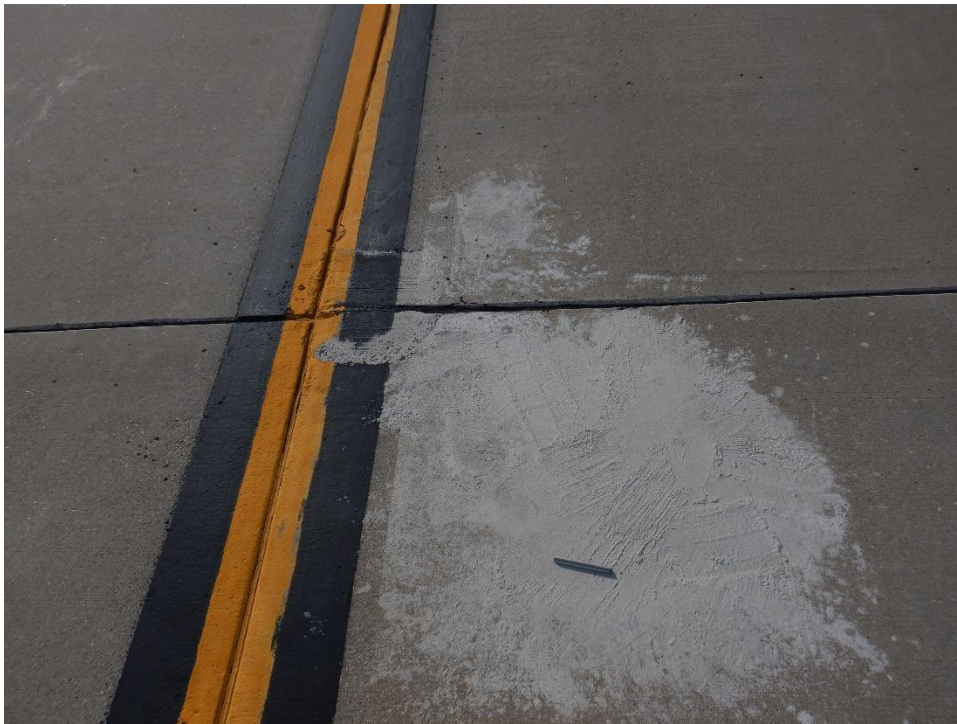
T01ES-01. Small Patching (Sample Unit No. 02).

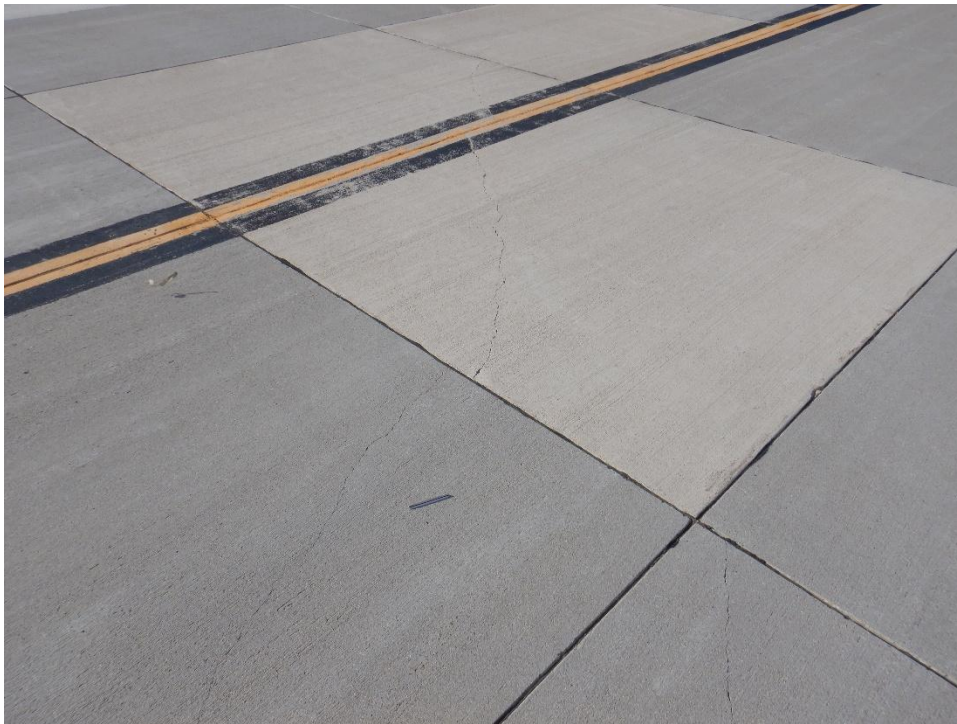
T01ES-02. LTD Cracking (Sample Unit No. 05).

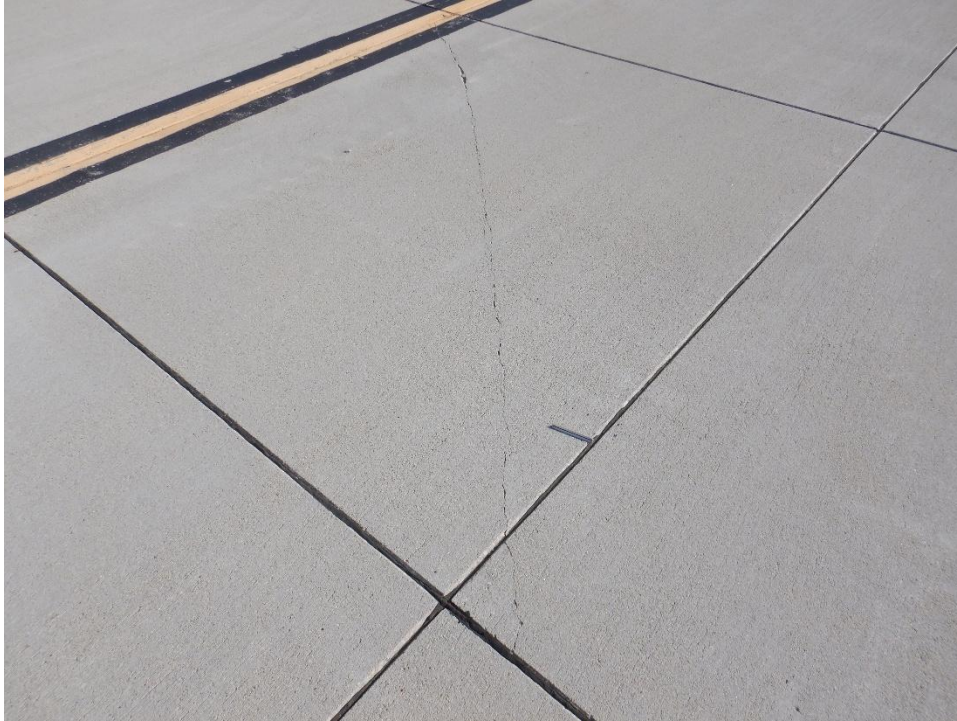
T01ES-02. LTD Cracking (Sample Unit No. 17).

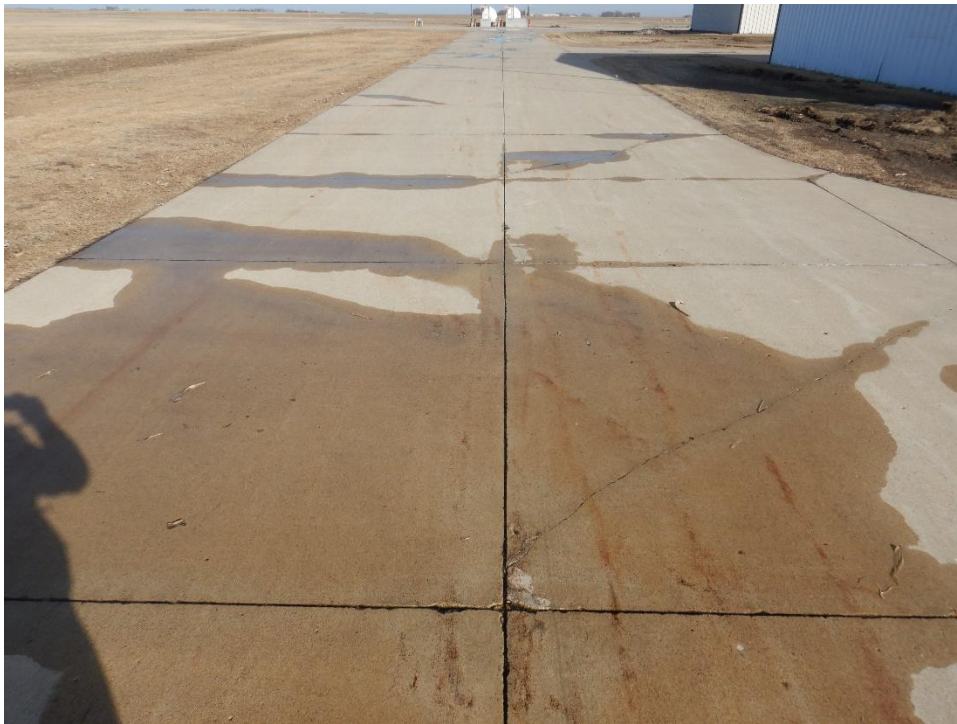
TH01ES-01. Overview.

The T-hangar area consisted of two sections. Section 01 contained low-severity ASR; medium-severity corner break, corner spalling, joint spalling, and shattered slab; all severities of faulting; medium- and high-severity joint seal damage; low- and medium-severity LTD cracking; popouts; and shrinkage cracking. Section 02 had low-severity corner break and large patching, medium- and high-severity joint seal damage, low- and medium-severity joint spalling and LTD cracking, and shrinkage cracking identified during the inspection.

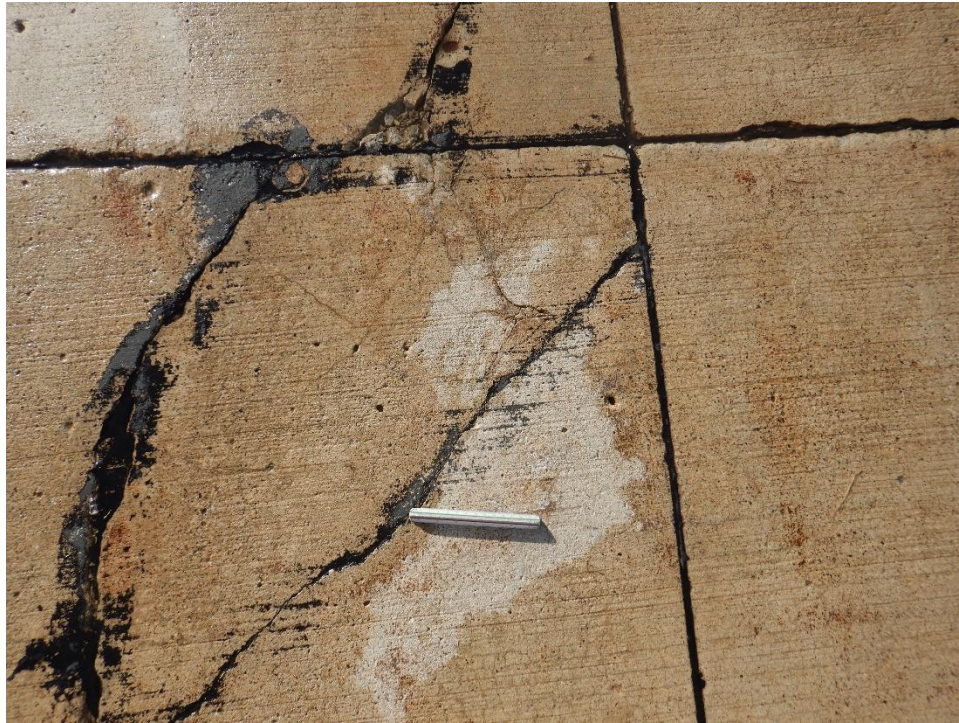
Estherville Municipal Airport was inspected on February 27, 2026. Eight pavement sections were defined during the inspection. Alkali-silica reaction (ASR) was recorded at this airport according to the PCI procedure where evidence of a precipitate was observed within some of the cracking in the concrete surface. It should be noted that laboratory testing in the form of petrographic analysis is the only definitive way to validate the presence of ASR; however, the formation of a precipitate is evidence of a reaction consistent with this type of materials-related distress.

TH01ES-01. ASR (Sample Unit No. 05).

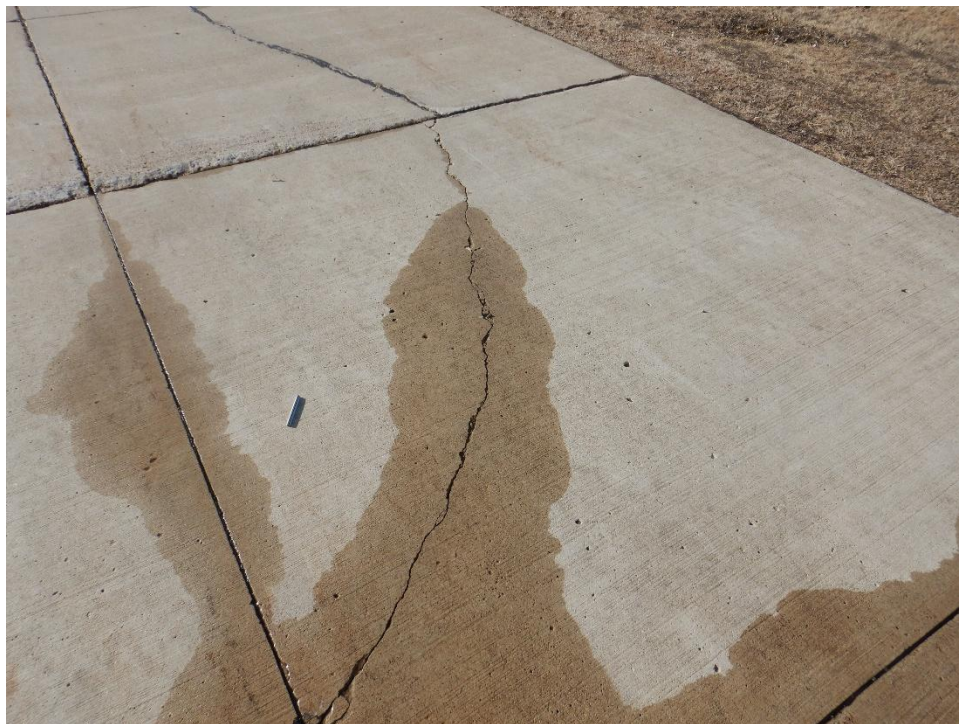
TH01ES-01. LTD Cracking (Sample Unit No. 05).

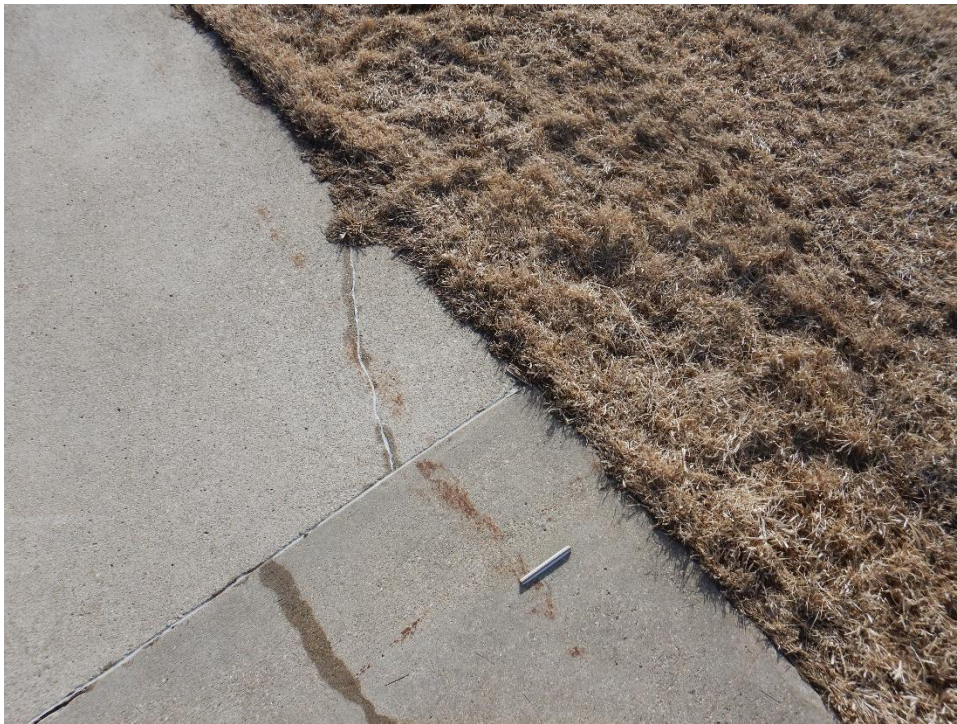
TH01ES-02. Corner Break (Sample Unit No. 02).

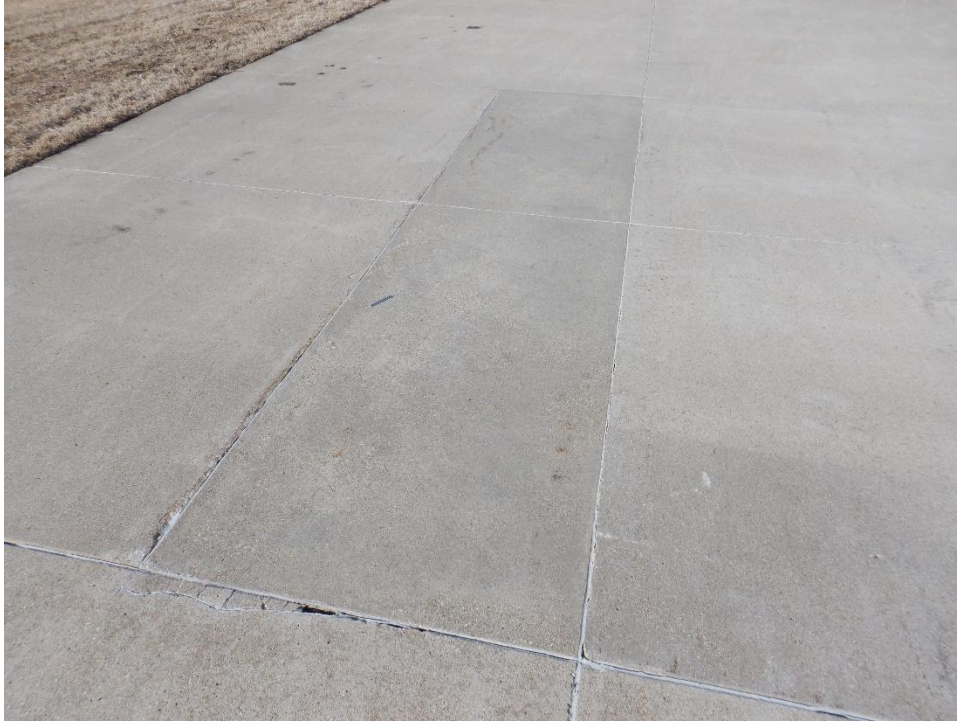
TH01ES-02. Large Patching (Sample Unit No. 02).
