# Forest City Municipal Airport/Trimble Field

## Pavement Management Report

**AUGUST 2026**

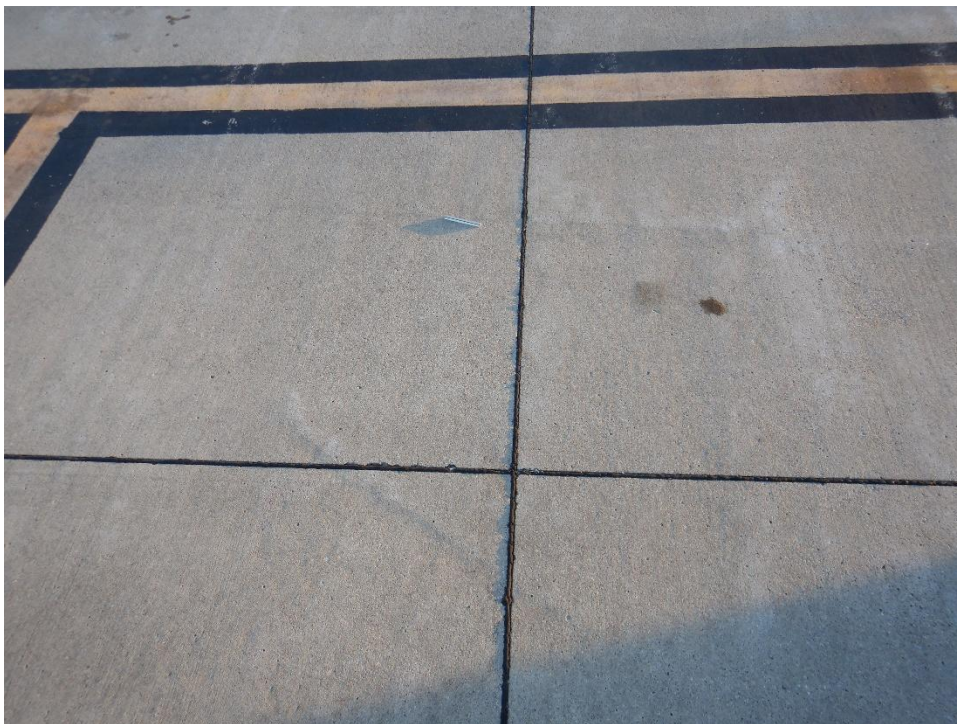
The apron area was defined by two sections. Low-severity corner spalling and medium-severity joint seal damage, joint spalling, and longitudinal, transverse, and diagonal (LTD) cracking were observed in Section 01. Section 02 contained medium-severity faulting and joint seal damage and low- and medium-severity corner break, joint spalling, and LTD cracking.

A01FC-01. Joint Seal Damage (Sample Unit No. 01).

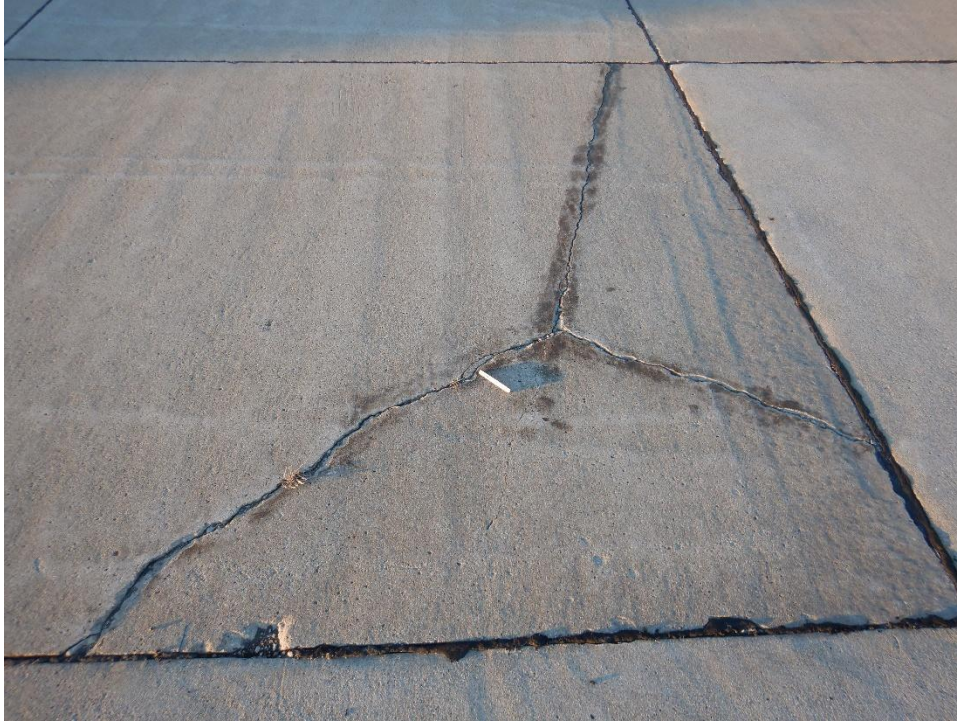
A01FC-01. LTD Cracking (Sample Unit No. 10).

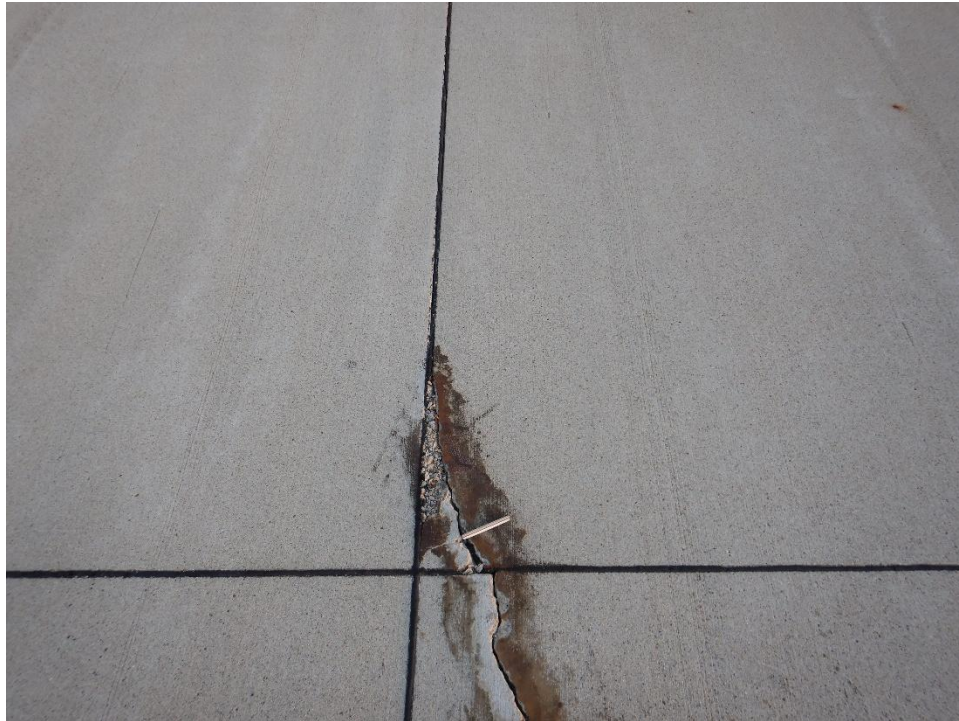
A01FC-02. Joint Spalling (Sample Unit No. 16).

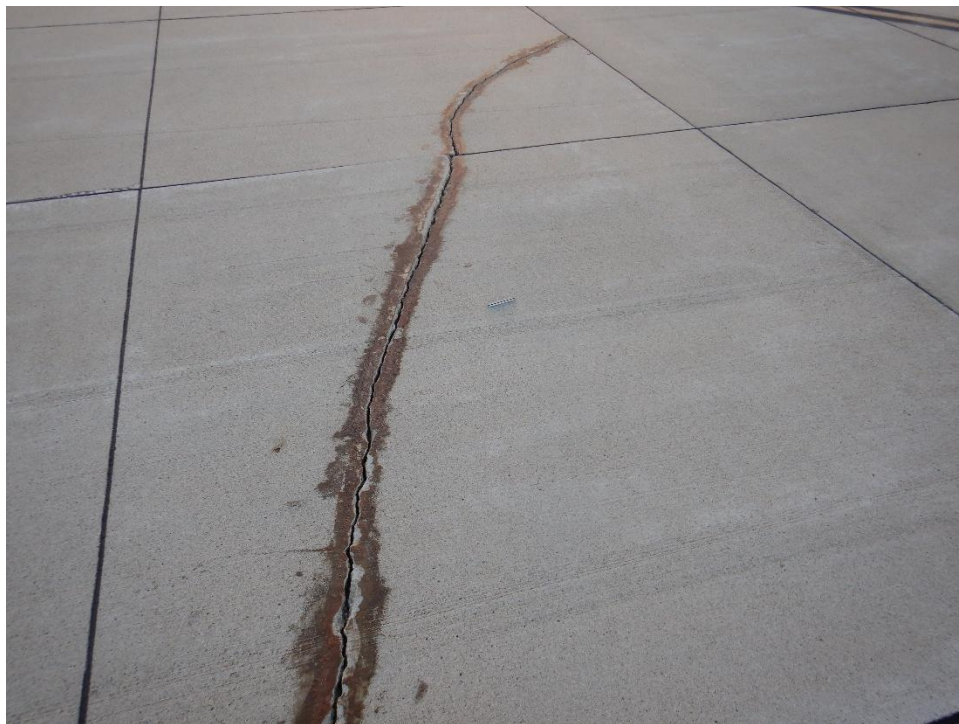
A01FC-02. LTD Cracking (Sample Unit No. 16).

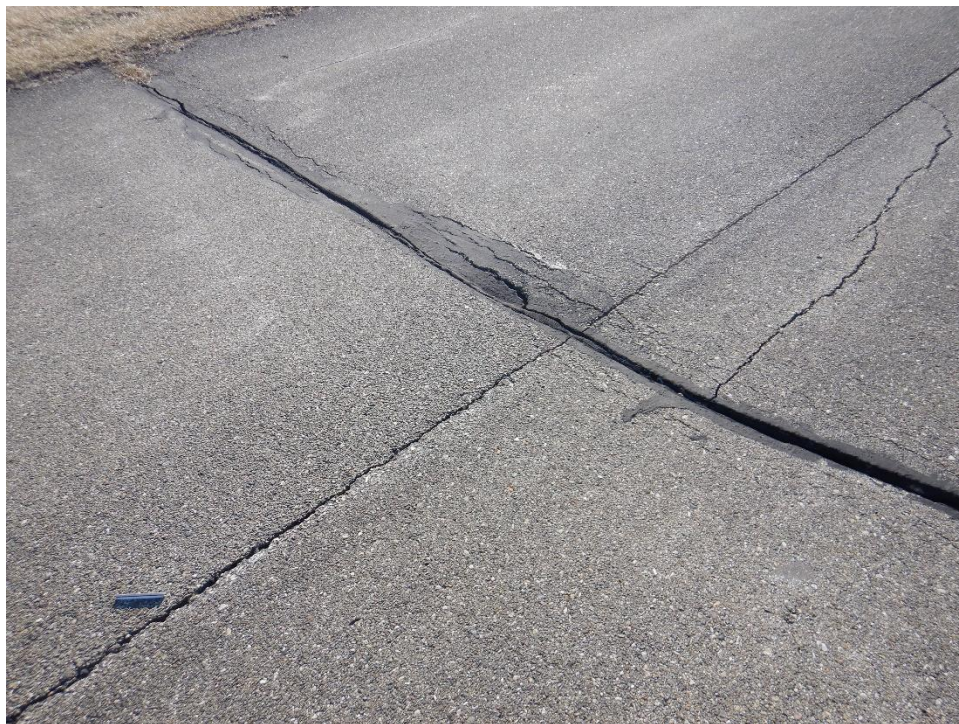
Runway 09/27 consisted of four sections. Section 01 contained all severities of longitudinal and transverse (L&T) cracking, low- and high-severity raveling, and low-severity weathering. All severities of L&T cracking and low-severity weathering were identified in Section 02. Section 03 had medium-severity alligator cracking, all severities of L&T cracking, and low-severity weathering recorded. All severities of L&T cracking, low-severity raveling, and medium-severity weathering were noted in Section 04. The low-severity L&T cracking on Runway 09/27 was unsealed, the medium-severity L&T cracking was recorded where either crack sealant was unsatisfactory or unsealed crack widths were greater than  $\frac{1}{4}$  inch, and the high-severity L&T cracking was noted where either secondary cracking was wider than 1 foot or crack widths were greater than 3 inches.

R09FC-01. L&T Cracking (Sample Unit No. 11).

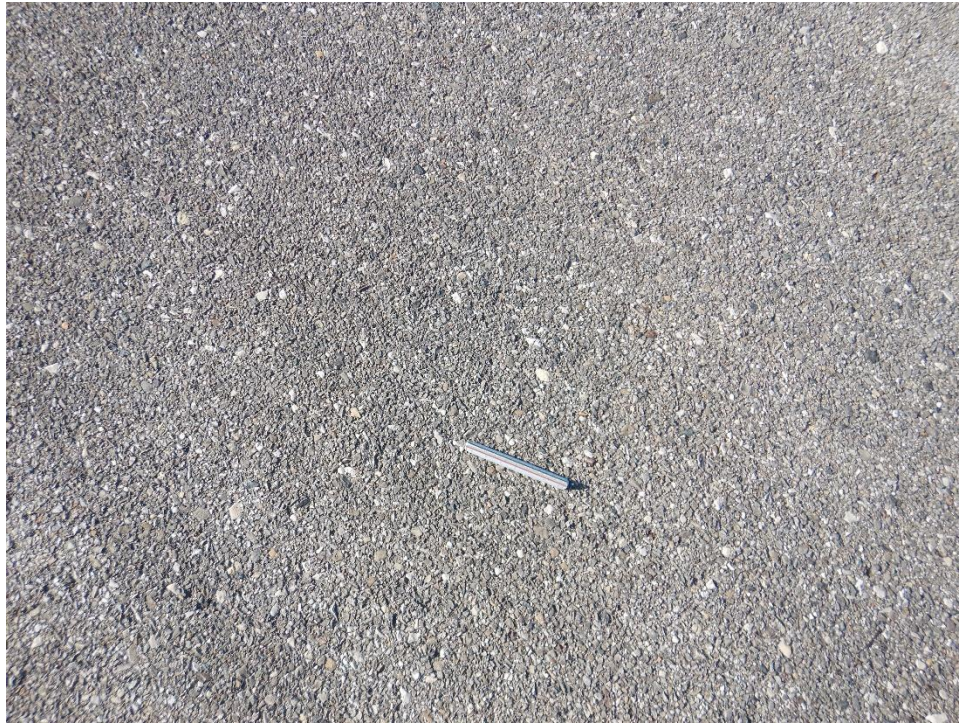
R09FC-01. Weathering (Sample Unit No. 11).

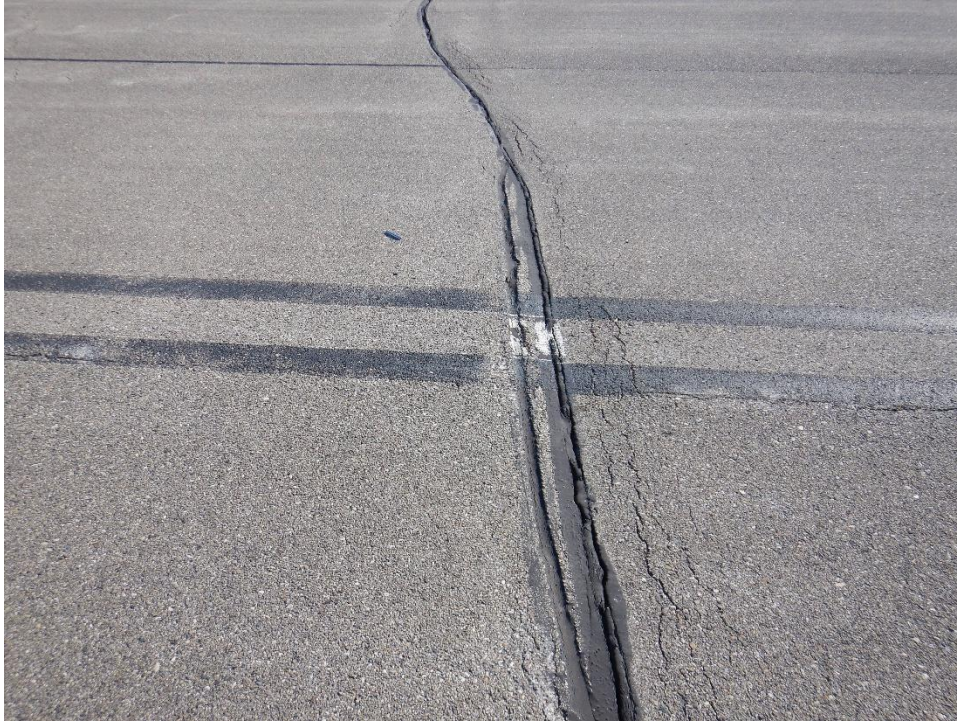
R09FC-02. L&T Cracking (Sample Unit No. 08).

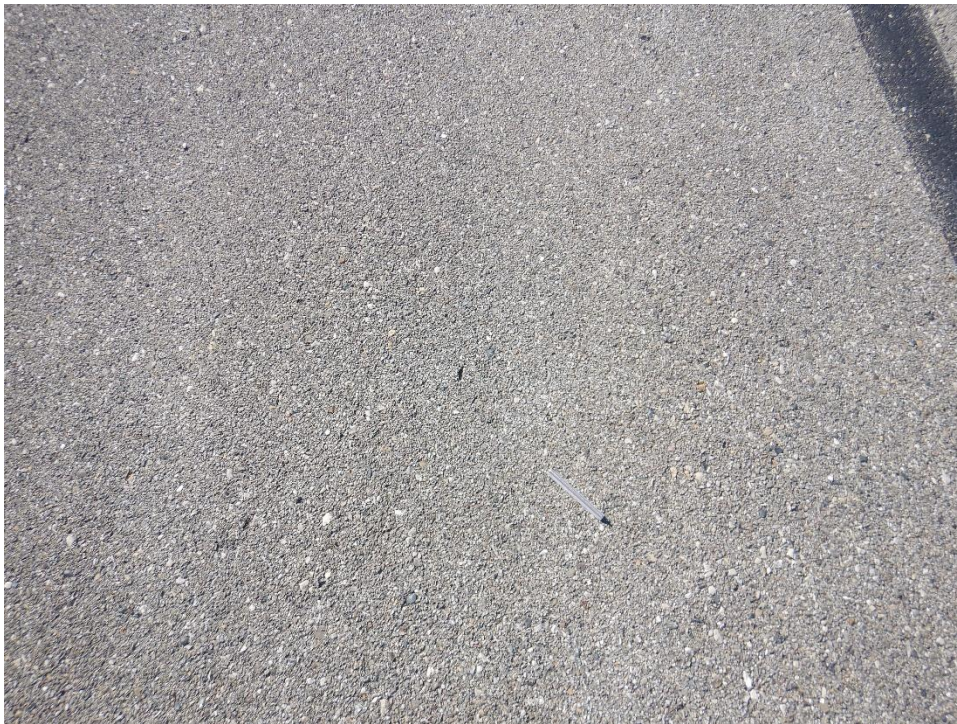
R09FC-02. Weathering (Sample Unit No. 08).

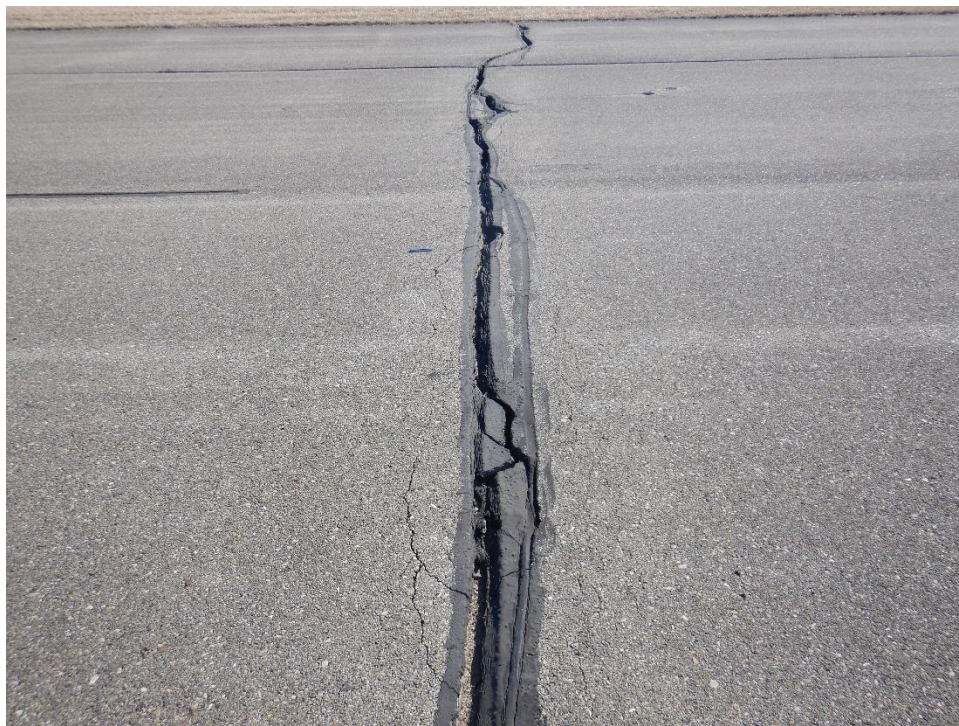
R09FC-03. L&T Cracking (Sample Unit No. 03).

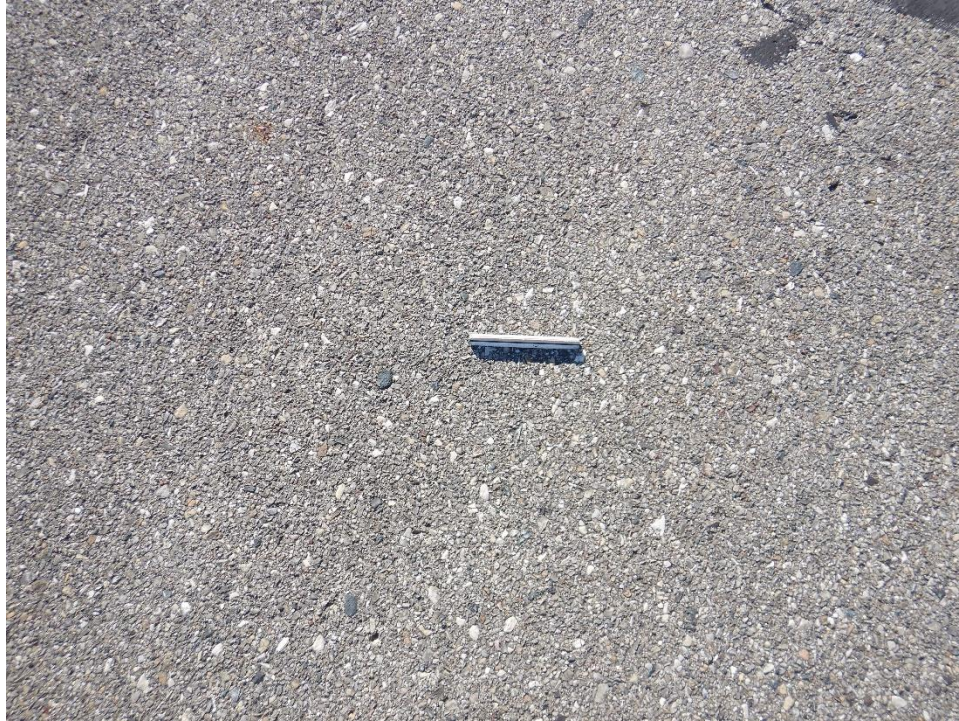
R09FC-03. Weathering (Sample Unit No. 03).

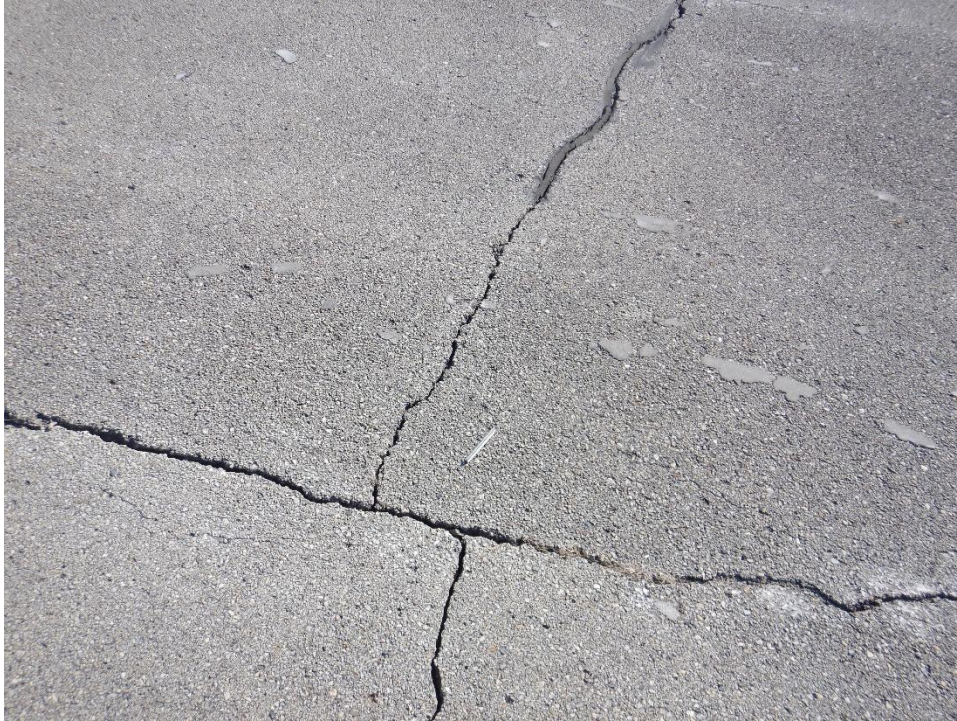
R09FC-04. L&T Cracking (Sample Unit No. 04).

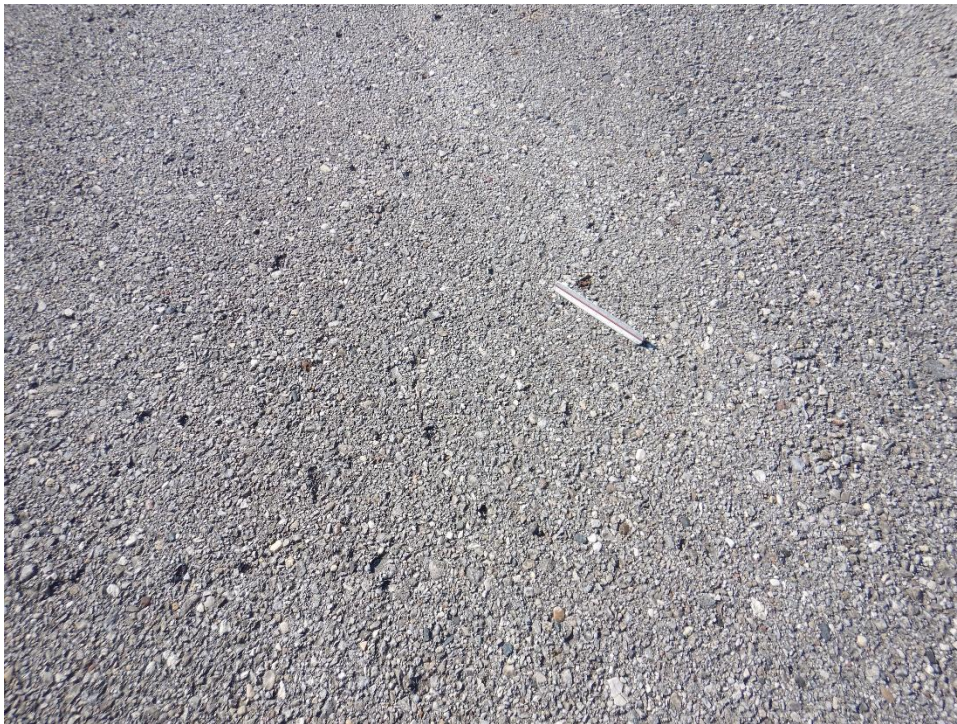
R09FC-04. Raveling (Sample Unit No. 04).

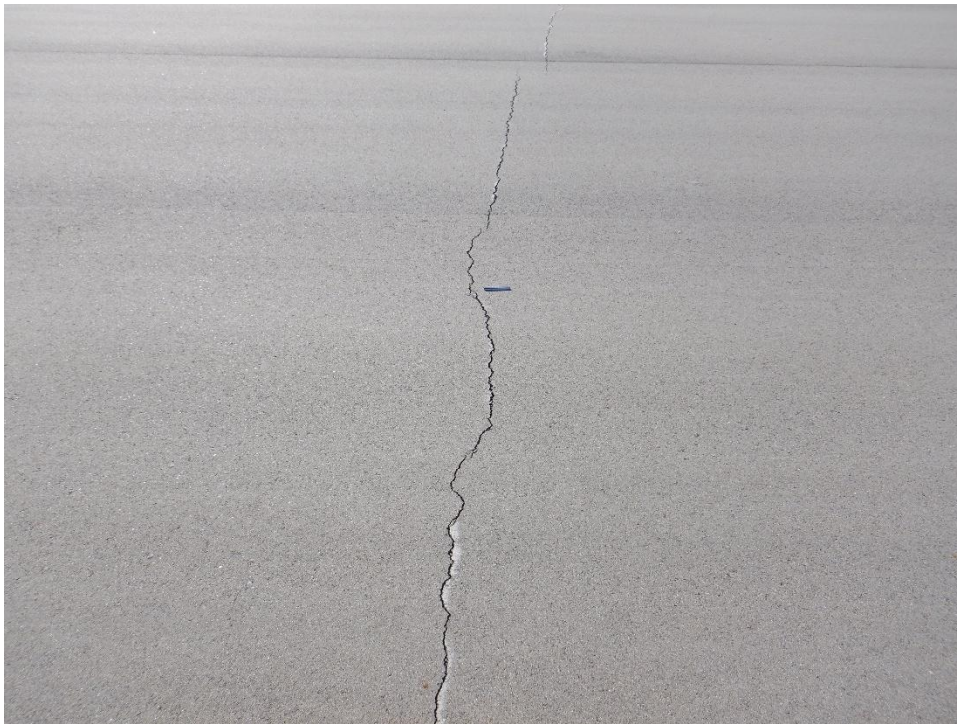
Runway 15/33 was defined by three sections. Sections 01, 02, and 03 had low- and medium-severity L&T cracking noted throughout. The low-severity L&T cracking was unsealed, and the medium-severity L&T cracking was due to unsealed crack widths that exceeded  $\frac{1}{4}$  inch. Section 03 also contained areas of low-severity raveling and medium-severity weathering.

R15FC-01. L&T Cracking (Sample Unit No. 23).

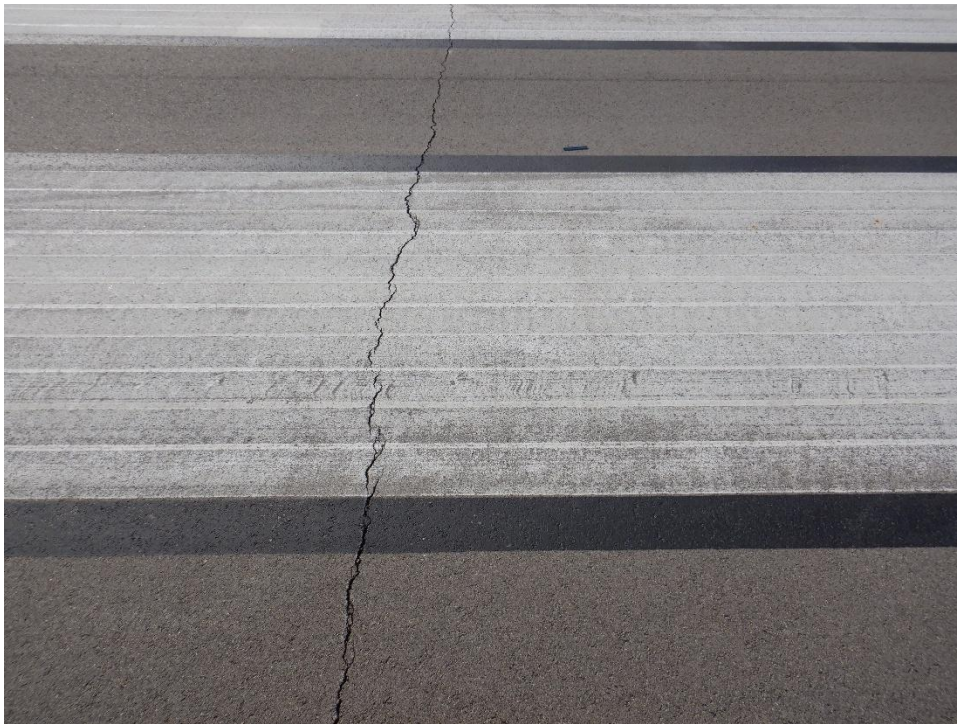
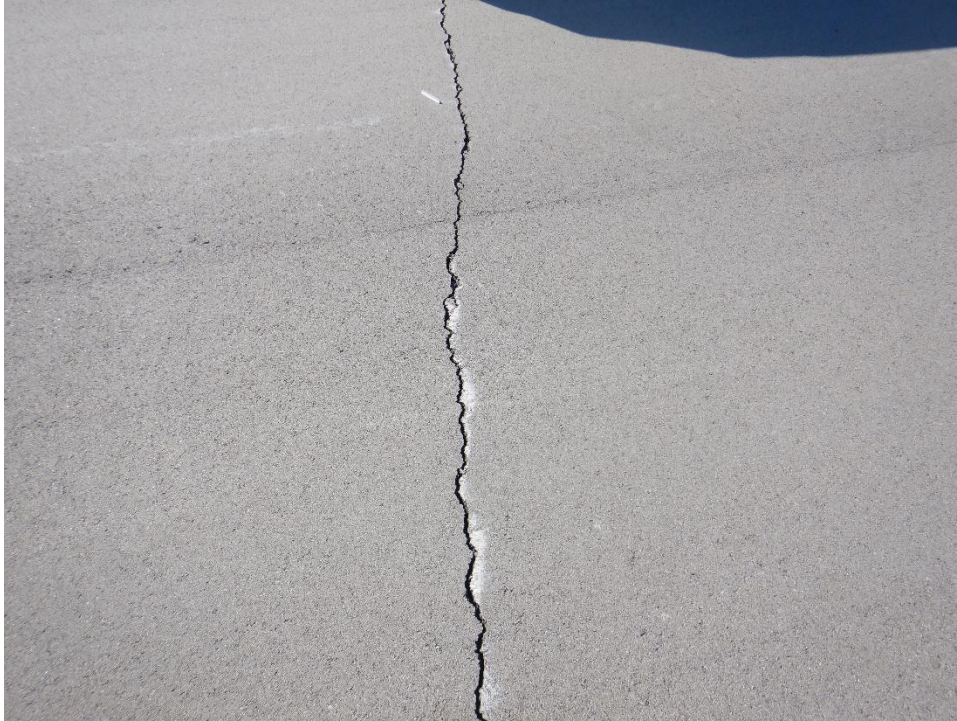
R15FC-02. L&T Cracking (Sample Unit No. 047) (1).

R15FC-02. L&T Cracking (Sample Unit No. 047) (2).

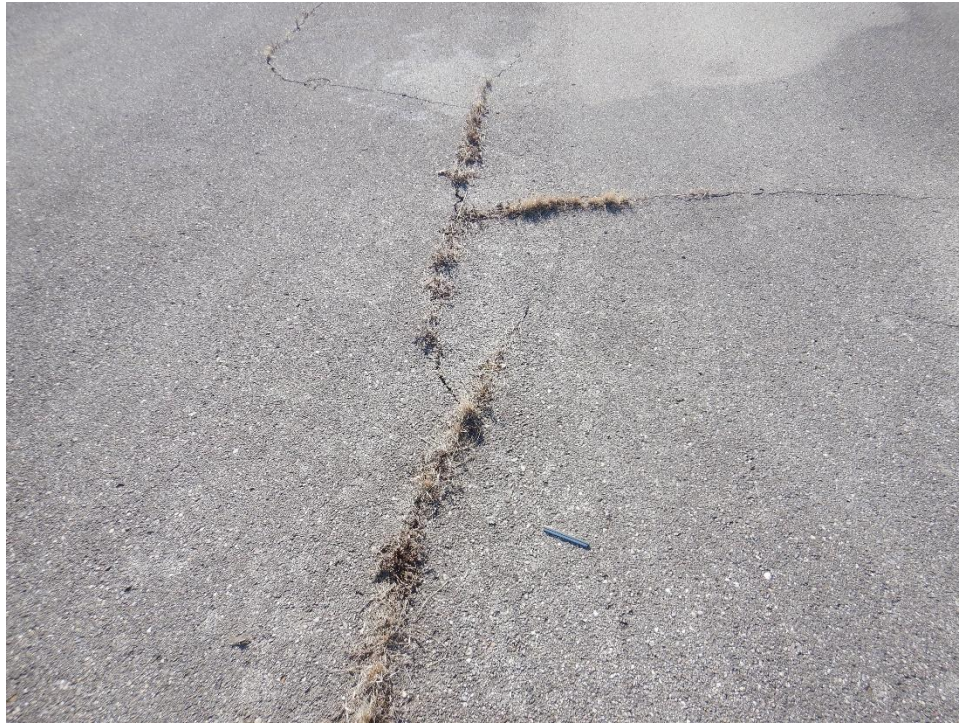
R15FC-03. L&T Cracking (Sample Unit No. 01).

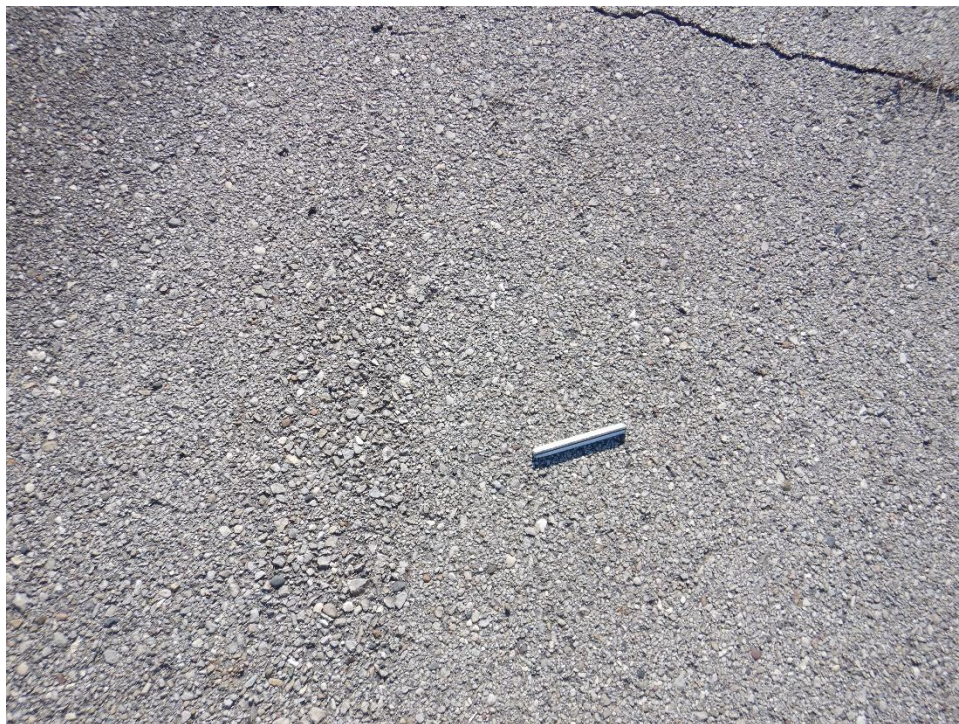
R15FC-03. Weathering (Sample Unit No. 01).

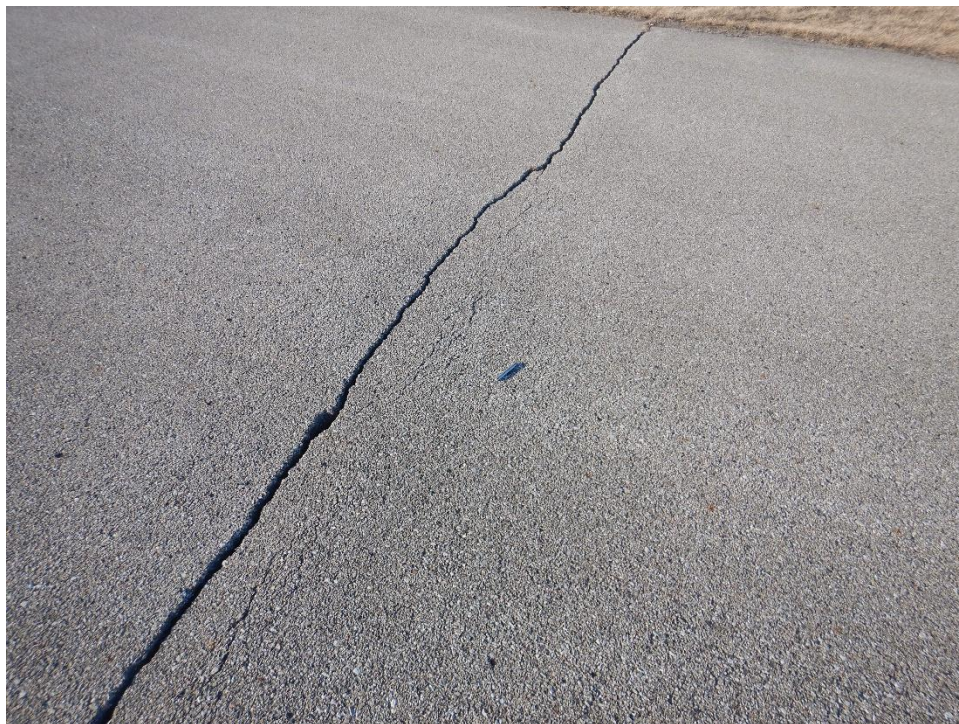
Taxiway 01 contained two sections. Low- and medium-severity L&T cracking and medium-severity weathering and raveling were identified in Section 01. Section 02 had areas of low- and medium-severity alligator cracking and depression, all severities of L&T cracking, low-severity patching, low- and high-severity raveling, and medium-severity weathering recorded during the inspection. The low-severity L&T cracking on Taxiway 01 was unsealed, the medium-severity L&T cracking was due to unsealed crack widths greater than  $\frac{1}{4}$  inch, and the high-severity L&T cracking was recorded in areas where either the development of secondary cracking was wider than 1 foot or crack widths exceeded 3 inches.

T01FC-01. L&T Cracking (Sample Unit No. 01).

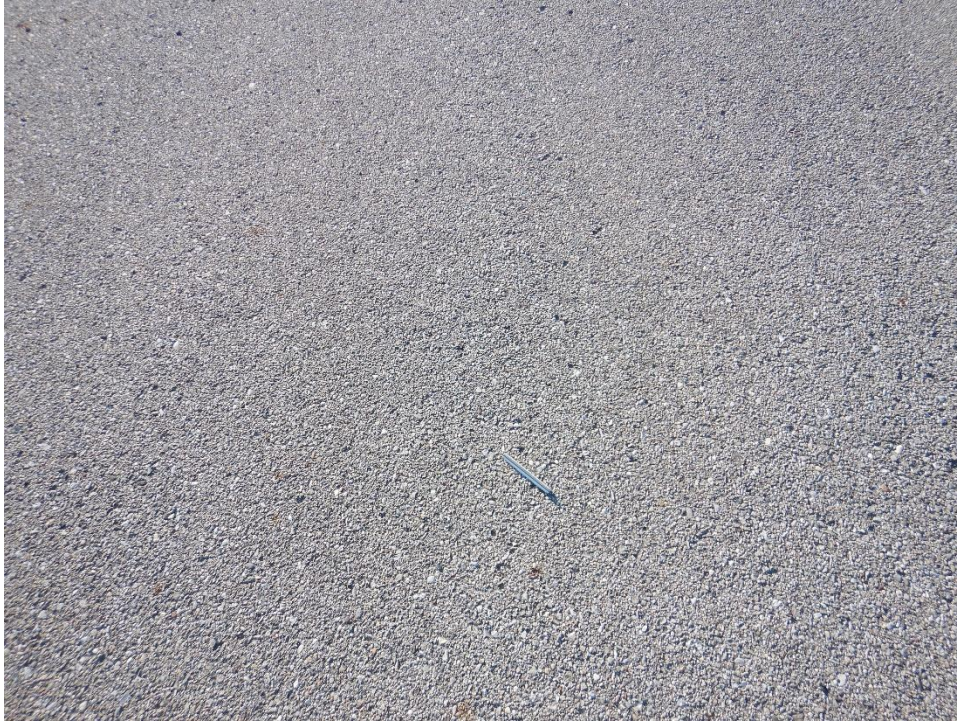
T01FC-01. Weathering (Sample Unit No. 01).

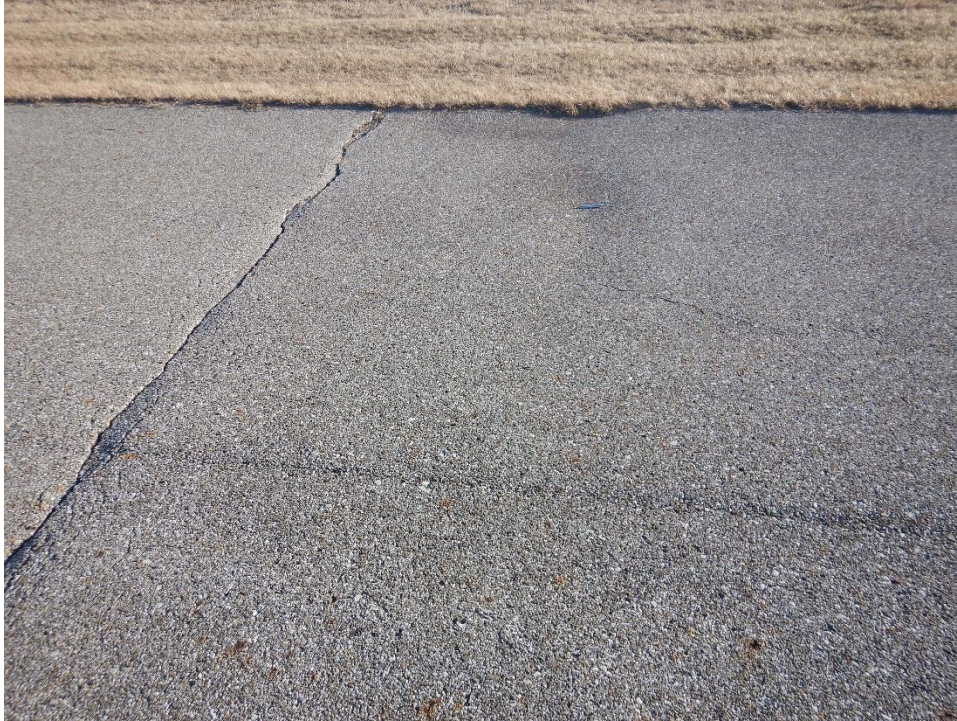
T01FC-02. Depression (Sample Unit No. 01).

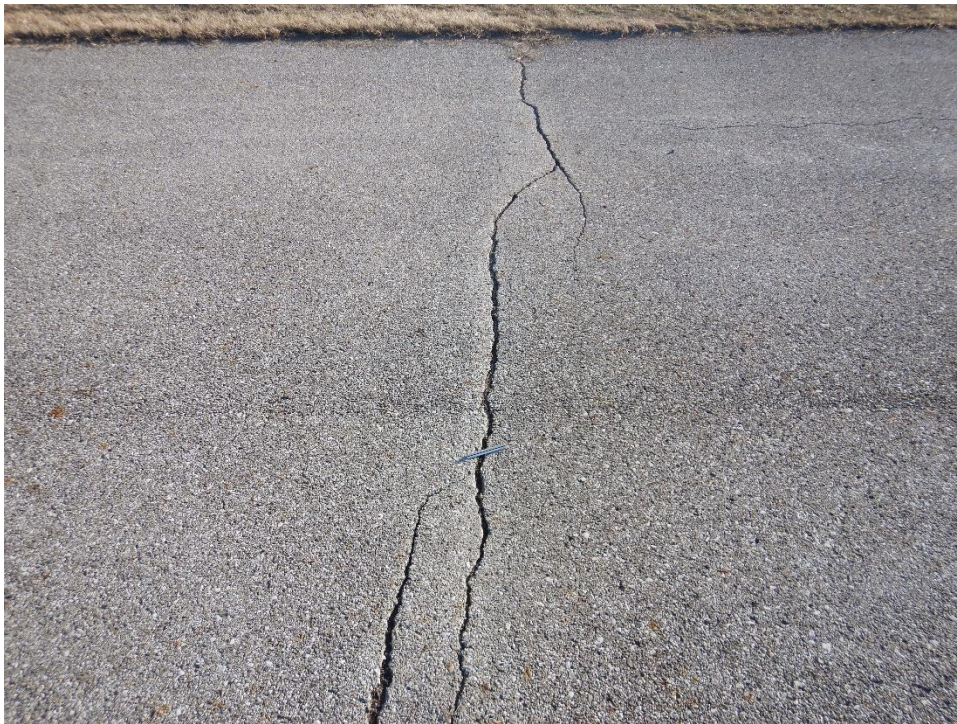
T01FC-02. L&T Cracking (Sample Unit No. 01).

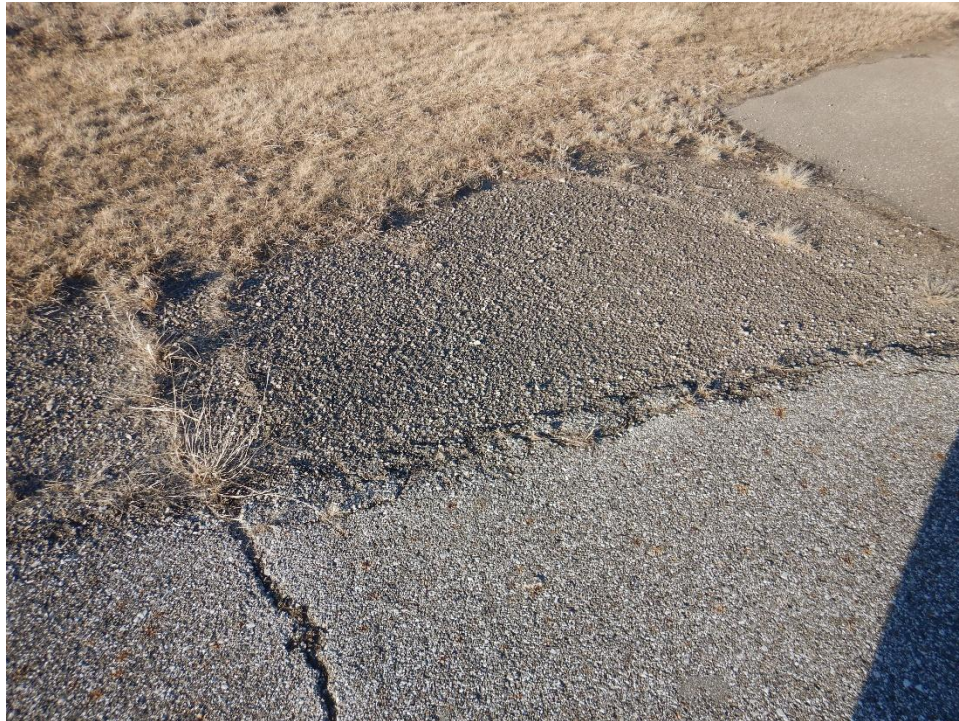
T01FC-02. Raveling (Sample Unit No. 02).

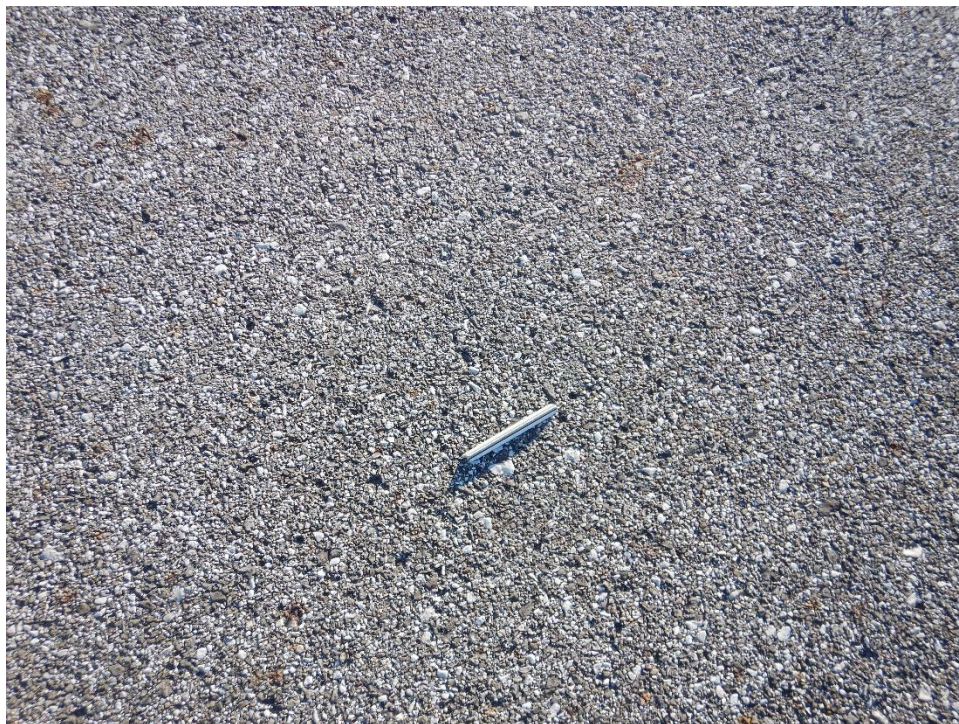
T01FC-02. Weathering and Raveling (Sample Unit No. 01).

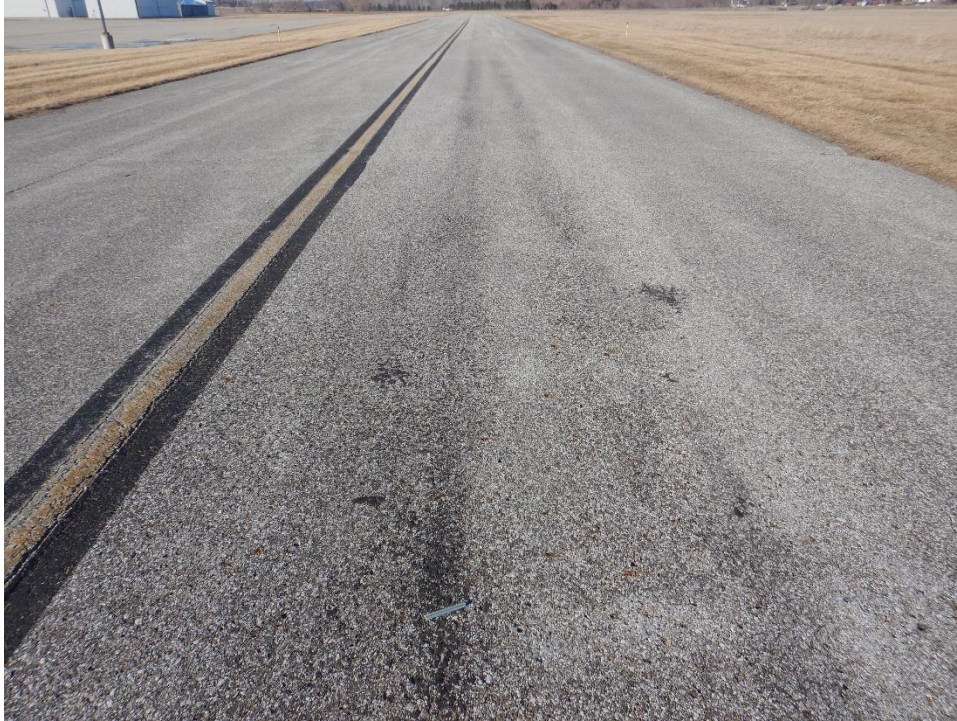
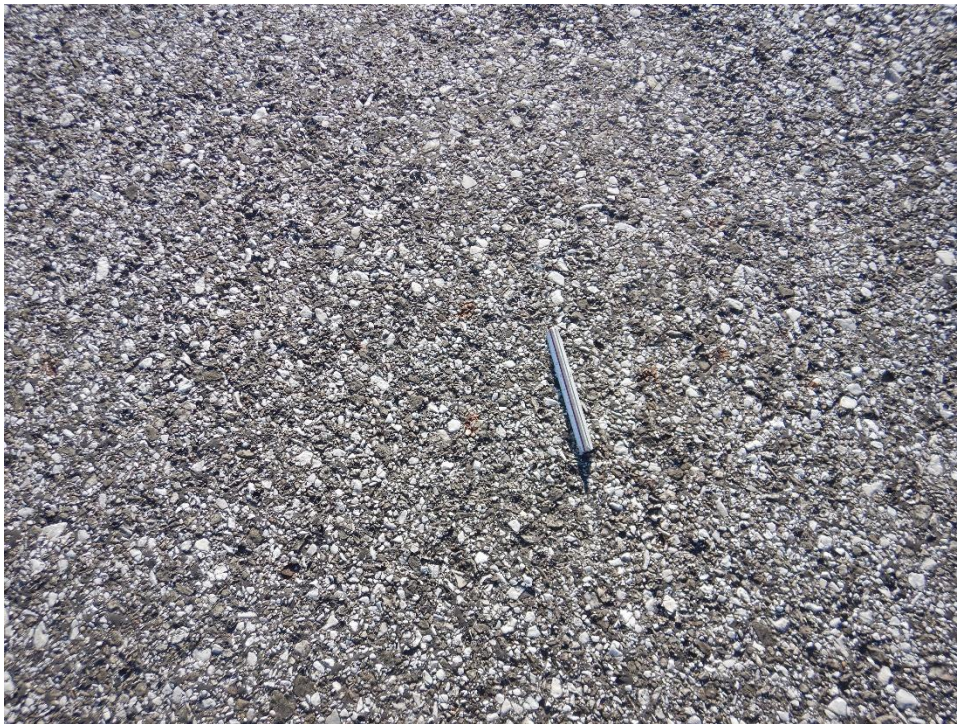
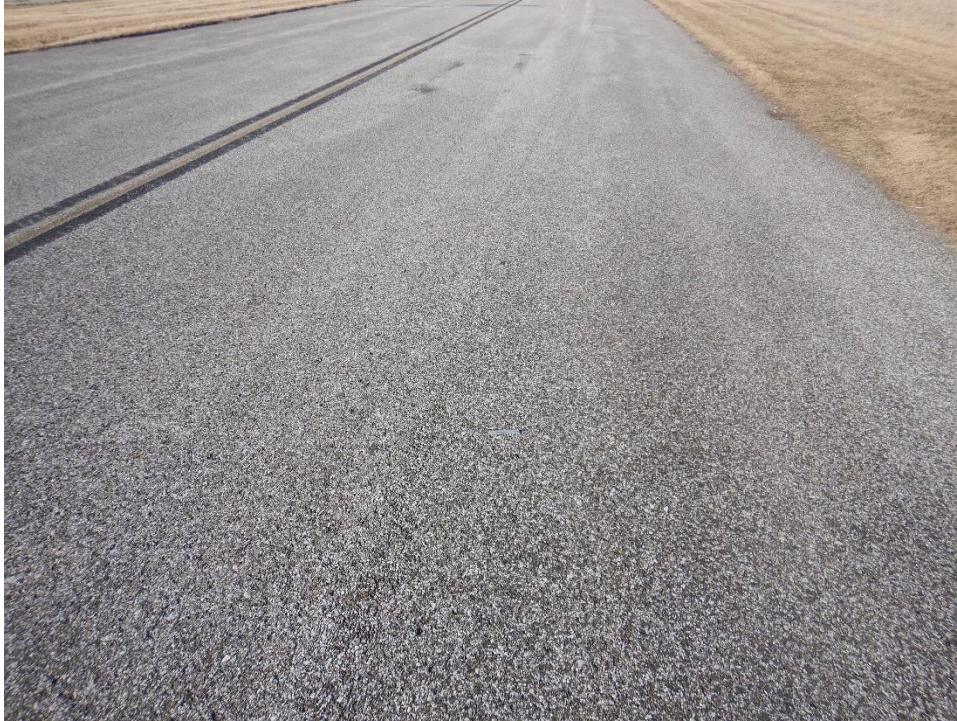
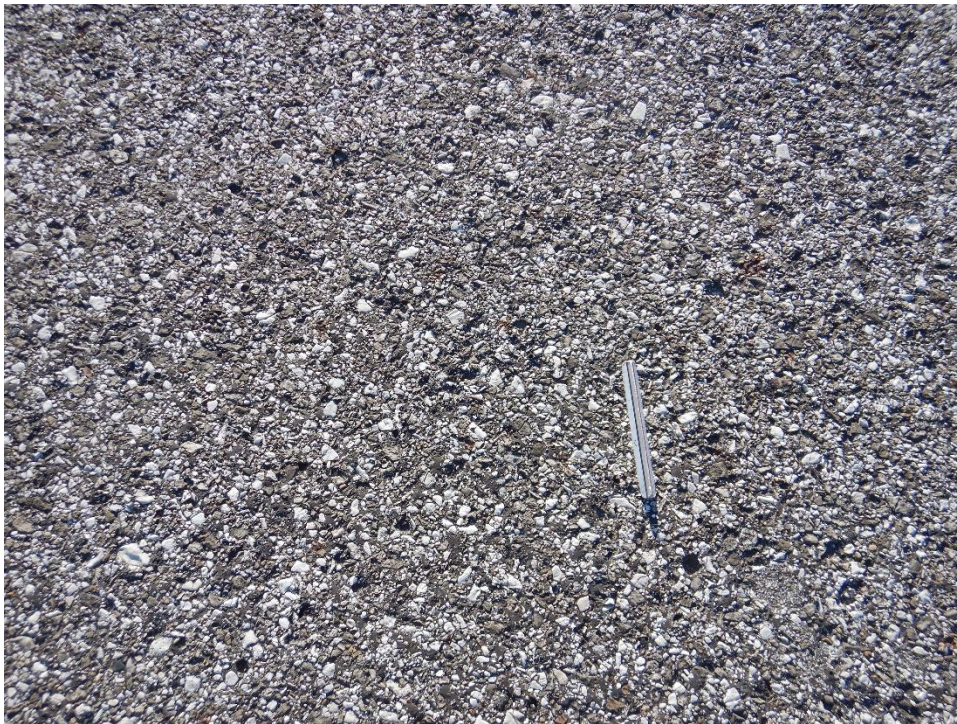
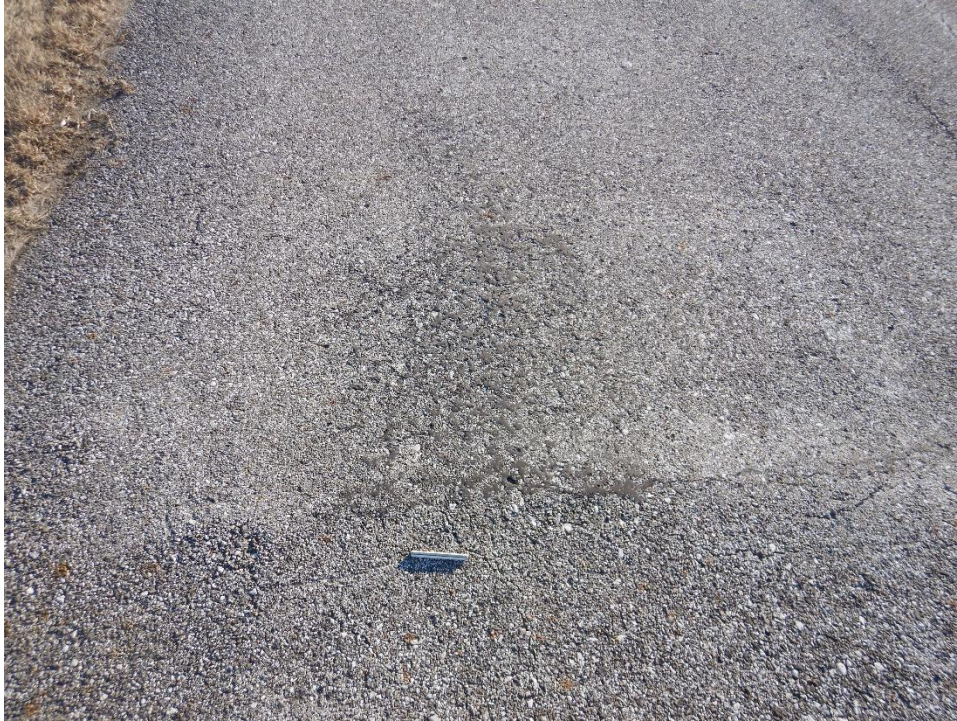
Taxiway 02 consisted of three sections. Section 01 was in *Poor* condition with medium-severity alligator cracking, bleeding, all severities of L&T cracking, low-severity patching and raveling, and medium-severity weathering observed. Section 02 contained all severities of L&T cracking and low-severity raveling and weathering. Low- and medium-severity L&T cracking and weathering and low-severity raveling were identified in Section 03. The low-severity L&T cracking on Taxiway 02 was both sealed and unsealed, the medium-severity L&T cracking was due to unsealed crack widths greater than  $\frac{1}{4}$  inch, and the high-severity L&T cracking was recorded in areas where either secondary cracking was wider than 1 foot or crack widths exceeded 3 inches.

T02FC-01. Bleeding (Sample Unit No. 02) (1).

T02FC-01. Bleeding (Sample Unit No. 02) (2).

T02FC-01. Bleeding (Sample Unit No. 03) (1).

T02FC-01. Bleeding (Sample Unit No. 03) (2).

T02FC-01. Bleeding (Sample Unit No. 04).

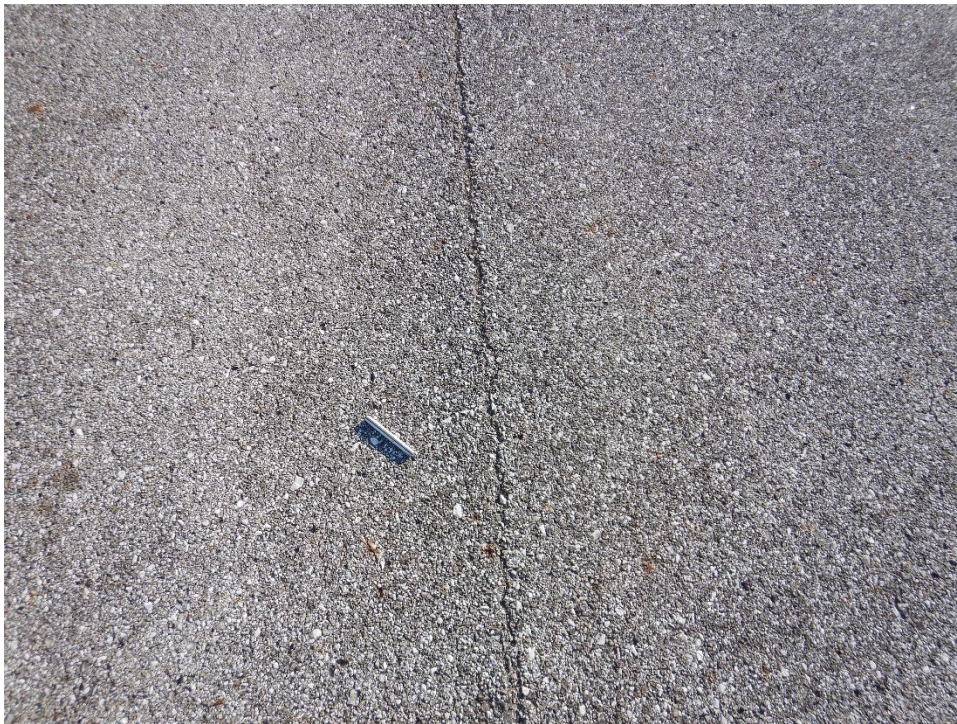
T02FC-01. L&T Cracking (Sample Unit No. 02).

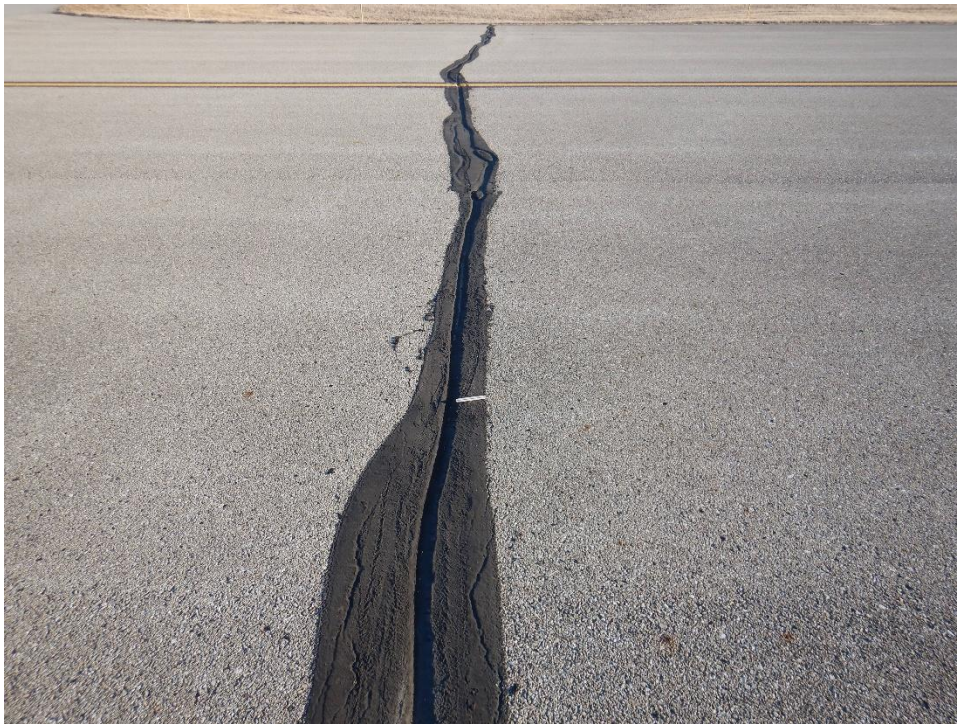
T02FC-02. L&T Cracking (Sample Unit No. 01).

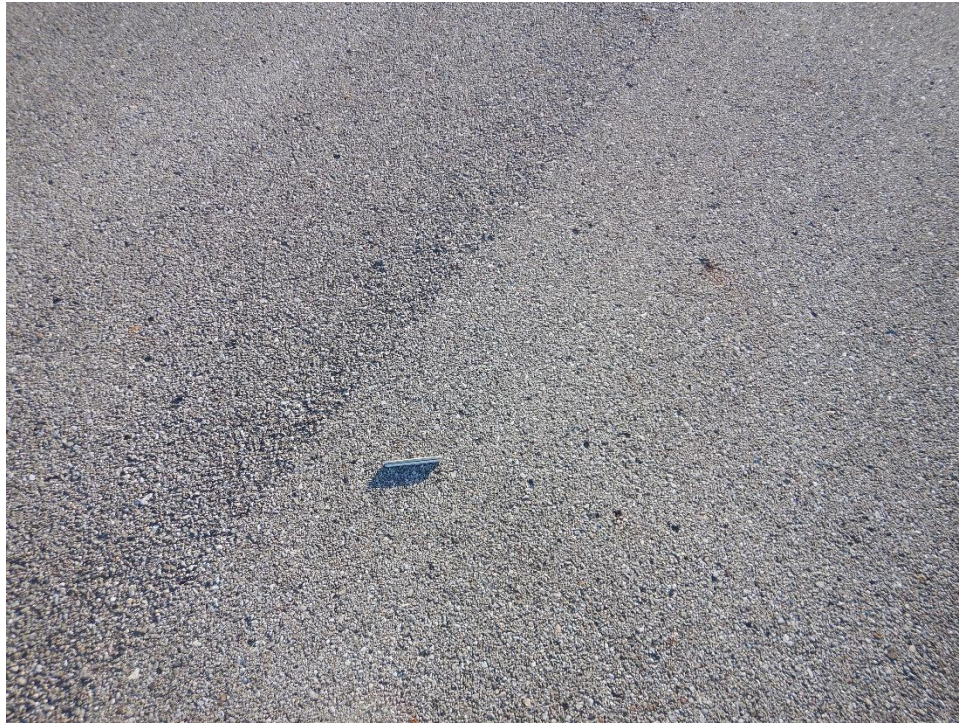
T02FC-02. Weathering (Sample Unit No. 01).
