# Forest City Municipal Airport/Trimble Field

## Pavement Management Report

**AUGUST 2026**

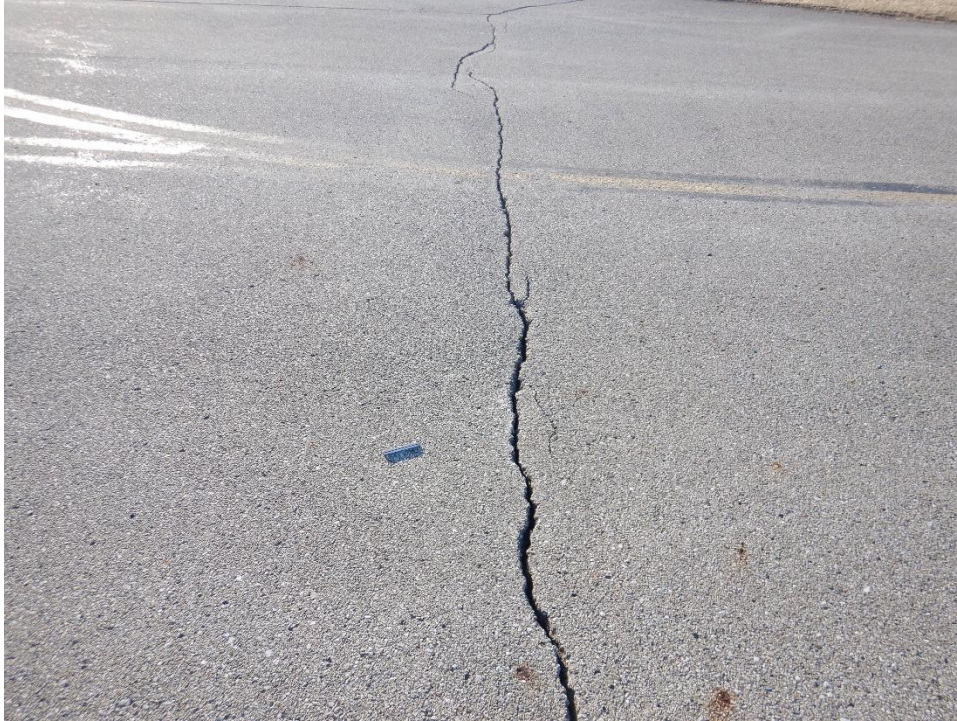
Taxiway 02 consisted of three sections. Section 01 was in *Poor* condition with medium-severity alligator cracking, bleeding, all severities of L&T cracking, low-severity patching and raveling, and medium-severity weathering observed. Section 02 contained all severities of L&T cracking and low-severity raveling and weathering. Low- and medium-severity L&T cracking and weathering and low-severity raveling were identified in Section 03. The low-severity L&T cracking on Taxiway 02 was both sealed and unsealed, the medium-severity L&T cracking was due to unsealed crack widths greater than  $\frac{1}{4}$  inch, and the high-severity L&T cracking was recorded in areas where either secondary cracking was wider than 1 foot or crack widths exceeded 3 inches.

T02FC-03. L&T Cracking (Sample Unit No. 01).

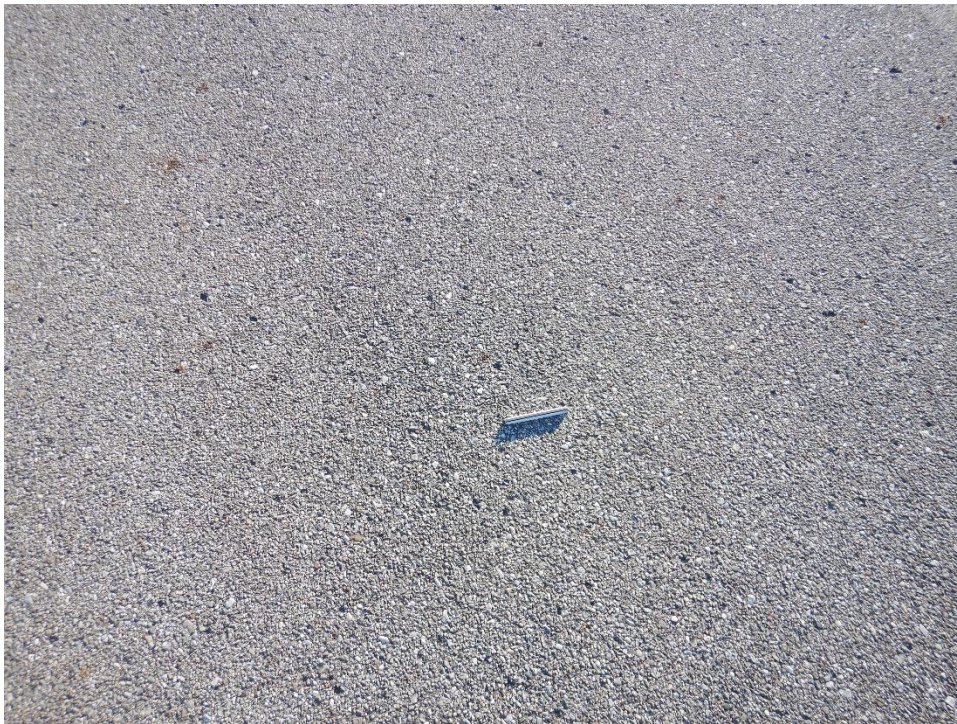
T02FC-03. Weathering and Raveling (Sample Unit No. 01).

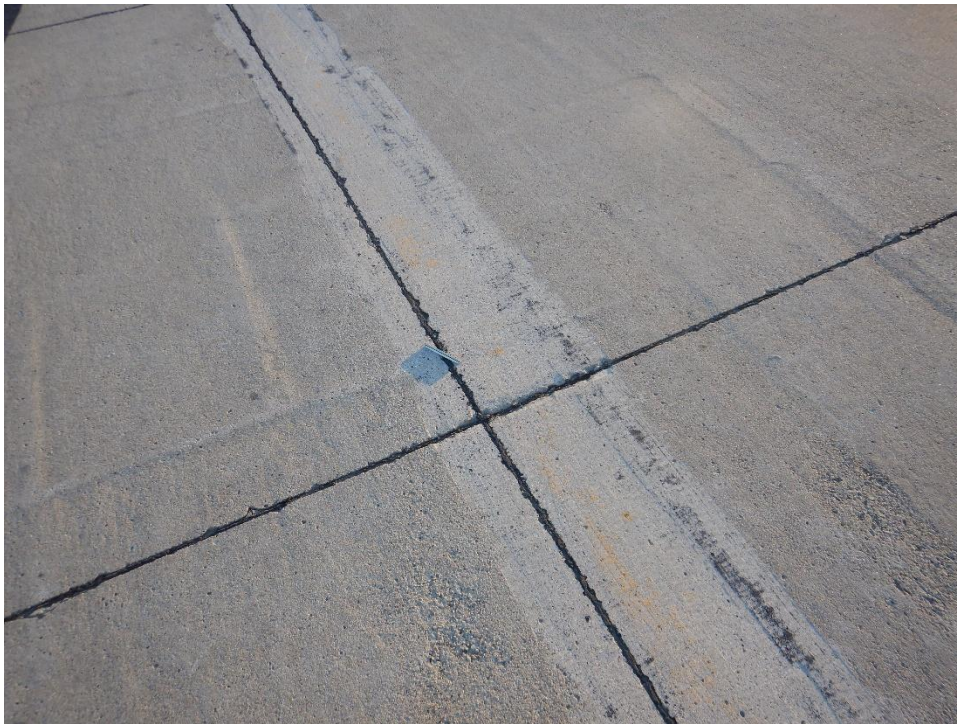
The T-hangar area consisted of four sections. Section 01 had only high-severity joint seal damage noted. Section 02 contained high-severity joint seal damage, medium-severity joint spalling, low- and medium-severity LTD cracking and shattered slab, and shrinkage cracking.

TH01FC-01. Joint Seal Damage (Sample Unit No. 01).

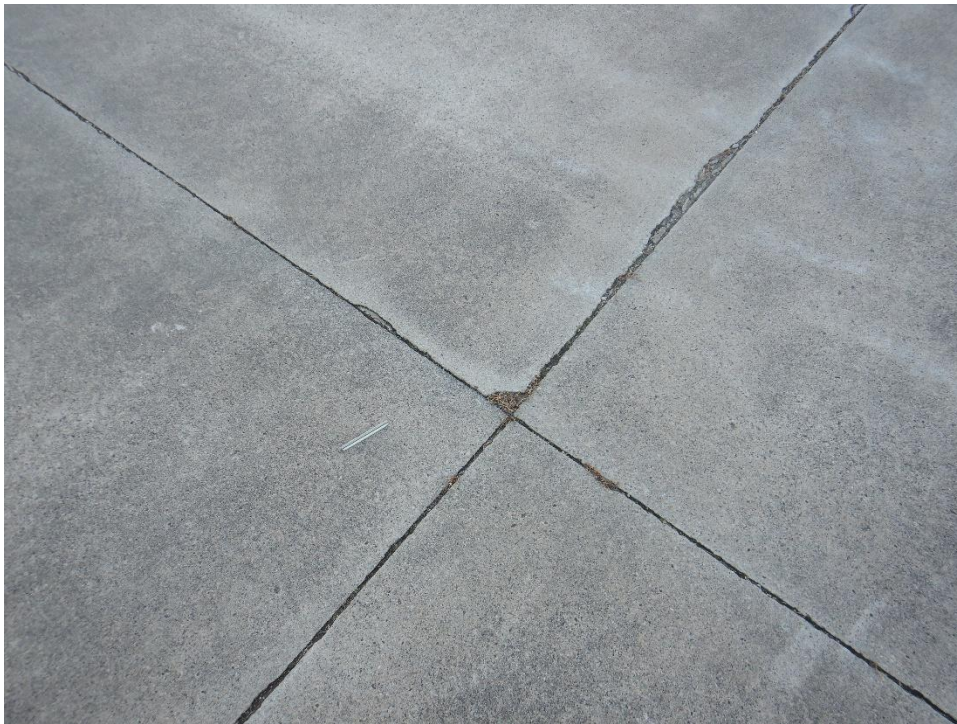
TH01FC-02. Joint Seal Damage (Sample Unit No. 01).

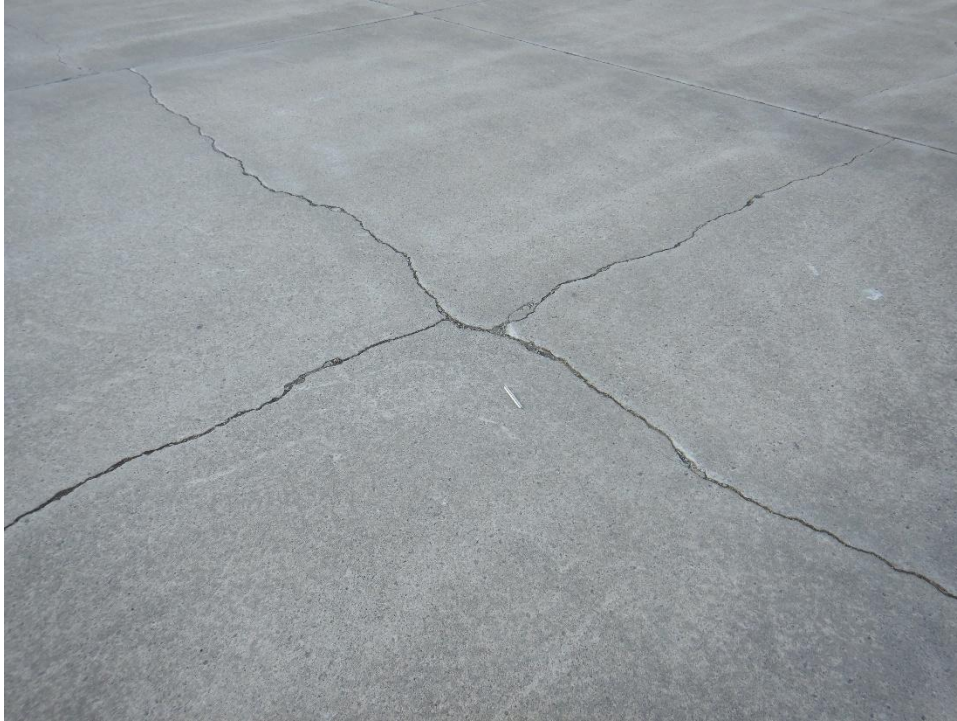
TH01FC-02. Shattered Slab (Sample Unit No. 01).

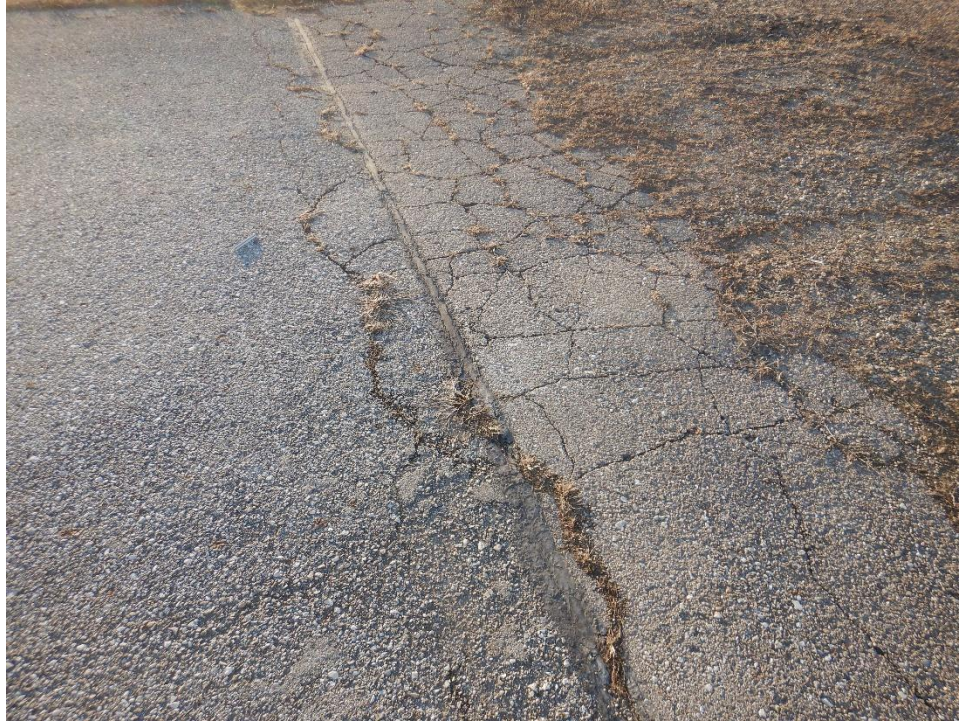
Medium-severity alligator cracking and weathering and low- and medium-severity L&T cracking were recorded in Section 03. Section 04 was in *Excellent* condition with no distress noted at the time of inspection.

TH01FC-03. Alligator Cracking (Sample Unit No. 01).

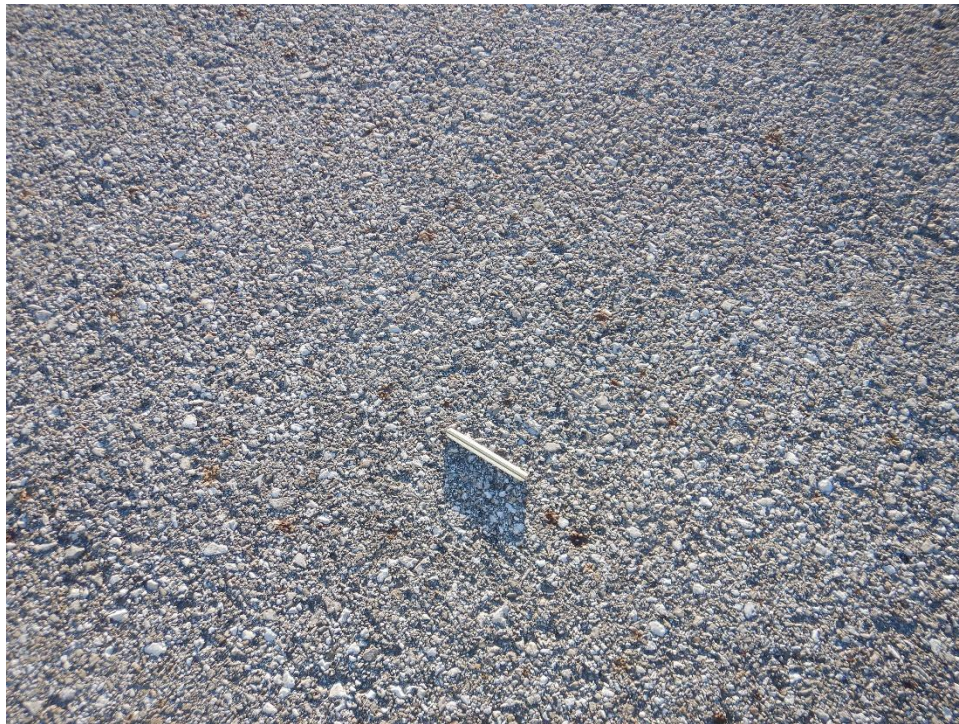
TH01FC-03. Weathering (Sample Unit No. 01).
