# Greenfield Municipal Airport

## PAVEMENT MANAGEMENT REPORT

**JULY 2022**

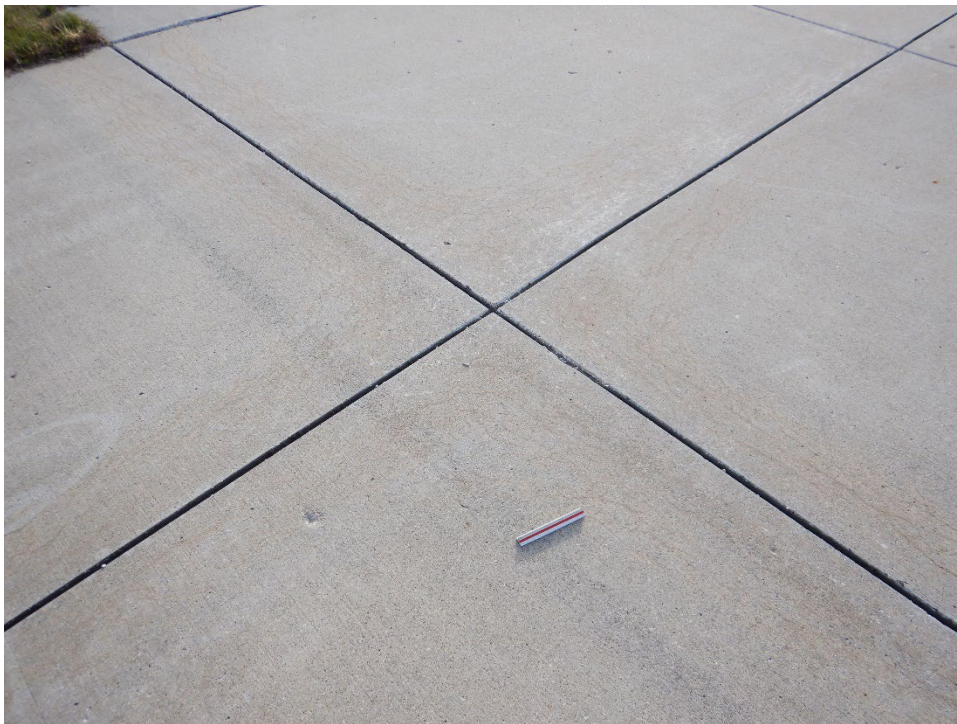
Apron 01 contained one section that had areas of low-severity corner spalling and small patching and low- and medium-severity ASR and LTD cracking.

A01GR-01. ASR (Sample Unit No. 09).

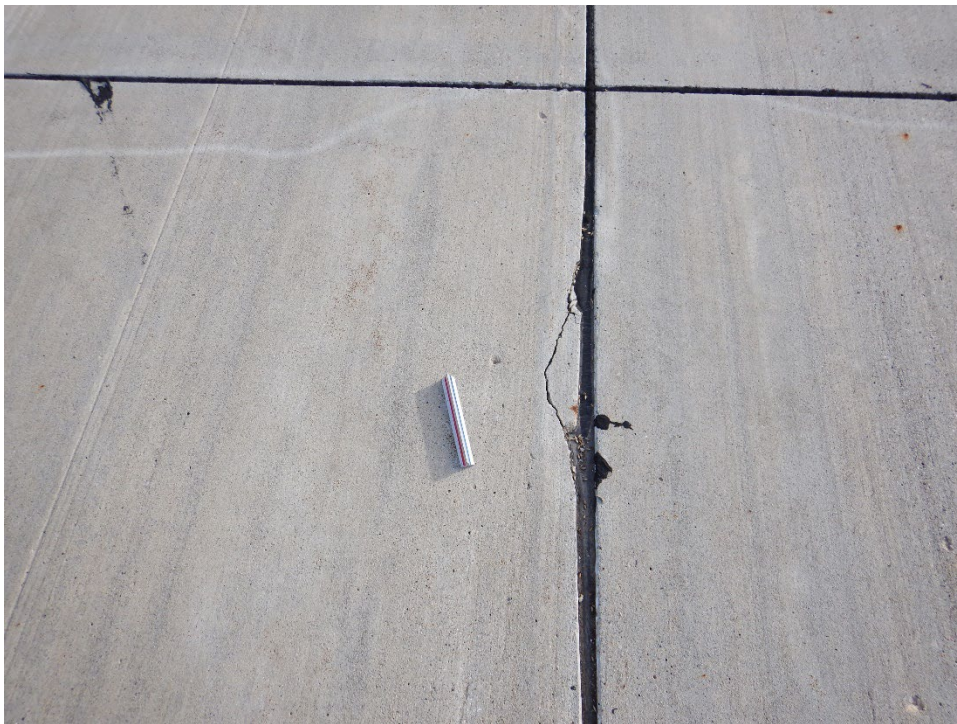
A02GR-01. Joint Spalling (Sample Unit No. 03).

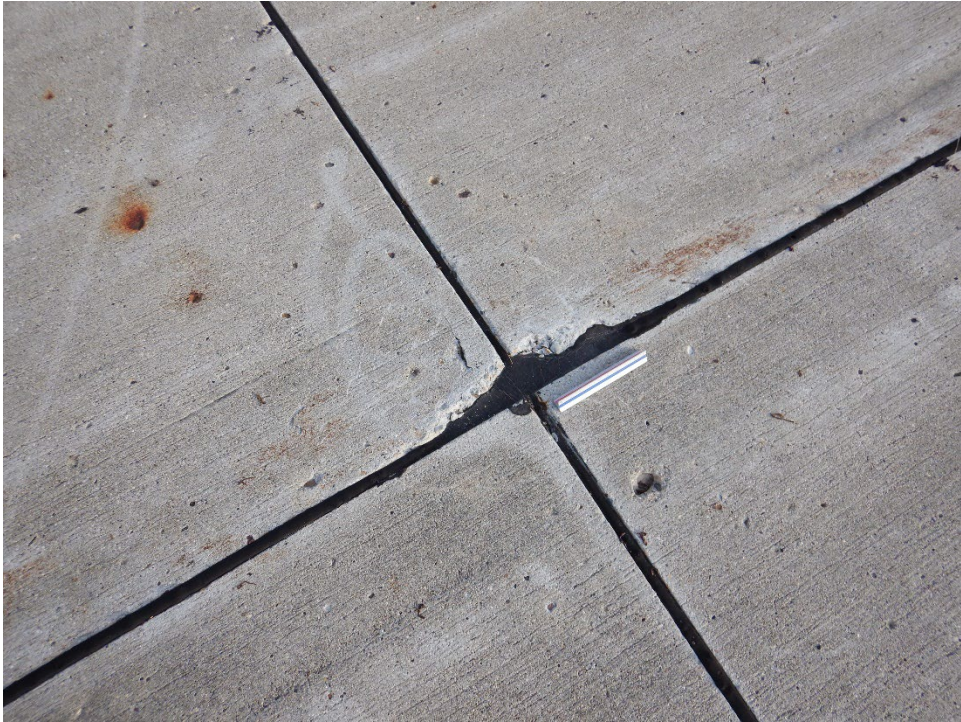
Runway 07/25 was defined by two sections. Section 01 contained areas of low- and medium-severity ASR and corner spalling, as well as low-severity joint seal damage, joint spalling, and small patching. Low-severity joint seal damage and joint spalling and low- and medium-severity longitudinal, transverse and diagonal (LTD) cracking were recorded in Section 02.

R07GR-01. ASR (Sample Unit No. 40).

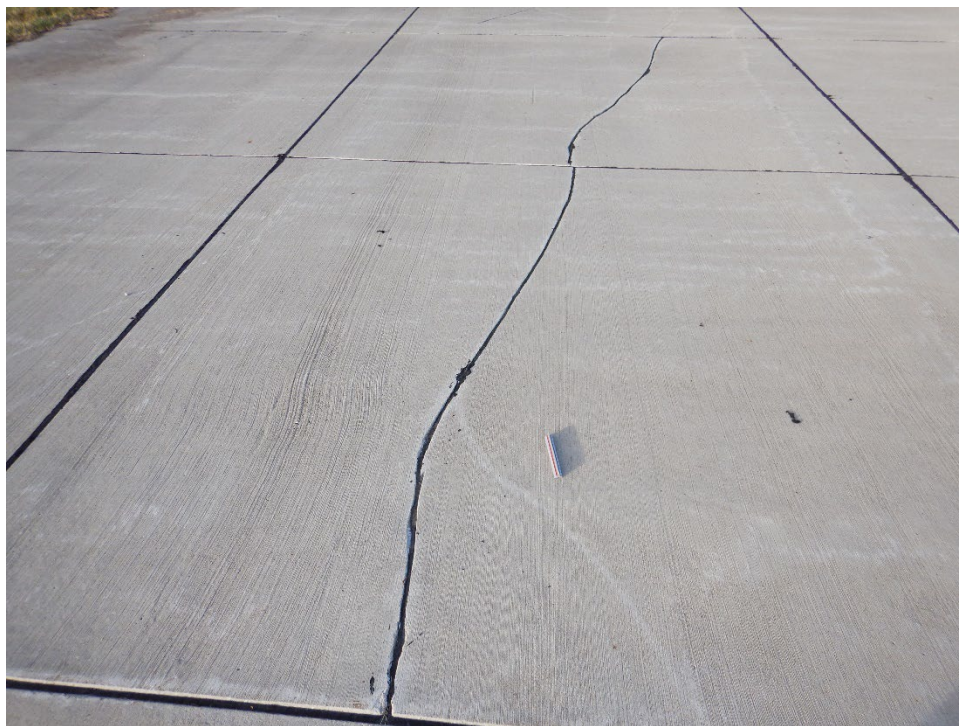
R07GR-02. LTD Cracking (Sample Unit No. 01).

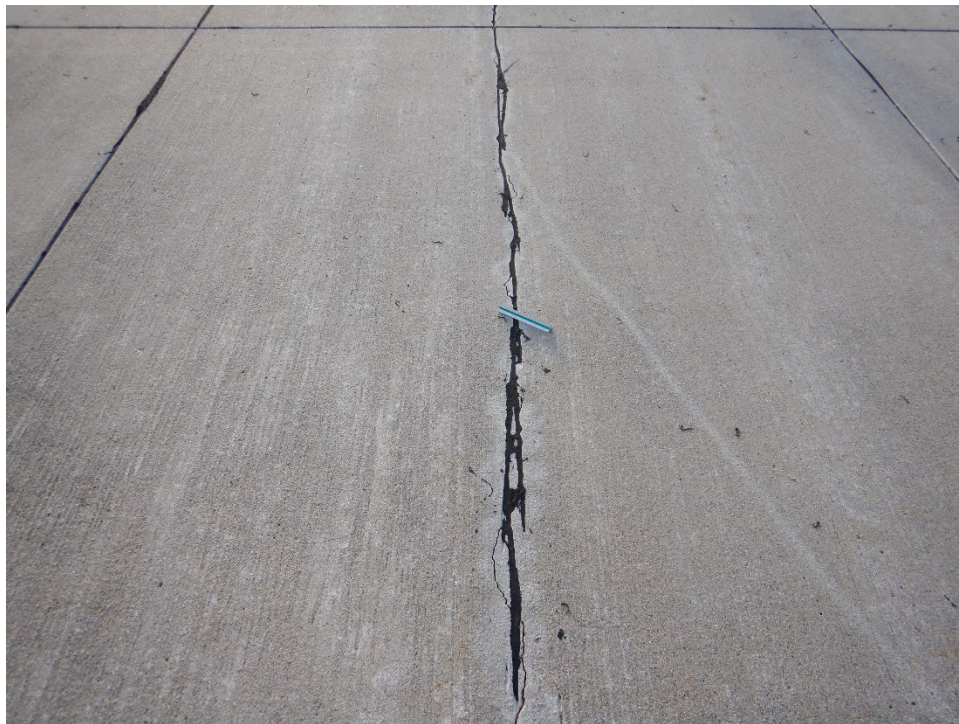
Runway 14/32 consisted of four sections. Areas of low-severity ASR, corner break, corner spalling, joint spalling, and large patching; low- and medium-severity LTD cracking; and shrinkage cracking were identified in Section 01. Section 02 contained low- and medium-severity ASR and LTD cracking; low-severity corner break, corner spalling, joint seal damage, joint spalling, and small patching; and shrinkage cracking. Shrinkage cracking and low-severity corner break, corner spalling, faulting, joint seal damage, joint spalling, and LTD cracking were noted in Section 03. Section 04 was in excellent condition with only areas of low-severity ASR and corner spalling identified at the time of inspection.

R14GR-01. LTD Cracking (Sample Unit No. 33).

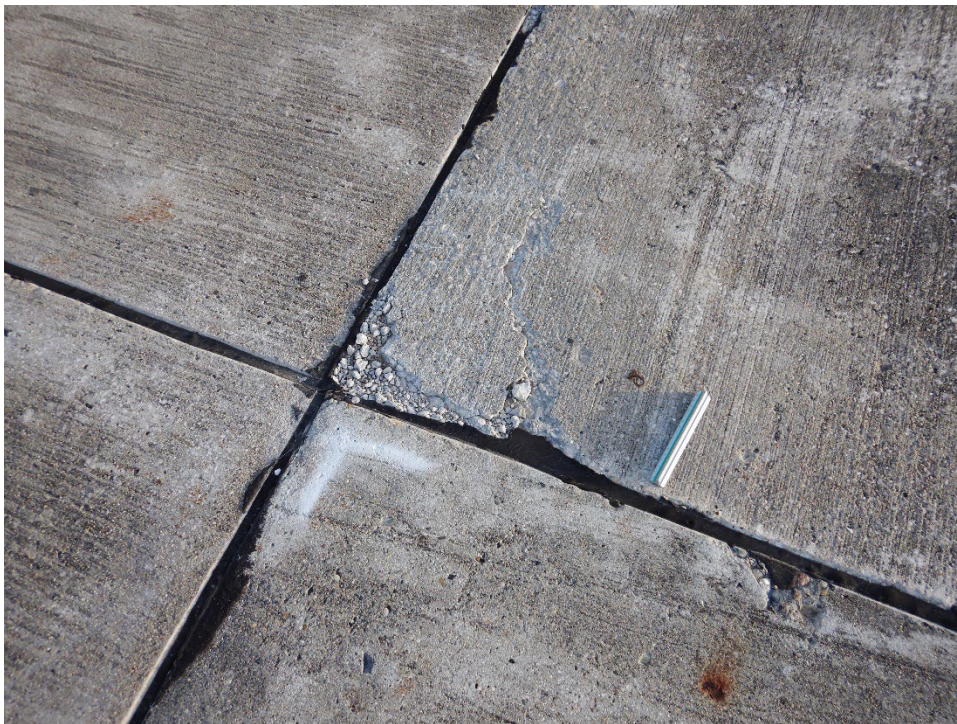
R14GR-02. ASR (Sample Unit No. 02).

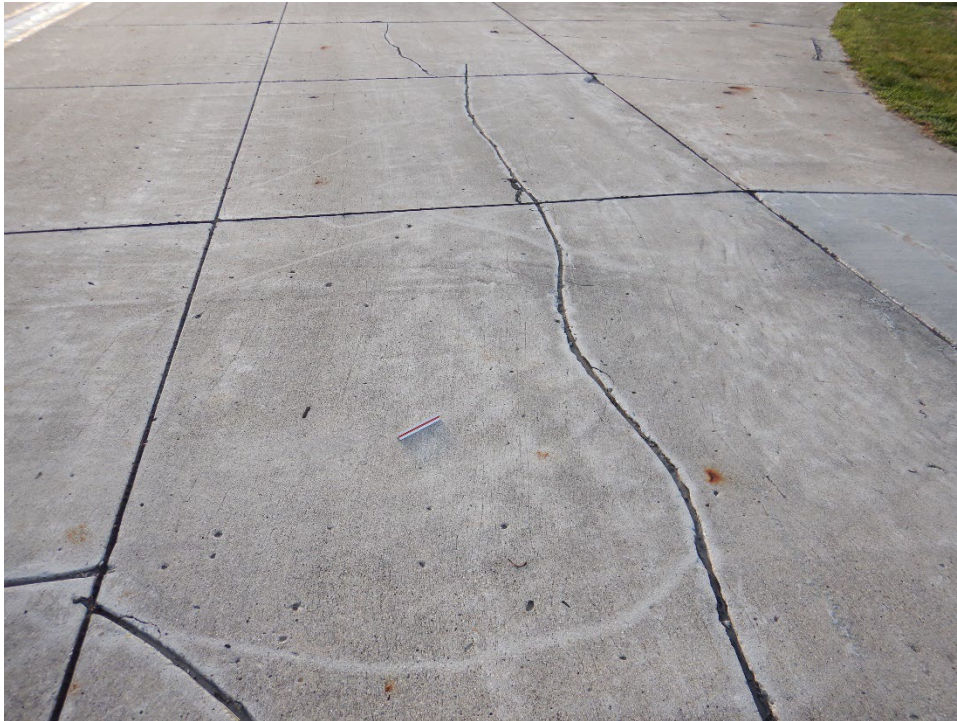
R14GR-02. LTD Cracking (Sample Unit No. 01).

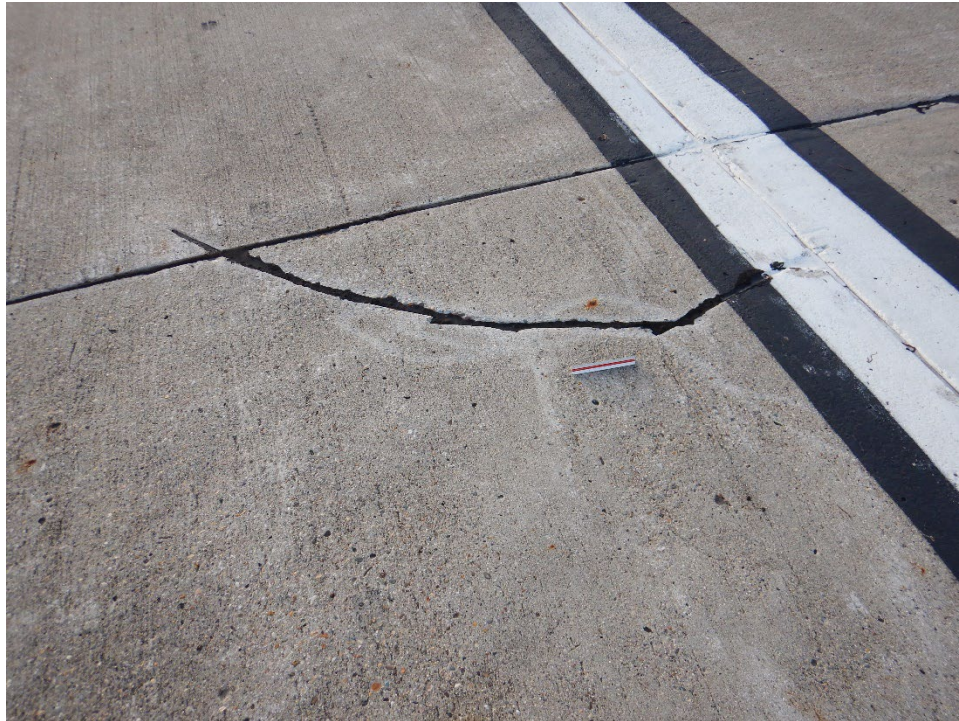
R14GR-03. Corner Break (Sample Unit No. 01).

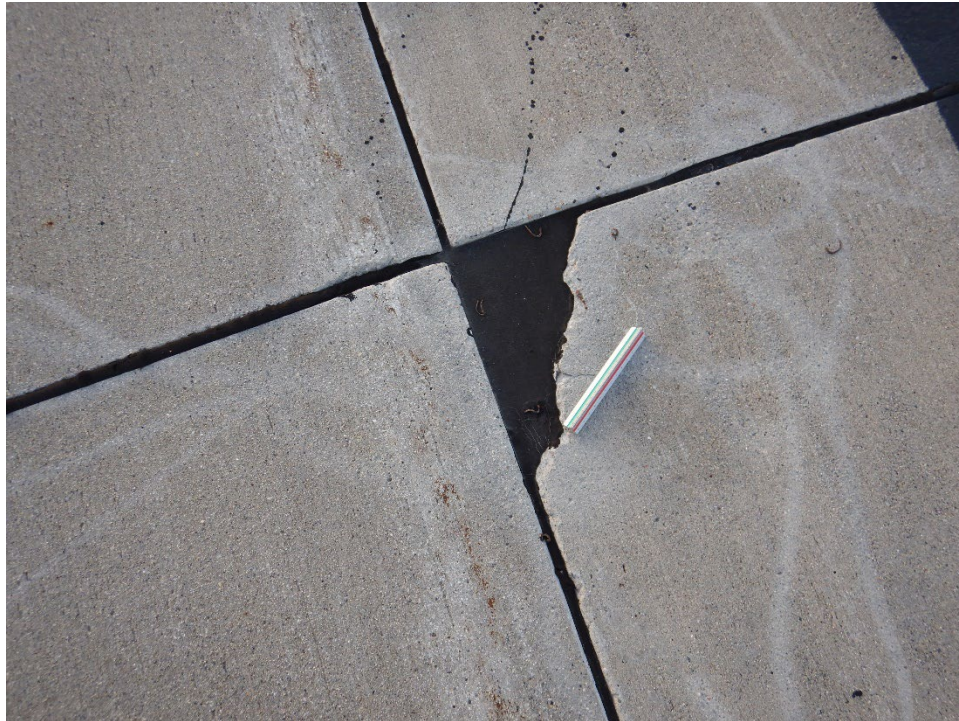
R14GR-04. Corner Spalling (Sample Unit No. 19).

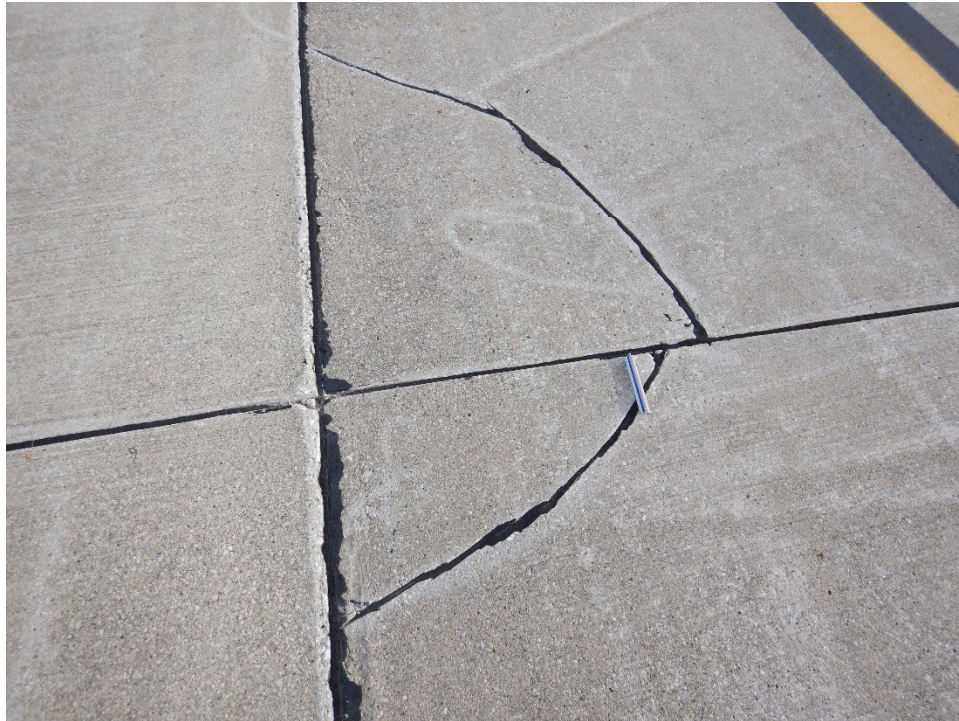
Taxiway 01 connected Runway 14/32 to the Apron 01 area and contained two sections. Section 01 contained low-severity corner break, medium-severity faulting, and low- and medium-severity joint spalling and LTD cracking. Section 02 was in excellent condition with no distress recorded at the time of inspection.

T01GR-01. Corner Break (Sample Unit No. 02).

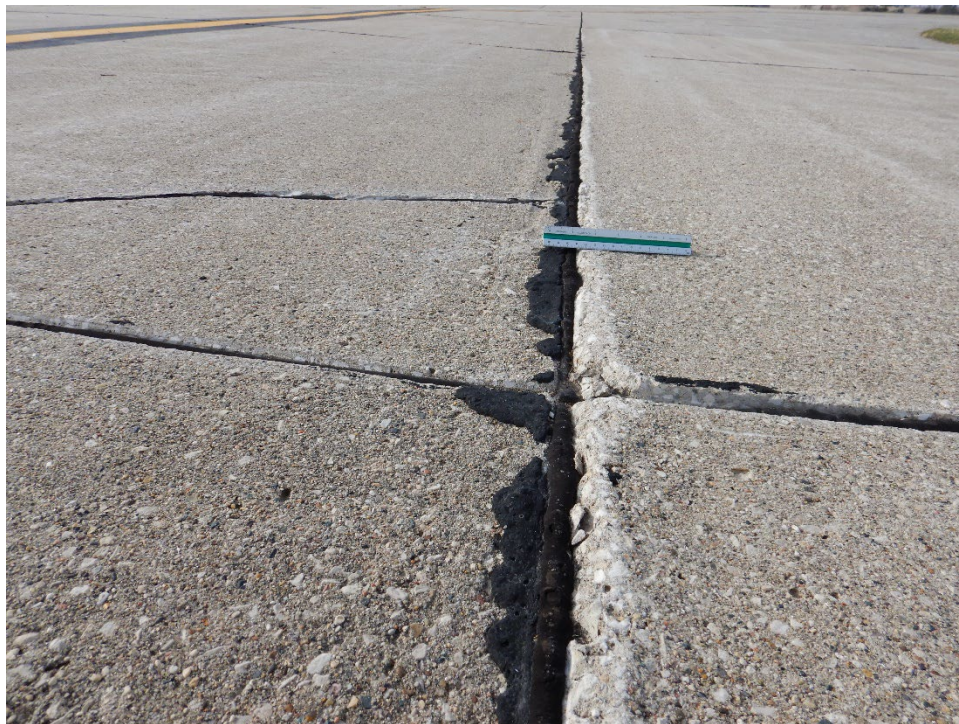
T01GR-01. Faulting (Sample Unit No. 02).

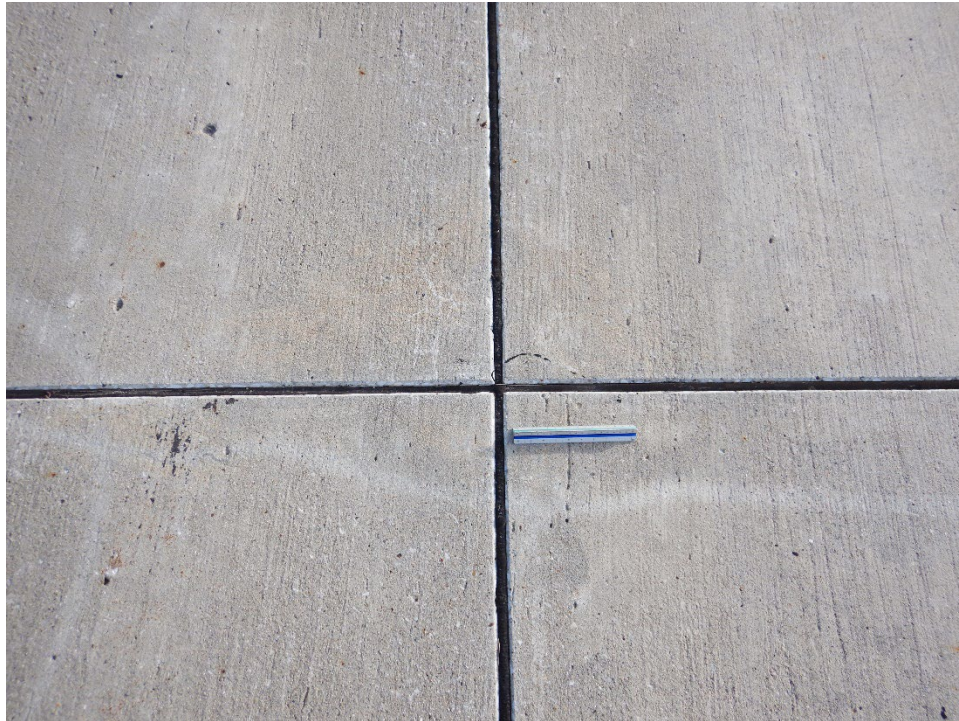
Taxiway 02 connected Apron 01 with Apron 02 and was defined by one section. Areas of low- and medium-severity ASR and LTD cracking, medium-severity corner spalling, low-severity joint seal damage, and shrinkage cracking were observed in Section 01.

T02GR-01. ASR (Sample Unit No. 15).

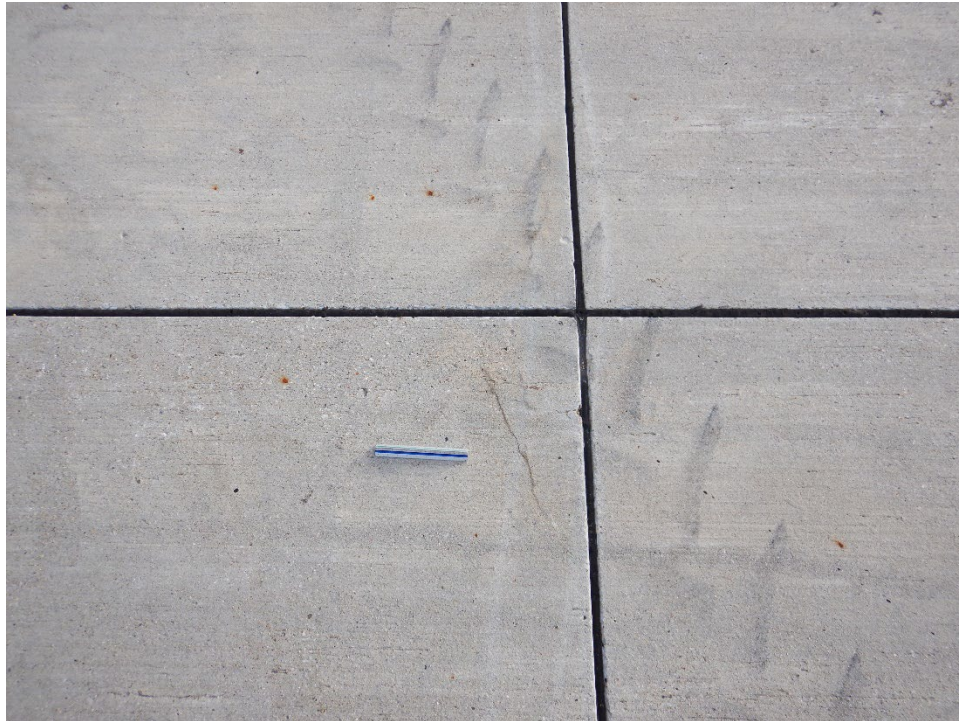
Taxiway 03 connected Runway 07/25 to the Apron 02 area and consisted of one section. Areas of medium-severity LTD cracking and low-severity ASR, corner break, faulting, and joint spalling were noted in Section 01 during the inspection.

T03GR-01. ASR (Sample Unit No. 02).

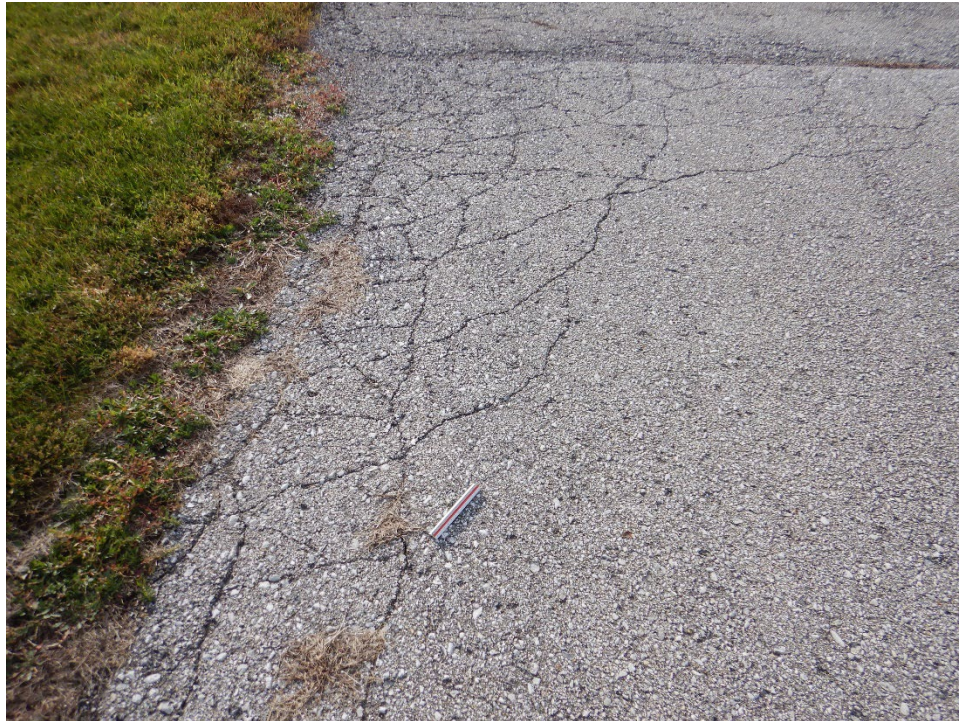
The T-hangar 01 area consisted of two sections. Section 01 was in poor condition with high-severity depression and medium-severity alligator cracking, longitudinal and transverse (L&T) cracking, patching, and raveling. Section 02 was also in poor condition with low-severity ASR,

TH01GR-01. Alligator Cracking (Sample Unit No. 01).

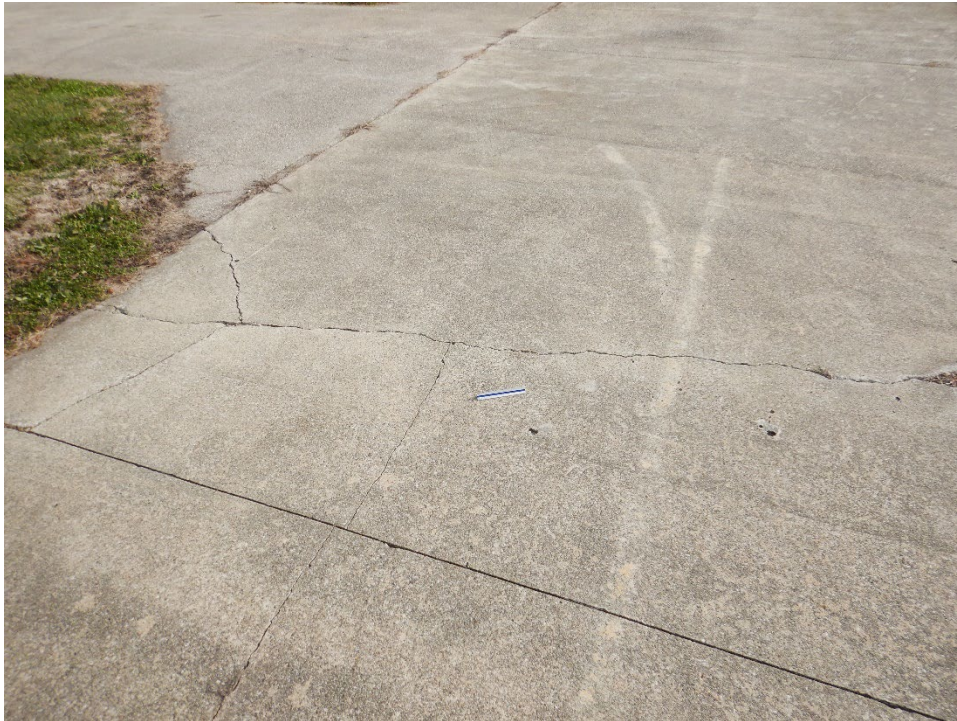
and corner break, high-severity joint seal damage, and low- and medium-severity LTD cracking and shattered slab.

TH01GR-02. Shattered Slab (Sample Unit No. 01).

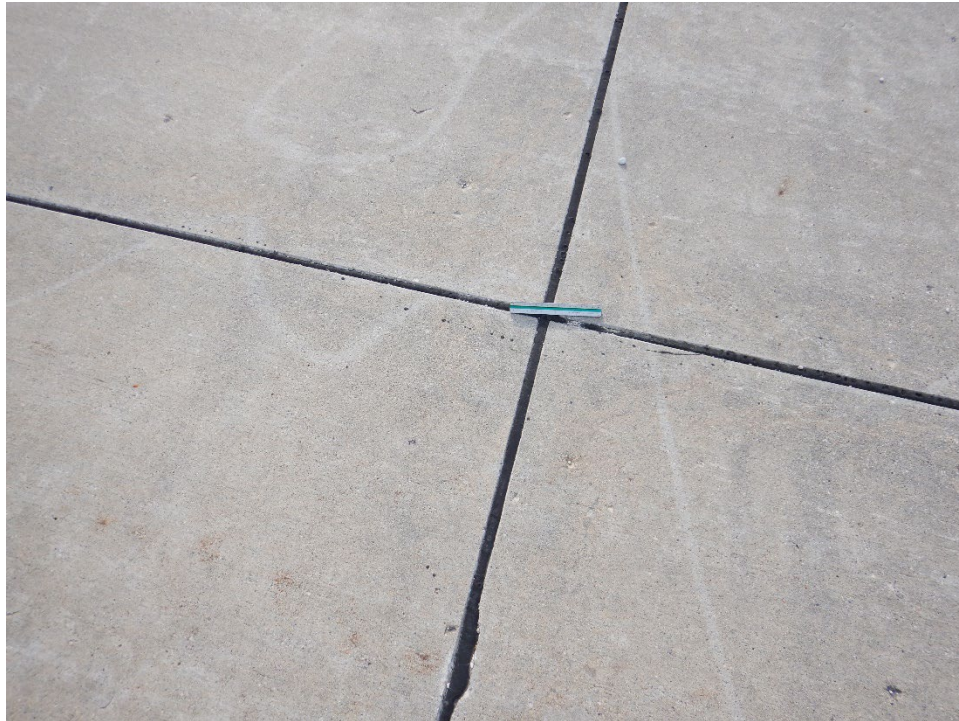
TH02GR-01. ASR (Sample Unit No. 01).

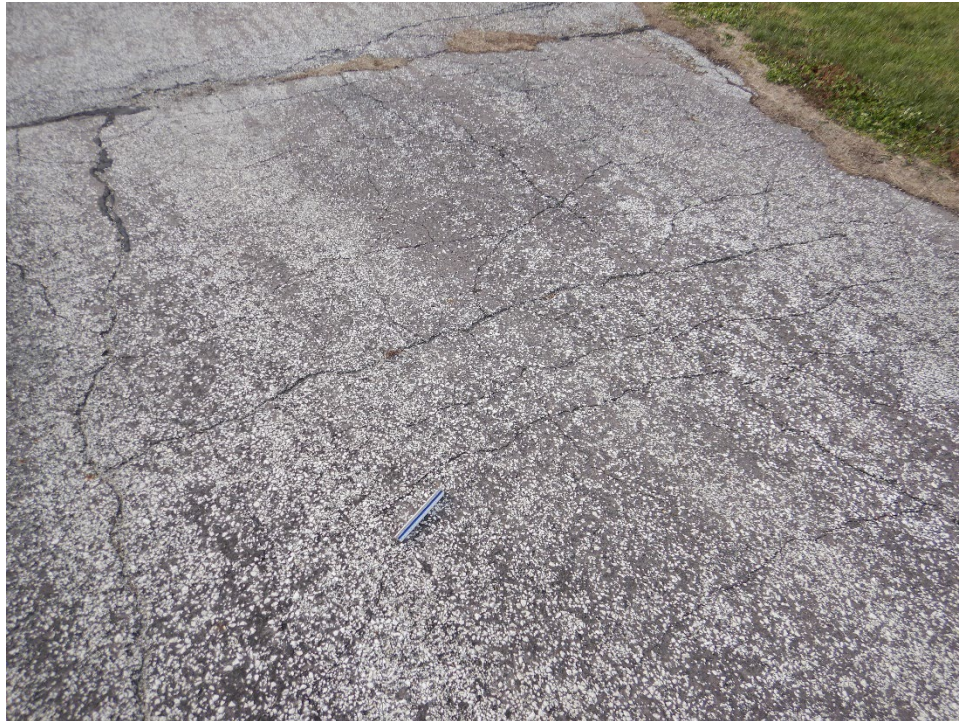
The T-hangar 02 area was divided into three sections. Section 01 contained low-severity ASR and LTD cracking. Section 02 was in poor condition with low-severity rutting and medium-severity alligator cracking, L&T cracking, and weathering noted at the time of inspection. Section 03 was also in poor condition with areas of low-severity corner break and LTD cracking, high-severity joint seal damage and joint spalling, and all severities of shattered slab recorded.

TH02GR-02. Alligator Cracking (Sample Unit No. 01).

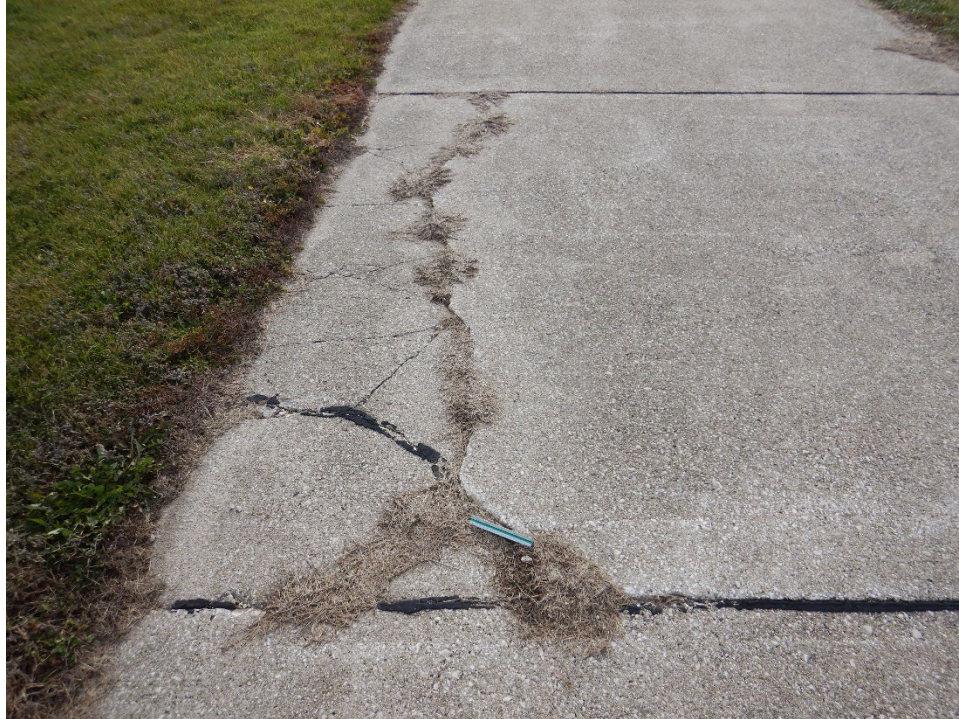
TH02GR-03. Shattered Slab (Sample Unit No. 01).
