# Greenfield Municipal Airport

## Pavement Management Report

**AUGUST 2025**

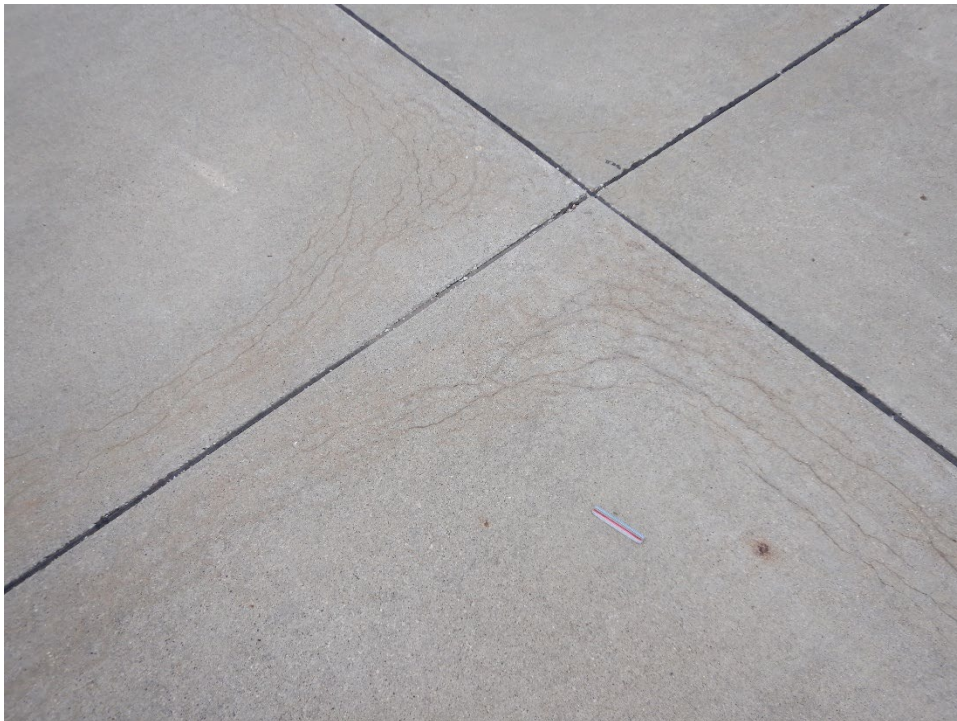
A01GR-01. ASR (Sample Unit No. 09).

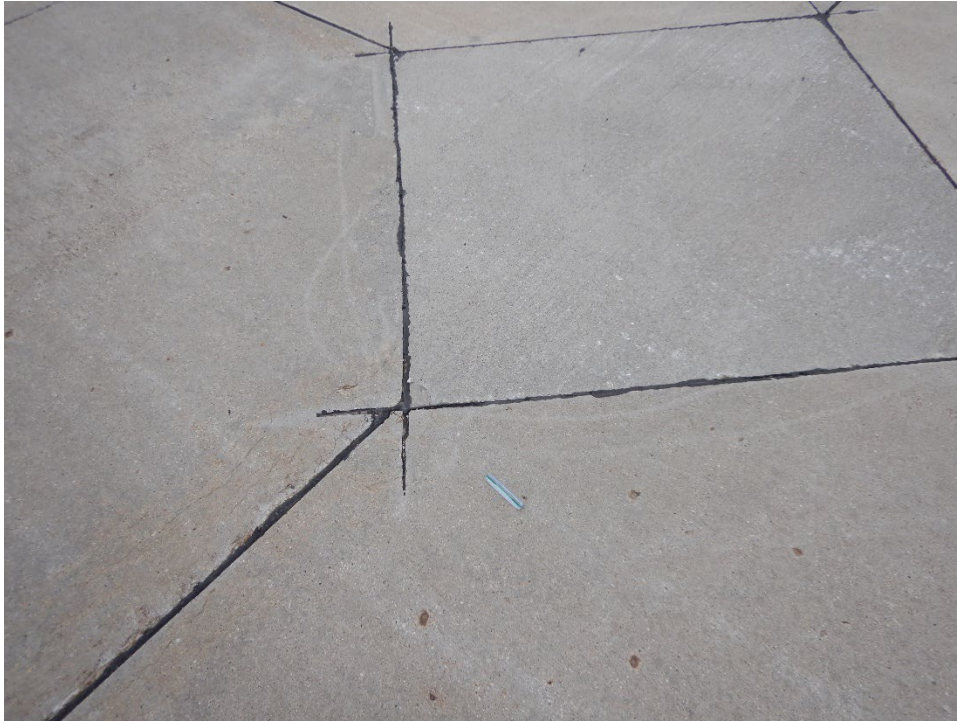
A01GR-01. Large Patching (Sample Unit No. 09).

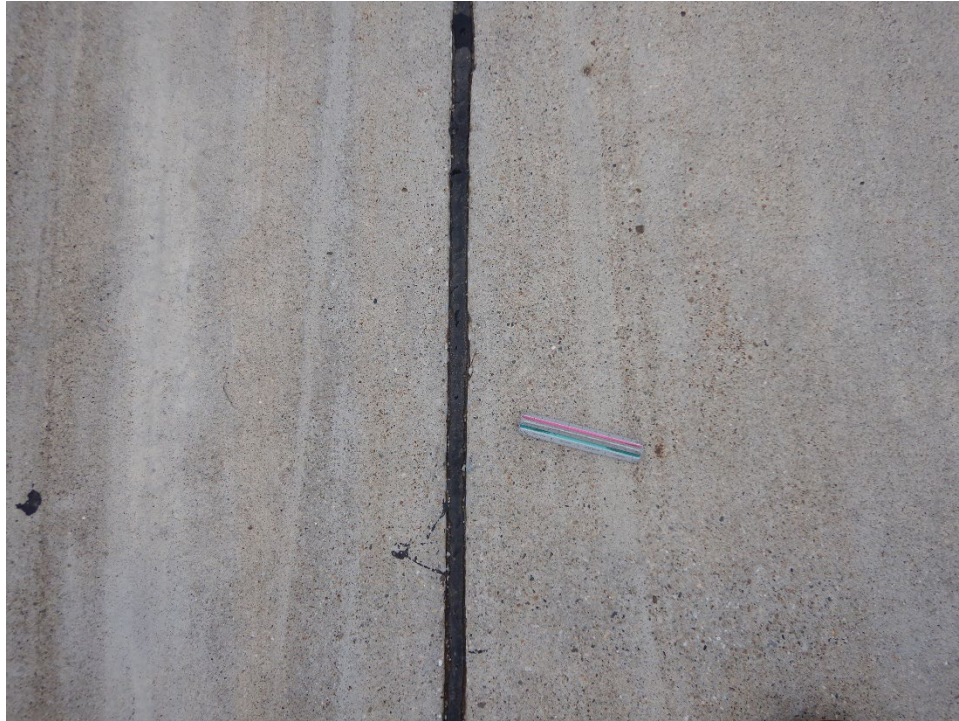
A02GR-01. Joint Seal Damage (Sample Unit No. 03).

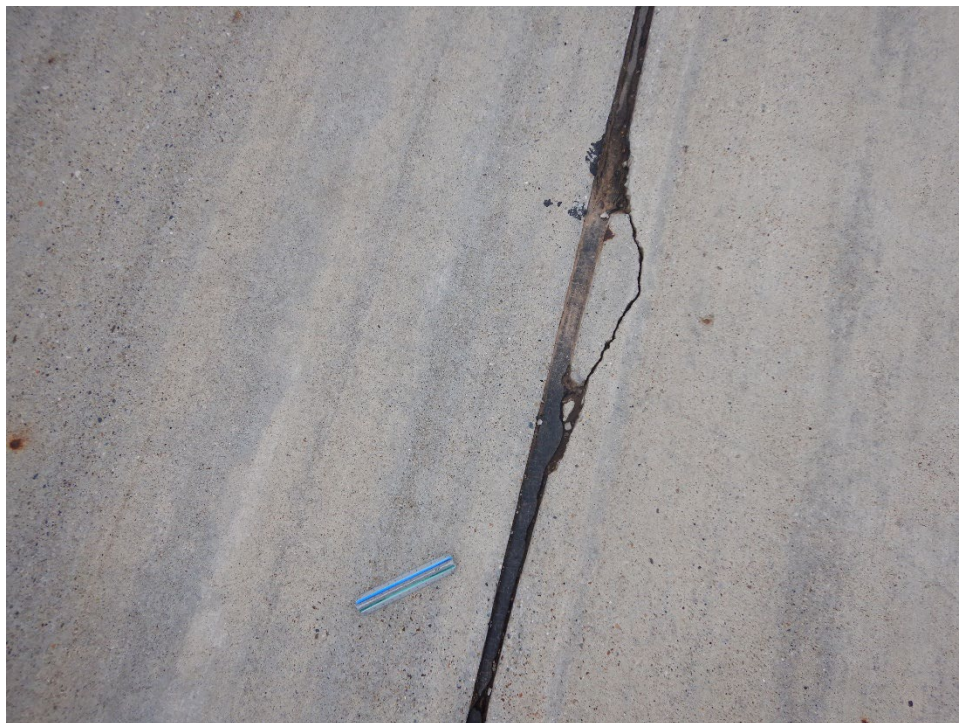
A02GR-01. Joint Spalling (Sample Unit No. 03).

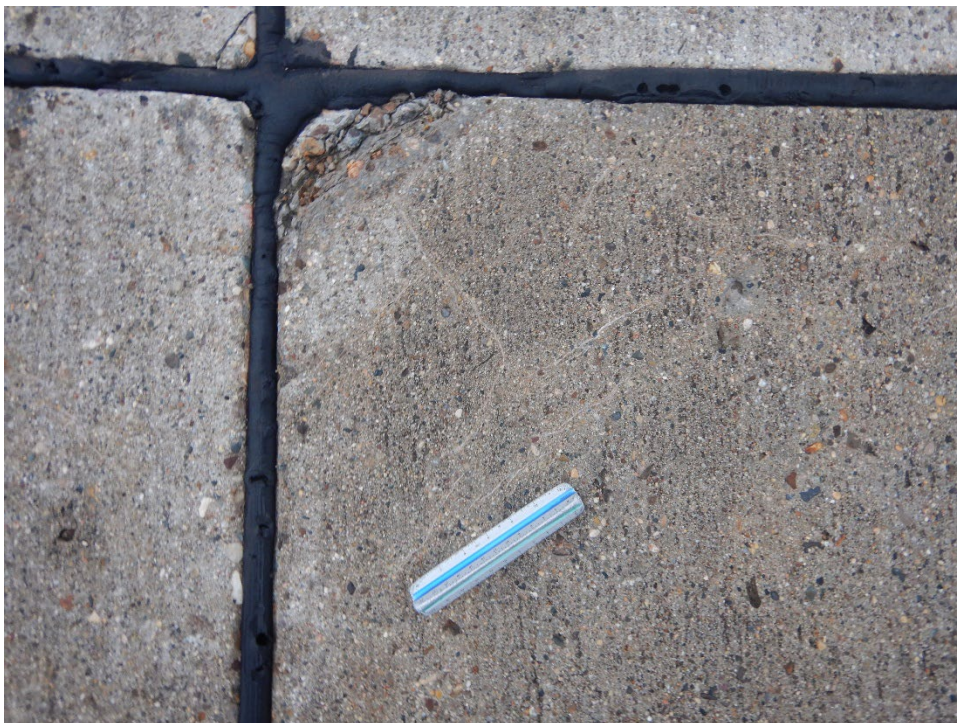
R07GR-01. ASR (Sample Unit No. 76).

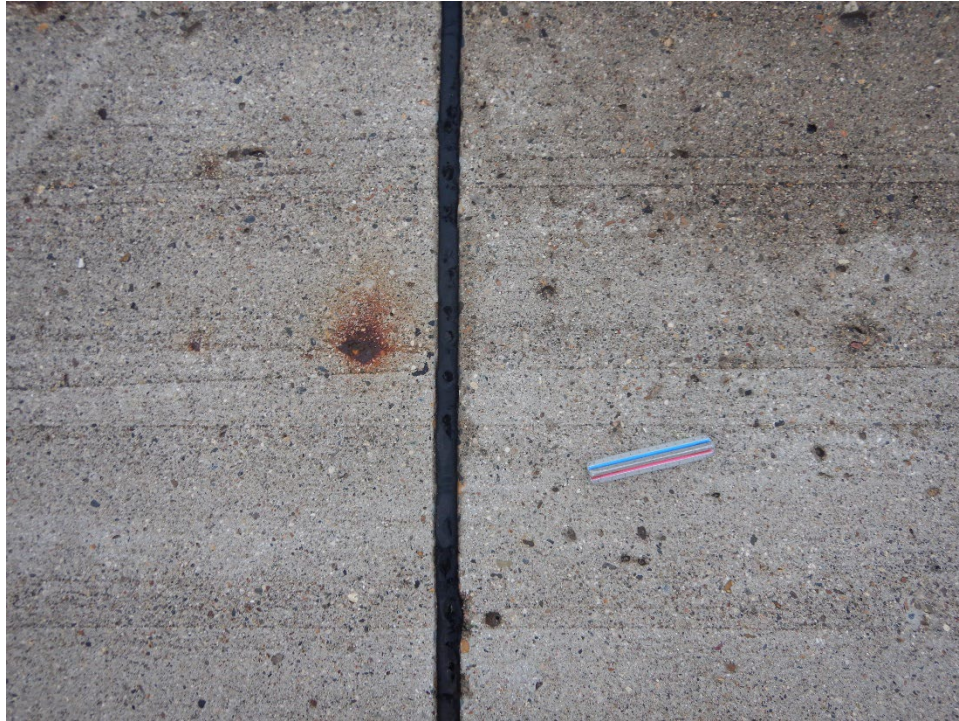
R07GR-01. Joint Seal Damage (Sample Unit No. 85).

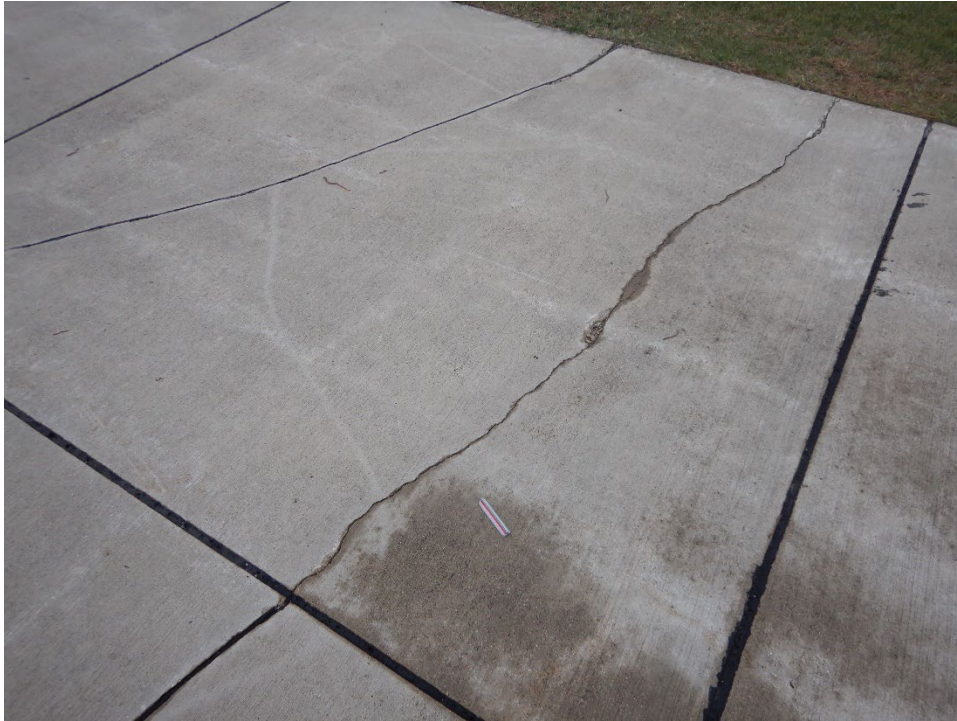
R07GR-02. LTD Cracking (Sample Unit No. 01).

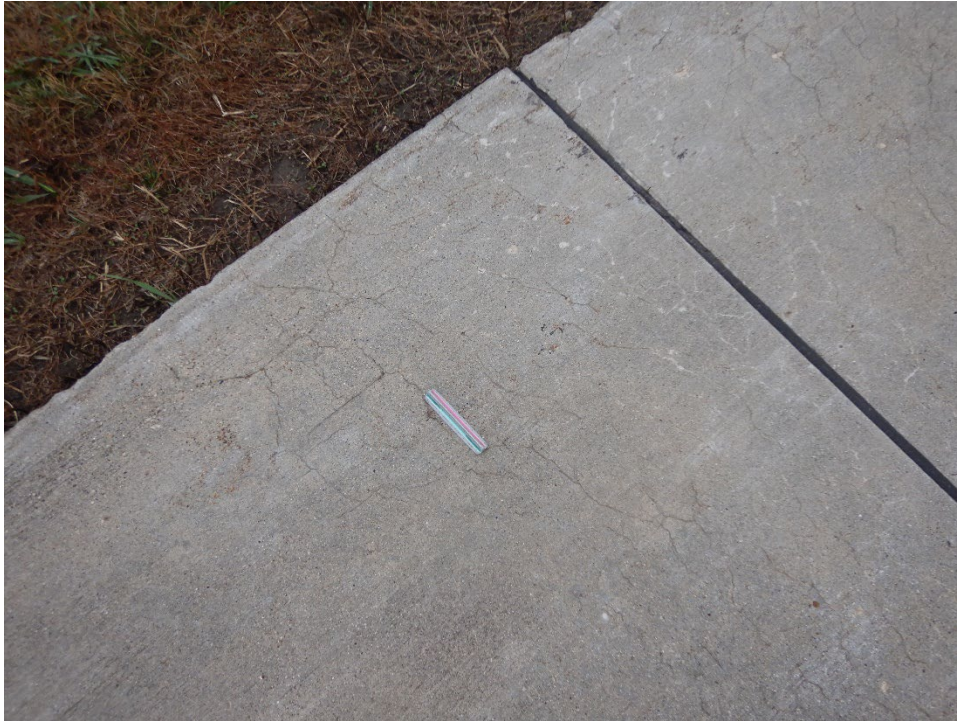
R14GR-01. ASR (Sample Unit No. 11).

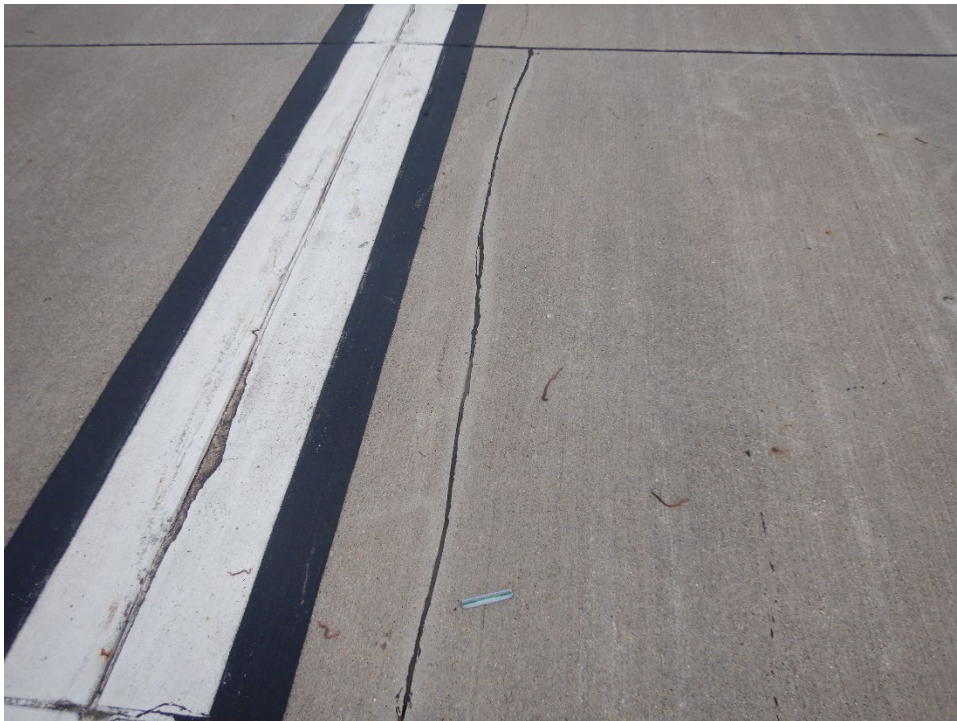
R14GR-01. LTD Cracking (Sample Unit No. 32).

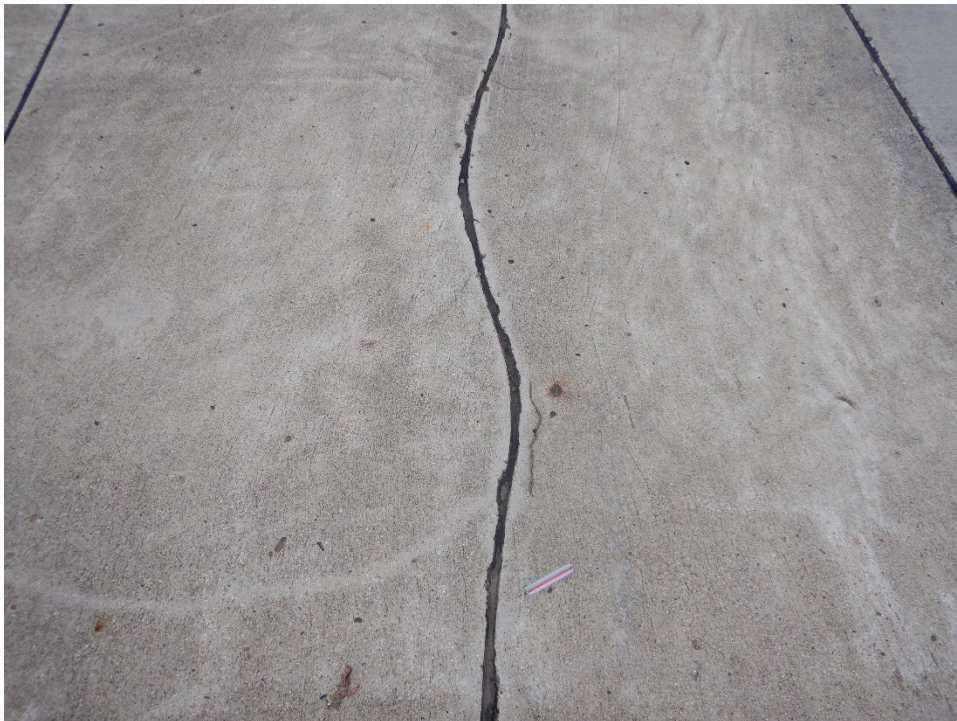
R14GR-02. LTD Cracking (Sample Unit No. 01).

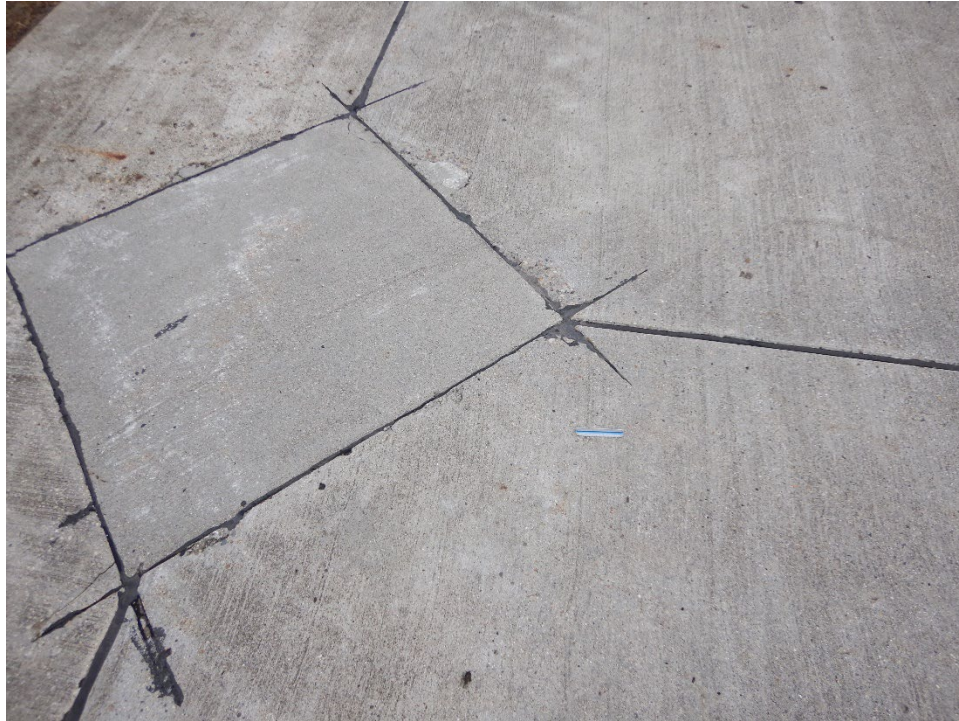
R14GR-02. Small Patching (Sample Unit No. 02).

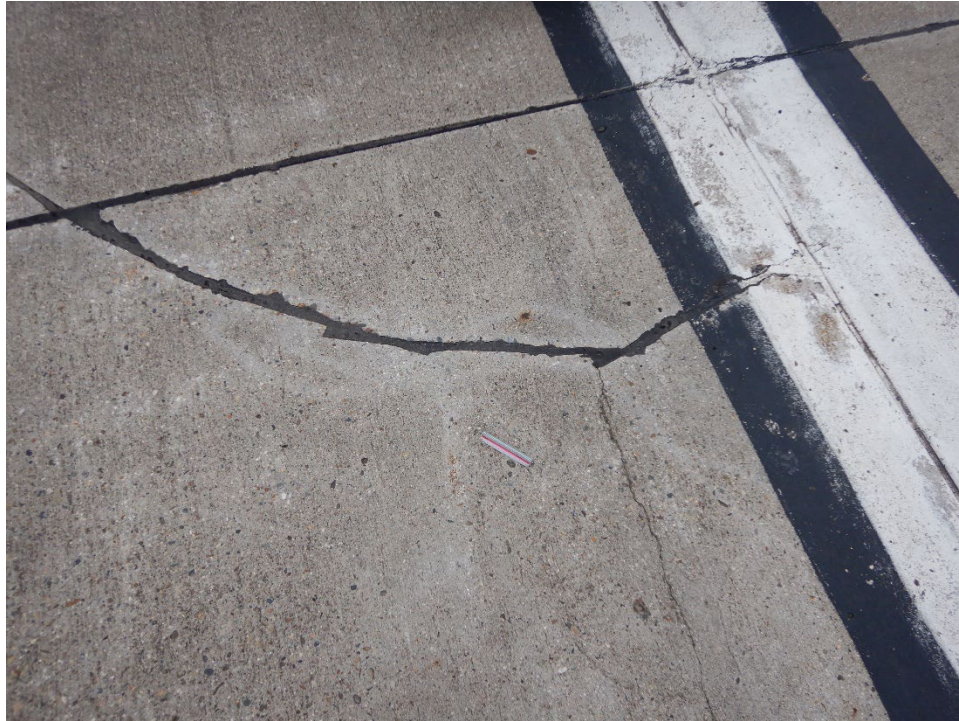
R14GR-03. Corner Break (Sample Unit No. 01).

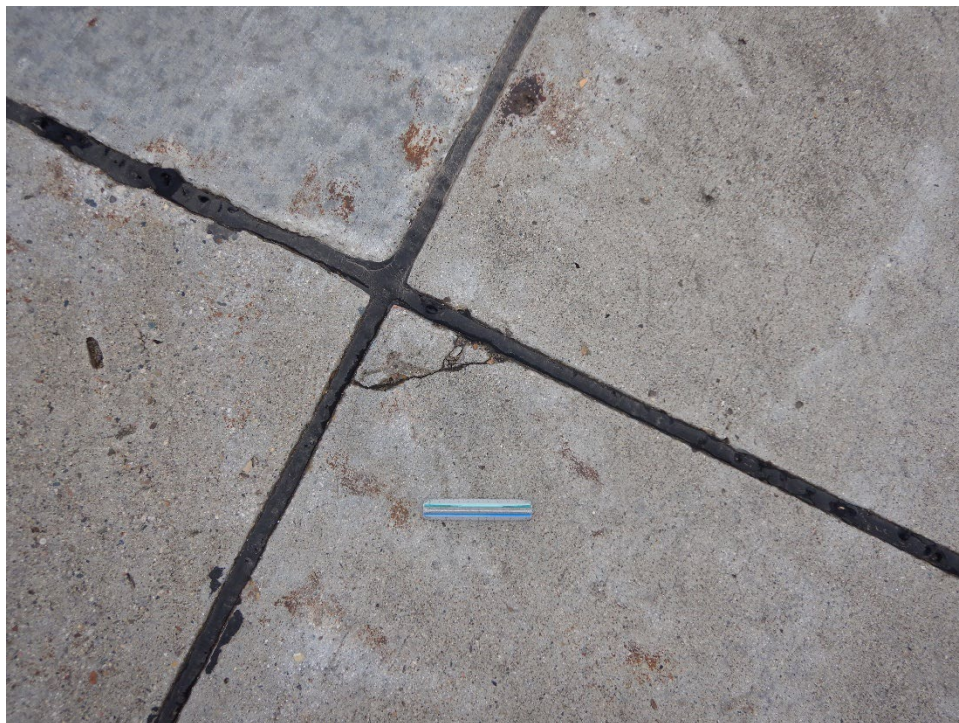
R14GR-03. Corner Spalling (Sample Unit No. 01).

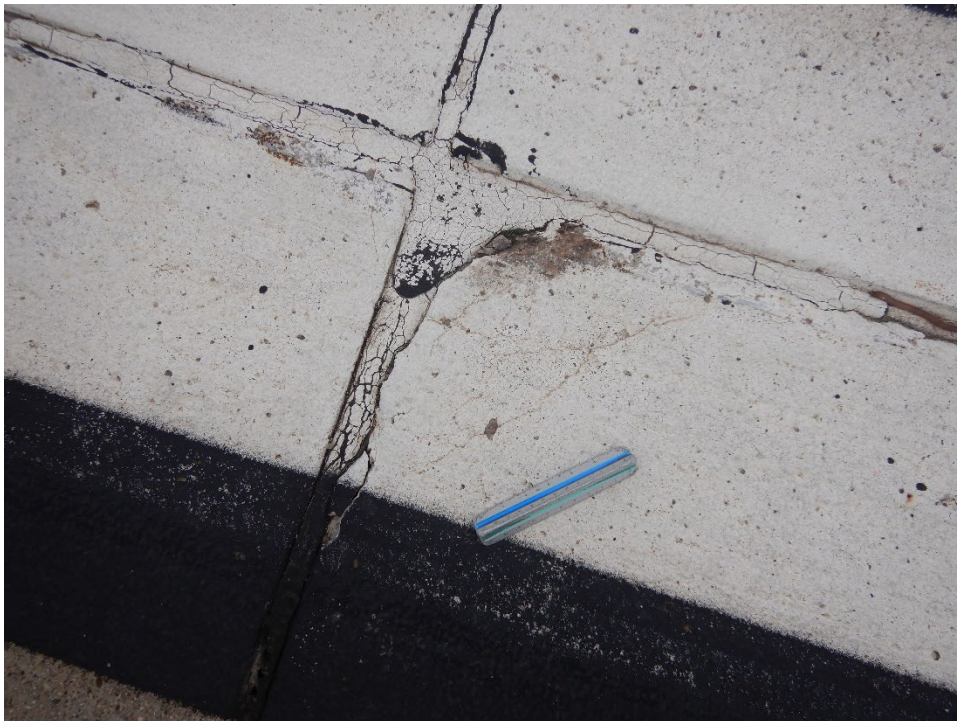
R14GR-04 ASR. (Sample Unit No. 16).

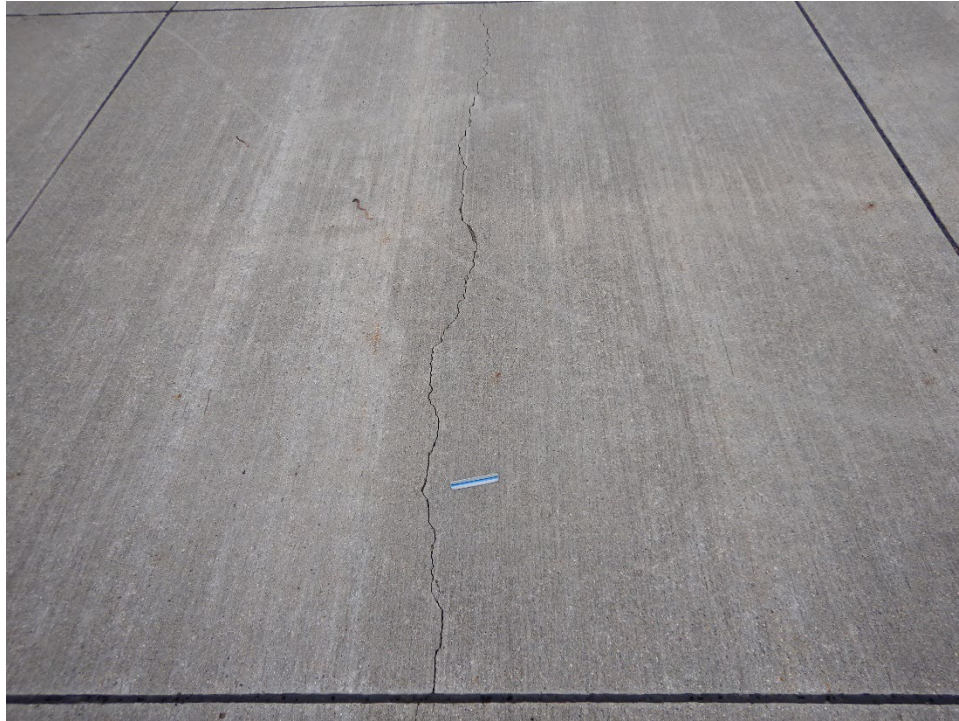
R14GR-04. LTD Cracking (Sample Unit No. 02).

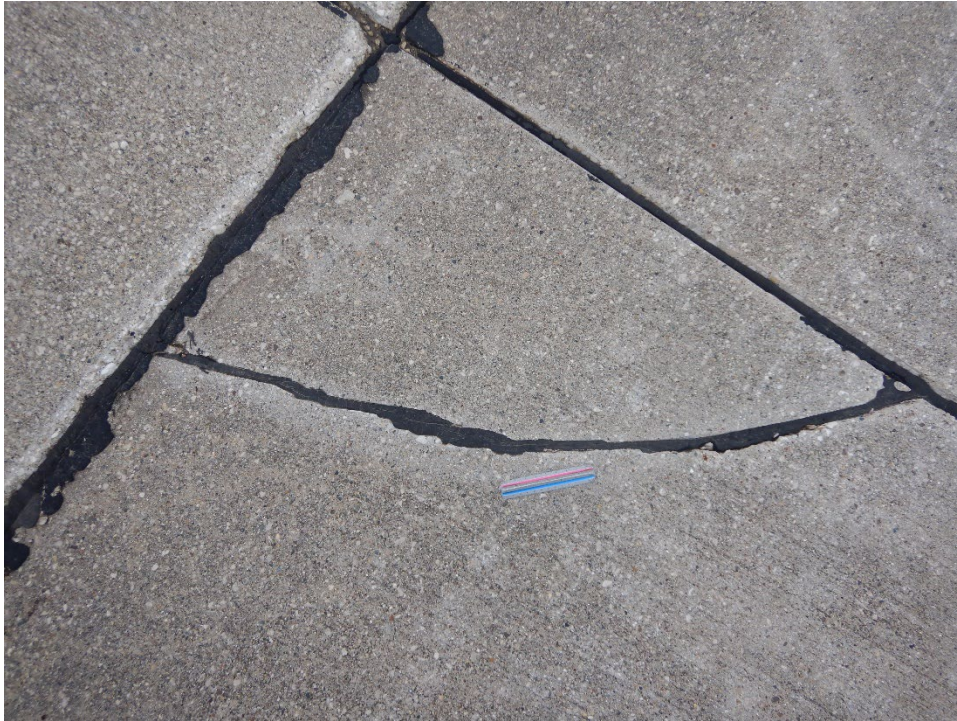
T01GR-01. Corner Break (Sample Unit No. 02).

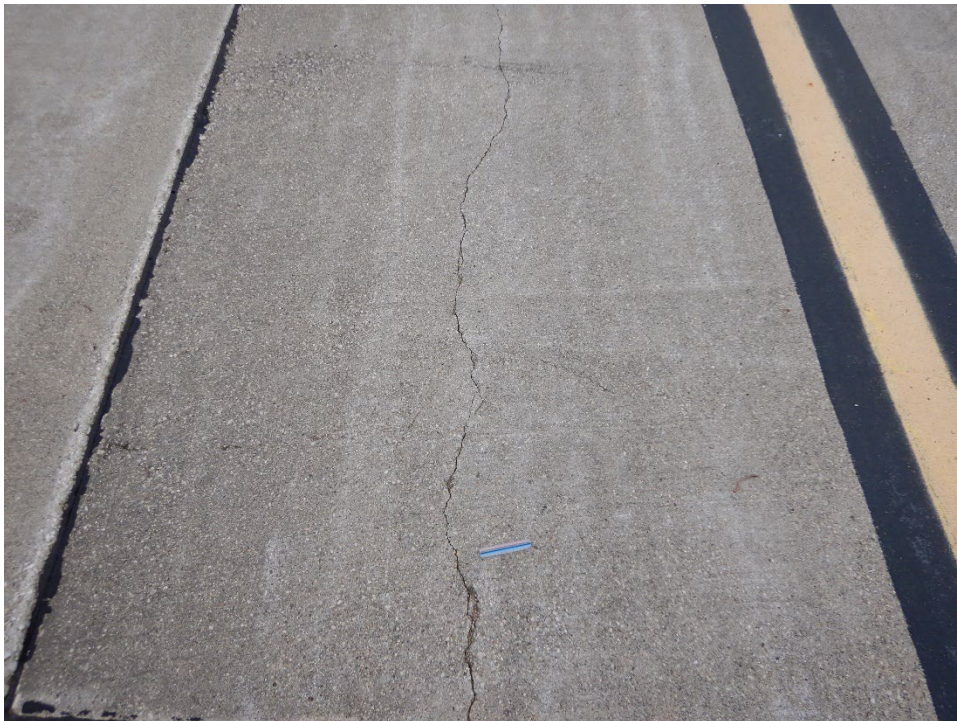
T01GR-01. LTD Cracking (Sample Unit No. 02).

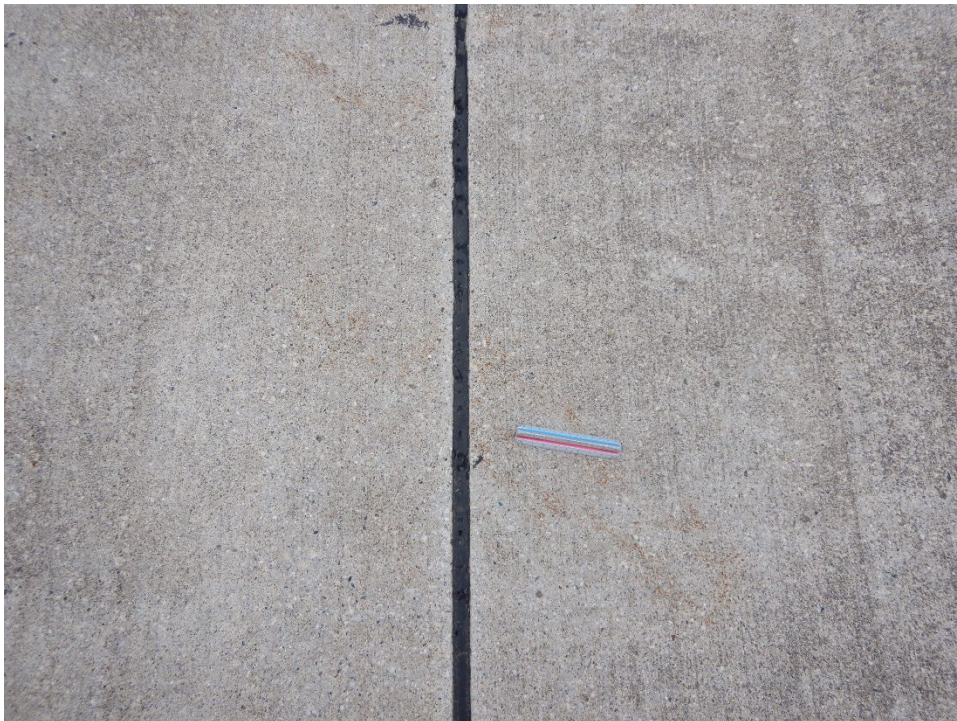
T01GR-02. Joint Seal Damage (Sample Unit No. 01).

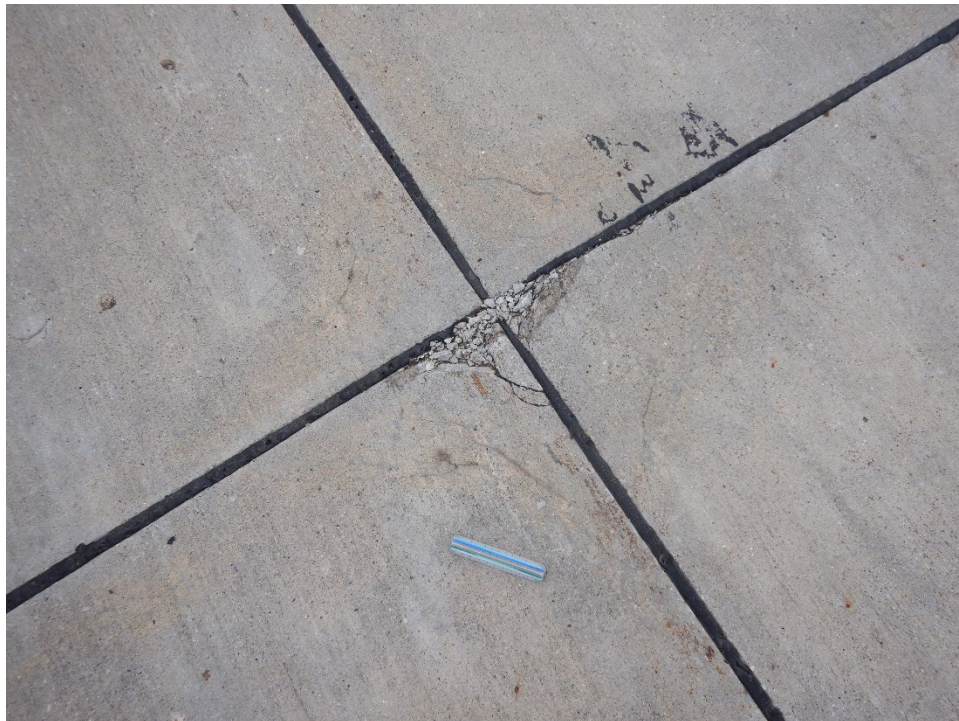
T02GR-01. ASR (Sample Unit No. 15).

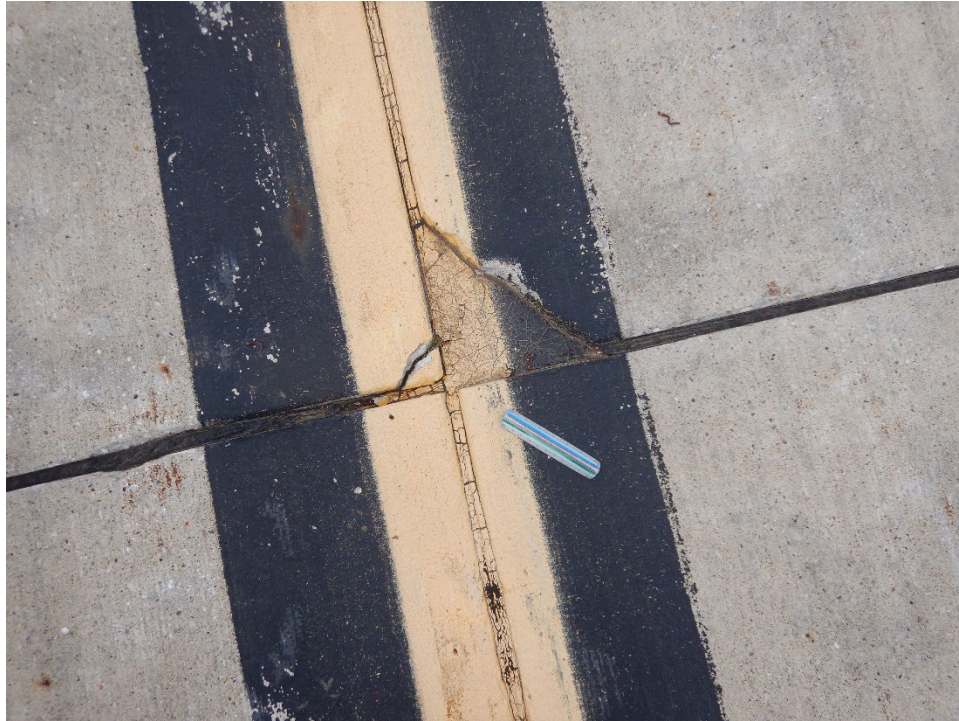
T02GR-01. Corner Spalling (Sample Unit No. 02).

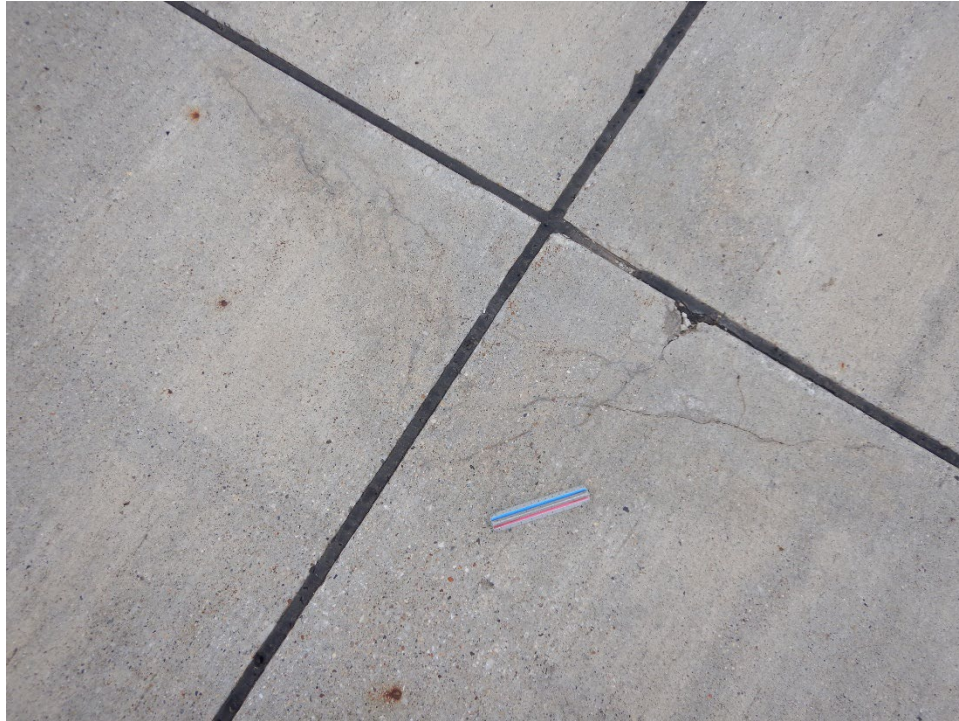
T03GR-01. ASR (Sample Unit No. 02).

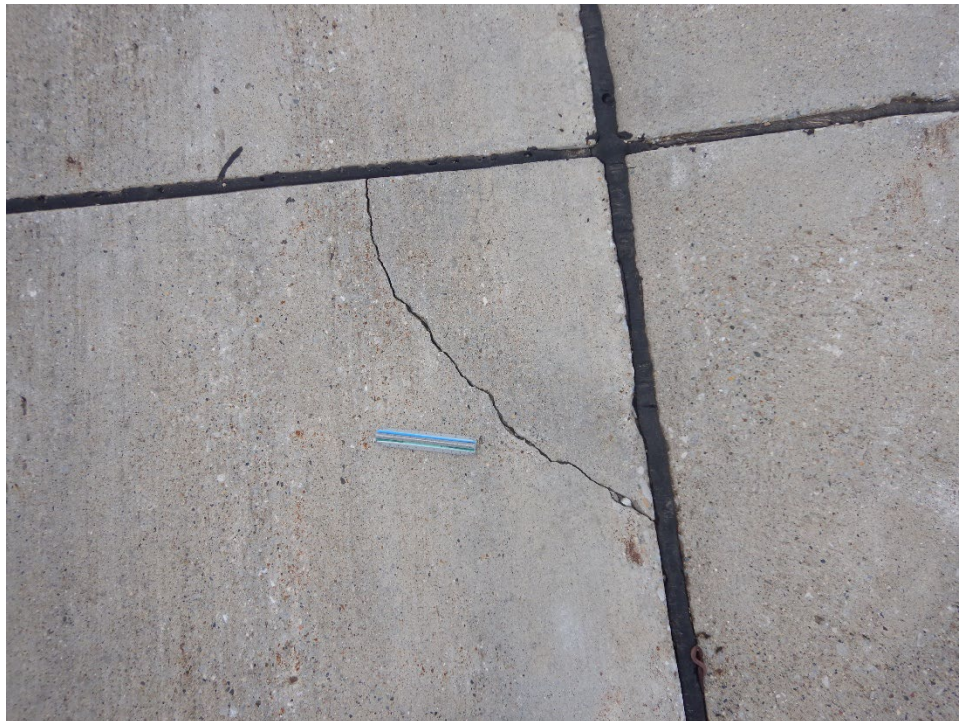
T03GR-01. Corner Break (Sample Unit No. 05).

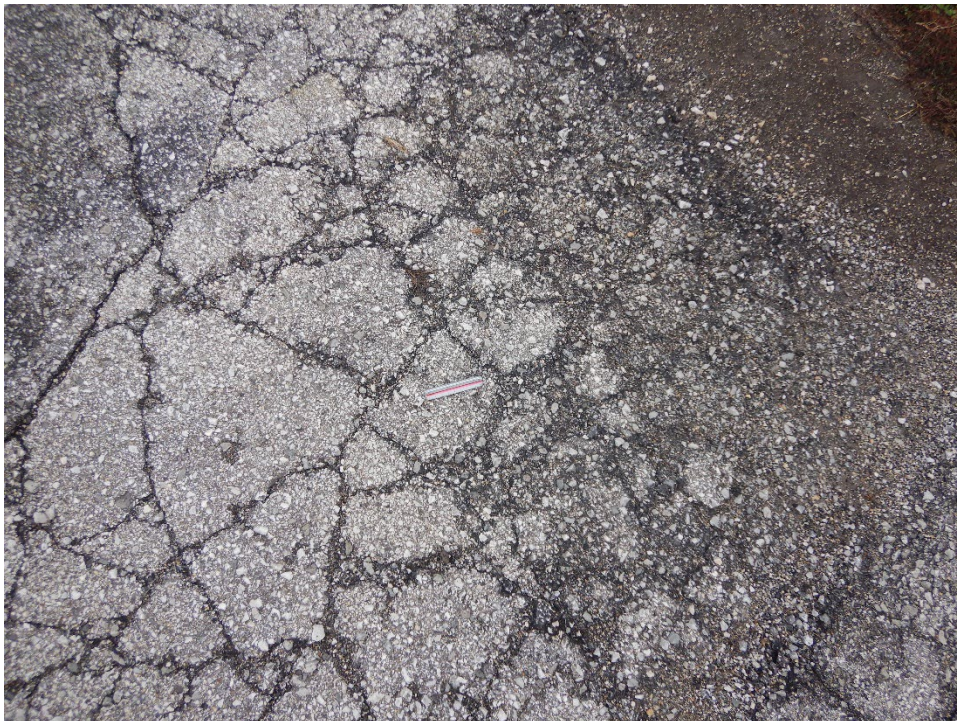
TH01GR-01. Alligator Cracking (Sample Unit No. 01).

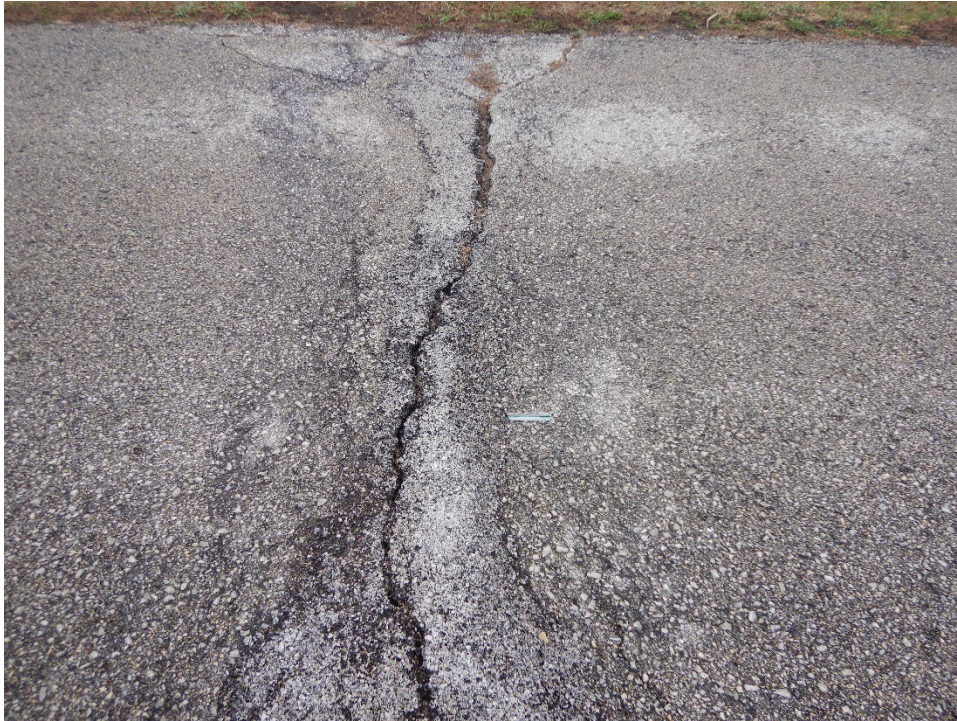
TH01GR-01. L&T Cracking (Sample Unit No. 01).

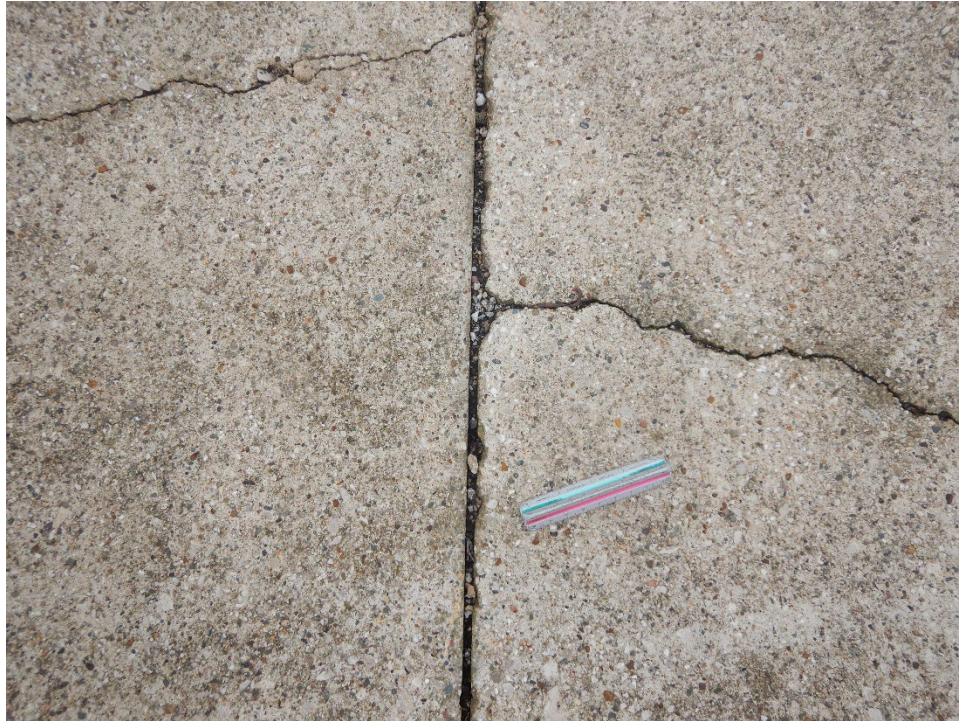
TH01GR-02. Joint Seal Damage (Sample Unit No. 01).

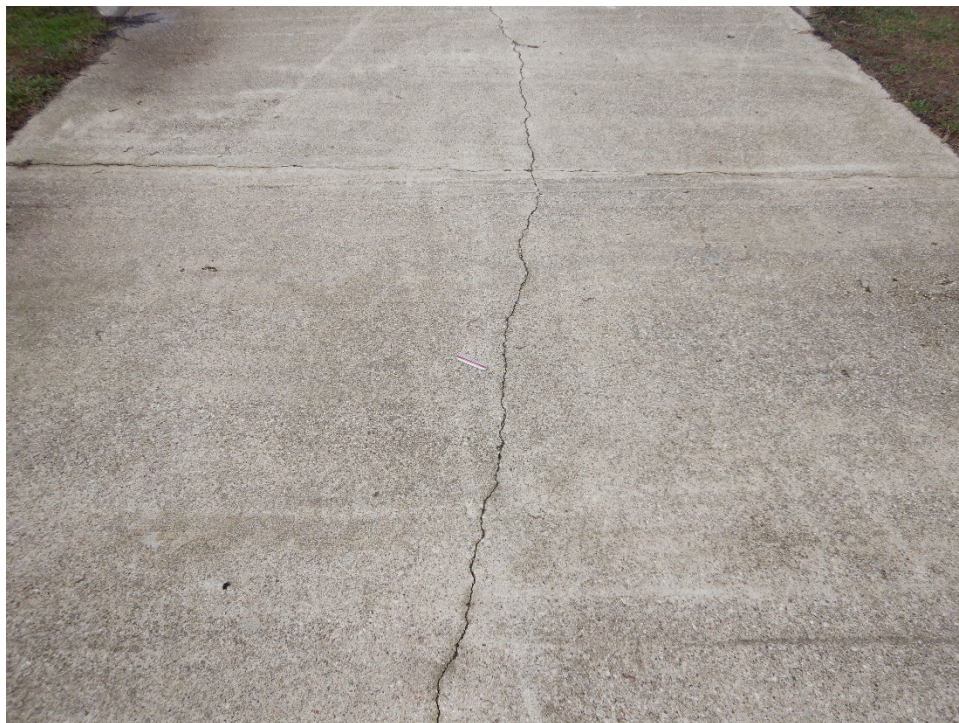
TH01GR-02. Shattered Slab (Sample Unit No. 01).

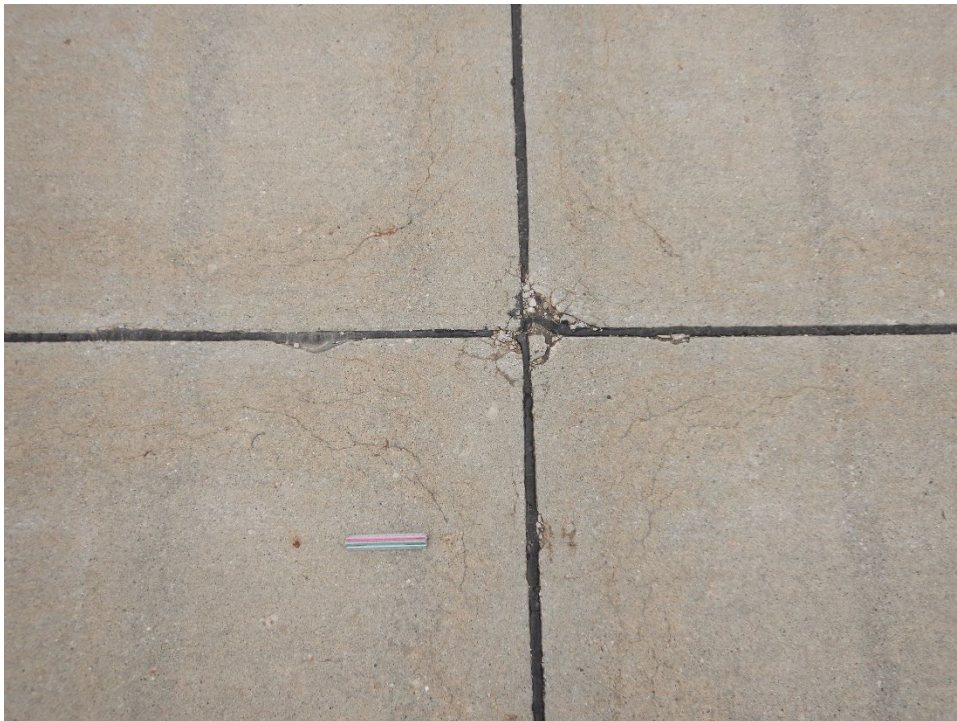
TH02GR-01. ASR (Sample Unit No. 02).

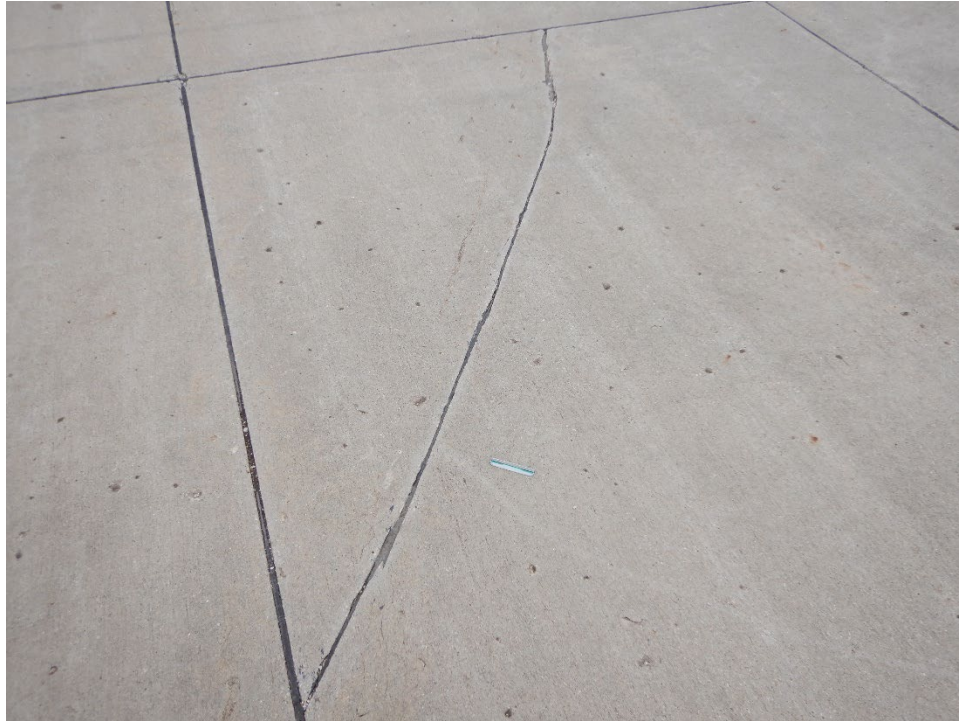
TH02GR-01. LTD Cracking (Sample Unit No. 02).

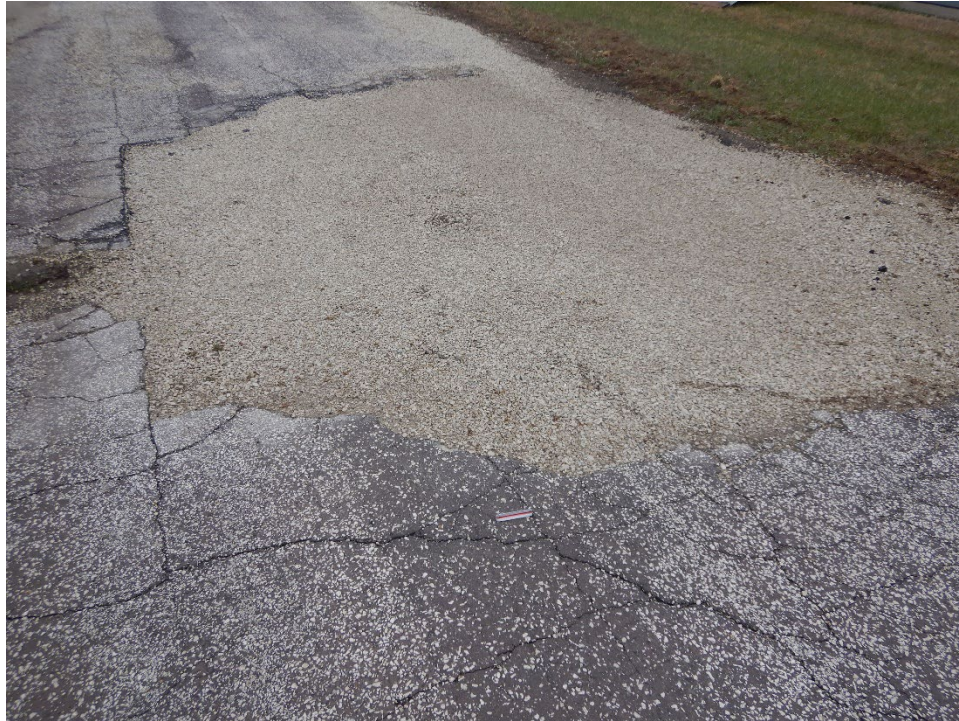
TH02GR-02. Alligator Cracking (Sample Unit No. 01) (1).

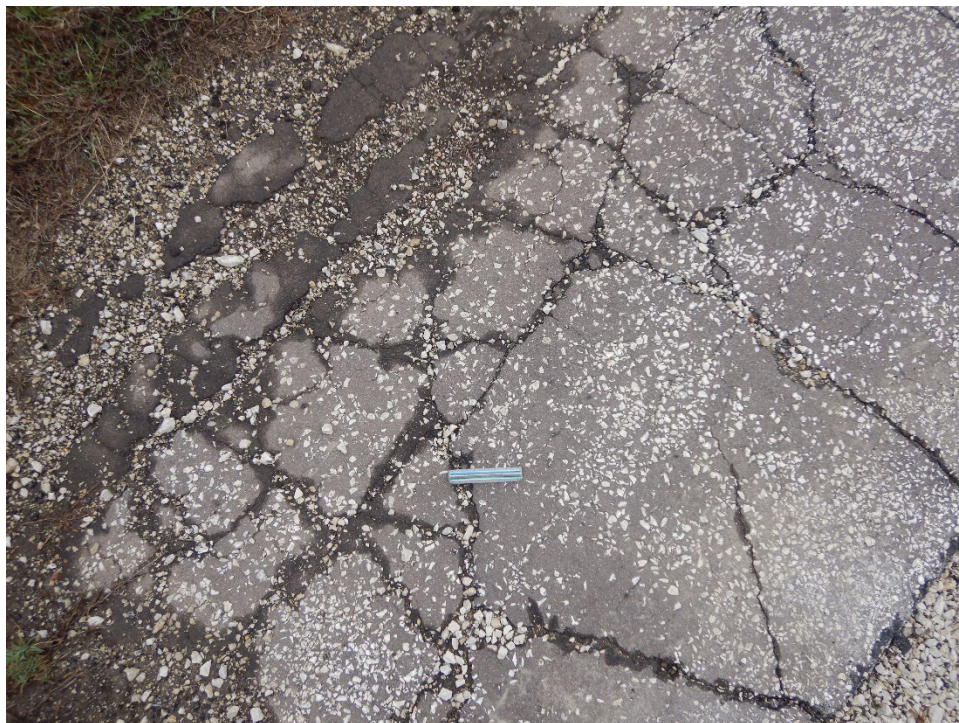
TH02GR-02. Alligator Cracking (Sample Unit No. 01) (2).

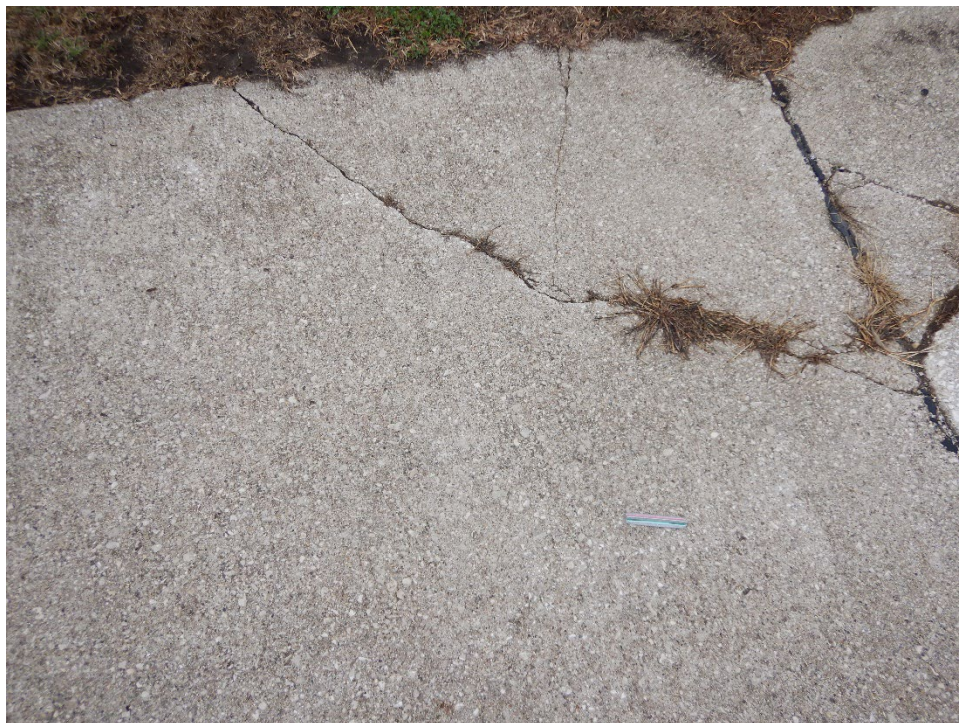
TH02GR-03. Corner Break (Sample Unit No. 01).

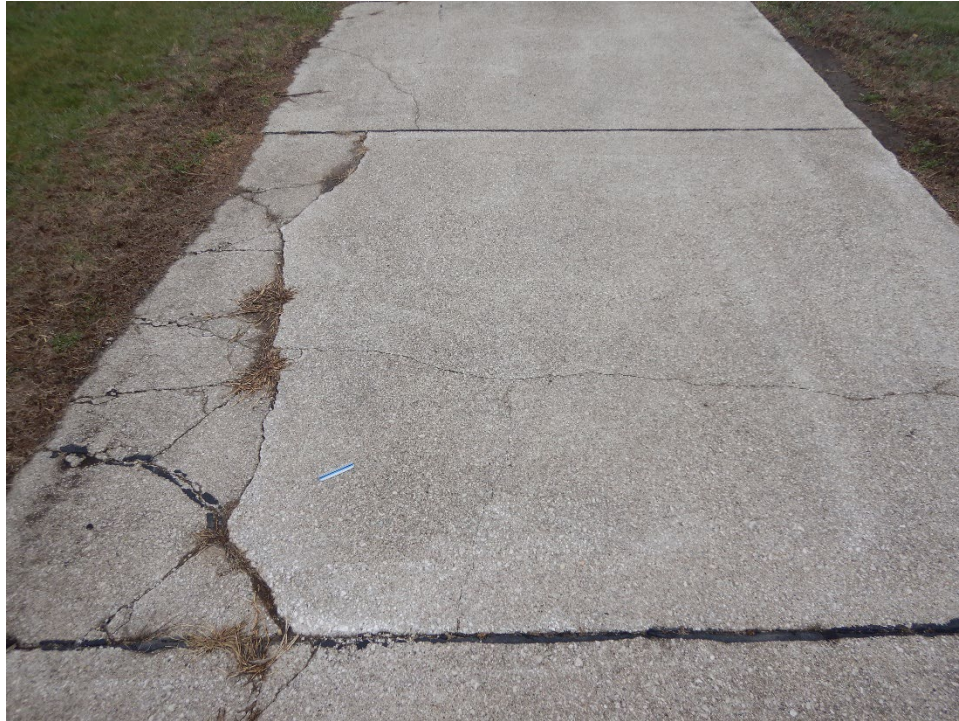
TH02GR-03. Shattered Slab (Sample Unit No. 01).
