# Grinnell Regional Airport

## Pavement Management Report

**AUGUST 2025**

# GRINNELL REGIONAL AIRPORT PAVEMENT MANAGEMENT REPORT

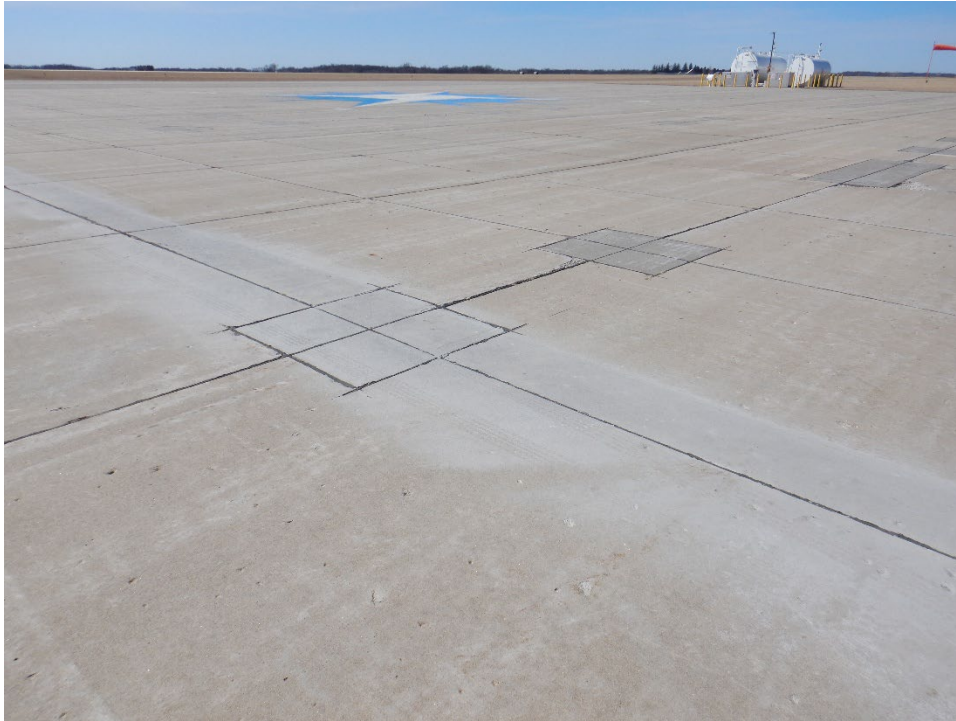
A01GL-01. Overview.

Apron was defined by six sections. Section 01 contained all severities of ASR and corner spalling; low- and medium-severity corner break and joint spalling; low-severity faulting, large patching, small patching, and LTD cracking; high-severity joint seal damage and shattered slab; and shrinkage cracking. Low- and medium-severity ASR, medium-severity joint seal damage, and low-severity LTD cracking and small patching were recorded in Section 02. In Section 03, low- and medium-severity ASR and LTD cracking, low-severity corner break and small patching, medium-severity joint seal damage and joint spalling, and shrinkage cracking were identified. Section 04 was recently rehabilitated and was in *Excellent* condition. No distresses were observed during the inspection. Section 05 contained medium-severity joint seal damage and low-severity ASR and LTD cracking. Only medium-severity joint seal damage was recorded throughout Section 06.

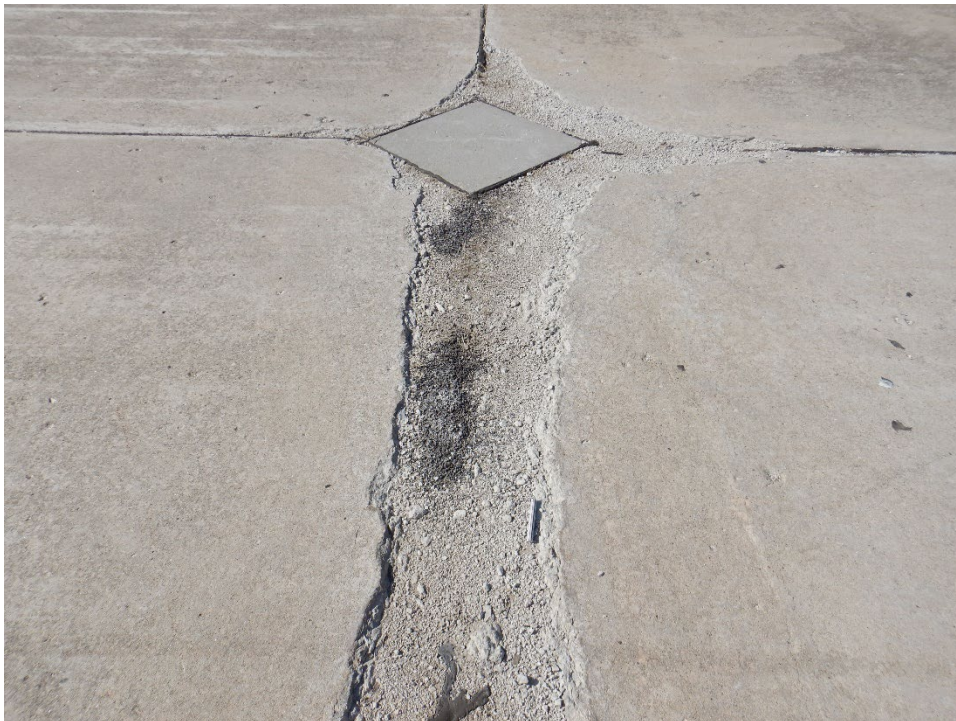
A01GL-01. ASR (Additional Sample Unit No. 01) (1).

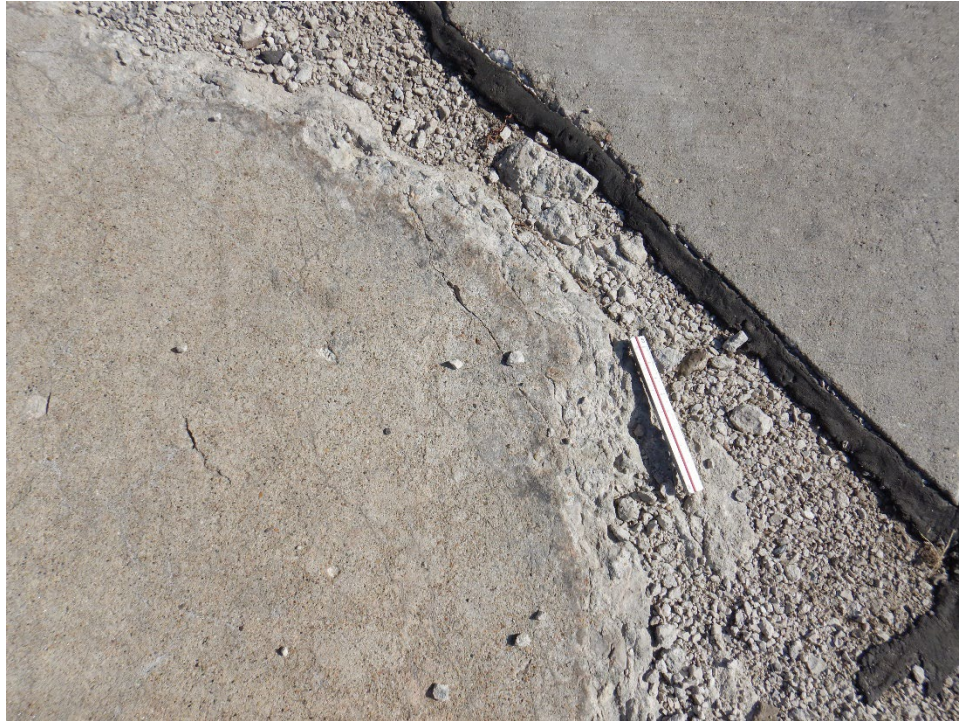
A01GL-01 ASR. (Additional Sample Unit No. 01) (2).

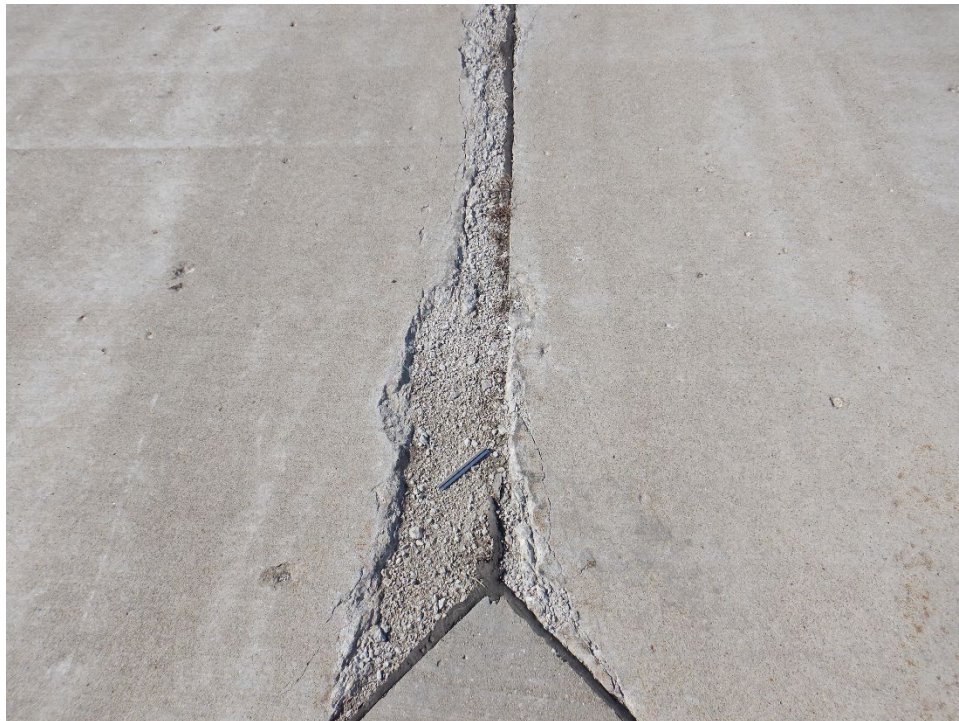
A01GL-01 ASR. (Sample Unit No. 02).

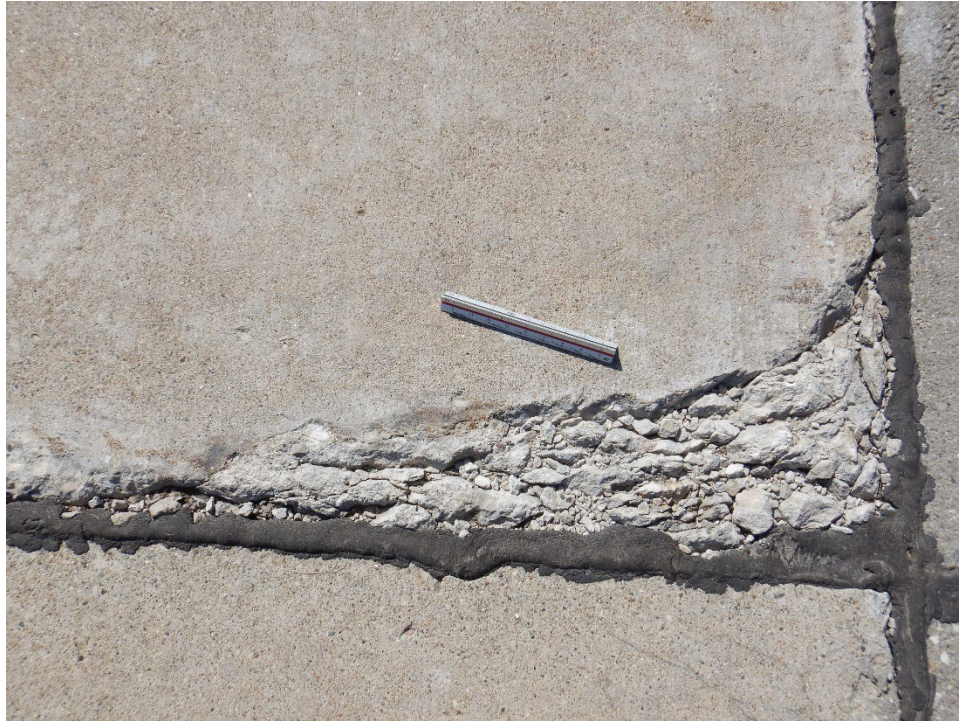
A01GL-01. ASR (Sample Unit No. 06).

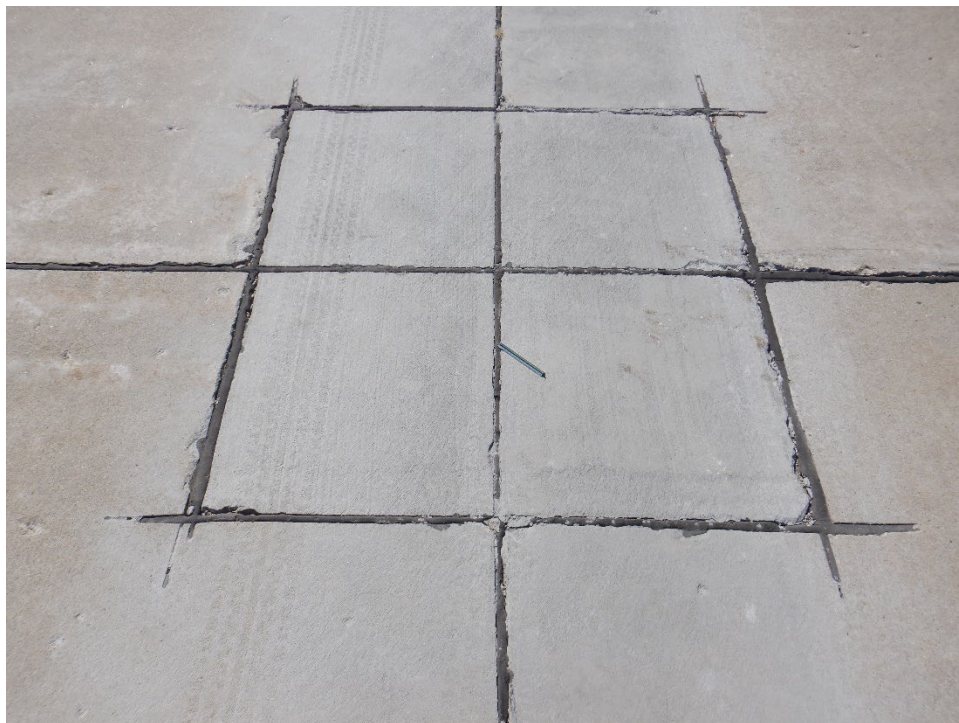
A01GL-01. Small Patching (Sample Unit No. 06).

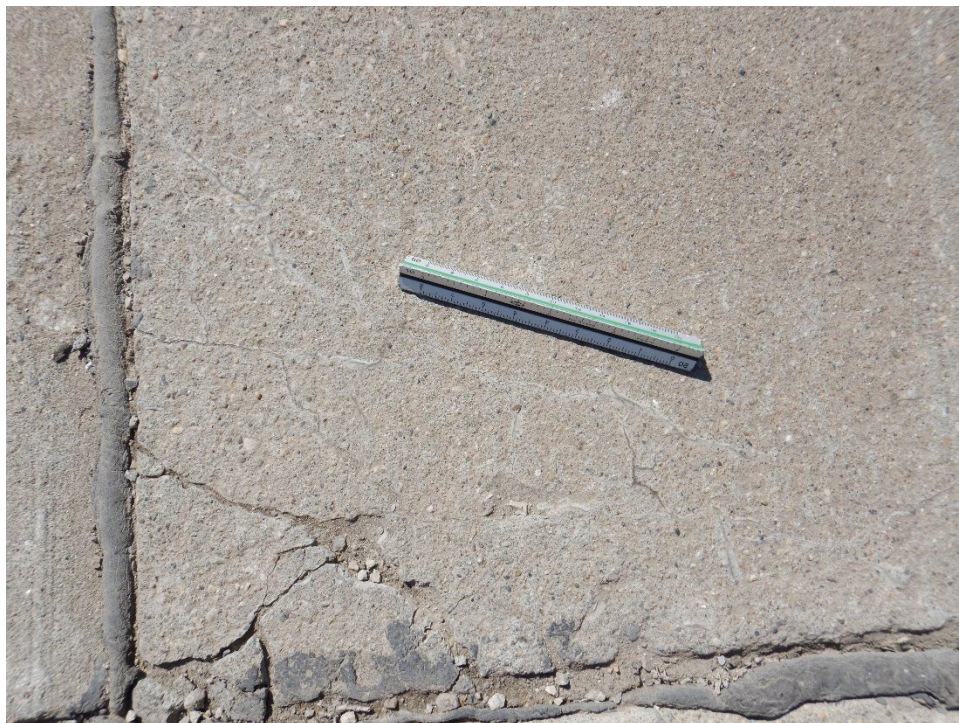
A01GL-02. ASR (Sample Unit No. 01).

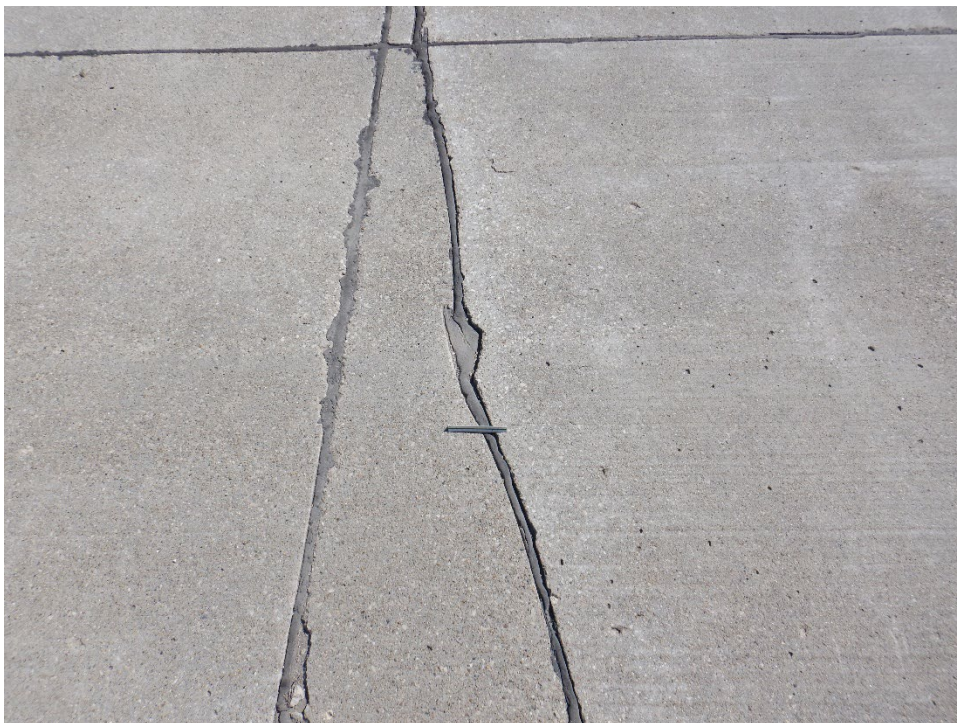
| <b>Distress Type</b> | <b>Probable Cause of Distress</b> |
|---|---|
| LTD Cracking | Combination of load repetition, curling stresses, and shrinkage stresses. |

A01GL-03. LTD Cracking (Sample Unit No. 02).

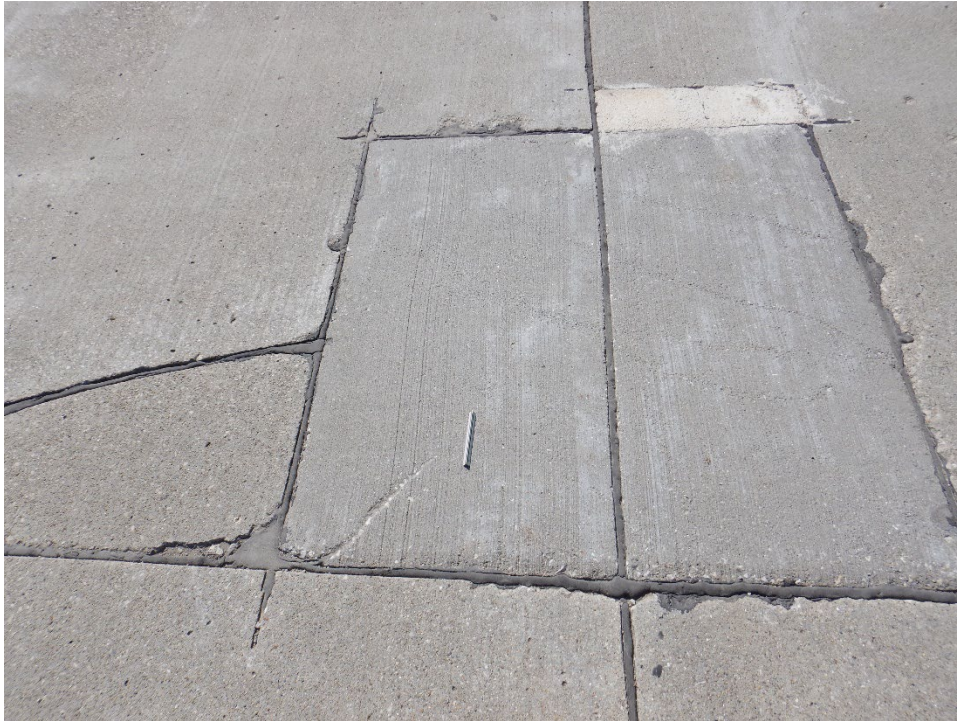
A01GL-03. Small Patching (Sample Unit No. 02).

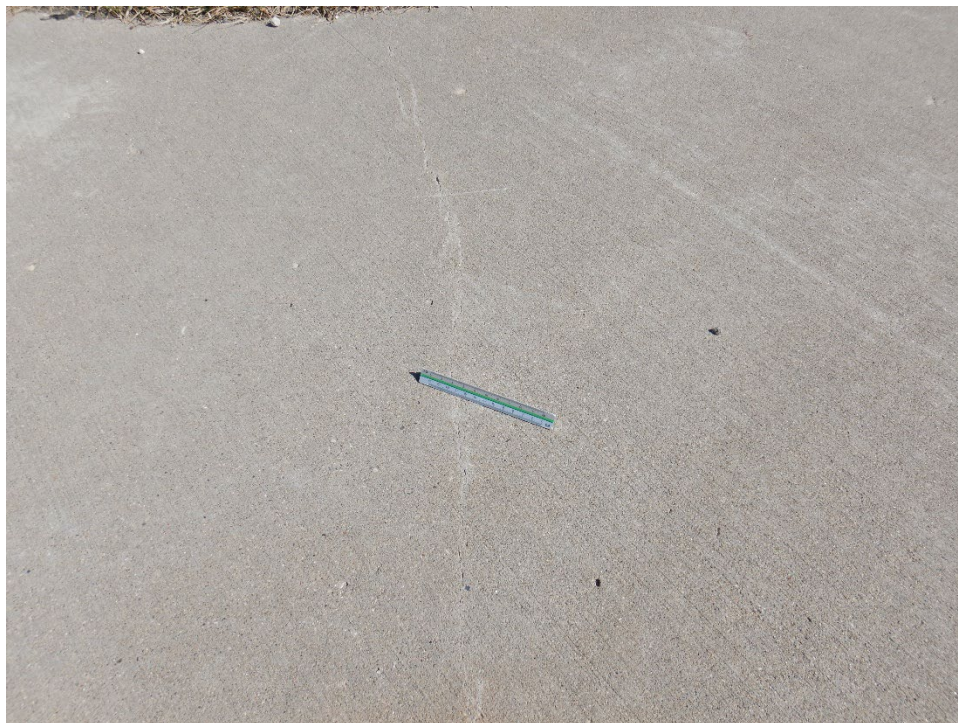
A01GL-05. LTD Cracking (Sample Unit No. 01).

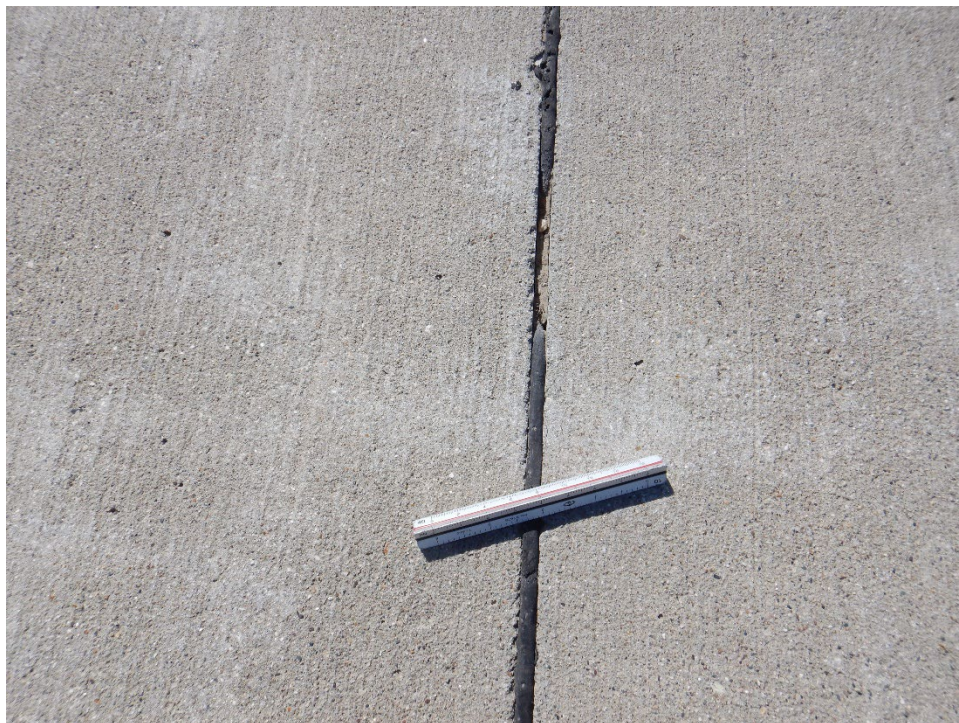
| <b>Distress Type</b> | <b>Probable Cause of Distress</b> |
|---|---|
| Joint Seal Damage | Stripping of joint sealant, extrusion of joint sealant, weed growth, hardening of the filler (oxidation), loss of bond to the slab edges, or absence of sealant in the joint. |

A01GL-06. Joint Seal Damage (Sample Unit No. 01).

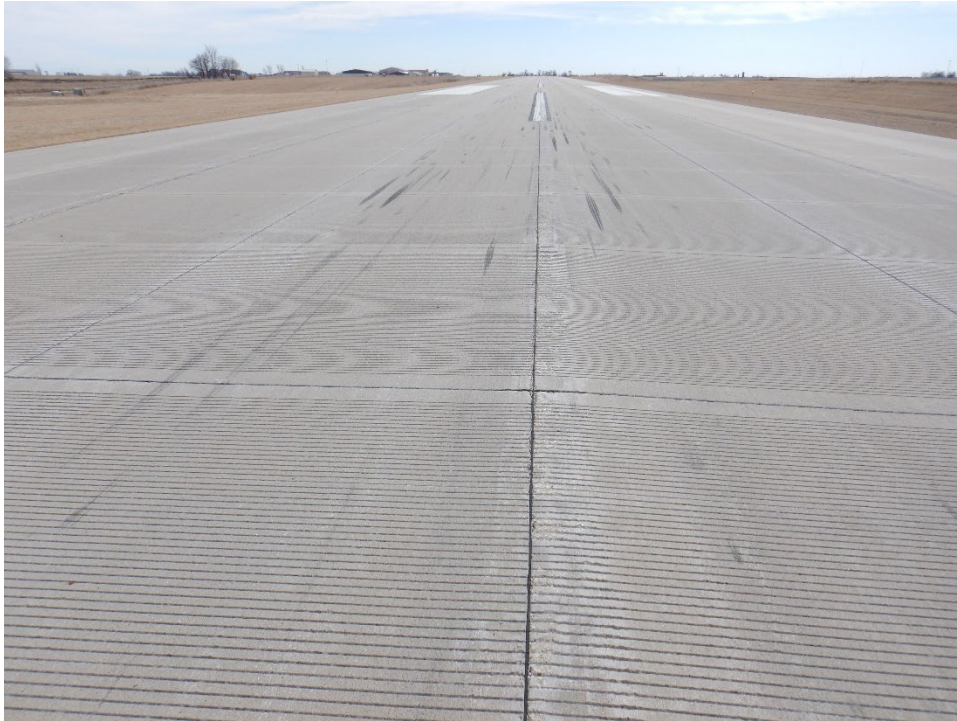
R13GL-01. Overview.

Runway 13/31 was defined by five sections. Section 01 contained areas of low- and medium-severity joint seal damage and low-severity corner spalling; faulting; and longitudinal, transverse, and diagonal (LTD) cracking. All severities of corner spalling and joint spalling, low- and medium-severity faulting, medium-severity joint seal damage, and high-severity small patching were identified in Section 02. An atypical area of medium-severity LTD cracking was observed and recorded as an additional sample unit in accordance with ASTM D5340. In Section 03, low-severity corner break and large patching; medium- and high-severity corner spalling; and medium-severity joint seal damage, joint spalling, and LTD cracking were recorded. Low-severity faulting; medium-severity corner spalling, joint seal damage, and joint spalling; and low- and medium-severity LTD cracking were recorded in Section 04. Section 05 contained low-severity faulting, high-severity joint seal damage, medium-severity joint spalling, and shrinkage cracking.

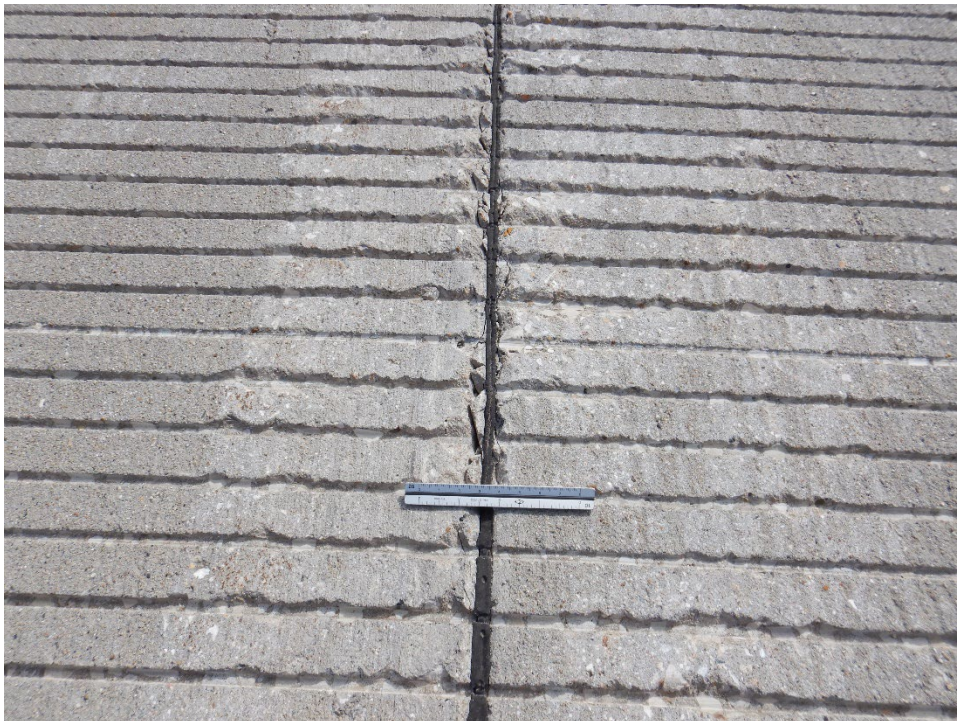
R13GL-01. Joint Seal Damage (Sample Unit No. 135).

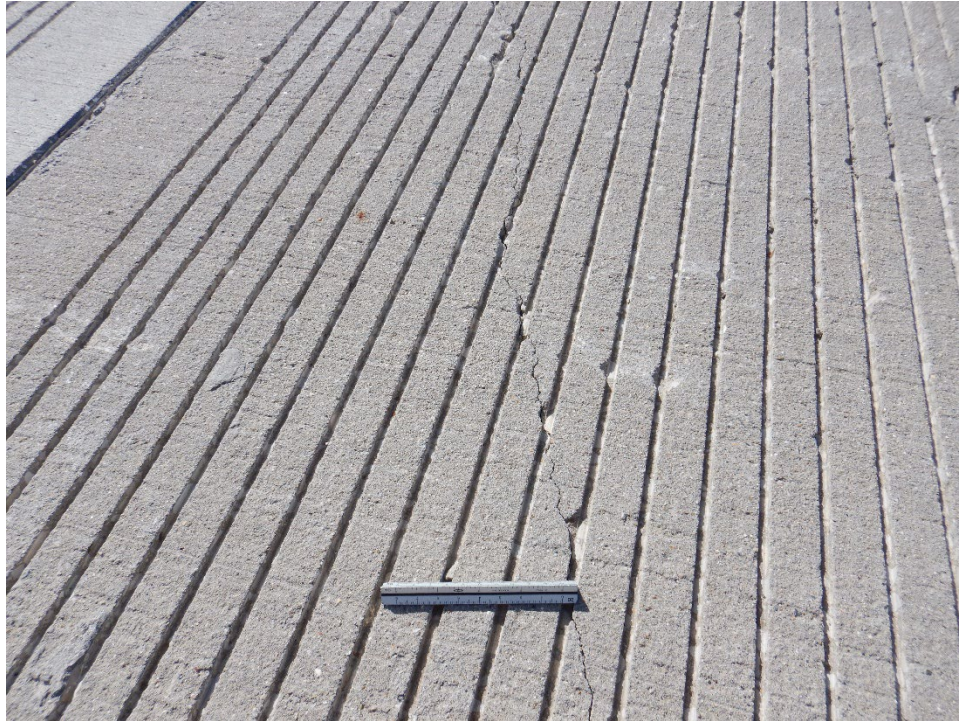
R13GL-01. LTD Cracking (Sample Unit No. 45).

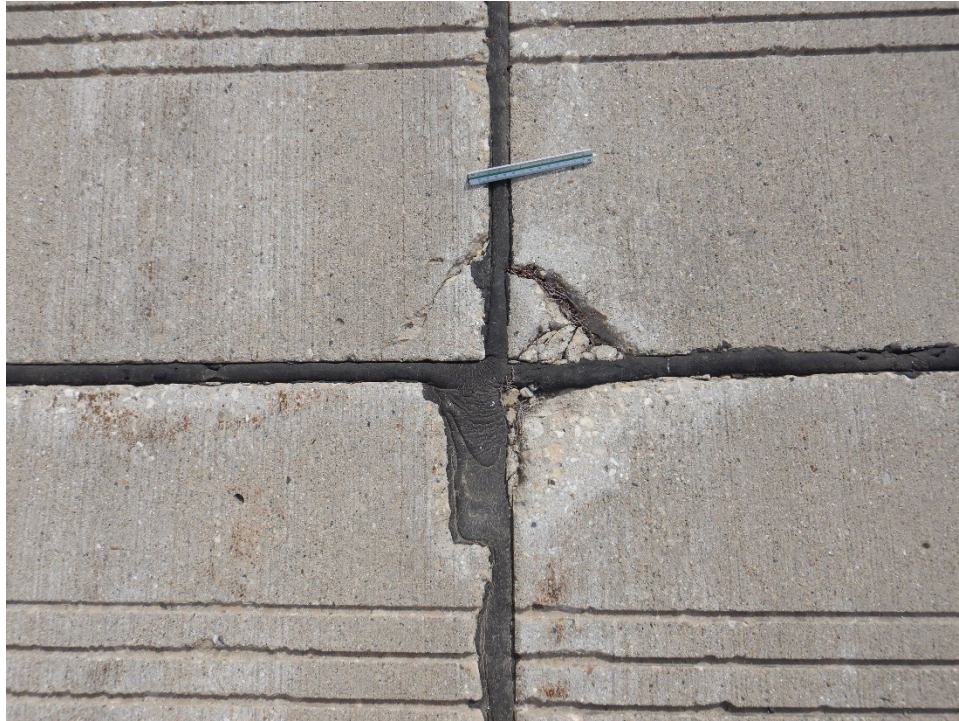
R13GL-02 Corner Spalling. (Additional Sample Unit No. 20).

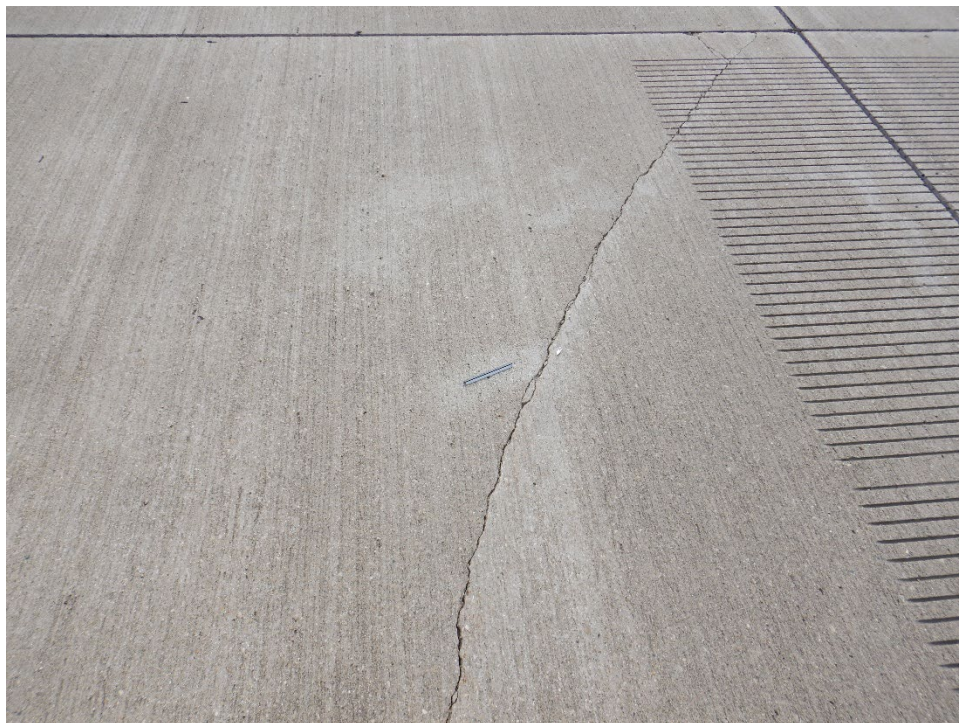
R13GL-02 LTD Cracking. (Additional Sample Unit No. 16).

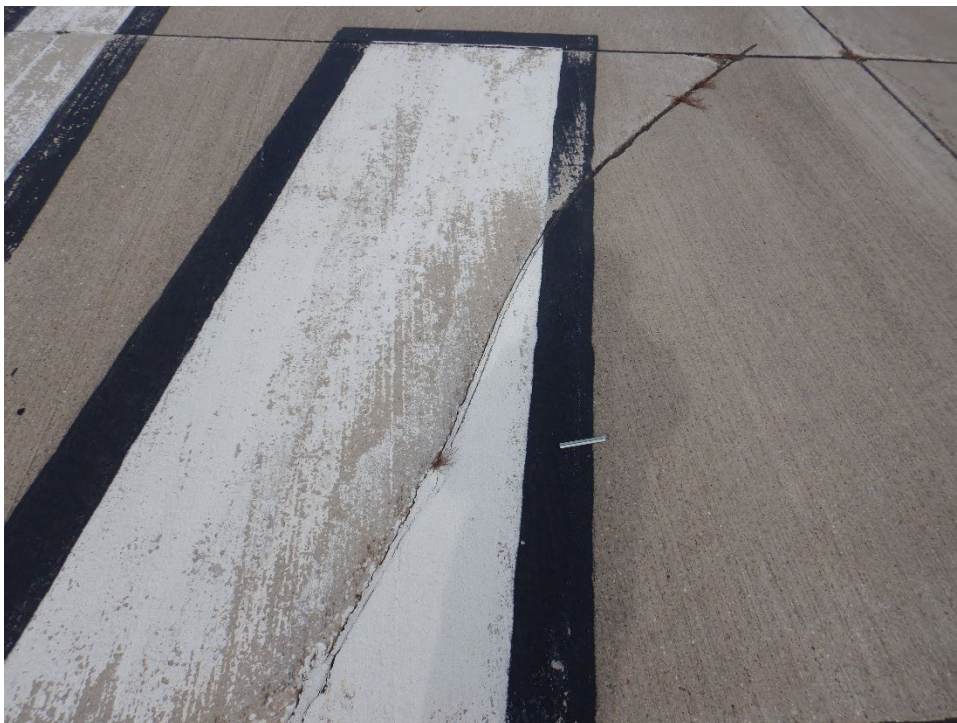
R13GL-03. LTD Cracking (Sample Unit No. 03).

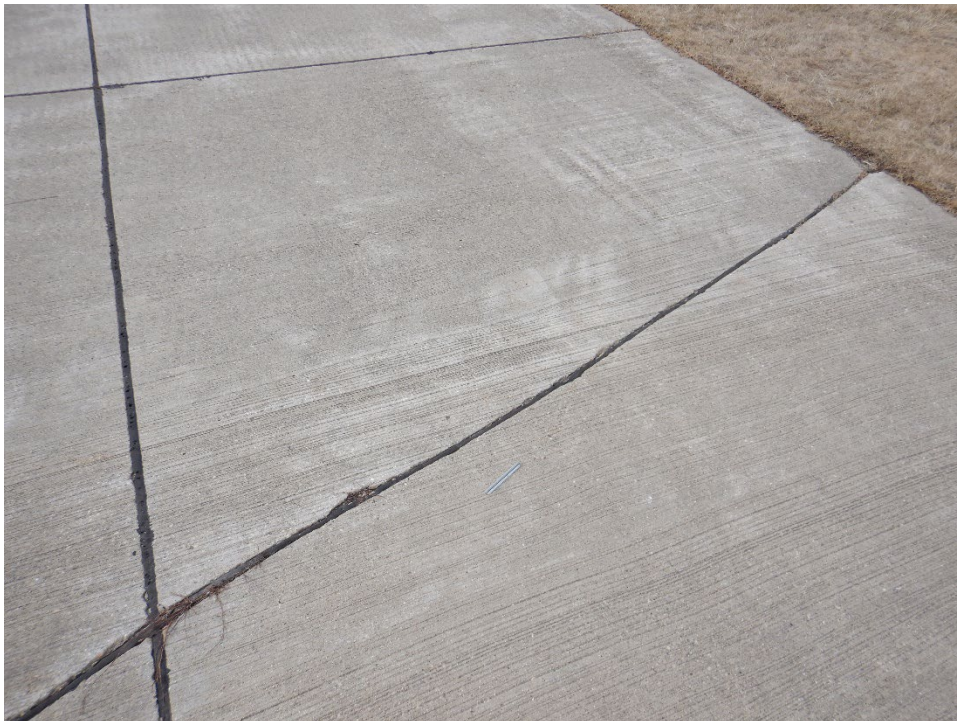
R13GL-04. LTD Cracking (Sample Unit No. 01).

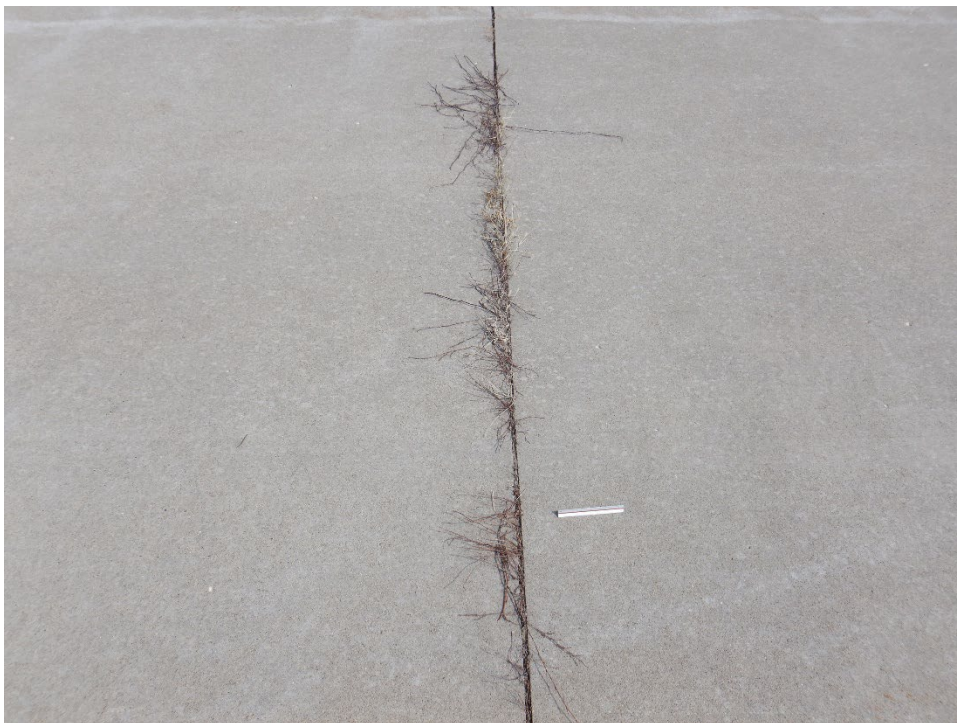
R13GL-05. Joint Seal Damage (Sample Unit No. 03).

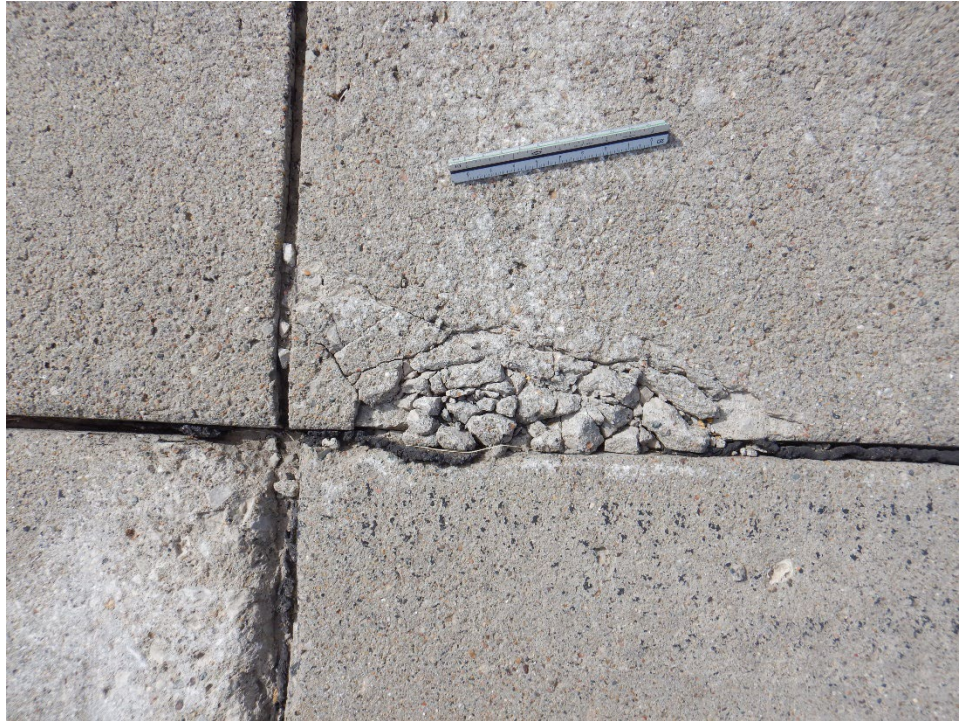
R13GL-05. Joint Spalling (Sample Unit No. 05).

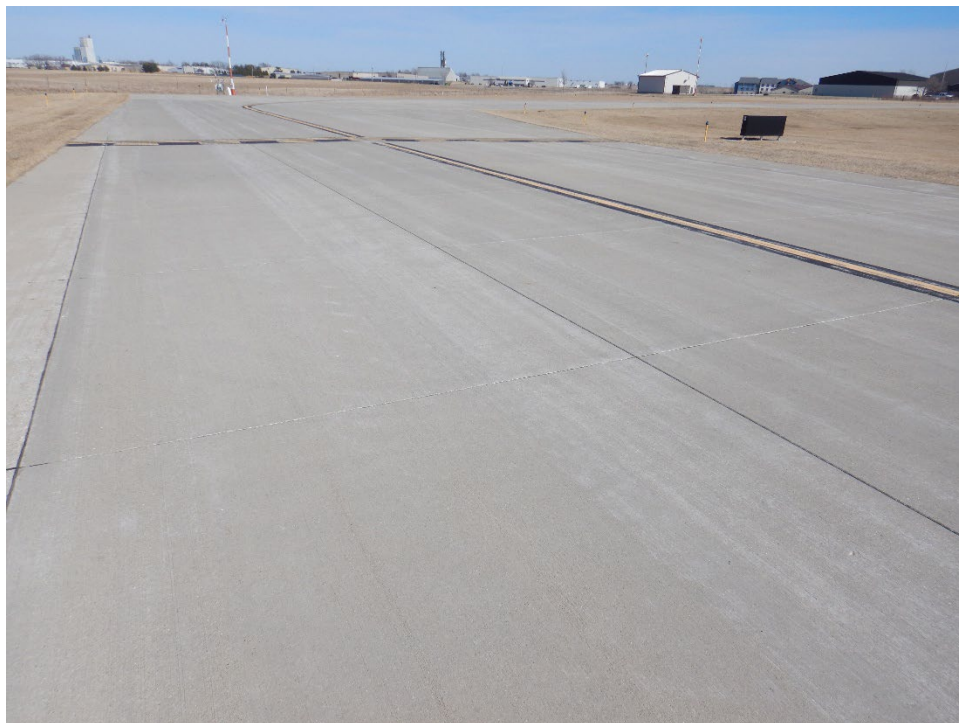
T01GL-01. Overview.

Taxiway 01 consisted of two sections that were in *Excellent* condition. Section 01 contained low- and medium-severity joint seal damage and medium-severity joint spalling. Only low-severity joint seal damage was recorded throughout Section 02.

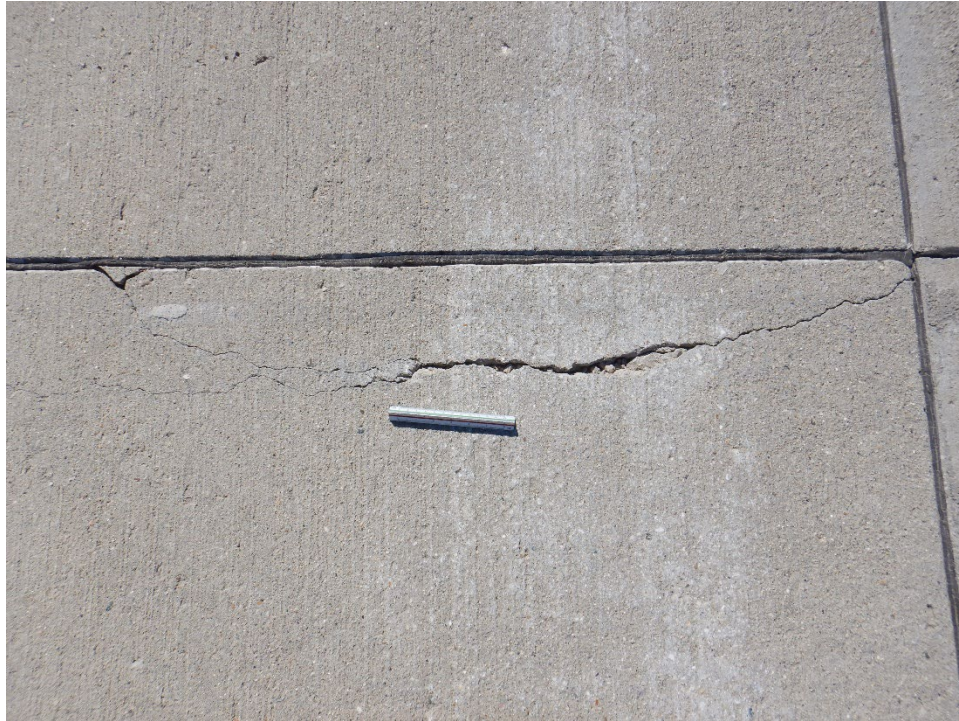
T01GL-01. Joint Spalling (Sample Unit No. 09).

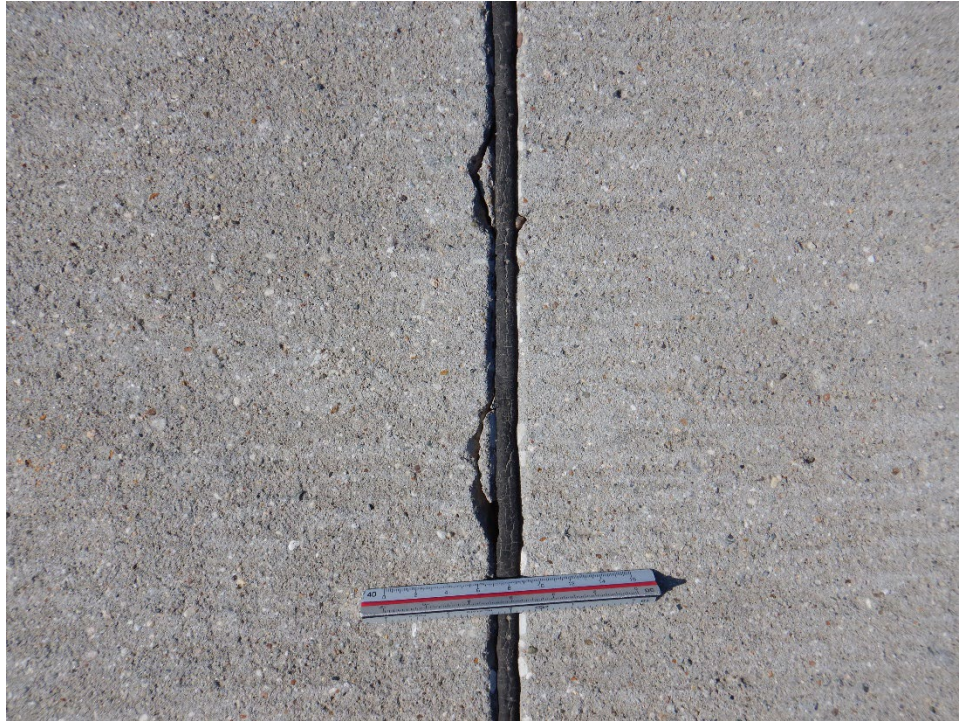
T01GL-02. Joint Seal Damage (Sample Unit No. 19).

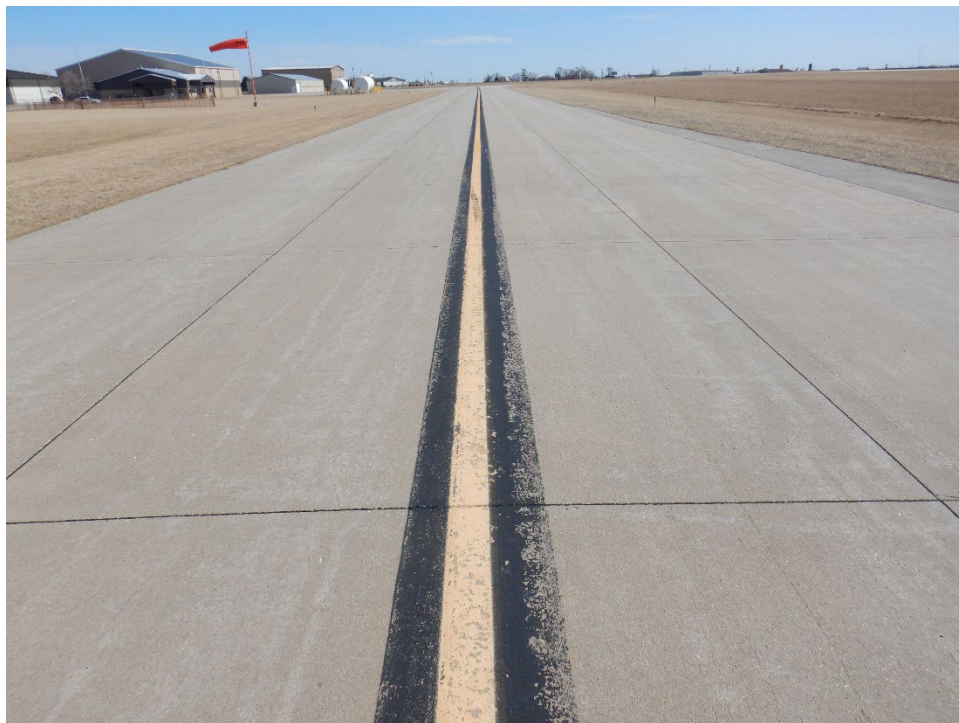
T02GL-01. Overview.

Taxiway 02 contained one section that had areas of low-severity ASR, medium-severity joint seal damage, low- and medium-severity joint spalling, and shrinkage cracking noted during the inspection.

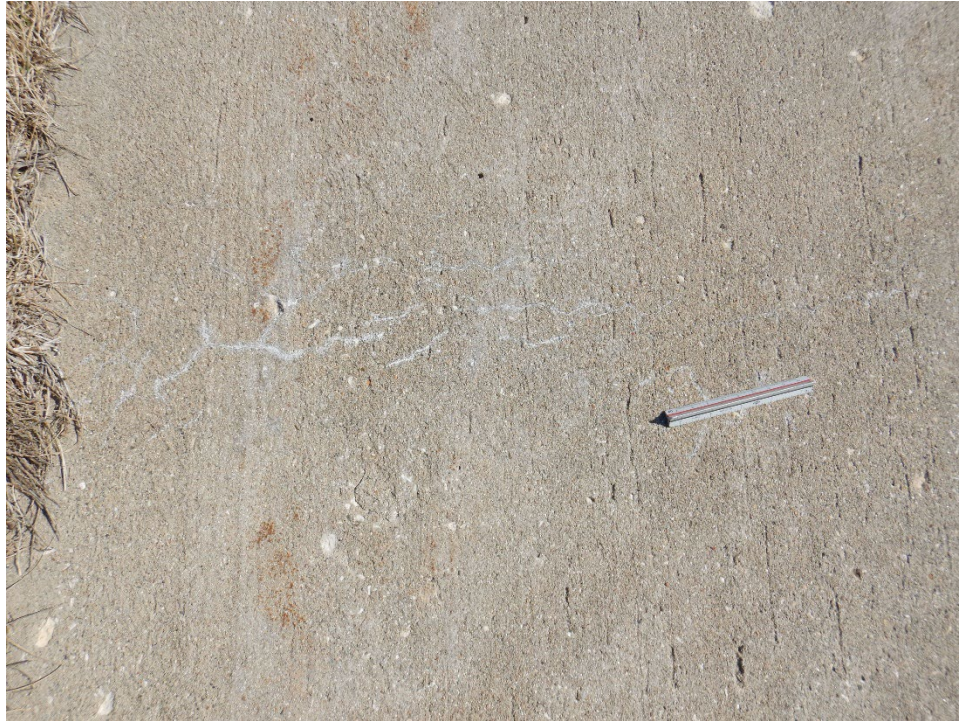
T02GL-01. ASR (Sample Unit No. 04).

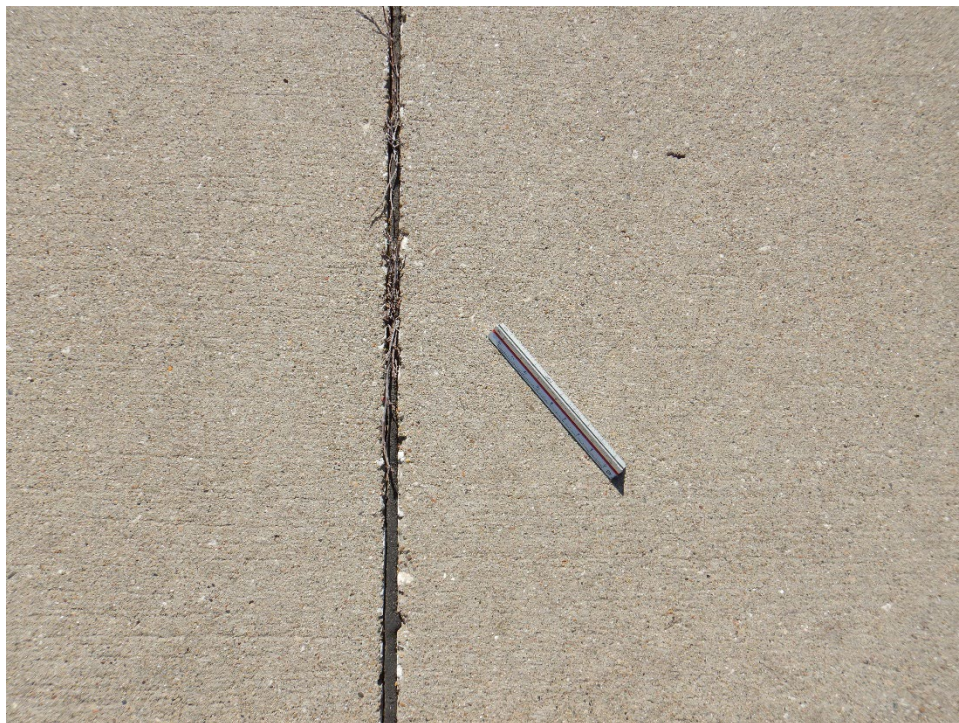
T02GL-01. Joint Seal Damage (Sample Unit No. 01).

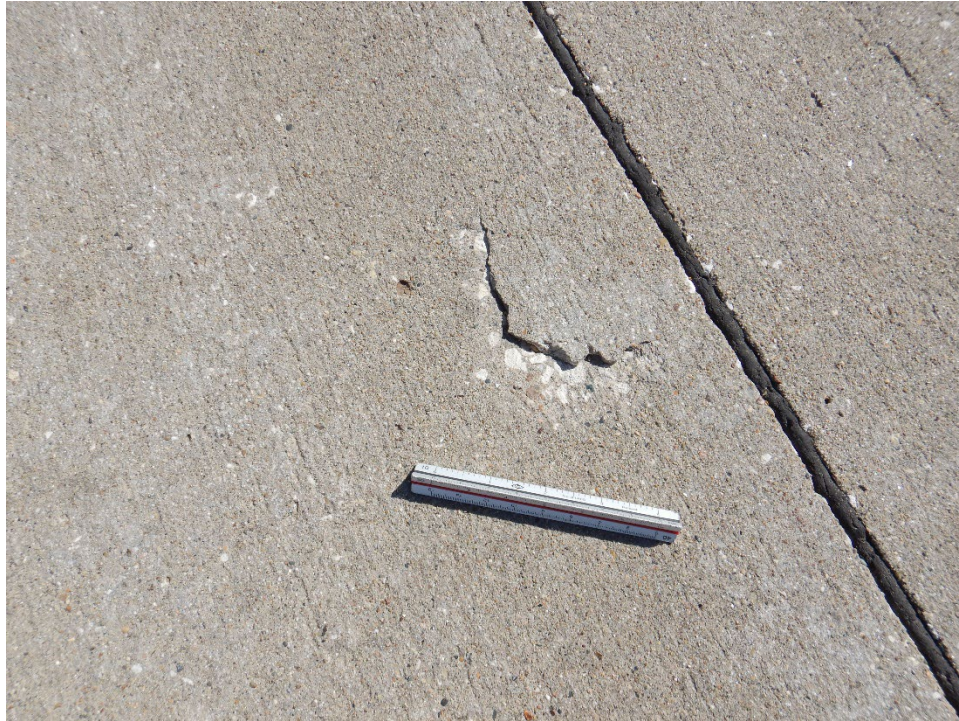
| <b>Distress Type</b> | <b>Probable Cause of Distress</b> |
|---|---|
| Shrinkage Cracking | Setting and curing of the concrete. |

T02GL-01. Shrinkage Cracking (Sample Unit No. 01).

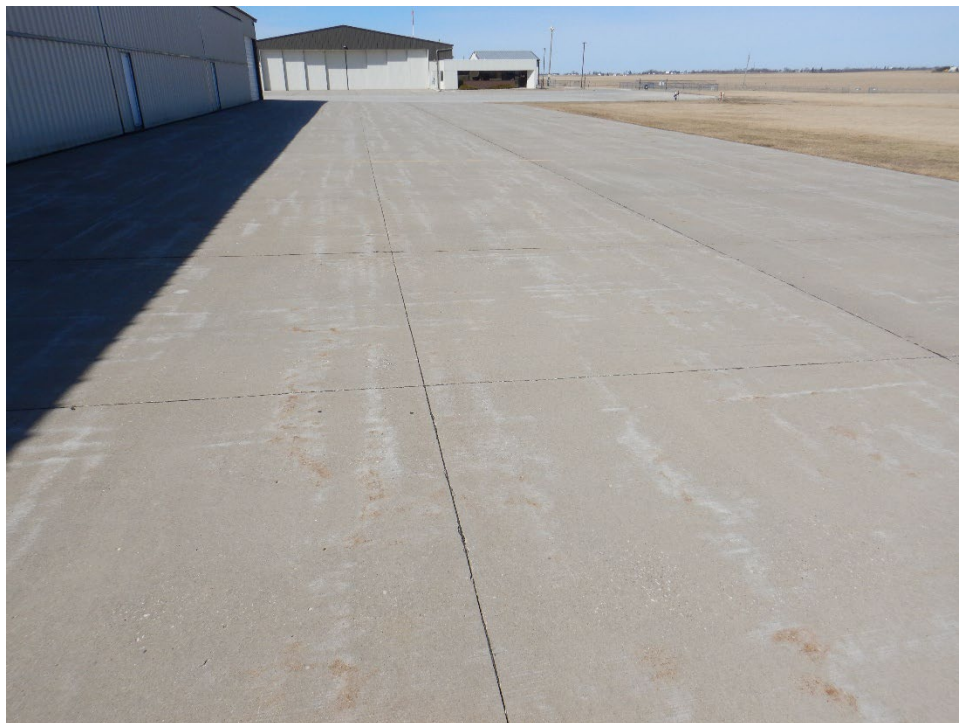
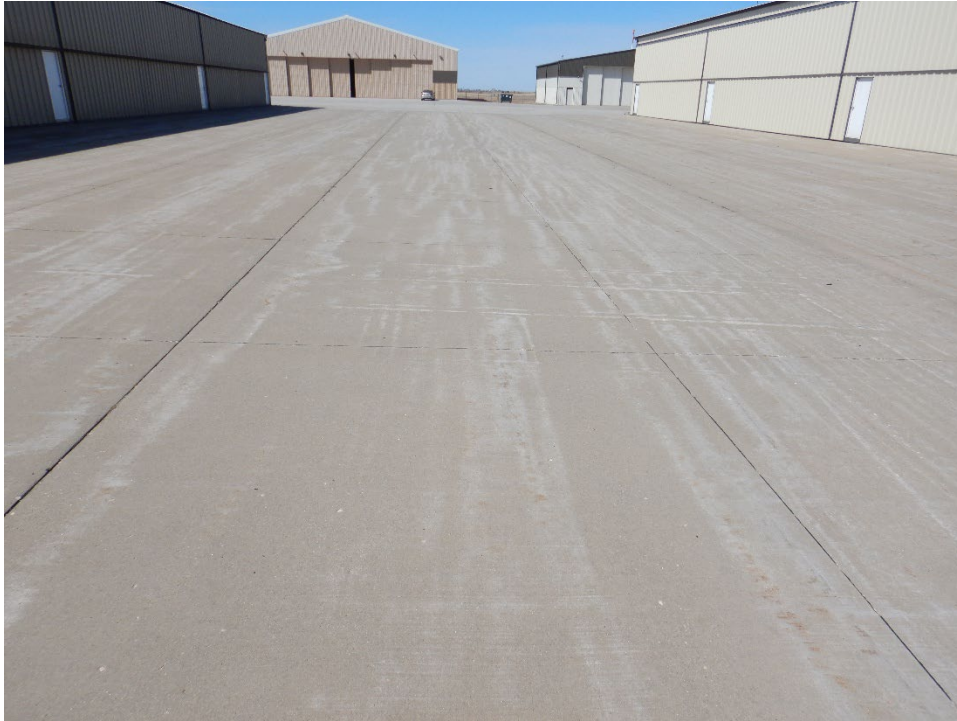
The T-hangar area consisted of two sections. Section 01 contained areas of low-severity ASR, large patching, and corner break; all severities of corner spalling; high-severity joint seal damage and shattered slab; medium-severity joint spalling and scaling; low- and medium-severity LTD cracking; and shrinkage cracking. Medium-severity joint seal damage and joint spalling were recorded in Section 02.

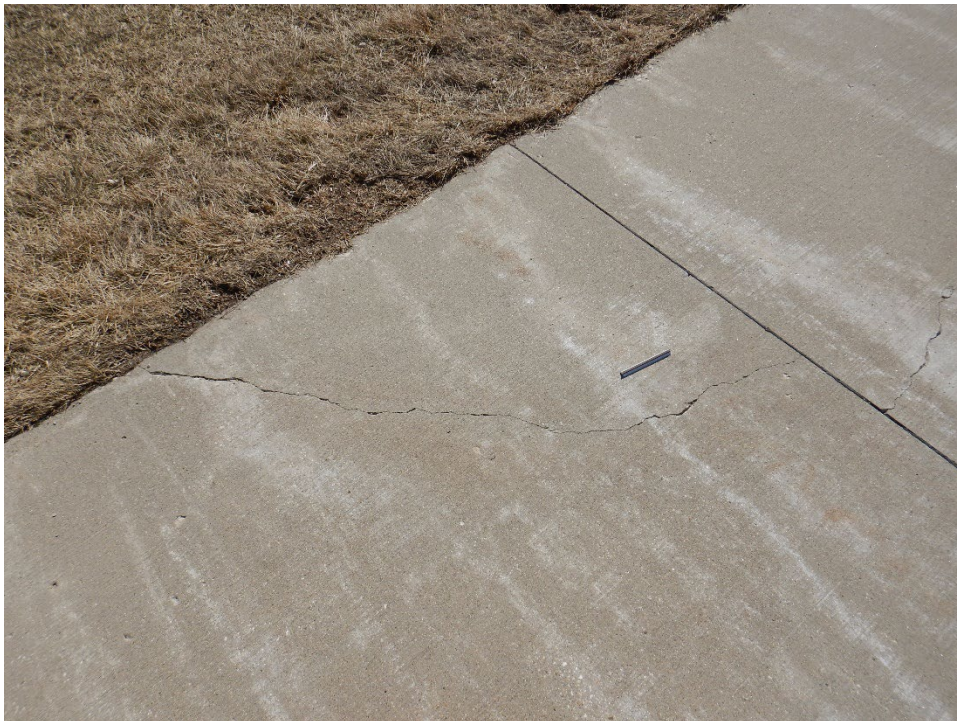
TH01GL-01. Corner Break (Sample Unit No. 08).

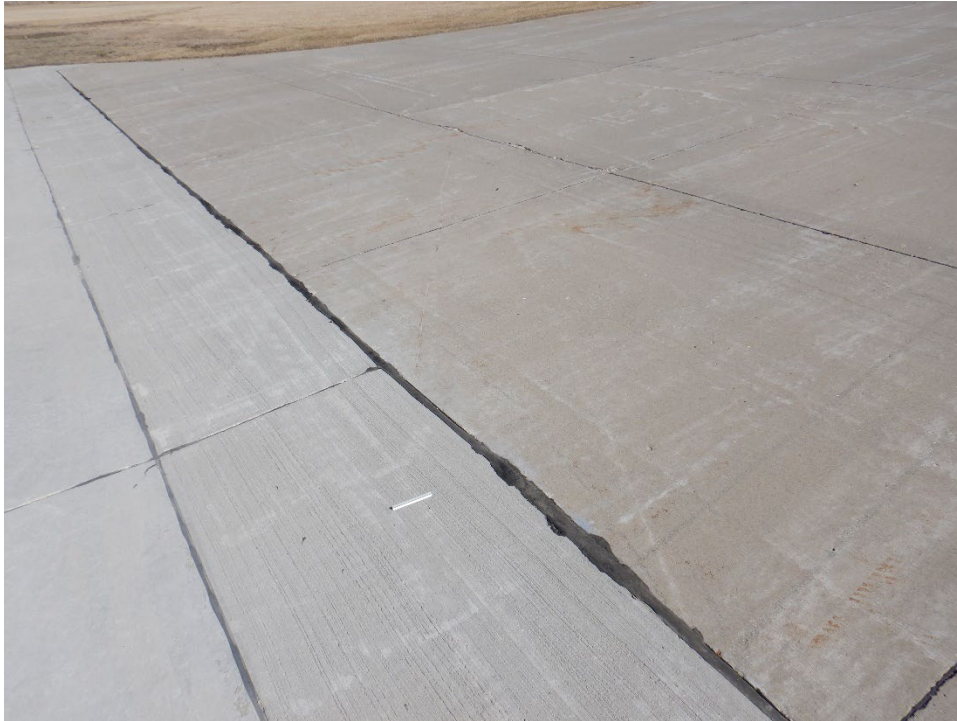
TH01GL-01. Large Patching (Sample Unit No. 01).
