# Grinnell Regional Airport

## Pavement Management Report

**AUGUST 2025**

# GRINNELL REGIONAL AIRPORT PAVEMENT MANAGEMENT REPORT

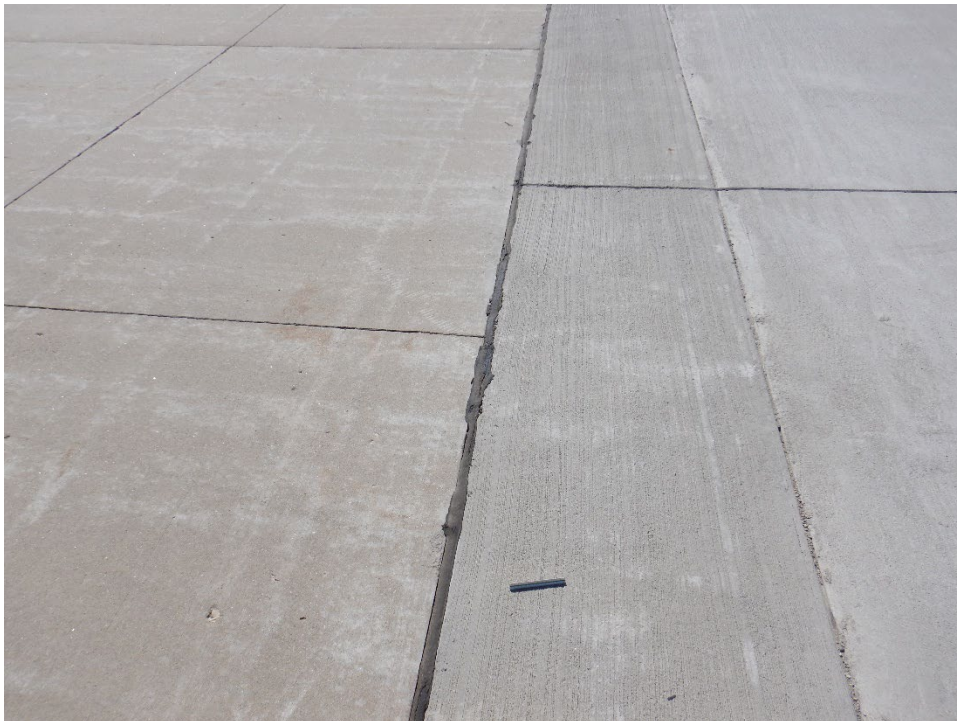
TH01GL-01. Large Patching (Sample Unit No. 05).

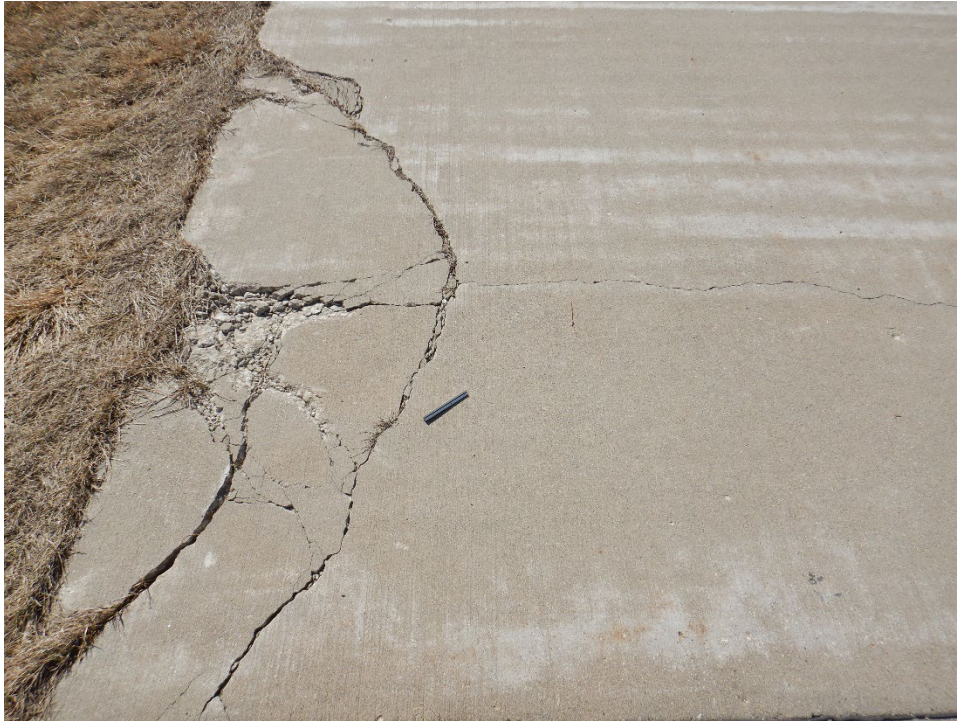
TH01GL-01. Shattered Slab (Sample Unit No. 08).

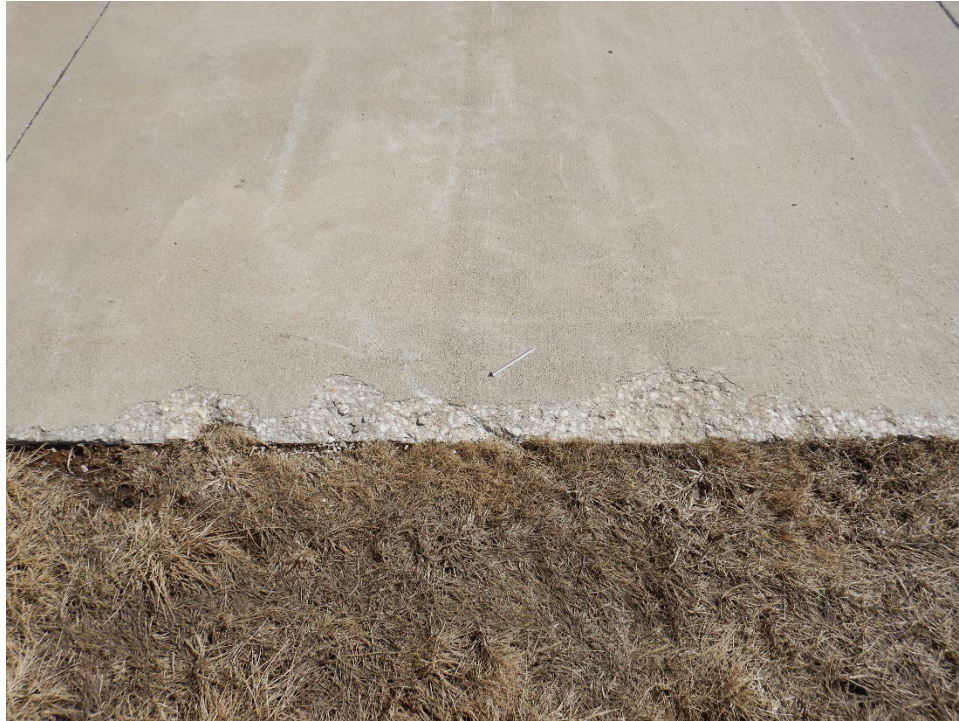
TH01GL-02. Joint Spalling (Sample Unit No. 02).
