# Harlan Municipal Airport

## Pavement Management Report

**AUGUST 2025**

# HARLAN MUNICIPAL AIRPORT PAVEMENT MANAGEMENT REPORT

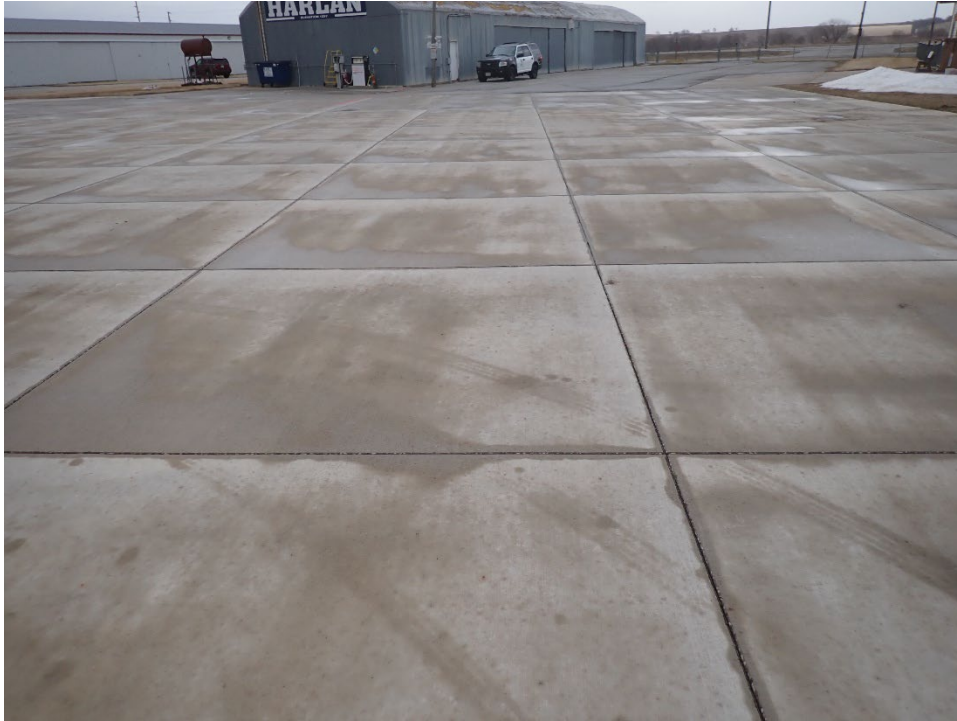
A01HL-01. Overview.

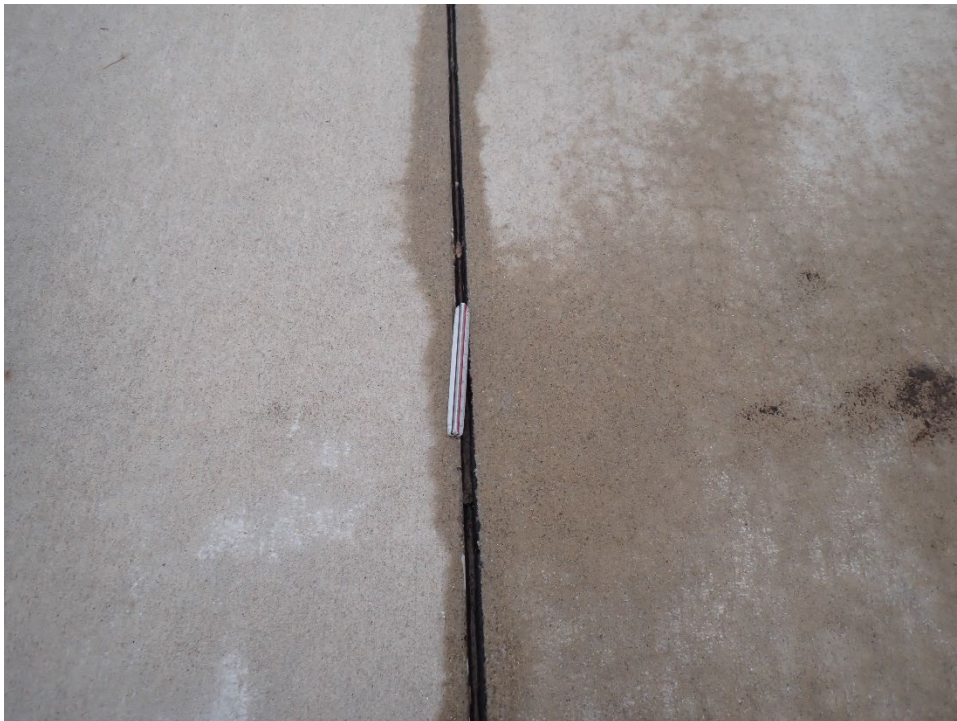
A01HL-01. Joint Seal Damage (Sample Unit No. 11).

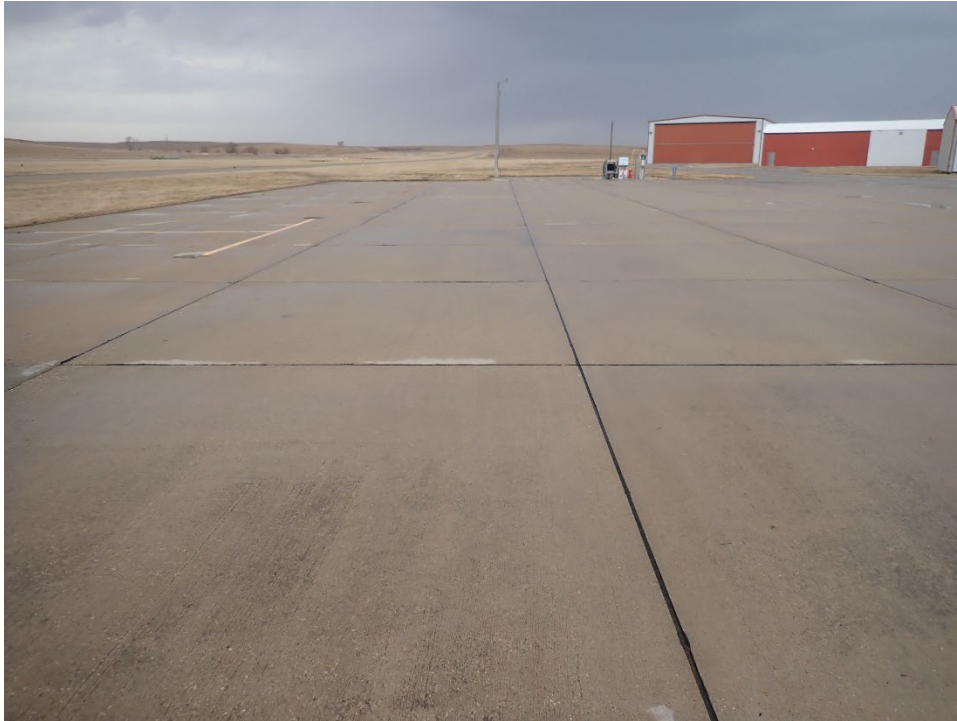
A01HL-02. Overview.

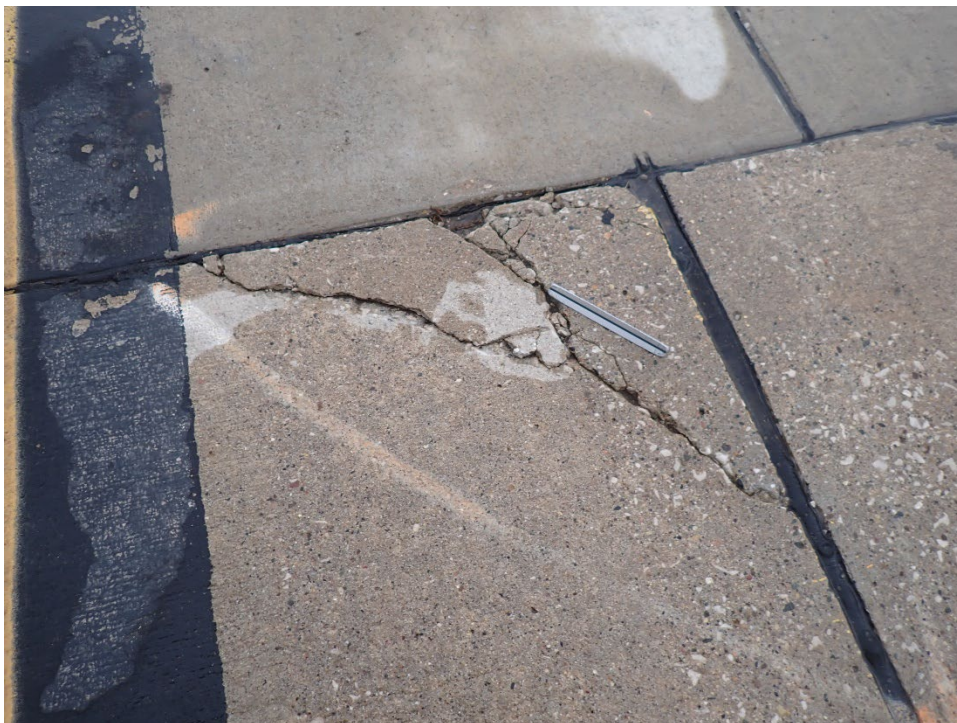
A01HL-02. Corner Spalling (Sample Unit No. 01).

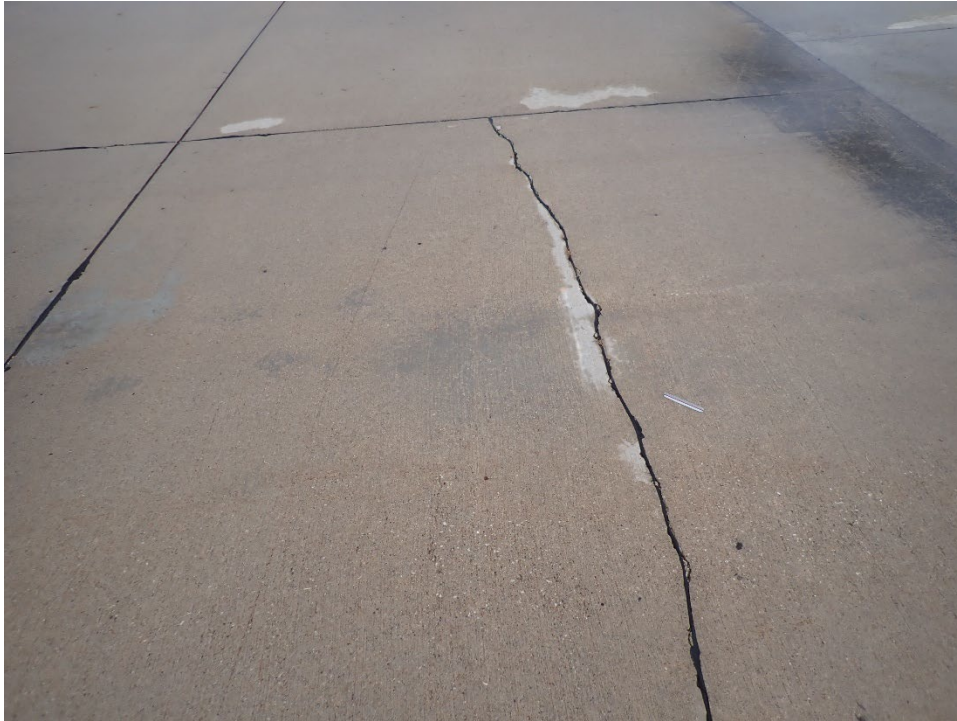
A01HL-02. LTD Cracking (Sample Unit No. 01).

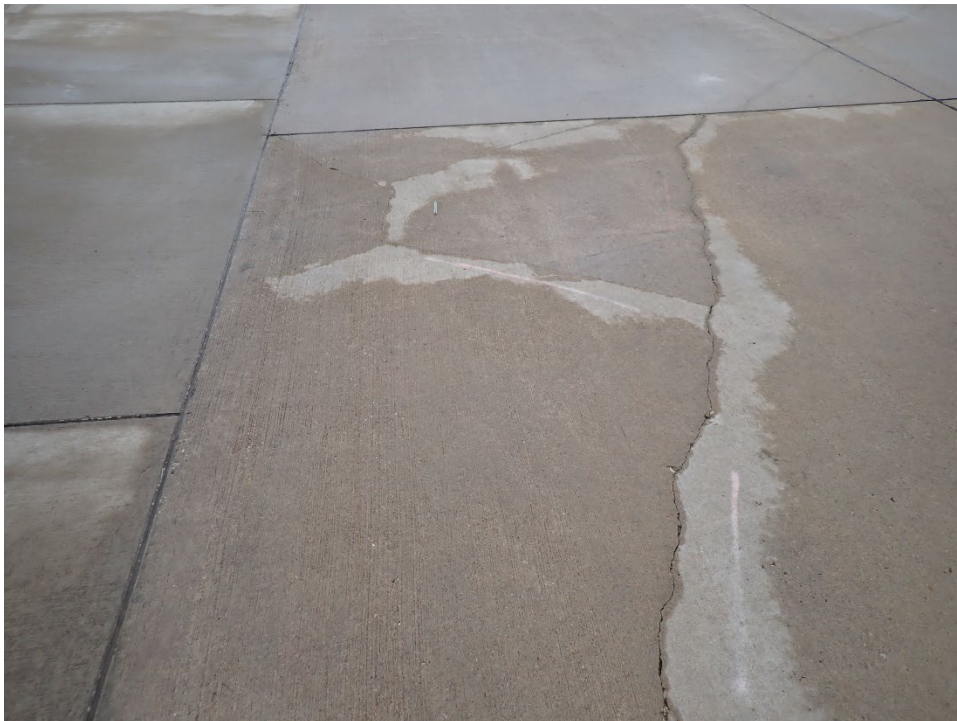
A01HL-02. Shattered Slab (Sample Unit No. 01).

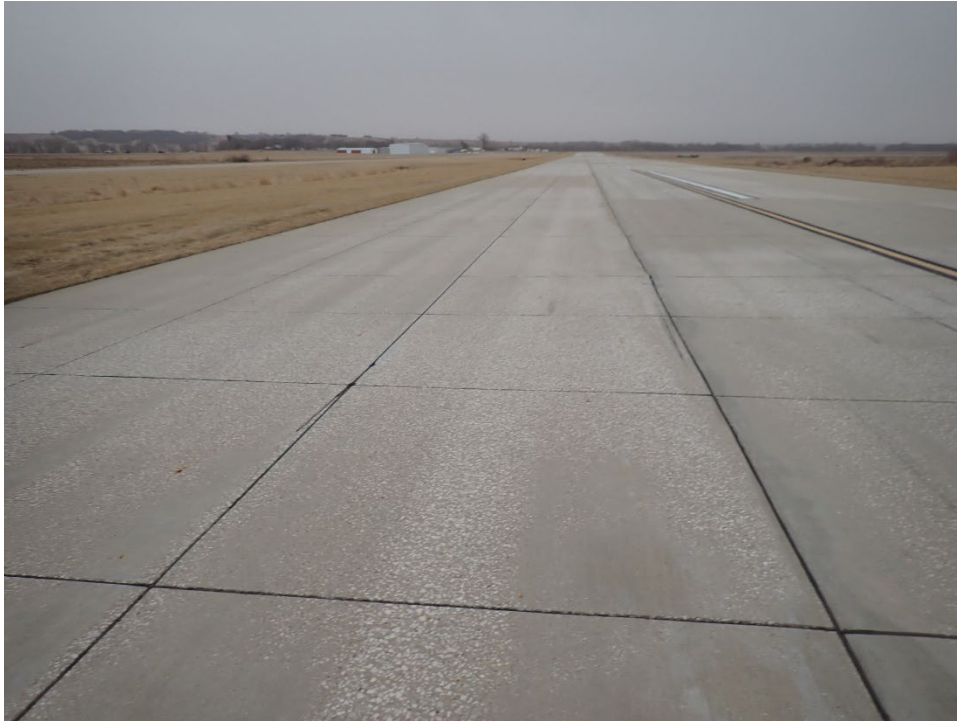
R15HL-01. Overview.

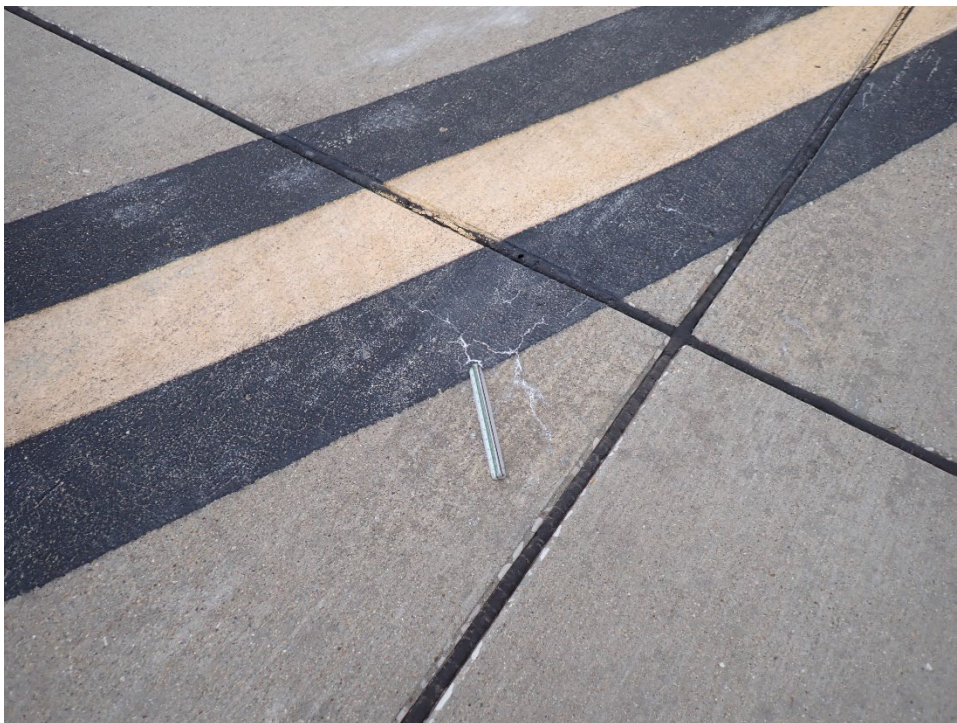
R15HL-01. ASR (Sample Unit No. 005).

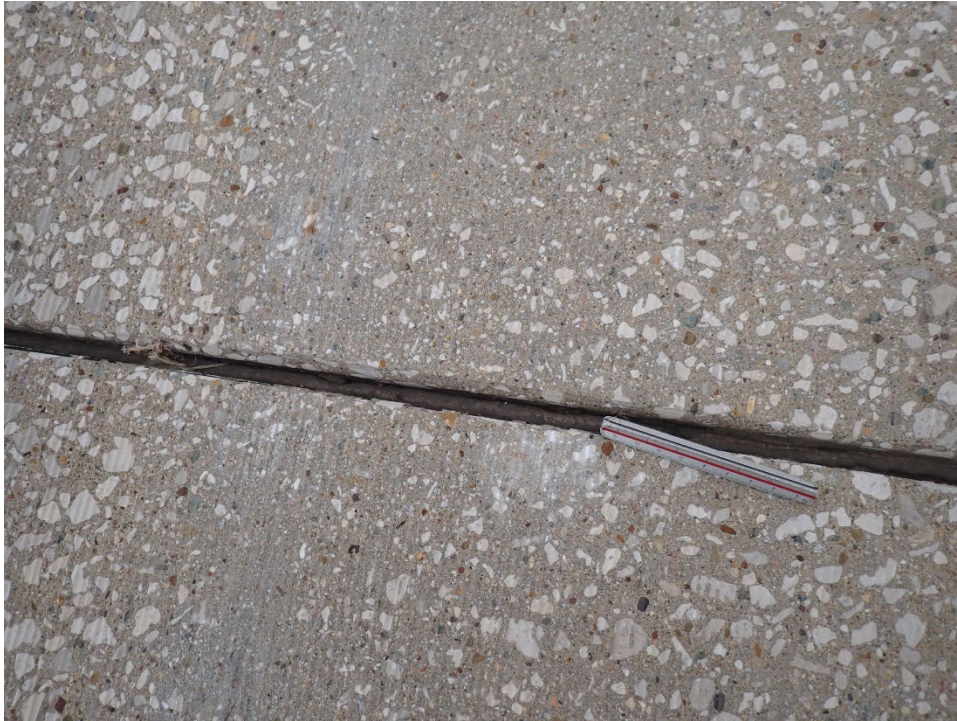
R15HL-01. Joint Seal Damage (Sample Unit No. 065).

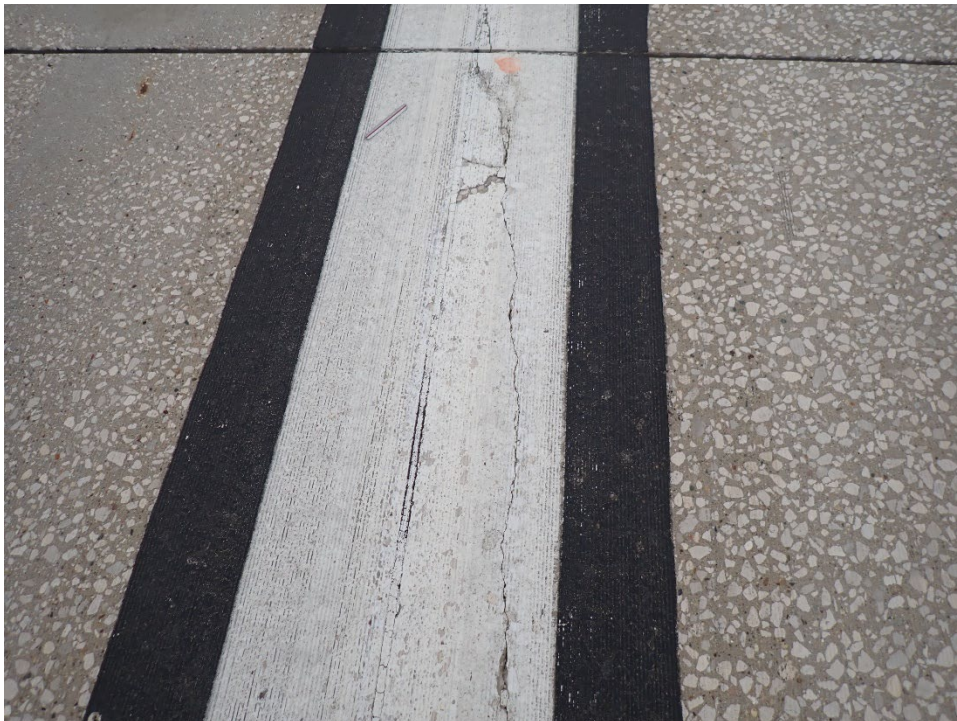
R15HL-01. Joint Spalling (Sample Unit No. 095).

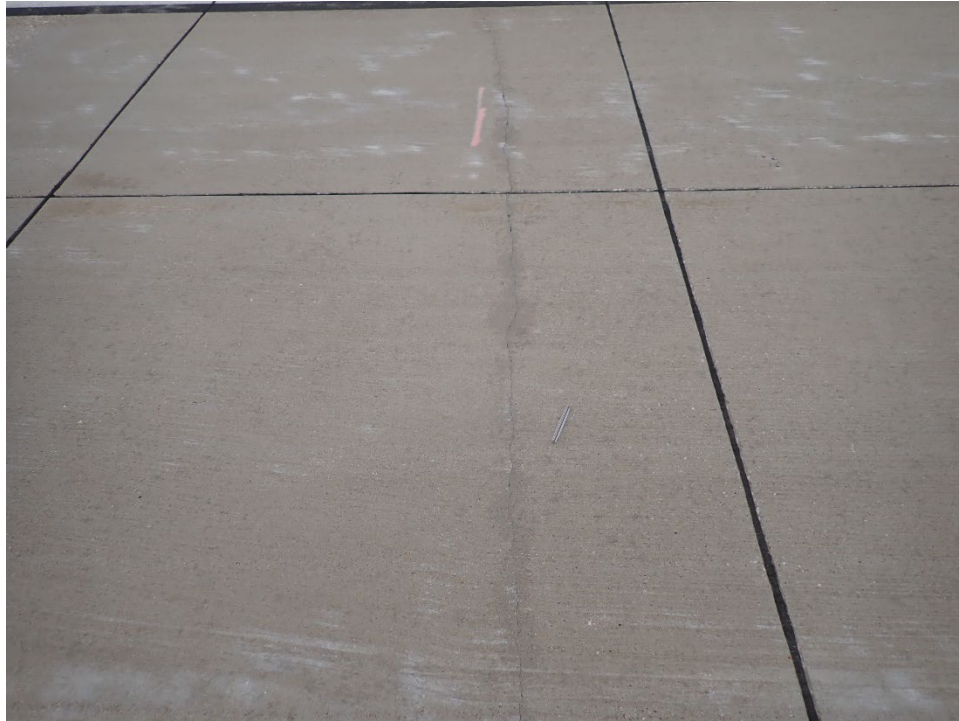
R15HL-01. LTD Cracking (Sample Unit No. 015).

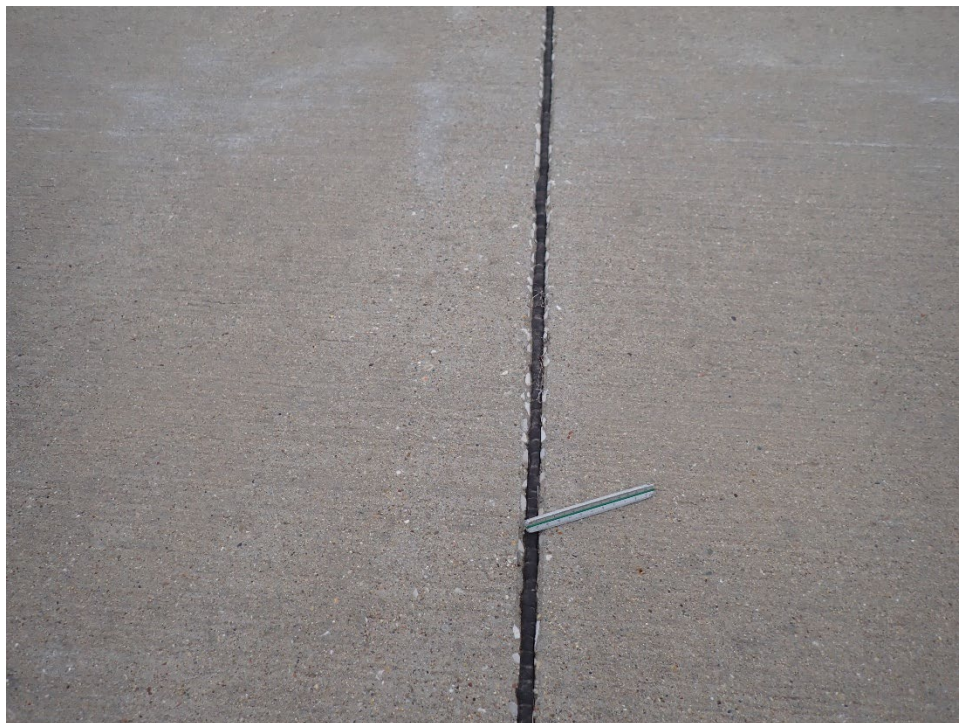
R15HL-02. Joint Seal Damage (Sample Unit No. 12).

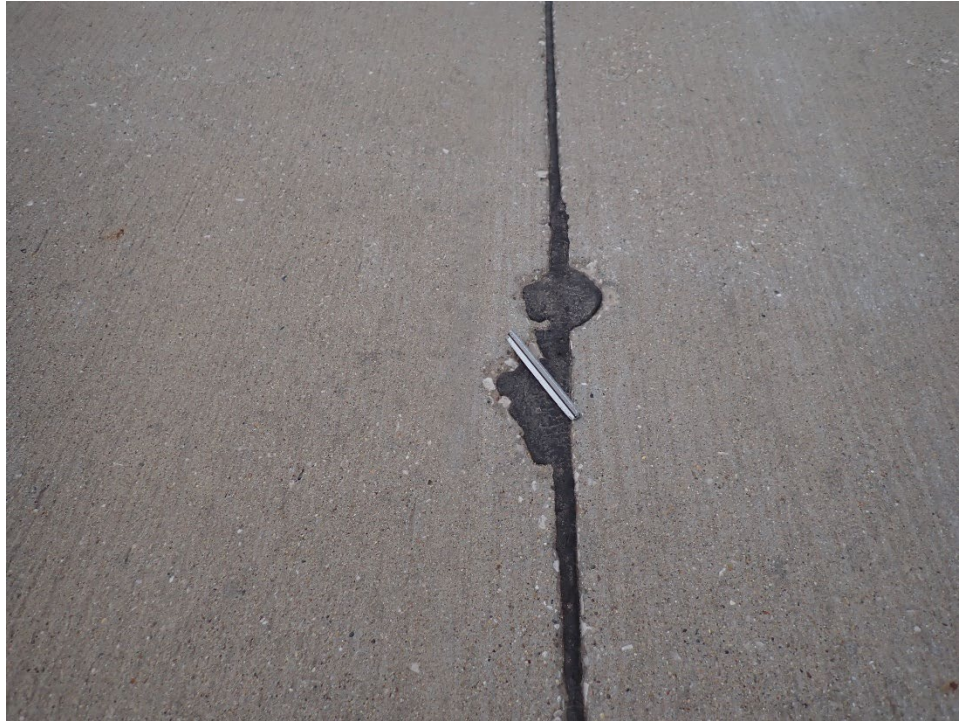
R15HL-02. Joint Spalling (Sample Unit No. 12).

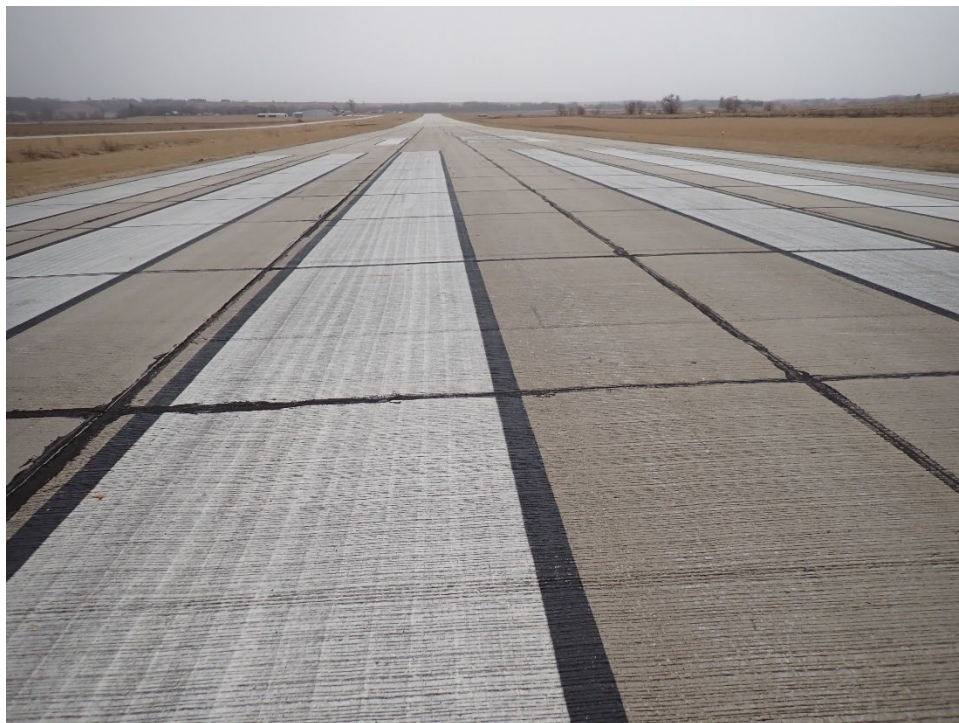
R15HL-03. Overview.

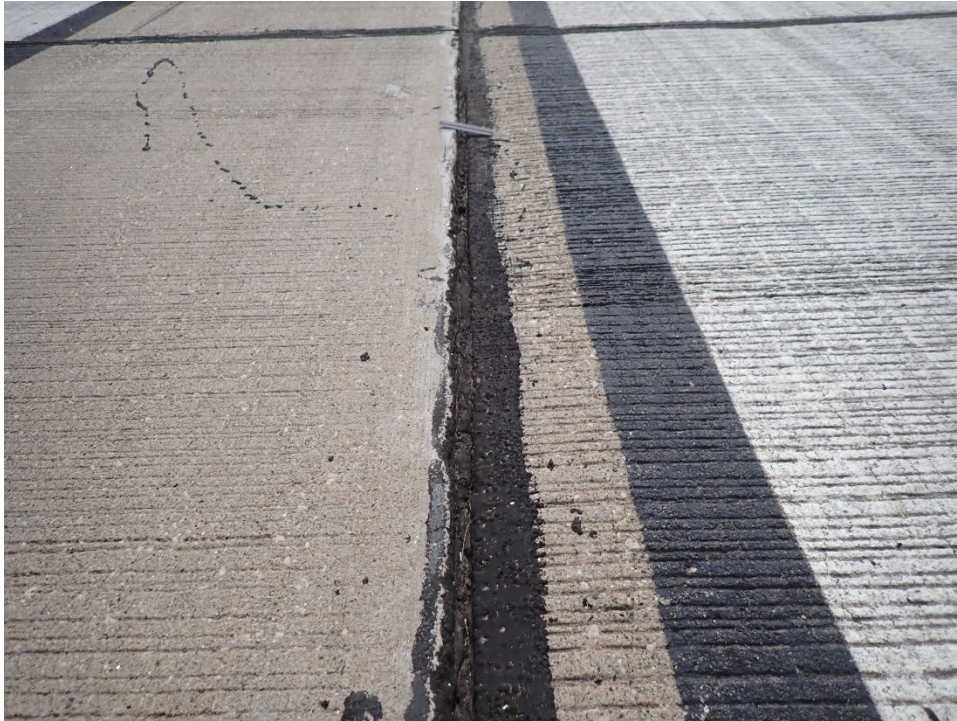
R15HL-03. Faulting (Sample Unit No. 11).

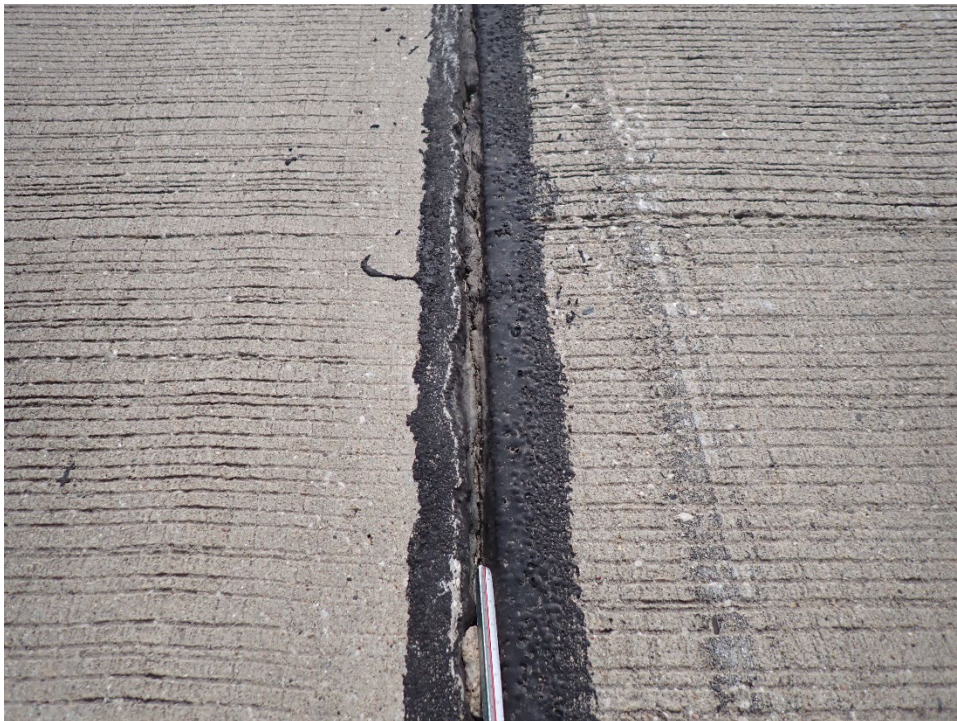
R15HL-03. Joint Seal Damage (Sample Unit No. 03).

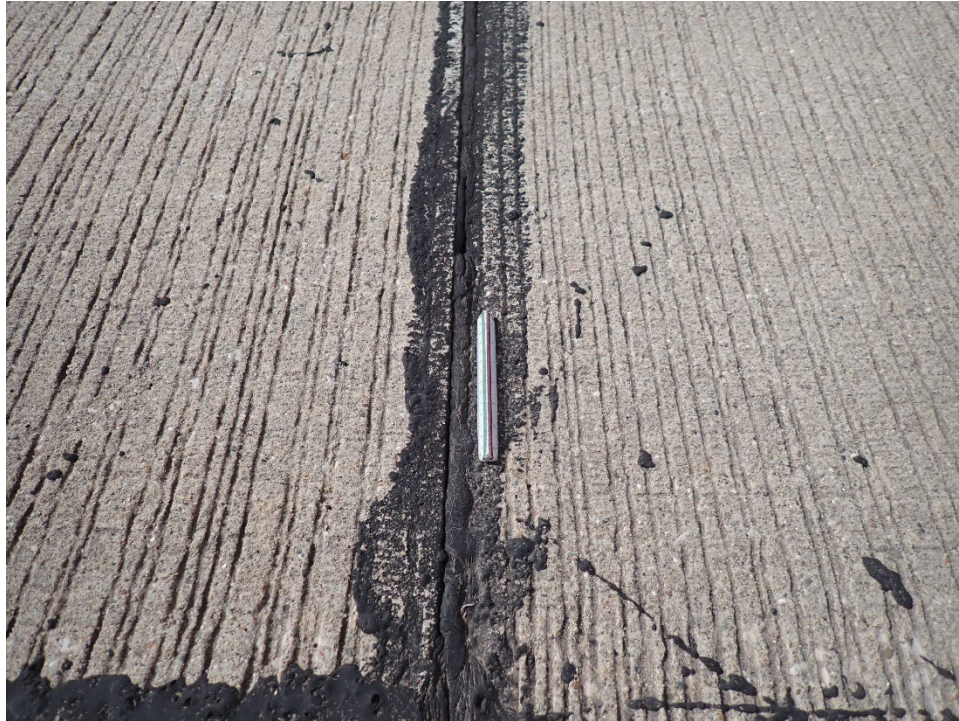
R15HL-03. Joint Seal Damage (Sample Unit No. 08).

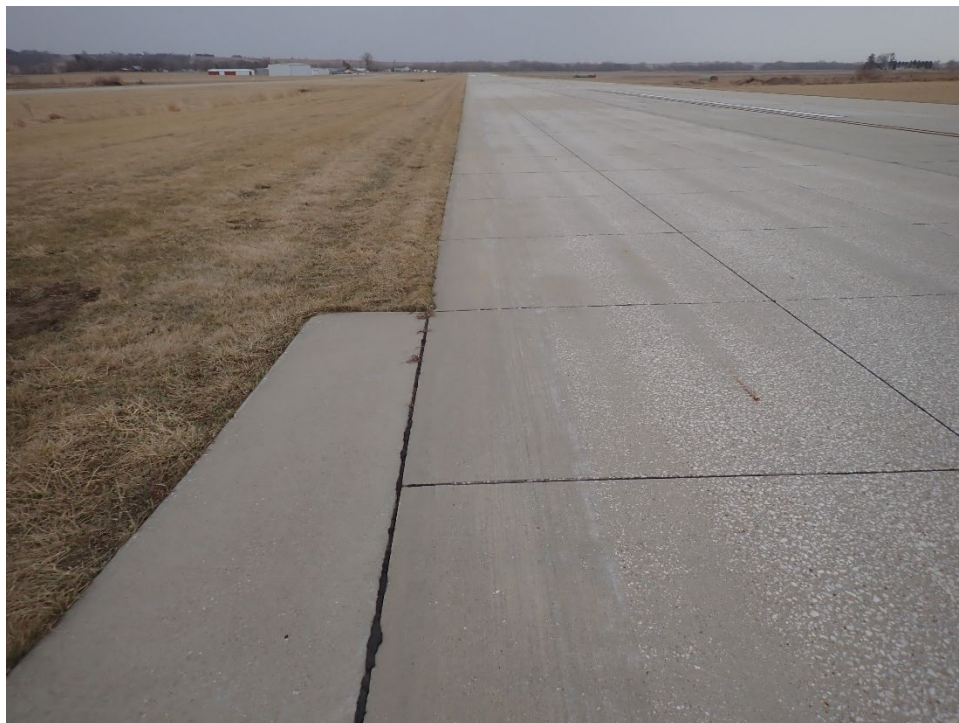
R15HL-04. Overview.

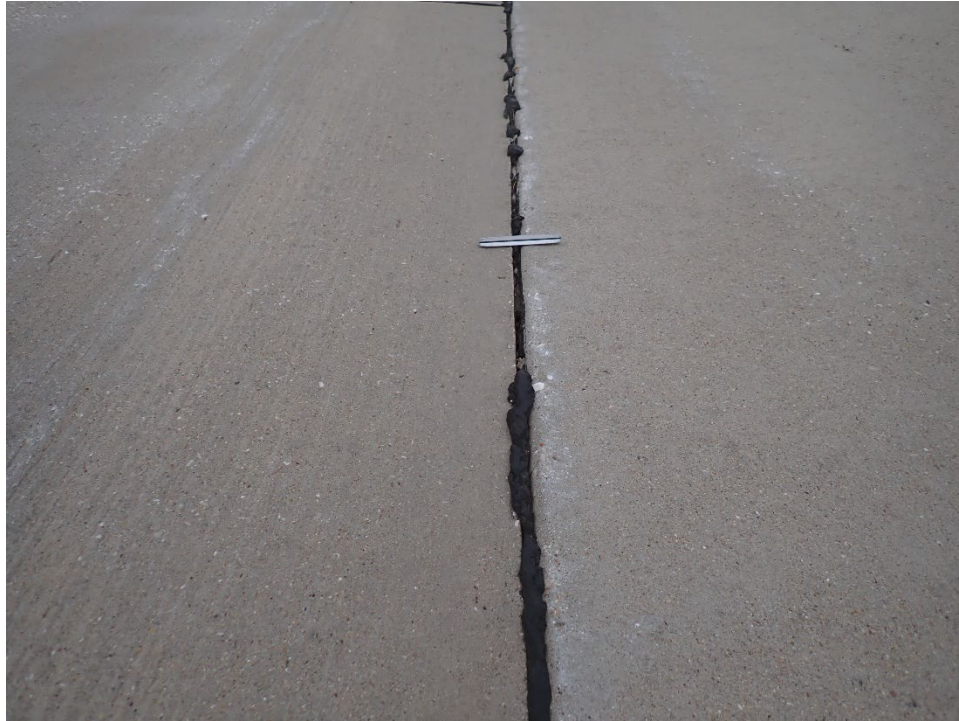
R15HL-04. Faulting (Sample Unit No. 02).

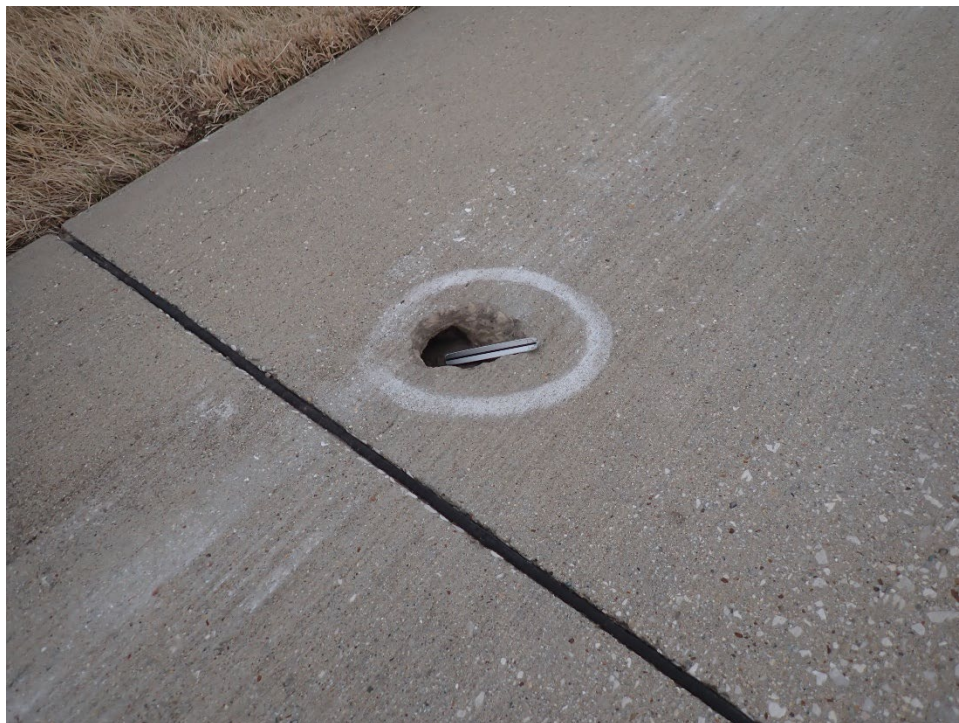
R15HL-04. Small Patching (Sample Unit No. 02).

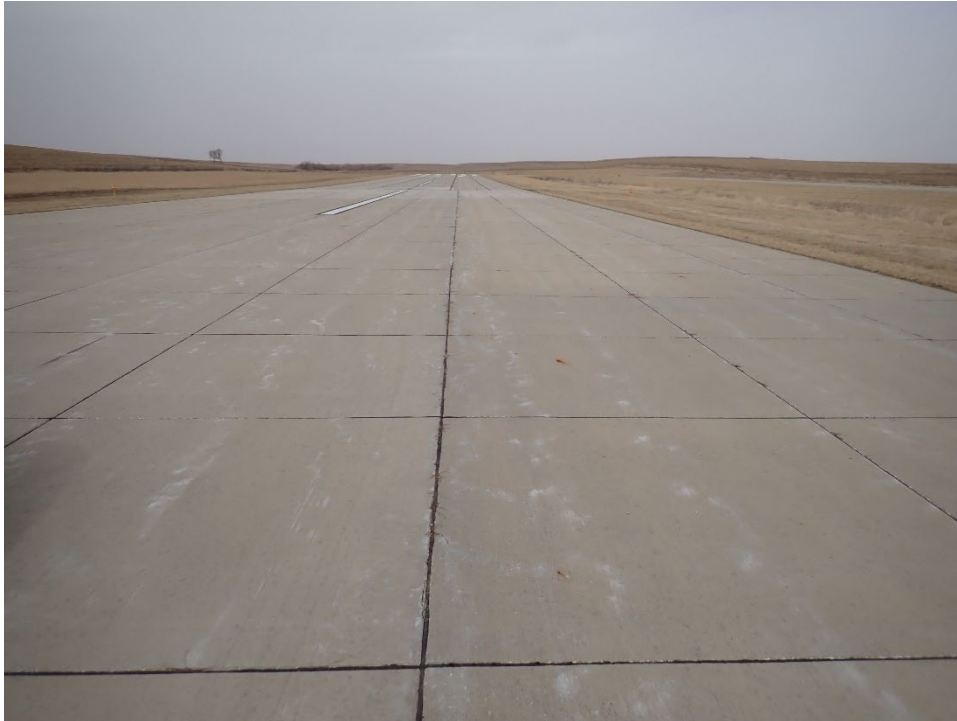
R15HL-05. Overview.

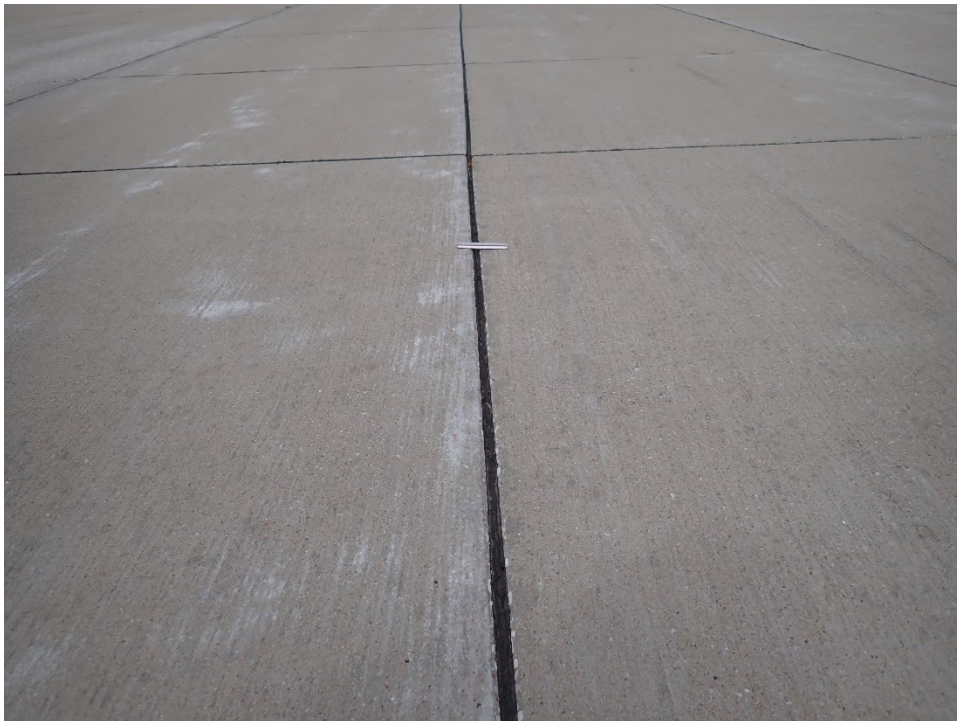
R15HL-05. Faulting (Sample Unit No. 14).

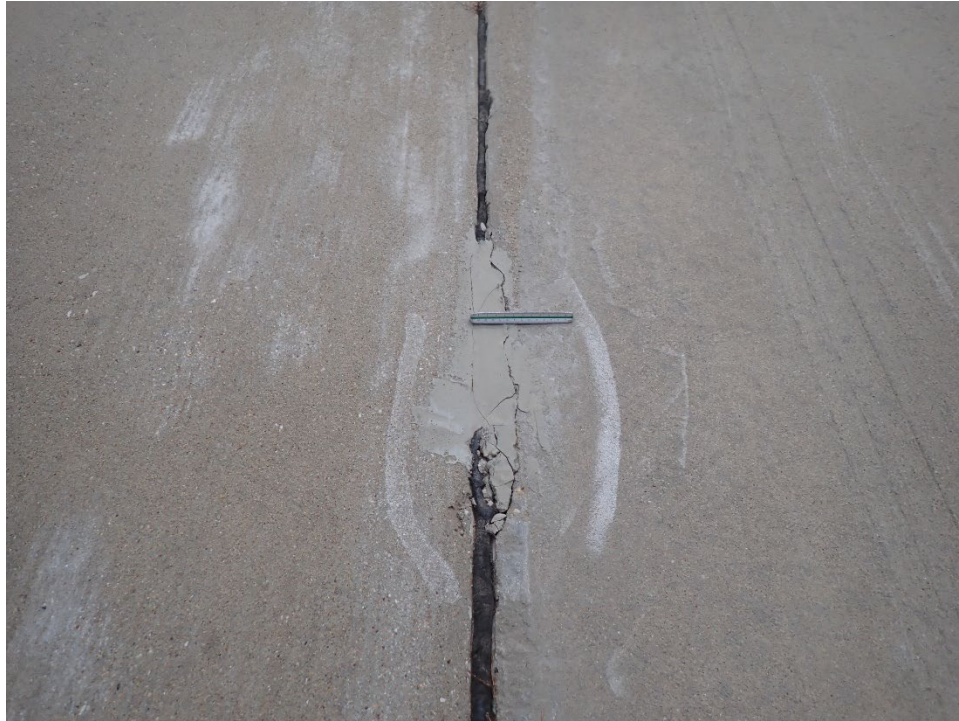
R15HL-05. Joint Seal Damage (Sample Unit No. 07).

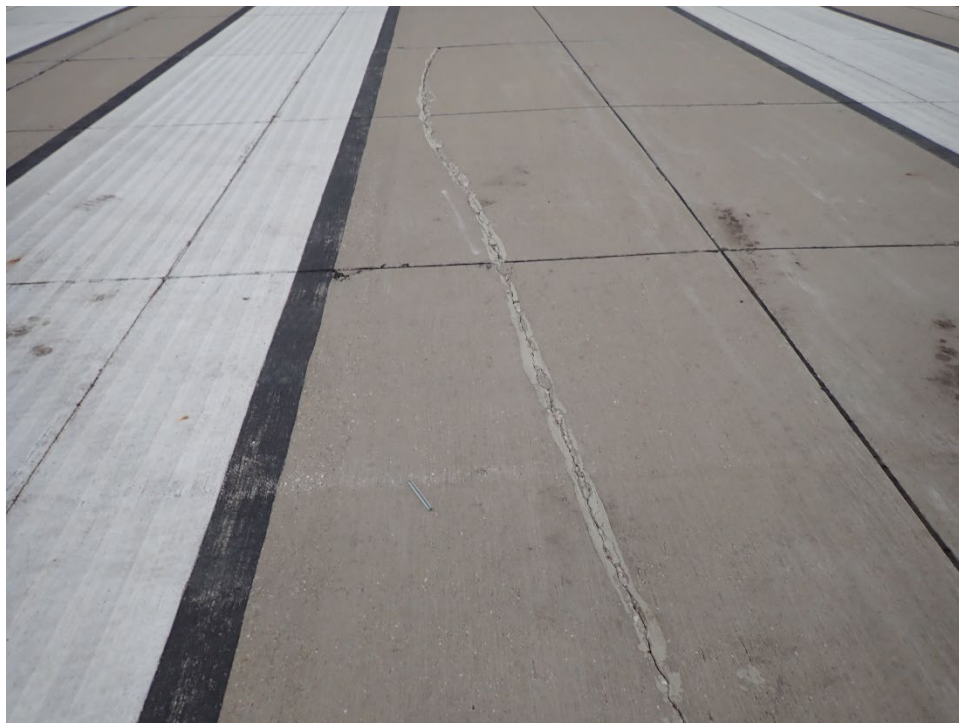
R15HL-05. LTD Cracking (Sample Unit No. 24).

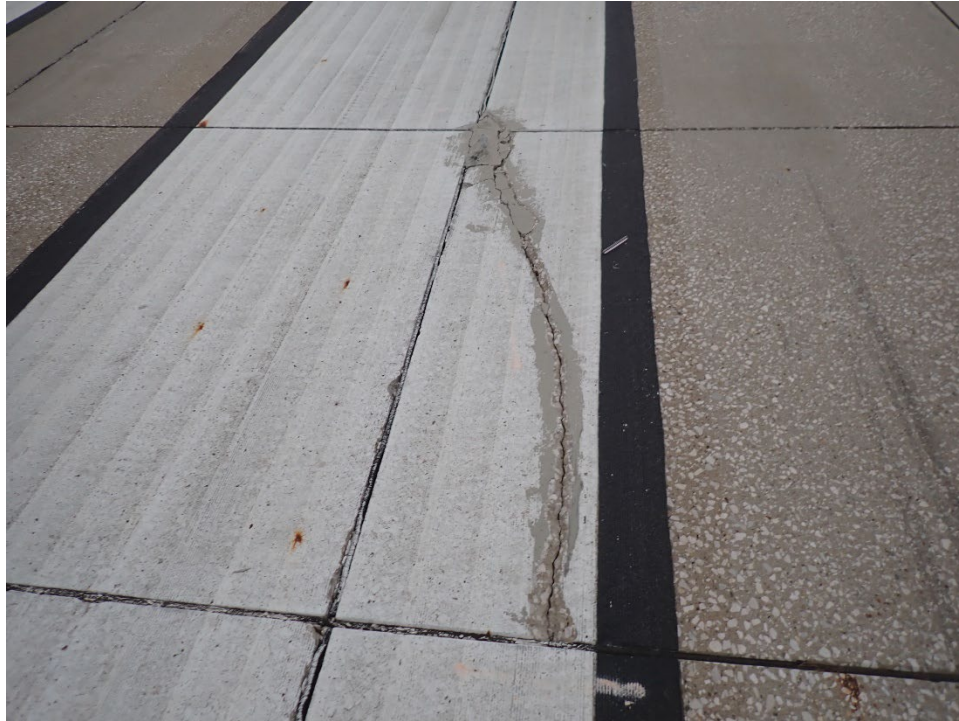
R15HL-05. LTD Cracking (Sample Unit No. 27).

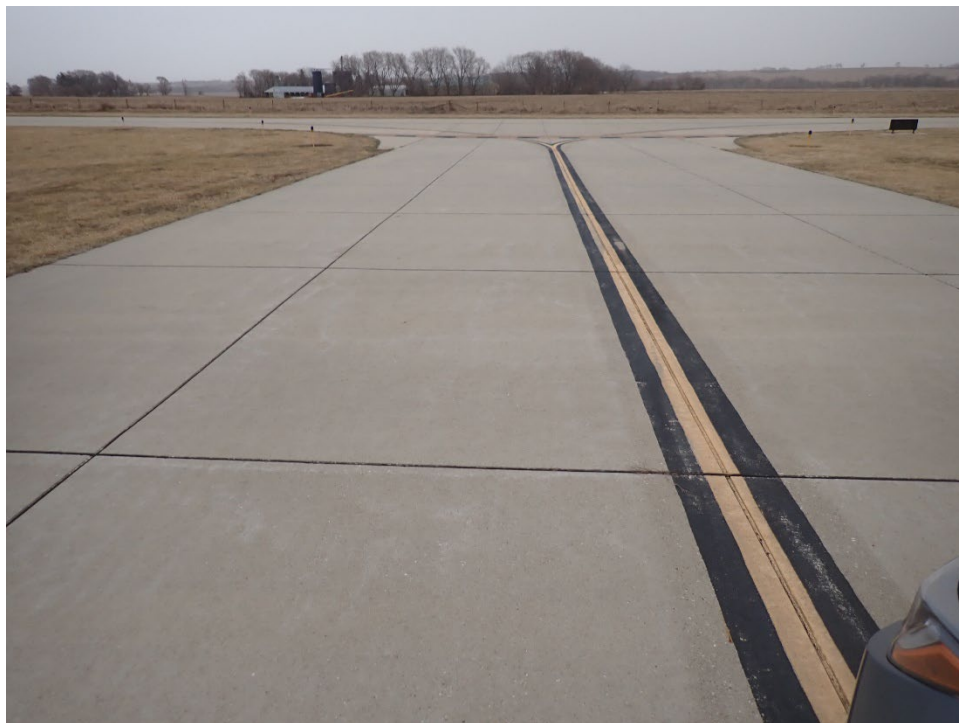
T01HL-01. Overview.

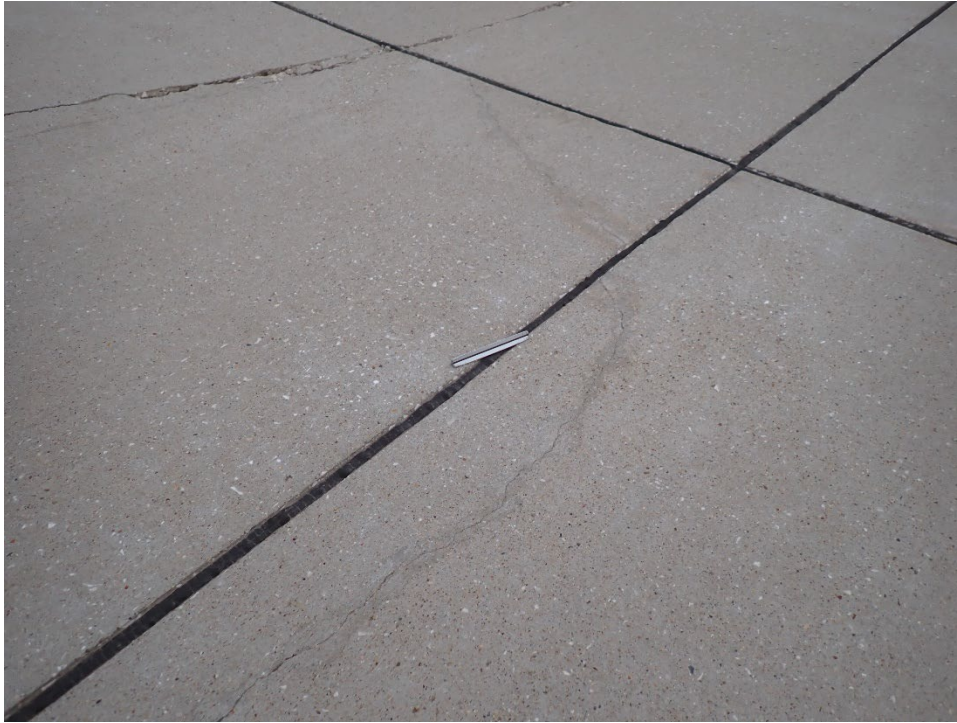
T01HL-01. ASR (Sample Unit No. 03).

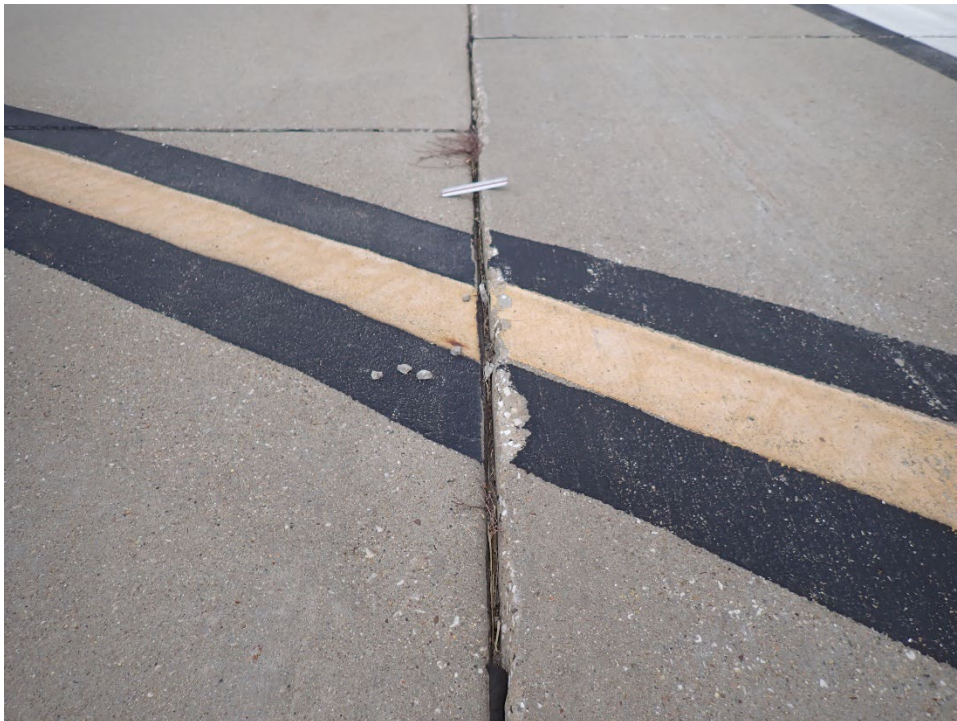
T01HL-01. Faulting (Sample Unit No. 02).

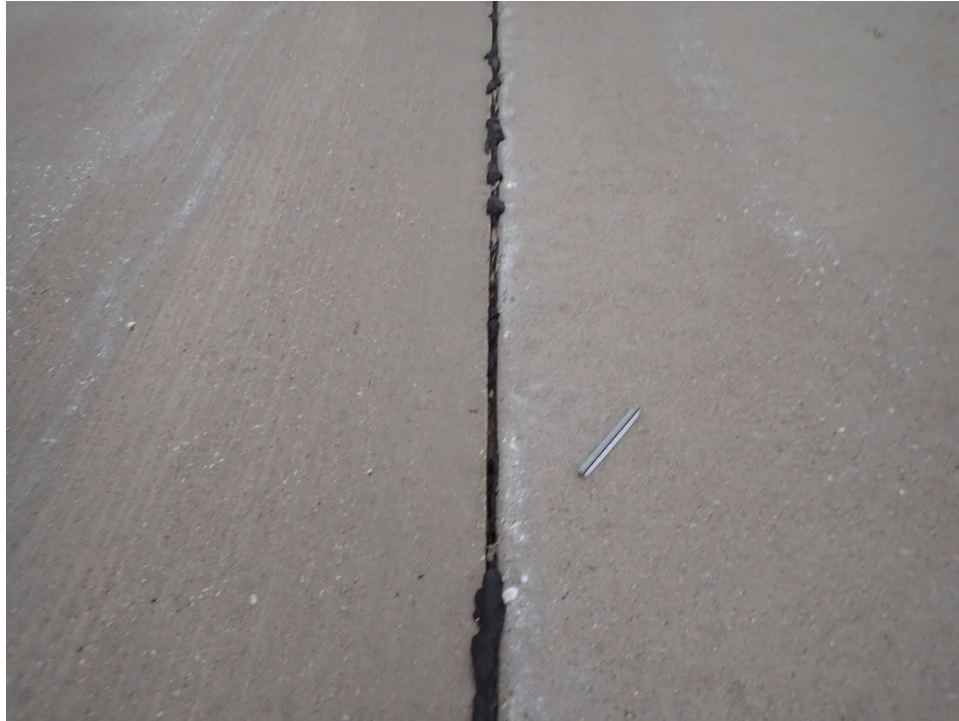
T01HL-01. Joint Seal Damage (Sample Unit No. 02).

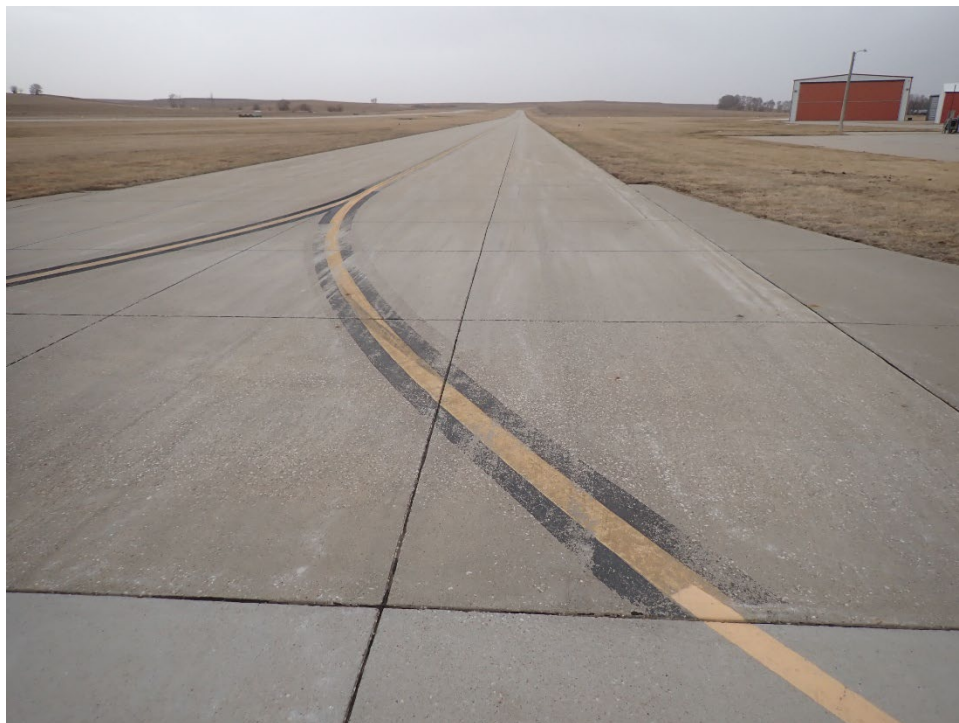
T02HL-01. Overview.

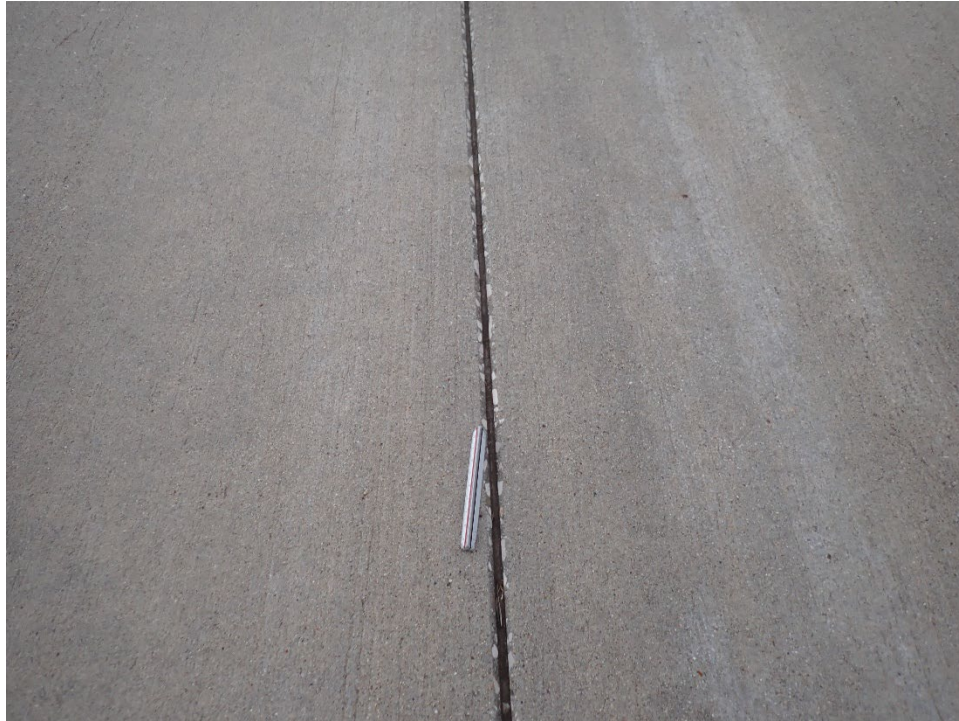
T02HL-01. Joint Seal Damage (Sample Unit No. 27).

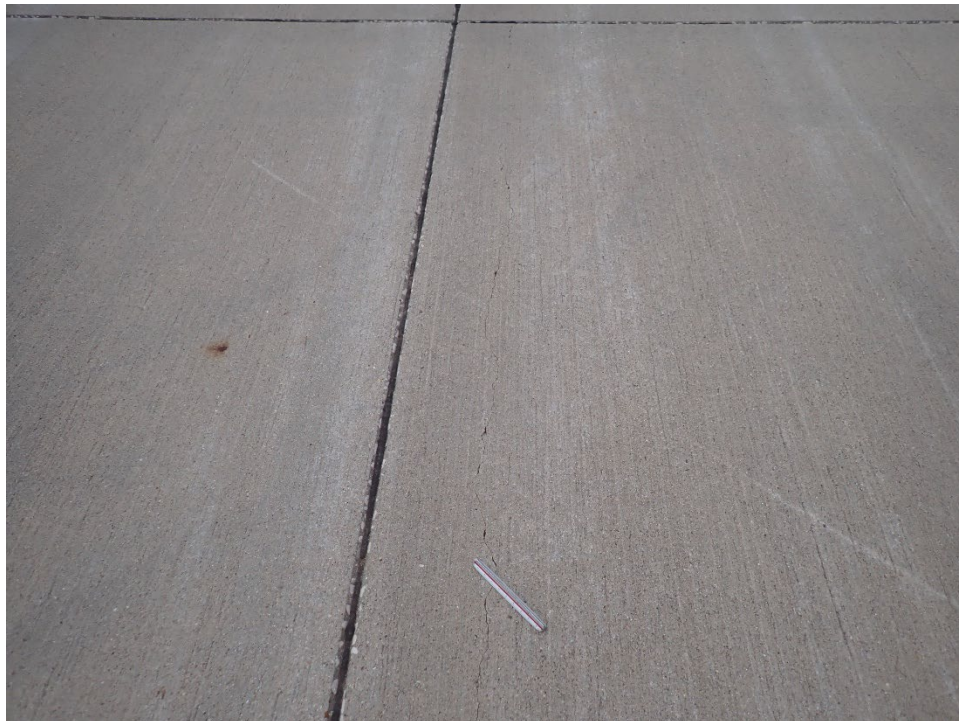
T02HL-01. LTD Cracking (Sample Unit No. 09).

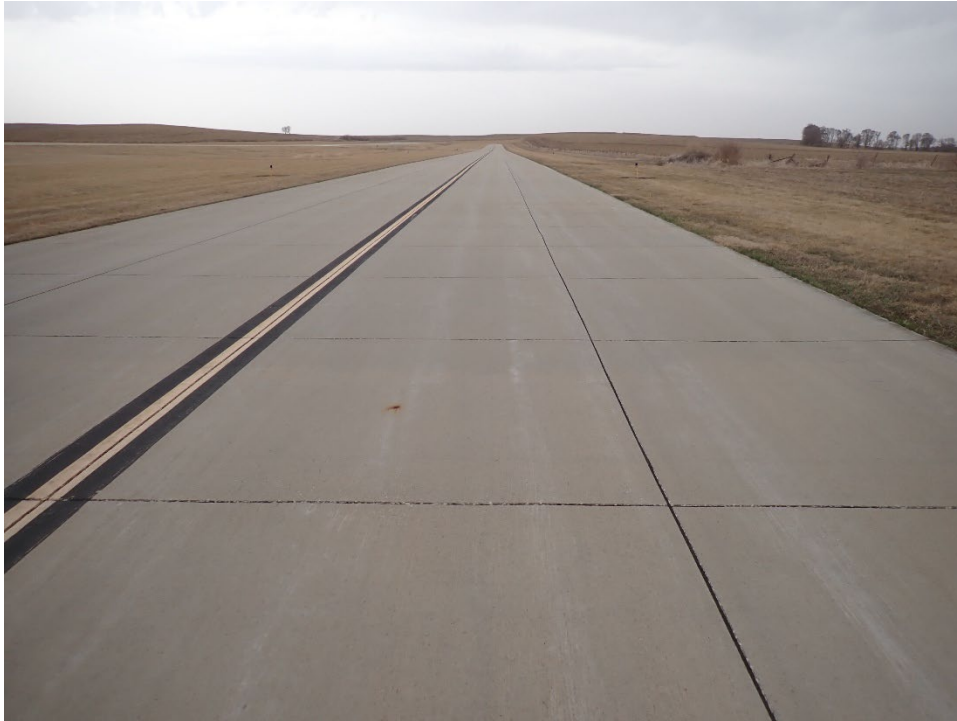
T02HL-03. Overview.
