# Harlan Municipal Airport

## Pavement Management Report

**AUGUST 2025**

# HARLAN MUNICIPAL AIRPORT PAVEMENT MANAGEMENT REPORT

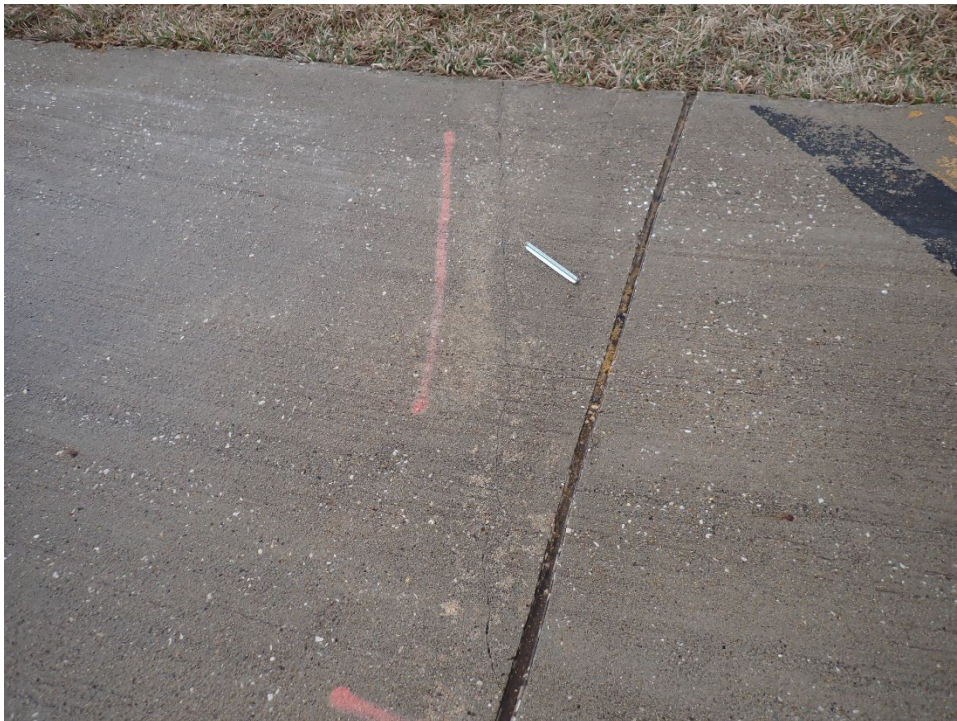
T02HL-03. Corner Break (Sample Unit No. 05).

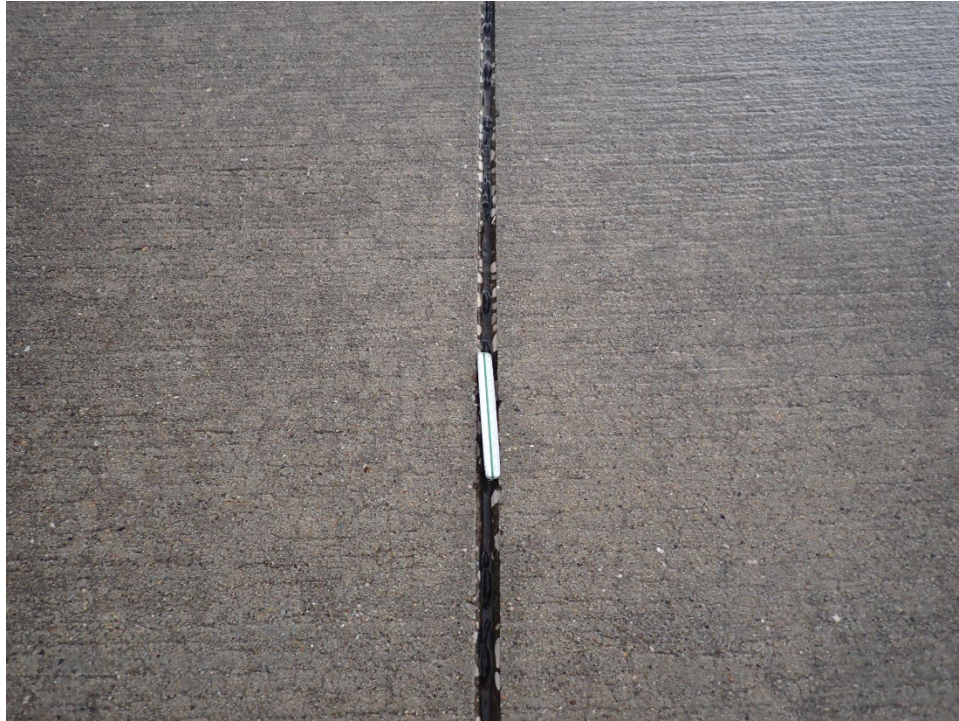
T02HL-03. Joint Seal Damage (Sample Unit No. 35).

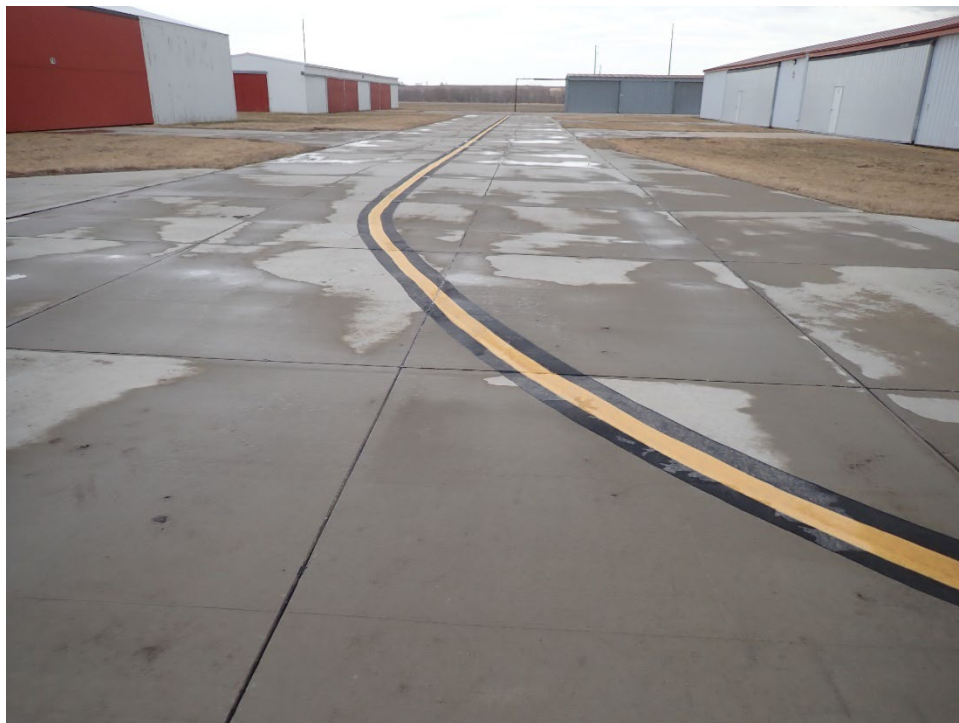
TH01HL-01. Overview.

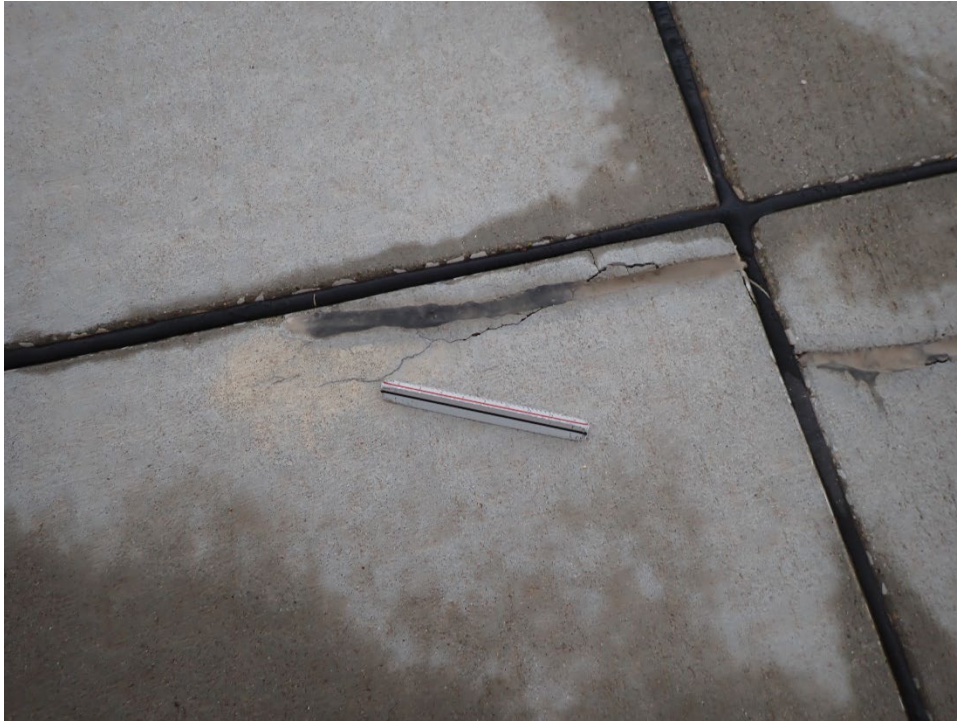
TH01HL-01. ASR (Sample Unit No. 10).

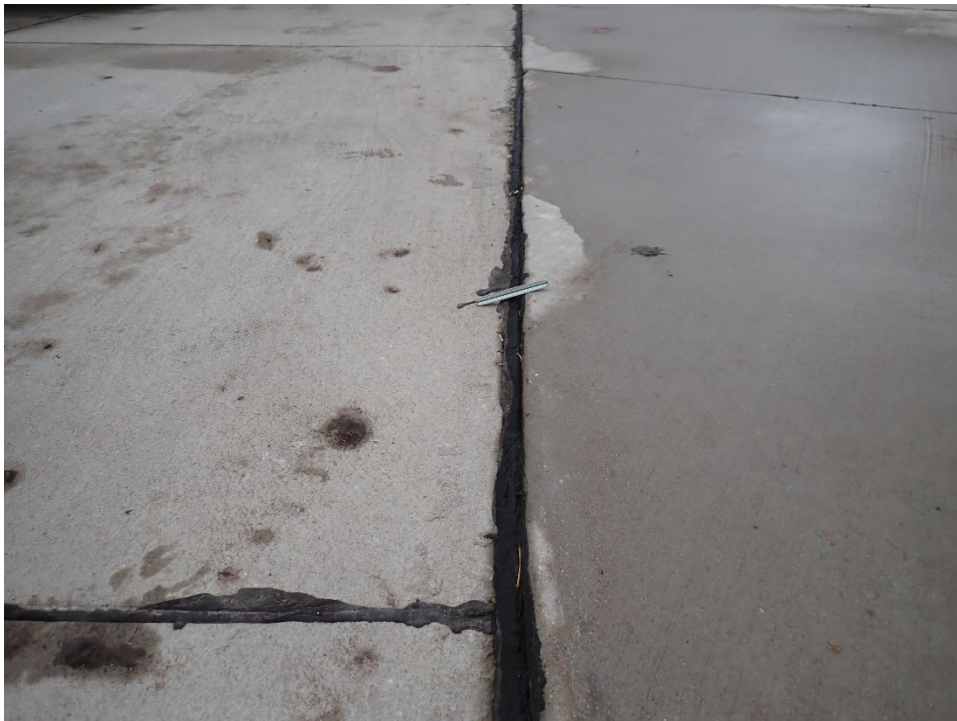
TH01HL-01. Faulting (Sample Unit No. 03).

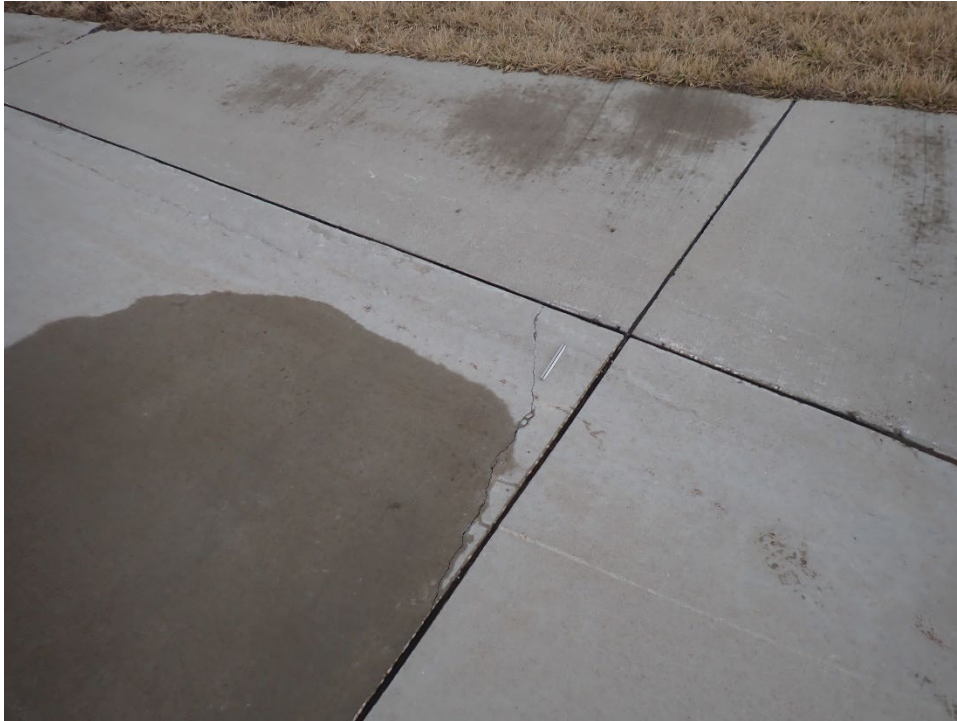
TH01HL-01. Joint Spalling (Sample Unit No. 10).

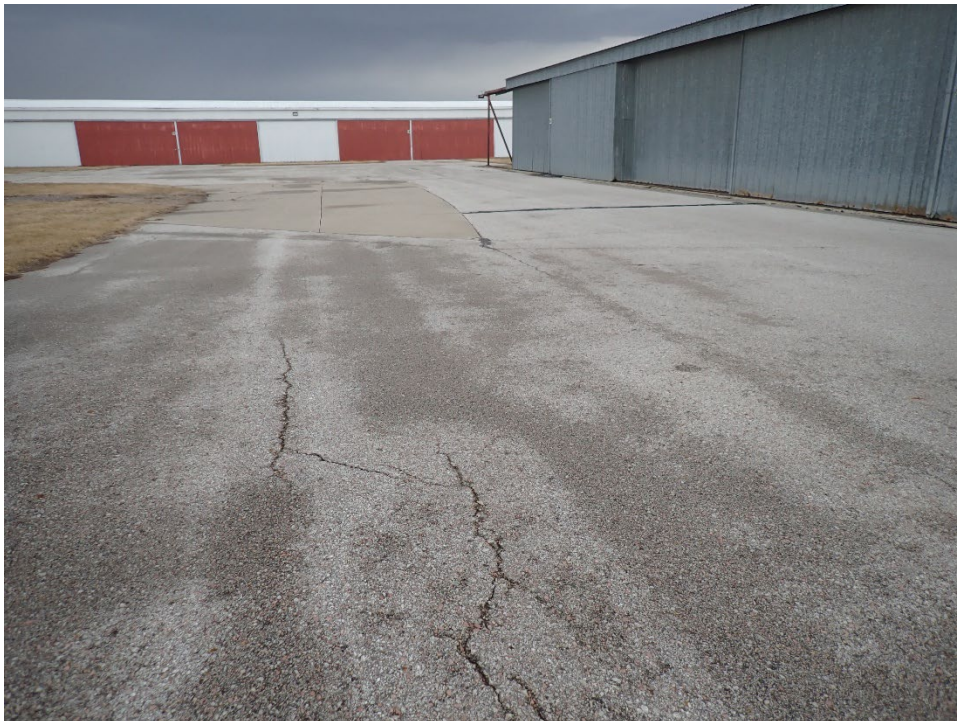
TH01HL-02. Overview.

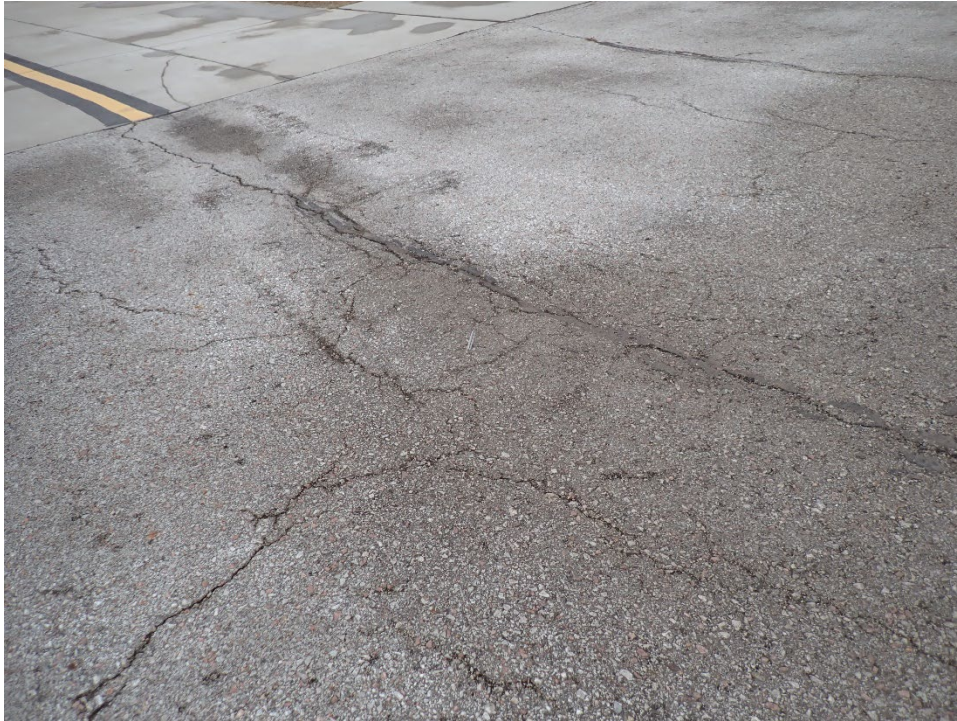
TH01HL-02. Alligator Cracking (Sample Unit No. 06).

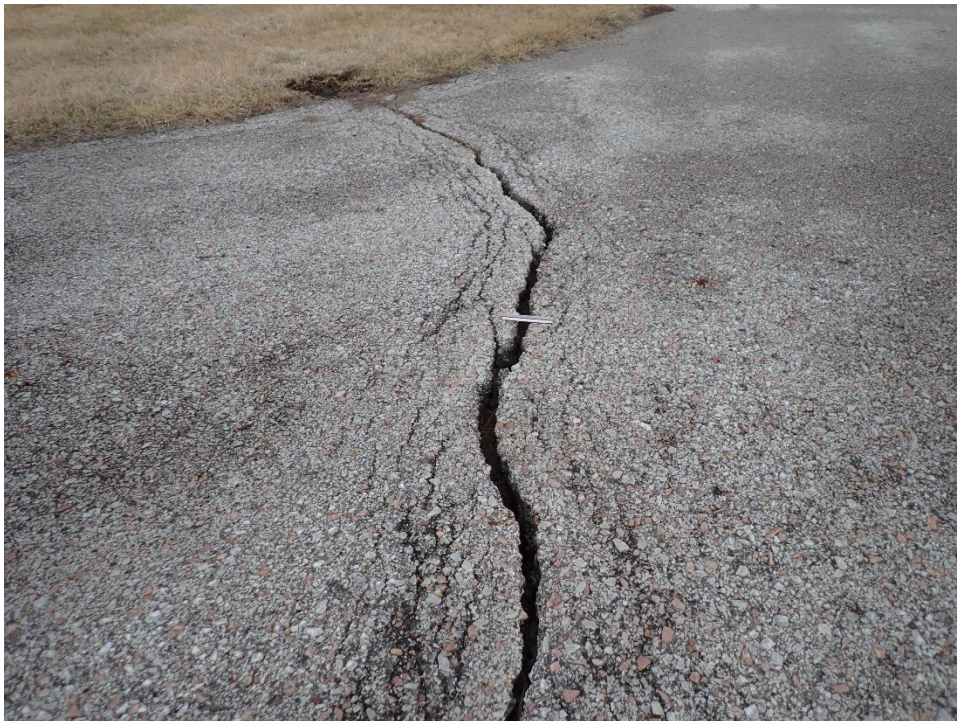
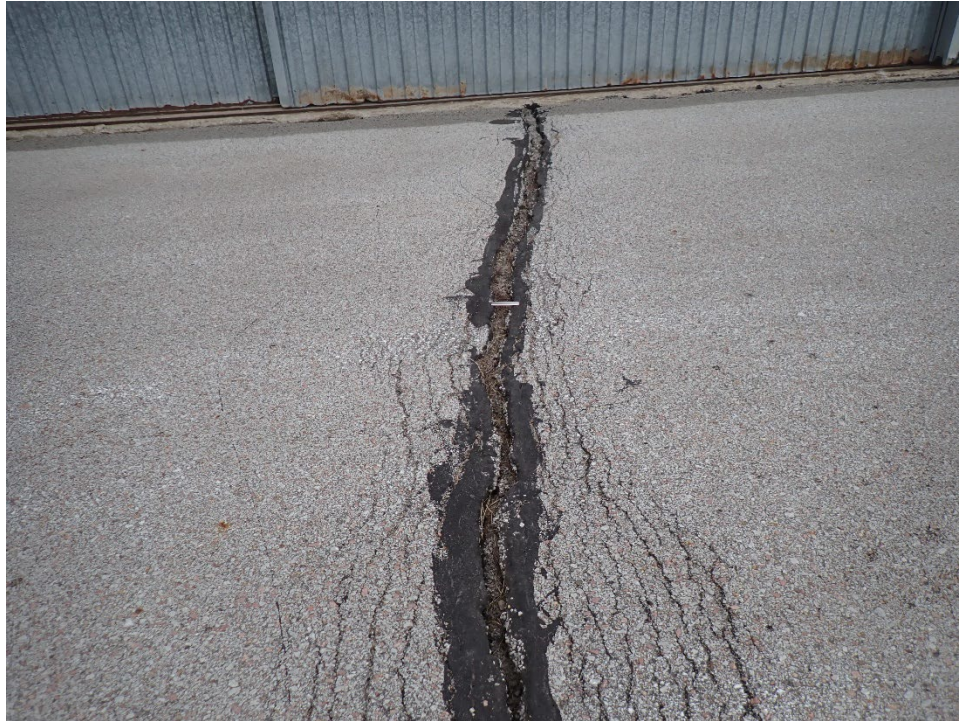
TH01HL-02. L&T Cracking (Sample Unit No. 05) (1).

TH01HL-02. L&T Cracking (Sample Unit No. 05) (2).

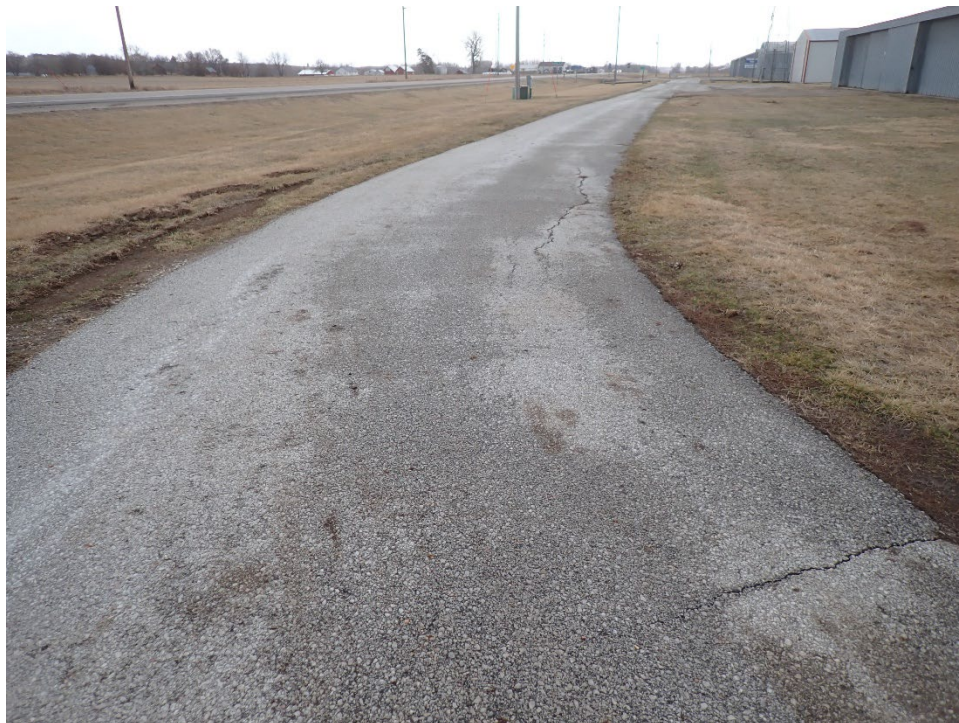
TH01HL-03. Overview.

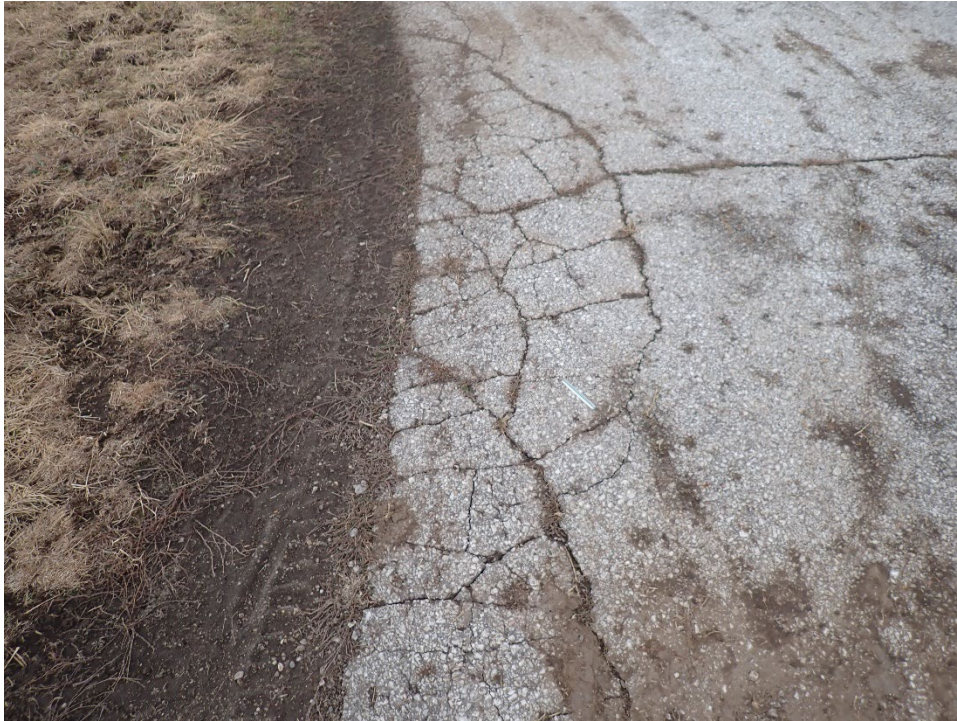
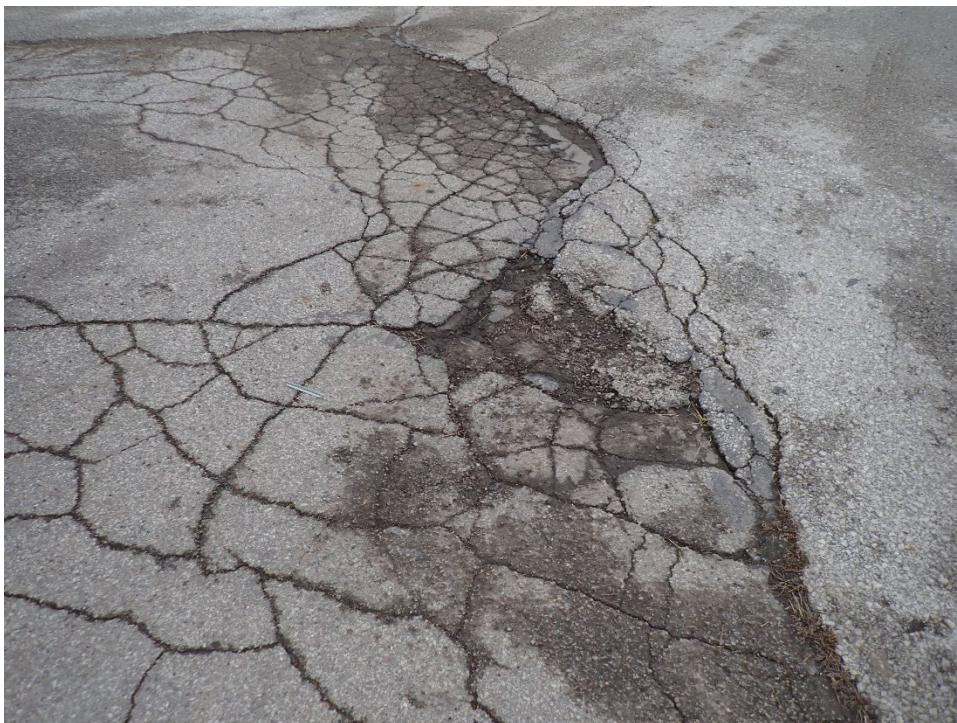
TH01HL-03. Alligator Cracking (Sample Unit No. 01) (1).

TH01HL-03. Alligator Cracking (Sample Unit No. 01) (2).

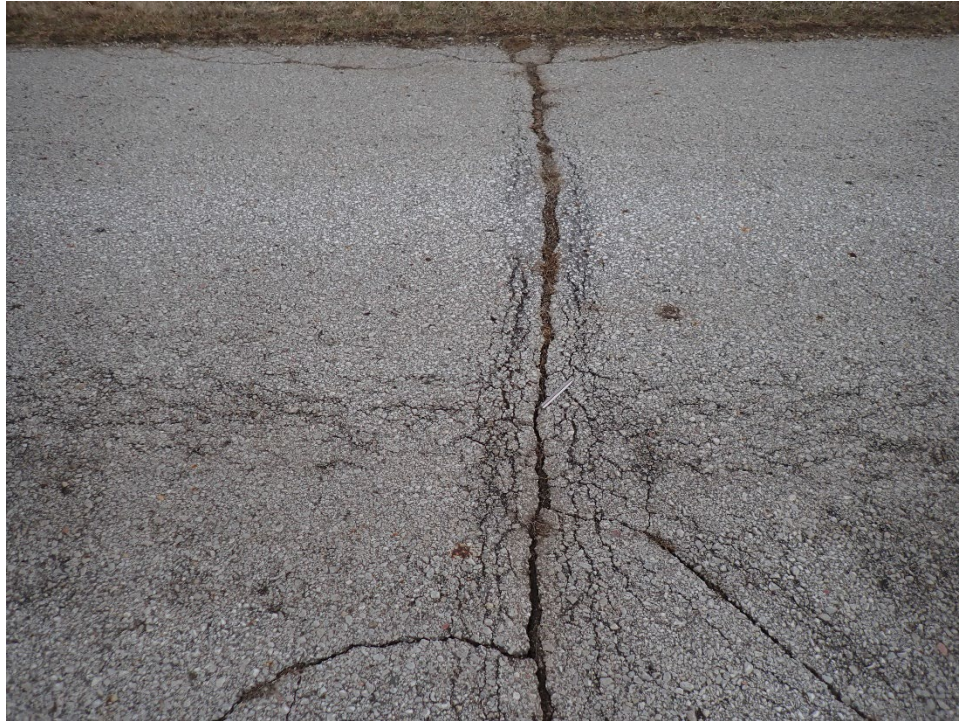
TH01HL-03. L&T Cracking (Sample Unit No. 01).

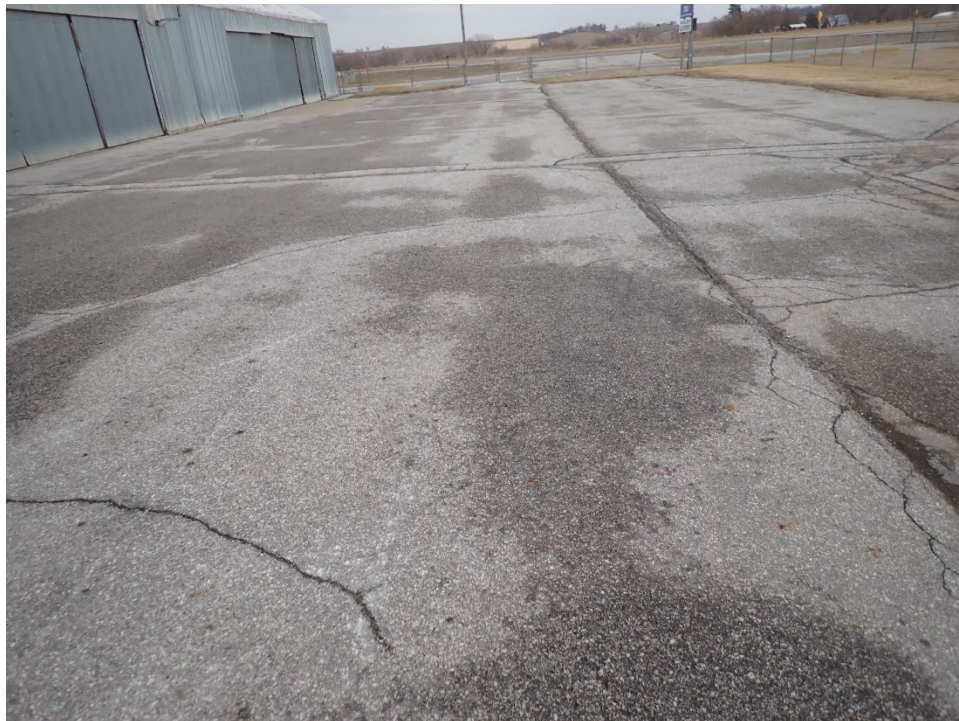
TH01HL-04. Overview.

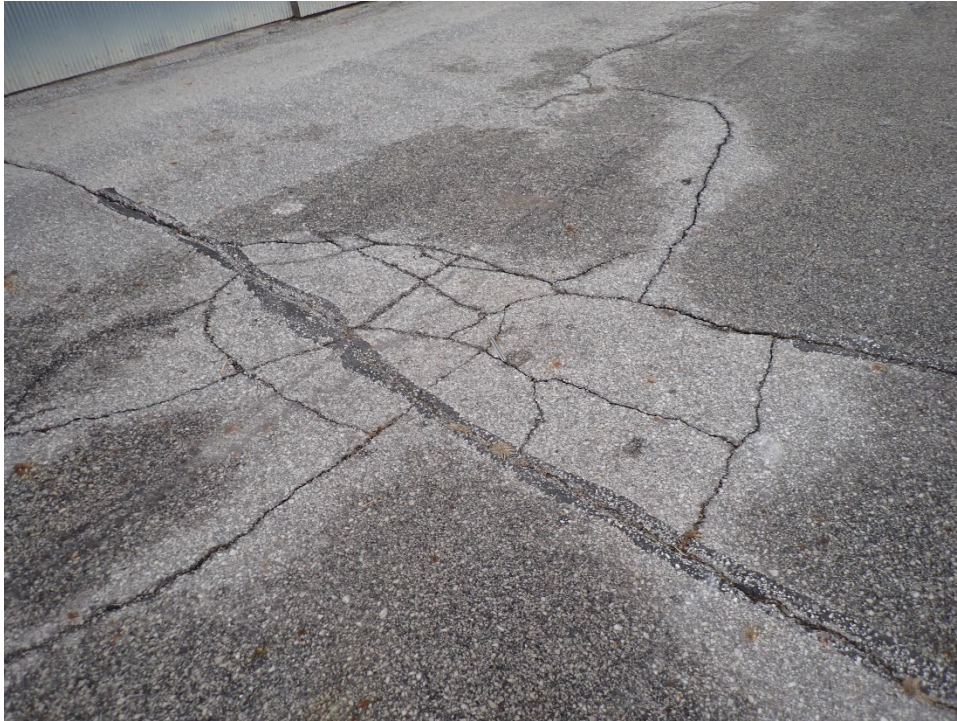
TH01HL-04. Alligator Cracking (Sample Unit No. 01).

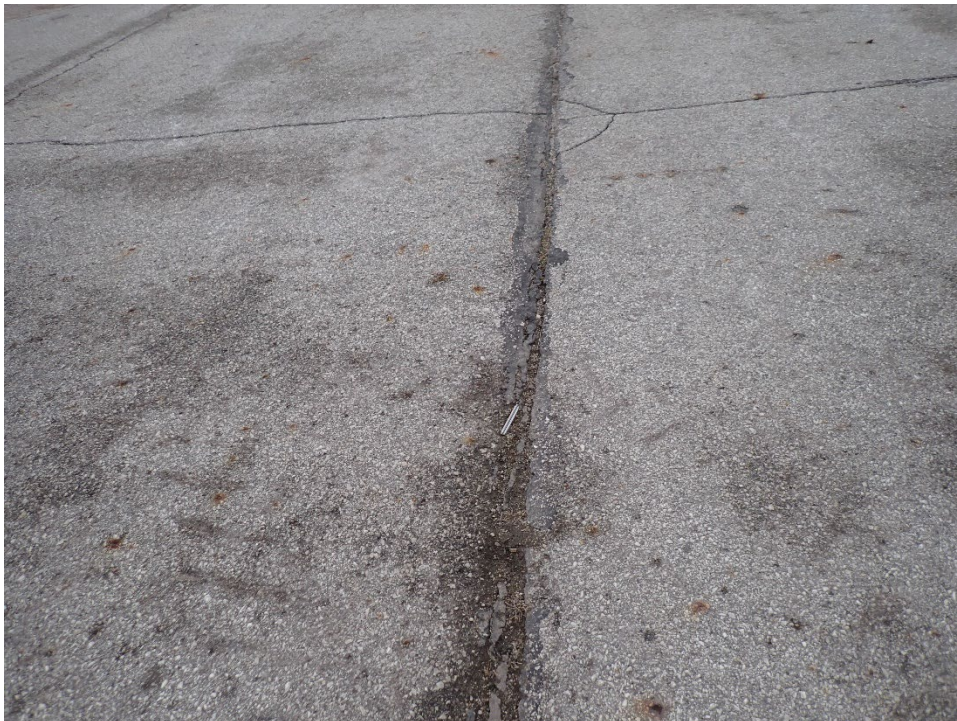
TH01HL-04. L&T Cracking (Sample Unit No. 01).

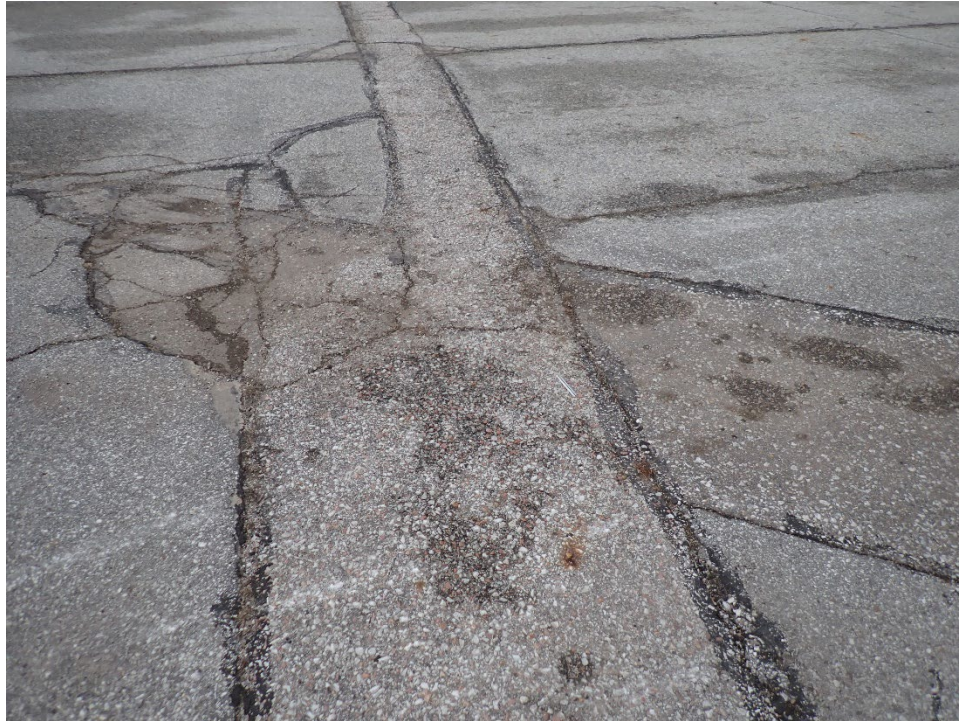
TH01HL-04. Patching (Sample Unit No. 01).
