# Humboldt Municipal Airport

## Pavement Management Report

**AUGUST 2026**

# HUMBOLDT MUNICIPAL AIRPORT PAVEMENT MANAGEMENT REPORT

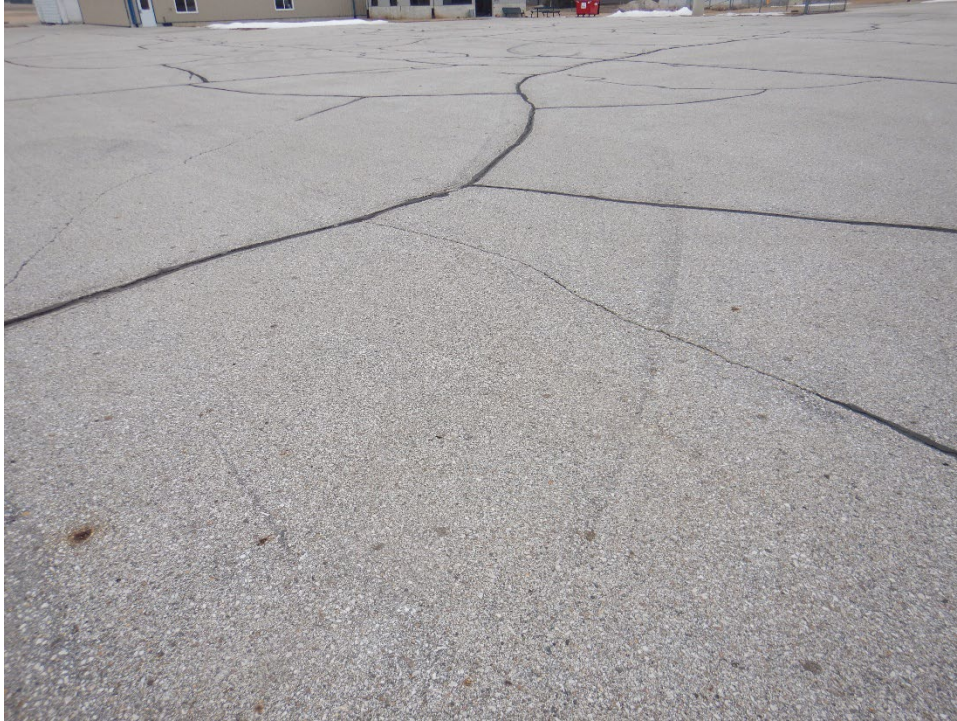
A01HU-01. Overview.

The apron area contained one section with all severities of L&T cracking, low-severity raveling, and low- and medium-severity weathering. The low-severity L&T cracking was unsealed and the medium-severity L&T cracking was recorded where either crack sealant was unsatisfactory or unsealed crack widths were greater than ¼ inch. The high-severity L&T cracking was recorded where secondary cracking was wider than 1 foot.

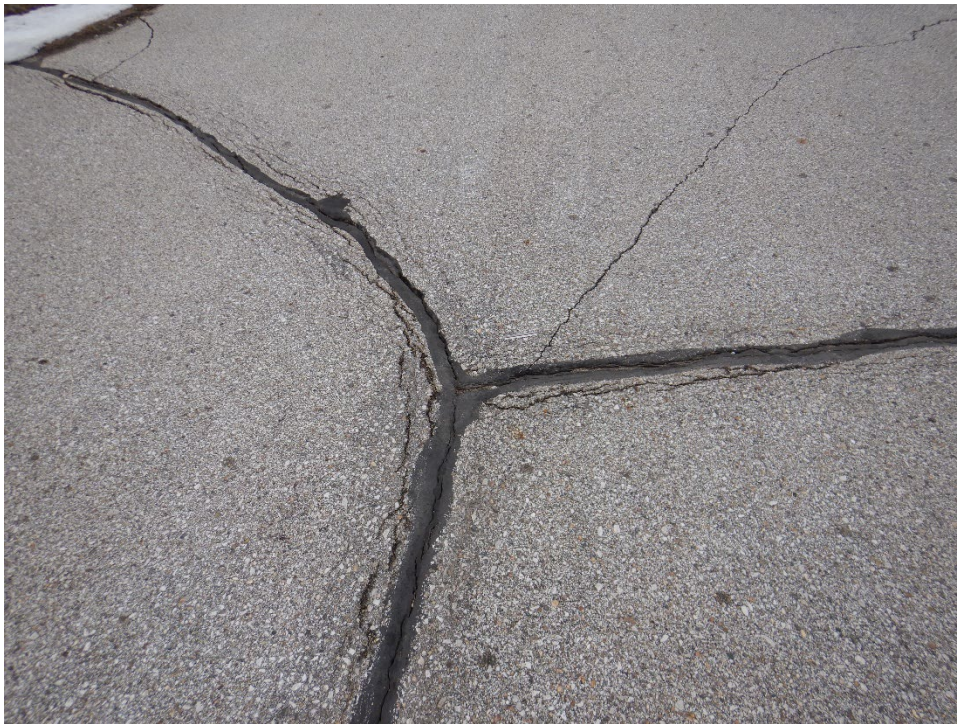
A01HU-01. L&T Cracking (Sample Unit No. 01).

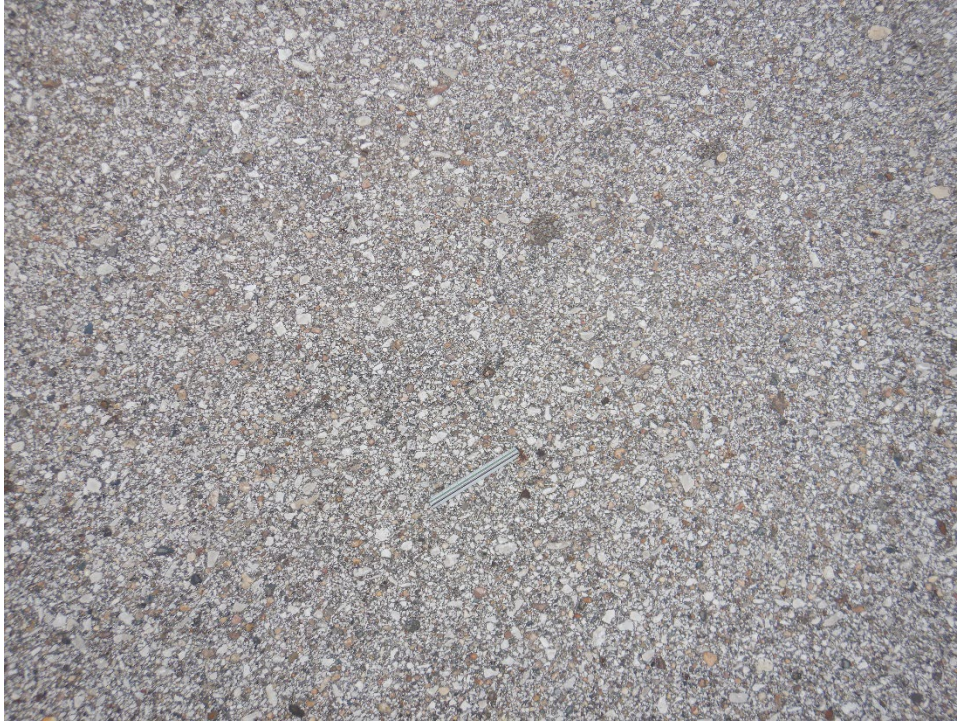
A01HU-01. Weathering (Sample Unit No. 01).

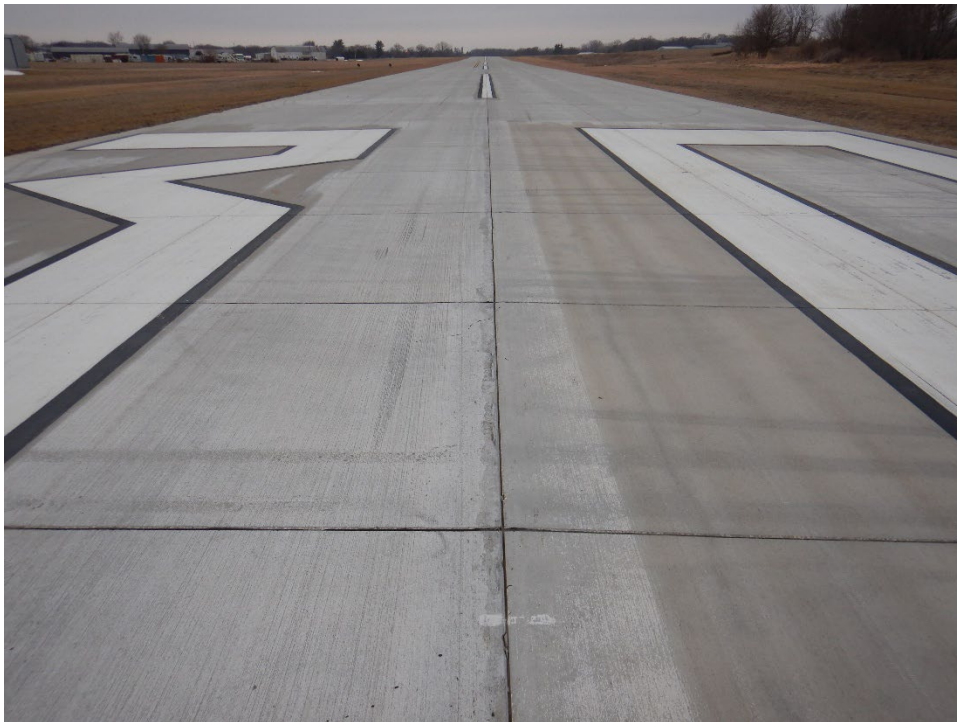
R12HU-01. Overview.

Runway 12/30 was defined by three sections. Section 01 was in *Excellent* condition and had only an atypical area of low-severity corner spalling that was noted and recorded as an additional sample unit in accordance with ASTM D5340. Section 02 was also in *Excellent* condition with only an atypical area of low- and medium-severity faulting observed that was recorded as an additional sample unit in accordance with ASTM D5340. Section 03 was in *Excellent* condition with no distress noted at the time of inspection.

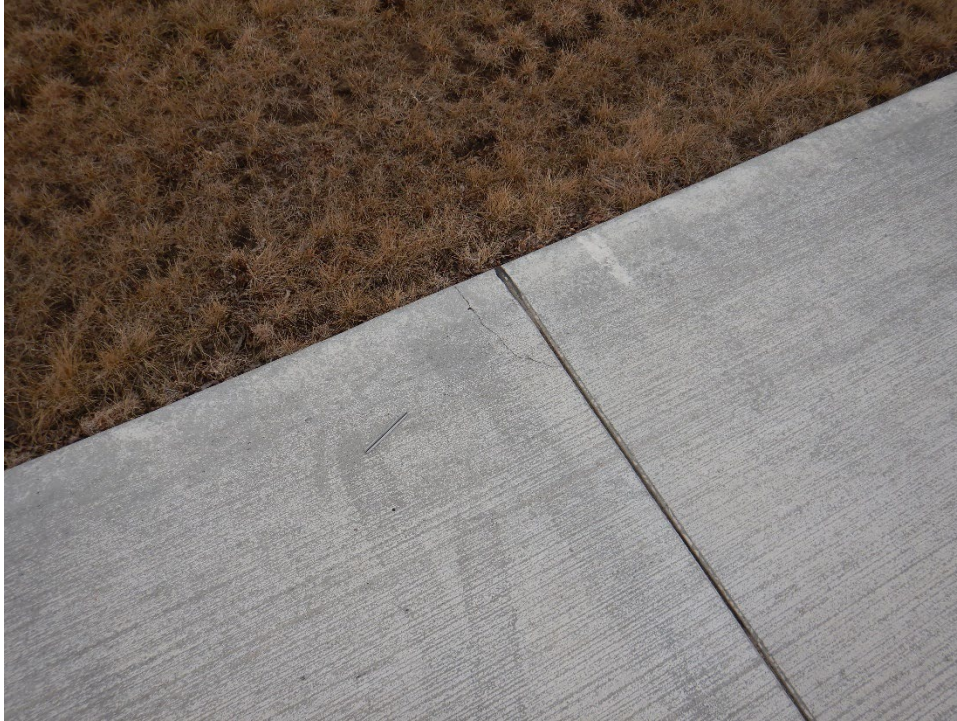
R12HU-01. Corner Spalling (Sample Unit No. 48).

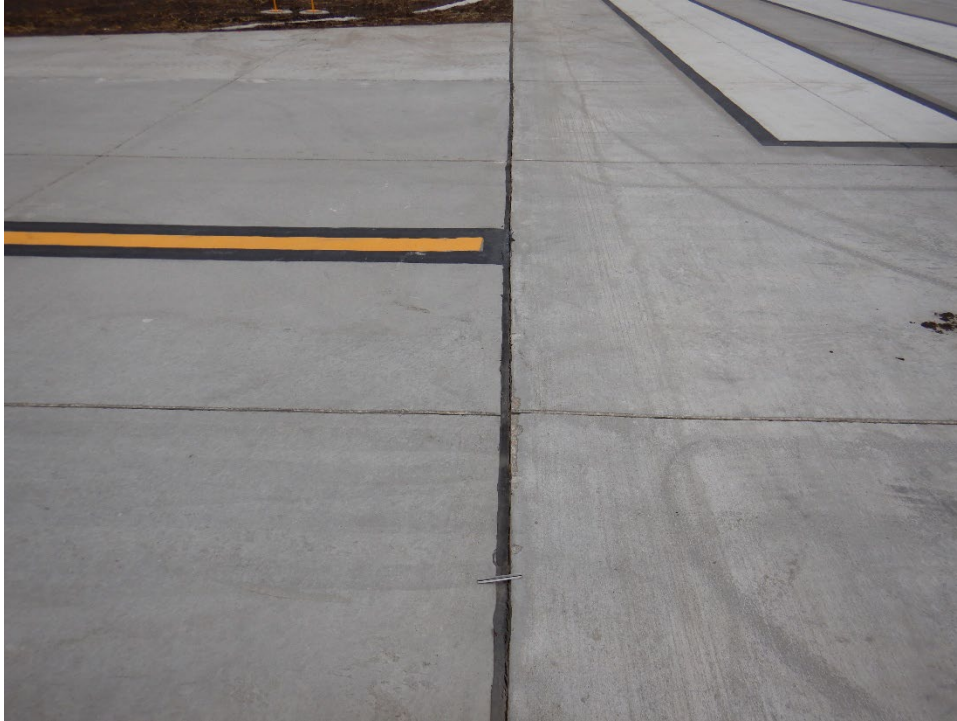
R12HU-02. Faulting (Additional Sample Unit No. 17).

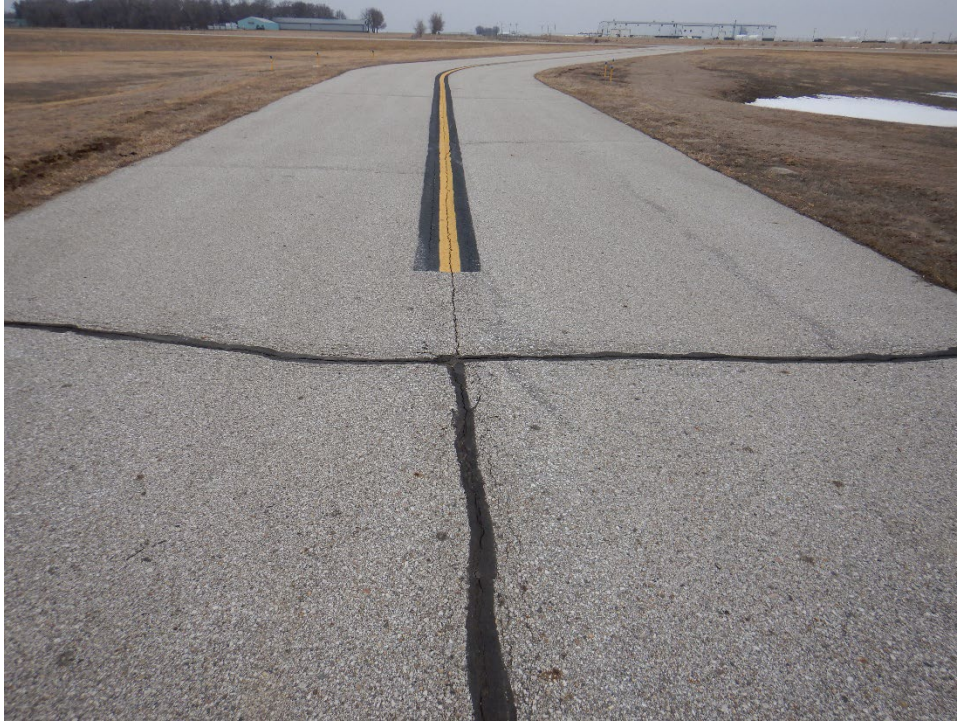
T01HU-01. Overview.

Taxiway 01 consisted of one section that contained all severities of longitudinal and transverse (L&T) cracking, low-severity raveling, and low- and medium-severity weathering. The low-severity L&T cracking was unsealed, and the medium-severity L&T cracking was recorded where either unsealed crack widths exceeded ¼ inch or secondary cracking had developed. The high-severity L&T cracking was observed in areas where secondary cracking was wider than 1 foot, especially in the transverse direction.

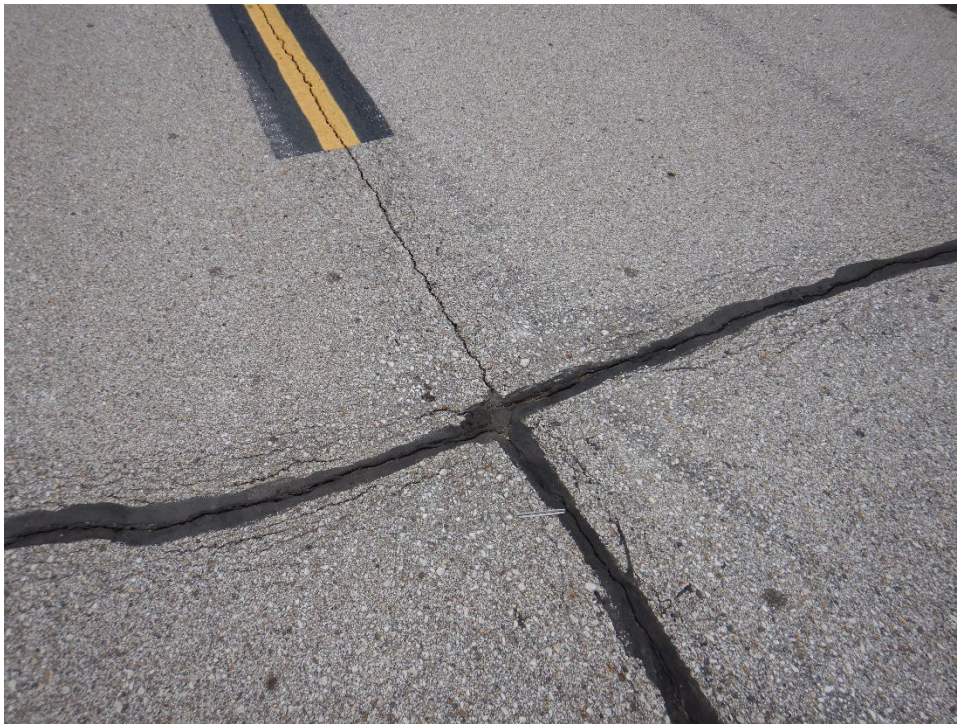
T01HU-01. L&T Cracking (Sample Unit No. 01).

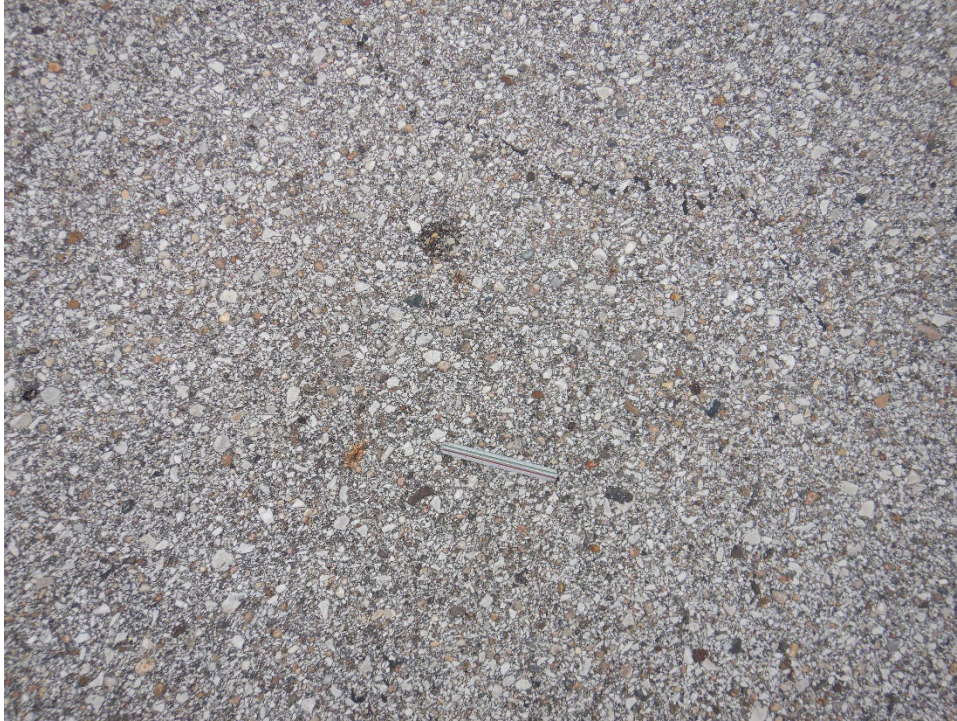
T01HU-01. Weathering (Sample Unit No. 01).

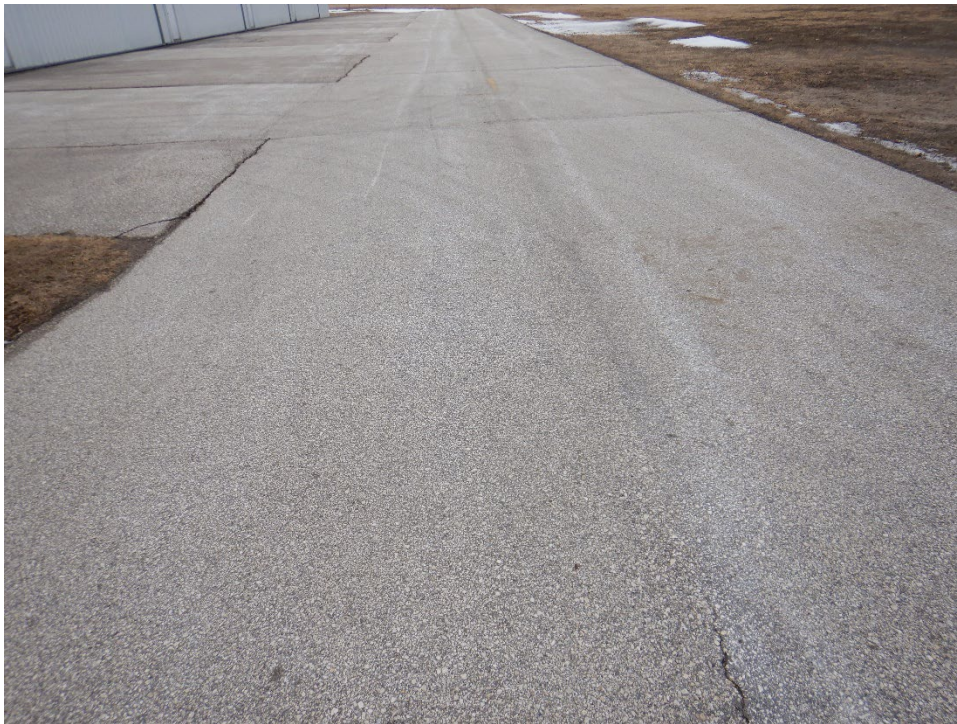
TH01HU-01. Overview.

The T-hangar area consisted of one section containing all severities of L&T cracking, low-severity raveling, and medium-severity weathering. The low-severity L&T cracking was unsealed; the medium-severity L&T cracking was noted where either crack sealant was unsatisfactory, unsealed crack widths were greater than ¼ inch, or secondary cracking had developed; and the high-severity L&T cracking was recorded in areas where secondary cracking was wider than 1 foot.

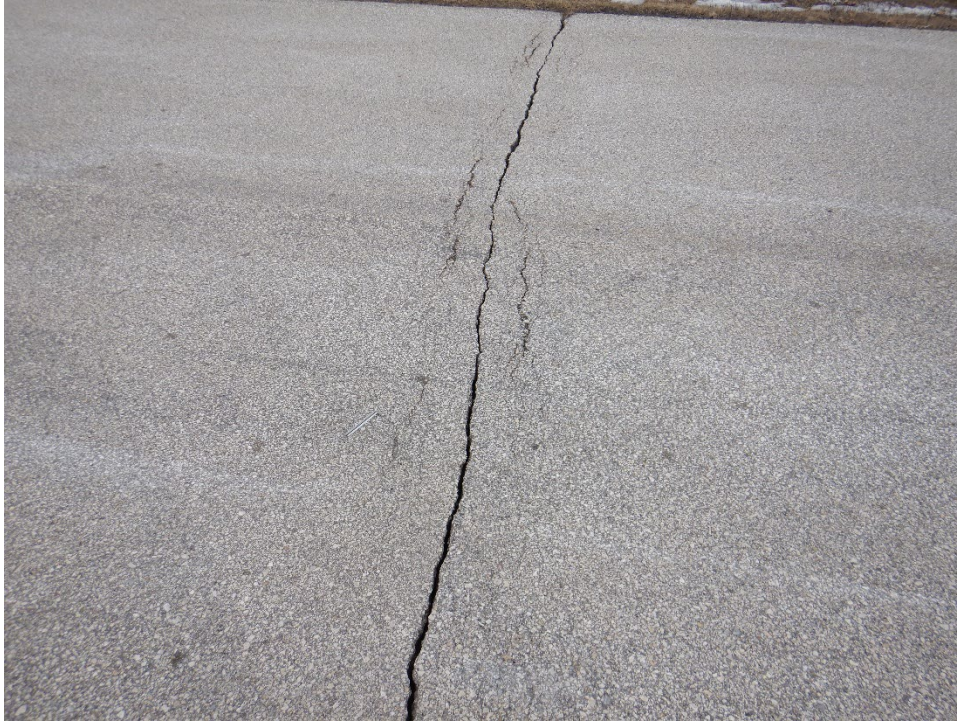
TH01HU-01. L&T Cracking (Sample Unit No. 01).

| Branch | Section | Distress Type | Severity | Distress Quantity | Distress Unit | Maintenance Action | Unit Cost | 2026 Estimated Cost |
|---|---|---|---|---|---|---|---|---|
| TH01HU | 01 | L&T Cracking | Medium | 549 | Ft | Crack Sealing - AC | \$2.78 | \$1,526 |
| TH01HU | 01 | L&T Cracking | High | 20 | Ft | Crack Sealing - AC | \$2.78 | \$56 |

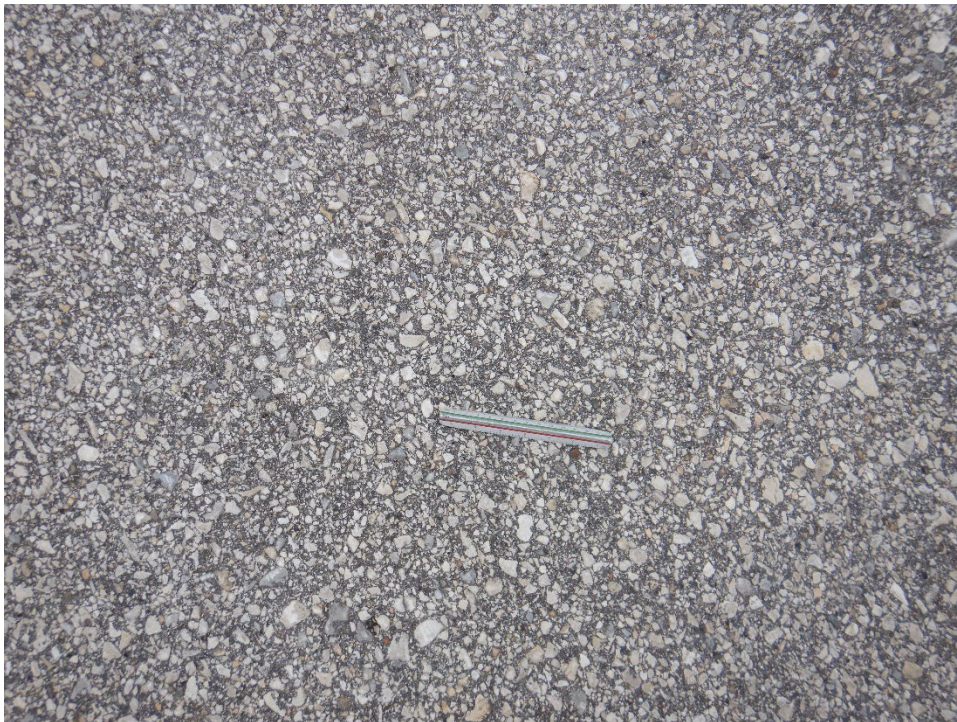
TH01HU-01. Weathering (Sample Unit No. 01).
