# Ida Grove Municipal Airport

## Pavement Management Report

**AUGUST 2025**

# IDA GROVE MUNICIPAL AIRPORT PAVEMENT MANAGEMENT REPORT

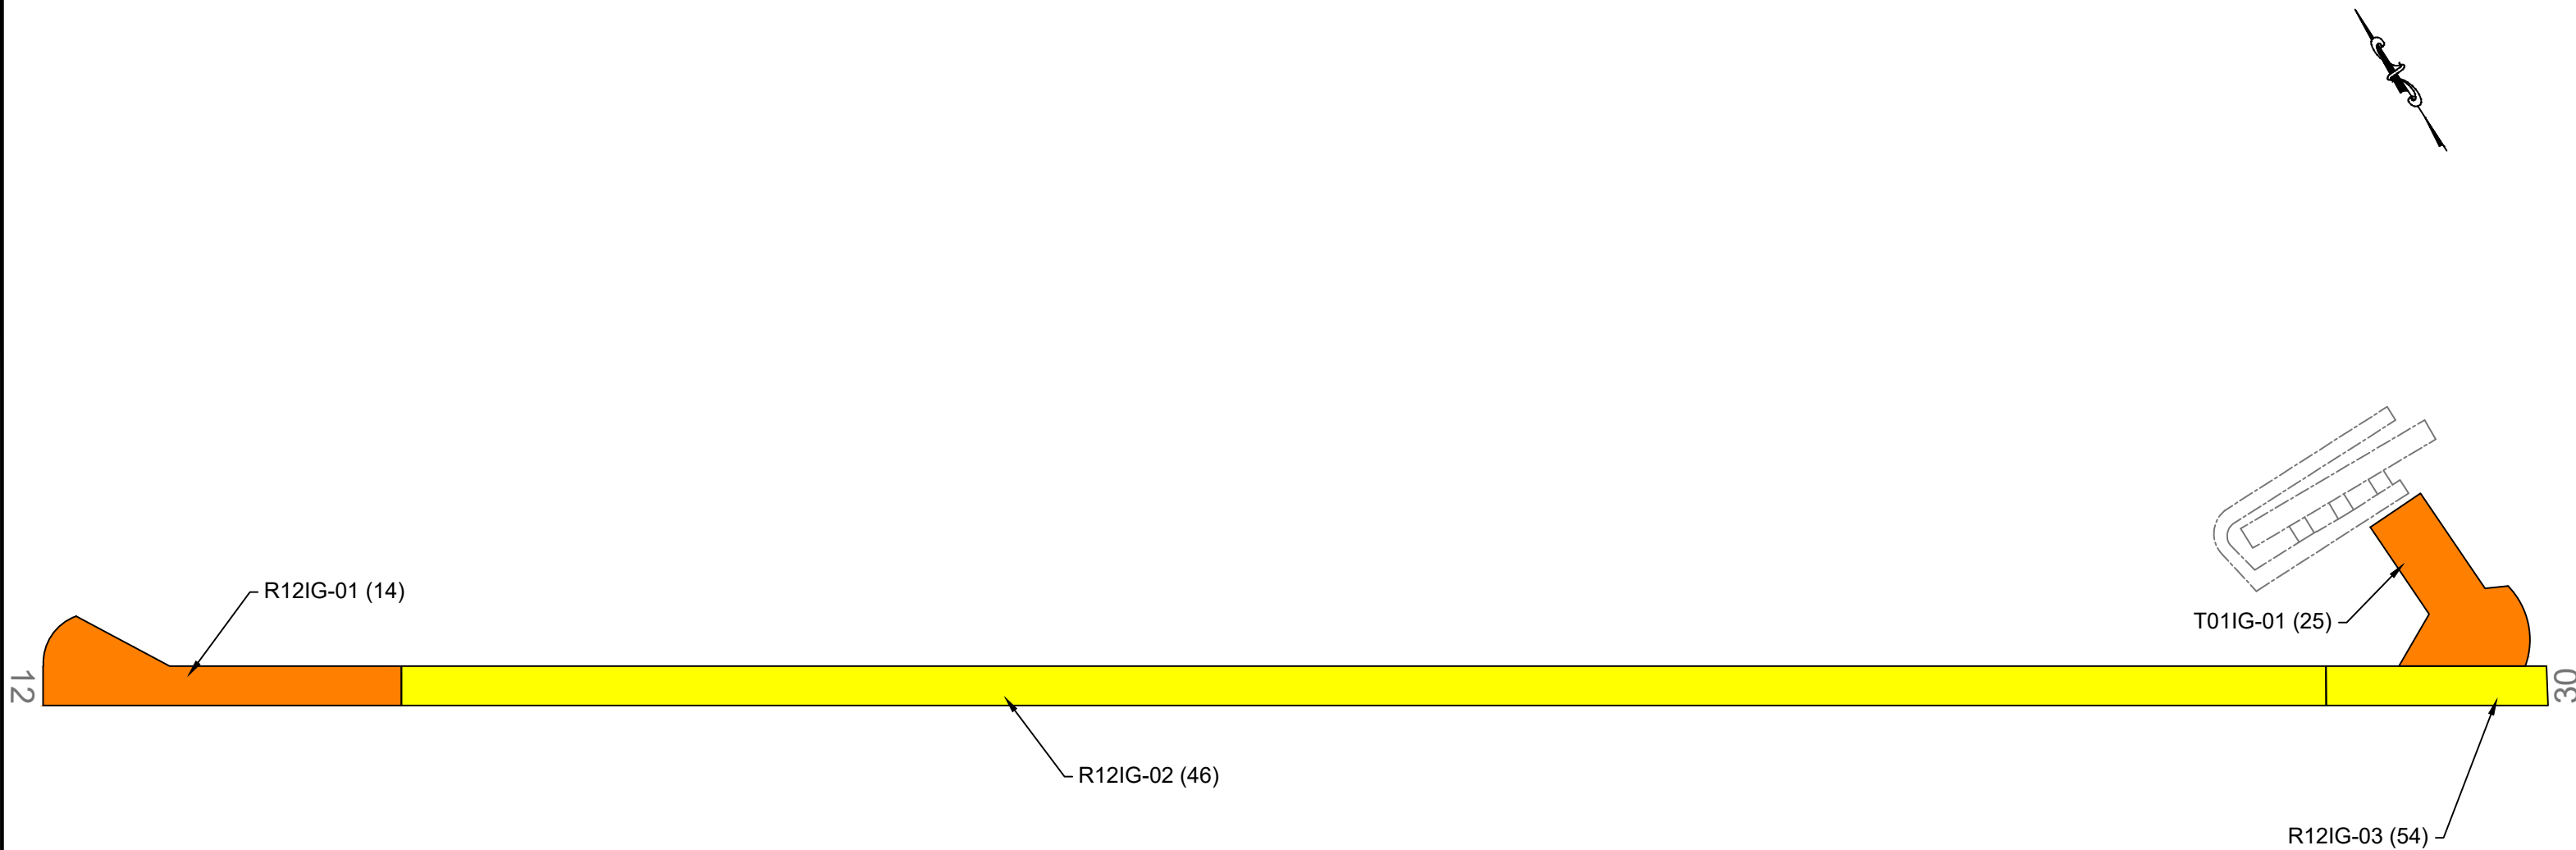
FIGURE 8. PCI MAP.

The pavements at Ida Grove Municipal Airport were inspected in March 2025. The 2025 area-weighted condition of Ida Grove Municipal Airport is 39, with conditions ranging from 14 to 54 (on a scale of 0 [failed] to 100 [excellent]). During the previous pavement inspection in 2018, the area-weighted PCI of the airport was 58.

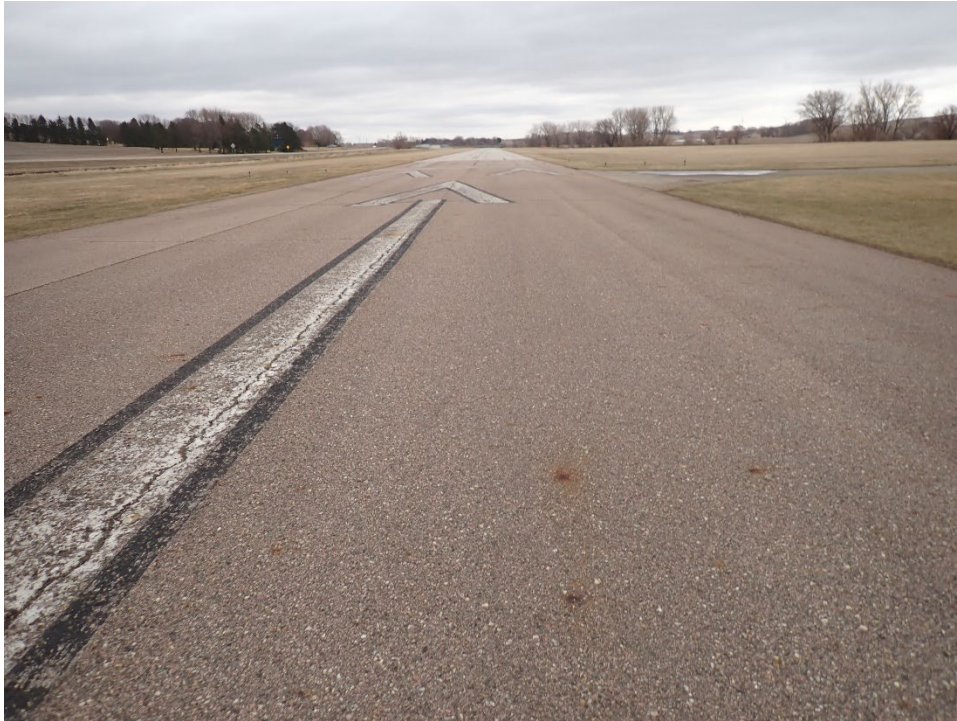
Runway 12/30 contained three sections. Section 01 was located at the western approach of Runway 12/30 and was in *Poor* condition. All severities of alligator cracking were identified within the wheel path. Smaller amounts of low-severity, unsealed longitudinal and transverse (L&T) cracking were observed, while greater quantities of medium-severity L&T cracking were recorded where either unsealed crack widths exceeded 1/4 inch, or secondary cracking associated with the primary crack was observed. High-severity L&T cracking was also recorded where the cracking had deteriorated, producing areas of parallel secondary cracking wider than 1 ft. Medium- and high-severity raveling, low-severity swelling, and high-severity weathering were also observed in Section 01. All severities of alligator cracking, located mostly along the pavement edge, were recorded in Section 02. Additionally, low-severity L&T cracking was identified in unsealed condition, while medium-severity L&T cracking was recorded where either unsealed crack widths exceeded 1/4 inch, crack sealant was no longer preventing water from penetrating into underlying pavement layers, or secondary cracking had developed. Notable amounts of medium- and high-severity patching were also recorded along with medium-severity weathering. Section 03 was defined as the eastern approach of Runway 12/30. Low- and medium-severity alligator cracking, all severities of L&T cracking, and medium-severity patching and weathering were recorded during the inspection.

R12IG-01. Overview.

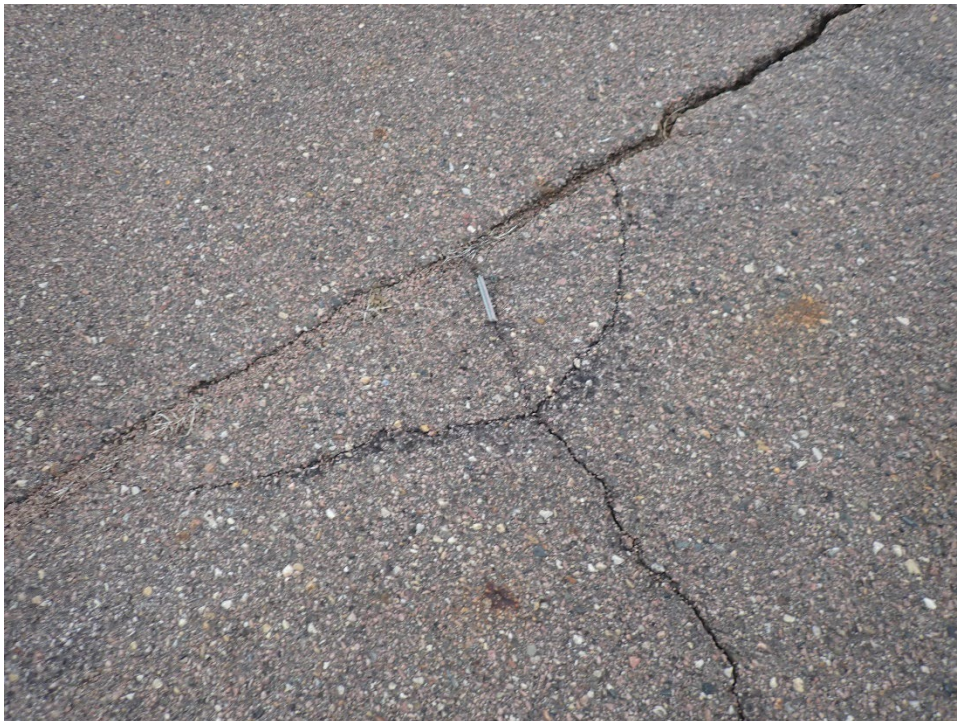
R12IG-01. Alligator Cracking (Sample Unit No. 04).

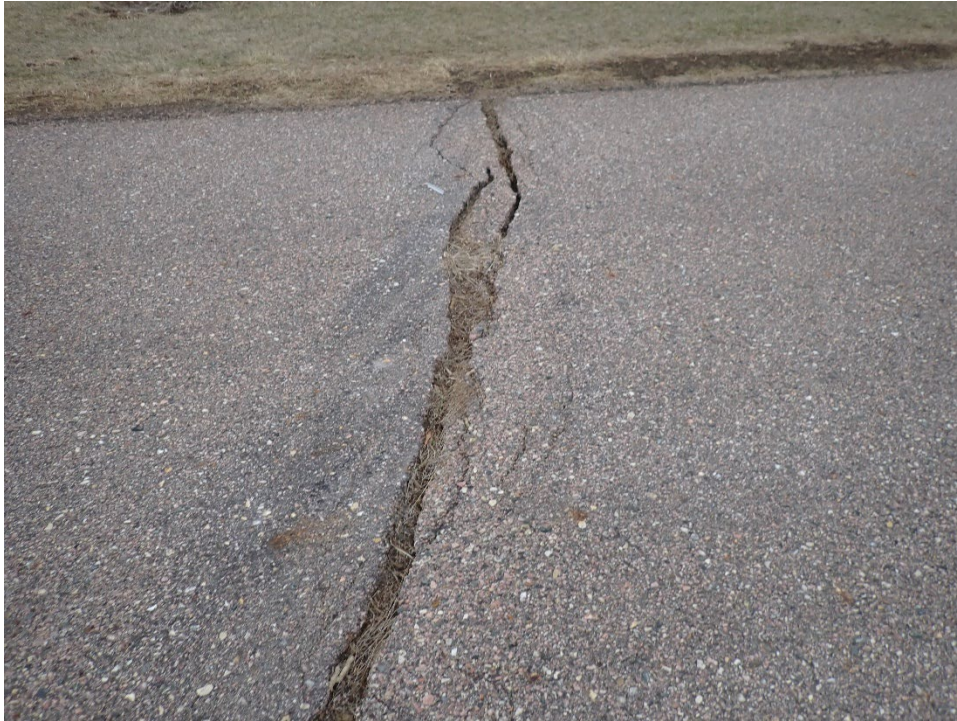
R12IG-01. L&T Cracking (Sample Unit No. 03).

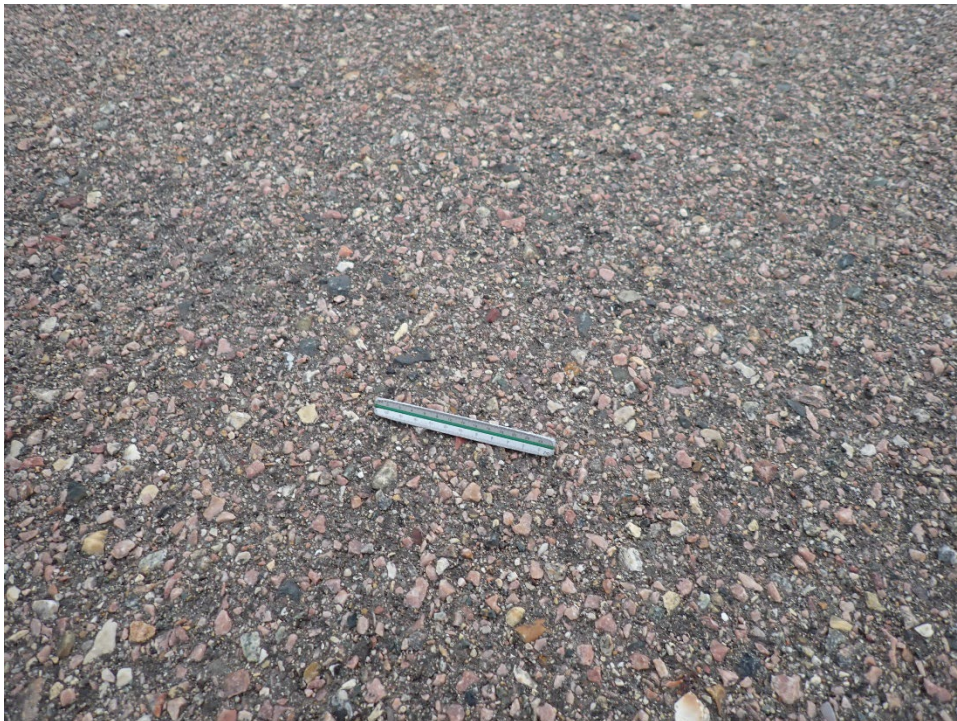
R12IG-01. Weathering (Sample Unit No. 04).

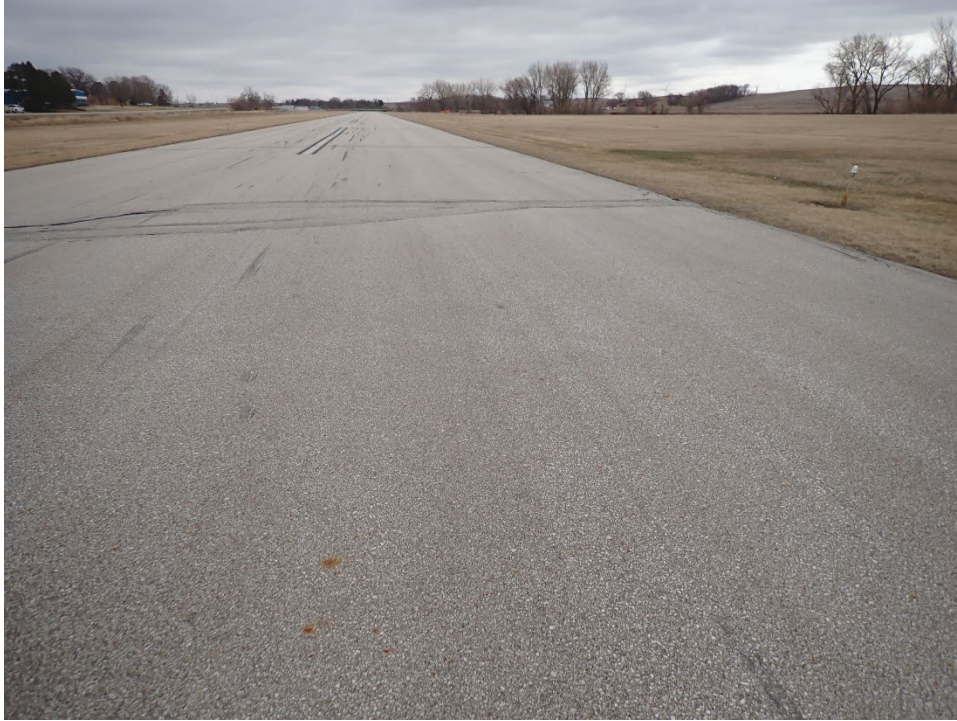
R12IG-02. Overview.

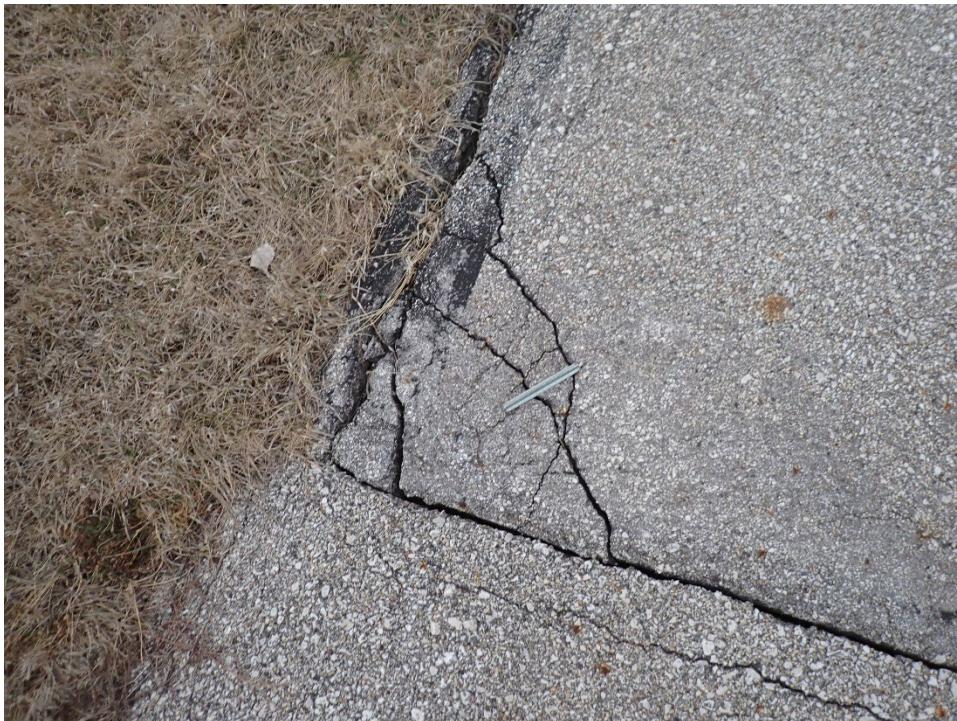
R12IG-02. Alligator Cracking (Sample Unit No. 05).

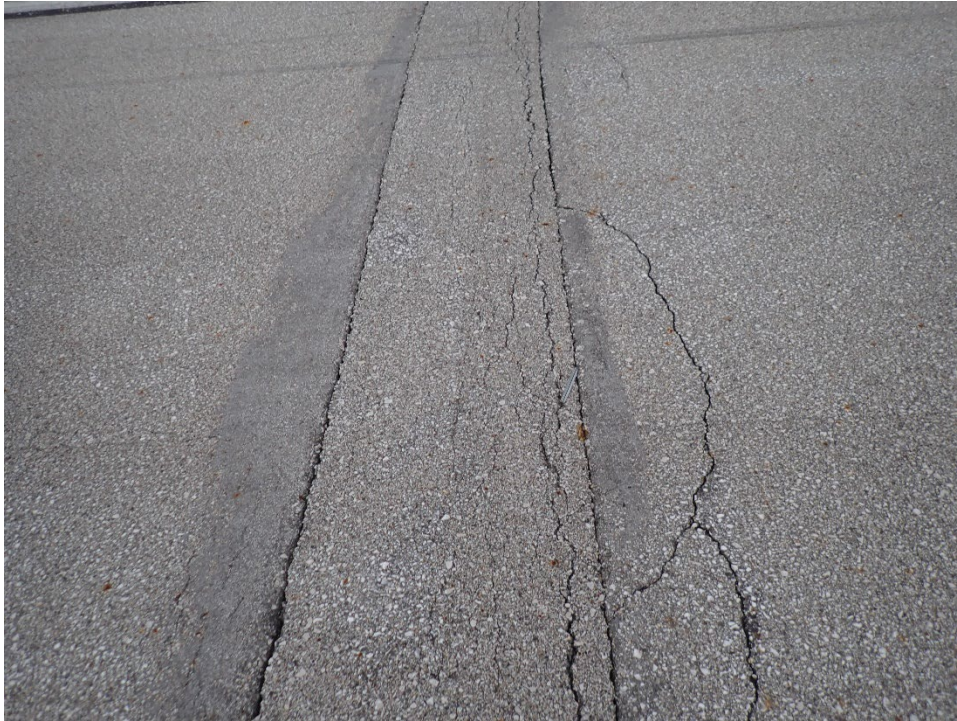
R12IG-02. Patching (Sample Unit No. 05).

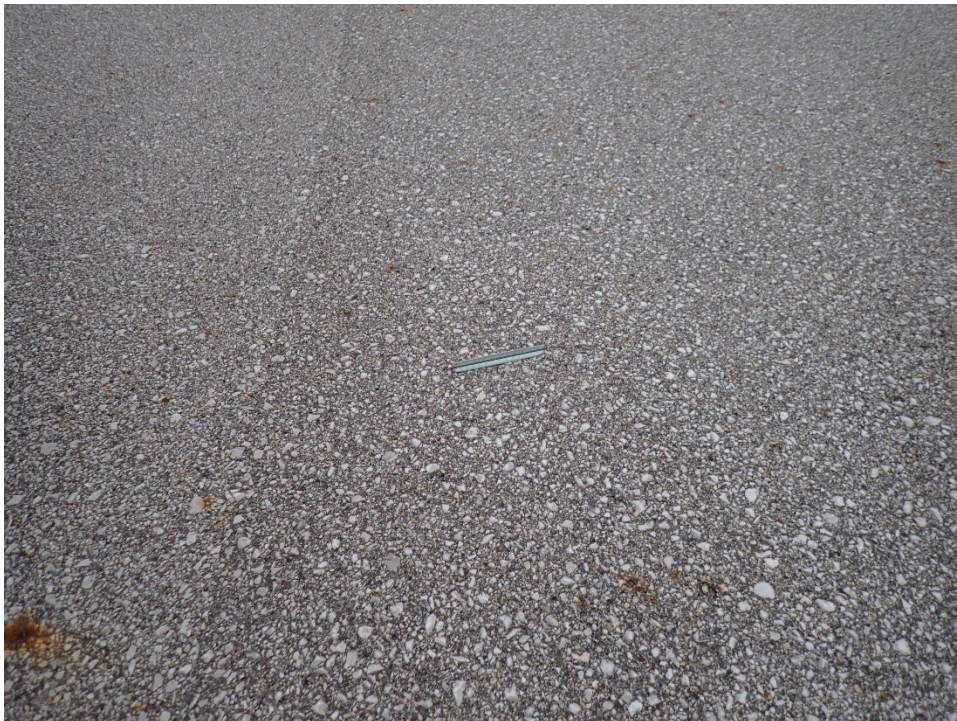
R12IG-02. Weathering (Sample Unit No. 22).

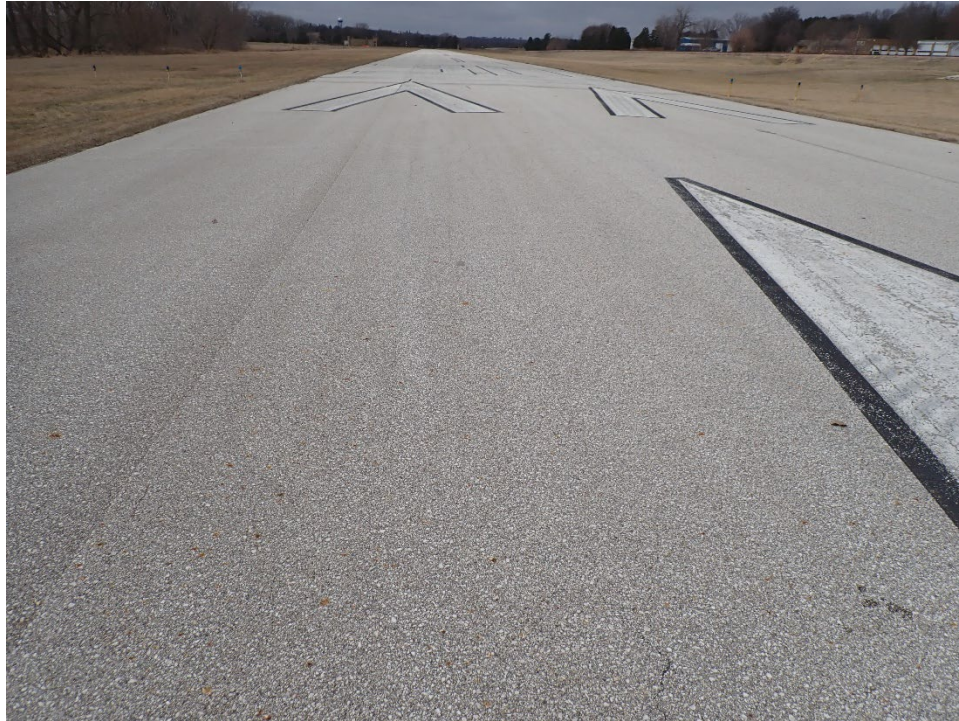
R12IG-03. Overview.

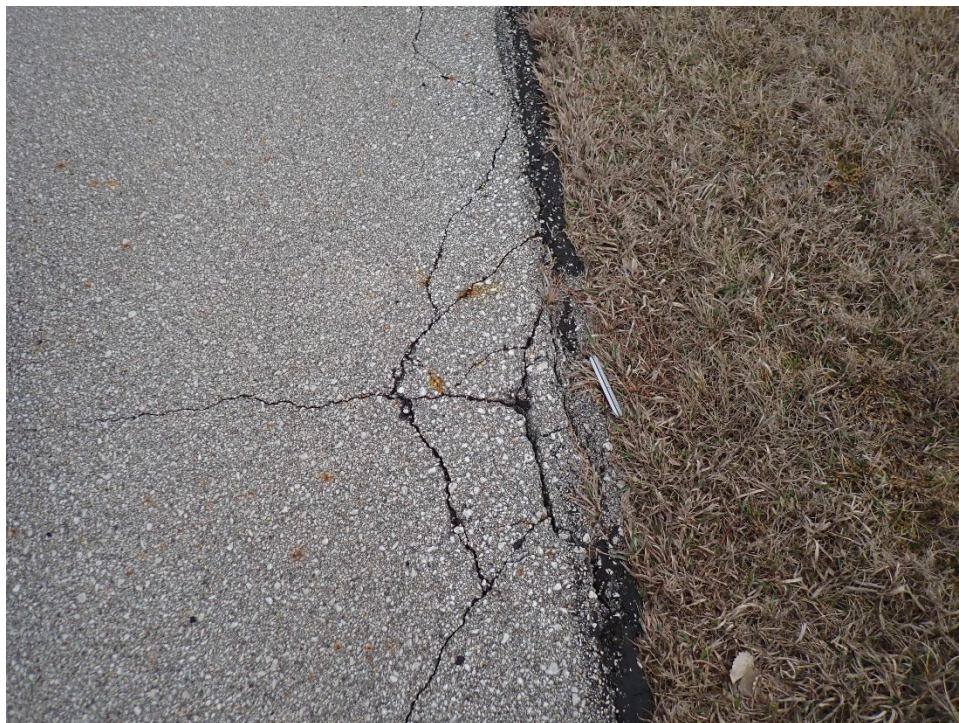
R12IG-03. Alligator Cracking (Sample Unit No. 01).

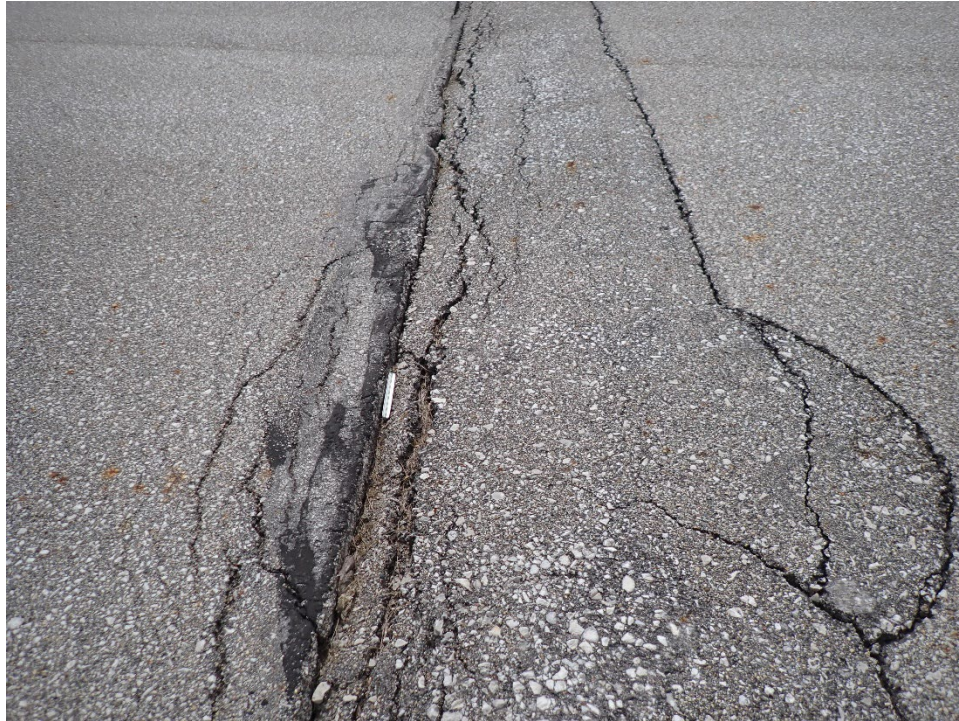
R12IG-03. Patching (Sample Unit No. 02).

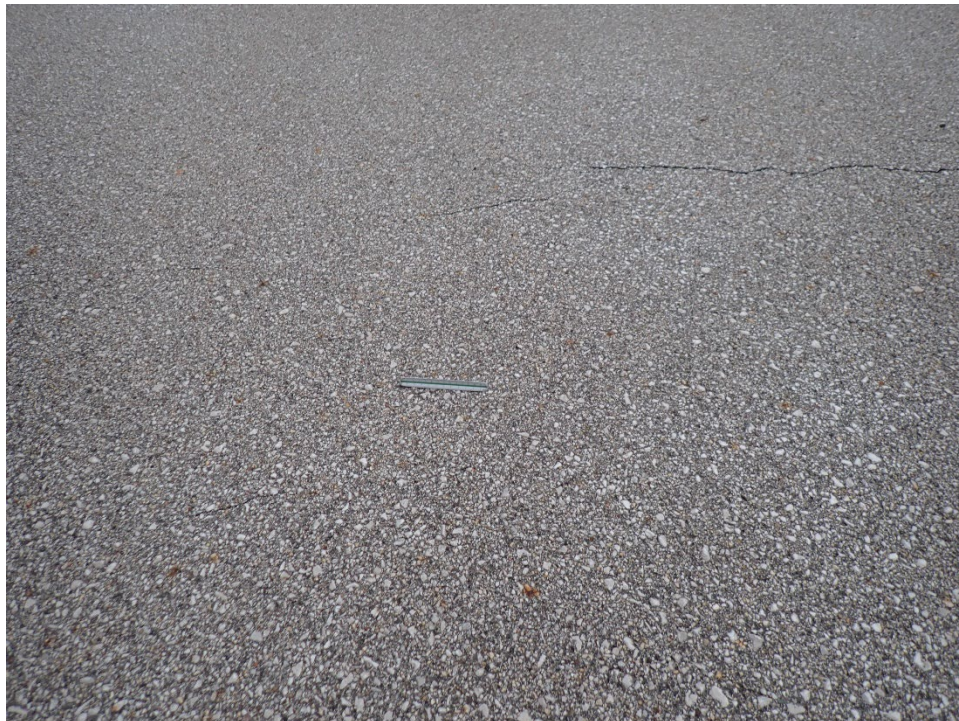
R12IG-03. Weathering (Sample Unit No. 01).

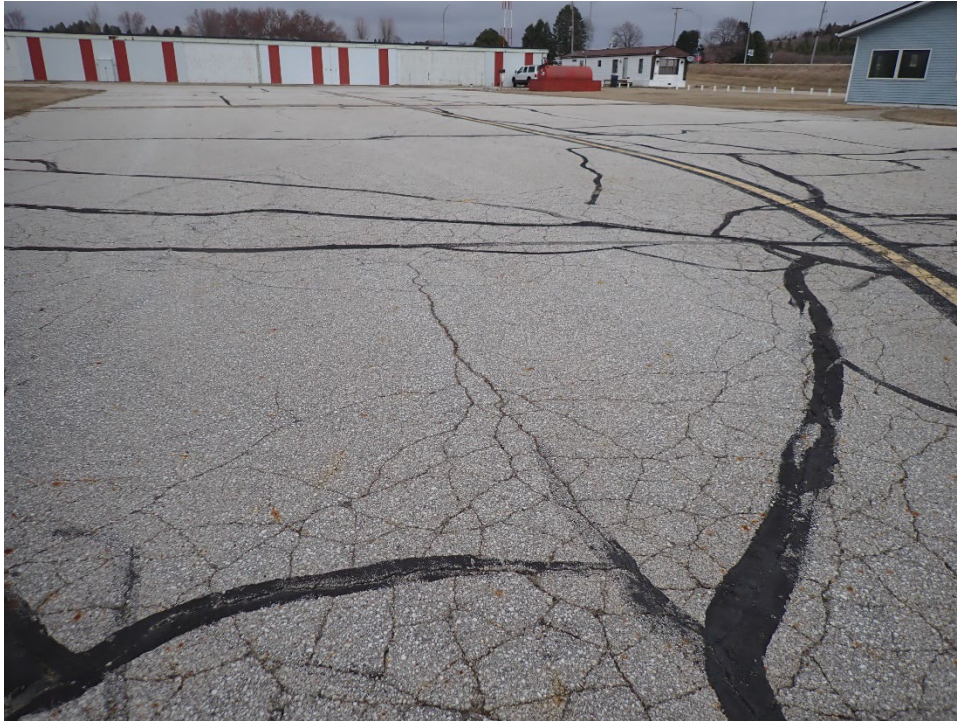
The taxiway was in *Poor* condition with amounts of all severities of L&T cracking, medium-severity alligator cracking and weathering, and low-severity patching and rutting identified in Section 01 during the inspection.

T01IG-01. Overview.

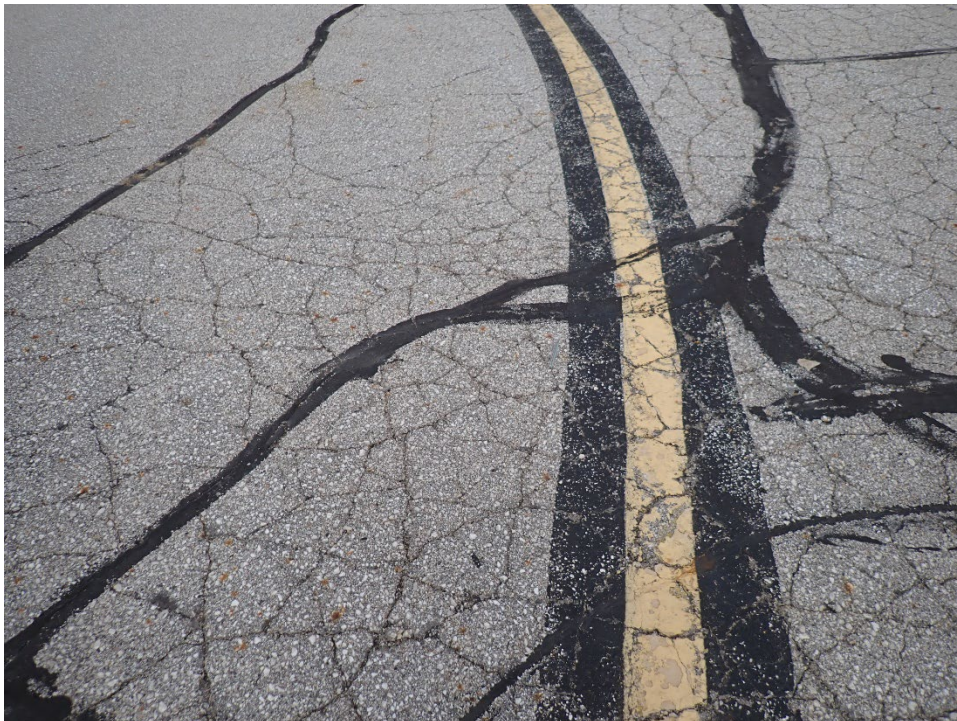
T01IG-01. Alligator Cracking (Sample Unit No. 03) (1).

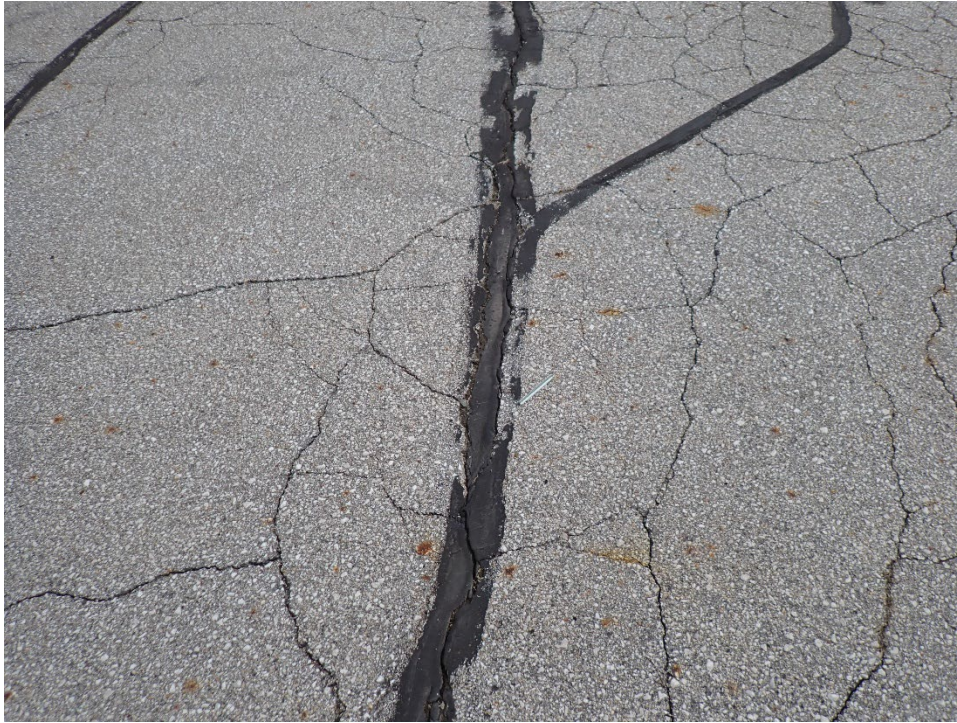
T01IG-01. Alligator Cracking (Sample Unit No. 03) (2).
