James H Connell Field at Independence Municipal Airport

Pavement Management Report

JULY 2023

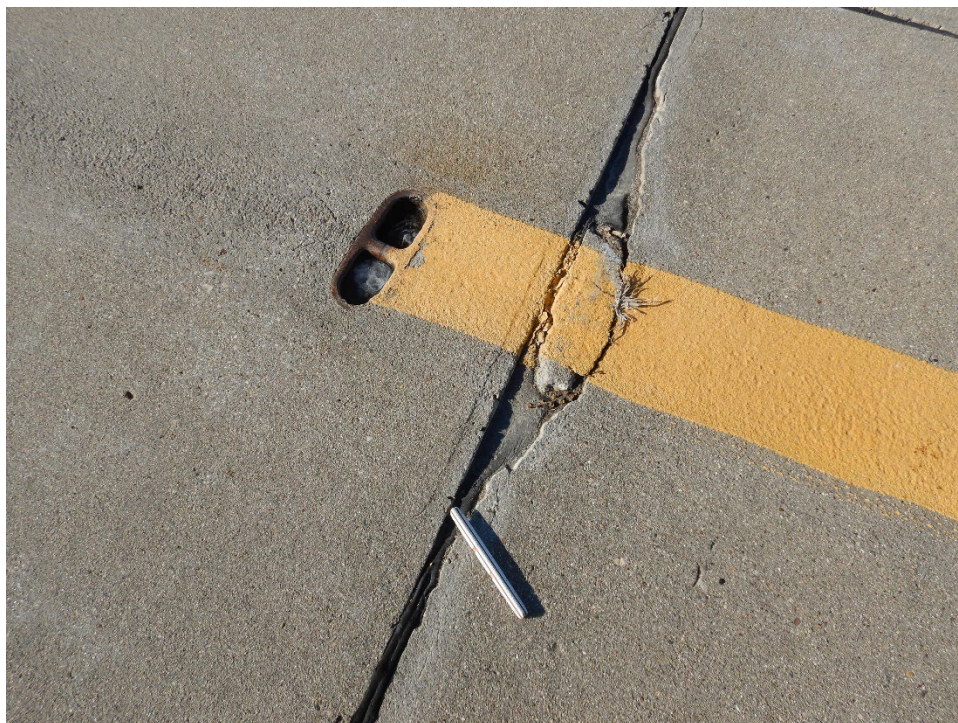
A01IN-01. Joint Spalling (Sample Unit No. 08).

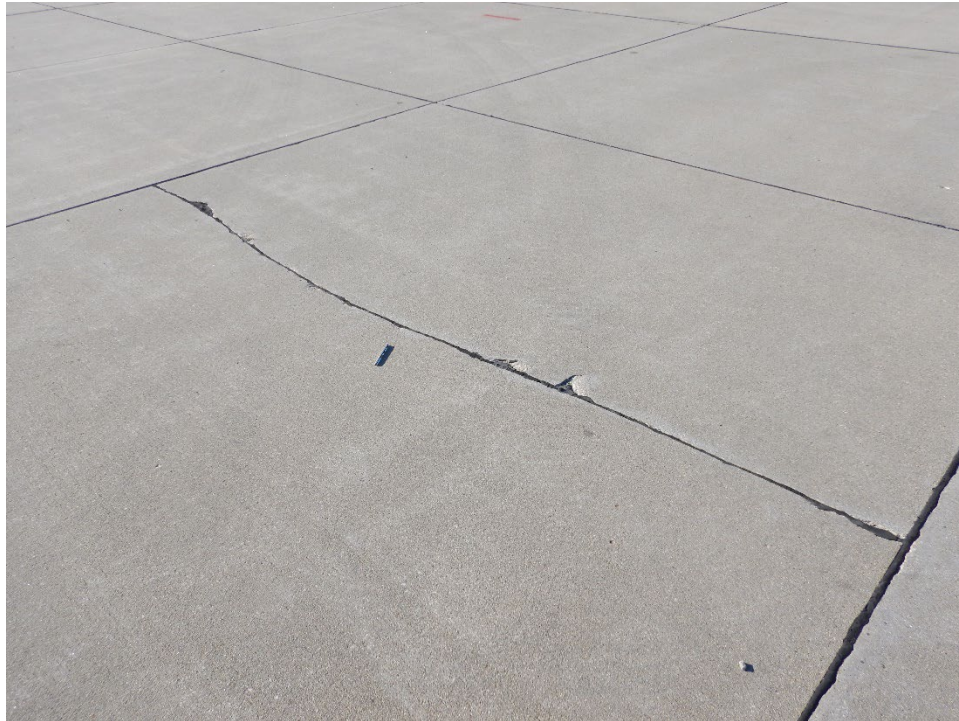
A01IN-01. LTD Cracking (Sample Unit No. 17).

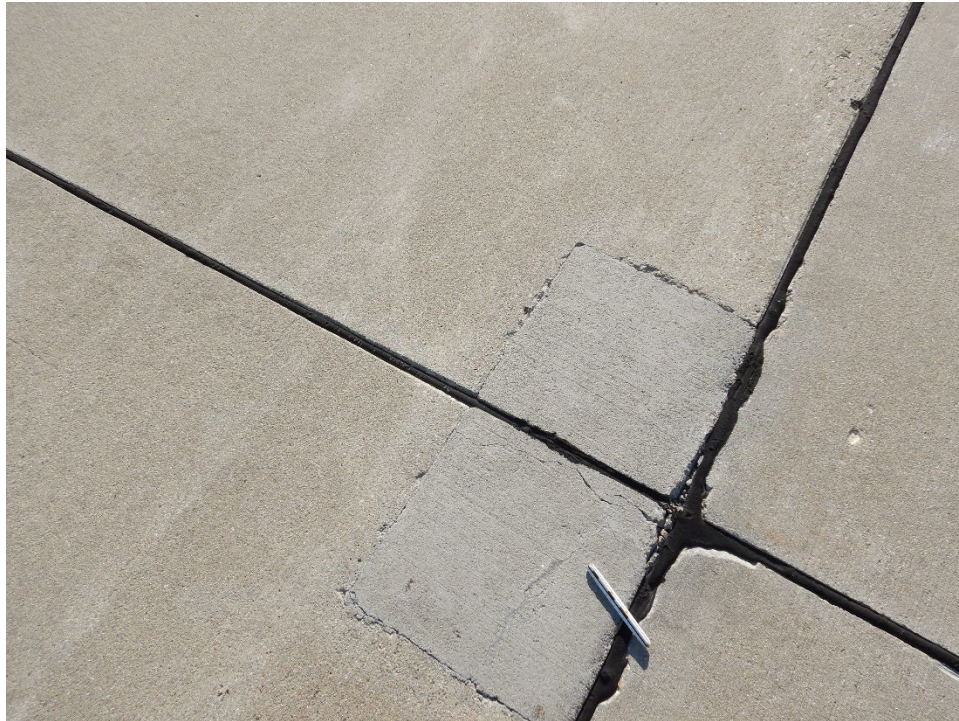
A01IN-02. Small Patching (Sample Unit No. 03).

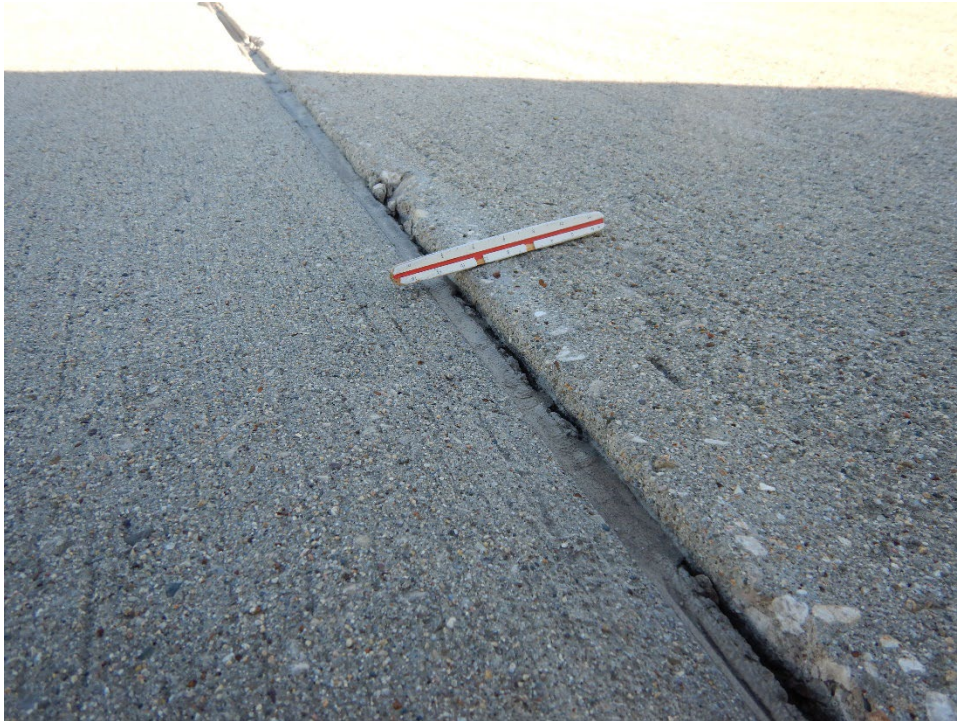
R18IN-01. Faulting (Sample Unit No. 22).

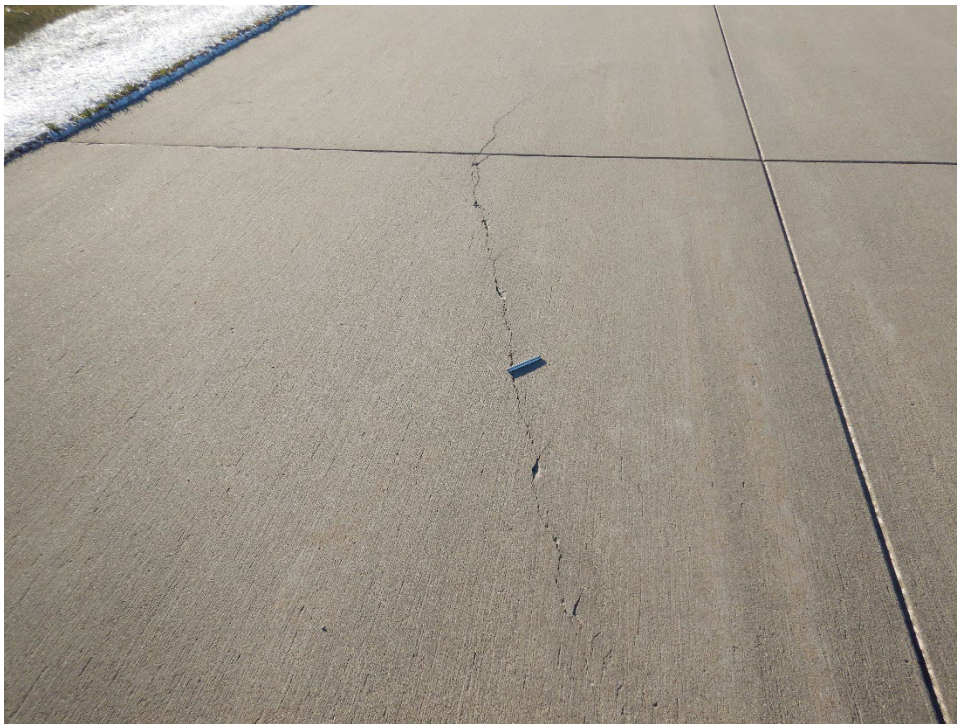
R18IN-01. LTD Cracking (Additional Sample Unit No. 055).

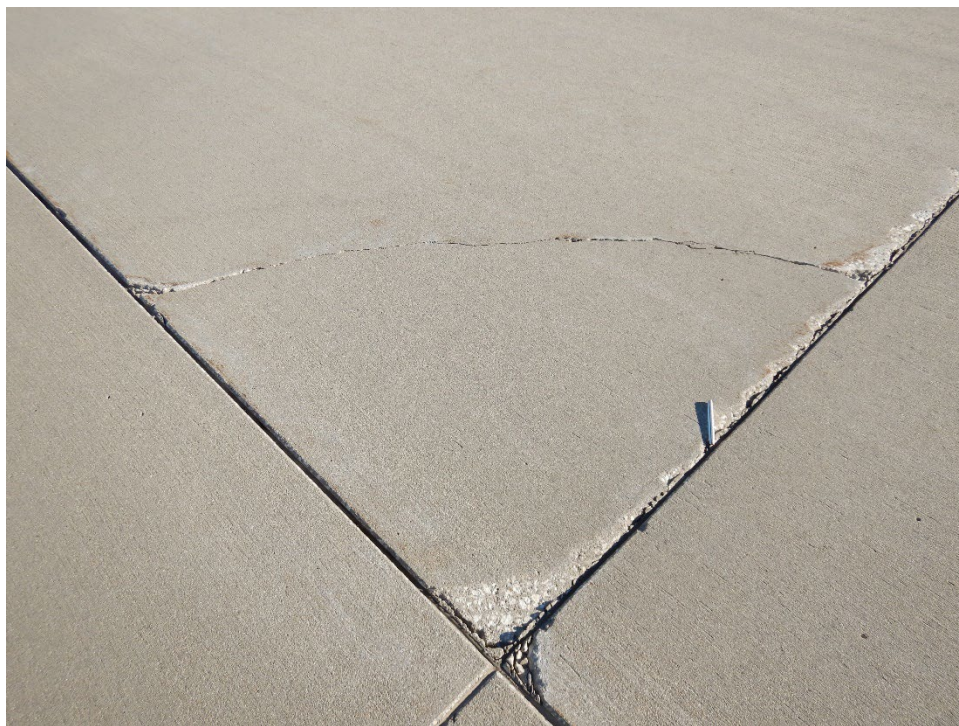
R18IN-02. Corner Break (Additional Sample Unit No. 22).

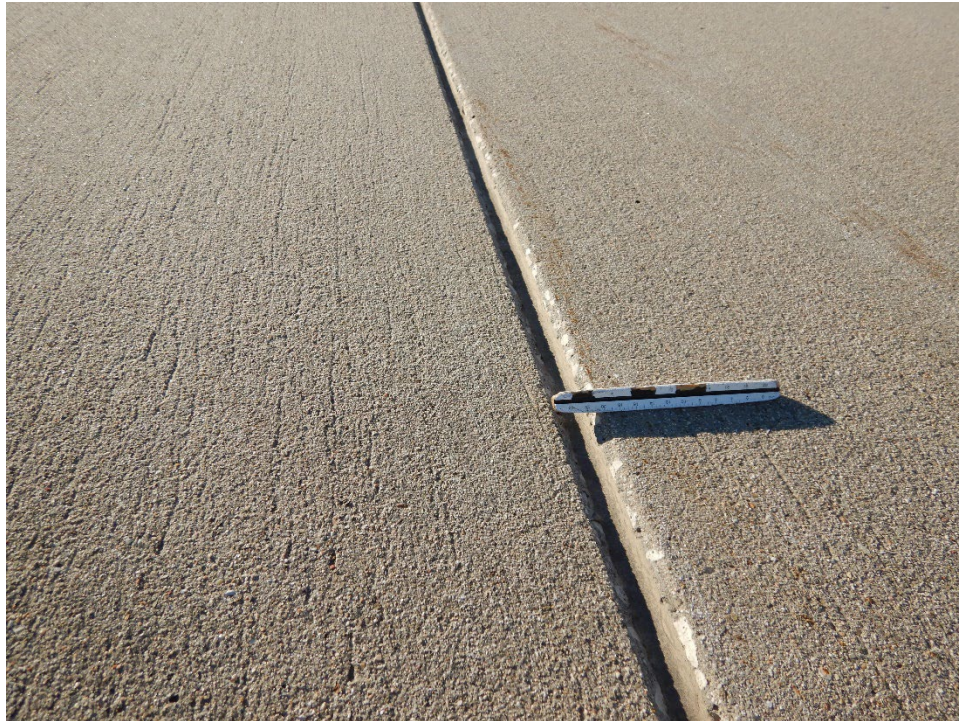
R18IN-02. Faulting (Sample Unit No. 03).

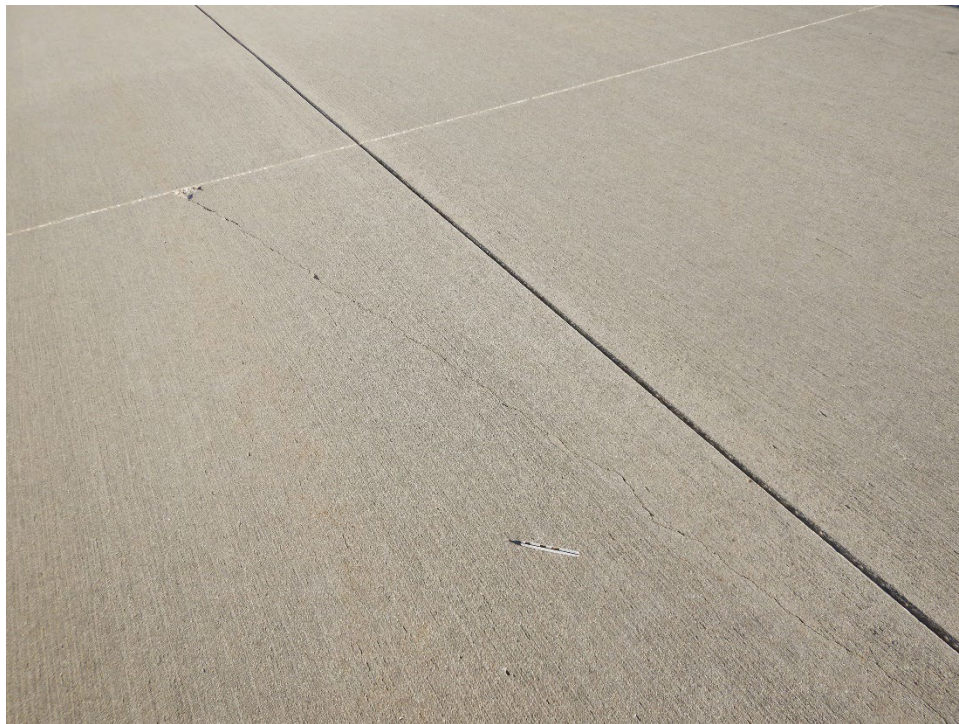
R18IN-02. LTD Cracking (Additional Sample Unit No. 24).

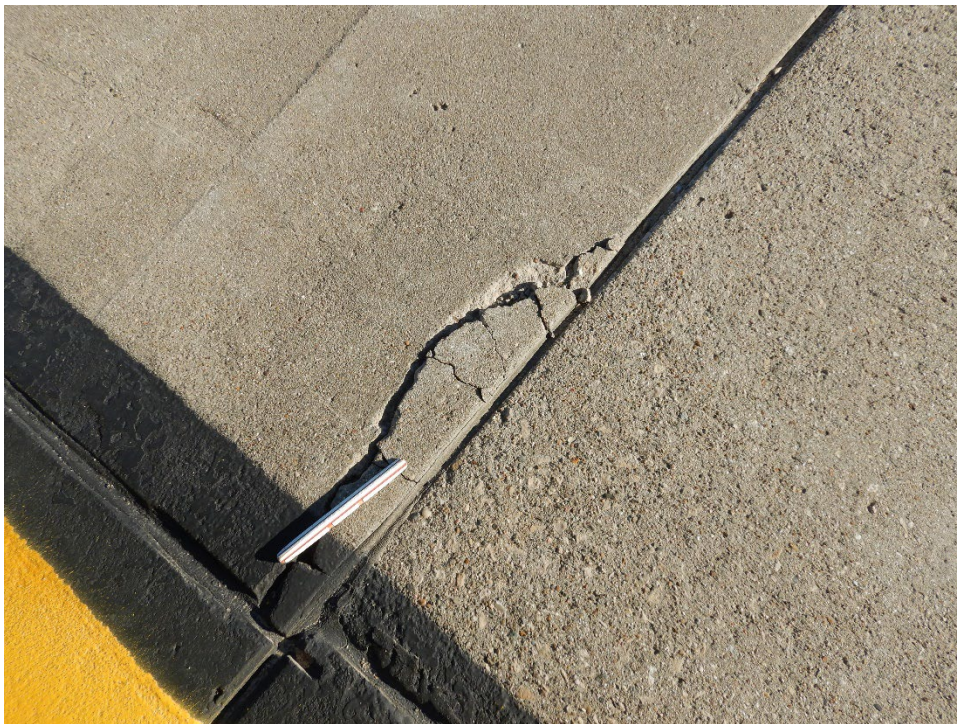
T01IN-01. Joint Spalling (Sample Unit No. 09).

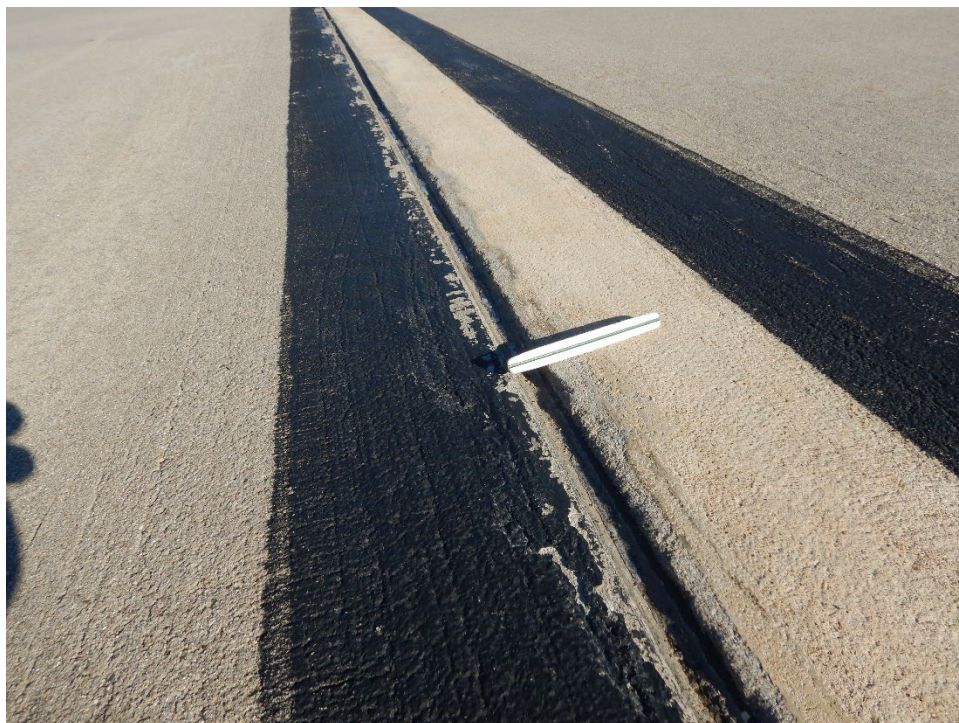
T02IN-01. Faulting (Sample Unit No. 70).

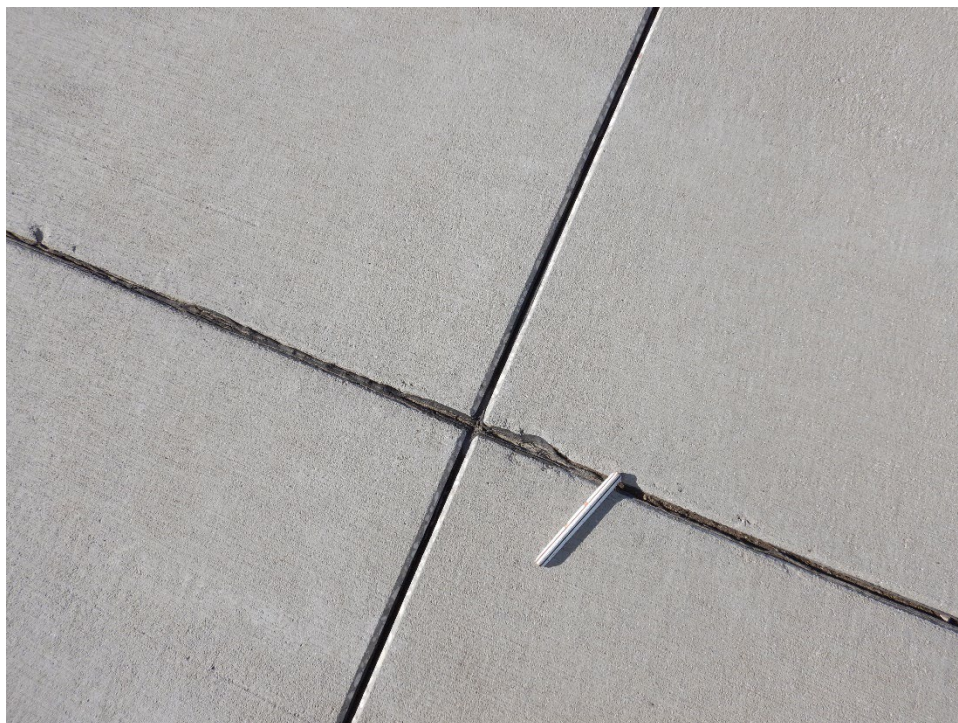
T03IN-01. Joint Seal Damage (Sample Unit No. 12).

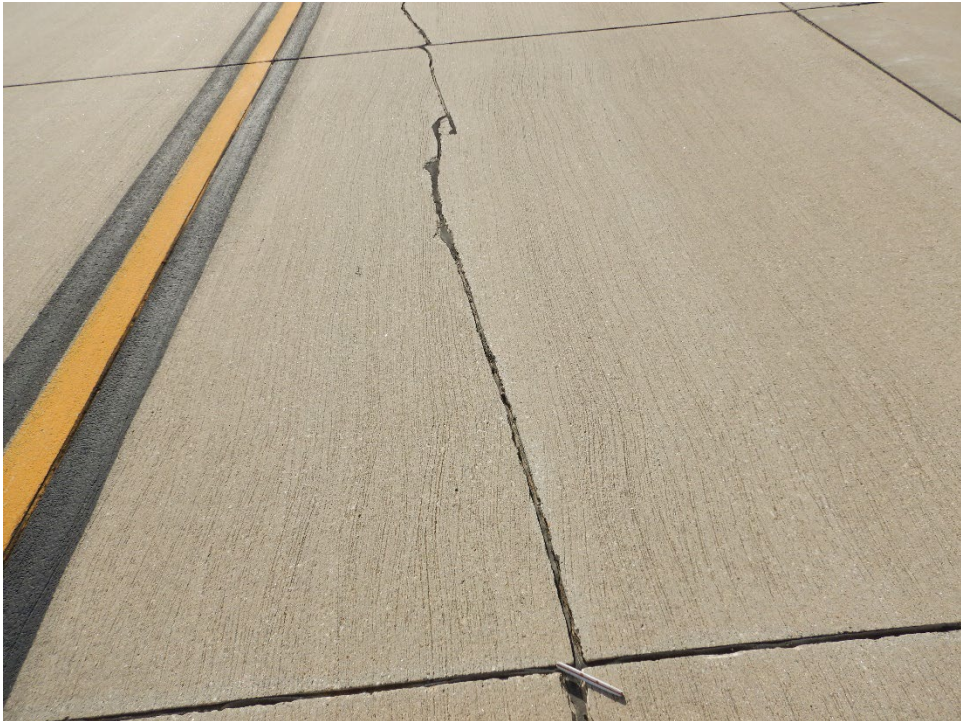
TH01IN-01. LTD Cracking (Sample Unit No. 02).

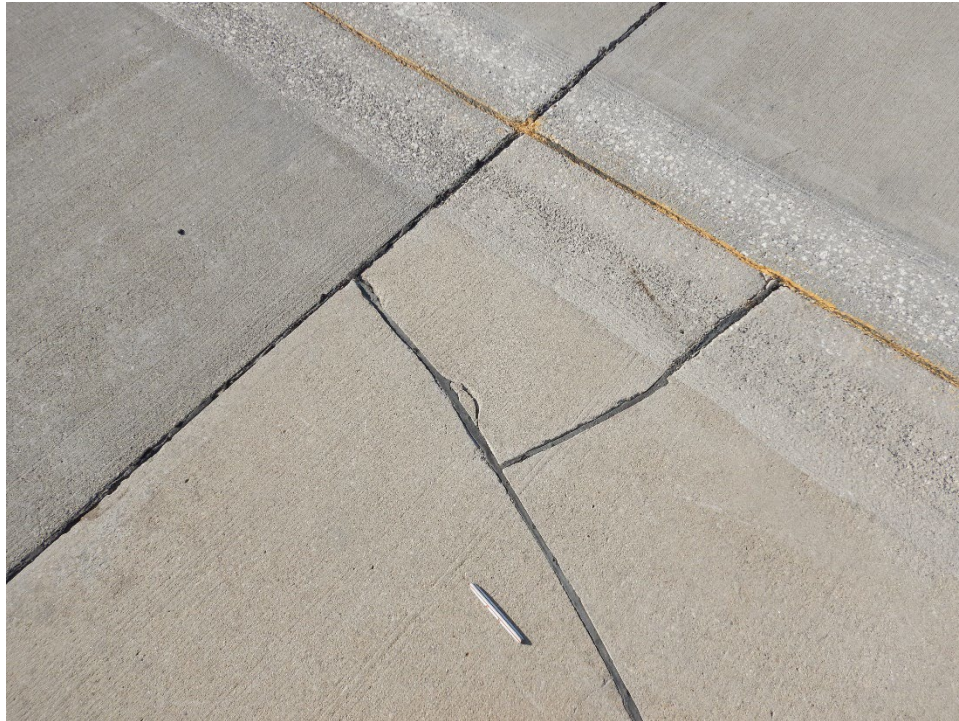
TH01IN-02. Corner Break (Sample Unit No. 03).

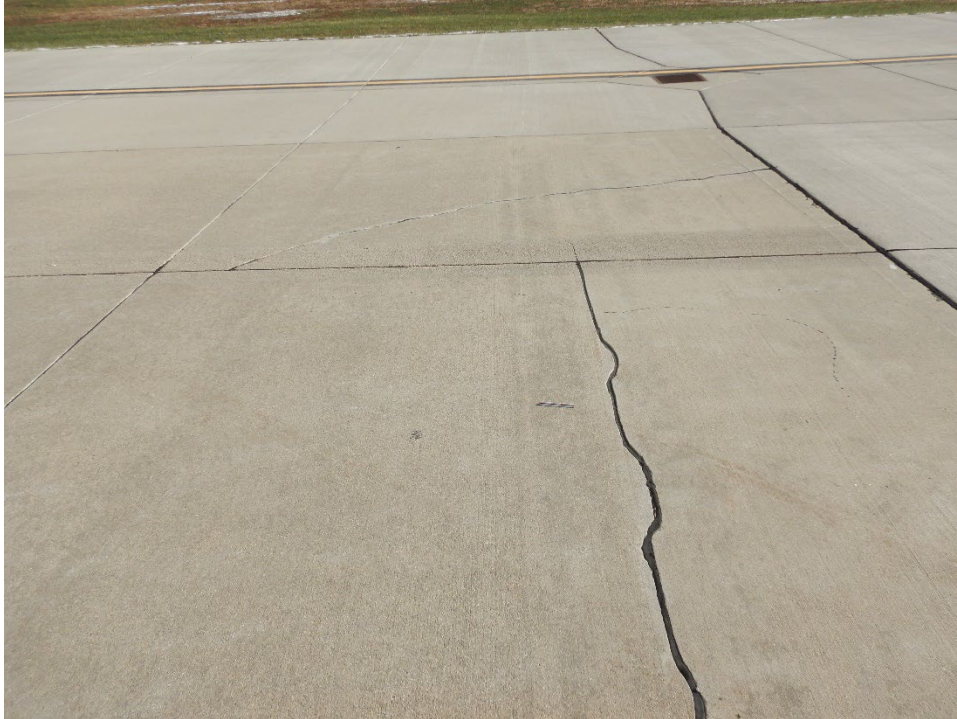
TH01IN-03. LTD Cracking (Sample Unit No. 02).
