# James H Connell Field at Independence Municipal Airport

## Pavement Management Report

**AUGUST 2026**

# JAMES H CONNELL FIELD AT INDEPENDENCE MUNICIPAL AIRPORT PAVEMENT MANAGEMENT REPORT

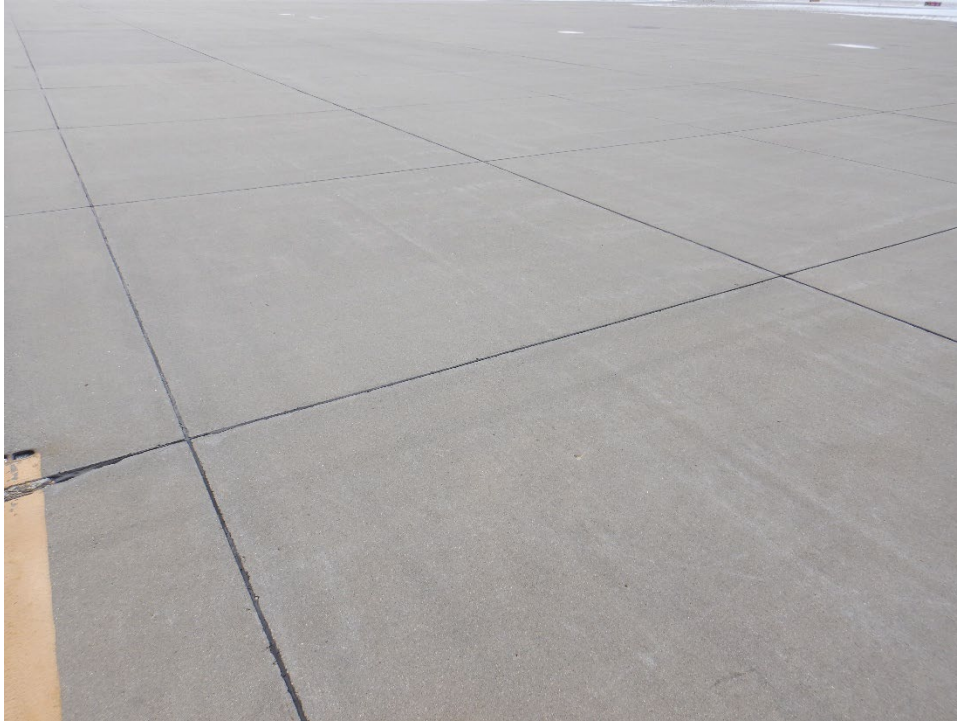
A01IN-01. Overview.

| Branch | Section | Surface Type | Section Area (sf) | LCD | 2026 PCI | % Distress Due to Load | % Distress Due to Climate/ Durability | % Distress Due to Other | Type of Distress |
|---|---|---|---|---|---|---|---|---|---|
| A01IN | 01 | PCC | 57,600 | 6/1/2004 | 81 | 55 | 28 | 17 | Corner Break, Faulting, Joint Spalling, Joint Seal Damage, Large Patch, LTD Cracking, Shrinkage Cracking, Small Patch |

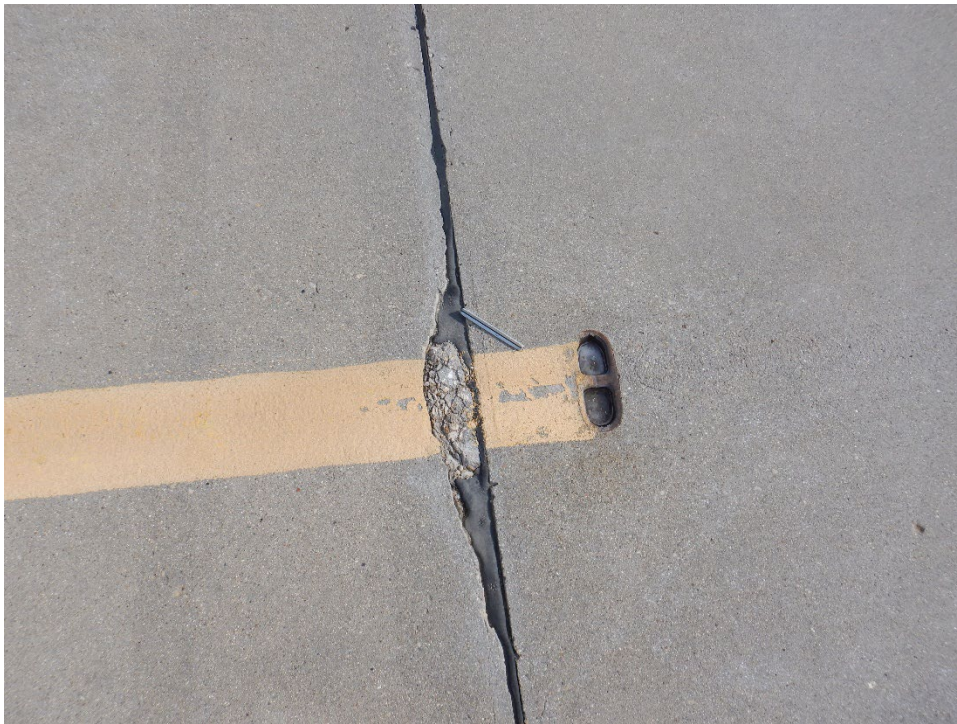
Apron 01 was defined by three sections. Section 01 contained low- and medium-severity corner break, joint spalling, and LTD cracking; low-severity faulting, large patching, and small patching; medium-severity joint seal damage; and shrinkage cracking. Medium-severity joint seal damage and low-severity small patching were identified in Section 02. Section 03 had low-severity faulting and joint seal damage recorded.

A01IN-01. Joint Spalling (Sample Unit No. 08).

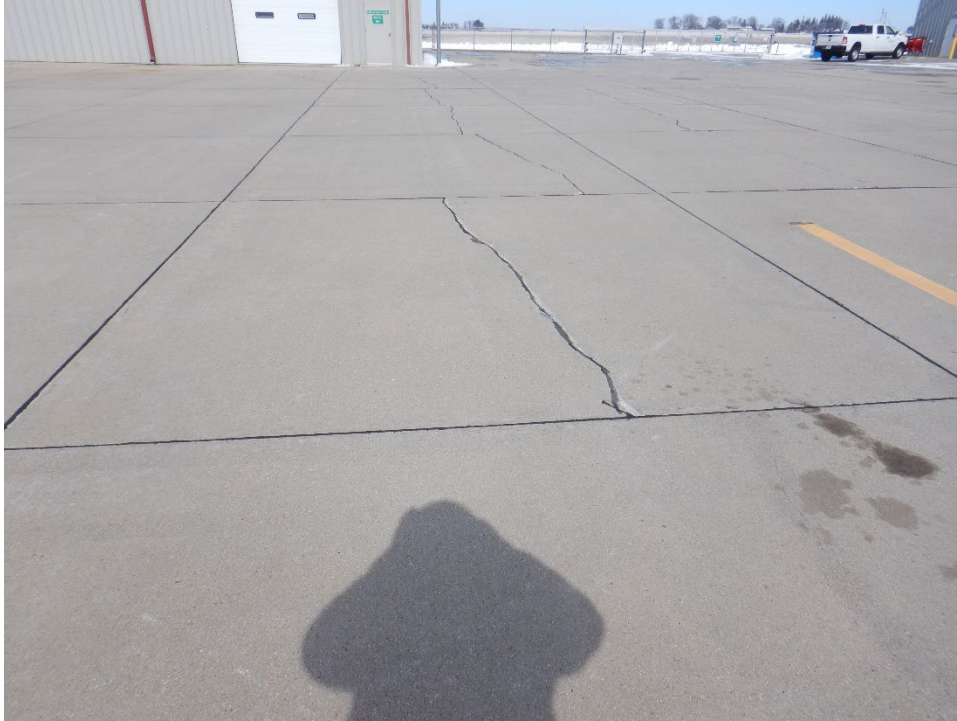
A01IN-01. LTD Cracking (Sample Unit No. 08).

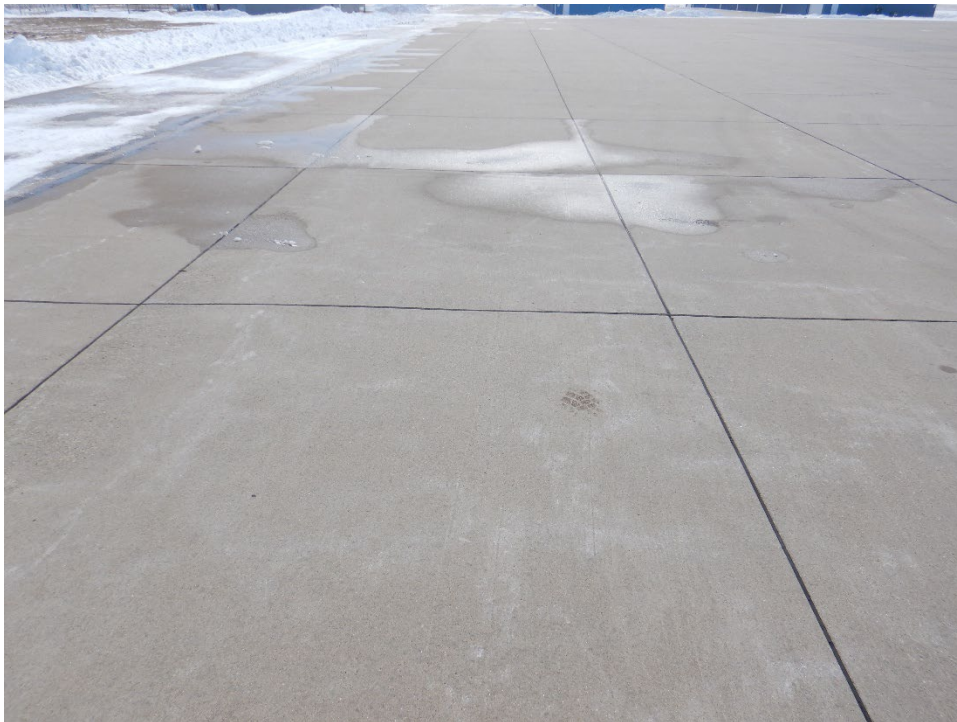
A01IN-02. Overview.

| Branch | Section | Surface Type | Section Area (sf) | LCD | 2026 PCI | % Distress Due to Load | % Distress Due to Climate/ Durability | % Distress Due to Other | Type of Distress |
|---|---|---|---|---|---|---|---|---|---|
| A01IN | 02 | PCC | 13,784 | 6/1/2008 | 93 | 0 | 92 | 8 | Joint Seal Damage, Small Patch |

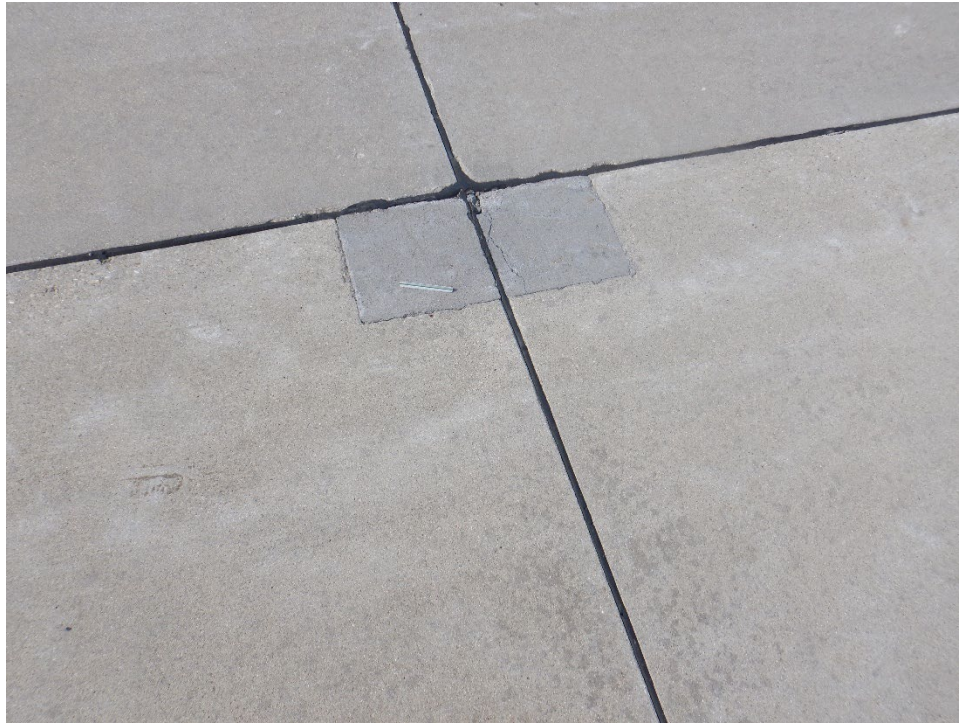
A01IN-02. Small Patching (Sample Unit No. 03).

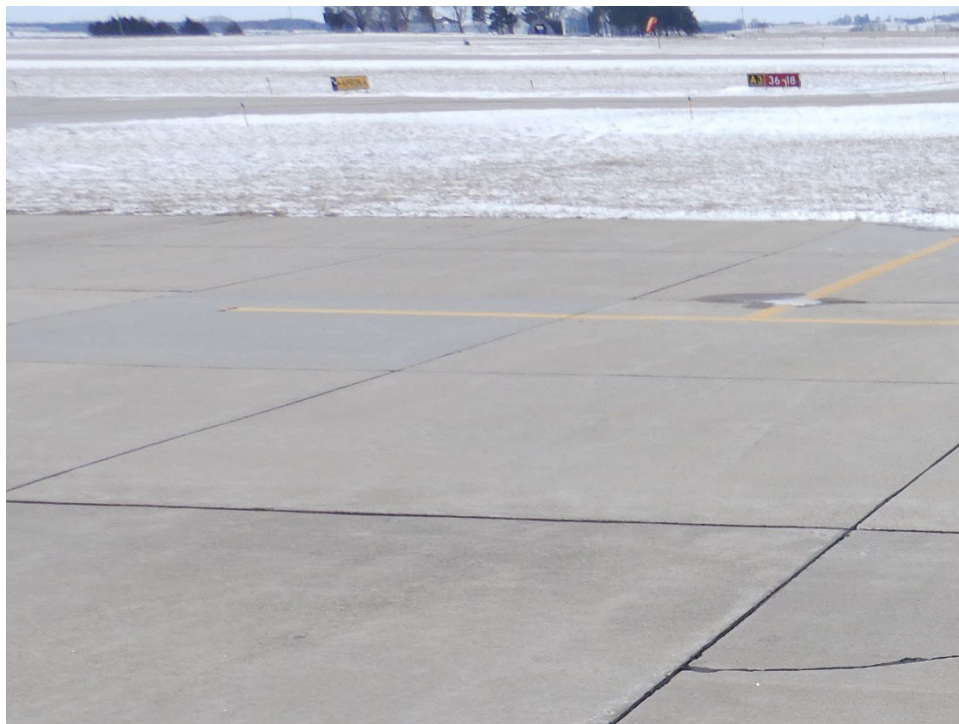
A01IN-03. Overview.

| Branch | Section | Surface Type | Section Area (sf) | LCD | 2026 PCI | % Distress Due to Load | % Distress Due to Climate/ Durability | % Distress Due to Other | Type of Distress |
|---|---|---|---|---|---|---|---|---|---|
| A01IN | 03 | PCC | 10,649 | 6/3/2007 | 94 | 0 | 30 | 70 | Faulting, Joint Seal Damage |

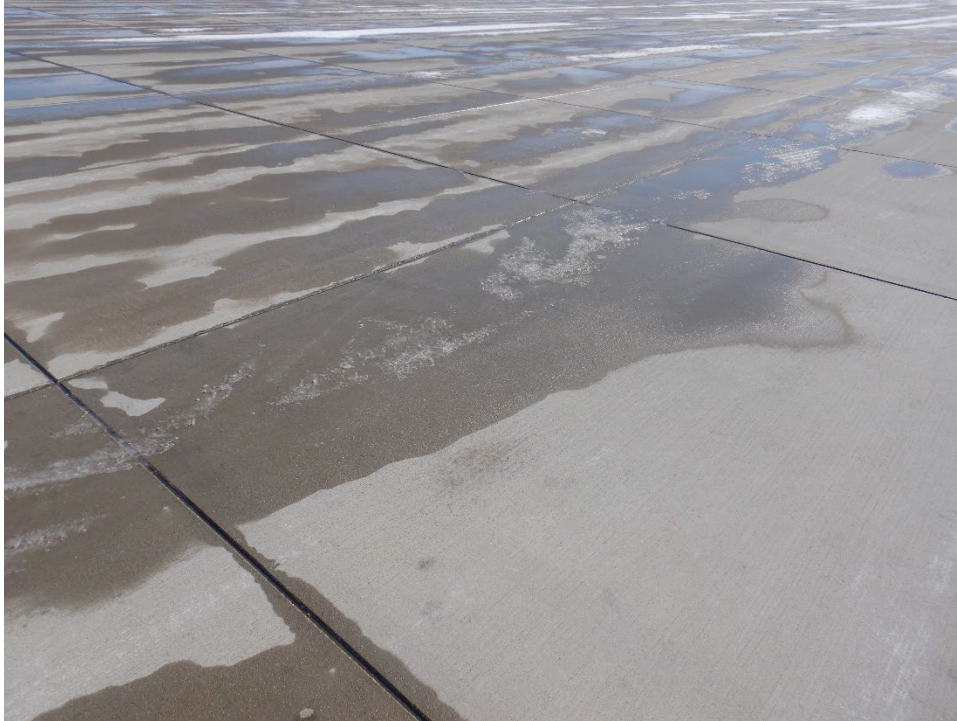
A02IN-01. Overview.

Apron 02 consisted of one section in *Excellent* condition with only low-severity LTD cracking identified at the time of inspection.

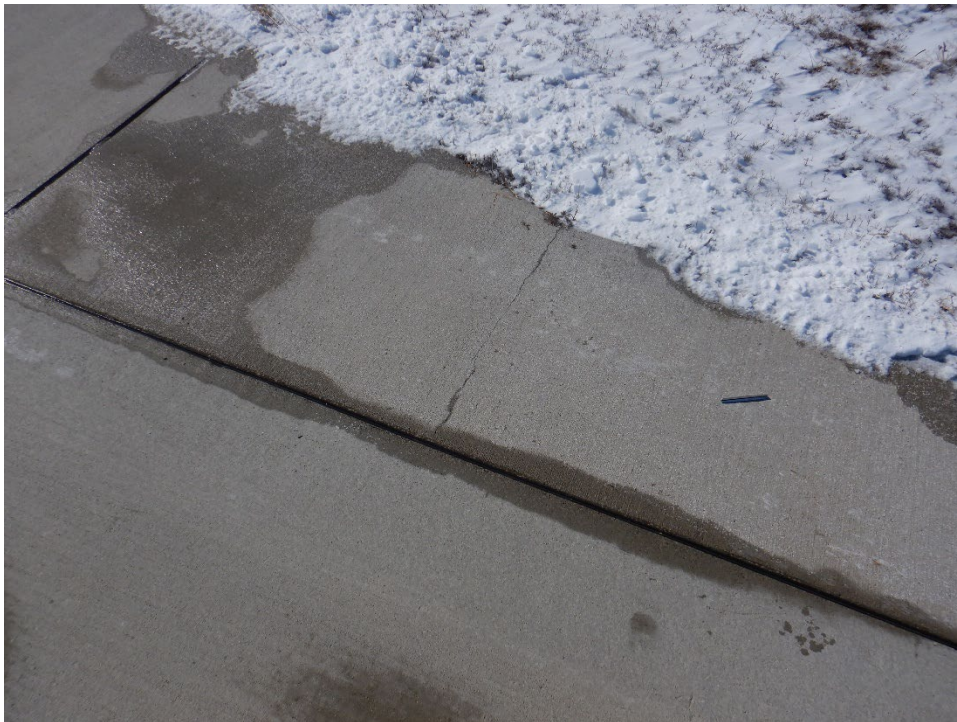
A02IN-01. LTD Cracking (Sample Unit No. 04).

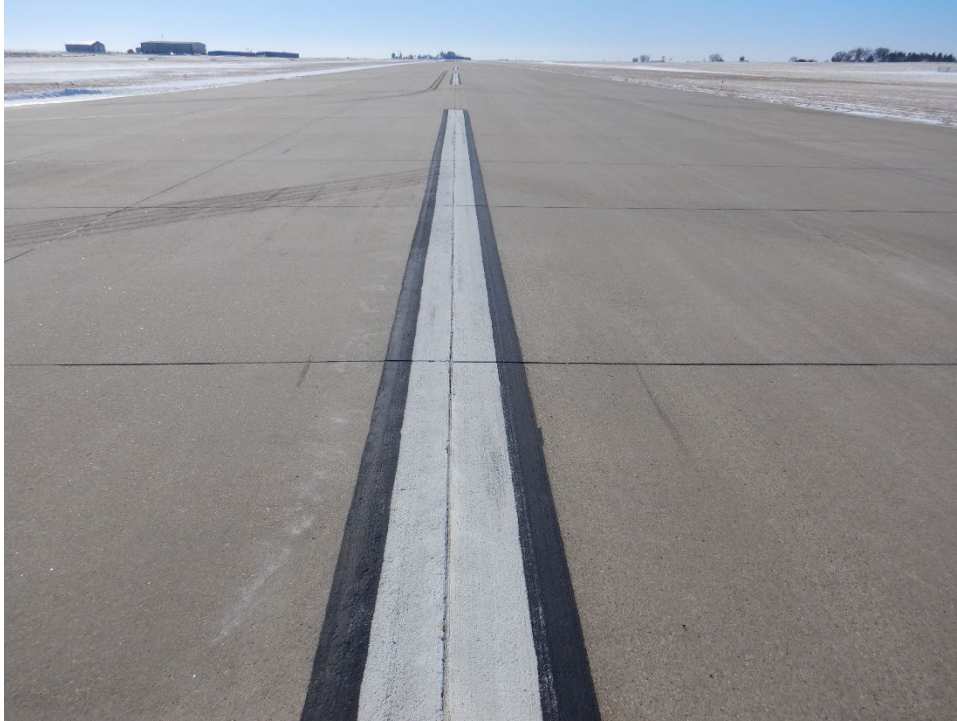
R18IN-01. Overview.

Runway 18/36 consisted of two sections. Section 01 was in *Excellent* condition and had low-severity faulting and joint seal damage identified during the inspection. Atypical areas of medium- and high-severity joint spalling; medium-severity longitudinal, transverse, and diagonal (LTD) cracking; and shrinkage cracking were observed and recorded as additional sample units in accordance with ASTM D5340. Section 02 had low-severity faulting and low- and medium-severity corner spalling and joint seal damage noted during the inspection. Atypical areas of medium-severity corner break, faulting, and joint spalling; high-severity corner spalling; and low- and medium-severity LTD cracking were observed and recorded as additional sample units in accordance with ASTM D5340.

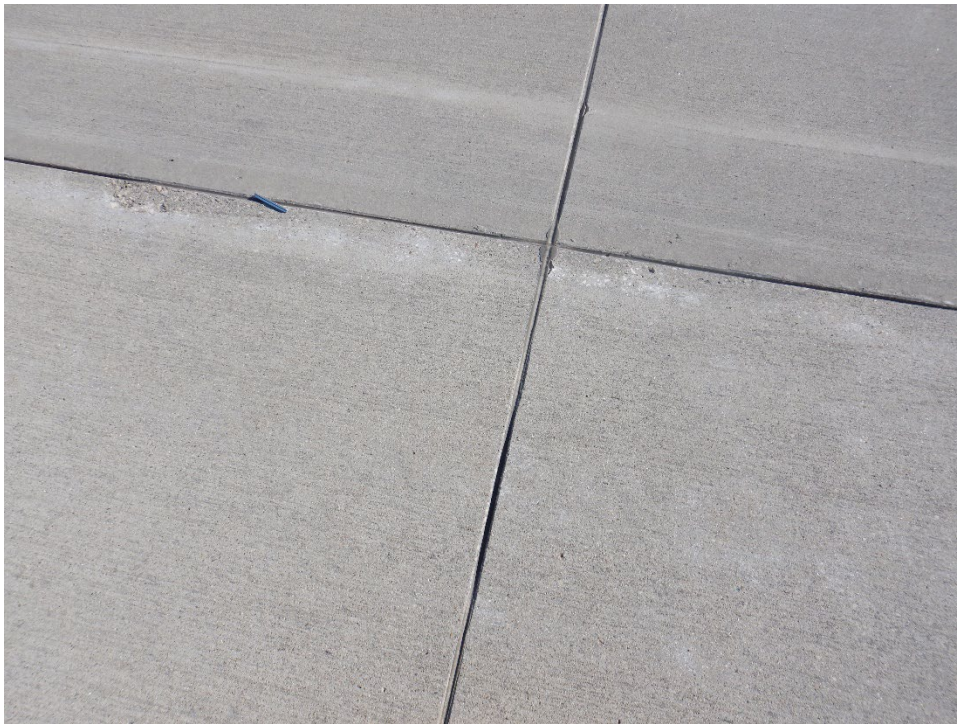
| <b>Distress Type</b> | <b>Probable Cause of Distress</b> |
|---|---|
| Joint Seal Damage | Stripping of joint sealant, extrusion of joint sealant, weed growth, hardening of the filler (oxidation), loss of bond to the slab edges, or absence of sealant in the joint. |

R18IN-01. Joint Seal Damage (Sample Unit No. 56).

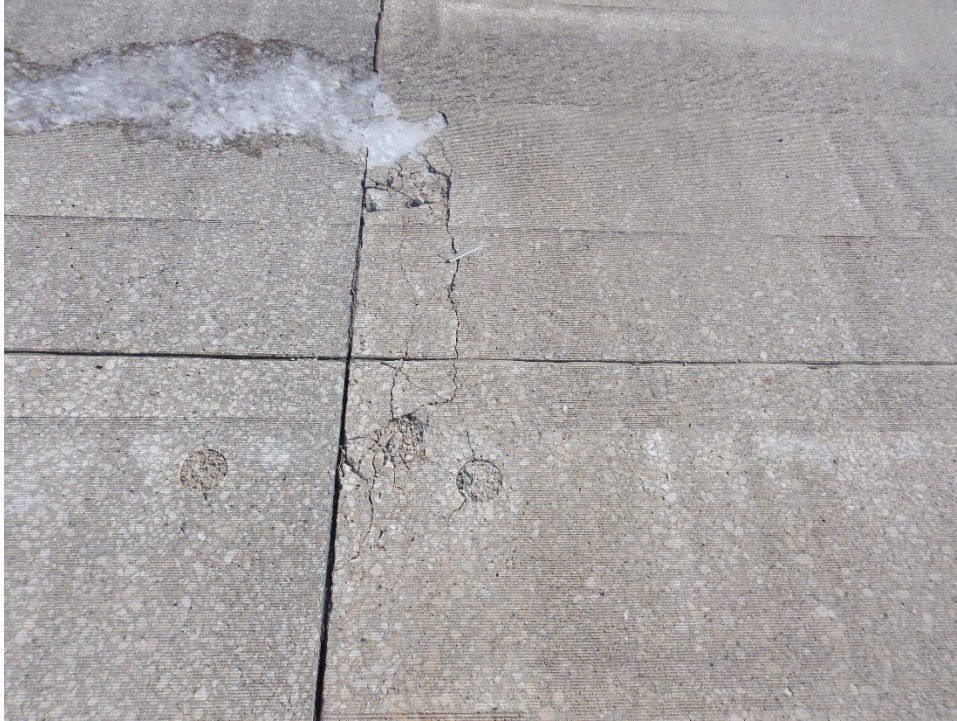
R18IN-01. Joint Spalling (Additional Sample Unit No. 01).

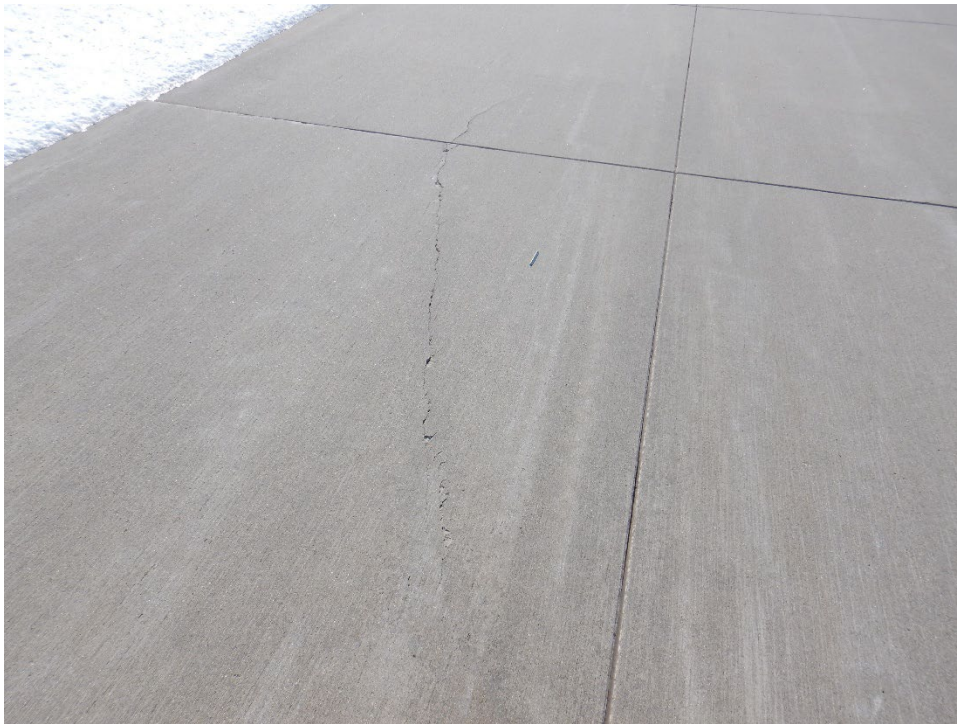
R18IN-01. LTD Cracking (Additional Sample Unit No. 55).

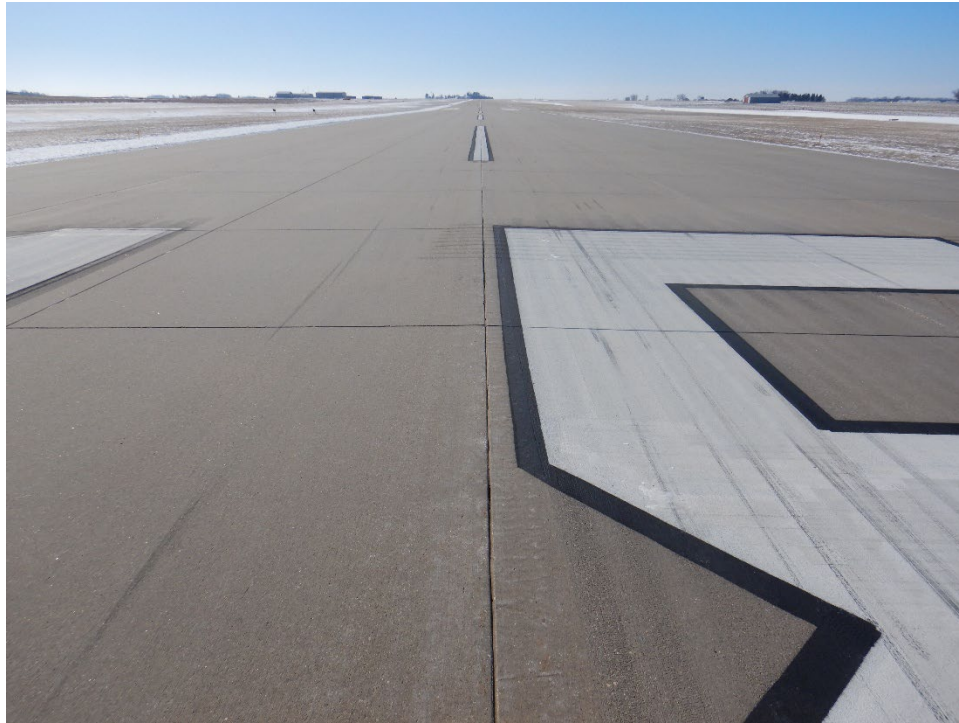
R18IN-02. Overview.

| Branch | Section | Surface Type | Section Area (sf) | LCD | 2026 PCI | % Distress Due to Load | % Distress Due to Climate/ Durability | % Distress Due to Other | Type of Distress |
|---|---|---|---|---|---|---|---|---|---|
| R18IN | 02 | PCC | 166,842 | 6/3/2008 | 87 | 22 | 37 | 41 | Corner Break, Corner Spalling, Faulting, Joint Spalling, Joint Seal Damage, LTD Cracking |

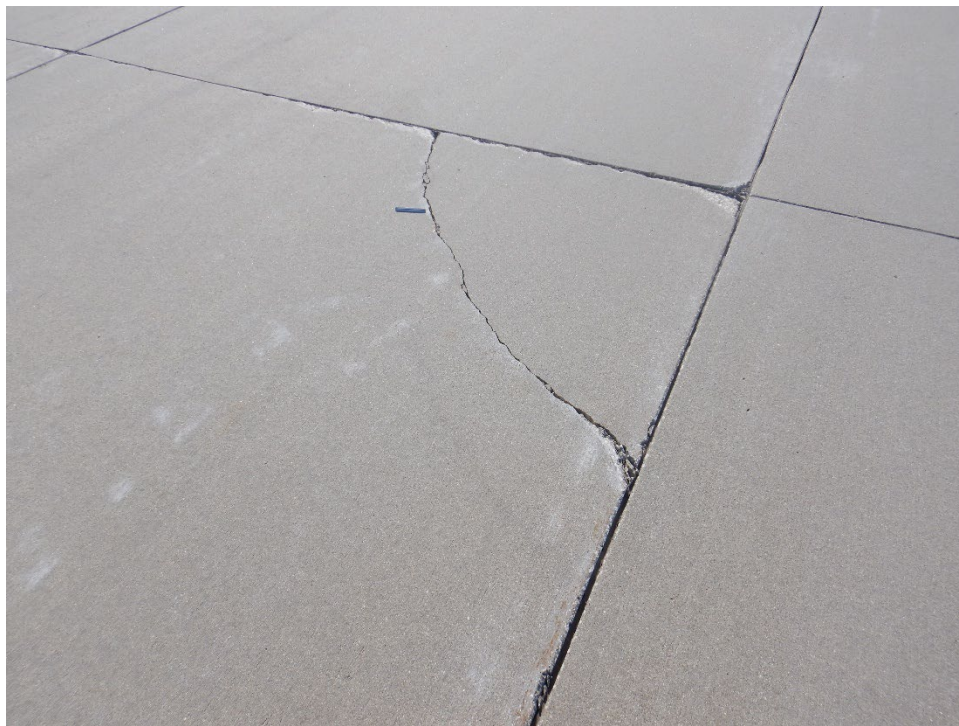
R18IN-02. Corner Break (Additional Sample Unit No. 22).

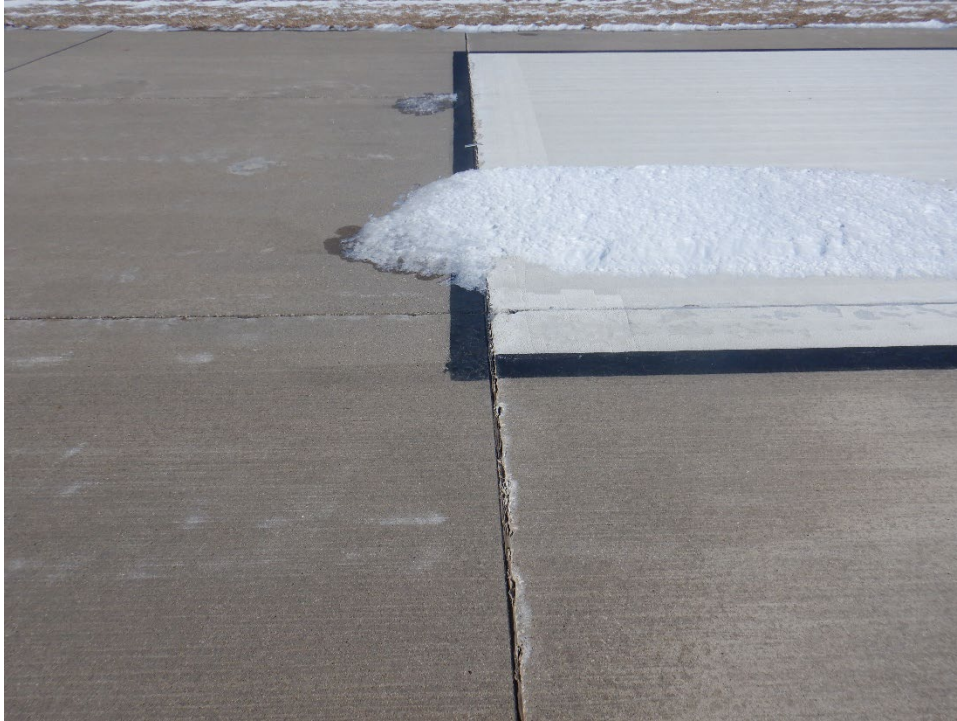
R18IN-02. Faulting (Additional Sample Unit No. 09).

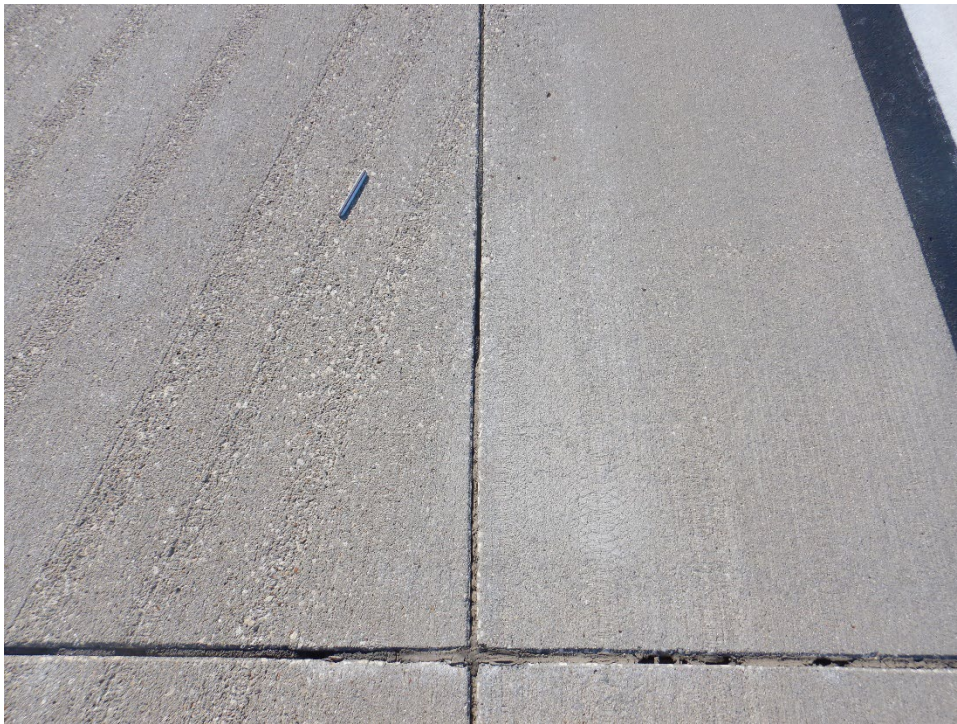
R18IN-02. Joint Seal Damage (Sample Unit No. 33).

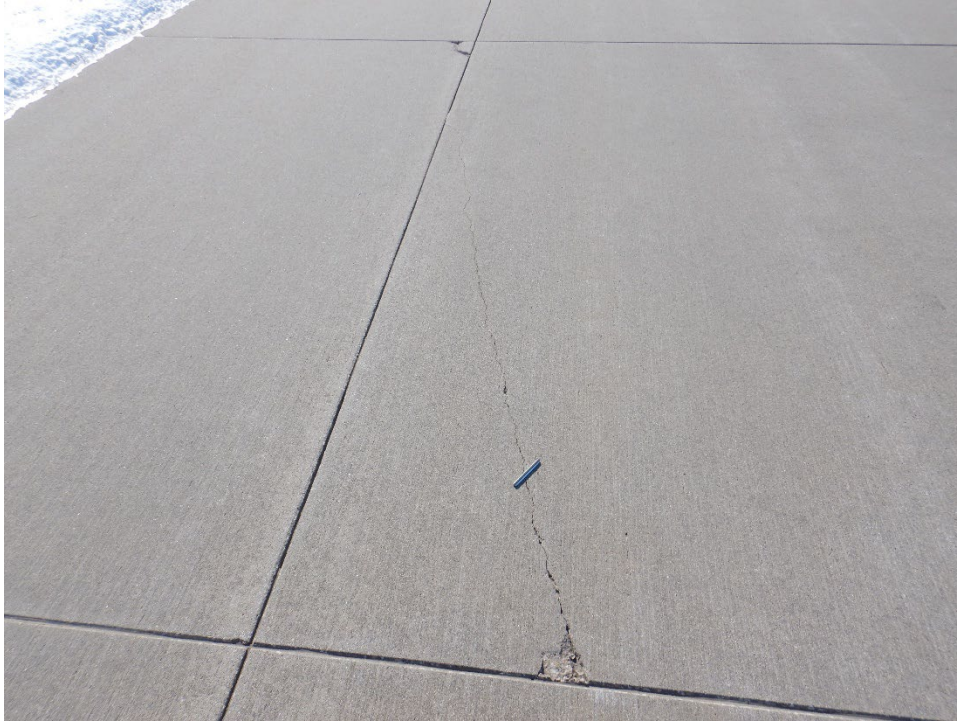
R18IN-02. LTD Cracking (Additional Sample Unit No. 26).

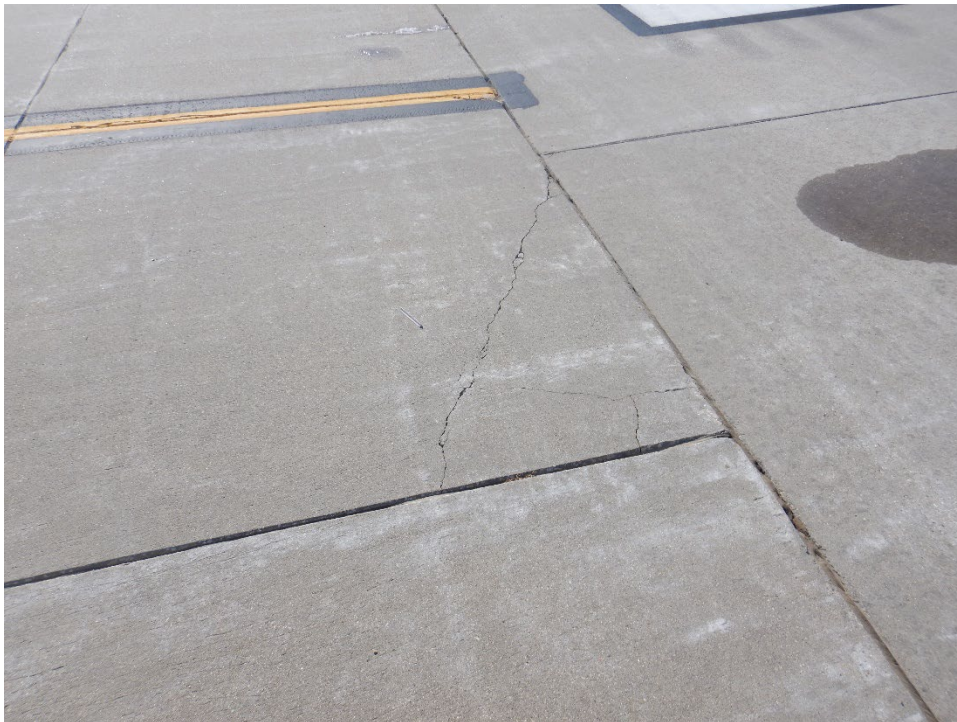
R18IN-02. LTD Cracking (Additional Sample Unit No. 41).

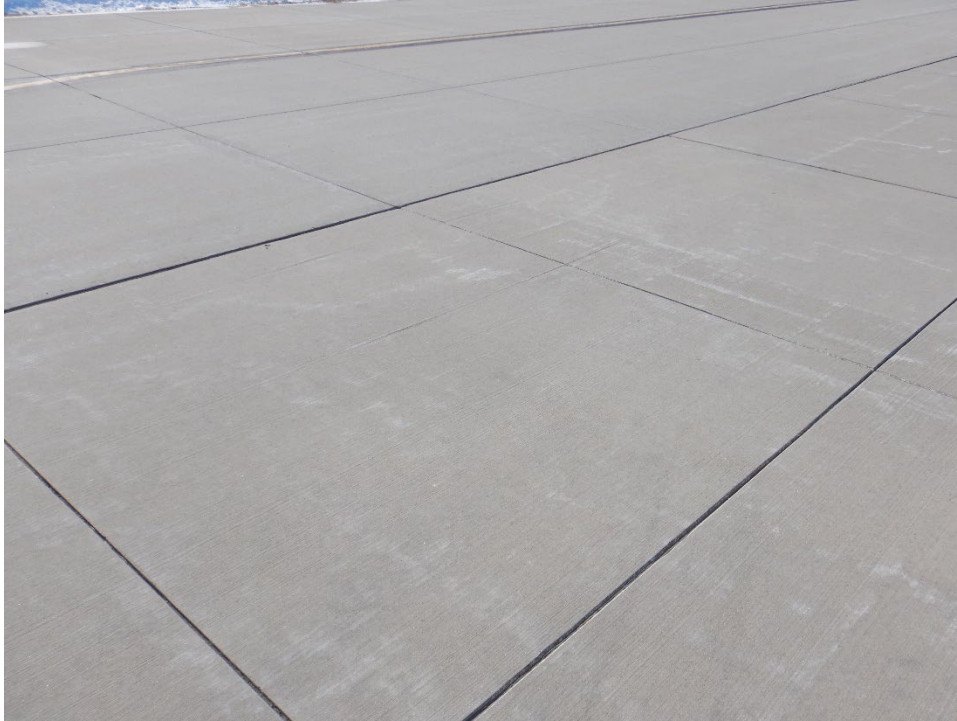
T03IN-01. Overview.

Taxiway 03 was defined by one section with medium-severity joint seal damage and low-severity LTD cracking observed.

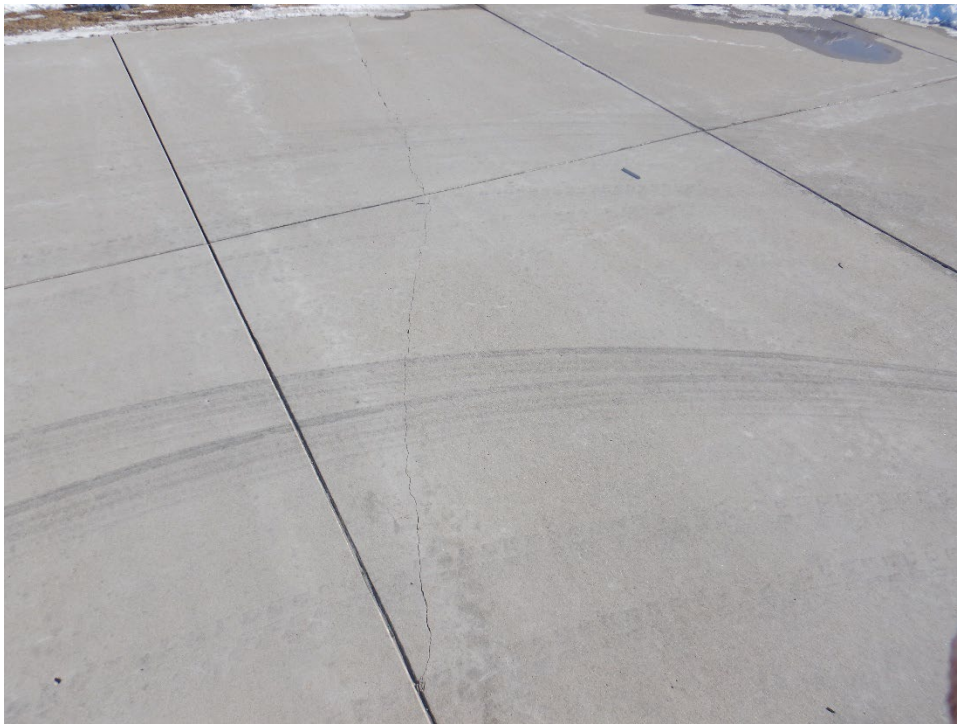
T03IN-01. LTD Cracking (Sample Unit No. 12).

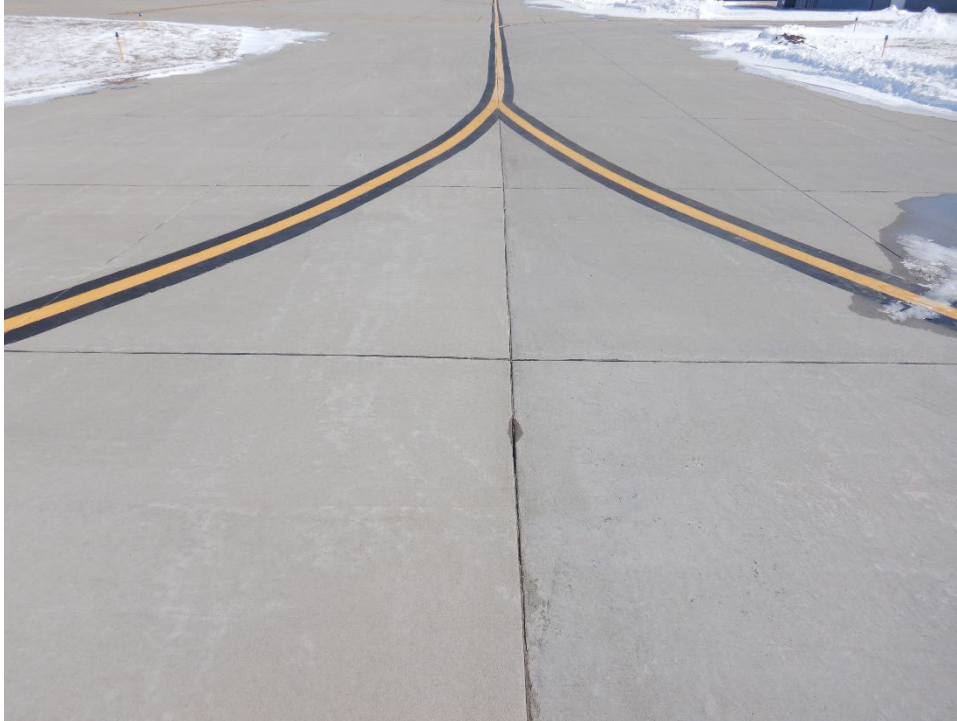
T04IN-01. Overview.

Taxiway 04 consisted of one section in *Excellent* condition that had low-severity joint seal damage and small patching observed. An atypical area of low-severity faulting was identified and recorded as an additional sample unit in accordance with ASTM D5340.

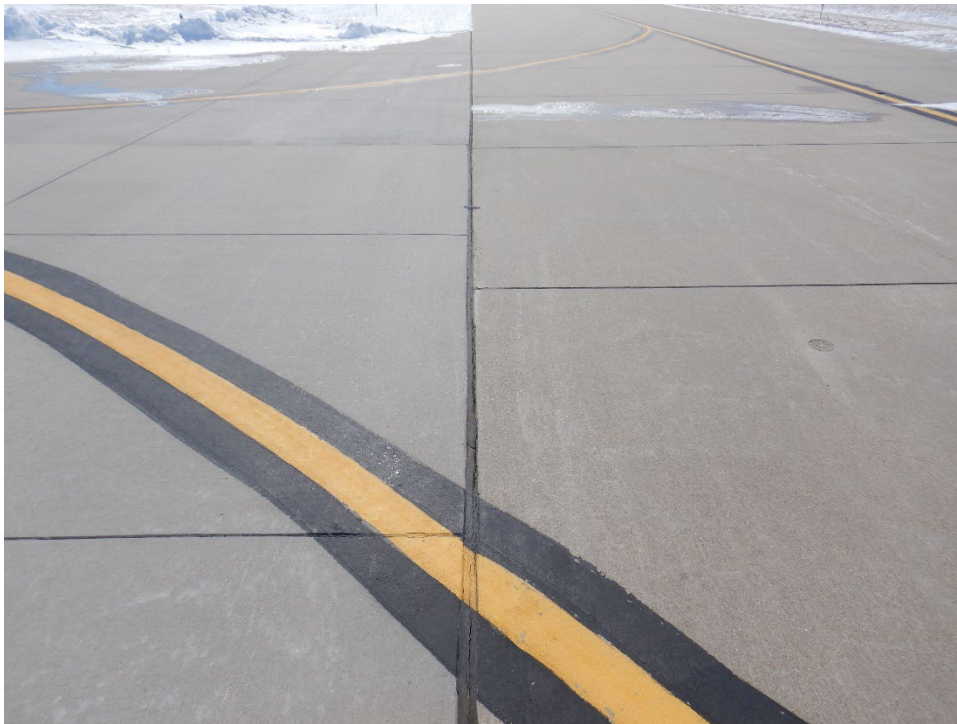
T04IN-01. Faulting (Additional Sample Unit No. 01).

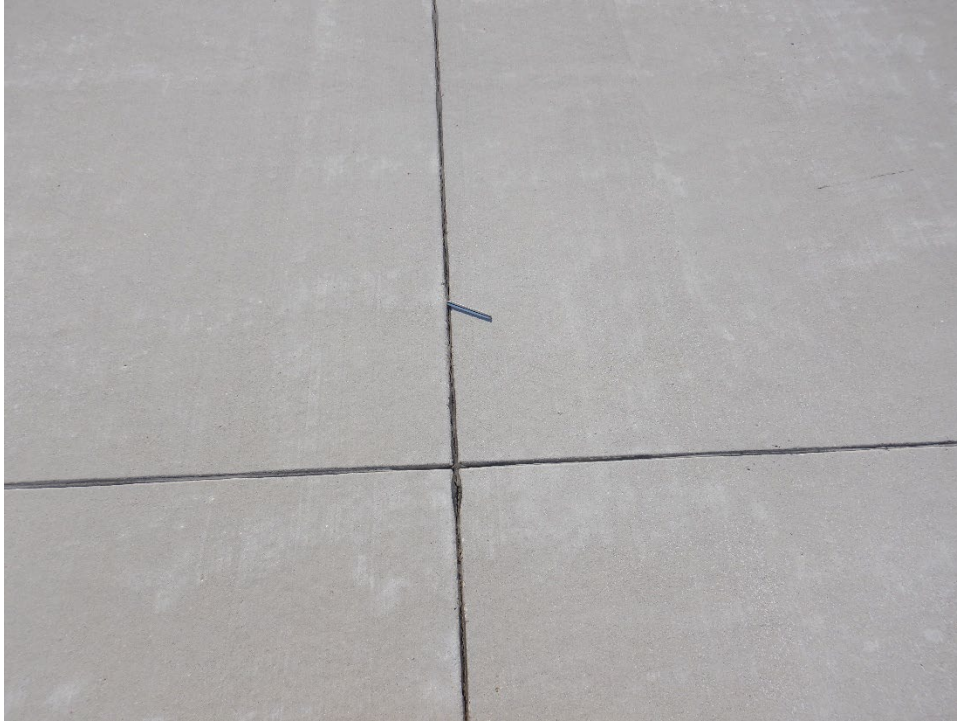
T04IN-01. Joint Seal Damage (Sample Unit No. 09).

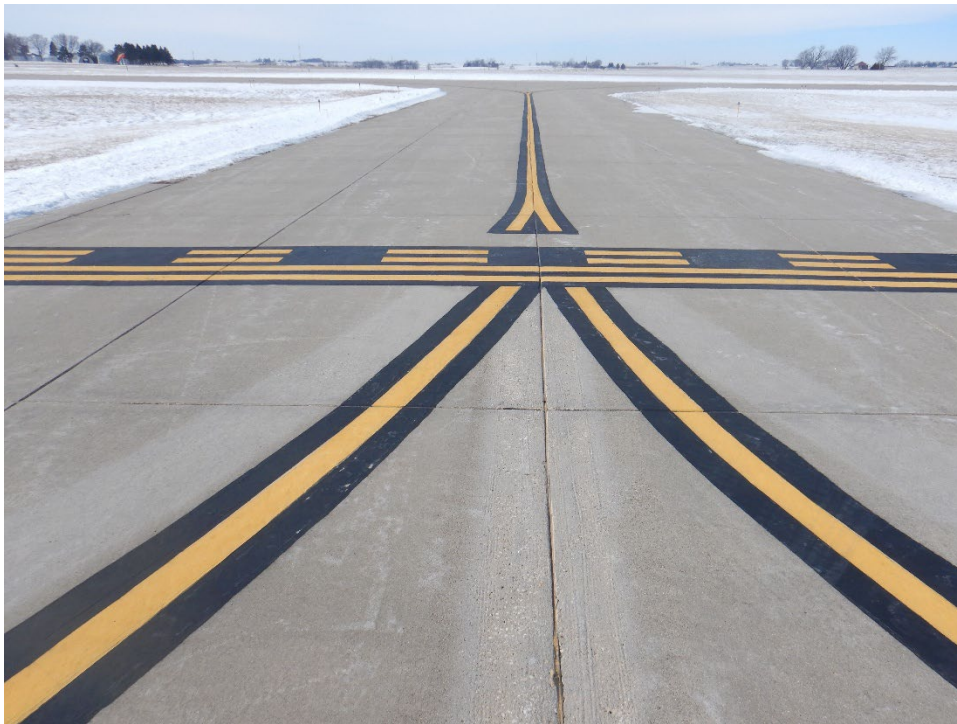
TA3IN-01. Overview.

Taxiway A3 consisted of one section. Medium-severity joint spalling and low-severity faulting and joint seal damage were identified in Section 01.

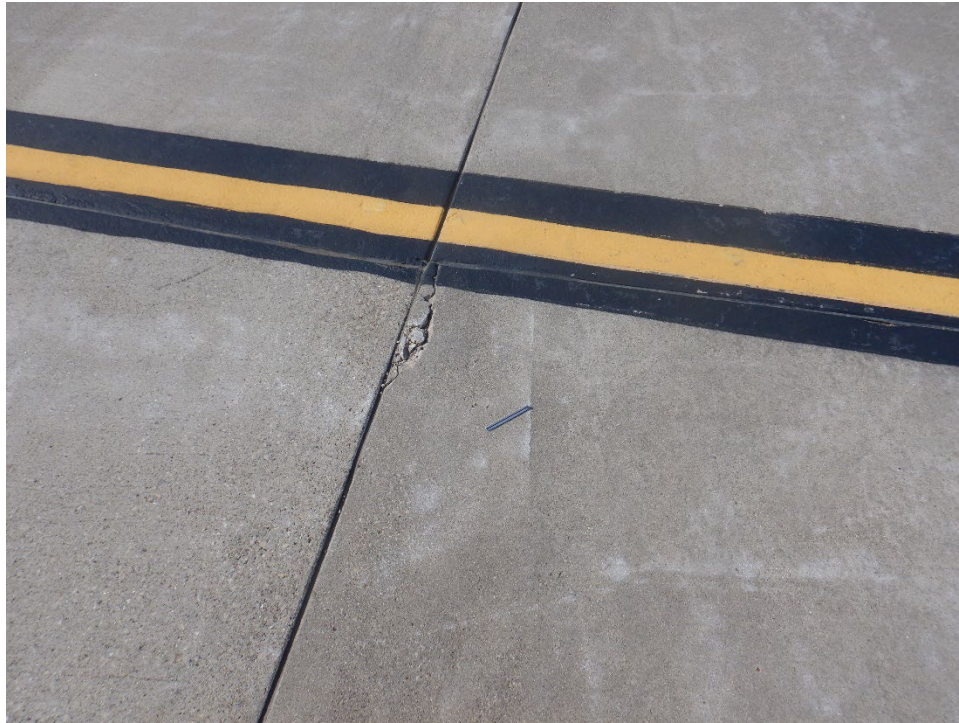
TA3IN-01. Joint Spalling (Sample Unit No. 09).

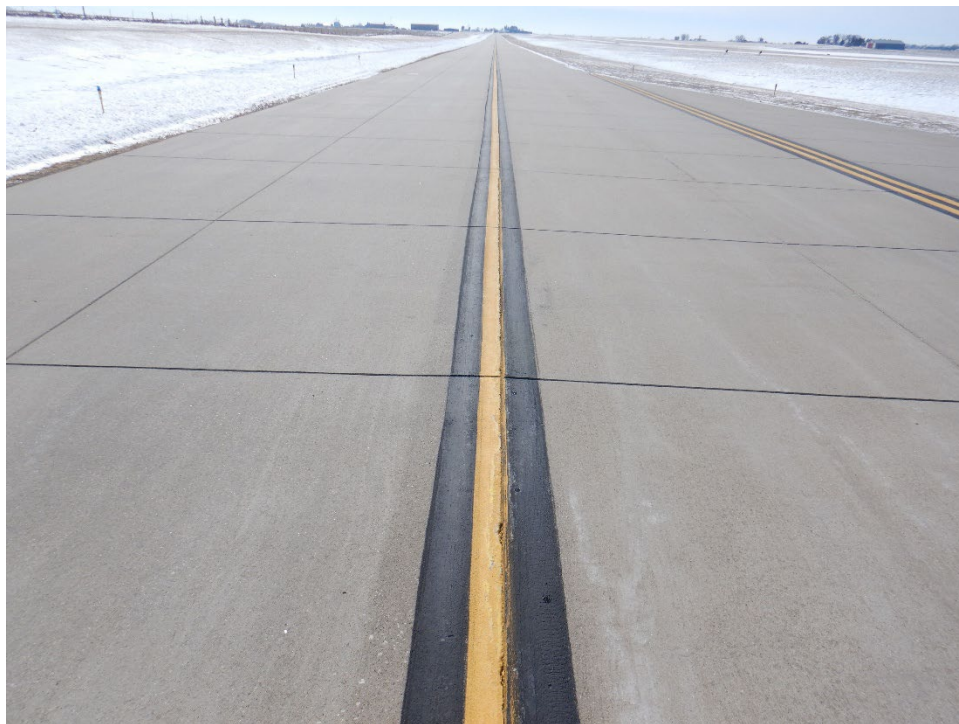
TAIN-01. Overview.

Taxiway A contained one section that was in *Excellent* condition. Section 01 had areas of low- and medium-severity corner spalling and low-severity faulting and joint seal damage observed during the inspection.

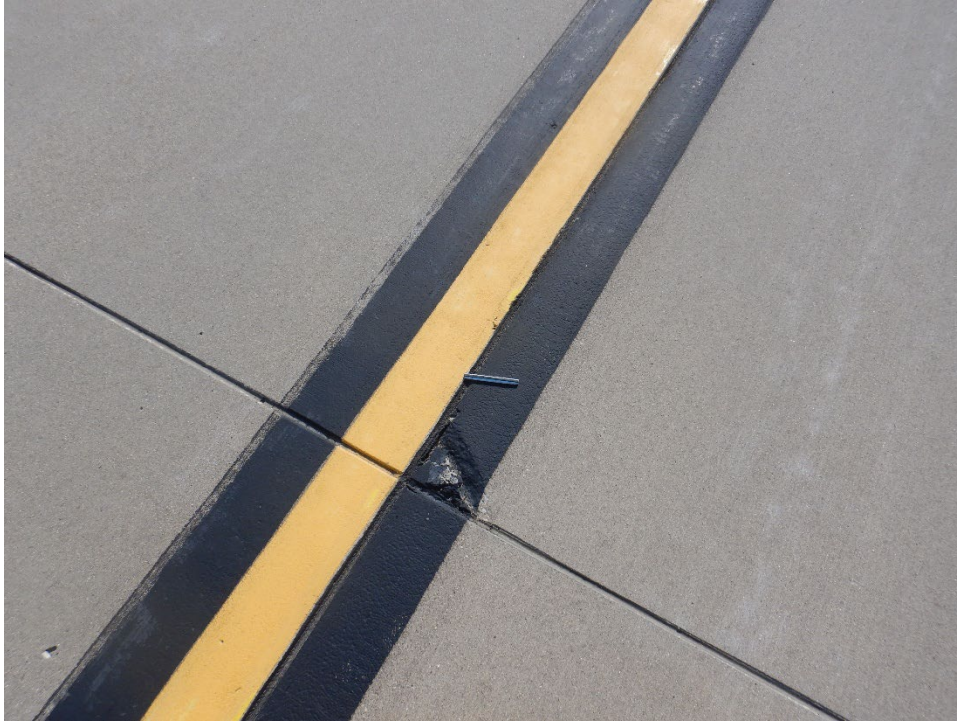
TAIN-01. Corner Spalling (Sample Unit No. 100).

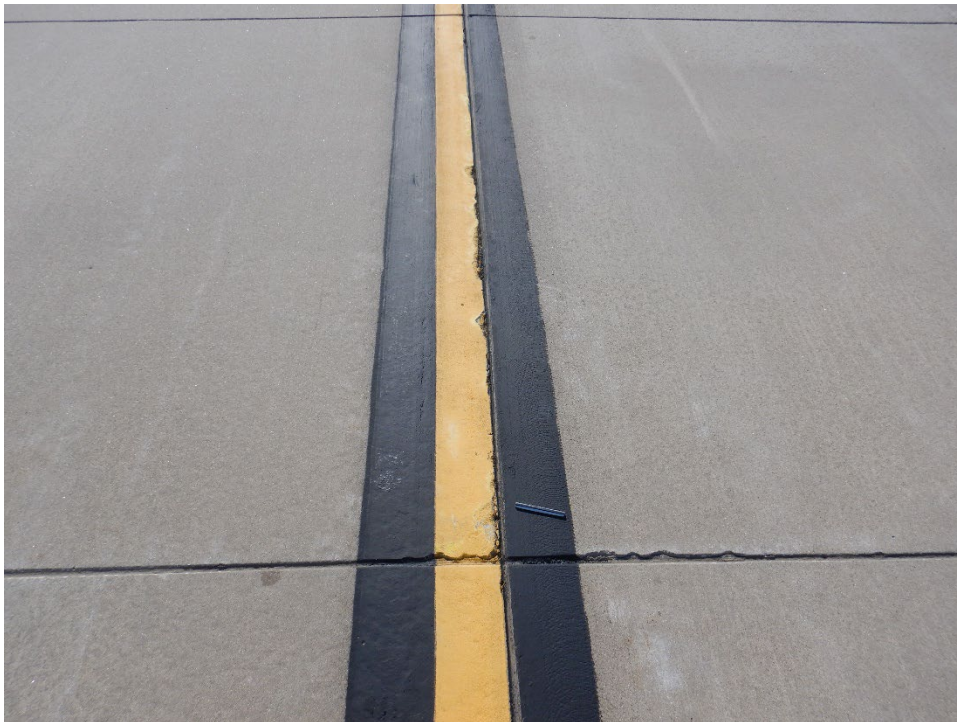
TAIN-01. Joint Seal Damage (Sample Unit No. 70).

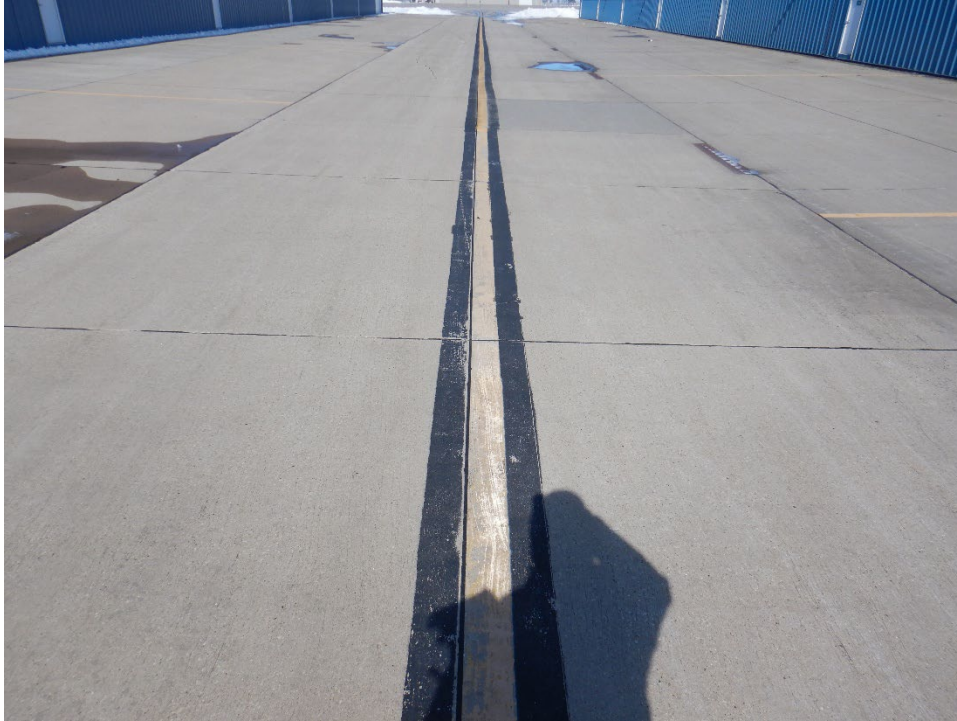
TH01IN-01. Overview.

The T-hangar area contained three sections. Section 01 contained low-severity corner break, corner spalling, joint seal damage, and joint spalling; low- and medium-severity LTD cracking; and shrinkage cracking. Low-severity corner break, LTD cracking, and small patching; medium-severity joint seal damage and shattered slab; and shrinkage cracking were recorded in Section 02. Section 03 had low-severity corner spalling, joint seal damage, and LTD cracking identified.

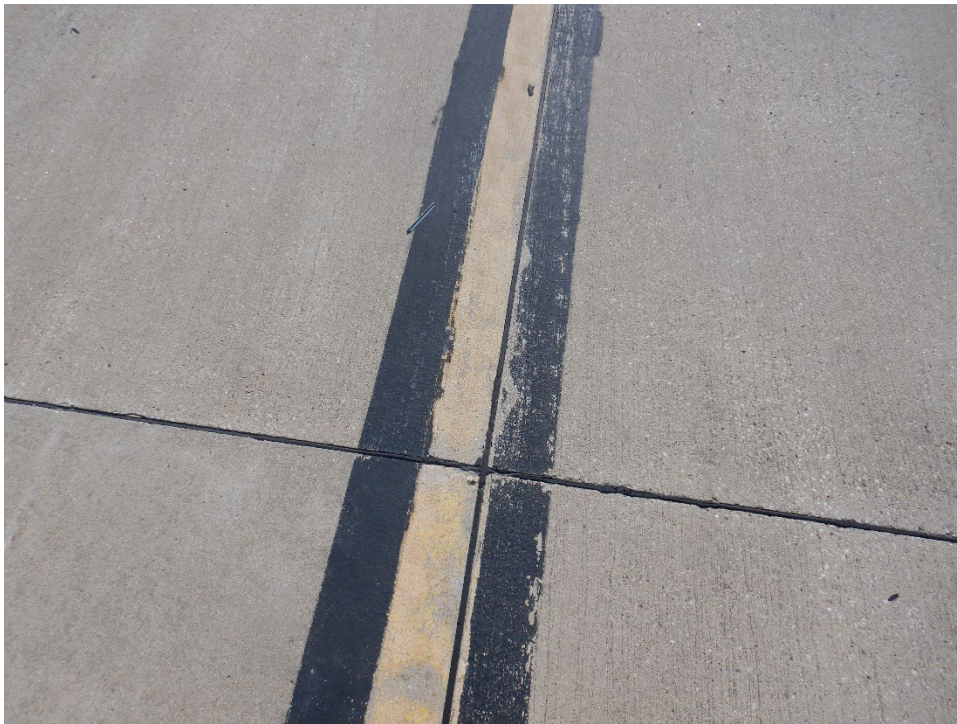
TH01IN-01. Joint Seal Damage (Sample Unit No. 03).

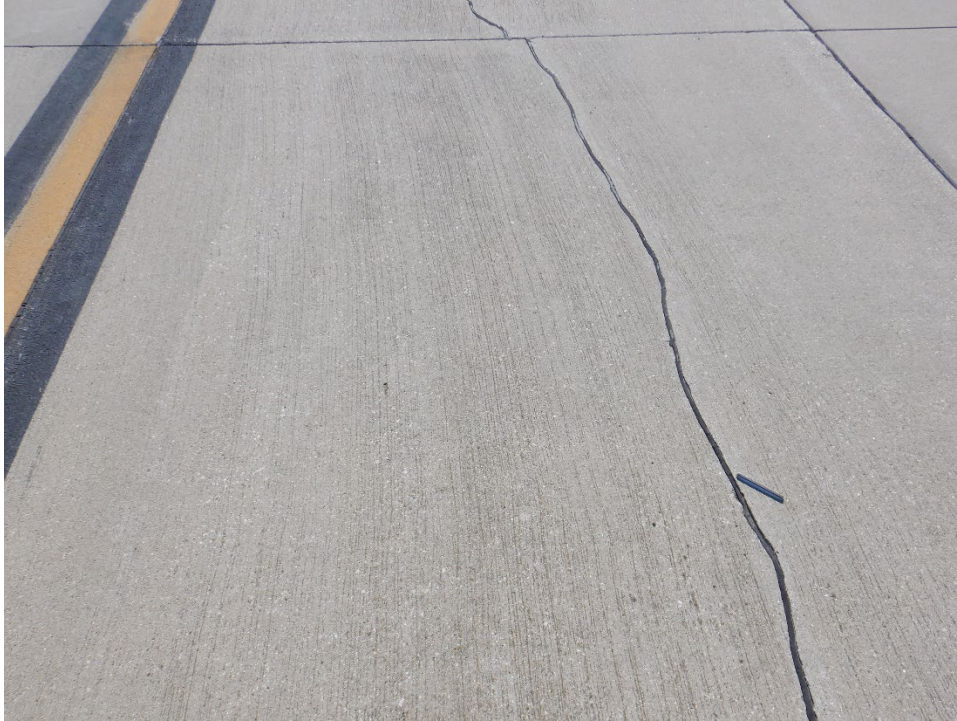
TH01IN-01. LTD Cracking (Sample Unit No. 03).
