# James H Connell Field at Independence Municipal Airport

## Pavement Management Report

**AUGUST 2026**

# JAMES H CONNELL FIELD AT INDEPENDENCE MUNICIPAL AIRPORT PAVEMENT MANAGEMENT REPORT

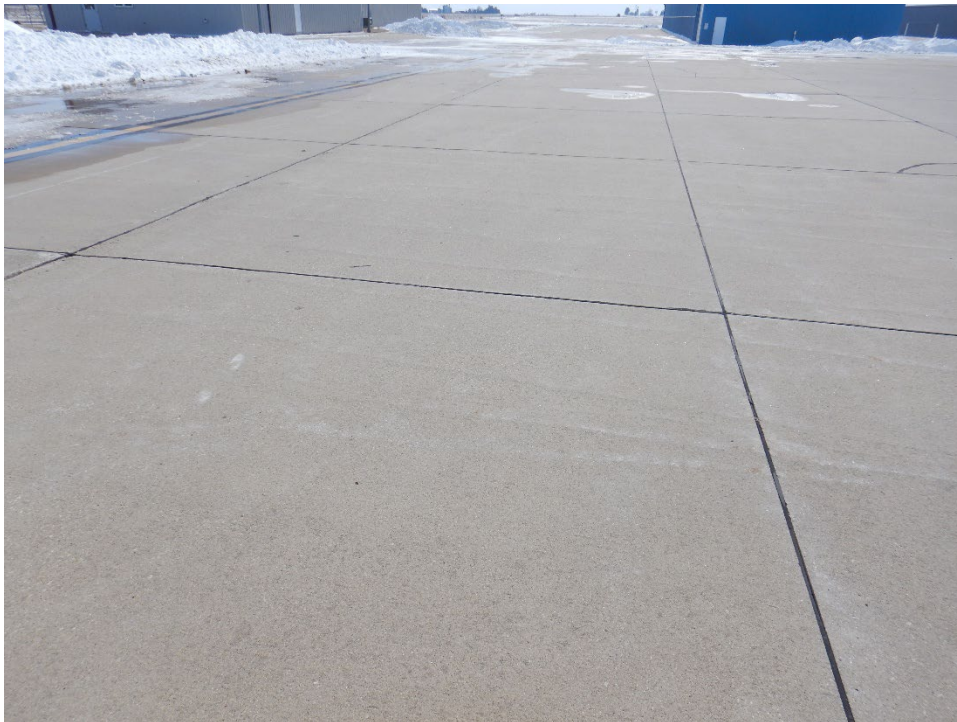
TH01IN-02. Overview.

| Branch | Section | Surface Type | Section Area (sf) | LCD | 2026 PCI | % Distress Due to Load | % Distress Due to Climate/ Durability | % Distress Due to Other | Type of Distress |
|---|---|---|---|---|---|---|---|---|---|
| TH01IN | 02 | PCC | 8,891 | 6/1/2007 | 76 | 71 | 23 | 6 | Corner Break, Joint Seal Damage, LTD Cracking, Shattered Slab, Shrinkage Cracking, Small Patch |

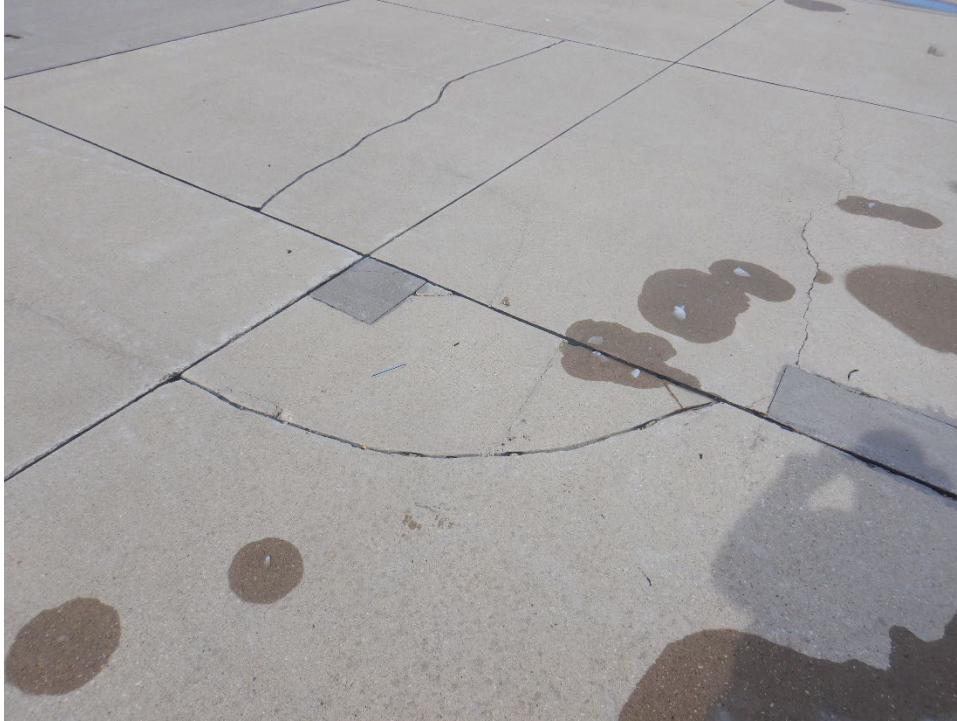
TH01IN-02. Corner Break (Sample Unit No. 02).

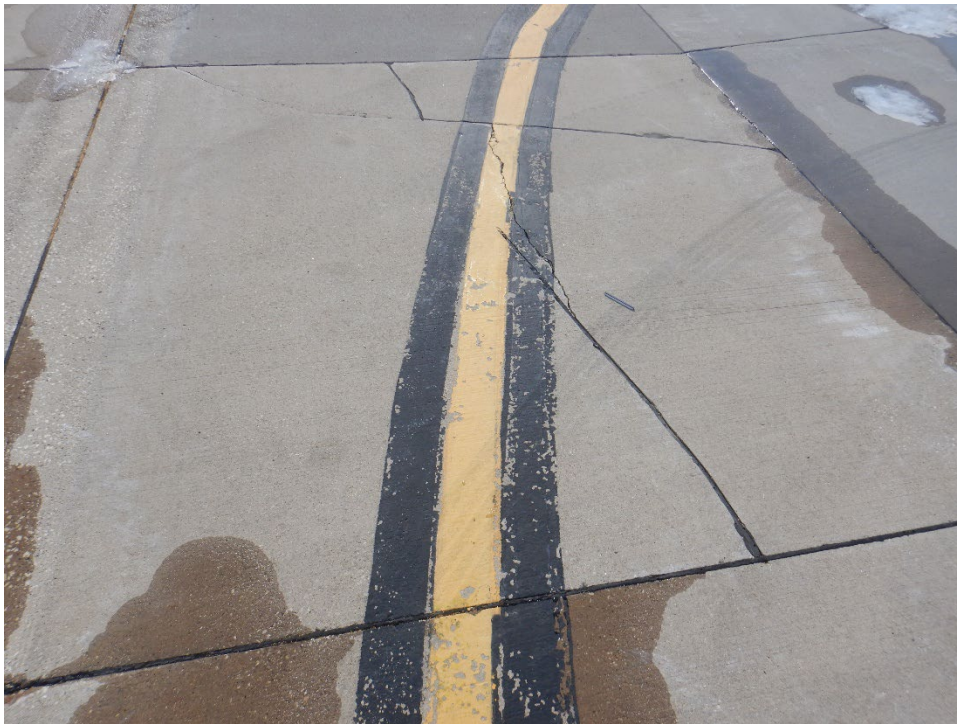
TH01IN-02. Shattered Slab (Sample Unit No. 03).

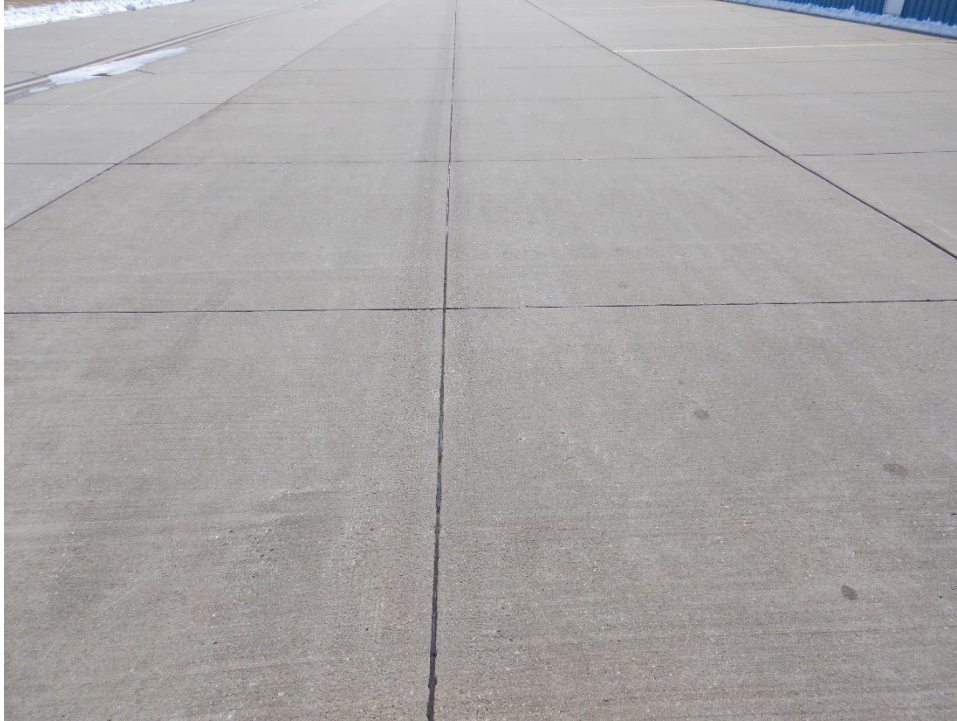
TH01IN-03. Overview.

| Branch | Section | Surface Type | Section Area (sf) | LCD | 2026 PCI | % Distress Due to Load | % Distress Due to Climate/ Durability | % Distress Due to Other | Type of Distress |
|---|---|---|---|---|---|---|---|---|---|
| TH01IN | 03 | PCC | 3,560 | 10/1/2010 | 92 | 63 | 23 | 14 | Corner Spalling, Joint Seal Damage, LTD Cracking |

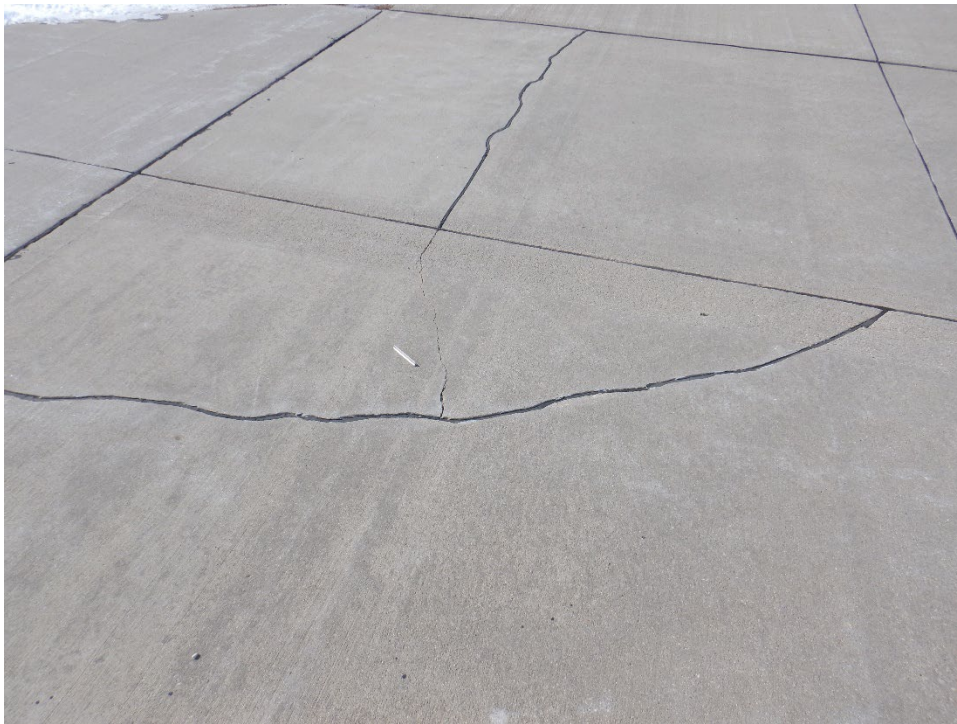
TH01IN-03. LTD Cracking (Sample Unit No. 02).
