# Jefferson Municipal Airport

## Pavement Management Report

**AUGUST 2025**

# JEFFERSON MUNICIPAL AIRPORT PAVEMENT MANAGEMENT REPORT

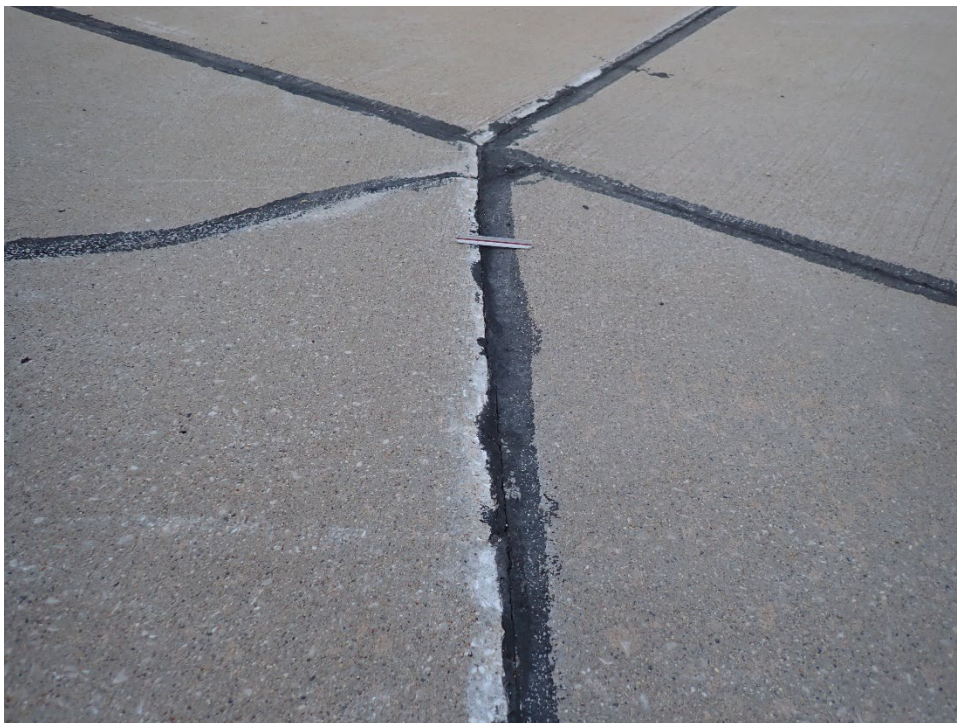
A01JE-01. Faulting (Sample Unit No. 20).

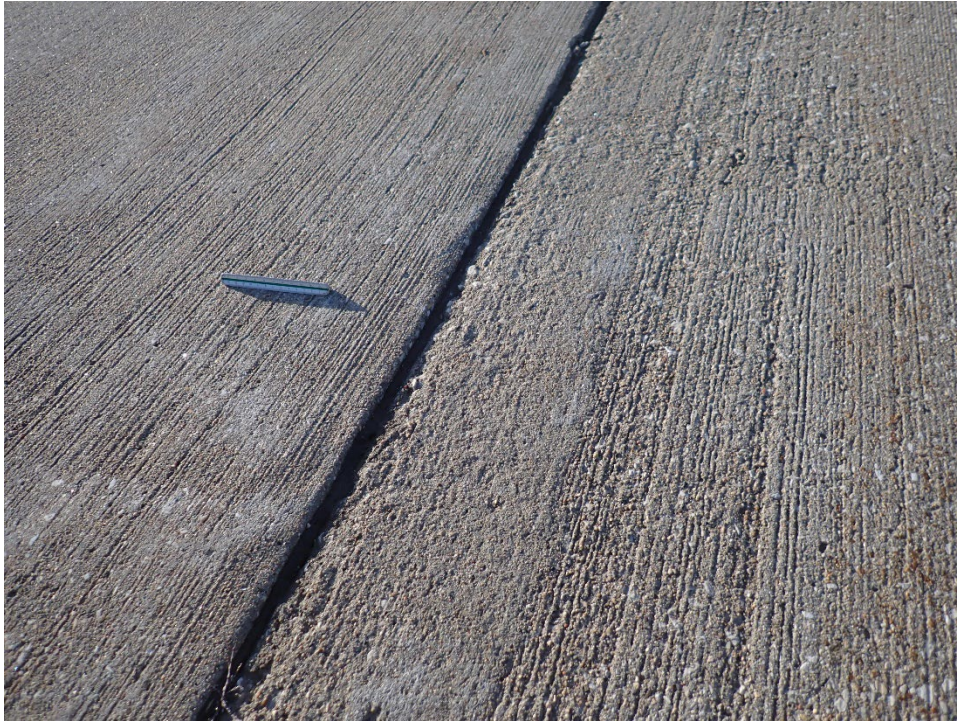
A01JE-01. Joint Seal Damage (Sample Unit No. 15) (1).

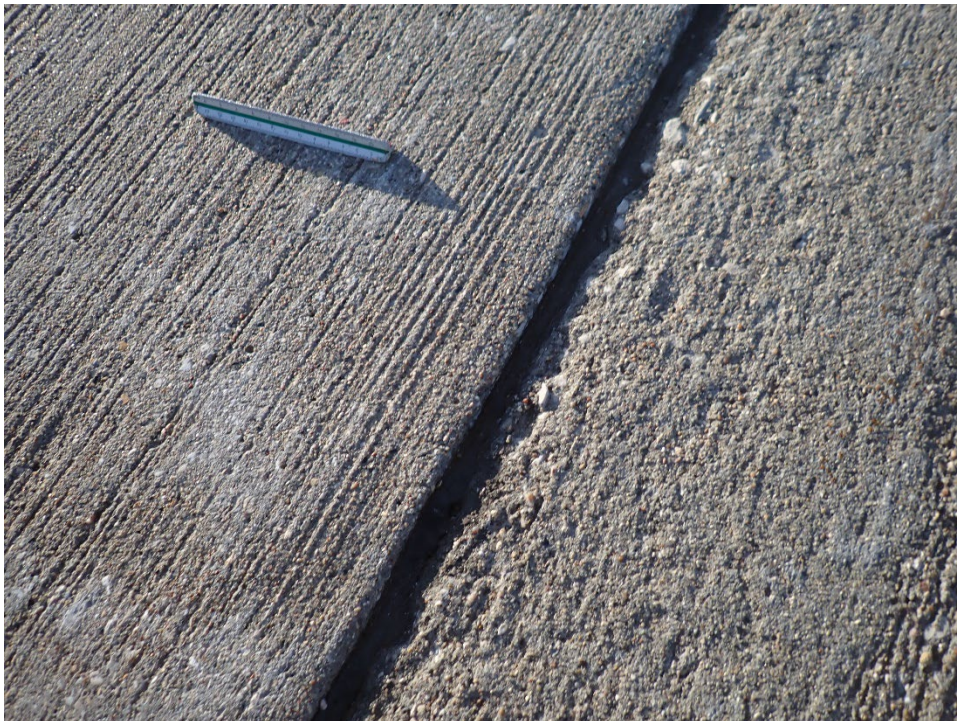
A01JE-01. Joint Seal Damage (Sample Unit No. 15) (2).

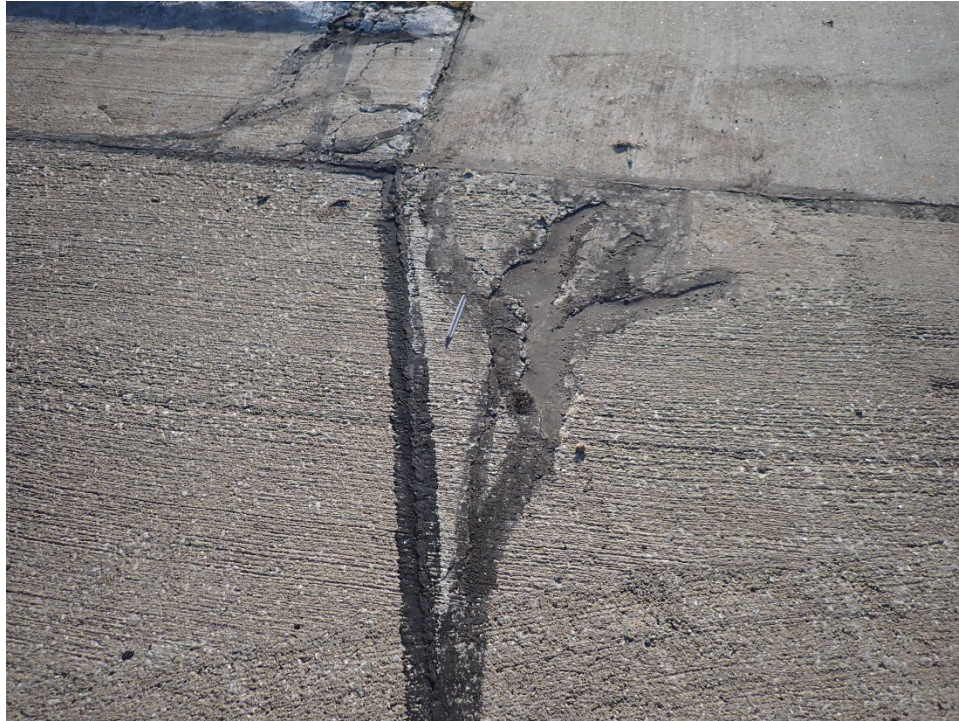
A01JE-01. Joint Spalling (Additional Sample Unit No. 12).

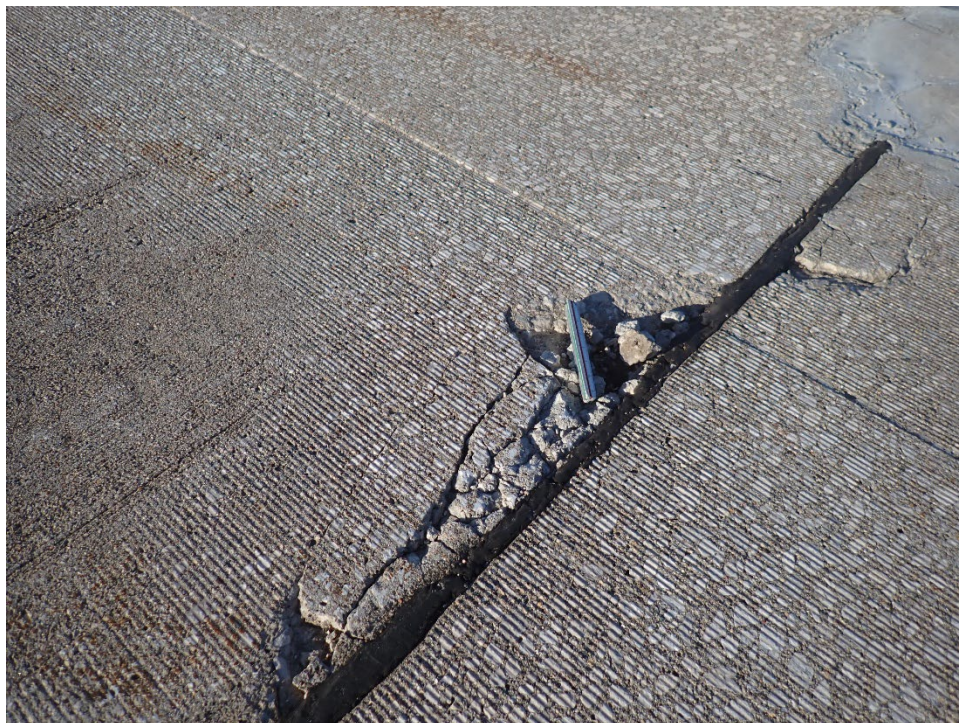
A01JE-01. Joint Spalling (Additional Sample Unit No. 18).

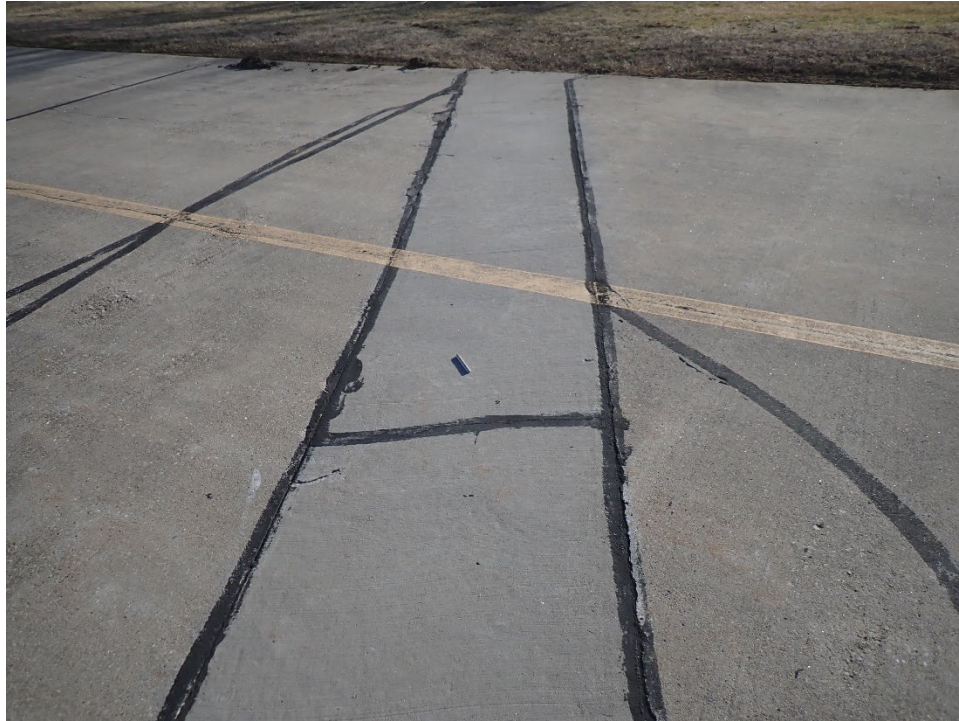
A01JE-01. Large Patching (Sample Unit No. 03).

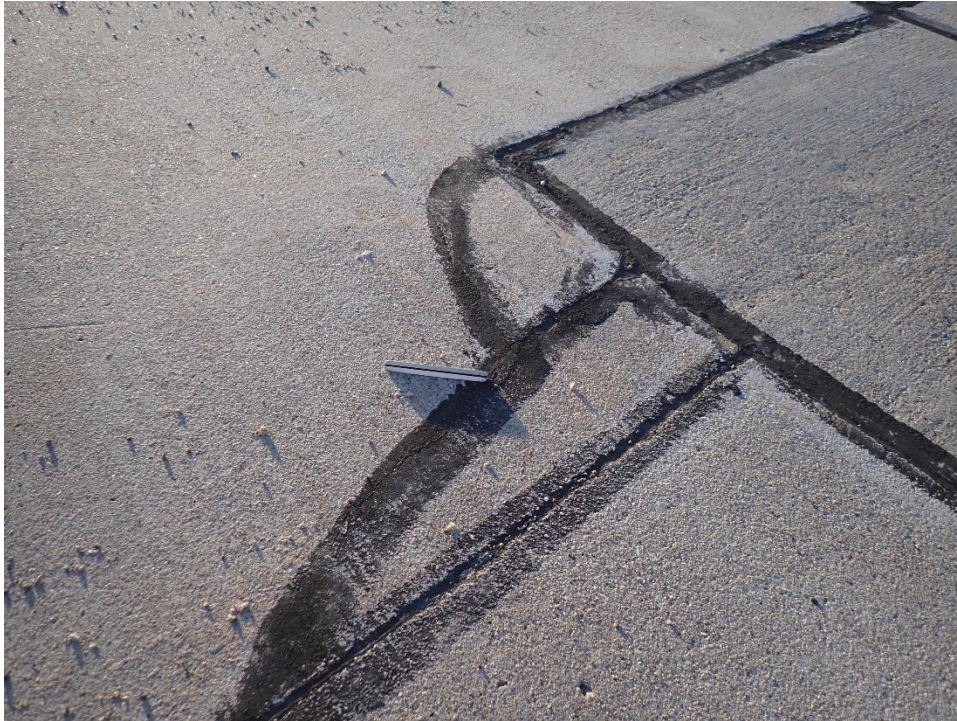
A01JE-02. Corner Break (Sample Unit No. 12).

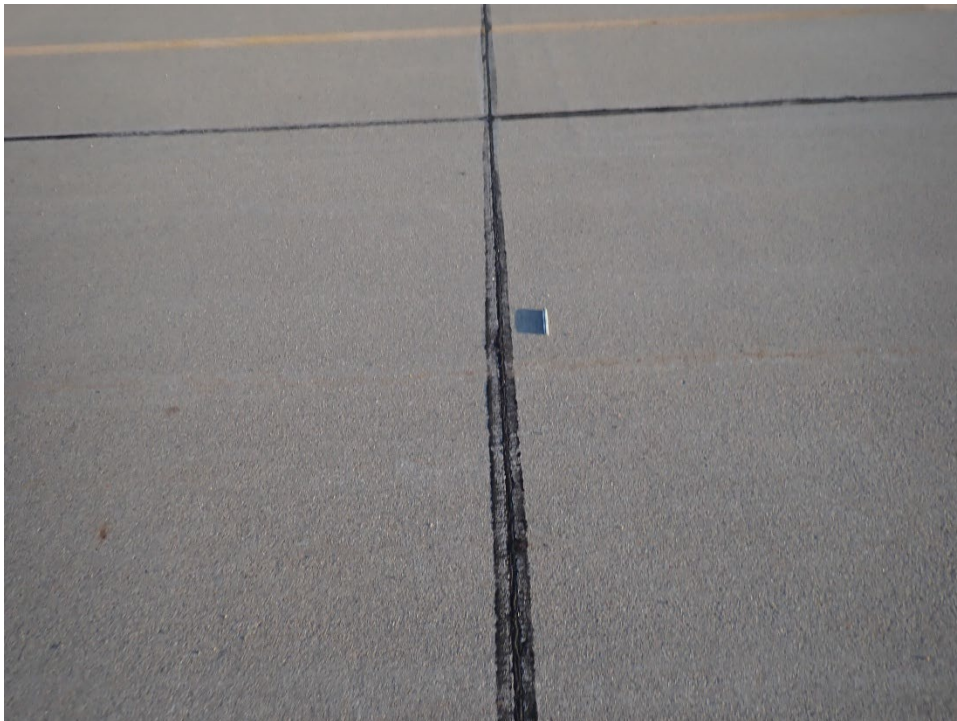
A01JE-02. Joint Seal Damage (Sample Unit No. 01).

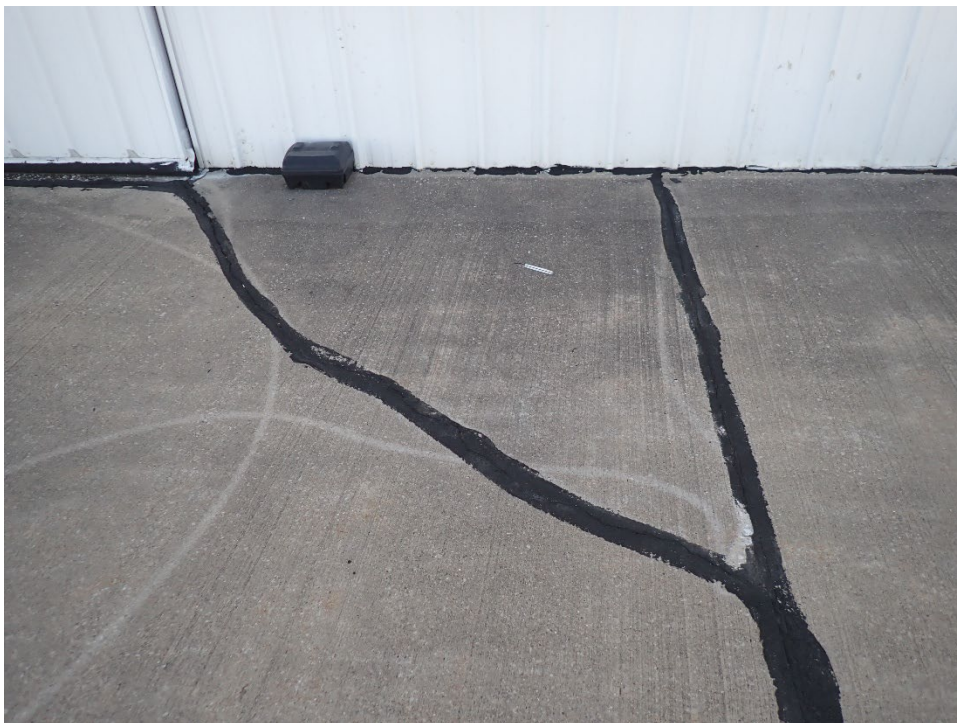
A01JE-03. Corner Break (Sample Unit No. 05).

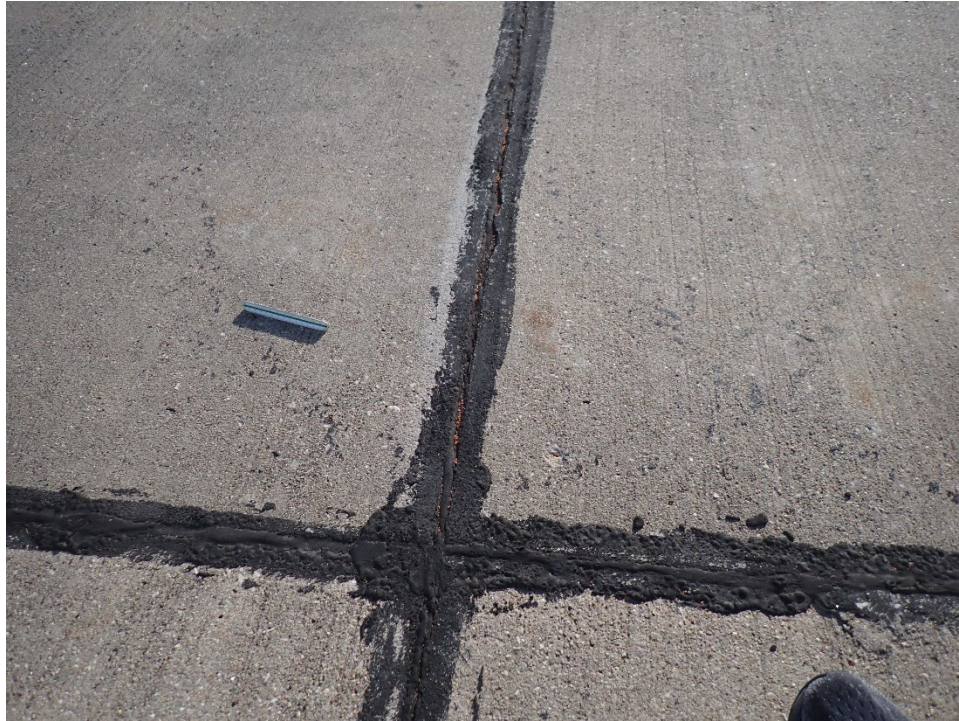
A01JE-03. Joint Seal Damage (Sample Unit No. 01).

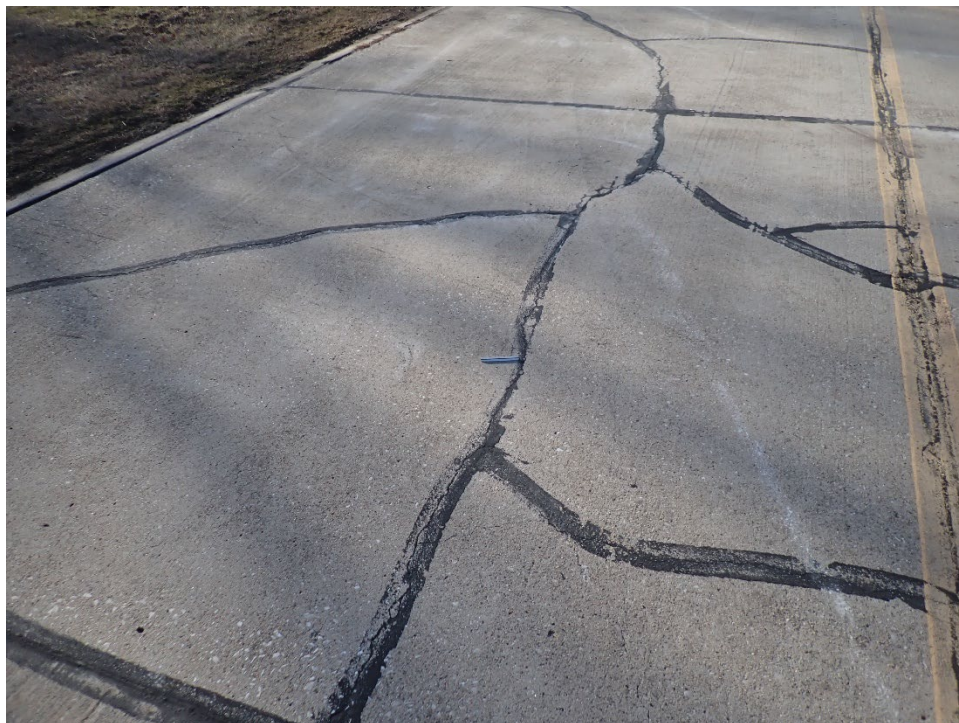
A01JE-03. Shattered Slab (Sample Unit No. 03).

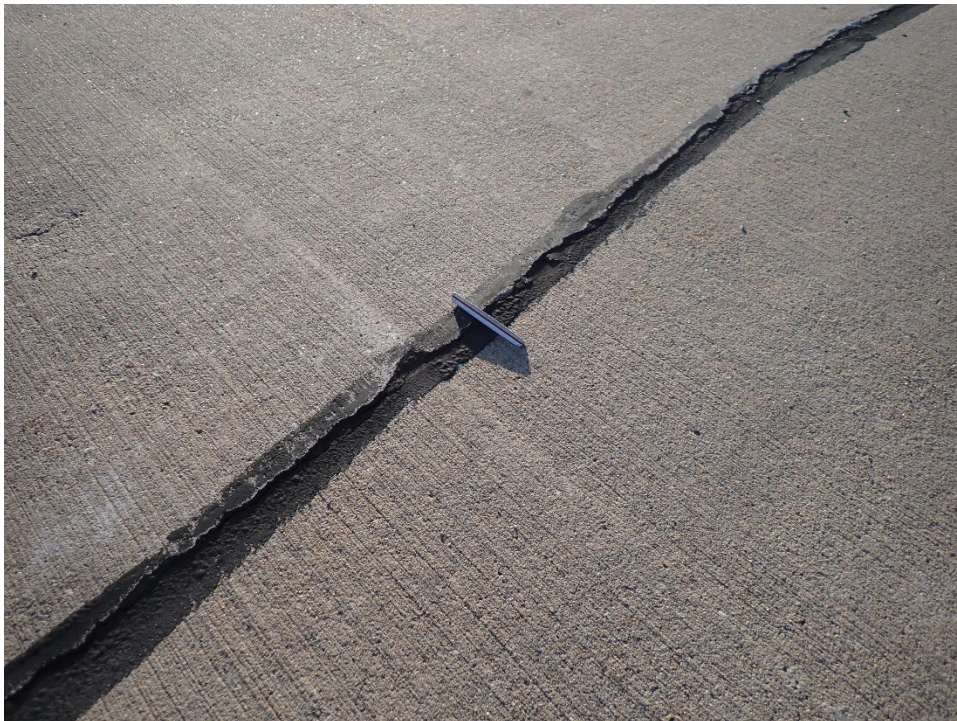
A02JE-01. Faulting (Sample Unit No. 05).

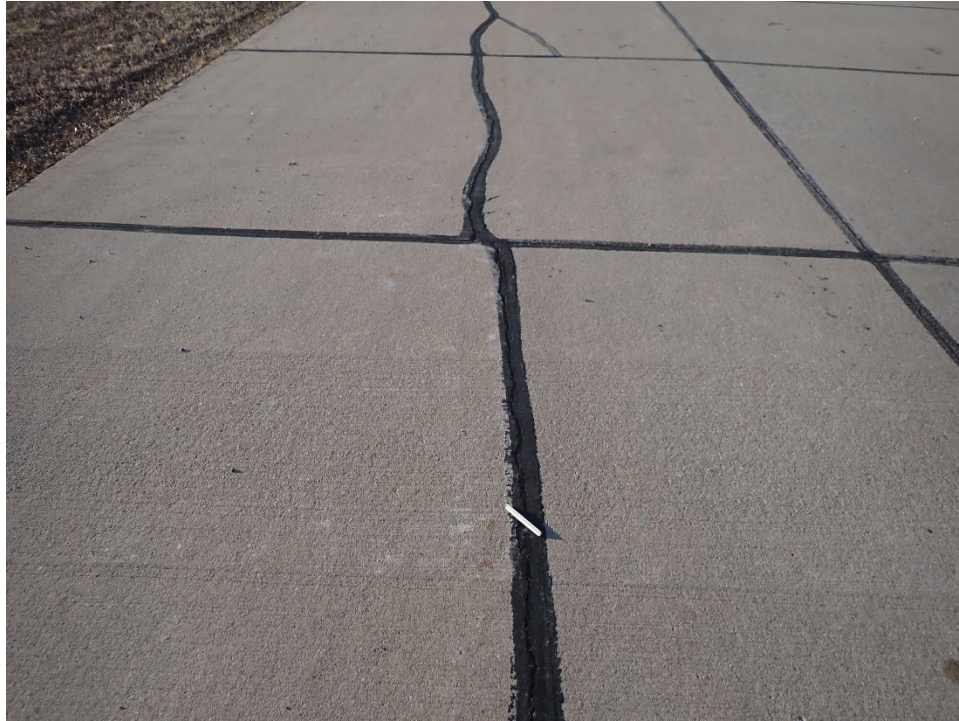
A02JE-01. LTD Cracking (Sample Unit No. 07).

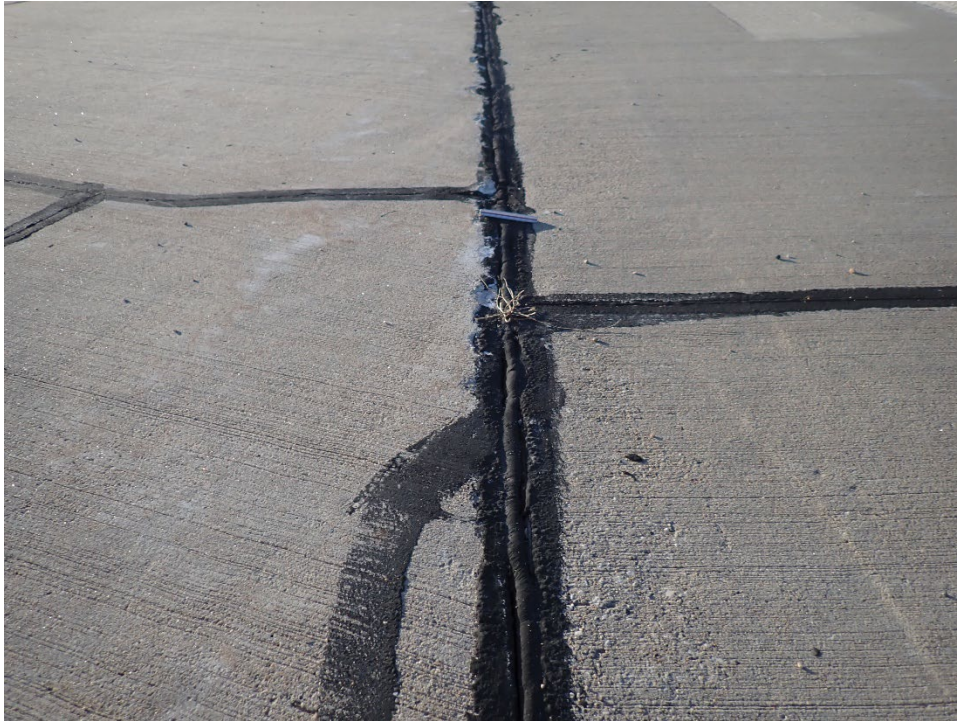
A02JE-02. Faulting (Sample Unit No. 02).

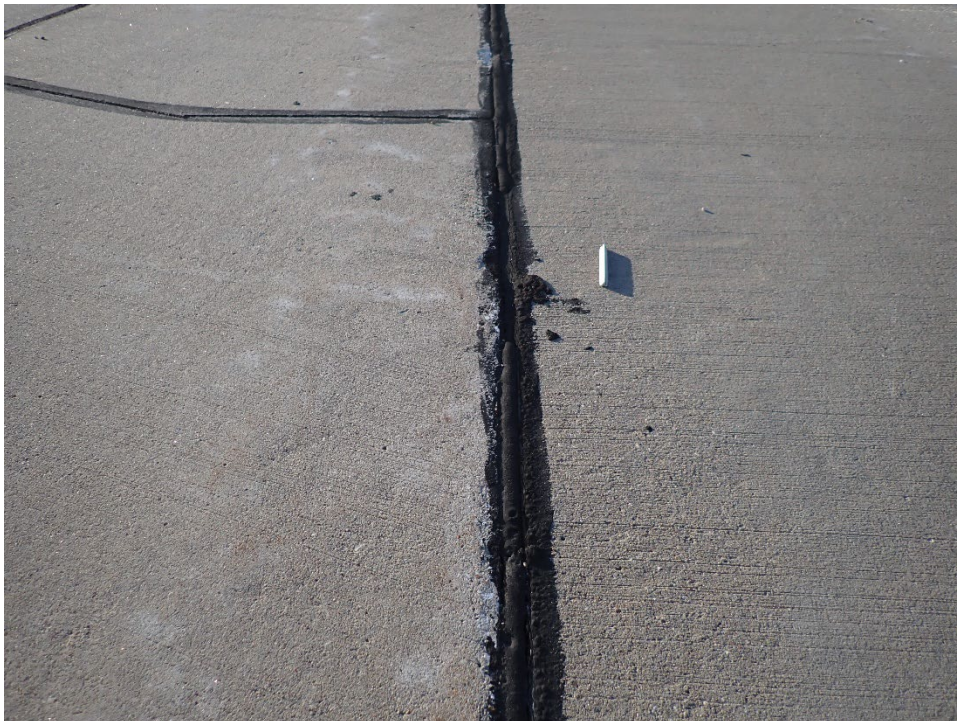
A02JE-02. Joint Seal Damage (Sample Unit No. 02).

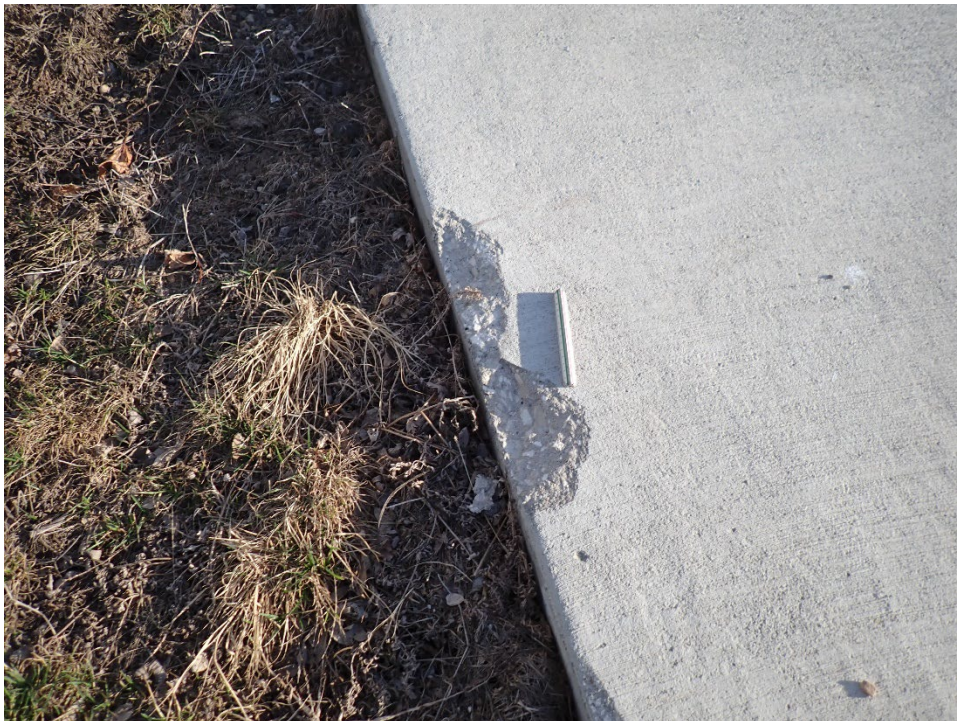
A02JE-03. Joint Spalling (Sample Unit No. 04).

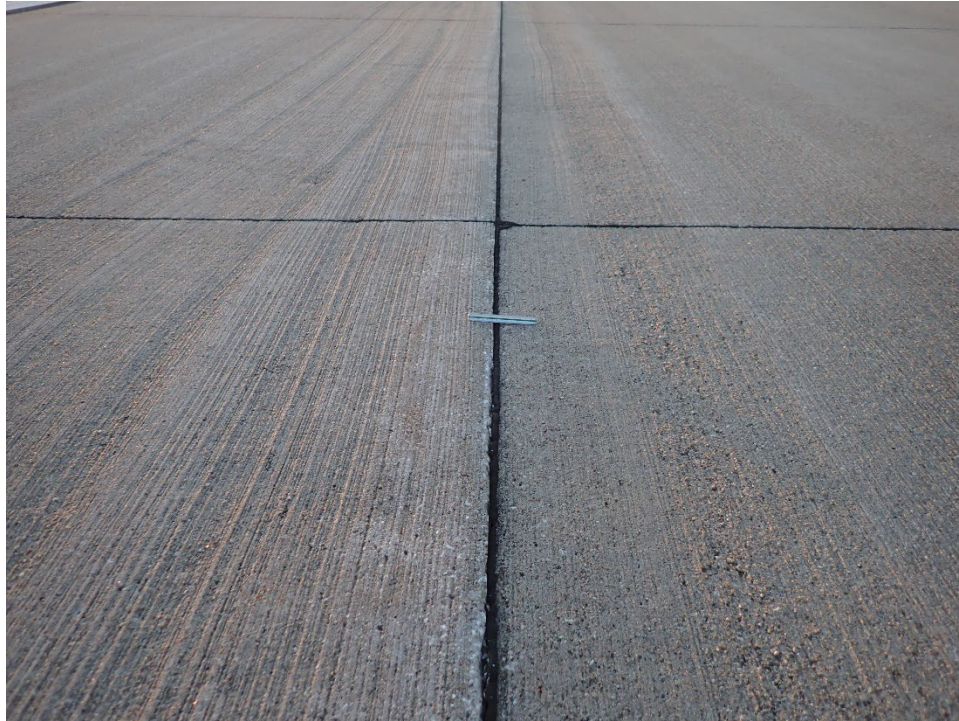
R14JE-01. Faulting (Sample Unit No. 11).

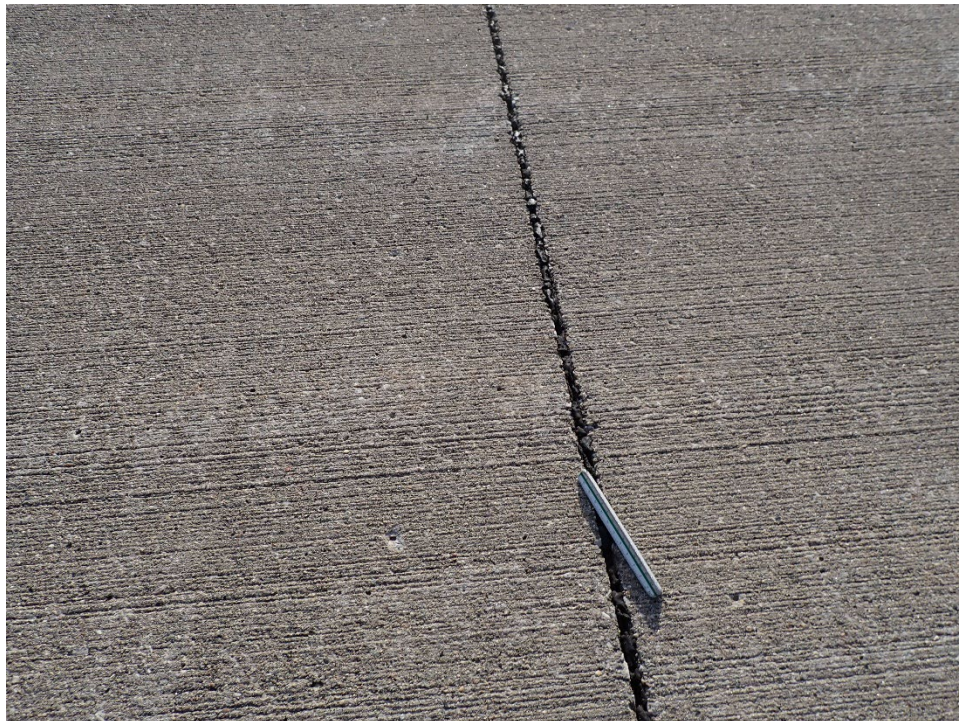
R14JE-01. Joint Seal Damage (Sample Unit No. 44).

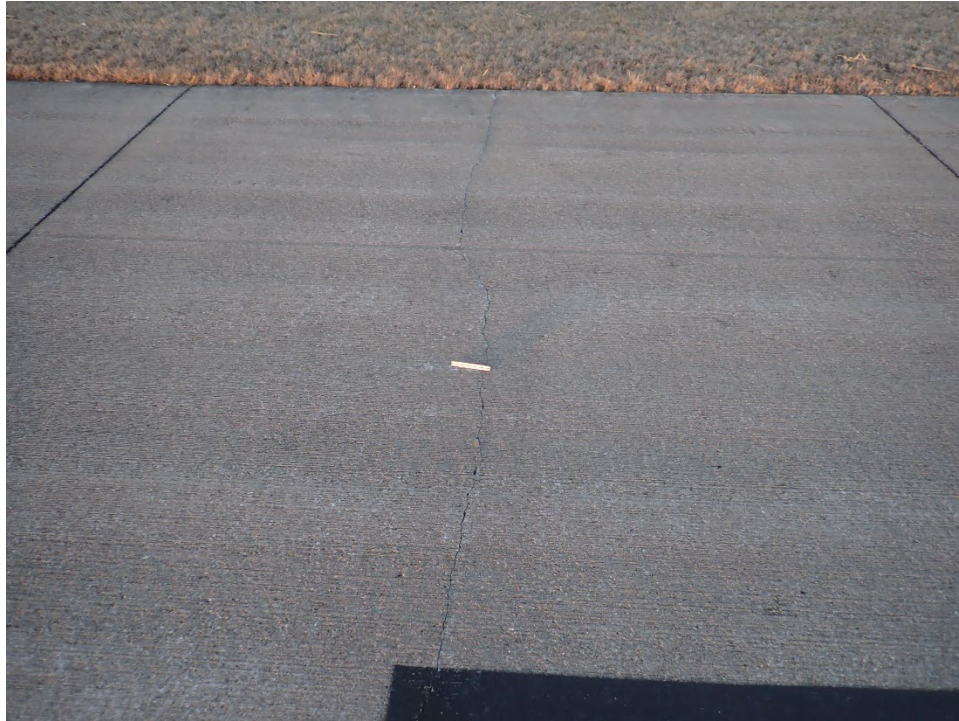
R14JE-01. LTD Cracking (Sample Unit No. 05).

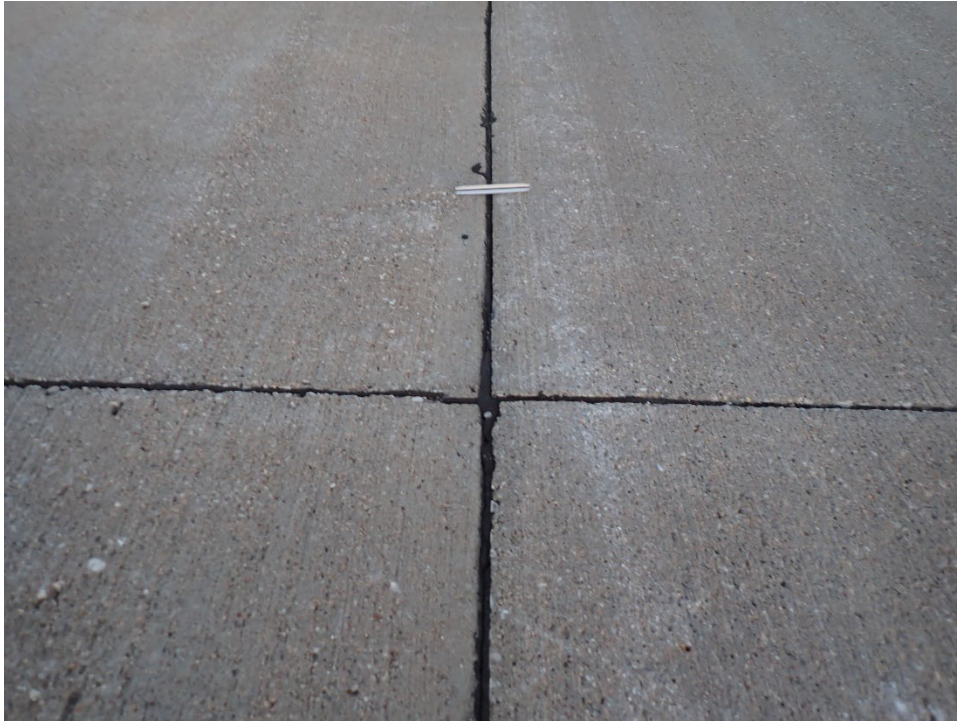
R14JE-02. Faulting (Sample Unit No. 04).

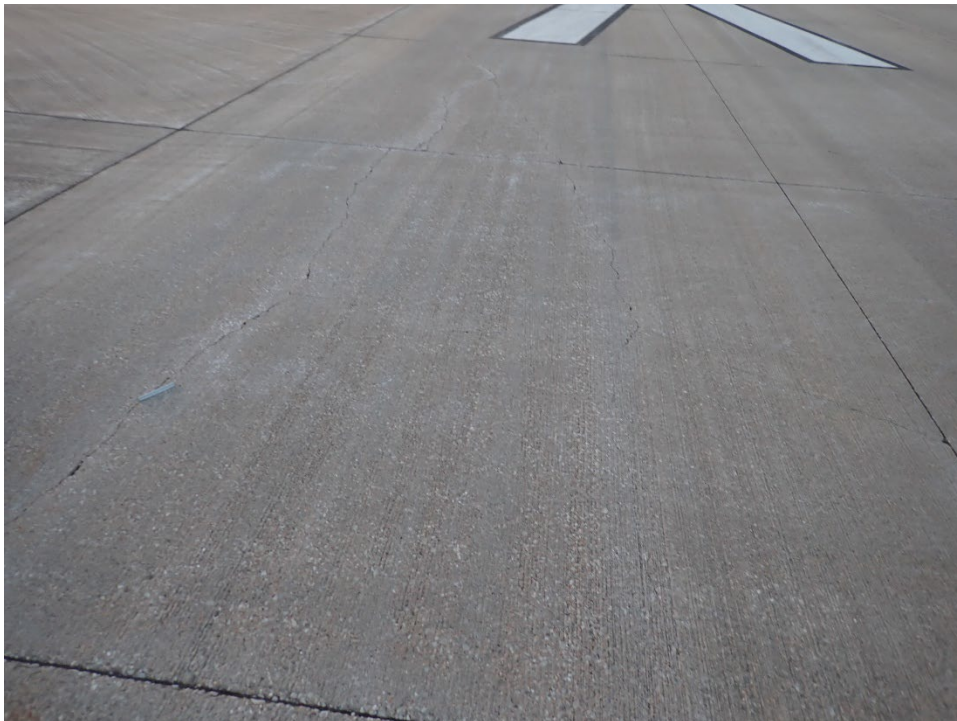
R14JE-02. Shattered Slab (Sample Unit No. 04).

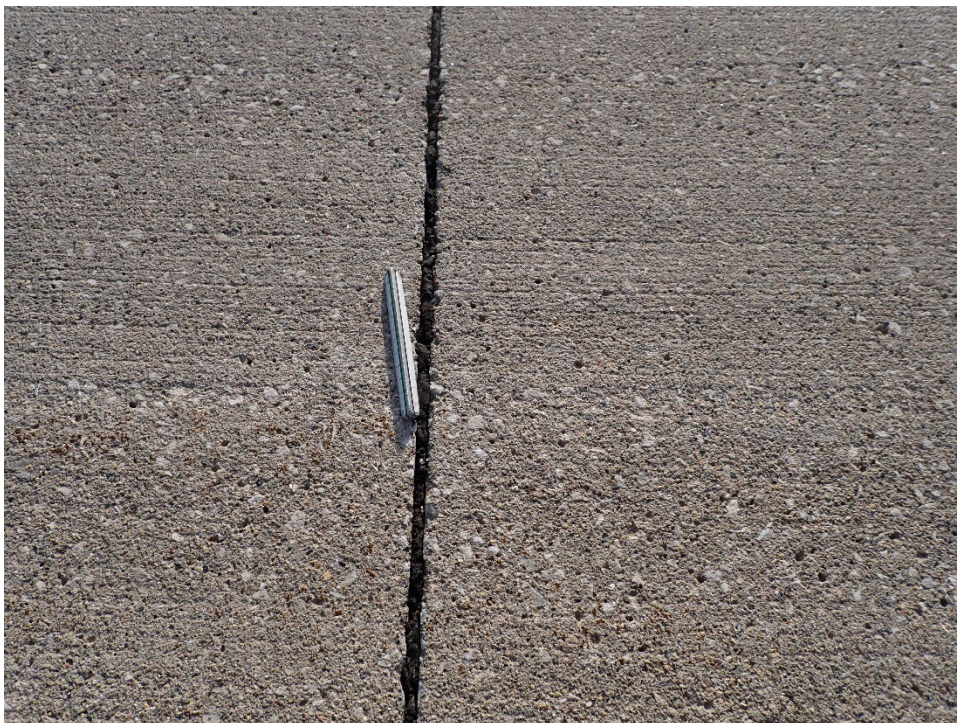
R14JE-03. Joint Seal Damage (Sample Unit No. 02).

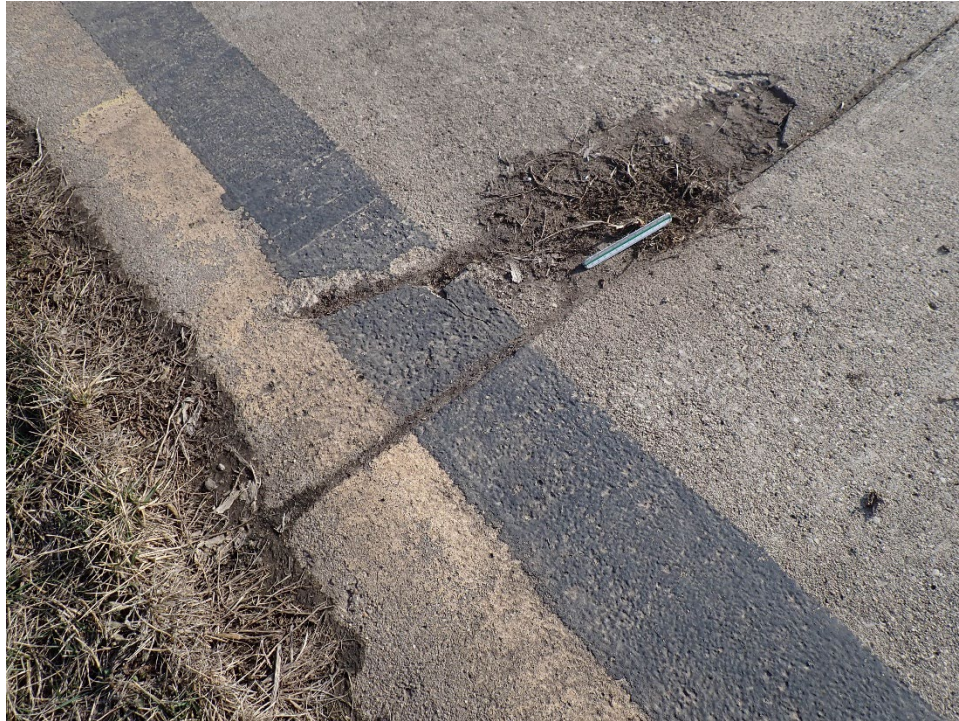
R14JE-03. Joint Spalling (Sample Unit No. 05).

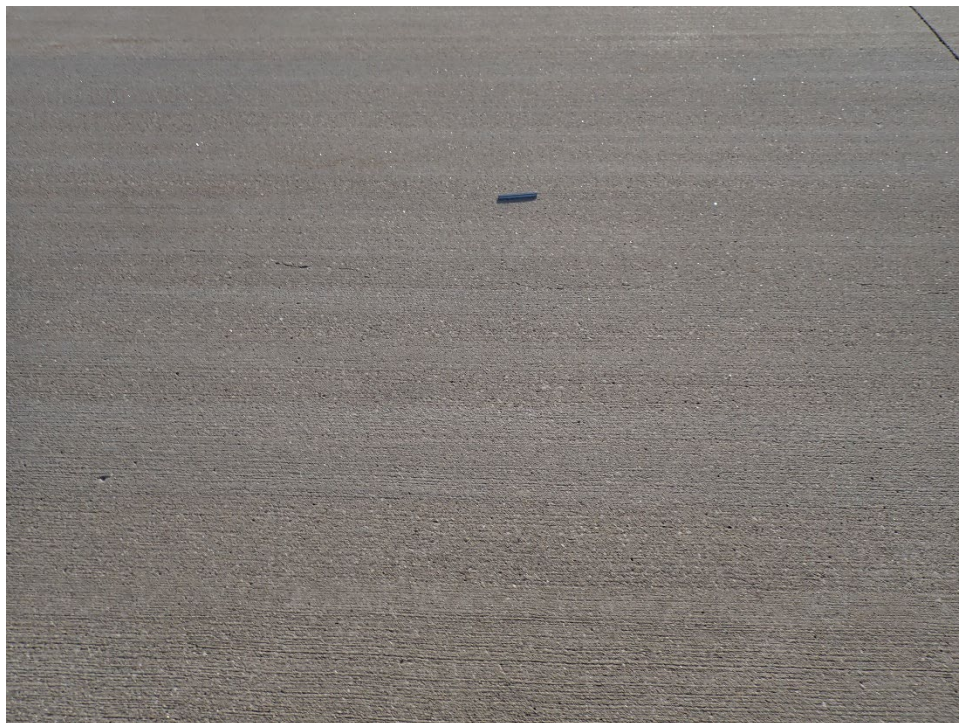
R14JE-03. LTD Cracking (Sample Unit No. 02).

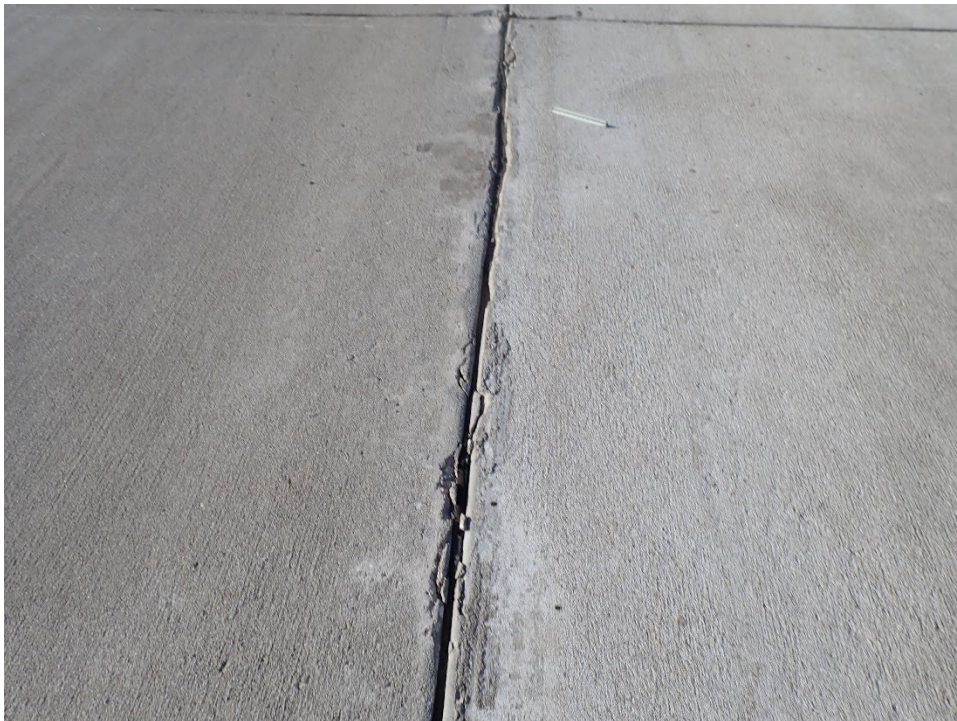
R14JE-04. Joint Seal Damage (Sample Unit No. 04).

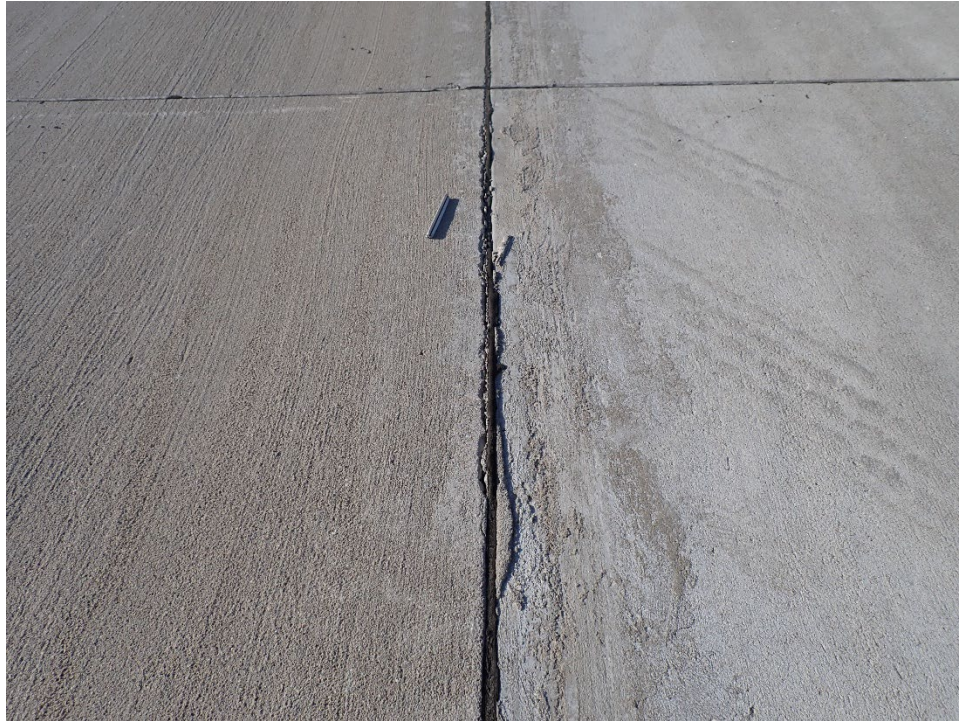
R14JE-04. Joint Seal Damage (Sample Unit No. 10).

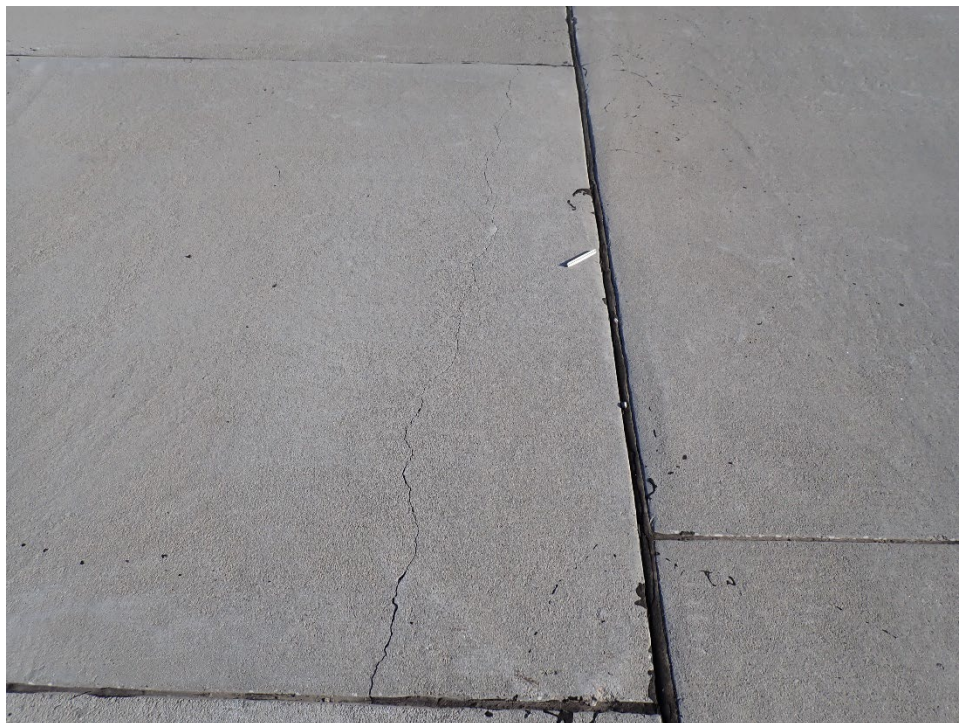
R14JE-04. LTD Cracking (Sample Unit No. 19).

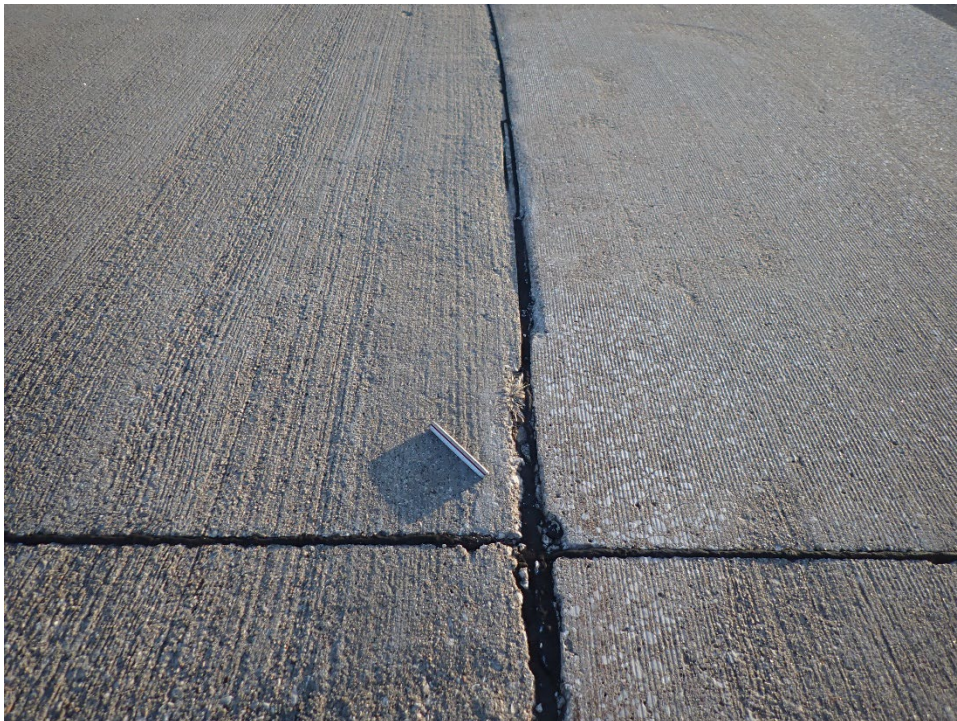
T01JE-01. Joint Seal Damage (Sample Unit No. 02).

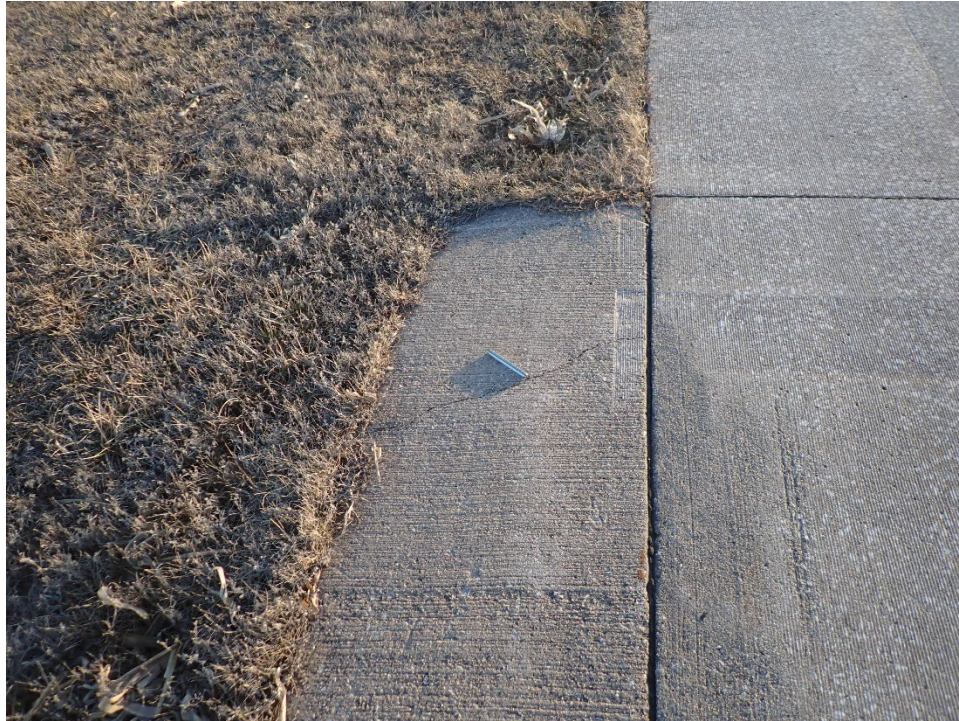
T01JE-01. LTD Cracking (Sample Unit No. 05).

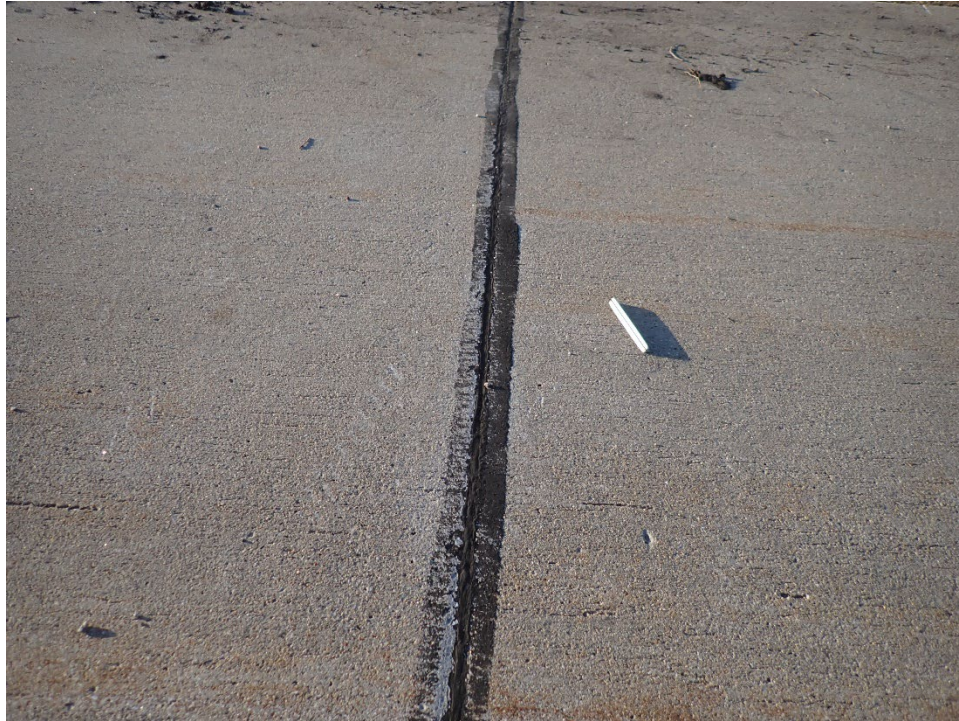
T02JE-01. Joint Seal Damage (Sample Unit No. 01).

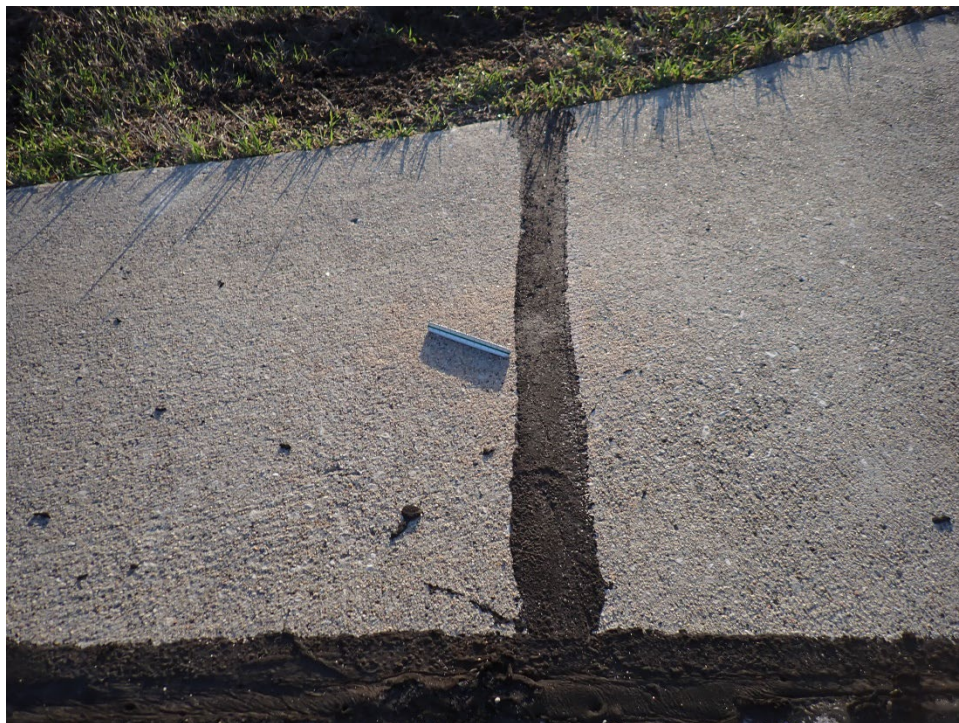
T02JE-01. LTD Cracking (Sample Unit No. 03).
