# Knoxville Municipal Airport

## Pavement Management Report

**AUGUST 2025**

# KNOXVILLE MUNICIPAL AIRPORT PAVEMENT MANAGEMENT REPORT

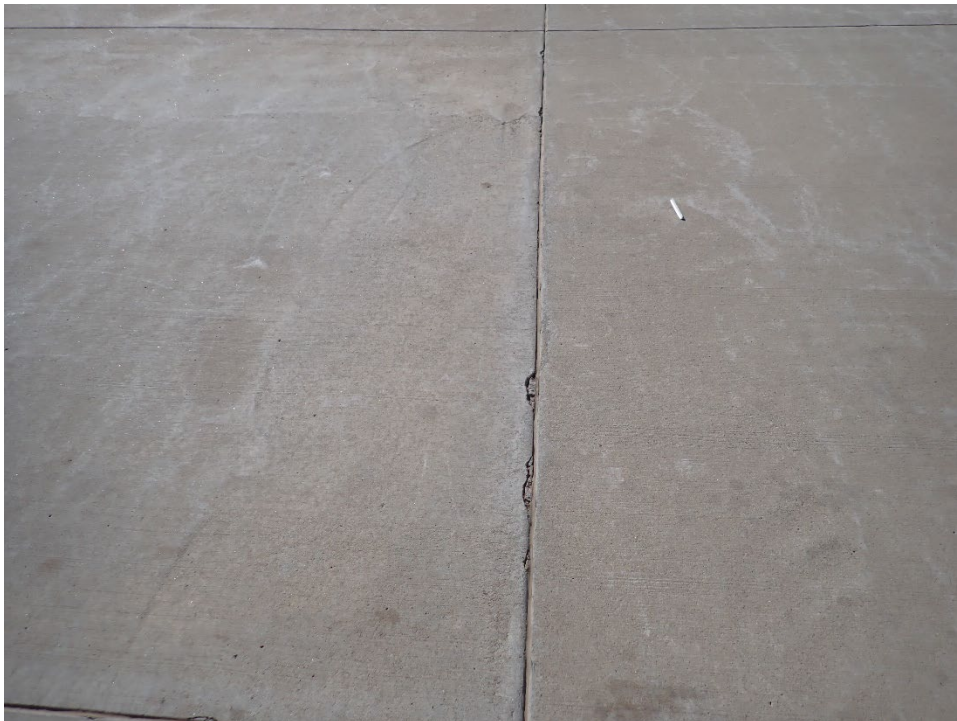
A01KN-01. Joint Seal Damage (Sample Unit No. 02).

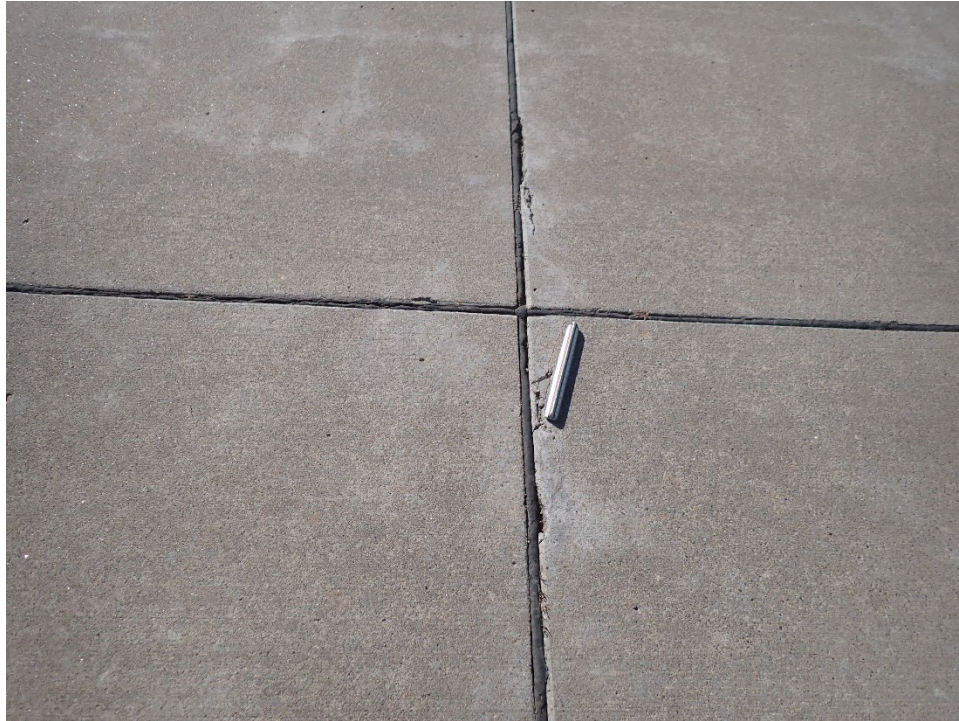
A01KN-01. Joint Spalling (Sample Unit No. 04).

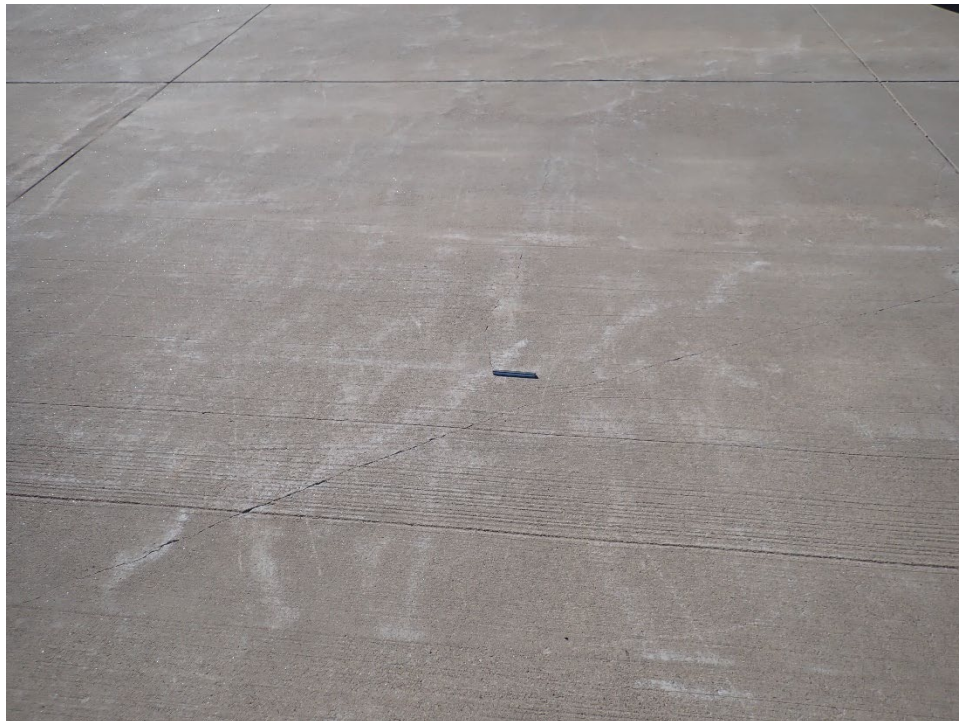
A01KN-01. Shattered Slab (Sample Unit No. 13).

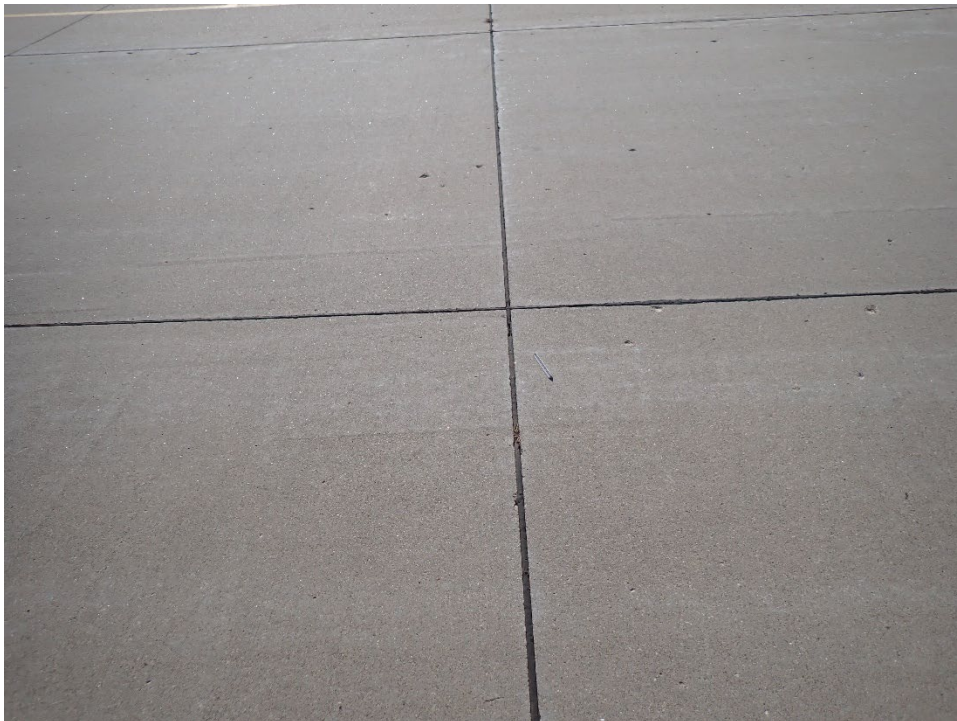
A02KN-01. Joint Seal Damage (Sample Unit No. 08).

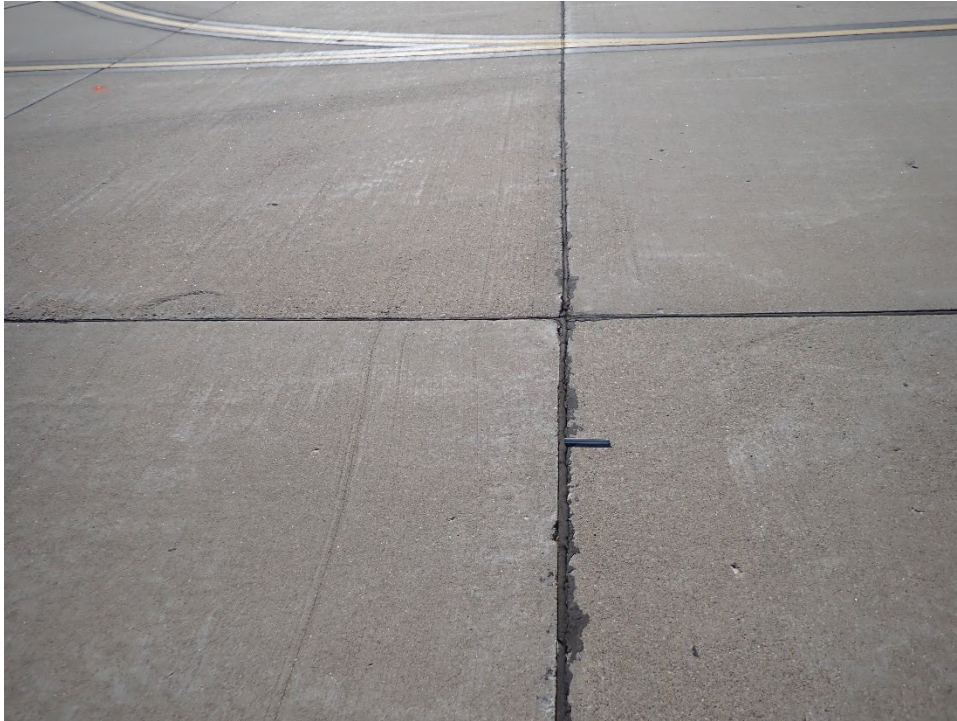
A02KN-01. Joint Seal Damage (Sample Unit No. 10).

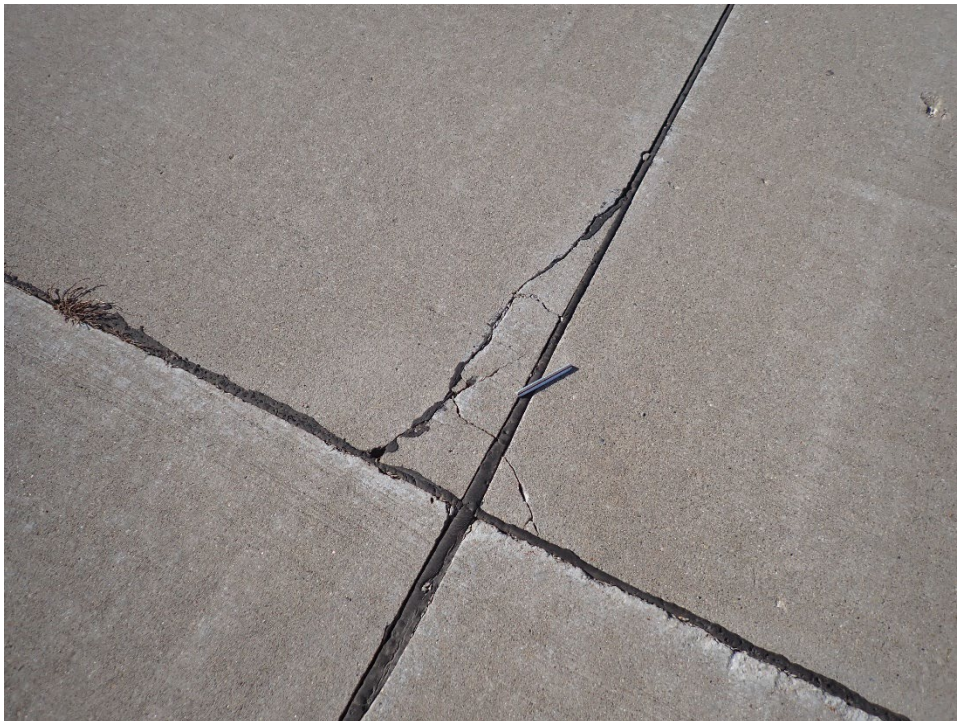
A02KN-01. Joint Spalling (Sample Unit No. 10).

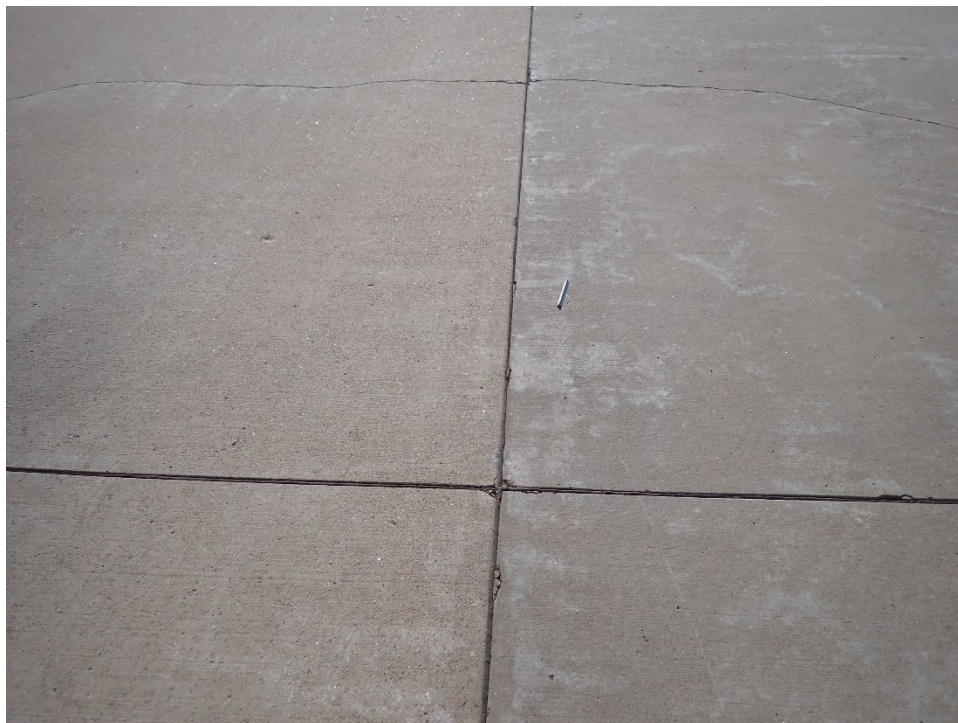
A02KN-02. Joint Seal Damage (Sample Unit No. 03).

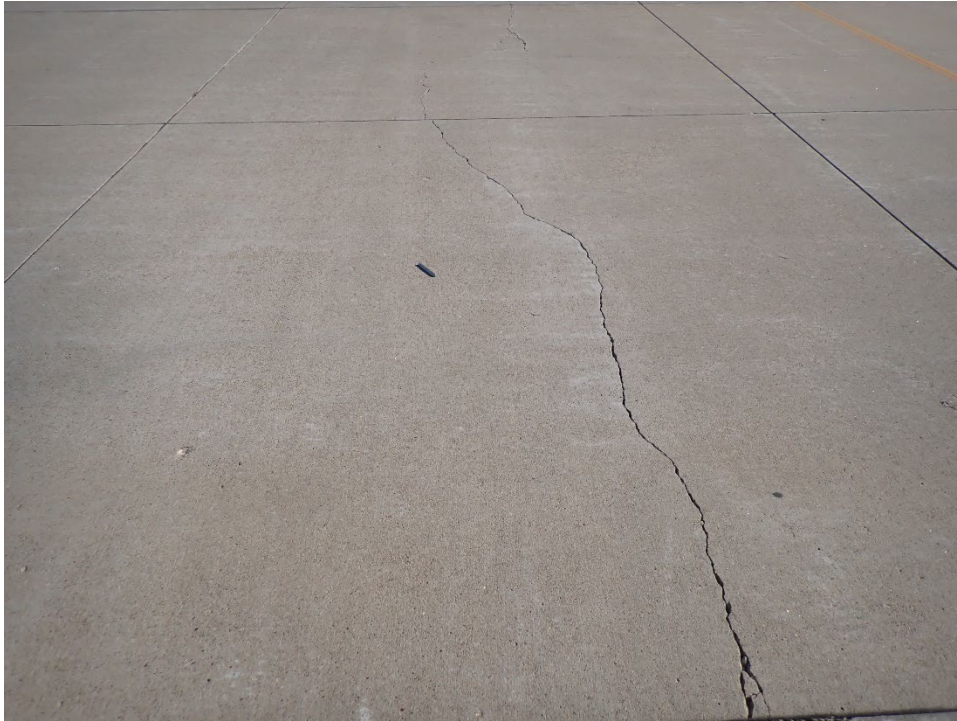
A02KN-02. LTD Cracking (Sample Unit No. 03).

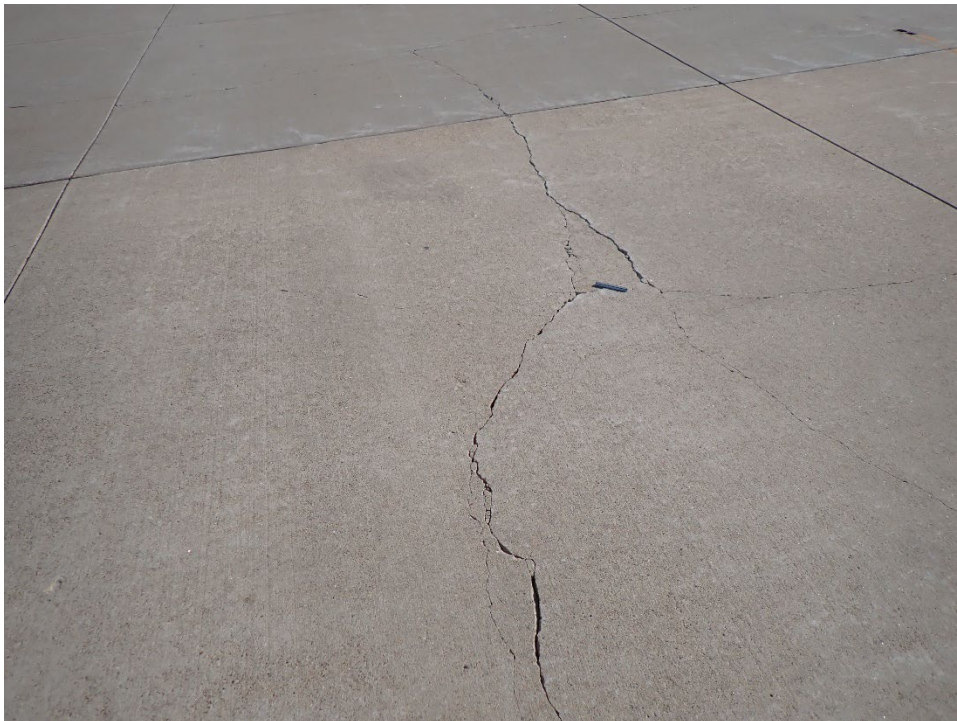
A02KN-02. Shattered Slab (Sample Unit No. 03).

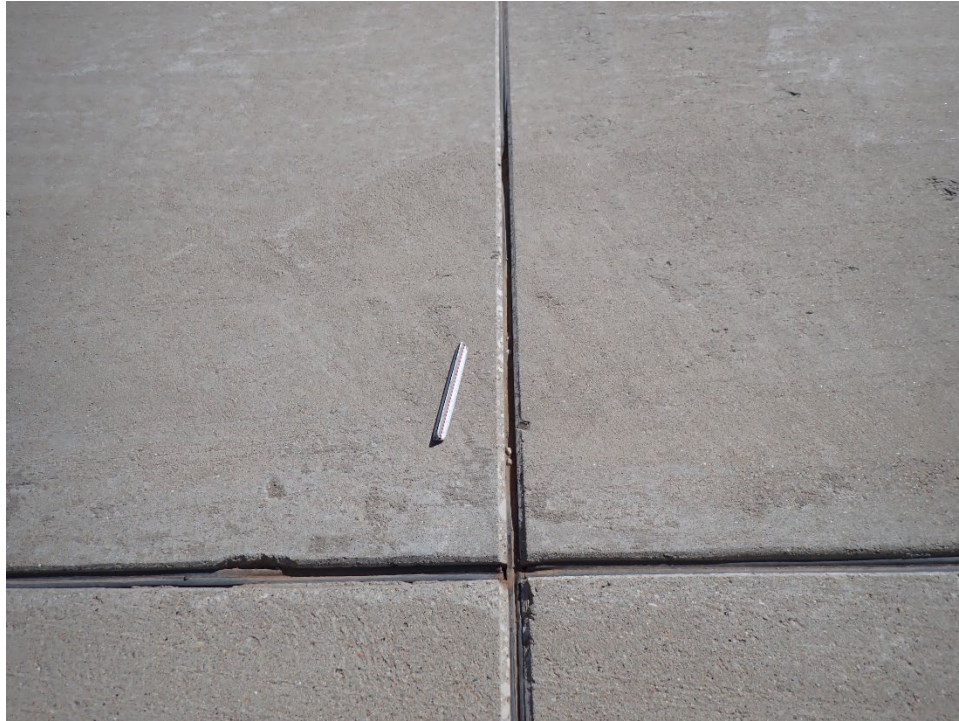
R15KN-01. Joint Seal Damage (Sample Unit No. 57).

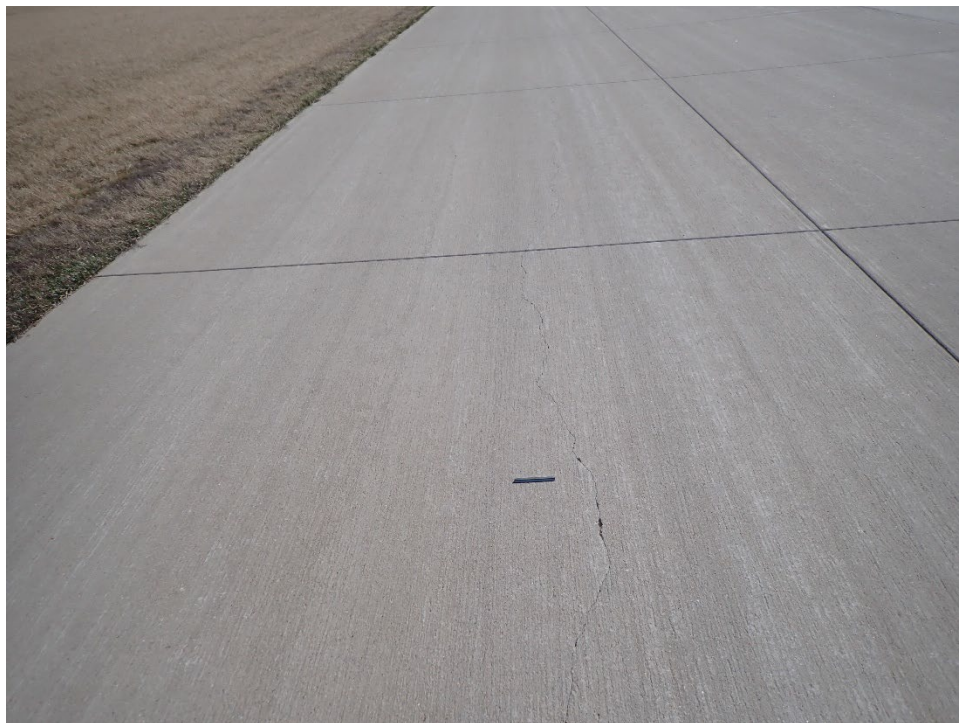
R15KN-01. LTD Cracking (Sample Unit No. 07).

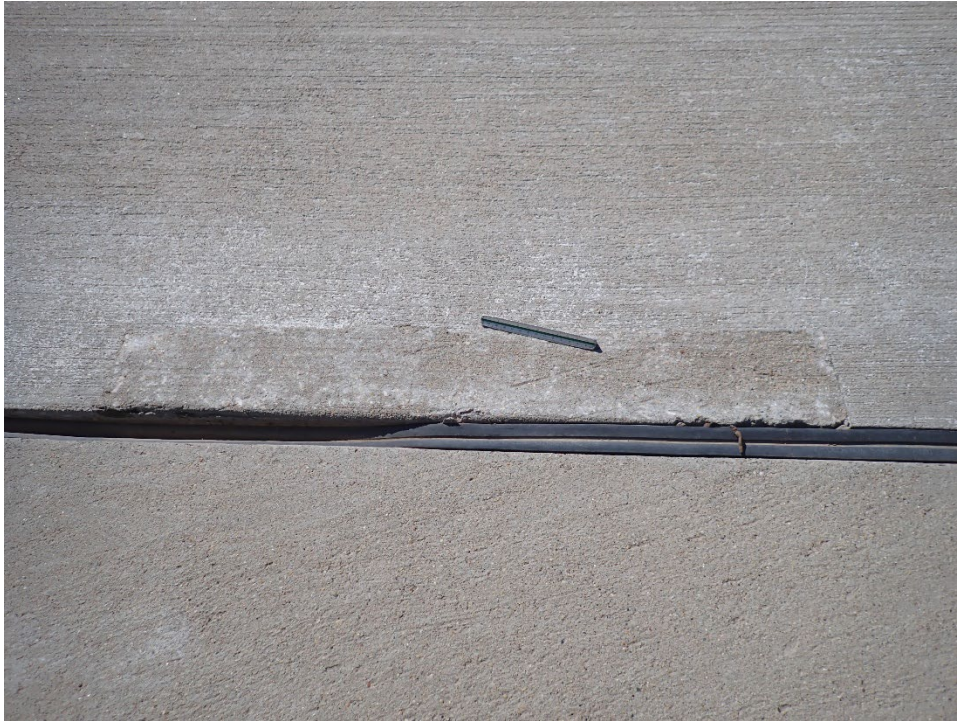
R15KN-01. Small Patching (Sample Unit No. 14).

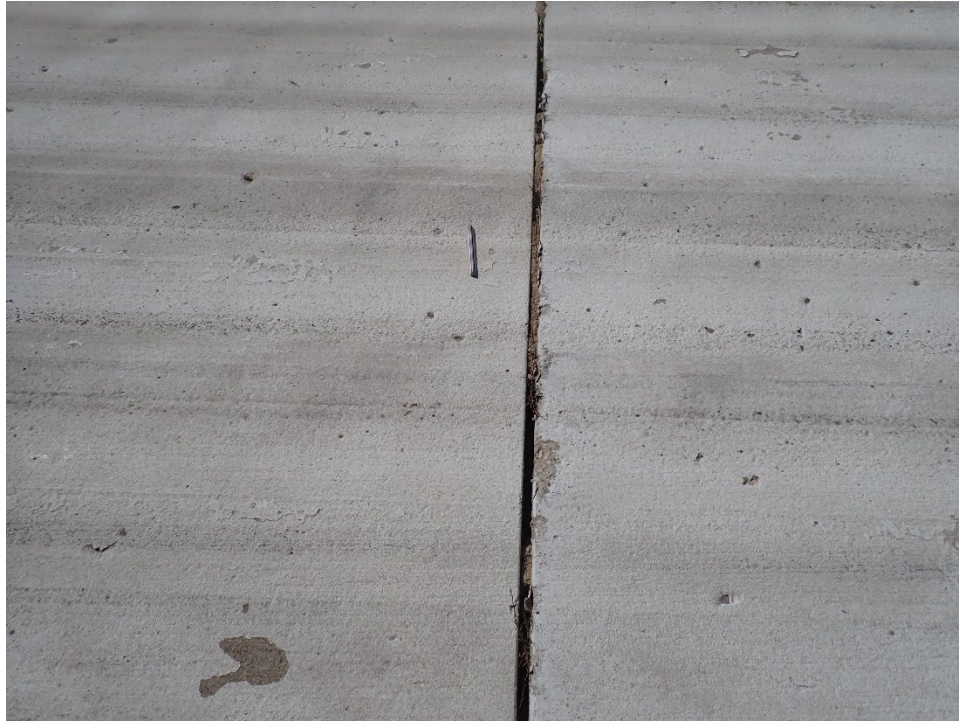
R15KN-02. Joint Seal Damage (Sample Unit No. 16).

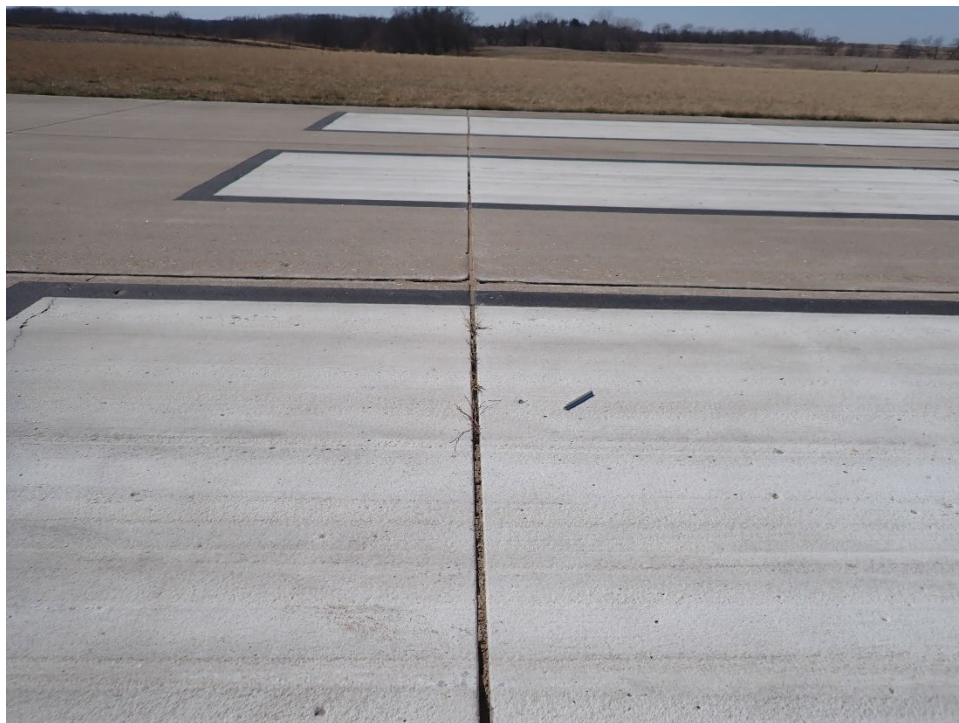
R15KN-02. Joint Seal Damage (Sample Unit No. 19) (1).

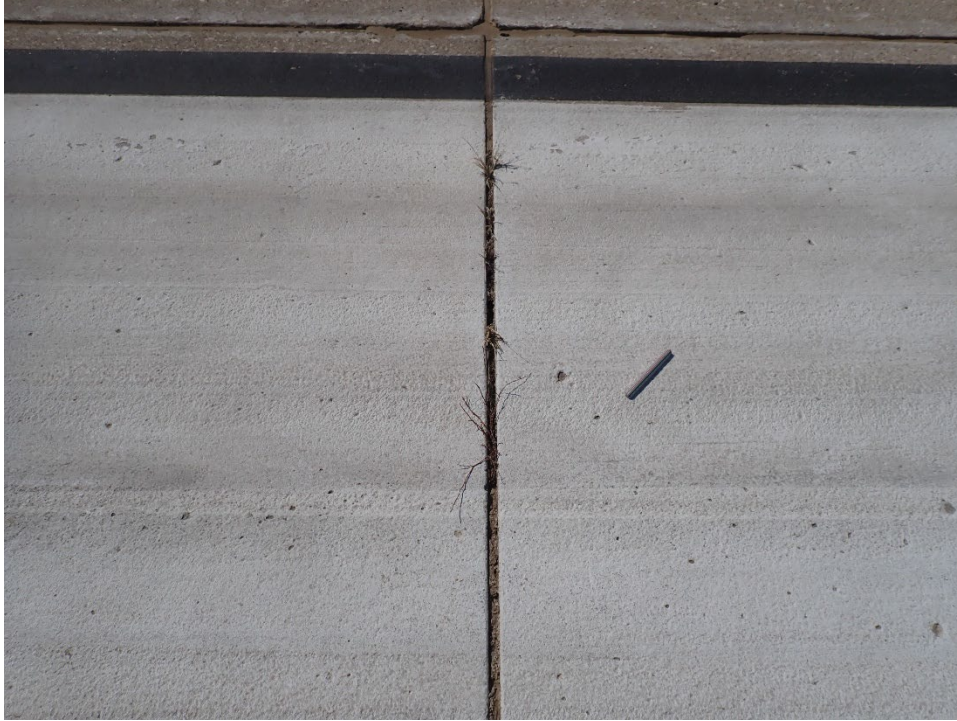
R15KN-02. Joint Seal Damage (Sample Unit No. 19) (2).

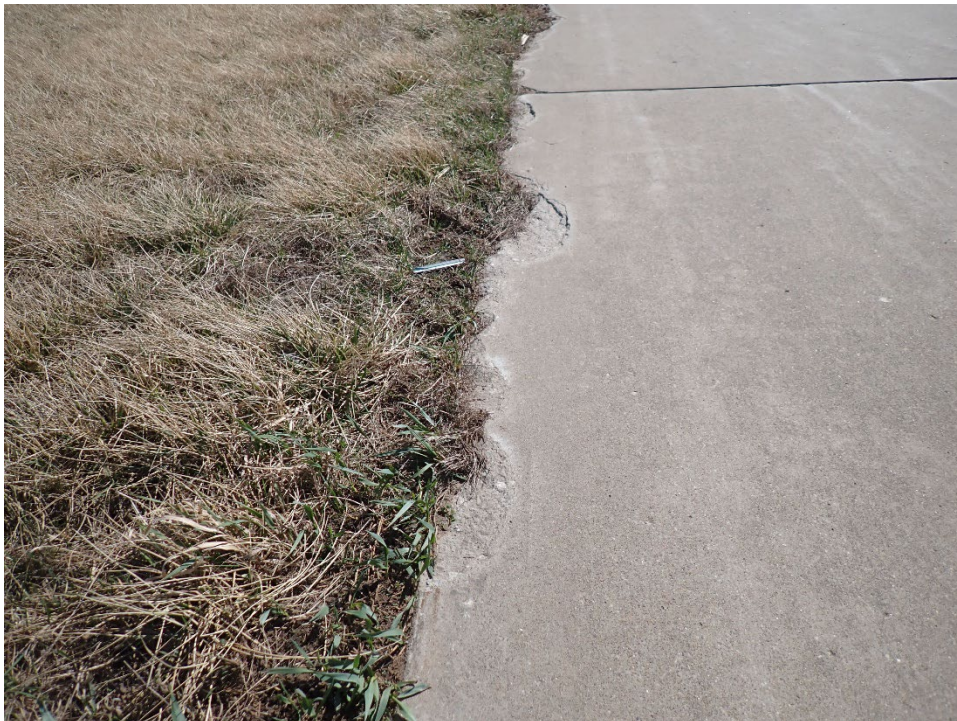
R15KN-02. Joint Spalling (Sample Unit No. 02).

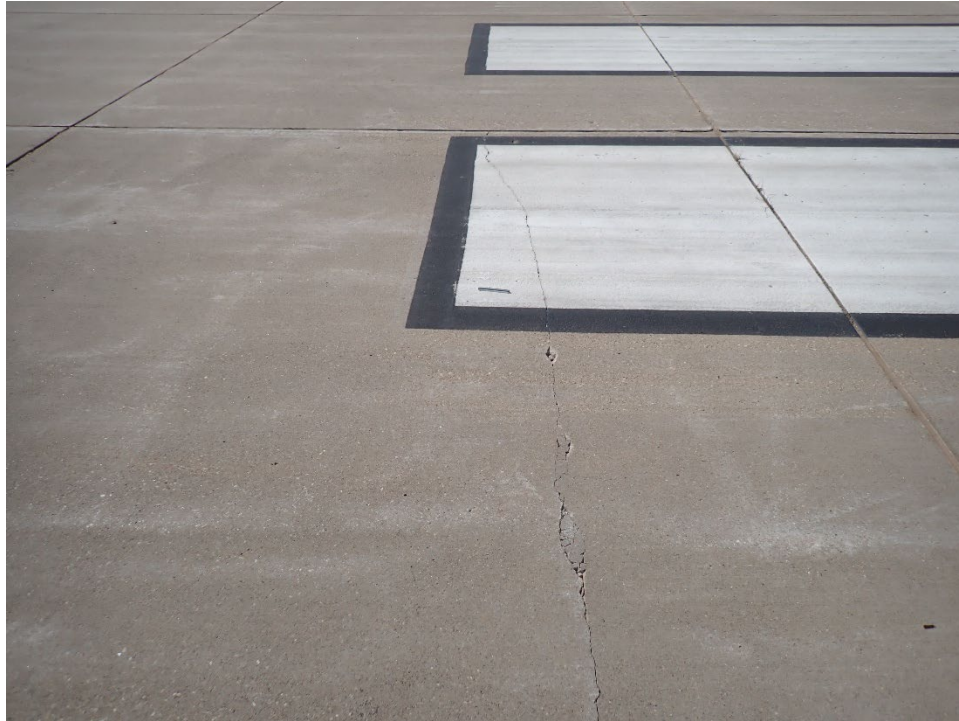
R15KN-02. LTD Cracking (Sample Unit No. 19).

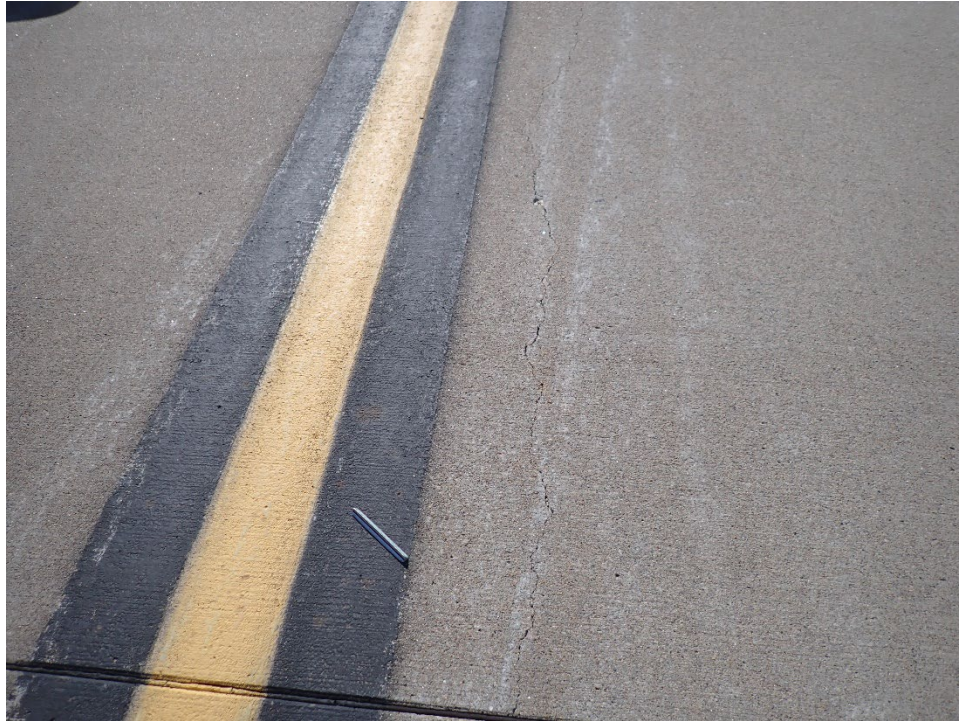
TAKN-01. Shrinkage Cracking (Sample Unit No. 04).

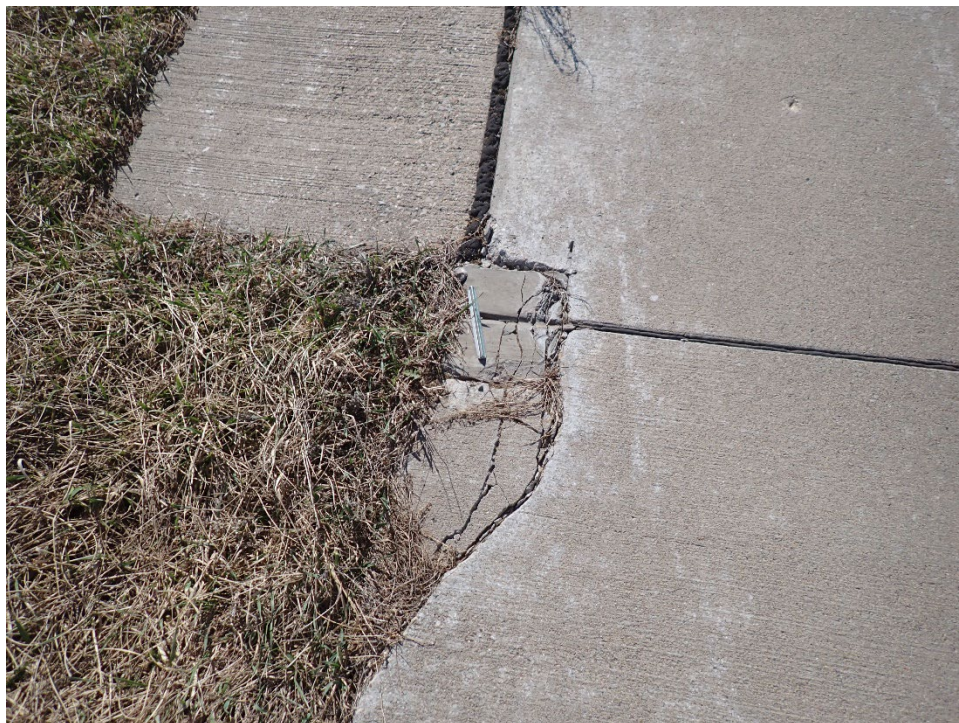
TAKN-01. Small Patching (Sample Unit No. 04).

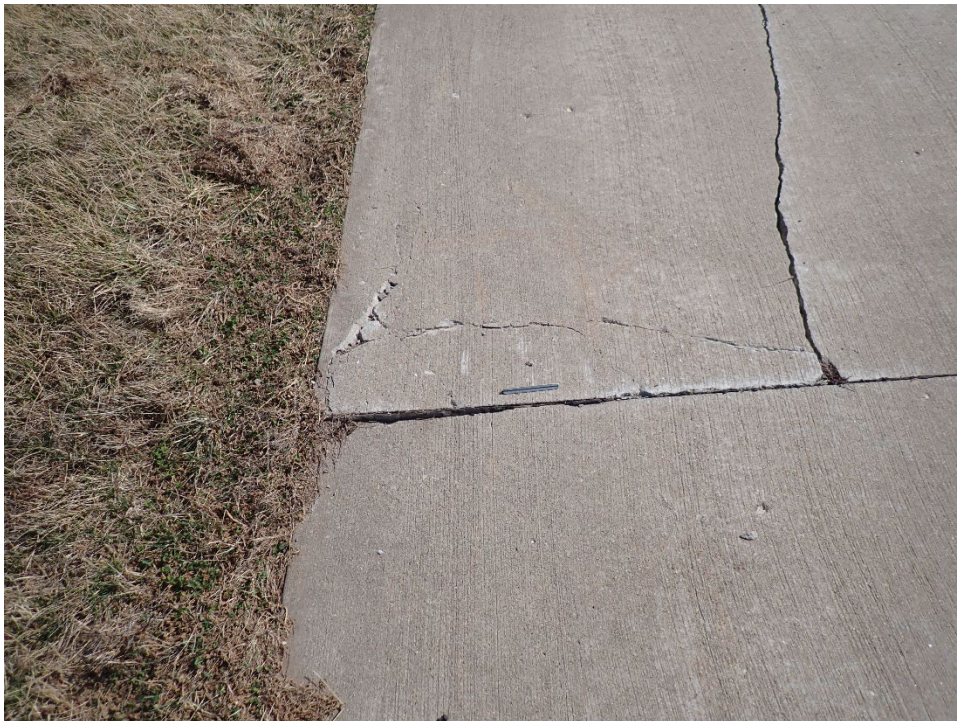
TBKN-01. Blow-Up (Sample Unit No. 12).

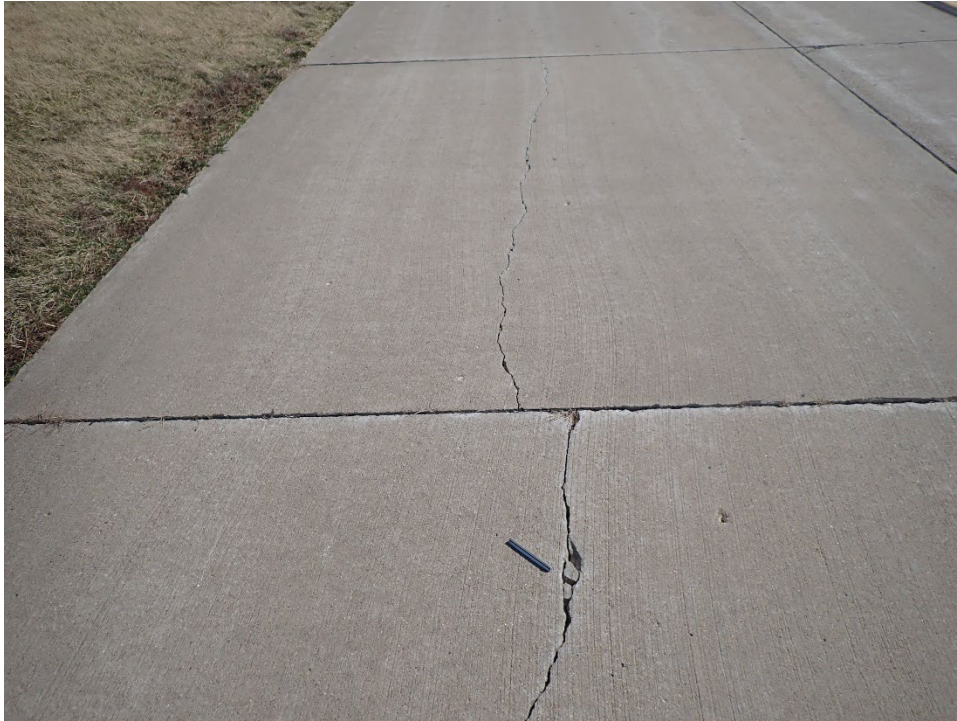
TBKN-01. LTD Cracking (Sample Unit No. 12).

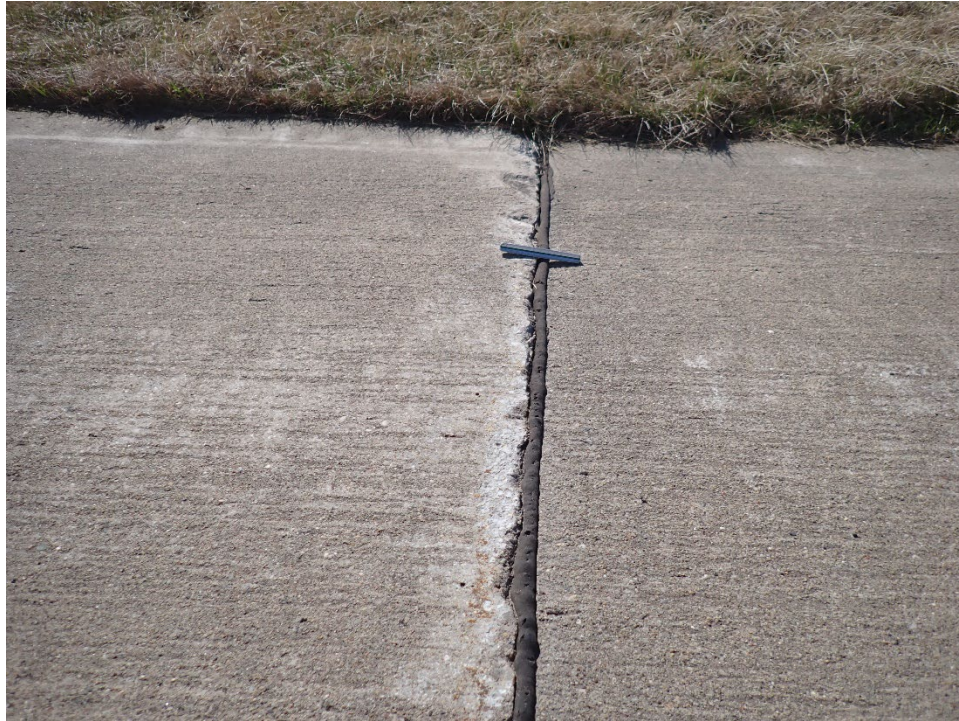
TBKN-02. Faulting (Sample Unit No. 20).

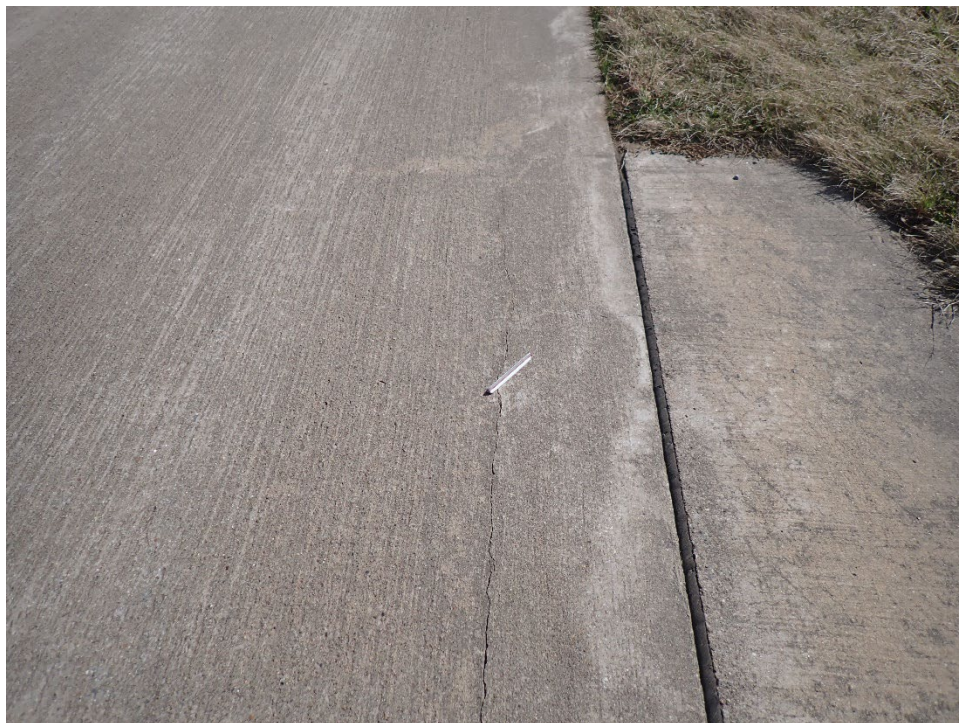
TBKN-02. Shrinkage Cracking (Sample Unit No. 23).

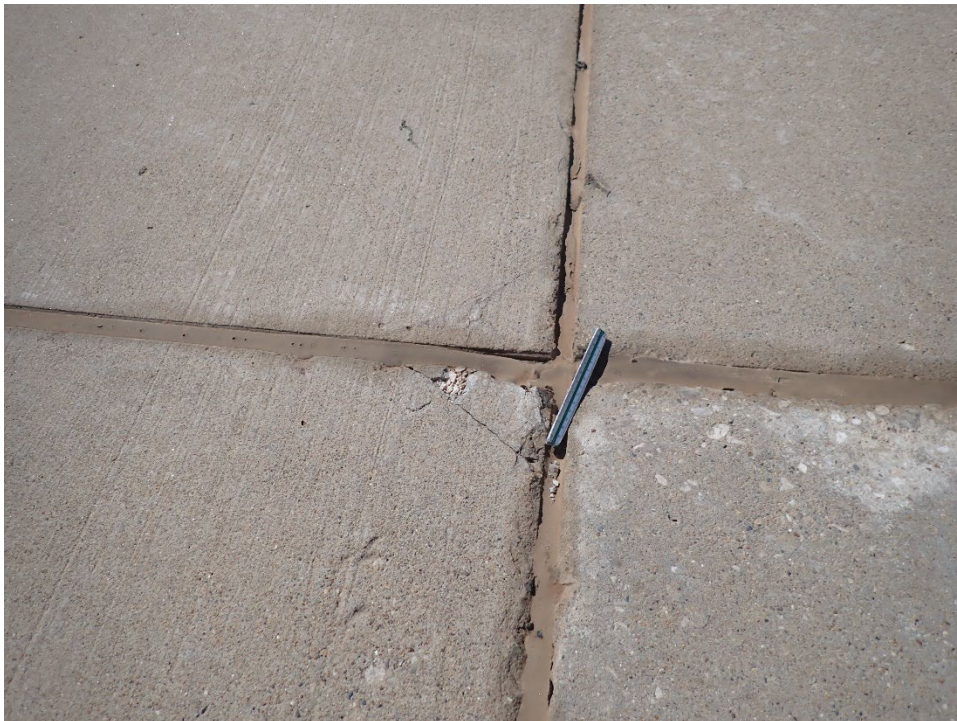
TBKN-03. ASR (Sample Unit No. 05).

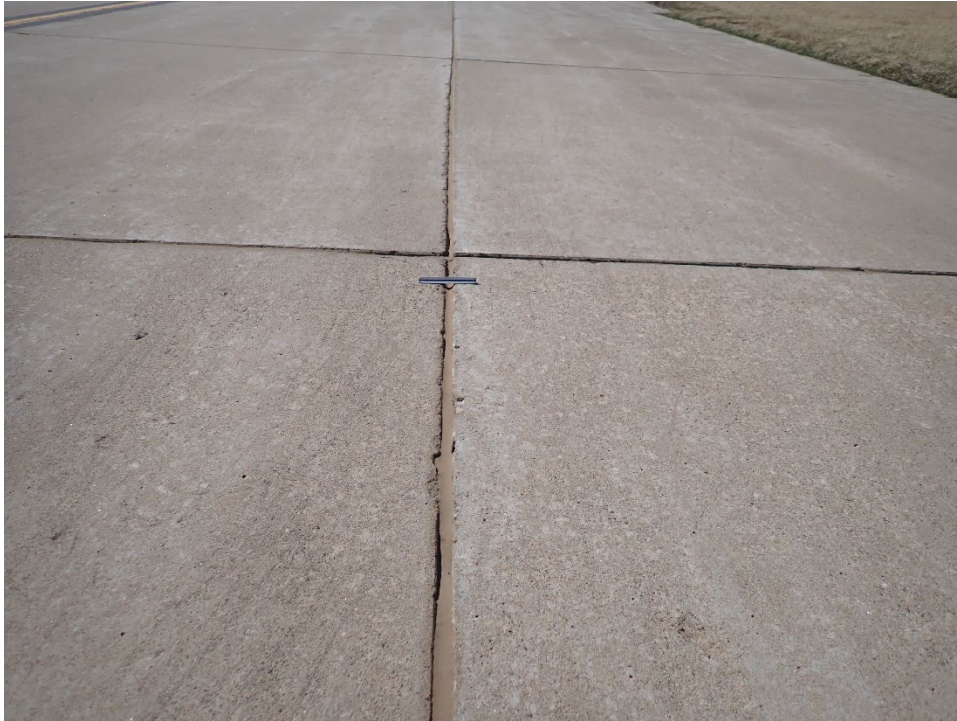
TBKN-03. Faulting (Sample Unit No. 02).

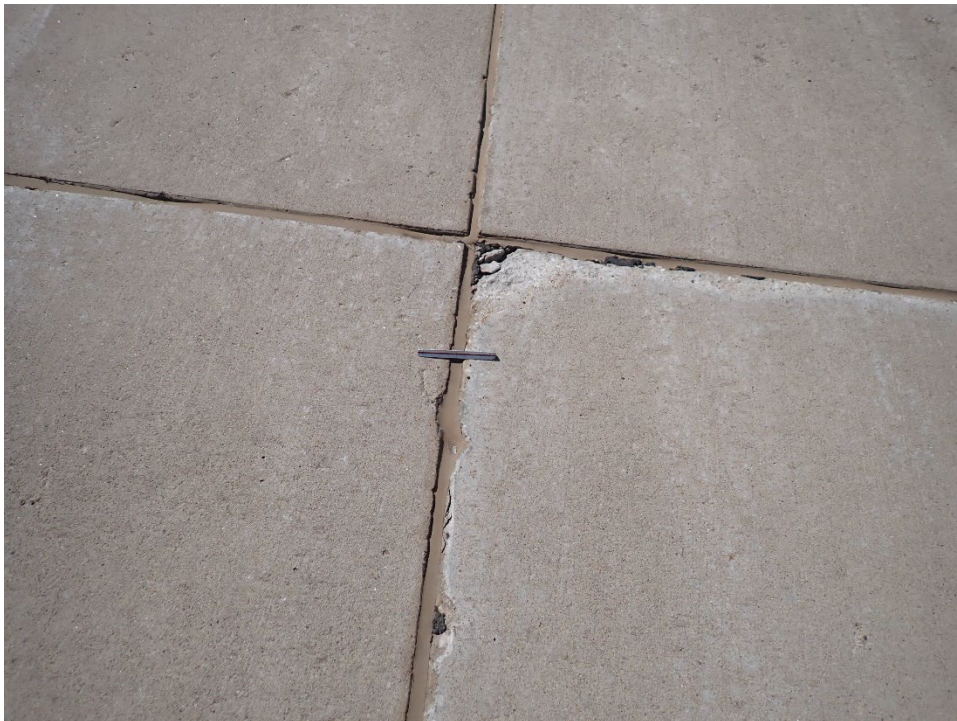
TBKN-03. Faulting (Sample Unit No. 05).

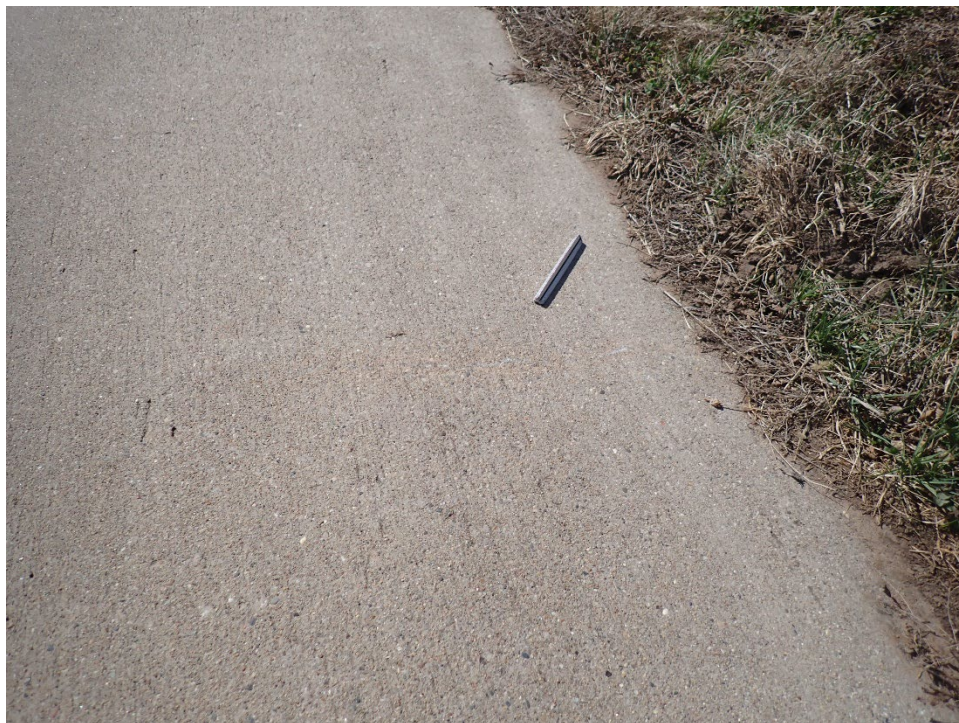
TBKN-04 ASR. (Sample Unit No. 01).

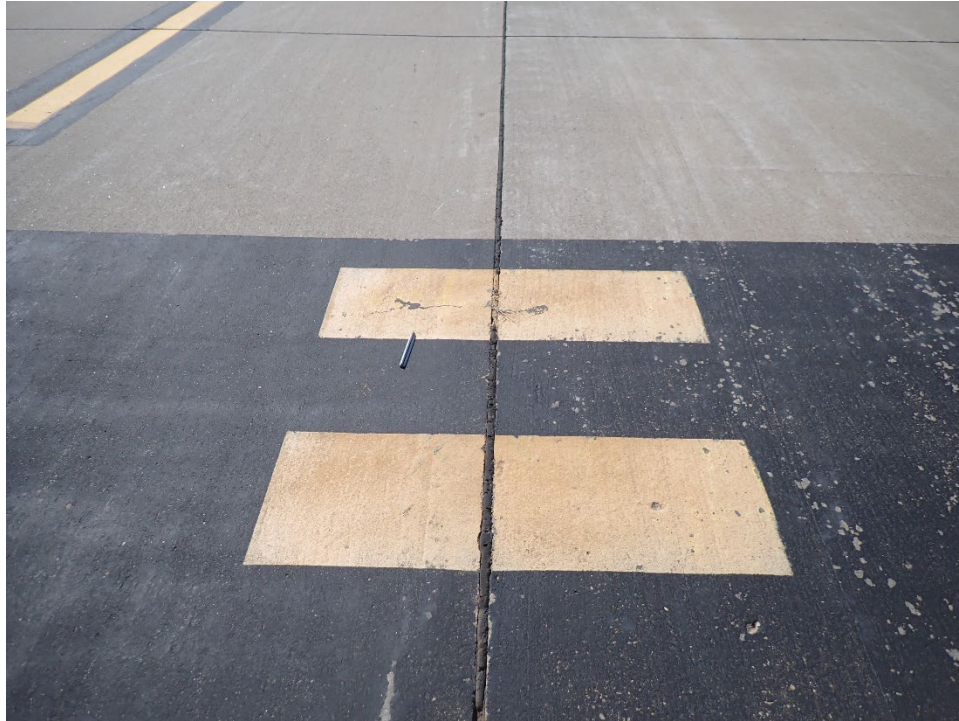
TBKN-04. Joint Seal Damage (Sample Unit No. 01).

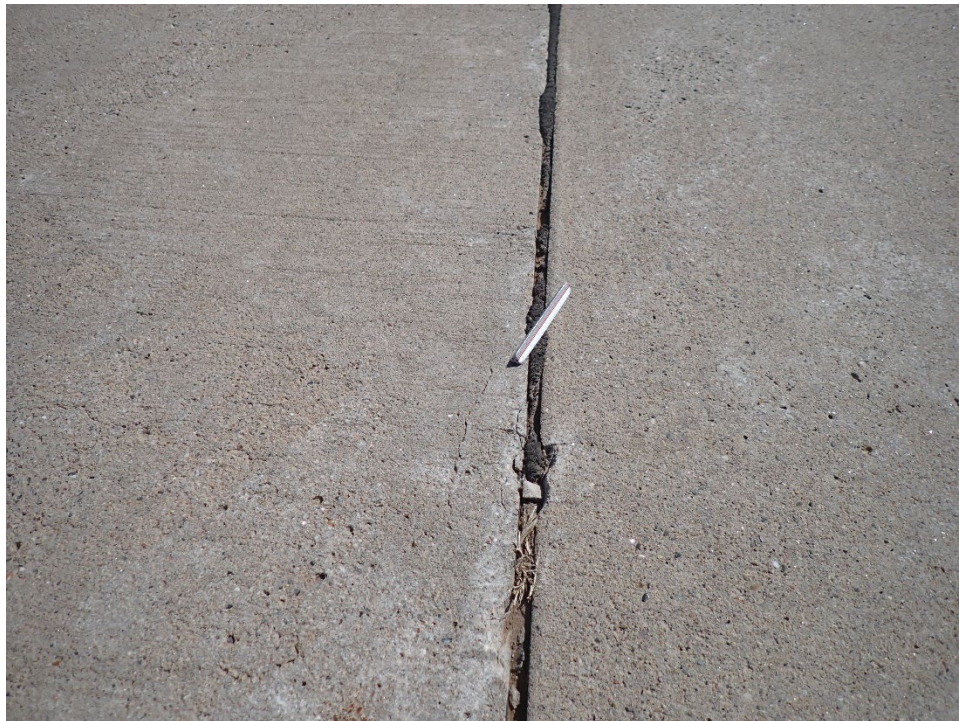
TBKN-04. Joint Spalling (Sample Unit No. 01).

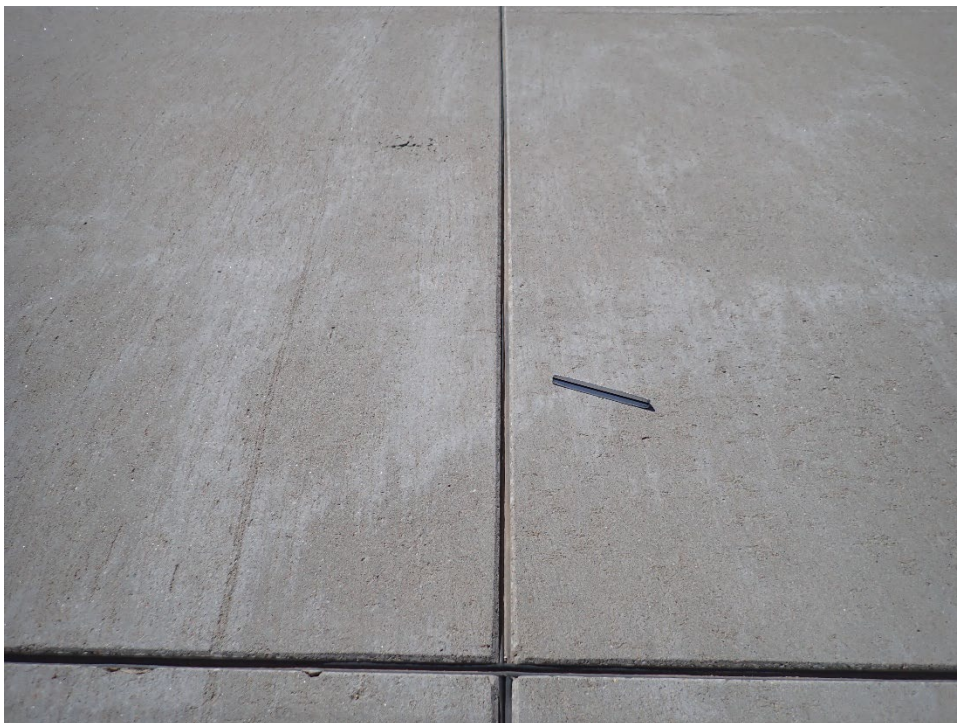
TBKN-05. Joint Seal Damage (Sample Unit No. 01).

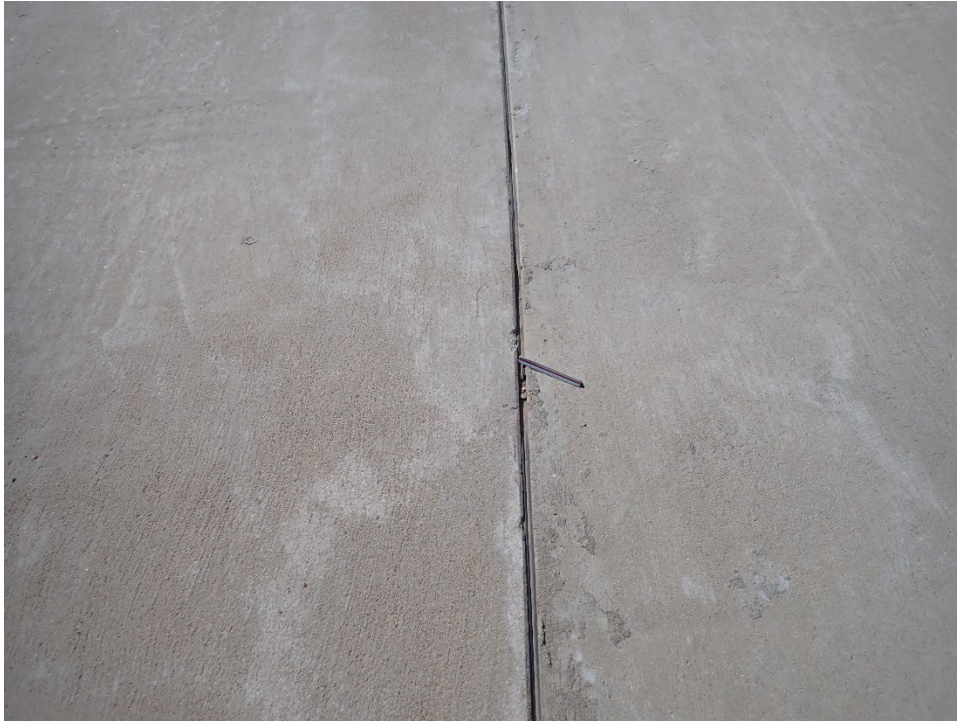
TBKN-05. Joint Seal Damage (Sample Unit No. 04).

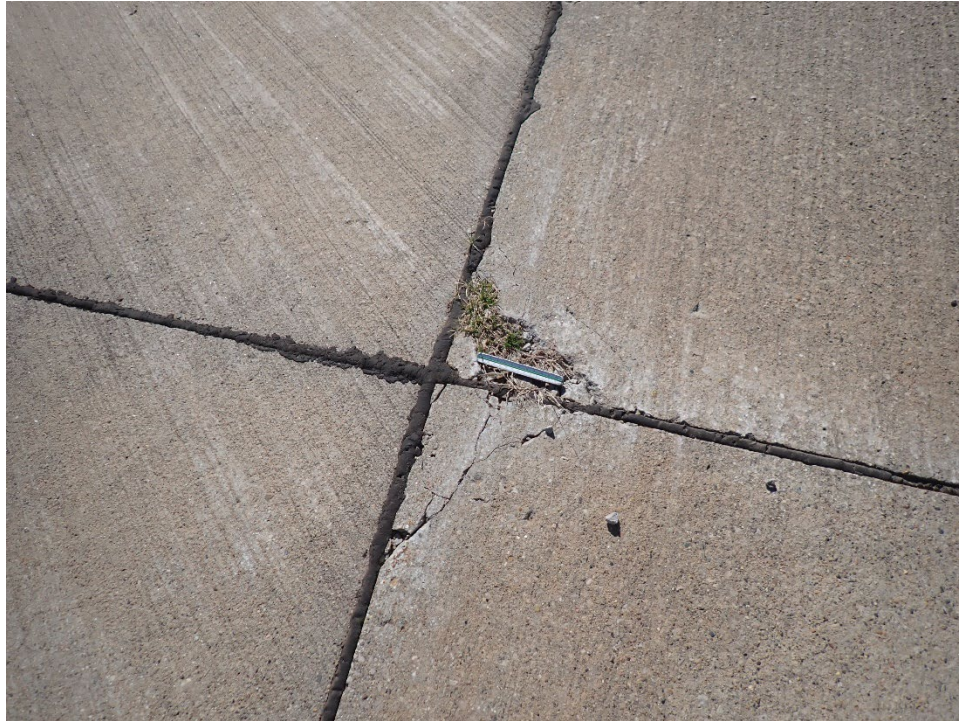
TCKN-01. Corner Spalling (Sample Unit No. 02) (1).

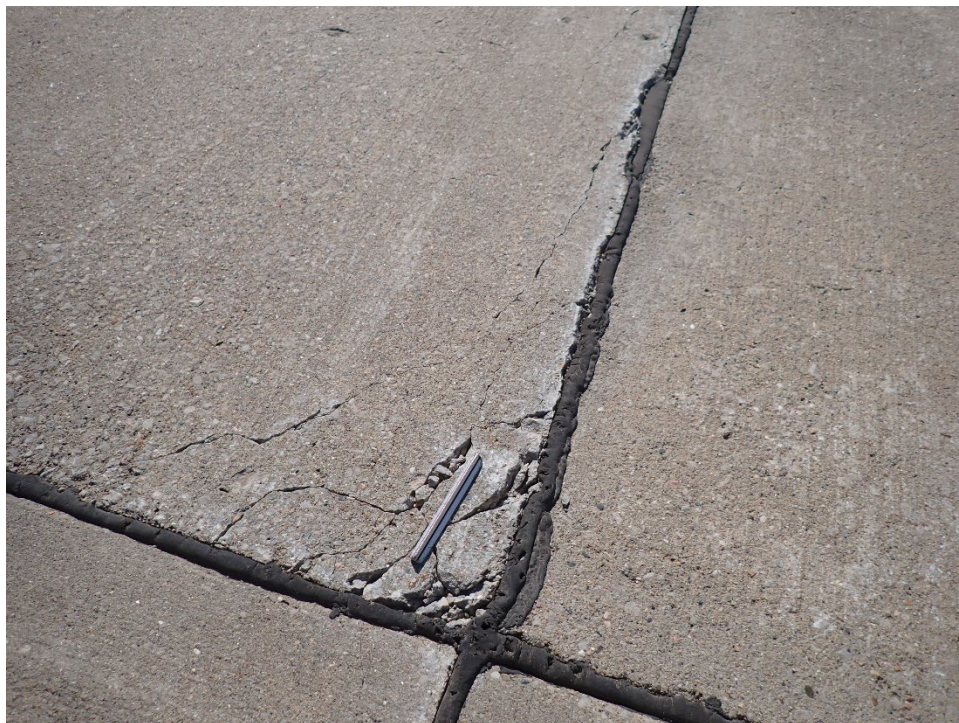
TCKN-01. Corner Spalling (Sample Unit No. 02) (2).
