# Knoxville Municipal Airport

## Pavement Management Report

**AUGUST 2025**

# KNOXVILLE MUNICIPAL AIRPORT PAVEMENT MANAGEMENT REPORT

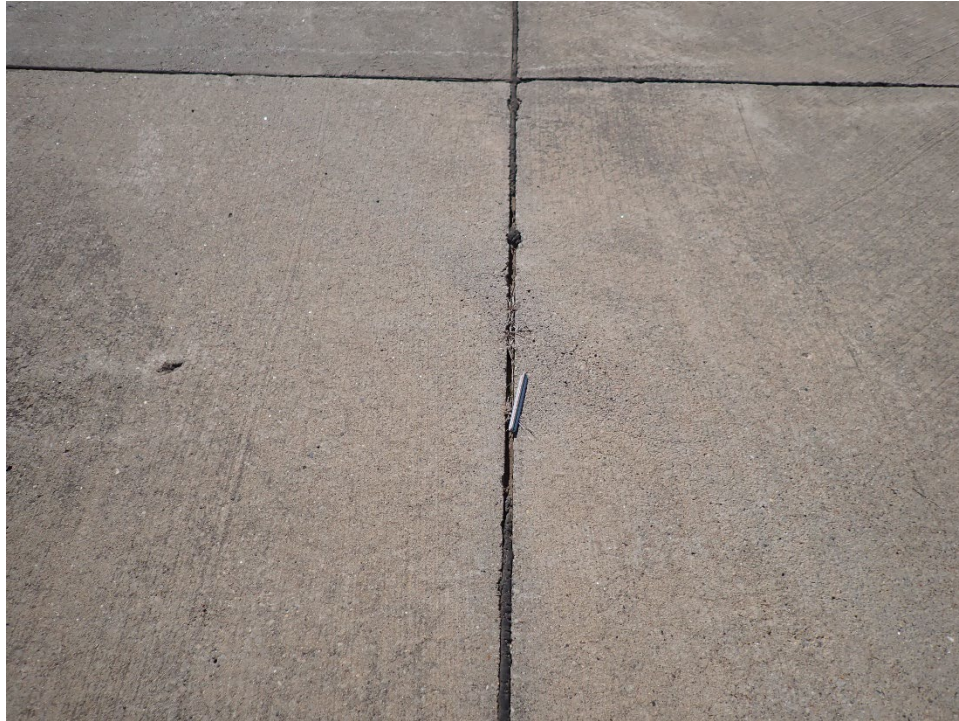
TCKN-01. Joint Seal Damage (Sample Unit No. 02).

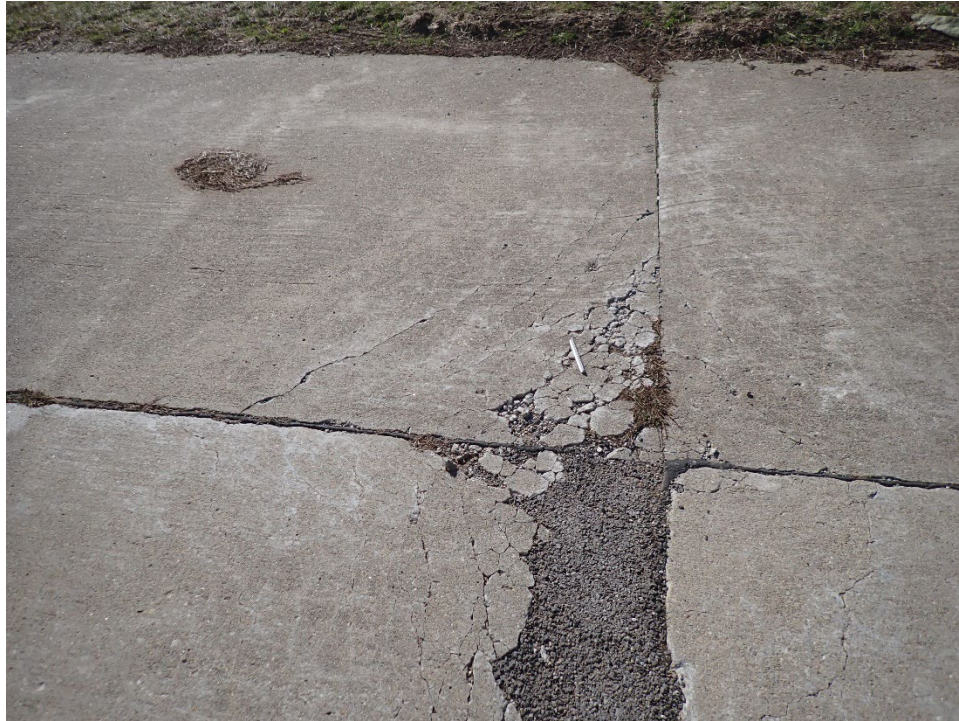
TH01KN-01. ASR (Sample Unit No. 04).

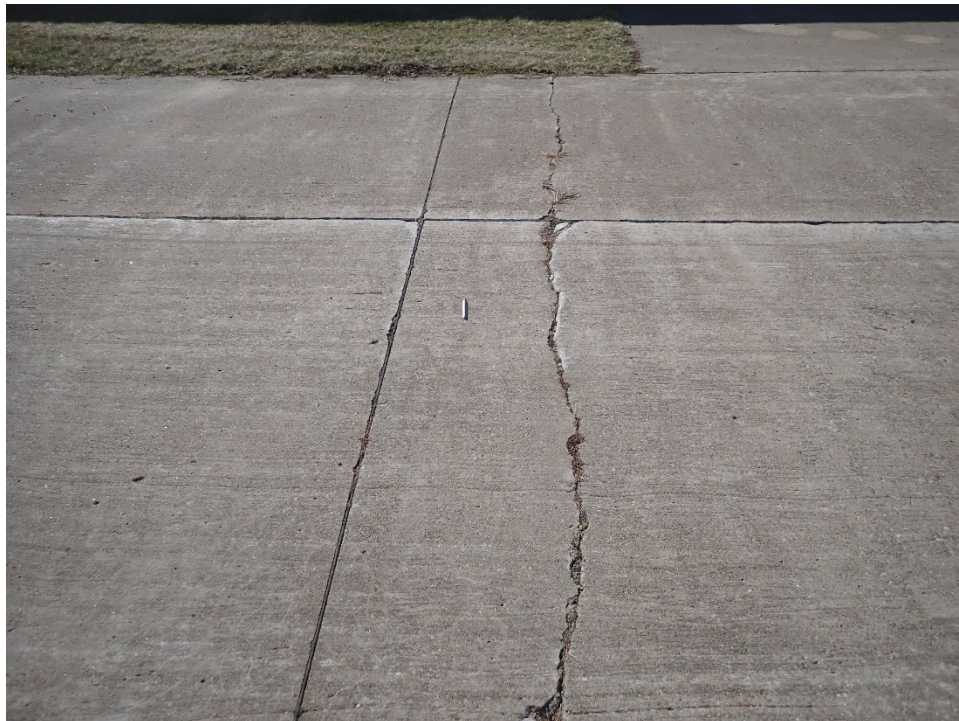
TH01KN-01. LTD Cracking (Sample Unit No. 04).

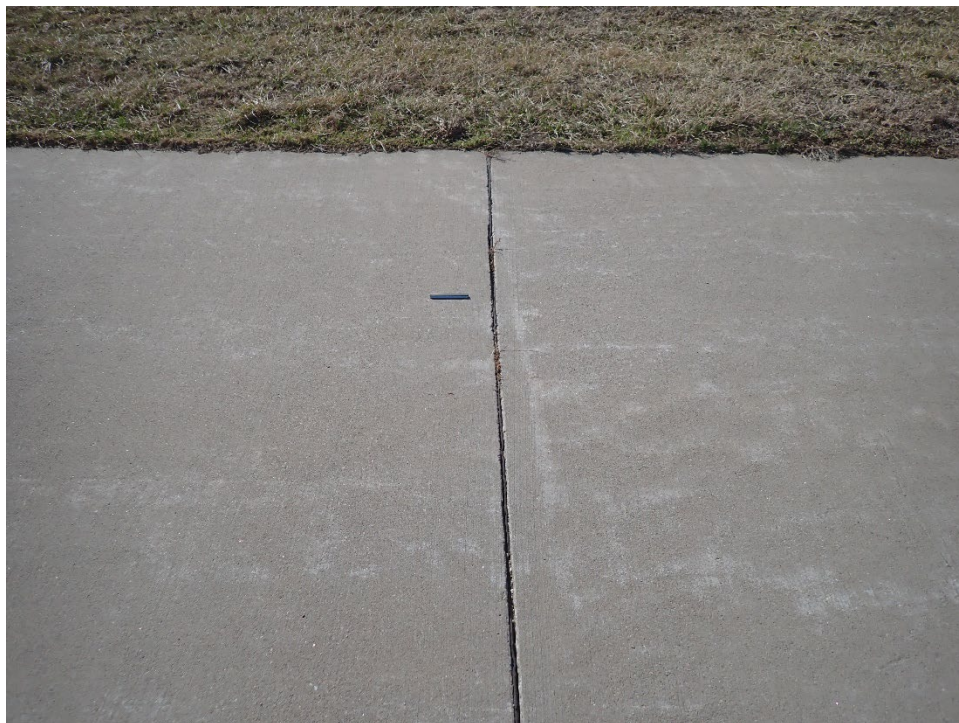
TH01KN-02. Joint Seal Damage (Sample Unit No. 01).

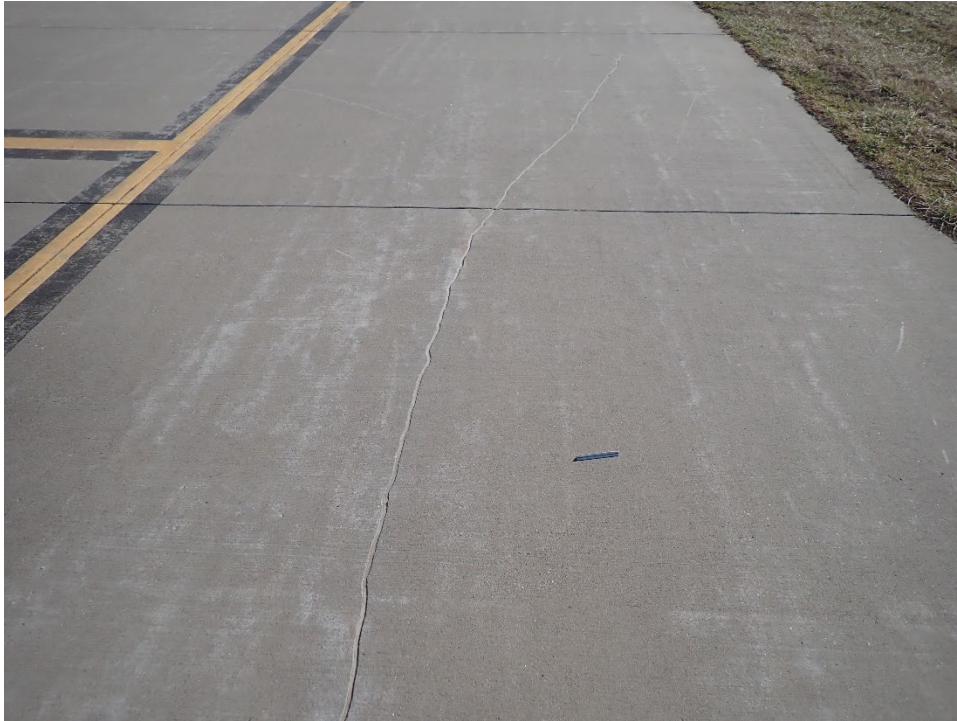
TH01KN-02. LTD Cracking (Sample Unit No. 02).
