# Lamoni Municipal Airport

## PAVEMENT MANAGEMENT REPORT

**JULY 2022**

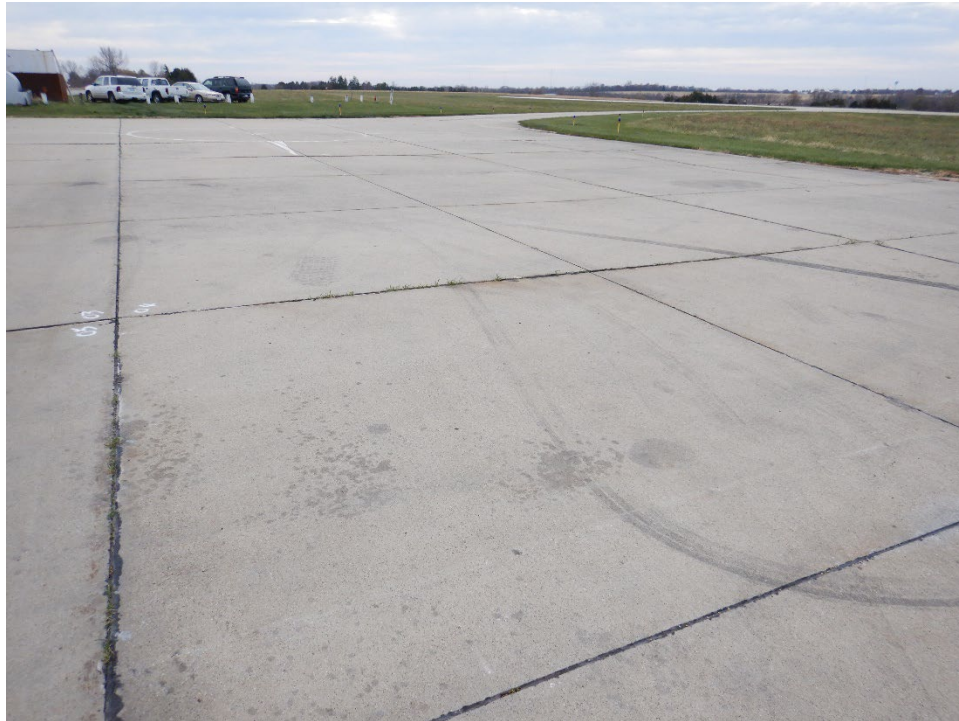
A01LA-01. Overview.

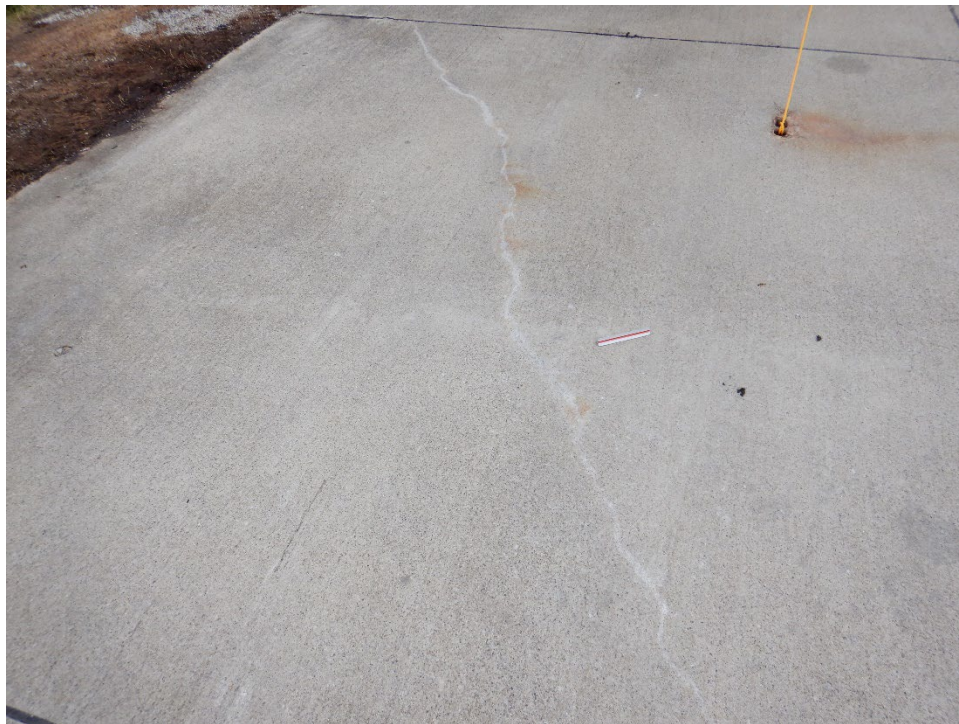
A01LA-01. ASR (Sample Unit No. 05)

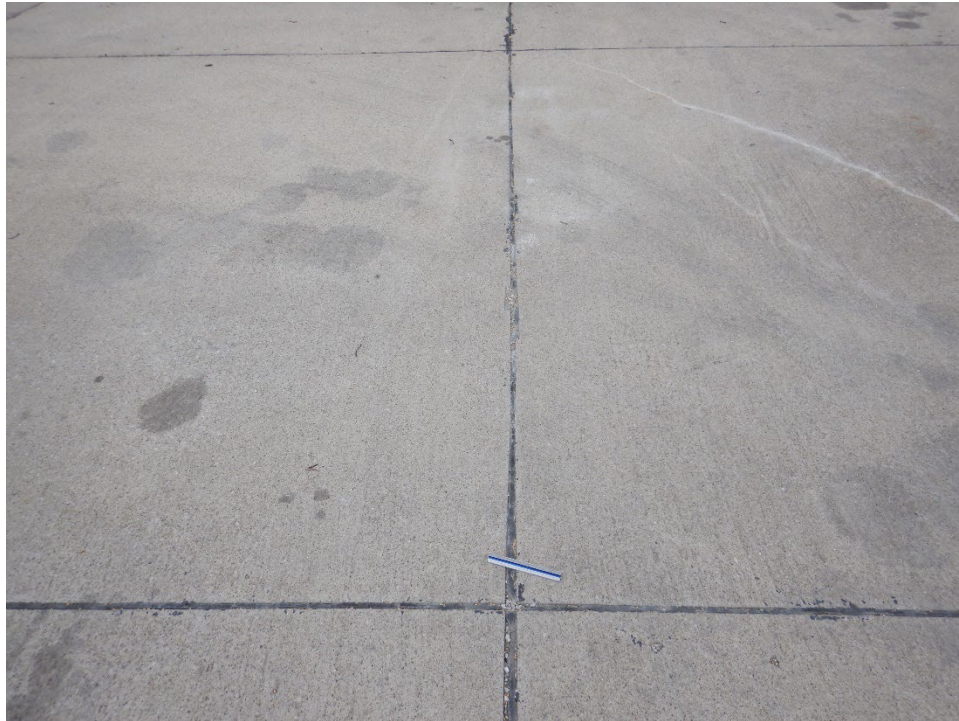
A01LA-01. Joint Seal Damage (Sample Unit No. 05).

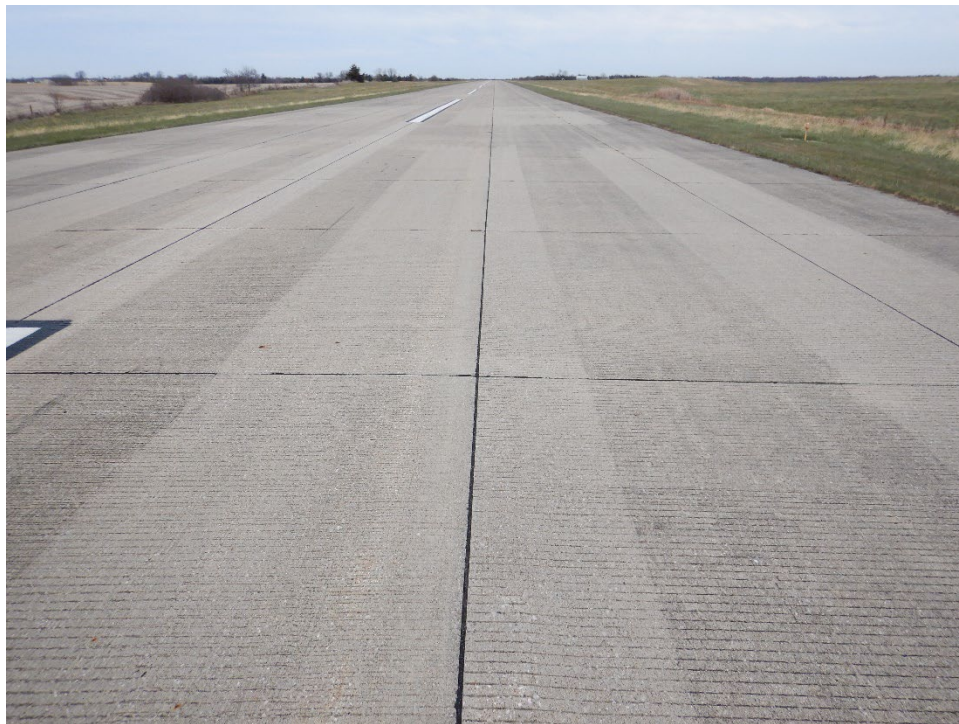
R18LA-01. Overview.

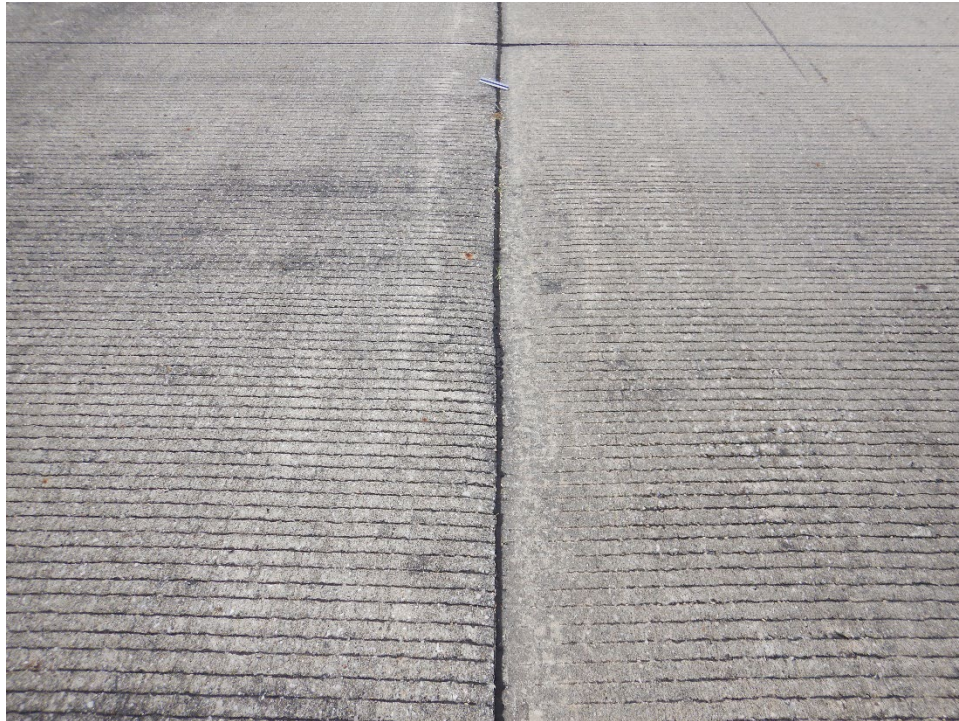
R18LA-01. Joint Seal Damage (Sample Unit No. 14).

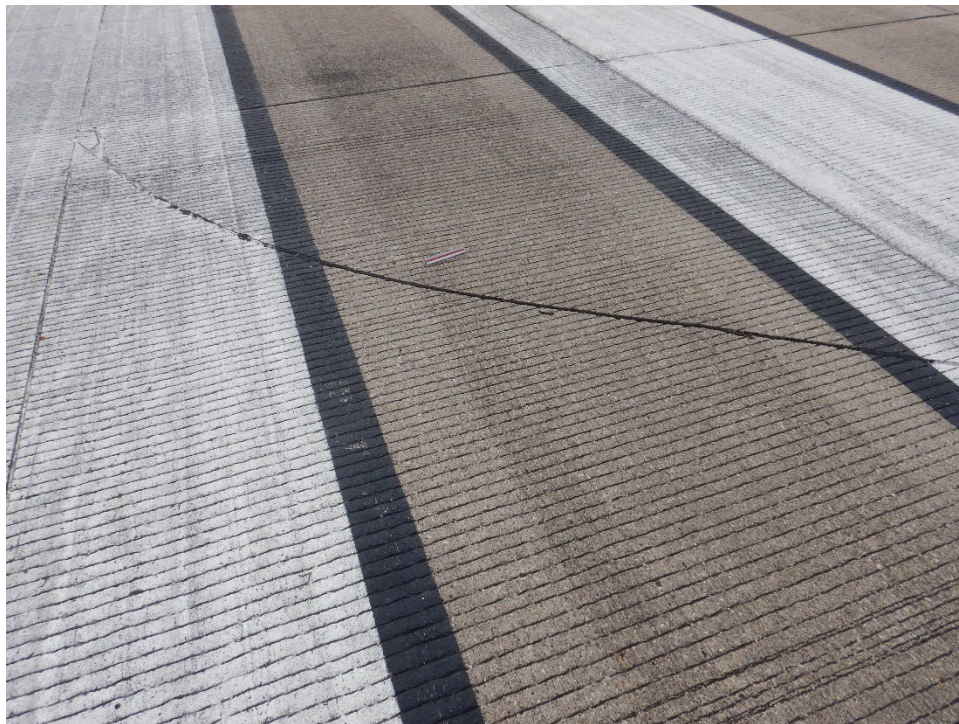
R18LA-01. LTD Cracking (Sample Unit No. 05).

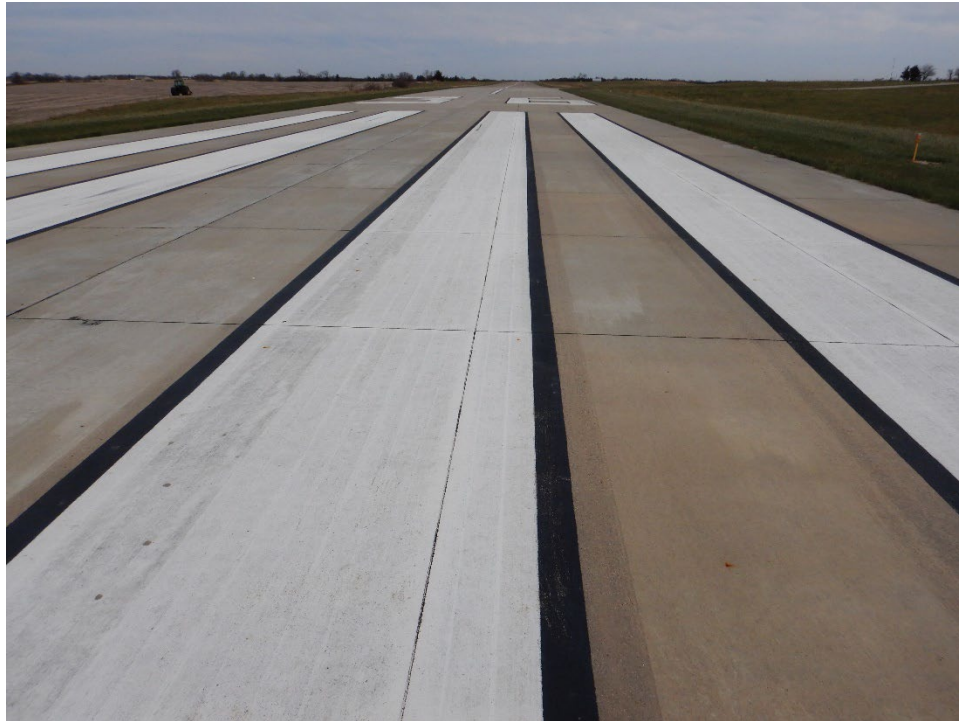
R18LA-02. Overview.

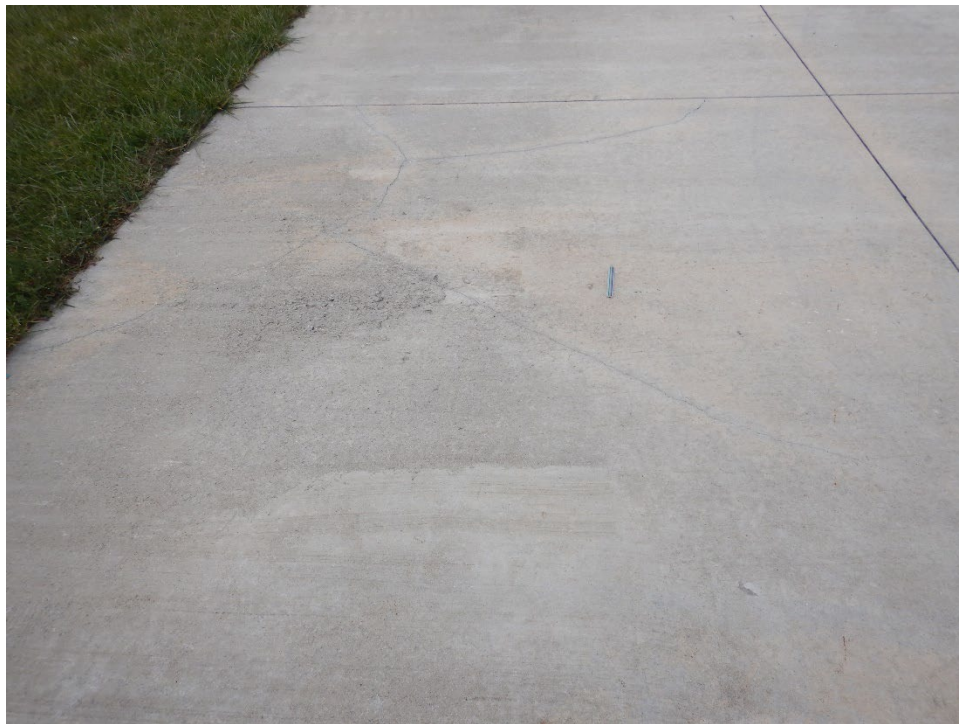
R18LA-02. Shattered Slab (Sample Unit No. 13).

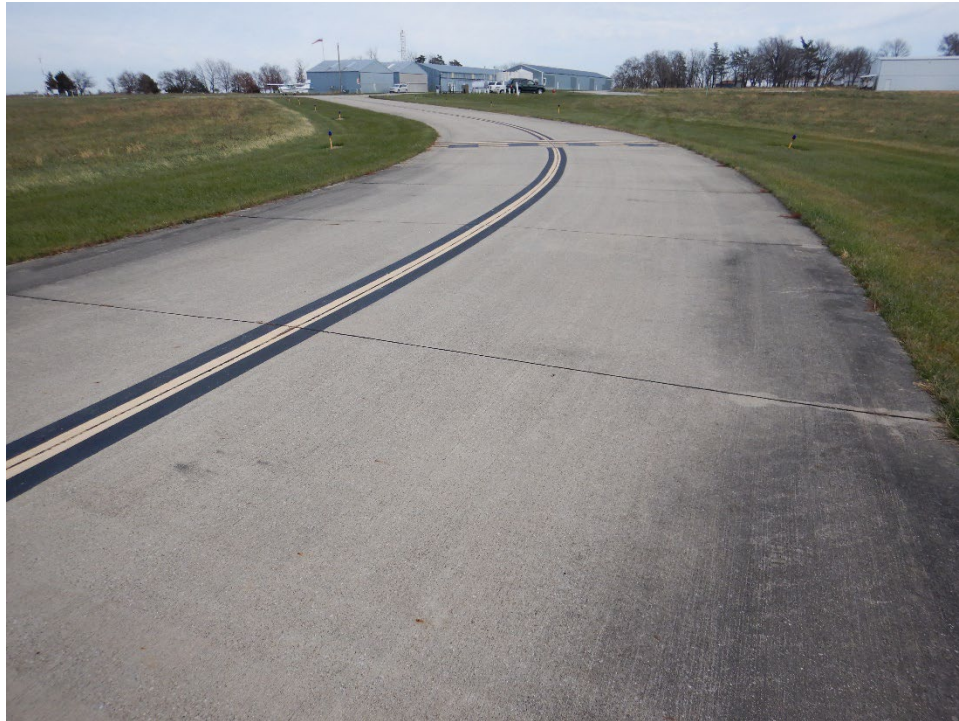
Taxiway 01 connected Runway 18/36 with the apron area and consisted of one section. High-severity joint seal damage and low-severity ASR and faulting were recorded in Section 01.

T01LA-01. Overview.

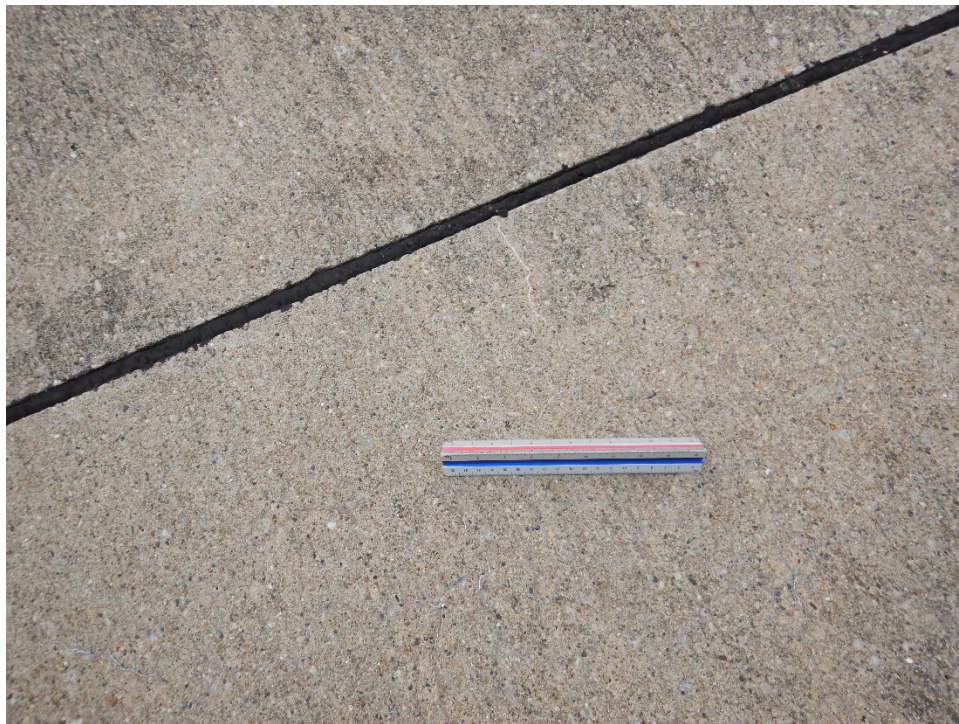
T01LA-01. ASR (Sample Unit No. 03).

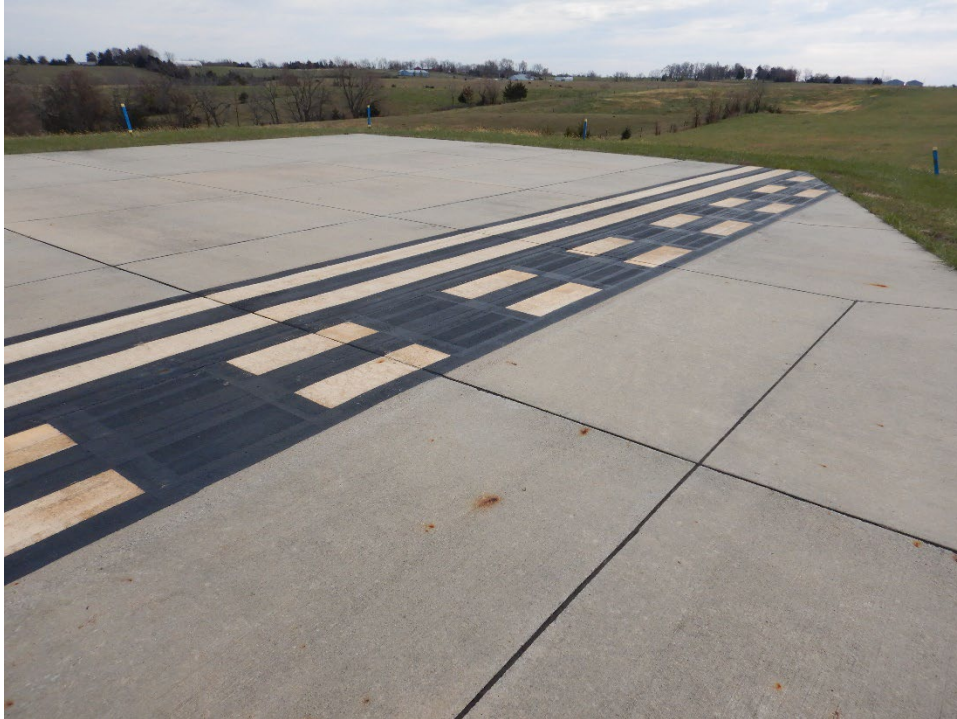
Taxiway 02 was defined by one section located at the Runway 18 approach. High-severity joint seal damage was noted throughout Section 01.

T02LA-01. Overview.

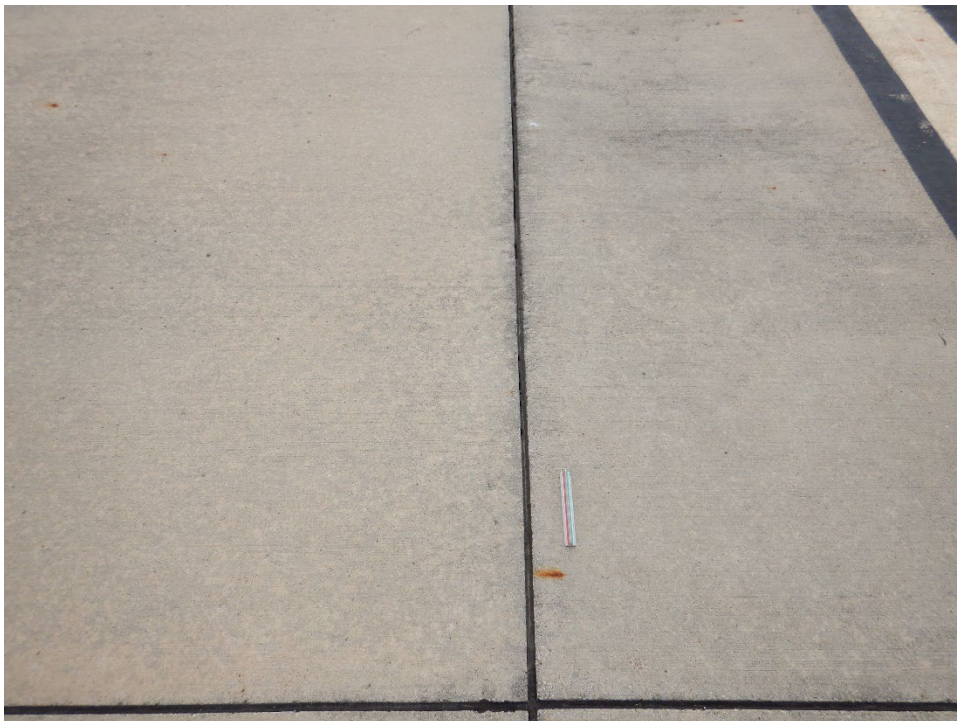
T02LA-01. Joint Seal Damage (Sample Unit No. 04).

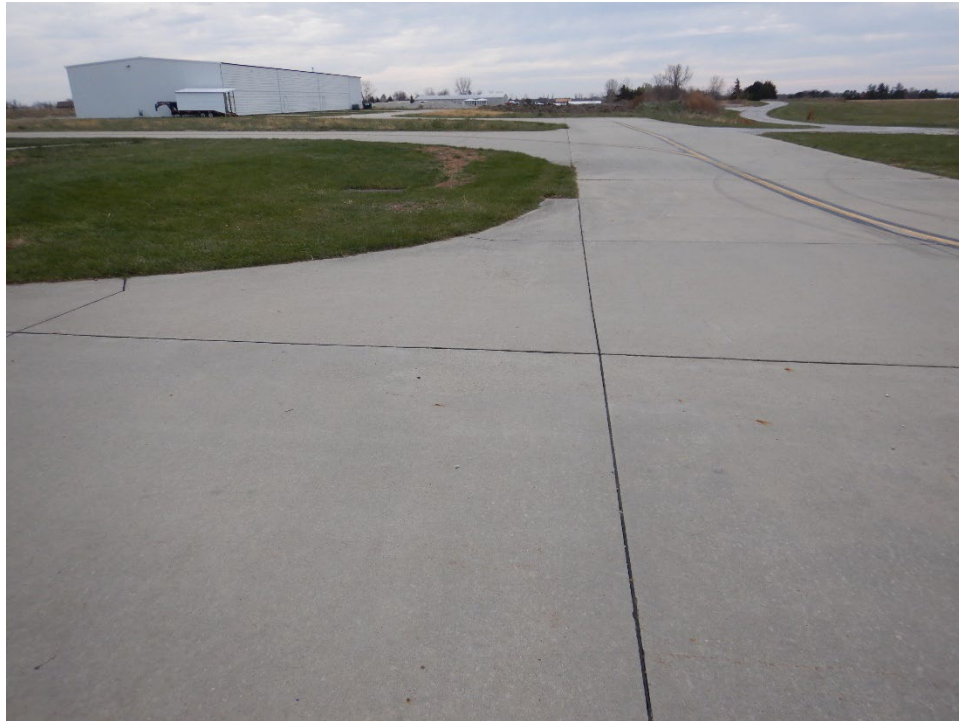
TH01LA-01. Overview.

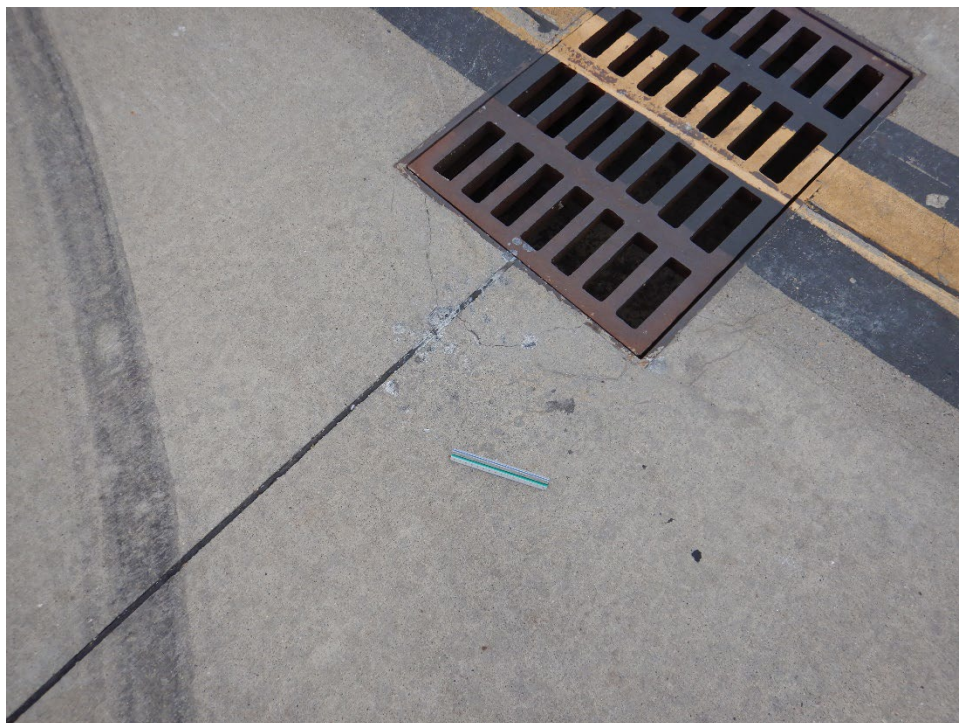
TH01LA-01. ASR (Sample Unit No. 01).

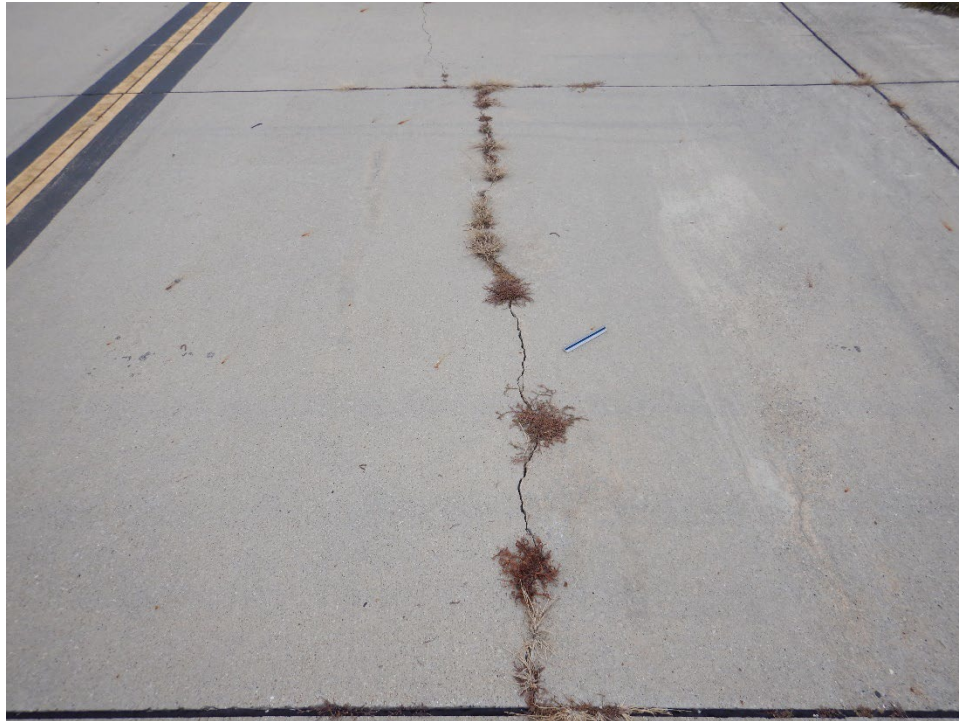
TH01LA-01. LTD Cracking (Additional Sample Unit No. 07).

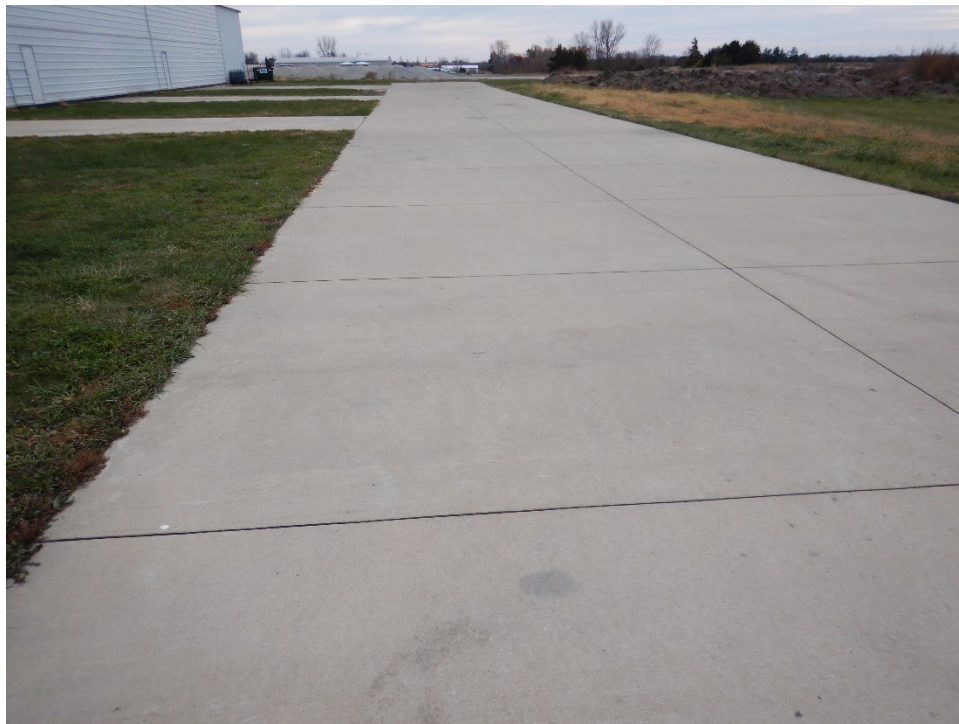
TH01LA-02. Overview.

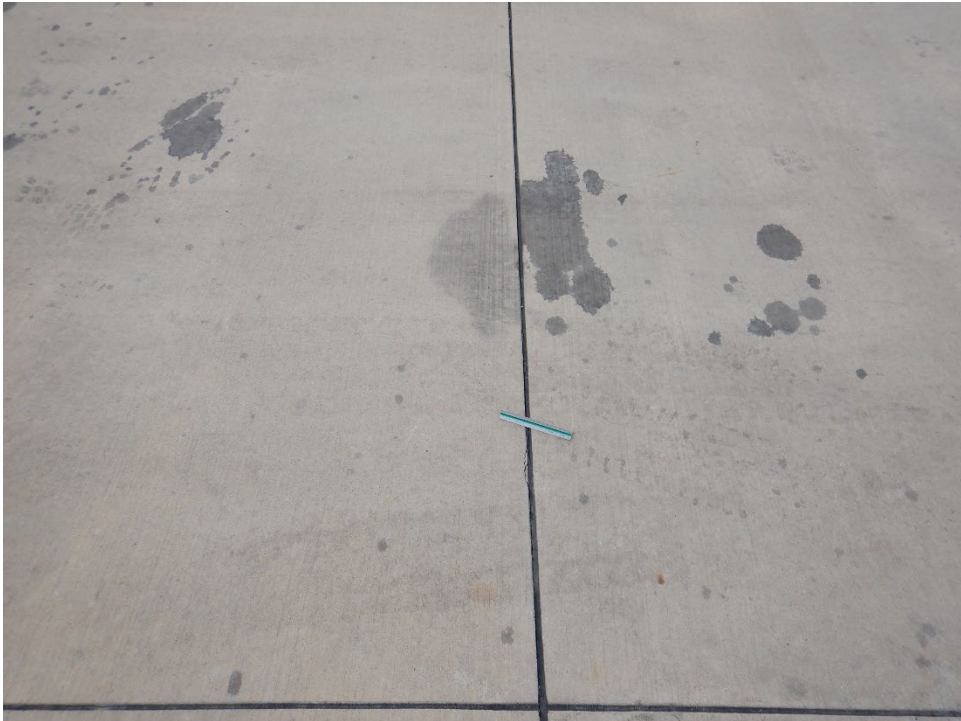
TH01LA-02. Joint Seal Damage (Sample Unit No. 02).
