# Lamoni Municipal Airport

## Pavement Management Report

**AUGUST 2025**

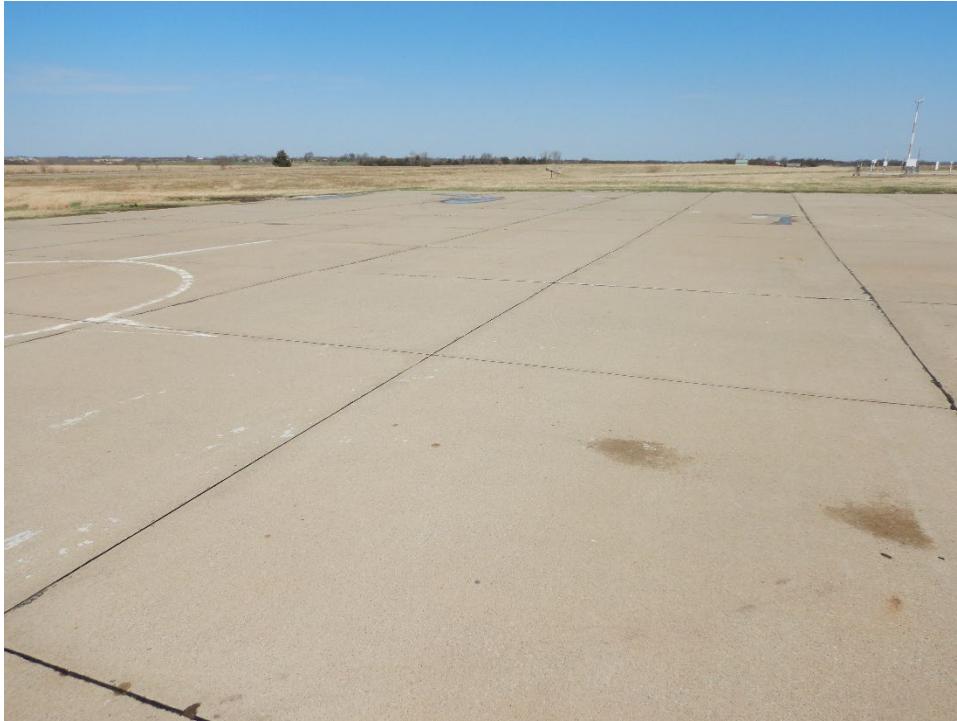
The apron area consisted of one section that was located between Taxiway 01 and the T-hangar area. In Section 01, low-severity ASR, low- and medium-severity faulting and LTD cracking, high-severity joint seal damage, all severities of joint spalling, pumping, and shrinkage cracking were recorded.

A01LA-01. Overview.

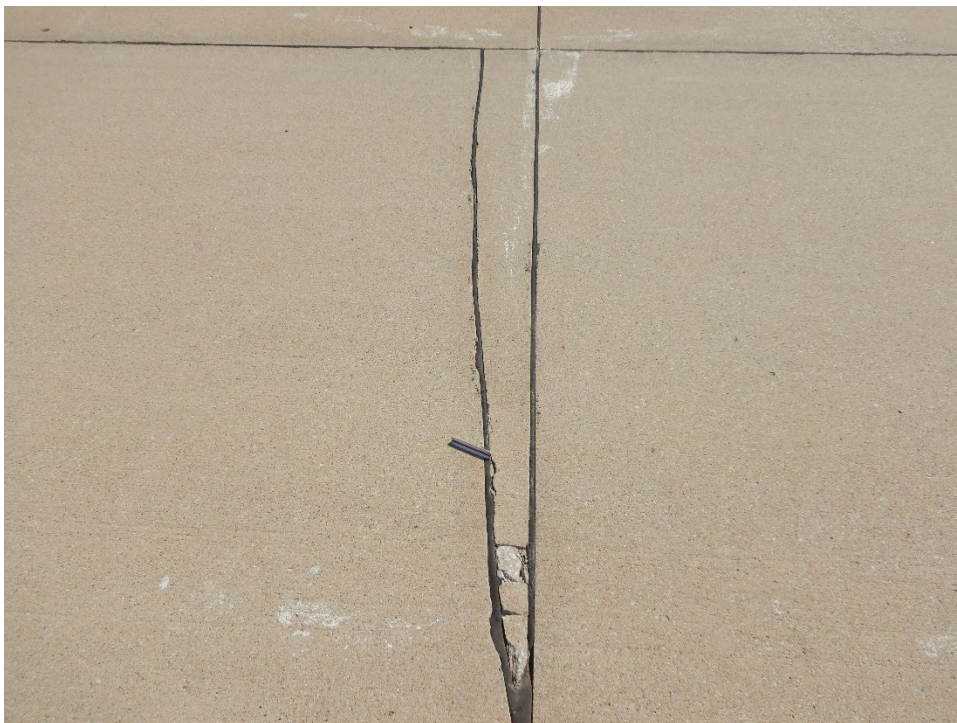
A01LA-01. Joint Spalling (Sample Unit No. 02).

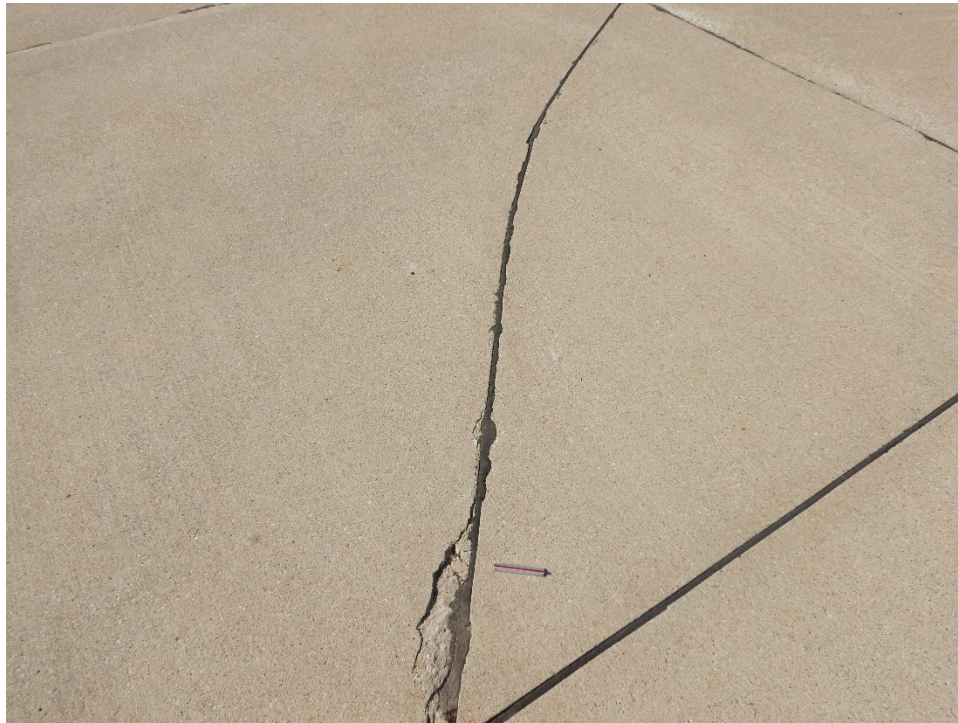
A01LA-01. LTD Cracking (Sample Unit No. 02).

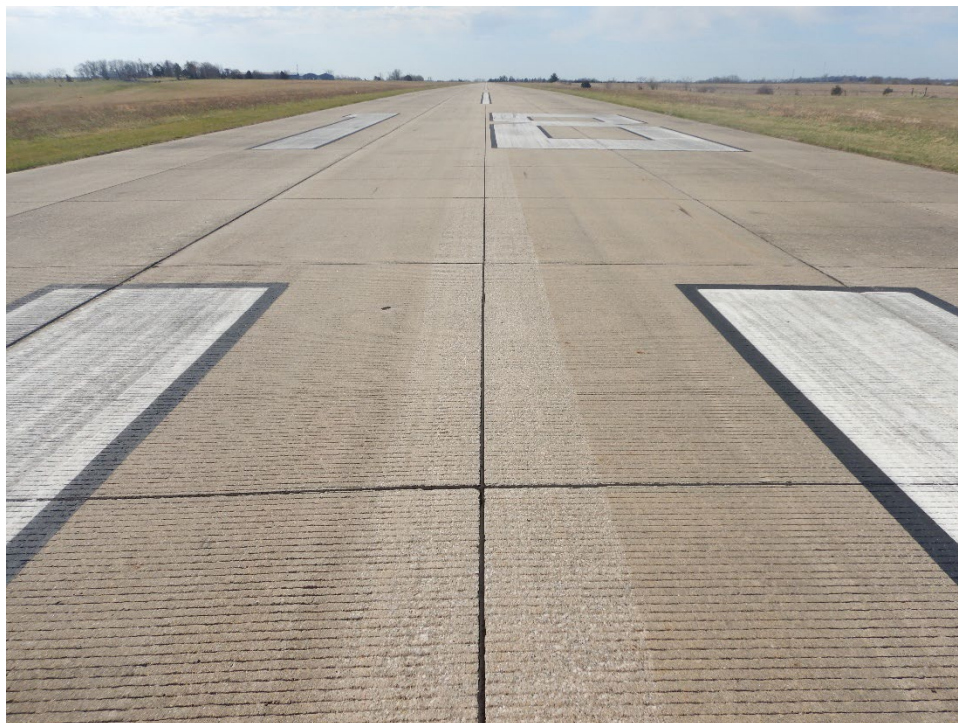
Runway 18/36 consisted of two sections. Low- and medium-severity corner spalling, joint spalling, and faulting; medium- and high-severity joint seal damage; and low-severity longitudinal, transverse, and diagonal (LTD) cracking were observed in Section 01. Section 02 had areas of medium-severity joint seal damage; low-severity joint spalling, LTD cracking, and shattered slab; and shrinkage cracking.

R18LA-01. Overview.

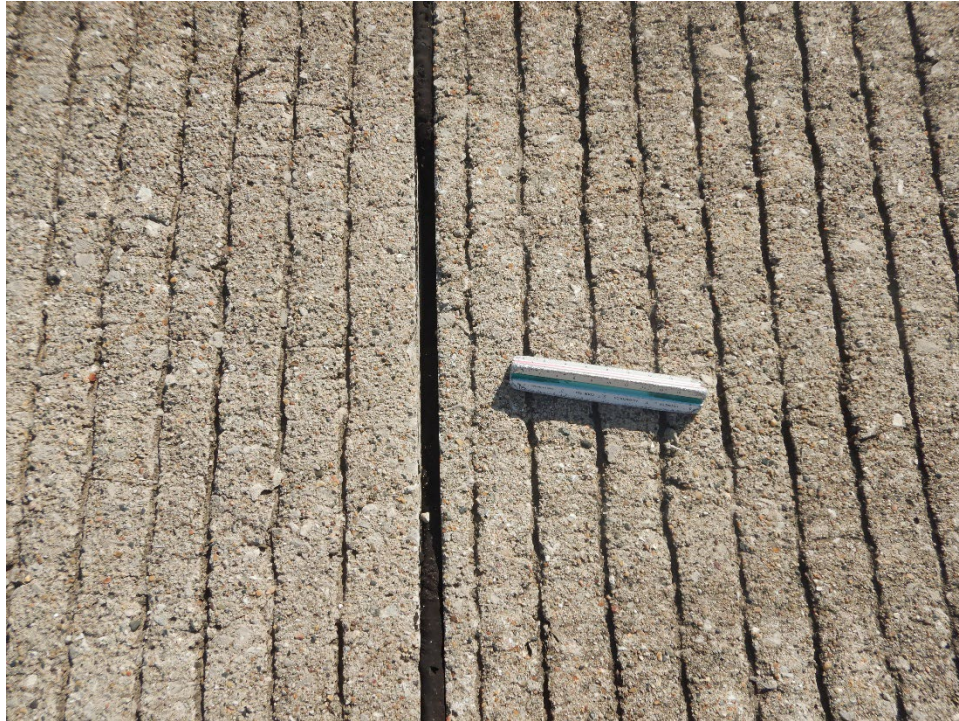
R18LA-01. Joint Seal Damage (Sample Unit No. 05).

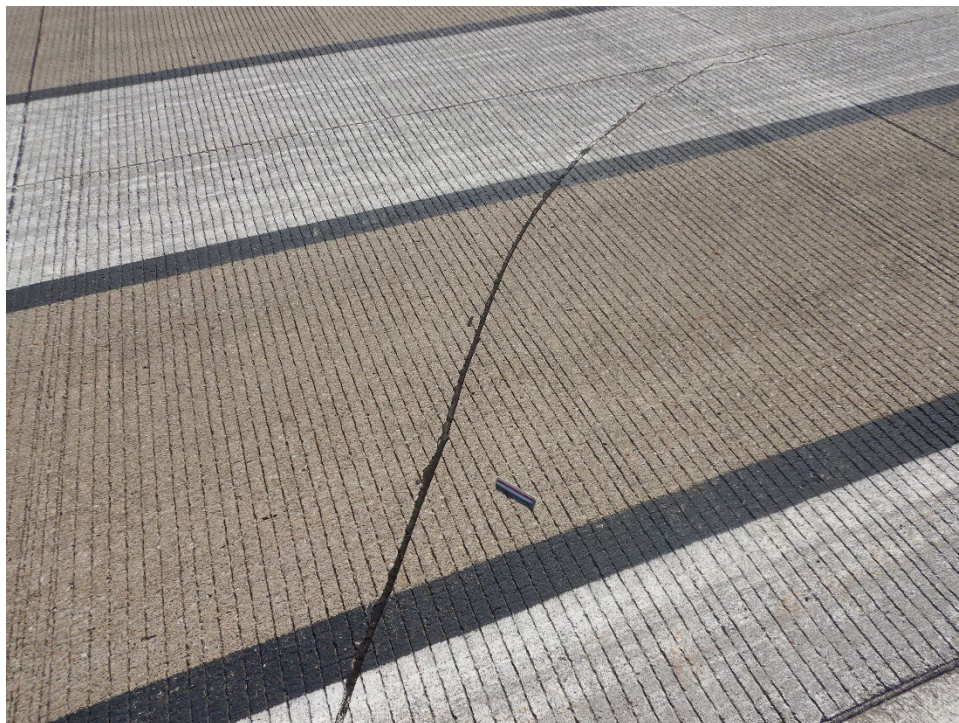
R18LA-01. LTD Cracking (Sample Unit No. 05).

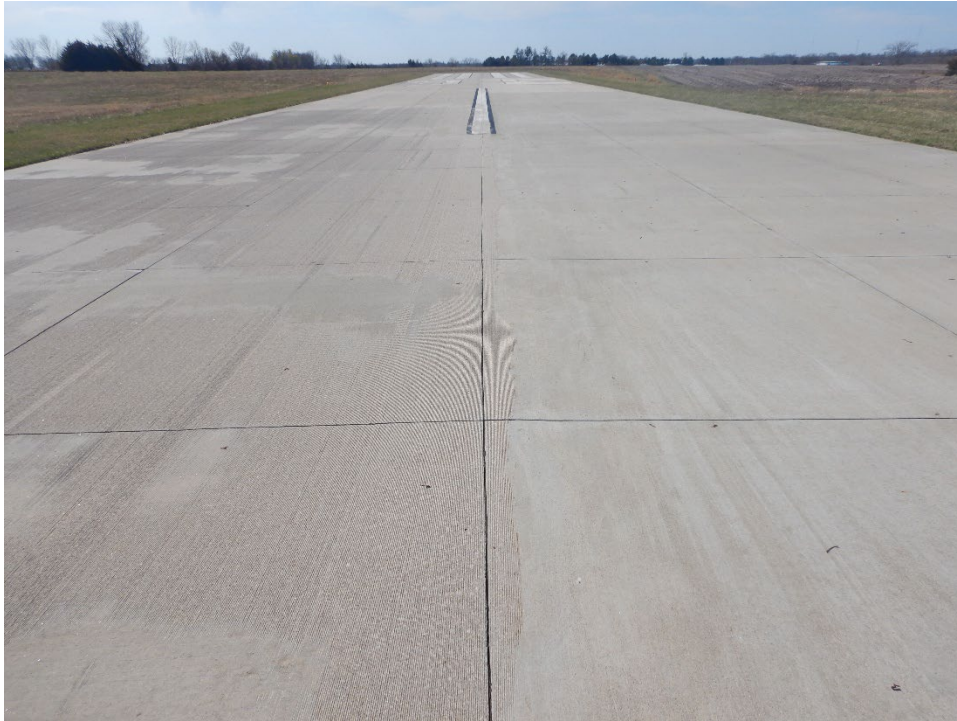
R18LA-02. Overview.

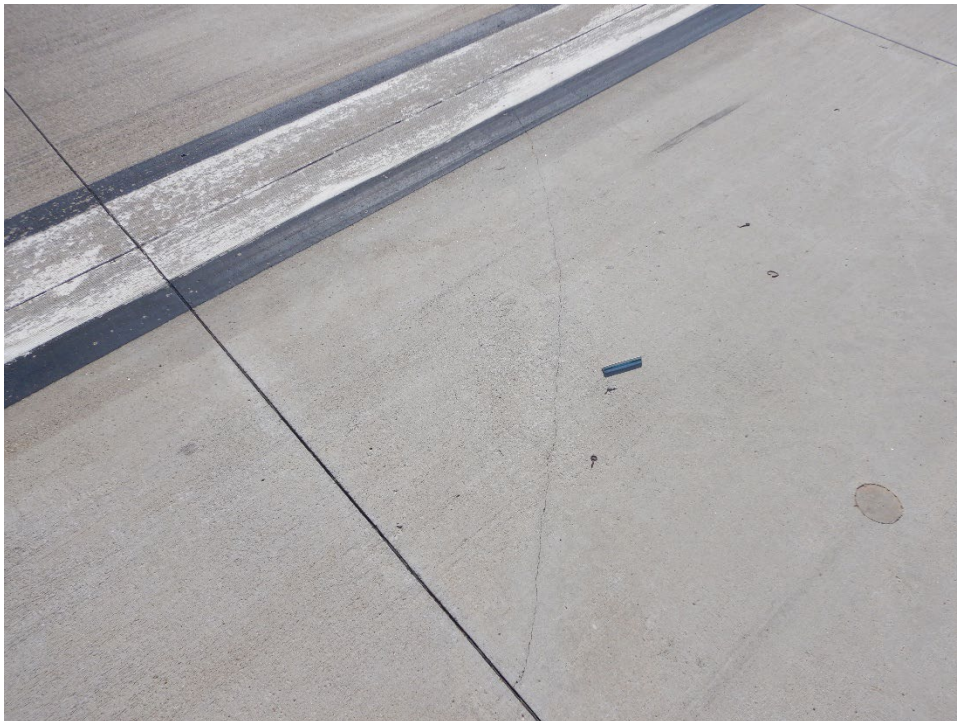
R18LA-02. LTD Cracking (Sample Unit No. 03).

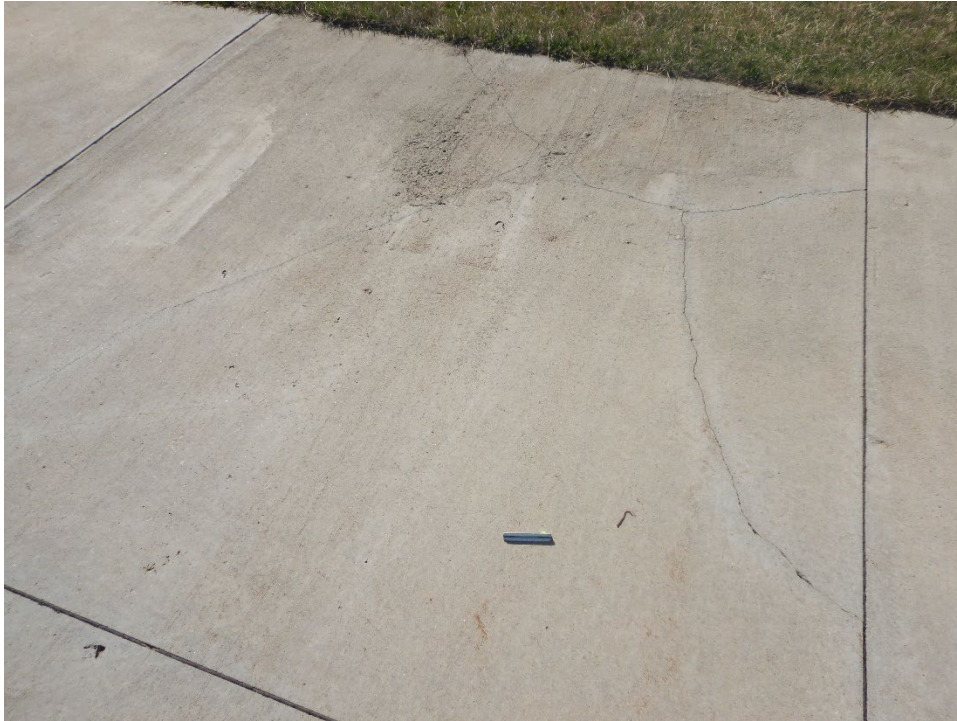
R18LA-02. Shattered Slab (Sample Unit No. 13).

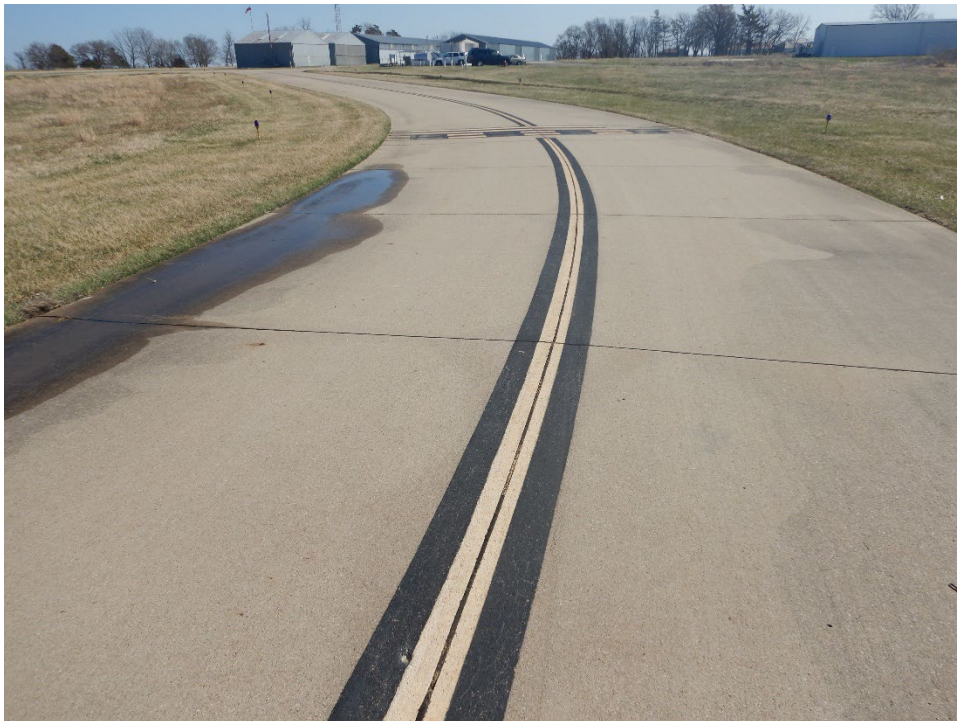
Taxiway 01 was defined by one section, which contained high-severity joint seal damage and low-severity ASR and faulting.

T01LA-01. Overview.

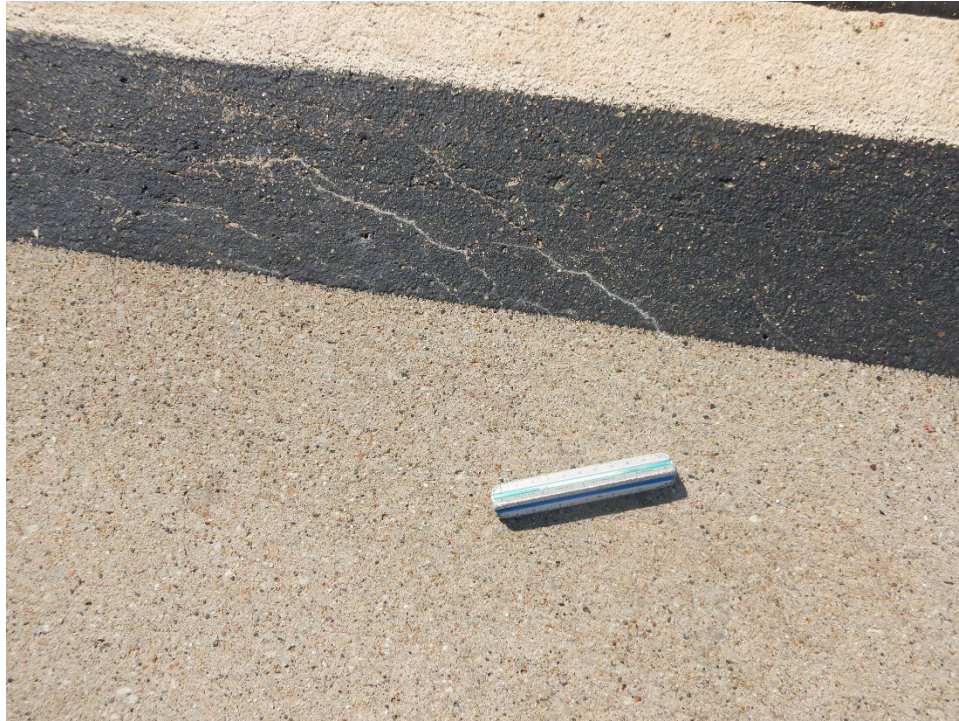
T01LA-01. ASR (Sample Unit No. 02).

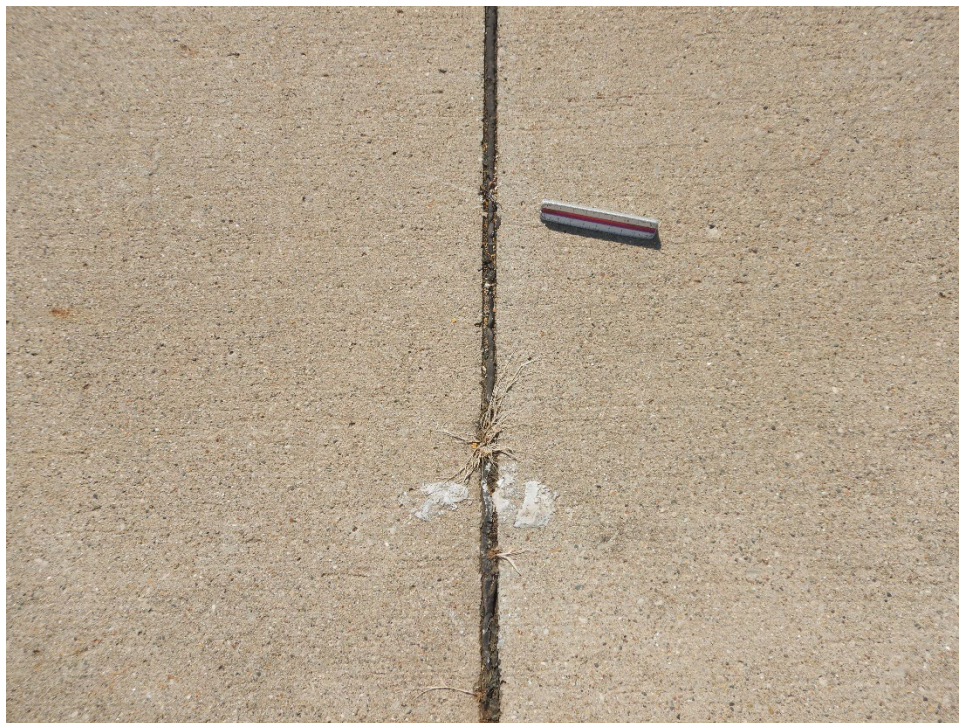
T01LA-01. Joint Seal Damage (Sample Unit No. 02).

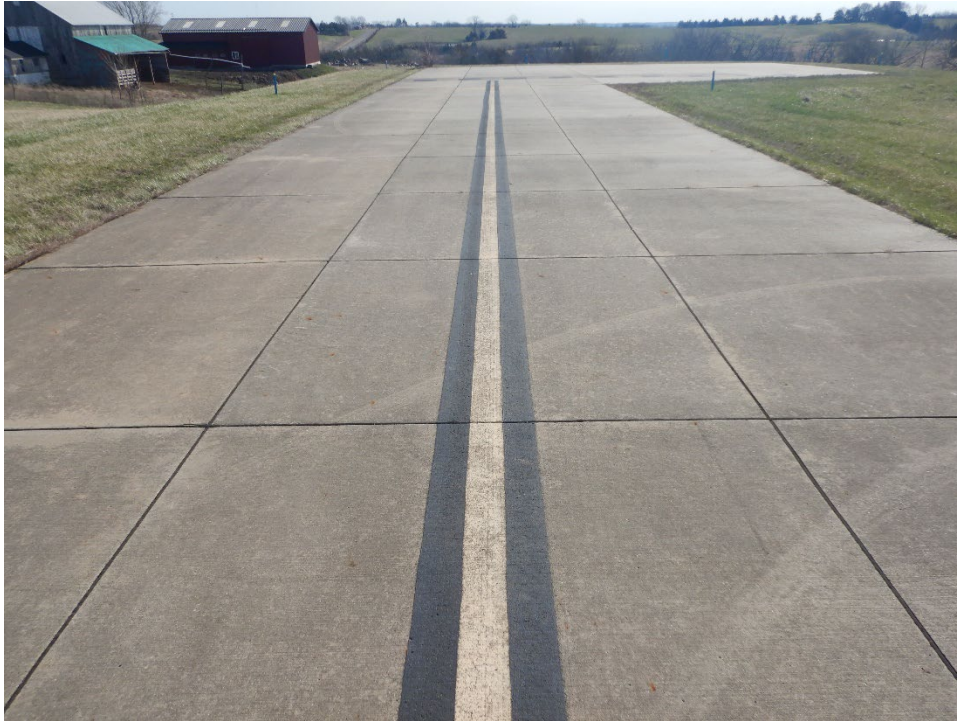
Taxiway 02 contained one section that only had medium-severity joint seal damage.

T02LA-01. Overview.

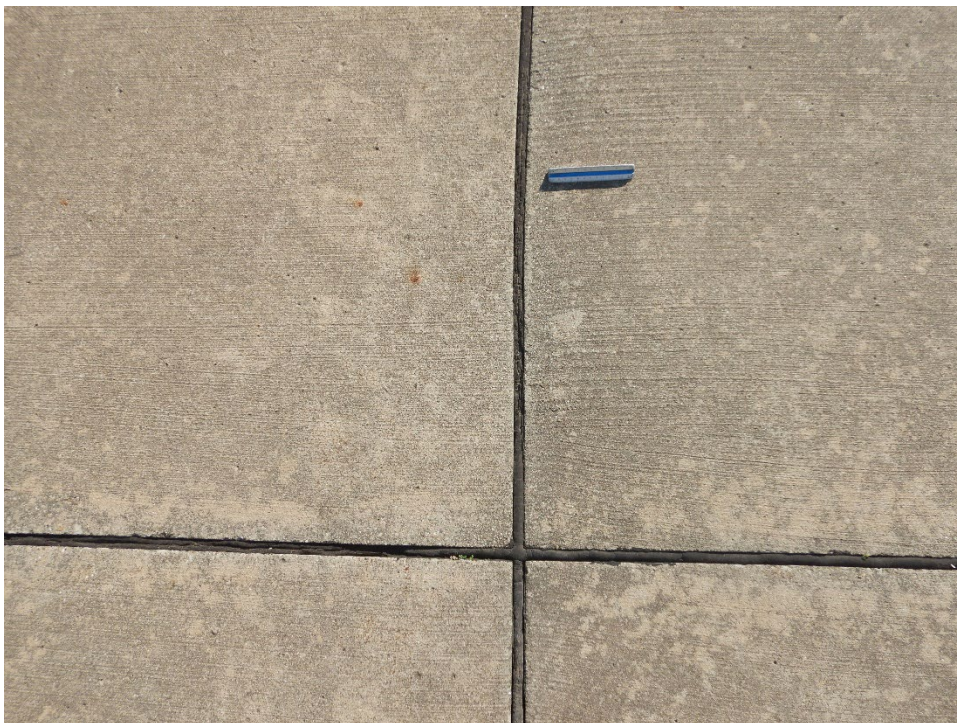
T02LA-01. Joint Seal Damage (Sample Unit No. 01).

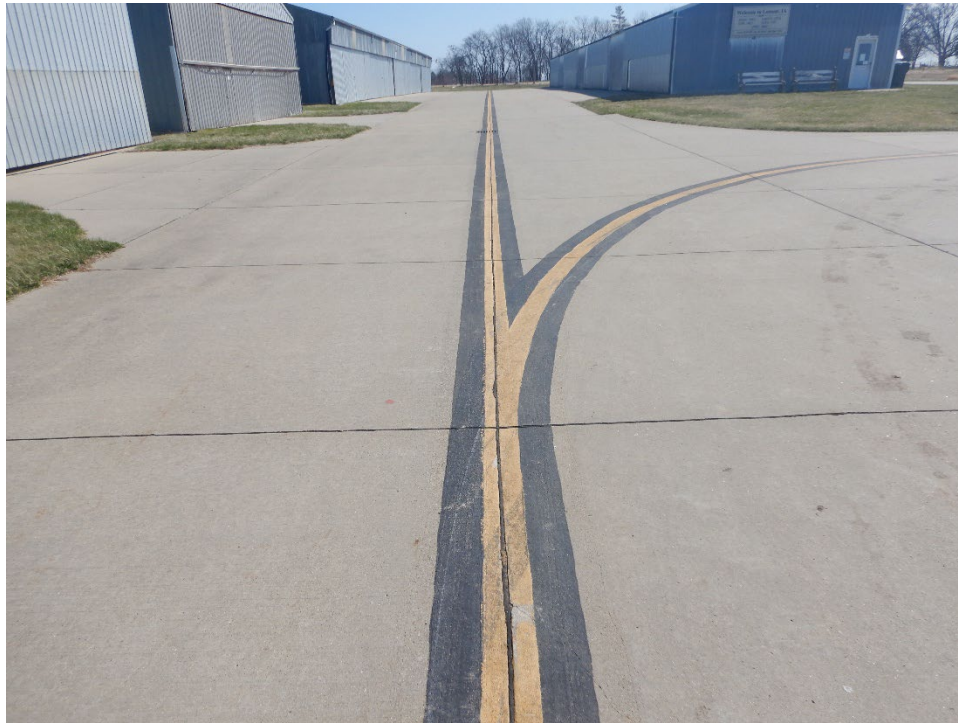
The T-hangar area was comprised of three sections. Section 01 had low-severity ASR and corner break, low- and medium-severity corner spalling and joint spalling, all severities of faulting, and high-severity joint seal damage. An atypical area of low- and medium-severity LTD cracking was observed and recorded as an additional sample unit in accordance with ASTM D5340. Section 02 contained medium-severity joint seal damage, low-severity joint spalling, and shrinkage cracking while Section 03 was recently constructed and was in *Excellent* condition with no distress noted at the time of inspection.

TH01LA-01. Overview.

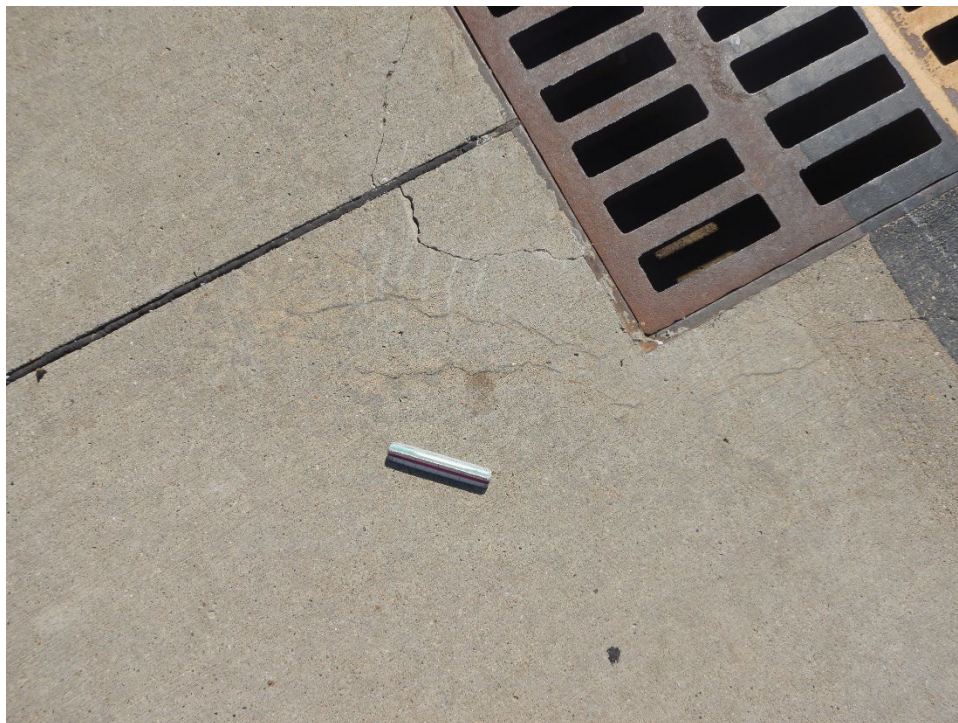
TH01LA-01. ASR (Sample Unit No. 01).

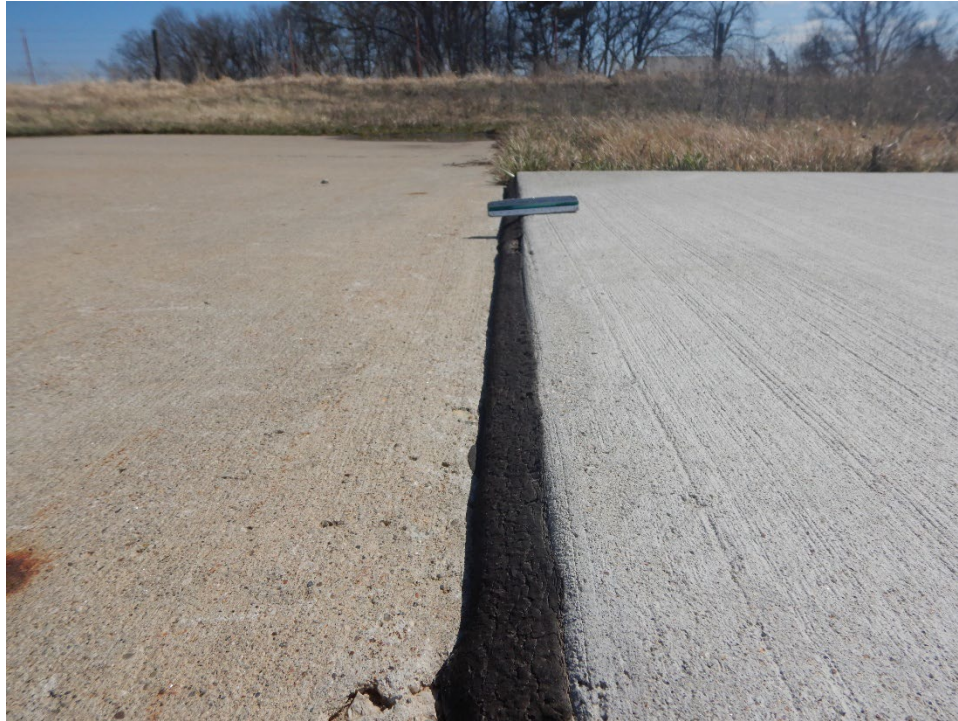
TH01LA-01. Faulting (Sample Unit No. 10).

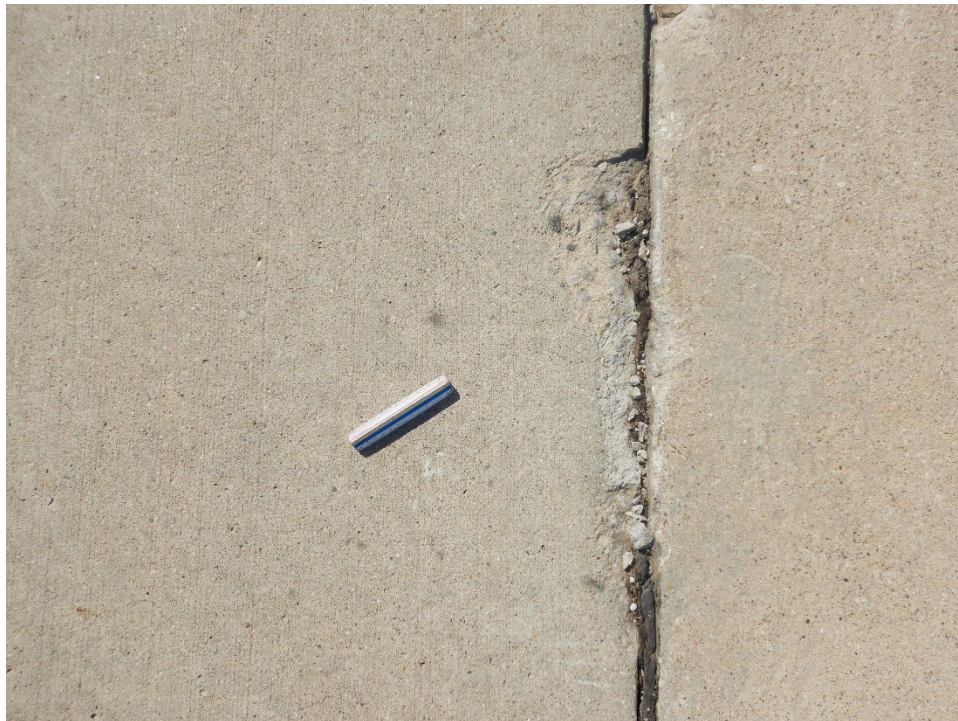
TH01LA-01. Joint Spalling (Sample Unit No. 01).

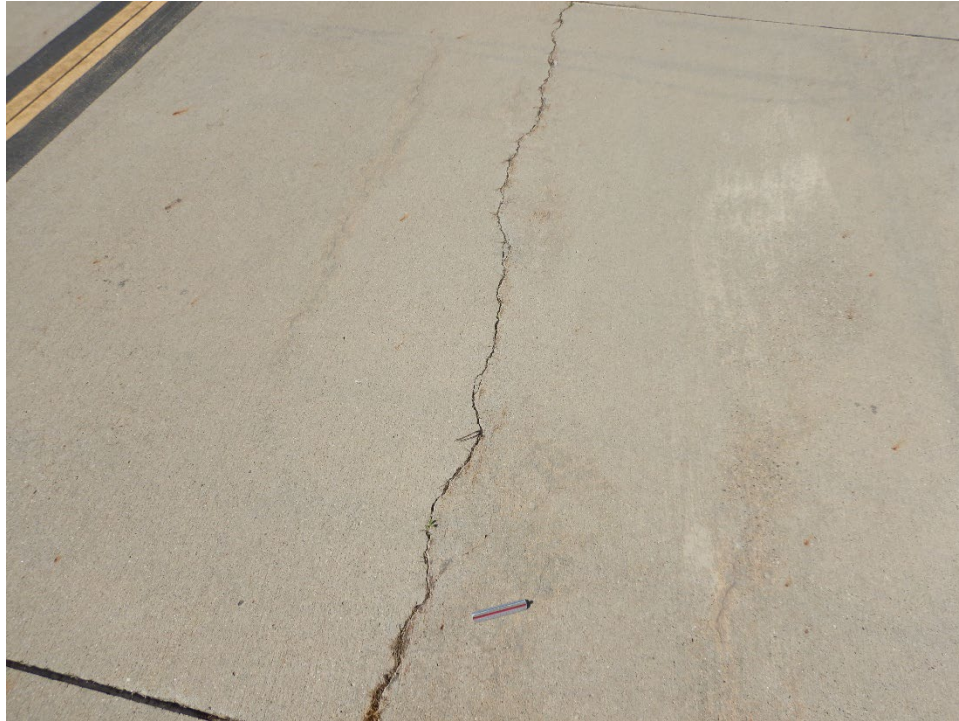
TH01LA-01. LTD Cracking (Additional Sample Unit No. 07).

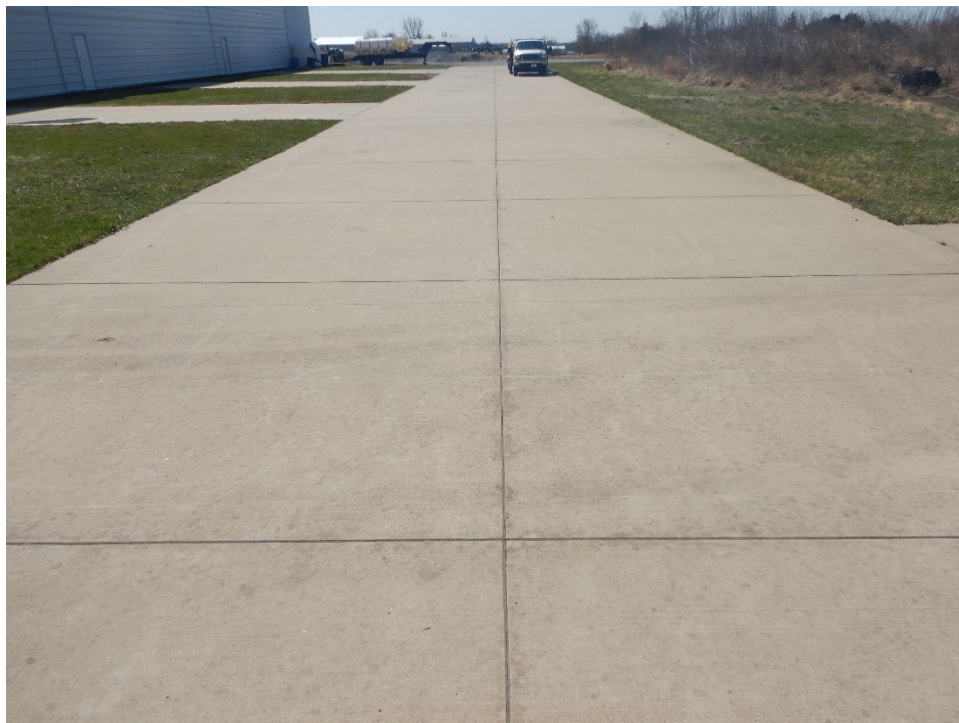
TH01LA-02. Overview.

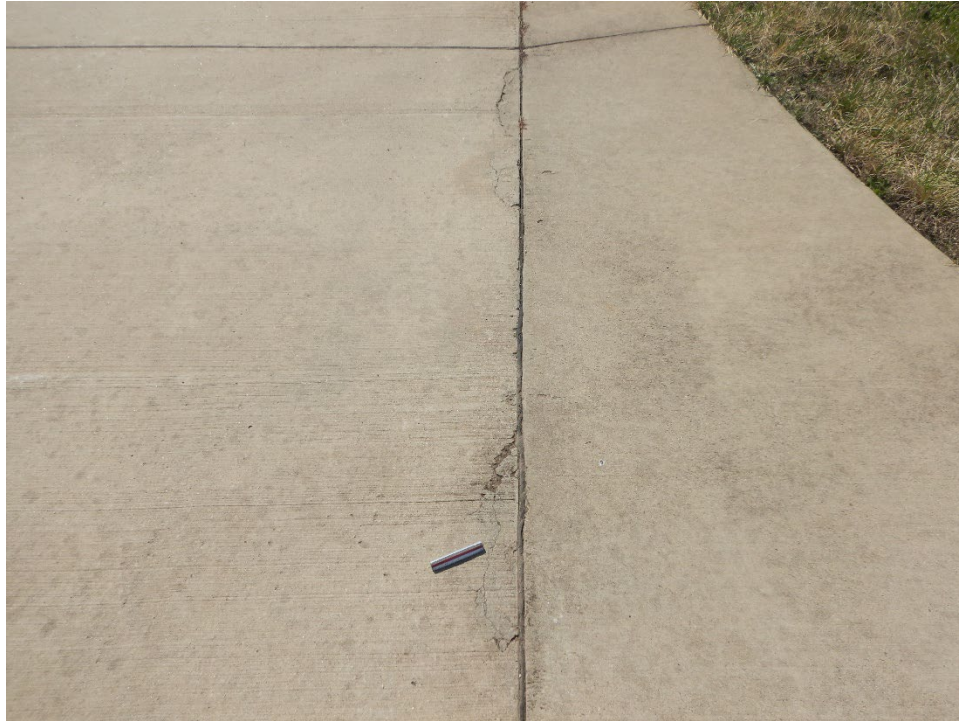
TH01LA-02. Joint Spalling (Sample Unit No. 01).

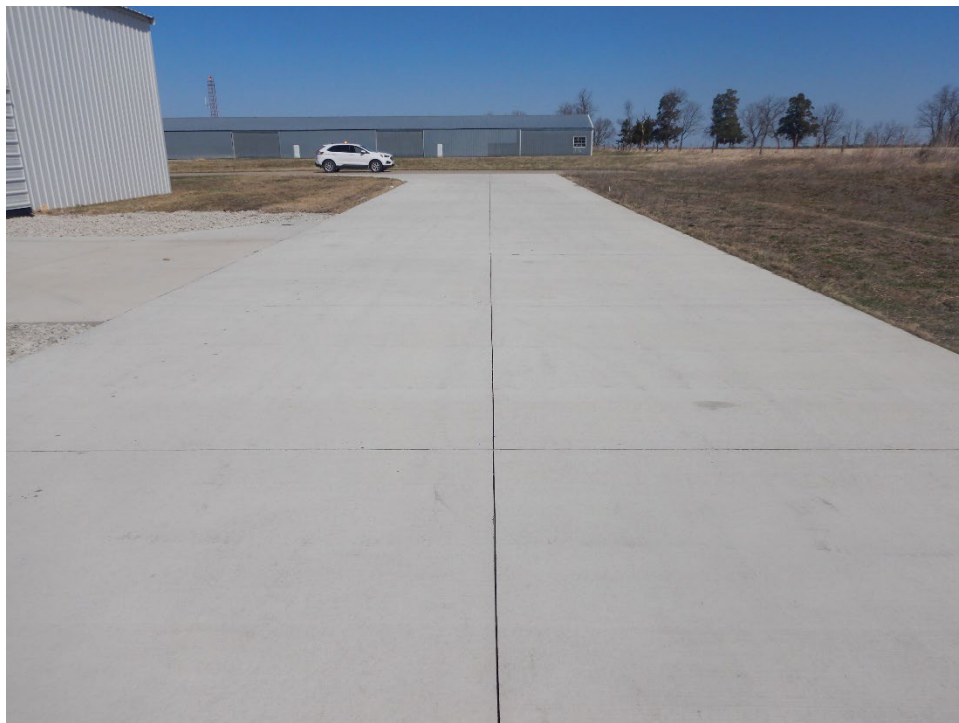
TH01LA-03. Overview.
